**APAE-110**

# **SM-1 reactor vessel closure stud investigation**

By  
D. L. Reali

Issued: March 23, 1962

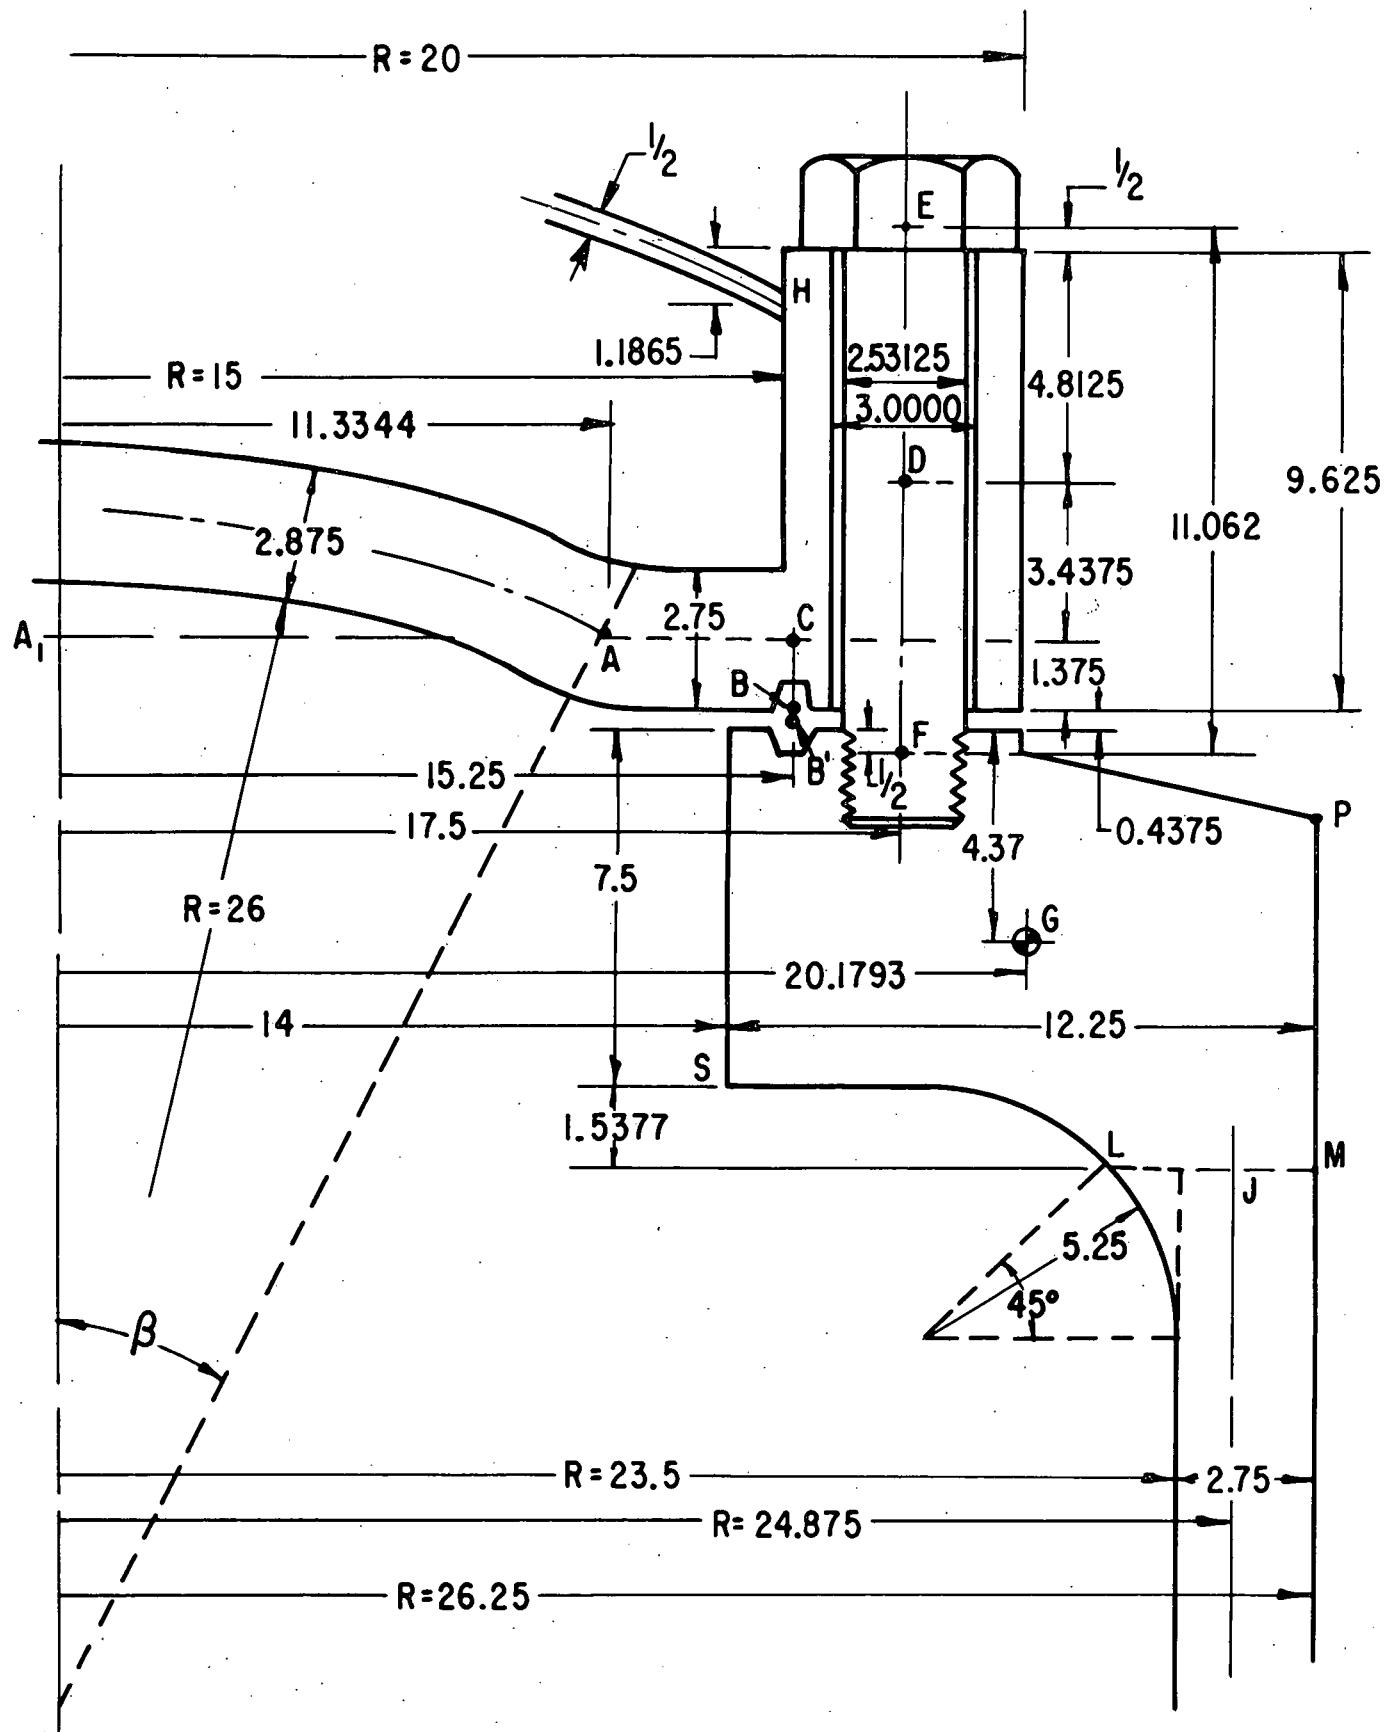
Figure 1. SM-1 Reactor Vessel Cover, Flange and Stud Region

The reactor vessel serves the purpose of containing the active core, its supporting structure, and the thermal shielding. The basic material of construction is A-212 carbon steel plate clad with 1/4 in. Type 304 stainless steel. The upper end of the vessel is closed by a bolted and gasketed dished cover, 2-3/4 in. thick, made of A-212 Grade B carbon steel clad with Type 304 stainless steel. The 2-3/4 in. hexagonal nuts were made from Type 304 stainless steel. The bolt holes in the cover were nickel plated.

STUD STRESSES PSI IN SECTION AT POINT "F" (REF. FIG. 1)  
( BOTTOM THREADED PORTION )

<u>Loading</u>	<u>Direct</u>	<u>Bending</u>	<u>Combined at</u>	
			<u>Left</u>	<u>Right</u>
Case A	12590T	6,450	19,040 T	6,140 T
Case B	13500T	4,570	18,070 T	8,930 T
Case C	19800T	7,380	22,420 T	27,180 T

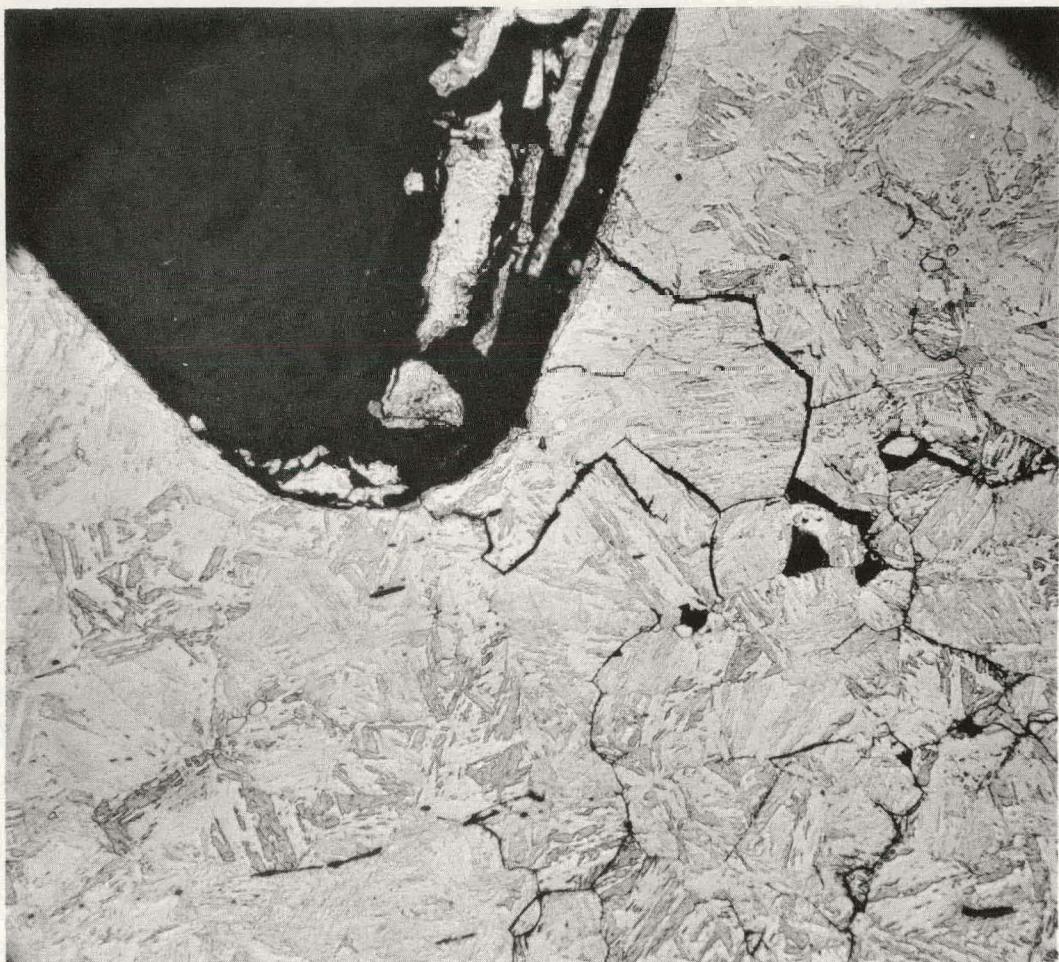
Figure 2. Intergranular Cracking in Thread of Failed SM-1 Reactor Vessel Stud "A". Rockwell Hardness C-38

All the samples examined revealed a microstructure of tempered martensite. Studs A and B were examined metallographically to determine the nature of the longitudinal and circumferential indications. In all the areas observed, the indications were found to be intergranular cracks. A typical circumferential is shown in Fig. 2 at 250 x magnification.

The threaded area of Stud 6, which included a circumferential indication, was sectioned for examination. The indication proved to be an intergranular crack, similar to that found in the failed studs.

The cracking found in the SM-1 studs was identified as stress corrosion cracks after metallographic examination of the failed areas. The intergranular path and the discontinuous nature of the crack propagation were typical of stress corrosion cracking in martensitic stainless steels.

1. Failure of the two Type 410 stainless steel reactor vessel studs was caused by stress corrosion cracking.
2. The cracks found in 12 of the 14 remaining studs removed from the reactor vessel were caused by stress corrosion cracking.
3. For this application, Type 410 stainless steel is susceptible to stress corrosion cracking at hardness values of Rockwell "C" 26 (260 B.H.N.) and higher. Studs having hardness values of Rockwell "C" 21 (235 B.H.N.) should be expected to perform satisfactorily.
4. Improper control of the heat treatment of the studs and the absence of stress relief treatment after the thread grinding operation were contributing factors to the failure of the SM-1 studs.

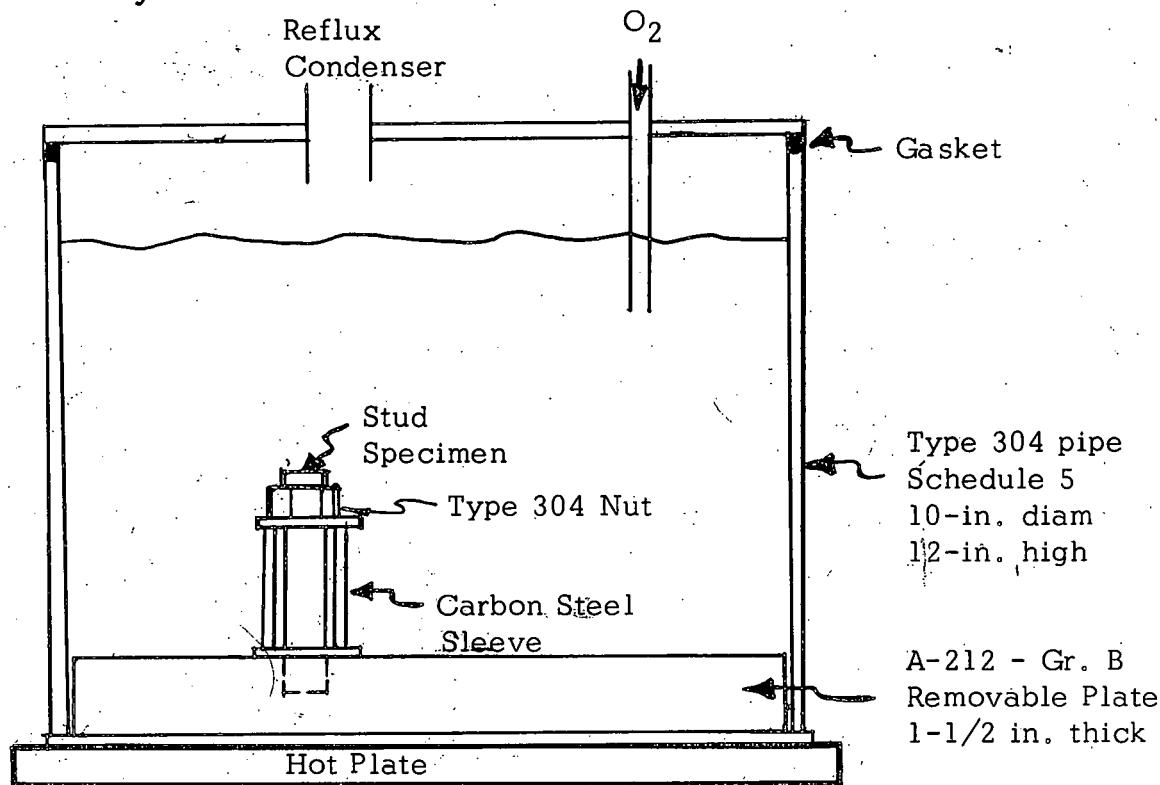
Figure 3 - CORROSION TEST APPARATUS

A corrosion test apparatus (Fig. 3) was designed and assembled in an attempt to duplicate in the laboratory the type of failure experienced by the reactor studs.

The carbon steel plate contained 13 tapped holes to accommodate the corrosion test specimens, which were miniature replicas of the reactor studs, scaled down to one-fourth of actual size. The dimensions of the specimens were as follows:

By employing a carbon steel sleeve and a Type 304 stainless steel nut, it was possible to stress the specimens to any designated level. The stress was calculated by measuring with a height gauge the distance the stud specimen elongated.

The carbon steel plate was removable so that corrosion in the female threads could be studied. With the water at boiling temperature, the threaded areas in the carbon steel plate would be a somewhat higher temperature, duplicating more closely the conditions in the reactor vessel body.

In addition to evaluating the variables (hardness and stress level), for which it was designed, the corrosion test used in this investigation would be applicable for evaluating the relative susceptibilities of various alloys to stress corrosion cracking for use as bolting material in a reactor vessel environment.

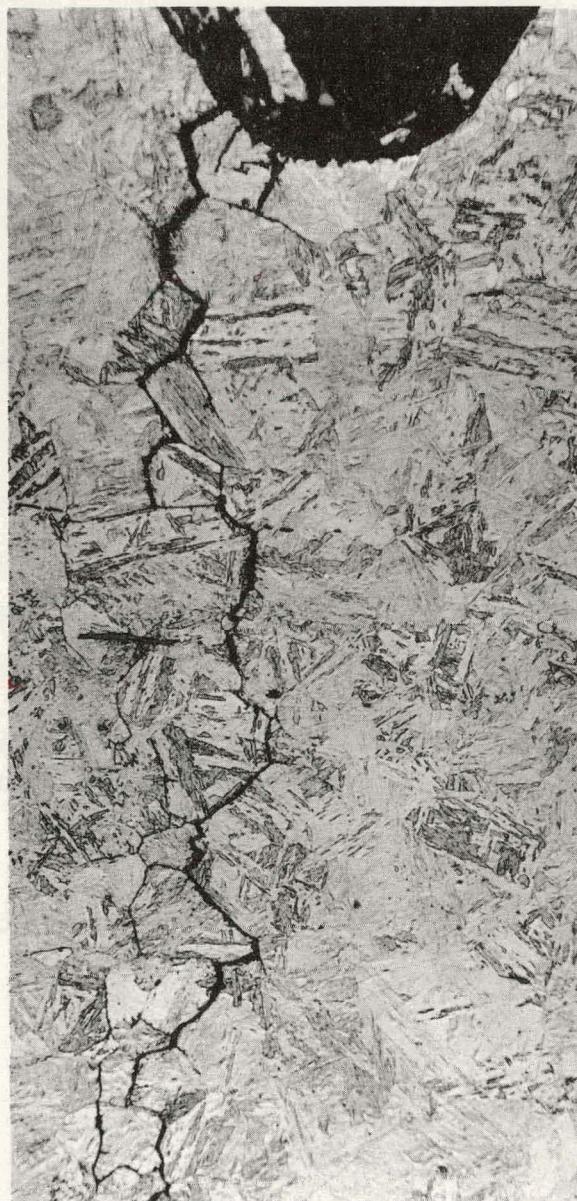
Figure 4. Intergranular Cracking in Thread of Laboratory Specimens 16E  
After 1000 Hr at 30000 psi and 1000 Hr at 58,000 psi.  
Rockwell Hardness C-40

The 13 stud specimens were magnetic particle inspected; no cracks were found. In order to verify the results of the magnetic particle inspection, a metallographic examination was made of stud 16E. Specimen 16E was selected for examination, since it was the stud most likely to be cracked, by virtue of its high hardness (40 R<sub>c</sub>) and high stress level (1000 hrs. at 30,000 psi. plus 1000 hrs. at 58,000 psi). Longitudinal and transverse areas of both the nut end and the plate end of this specimen were examined. The results of the metallographic examination revealed that intergranular cracking had occurred circumferentially at the last engaged thread of the nut end.

All the cracks were intergranular and all were found at the last engaged thread on the nut end of the specimens. It can be seen from the above data, that the depth of cracking is roughly proportional to the time multiplied by the stress, at the Rockwell "C" hardness level.

Typical circumferential cracking similar to that observed in the reactor vessel studs is shown in Fig. 4.

The results of the laboratory corrosion tests, which were conducted on specimens of Type 410 stainless steel taken from the actual SM-1 studs, demonstrated how susceptibility to stress corrosion cracking is affected by hardness level of the material. Specimens having hardnesses of Rockwell "C" 20, 26, 31, and 40 were tested; only Rockwell "C" 40 specimens were found to be cracked after 2000 hr of testing. For these tests, the hardness proved to be more critical than the stress level or the time of testing. This is evidenced by the fact that the Rockwell "C" 40 specimen 16C (1000 hr at 30,000 psi or  $3 \times 10^7$  psi-hours) contained cracks, while the Rockwell "C" 31 specimen 11C (1000 hr at 30,000 psi and 1000 hr at 58,000 psi or  $8.8 \times 10^7$  psi-hours) did not crack.
