Report No. ACNP-6107

**PATHFINDER ATOMIC POWER PLANT**  
**NOZZLE GALLING TEST, FINAL REPORT**

DECEMBER 29, 1961

Submitted to  
**U. S. ATOMIC ENERGY COMMISSION**  
**NORTHERN STATES POWER COMPANY**  
and  
**CENTRAL UTILITIES ATOMIC POWER ASSOCIATES**  
by  
**ALLIS-CHALMERS MANUFACTURING COMPANY**  
**NUCLEAR POWER DIVISION**  
**Milwaukee 1, Wisconsin**

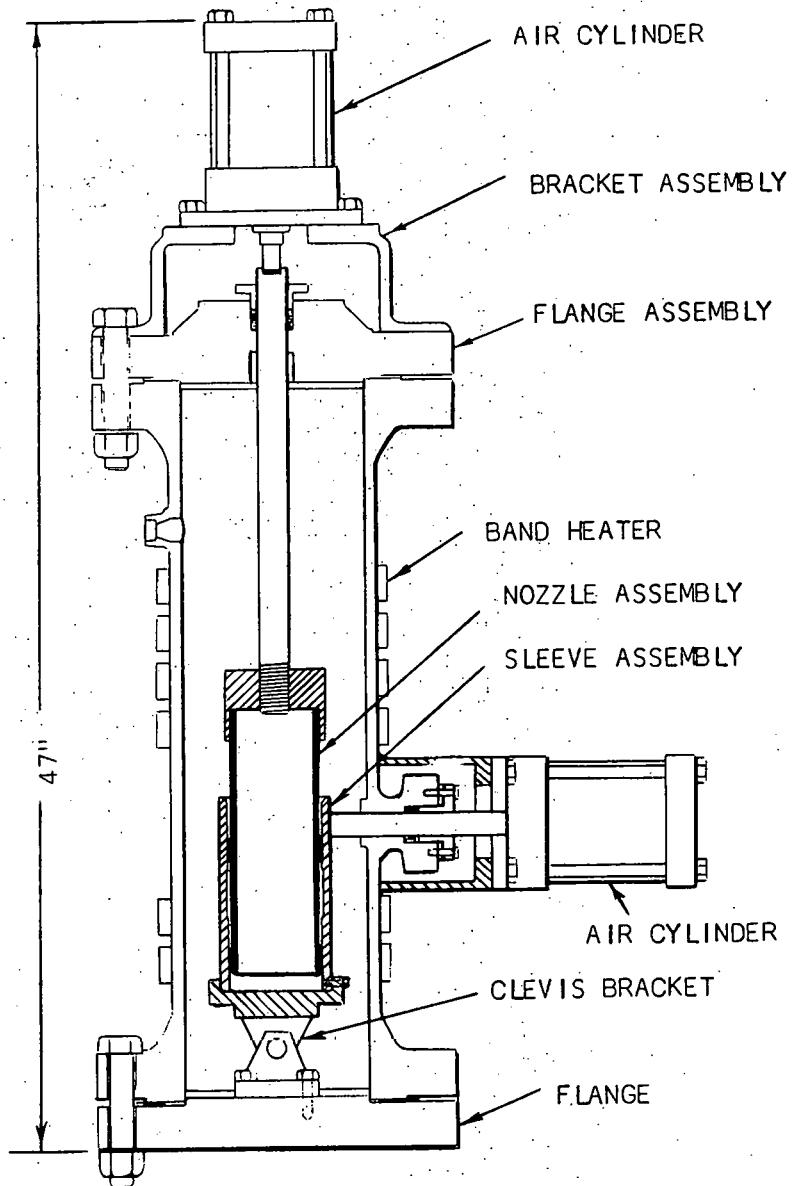
Figure 1. Nozzle-Galling Test Assembly.

The test apparatus (Figure 1 and 2) consists of an 8-in pipe with welded neck flanges and with blind flanges bolted to each end. On one end and on one side, 5-in dia. air cylinders are attached with shafts extending into the housing. The nozzle is attached to the shaft of the vertical cylinder, which moves the nozzle up and down, simulating motion due to temperature and flow fluctuations in the reactor. The sleeve is attached

to the lower blind flange by means of a clevis bracket. The horizontal cylinder provides a horizontal load on the sleeve simulating the condition where the nozzle and sleeve are not aligned.

Gages on the air supply lines and on the side of the test housing indicate pressure in the air cylinders and pressure vessel. The test is heated to reactor temperature and pressure by six 900-watt electrical band heaters. The test housing is surrounded by 2-1/2-in thick insulation, which is not shown. The interior of the carbon steel housing is coated with sprayed aluminum to reduce corrosion at high temperatures.

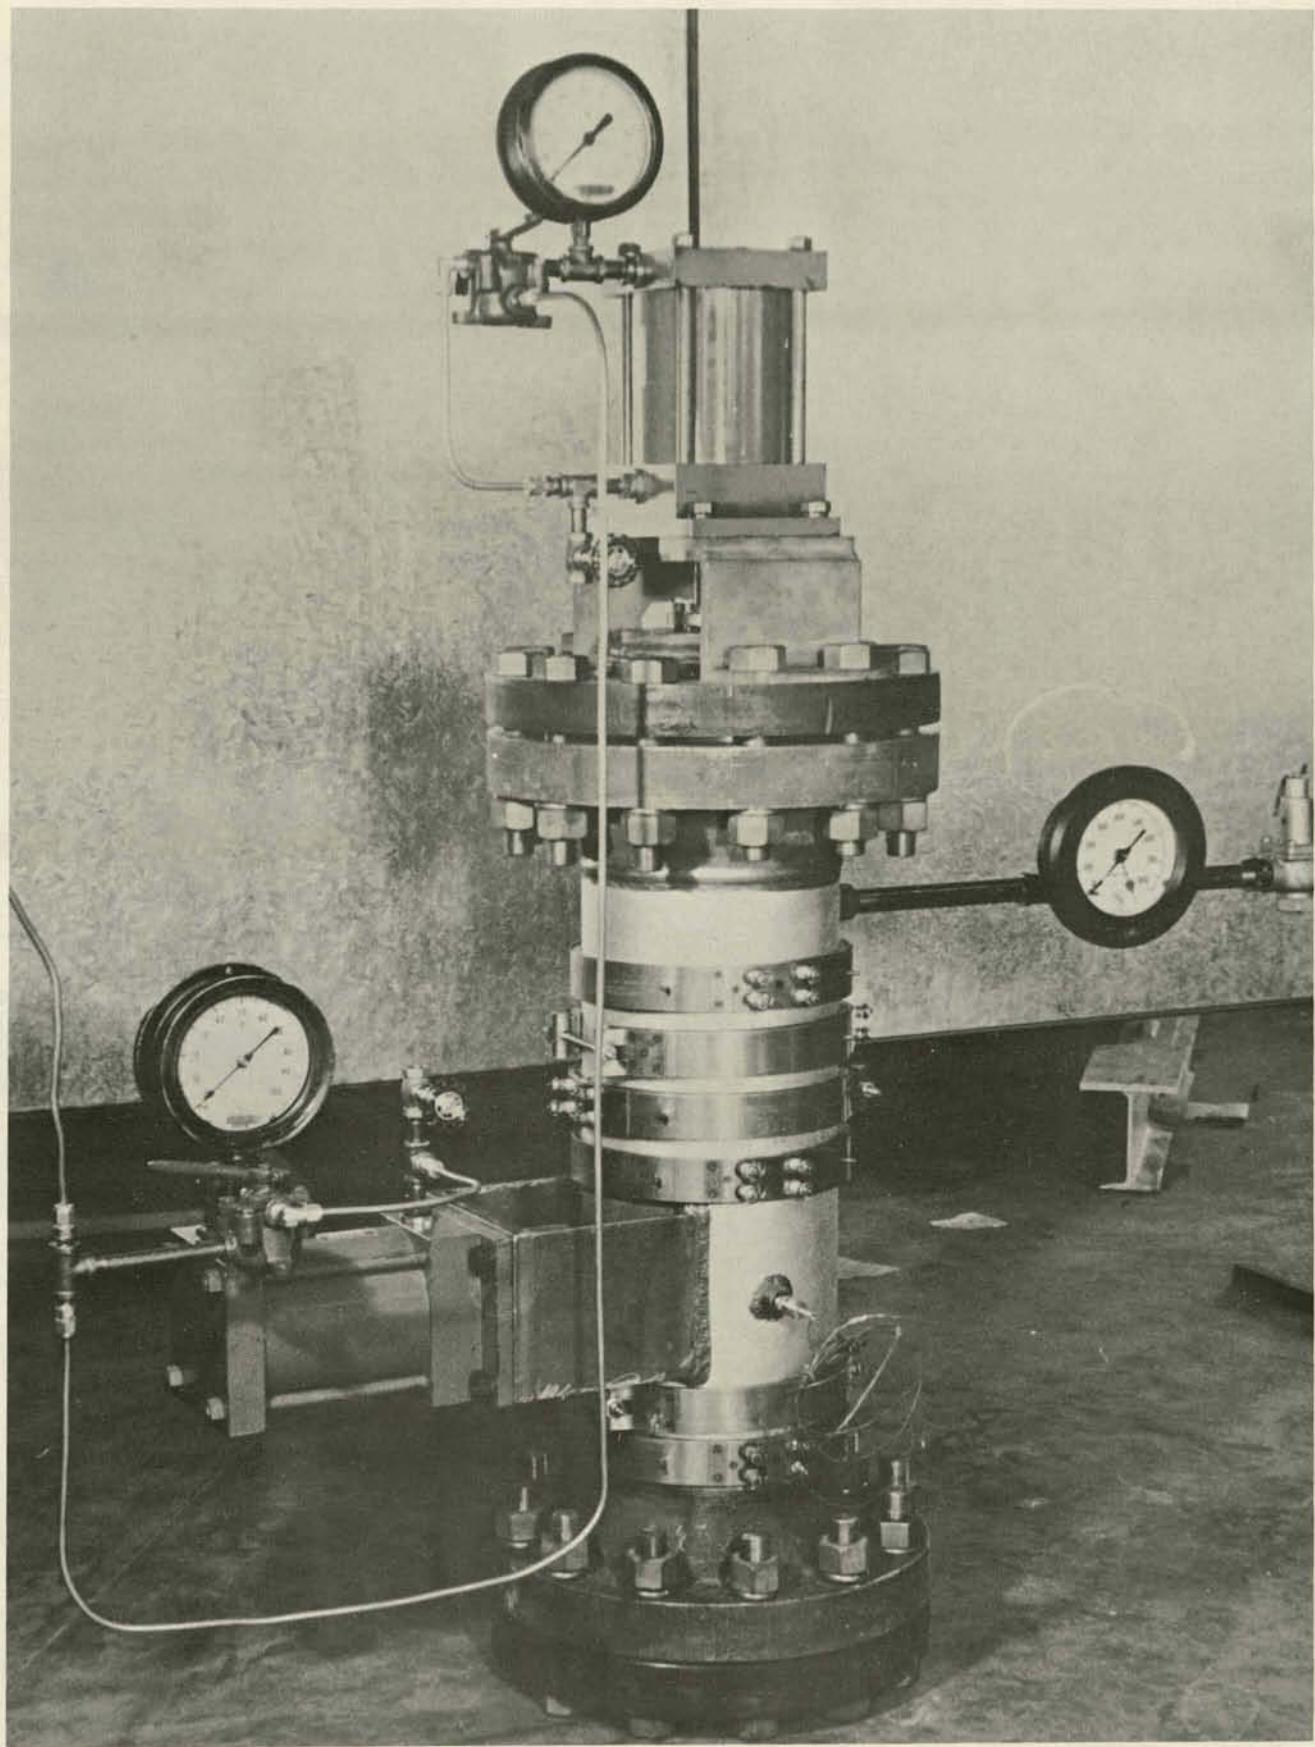
Figure 2. Nozzle-galling test assembly.

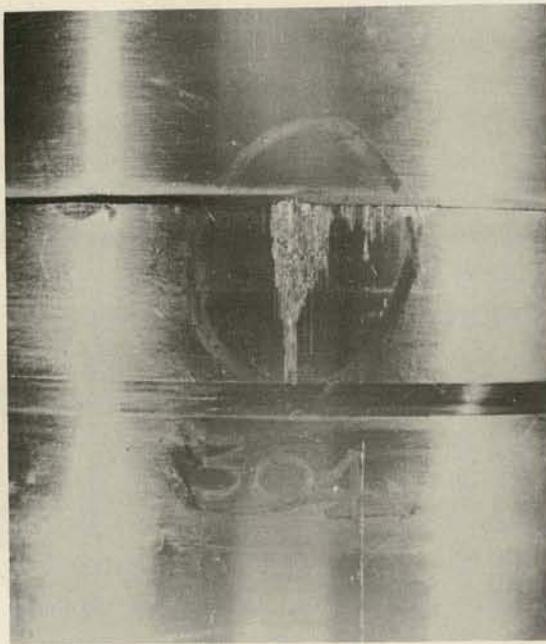
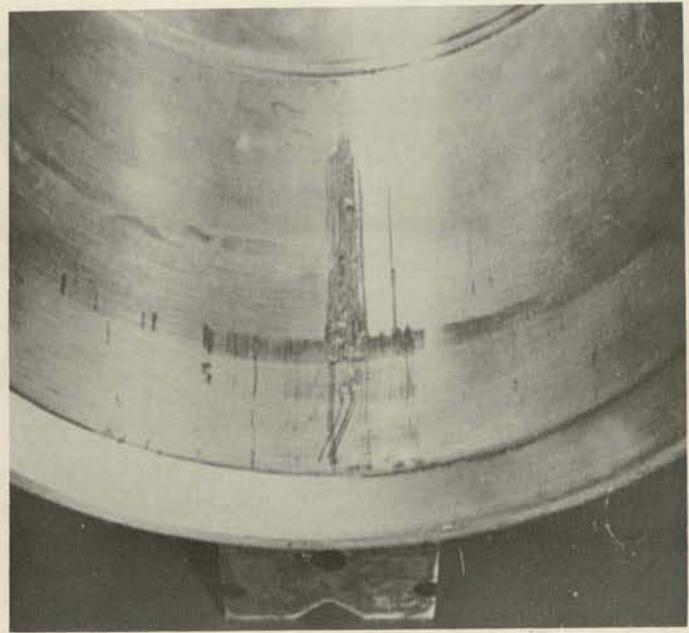
Figure 3. Test 1 - 304 stainless steel nozzle (left) and 304 stainless steel sleeve (right) after galling test with no horizontal load. (NP Photo 18A-5, -10)

Severe galling was noted on both nozzle and sleeve (Figure 3) when the test was disassembled. Although the test had been intended only as a test of the test apparatus, the galling was so severe that no further test of 304 stainless steel was made.

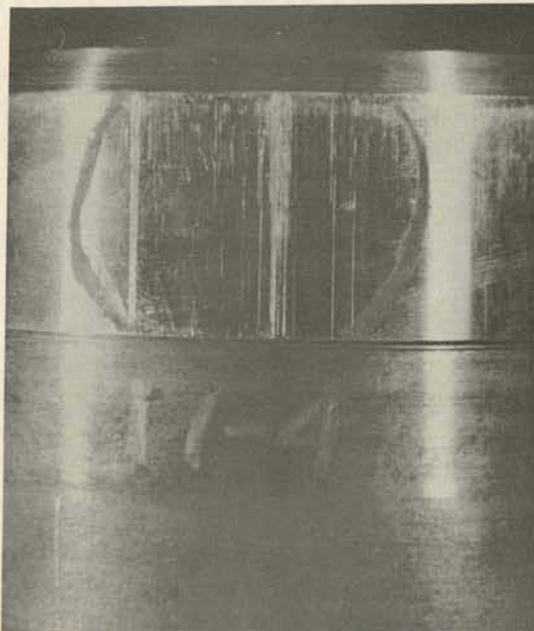
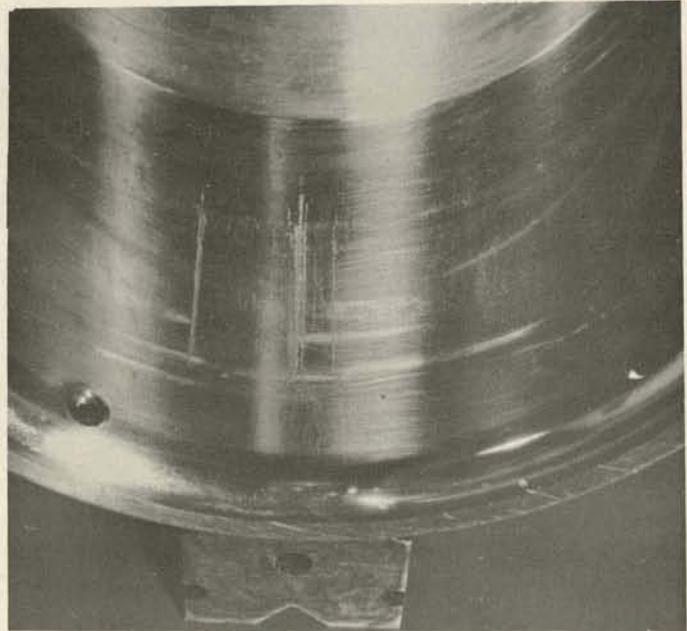
Figure 4. Test 2 - 17-4PH stainless steel nozzle (left) and 304 stainless steel sleeve (right) after galling test with no horizontal load. (NP Photo 18A-7, -9)

When the test was disassembled, the nozzle and sleeve were both slightly marred. The marring appeared to consist of scratches rather than galling in that no metal was picked up by either nozzle or sleeve (Figure 4).

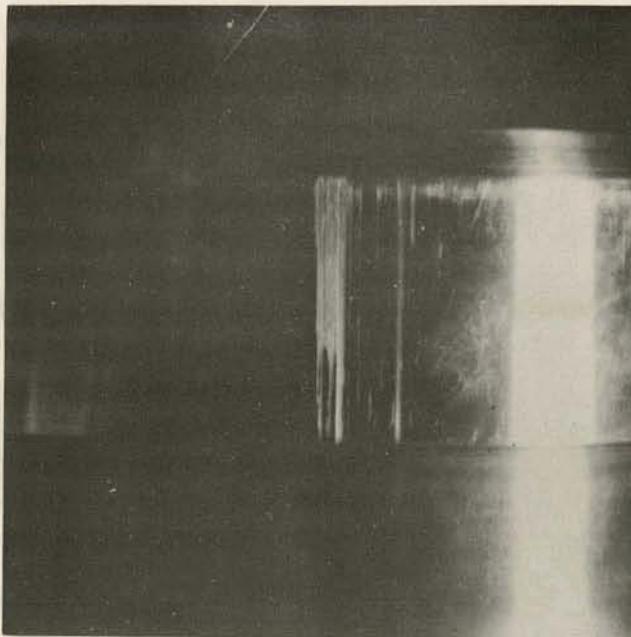
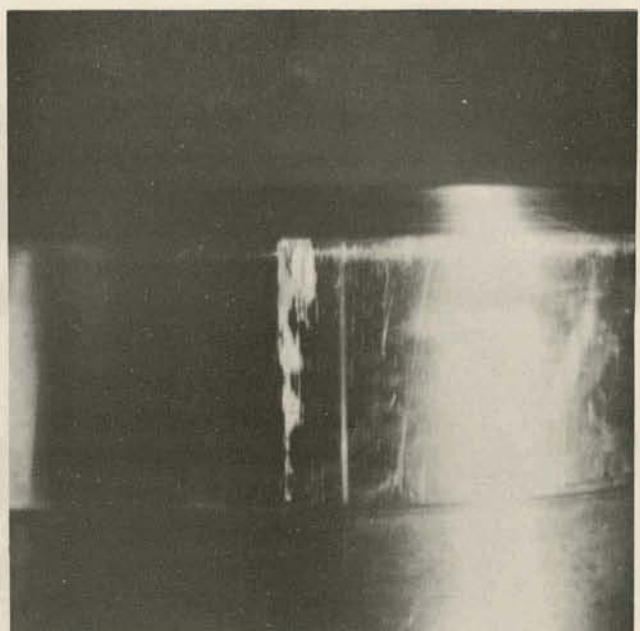
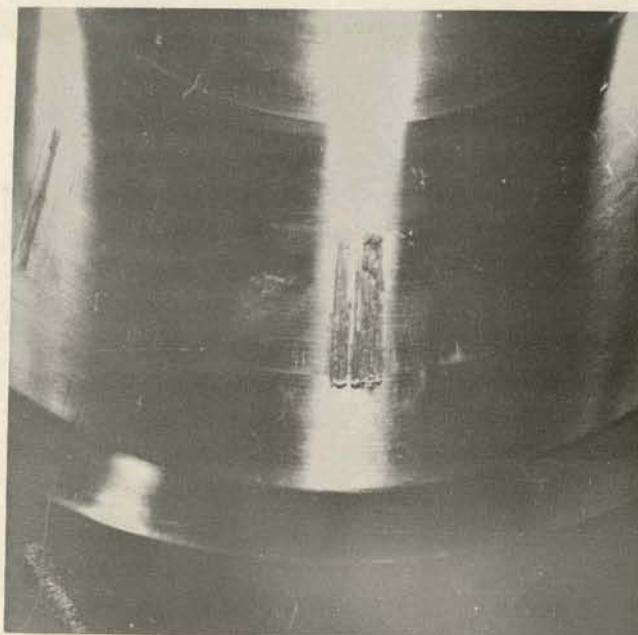
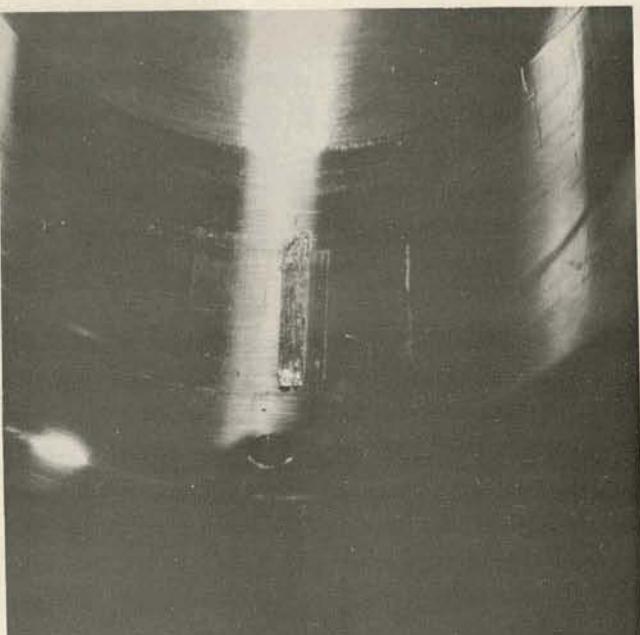
Figure 5. Test 2 - 17-4PH stainless steel nozzle (top) and 304 stainless steel sleeve (bottom) after galling test with 165-lb horizontal load. (NP Photo 18A-12, -13, -15, -16)

The nozzle and sleeve were then tested at 620 psi, 492 F. The nozzle was cycled 100 times with no horizontal force. The operating force leveled off to about 33 lb net downward force. A 165 lb net horizontal load was applied and the net force required to move the nozzle increased to 482 lb net on the third stroke and to 978 lb net on the fourth. The horizontal load was then reduced to 70 lb net and the operating force decreased to 592 lb net for the next six cycles. The horizontal load was removed entirely, and the nozzle was operated for ten cycles. The force required to operate the nozzle decreased to 425 lb net. The increase in force required to move the nozzle, (33 to 425 lb net), was attributed to galling.

When the test was disassembled, considerable galling of both the nozzle and sleeve was evident (Figure 5).

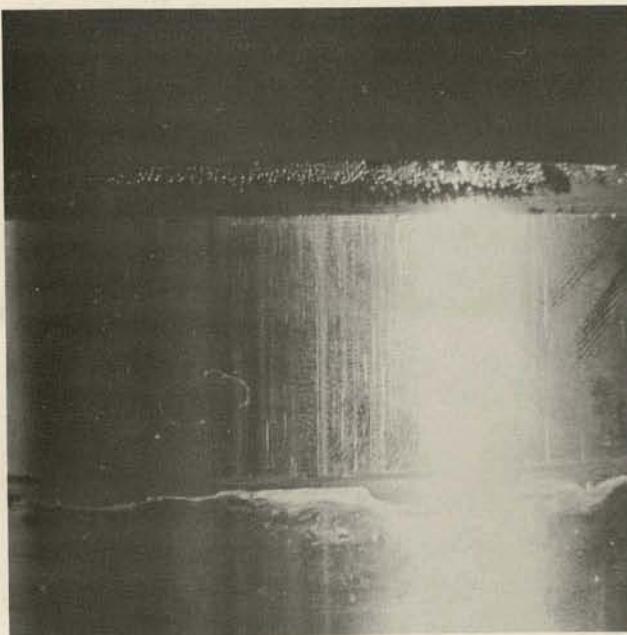
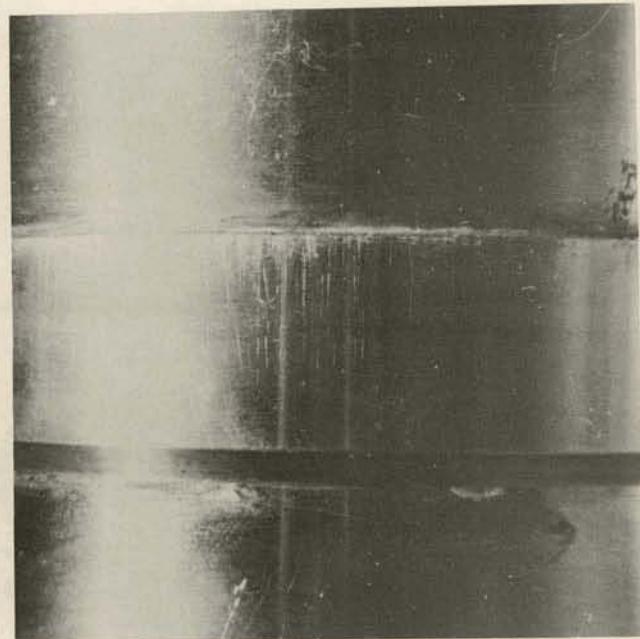
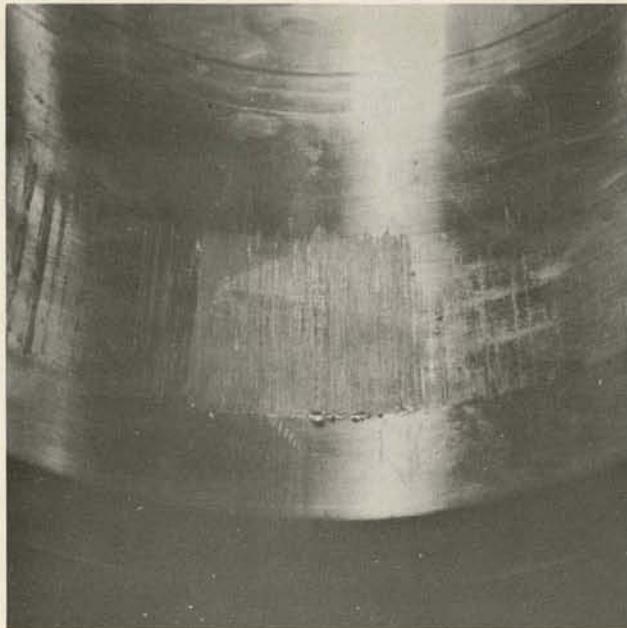
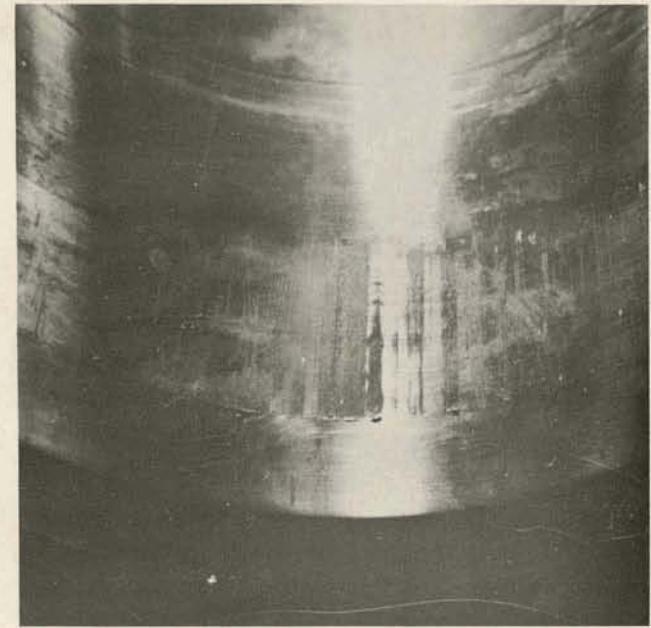
Figure 6. Test 3 - Chrome-plated 304 stainless steel nozzle (top) and 304 stainless steel sleeve (bottom) after galling test with 155-lb horizontal load. (NP Photo 18A-18, -19, -23, -25)

The second test run consisted first of 50 cycles with no horizontal load during which the operating force leveled off at 60 lb net. A 155 lb net horizontal load was then applied. On the first stroke, the operating load increased to 575 lb net downward. On the second and third strokes, the required force increased to 673 lb net downward. From the fourth through tenth cycles, the horizontal load was decreased to 82 lb net. The corresponding vertical force required decreased to 60 lb net downward, which was the same force required at the beginning of the test.

When the test was disassembled, the nozzle was not marred but the sleeve was badly scratched. No galling was evident (Figure 6).

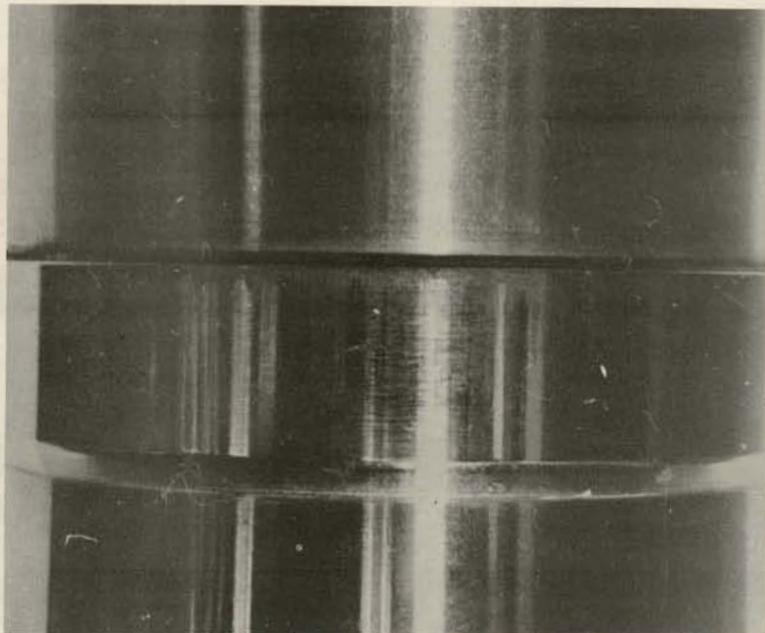
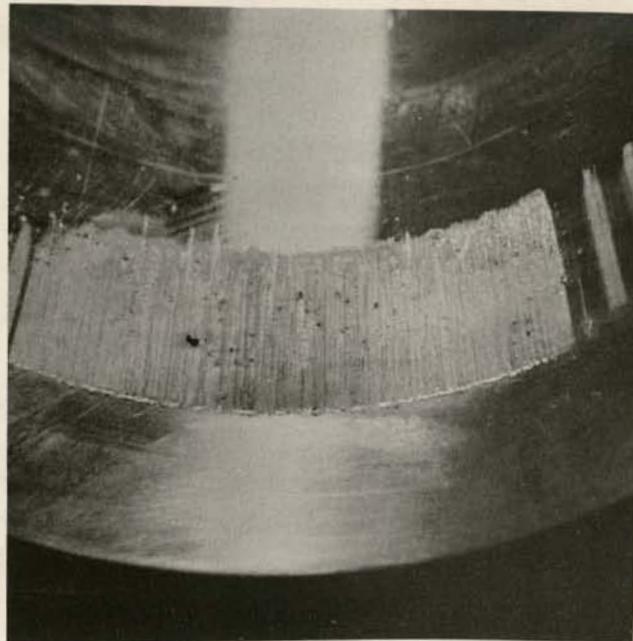
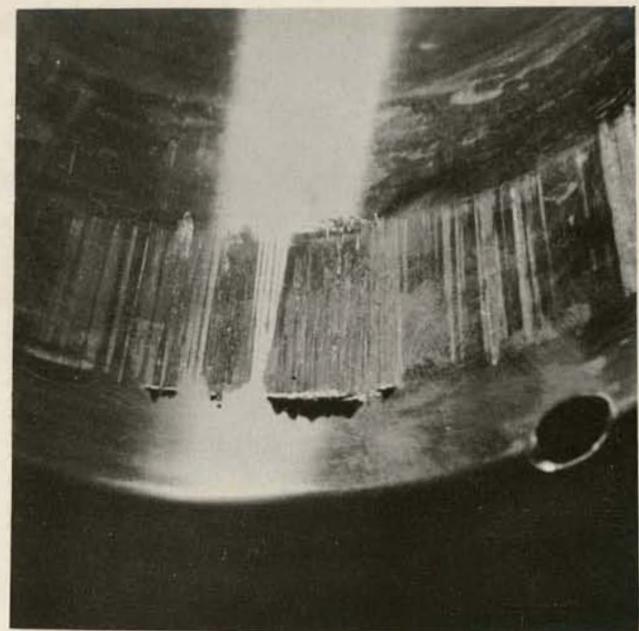
Figure 7. Test 4 - Chrome-plated 304 stainless steel nozzle (top) and 304 stainless steel sleeve (bottom) after galling test with 290-lb horizontal load. (NP Photo 18A-0-26, -28, -29)

The test was reassembled, and the nozzle was again operated with no horizontal load for 50 cycles. The vertical force required was 20 lb net with a housing pressure of 600 psi. Upon the application of a 290 lb net horizontal load for ten cycles, the vertical force required increased to 960 lb net. When the horizontal load was removed, the vertical force required decreased to 70 lb net.

When the test was disassembled, the sleeve was severely scratched but no galling was evident. The metal from the scratches in the sleeve was deposited at the end of the stroke (Figure 7).

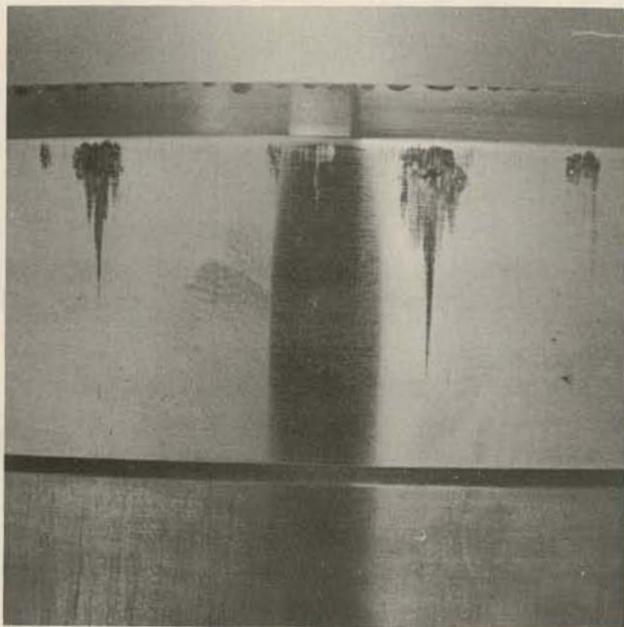
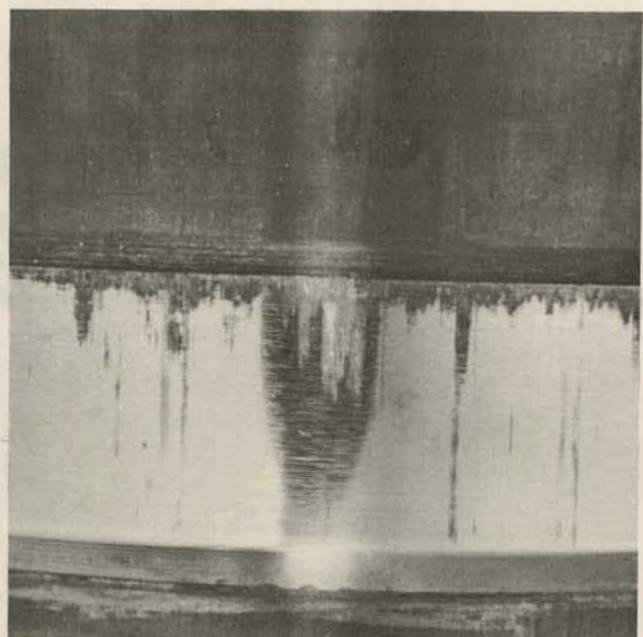
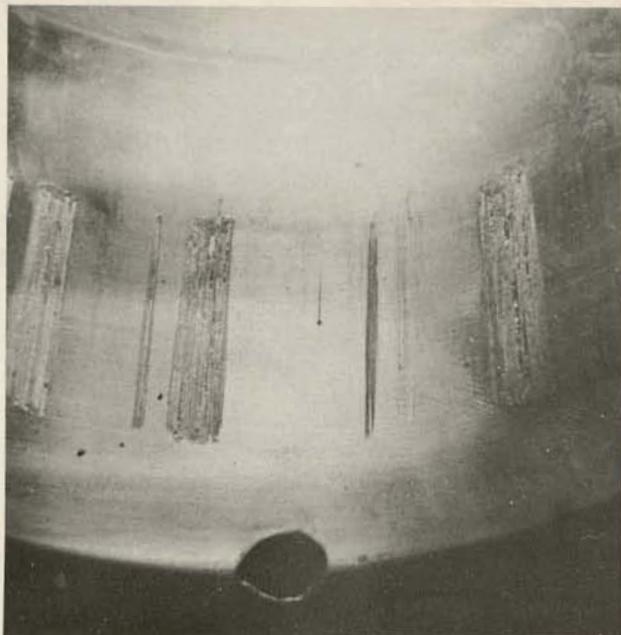
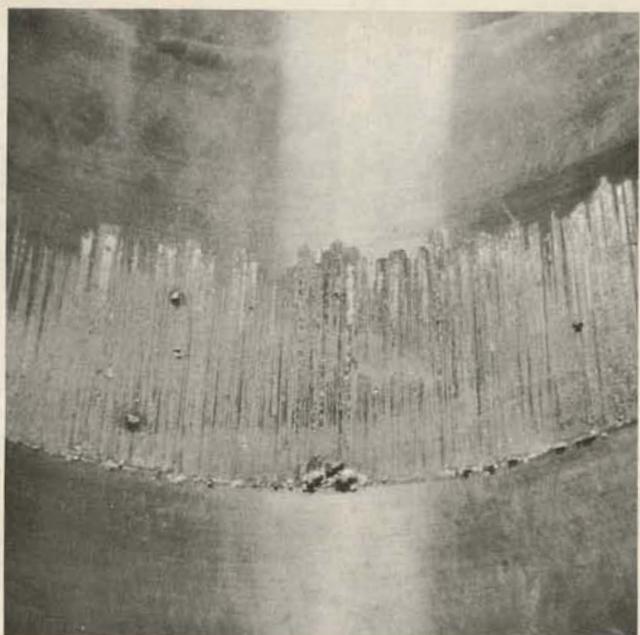
Figure 8. Test 5 - Chrome-plated 304 stainless steel nozzle (top) and 304 stainless steel sleeve (bottom) after galling test with 268-lb horizontal load. (NP Photo 18A-0-33,-34,-39, -40)

net horizontal load was applied, the required vertical force increased to 930 lb net. After the horizontal load was removed, the vertical force required decreased to 65 lb net.

No galling was found on either the nozzle or the sleeve after disassembly. Severe wear in the form of scratches were found on the sleeve, and metal from the scratches formed a ridge at the end of the stroke (Figure 8).

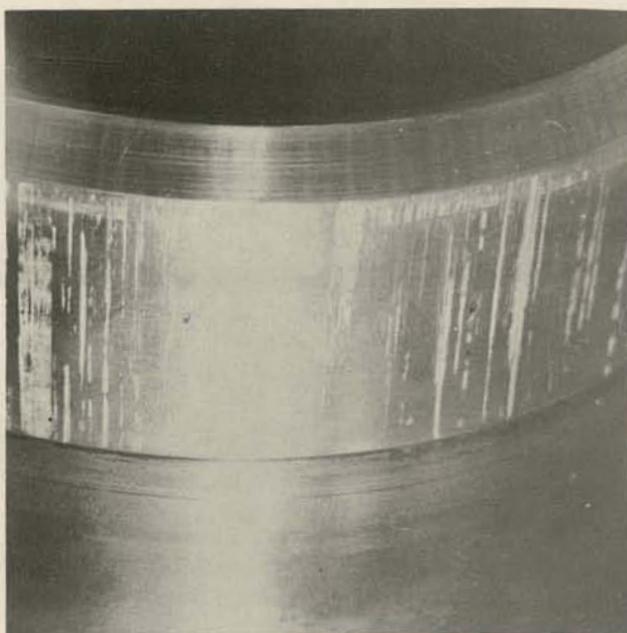
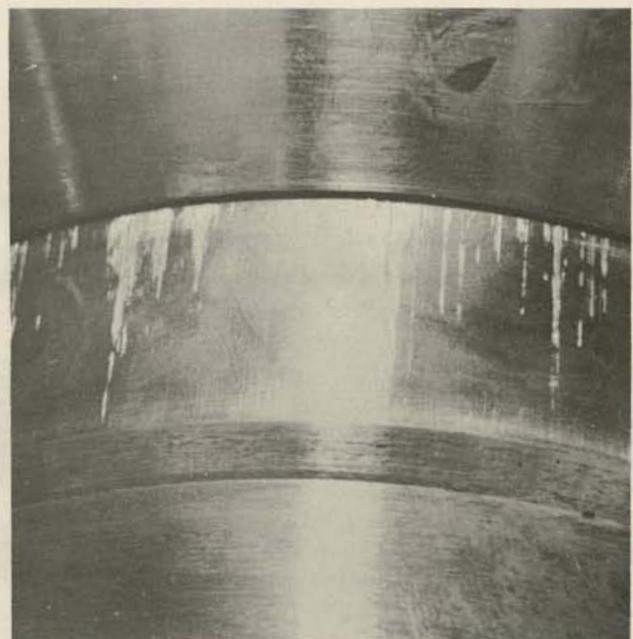
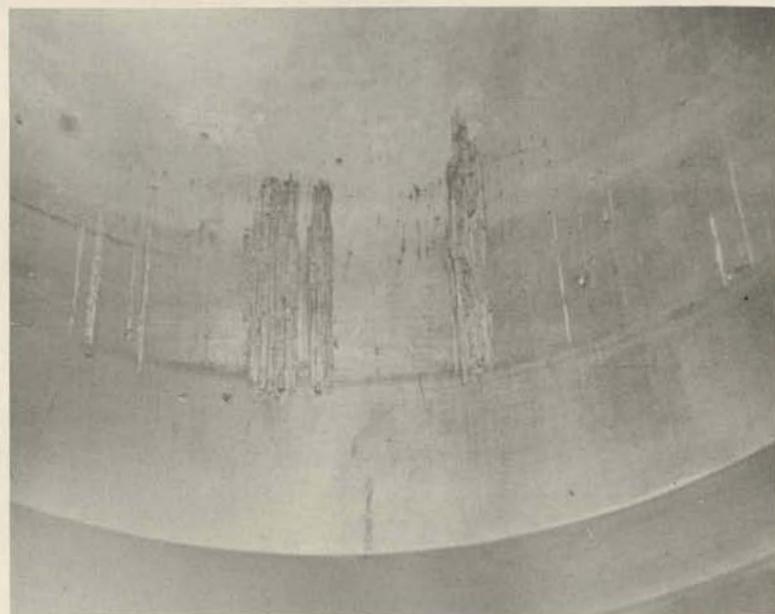
Figure 9. Test 6 - 17-4PH stainless steel nozzle (top) and 304 stainless steel sleeve (bottom) after galling test with no horizontal load. (NP Photo 18A-0-30, -31, -32)

The nozzle was tested for 100 cycles with no horizontal load. The required vertical load was 20 lb net with the housing at 620 psi. The test was disassembled, and some wear on both nozzle and sleeve was evident. (Figure 9)

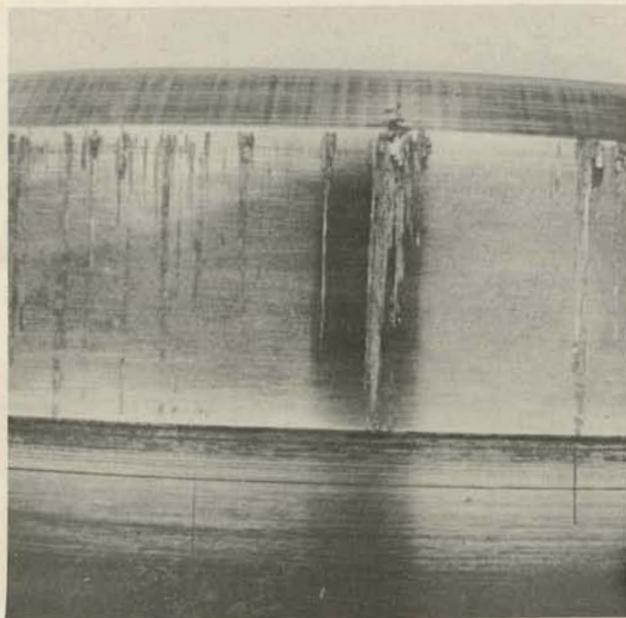
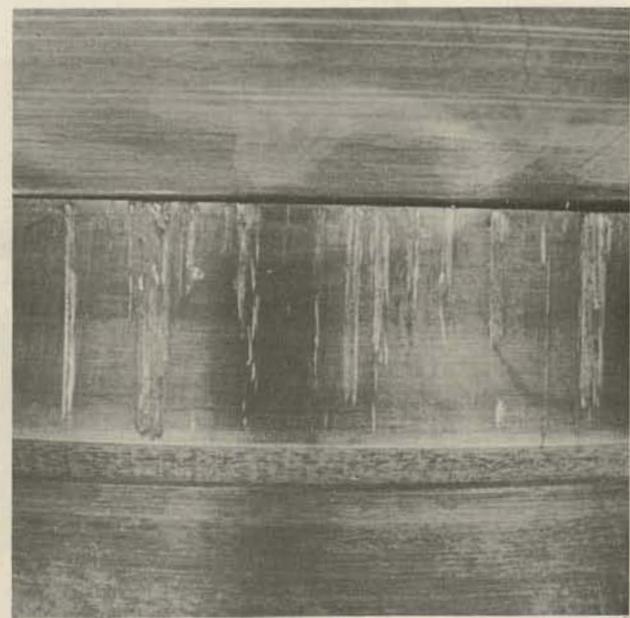
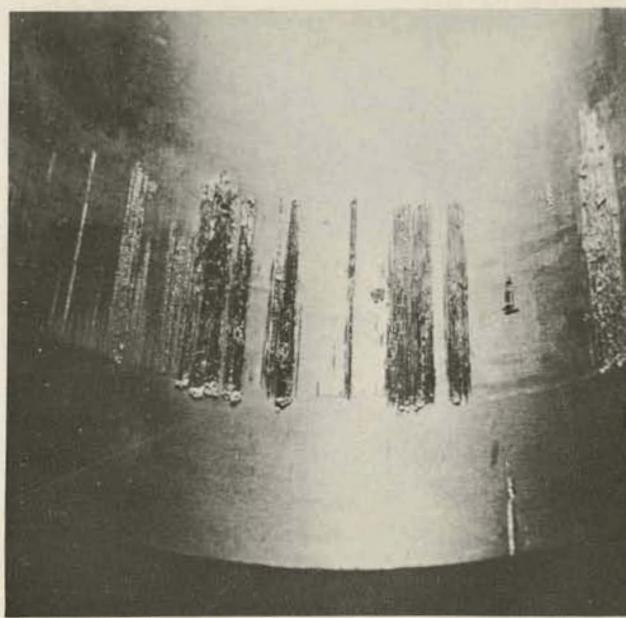
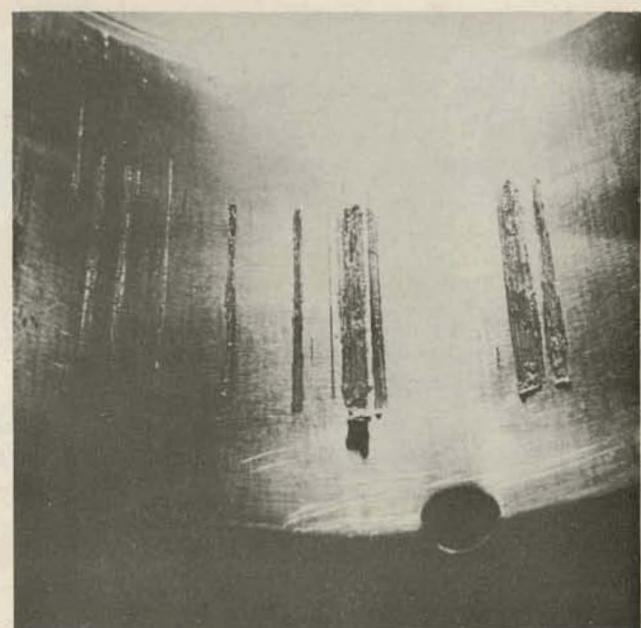
Figure 10. Test 6 - 17-4PH stainless steel nozzle (top) and 304 stainless steel sleeve (bottom) after galling test with 300-lb horizontal load. (NP Photo 18A-0-35, -36, -37, -38)

The nozzle was then tested for ten cycles with 300 lb. net horizontal load. The required net vertical load was 1108 lb at a housing pressure of 540 psi. After removing the horizontal load, the required vertical load decreased to 140 lb. net.

Severe wear and galling were noted on both nozzle and sleeve after the test was disassembled (Figure 10). The spring had no discernible effect on the performance of the nozzle.
