Operation UPSHOT-KNOTHOLE

Project 23.15

EFFECTS OF OVERPRESSURES IN GROUP SHELTERS ON ANIMALS AND DUMMIES

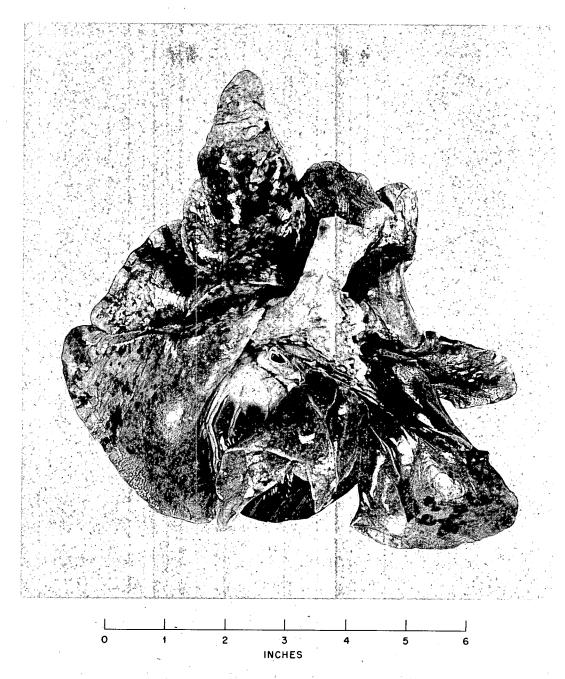
Fig. 3.6—Posterior view of lungs and heart of Animal D-10 (position 602-7). Large hemorrhages are visible in the apical and cardiac lobes. Smaller hemorrhages are seen in tongues and apex of intermediate lobe and in the right diaphragmatic lobe. The left side of this animal was presented to the shock.

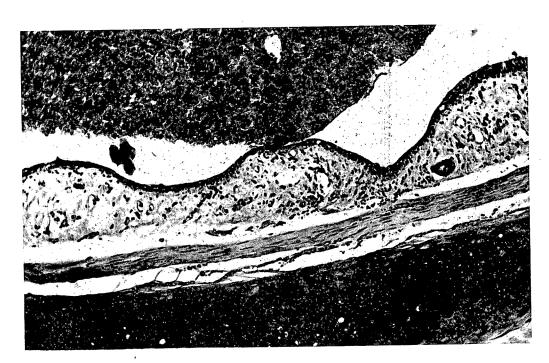
Fig. 3.9—Lung (microscopic), bronchial blood. Upper illustration: a recently formed thrombus partially fills a pulmonary vessel. This phenomena was found in only two of the animals.

Lower illustration: large bronchus containing clotted blood in lumen. A mild inflammatory cell infiltrate is seen in the submucosa.
