## DESIGNING MAGNETIC SYSTEMS FOR RELIABILITY

P.J. Heitzenroeder  
Princeton University  
Princeton Plasma Physics Laboratory  
P.O. Box 451  
Princeton, New Jersey 08543 USA

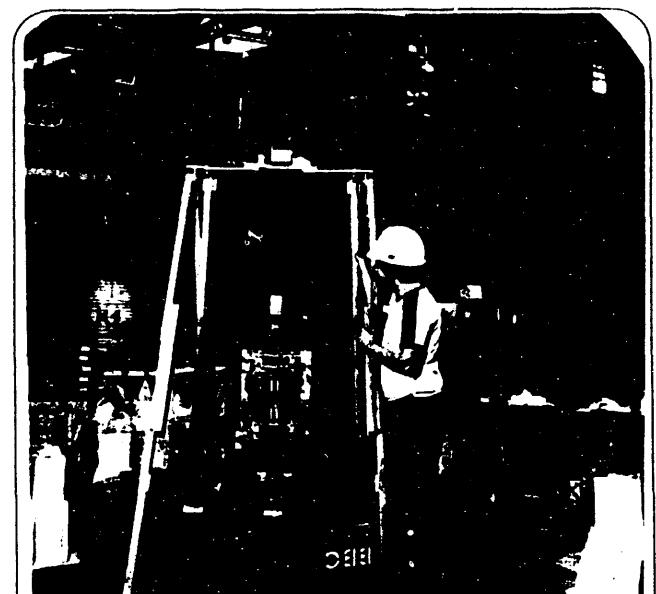
Figure 4. TFTR PF Lead Splicing.

**Leads:** To avoid brazed regions in a lead transition area, the transition piece is cut from a plate of copper which is then gun drilled to form the water passage and then formed, as shown in Fig. 3. The TFTR PF coils were fabricated and vacuum pressure impregnated with relatively short lead stem extensions. After being transported to the Test Cell, the remainder of the lead stem was joined to the stem so as to form a monolithic coil/stem assembly.[7] This design moves the position of the first non-integral joint outside of the main of the tokamak into a region of lower field and where access is much better. The lead joining procedure, shown in Fig. 4, involved brazing, insulating, and VPI.
