ORNL/TM-11382

## **Shield Design, Analysis, and Testing Against a 3 km/s Projectile**

**DEFENSE AND SPACE PROGRAMS**

Prepared for  
U.S. Air Force Weapons Laboratory  
Kirtland Air Force Base  
Albuquerque, New Mexico  
under Interagency Agreement DOE No. 40-1663-A1

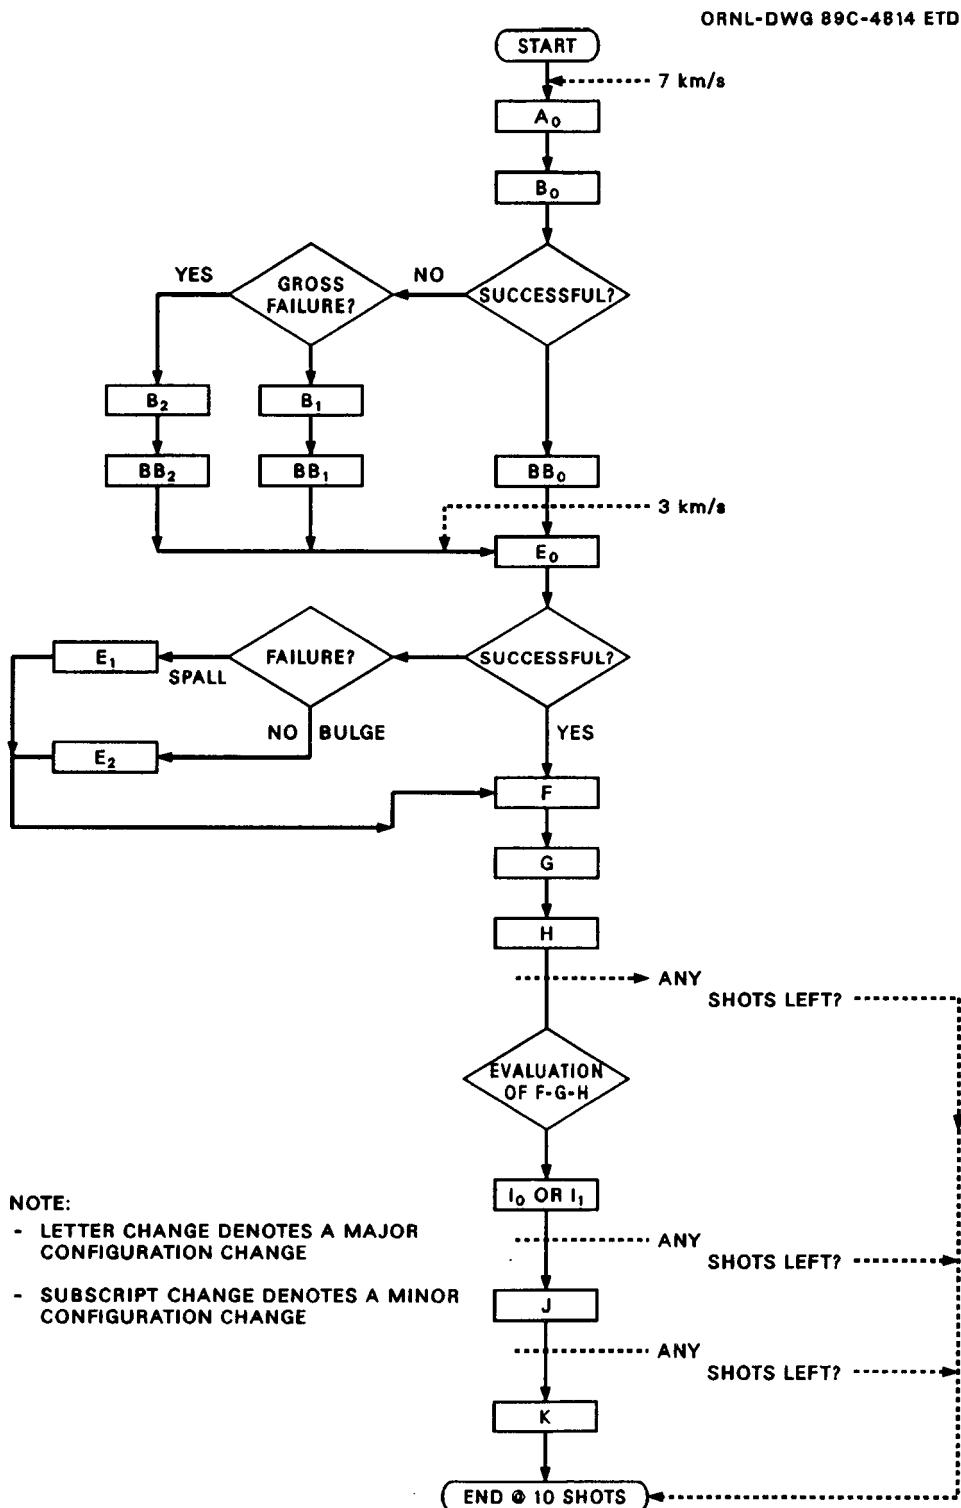
Figure 1. Experimental test design matrix

A discussion of the experimental design logic used during testing is included in this report. This experimental design procedure was initiated as part of the Fast Track Shield Program [Oak Ridge National Laboratory (ORNL) staff, 1989] and was further developed during this study. The basic element of this experimental procedure is flexibility during testing. To achieve this flexibility, which in turn allows rapid development of a shield design, a test matrix for design decisions was developed before testing rather than a list of specific configurations to be tested. An example of a matrix used during a test series is shown in Figure 1. Design decisions can be made at any time during a test series allowing use of all known experimental results, especially those of the immediately previous test(s).

Decisions made during testing were based on experimental results that indicated certain performance levels. The criteria for a successful shield were that of a back plate which had bulged or deformed but not perforated in any way, nor had any evidence of spall from the back surface. Shields with either penetration or spallation were classified as failures. In the low velocity testing, no disrupter or back plate configuration changes were made due to the limited number of test shots available. For each test, the front plate configuration was changed. These changes were based primarily on the back plate results of the previous shots. Consideration was also given to the

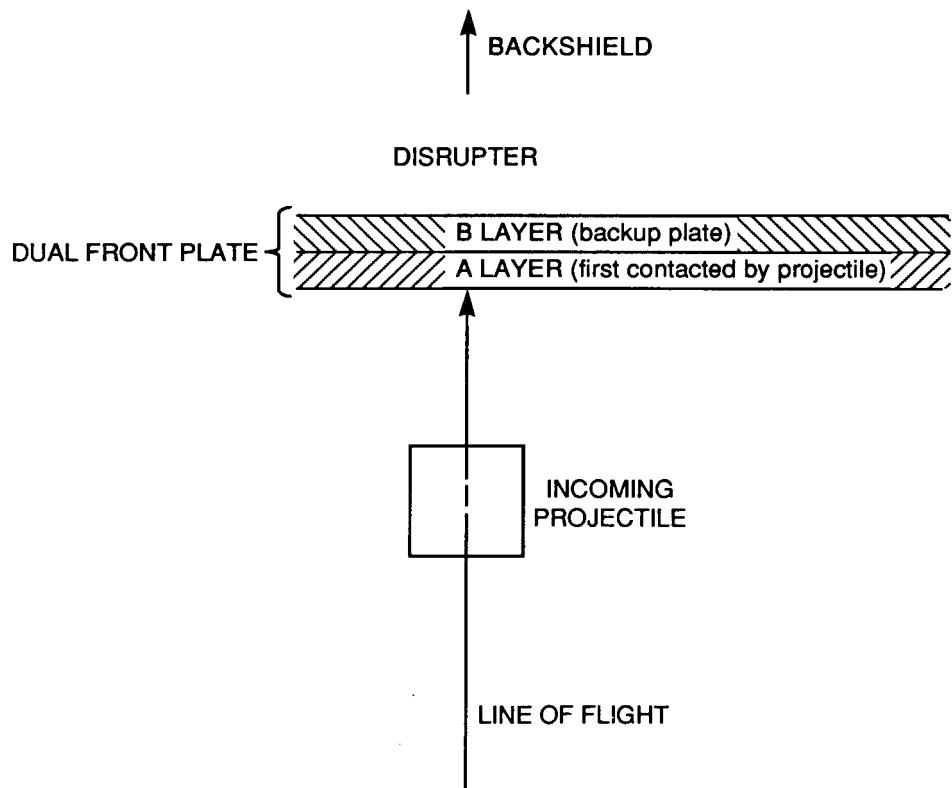
ORNL-DWG 89-4904 ETD

Figure 2. Nomenclature used in a dual front plate configuration

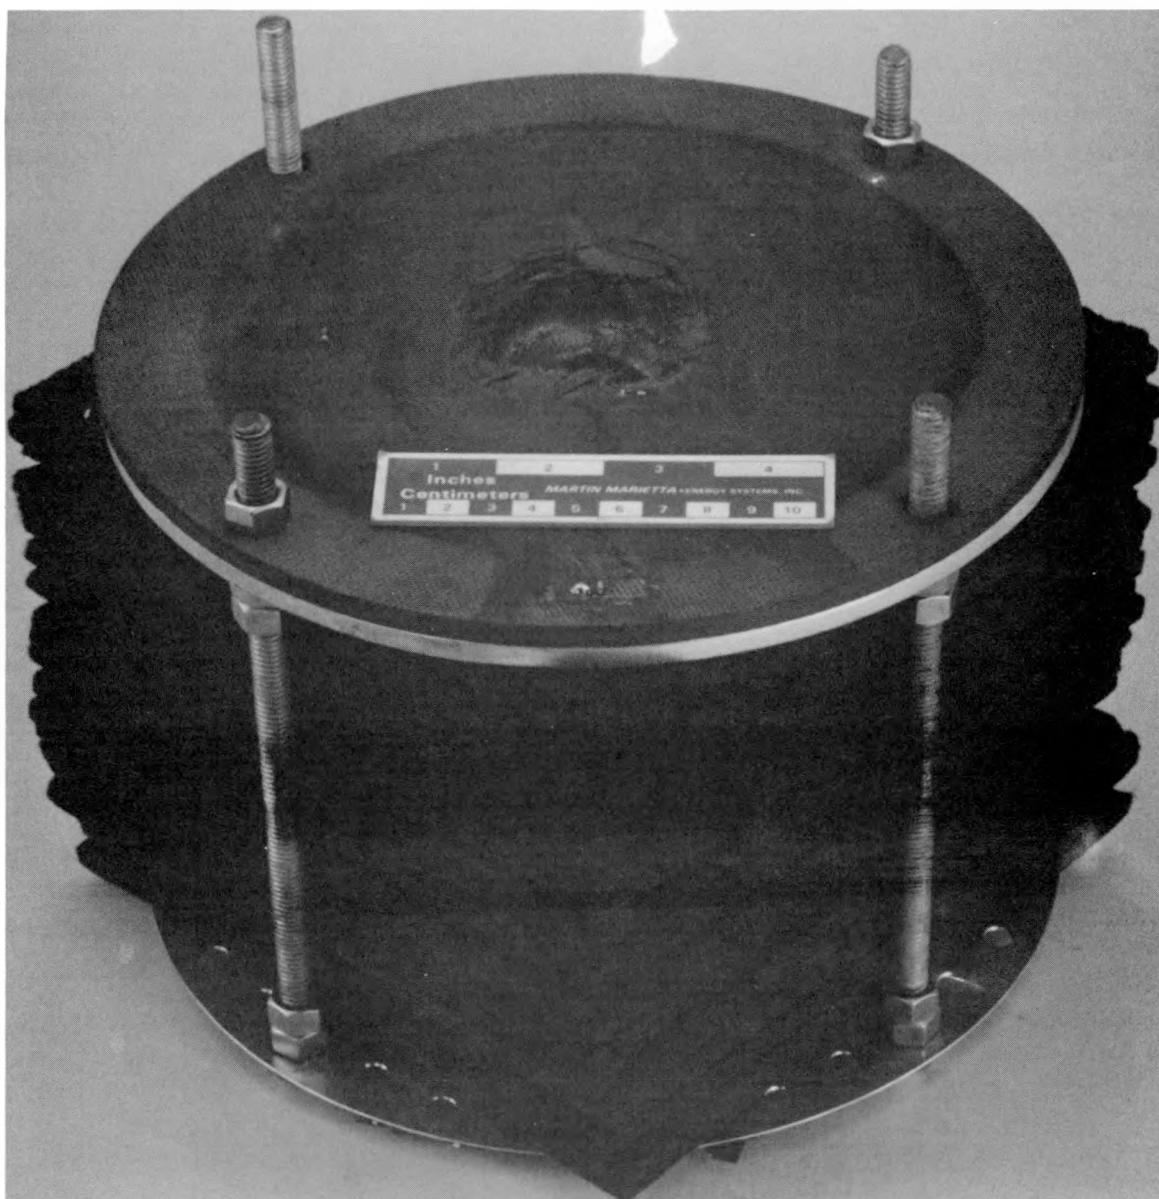
Figure 3. Shield 69 front plate damage

Shield 69. A large, ragged-edge, almost round hole was produced in the K-Karb plate, varying from 4.6 cm to 4.0 cm in diameter. The average diameter was 4.2 cm. The hole through the aluminum plate was much smaller, from 3.0 to 2.6 cm in diameter with an average diameter of 2.8 cm. Shield 69 is shown in Figure 3.

the same areal density. The damage to the B plate of shield 72 was different. As can be seen from Figure 5, the hole in the lead B plate was larger than the hole in the ceramic A plate. In both Figures 3 and 4, the opposite can be seen with the hole in the B plate being visible through the larger hole in the A plate. The hole in the lead measured from 4.4 cm to 4.0 cm and averaged 4.2 cm in diameter.

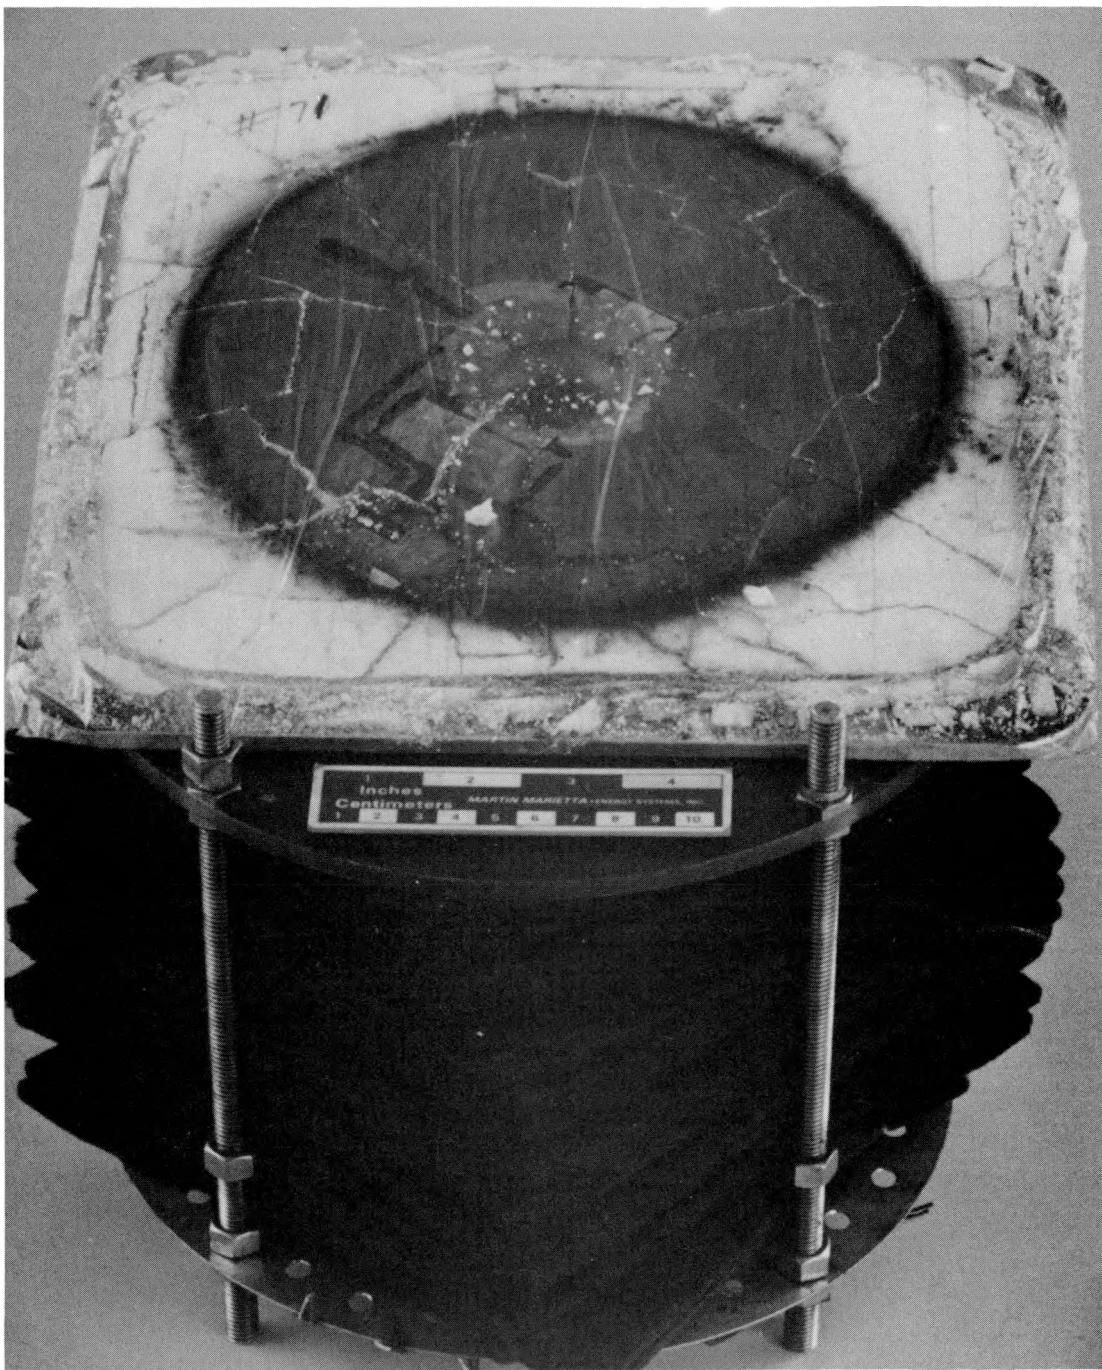
ORNL PHOTO 8249-89

Shield 71. As shown in Figure 4, the ceramic plate was seriously cracked by the impact. A hole, measuring from 4.0 to 3.6 cm diameter with an average of 3.8 cm, was created. Around the hole is an area of tiny cracks, indicative of brittle failure. Several large cracks extend from the center damage to the edge of the plate. The ceramic plate was held together by the test holder hardware;

Figure 4. Shield 71 front plate damage

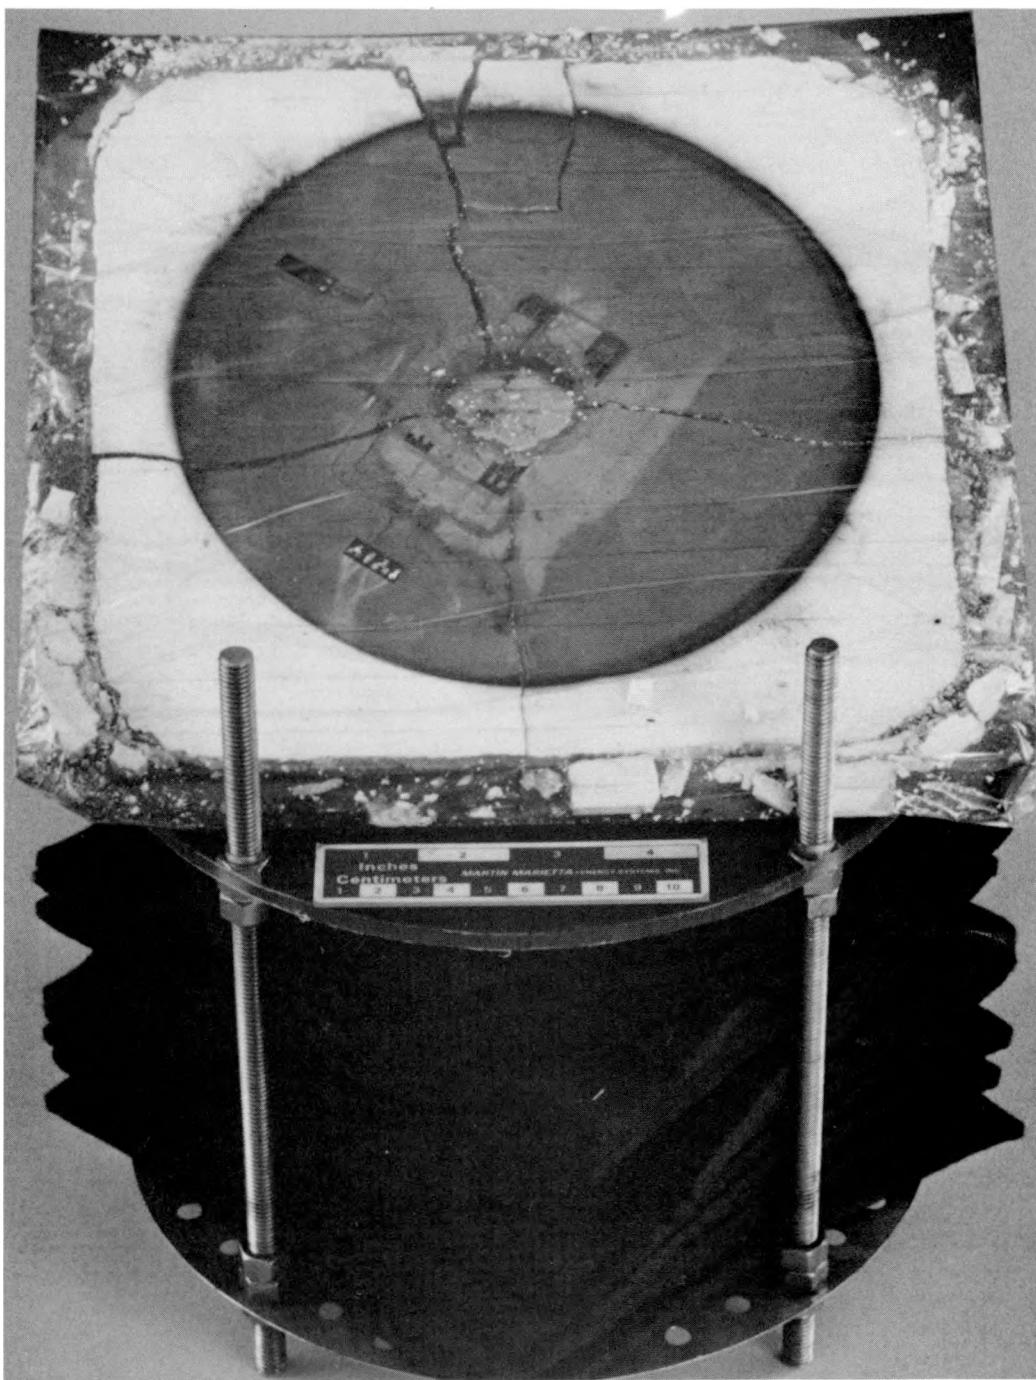
ORNL PHOTO 8248-89

Figure 5. Shield 72 front plate damage

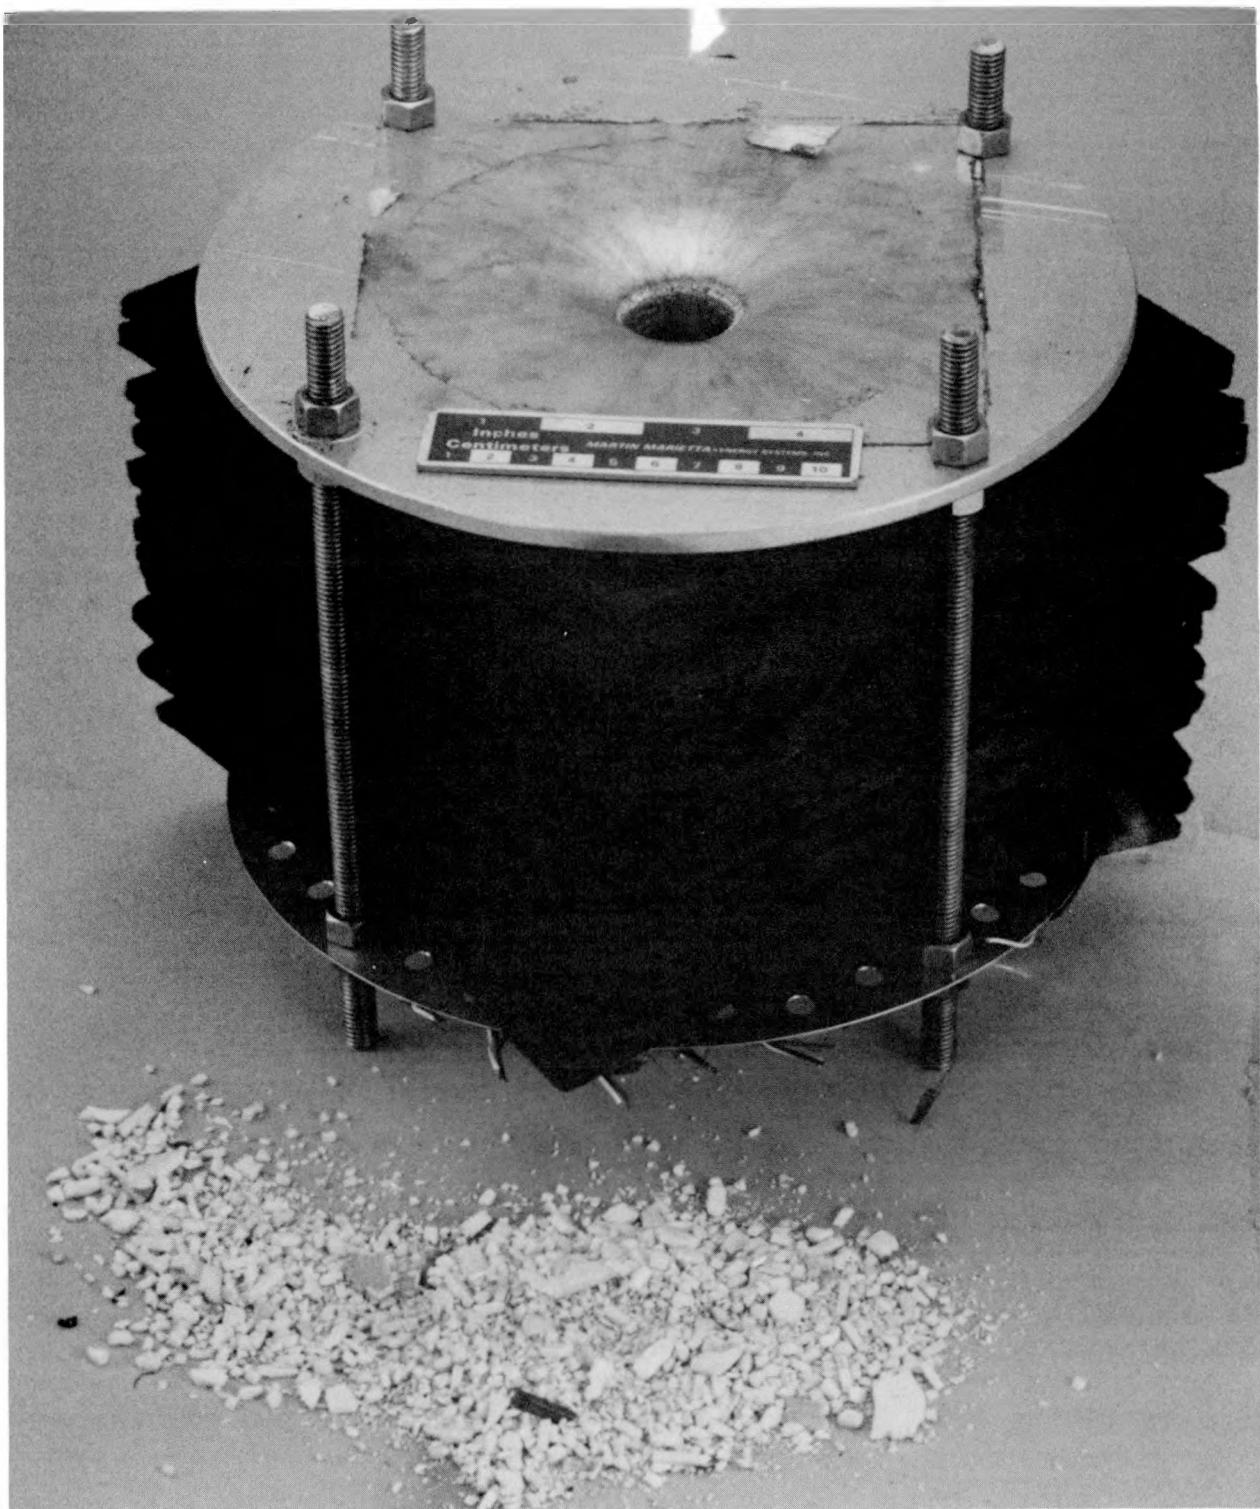
Figure 6. Shield 73 front plate damage

Shield 73. No hole could be measured for the A front plate, since the ceramic layers were completely shattered into very small pieces. This is shown in Figure 6, which includes some of the debris removed from the test tank. A very nearly circular hole, with average and maximum diameters of 3.6 cm and a minimum of 3.4 cm, was produced in the aluminum B plate.

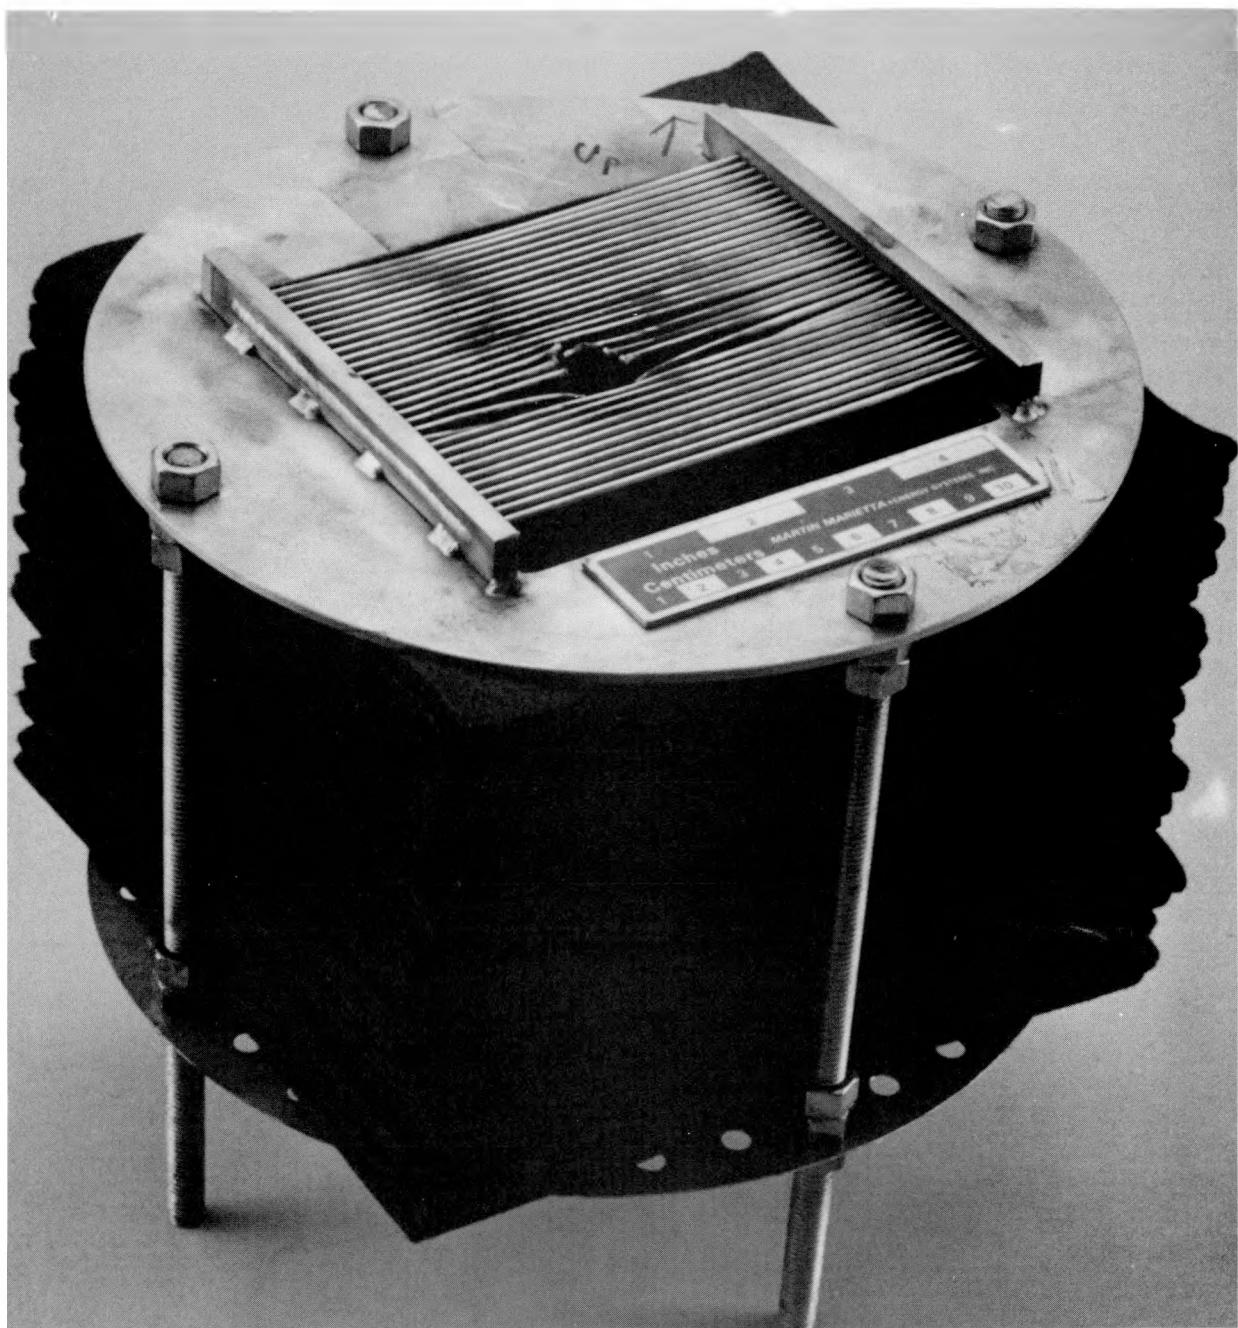
ORNL PHOTO 8242-89

Shield 78. This shield is shown in Figure 7. Five of the stainless steel wires were broken/damaged by the impact. The resulting hole was elliptical in shape, measuring 2.2 cm on the major axis and 1.5 cm on the minor axis.

Figure 7. Shield 78 front plate damage

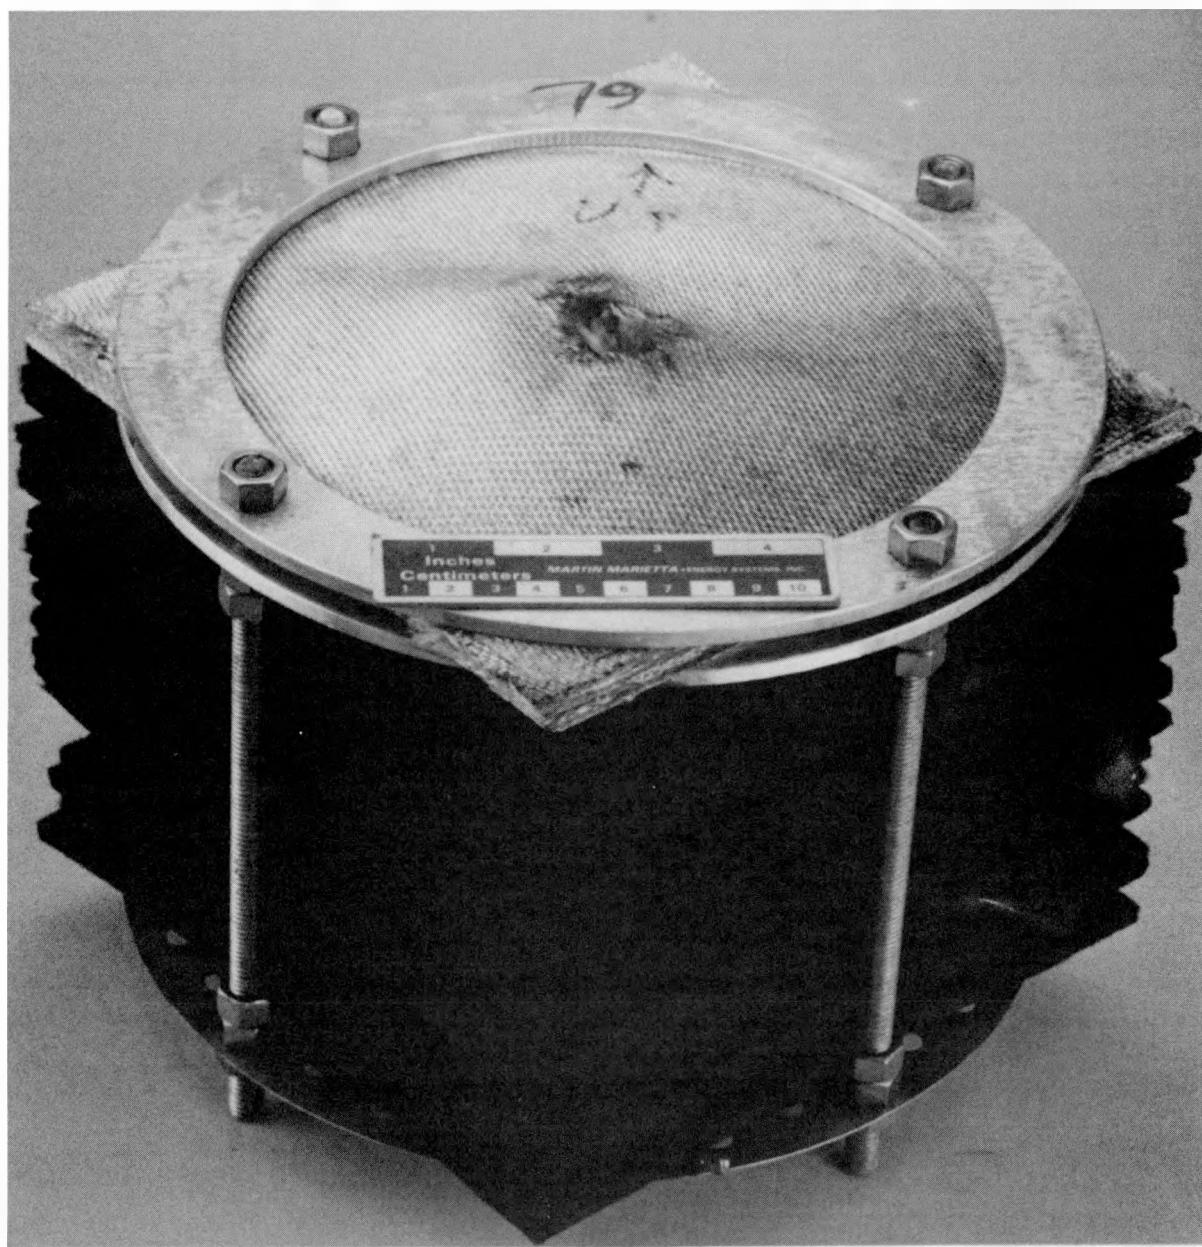
Figure 8. Shield 79 front plate damage

Shield 79. Due to the nine layer beta-cloth A plate used, the hole produced was quite ragged, with very many frayed ends of material making a truly accurate measurement of hole diameter almost impossible. A best estimate is approximately 1.5 cm to 2 cm diameter. Figure 8 shows the beta-cloth damage for shield 79. The hole made in the aluminum B plate was slightly larger, measuring 2.5 cm in diameter.

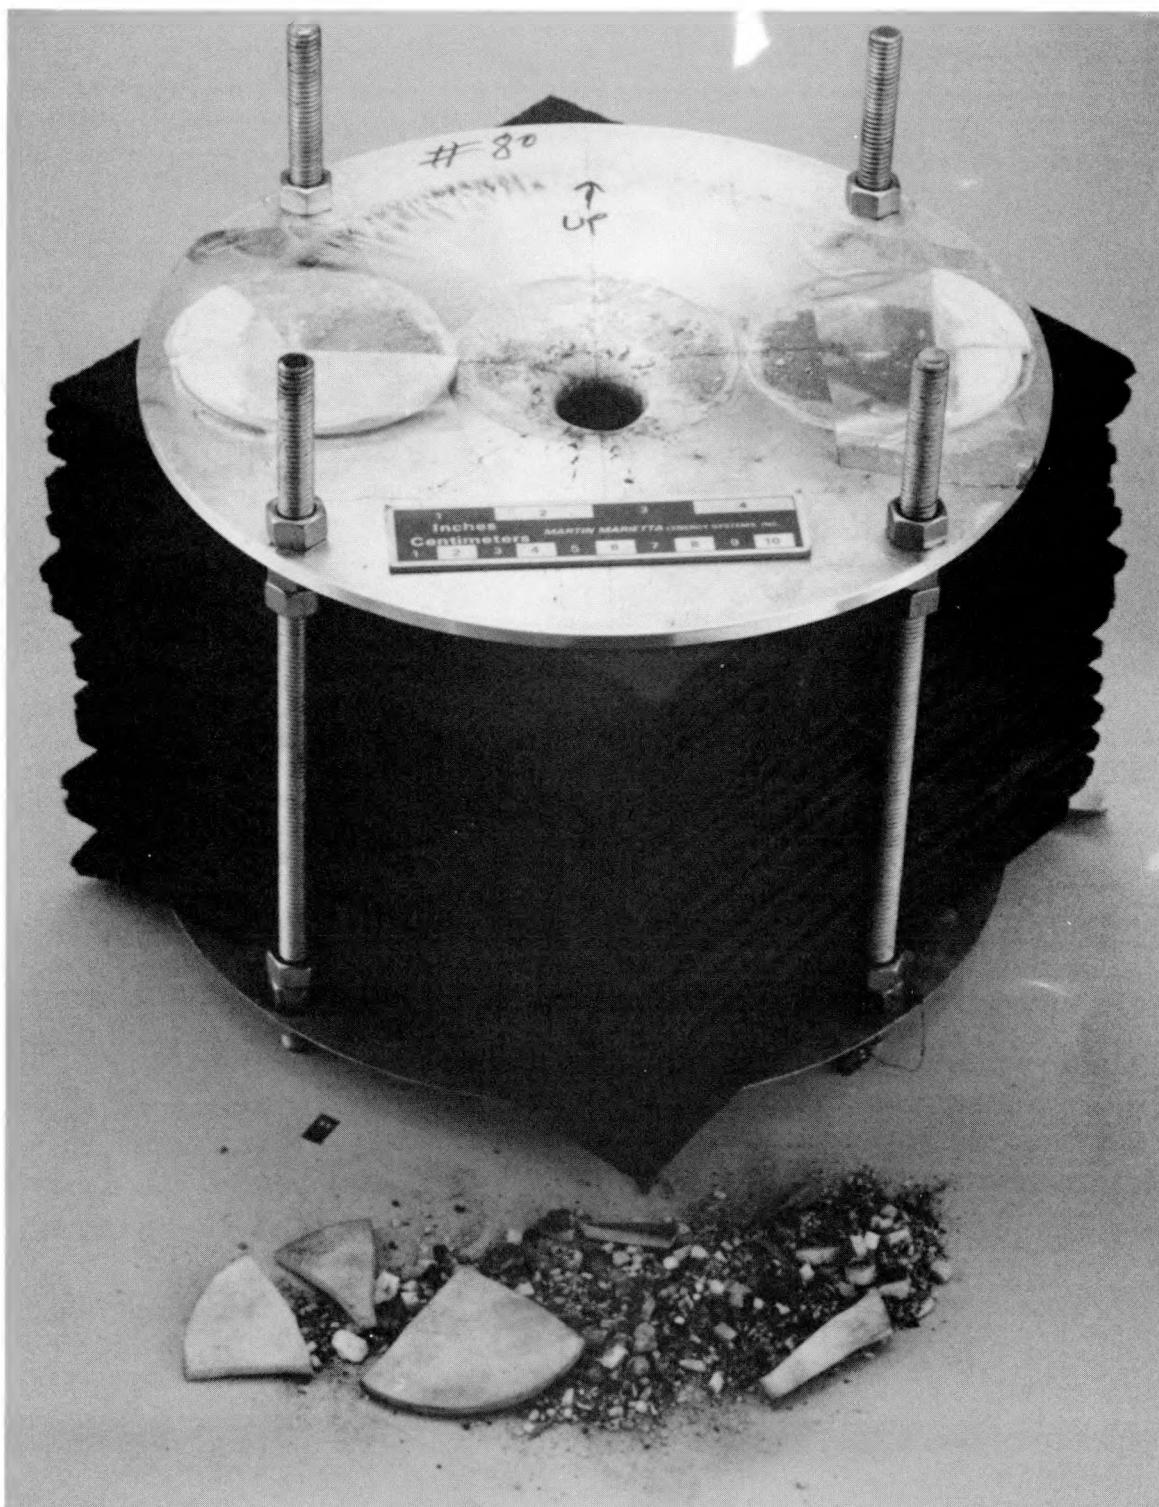
ORNL PHOTO 8243-89

Shield 80. Even though glued to the aluminum B plate, the ceramic tiles used as the shield 80 A plate were broken/shattered/jarred loose by the impact. Figure 9 includes debris removed from the test tank after shield 80. The hole made in the aluminum plate averages 2.3 cm in diameter, with a maximum of 2.4 cm and a minimum of 2.2 cm.

Figure 9. Shield 80 front plate damage

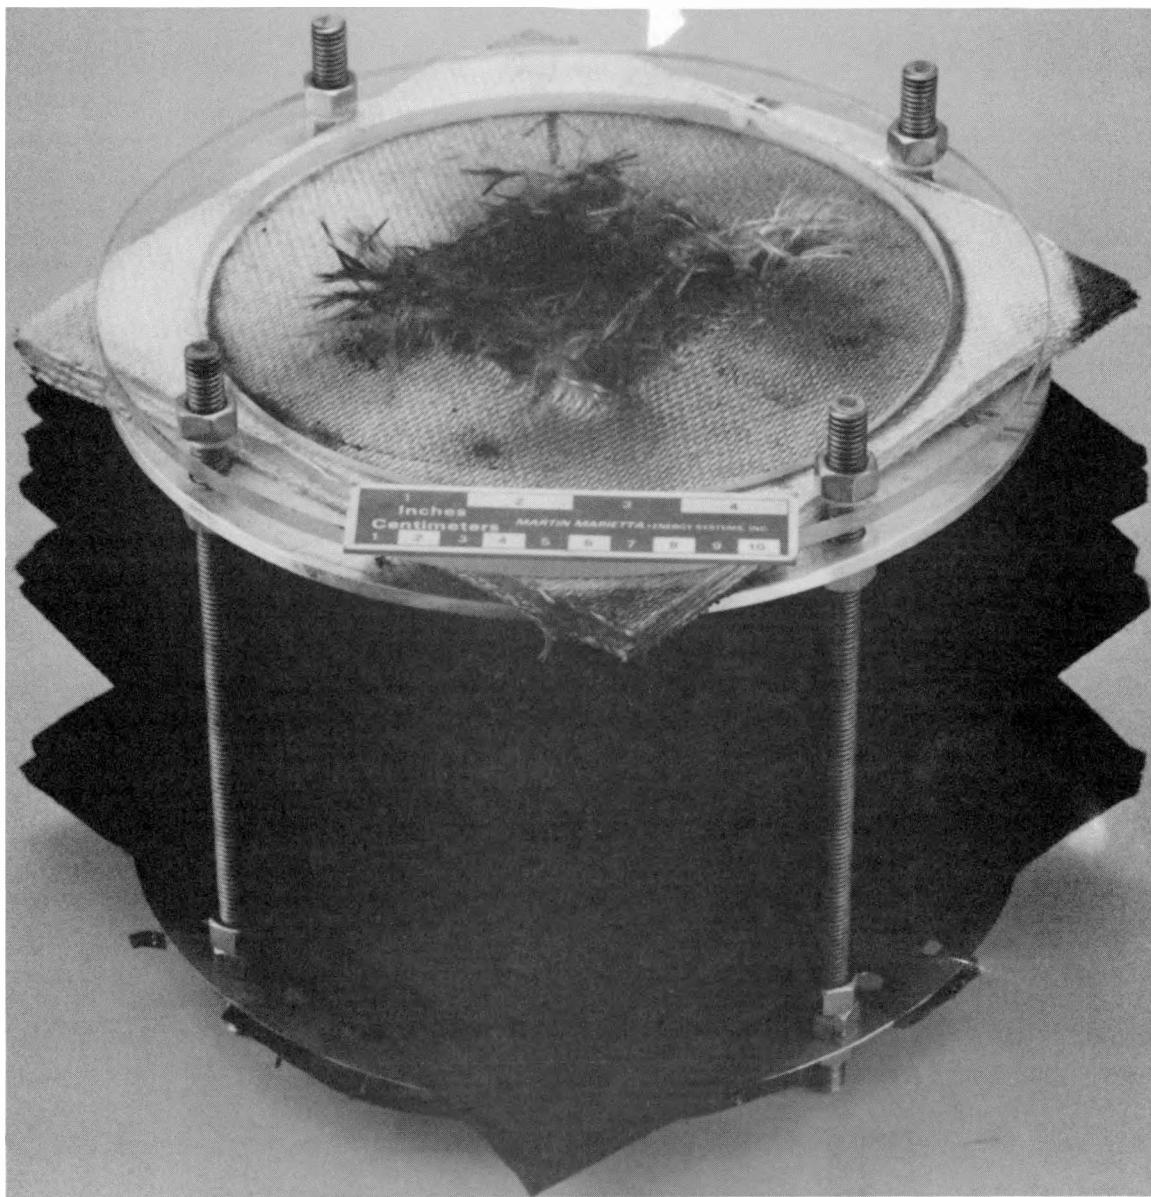
Shield 81. This was an exact repeat of shield 79 but at a test velocity of 7 km/s. The front plate damage to the beta cloth can be seen in Figure 10. Again, exact measurement of the hole diameter is made difficult by the numerous frayed material ends, but a best estimate is

Figure 10. Shield 81 front plate damage

approximately 4.5 cm diameter. The hole in the aluminum B plate measured from 3.6 cm to 3.2 cm in diameter with an average of 3.4 cm. Figure 11 shows shield 79 and shield 81 together for quick comparison.

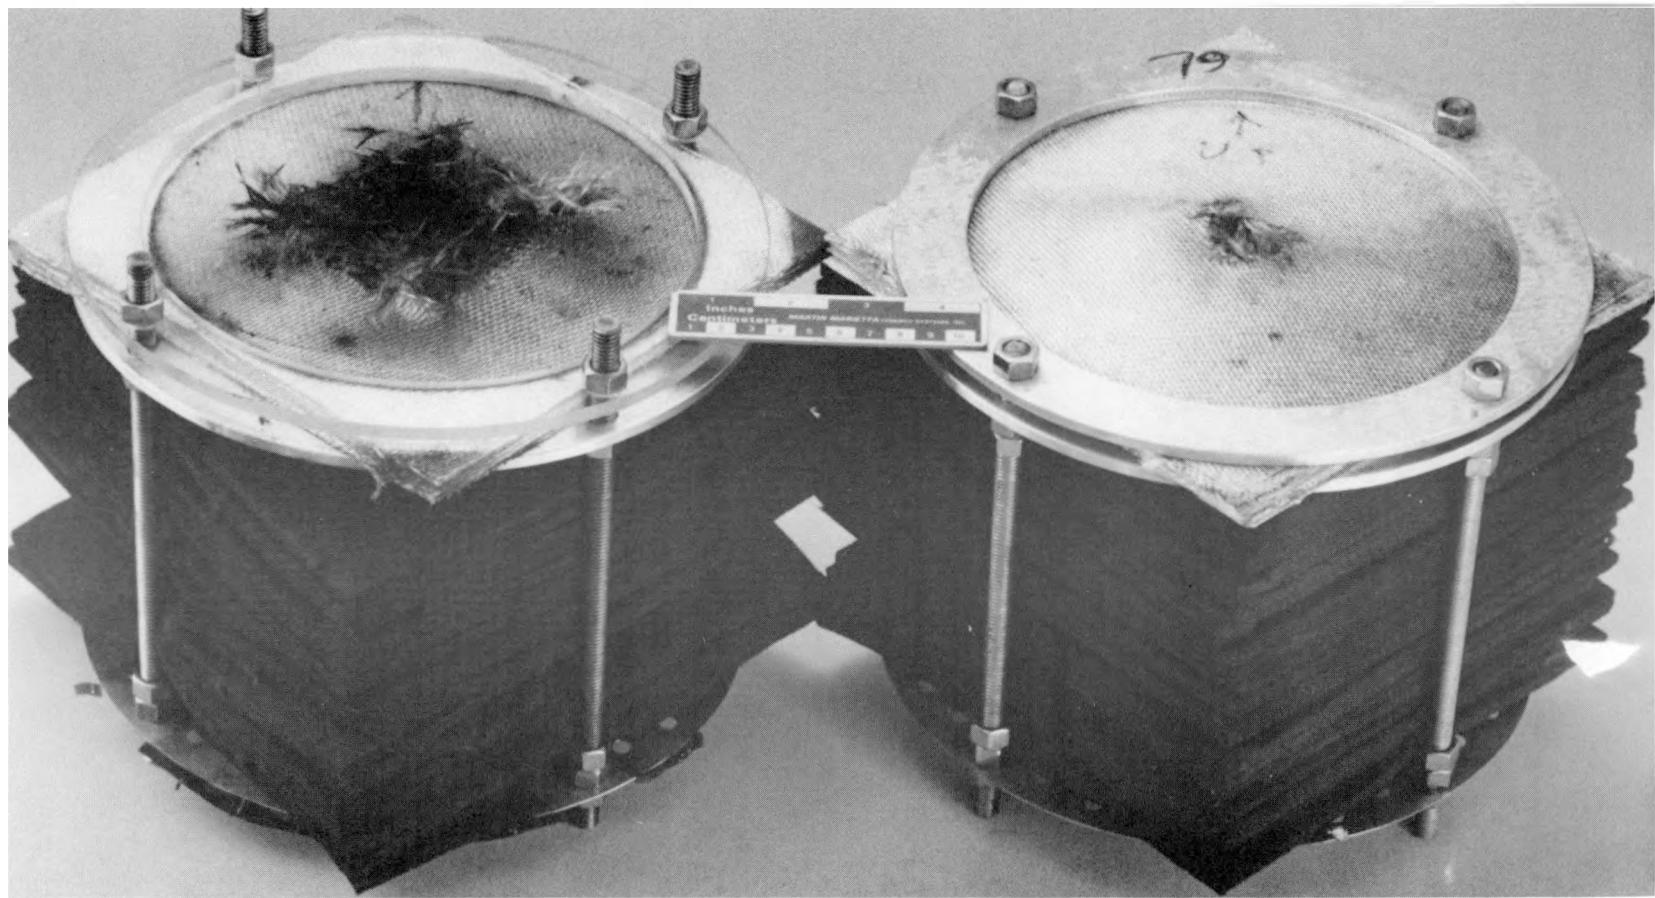
Figure 11. Comparison of shield 79 and shield 81 front plates

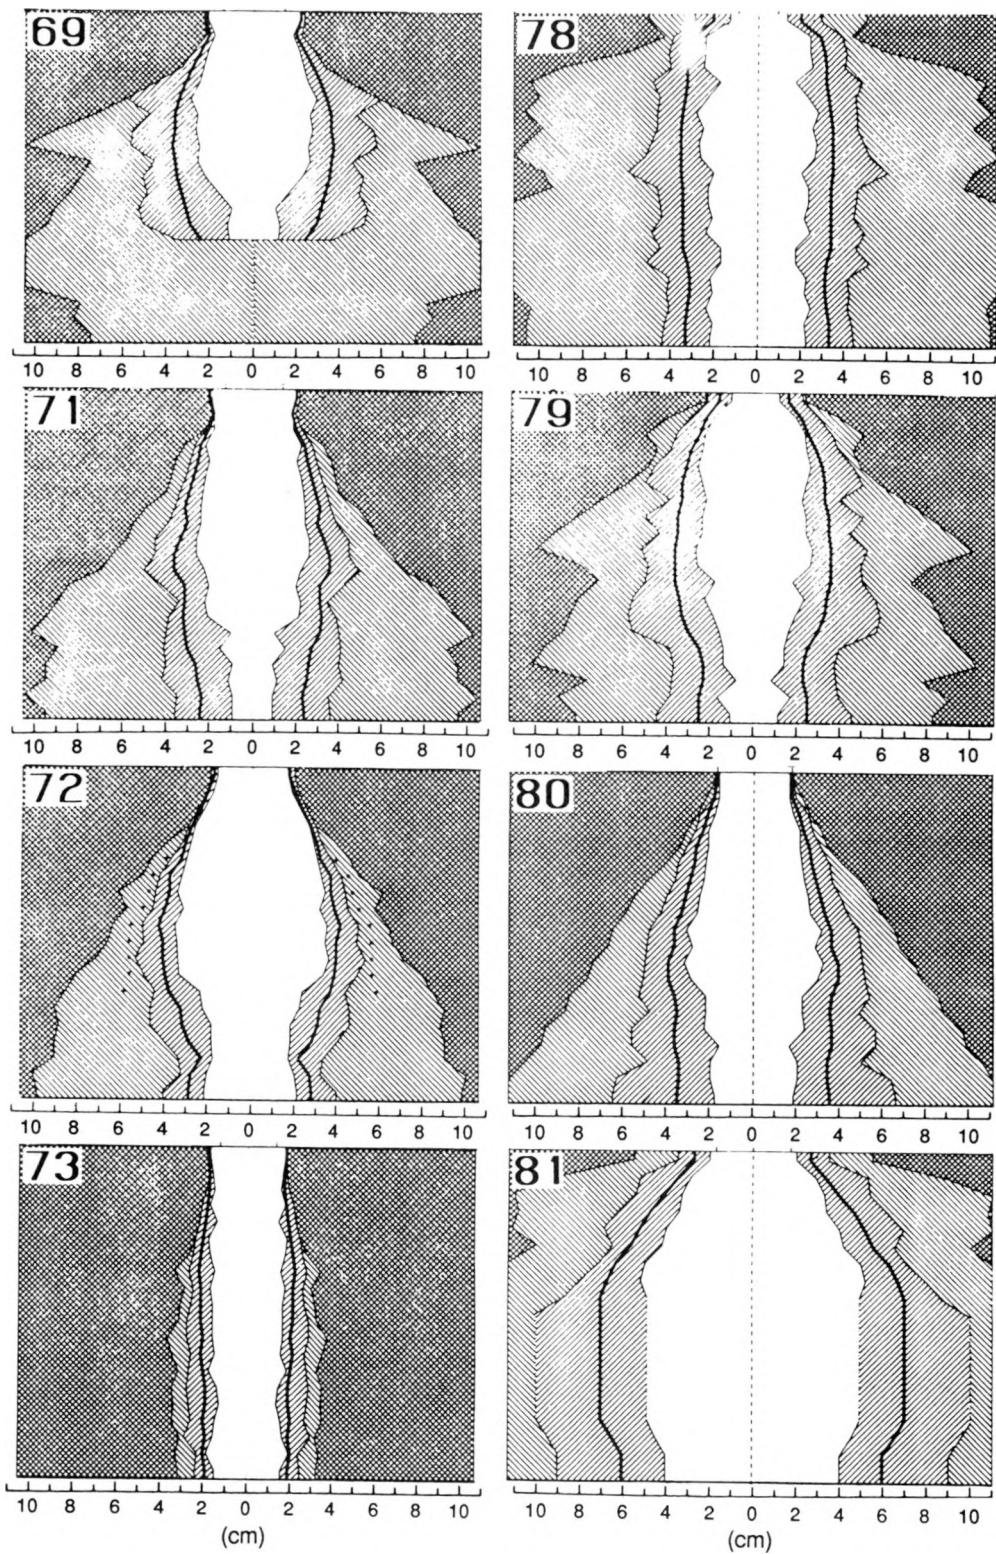
ORNL-DWG 89-4903 ETD

Each shield assembly was taken completely apart, and measurements were made of the damage profile in the disrupter layers. The blast damage profiles for each shield are shown in Figure 12. Several notes of interest concerning material found in the disrupter layers are:

Figure 12. Disrupter damage profiles

4. In shield 73, all disrupter damage was caused by one large semi-flat piece of spall from the back of plate B. The damage profile shown in Figure 12 shows the path of this spall straight from the back of the front plate to the back plate where it was found. The maximum and minimum hole diameters measured in the disrupter layers corresponded to the irregular diameter of the piece of spall. Blast damage outside the hole was due only to tears in the felt at the corners of the hole. The spall piece measured approximately 4 cm in diameter. The weight of the piece after removal of ceramic and carbon dust was found to be slightly over 4 grams.

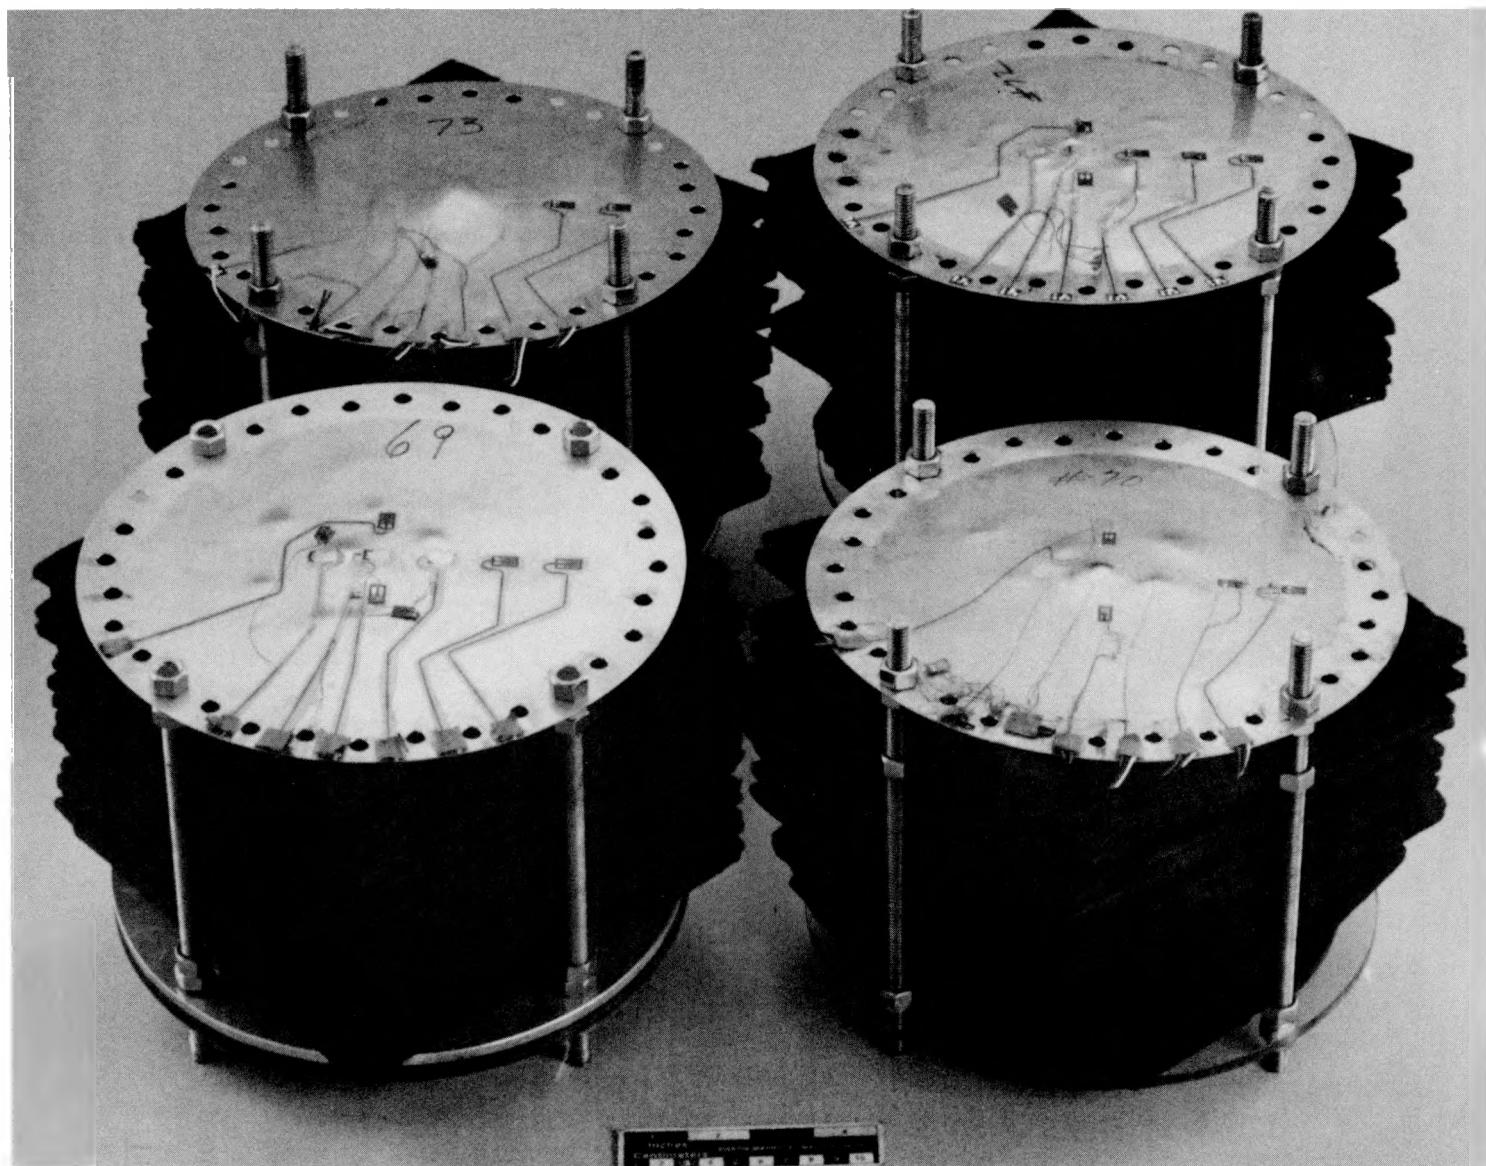
Figure 13. Back plate damage for shields 69, 71, 72, and 73

However, the small bulges are significantly more numerous and smaller in size, as shown in Figure 13. Another difference, which is not apparent from external comparison of the back plates, is found on the inside surface of the back plates. For shields 69 and 71, the inside surface of the shield is smooth like the back surface. On the back, the damage is smooth bulges; on the inside, the damage is smooth craters. This is in contrast to shield 72, which has particles of ceramic embedded in the surface. For each smooth bulge on the back surface, the corresponding inside surface crater has a tiny particle of ceramic embedded in it. These particles can be examined by touch more easily than they can be seen. They feel like a piece of grit.

Shield 73. The back plate of shield 73 has one large bulge superimposed on an almost negligible overall bulge. As indicated from the disrupter results, this was due to the impact of the single large piece of spall debris. The piece of spall is roughly circular but has three tears in it, giving it an irregular, three-lobed appearance. On the back plate, the bulge produced is correspondingly irregularly shaped, and the piece of spall can only be fitted into the bulge in one orientation for a matching fit. Figure 13 also includes the back plate of shield 73.
