ORNL/TM-11382

## **Shield Design, Analysis, and Testing Against a 3 km/s Projectile**

**DEFENSE AND SPACE PROGRAMS**

Prepared for  
U.S. Air Force Weapons Laboratory  
Kirtland Air Force Base  
Albuquerque, New Mexico  
under Interagency Agreement DOE No. 40-1663-A1

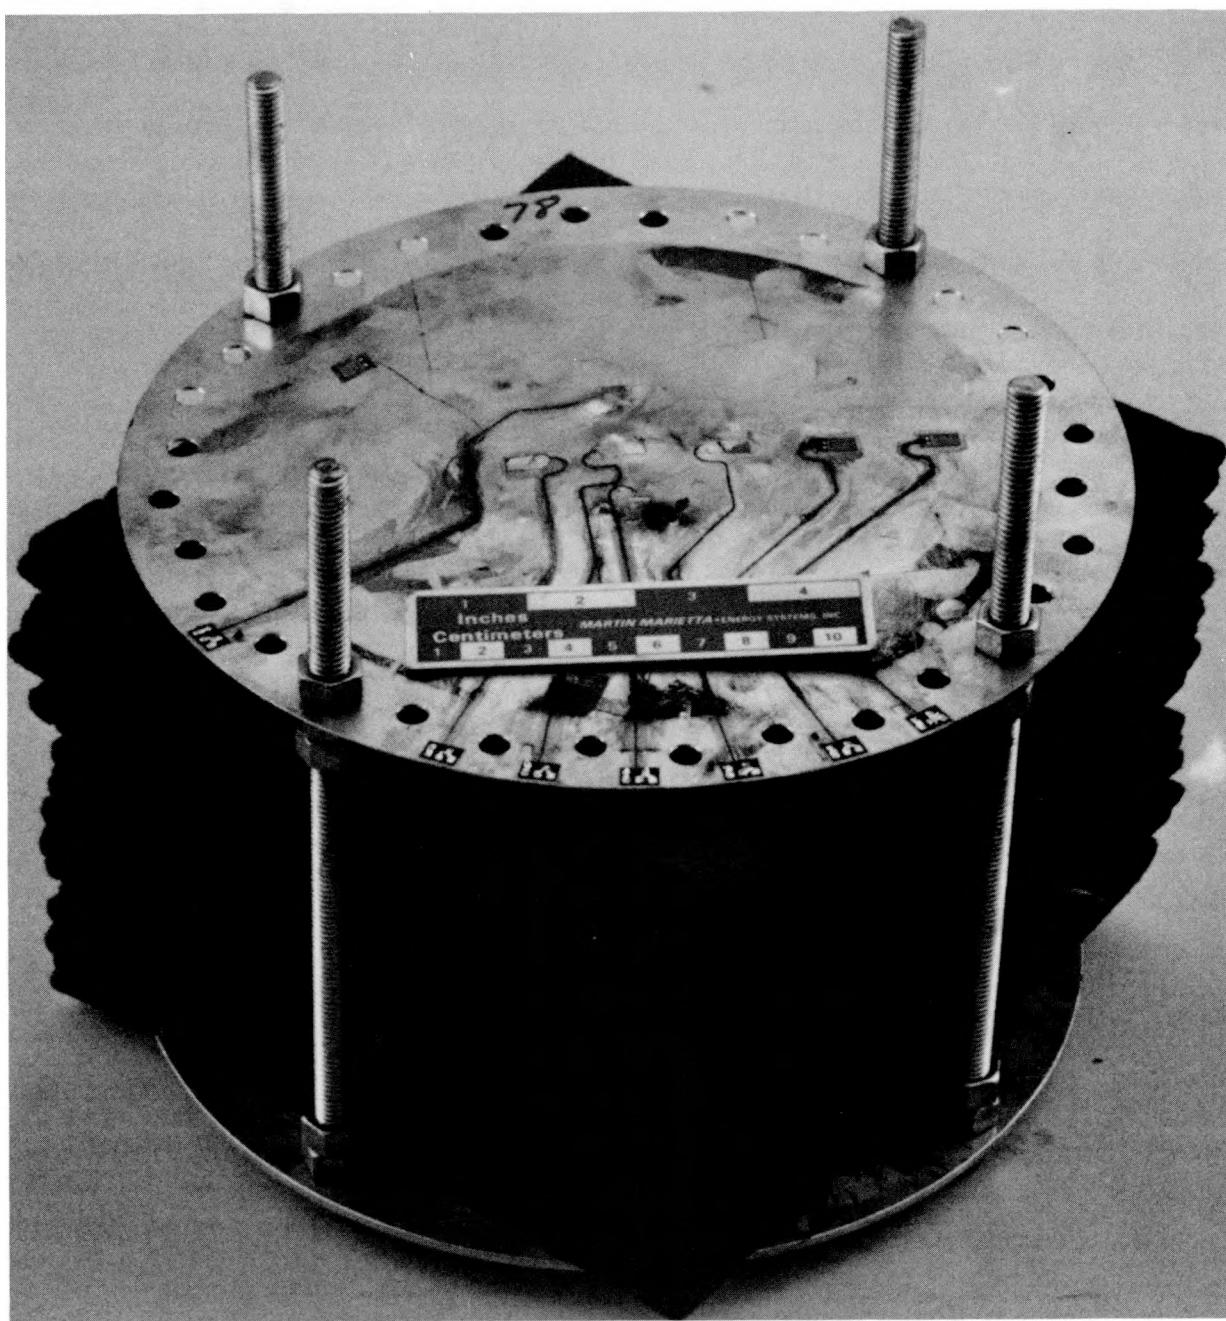
ORNL PHOTO 8258-89

Shield 78. The back plate of shield 78 was breached in one location. There were also several small bulges produced. Figure 14 shows the back plate for shield 78. The witness plate for shield 78 sustained serious damage and was also perforated.

Figure 14. Shield 78 back plate damage

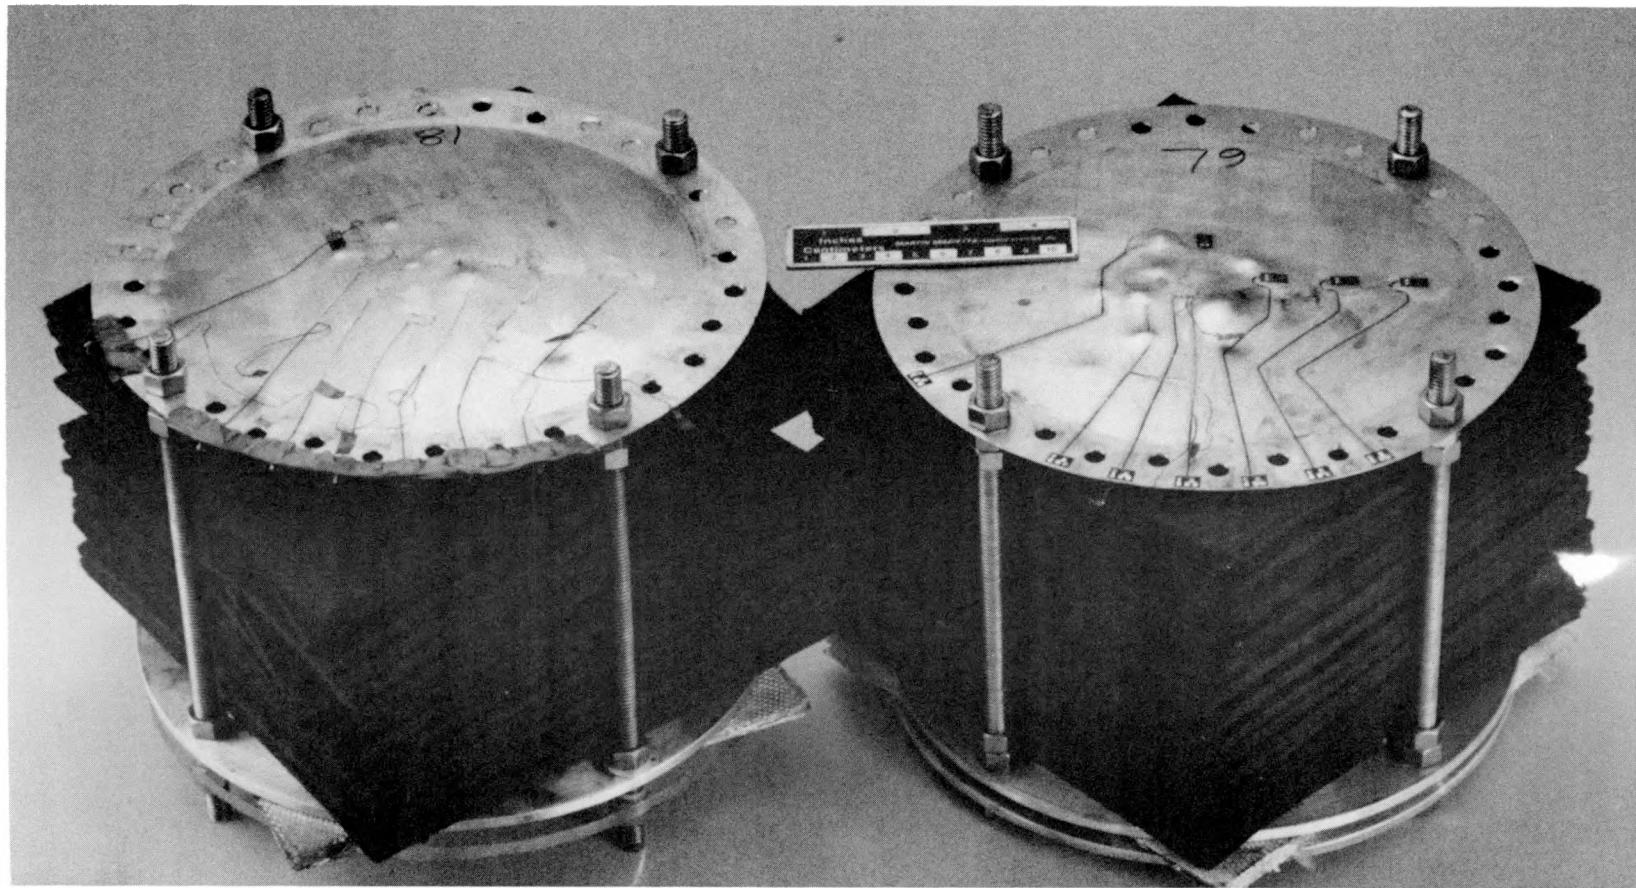
ORNL PHOTO 8247-89

Shield 79. The back plate damage produced by this shot was very similar to the damage for shields 69 and 71, consisting of a slight overall bulge with several smaller bulges. This is shown in Figure 15.

Figure 15. Back plate damage for shields 79 and 81

Shield 81. This back plate is also shown in Figure 15. As a repeat of shield 79 at higher velocity, the two are compared. The overall bulge of shield 81 is more pronounced, there were still several small bulges produced, and the small bulges tended to be smaller for shield 81 than shield 79.

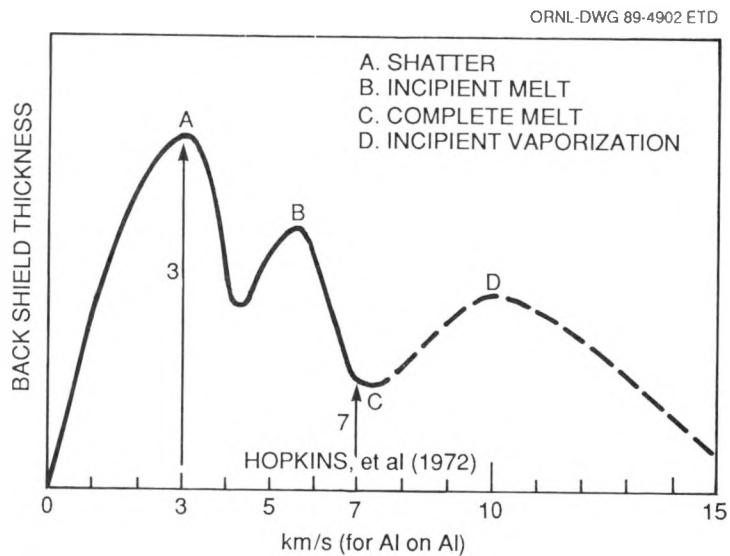
Test configurations and results for the 3 km/s study were, as mentioned previously, quite different from the 7 km/s work. An indication of the reason behind this phenomena can be seen in Figure 17, a graph of back shield thickness versus projectile velocity (Hopkins, et. al., 1972). These results are for layered shields. Figure 17 shows a very high damage peak near the 3 km/s velocity with a low damage area occurring in the 7 km/s region. The breakup of the projectile and the state of the projectile debris cause the different damage levels shown in Figure 17, as indicated on the graph. The low hypervelocity region was therefore expected to be quite damaging, and the layered shields tested were configured accordingly.

Figure 17. Back plate damage versus velocity

As shown in Figure 17, the same section of the damage curve covers the ballistics region and the velocities around 3 km/s. Therefore, the ballistics area of shielding was researched as a possible starting point (Thomson, 1955; Wilkins et al., 1969; Goldsmith and Finnegan, 1971; Nicol et al., 1988). Referring again to Figure 17 and the appropriate section of the damage curve, the slope of this section is quite steep, indicating a rapid rate of increasing damage with the peak occurring shortly after 3 km/s. Thus the damage at 3 km/s would be much greater than at ballistics velocities and, with the materials properties transition previously mentioned to be considered also, the layered shield designs initially selected for testing were not merely heavy ballistics armor. Using ballistics-type armor, while it might lead to a successful shield in terms of performance, would not provide significant weight reduction.

According to previous research on the projectile velocity effect on layered shield effectiveness, as shown in Figure 17, a shield that is successful against a 3 km/s threat should be successful against the same threat at 7 km/s, since damage level at 7 km/sec is much lower. The results of Figure 17 are for tests using identical front shields and measuring back plate damage. However, the effect of a too-thick single-layer front shield is known to be damaging at the 7 km/s velocity (ORNL staff, 1989), and dual plate front shields have not been extensively studied at the higher velocity. For these reasons, the lightest of the successful shields against the 3 km/s threat was tested against the same projectile at 7 km/s. This was shield 81. The weight reduction for the same shield stackup but a different reference shield was considerable, down to 16.7%. This is in comparison to the

The damage to the shield was extensive, even though the back plate did not fail. This indicates caution should be used in applying the damage curve of Figure 17. The variation in the front plate configuration is very important and could more than override the lesser damage potential.

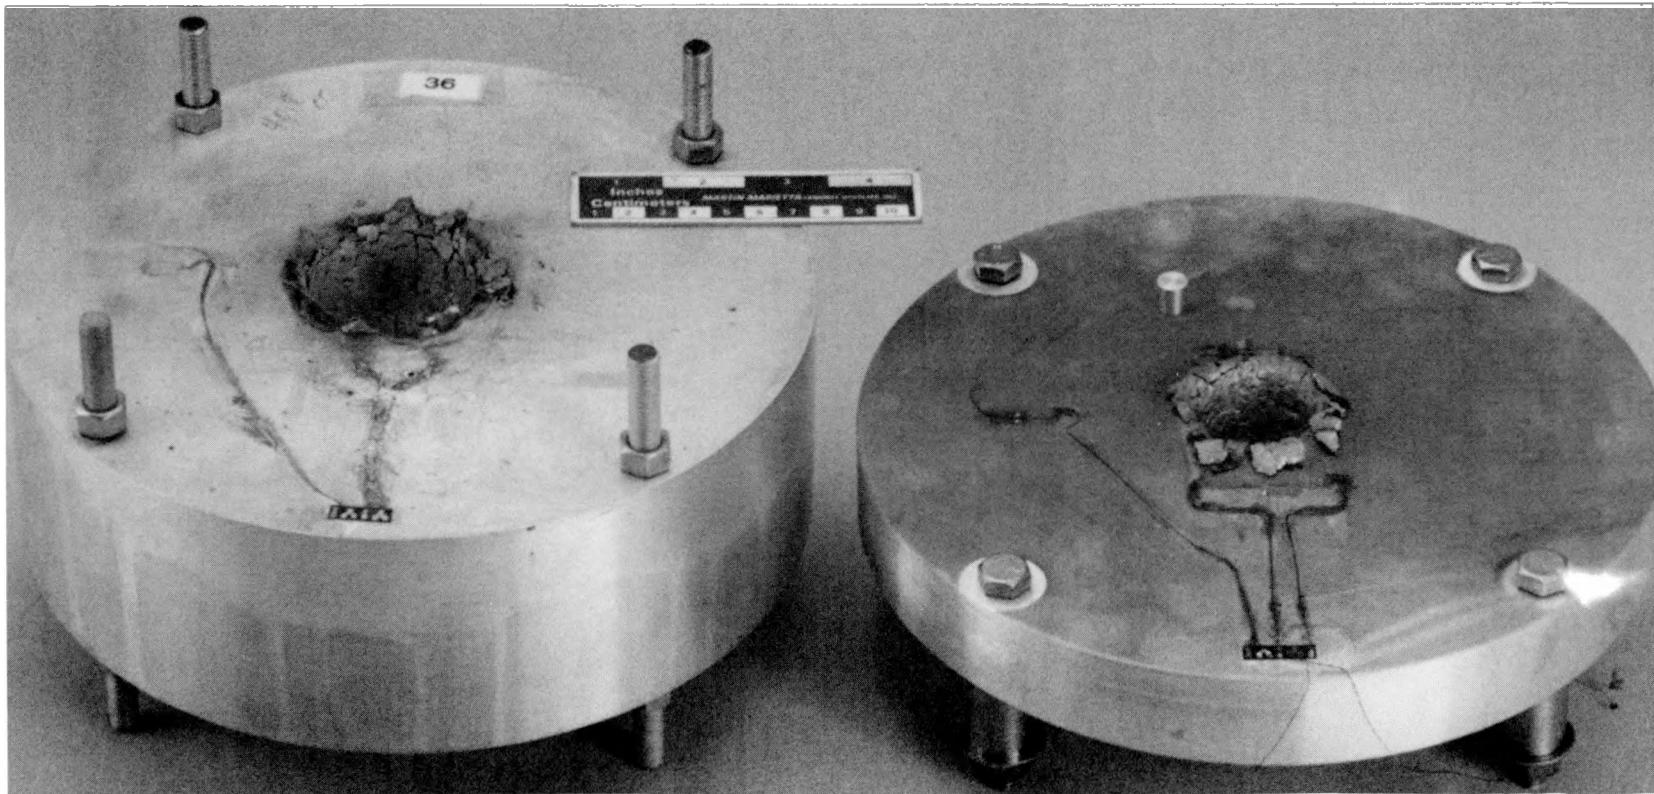
ORNL PHOTO 8252-89

energy as the governing factor in the solid aluminum shield thickness, the 3 km/s reference shield is much thinner than the 7 km/s reference shield. This is shown in Figure 18, which contains both the 3 and 7 km/s reference shields. Comparing the two, the 3 km/s reference shield is 3.175 cm thick (areal density = 8.636 g/cm<sup>2</sup>) while the 7 km/s reference shield is 7.870 cm thick (areal density = 21.406 g/cm<sup>2</sup>). The 3 km/s shield is 40.3% of the weight for the 7 km/s shield. (As a side note of interest, this comparison is limited to the impact of aluminum projectiles onto aluminum shields. Factors other than projectile energy must be considered for solid shields and projectiles of different materials.)

Figure 18. Reference thickness solid shields for 3 and 7 km/s

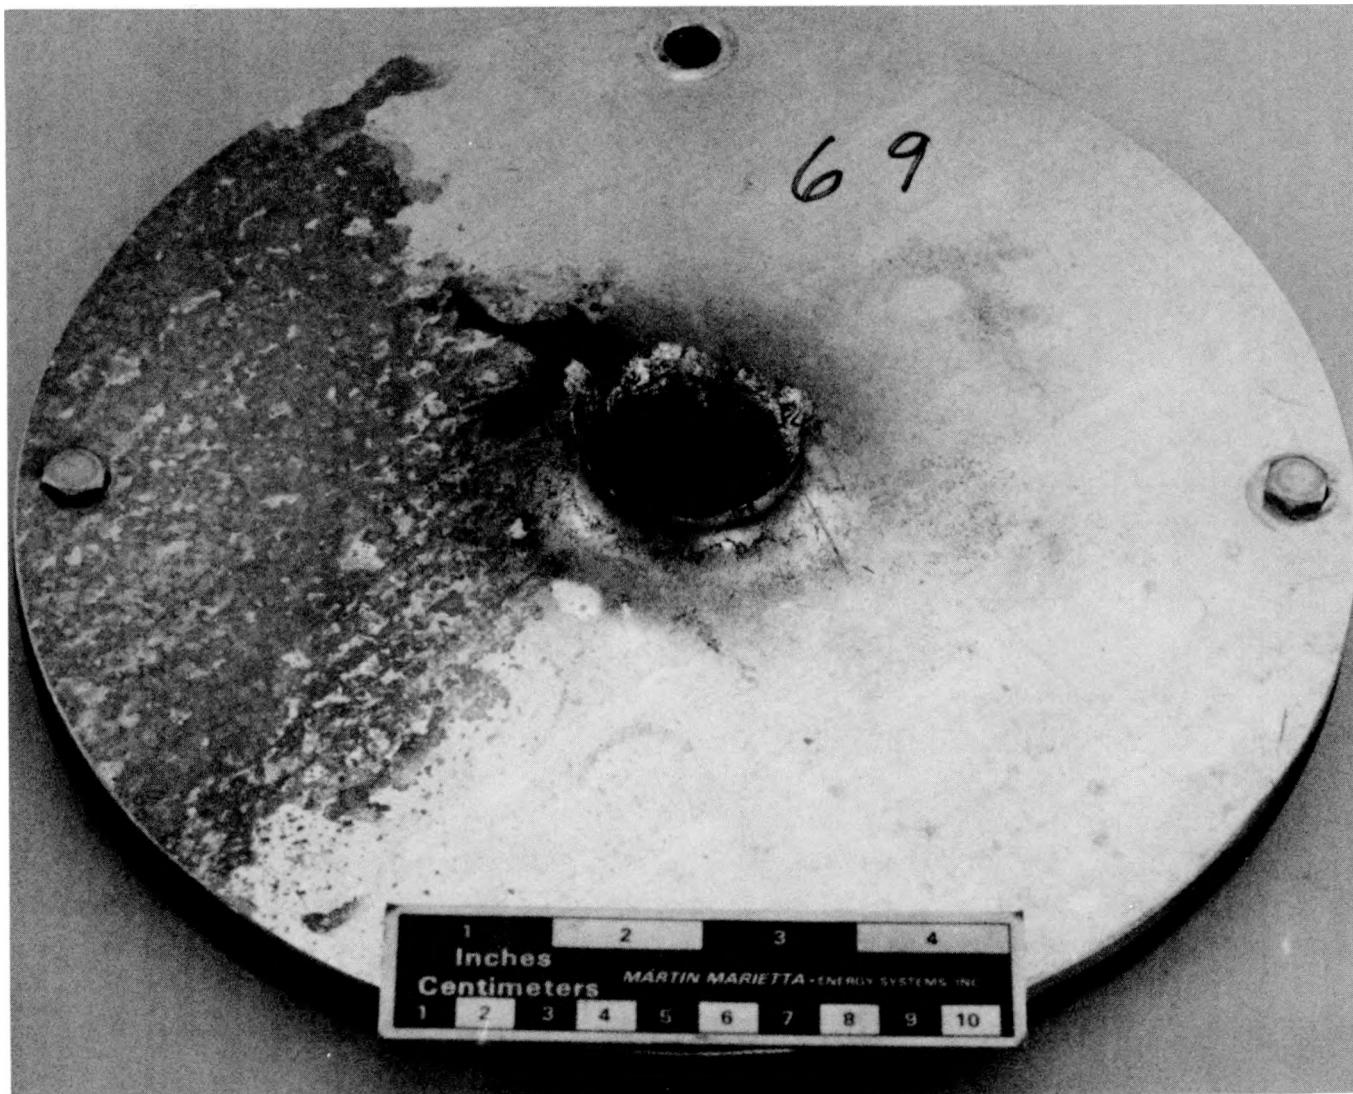
Figure 19. Shield 69 B layer, exit side

In discussing shield 69, several points are of interest. The A layer, while it had a large hole, was not fractured at all, and there was very little ejecta produced. Significant amounts of the incoming energy can be converted to kinetic energy of ejecta, with smaller amounts expended in fracture energy (Nicol et al., 1988). For this shield, almost no energy was absorbed this way. The B shield was somewhat dished back, with a large, axisymmetric hole produced; i.e., the front side was smooth, with no lip, while the exit side of the plate was extended into a tapering lip. This exit lip was slightly turned outward but not enough to describe as petaled. The exit side of shield 69's B plate is shown in Figure 19. From Thomson (1955), this type of hole requires 2.66 times less energy to produce than a symmetric hole having a material lip formed upon both the entry and exit

sides, as characteristic of the hypervelocity impact front plate holes. The axisymmetric hole is very typically found in backup plates used in ballistics testing. However, the energy expended in forming this type hole is significant, with incoming kinetic energy being used in the bending of the plate (Nicol et al., 1988). The creation and velocity of spall particles found in the disrupter layers also used a significant amount of energy. This energy was absorbed partly by the disrupter, from the large number of particles found in the layers and partly by impact on and deformation of the back plate. The shape of the blast profile in the disrupter is significant in that it is most similar to the shape of the blast profile for shield 78 (both are shown in Figure 12). Shield 78 did not have an A layer; the projectile impacted directly onto a metal surface. The similarity between the two, combined with the fact that shield 69 has the shortest travel time of the three setups with identical B plates, indicated that the A plate for shield 69 was not particularly effective. The disrupter layers were effective in slowing and stopping significant amounts of debris. Also, the back plate completely stopped all impacting debris and was not seriously deformed, indicating at least some degree of underutilization.

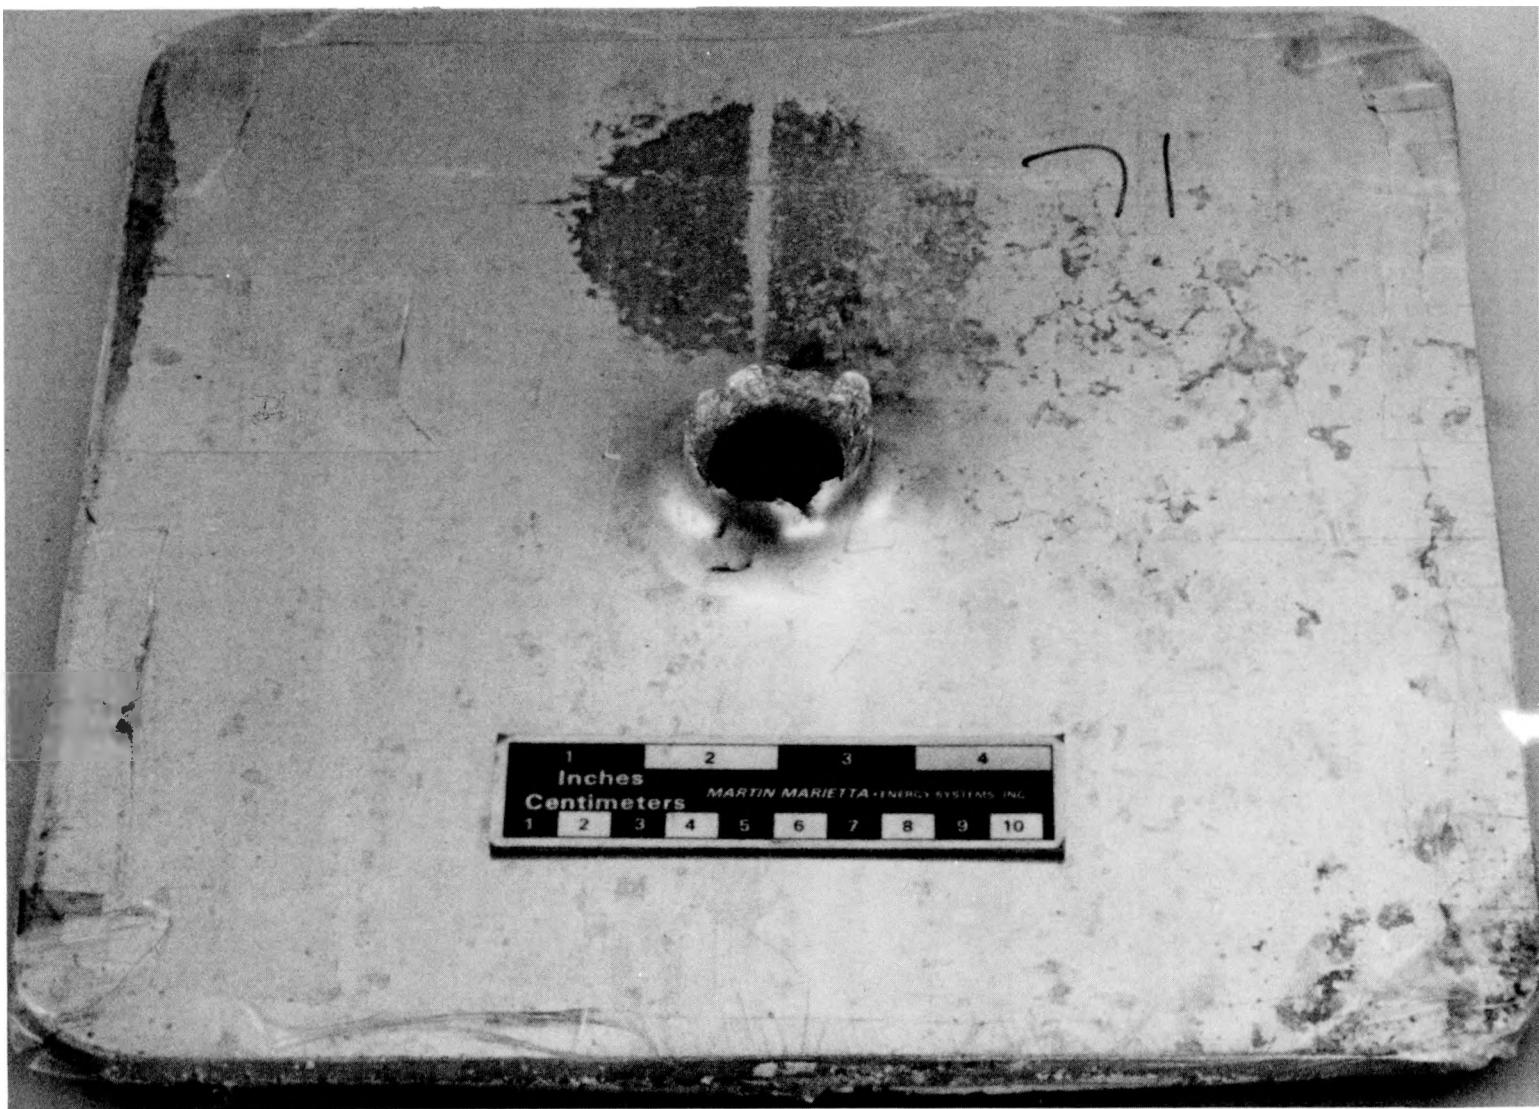
Figure 20. Shield 71 B layer, exit side

Results for shield 71 were similar to those for shield 69 in some ways. The type of hole formed in the B plate is very similar with the hole for 71 being just slightly smaller. The B plate for shield 71 is shown in Figure 20 from the exit side. Again, the disrupter was effective in stopping significant amounts of debris. The back plates were also very similar in the amount of energy absorbed. However, major differences can be seen in the front plates and there is a noticeable difference in the shape of the blast damage profile in the disrupter. The A plate was extensively fractured, especially in the region around the hole, with a significant amount of ceramic ejecta produced. This indicates that more energy was used in penetration of the A layer. The similar performance of the B layers is expected as they are identical in both material and thickness.

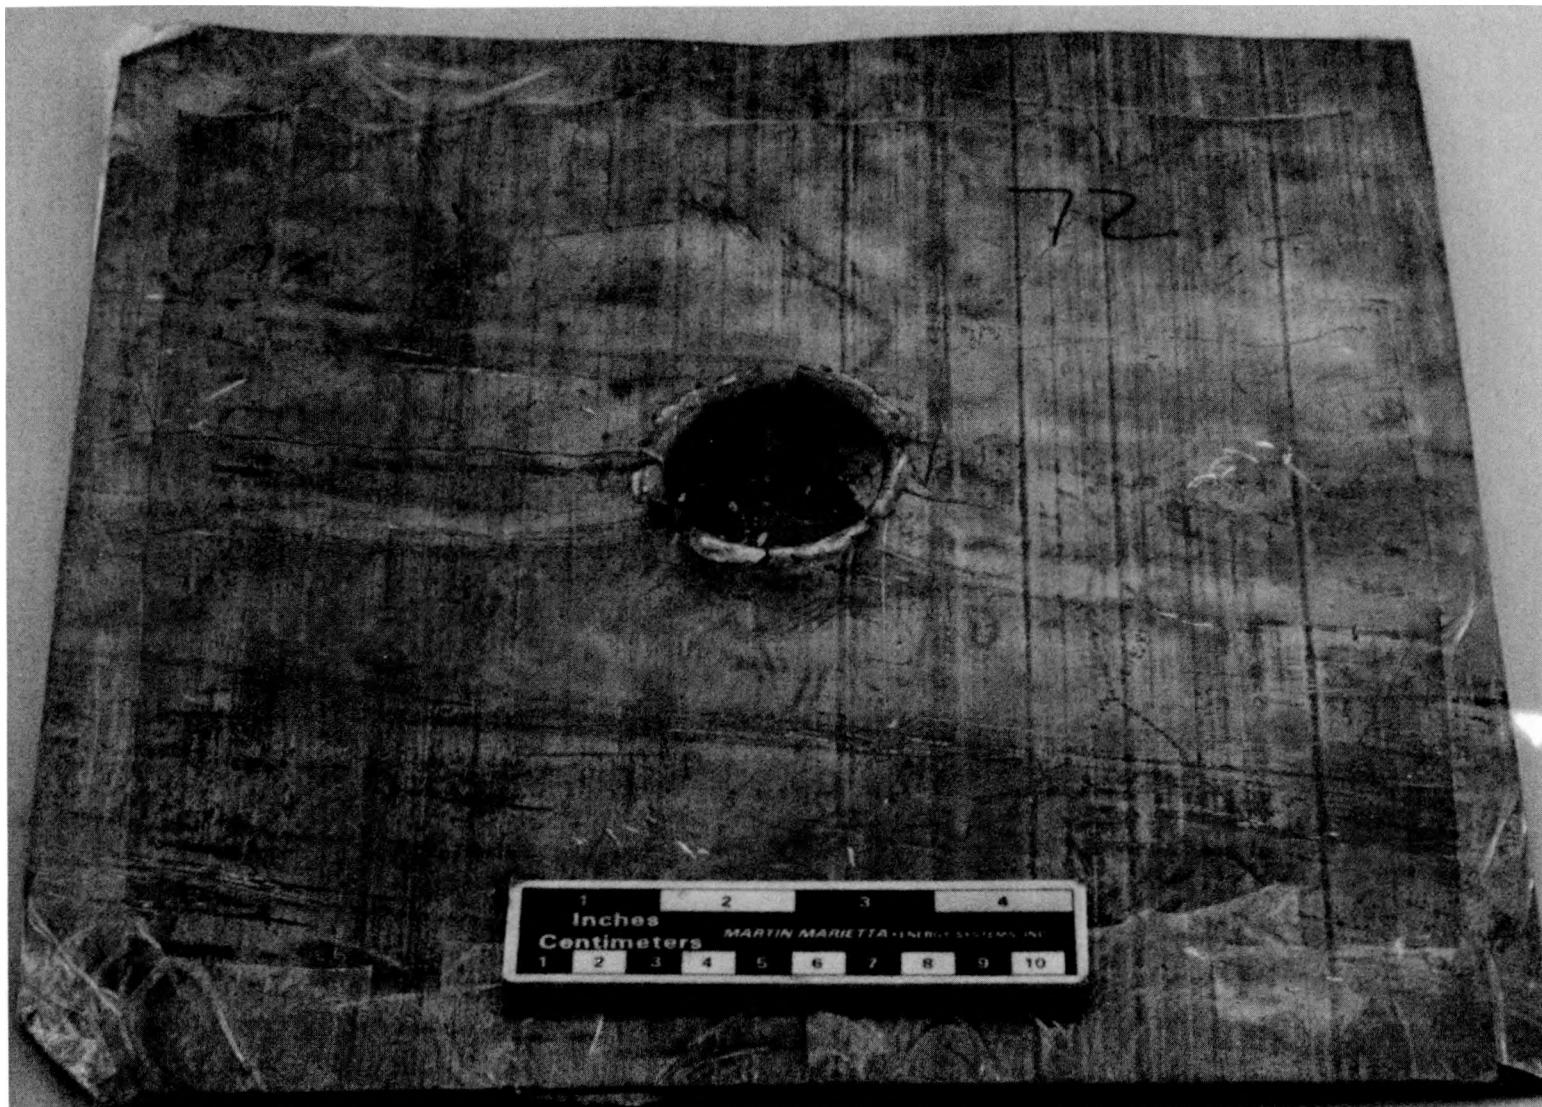
The A plate results for shield 72 were similar to those of shield 71, since both shields used the same type A plate. Less fracturing and less outward ejecta were produced by shield 72. While less ceramic debris was produced overall, more of the ceramic debris traveled into the shield. Thus a significant amount of kinetic energy was transferred to plate debris, but the travel direction differed. The disrupter and back plates were again quite effective, if possibly underutilized. A note of interest concerning shield 72 is the "ring" of damage from the lead found in the disrupter, referring again to Figure 12. This corresponds well with the hypervelocity work of Piekutowski (1987), who reported on the debris cloud material distribution from hypervelocity impact. Material from the front shield would be expected in the outer regions of the blast damage, which is where the lead fragments were found. In evaluating the relative performance of the shield components, the lead B plate did not perform as well as the aluminum plates, despite its equal areal density. The soft, weak lead allowed the ceramic to break away from the projectile rather than forcing the projectile to fracture, compress, and travel through the ceramic. This point is further supported by the fact that the travel time for shield 72 is less than for shield 71 and approximately the same as for shield 69. The lead plate was not dished to any significant degree with relatively little energy absorbed in this way. The exit side of the lead hole also differed from the aluminum plate results, having a lip that had curled around until it could be described best as petalled. This is shown in Figure 21.

Figure 21. Shield 72 B layer, exit side

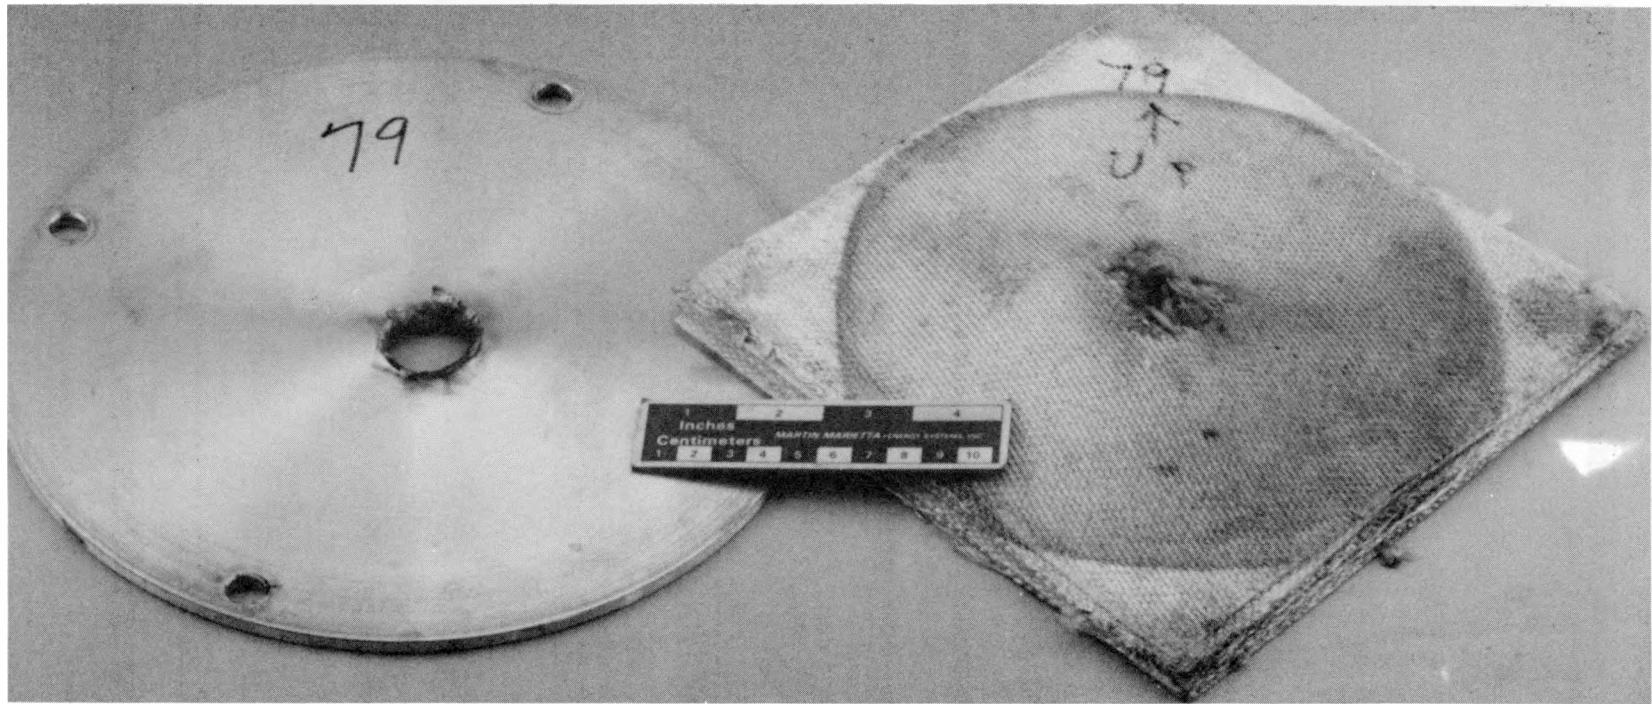
ORNL PHOTO 8238-89

Shield 79 was an A/B type front plate stackup. Both front plate layers are shown in Figure 25 with the entry side of the A layer and the exit side of the B layer visible. The A layer was damaged over a relatively small area, and there were essentially no ejecta. The B layer was only very slightly dished, unlike the previously tested B layers. The disappearance of dishing corresponds to an increase in projectile speed (Goldsmith and Finnegan, 1971). Since the initial impact speed was the same, the projectile velocity was reduced less across the A layer of 79 than the other A layers tested. This phenomenon is also evident by the axisymmetric appearance of the hole in the B layer, as the hole has a definite lip on the entry and exit sides. The exit hole lip is no longer extended and tapered as in the previously discussed plates. The exit hole side lip is more irregular than the entry side, having debris particles only partially separated still on the rim. The appearance of the B layer indicates the projectile debris penetrated the B layer at a higher velocity than for the previous shield B layers. Also, the axisymmetric type hole formed required more energy (Thomson, 1955). The disrupter layers again were effective in slowing and stopping significant amounts of debris, as was the back plate. The travel time from front to back impact was less than for the four previously tested A/B type shields, which all had both thicker and heavier A and B plates. A complete set of flash x-ray data was obtained for shot 79 and is shown in Figure 26. These data for distance versus time, also in Table 3, indicate a good velocity reduction across the front plate. Large pieces of high density debris are visible, matching the aluminum debris fragments found during posttest disassembly. The A/B combination used was effective, but the individual contributions of the two layers are not well defined. A significantly greater amount of energy was absorbed by the B plate, as previously discussed. However, the travel time for shield 80, which had

Figure 25. Shield 79 A layer, entry side, and B layer, exit side

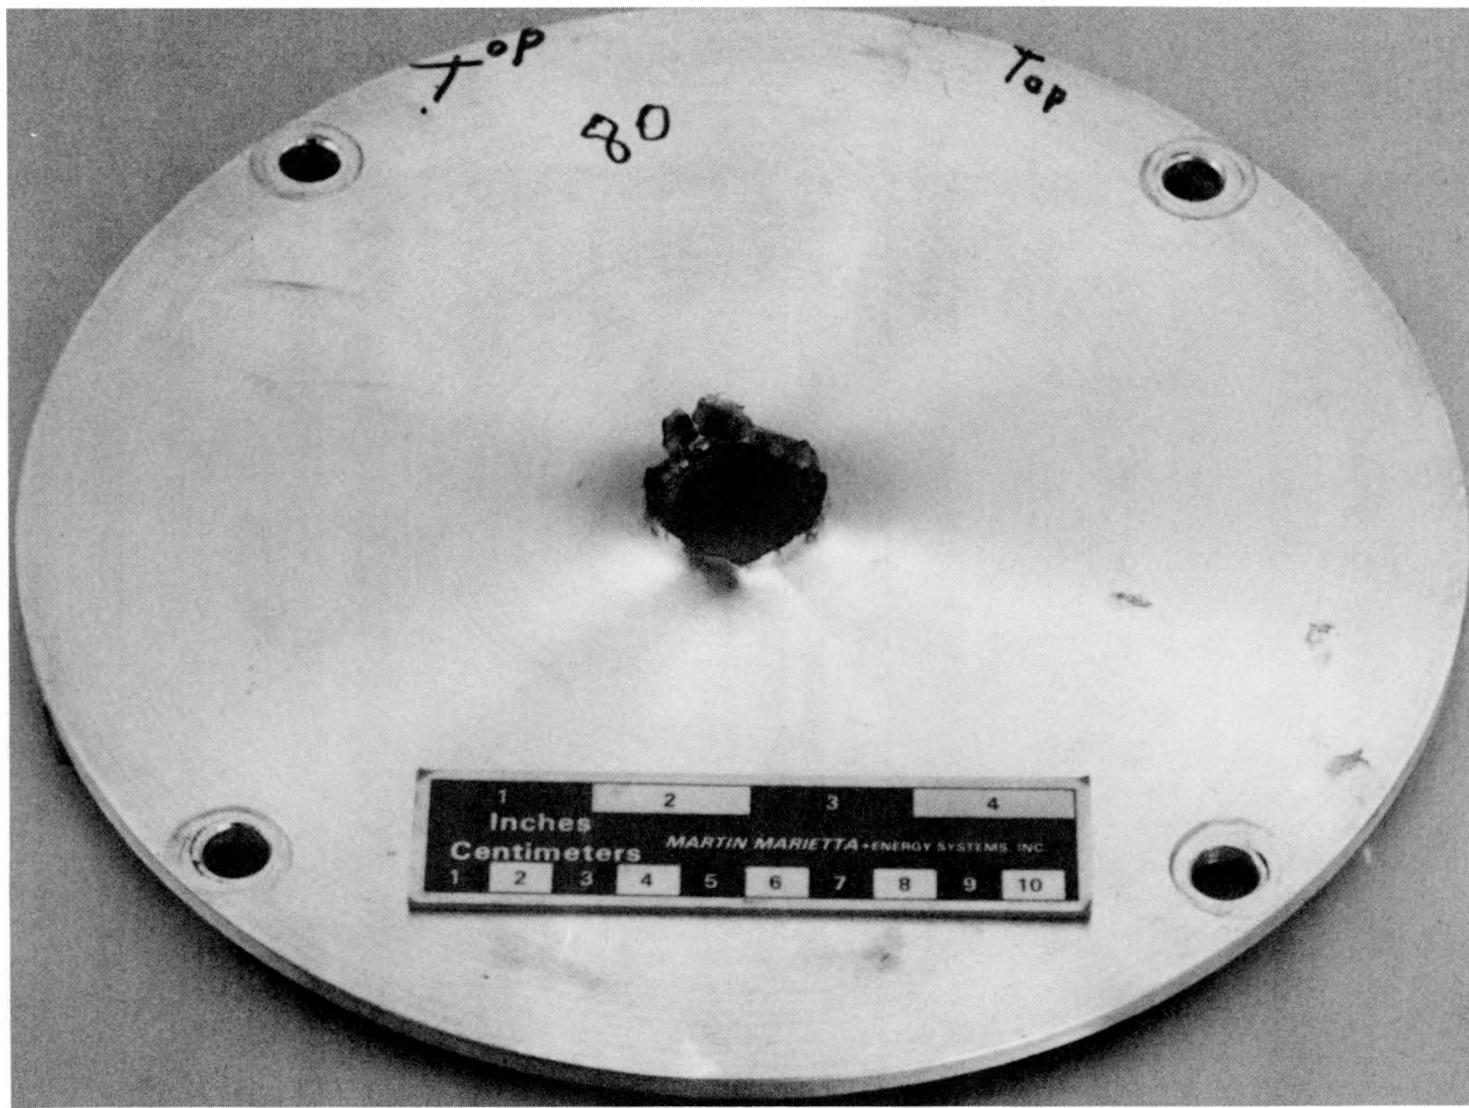
In the evaluation of the different layers of shield 80, the A layer, as mentioned previously, was very fractured and considerable ejecta were produced using projectile energy in the process. The B plate, shown on the exit side in Figure 27, was very definitely dished and had no lip on the entry side, with a small, tapered lip on the exit side. The combined effect of this A/B plate configuration was not as effective as that of the previous shield. This can be seen from the flash x-ray data and the back plate failure for shield 80. Flash x-ray data for test 80 is shown in Figure 28 and in Table 3. These data show the lesser velocity reduction and slightly higher density debris for shot 80 as compared to shot 79. Considering the energy distribution and layer utilization of shield 80, it is thought that the A layer was too heavy, either too thick or too dense, and that a performance improvement would result if the A layer were lessened. This would shift more of the load to the B plate and thus use it more effectively, while also reducing shield weight. Again, the disrupter and back shield were effective; the back shield was overloaded due to the front plate configuration. Increasing the back shield would also improve this configuration's performance but would be inefficient in terms of weight.

Figure 27. Shield 80 B layer, exit side

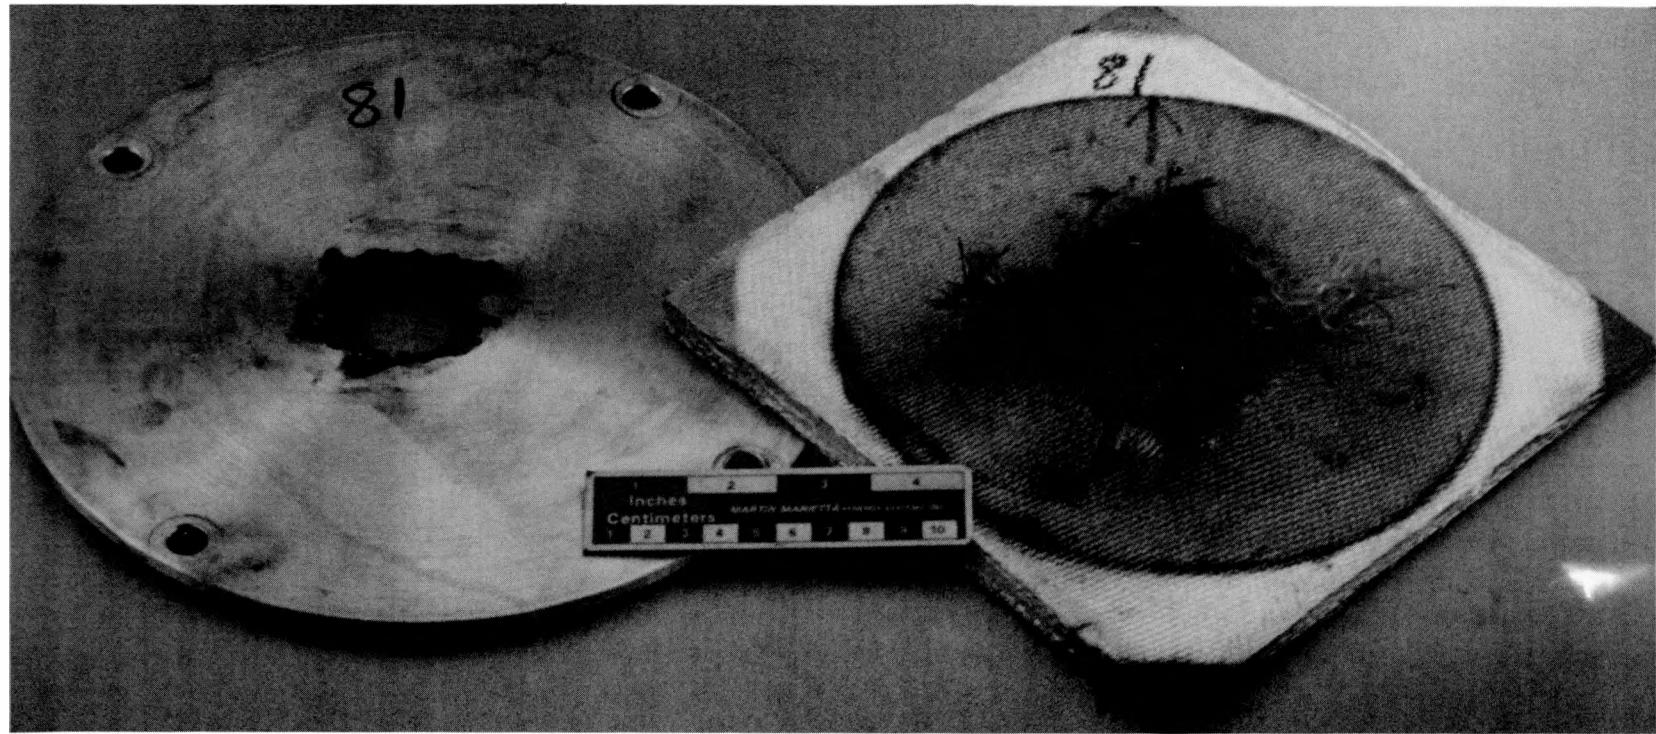
Comparing shield 81 with shield 79, the damage to the A and B layers of shield 81 was much greater than for shield 79. The entry side of the A layer and the exit side of the B layer are shown for shield 81 in Figure 29. The greater level of damage can be seen by comparing Figures 25 and 29. A much larger hole with significantly more frayed cloth surrounding it was produced in the A layer of shield 81. In the B layer, the hole was also much larger than for shield 79. The appearance of the B layer holes was quite similar. The lip on the entry side of the B layer of shield 81 was more pronounced, and there was no dishing at all. These phenomena correspond to the higher velocity and energy level of the 7 km/s projectile. In the disrupter layers, the blast was much more spread out, as shown in Figure 12. The blast did more damage to the disrupter layers with large sections blown completely out of the shield 81 stackup. Flash x-ray data for shot 81 is shown in Figure 30. From this data point and the back plate data for travel versus time, the debris cloud was definitely traveling very rapidly, in comparison with the debris cloud of shot 79 (Table 3). However, the velocity reduction across the front plate was quite large, as a typical travel time for a successful 7 km/s shield is approximately 50  $\mu\text{sec}$ , versus 95  $\mu\text{sec}$  for shield 81. By comparing the debris cloud for shot 81 (Figure 30) with the debris cloud for shot 79 (Figure 26), it can be seen that the debris in the high velocity cloud of shot 81 is generally of lower density. The back plate was more bulged overall, indicating a significant blast wave loading.

Figure 29. Shield 81 A layer, entry side, and B layer, exit side

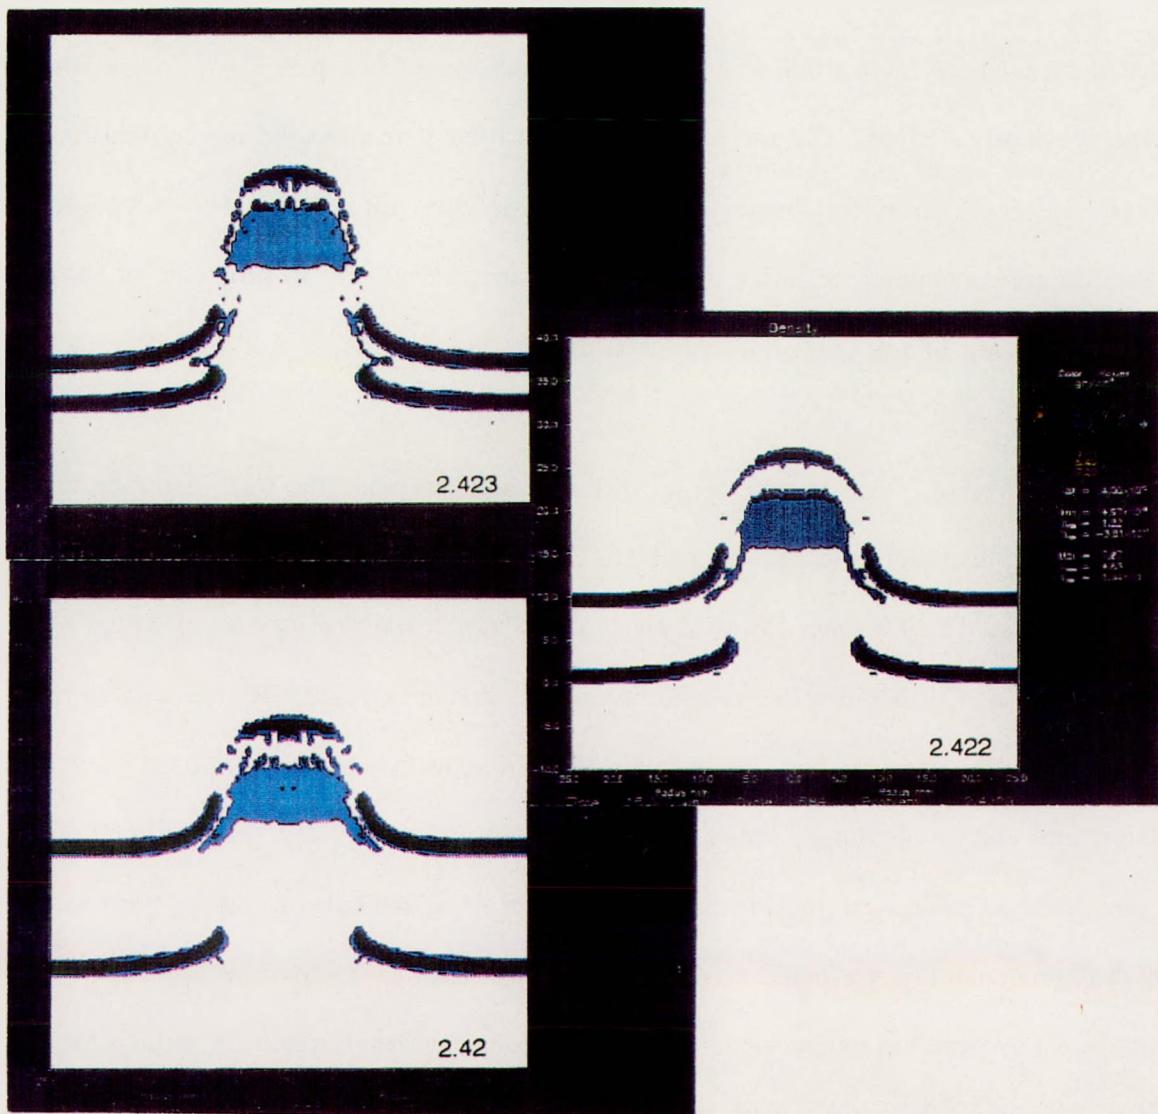
Analytical work included a short study of two closely spaced ceramic front plates to determine if shock wave reinforcement could be achieved and, thus, provide projectile breakup. Three cases were studied; Figure 35 shows the results for these cases at 15  $\mu$ sec. As can be seen in this figure, the projectile did not break up for any of the three configurations run. However, two advantages were seen in the dual front plate configuration. First, the velocity of the projectile was reduced by about 25% from the single plate configuration (Table 4). Also, the amount of front plate debris

Figure 35. Results at 15  $\mu$ sec for the spaced ceramic front plates

ahead of the projectile was less for these configurations than for the single ceramic plate configuration. This can be seen by comparison of Figures 35 with Figure 34, which shows the results of problem 4.52 (the single ceramic plate.)

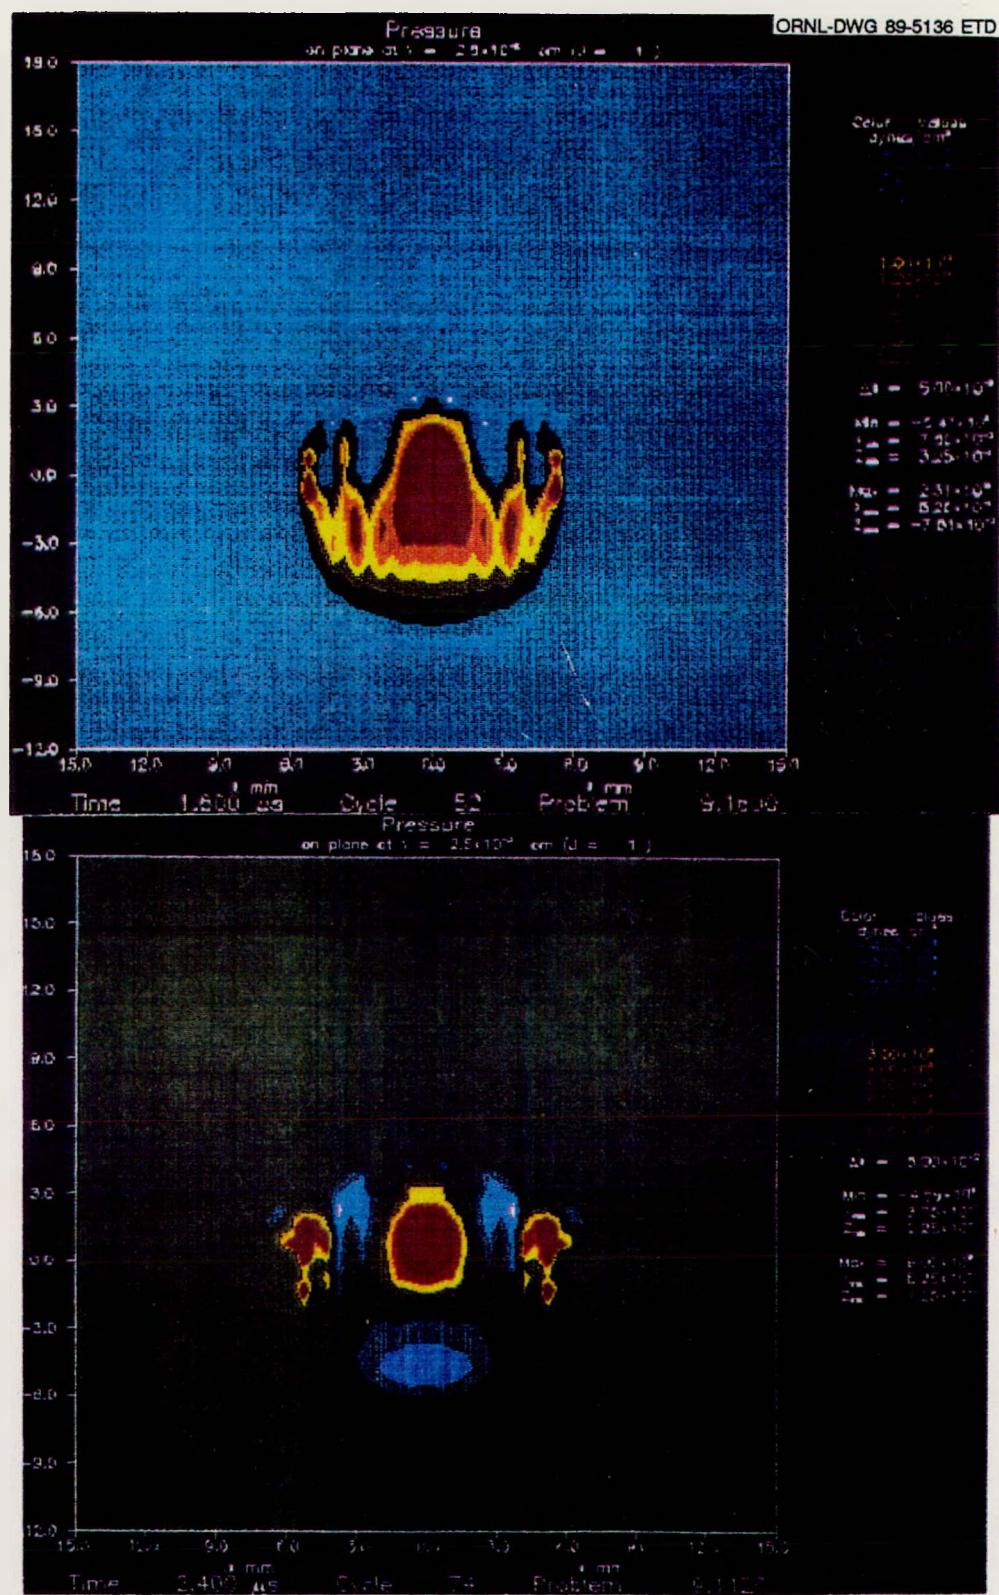
Figure 37. Pressure plots for problem 9.112 at 2.4  $\mu$ sec and problem 9.16 at 1.6  $\mu$ sec

of the ensuing projectile breakup for problem 9.16. In contrast, for problem 9.112 at 2.4  $\mu$ sec, three separate and smaller high pressure areas are visible. Projectile breakup was poor for this configuration. The results for problem 3.15, the tantalum projectile into the closely spaced tantalum wire, were very similar to those of problem 9.16. It is significant to note that these results were for a spherical projectile. With the projectile breakup dependent upon the compression wave interaction set up by the initial contact phenomena, it is logical to predict that the breakup of a cylindrical projectile would require a differently configured front shield.
