ORNL/TM-11382

## **Shield Design, Analysis, and Testing Against a 3 km/s Projectile**

**DEFENSE AND SPACE PROGRAMS**

Prepared for  
U.S. Air Force Weapons Laboratory  
Kirtland Air Force Base  
Albuquerque, New Mexico  
under Interagency Agreement DOE No. 40-1663-A1

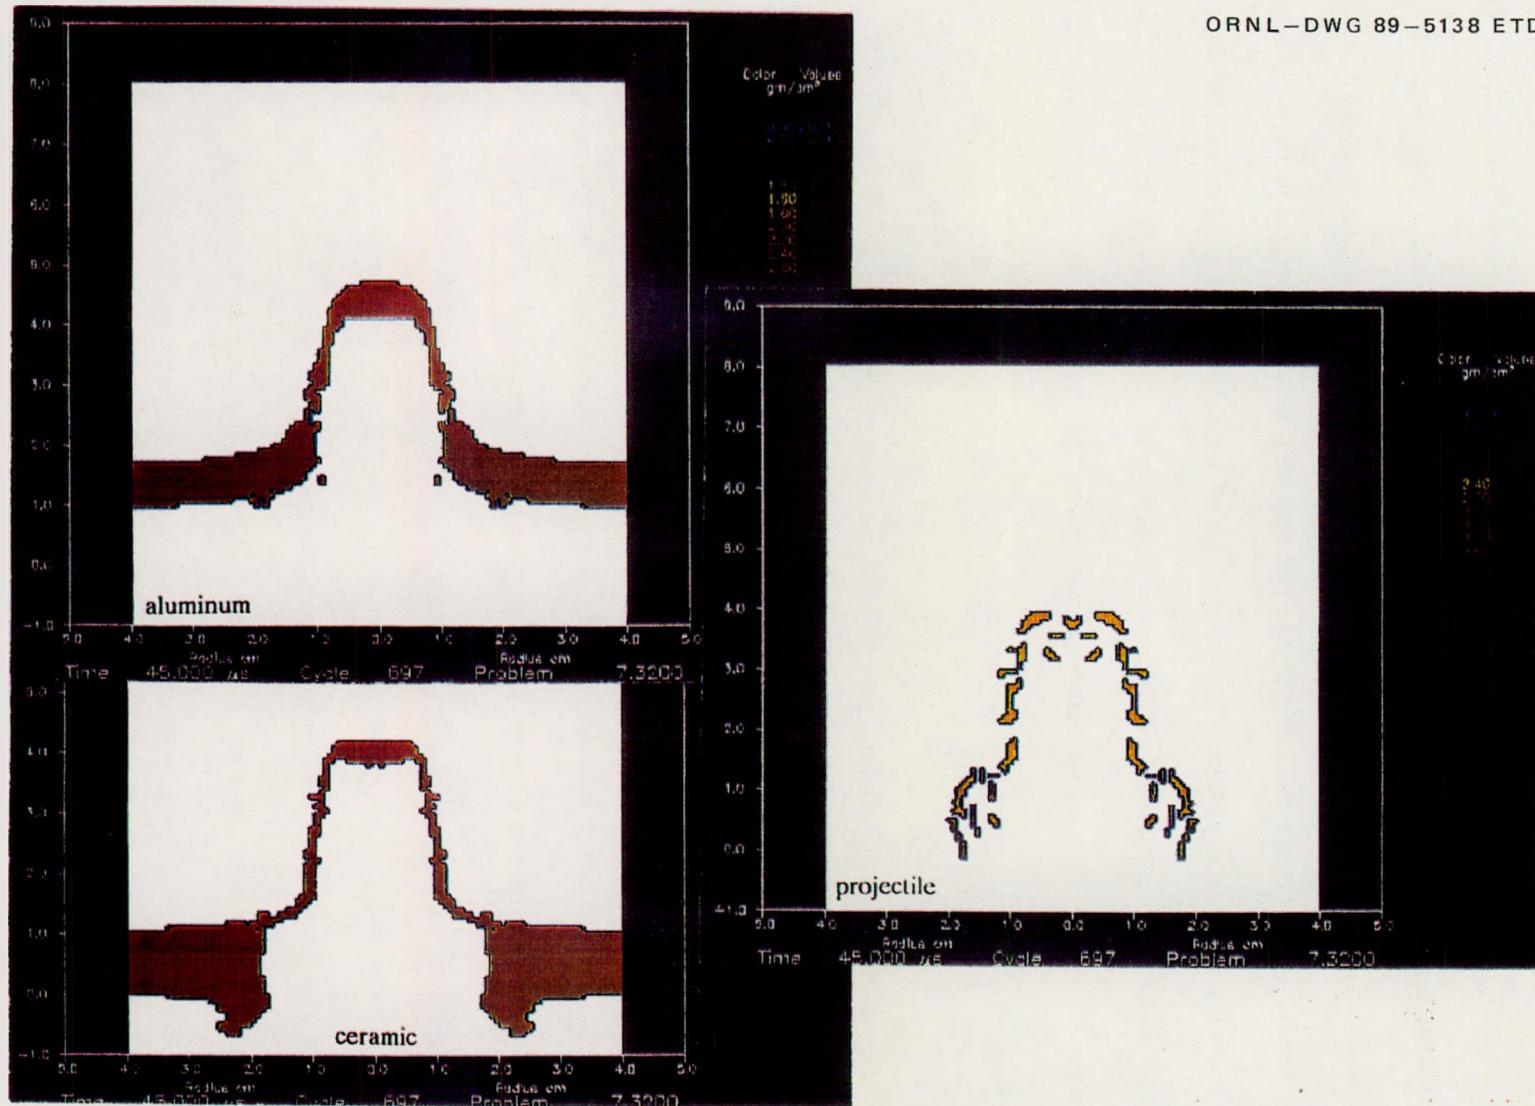
Figure 39 shows the same problem at the same time, but the components are separated onto separate plots. From these plots, further notes of interest are the large amount of ceramic traveling into the shield and the good breakup of the projectile. While not visible from a density plot, the velocity reduction across the front plate was also significant, down to 0.68 km/s.

Figure 39. Individual component density plots for problem 7.32 at 45  $\mu\text{sec}$
