Effects of Oblique Impact on Hypervelocity Shield Performance

DEFENSE AND SPACE PROGRAMS

DATE PUBLISHED - JANUARY 1990

Prepared for
U.S. Air Force Weapons Laboratory
Kirtland Air Force Base
Albuquerque, New Mexico
under Interagency Agreement DOE No. 40-1663-A1

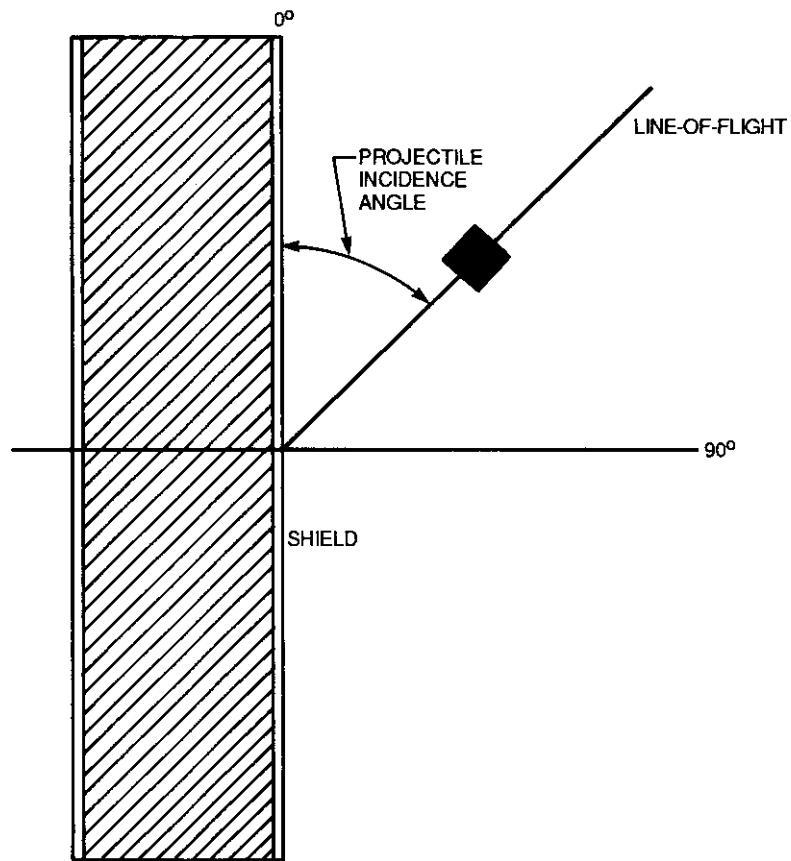
Figure 1. Angle nomenclature

the projectile incidence angle. The angle, as shown, is measured between the projectile line of flight and the surface of the front shield. The projectile used in shield testing was an aluminum cylinder with a mass of 1.75 grams and a length to diameter ratio of one. The impact velocity was 7 km/s. Testing consisted of firing a cylinder, as described above, into a layered shield assembly. For each test, the impact velocity was held constant at 7 km/s, but the orientation of the shield with the projectile line of flight was changed to provide the different incident angles. Shield hardware assemblies for the tests were identical, leaving the incidence angle as the sole variable. Experimental procedures, test hardware, and test results are covered in the correspondingly entitled report sections.

Schonberg et al. (1988) conducted oblique impact tests of aluminum spheres on aluminum plates at velocities from 5.0 to 7.5 km/s. The ratio of plate thickness to projectile diameter was from 0.20 to 0.33. This study included considerable analysis of the damage caused by debris generated which traveled external to the shield, called ricochet damage. One conclusion of this study was the existence of a critical angle, below which the damage was primarily external to the shield. Above this angle, closer to the orthogonal impact case, damage was primarily to the back shield. This angle was estimated to be between 30° and 25°, using the convention of Figure 1. Again, further research was recommended.

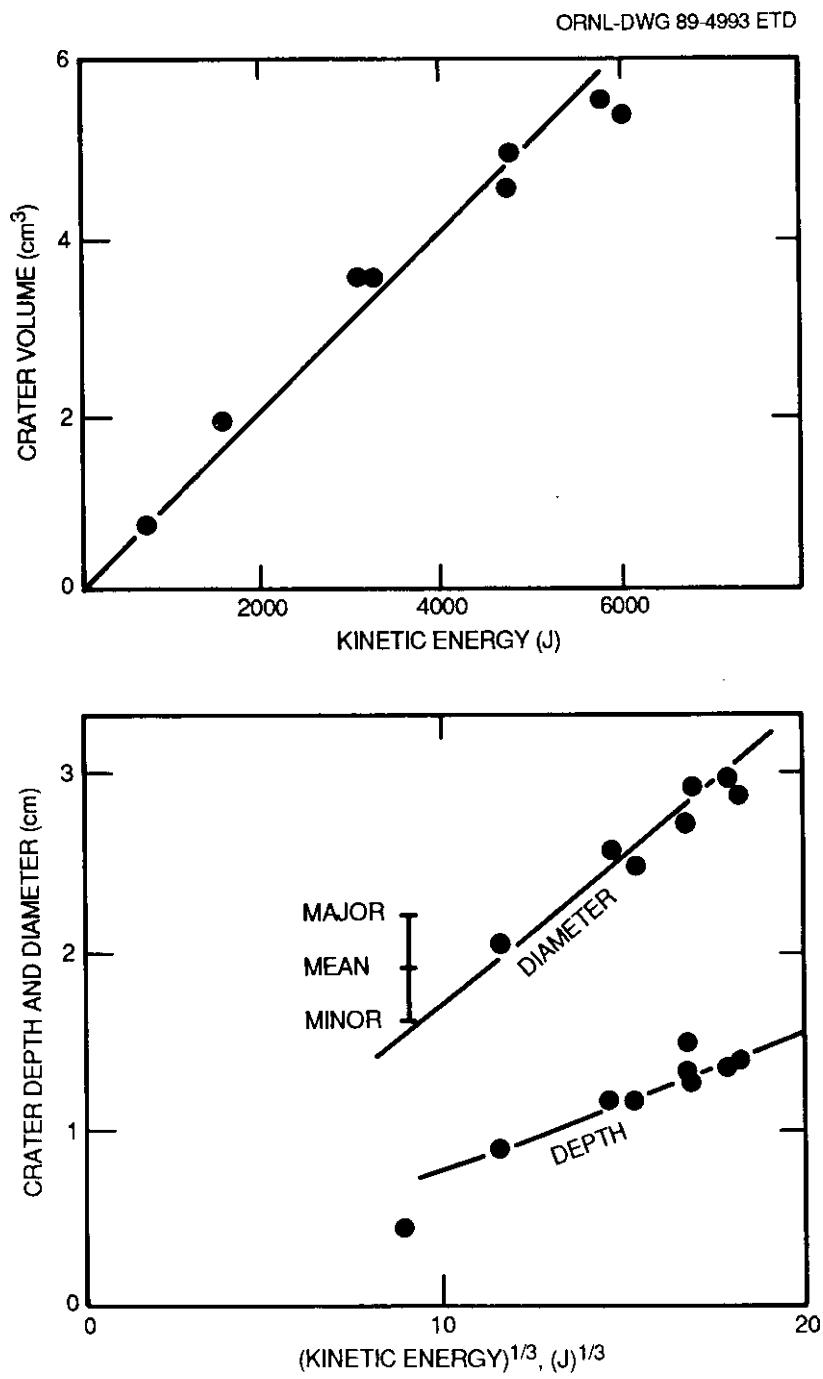
Hypervelocity projectile impact into semi-infinite aluminum targets was studied by Cable (1965) for incidence angles from 20° to 90°. As the incidence angle decreased from 90° to 20°, crater depth, diameter, and volume all decreased. Incoming projectile kinetic energy can be divided into two components, with one component parallel and one component perpendicular to the target surface. Crater volume was shown to be proportional to the perpendicular, or normal, component of the projectile kinetic energy. Since the craters formed were essentially hemispherical, both the crater diameter and crater depth were proportional to the cube root of the normal component of the kinetic energy. These results are shown in Figure 2.

Figure 2. Crater parameters in semi-infinite aluminum (after Cable, 1966)

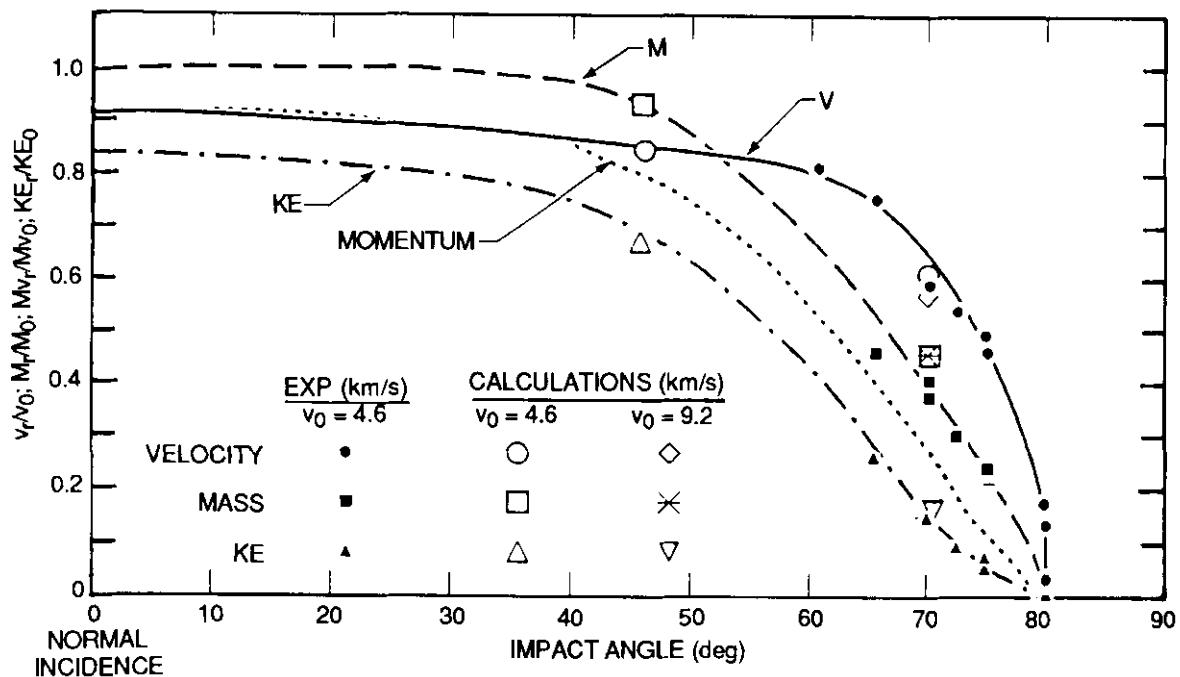
Debris clouds characteristics from oblique impact were studied by Orphal et al (1982) for the case of a stainless steel projectile onto a silica phenolic/aluminum composite. Target thickness to projectile diameter was kept constant at a ratio of 0.6, while the incidence angle was varied from 45° to 80° . These angles correspond to angles of 45° to 10° on Figure 1, as Orphal used a different convention and measured incidence angle from the shot line to a line normal to the target. For the conditions of the tests performed by Orphal et al. (1982), there was little reduction in the velocity of the debris cloud until the incidence angle was within 30° of the target surface. The velocity of the debris cloud was reduced to zero when the angle of the shot line was 10° , possibly indicating ricochet of the projectile. Reduction of the mass of material in the debris cloud began to be significant at an angle of 45° and also appeared to go to zero at an angle of 10° . These results are shown in Figure 3, again noting the different angle measurement convention.

Figure 3. Residual debris cloud characteristics (after Orphal, 1982)

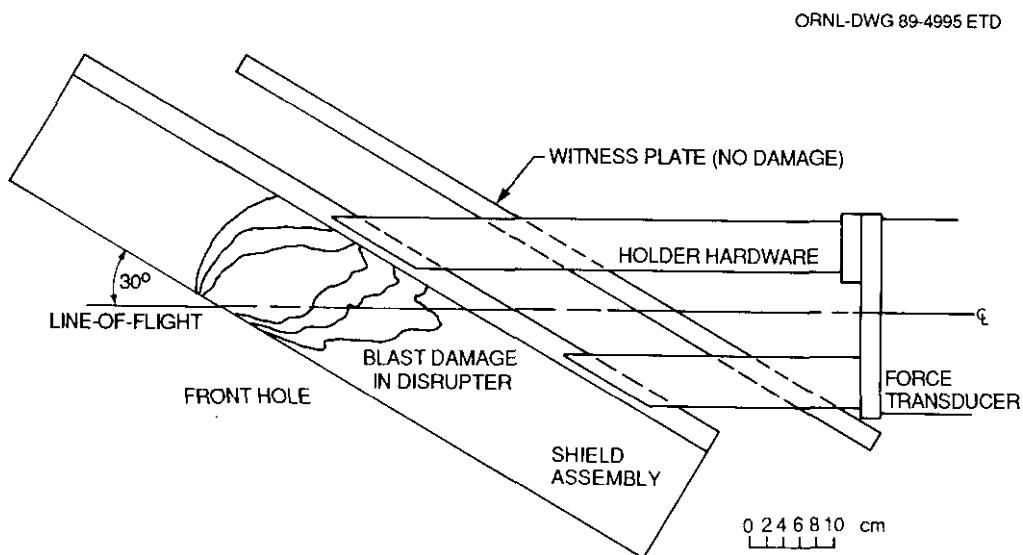
The ASP Program included four test series (Series 4 through 7) over a period of three years, 1987 through 1989. The four shots covered in this report were part of Series 4, shots 39 and 41, and Series 5, shots 61 and 62. Series 4 was conducted in late 1987 and Series 5 in early 1988. For shots 39 and 41, the projectile line of flight was perpendicular to the shield surface, providing a 90° incidence angle. The standard test hardware setup, as used in the earlier test series of the ORNL Fast Track Program (ORNL Staff, 1989), was used for these tests. For shot 61, the angle of incidence was 30°. The test setup and holder hardware arrangement are shown in Figure 4.

Figure 4. Test setup for shot 61

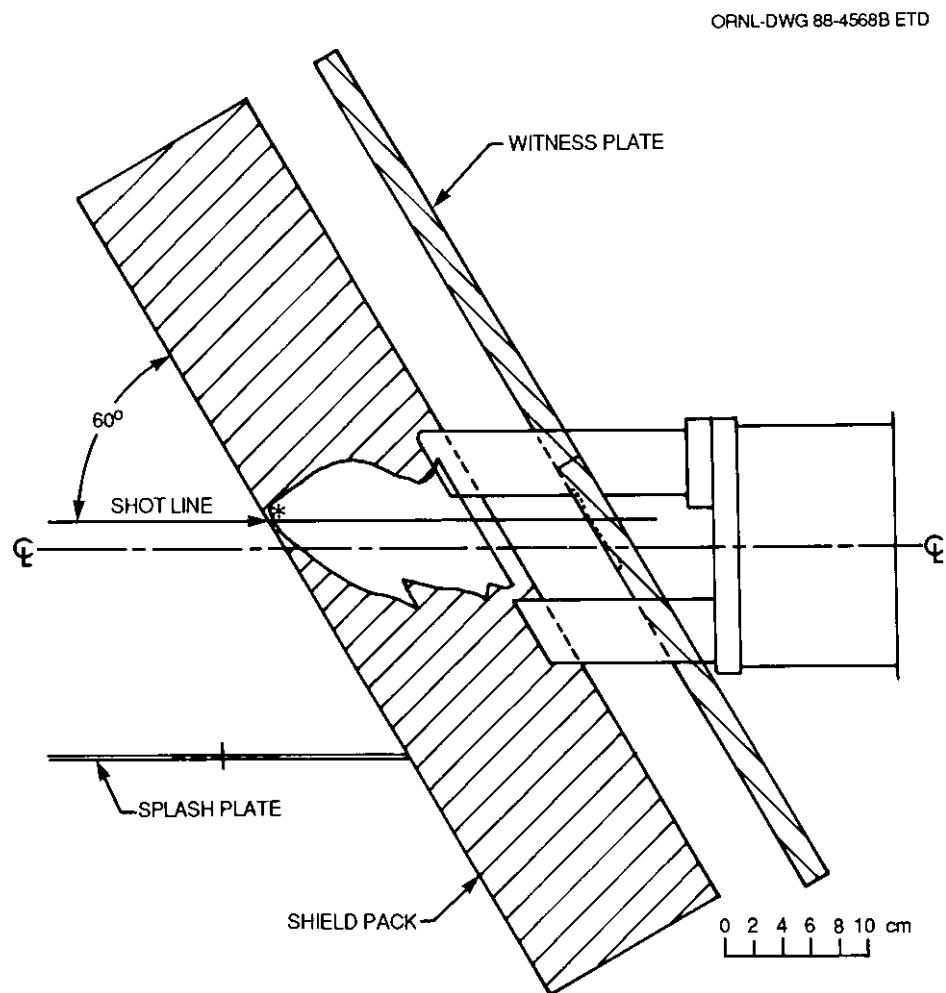
After shot 61, the holder hardware was changed. The setup for test 62, using an incidence angle of 60° , is shown in Figure 5. Impact velocity for both tests was 7 km/s. The projectile used was a 1.75 gram aluminum cylinder, with a length to diameter ratio of one.

Figure 5. Test setup for shot 62

Two normal impact shields are included in this study: (1) the homogeneous aluminum reference thickness to stop the aluminum projectile at 7 km/s with the back surface bulged but without spalling and (2) the lightest weight successful layered shield to stop the same threat. For the first of these two, shield 39, the solid shield was 7.87 cm of 6061T0 aluminum, areal density 21.4 g/cm². Shield 41 was composed of a 0.16 cm thick 2024T3 aluminum front shield, 0.97 gr/cm² carbon felt disrupter, and a back shield of 0.90 cm 304L stainless steel. With a 0.14 gr/cm² polyurethane spall catcher on the rear side of the back plate, the total areal density of shield 41 was 2.273 gr/cm². The shield hardware for shields 61 and 62 was identical to that of shield 41, with the exception of the omission of the spall catcher layer. [This layer was not necessary for the study of phenomena associated with oblique impact, primarily due to its location. For more information on the function and performance of the spall catcher layer, see the ORNL Fast Track Report (ORNL Staff, 1989).] Included behind the shields for shots 61 and 62, parallel to the back plate and 10.16 cm distant, was a 2.54 cm thick aluminum witness plate. These plates are visible in Figures 4 and 5. For shot 62, a "splash" plate was also included, to catch the debris generated external to the shield pack. This is shown in Figure 5.

can be seen from the spread of damage on the splash plate, shown in Figure 5. The setup for test 61 did not include a splash plate, so there is insufficient experimental data to fully discuss the generation and spread of the external debris.

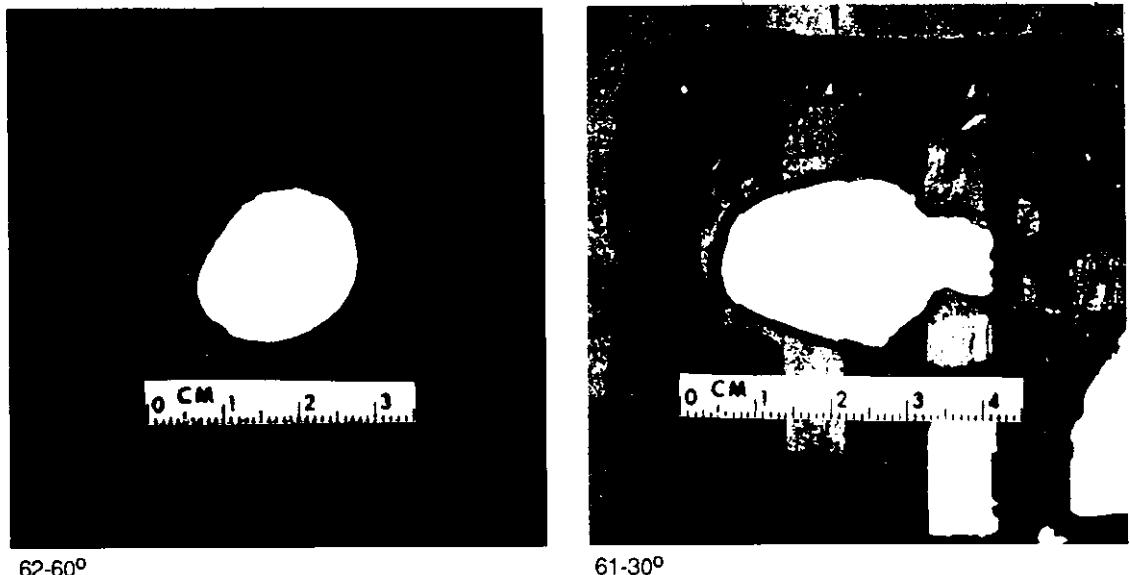
ORNL-DWG 89-4996 ETD

The front plate damage for shields 61 and 62 is shown in Figure 6. Front plate holes generated by oblique impact are dependent on the incidence angle as well as such variables as front plate thickness and projectile diameter. To study the results due to incidence angle effects only, the front plate hole produced by an oblique impact can be normalized by the front plate hole produced under the same conditions but with a 90° incidence angle. This was done for the data given by Schonberg et al. (1987), Merzhievskii and Urushkin (1980), and the results of another ORNL

Figure 6. Front plate damage for shields 61 and 62

1. The experimental results for front plate damage, previously shown in Figure 6, correspond well with the analytical results obtained. Table 3 shows the comparison of the two in terms of major and minor axis measurements, with the normal case diameter included also. In Figures 22 and 23, the analytical results for the 30° and 60° degree incidence angles are shown with the experimental results superimposed.

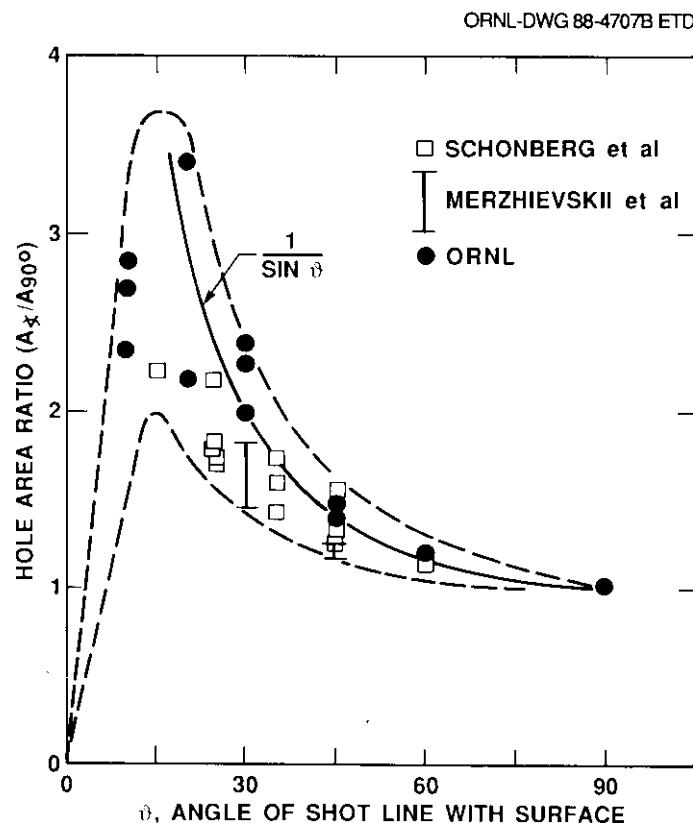
study (Thomas, 1988). These results are shown in Figure 7. The curve $1/\sin \alpha$, where α is the incidence angle, is based on simple geometric considerations and the following assumptions:

1. A circular hole for a 90° impact and an elliptical hole for non-orthogonal incidence angles.
2. The diameter of the circular hole is equal to the minor axis of the ellipse.

Figure 7. Front plate hole area versus incidence angle

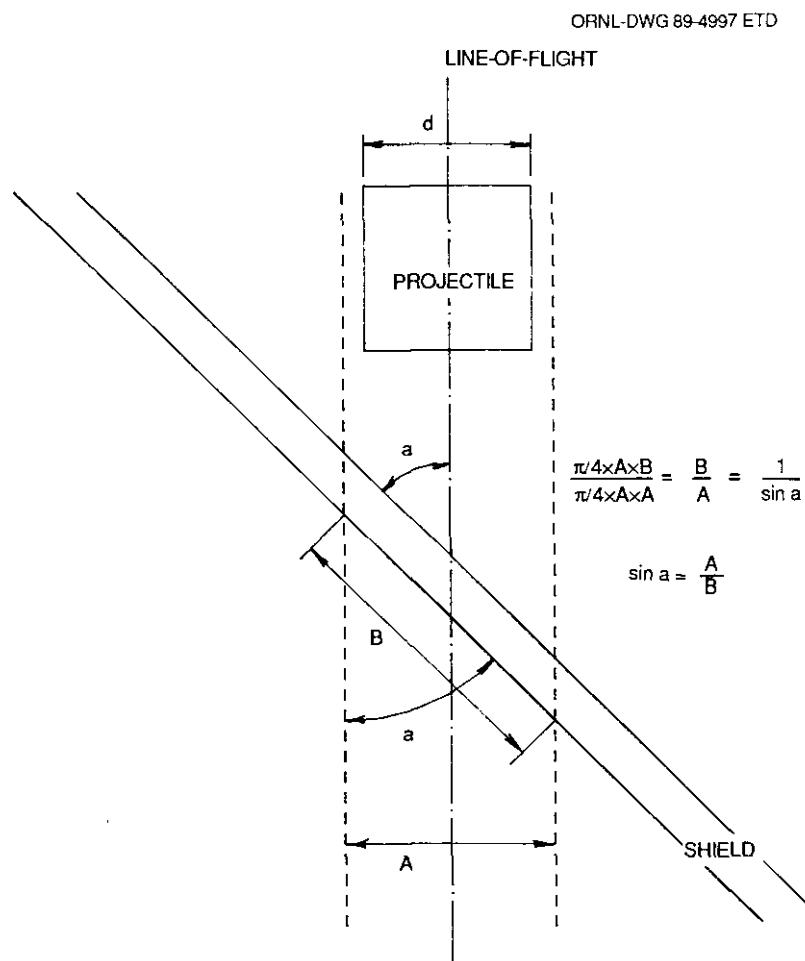
By the geometry of the impact situation and assuming the elliptical hole is created by the same "cookie cutter" that created the 90° hole,

$$\frac{B}{A} = \frac{1}{\sin \alpha},$$

as illustrated in Figure 8. For the case of a cylindrical projectile, the "cookie cutter" assumption includes the assumption that the projectile axis is oriented along the projectile line of flight. The results shown in Figure 7 show two interesting trends: (1) the approximation of $1/\sin a$ is fairly accurate for angles above 15 to 20 and (2) the scatter of the results increases as the angle of incidence decreases.

Figure 8. Geometry of "cookie cutter" approximation

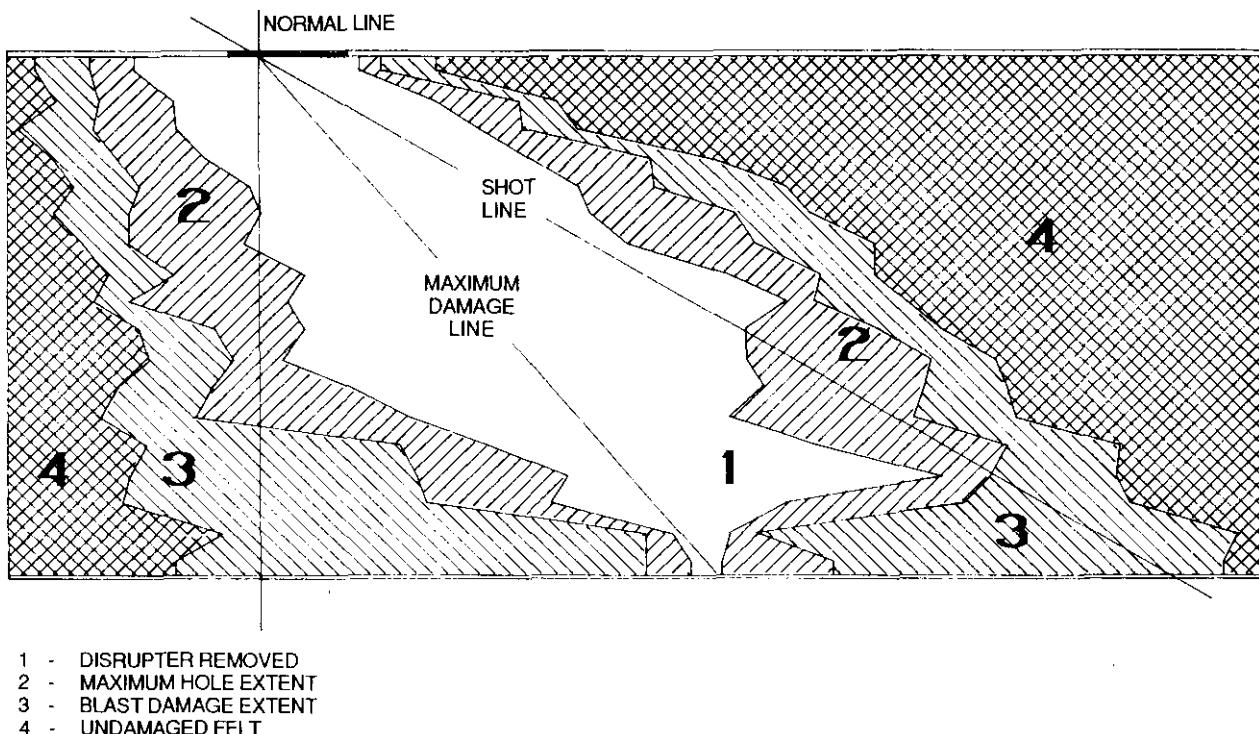
ORNL-DWG 89-4998 ETD

of the damage in the disrupter layers gives information on the amount, direction, and source of the debris. Each shield disrupter pack was examined by layer in posttest disassembly, and the damage pattern noted. Three observations were recorded:

1. The minimum dimension of the main hole in the layer.
2. The maximum dimension of the main hole in the layer.
3. The maximum spread of any blast damage such as pinholes or tears in the layer.

These results are shown in Figure 9 for shot 61 and Figure 10 for shot 62. Also shown on these figures are the line of flight of the projectile and its continuation into the shield, the line of maximum damage, and a normal line into the shield from the point of impact. Examination of the damage for shield 61 (30° incident angle) shows a wide spread of blast damage, from spall and from penetration. The two effects are approximately equal, possibly with a slight preponderance of

Figure 9. Disrupter blast damage profile for shot 61

2. Analytically obtained density plots of the debris clouds show a much more pronounced spall damage area for the 30° case than for the 60° case, referring to Figures 18 and 19. This corresponds very well with the damage profiles seen in the disrupter, both during the test in the flash x-ray data (Figures 11 and 12) and afterwards in the remaining damage profiles (Figures 9 and 10).

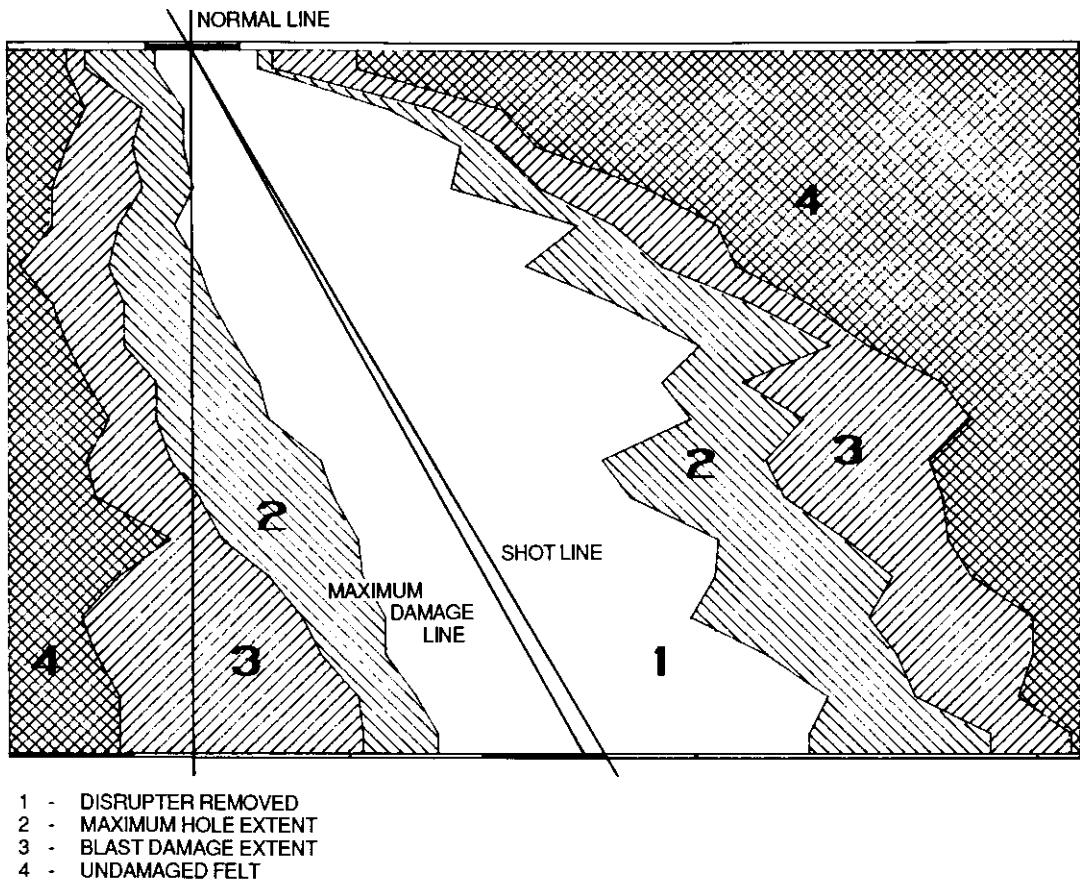
Figure 10. Disrupter blast damage profile for shot 62

penetration damage along the shot line. The line of maximum damage lies between the two damage areas, where the effects have overlapped. For shield 62 (60° incident angle), examination of the damage profile shows only a very slight spall effect, with almost all the damage occurring due to projectile penetration. The line of maximum damage is very close to the continuation of the line of flight. The flash x-ray data for these two tests show the debris clouds while traveling through the disrupter layers, and the phenomena discussed can be seen as it is developing. Figure 11, for shot 61 at 13.1 μ sec, very clearly shows two lobes of damage, one from spall and one from projectile penetration. The direct penetration of the projectile during test 62 can be seen in

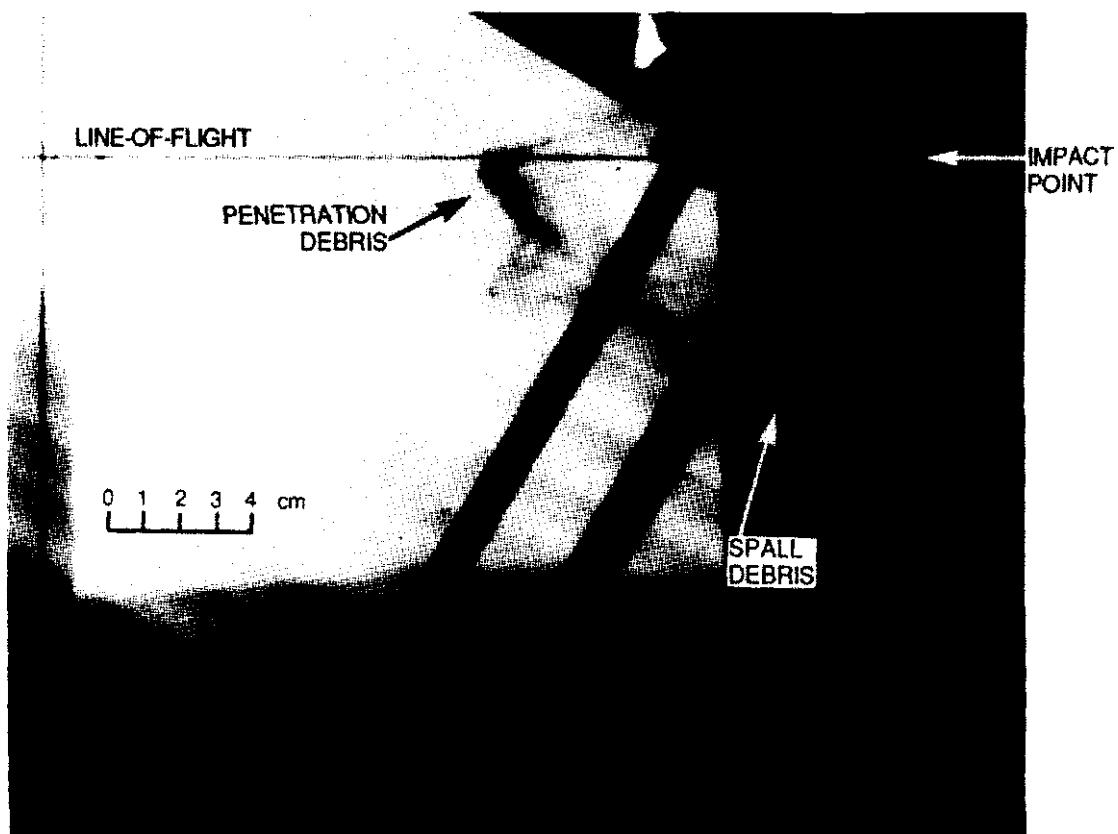
ORNL PHOTO 7013-89

Figure 11. Flash x-ray data for shot 61 at 13.1 μ sec

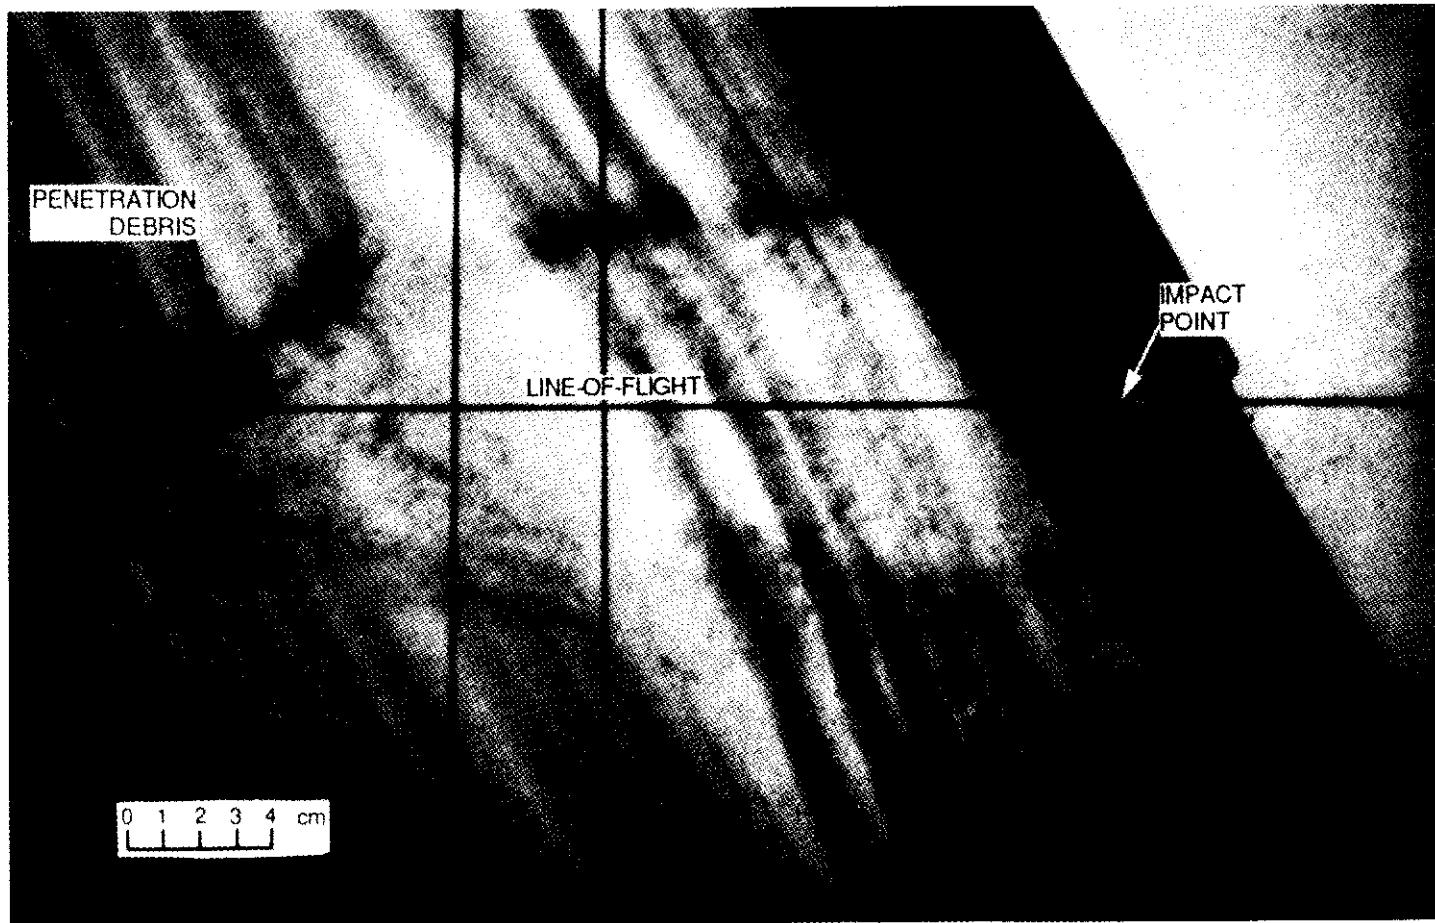
ORNL PHOTO 7014-89

the flash x-ray data, taken at 35.5 μ sec, and shown in Figure 12. The deviation of the line of maximum damage from the projectile line of flight appears to increase as the angle of incidence increases, and damage shifts from penetration to spall. This effect is shown in Figure 13, which includes data from shots 61 and 62, another ORNL study (Thomas, 1988) and the Schonberg et al. (1988) study.

Figure 12. Flash x-ray data for shot 62 at 35.5 μ sec

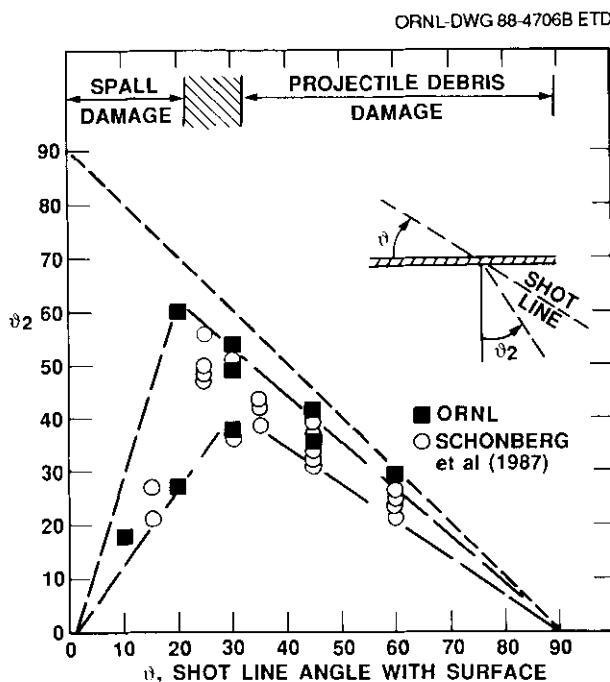
Figure 13. Location of maximum back plate damage versus incidence angle

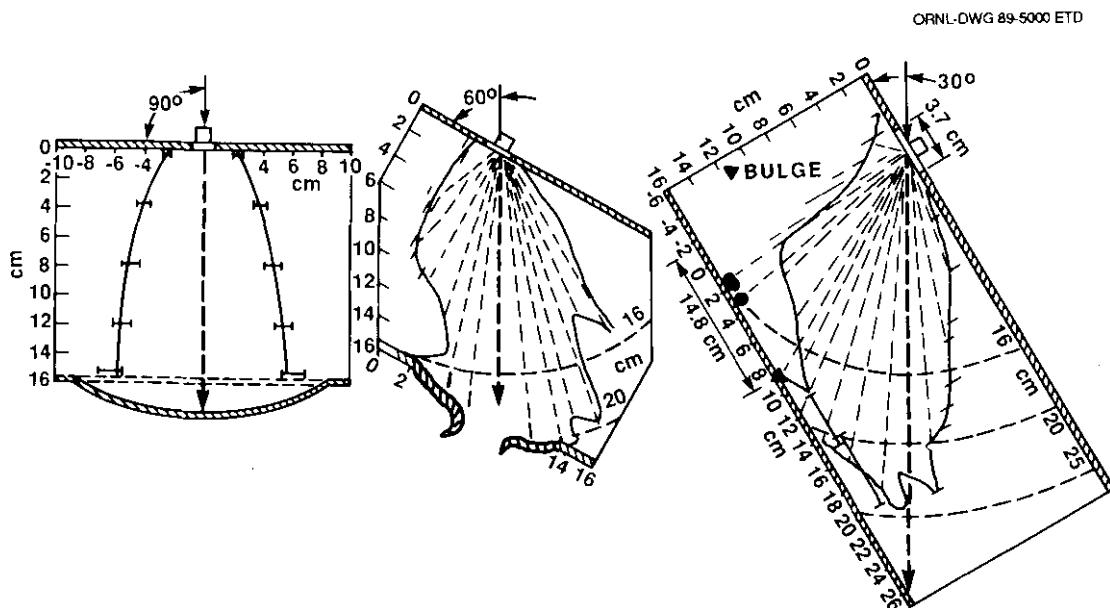
Back plate damage was widely different for shields 61 and 62. Damage to the back plate of shield 61 was quite minimal, with no overall bulge at all. One small bulge, approximately 1/2 cm in diameter and less than 0.2 cm high, was the only sign of back plate damage. In contrast, the back plate damage for shield 62 was very serious. A general bulge with a 5 1/2 cm by 3 1/2 cm hole having 4 petals resulted from the test. This corresponds to the high level of projectile penetration seen in the x-ray and disrupter layer data. Considering the results for shot 41 with those for shots 61 and 62, back shield survivability can be seen to be a function of the angle of incidence. The same layered shield configuration, tested at different angles, showed widely different results. This is shown in Figure 14, showing the success at 90°, the failure at 60°, and the success at 30°.

Figure 14. Back shield survivability versus incidence angle

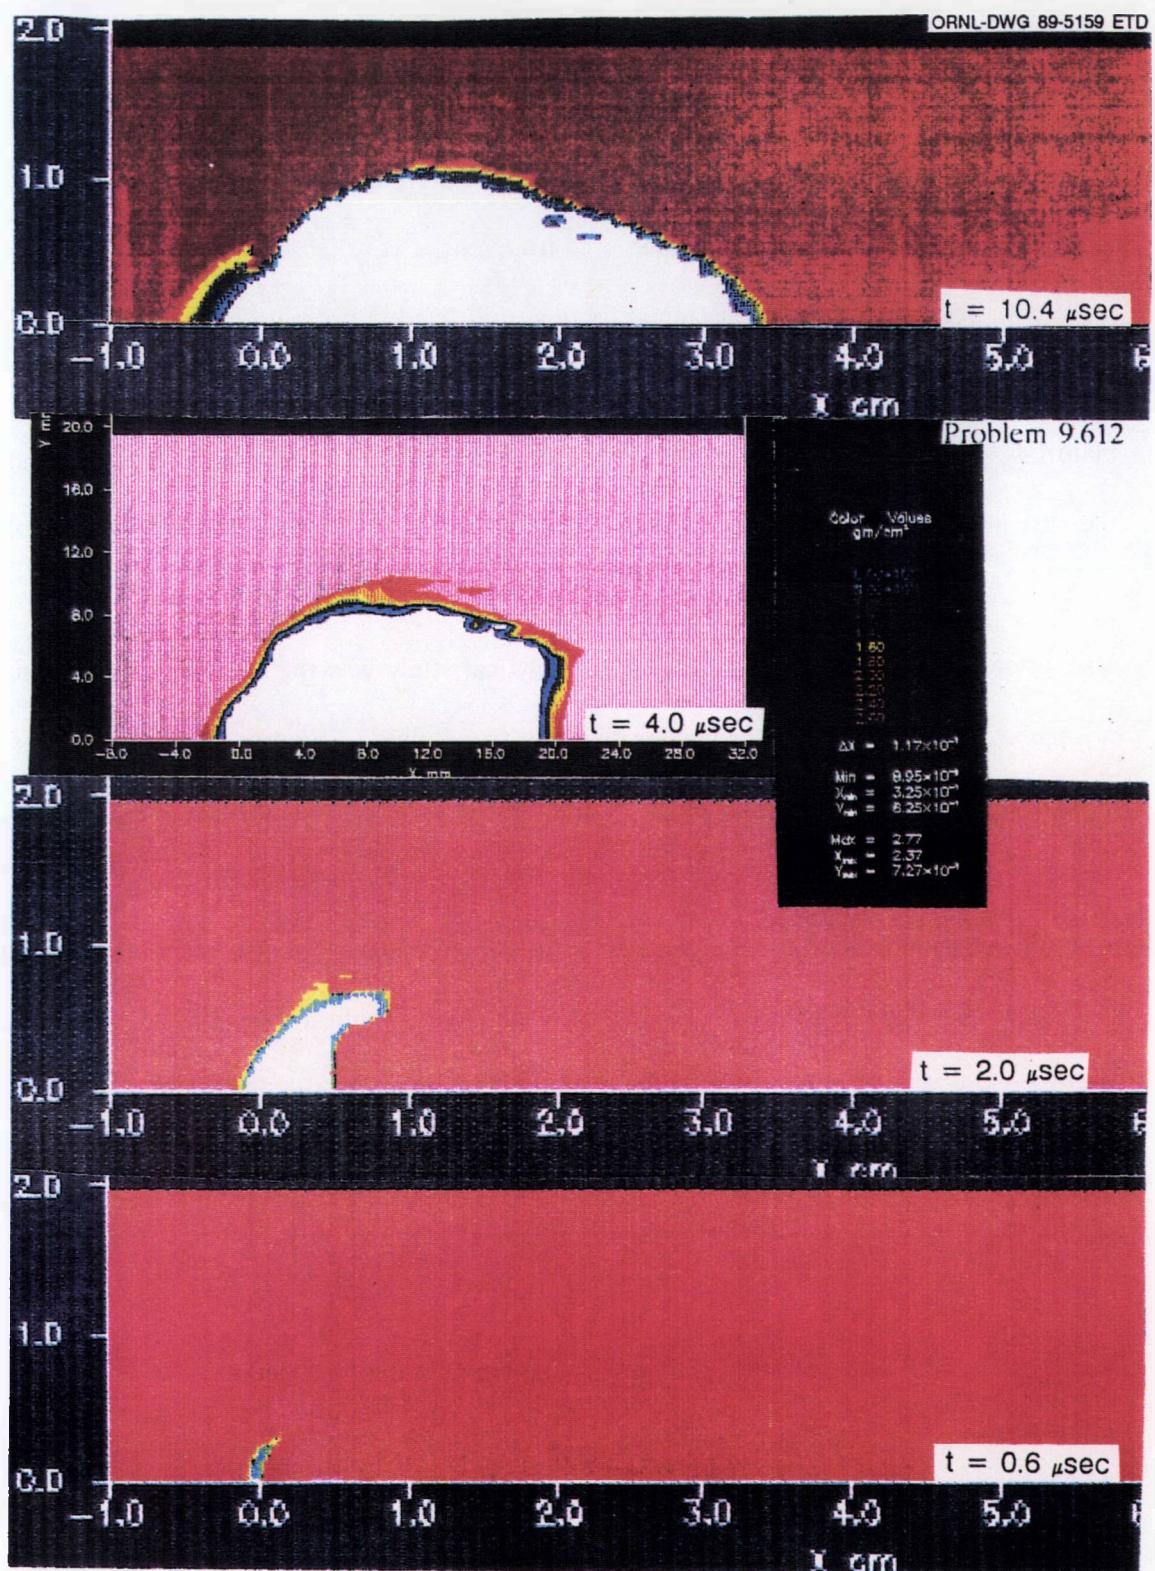
One interesting result obtained from the analytical study was the relative times required for the complete interaction of the projectile with the front plate. Figure 15 shows a series of density plots outlining the development of the hole in the front plate for problem 9.612, the 30° incidence angle case. The hole was still being formed at 4 μ sec after initial contact, and over 10 μ sec were required to obtain the full hole size. The hole development for the 60° case, problem 9.616, is shown in the density plots of Figure 16. Complete hole formation has been obtained by approximately 8 μ sec. In contrast, the front plate hole for the 90° baseline case had become essentially complete before 5 μ sec. (Note: For all color figures, the red/pink areas correspond to high density areas, with shadings down to blue as the low density areas.)

Figure 15. Front plate damage development for a 30° incidence angle

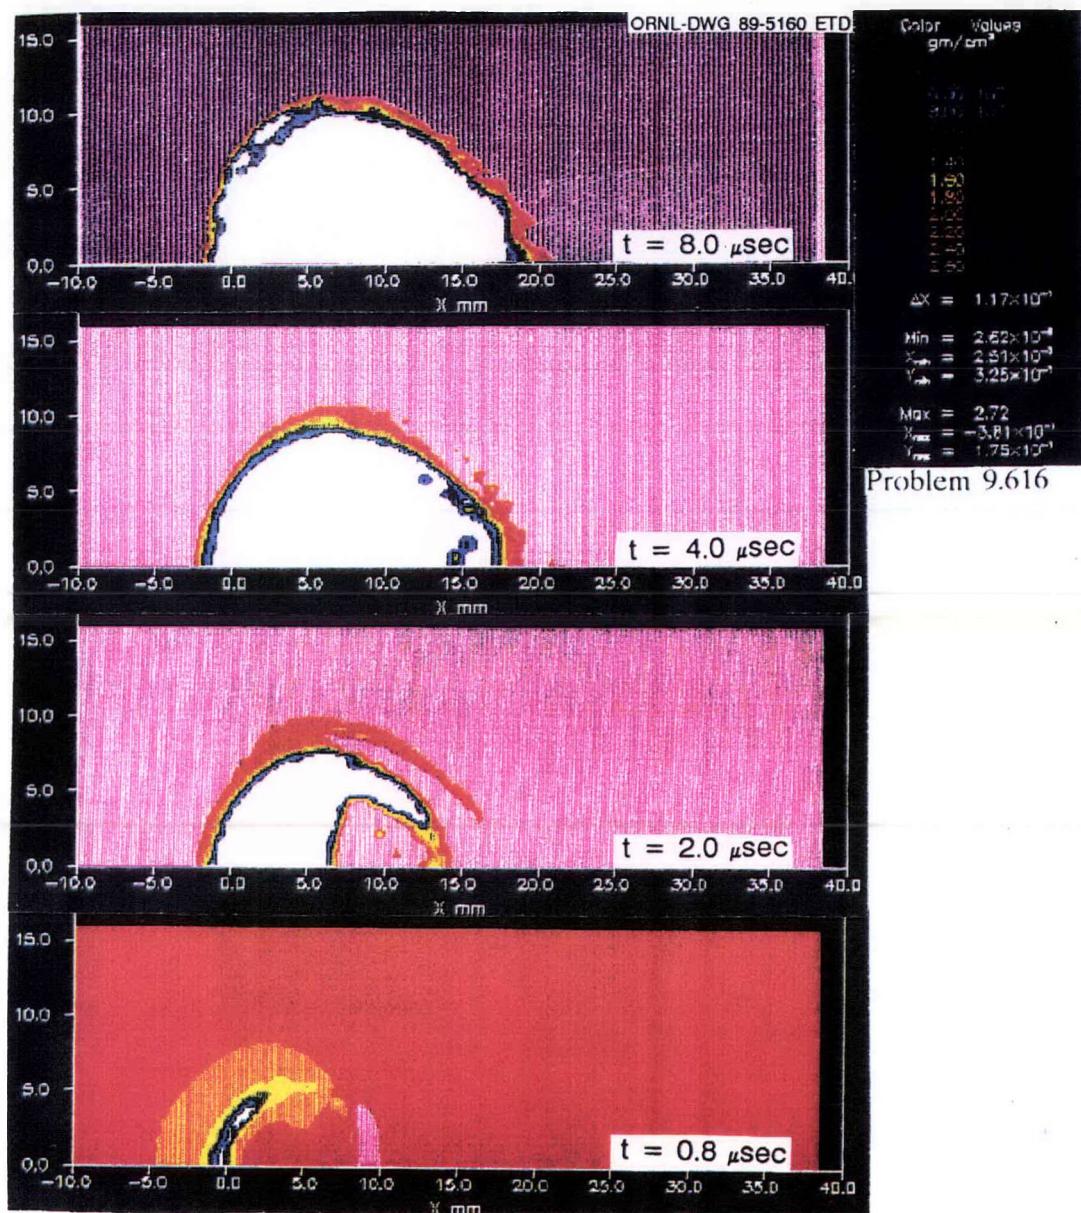
Figure 16. Front plate damage development for a 60° incidence angle

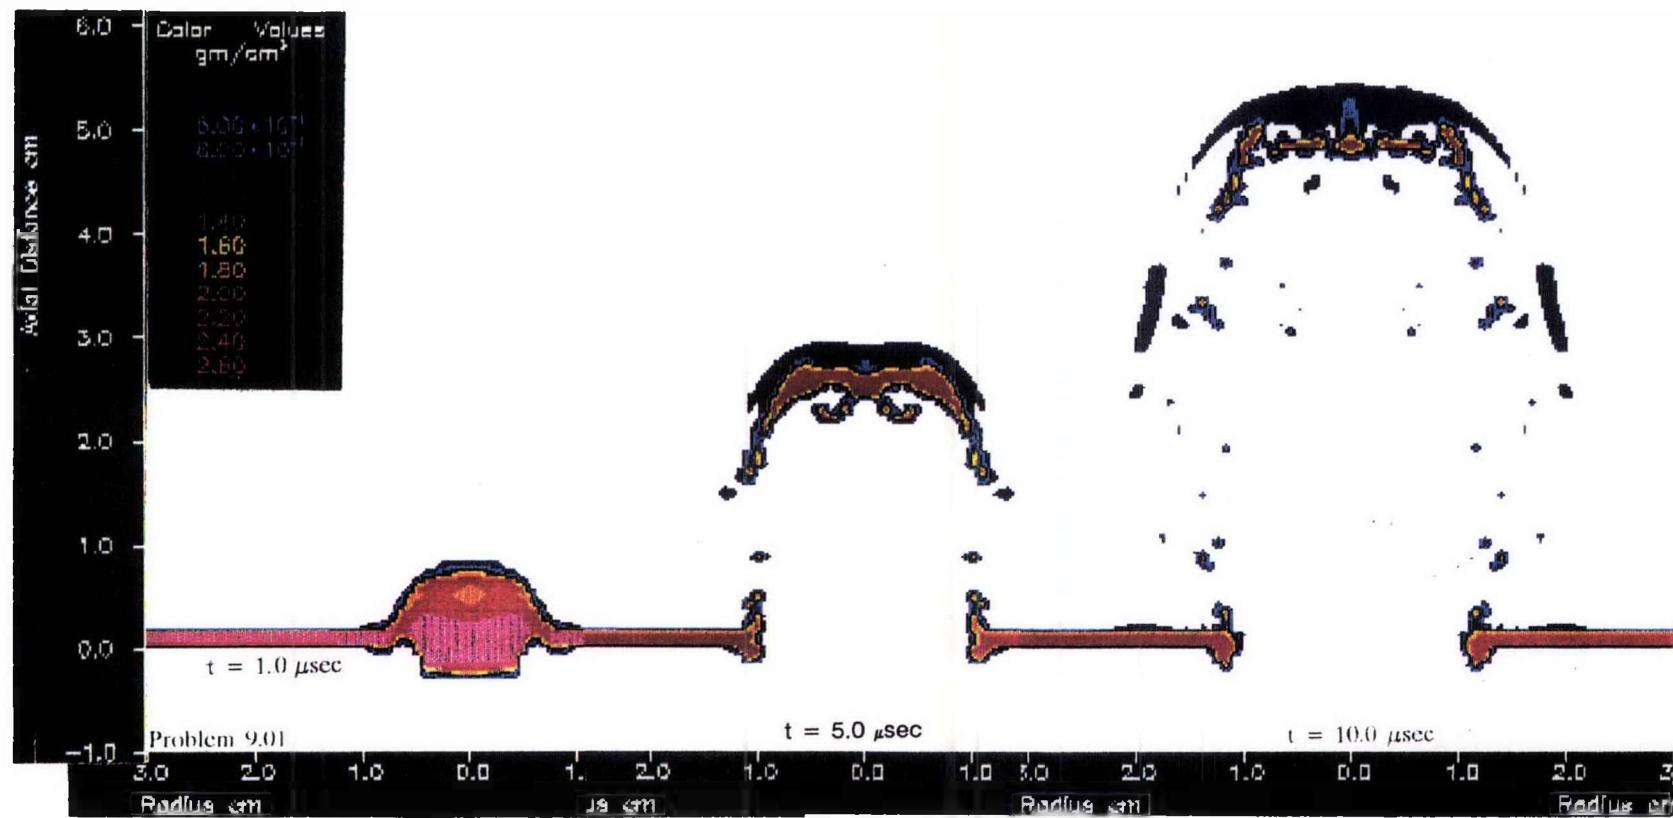
The impact event and resulting projectile penetration/breakup for the baseline 90° case, problem 9.01, are shown in Figure 17. The breakup of the projectile and the condition and spread of the resulting debris cloud for this case are useful for comparison to the results for the oblique impact cases. The debris for the normal impact consists primarily of low density material, with some small separated patches of high density aluminum.

Figure 17. Normal impact debris cloud development

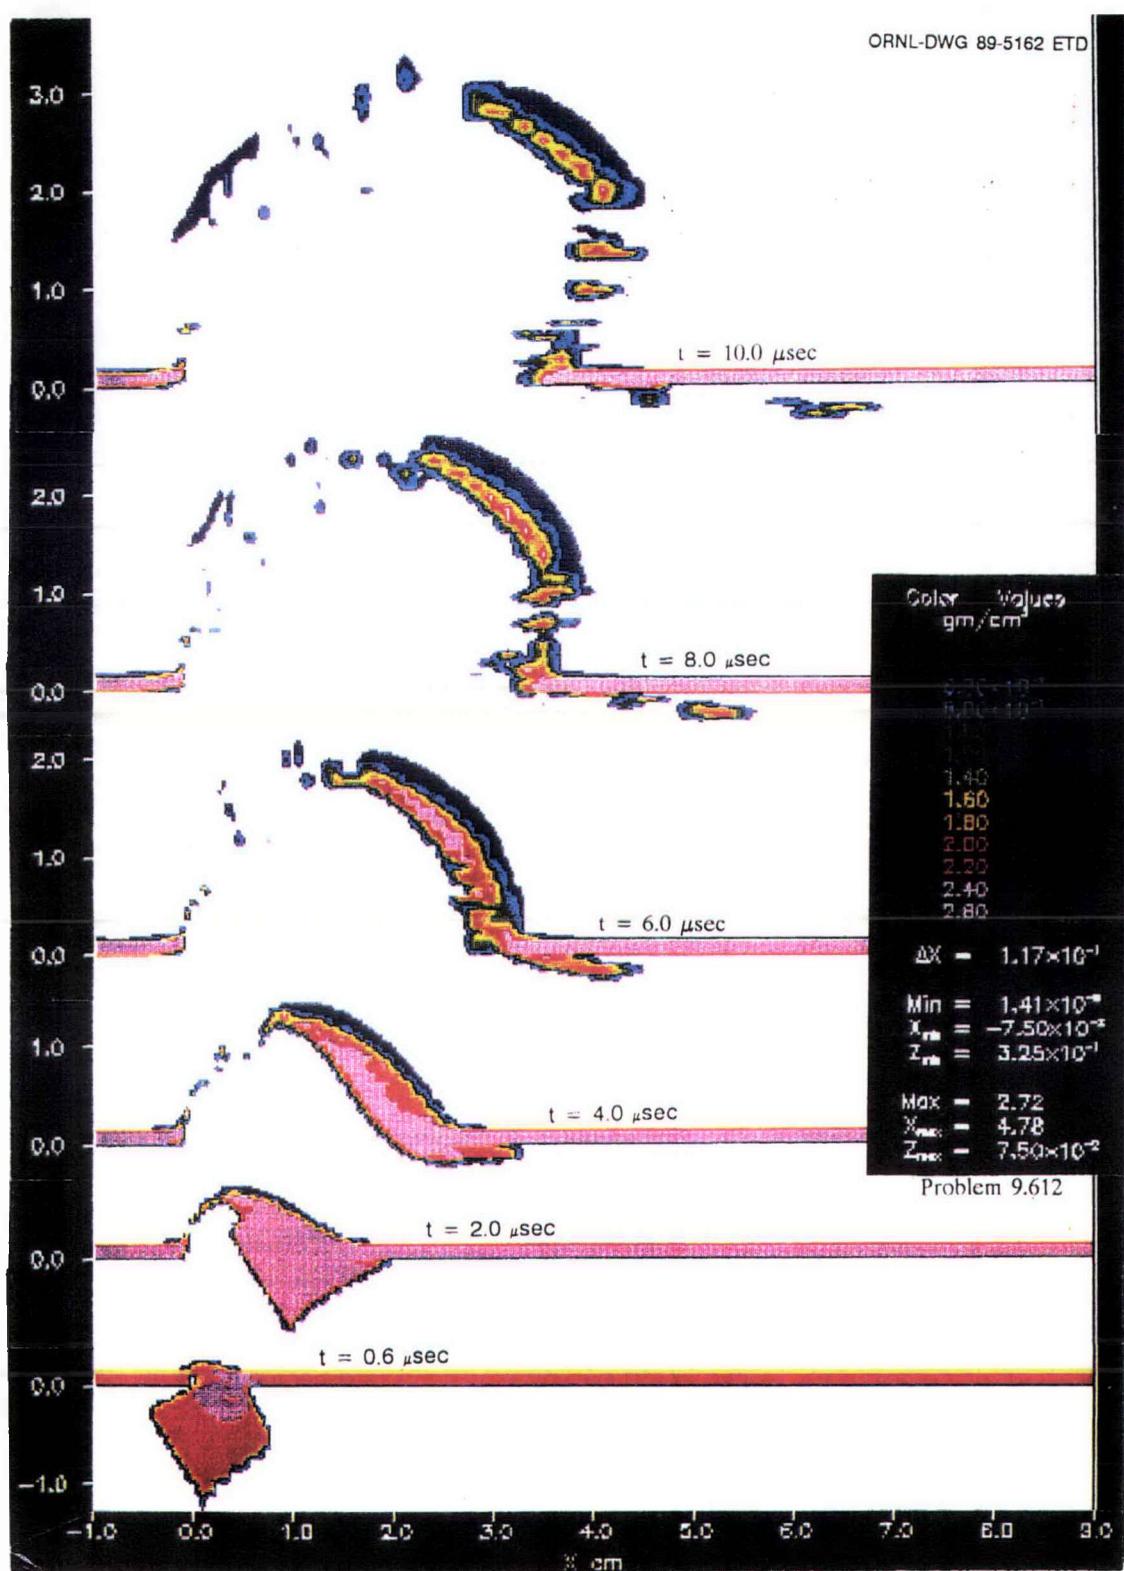
A comparable series of density plots from problem 9.612 (the 30° case) is shown in Figure 18. In comparison with the orthogonal impact event, the debris is generally less broken up. A thicker cap of material is left after penetration, with several small separate high density areas. A significant part of the debris inside the shield appears to be due to spall from the front shield, while the main part of the debris is continuing generally along the shot line. Also, a considerable amount of material is visible outside the shield as ejecta.

Figure 18. Debris cloud development after a 30° impact
