Effects of Oblique Impact on Hypervelocity Shield Performance

DEFENSE AND SPACE PROGRAMS

DATE PUBLISHED - JANUARY 1990

Prepared for
U.S. Air Force Weapons Laboratory
Kirtland Air Force Base
Albuquerque, New Mexico
under Interagency Agreement DOE No. 40-1663-A1

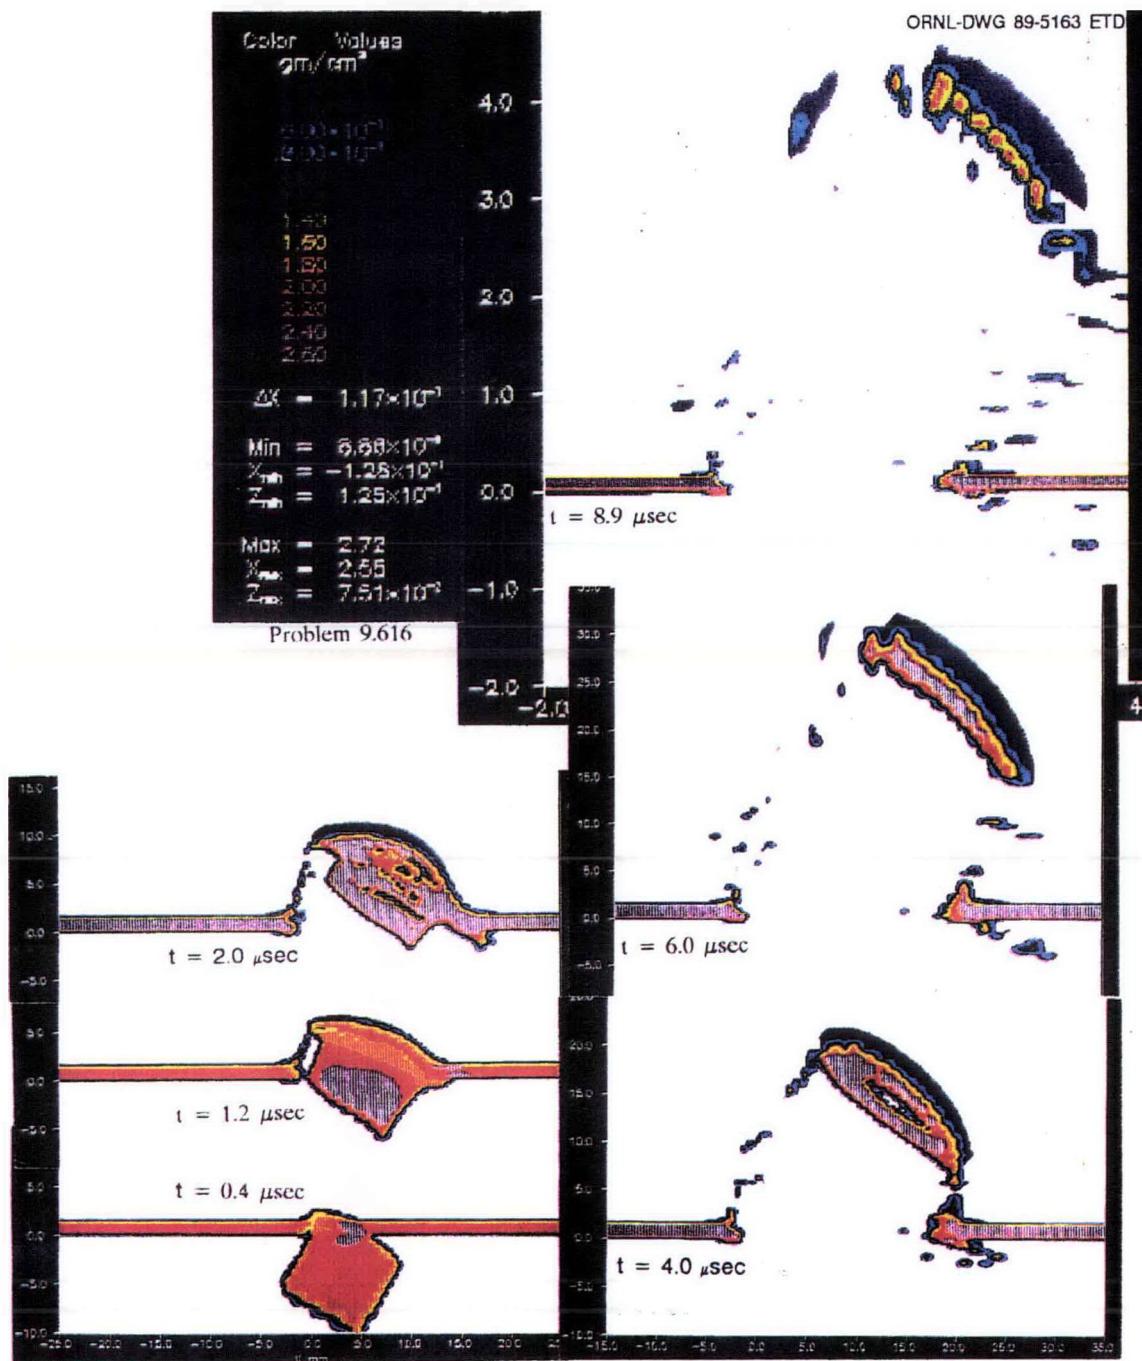
Figure 19 is a similar series of density plots for problem 9.616, the 60° incidence angle case. Using the normal impact as a comparison, the debris is again less broken up, with a thick cap containing high density patches of material remaining. However, this result is more pronounced for the 60° case, as a comparison of the debris clouds of Figures 18 and 19 reveals. The amount of high density material left after the 60° impact is much greater, and it is less spread out. Also, due to the angle of direction toward the back plate, the debris for the 60° case has much less distance to travel through and be slowed by the disrupter, increasing the probability for damage to the back plate. The debris for the 60° case, referring again to Figure 19, shows much less spall debris than that of the 30° case.

Figure 19. Debris cloud development after a 60° impact

2. Analytically obtained density plots of the debris clouds show a much more pronounced spall damage area for the 30° case than for the 60° case, referring to Figures 18 and 19. This corresponds very well with the damage profiles seen in the disrupter, both during the test in the flash x-ray data (Figures 11 and 12) and afterwards in the remaining damage profiles (Figures 9 and 10).

Preliminary comments only can be made with regard to the external debris generated. The analysis showed debris outside the shield, referring to problem 9.616 as shown in Figure 19, and this is in general agreement with the results seen on the splash plate for the 60° test. However, analytical results indicate a greater amount of splash for a 30° incidence angle impact, especially in the downstream (within $\pm 90^\circ$ of the projectile line-of-flight) direction. This is indicative of a higher damage potential outside the shield and possibly also indicative of incipient ricochet if the incidence angle is further reduced. No experimental results for the external damage due to the 30° impact were obtained in this study. These analytical results do correspond with those seen in the studies by Schonberg et al. (1988) and Thomas (1988) in which the external damage did increase as the incidence angle decreased.

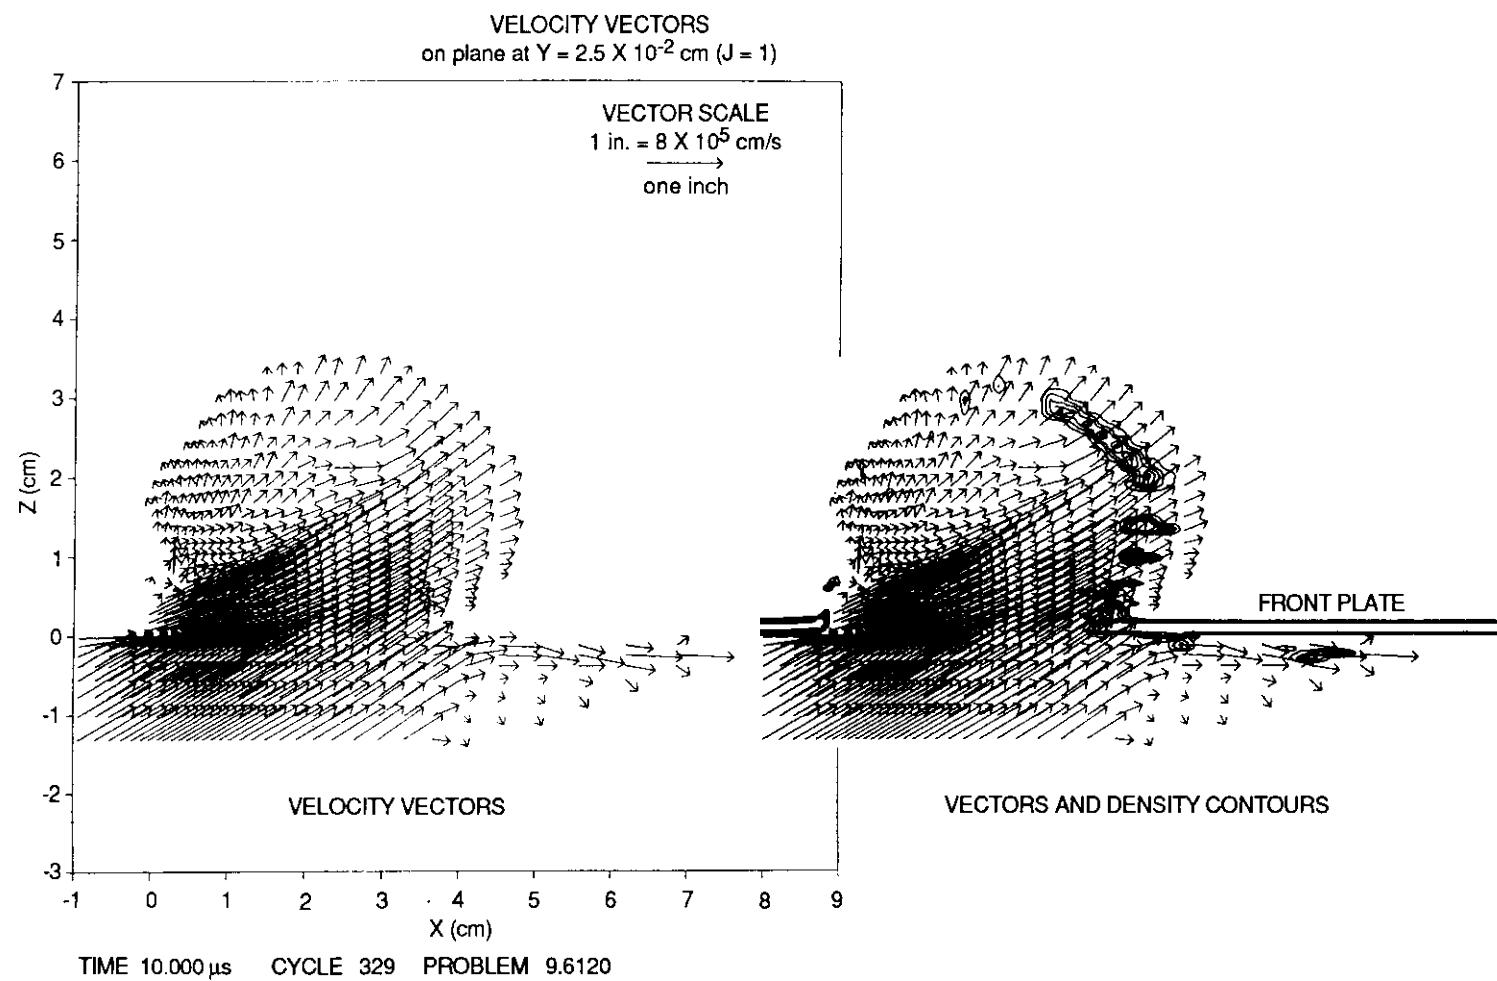
Further insight into the damage potential of the debris clouds from the different impact cases can be obtained by examination of the velocity vectors for each case. The velocity vectors for problem 9.612 (30° case) at 10 μ sec after impact are shown in Figure 20, both with and without a density plot superimposed. The portion of the debris due to spall and thus moving directly toward the back plate has been drastically reduced in velocity. The debris cloud overall is shown as still somewhat spreading. In contrast, the same type results for problem 9.616 (60° case), given in Figure 21, show that the main section of high density debris is not expanding, but rather is

Figure 20. Velocity vectors and debris cloud at 10 μ sec after a 30° impact

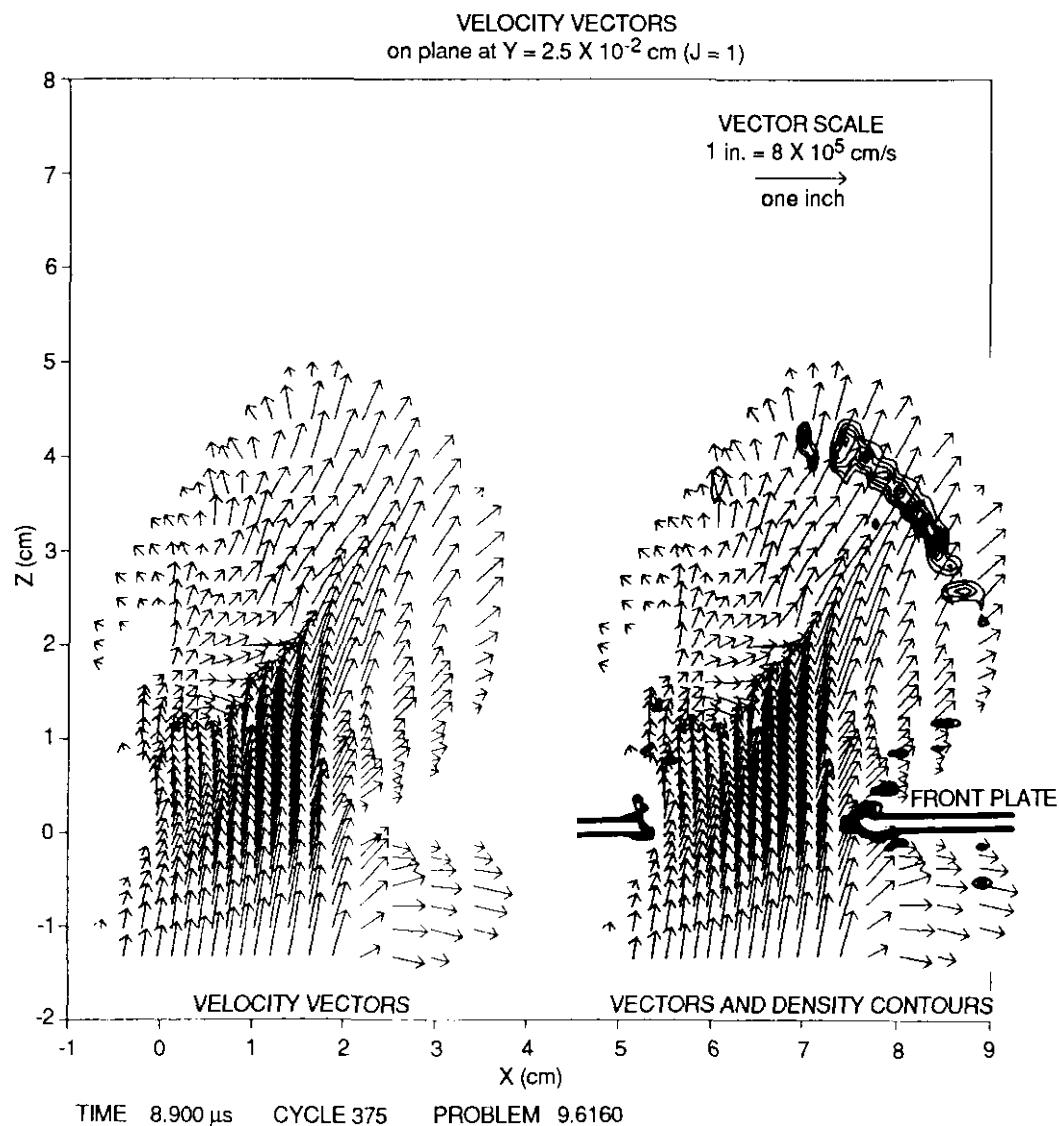
Figure 21. Velocity vectors and debris cloud at 8.9 μ sec after a 60° impact

continuing along the penetration line toward the back plate. Also, the velocity in this 60° case has not been slowed as much as for the 30° case. A very small amount of spall is visible, again moving slowly.

Overall, the analysis results clearly show a much higher damage potential in the debris cloud after the 60° impact than the 30° impact. The debris is of higher density, less dispersed, its velocity is

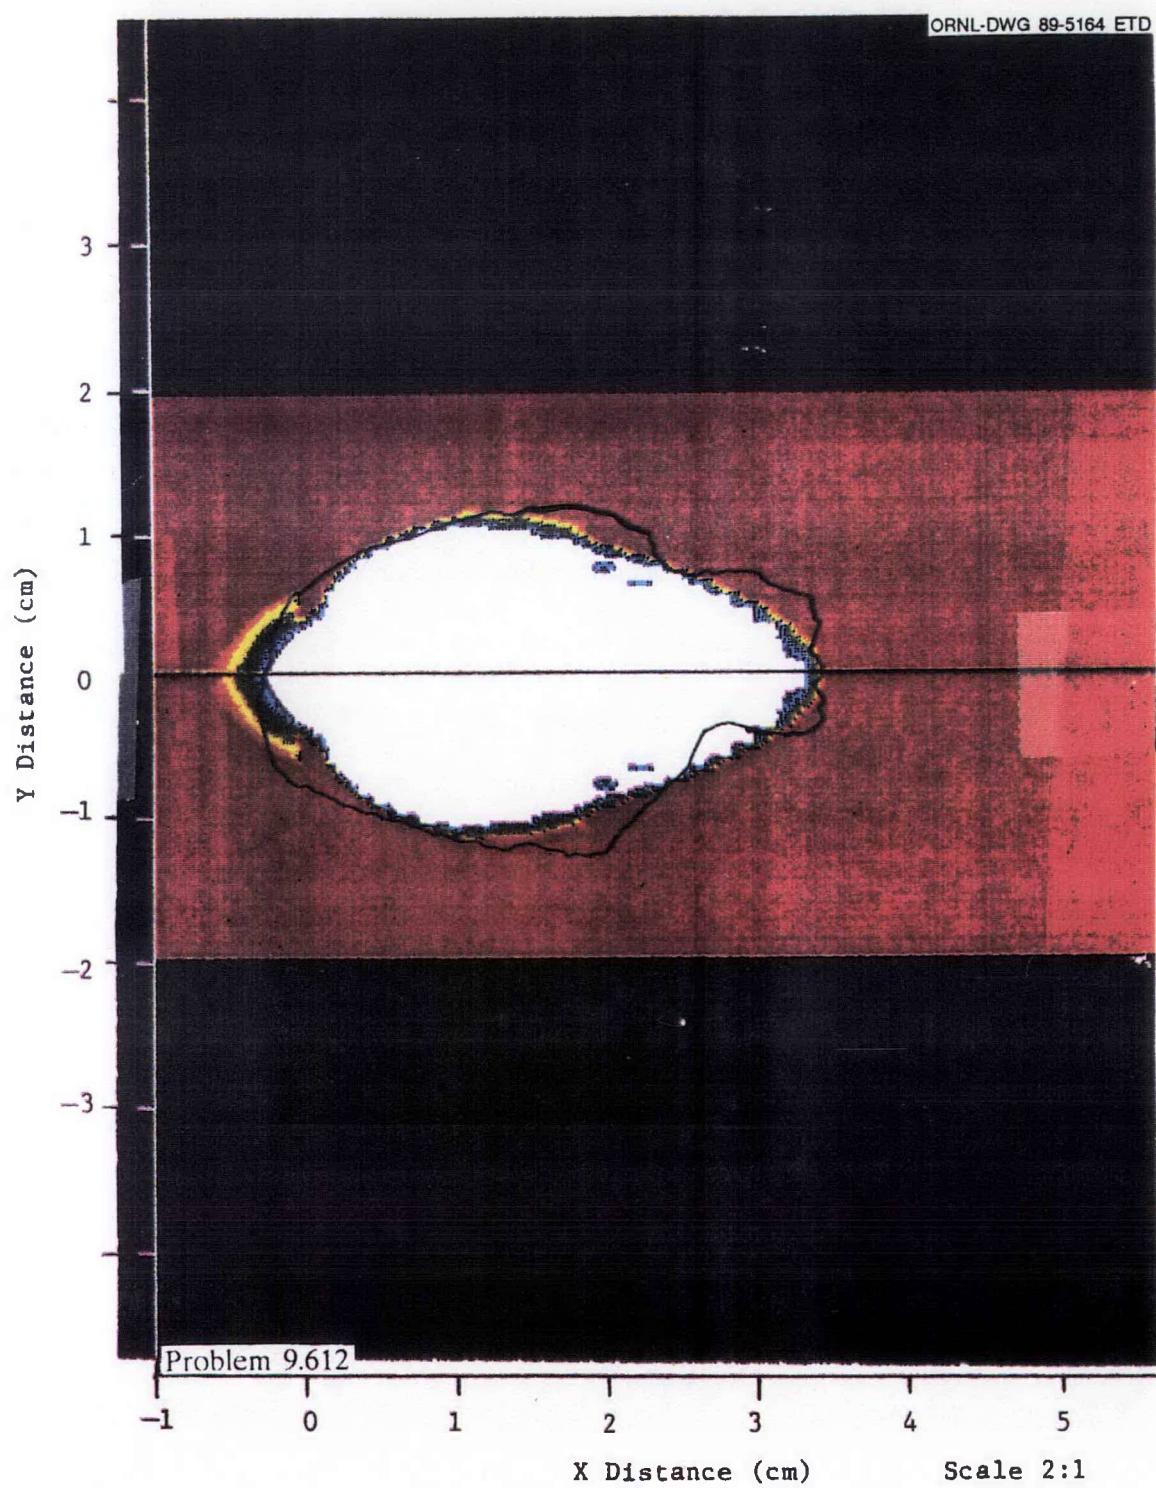
1. The experimental results for front plate damage, previously shown in Figure 6, correspond well with the analytical results obtained. Table 3 shows the comparison of the two in terms of major and minor axis measurements, with the normal case diameter included also. In Figures 22 and 23, the analytical results for the 30° and 60° degree incidence angles are shown with the experimental results superimposed.

Figure 22. Analytical and experimental front plate damage from a 30° impact

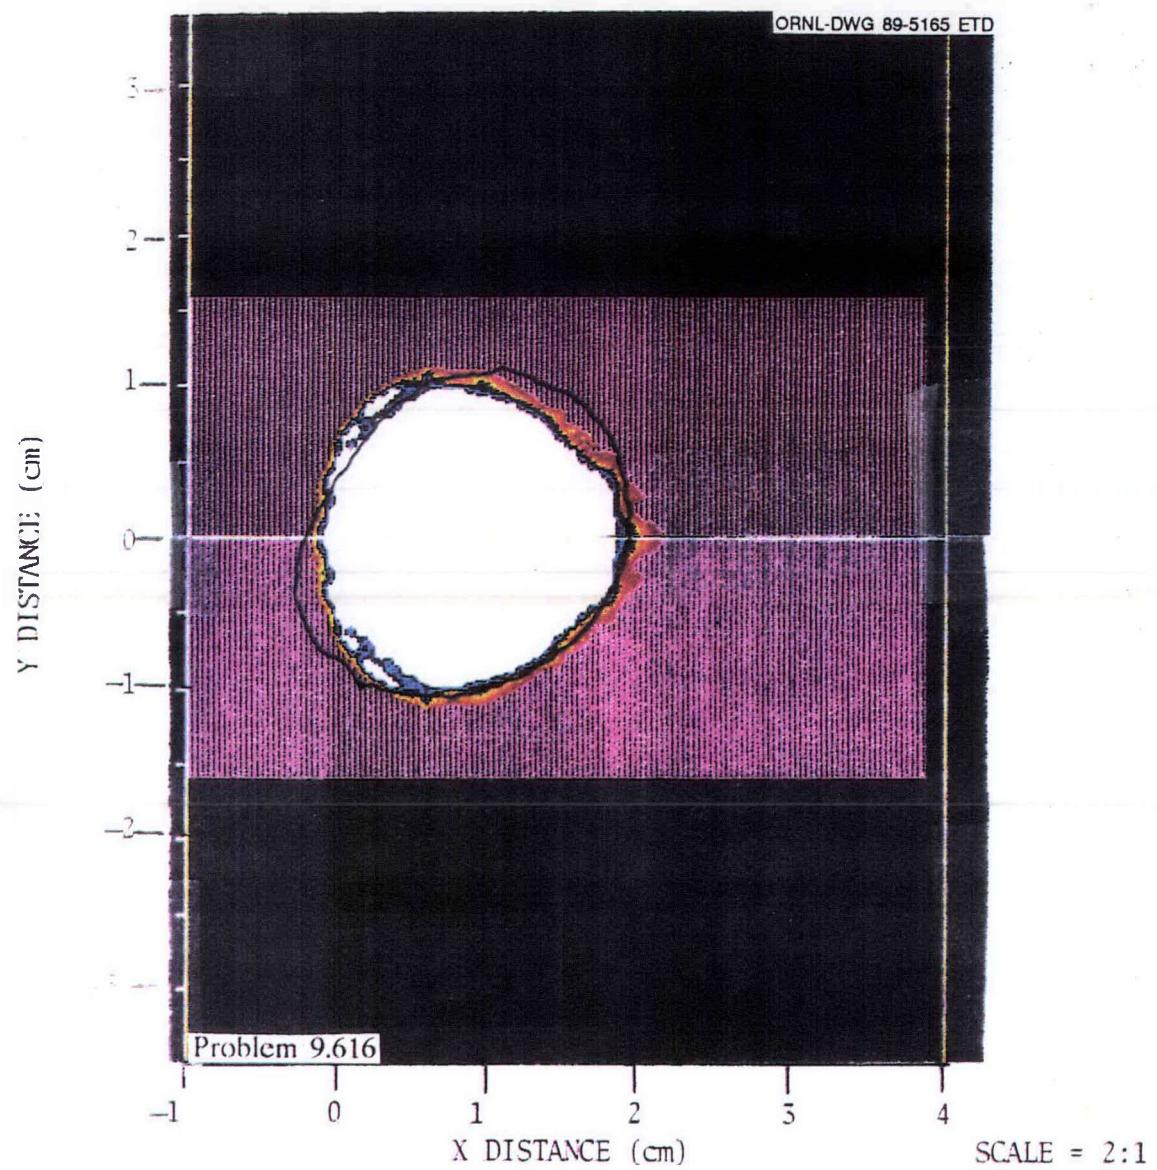
Figure 23. Analytical and experimental front plate damage from a 60° impact
