## POST-ACCIDENT EXAMINATION OF PLATINUM RESISTANCE THERMOMETERS INSTALLED IN THE TMI-2 REACTOR

R. M. Carroll  
R. L. Shepard

Published September 1985

Oak Ridge National Laboratory  
Oak Ridge, Tennessee

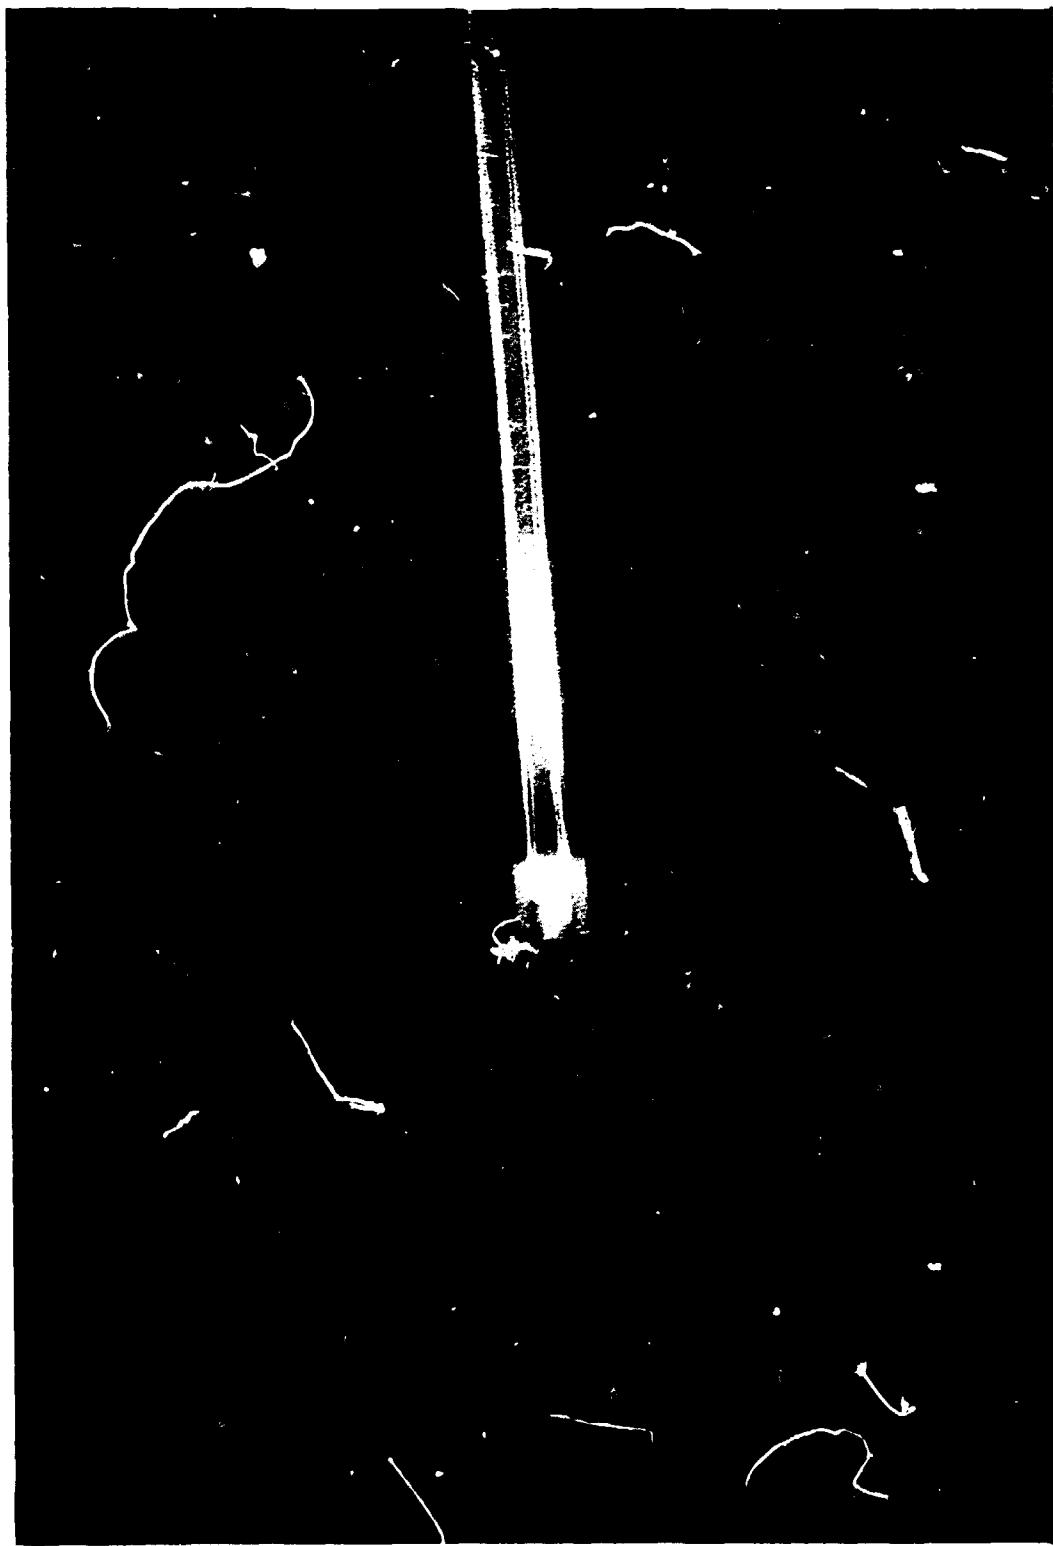
Figure 4. Radiograph of PRT S/N 3670 in the thermowell shows the relation of the silver bushing to the reduced section of thermowell.
