DECONTAMINATION AND DECOMMISSIONING OF THE ORGANIC MODERATED REACTOR EXPERIMENT FACILITY (OMRE)

Published September 1980

**EG&G Idaho, Inc.
Idaho Falls, Idaho 83415**

ABSTRACT

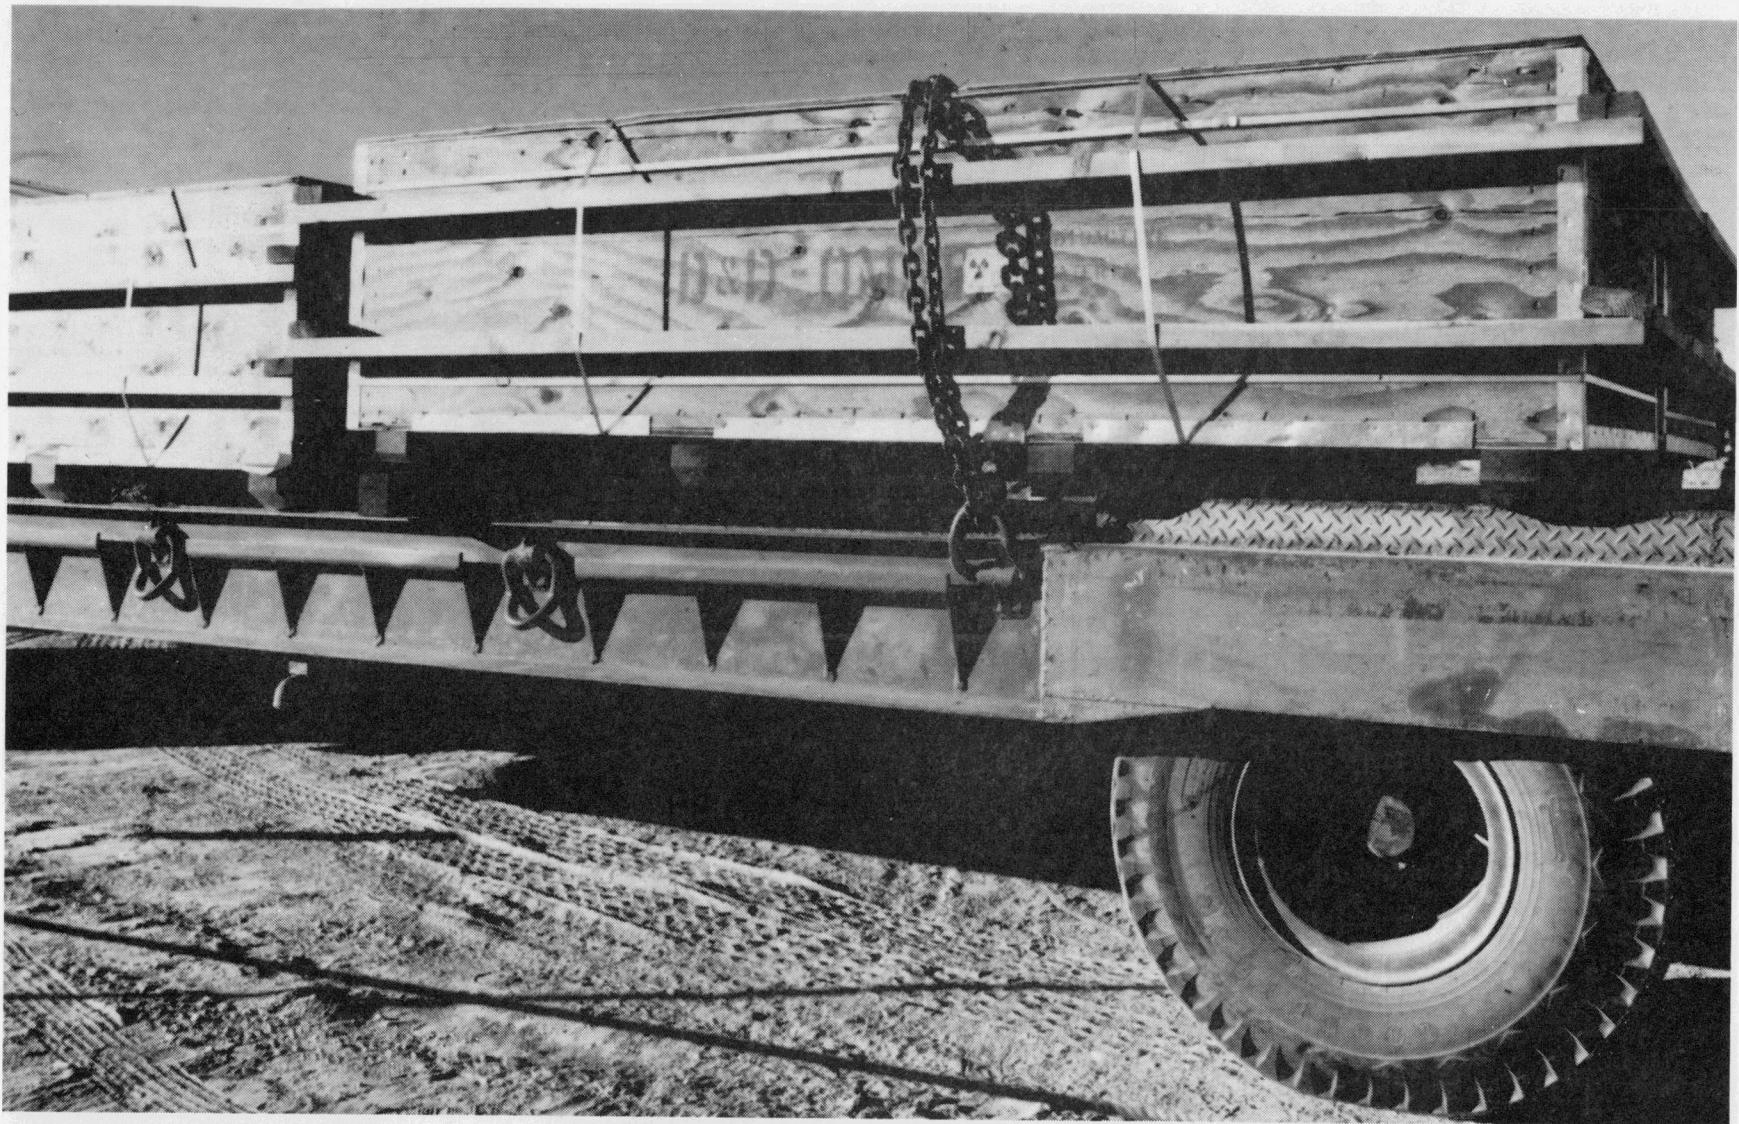
Figure 72. Improper loading of soil box.

In October 1978, a shipment of radioactive soil enroute from OMRE to RWMC sprung a leak and spilled an estimated 0.5 ft³ of soil. An investigation of this incident was conducted by a specially appointed committee, and a report¹⁶ was issued with recommendations aimed at preventing future such incidents. In summary, one 2 x 4 x 8 ft plywood box (about 5,500 lbs) was transported with supports under the ends only and the weight of the soil opened a bottom seam of the box. Figure 72 shows the improperly loaded box with the unsupported center and a tie-down chain aggravating the situation. Figure 73 shows one box on the verge of opening the bottom seam, and Figure 74 is a close-up view of the opened seam. Some soil was collected from the truck bed, and radiation was measured at 5,000 cpm. The personnel involved, the truck tires, and roadway were monitored and no detectable radiation was found. As a result of this incident the box design was strengthened and specific instructions regarding shipping and tie-down were emphasized.

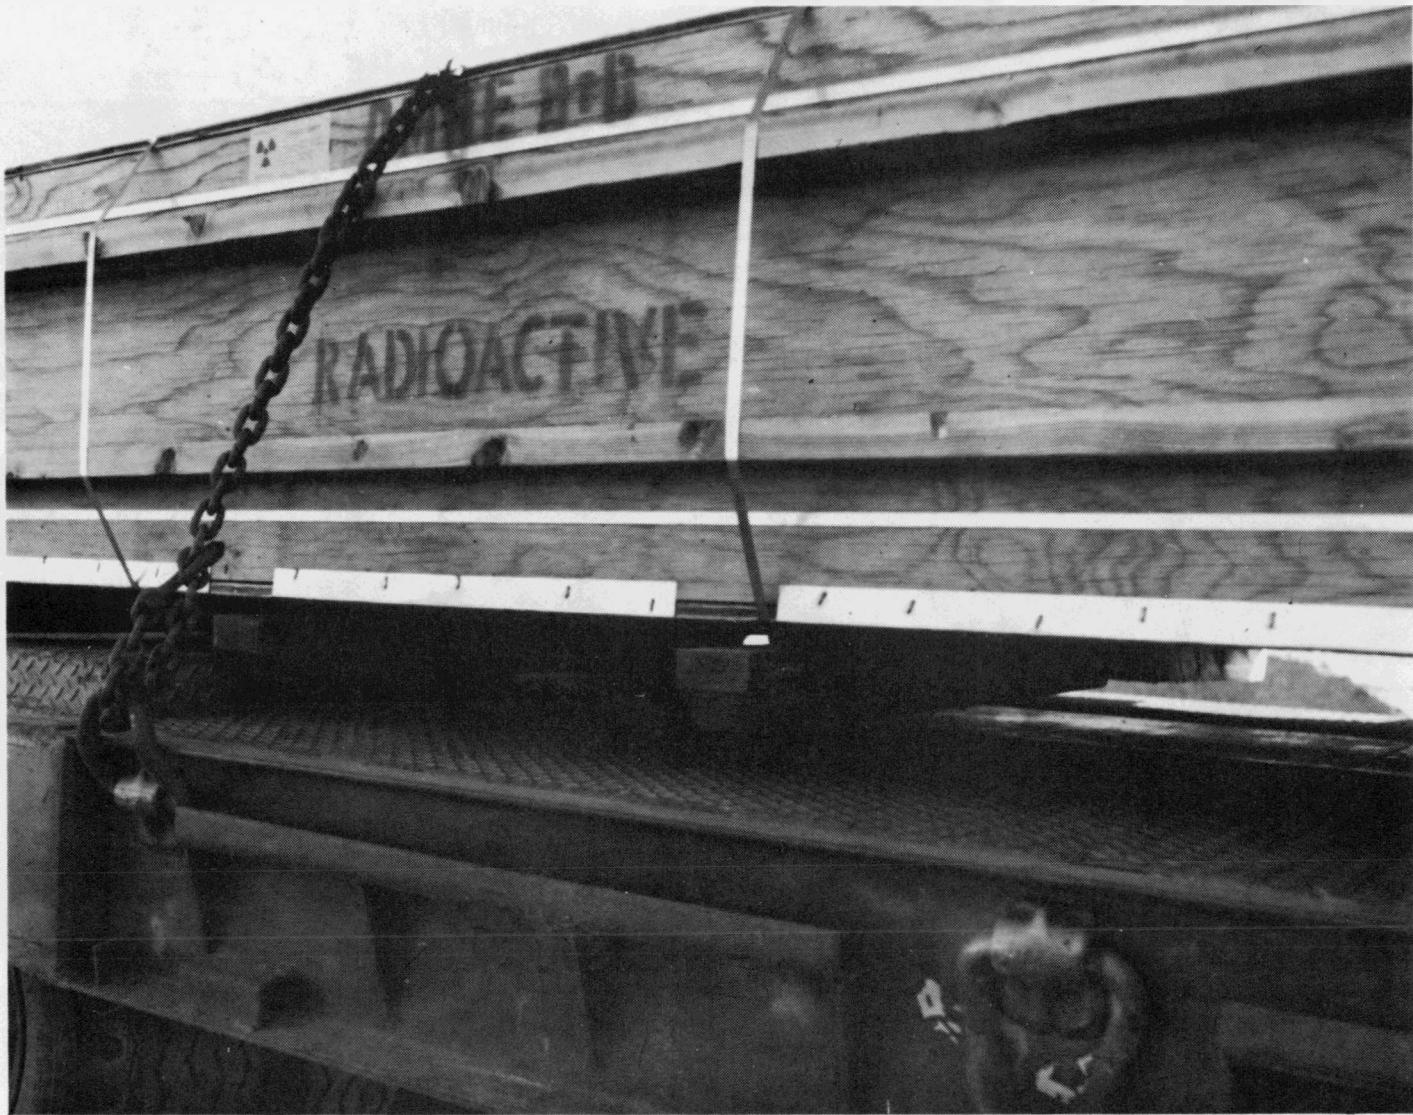
Figure 73. Soil box skids separating because support was inadequate.

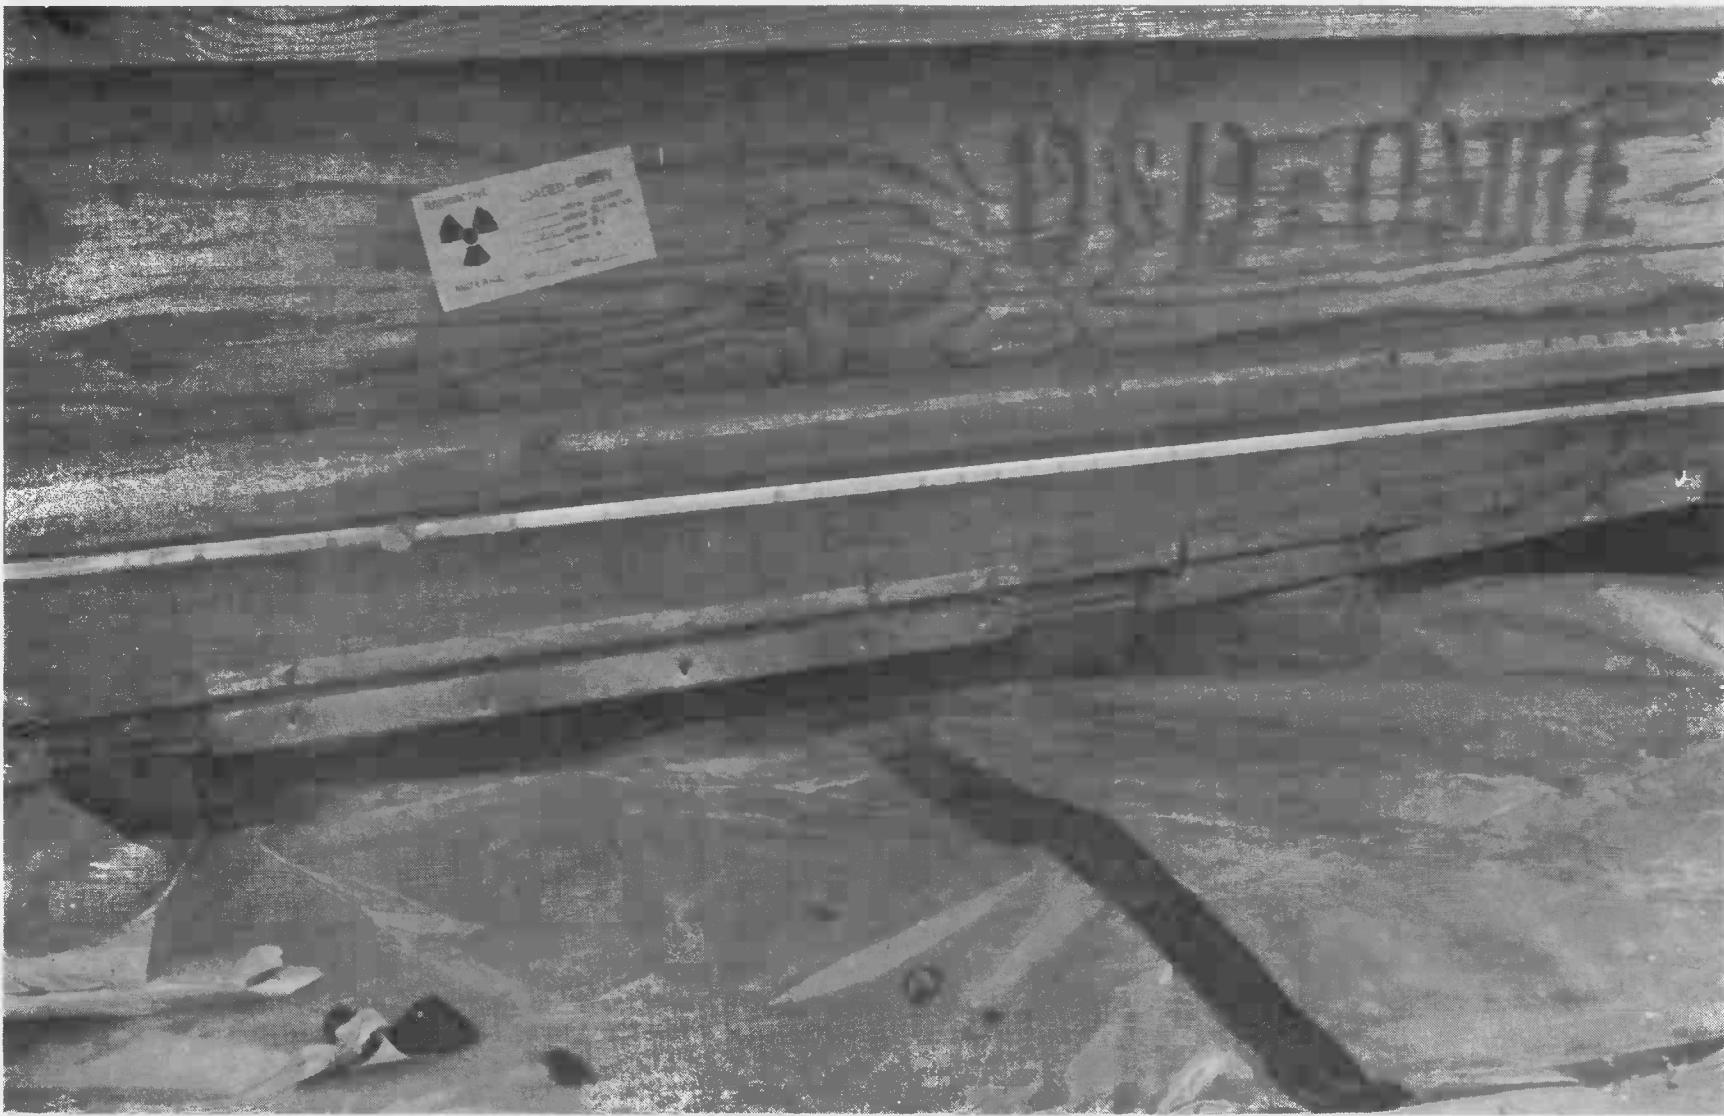
Figure 74. Ruptured bottom seam of soil box.
