Electroless Nickel and Ion-Plated Protective Coatings for Silvered Glass Mirrors

April 1982

PNL-4257
UC-62

Pacific Northwest Laboratory
Richland, Washington 99352

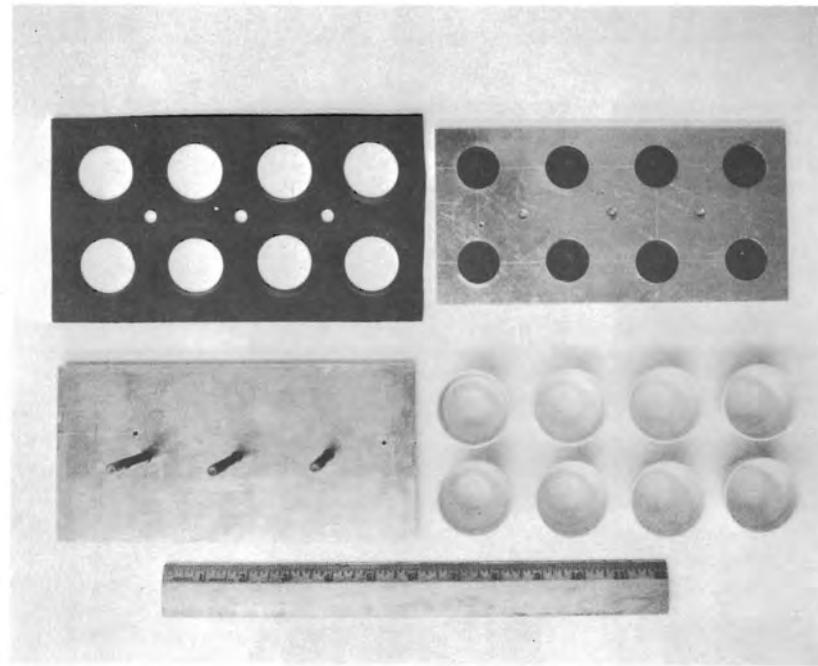
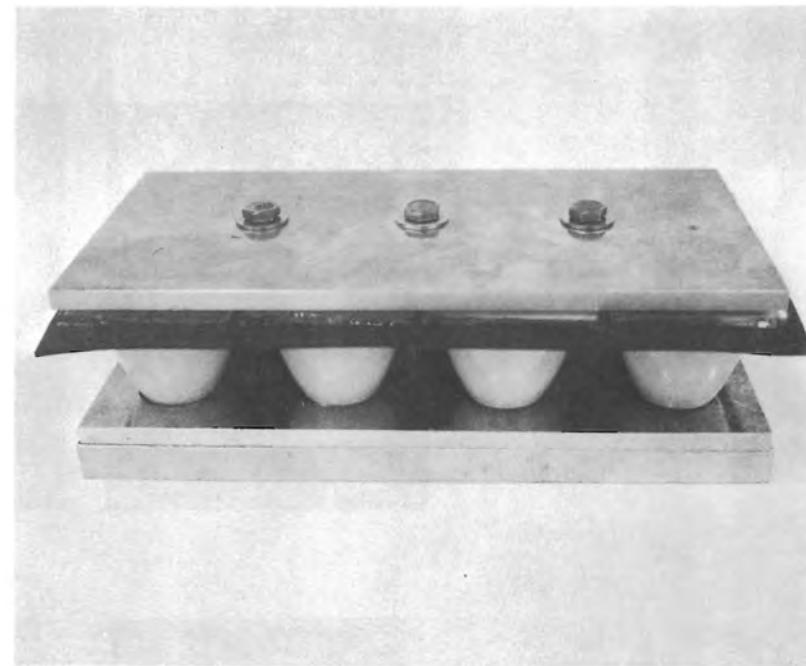
FIGURE 1. The Water Vapor Exposure Test Fixture Shown Broken Down (a) and Assembled with Mirror Coupons in Place (b)

The samples exposed to heat and water vapor were placed in the test fixture shown in Figure 1. The mirror coupons were centered over a neoprene gasket which was fitted to a ceramic container. The container was partially filled with deionized water. The coating to be tested was then in direct contact with the water vapor while the glass side of the mirror was kept dry, thus allowing an undegraded view of the interface. The entire fixture was placed in an oven for the predetermined time periods called for in the experiment. The relative humidity in the containers rapidly approached 100%. Condensation was usually observable on the mirror backs, especially near the neoprene seal. All data was consequently recorded at the center of the exposed area.

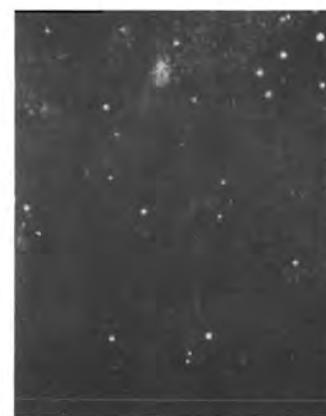
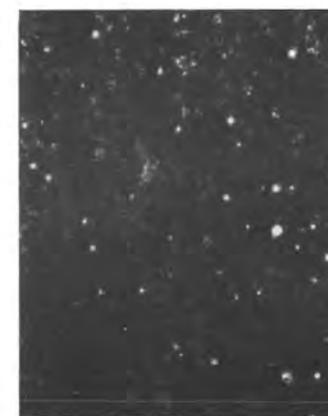
FIGURE 2. Darkfield Micrographs of Manufacture B Standard Mirrors Stressed for 336 Hours in 80°C Dry and Moist Environments

The micrographs of the reference mirrors are shown in Figures 2 and 3. Samples from the two different manufacturers are shown for the heat only and heat plus water vapor environments after exposure for 336 hours.

The degradation is most visible in the 100X micrographs. It is characterized by apparent agglomeration of the silver layer. Both sets of mirrors show more severe degradation in the heat plus water vapor environment than in the heat only environment. The variation between the two sets of mirrors is typical of each manufacturer's samples. The samples from manufacturer C show consistently less degradation than those from B in both environments.

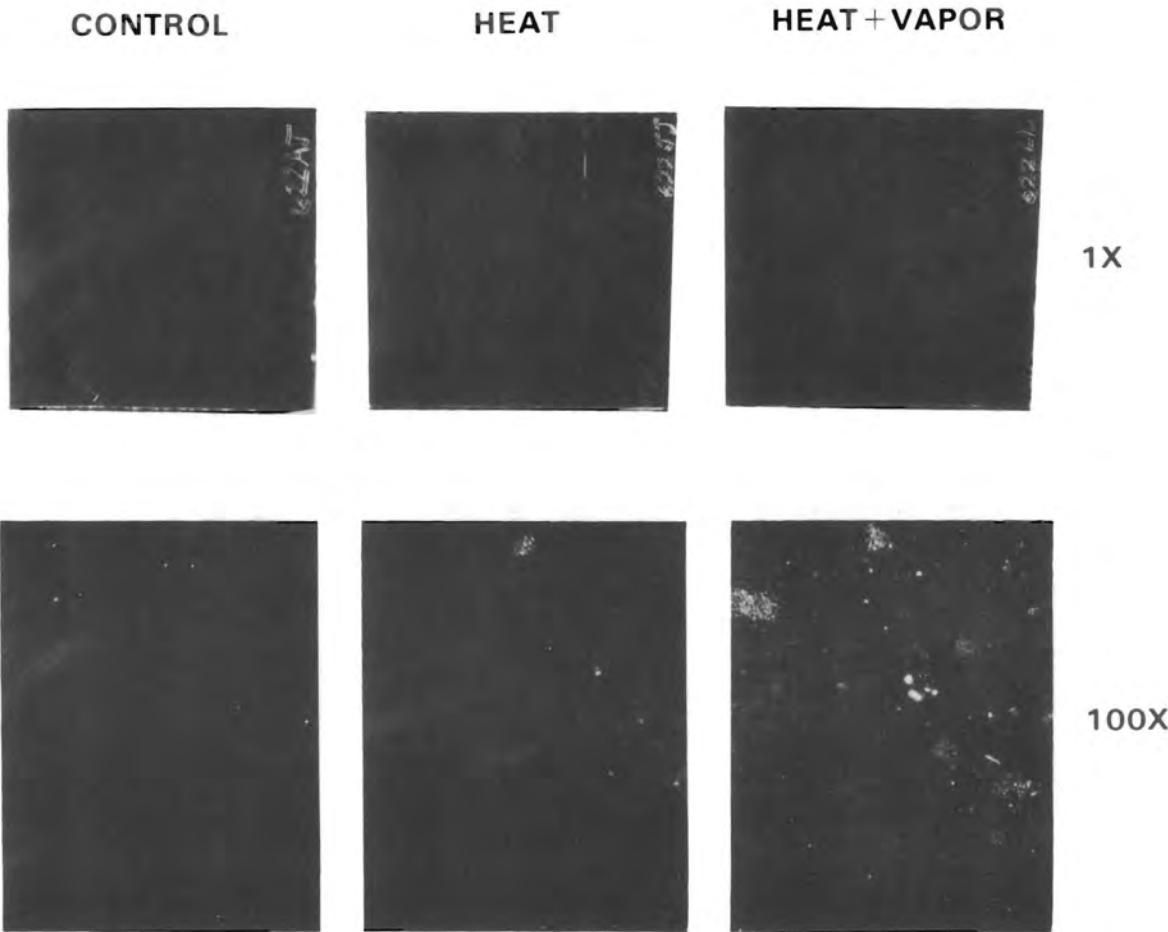
FIGURE 3. Darkfield Micrographs of Manufacture C Standard Mirrors Stressed for 336 Hours in the 80°C Dry and Moist Environments

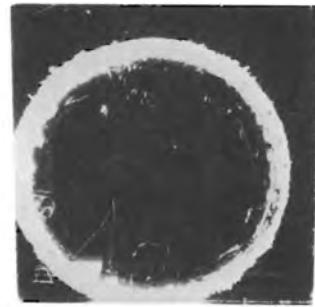
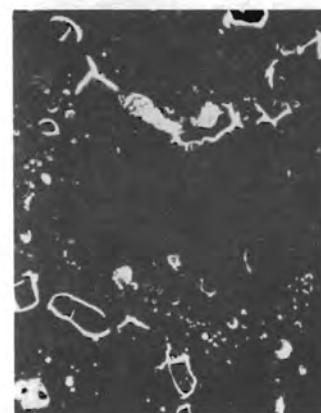
FIGURE 4. Darkfield Micrographs of the Ion Plated Silver, Aluminum Backed Mirrors Stressed for 336 Hours at 80°C in Dry and Moist Environments

Micrographs of the ion-plated mirrors on soda-lime silicate float glass exposed for 336 hours under conditions identical to the reference set are shown in Figures 4 to 8. Qualitatively, the mirrors on the soda-lime silicate float glass substrate behaved similarly to those on the aluminoborosilicate fusion glass. The fusion glass mirrors generally showed slightly less severe degradation than the float glass mirrors. The mirrors backed with Ni, Cr and Al showed less degradation than the reference mirrors after 336 hours in the heat only environment, but all the ion-plated mirrors were more severely degraded than the reference mirrors after exposure to the heat plus vapor environment. Apparently the metallic overcoatings successfully stabilized the silver film from agglomeration in the dry heat environment. The severe degradation in the moist environment may be due to the suspected porous nature of the ion-plated metallic overcoat.

The modes of failure differed for the different overcoating materials, but were again consistent for the two substrate materials. Cracking and peeling were observed in the Ni and 304 stainless steel overcoated mirrors. In fact, cracking was evident in the unexposed 304 stainless steel samples and it became more severe in both stress environments. The Cr overcoated mirror degraded by means of pinhole formation that may have been accompanied by some agglomeration of the silver. The Al and Al/Cu overcoated mirrors exhibited massive delamination and flaking of the metal layers in both environments.

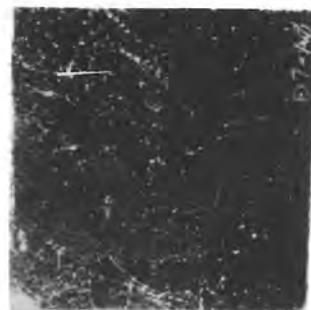
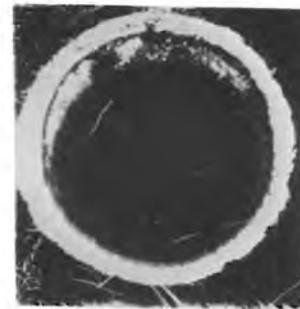
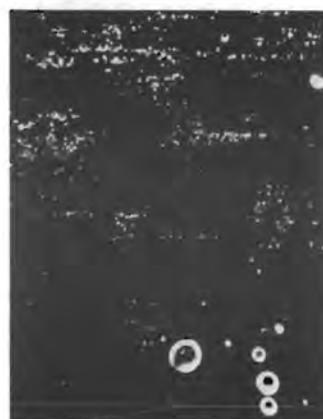
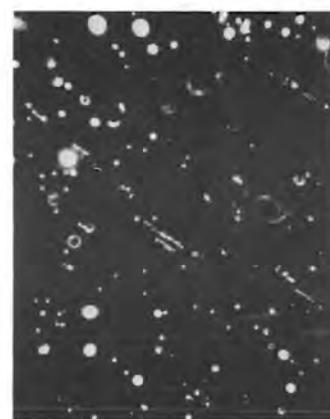
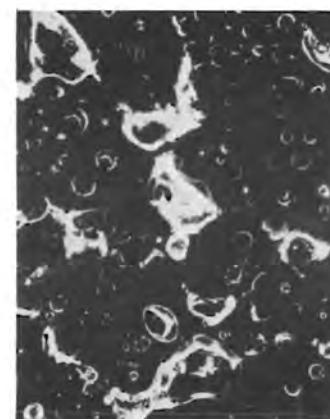
FIGURE 5. Darkfield Micrographs of the Ion Plated Silver, Aluminum (.35)/Copper(.65) Backed Mirrors Stressed for 336 Hours at 80°C in Dry and Moist Environments

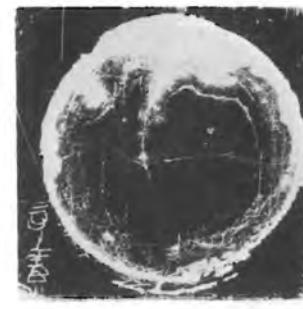
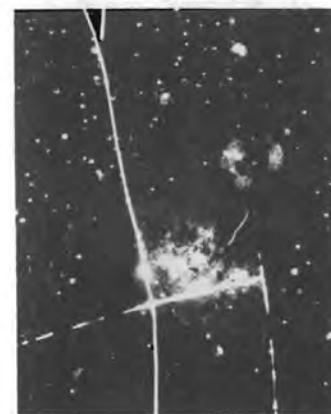
FIGURE 6. Darkfield Micrographs of the Ion Plated Silver, Chromium Backed Mirrors Stressed for 336 Hours at 80°C in Dry and Moist Environments

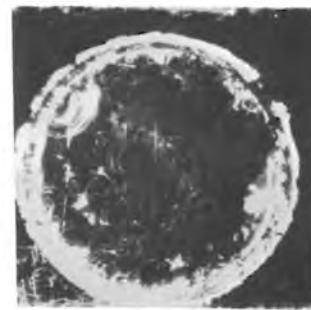
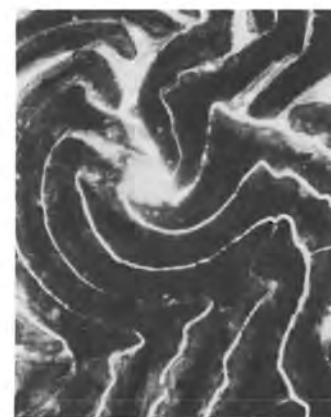
FIGURE 7. Darkfield Micrographs of the Ion Plated Silver, 304 Stainless Steel Backed Mirrors Stressed for 336 Hours at 80°C in Dry and Moist Environments

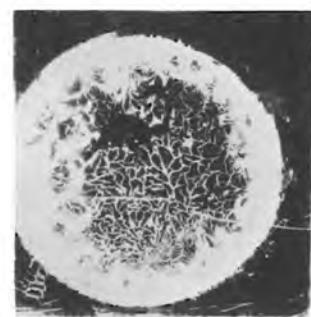
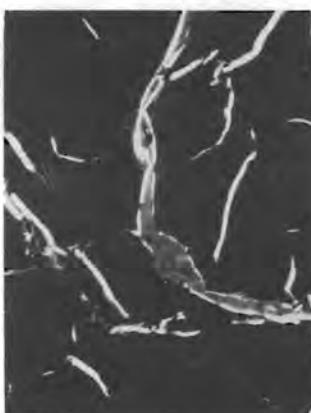
FIGURE 8. Darkfield Micrographs of the Ion Plated Silver, Nickel Backed Mirrors Stressed for 336 Hours at 80°C in Dry and Moist Environments

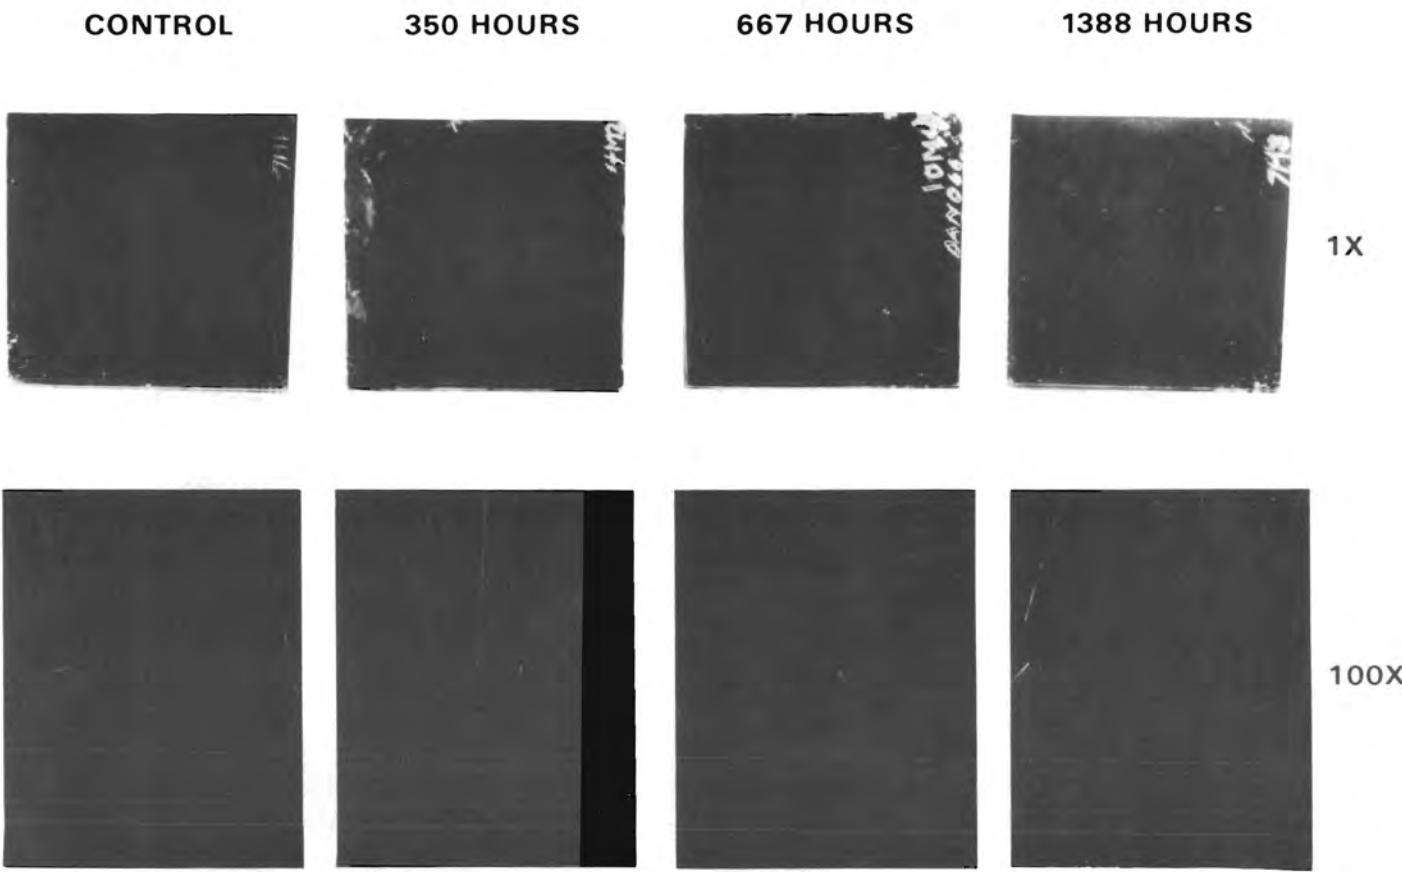
FIGURE 9. Darkfield Micrograph of Standard Silver/Copper, Electroless Nickel Backed Mirrors Stressed at 80°C in a Dry Environment

The results of similar tests performed on the standard silver/copper mirrors overcoated with a chemically deposited nickel coating are shown in Figures 9 and 10. No appreciable degradation was observed after 336 hours,

so the exposure time was extended to 1388 hours. Note that no visible degradation is evident after 1388 hours in the heat only environment. No appreciable degradation is observable in 667 hours of the heat and water vapor environment. After 1388 hours the mode of failure in the heat plus vapor environment again appears to be agglomeration. These results show dramatic improvement in stability compared to either the reference standard mirrors or the ion-plated mirrors.

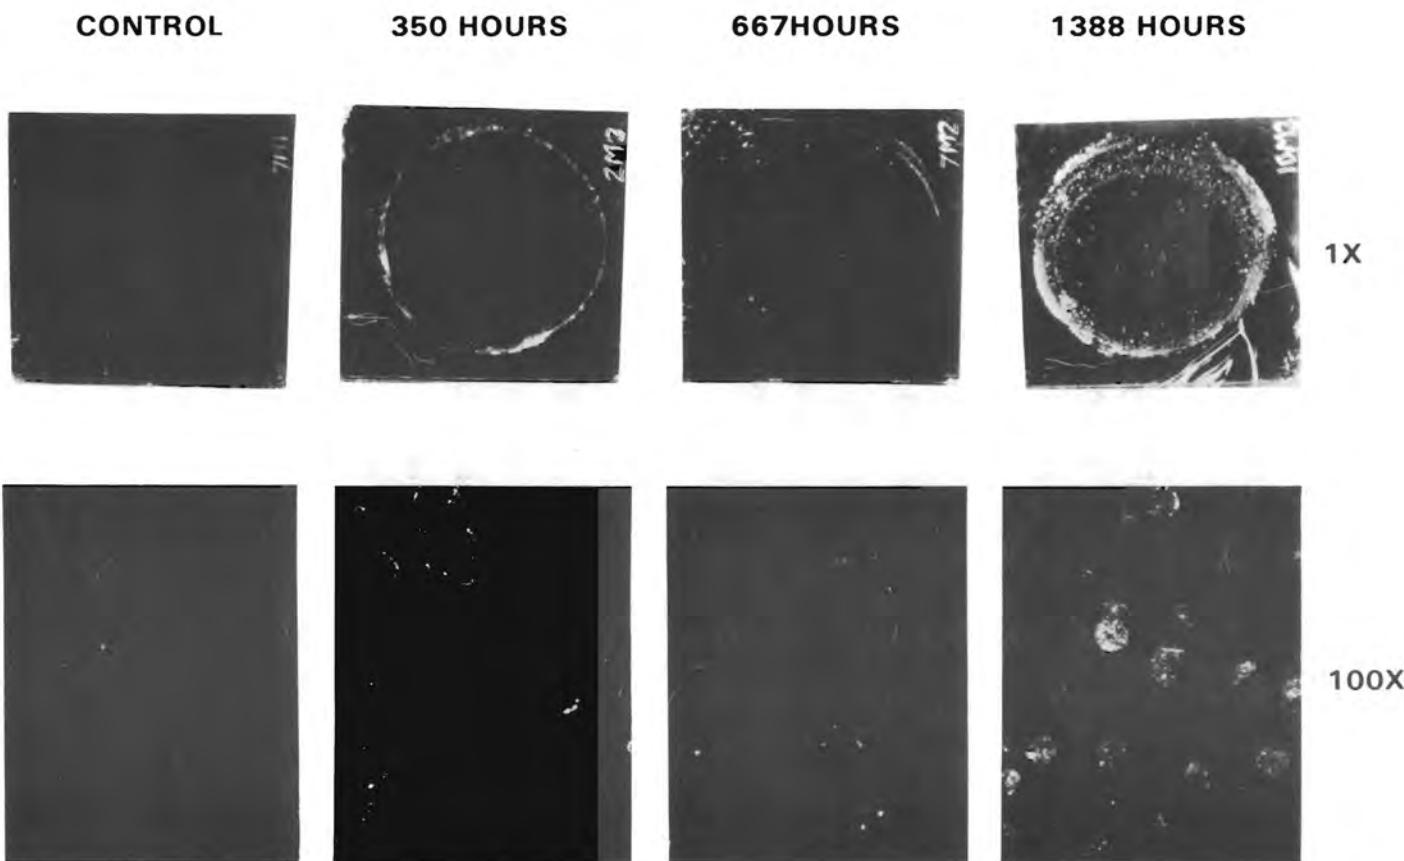
FIGURE 10. Darkfield Micrographs of Standard Silver/Copper,
Electroless Nickel Backed Mirrors Stressed at
80°C in a Moist Environment

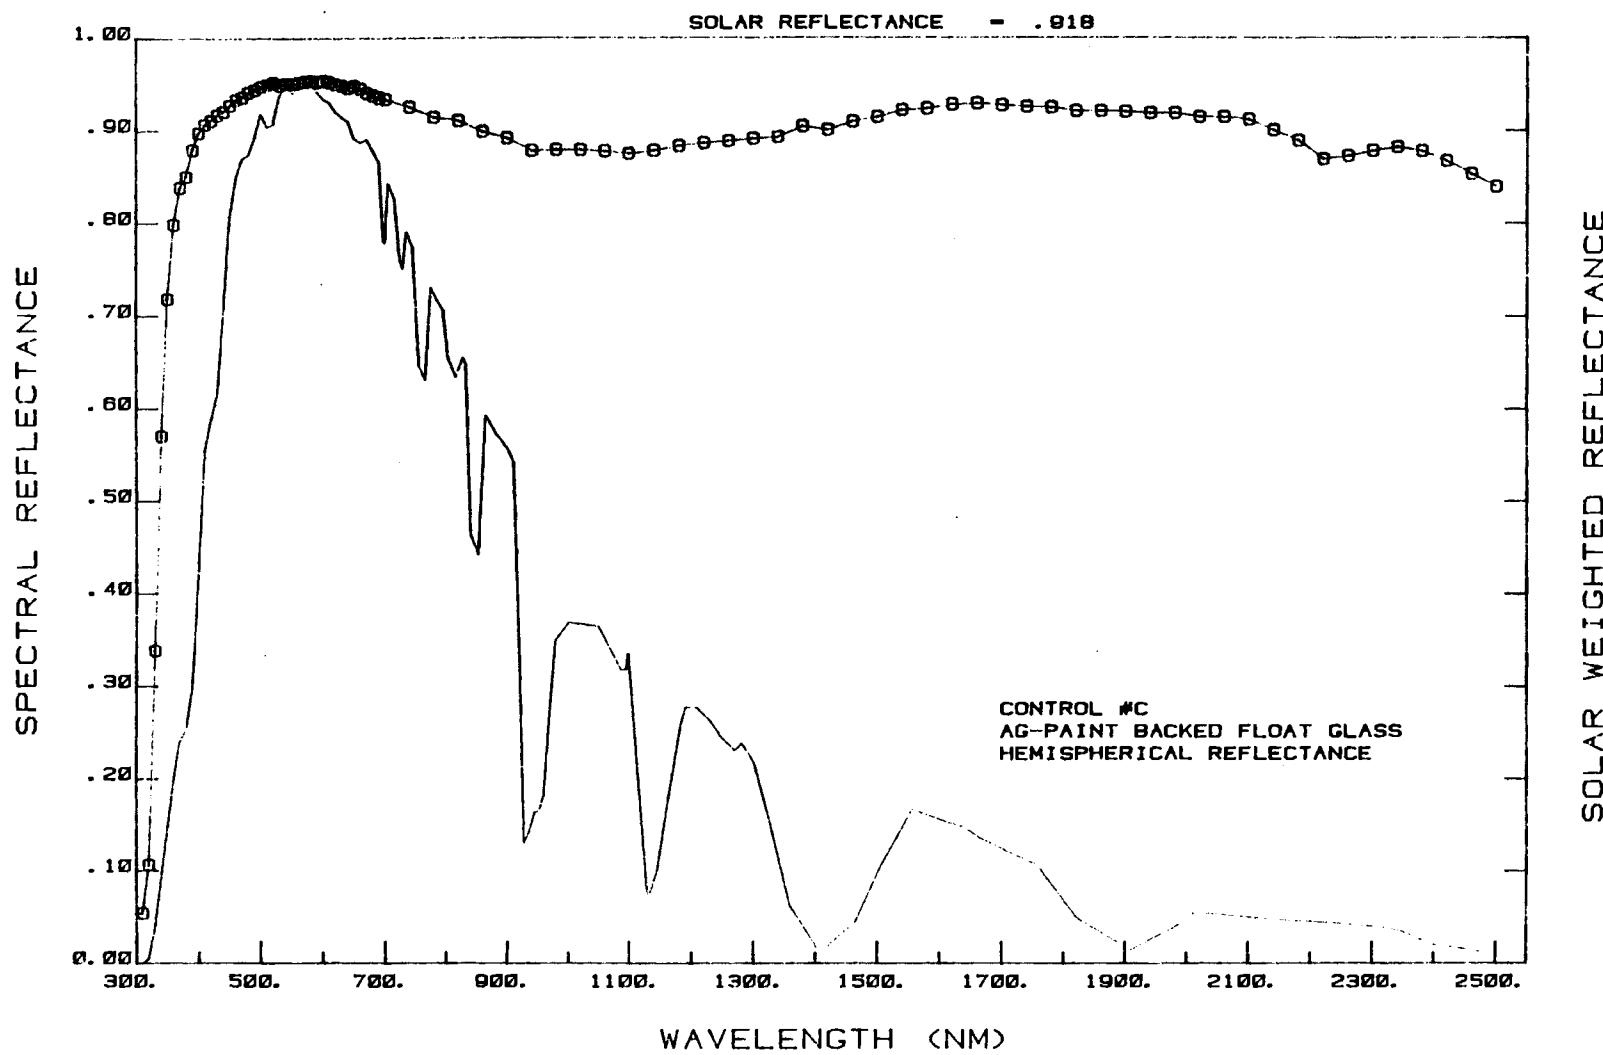
FIGURE 11. Spectral Hemispherical Reflectivity of Manufacture C Mirror prior to Accelerated Environmental Exposure

The actual spectral hemispherical and diffuse reflectance data for a typical reference standard mirror taken before and after stress testing is shown in Figures 11 and 12. The spectral hemispherical reflectance curves

for all the other mirror types before stressing look very similar to the reference standard mirror data. The ratio of stressed/unstressed hemispherical reflectances for this mirror is plotted in Figure 13 to more clearly define the induced changes. The most significant changes in reflectivity are found in the UV-visible region (300-750 nm) of the spectra.

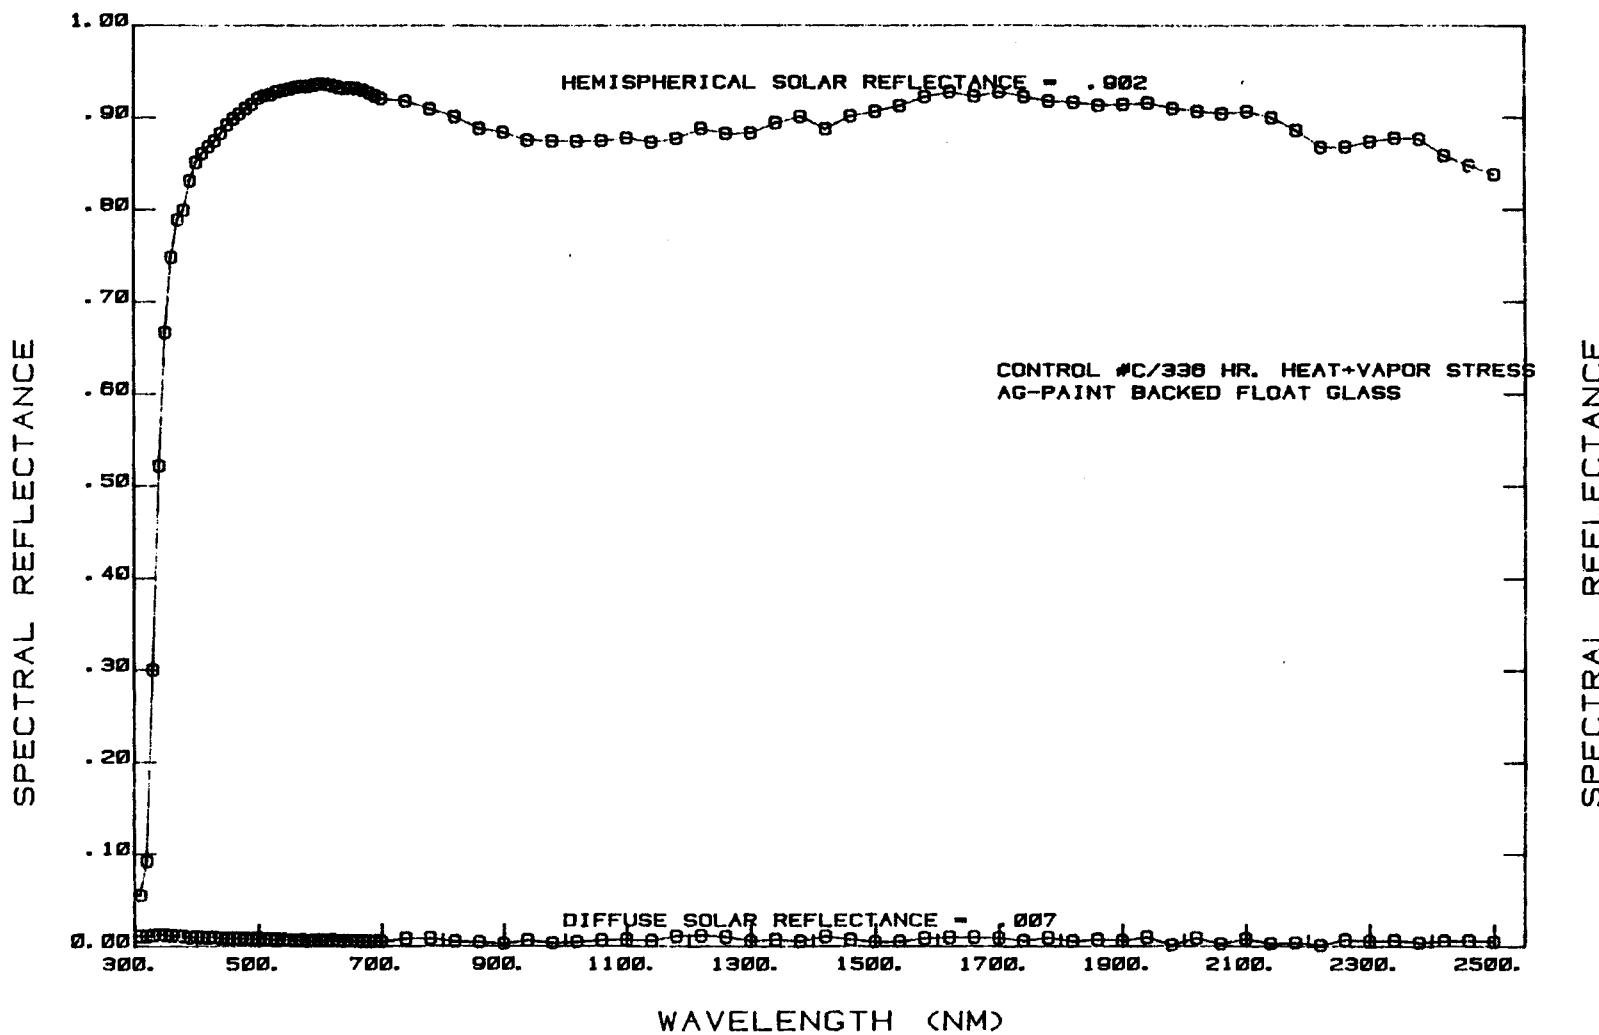
FIGURE 12. Hemispherical and Diffuse Reflectance Curves for Manufacture C Mirror after 336 Hours in an 80°C Heat and Vapor Environment.

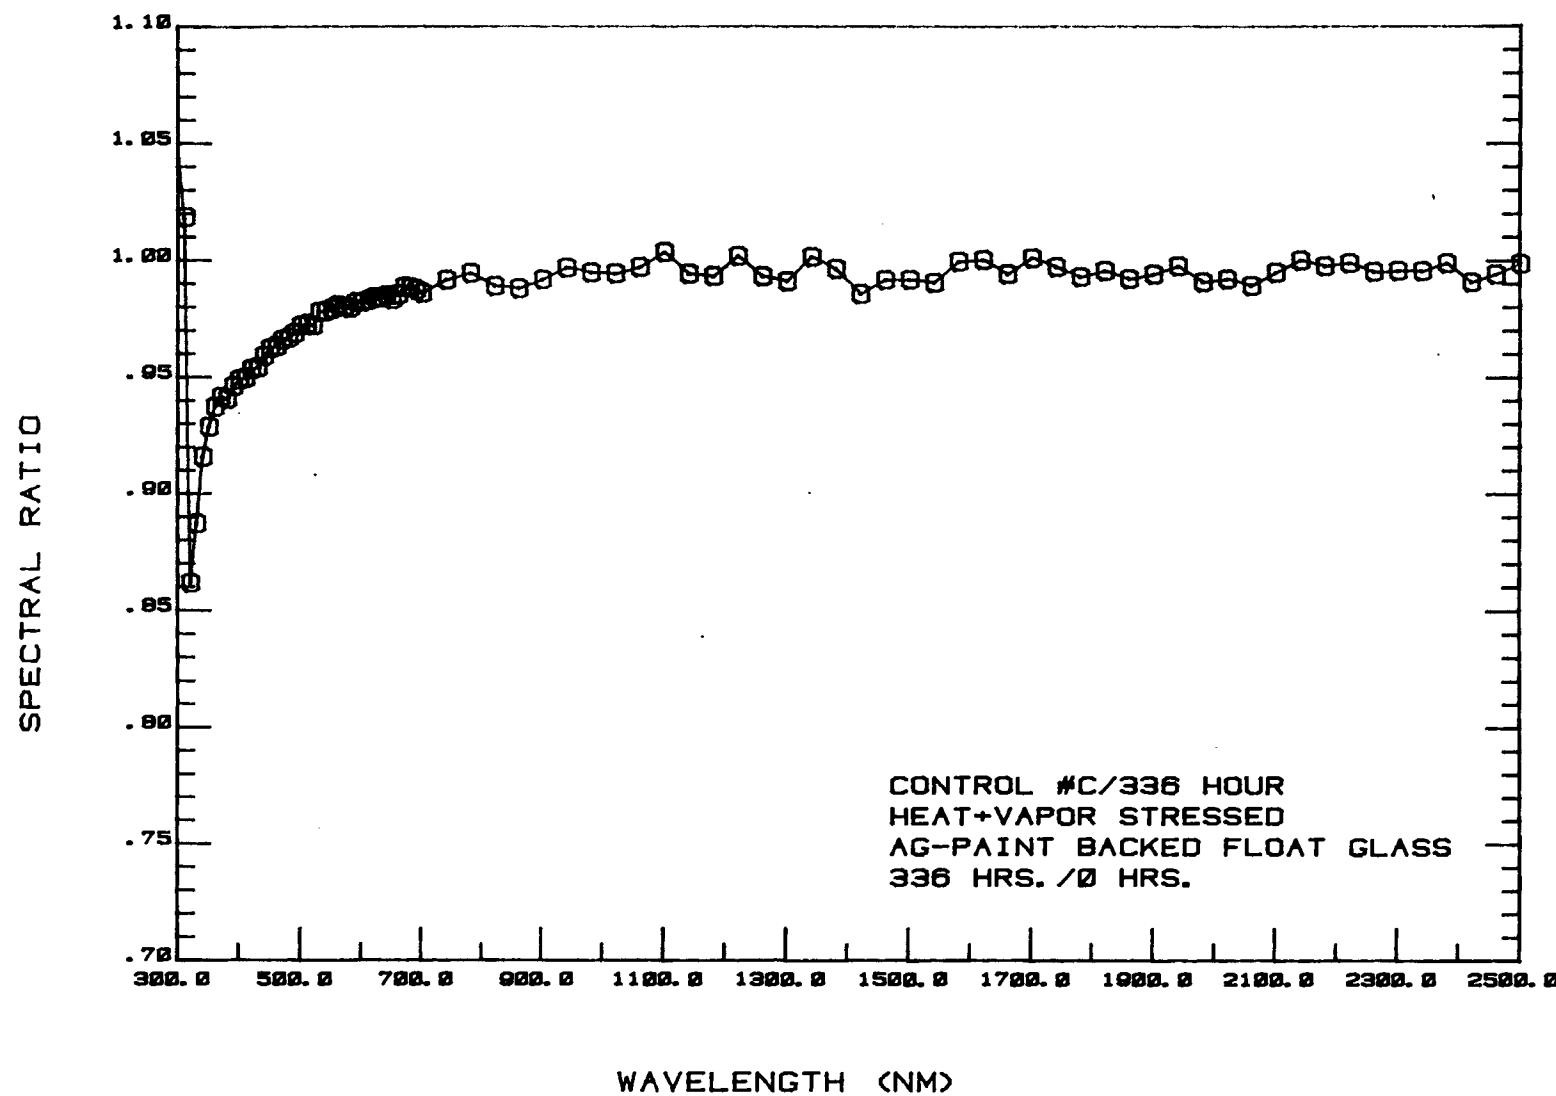
FIGURE 13. After Stress/Before Stress: Reflectivity Ratio Curve for Manufacturer C Mirror.

In general, the reflectance of most of the degraded mirrors, after exposure in either dry heat or heat plus vapor environments, is characterized by an abrupt drop in reflectance in the 320 - 330 nm region. This absorption may be associated with the silver surface plasmon that is found close to this wavelength region.⁽⁶⁾ Due to the very low reflectance of silver in the 310-330 nm region, small changes in reflectance here will be greatly magnified in the ratio curve, and the absolute magnitude of the initial reflectance drop is small. The reflectivity ratio approaches unity after this initial absorption and, except for the most severely degraded mirrors, the reflectivity ratio remains close to unity through the NIR region. This severity of the degradation of a mirror can be directly related to the reflectance loss in the UV-visible region.

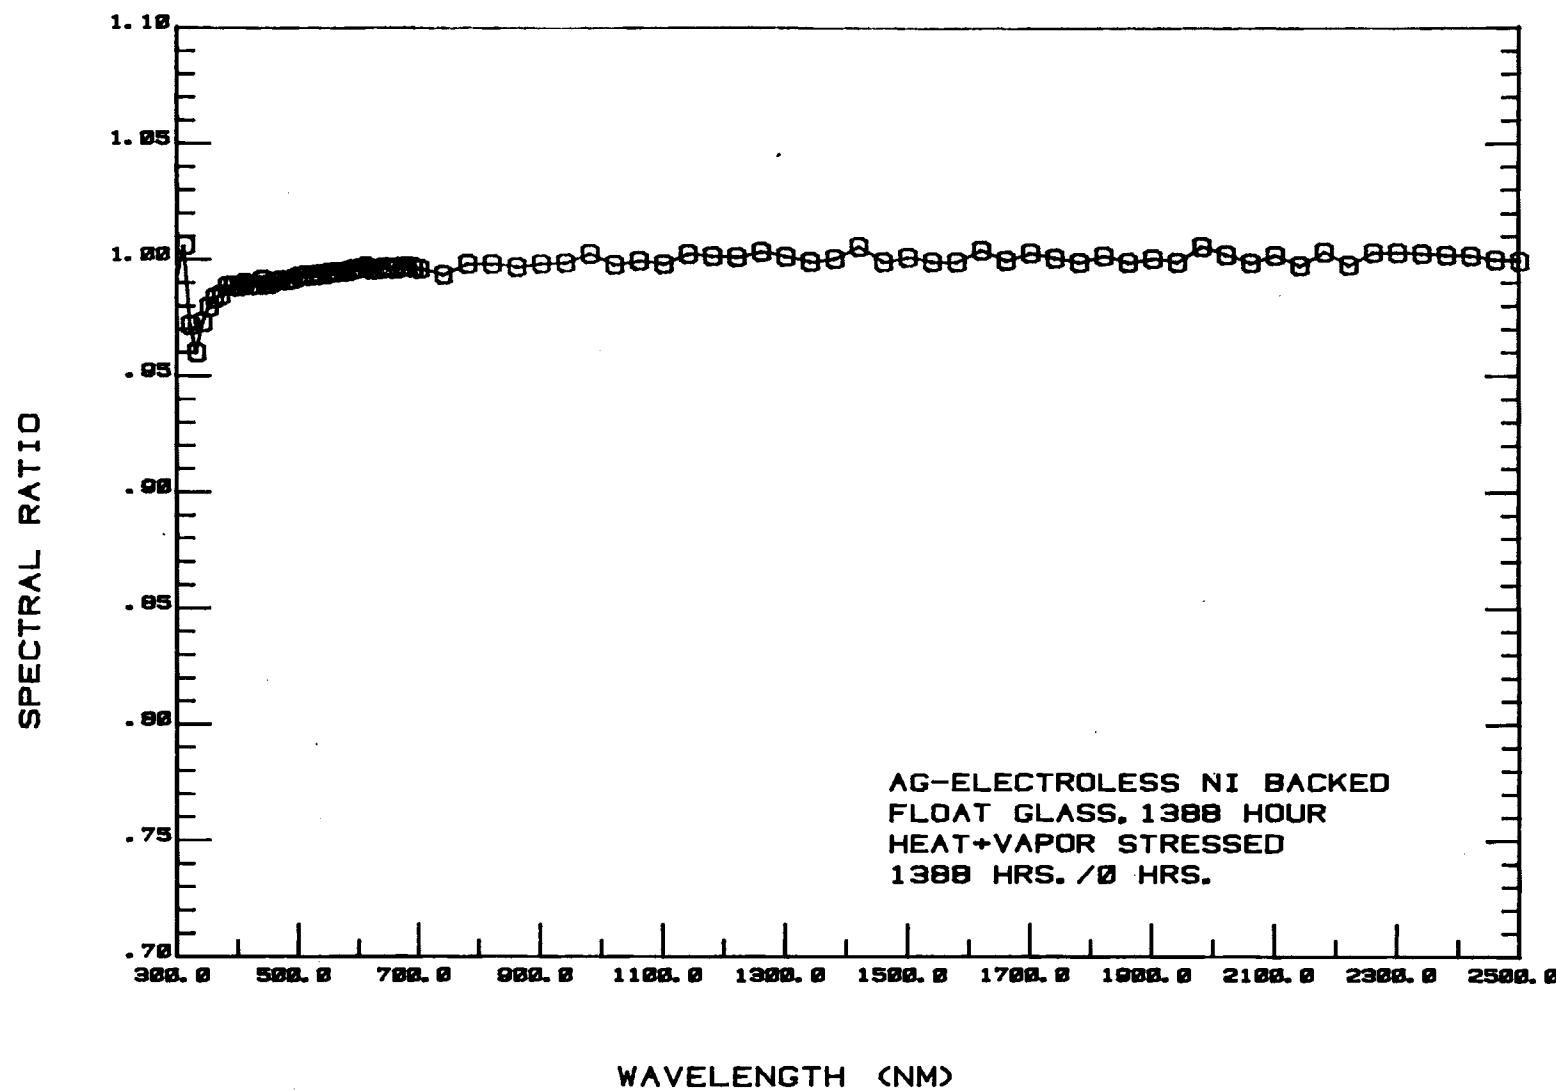
FIGURE 14. After Stress/Before Stress: Reflectivity Ratio
Curve for Electroless Nickel Overcoated Mirror

The reflectivity ratio curve for the less severely degraded electroless Ni overcoated mirror is given in Figure 14. Figure 15 shows the ratio curve for the severely degraded aluminum backed ion plated mirror. Some of the ion-plated mirrors exhibited enhanced reflectivity in the UV after exposure to the dry heat environment. The curve for one such mirror (Cr backed) is displayed in Figure 16.

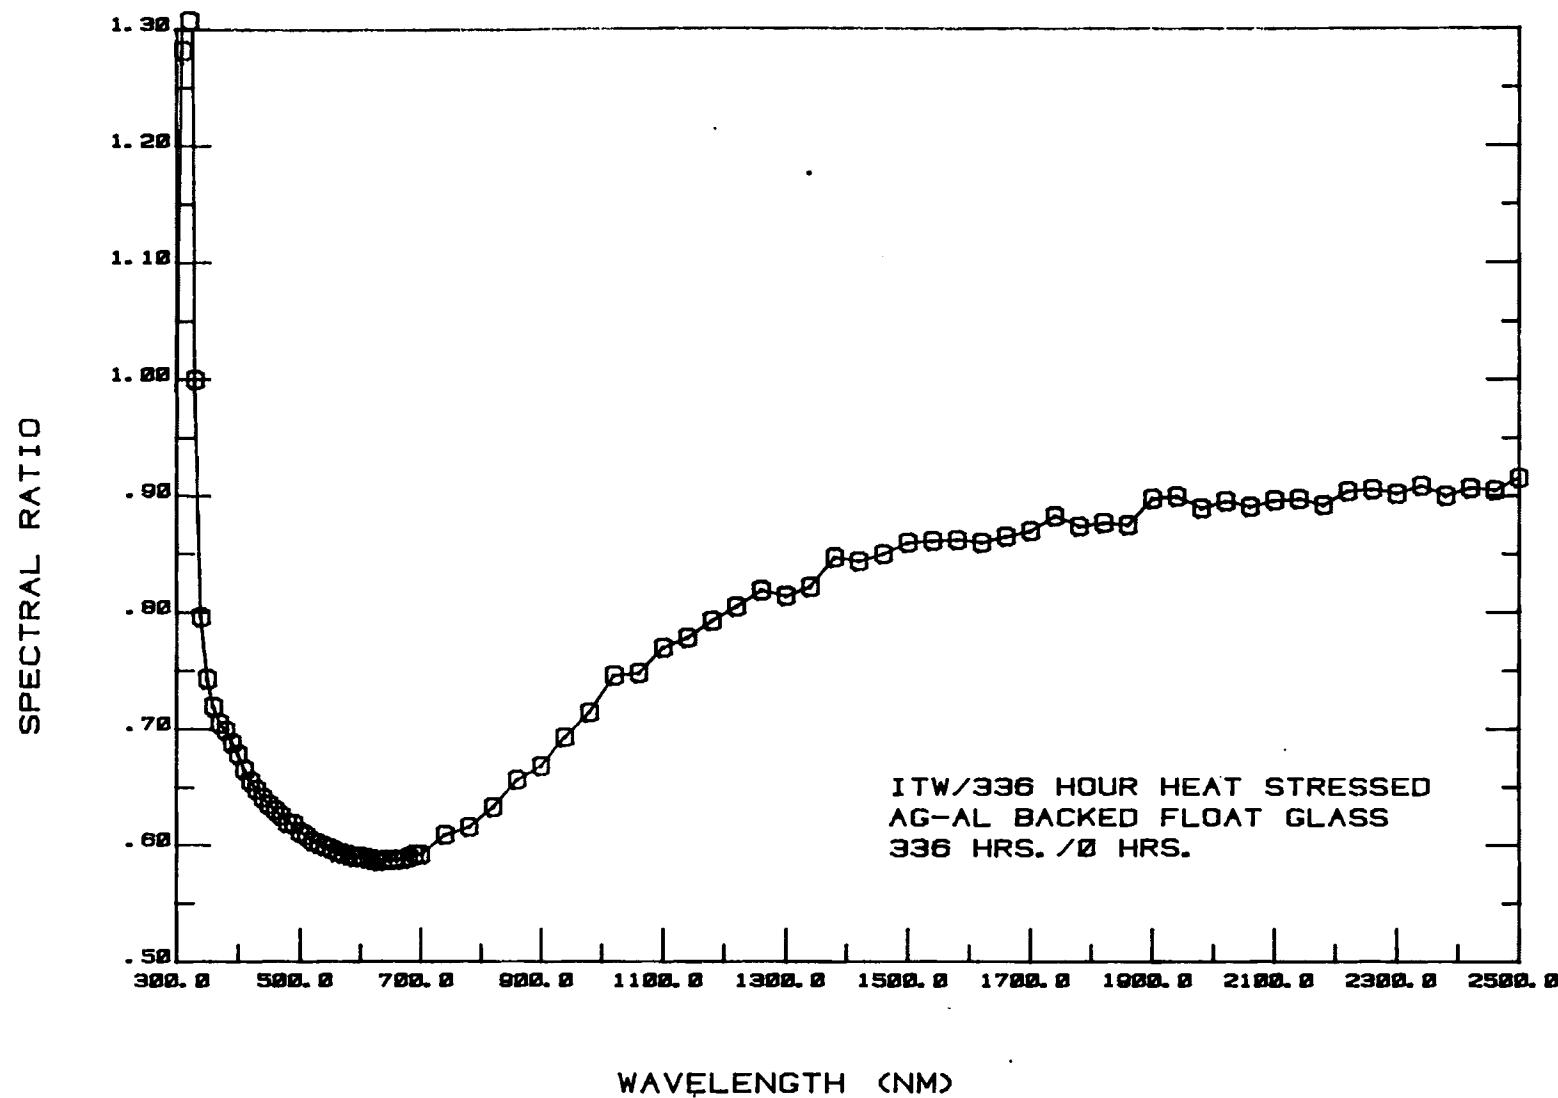
FIGURE 15. After Stress/Before Stress: Reflectivity Ratio Curve for the ITW Aluminum Backed Mirrors

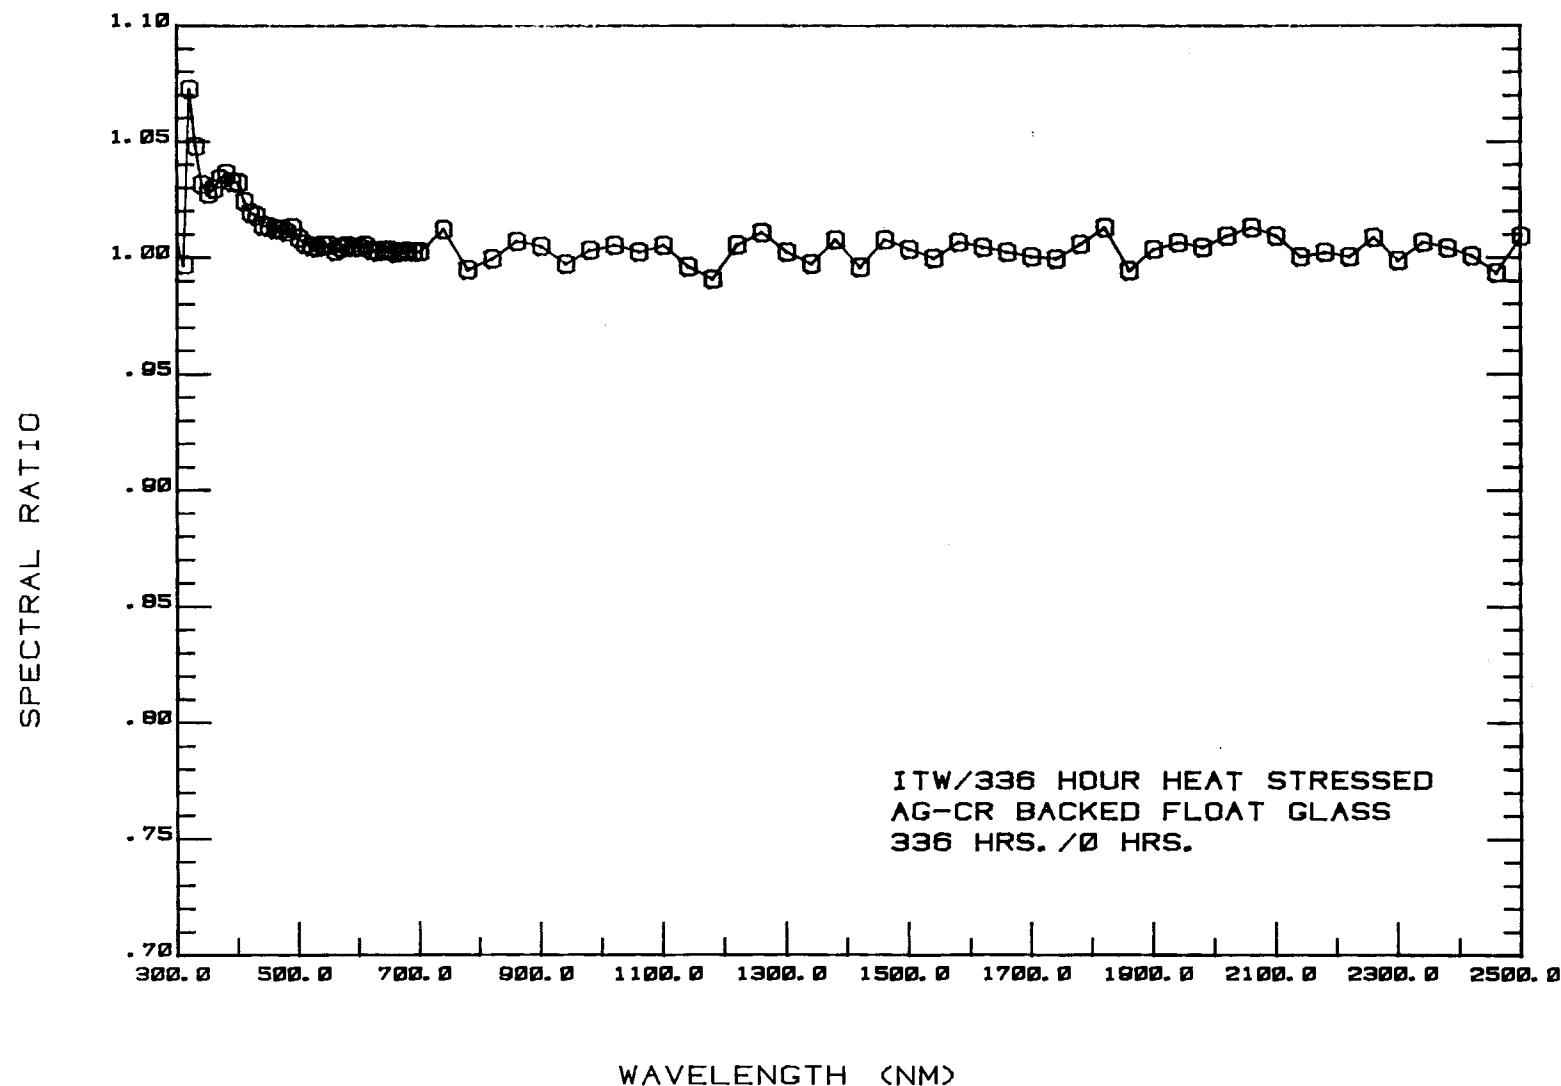
FIGURE 16. After Stress/Before Stress: Reflectivity Ratio
Curve for the ITW Chromium Backed Mirror
