Paper presented at the Fifth Tandem Conference,
Catania, Italy, June 9-12, 1980
(to be published in Nuclear Instruments and Methods as part of the
conference proceedings)

THE 25 MV TANDEM ACCELERATOR AT OAK RIDGE*

C. M. JONES

Oak Ridge National Laboratory, Oak Ridge, TN 37830, USA

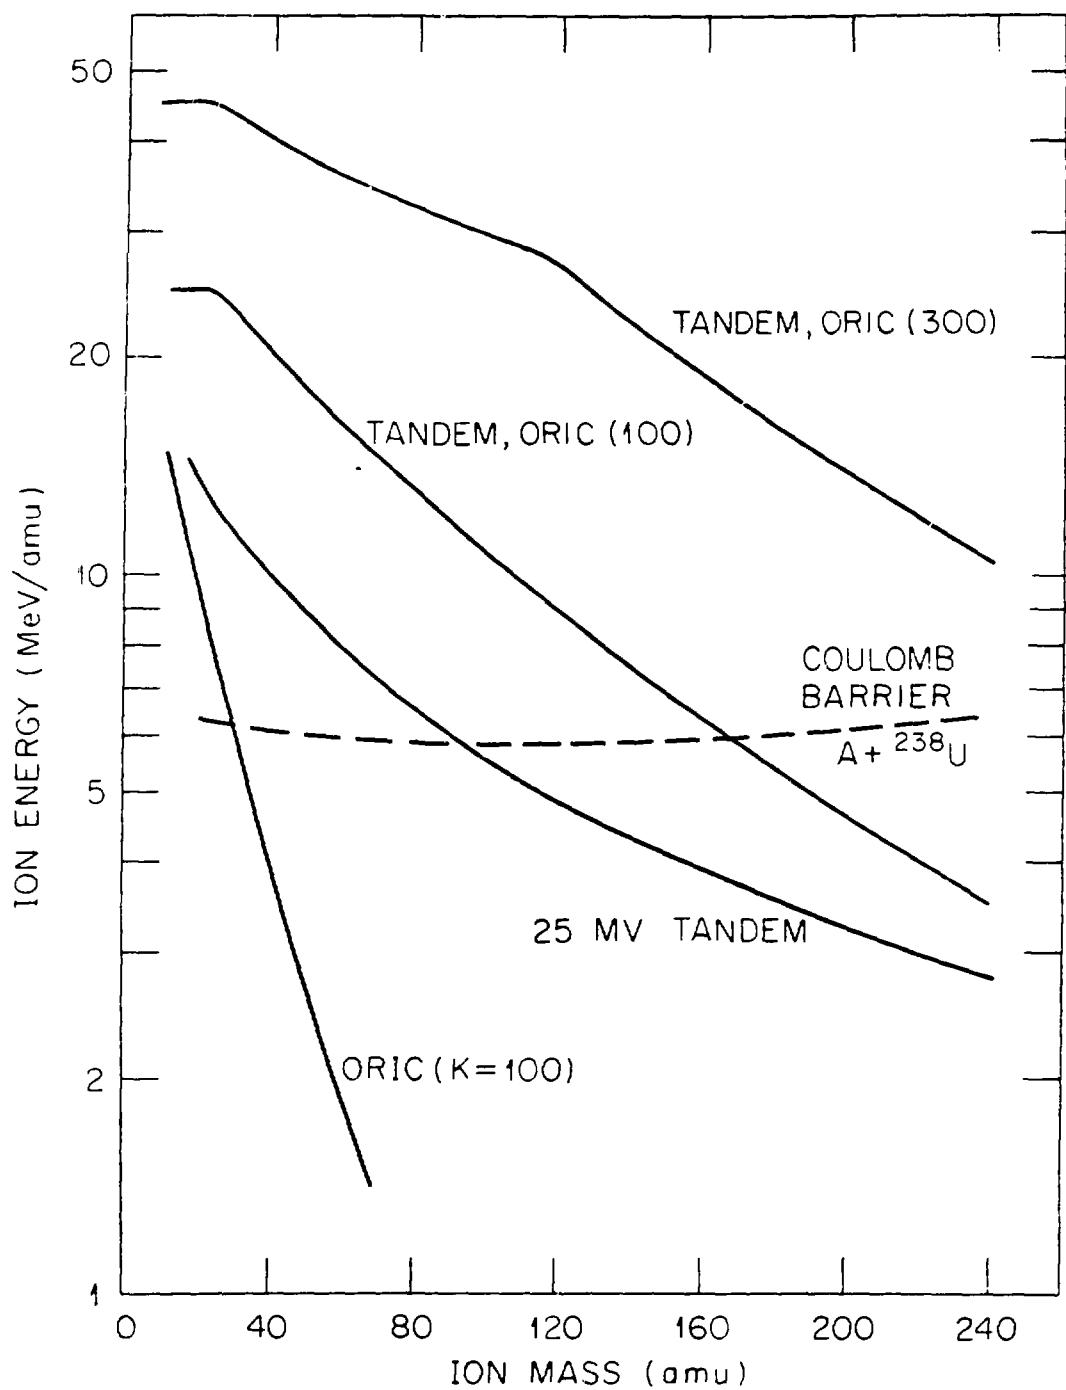
ORNL-DWG 78-3538R

Fig. 1. Ion energy performance functions for the present Oak Ridge Isochronous Cyclotron (ORIC), the Oak Ridge 25 MV tandem accelerator, coupled operation of the 25 MV tandem accelerator and the present ORIC (labeled, TANDEM, ORIC (100)), and coupled operation of the 25 MV tandem accelerator and ORIC as upgraded in the proposed Phase II of the Oak Ridge heavy-ion accelerator facility project (labeled TANDEM, ORIC (300)). Assumptions used in calculating these functions are discussed in the text.

General features of the performance of the Phase I and II accelerators are shown in Figure 1 where ion energy per nucleon is plotted as a function of ion mass. All functions in this figure were calculated for a nominal final intensity of 10^{11} particles/sec. Functions for the tandem accelerator and Phase I and II coupled operation were calculated with an assumed injected beam of 3.6×10^{13} particles/sec. The tandem accelerator function was calculated with the assumption of a gas stripper in the terminal and a foil stripper 1/3 of the way down the high energy acceleration tube. The coupled operation functions were calculated with the assumption of a gas stripper in the tandem accelerator terminal. The

change in slope which occurs in the Phase II curve at about mass 120 is due to a focusing limitation which results from a limit on the azimuthal variation of the magnetic field due to saturation of the existing iron poles.

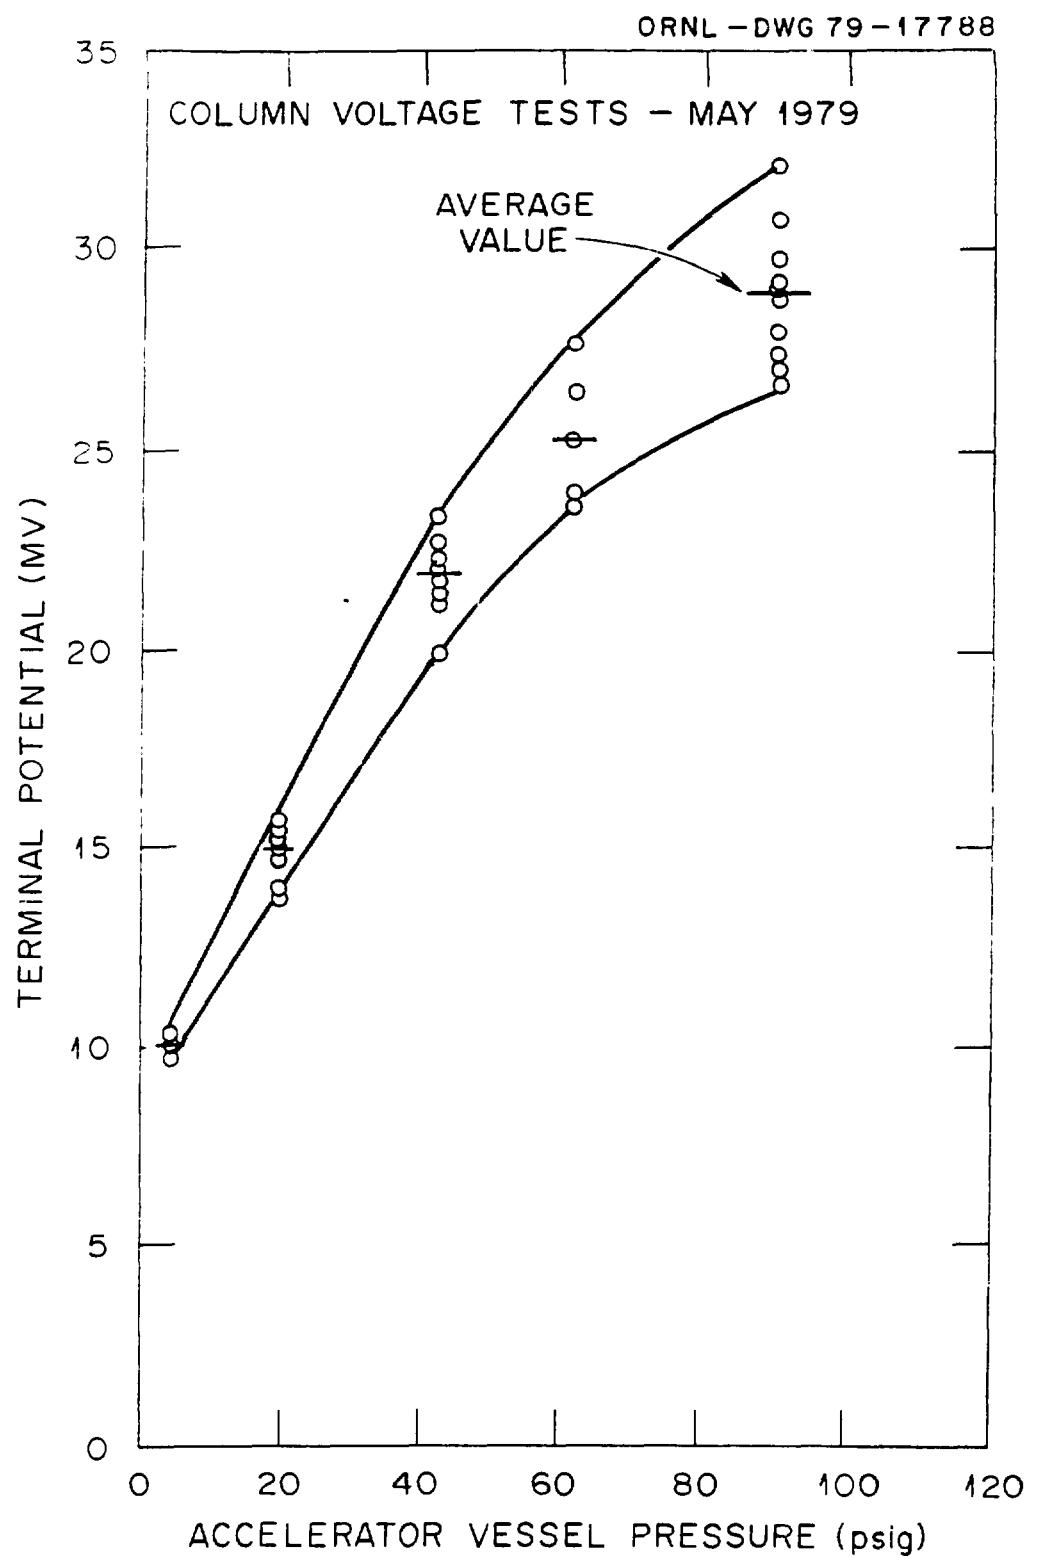
Fig. 3. Values of terminal voltage at breakdown plotted as a function of accelerator vessel pressure (gauge) for the May-1979 column voltage tests of the Oak Ridge 25 MV tandem accelerator. The absolute voltage scale has an estimated uncertainty of $\pm 5\%$.

Tests of the voltage holding capability of the column structure before installation of acceleration tubes were performed by NEC in May 1979. In these tests, the accelerator was filled with SF₆ to a set of test pressures ranging between 0.034 MPa (gauge) (5 psig) and 0.62 MPa (gauge) (90 psig). At each test pressure, a set of measurements was made in which the terminal potential was slowly increased until a spark occurred, thus giving a distribution in breakdown voltage for each test pressure. These data are shown in Figure 3 where each circle represents a breakdown or spark (total of 33). The absolute calibration for the voltage scale of these measurements was established from previous calibrations (in other NEC accelerators) of current vs gradient in the corona voltage grading system and is estimated to be accurate to $\pm 5\%$. At the highest pressure, 0.62 MPa (gauge), the breakdown voltage ranged from 26.4 to 32.0 MV with an average value of 28.8 MV.

At the two higher pressures, 0.41 and 0.62 MPa (60 and 90 psig), there is good evidence for a conditioning phenomena in the sense that breakdown voltage tends to increase with breakdown number. For the highest pressure, for which we have thirteen data points, this increase

averages about 1.3% per breakdown and does not appear to change over the thirteen breakdowns. That is, the breakdown voltage does not appear to level off with breakdown number for the number of breakdowns observed.

Data similar to that of Figure 3 for High Voltage Engineering Corporation type MP [7] and XTU [8,9] tandem accelerators and the NEC type 20 UR tandem accelerator [10] show little change in slope up to pressures of 0.62 MPa (gauge) (90 psig). A comparison of these data with that shown in Figure 3 and the high pressure conditioning effect described above suggest that the change in slope exhibited by the data

in Figure 3 at pressures above 0.28 MPa (gauge) (40 psig) is due to dirt. As indicated, it was not possible to test this hypothesis due to schedule constraints. However, we believe these tests indicate that, even without this hypothesis, the column structure has been shown to be electrostatically adequate for the design voltage of 25 MV.
