**EPRI-NASA Cooperative Project on  
Stress Corrosion Cracking of Zircaloys**

**NP-717  
Research Project 455-1**

**Final Report, March 1978**

**SRI INTERNATIONAL  
333 Ravenswood Avenue  
Menlo Park, California 94025**

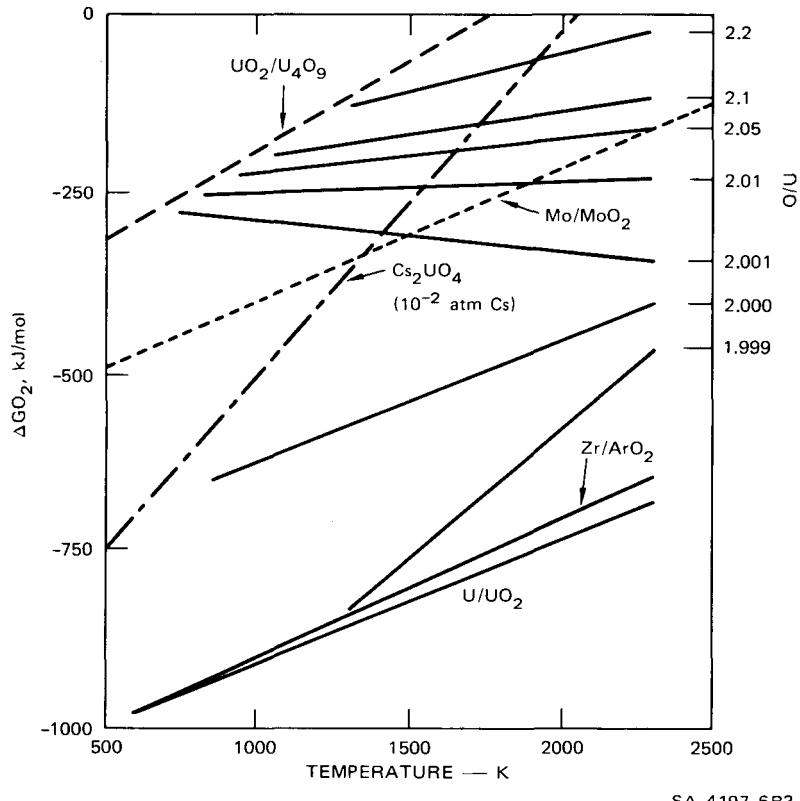
SA-4197-6R3

FIGURE 2-15 OXYGEN POTENTIALS FOR  $UO_{2+x}$  FROM BLACKBURN/MODEL (FULL LINES) AND FOR FORMATION OF SOME SOLID OXIDES AND FOR THE REACTION  $2Cs(g) + O_2 + UO_2(s) = Cs_2UO_4(s)$

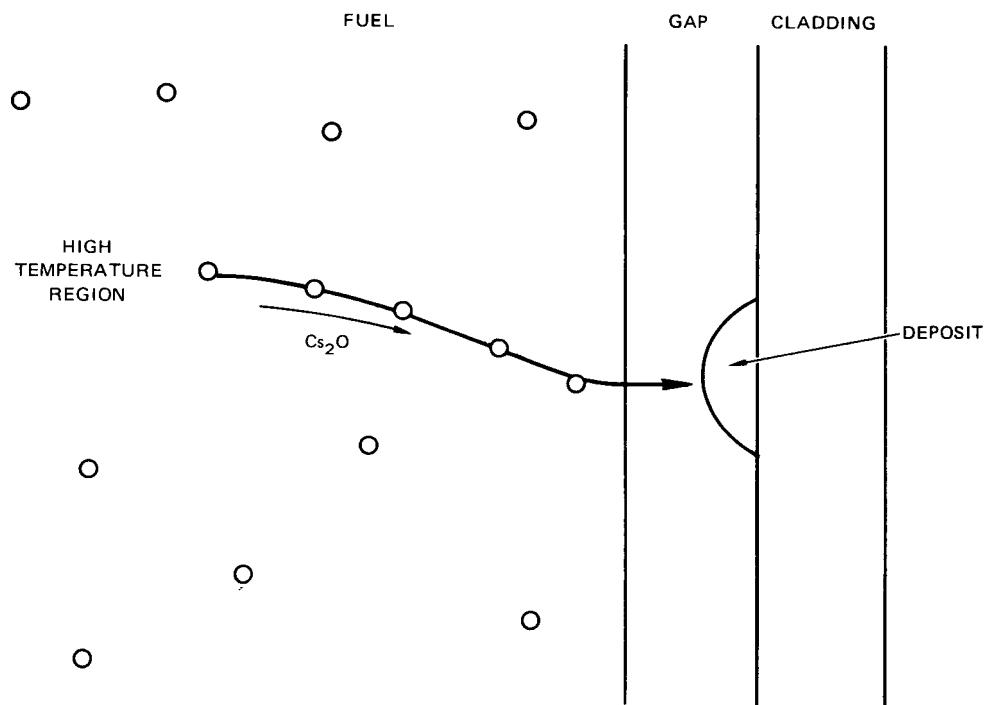
(a) Cs<sub>2</sub>O VAPOR RELEASED FROM HOT CENTRAL FUEL TRAVELS ALONG FUEL CRACKS OR INTERCONNECTED POROSITY AND FINALLY DEPOSITS ON CLADDING

A model for the formation of the more massive Cs-U ceramic deposits must consider the transport of Cs, O, and U. We propose the following model, which is illustrated in Figure 2-16. When the center of the fuel became hot enough to release fission products, gaseous Cs<sub>2</sub>O was evolved. It was transported to the gaps between pellets, and then to the cladding at pellet interfaces, where it deposited to form type b deposits. The deposit, according to this model, was originally rich in Cs<sub>2</sub>O, but at some time it came in contact with the fuel. The Cs<sub>2</sub>O melted and dissolved some UO<sub>2</sub> to form a higher melting solid that solidified into the observed deposit.

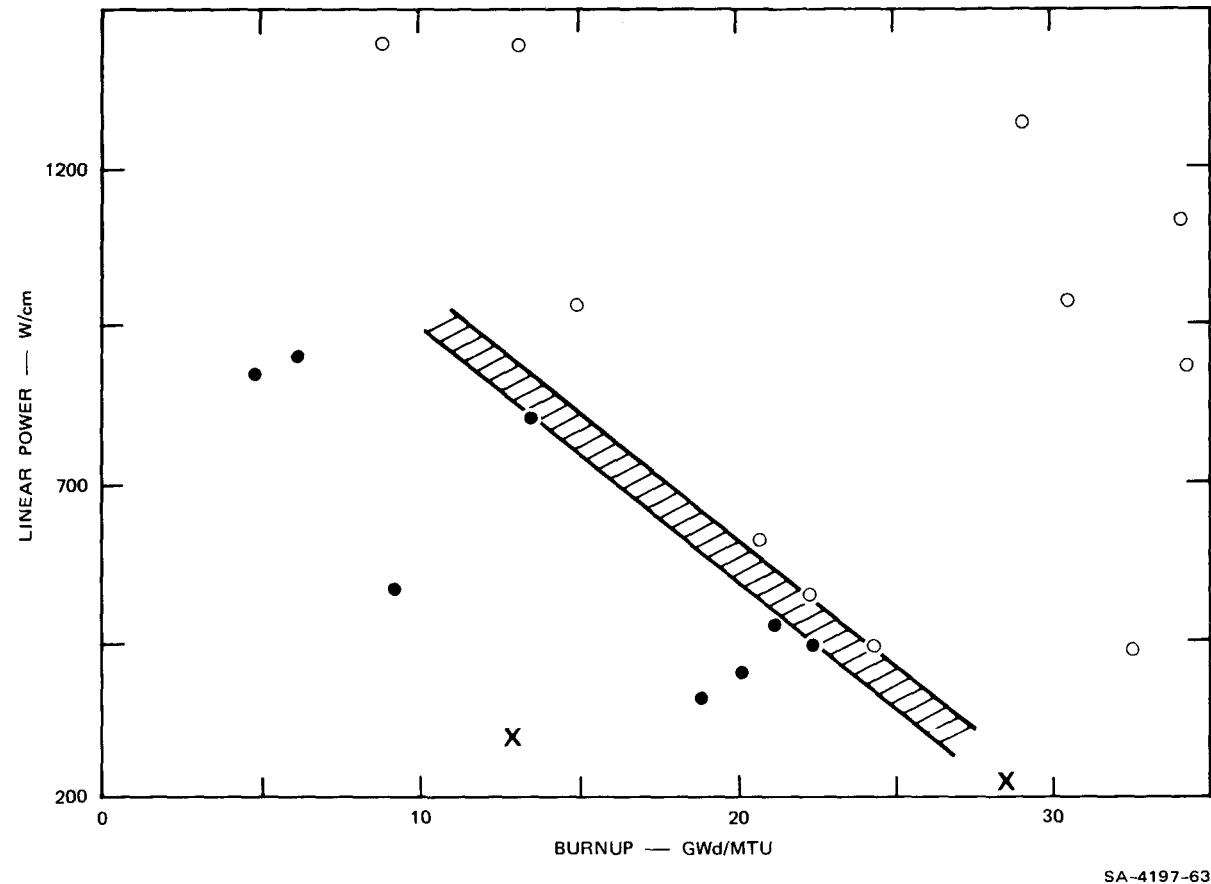
FIGURE 2-17 CONDITIONS FOR FORMATION OF FUEL-CLAD REACTION LAYER FROM BAZIN ET AL

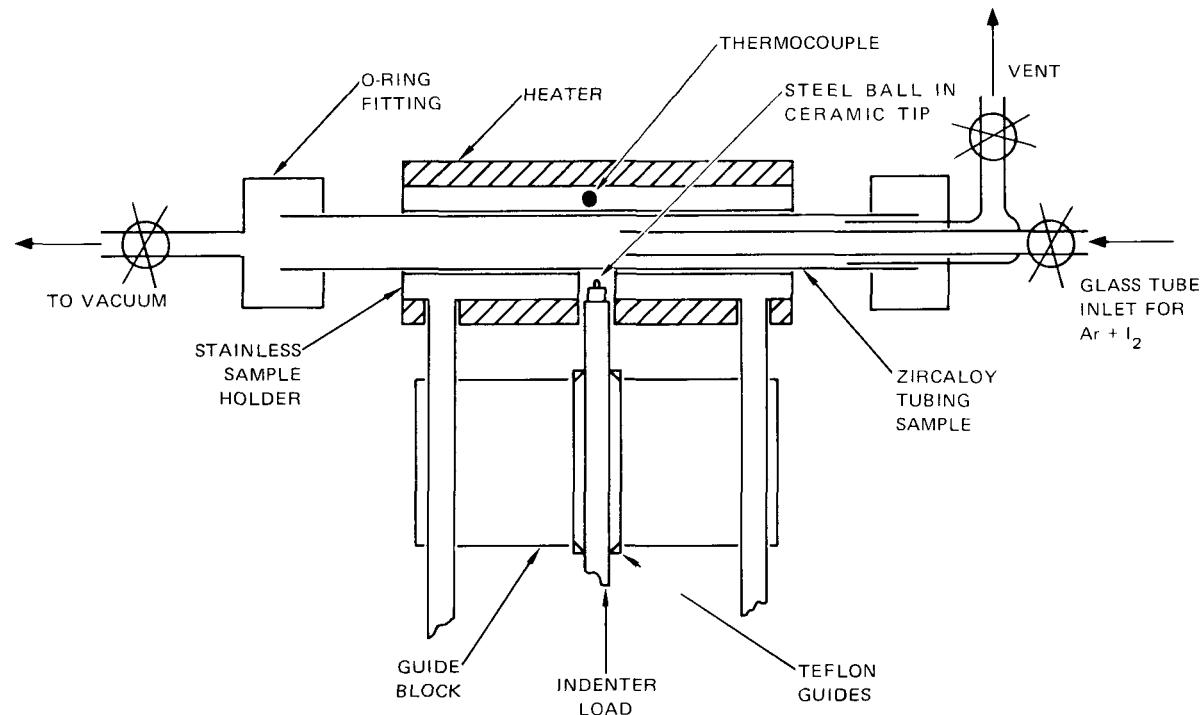
SA-4197-172

FIGURE 4-1 SCHEMATIC DIAGRAM OF INDENTER APPARATUS FOR TUBING SAMPLES

The system used for the tests on tubing is illustrated in Figure 4-1. The central part of the tube sample was heated in a small furnace. The test temperatures chosen were 590 K for Zircaloy-2 tubing and 630 K for Zircaloy-4 tubing because these are approximately the temperatures of operation of BWR and PWR claddings. The sample was strained locally by pressing a 1.6-mm-diameter steel ball against its outside surface. A lever system and a known dead weight were used to generate accurate indenter loads. The direction of motion of the indenter was parallel to the diameter of the tube and perpendicular to its length. As the tube wall was strained by the indenter, a small dimple (typically 1-2 mm in diameter) developed on the inside surface of the tube that was exposed to an Ar-I<sub>2</sub> gas stream flowing through the tube interior. The mixed gas was dried over Drierite before entering the tube sample in the vicinity of the dimple location. The tube sample could be evacuated to

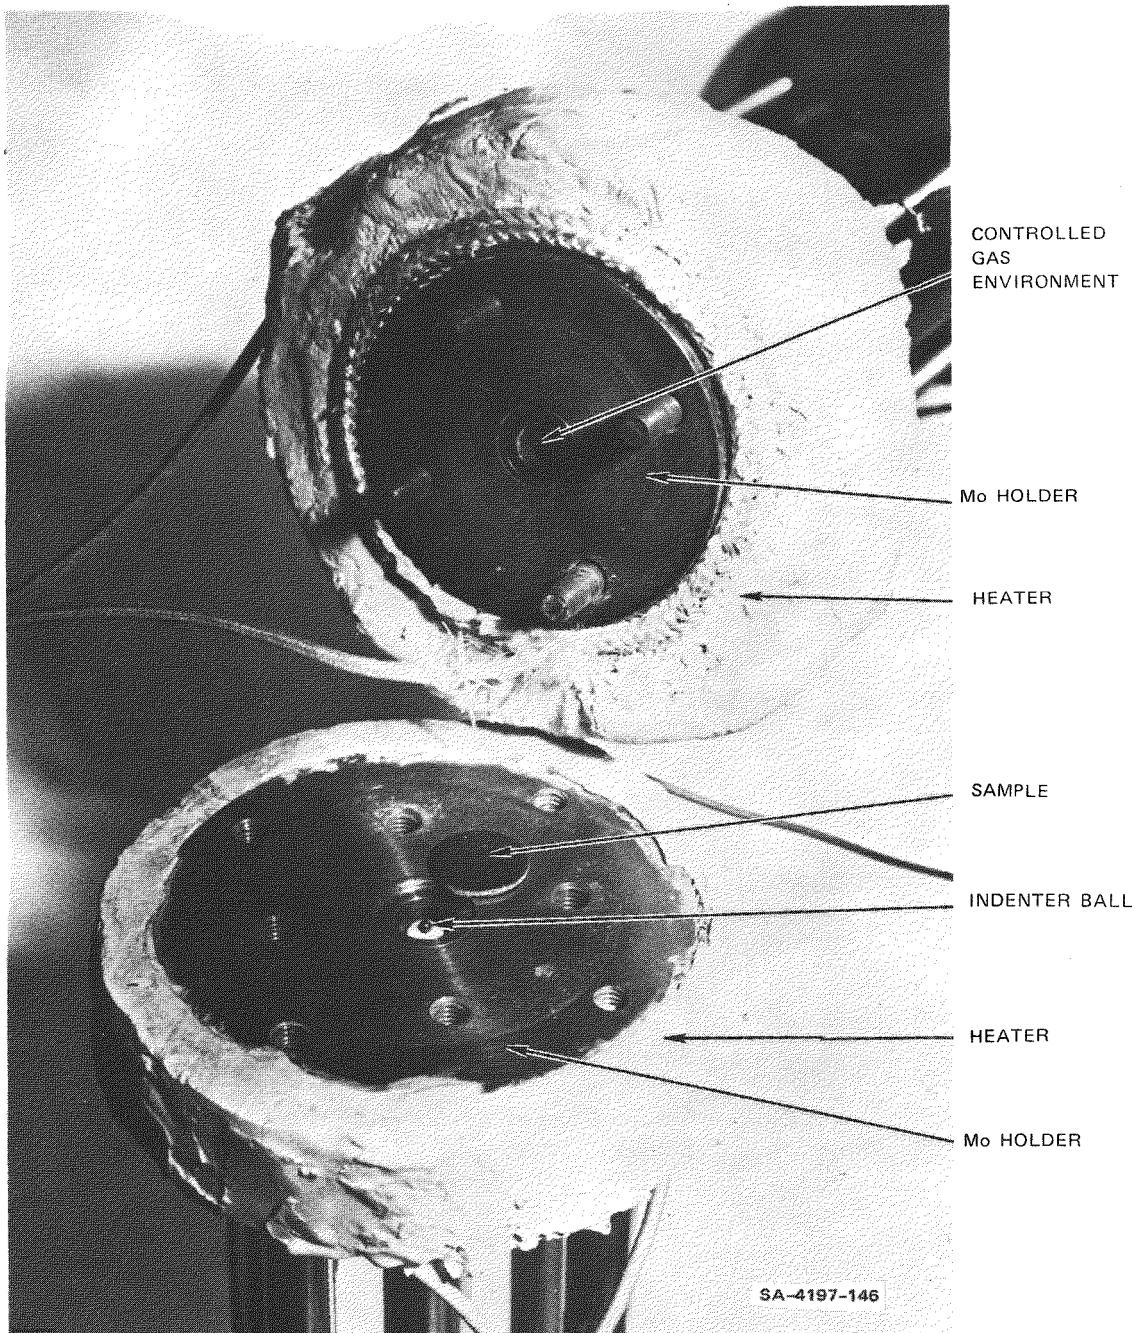
FIGURE 4-2 PHOTOGRAPH OF THE INDENTER APPARATUS FOR SHEET SAMPLES

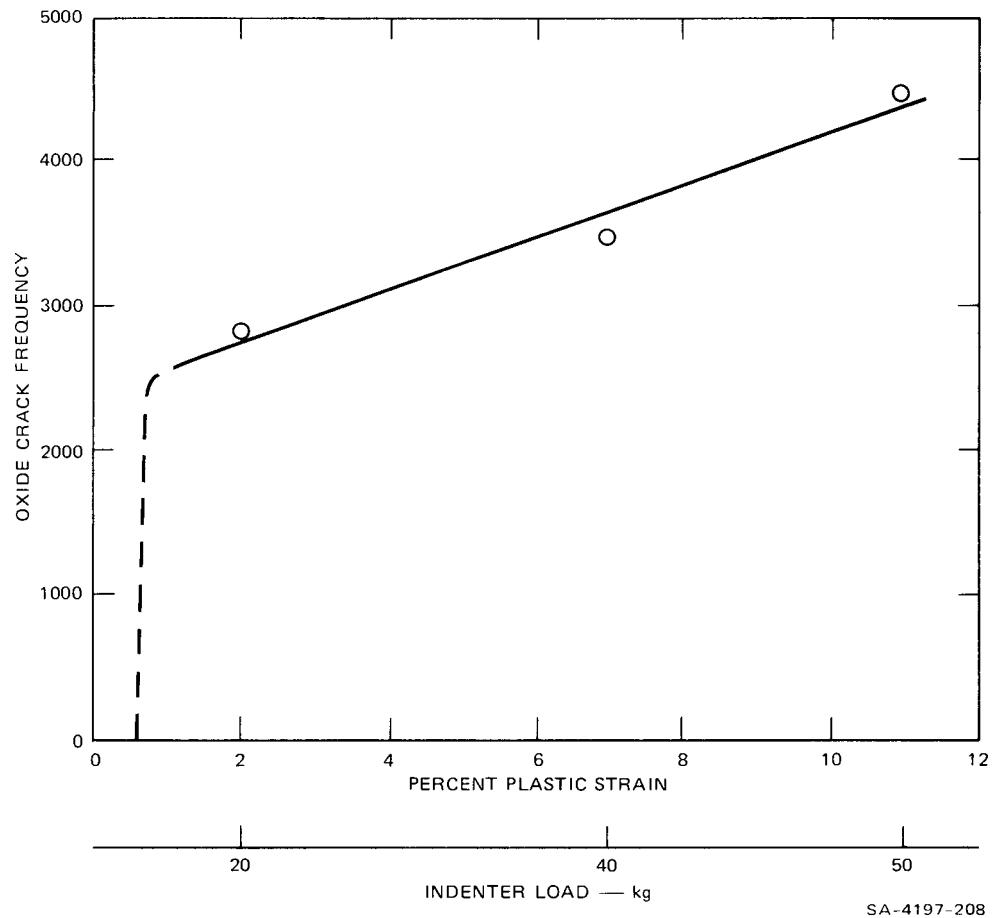
FIGURE 4-19 OXIDE CRACKING FREQUENCY OBSERVED WITH SLIGHTLY OXIDIZED ZIRCALOY-4 TUBING AS A FUNCTION OF STRAIN (LOAD)

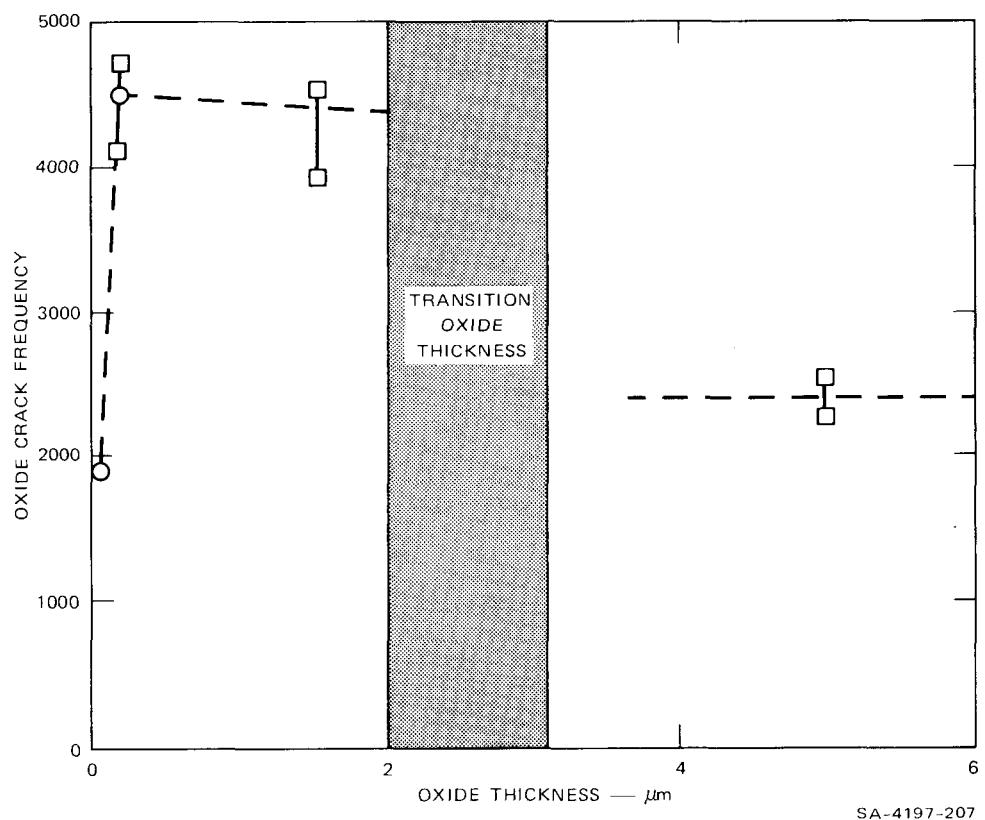
FIGURE 4-20 OXIDE CRACKING FREQUENCY AS A FUNCTION OF OXIDE THICKNESS AT CONSTANT STRAIN AND TEMPERATURE

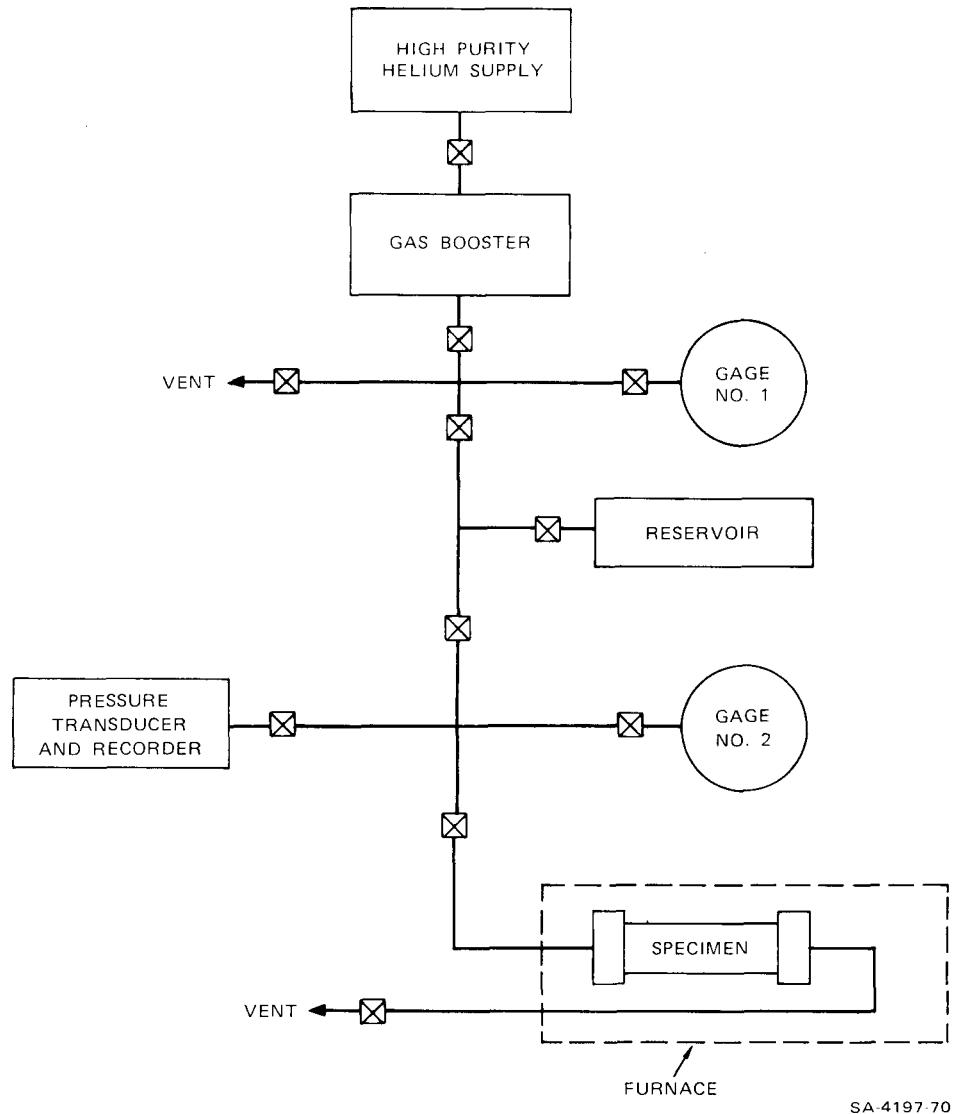
FIGURE 5-3 SCHEMATIC OF THE TUBE PRESSURIZATION SYSTEM USED AT SRI INTERNATIONAL

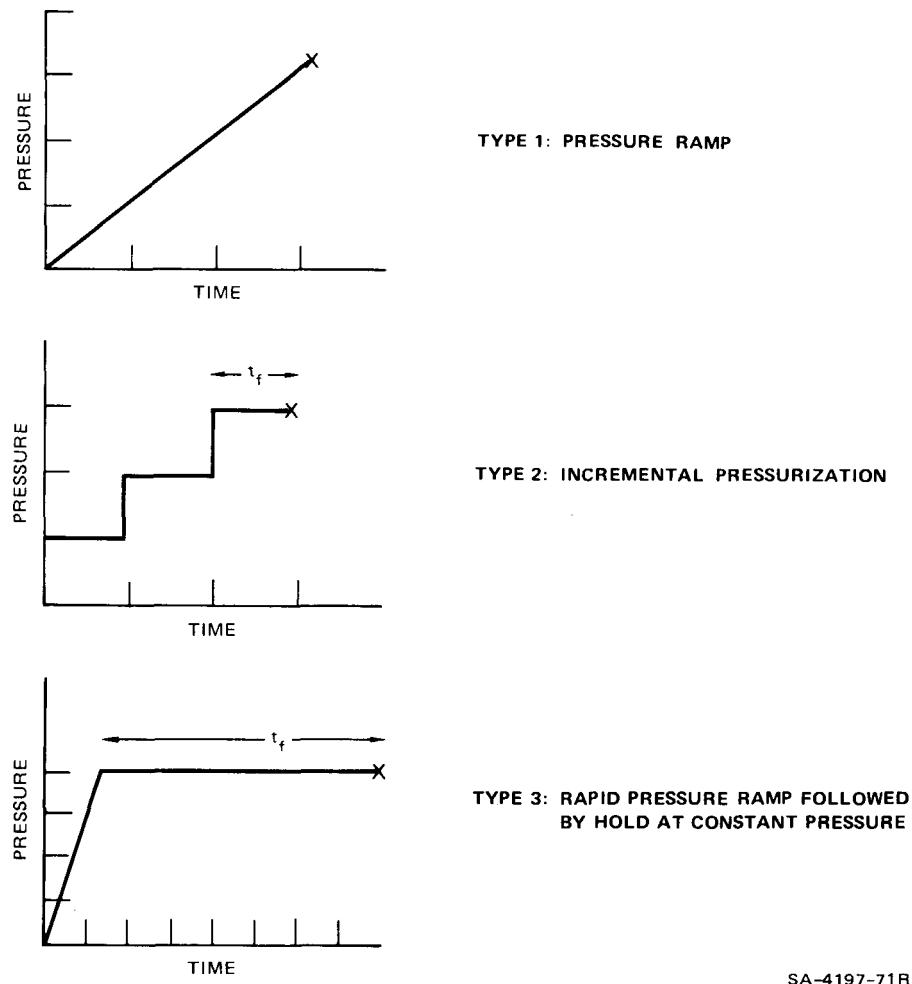
SA-4197-71R

FIGURE 5-4 THREE TYPES OF PRESSURE-TIME CURVES EMPLOYED IN THE TUBE PRESSURIZATION TESTS

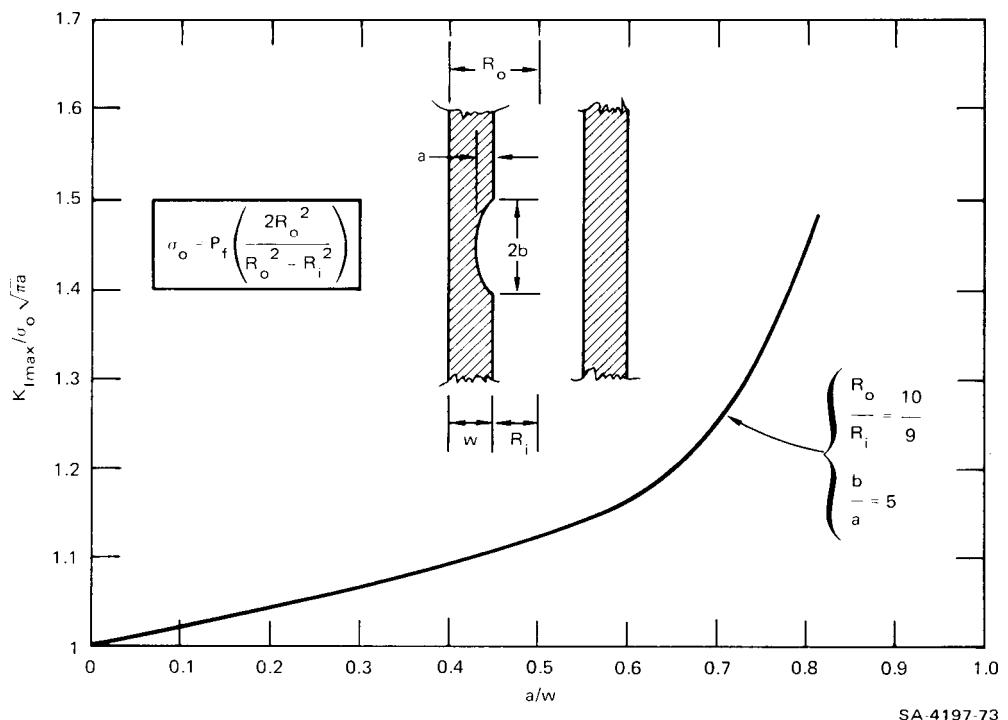
FIGURE 5-5 STRESS INTENSITY CALIBRATION CURVE FOR A PRESSURIZED, INTERNAL, SEMIELLIPTICAL SURFACE CRACK IN AN INTERNALLY PRESSURIZED CYLINDER (FROM REFERENCE 5-4)

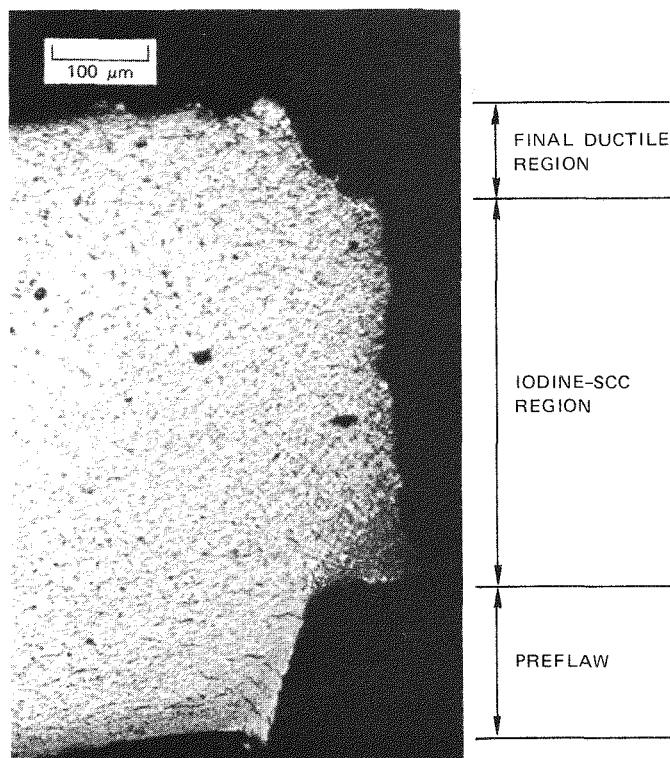
SA-4197-304

FIGURE 5-9 CROSS SECTION THROUGH THE FRACTURE SURFACE OF SPECIMEN Zr-4-17 (7FD11 ZIRCALOY-4)

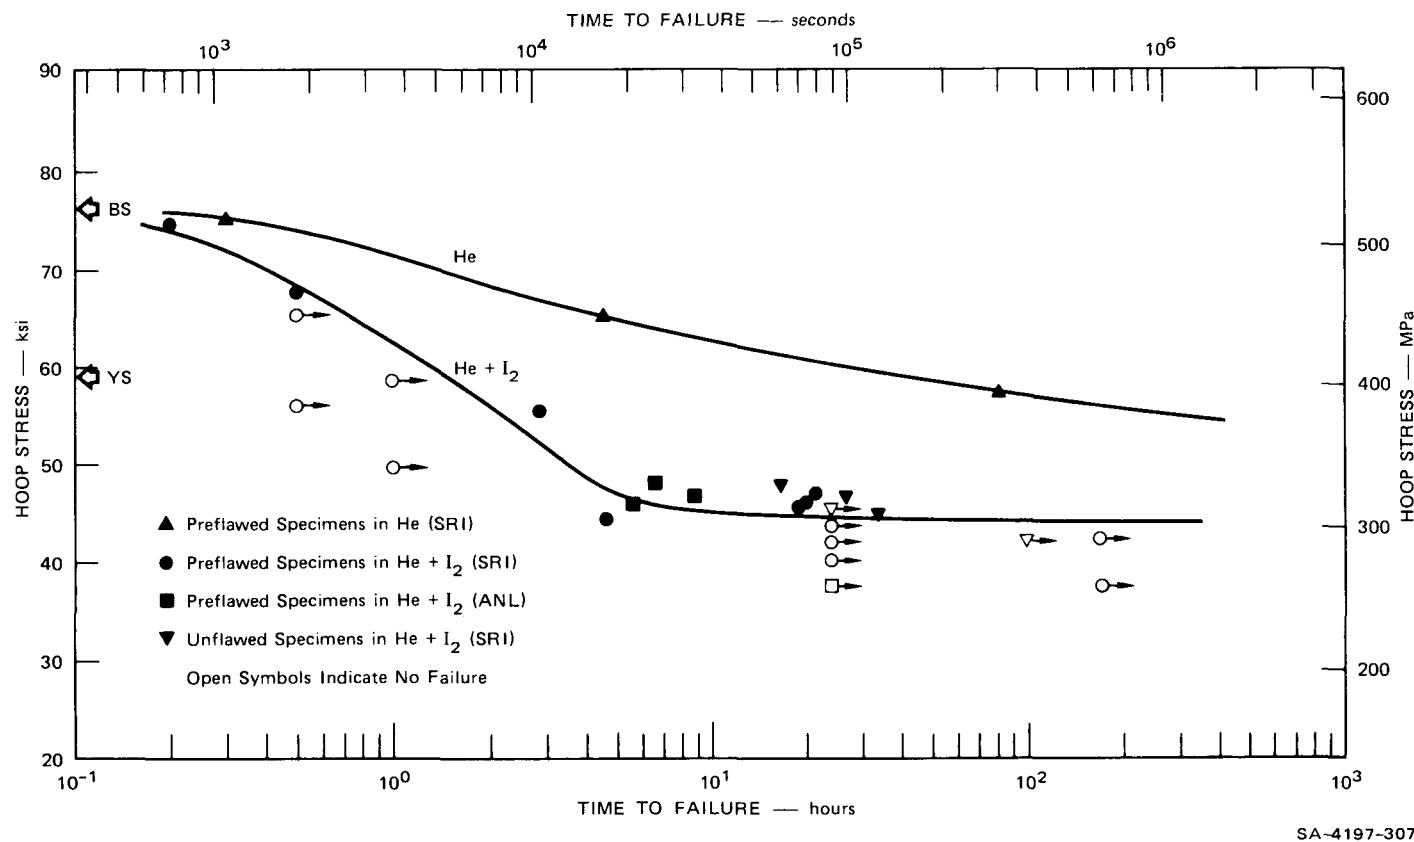
FIGURE 5-13 RESULTS OF TUBE PRESSURIZATION TESTS ON 7FD11 ZIRCALOY-4 SPECIMENS AT 630 K

The He + I<sub>2</sub> curve approximately defines the minimum conditions required for iodine-induced failure and may be somewhat conservative because of the scatter in the data.

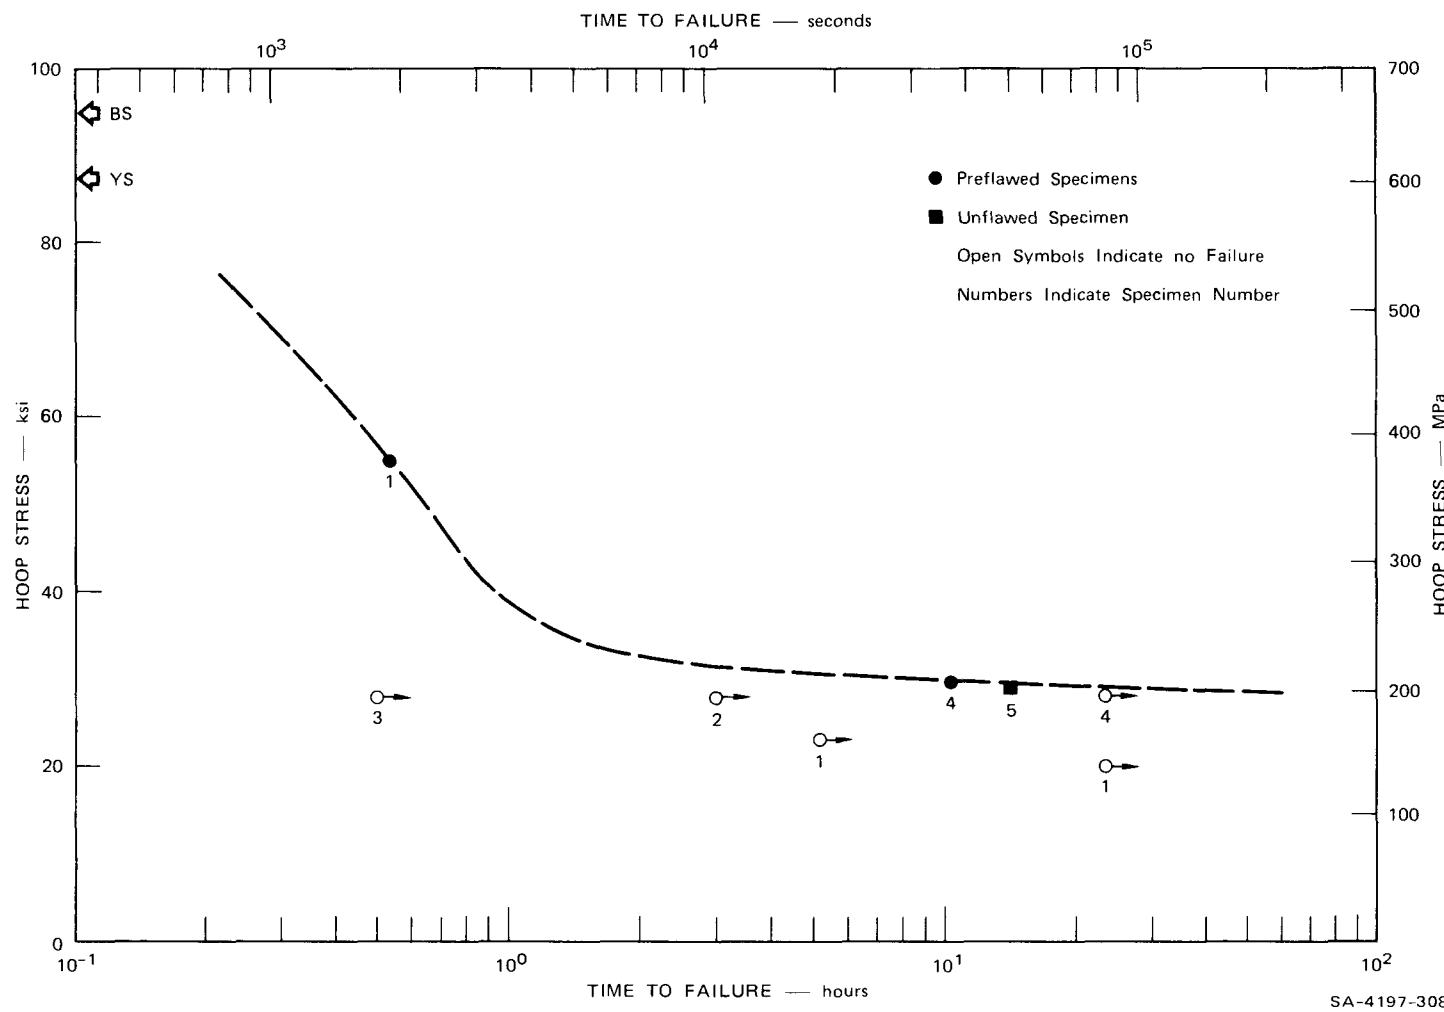
FIGURE 5-14 RESULTS OF TUBE PRESSURIZATION TESTS AT ANL ON IRRADIATED H.B. ROBINSON CLADDING SPECIMENS EXPOSED TO IODINE AT 630 K

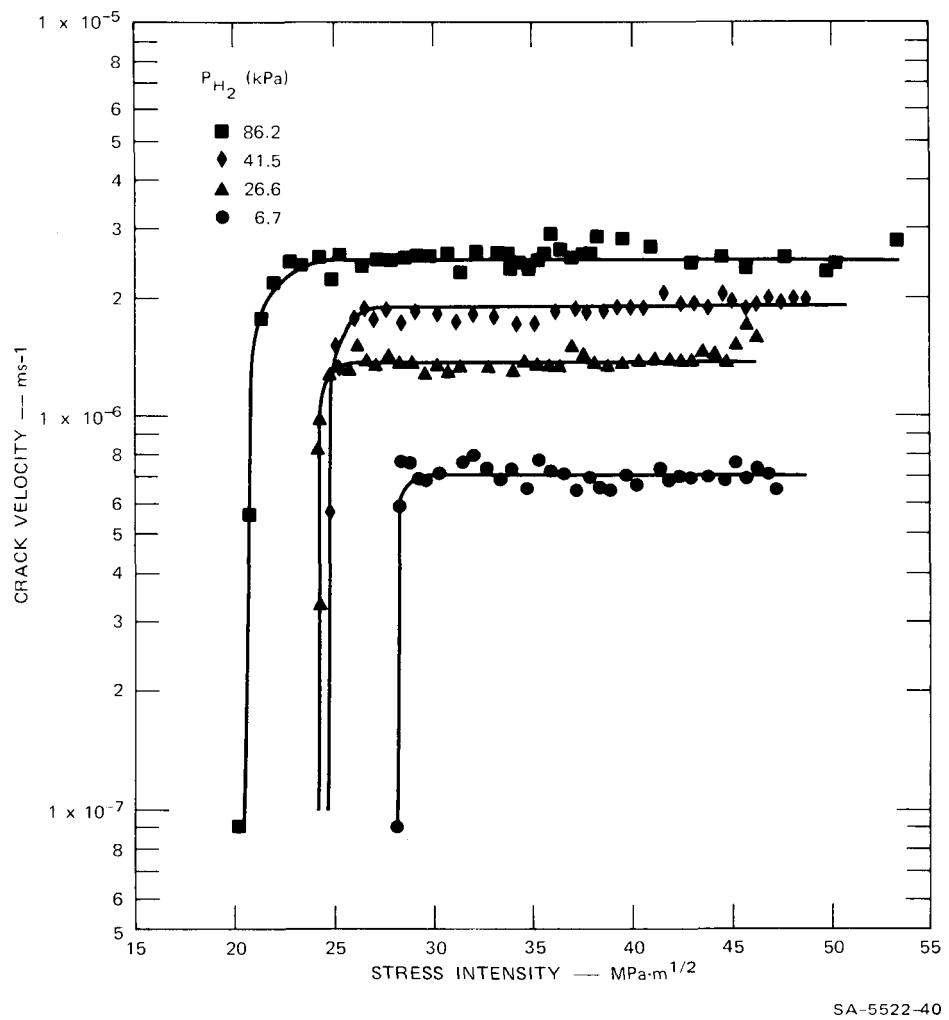
FIGURE 6-1 INFLUENCE OF HYDROGEN PRESSURE ON THE SLOW CRACK GROWTH BEHAVIOR OF ANNEALED ZIRCALOY-4 AT 297 K

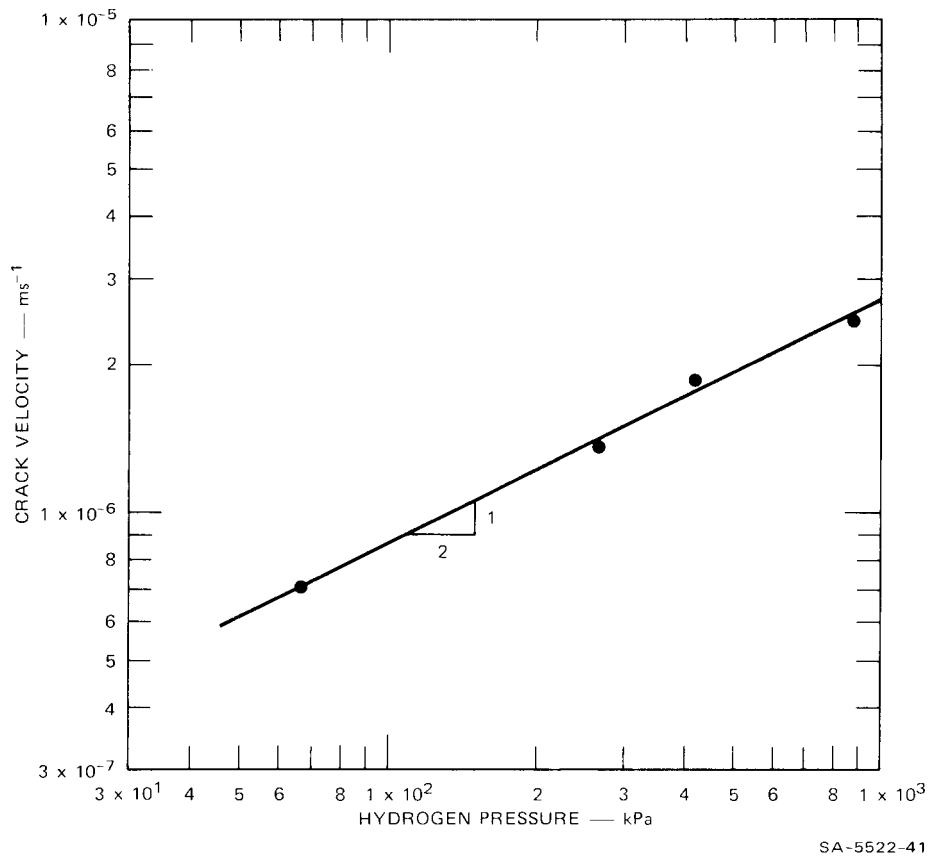
FIGURE 6-2 HYDROGEN PRESSURE DEPENDENCE OF STAGE 2 CRACK GROWTH  
IN ANNEALED ZIRCALOY-4 at 297 K

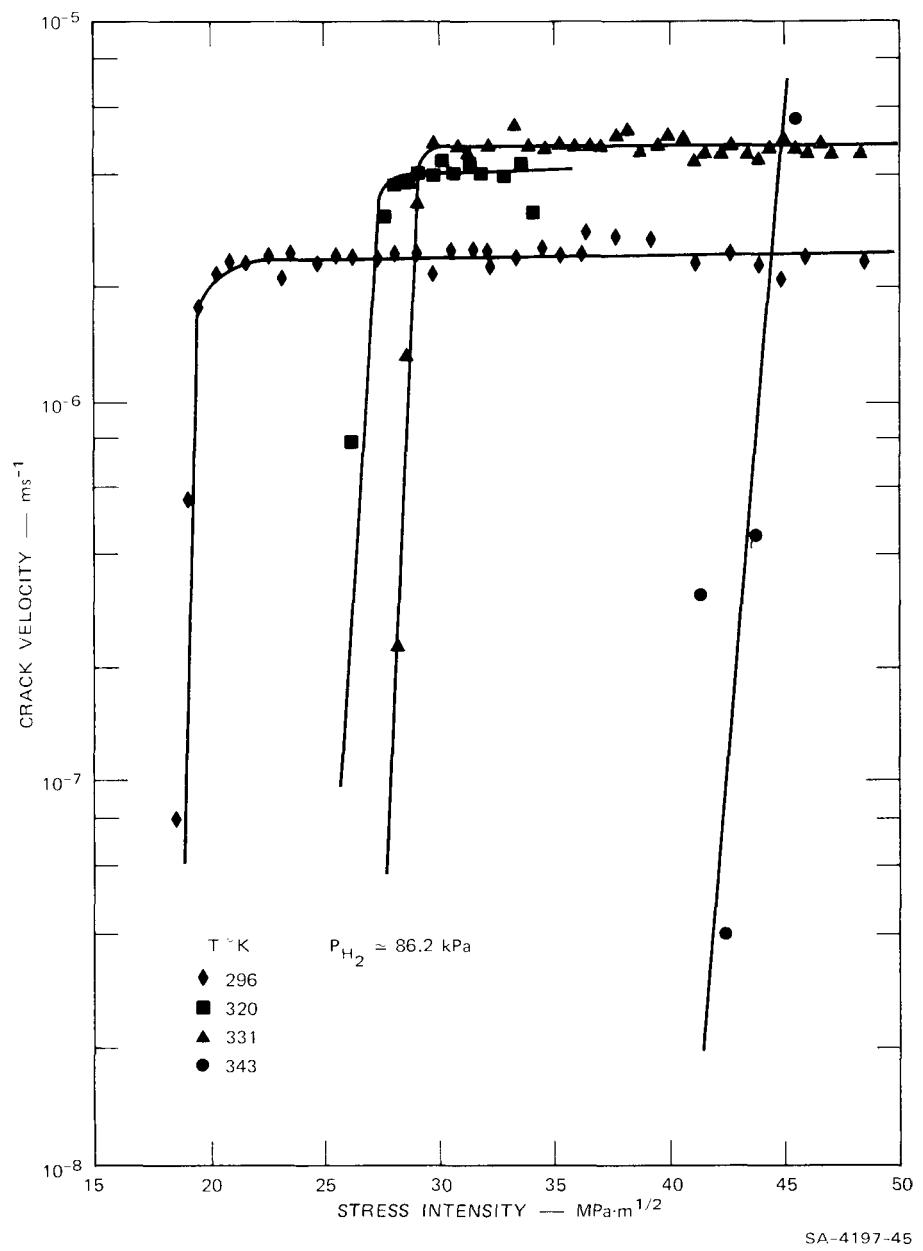
FIGURE 6-3 EFFECT OF TEMPERATURE AND STRESS INTENSITY ON CRACK VELOCITY FOR ANNEALED ZIRCALOY-4 TESTED IN HYDROGEN

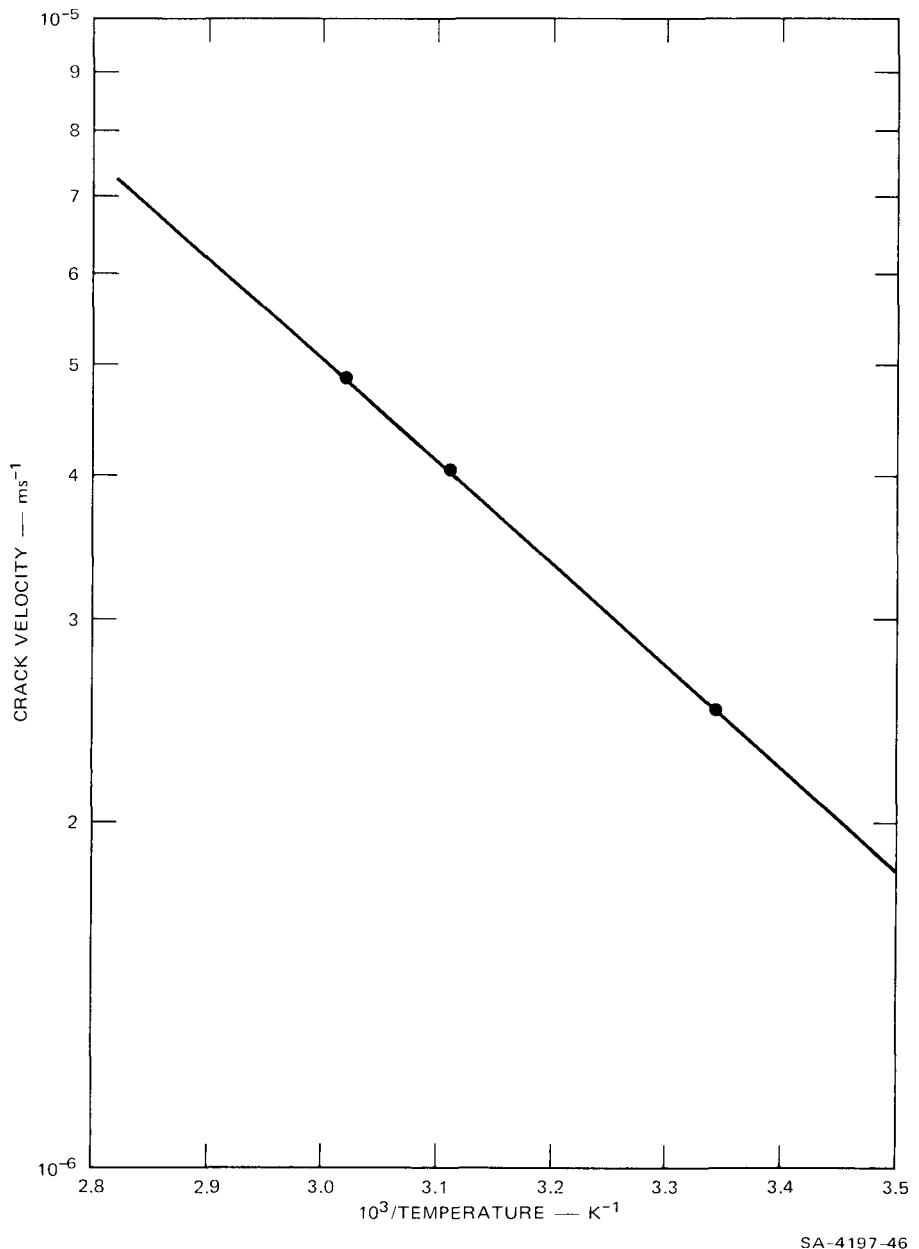
FIGURE 6-5 ACTIVATION ENERGY PLOT FOR STAGE 2 CRACK GROWTH RATE IN ANNEALED ZIRCALOY-4 EXPOSED TO HYDROGEN AT A PRESSURE OF  $\sim 86$  kPa

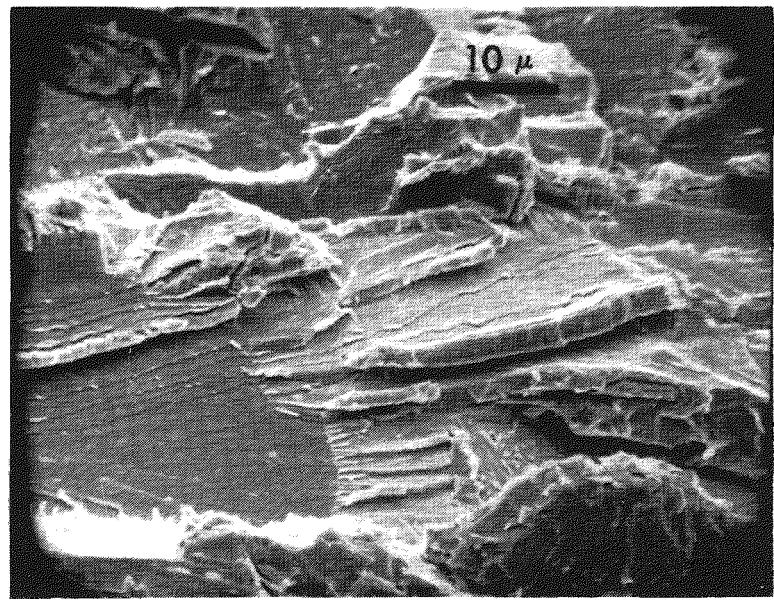
SA-4197-86

FIGURE 6-6 FRACTURE SURFACE OF ANNEALED ZIRCALOY-4 PLATE FOLLOWING SLOW CRACK GROWTH IN HYDROGEN AT 297 K AND A PRESSURE OF ~86 kPa

Fractographic observations did not completely clarify the nature of the rate controlling process, but they did demonstrate that hydride formation is involved in hydrogen-induced slow crack growth. Figure 6-6 shows that the process is very crystallographic with many cleaved facets and unidirectional slabs of zirconium hydride on the fracture surface. Moreover, the cross section in Figure 6-7 shows that the entire fracture surface was covered with a  $10\text{-}\mu\text{m}$ -thick layer, which was identified as ZrH by x-ray diffraction.

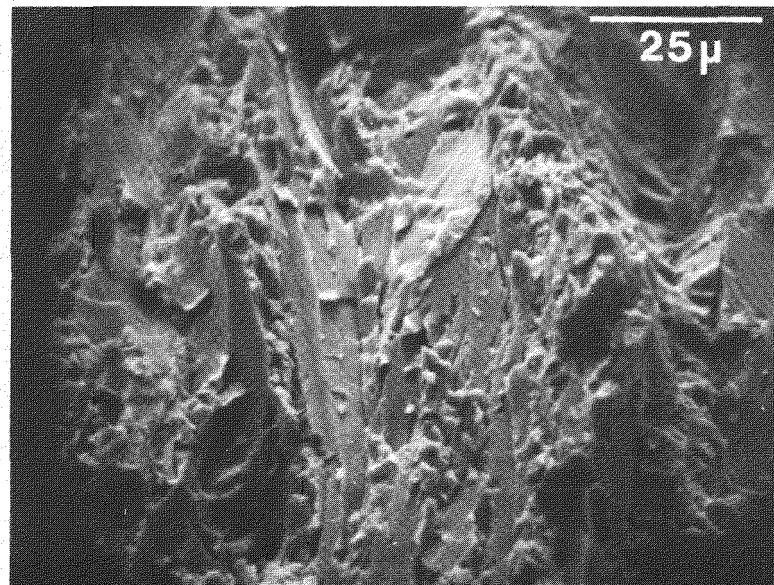
WACHOB/NASA  
SA-4197-164

FIGURE 6-12 STRESS CORROSION CRACKED REGION PRODUCED IN A STRESS-RELIEVED ZIRCALOY-4 SPECIMEN AFTER EXPOSURE TO BROMINE FOR 4-1/2 HOURS AT 633 K

Iodine, bromine and chlorine environments at  $\sim 633\text{ K}$  appear to be similarly aggressive in their ability to promote stress corrosion crack growth in stress-relieved Zircaloy-4. The threshold stress intensity under plane strain conditions for both iodine and bromine is about  $9 \text{ MPa}\cdot\text{m}^{1/2}$ . An environment initially containing zirconium iodide ( $\text{ZrI}_4$ ) is as aggressive as an environment initially containing

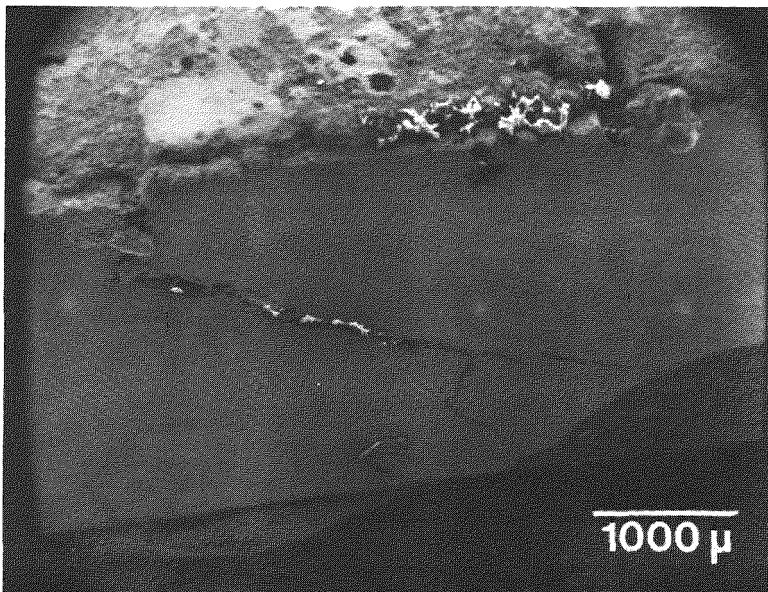
SA-4197-199

FIGURE 6-19 A 4-POINT BEND SPECIMEN OF STRESS-RELIEVED ZIRCALOY-4 AFTER FAILURE IN CADMIUM AT 633 K

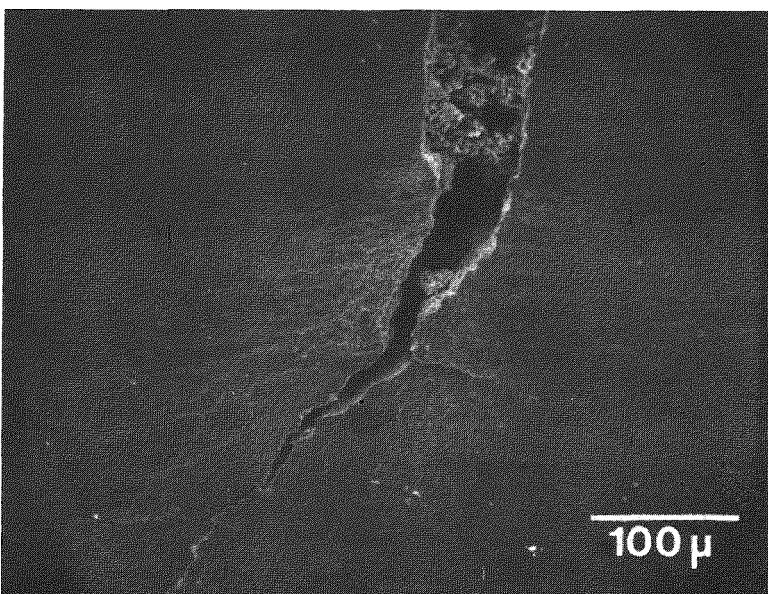
FIGURE 6-20 CRACK BRANCHING AND PLASTIC DEFORMATION THAT OCCURRED UPON LOADING IN LIQUID CADMIUM AT 633 K

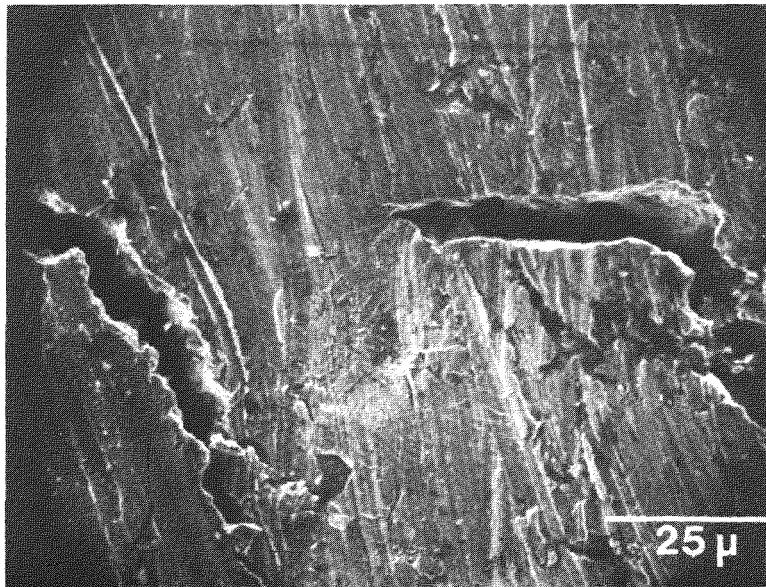
FIGURE 6-21 A PLASTICALLY DEFORMED BRIDGE IN A 4-POINT BEND SPECIMEN OF STRESS-RELIEVED ZIRCALOY-4 AFTER FAILURE IN THE ELASTIC REGION IN CADMIUM AT 633 K

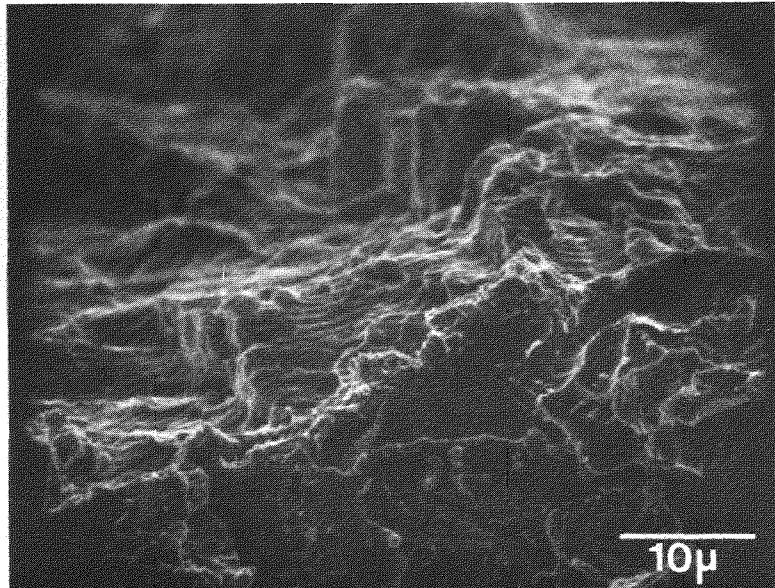
FIGURE 6-22 THE PREFATIGUE CRACK — STRESS CORROSION CRACK REGION IN A 4-POINT BEND SPECIMEN OF STRESS-RELIEVED ZIRCALOY-4 AFTER FAILURE IN CADMIUM AT 633 K

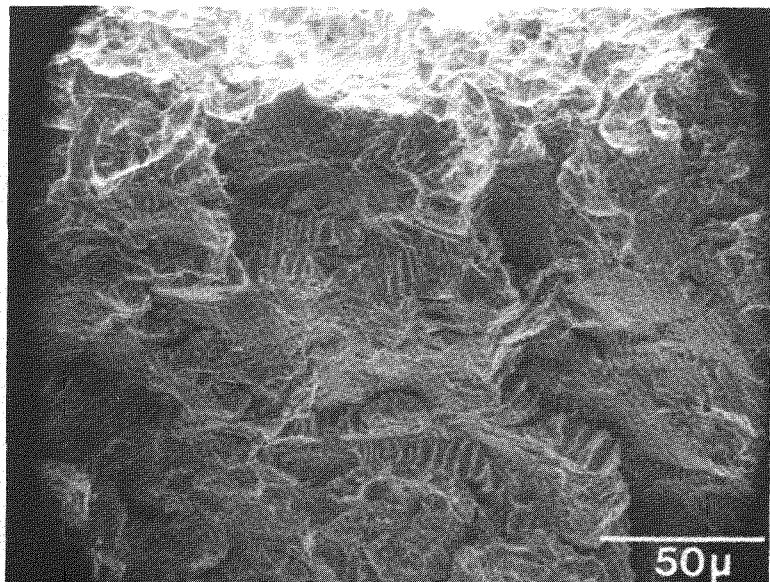
FIGURE 6-23 A TYPICAL FRACTURE SURFACE OF A 4-POINT BEND SPECIMEN OF STRESS RELIEVED ZIRCALOY-4 AFTER FAILURE IN LIQUID CADMIUM AT 633 K

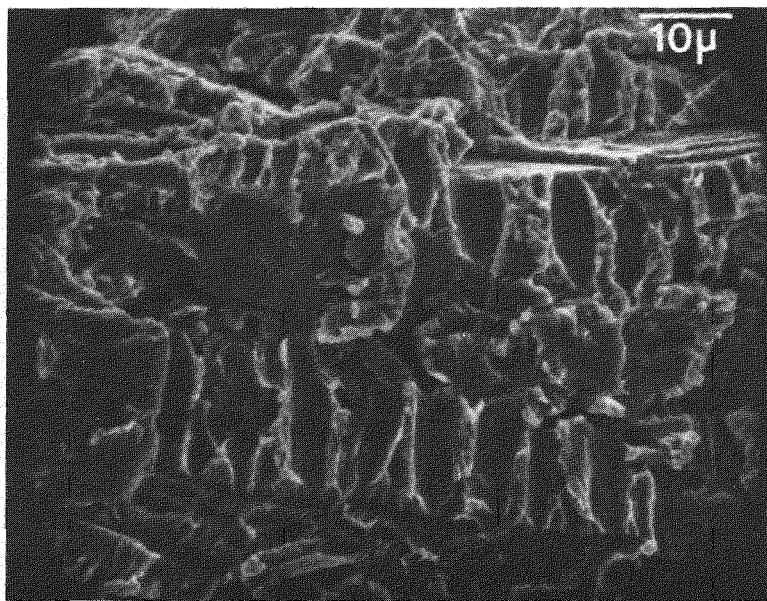
FIGURE 6-24 THE CHARACTERISTIC FLUTED REGIONS AFTER FAILURE IN CADMIUM AT 633 K

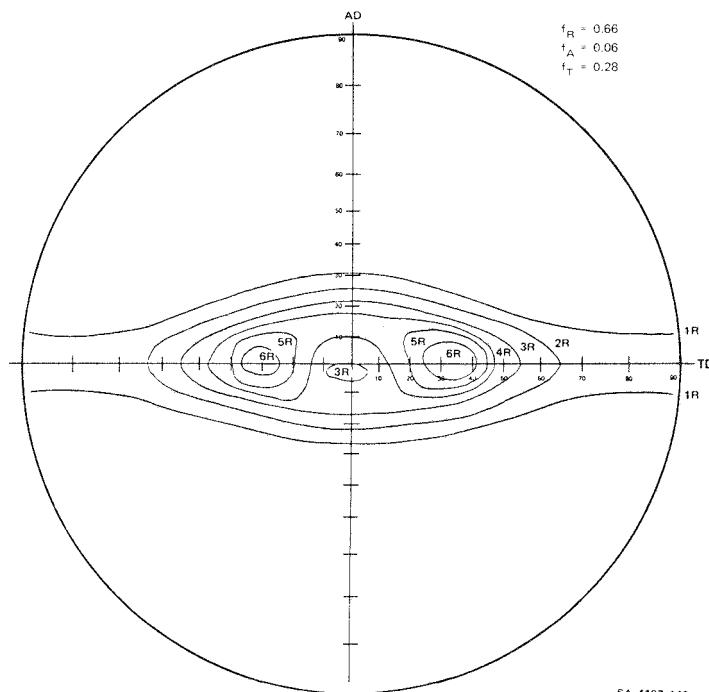
FIGURE A-3 MICROSTRUCTURE AND HARDNESS (a) AND BASAL POLE FIGURE (b) FOR THE 7AH11-H LOT OF ZIRCALOY-2 TUBING
