**EPRI-NASA Cooperative Project on  
Stress Corrosion Cracking of Zircaloys**

**NP-717  
Research Project 455-1**

**Final Report, March 1978**

**SRI INTERNATIONAL  
333 Ravenswood Avenue  
Menlo Park, California 94025**

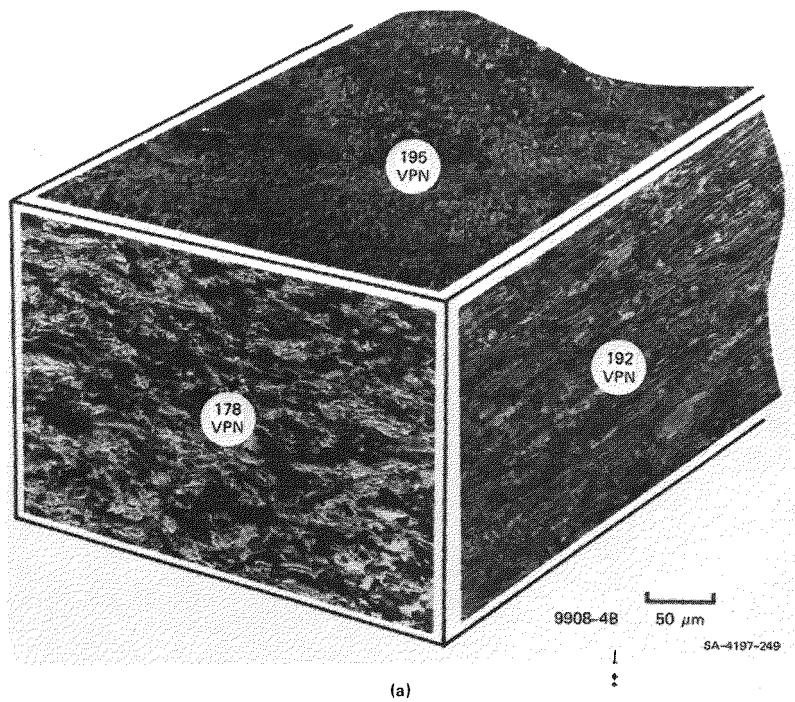
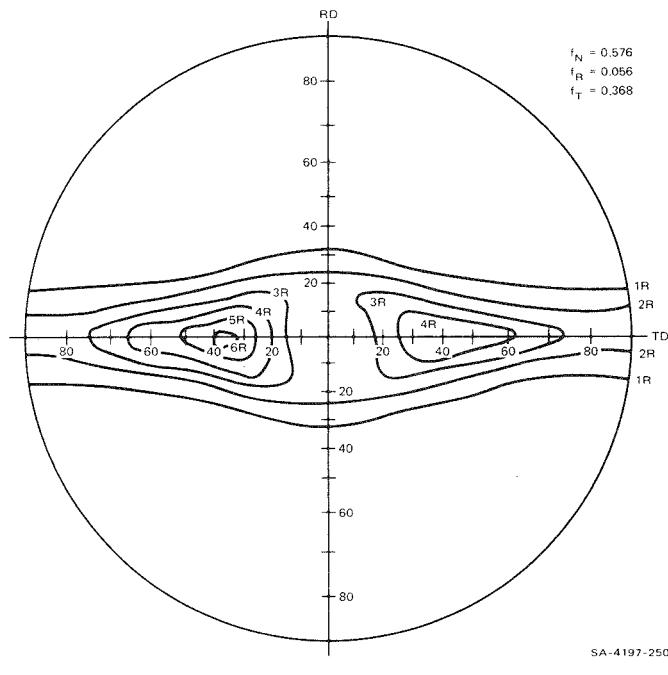
FIGURE A-10 MICROSTRUCTURE AND HARDNESS (a) AND BASAL POLE FIGURE (b) FOR THE 9908-4B LOT OF ZIRCALOY-2 SHEET

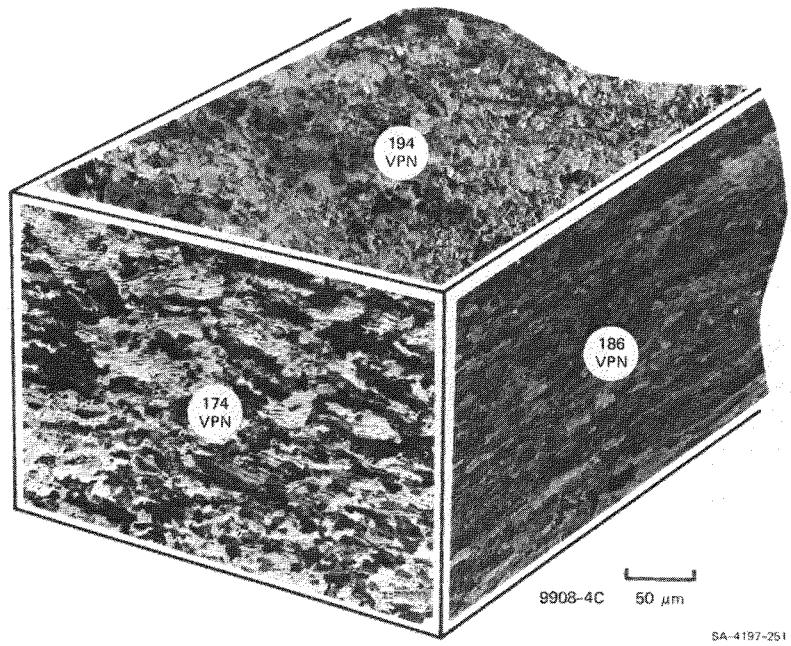
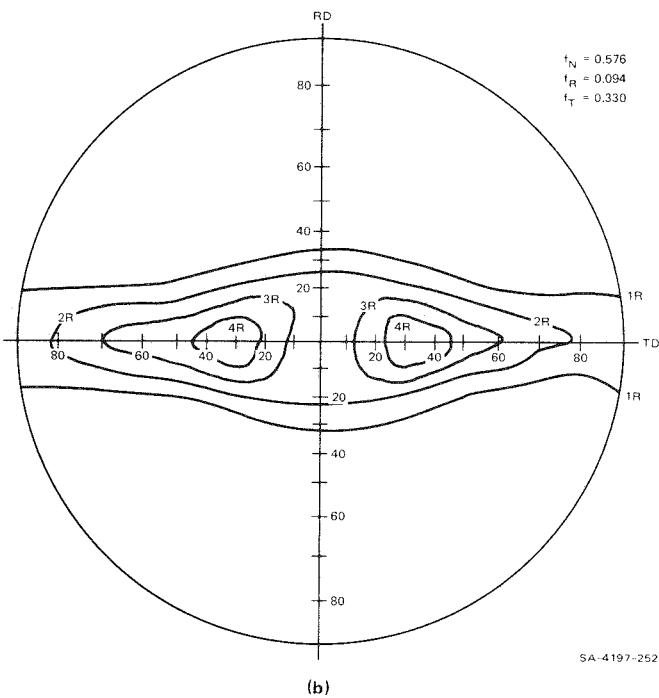
FIGURE A-11 MICROSTRUCTURE AND HARDNESS (a) AND BASAL POLE FIGURE (b) FOR THE 9908-4C LOT OF ZIRCALOY-2 SHEET

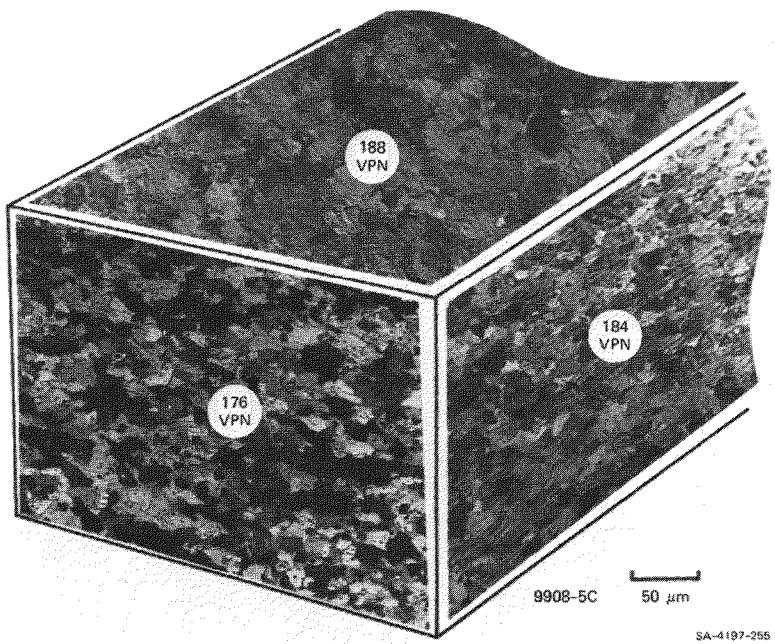
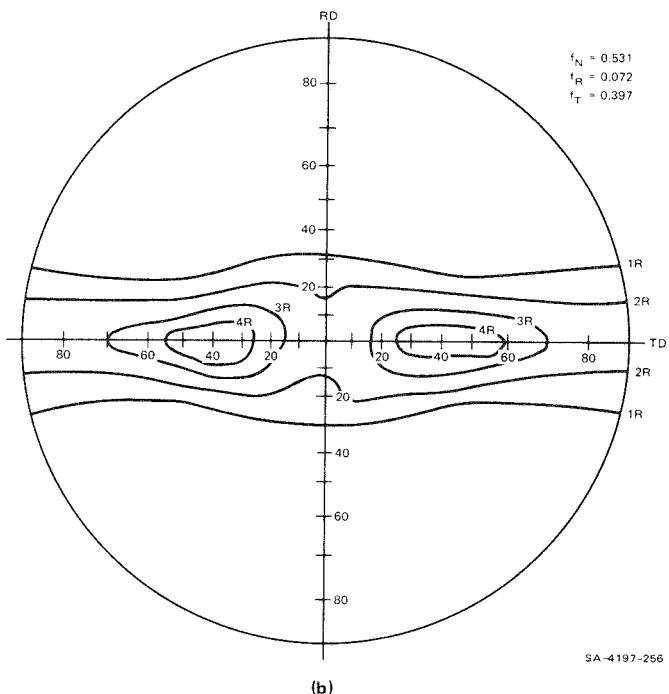
FIGURE A-13 MICROSTRUCTURE AND HARDNESS (a) AND BASAL POLE FIGURE (b) FOR THE 9908-5C LOT OF ZIRCALOY-2 SHEET

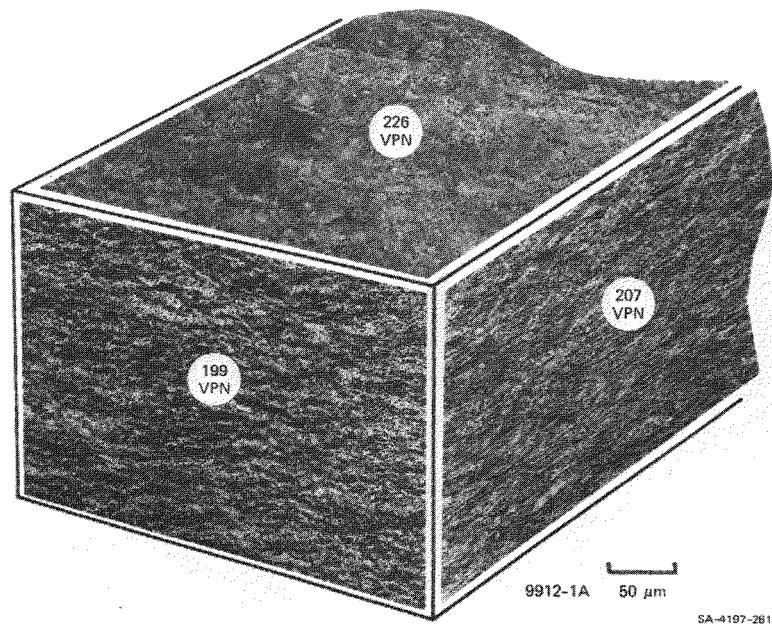
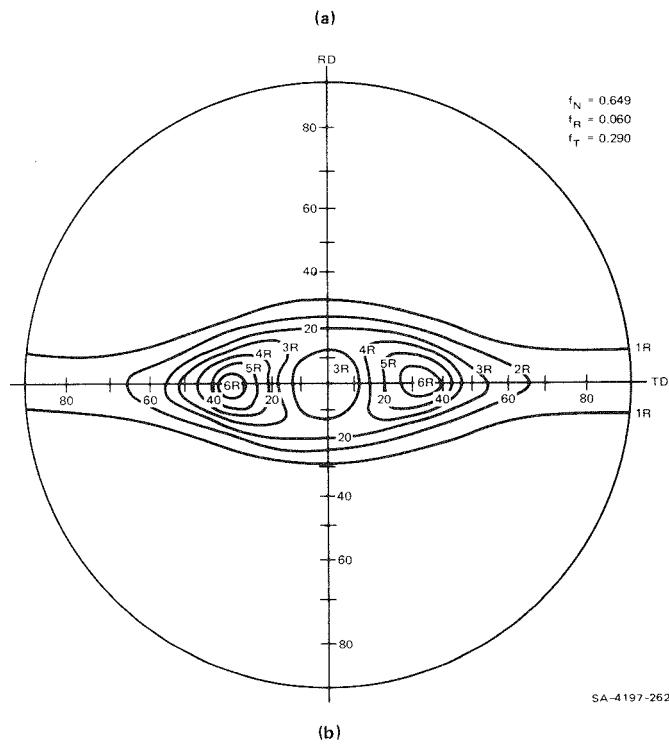
FIGURE A-16 MICROSTRUCTURE AND HARDNESS (a) AND BASAL POLE FIGURE (b) FOR THE 9912-1A LOT OF ZIRCALOY-2 SHEET

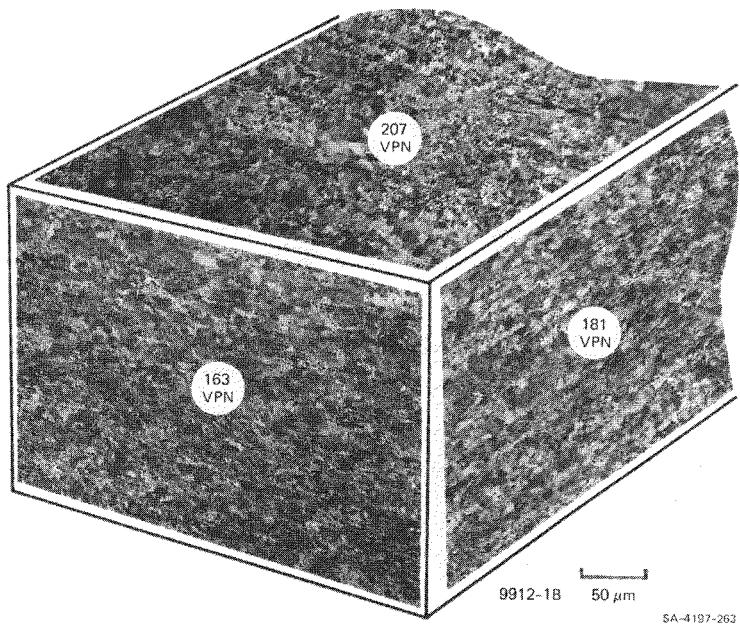
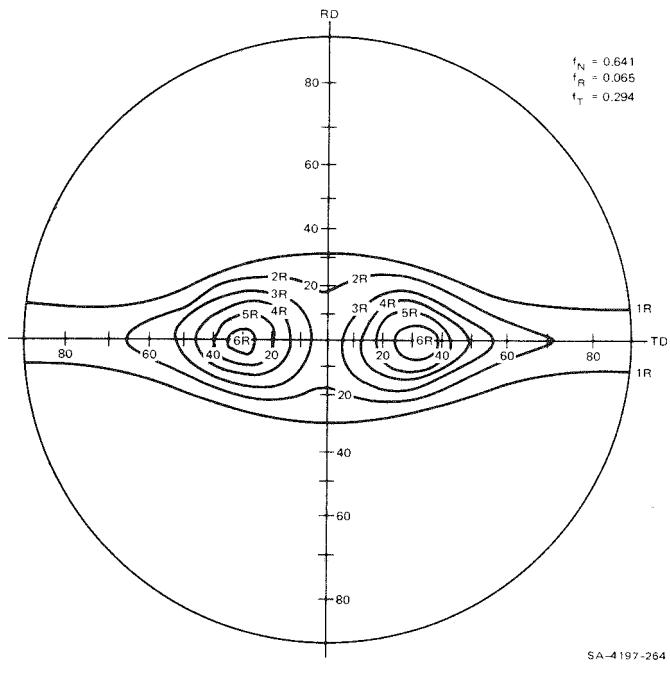
FIGURE A-17 MICROSTRUCTURE AND HARDNESS (a) AND BASAL POLE FIGURE (b) FOR THE 9912-1B LOT OF ZIRCALOY-2 SHEET

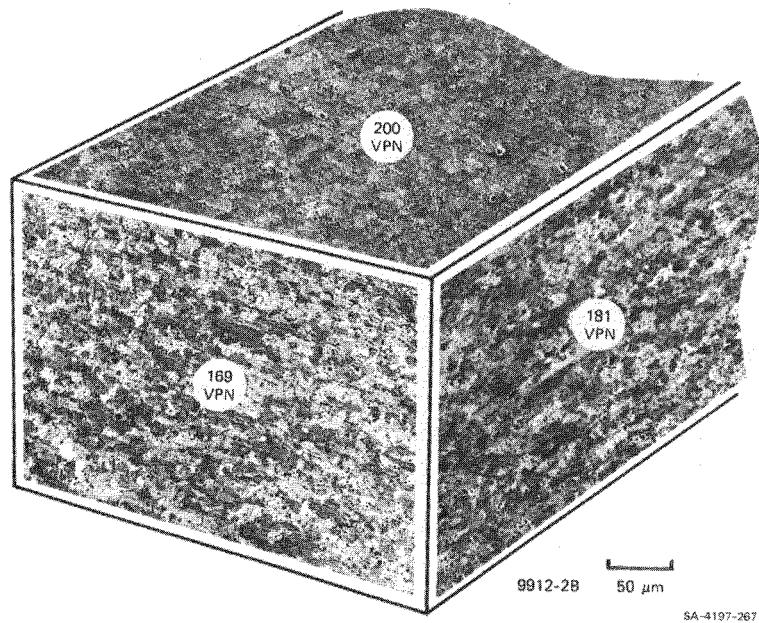
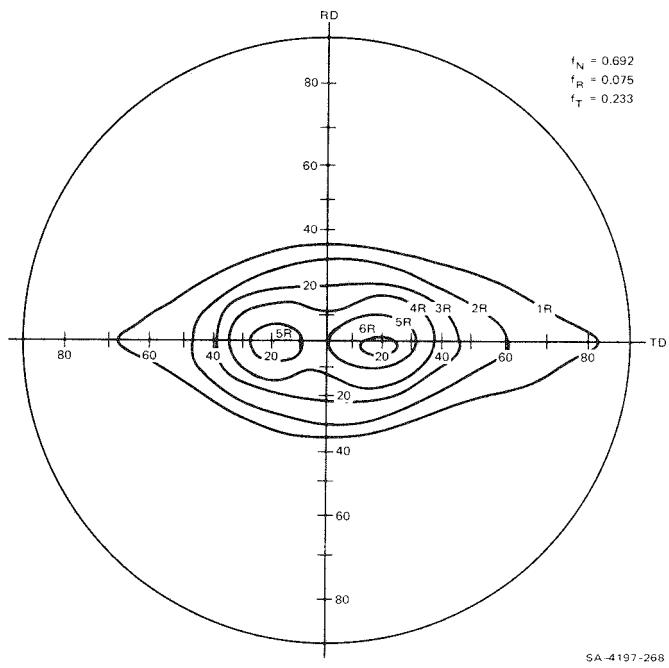
FIGURE A-19 MICROSTRUCTURE AND HARDNESS (a) AND BASAL POLE FIGURE (b) FOR THE 9912-2B LOT OF ZIRCALOY-2 SHEET
