Chemical Technology Division

DROP TESTS OF THE THREE MILE ISLAND KNOCKOUT CANISTER

Date of Issue - September 1986

Prepared by the  
OAK RIDGE NATIONAL LABORATORY  
Oak Ridge, Tennessee 37831  
operated by  
MARTIN MARIETTA ENERGY SYSTEMS, INC.  
for the  
U.S. DEPARTMENT OF ENERGY  
Under Contract No. DE-AC05-84OR21400

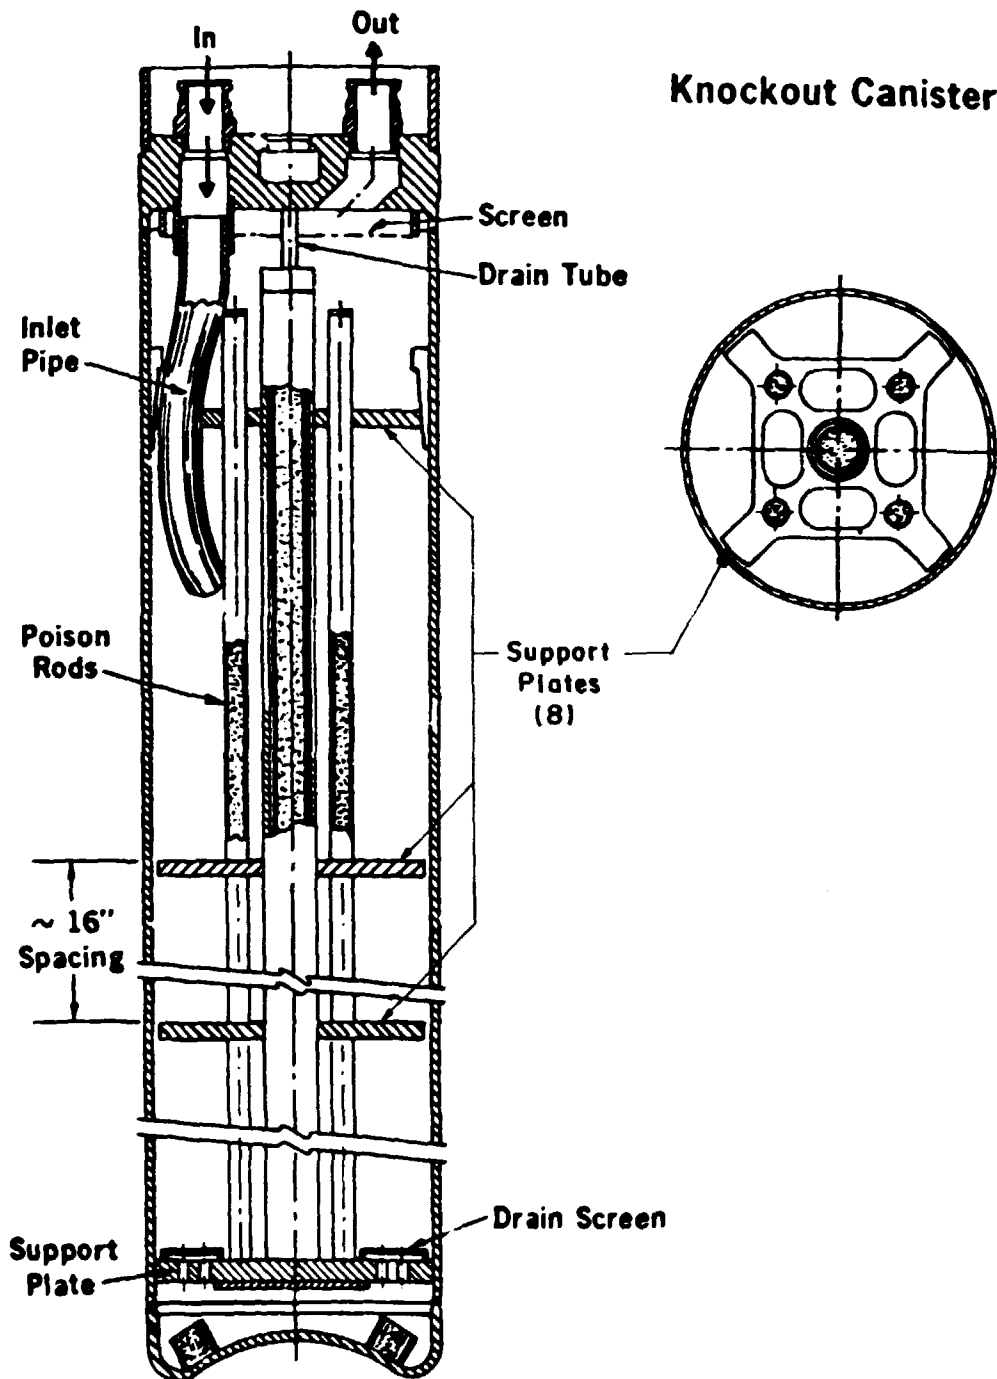
Fig. 2.1. Knockout defueling canister.

The knockout canister (Fig. 2.1) is one of three types of defueling canisters that have been designed to implement the removal and storage of fuel debris from the damaged TMI-2 reactor. The three canisters, called the fuel, knockout, and filter canisters, all use a 35.6-cm-O.D. (14-in.-O.D.), 0.64-cm-wall (0.250-in.-wall) pipe made of 304L stainless steel as the outer shell. In each type, the lower head is a reversed dish made of 0.45-cm (0.375-in.)-thick 304L stainless steel. The upper head of the knockout canister is a flat plate closure that is welded to the shell. The thick, metal plate upper heads are made of 10.1-cm (4-in.)-thick 304L stainless and contain penetrations for hydraulic loading and dewatering. The head has a recess machined into the center for interfacing with the handling grapple. The penetrations in the upper head are fitted with quick-disconnect couplings using a nuclear-grade pipe sealant during attachment to the top head. A skirt on the upper head extends 10.1 cm (4 in.) beyond the top to protect the disconnect fittings. The total length of the knockout canister is 380 cm (149.75 in.).

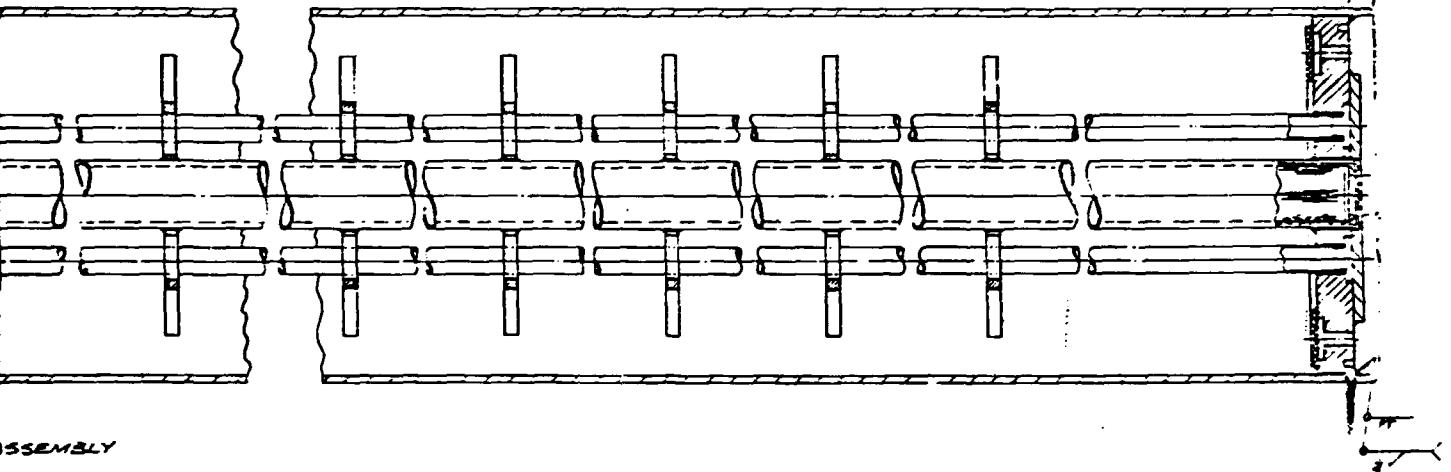
Fig. 2.2. Lower support plate for internal poison rod assembly.  
Source: Engineering drawing No. 1150950E, Babcock & Wilcox, Lynchburg,  
Virginia, 1984.

Fig. 2.3. Central absorber rod canister. Source: Engineering drawing by J. W. Lynchburg, Virginia, 1984.

rod array for knockout defueling  
Drawing No. 1154034F, Babcock & Wilcox,

The internal assembly (Fig. 2.2) is supported from a 3.175-cm (1.25-in.)-thick lower support plate and is positioned at the top of the canister by welded chock blocks at the upper support plate. An absorber array of four outer rods around a central rod is located in the canister for criticality control. The outer rods are 3.34 cm (1.315 in.) in

diameter and have a 6.0-mm (0.25-in.) wall tube filled with neutron-absorbing B4C pellets. The central absorber rod is comprised of a 7.30-cm (2.875-in.)-diam strong-back tube with a 7.9-mm (0.312-in.) wall. Inside this tube is a 5.39-cm (2.125-in.) rod with a 1.6-mm (0.063-in.) wall filled with the B4C pellets. Seven intermediate support plates cradle the rods along their lengths and have a 3.0-mm (0.125-in.) radial clearance to the shell (Fig. 2.3). All support parts are constructed of 304L stainless steel, whereas the tubes containing the B4C pellets are made of 316L stainless steel.

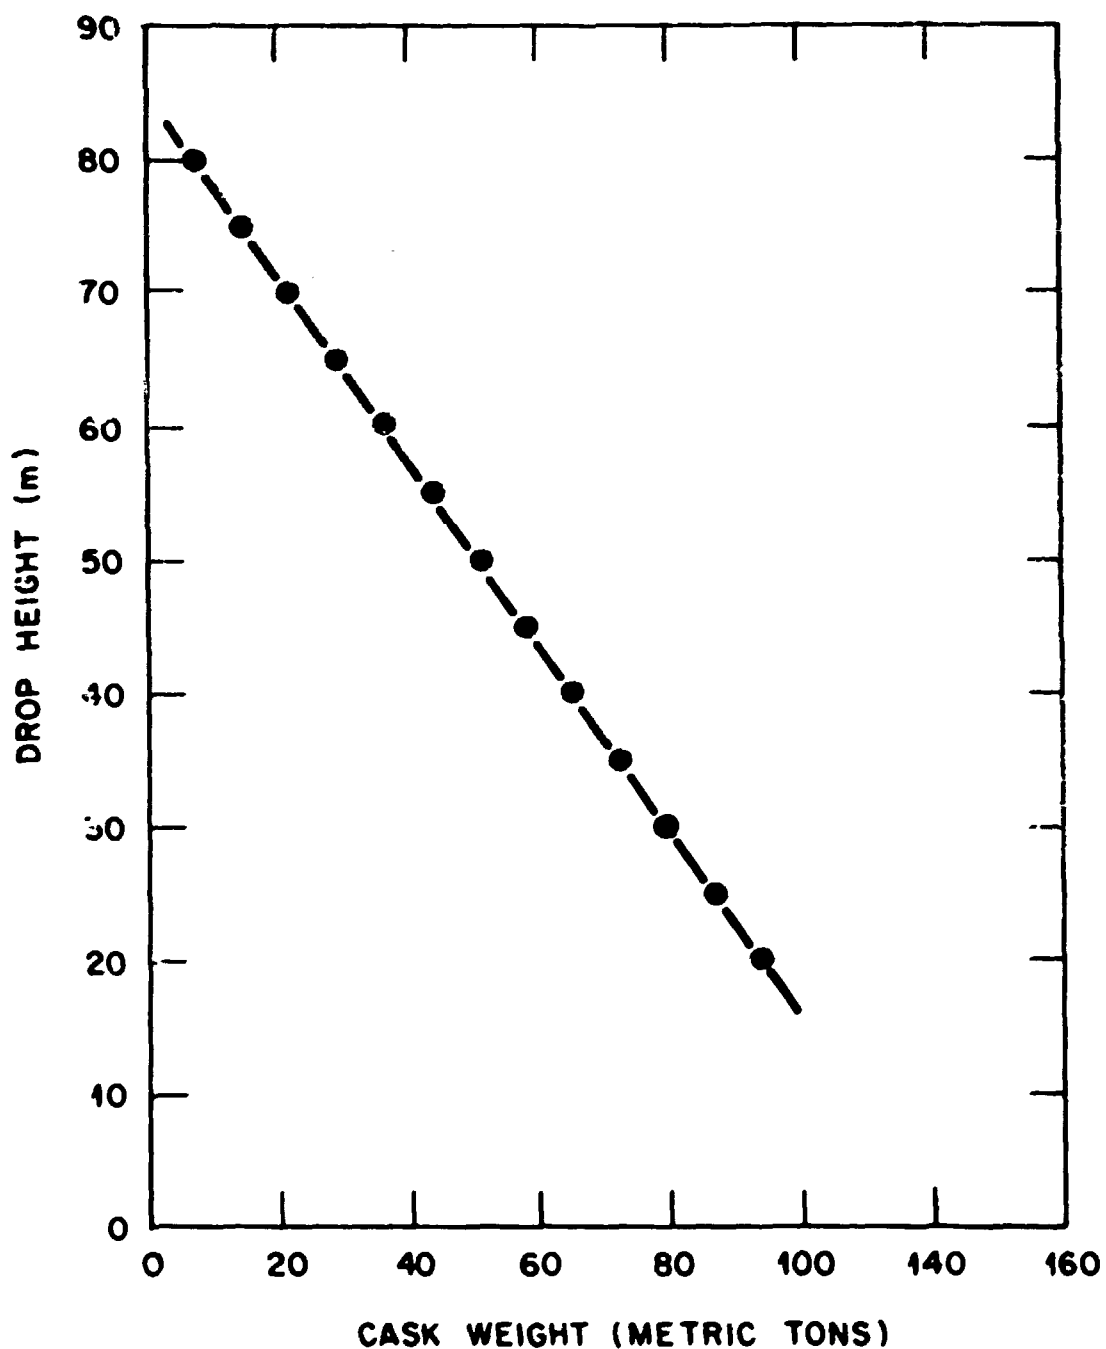
Fig. 3.2. Engineering assessment data for cask weight vs drop height at the ORNL Drop Test Facility.

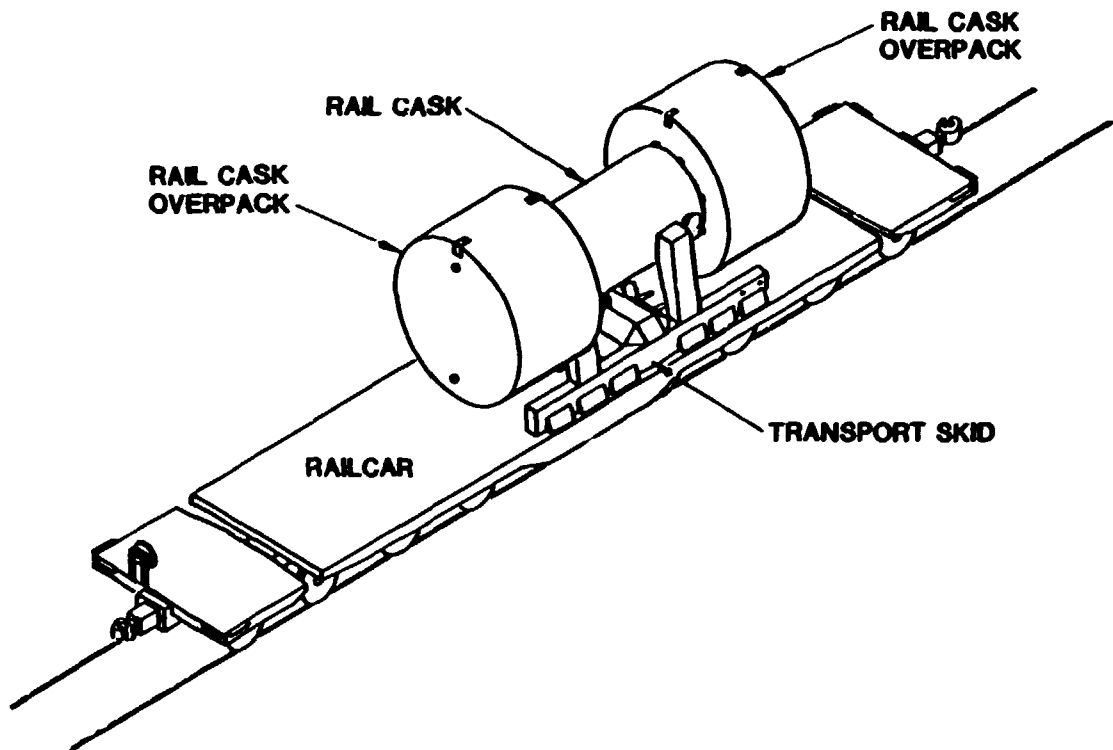
Fig. 4.1. NuPac 125-B rail shipping cask on transport skid.

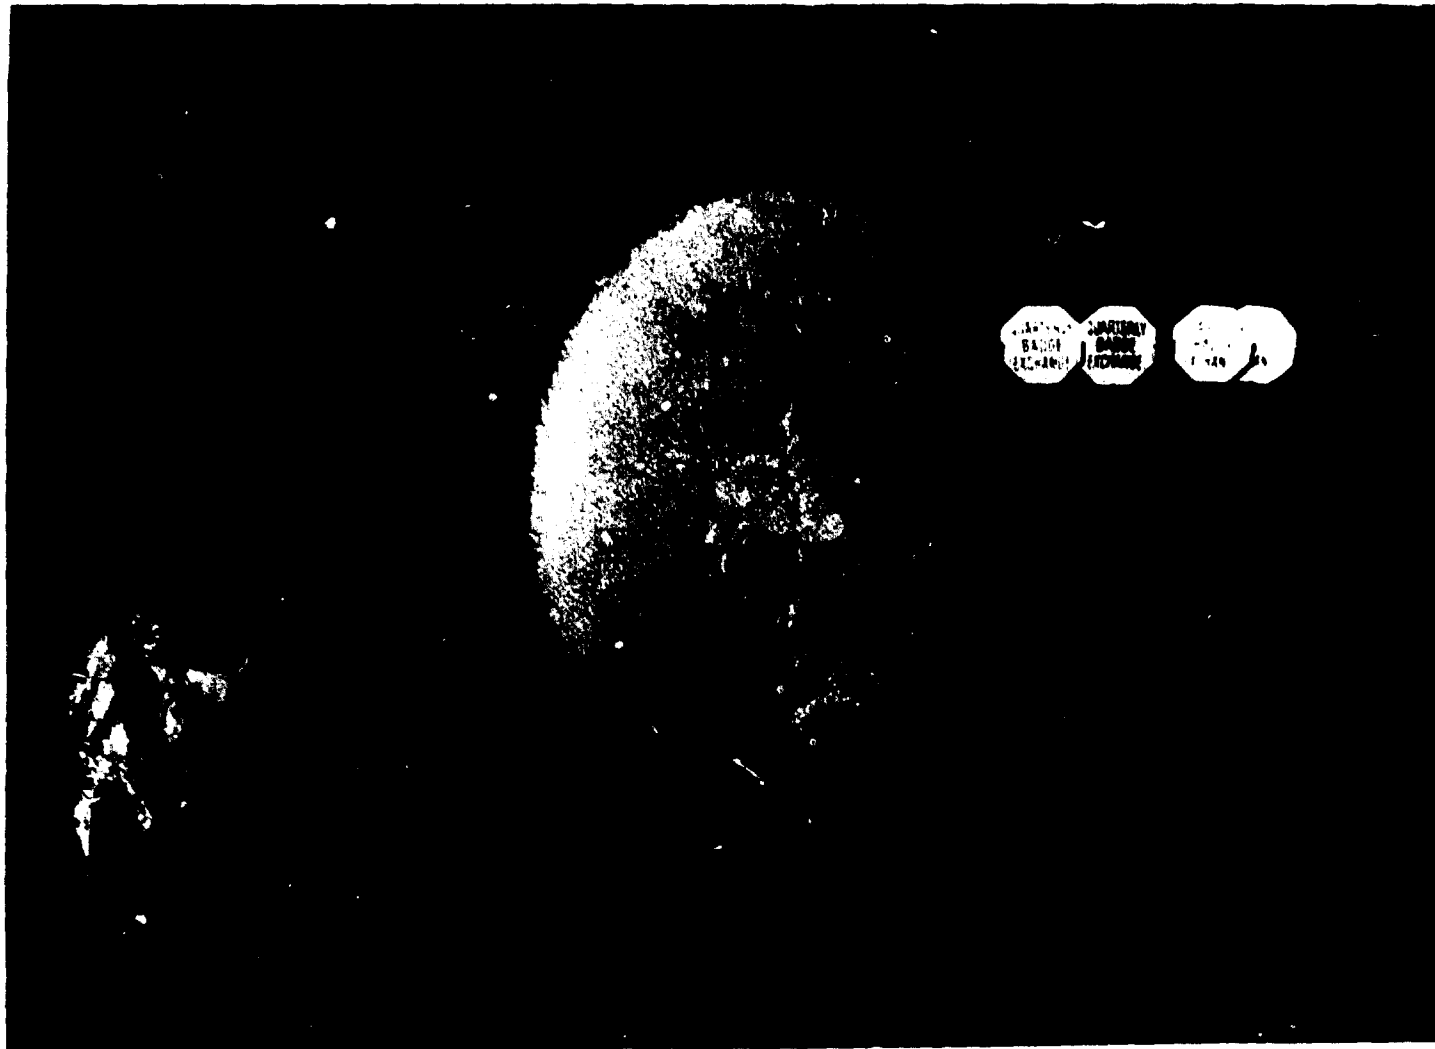
Fig. 4.2. Impact limiter of high density foam on cask simulation vessel.

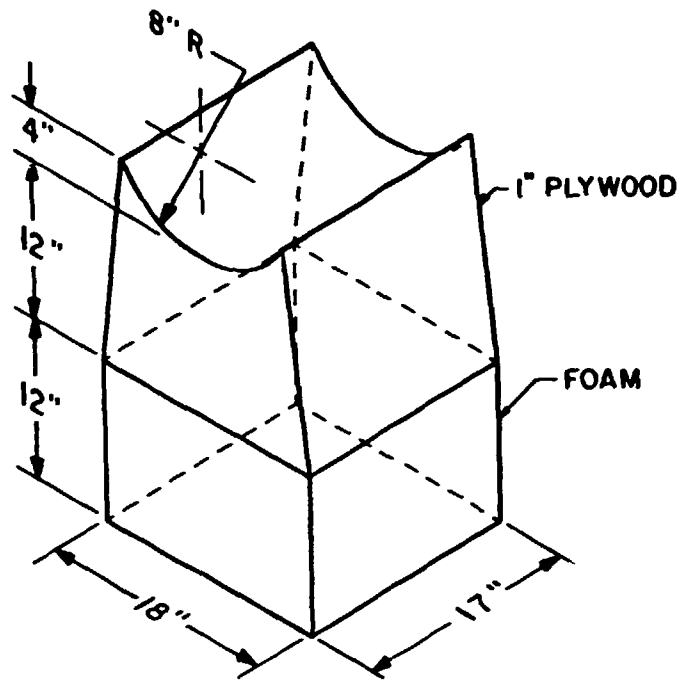
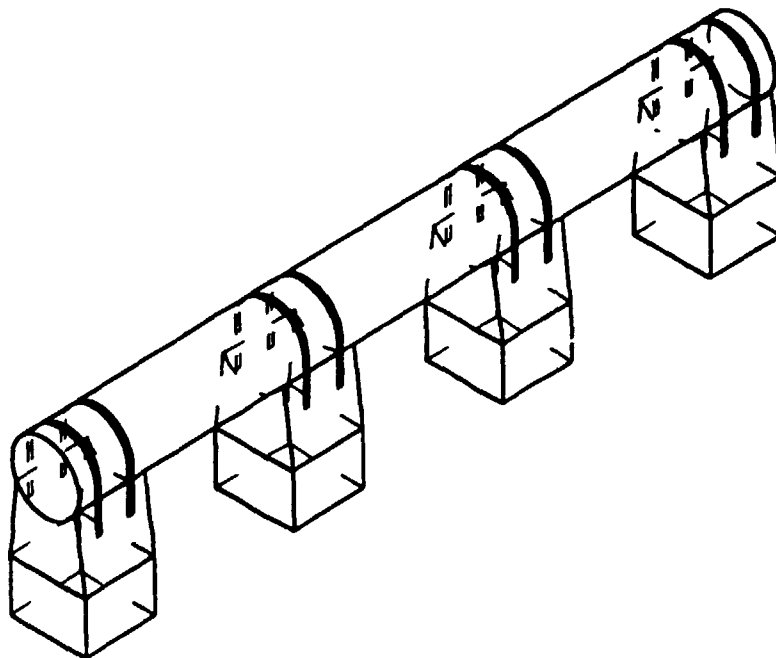
Fig. 4.4. Schematic of impact limiters for various horizontal drop tests.

larger in a horizontal drop test than in a vertical drop test, it was decided to divide the limiter into four equal sections distributed evenly along the CSV's horizontal surface (shown in Figs. 4.4 and 4.5).

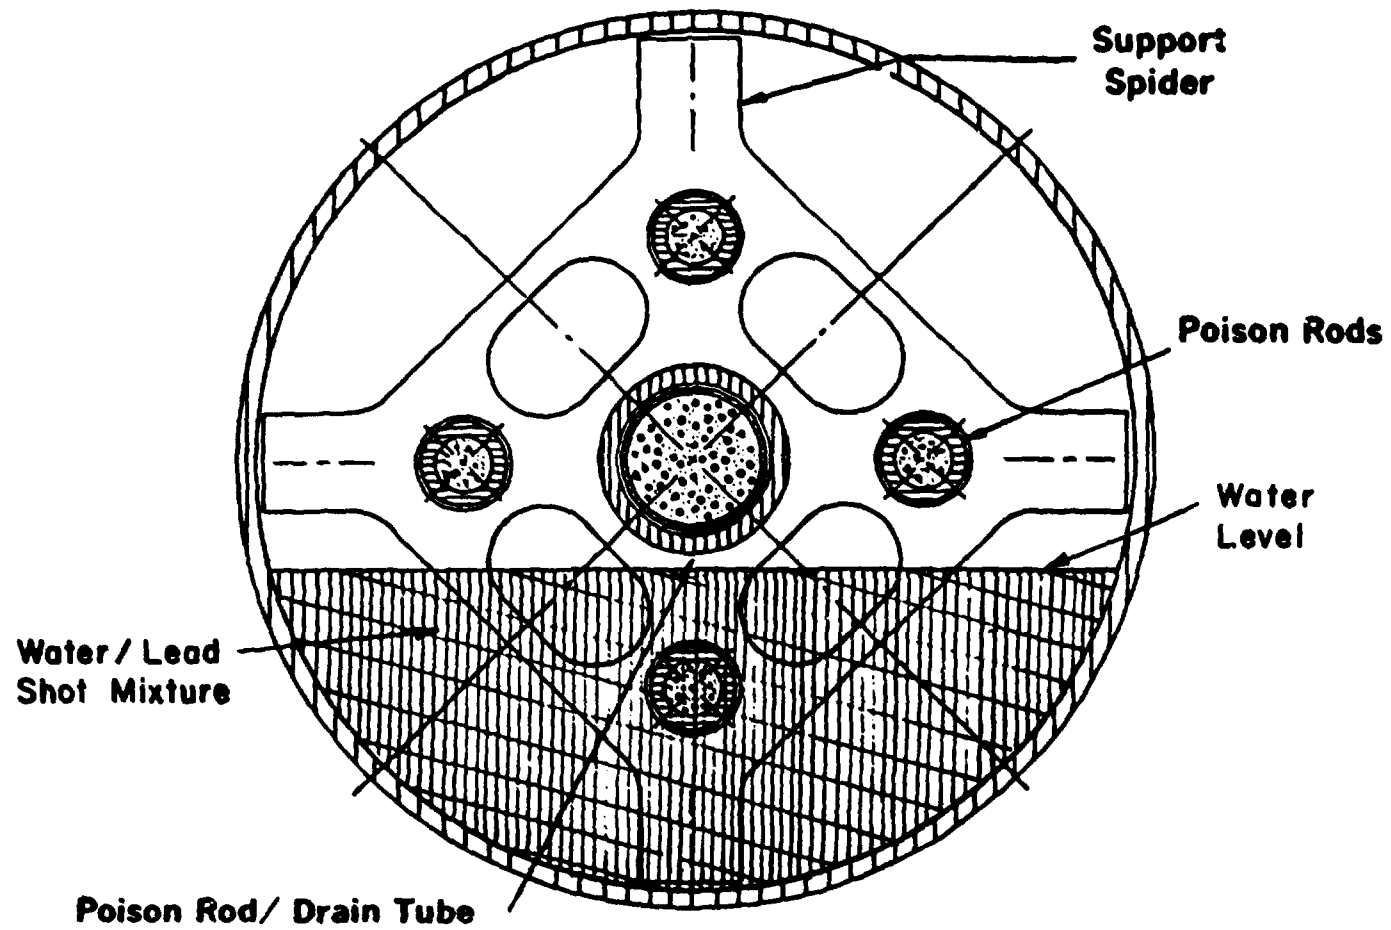
Fig. 5.1. Cross-section of knockout canister at mid-plane.

resulting in maximum forces on the poison structures. To achieve this same condition, the simulated fuel was frozen and the canister rotated to place the bulk of the material above the internal poison rods during the drop tests.

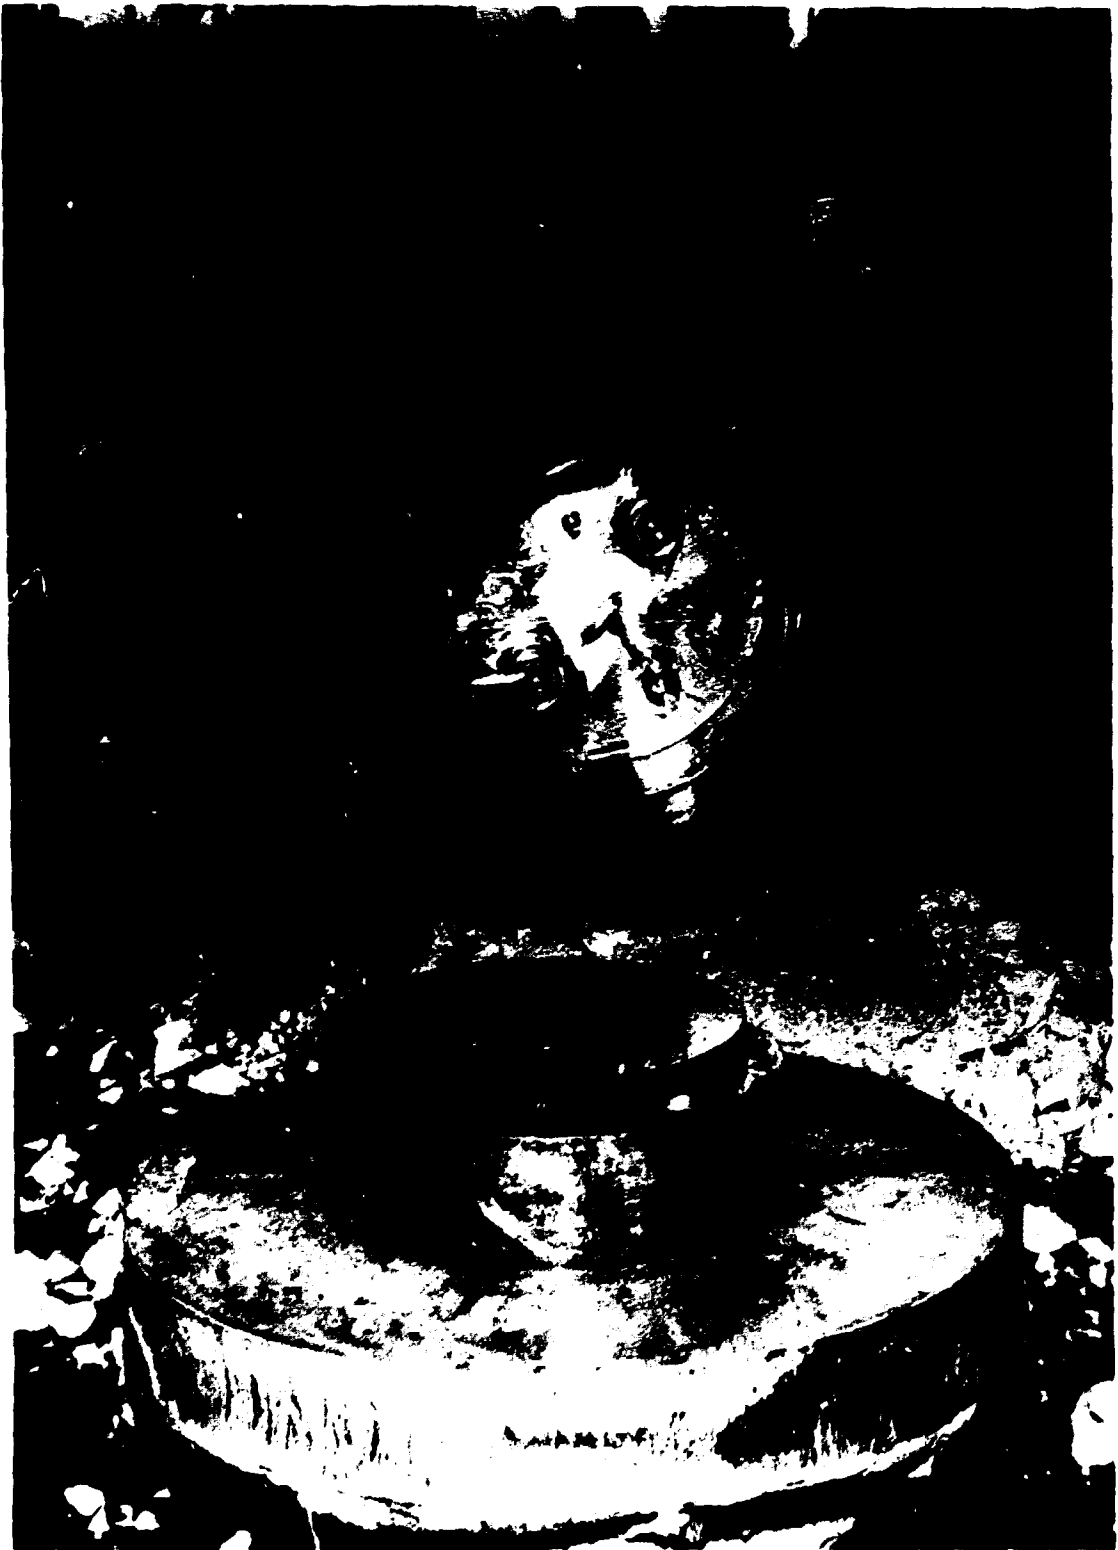
Fig. 5.4. Impact end of knockout defueling canister after first vertical drop test.

A visual examination of the canister after it was removed from the CSV following the vertical drop test indicated that no external damage resulted from the test (see Figs. 5.3 and 5.4). One of the caps placed on each of the fittings prior to the test fell off during the impact, but, even with this cap removed, no leakage from the fittings was detected. A canister pressure reading of 214 kPa, absolute (31 psia), was taken by means of the inlet plug. This higher internal pressure was attributed to the increase in temperature inside the canister, which resulted from its exposure in ambient air at a temperature of  $\sim 21^{\circ}\text{C}$  ( $\sim 70^{\circ}\text{F}$ ).

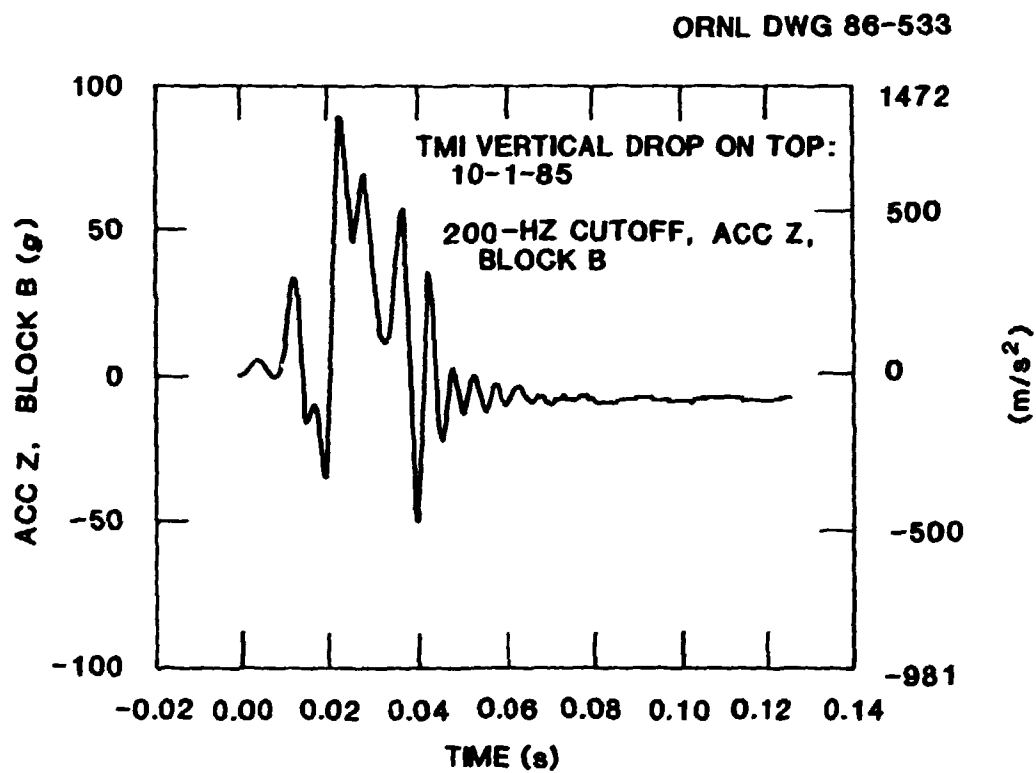
Fig. 5.6. Plot of output from vertical accelerometer mounted on block B in knockout defueling canister during vertical drop test.

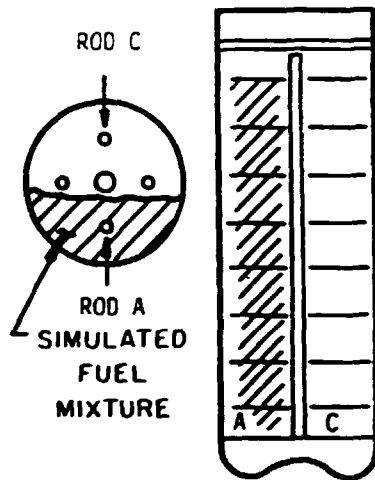
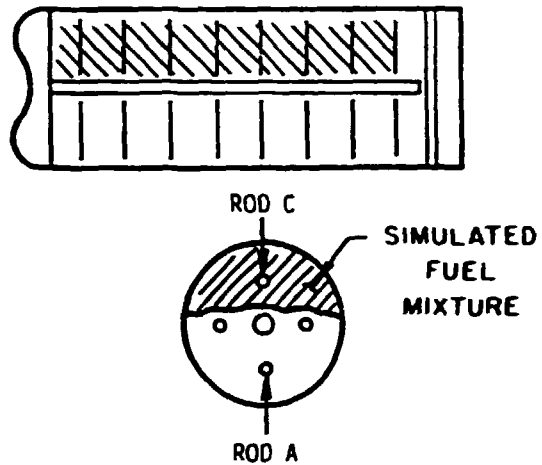
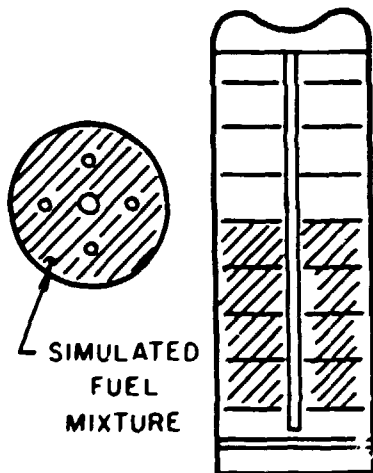
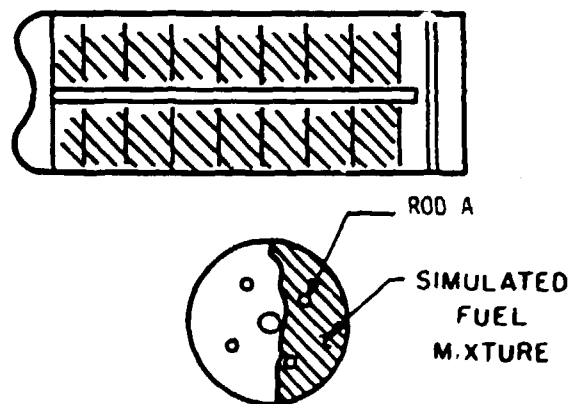
CONFIGURATION A  
- Bottom Impact

CONFIGURATION B  
- Side Impact/Bending

CONFIGURATION C  
- Top Impact

CONFIGURATION D  
- Side Impact/Torsion

Fig. 6.1. Drop test configurations.

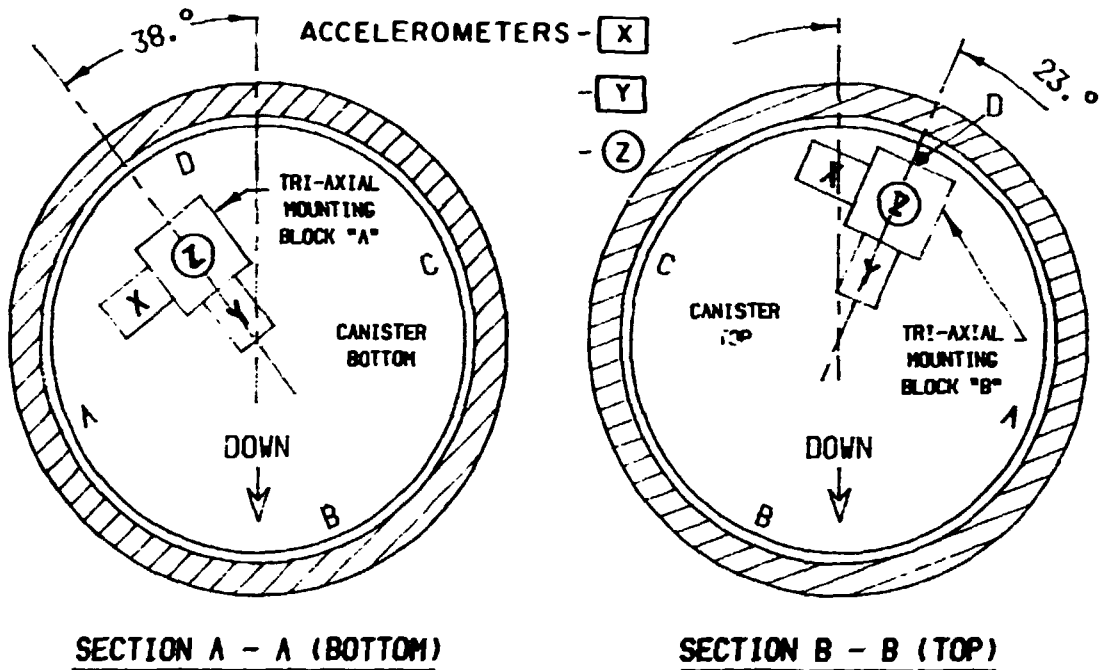
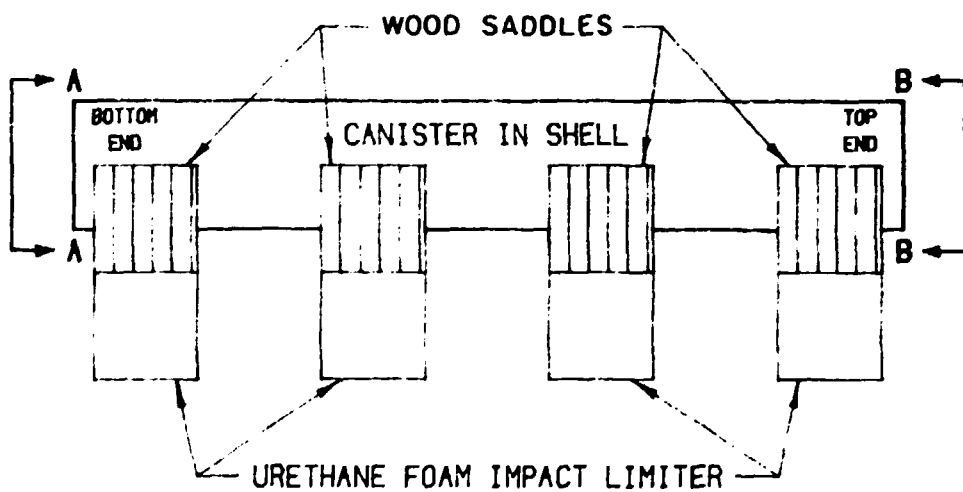
ORNL DWG 86-447R

Fig. 7.2. Schematic diagram of knockout canister showing location and orientation of accelerometers.

Instrumentation installed for the first horizontal drops included six accelerometers mounted on triaxial blocks located at the ends of the canister, as shown in Fig. 7.2. The block located at the bottom of the canister was attached by bolts to a plate welded to the canister bottom, and the block located at the top was attached by bolts to a plate epoxied to the top of the canister. The ranges of the vertical (y) accelerometers used in this drop were -200 to +200 g, and the ranges of those installed in the horizontal (x and z) axes were -100 to +100 g. The general instrumentation scheme was the same as depicted in Fig. 4.6 for the vertical drop test.

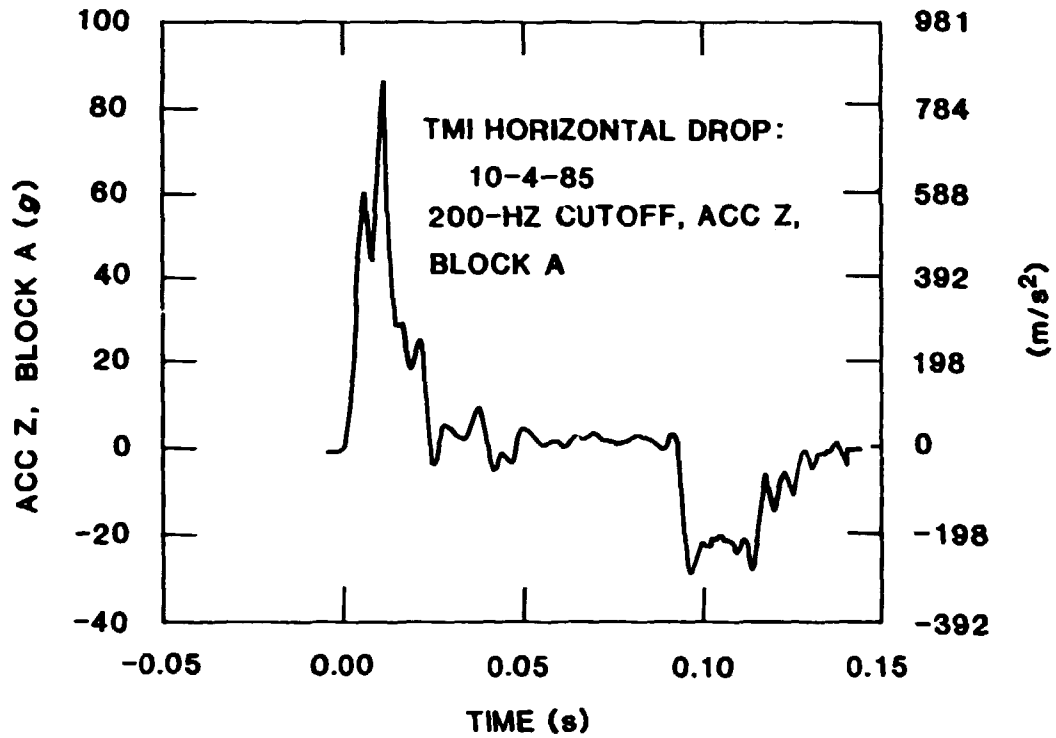
ORNL DWG 86-532

Fig. 7.3. Plot of output from vertical accelerometer mounted on bottom of knockout defueling canister during horizontal drop test.

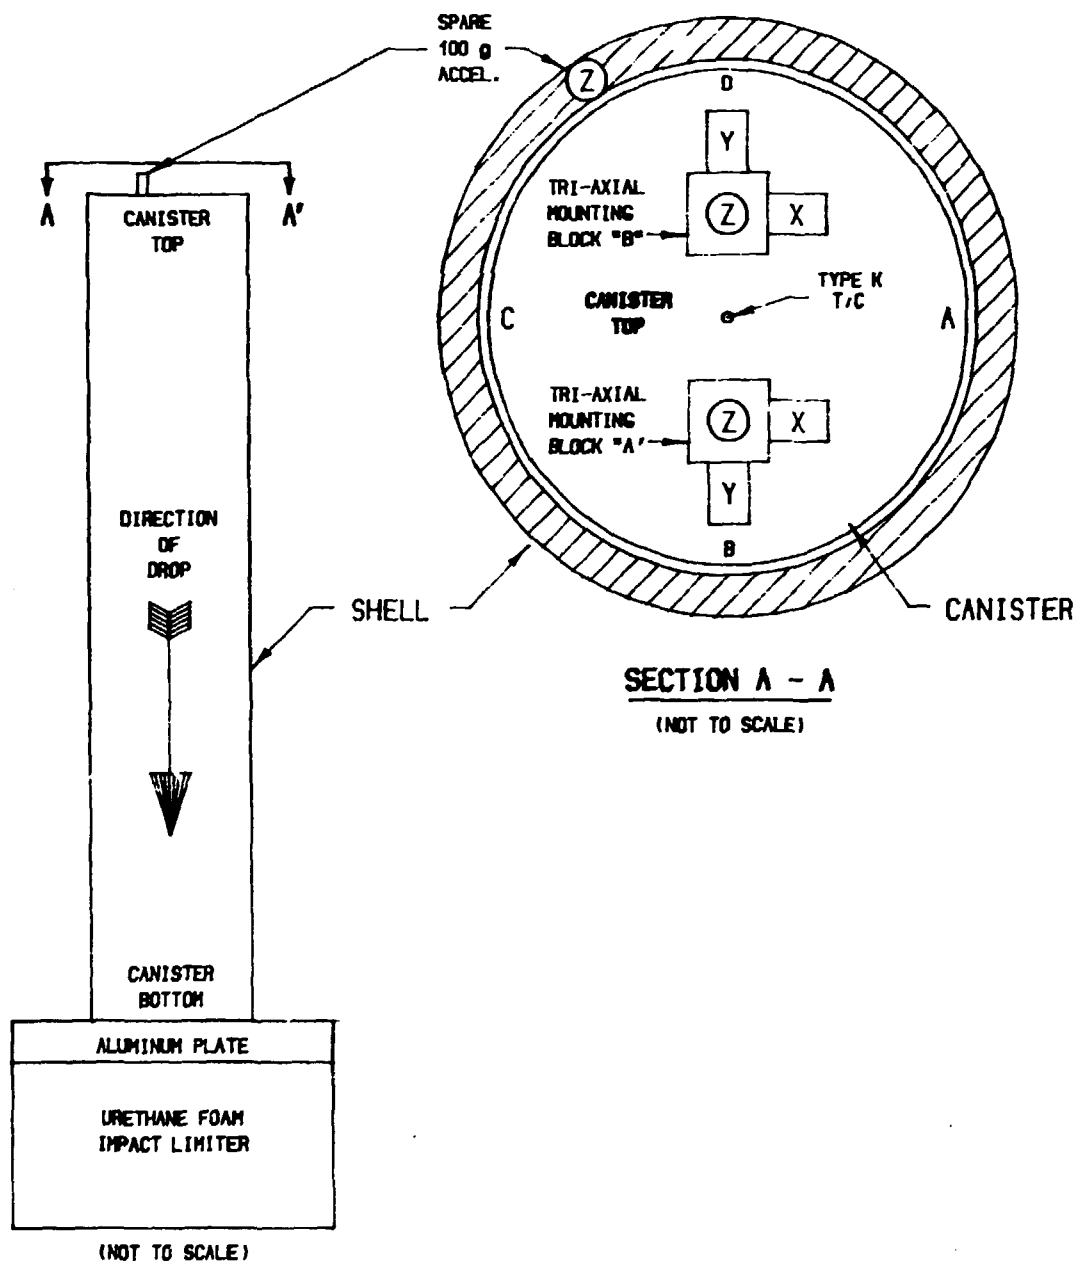
Fig. 9.1. Schematic of knockout defueling canister bottom showing the vertical (z), and horizontal (x,y) accelerometers locations.

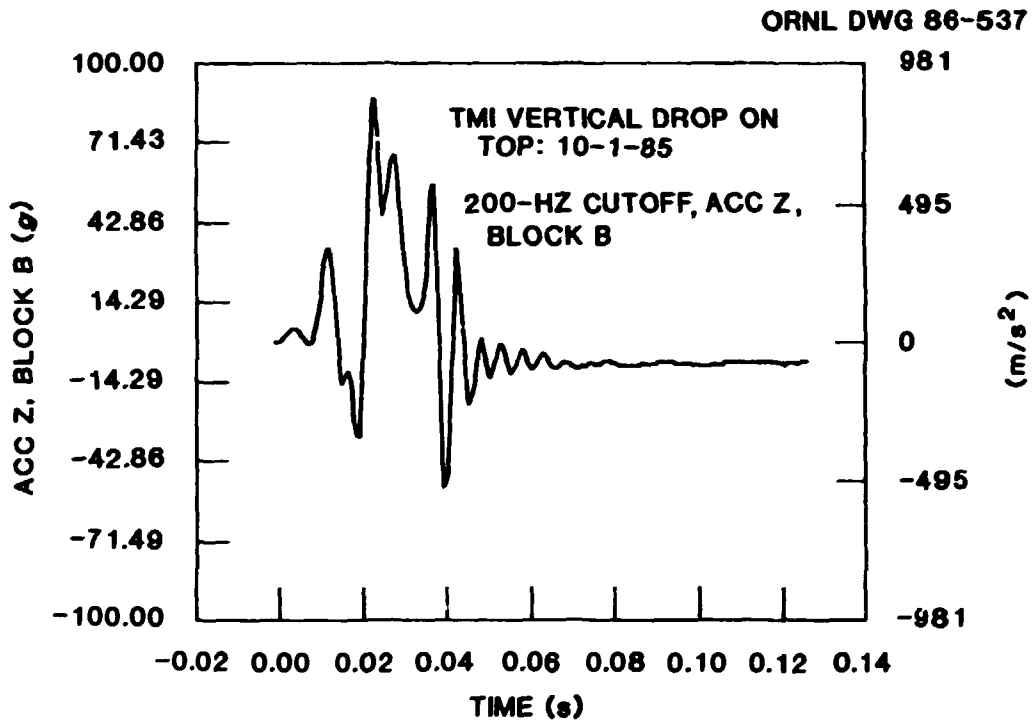
Fig. 9.2. Plot of output from vertical accelerometer mounted in the knockout defueling canister during the vertical drop test.

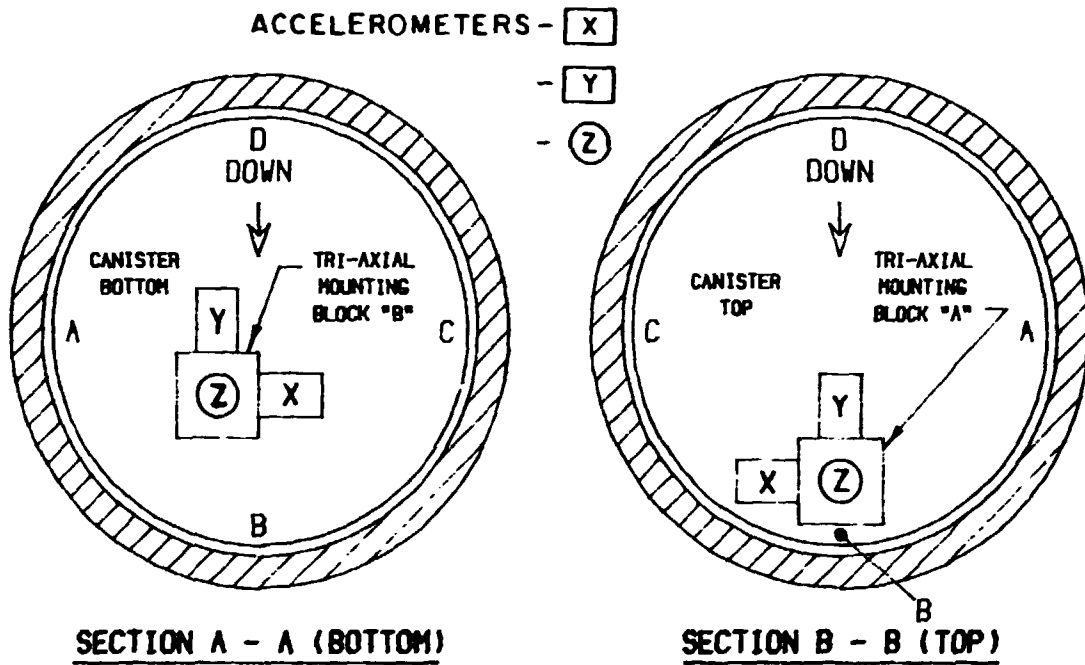
Fig. 11.1. Schematic of knockout defueling canister showing locations of accelerometers during the horizontal drop test with internal torque.

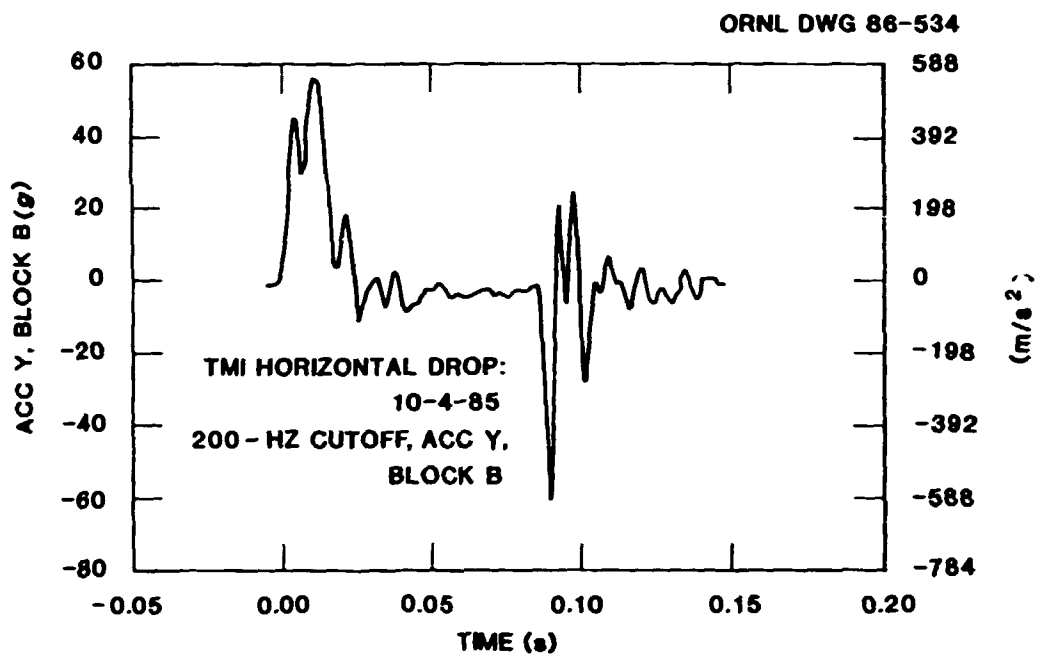
Fig. 11.2. Plot of output for vertical accelerometer of knockout defueling canister during a horizontal drop test. Data has been corrected for a 22° angle of rotation during drop.

During its descent, the canister rotated about its horizontal axis through an angle of approximately 22°. The plot of the vertical acceleration data (Fig. 11.2) has been corrected for this rotation. Plots of the horizontal components of acceleration for this drop test (found in Appendix B) have not been corrected for this rotation.

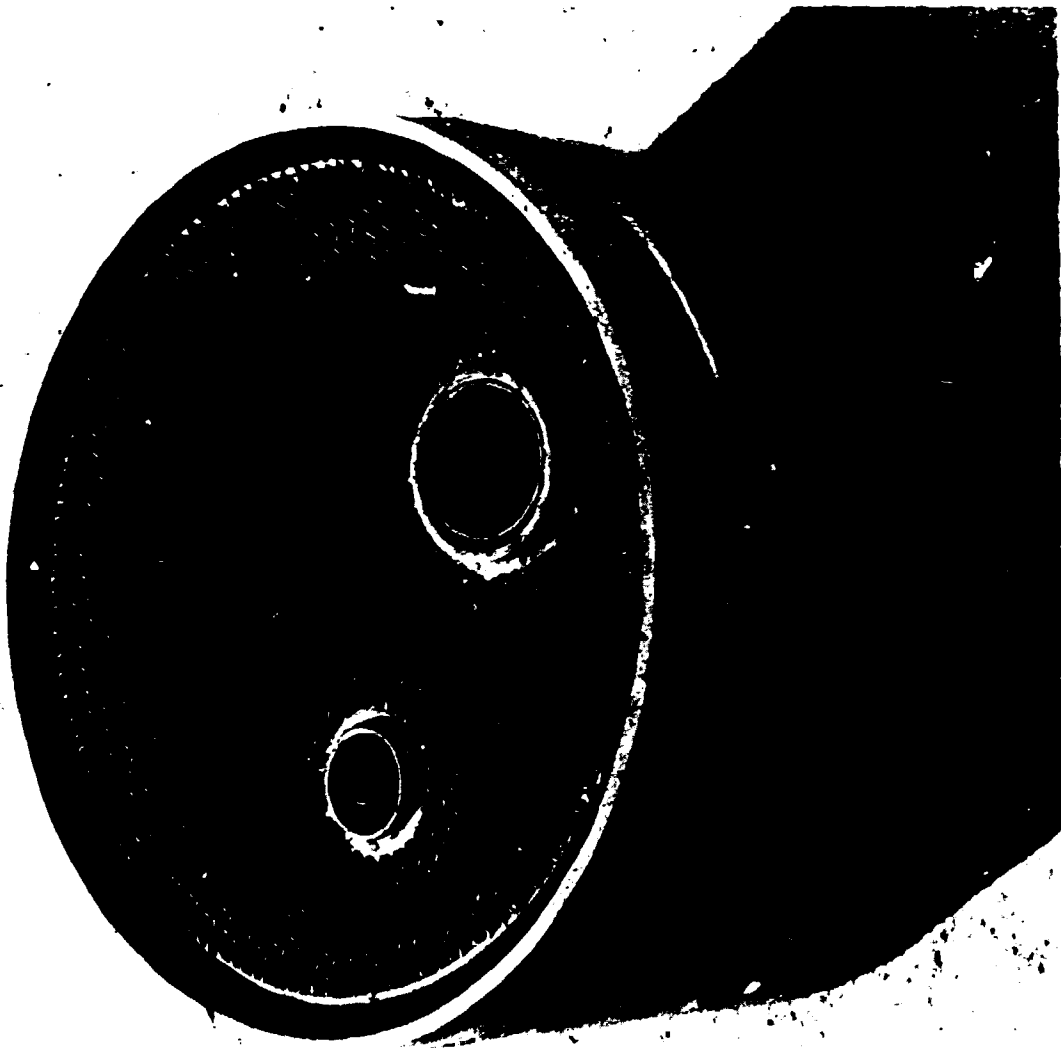
ORNL PHOTO 7876-85

Fig. 12.1. Top head of the knockout defueling canister after all of drop tests.

the bottom head and the top head were cut from the shell (Figs. 12.1 and 12.2, respectively). The next step in the disassembly was to cut a section from the shell's circumference, ~5 cm (~2 in.) above the bottom of the support plate (Fig. 12.3) and remove the inner assembly (Fig. 12.4). The entire assembly was easily extracted from the outer shell, indicating no significant permanent damage to any of the poison rods or support plates had occurred.

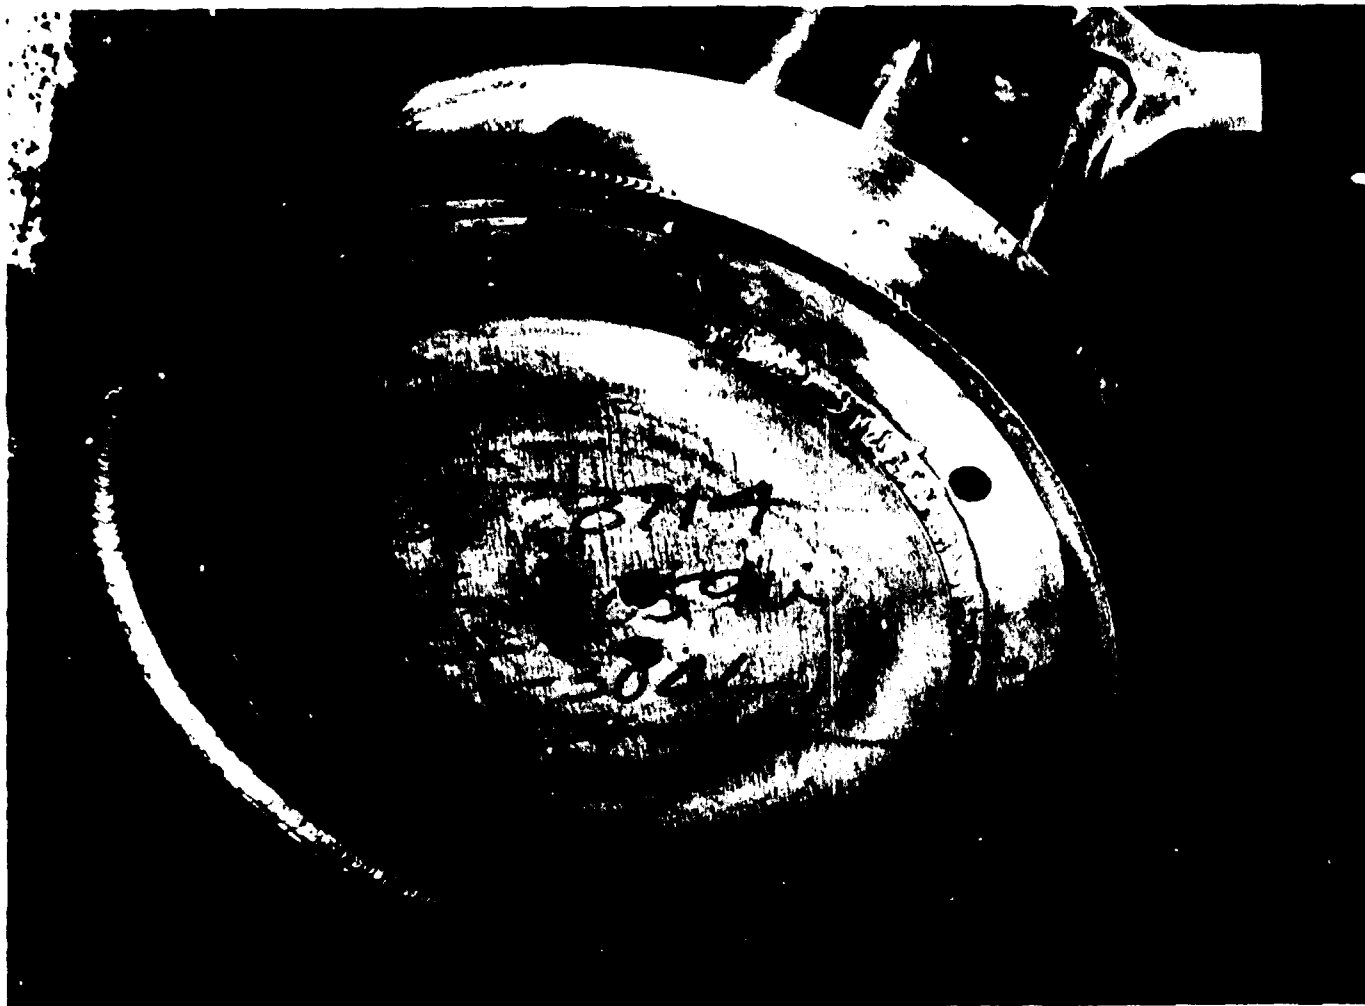
Fig. 12.3. Cross section removed from the knockout defueling canister showing the lower support plate that holds absorber rod in position.

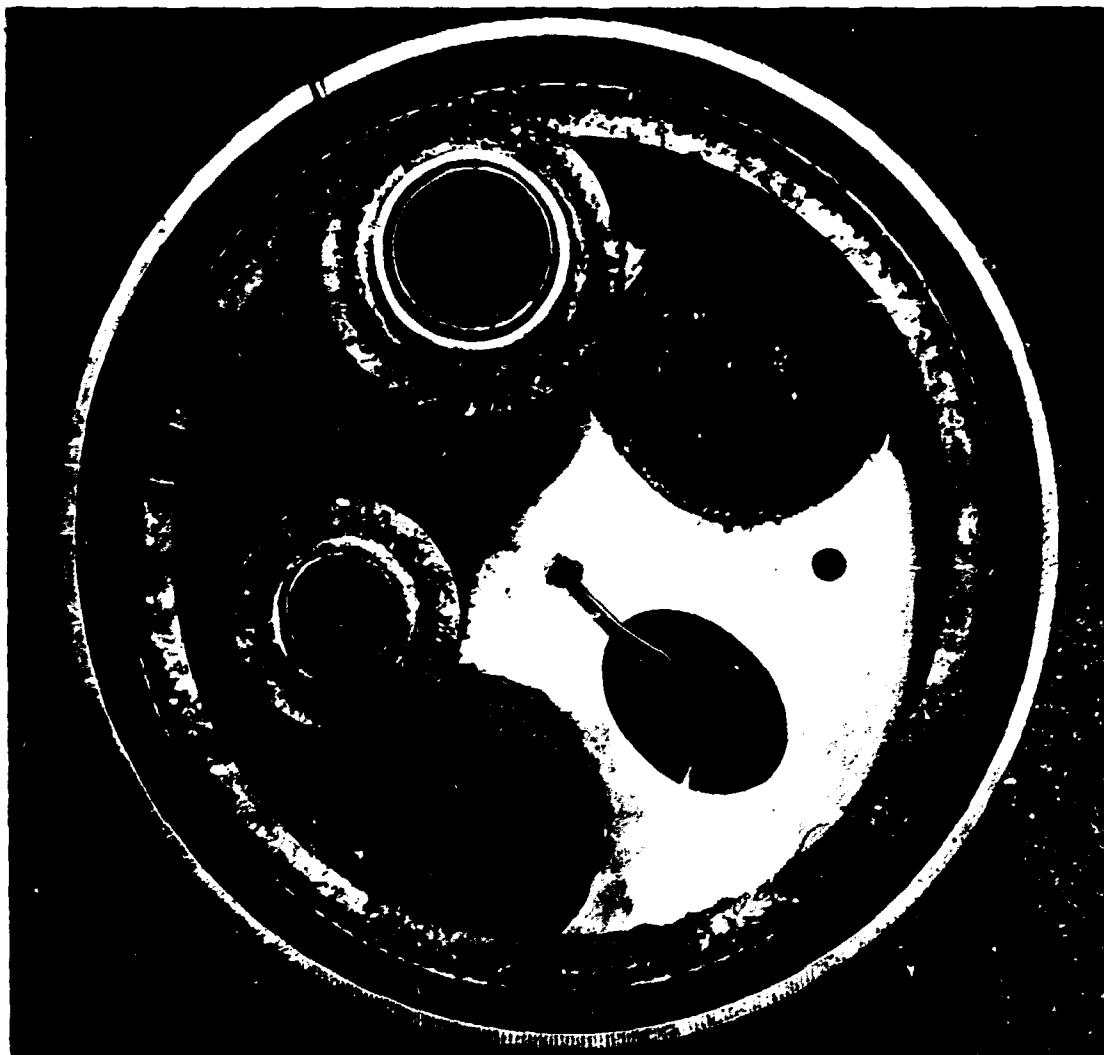
ORNL PHOTO 8618-85

Fig. 12.5. Knockout defueling canister top head showing O<sub>2</sub>-H<sub>2</sub> recombiner packets. Screen has been removed from a packet.

The stainless steel screens covering the recombiner pellets were removed to allow examination of the pellets (see Figs. 12.5 and 12.6). This inspection revealed that the recombiner material was undamaged and that the screens adequately contained the pellets within the designed containers in both the bottom and top heads.
