Chemical Technology Division

DROP TESTS OF THE THREE MILE ISLAND KNOCKOUT CANISTER

Date of Issue - September 1986

Prepared by the  
OAK RIDGE NATIONAL LABORATORY  
Oak Ridge, Tennessee 37831  
operated by  
MARTIN MARIETTA ENERGY SYSTEMS, INC.  
for the  
U.S. DEPARTMENT OF ENERGY  
Under Contract No. DE-AC05-84OR21400

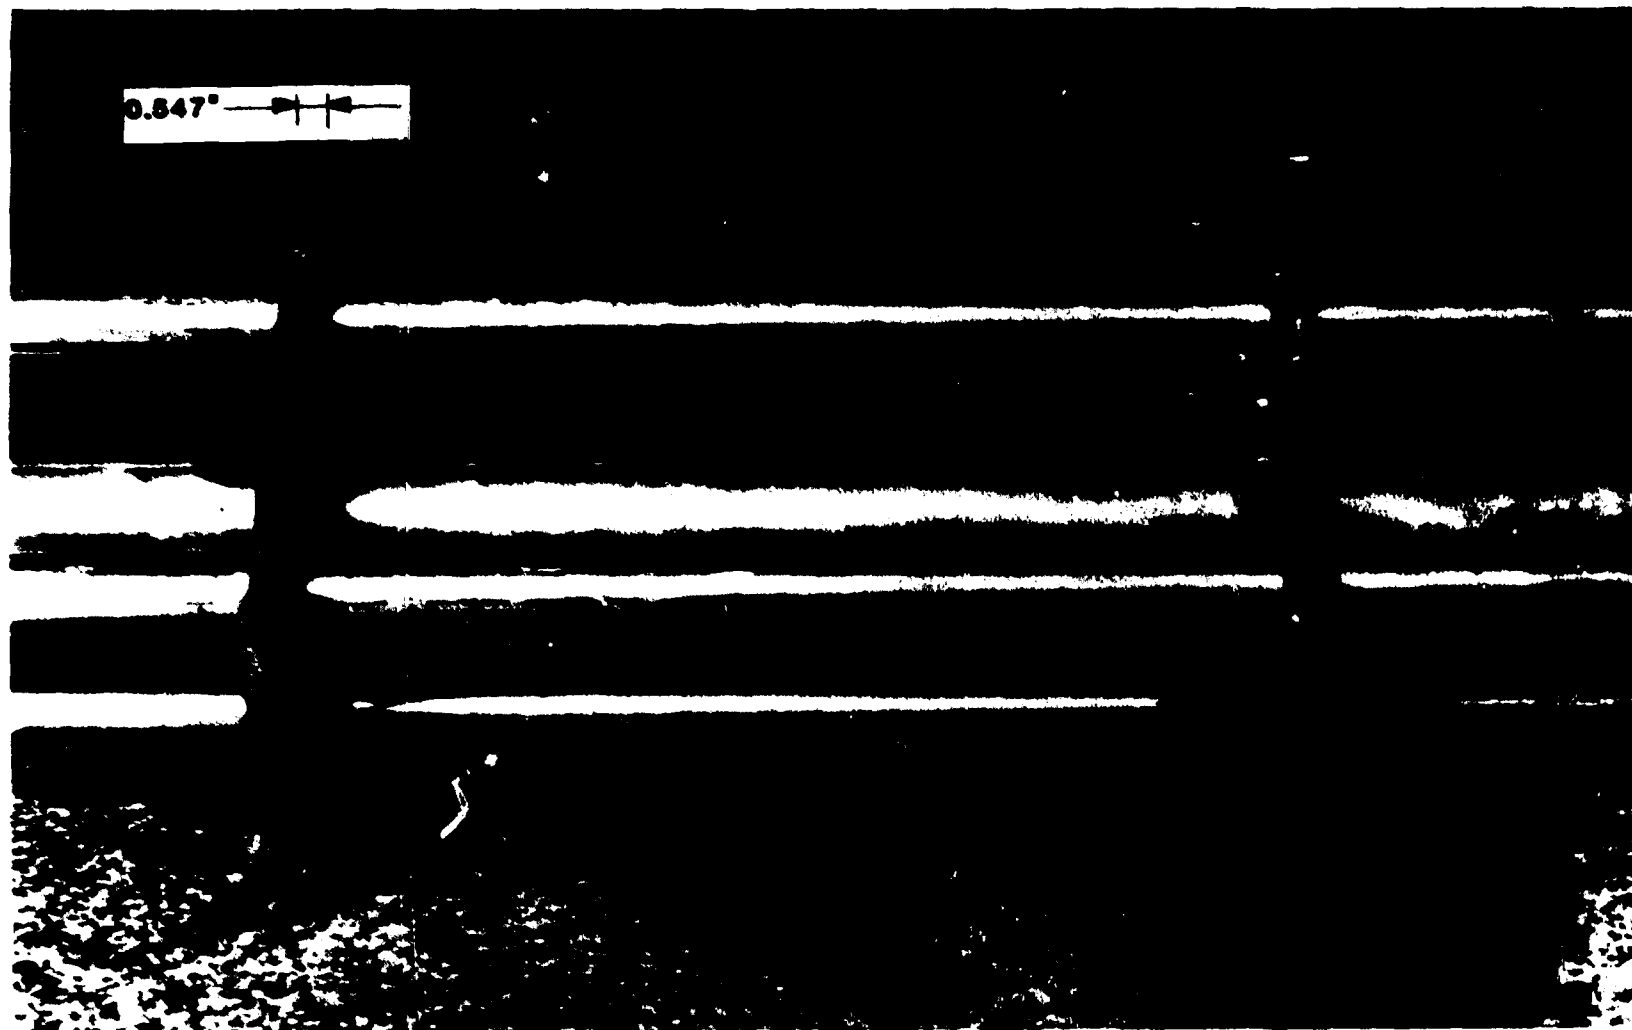
Fig. 12.8. Internal support spider showing displacement resulting from the drop tests.

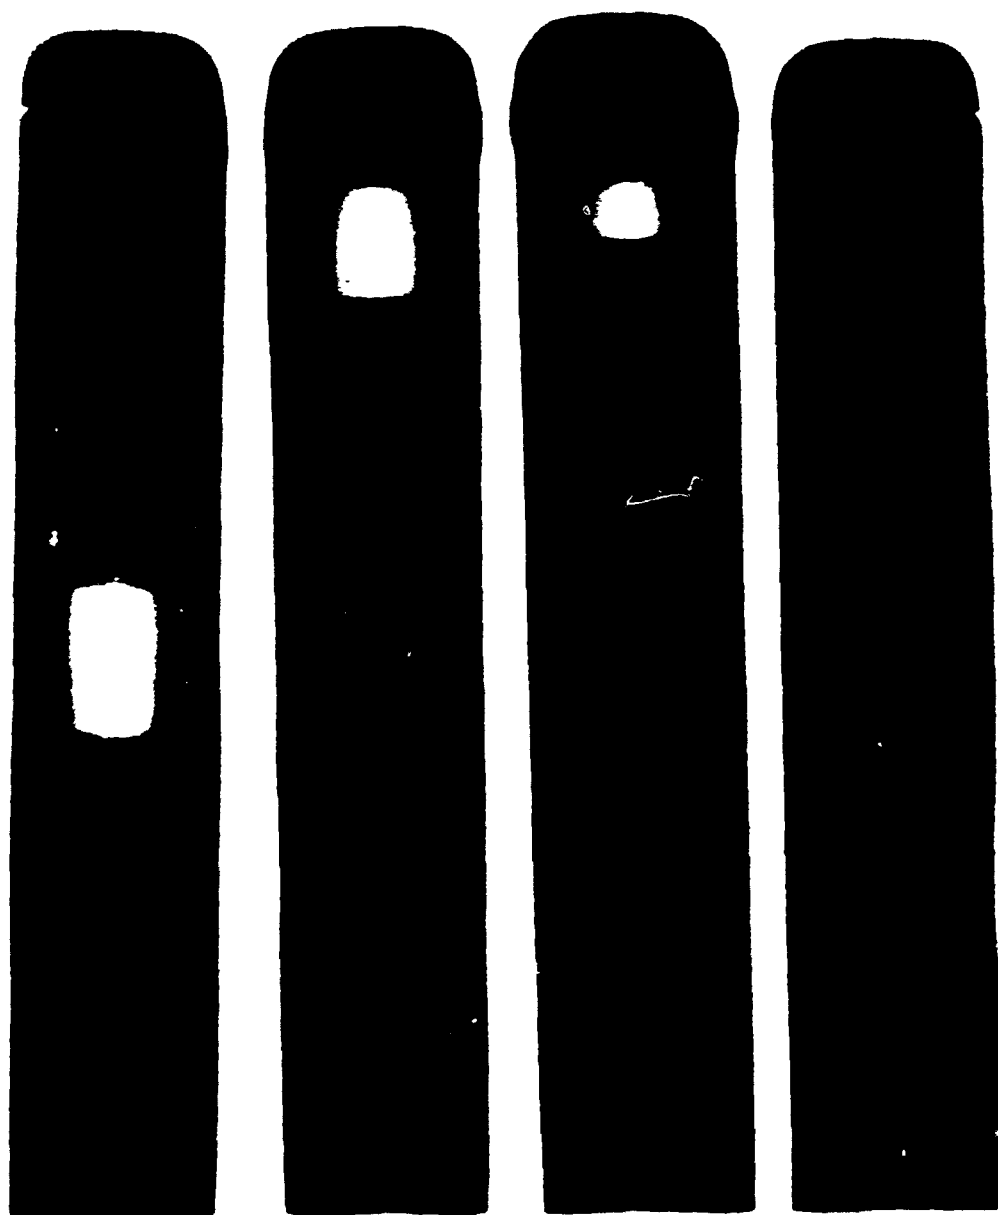
Fig. 12.11. X-ray photograph of the absorber rods after the drop tests. The dark spaces are vacancies resulting from cracked pellets.

pellets in tube B had cracked, causing the stack within the tube to be ~10 mm (~0.45 in.) shorter than its original length (Fig. 12.11). The broken pellets generally remained in pieces, thus contributing to the overall criticality control. The pellets in the remaining tubes were still in pristine condition, with no void space in the end when the tube was placed upright.

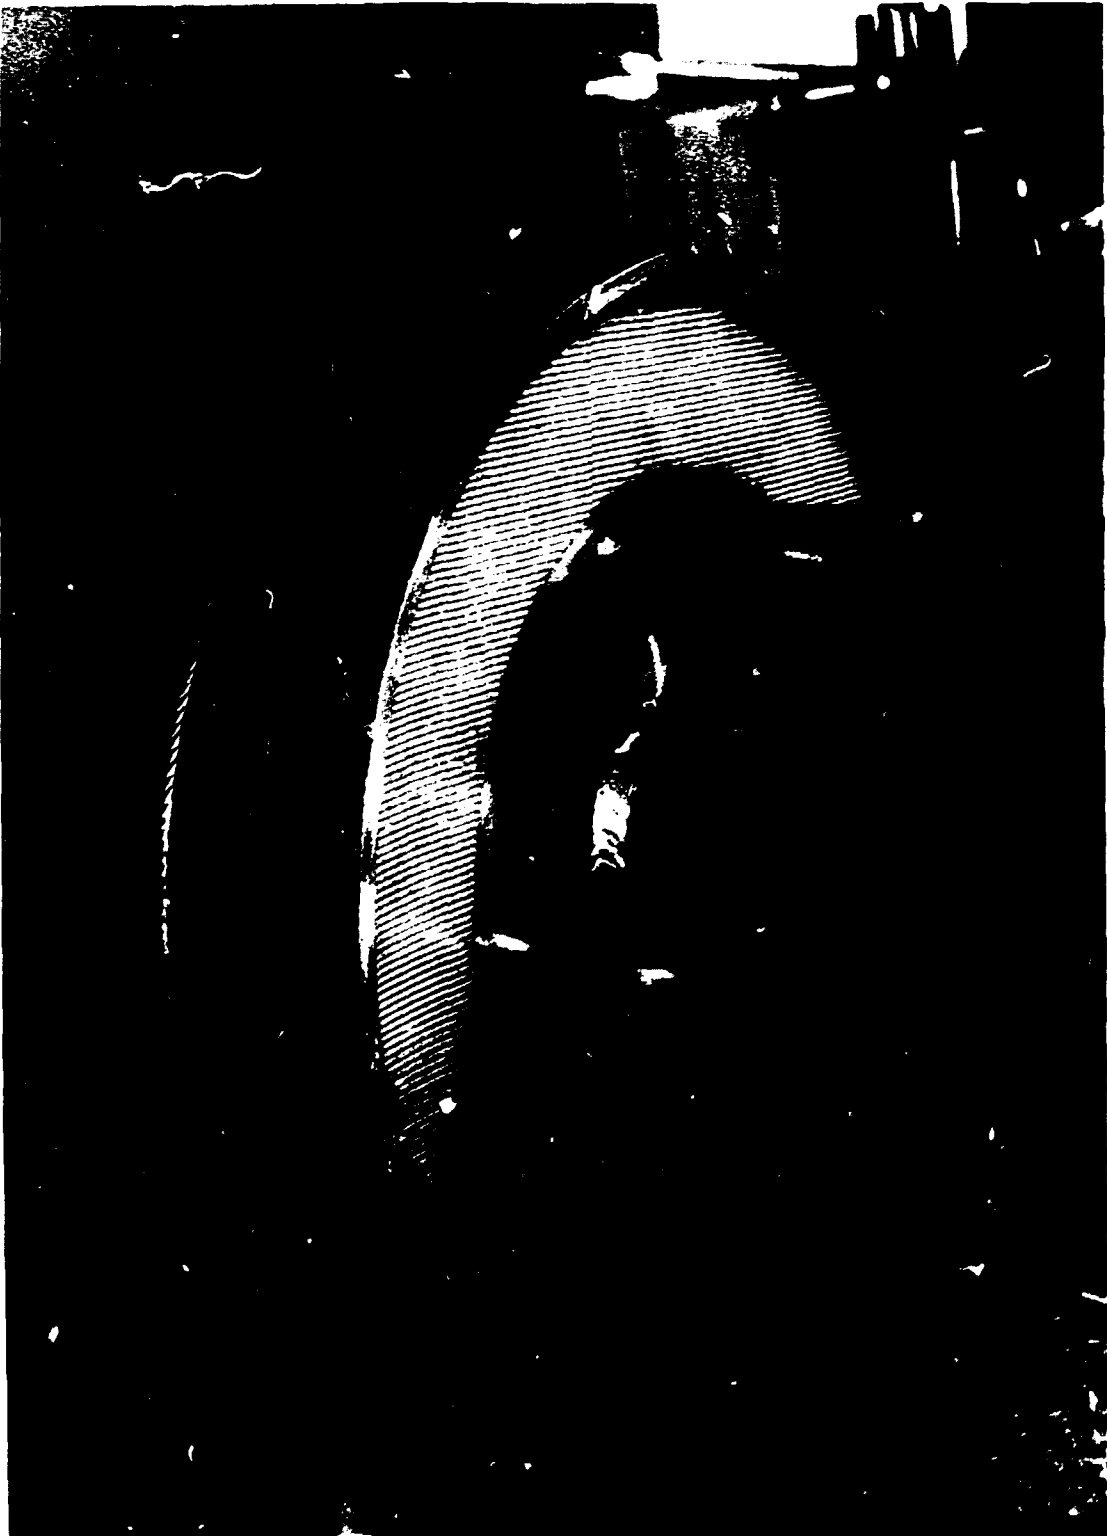
Fig. 13.1. Top surface of the lower support plate of the knockout defueling canister after drop testing.

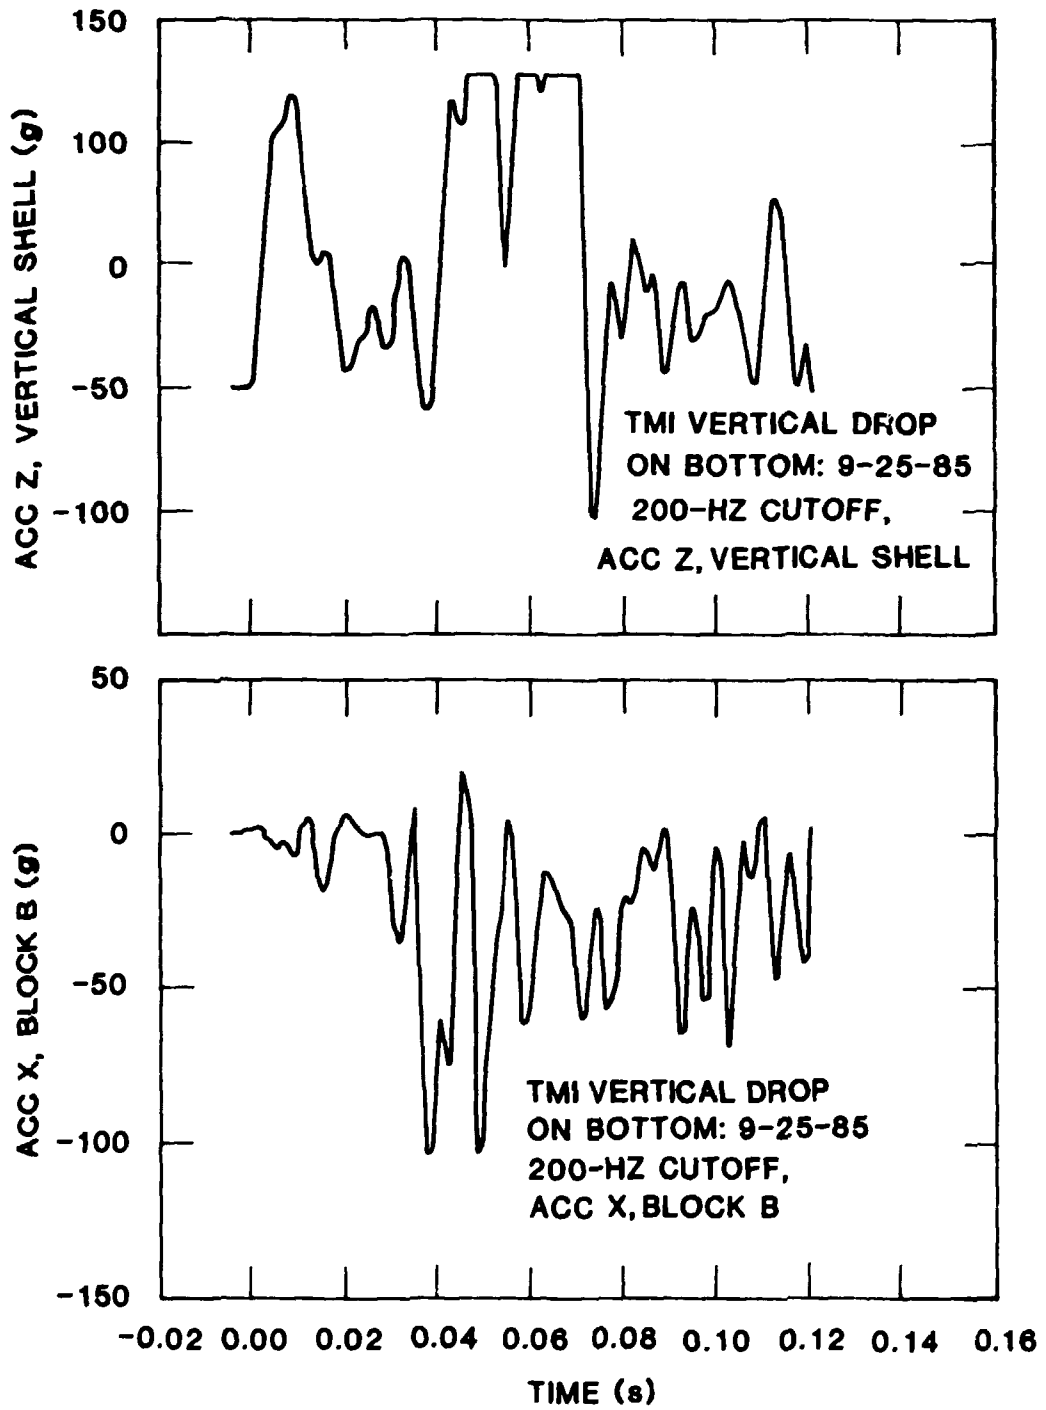
In ORNL DWG 86-529 (in Appendix B), note that the tops of the positive peaks in the data plot are flattened, which indicates that the range of this accelerometer was exceeded. However, these data were from a low-range (-100 to +100 g) accelerometer that was added to the shell when the Z accelerometer on Block A (see Fig. 5.5) was determined to be defective.
