Crash Testing of Nuclear Fuel Shipping Containers

Robert M. Jefferson, H. Richard Yoshimura

CRASH TESTING OF NUCLEAR FUEL SHIPPING CONTAINERS*

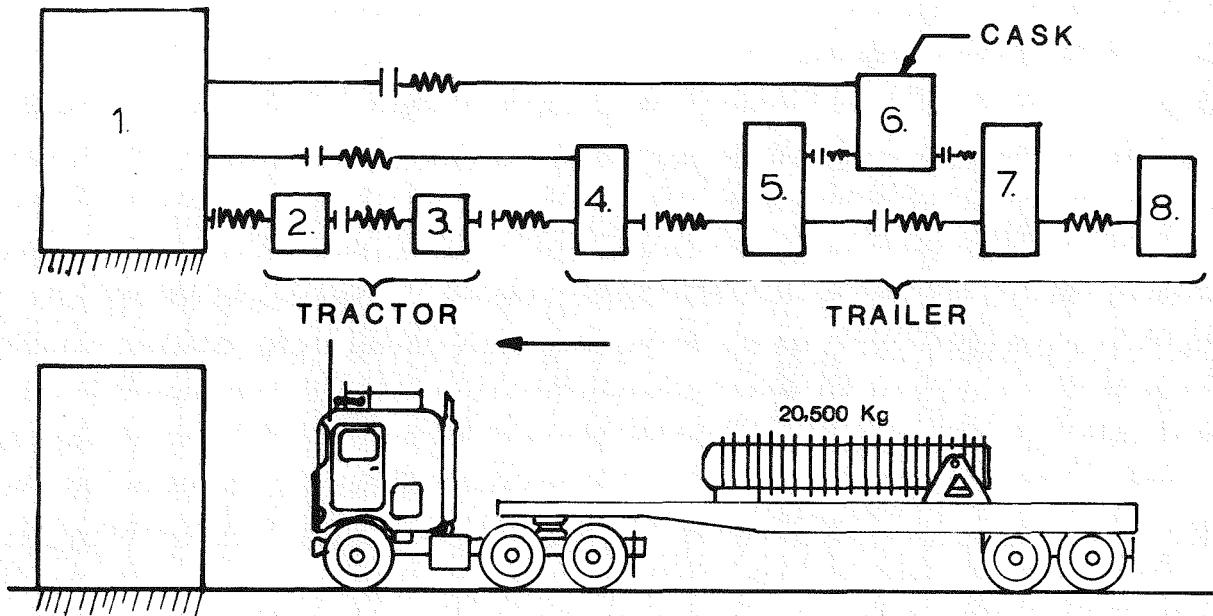
Figure 1. SHOCK tractor-trailer model.

Mathematical models for the three full scale tests were constructed using this SHOCK code (6). Figure 1 illustrates the

model for the tractor-trailer impact. Here the system, including the target, is modeled with 8 discrete masses and 10 couplings. Mass 1 (the target) is held fixed, and the remaining masses are given initial velocities equal to the test impact velocity. In this model, coupling 3-4 represents the tractor-trailer kingpin connection, and couplings 5-6 and 6-7 simulate the cask tiedowns. Couplings 1-4 and 1-6 represent the interactions between the end of the trailer and the target, and the cask and target. These are given appropriate amounts of travel without loading. The rest of the couplings represent frame elements.

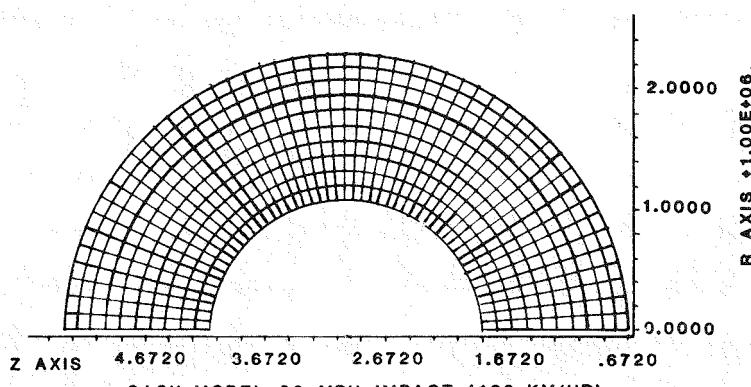
2a. HONDO Mesh - Undefomed

Figure 2a illustrates the mesh for a model cask (6). The cask cross section, including the outer and inner shells and the lead shielding, is modeled. Figure 2b illustrates the severely deformed mesh after a 130 kph side-on impact.

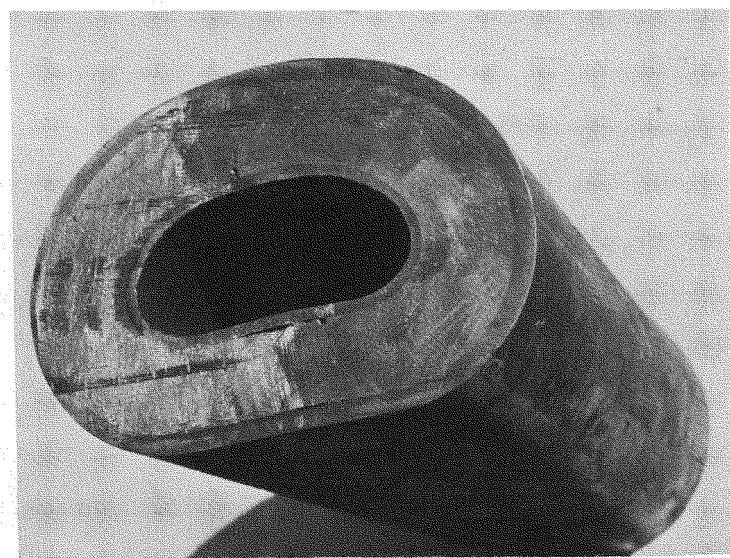
2c. Photograph of Cask Deformation

Figure 2c illustrates the 1/8-scale model cross section after a side-on impact into a steel target at the same velocity. As can be seen, there is good quantitative agreement between the code and the scale model results.

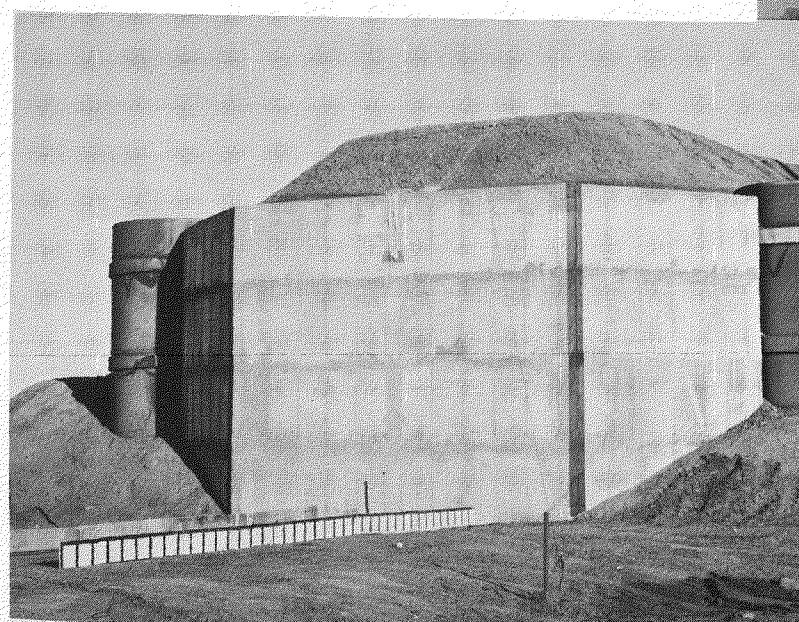
3b. Target

The impact target used in these tests was designed to be very massive and rigid. It consisted of a heavily reinforced 626 metric ton concrete structure backed with more than 1580 metric tons of earth (Figure 3b). For all practical purposes, considering the masses and velocities involved in the tests, the target is essentially unyielding. An object of this size and weight is rarely, if ever, found along normal truck routes. To save costs, this target is also to be used in the special railcar impact test.

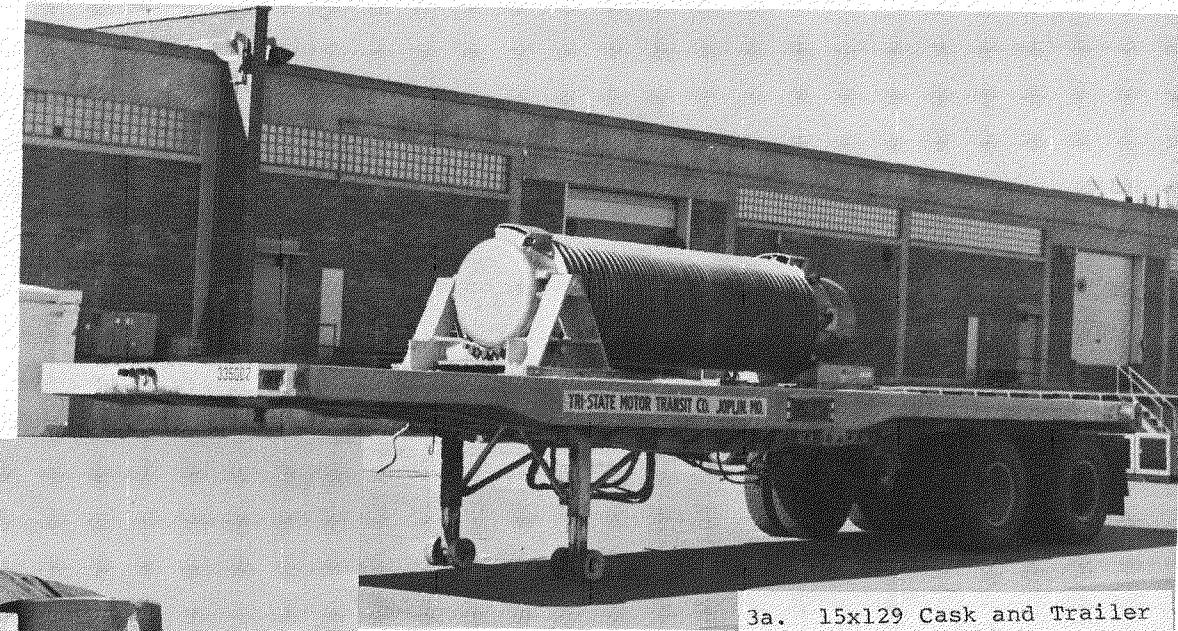
3a. 15x129 Cask and Trailer

In the truck-cask impact tests, an obsolete spent fuel cask weighing 20.5 metric tons was obtained complete with its normal transport trailer and tiedowns as shown in Figure 3a. In its original configuration, the cask was mounted with the head facing the rear of the trailer. Since most modern casks are shipped head forward, this test cask was reversed on the trailer to better simulate current transport conditions. The

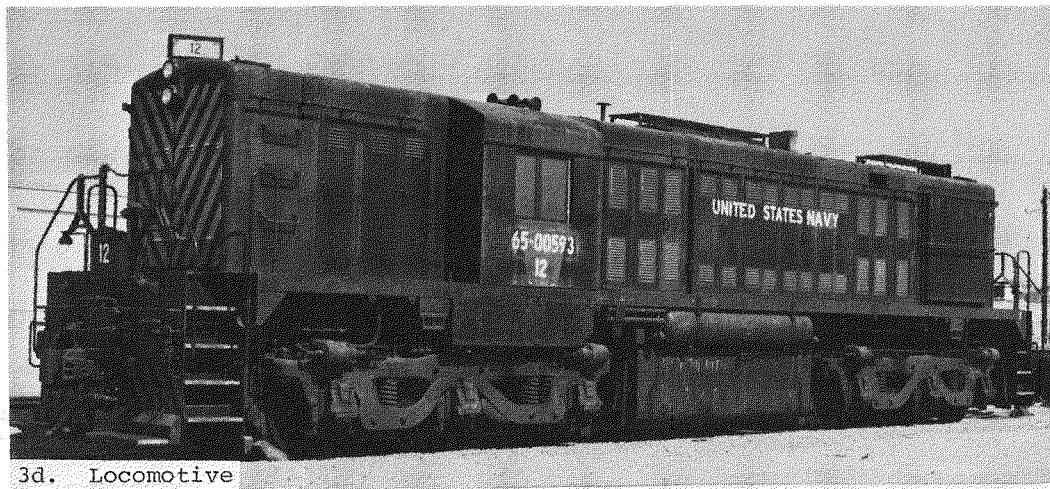
3d. Locomotive

A military surplus 109 metric ton diesel-electric locomotive was obtained for the grade-crossing test. This locomotive, shown in Figure 3d, was originally powered by a V-12 diesel engine through six traction motors in two three-axle trucks. Since the engine needed extensive repairs and was not required to accelerate the locomotive to the test speed, the pinion gears were removed to allow the locomotive to free-wheel. The weight of the engine and alternator in this design is supported by two I-beams running the length of the locomotive. Although lighter in weight, the locomotive construction is quite similar to modern locomotives.

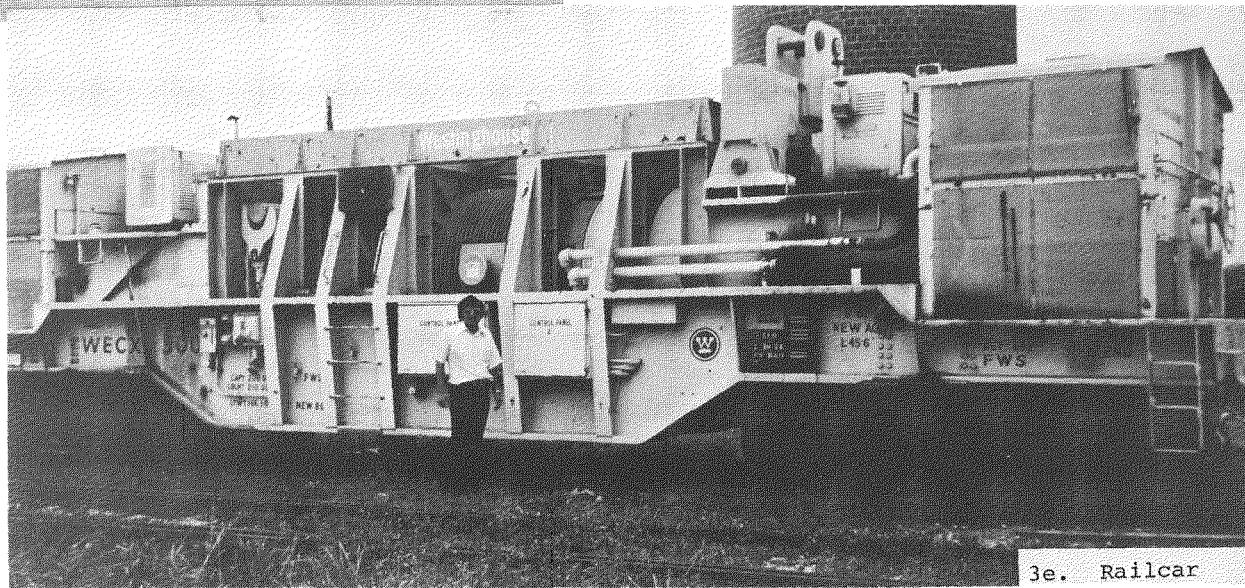
3e. Railcar

In the impact and fire test of a railcar and cask system, a 68.2 metric ton railcar with a 61.8 metric ton rail cask has been obtained for testing. This cask, while similar in construction to those tested earlier, is larger and capable of containing more spent fuel elements. The special railcar system, which is equipped with three-axle trucks, is shown in Figure 3e. Secondary cooling systems are shown at both ends of the car.

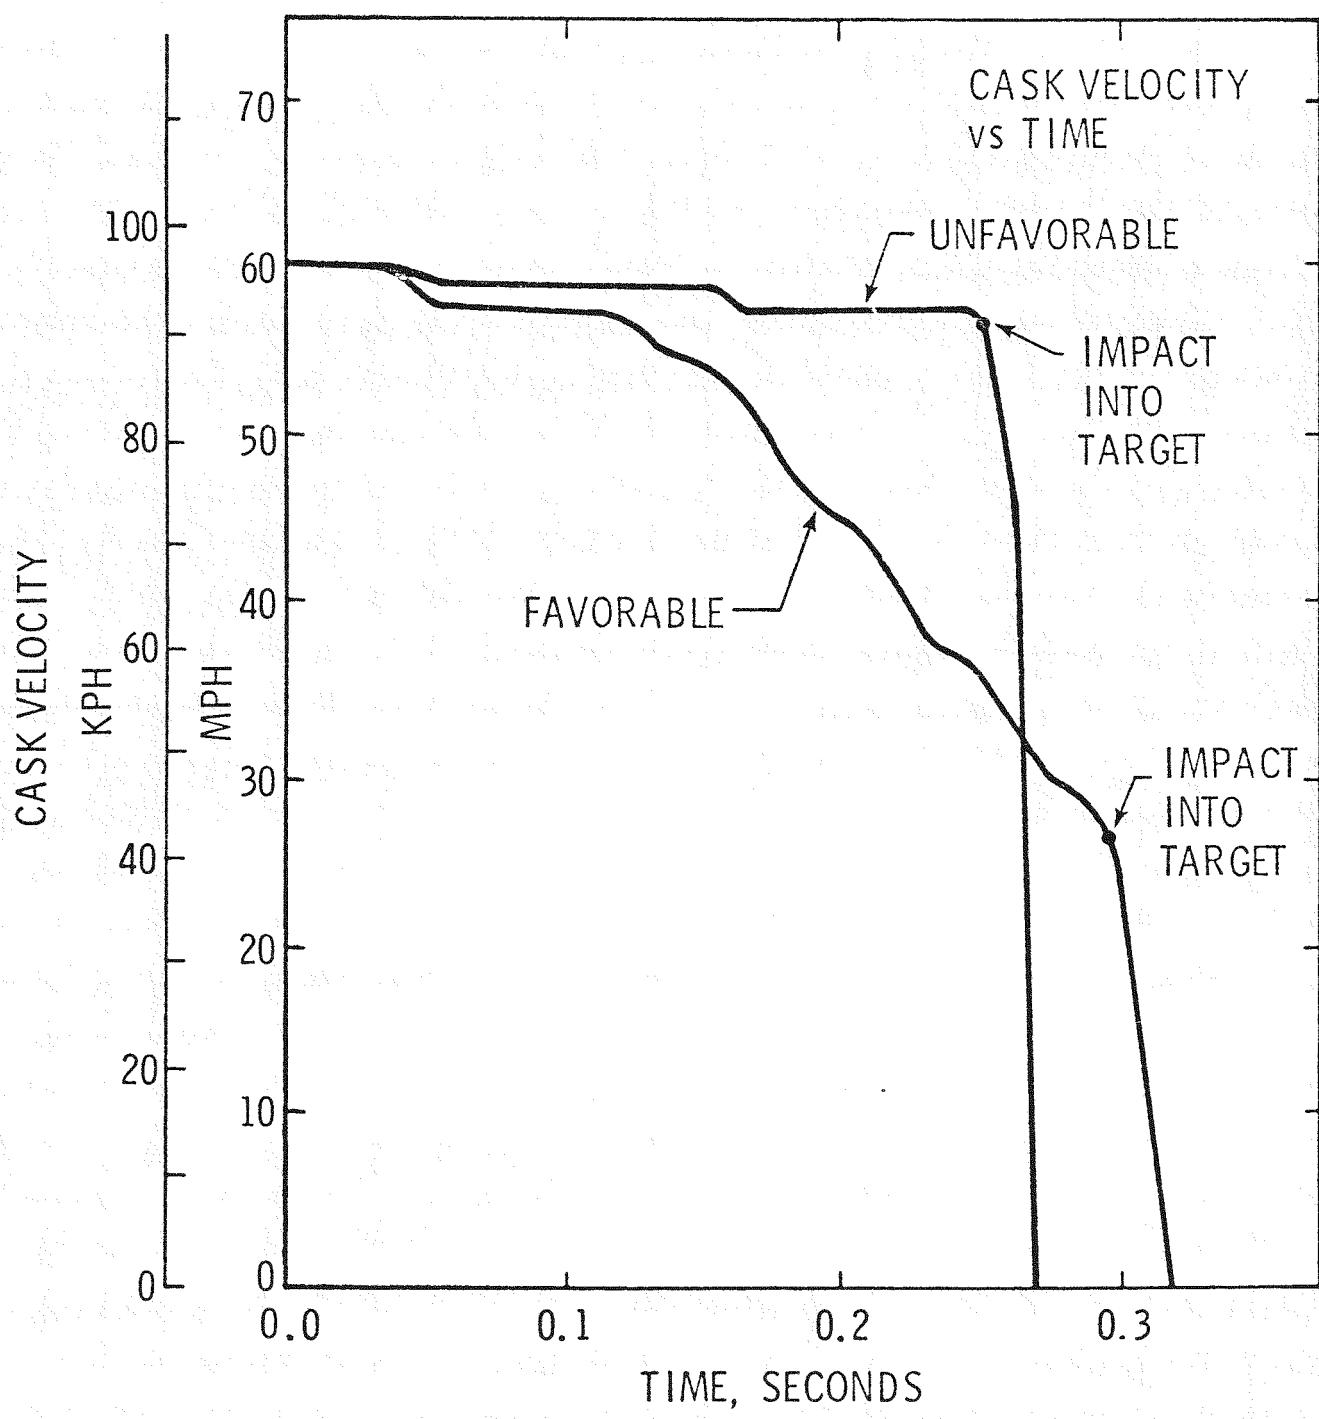
Figure 4. SHOCK predictions.

As indicated on Figure 4, when it is assumed that the tiedown either did not fail or failed late in the impact (favorable), the cask was continuously slowed as the components of the transport system crushed. Under these conditions, the container should impact the wall at less than 48 kph (13.3 m/s).

In the worst-case condition (unfavorable) the tiedown structure in the SHOCK model was intentionally weakened so that the container would break away early in the impact, with little velocity reduction. This resulted in the prediction of a large velocity change at impact with the wall as shown in Figure 4. Such a large velocity change would crush the impact limiter and cause cask deformation. The favorable response condition was determined to be the more realistic case. From the graph, the cask impact velocity with the target would be about half the

initial velocity of the system. In this case, the impact limiter, designed for the 9 meter drop test (impact velocity 13.4 m/s), would reduce the velocity of the cask even further, resulting in no structural deformation to the cask. The code predicted only partial crushup of the impact limiter.

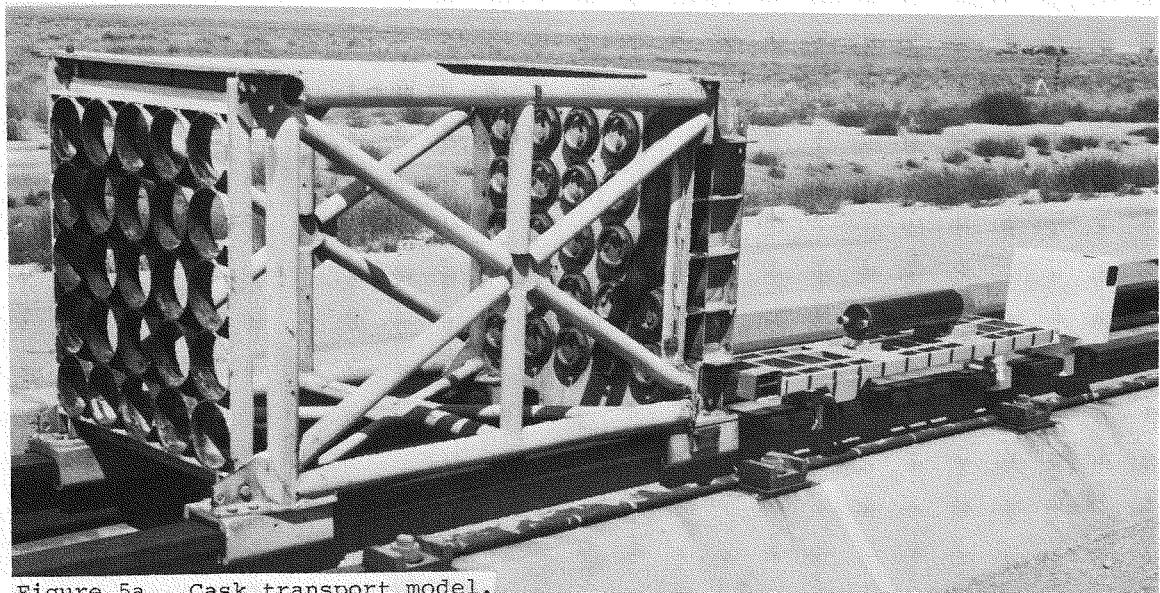
Figure 5a. Cask transport model.

Scale Model Test -- A 1/8-scale model of the cask transport system shown in Figure 5a was tested at Sandia's Rocket Sled Track Facility. To assess damage to the cask structure, an adequate model (excluding fins) of the cask and impact limiter was constructed. The tractor-trailer model was designed with emphasis on the major masses and structural elements. Only those elements expected to contribute significantly to the cask dynamics were included. The model, therefore, simulated the major dynamics and resultant damage expected in the full scale test.

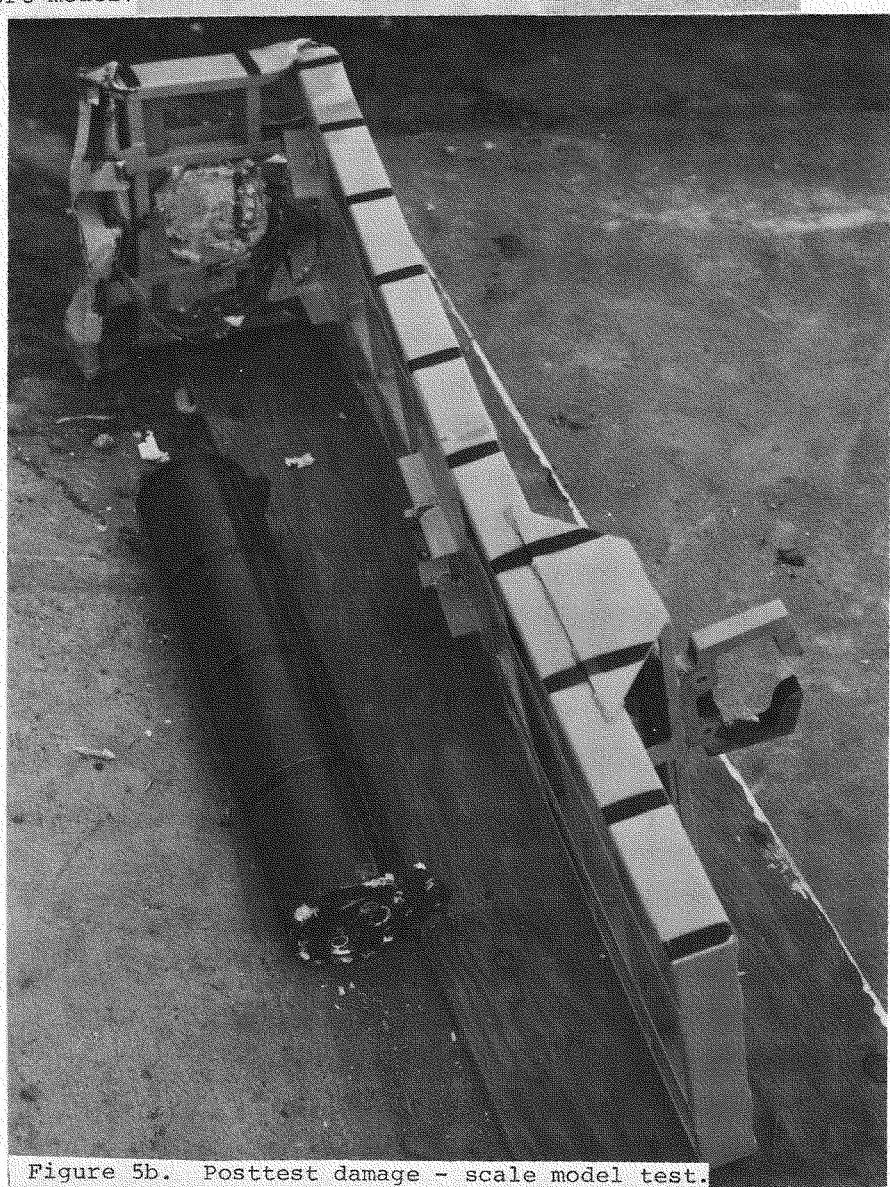
Figure 5b. Posttest damage - scale model test.

Using a rocket, the model transport system was propelled into a scaled concrete wall at 97 kph. A posttest view of the damage is shown in Figure 5b. Scale model results agreed closely with analytical predictions. High-speed data films showed that the transport and cask system response closely followed that predicted in the case where the tiedown did not fail. The impact limiter was partially crushed, and the cask was undamaged except for minor deformations around the tiedown attachment points.

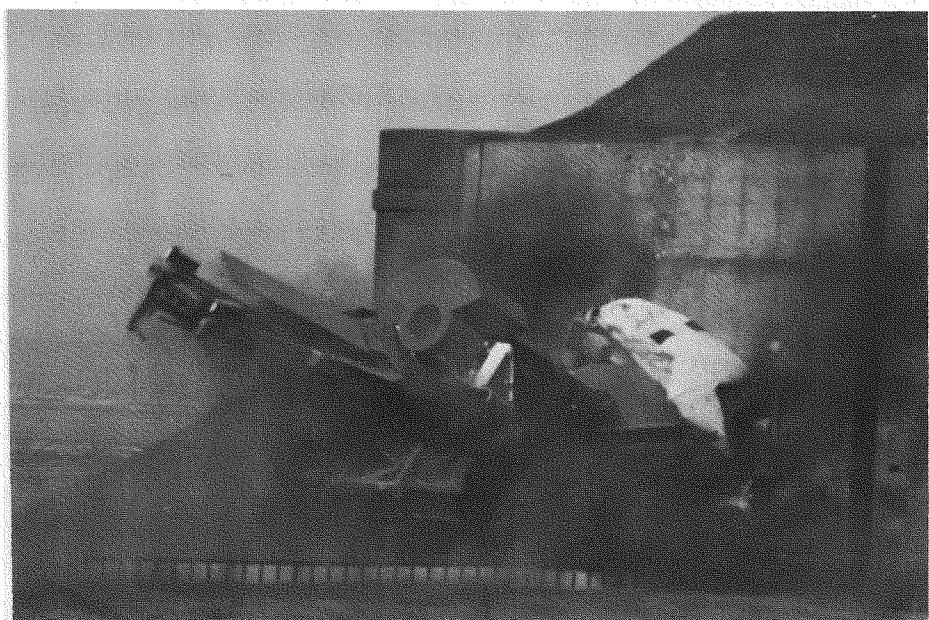
6b. Impact

As predicted by the conclusions drawn from both the analytical and scale model test results, the tractor was completely destroyed in the crash. The tractor's fifth wheel attachment failed, and the trailer moved forward through the cab to impact the wall. Crushing and buckling upwards, the trailer and other crushed structure gradually reduced the velocity of the cask to about half its original impact velocity. The impact limiter then contacted the bent trailer and other debris to slow the cask even further. Although the tiedowns did not break loose during impact, posttest inspection of the debris indicated that the cask tiedowns had almost failed. The cask remained horizontal as predicted until impact with the crushed debris and wall. Forces to the cask were limited by crushing of the tractor-trailer structure and by the compressive strength of the balsa wood in the impact limiter. Following the main impact, the cask and trailer rotated to about 30 degrees relative to horizontal and returned to the roadbed in front of the target (Figure 6b).

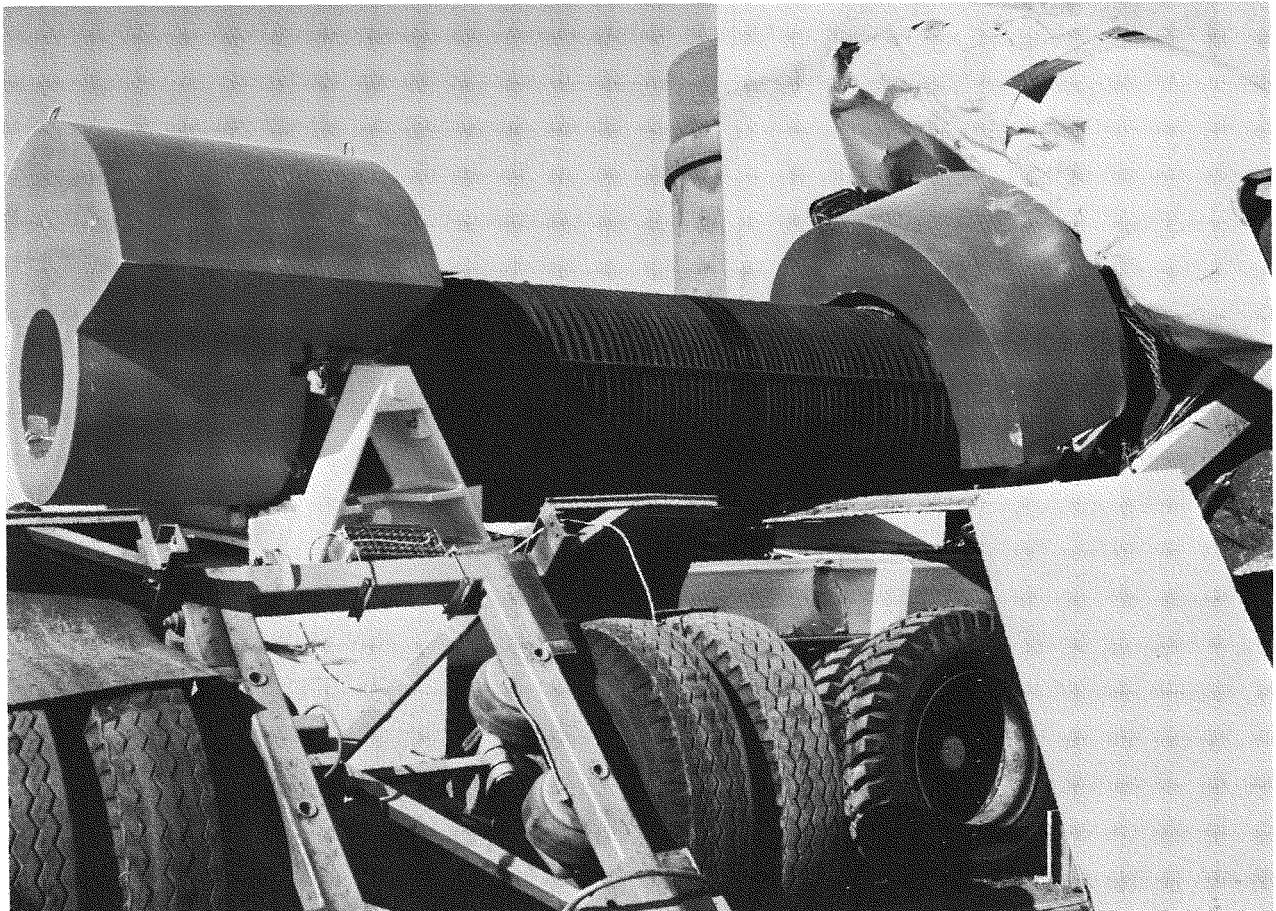
6c. Posttest Accident Views - 100 kph Test

Figure 6c shows the posttest condition of the cask and transport system. The cask remained intact, sustaining only

superficial damage to the external fins and piping. Instrumentation near the cask head indicated strains below the yield strength of the material. Rigid body accelerations on the cask were about 20 g's. The cask head was easily removed, and the fuel assembly was found to be intact and undamaged.

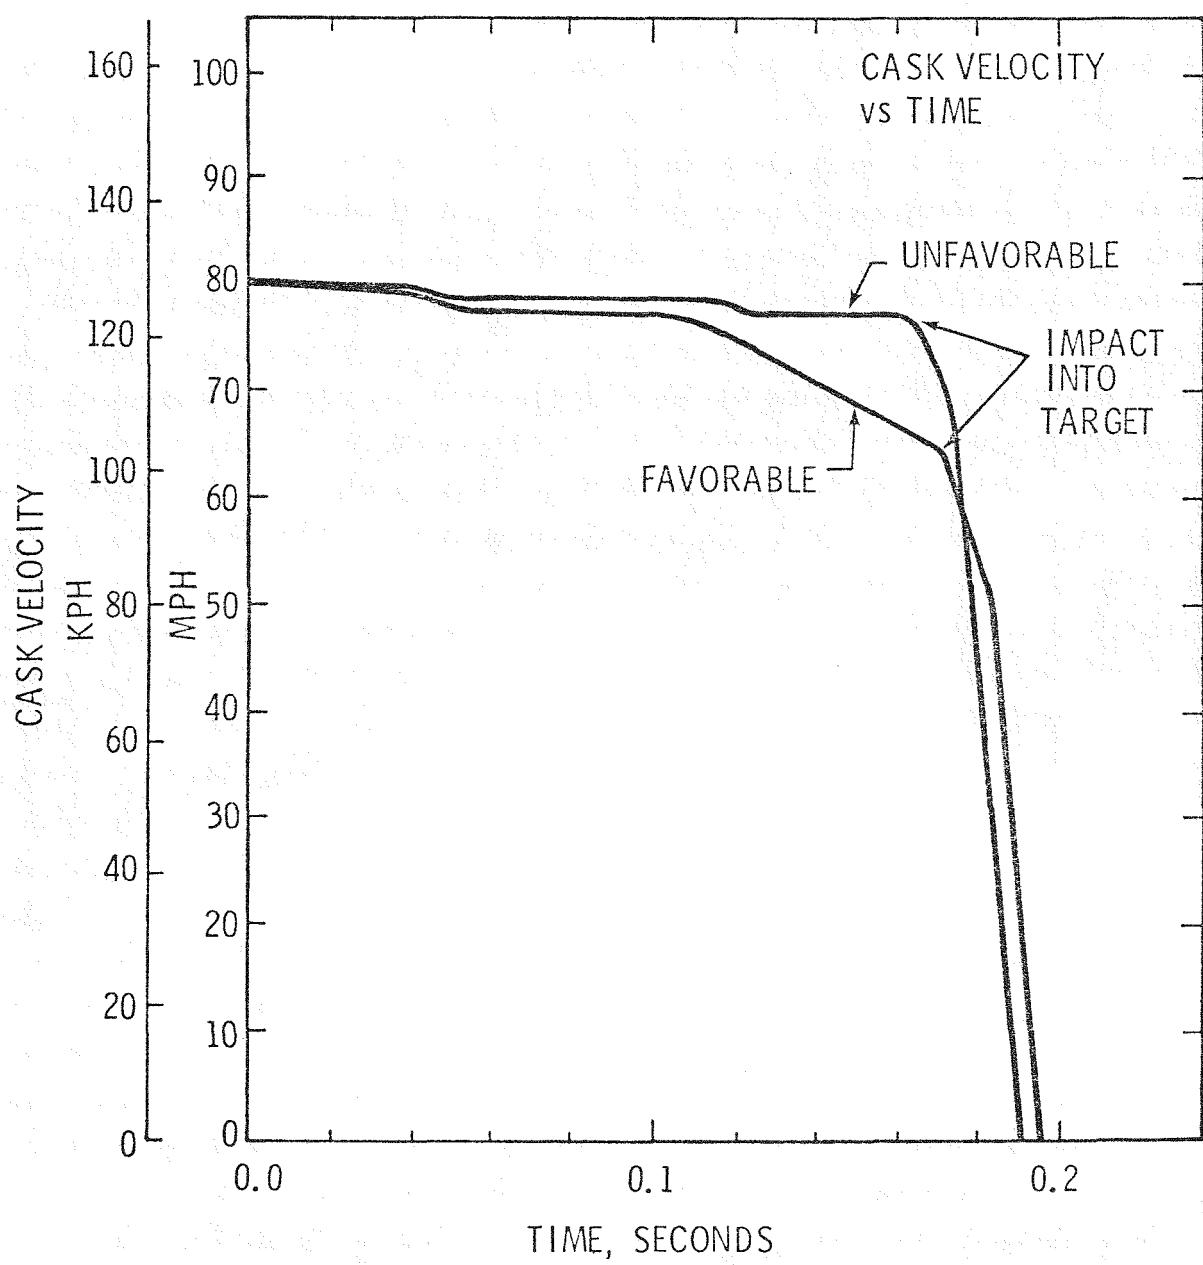
Figure 8. Pretest SHOCK comparison - 130 kph test.

Analyses -- For the second test, the same lumped-parameter SHOCK model was used to calculate the transport system response with a higher initial velocity (130 kph). Again, the tiedown parameters in the model were varied to obtain information for a range of system response. Figure 8 shows the favorable and unfavorable system response calculated by the SHOCK model (11). Note that the curves for the two responses are not widely separated as in the first case. This indicates that the system completely expends its capability to absorb kinetic energy during crushup even in the favorable case. The influence of the tiedown structure would, therefore, have less effect in this test with the predicted impact velocity of the cask into the wall varying from 105 to 122 kph. Since the structure of the trailer was identical to that of the trailer used in the 100 kph test, it was assumed that the tiedown response would be similar; that

is, the tiedowns would follow the favorable response curve and the impact velocity of the cask would be approximately 105 kph.

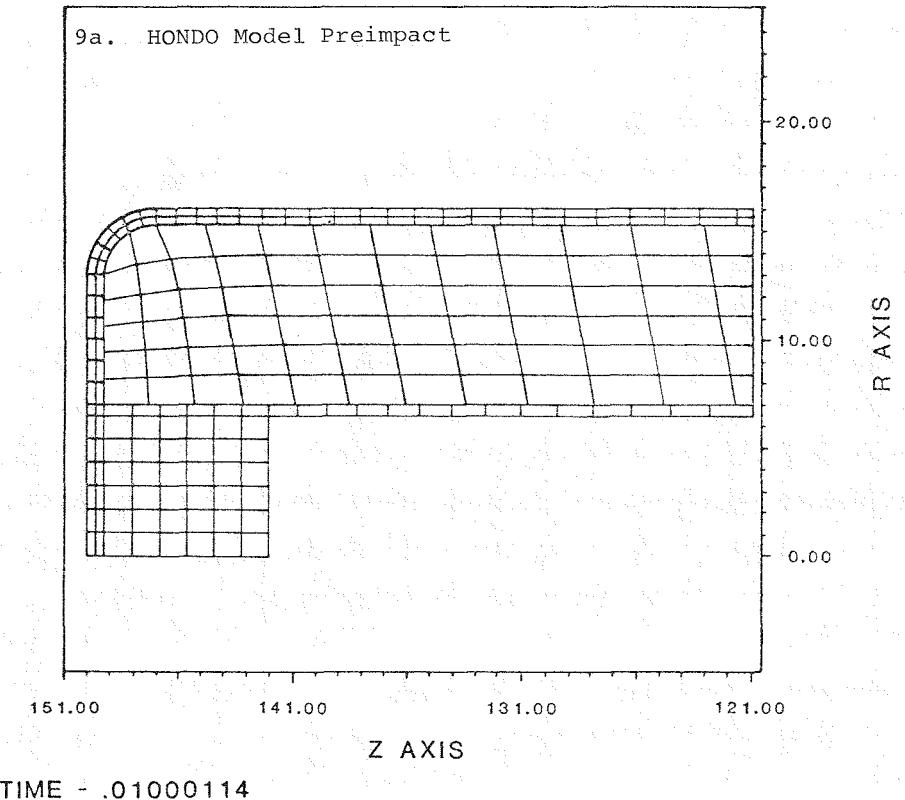
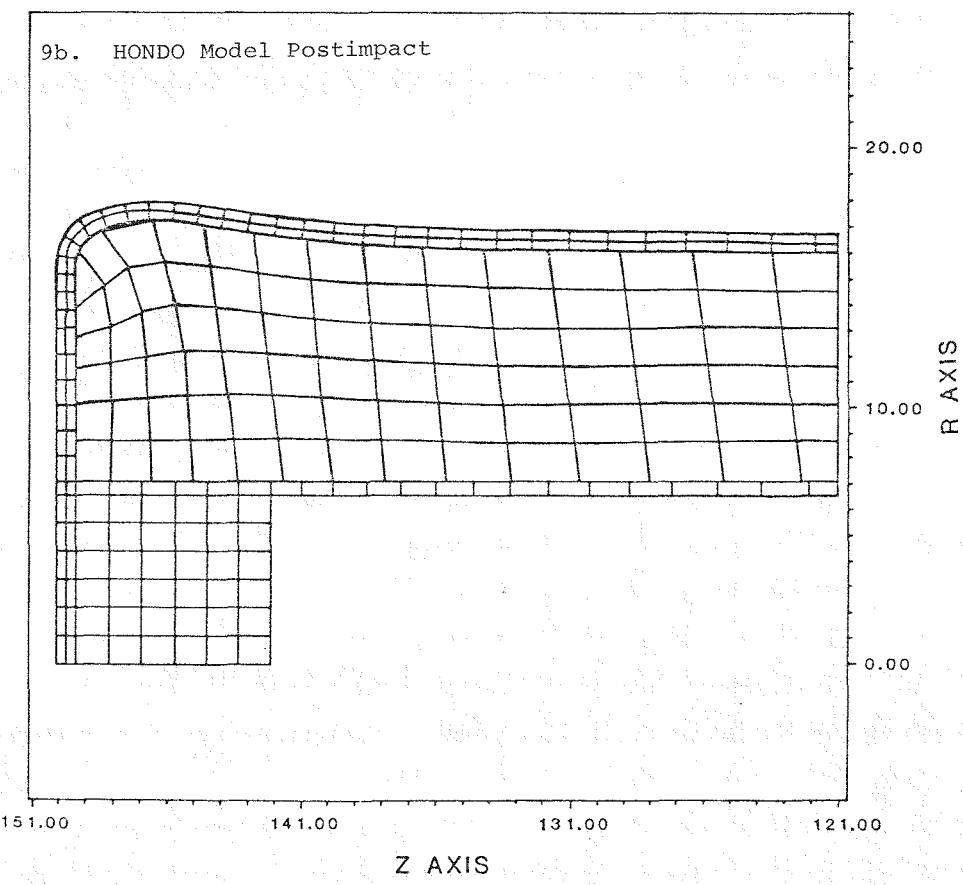
Figure 9. HONDO model.

Figure 9a shows a finite-element model of the test cask before impact into an unyielding surface (11). Both the outer and inner steel shells are modeled with small elements. The lead, shown between the steel shells, has coarser elements. Figure 9b shows the test cask after a 105 kph impact. Although there is significant bulging of the impacted end, static analysis of the cask-head closure bolts indicated that the bolts would not fail. It was also predicted that the deformations might be severe enough to the head to cause minor seepage of fluid from within the container.

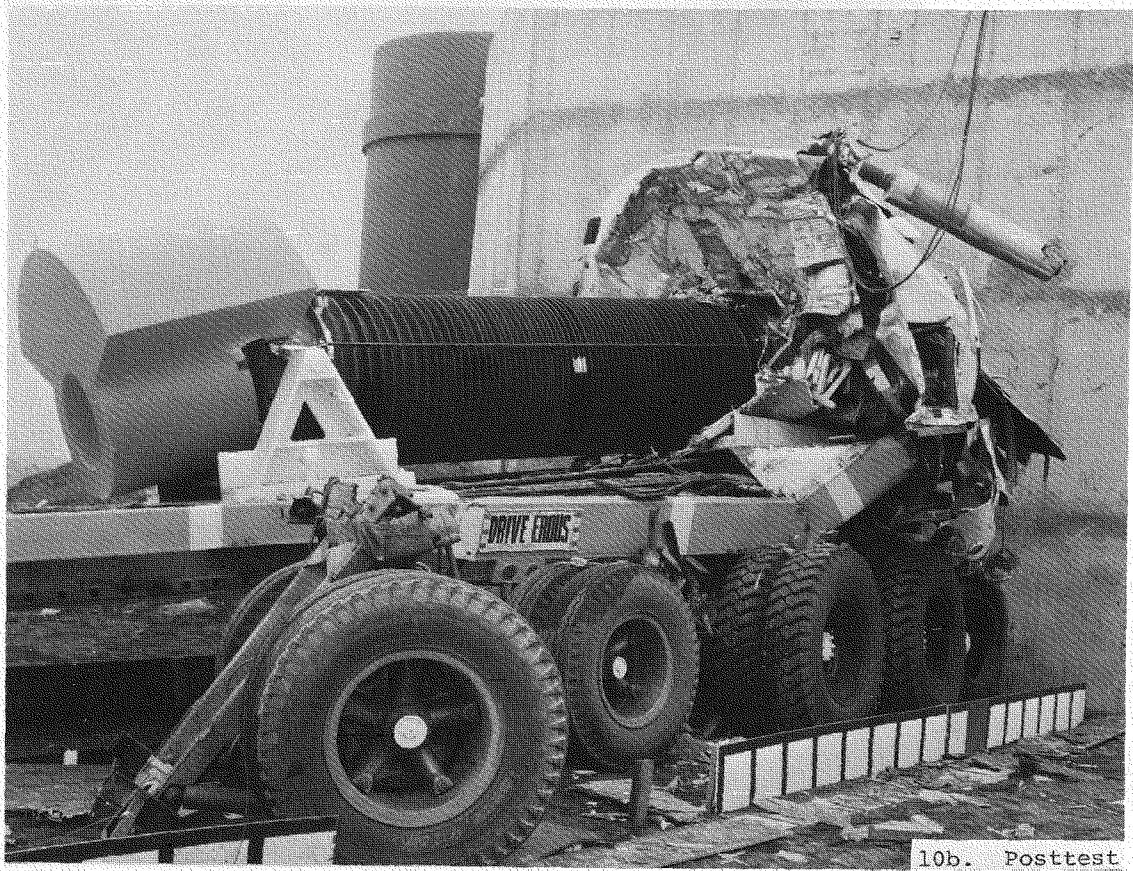
10b. Posttest

Figure 10b shows the condition of the cask and transport system after the second test. After removal of the cask from the trailer, seepage at a rate of about two drops per minute was detected from the cask head. The seepage later stopped after releasing about 100 cc of fluid. Inspection of the cask revealed that the head was peened onto the cask and that the front of the cask had bulged. Several dents found on the surface of the cask head (Figure 10c) were caused by the impact of the trailer fifth wheel pin, which was forced in front of the cask by buckling of the trailer. Slight bending of the front portion of the cask occurred due to nonsymmetric impact conditions. As predicted, the front portion of the cask was permanently deformed (bulged). Rigid body accelerations measured on the cask were about 70 g's (11). The cask head was removed with great difficulty after which inspection of the fuel assembly revealed deformation of

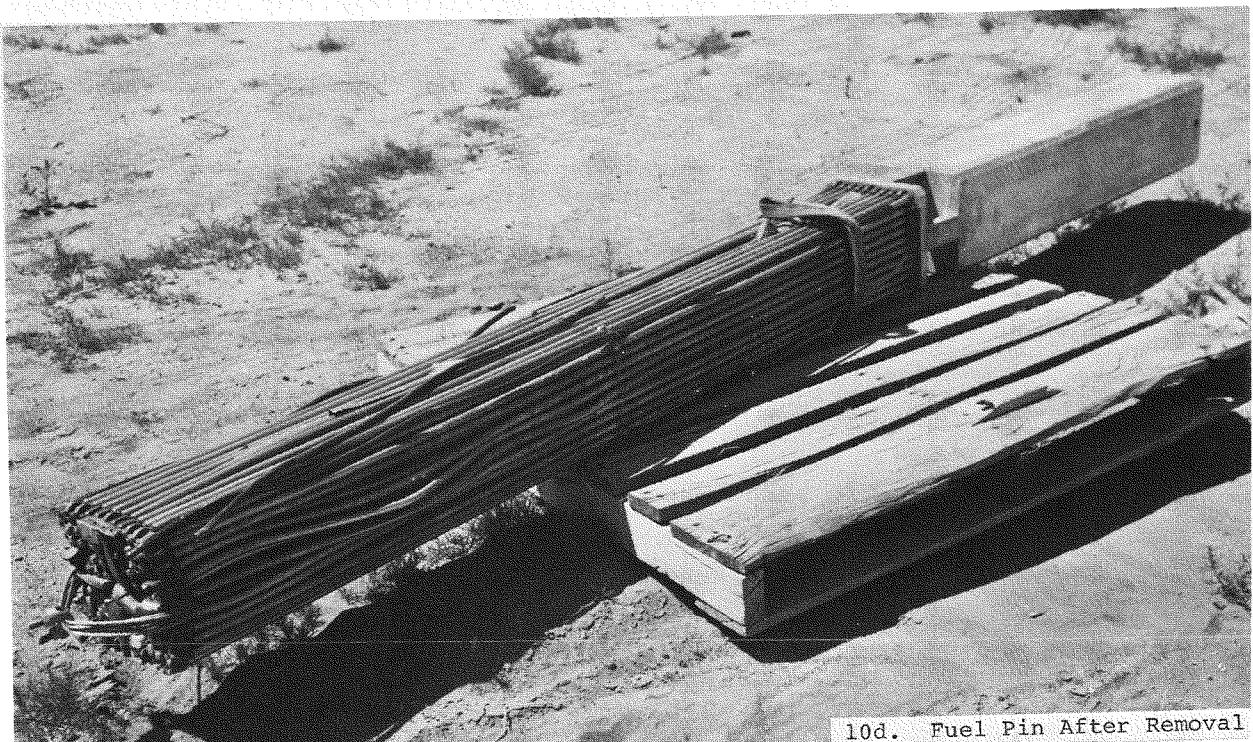
10d. Fuel Pin After Removal

the impact end. Some fuel-pin buckling occurred as shown in Figure 10d; however, no clad failure was detected.

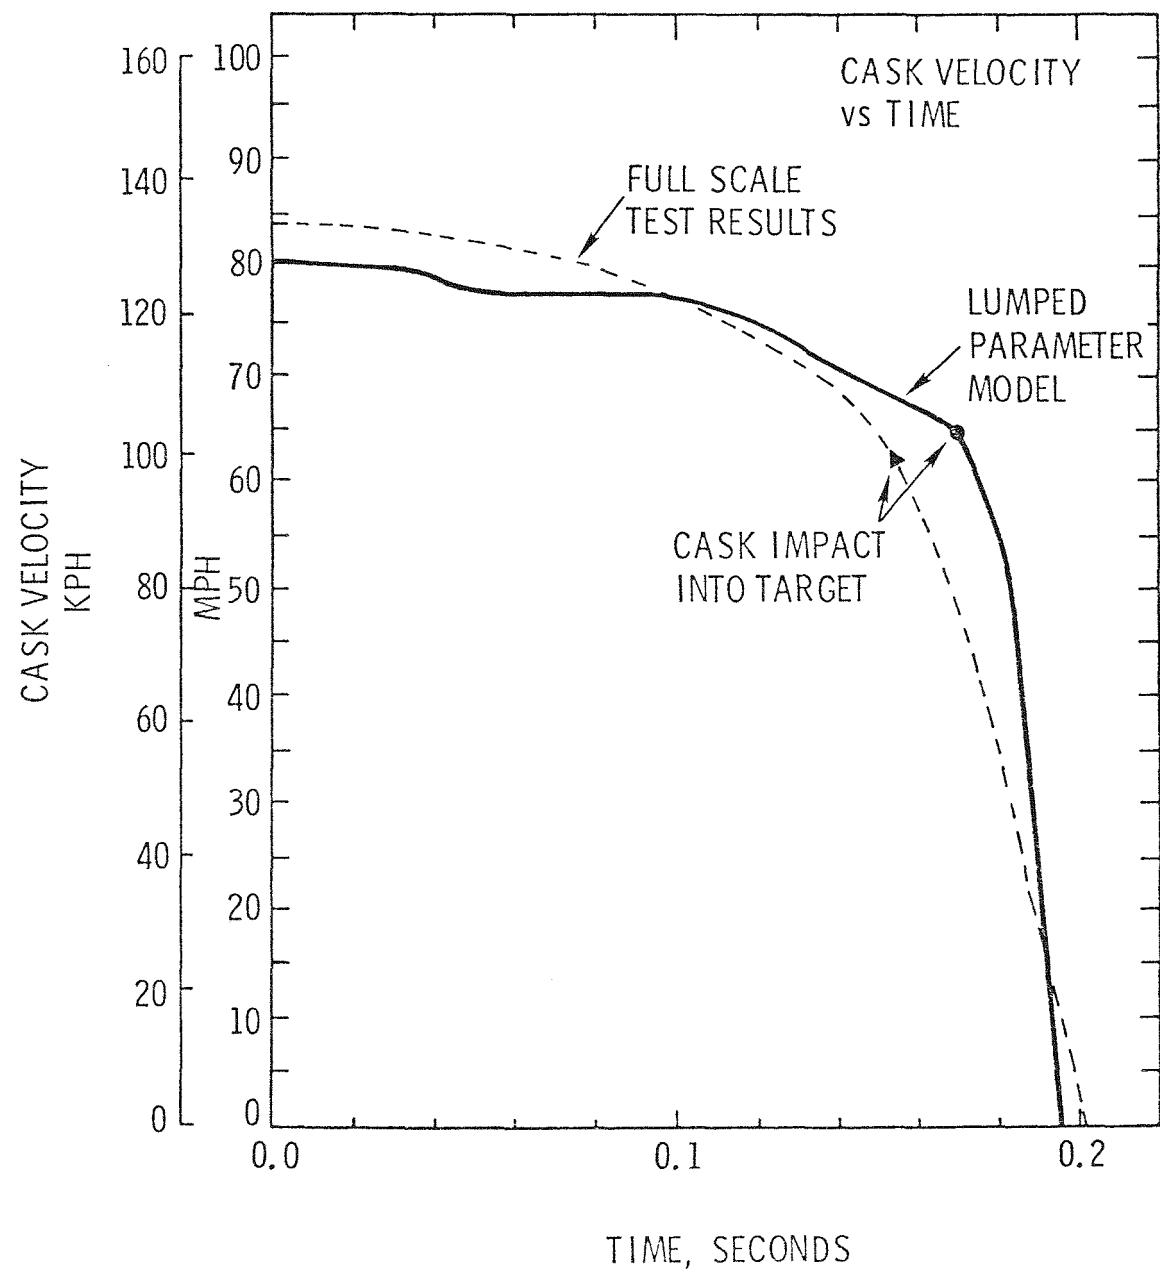
Figure 11. Comparison of analytical and full scale results.

Analyses -- An analytical investigation of a grade-crossing accident involving the 130 kph impact of a 186 metric ton locomotive into a 22.7 metric ton spent fuel cask at a grade crossing was performed as the first step in this portion of the program (12). In this analysis, various configurations were evaluated. The first involved a superstructure impact in which the frame of the locomotive passes beneath the cask. Results of this analysis indicated that cask damage would be limited to minor deformations from impact with the engine-alternator unit of the locomotive. The second configuration involved a full-frame centerline impact between the cask and locomotive. This impact condition would occur only if the cask is placed on a lowboy transport trailer which is not used to transport current commercial spent fuel casks. This analysis indicated that the cask would be moderately deformed after a centerline impact with the locomotive frame.

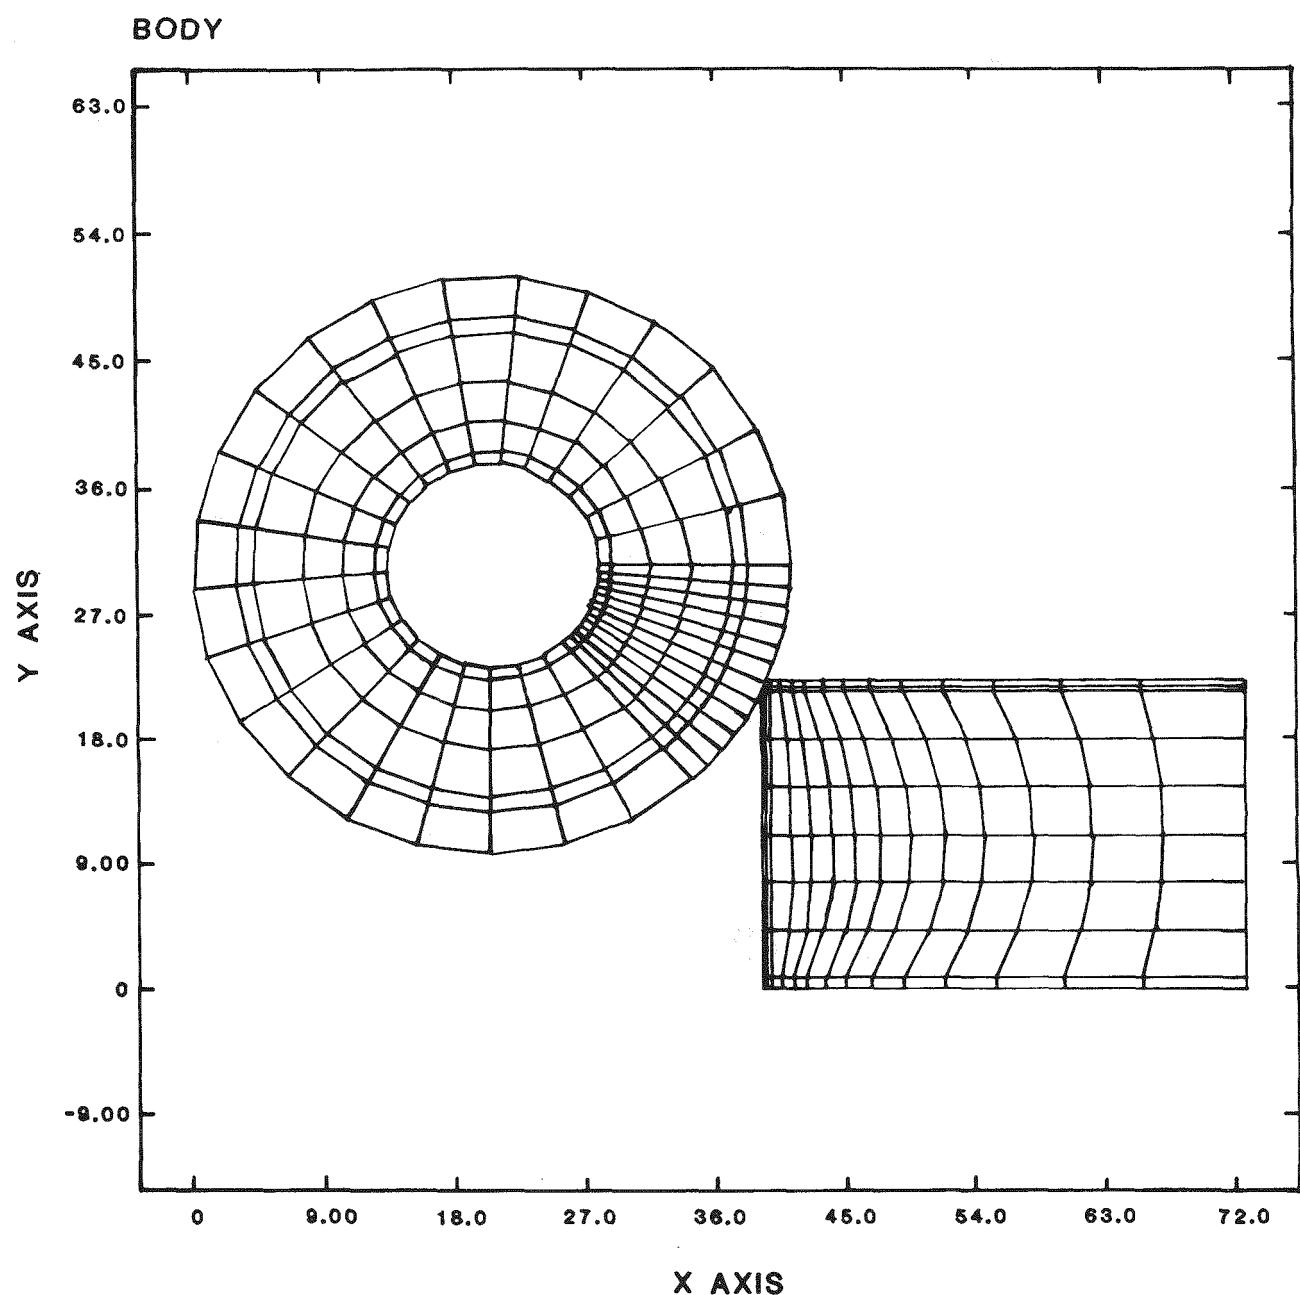
Figure 12. HONDO model.

The major thrust of the remainder of the analysis involved using the finite-element HONDO code. The frame and cask impact condition is depicted in Figure 12. The HONDO model indicated that the twin I-beams of the frame would be crippled and form a ramp, causing the cask to be lifted into the superstructure. Once into the superstructure, the forces acting upon the cask would be limited by crush-up of the thin structural shell of the locomotive. Since the impact forces generated by the frame would be limited by crippling of the I-beam members, the effect of increasing locomotive or train mass would be negligible in increasing damage to the cask.

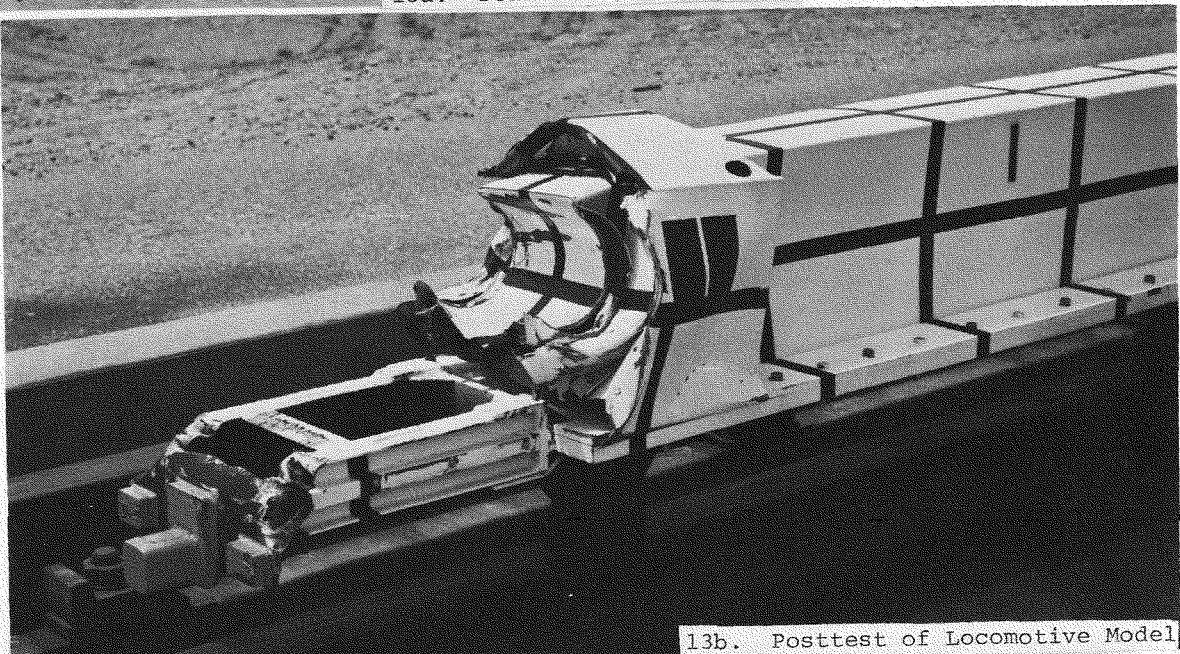
13b. Posttest of Locomotive Model

predicted by the analyses, the I-beam section of the frame failed by buckling to form a ramp that lifted the cask into the superstructure (Figure 13b). Posttest inspection of cask damage showed that the fins were scraped away by the frame and that two 2.5 mm depressions were formed at the point of impact with the I-beams (Figure 13c) but the cask shell was not ruptured.

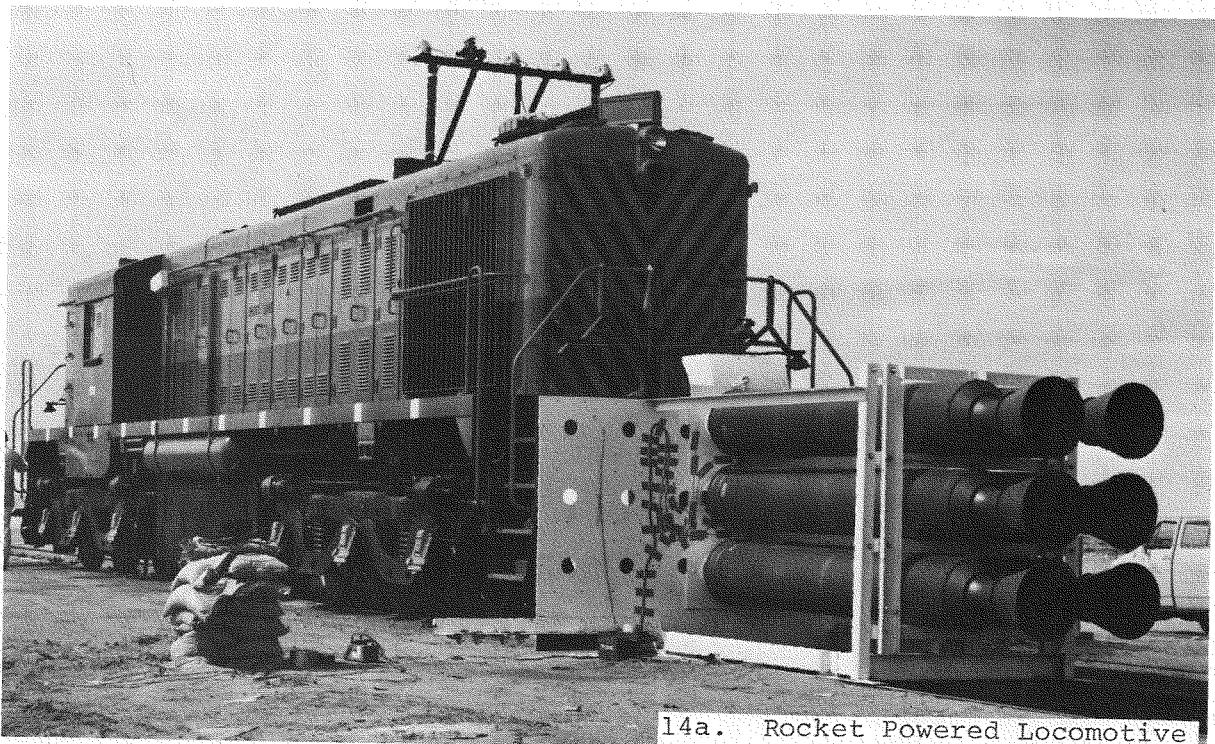
14a. Rocket Powered Locomotive

Full Scale Test -- The locomotive grade-crossing test was conducted on April 24, 1977. The test cask was loaded with a fresh Savannah Core II Fuel assembly. Rockets accelerated the 109 metric ton locomotive to test speed (Figure 14a) after which it coasted to an impact at 131 kph. As predicted by pre-test analysis and scale model test results, the frame of the locomotive was crippled forming a ramp, which allowed the cask to rise into the superstructure (Figure 14b). As shown in Figure 14c, failure of the locomotive frame closely resembled that in the model test. After superstructure crush-up, the cask rolled off to the right side of the locomotive, tumbled in the dirt, and came to rest between the rails. Posttest inspection of the cask indicated that the deformation behavior of the cask was very similar to that of the scale model. Two 26 mm depressions which were caused by the impact with the I-beam members of the frame were left on the surface of the cask. Leak testing of the cask after impact indicated a small leak in the head seal, when the cask was pressurized. This leakage, had the cask contained water, would have cause essentially no risk to the public. The cask head was removed without
