Crash Testing of Nuclear Fuel Shipping Containers

Robert M. Jefferson, H. Richard Yoshimura

CRASH TESTING OF NUCLEAR FUEL SHIPPING CONTAINERS*

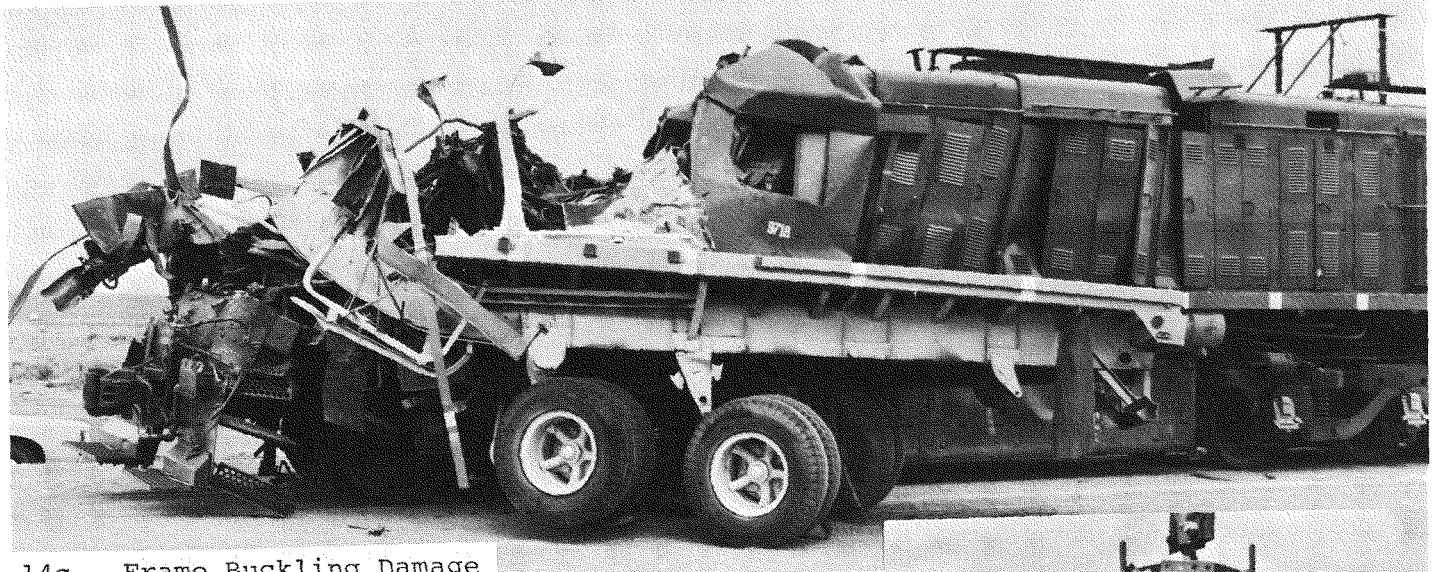
14c. Frame Buckling Damage

Full Scale Test -- The locomotive grade-crossing test was conducted on April 24, 1977. The test cask was loaded with a fresh Savannah Core II Fuel assembly. Rockets accelerated the 109 metric ton locomotive to test speed (Figure 14a) after which it coasted to an impact at 131 kph. As predicted by pre-test analysis and scale model test results, the frame of the locomotive was crippled forming a ramp, which allowed the cask to rise into the superstructure (Figure 14b). As shown in Figure 14c, failure of the locomotive frame closely resembled that in the model test. After superstructure crush-up, the cask rolled off to the right side of the locomotive, tumbled in the dirt, and came to rest between the rails. Posttest inspection of the cask indicated that the deformation behavior of the cask was very similar to that of the scale model. Two 26 mm depressions which were caused by the impact with the I-beam members of the frame were left on the surface of the cask. Leak testing of the cask after impact indicated a small leak in the head seal, when the cask was pressurized. This leakage, had the cask contained water, would have cause essentially no risk to the public. The cask head was removed without

Comparison of the damage to the cask and locomotive indicated that the overall response of the full scale test agreed with pretest analytical and scale model predictions.

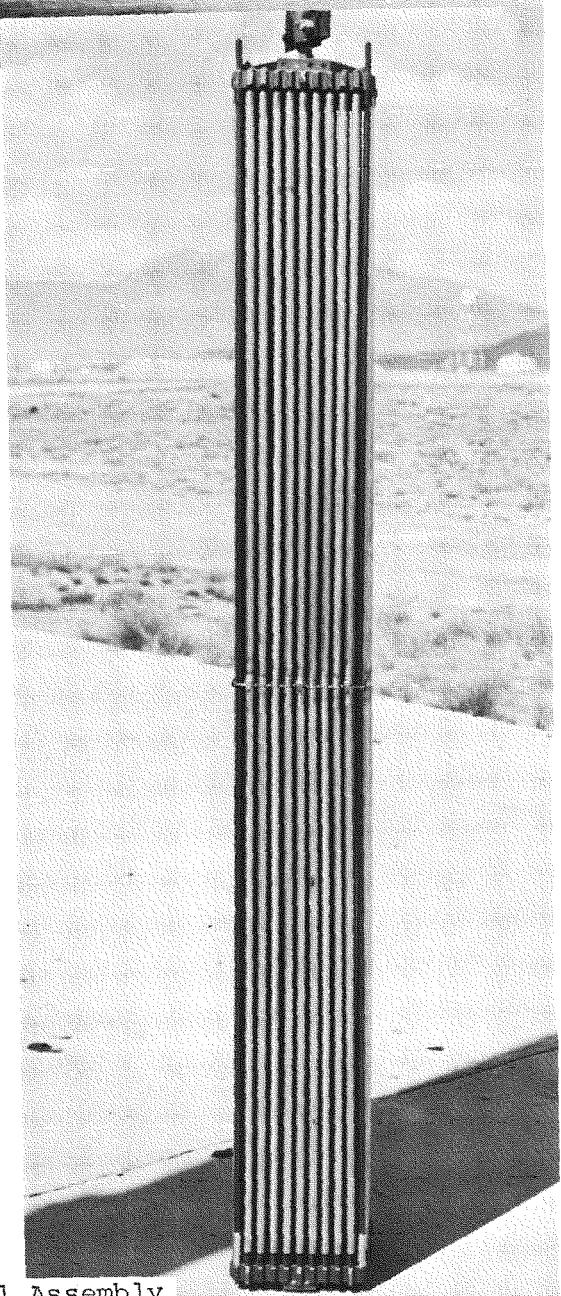
14d. Posttest Fuel Assembly

There was some bowing of the fuel pins as shown in Figure 14d; however, no clad failure was detected.
