TREE-NUREG-1173

**EXPERIMENT DATA REPORT
IFA-226 POSTIRRADIATION
EXAMINATION**

September 1977

One such experiment was instrumented fuel Assembly 226 (IFA-226) irradiated in the HBWR from November 1971 through September 1975. IFA-226 contained twelve, mixed plutonium-uranium oxide fuel rods arranged in two, six-rod clusters. The assembly was designed to study fuel-cladding mechanical interaction, fuel thermal response, and fission gas release as a function of fuel density, initial fuel-to-cladding gap, rod power, and burnup. Data were obtained from fuel rod centerline thermocouples, fission gas pressure transducers, and cladding elongation sensors.

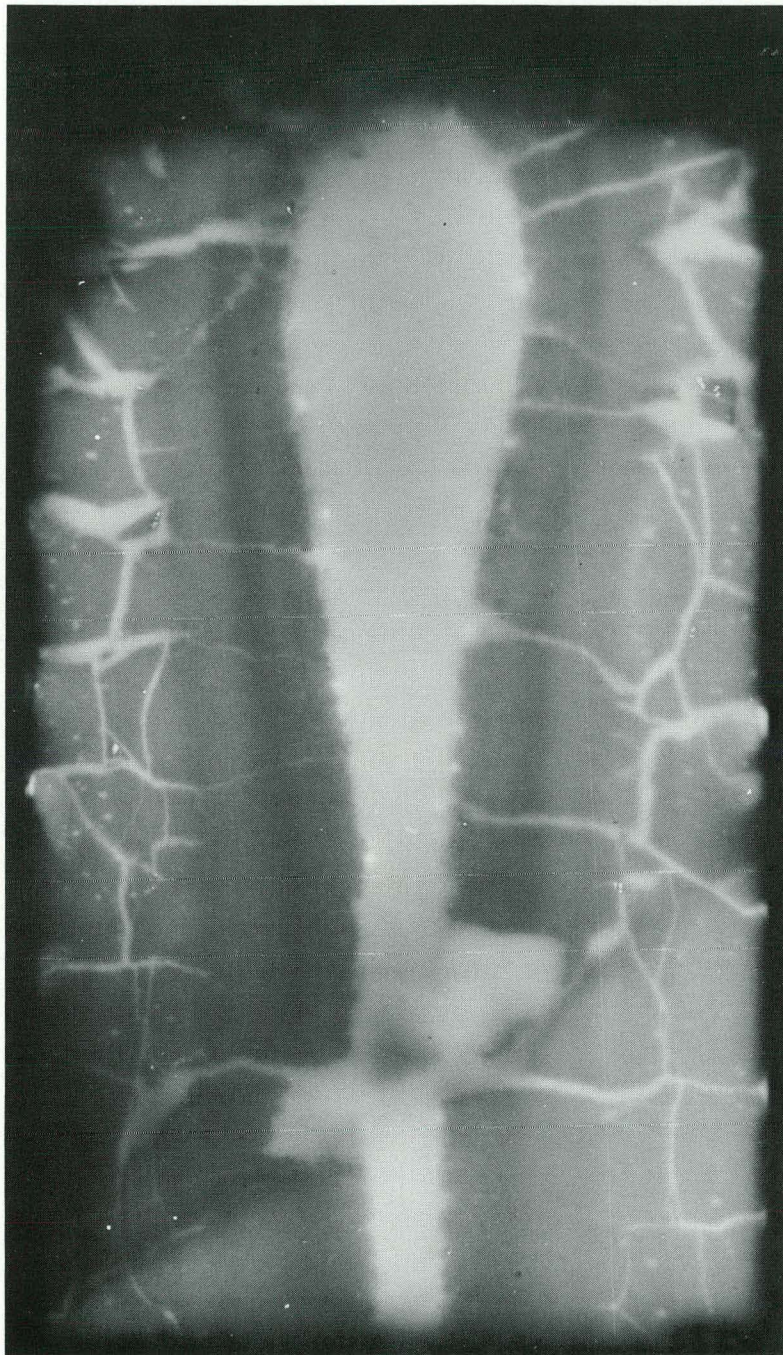
Fig. 120, β/γ -auto., polished

The black shadow seen in the β/γ -autoradiographs - figs. 120-121, and the sharply defined missing fuel in the etched α -autoradiograph - fig. 119 are the result of an underlying trace of an erroneous cutting.

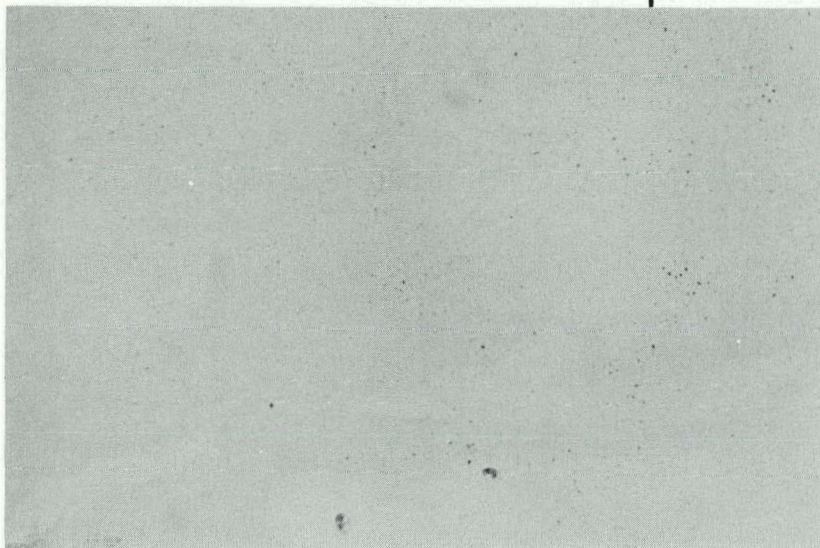
Fig. 140 Polished, X 400

The section contains a secondary fuel crack - fig. 128. Three zones in the β/γ -autoradiographs - fig. 131-132 - are seen, as in sample 9-2A. Notice the area with very small pores in fig. 140.

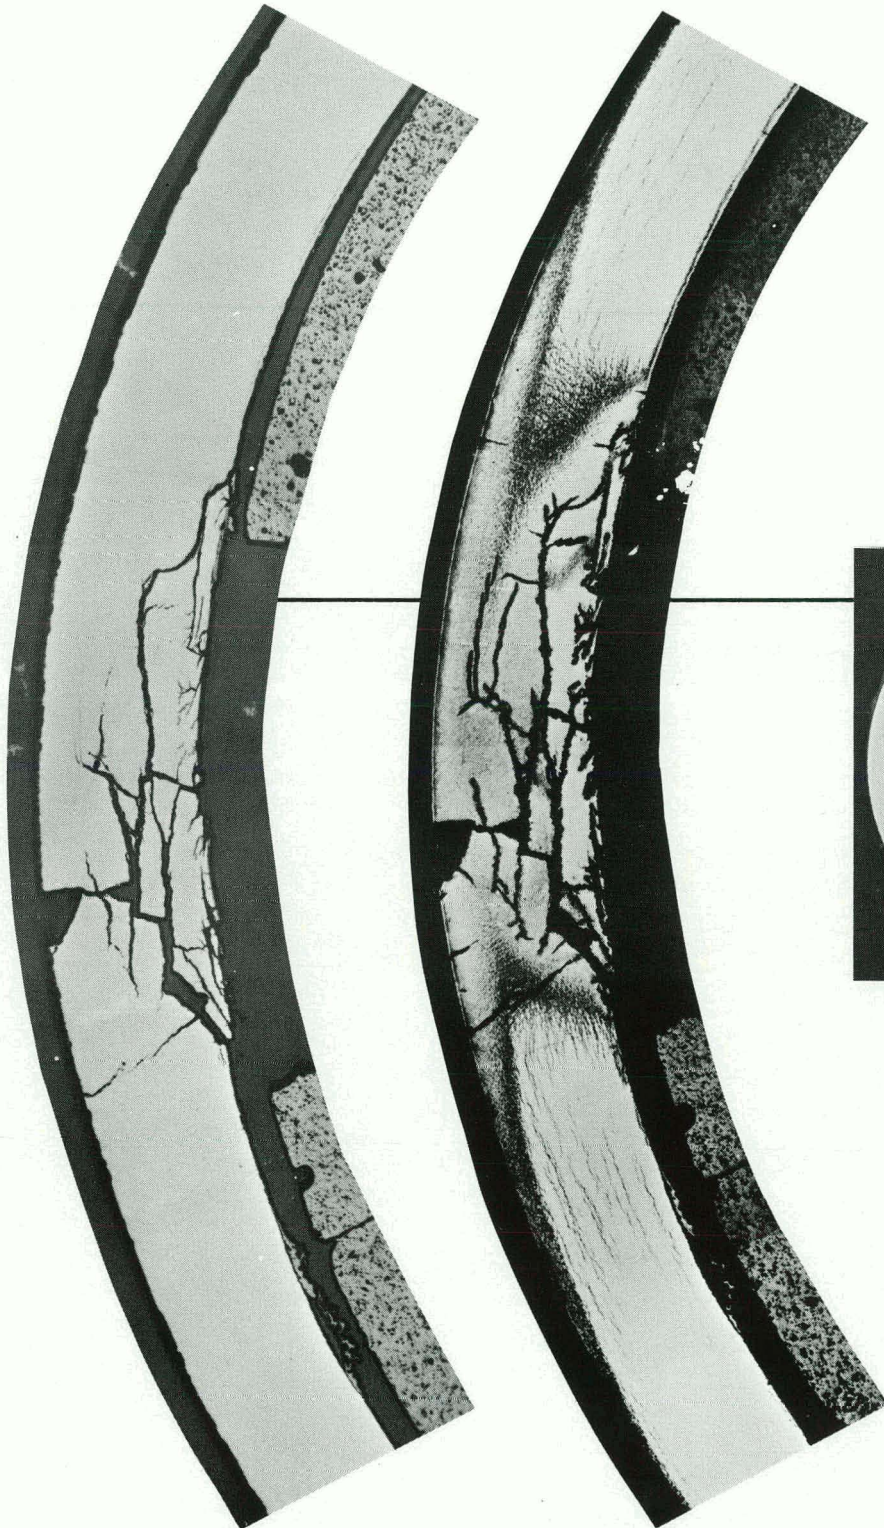
This shows a cladding failure - figs. 249, 250, 263 and 264. Small interactions are seen - figs. 259-260. At two other positions - apart from the failure position - there are zones with hydride concentration or radial hydrides - figs. 257-258. There are layers between fuel and cladding as in sample 11-2-A. Some Pu-concentrations are observed - fig. 256.

Fig. 249 Polished, X 30

Fig. 250 Etched, X 30
