DEMOLITION OF THE WASTE EVAPORATOR FACILITY AT OAK RIDGE NATIONAL LABORATORY

Gerald J. Mandry
Lockheed Martin Energy Systems
P. O. Box 2008
Oak Ridge, Tennessee 37831-6050
(423)576-5557

Chad L. Becker
Allied Technology Group, Inc.
99A Midway Lane
Oak Ridge, Tennessee 37830
(423)482-3275

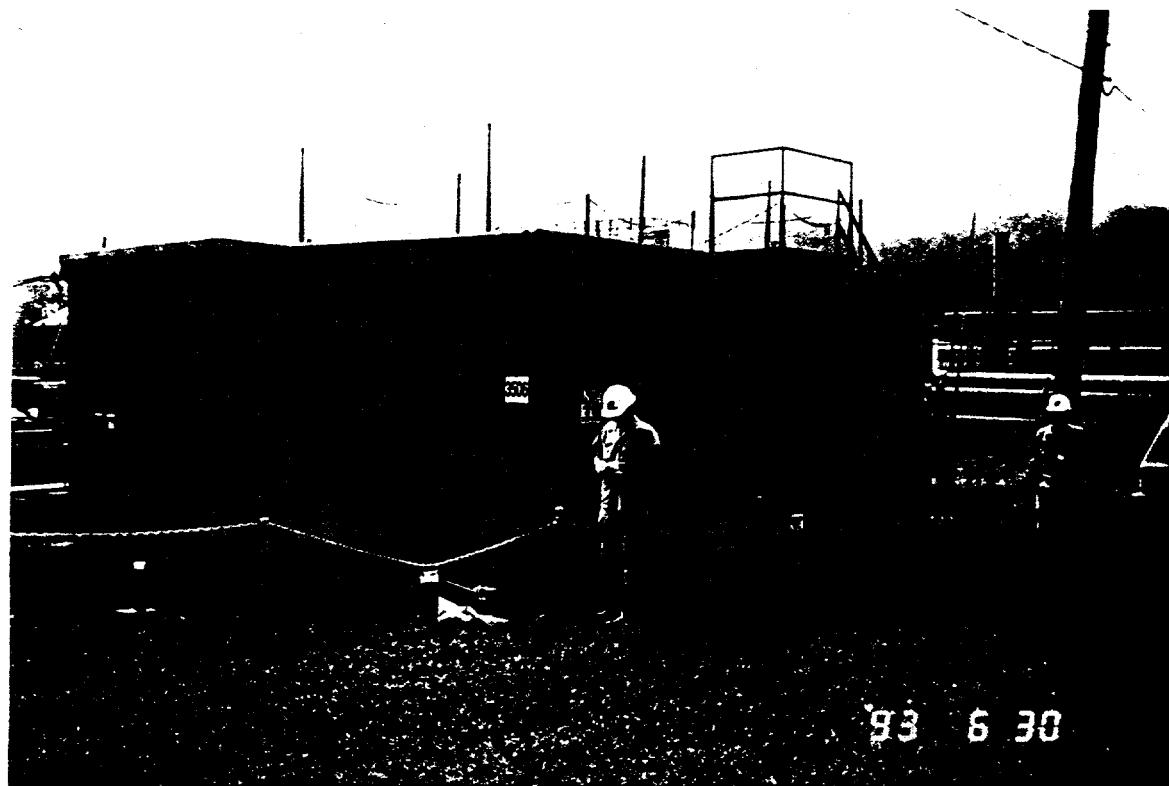
Fig. 1. The Waste Evaporator Facility during the site characterization phase

The WEF was a split-level building with approximate dimensions of 22 x 28 x 11 ft and consisted of an operating gallery and a hot cell. The operating gallery was a wood structure (except for the floor and west wall) with a crawlspace under the floor. The hot cell was a reinforced concrete cell, with 2-ft-thick walls in the north half and 3-ft-thick walls in the south half and contained a stainless-steel floor liner. The hot cell extended 6 ft below ground level. All process equipment had been removed from both the

The WEF was accepted into the Surplus Facilities Management Program in 1976, and periodic surveillance and maintenance had been performed since that time. The building structure was basically sound, although roof repairs were performed because of deterioration due to rainwater infiltration. The interior had been decontaminated before being used in the incineration experiments, resulting in low levels of radioactivity, which were primarily associated with the piping and some surface contamination. The facility was unoccupied and locked, and accessed by personnel only occasionally.

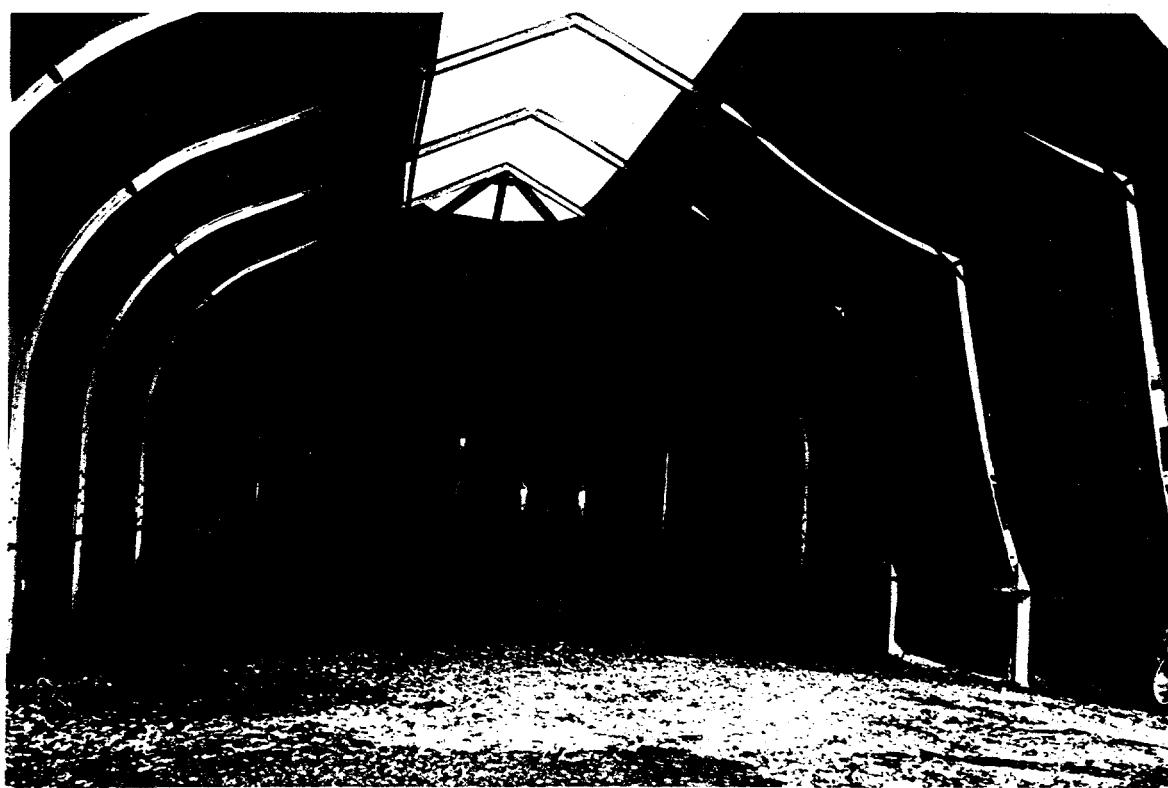
Fig. 4 View of the Waste Evaporator Facility area after completion of site restoration

Site restoration began once the remaining concrete pieces were removed. Final restoration consisted of placing layers of sand, a geomembrane, dirt, and gravel over the below-grade area. The containment tent was left in place to serve as a storage area for the excess blocks, and as a staging area for the adjacent Gunite tank remediation project.
