**<sup>238</sup>Pu FUEL-FORM PROCESSES  
QUARTERLY REPORT**

**JANUARY - MARCH 1982**

**E. I. du Pont de Nemours & Co.  
Savannah River Laboratory  
Aiken, SC 29808**

### **ANALYTICAL STUDIES OF WELD QUENCH CRACKING IN DOP-26 IRIDIUM ALLOY-CLAD VENT SETS**

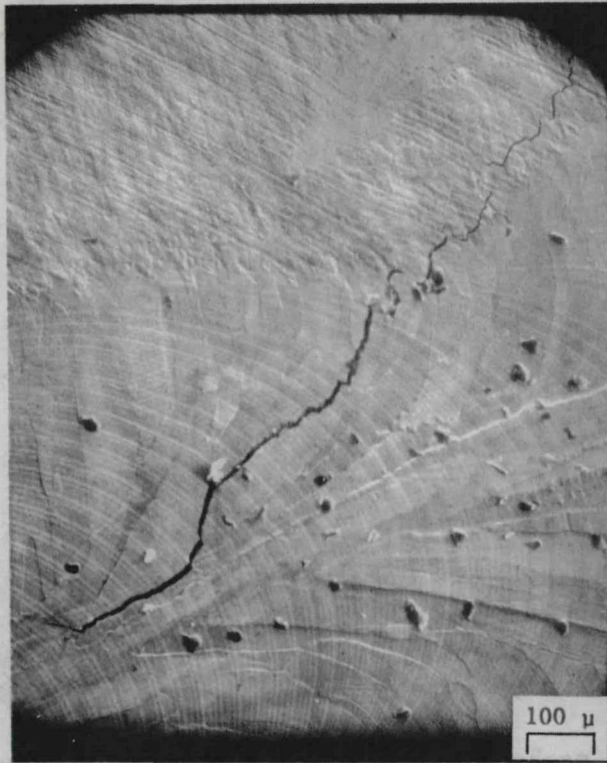
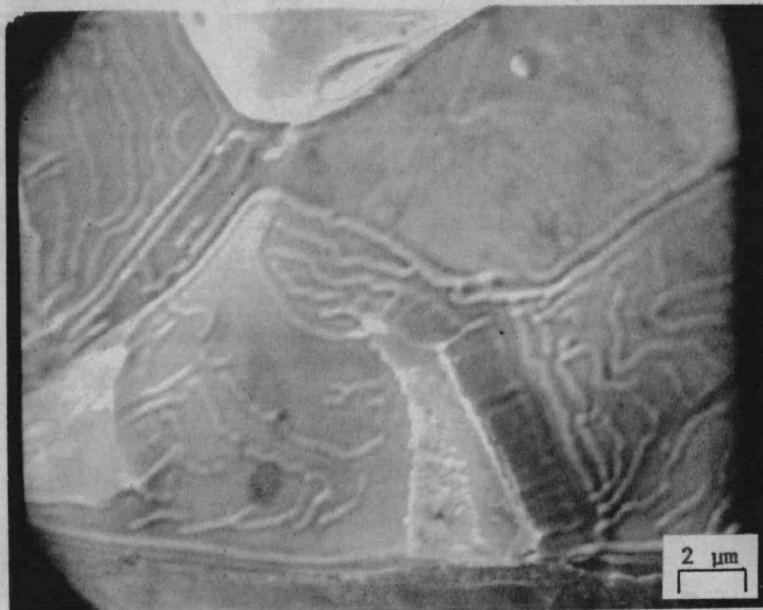
a. Location of crack B

b. Ridge network porosity on grain boundaries in crack

Figure 3. Large Crack B in CVS T25

Several types of cracks were detected on the interior weld bead. Two large cracks extended from near the weld centerline out to the unwelded alloy in the bottom cup beneath the quench taper as shown in Figure 1. Grain-boundary surfaces in these cracks had extended ridge network porosity (Figures 2 and 3). Smaller cracks were detected in alloy welded on the first pass adjacent to alloy rewelded in the overlap region (Figure 4) and in unwelded alloy adjacent to weld (Figure 5).

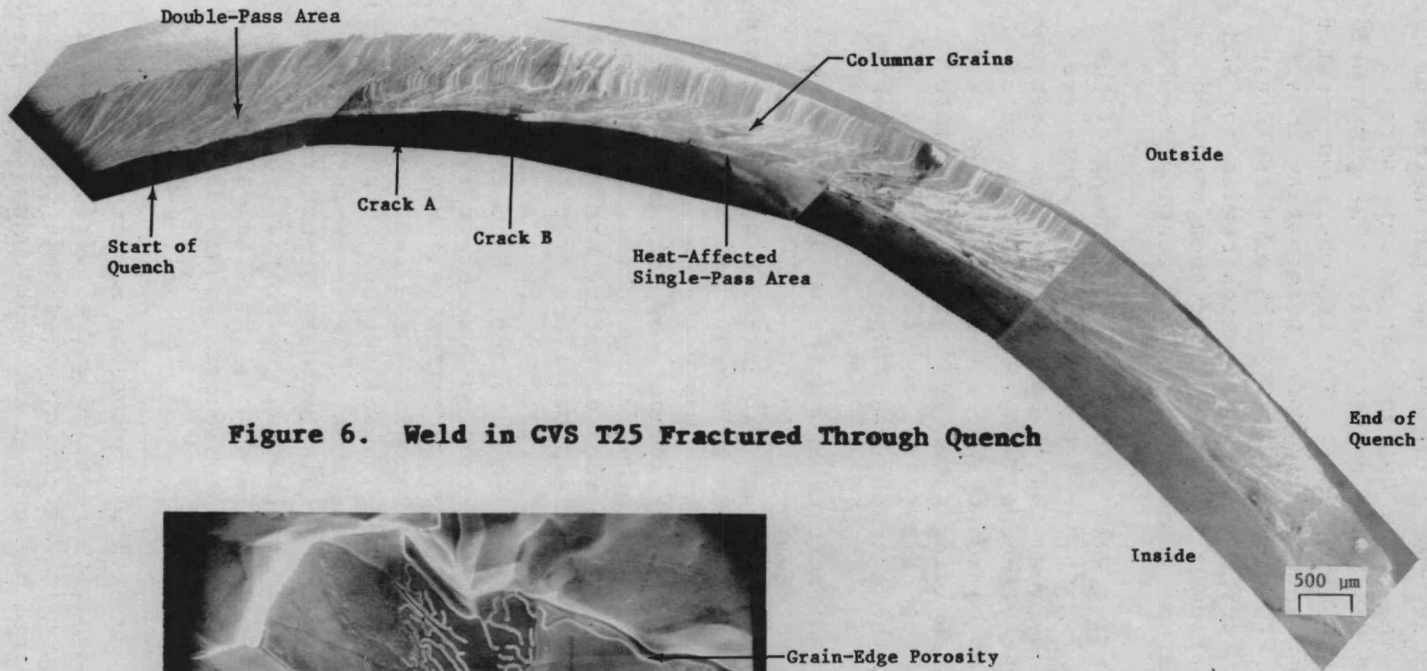
Figure 6. Weld in CVS T25 Fractured Through Quench

The weld was fractured along the centerline through the quench revealing the double-pass weld area (melted twice), the columnar grain region and the heat-affected, single-pass weld area (melted once) as shown in Figure 6. Ridge network porosity on grain faces and another type of porosity along grain edges (Figure 7) were detected only in the heat-affected, single-pass weld area where the large cracks were located.

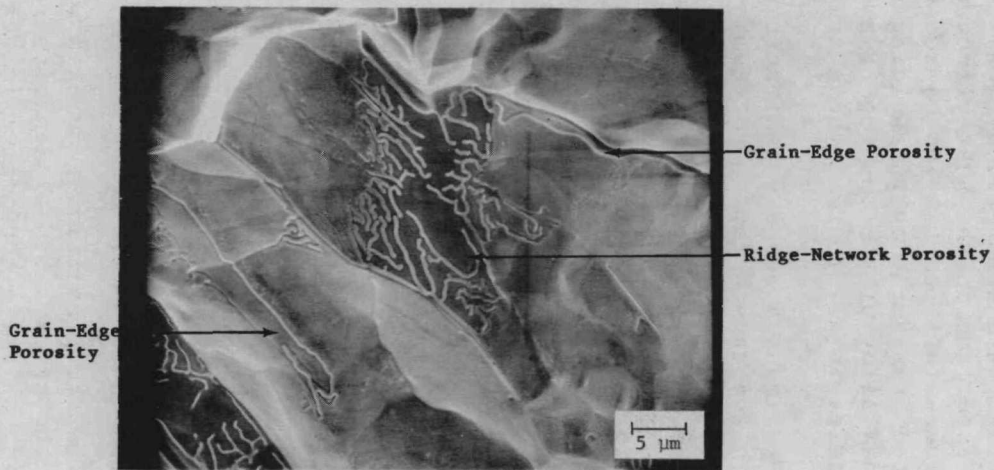
Figure 7. Porosity on Grains Boundaries in Heat-Affected Single-Pass Weld Area Near Cracks A and B

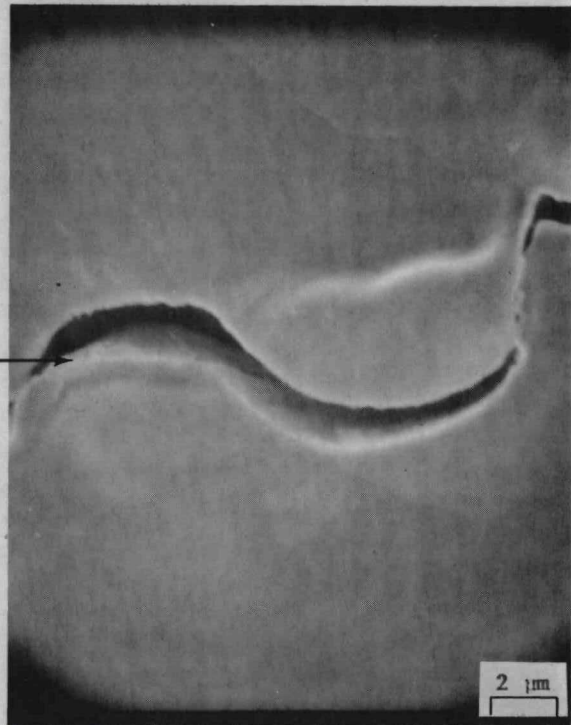
Ridge-Network Porosity  
on Crack Grain Boundary

Figure 9. Small Crack A in CVS T36 Specimen 7

Specimens of the interior weld bead at the beginning of the first quench are shown in Figure 8. Two small cracks where grain boundaries were separated by less than 2  $\mu\text{m}$  were detected near the weld centerline in the heat-affected, single-pass weld ahead of the area where full penetration ceased (Figures 9 and 10). Two cracks oriented transverse to the welding direction extended out into unwelded alloy of the top cup (Figures 11 and 12). Grain boundaries in all four of these cracks had ridge network porosity.

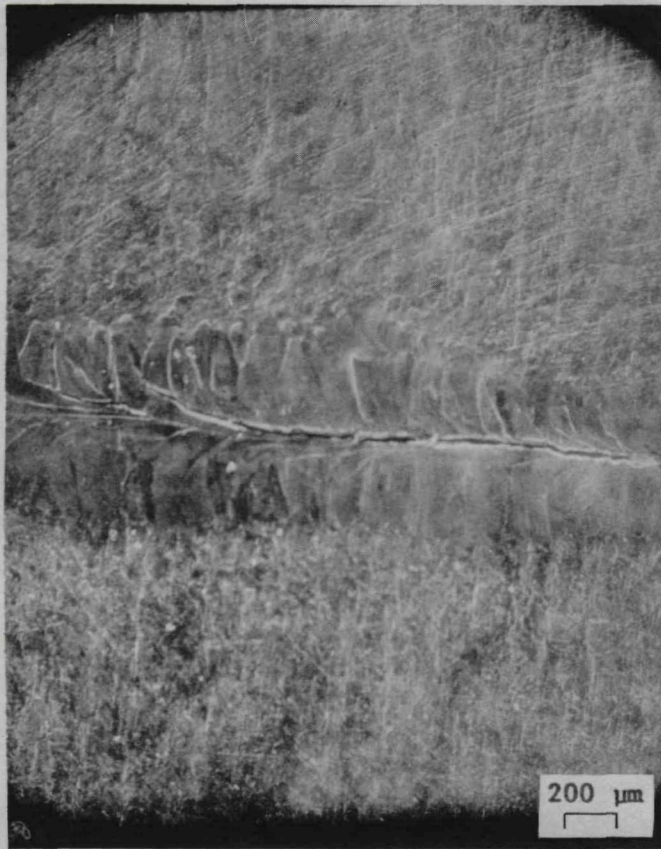
a. Large crack

b. Small iridium grains and ridge network porosity on crack surface

Figure 19. Large Crack Under Short Overlap Weld with Incomplete Penetration on Girth Weld of CVS T39

With two exceptions, the weld quench cracks in CVS T39 (MER alloy) had ridge network porosity distributions similar to those observed in CVS T38. One exception was the second short overlap weld on the girth weld which did not have full penetration and produced a 2000- $\mu\text{m}$ -long crack in the centerline of the single-pass weld beneath the overlap (Figure 19). In addition to ridge network porosity, agglomerates of 5-10  $\mu\text{m}$  iridium particles were detected on the crack surface near the inner edge. The cause of formation of these small iridium particles and whether they influence cracking are uncertain. ORNL has detected similar iridium structures in cup delaminations that intersect the surface.<sup>6</sup>
