**Test of 6-in.-thick Pressure Vessels
Series 3: Intermediate Test Vessel V-7A
Under Sustained Loading**

ORNL/NUREG-9
Dist. Category NRC-5

TEST OF 6-IN.-THICK PRESSURE VESSELS
SERIES 3: INTERMEDIATE TEST VESSEL V-7A
UNDER SUSTAINED LOADING

Prepared by the
OAK RIDGE NATIONAL LABORATORY
Oak Ridge, Tennessee 37830
operated by
UNION CARBIDE CORPORATION
for the
DEPARTMENT OF ENERGY

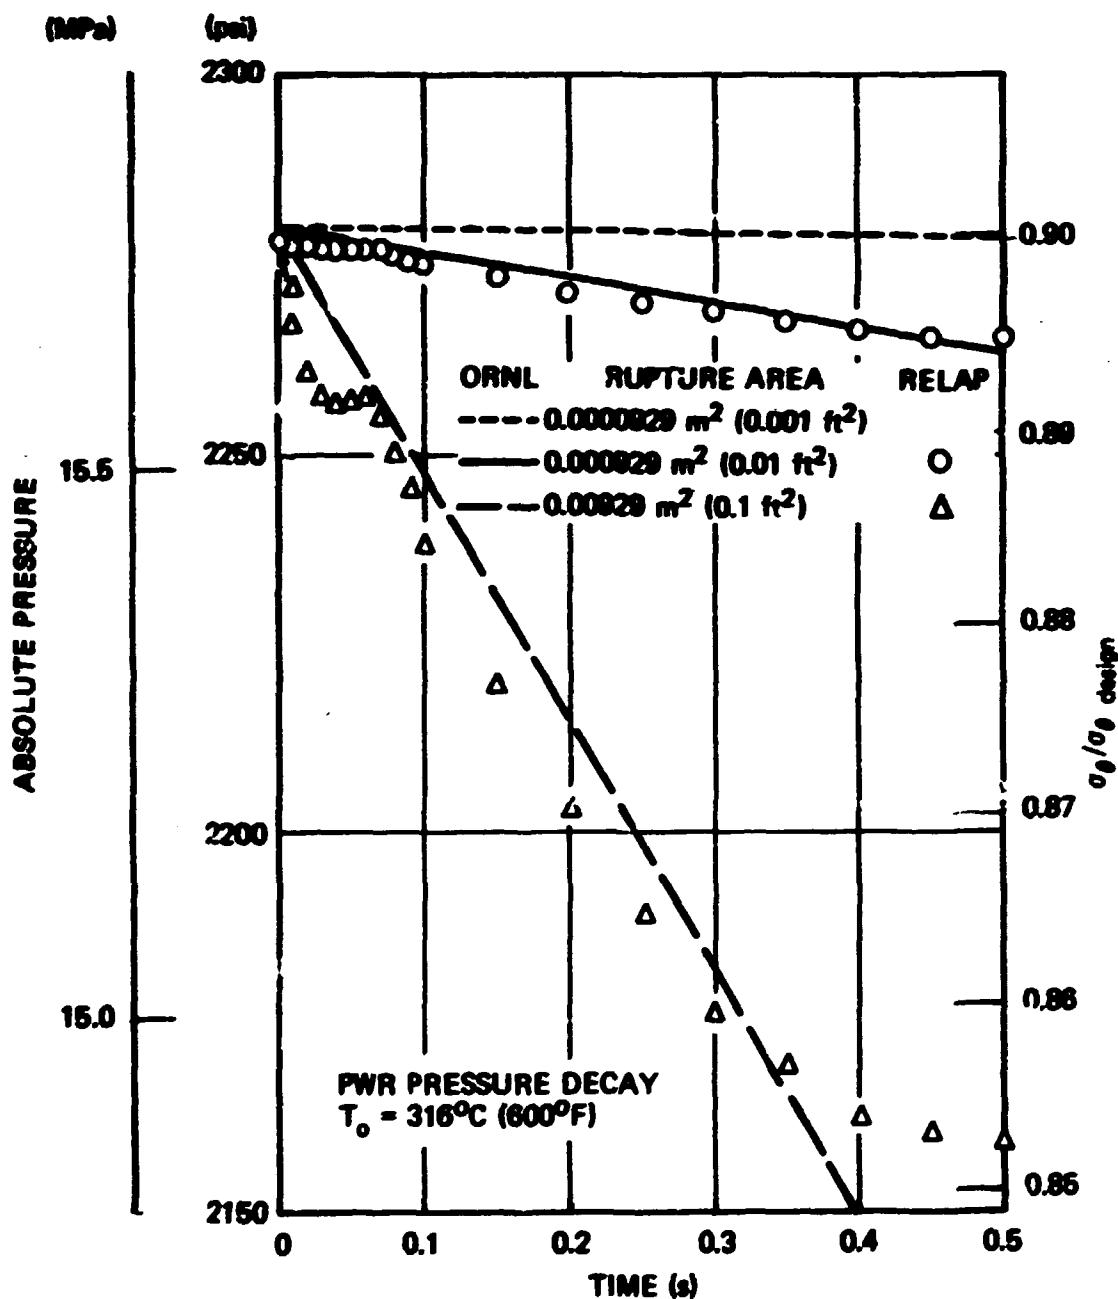
ORNL-DWG 78-2515

Fig. 2.1. Pressure and circumferential stress vs time for a PWR initially under normal operating conditions.

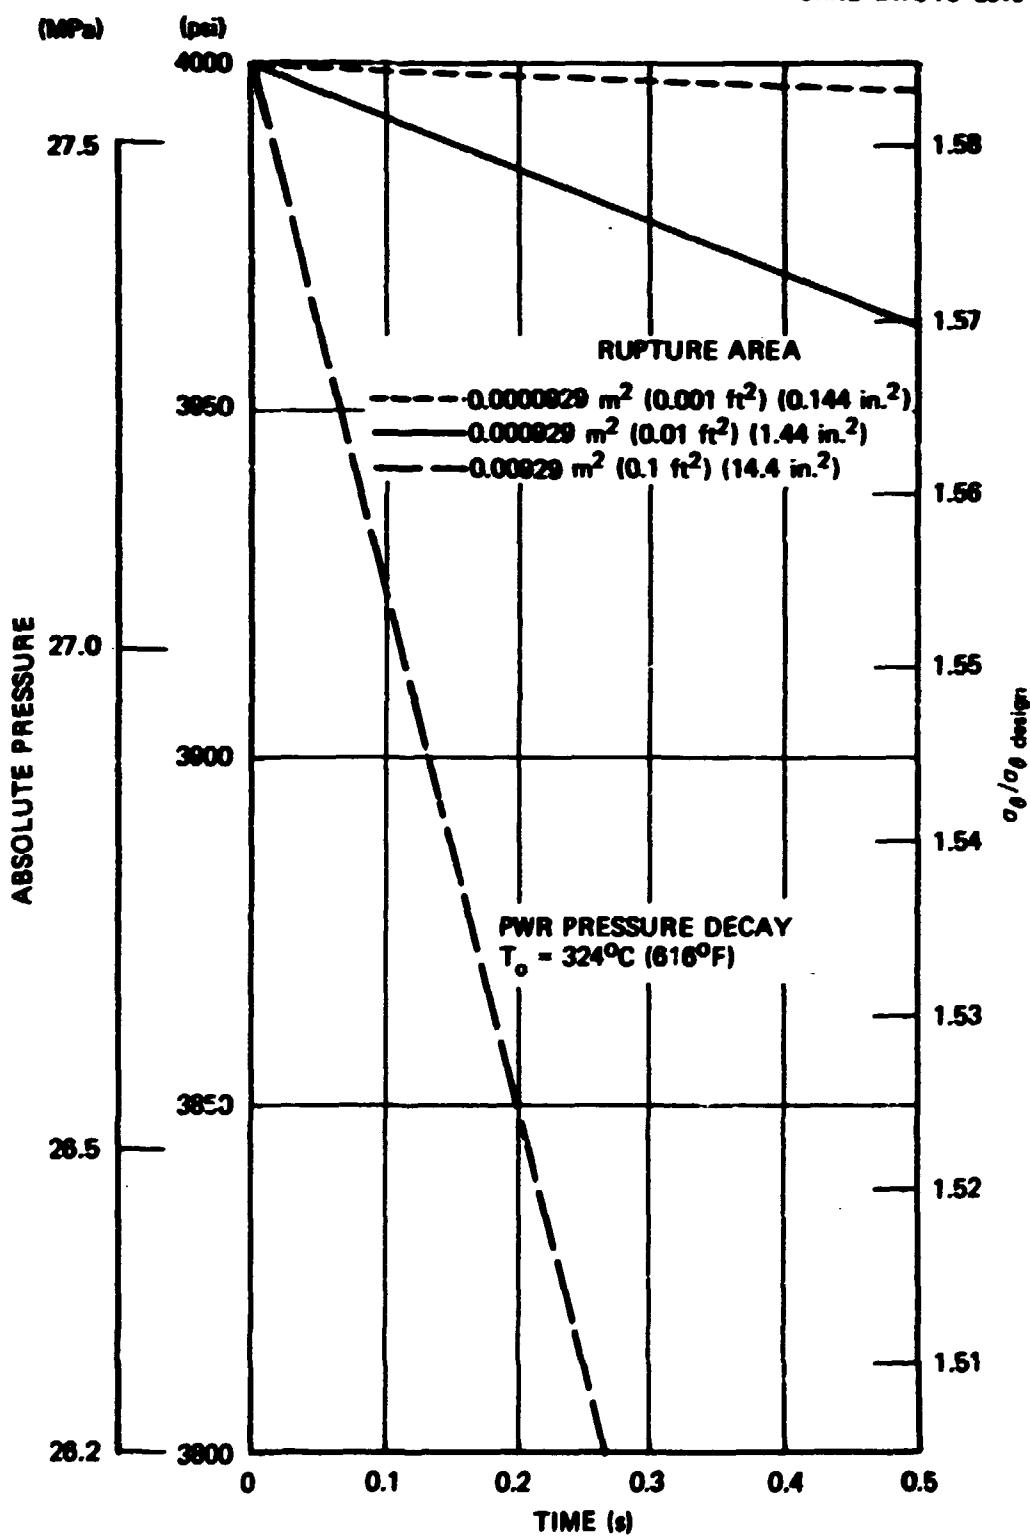
ORNL-DWG 78-2516

Fig. 2.2. Pressure and circumferential stress vs time for a PWR initially under abnormal operating conditions.

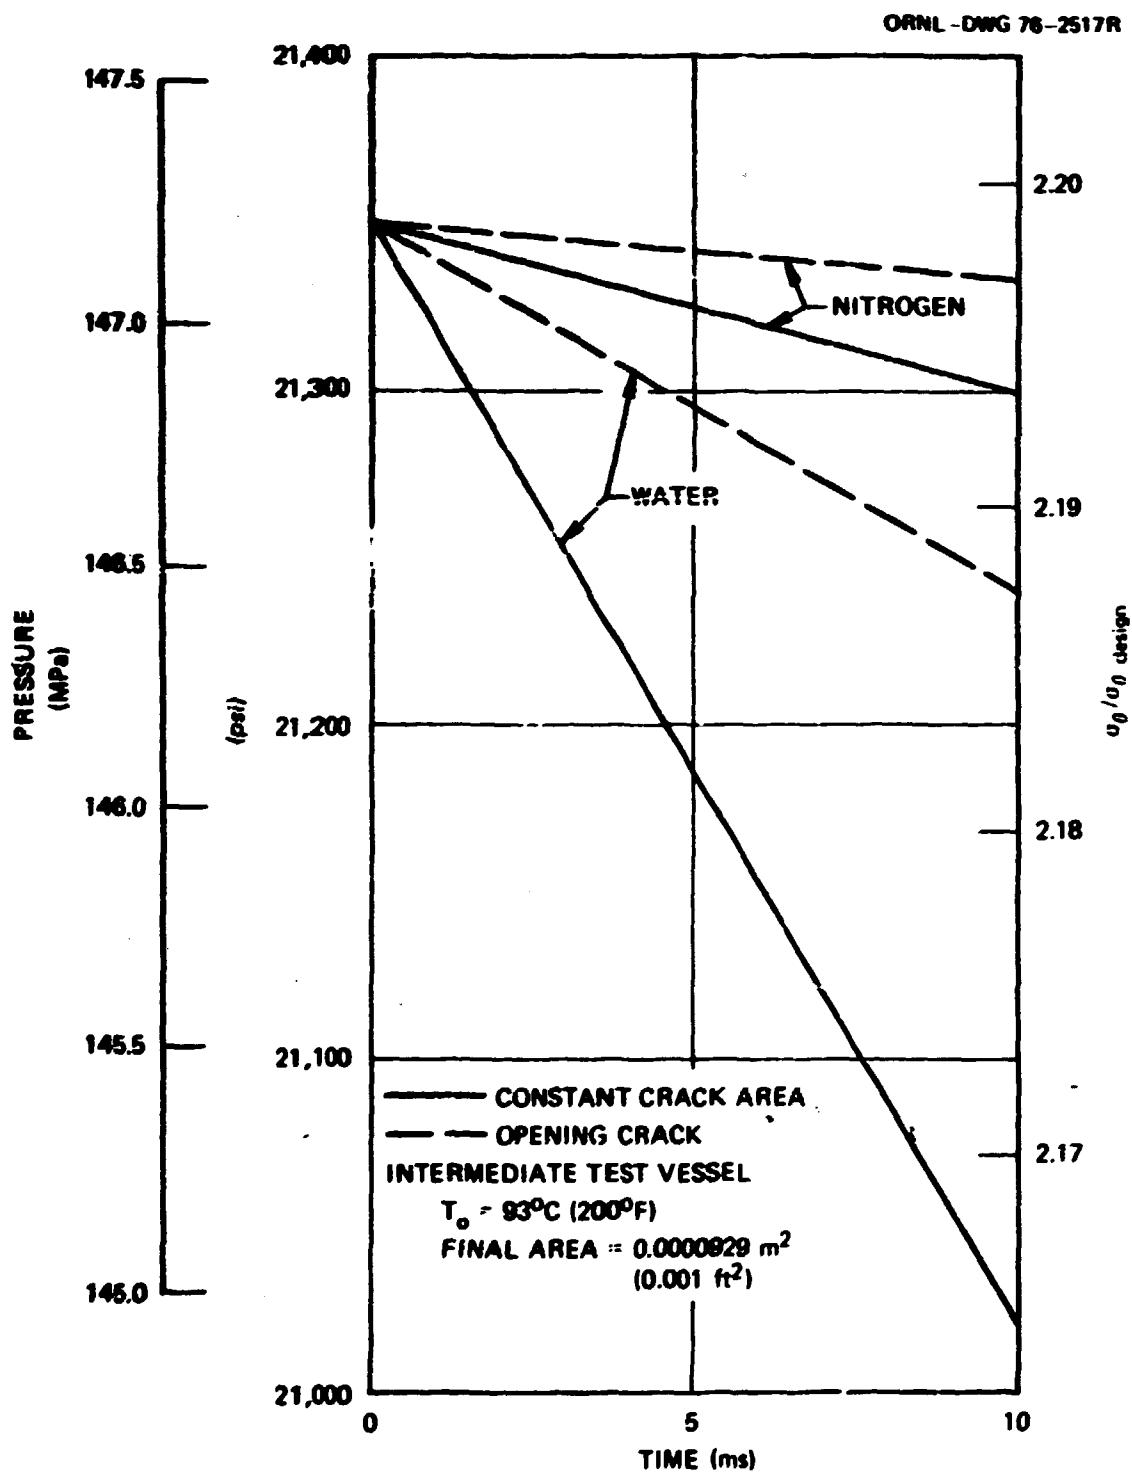
Fig. 2.3. Pressure and circumferential stress vs time for an intermediate test vessel at 93°C (200°F).

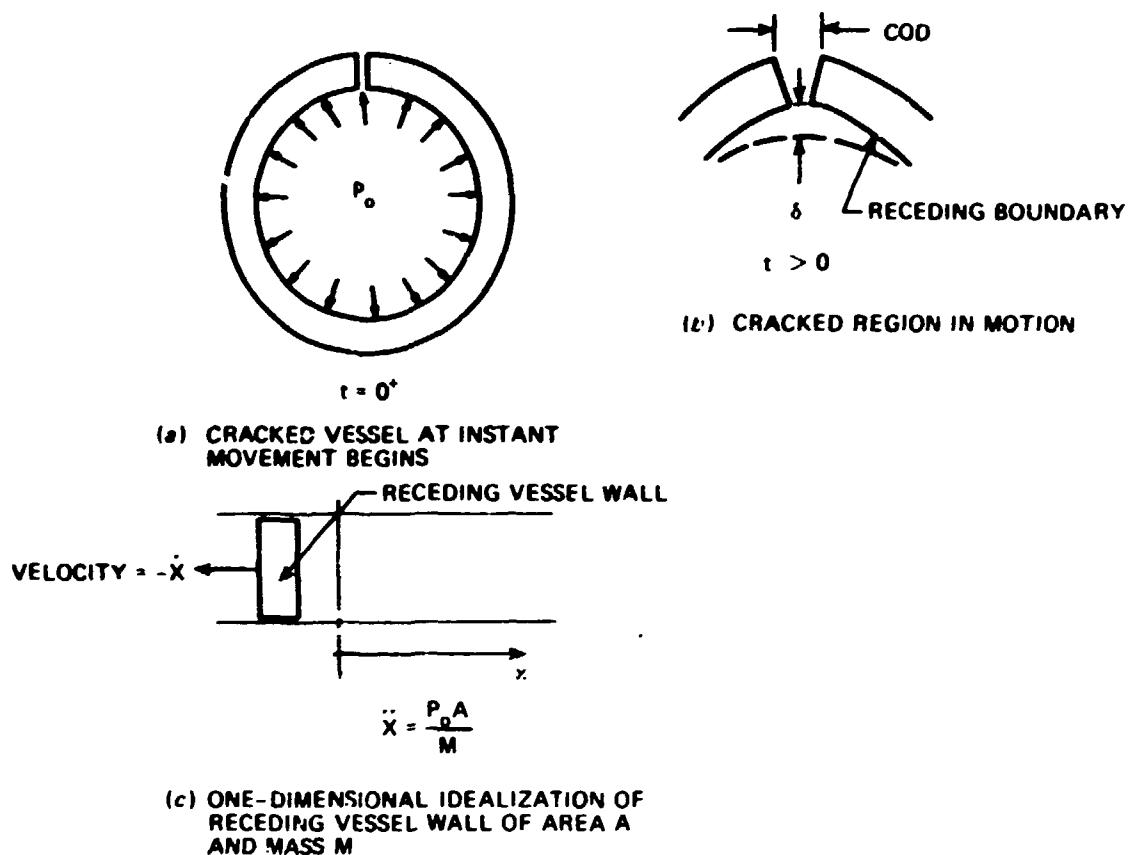
Fig. 2.4. Receding boundary problem.

Rapid change in pressure. When a crack pops in or runs unstably, there is an attendant local movement of the inside surface of the vessel. The recession of the pressure boundary, illustrated in Fig. 2.4, will generate a local decompression wave affecting the load on the boundary and, as a consequence, the stress field near the flaw. The decrease in pressure on the receding boundary is immediate, while the effect at a distance is delayed. In both locations, the magnitude of the change is determined by the speed of the receding boundary and the thermodynamic properties of the pressurizing medium.

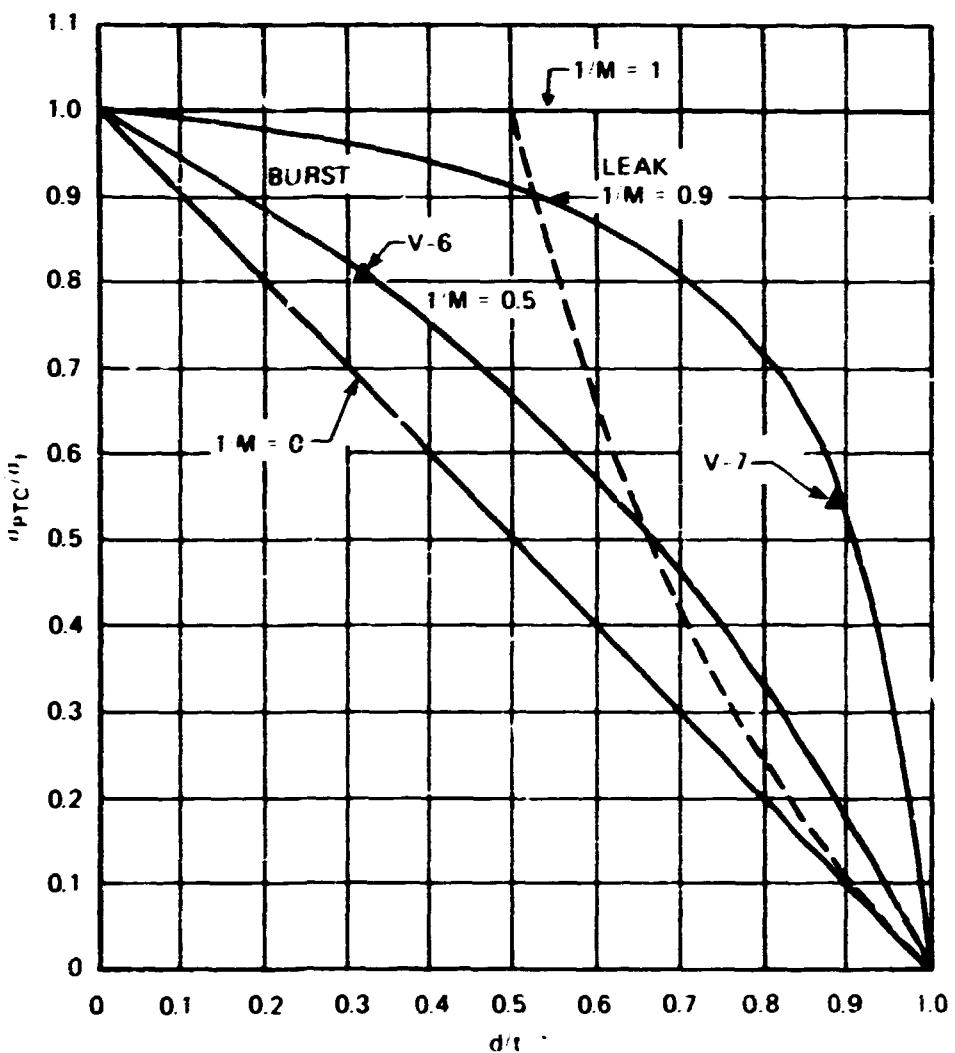
ORNL DWG 78 55

Fig. 2.7. Diagram of failure conditions as predicted by the BMI upper-shelf ligament plastic instability model for part-through surface cracks in pressurized cylinders.

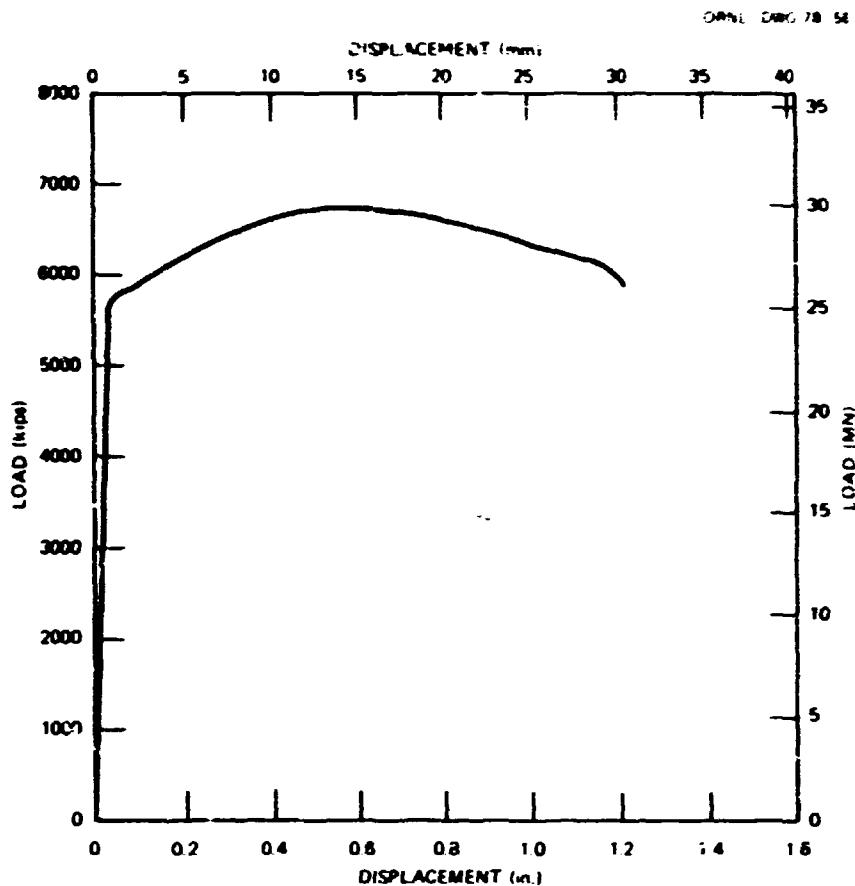
Fig. 2.11. Load vs crack-opening displacement (crack mouth clip gage) for 152-mm-thick (6-in.) surface-flawed intermediate tensile specimen 14 of A533, grade B, class 1 steel tested at 93°C (200°F) by the Southwest Research Institute.

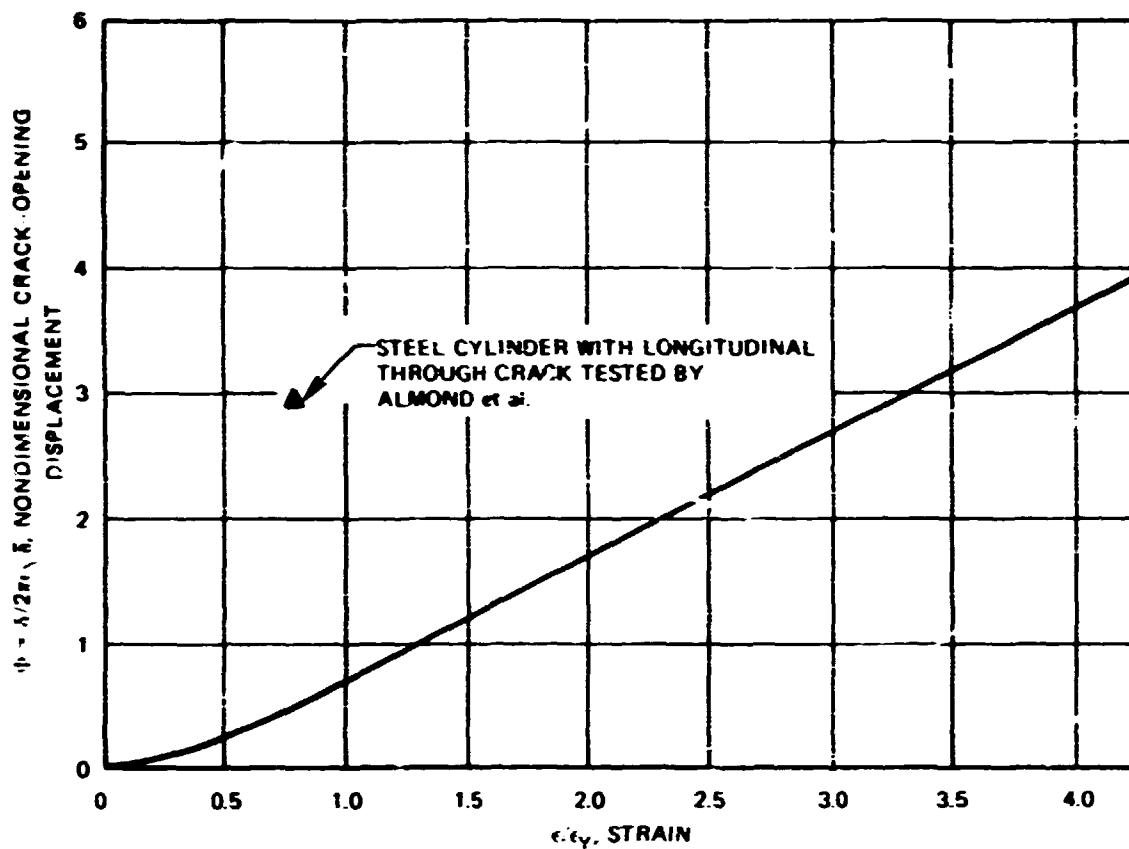
ORNL-DWG 78-58

Fig. 2.13. Normalized crack-opening displacement diagram and plotted point for a through-cracked pressurized pipe test.

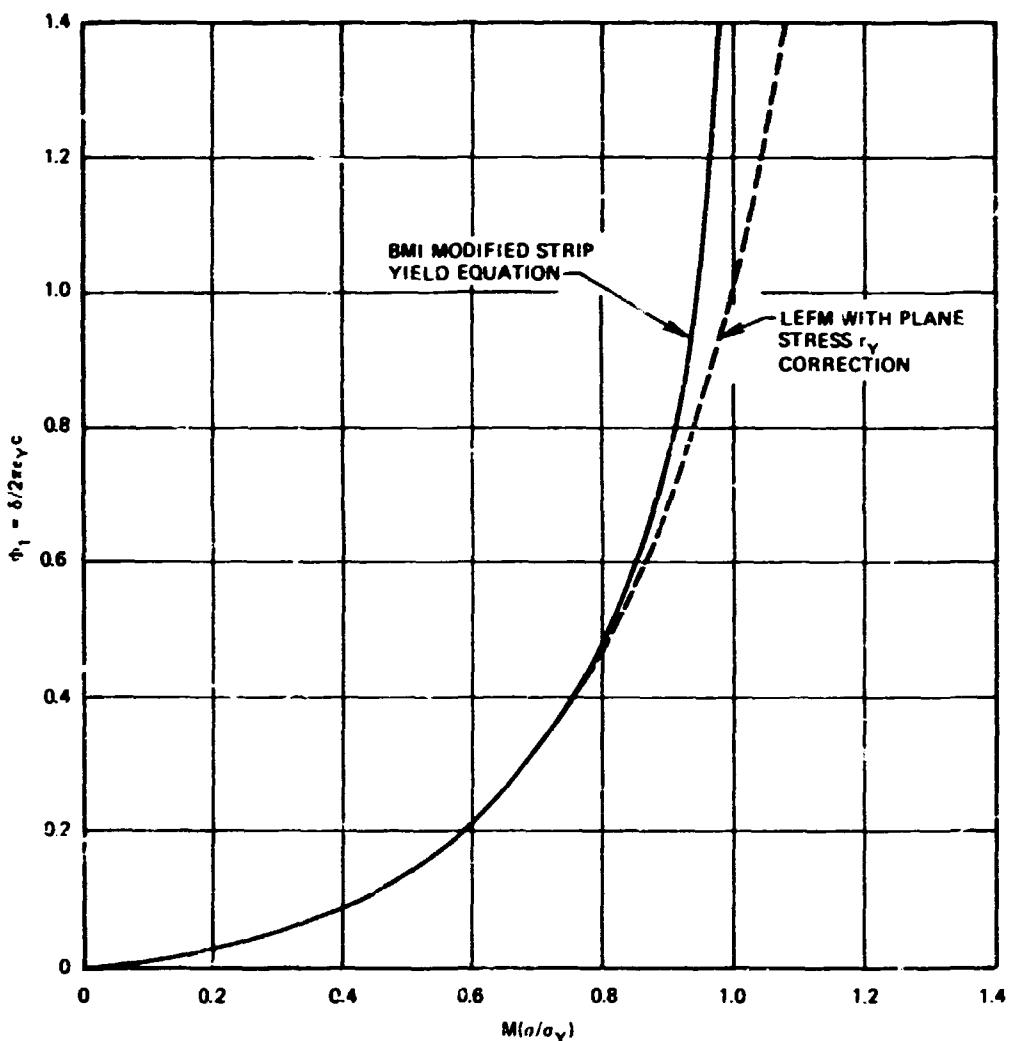
ORNL-DWG 78-50

Fig. 2.14. Comparison of crack-opening displacements predicted by the BMI modified strip yield equation and by linear elastic fracture mechanics (LEFM) with a plane stress plastic-zone-size (r_y) correction.

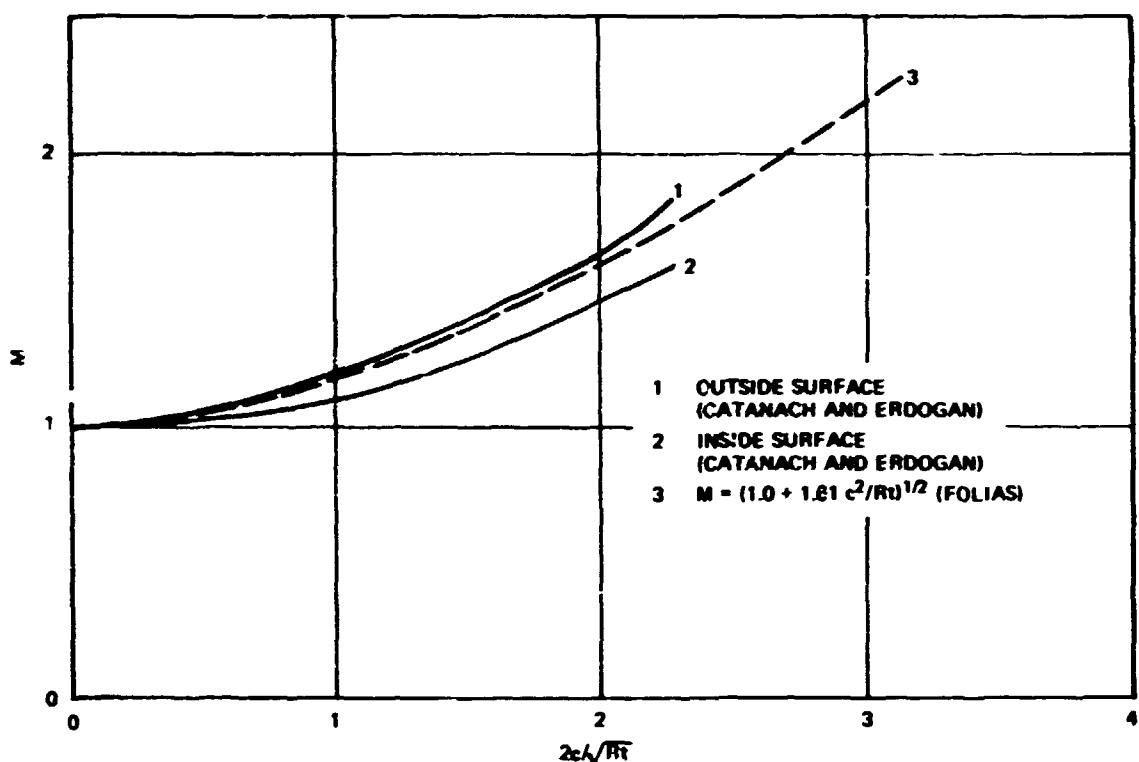
Fig. 2.15. Theoretical bulging factors as a function of cylinder geometry.

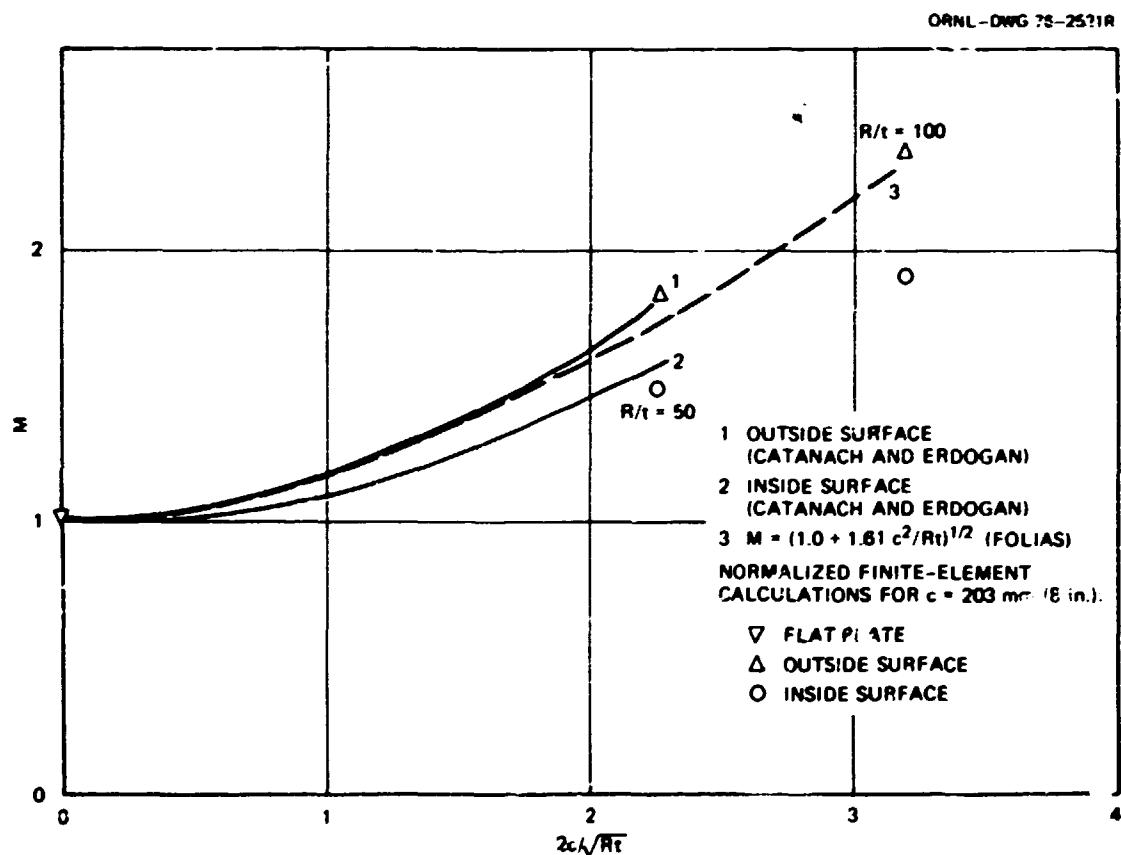
Fig. 2.16. Bulging factor test cases for a flat plate and two thin shallow shells.

minimize computer costs. The first problem that was solved consisted of a large flat plate with a center slit. The stress-intensity factor determined by the finite-element approach was found to be 1.27% above the theoretical value for an infinite plate; that is, $K_I = \sigma\sqrt{\pi c}$, where σ is the far field stress and c is the crack half-length. The numerically determined value normalized by the theoretical value is shown in Fig. 2.16 as a triangle. Since a flat plate can be thought of as the limiting case of a cylinder with a radius of curvature equal to infinity, the flat plate point is plotted with an abscissa value of zero. Figure 2.16 also shows the results for the inner and outer surface values of the bulging factor determined from the finite-element results for cylinders with mean radius to wall thickness ratios of 50 and 100. At an abscissa value of 2.25, the

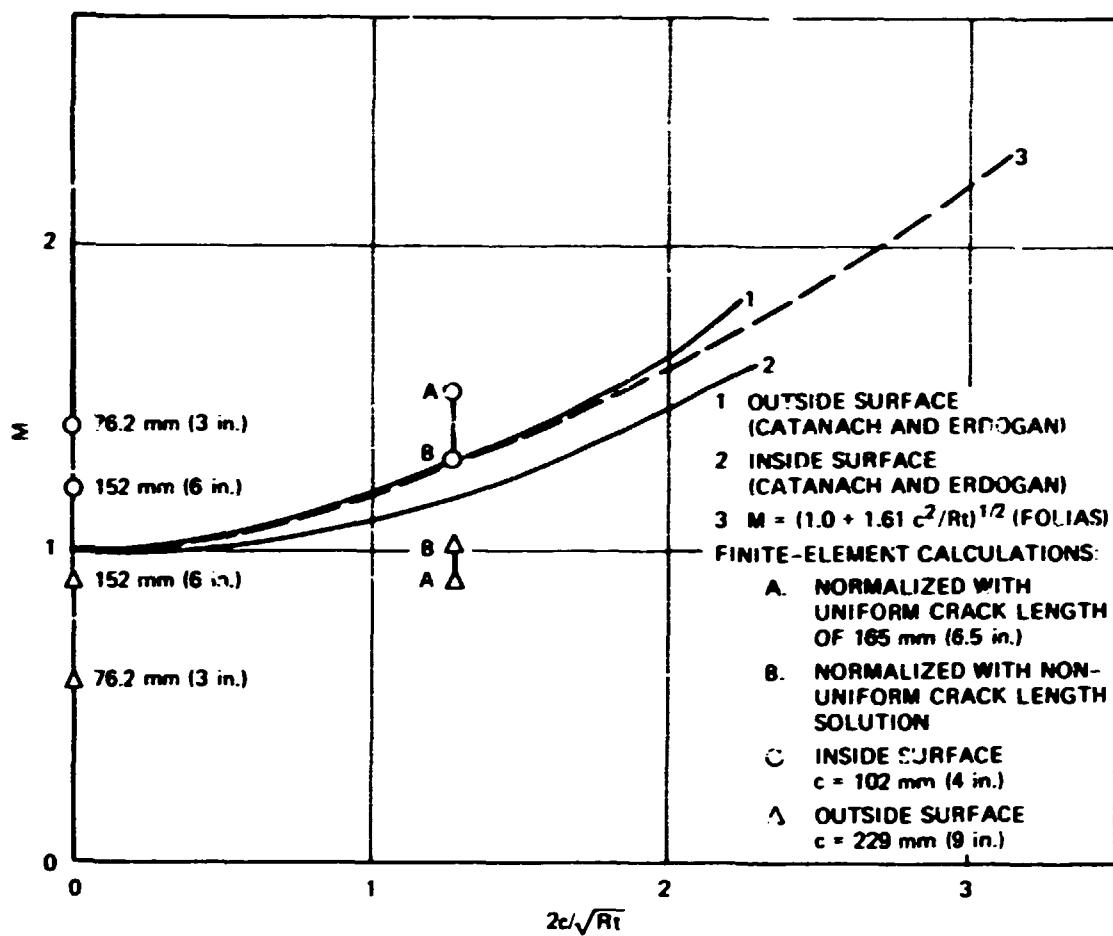
Fig. 2.18. Bulging factors for nonuniform crack length in flat plates and V-7A.

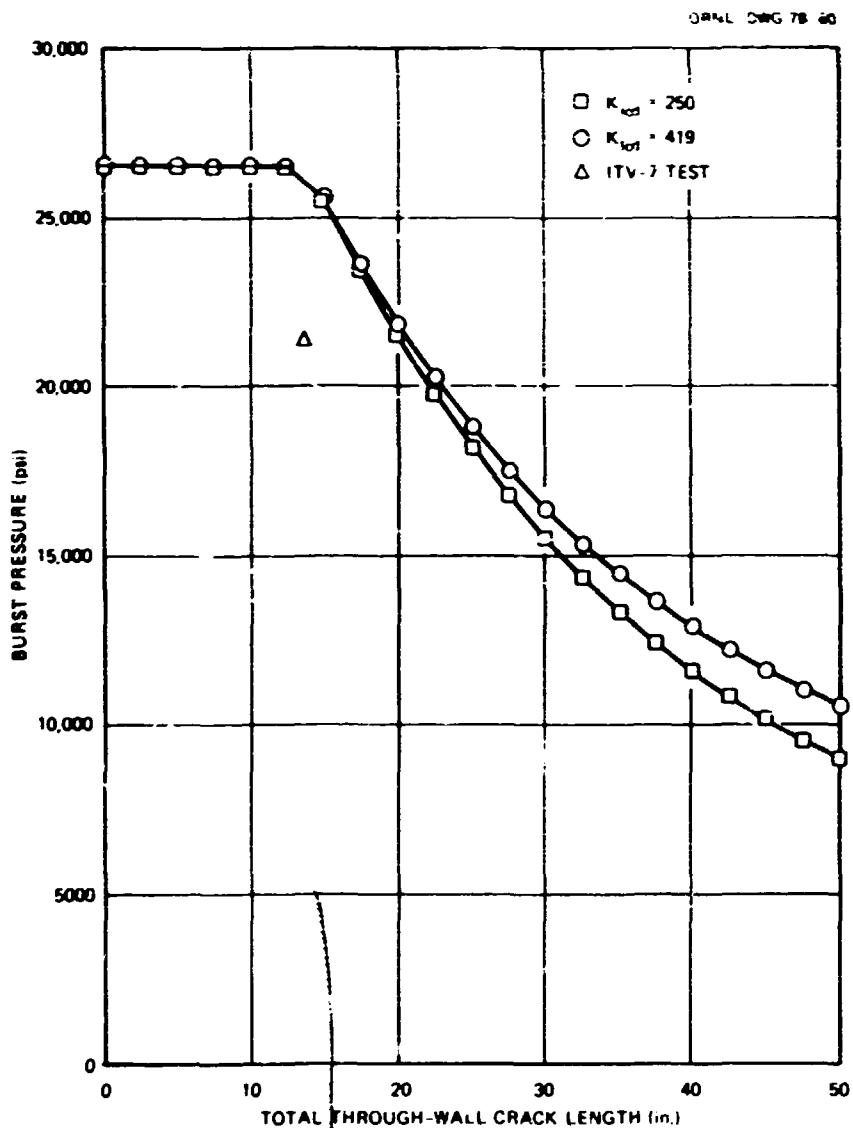
Fig. 2.19. Burst pressure vs crack length for intermediate vessel tests V-7 and V-7A (1 in. = 25.4 mm; 1 psi = 6895 kPa).

Equations (30) and (62) to (65) were used to calculate the V-7A burst pressure for different crack lengths and for different values of plane strain fracture toughness. These results plus the V-7 experimental point are plotted in Fig. 2.19. The experimental point corresponds to the pressure at which leaking was detected for the V-7 test based on a nominal crack length of 343 mm (13.5 in.), which was discussed in the previous section concerning the bulging factor correction. The predicted margin against burst is thus the difference between the leak pressure from the V-7 test and the burst pressure determined from the curve for a nominal crack length of 343 mm (13.5 in.). This margin is approximately 36 MPa (5200 psi). The curve corresponding to a toughness of $460 \text{ MN}\cdot\text{m}^{-3/2}$ (419 ksi $\sqrt{\text{in.}}$) is nearly coincident with a limit curve that would be found if the toughnesses were assumed to tend toward an infinite value (i.e., the upper curve in Fig. 2.19 is essentially independent of toughness). For comparison purposes, burst calculations based on an arbitrary plane strain fracture toughness of $275 \text{ MN}\cdot\text{m}^{-3/2}$ (250 ksi $\sqrt{\text{in.}}$) were also made and are shown in Fig. 2.19.

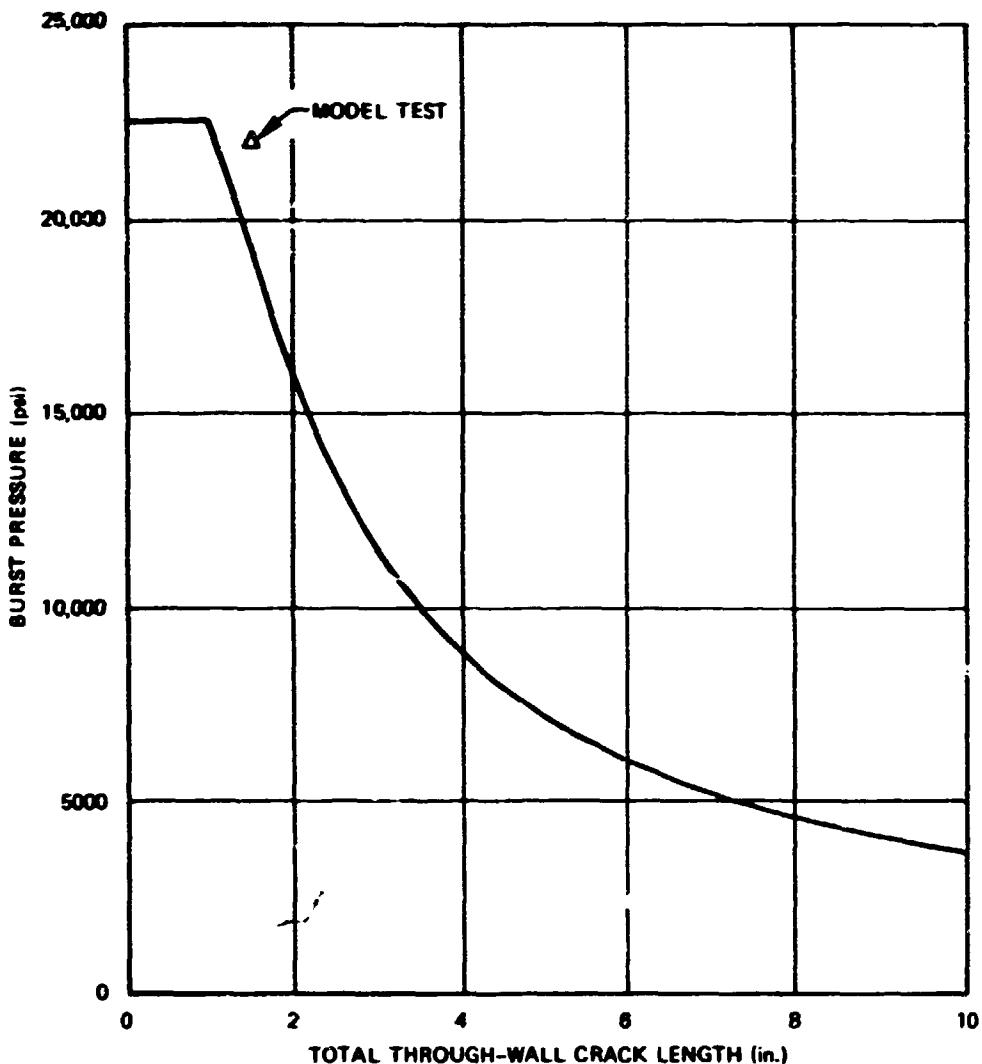
Fig. 2.20. Burst pressure vs crack length for a small-scale model (1 in. = 25.4 mm; 1 psi = 6895 kPa).

Burst calculations were also carried out for the pneumatically loaded model test No. 10 which is described on pages 51-55 of Ref. 8. The results of those calculations are shown in Fig. 2.20. As in the case of vessel V-7, the curve associated with the appropriate toughness, estimated to be 137

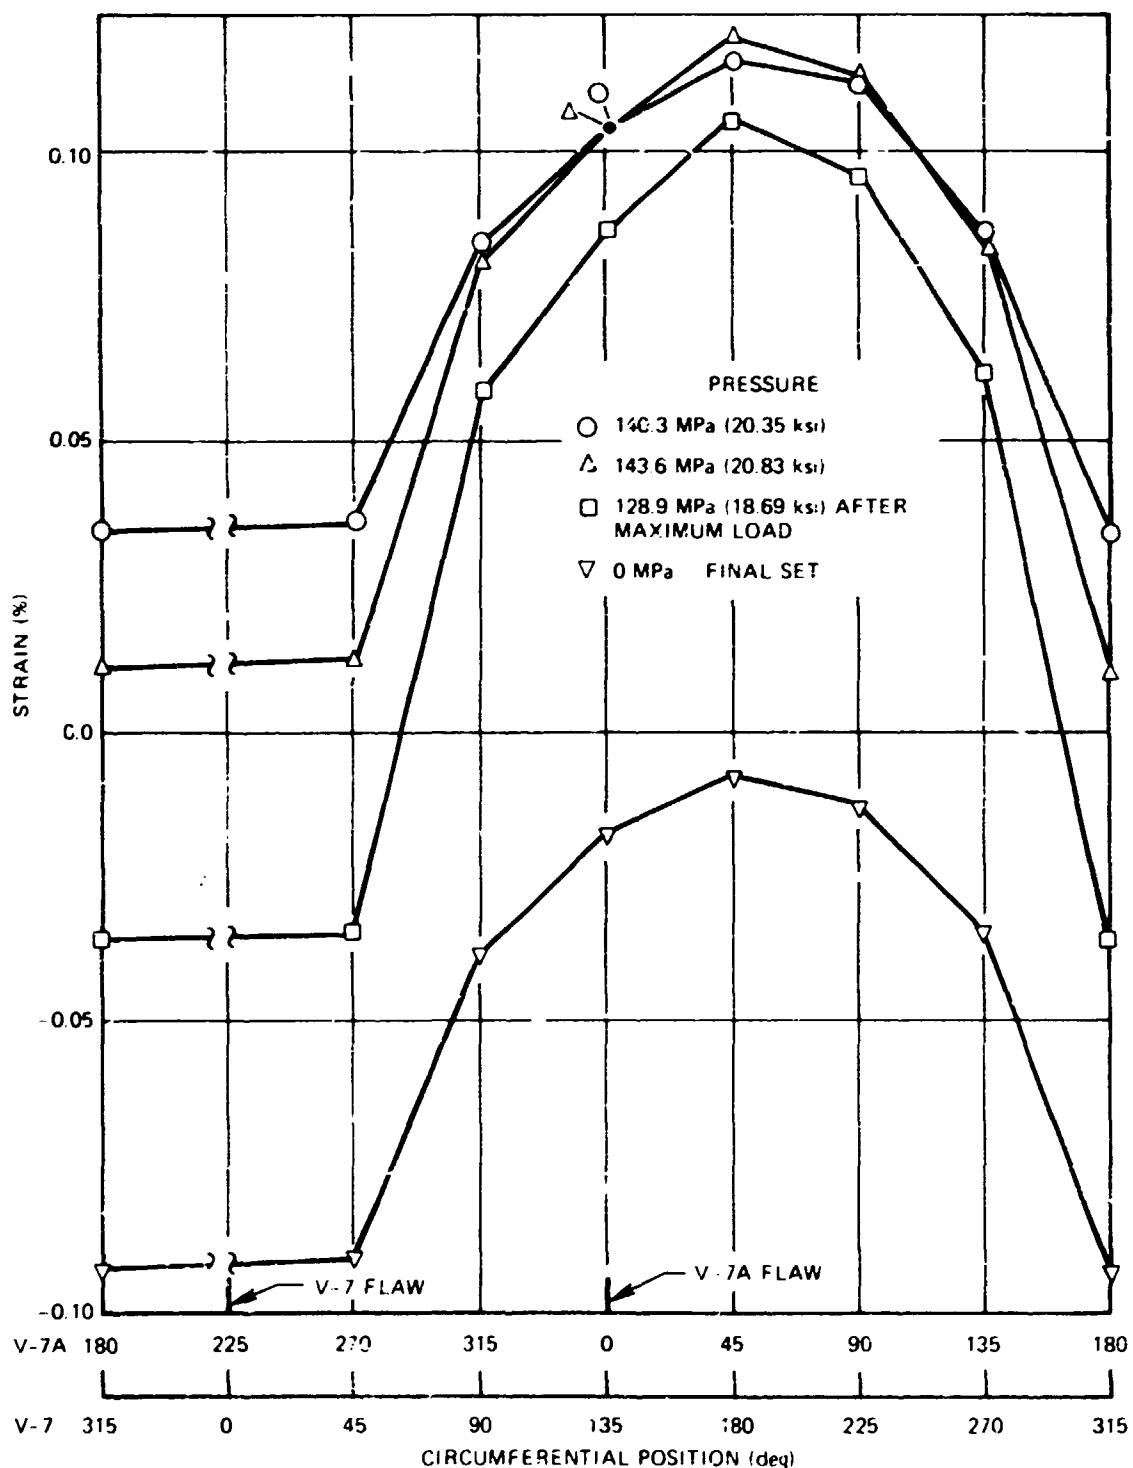
Fig. 3.1. Outside circumferential strain distribution at midplane of vessel V-7 near maximum pressure and after depressurization.

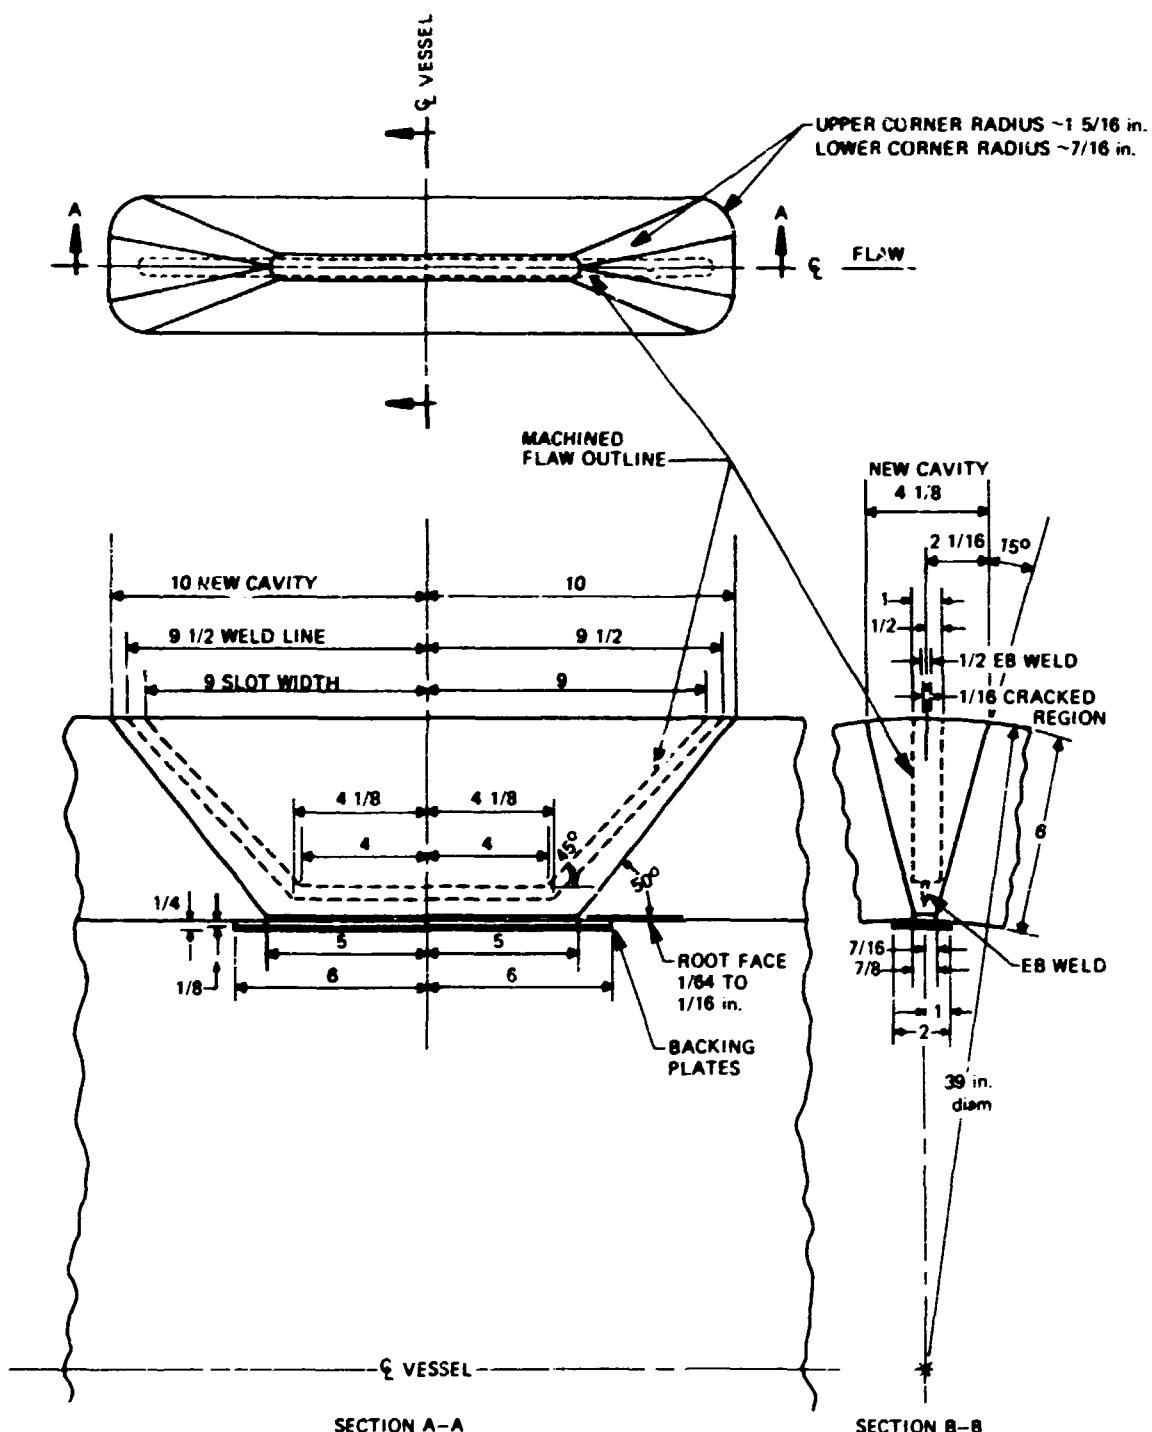
Fig. 3.8. Design of repair-preparation cavity in vessel V-7 (1 in. = 25.4 mm).

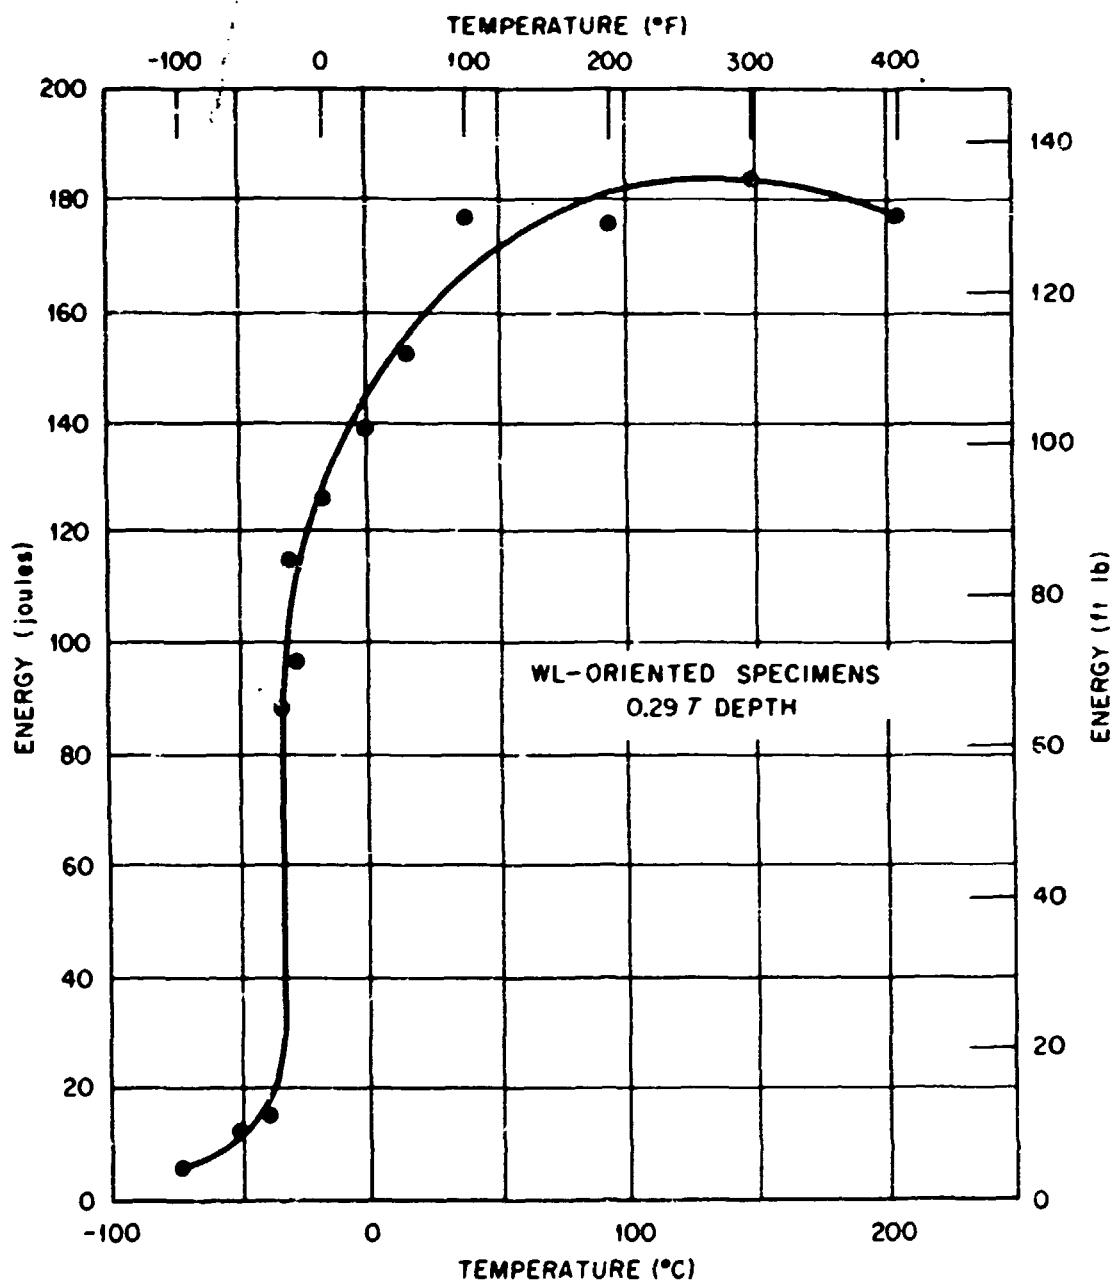
ORNL-DWG 76-5877

Fig. 3.16. Variation of Charpy V impact energy with temperature for test weldment W-1.

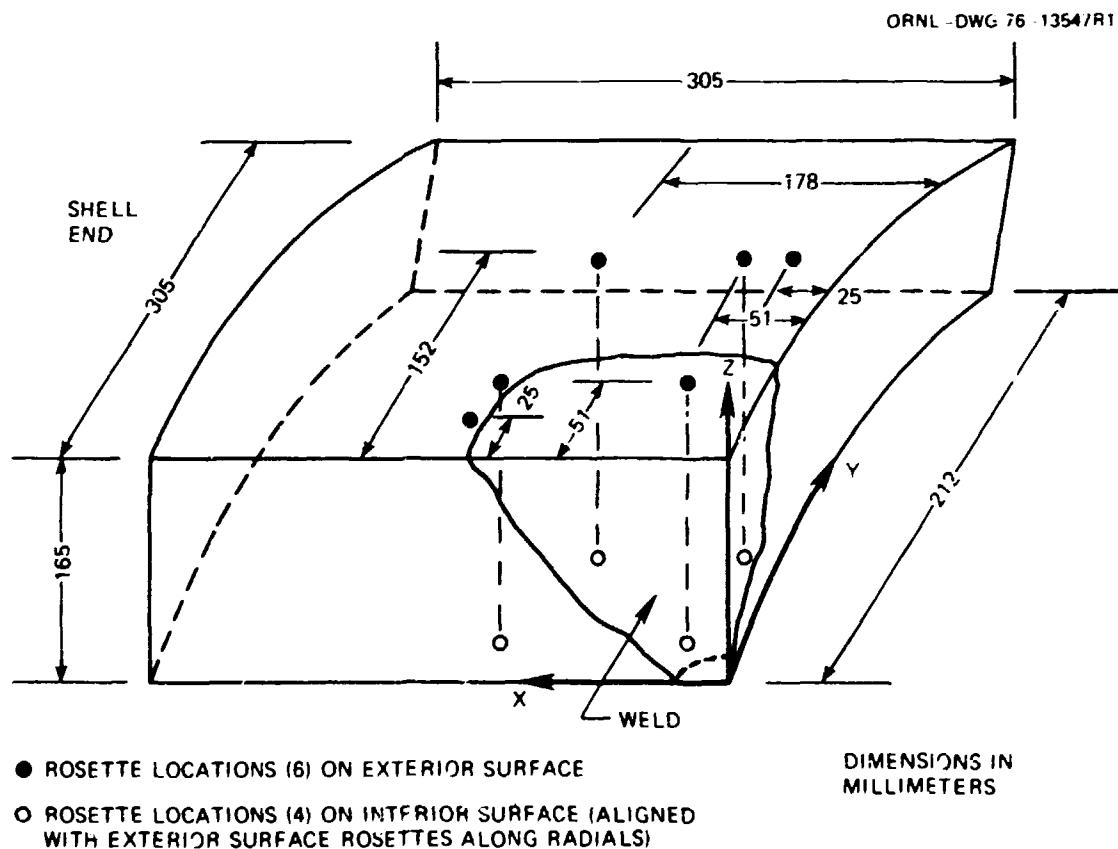
Fig. 3.24. Schematic of section removed from weld procedure qualification piece for residual stress measurements (1 mm = 0.03937 in.).

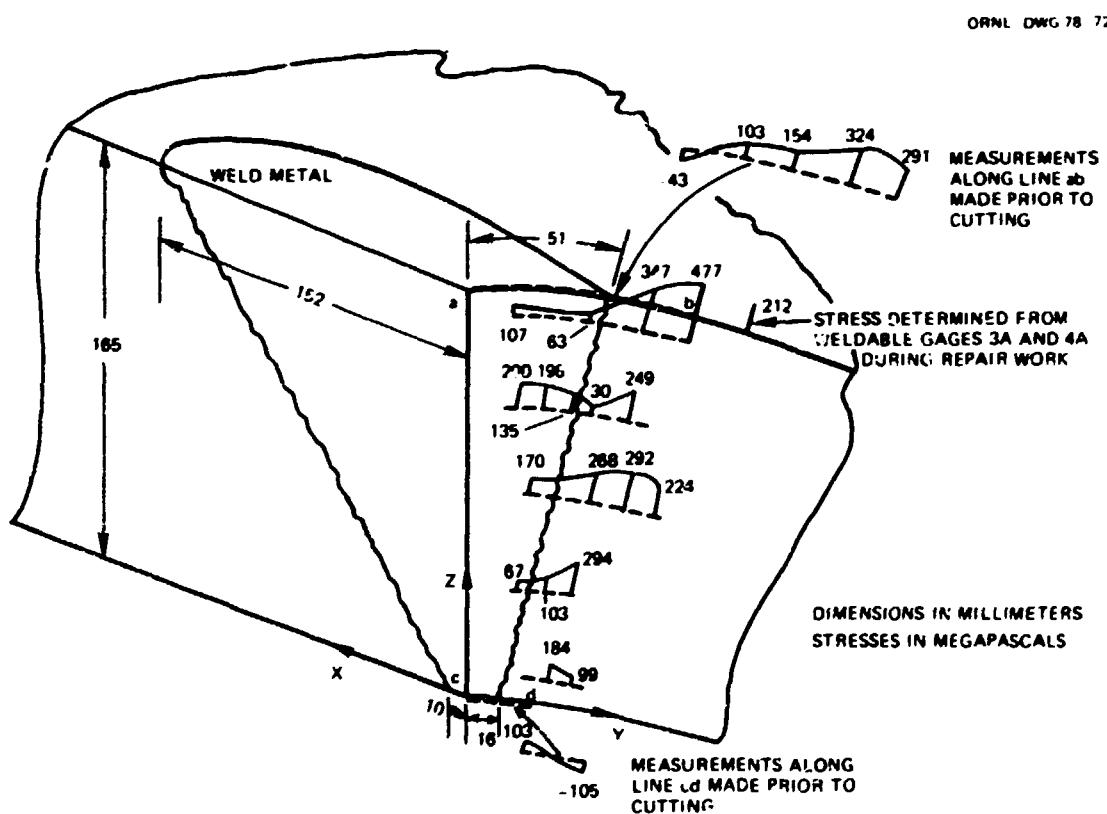
Fig. 3.25. Circumferential residual stresses in the V-9 prolongation weldment made for qualification of the welding procedure used in repair of vessel V-7. Values on the cut plane (Y-Z) have been adjusted to account for the relief of stresses during cutting. (1 mm = 0.03937 in.; 1 MPa = 145 psi.)
