**Test of 6-in.-thick Pressure Vessels
Series 3: Intermediate Test Vessel V-7A
Under Sustained Loading**

ORNL/NUREG-9
Dist. Category NRC-5

TEST OF 6-IN.-THICK PRESSURE VESSELS
SERIES 3: INTERMEDIATE TEST VESSEL V-7A
UNDER SUSTAINED LOADING

Prepared by the
OAK RIDGE NATIONAL LABORATORY
Oak Ridge, Tennessee 37830
operated by
UNION CARBIDE CORPORATION
for the
DEPARTMENT OF ENERGY

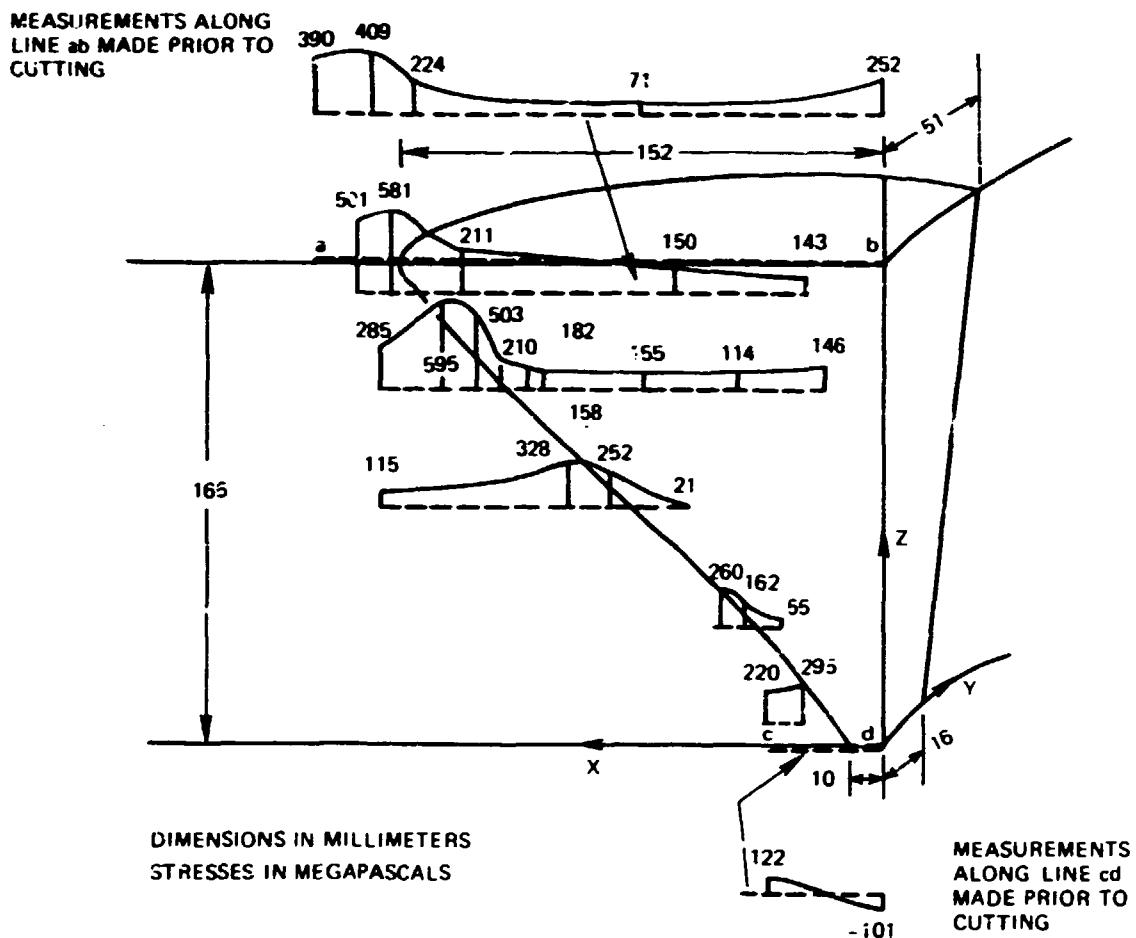
Fig. 3.26. Axial residual stresses in the V-9 prolongation weldment made for qualification of the welding procedure used in repair of vessel V-7. Values on the cut plane (X-Z) have been adjusted to account for the relief of stresses during cutting. (1 mm = 0.03937 in.; 1 MPa = 145 psi.)

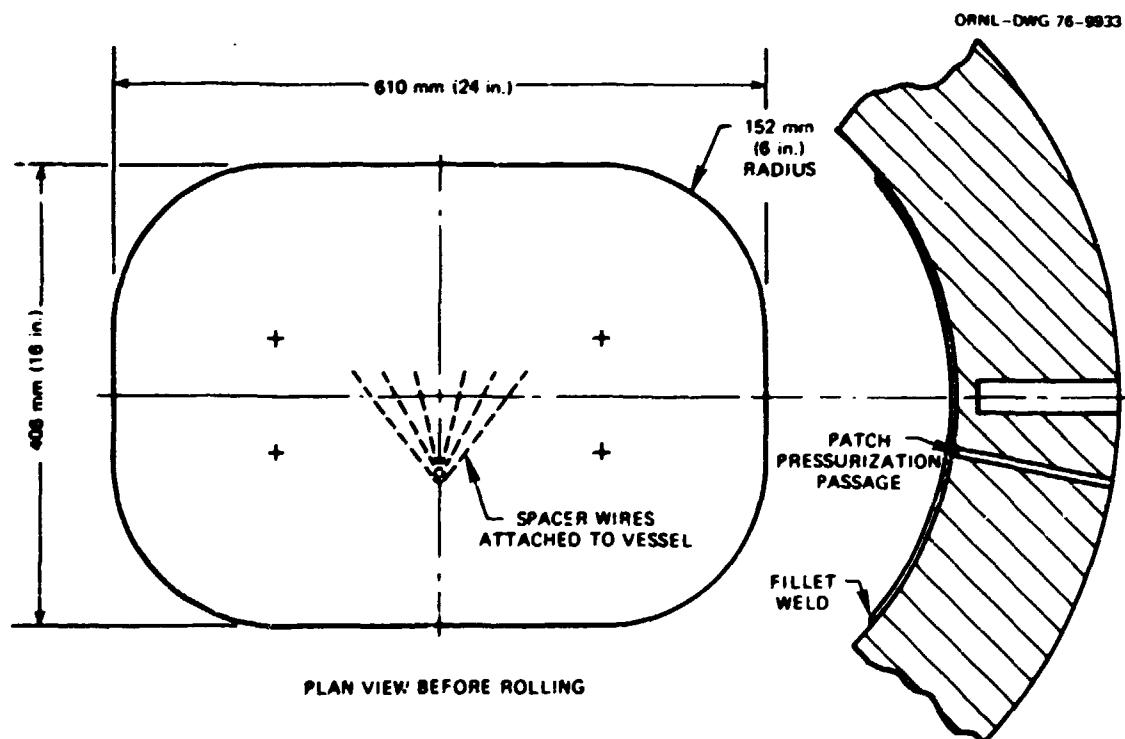
Fig. 3.29. Design of leak-retarding patch for vessel V-7A.

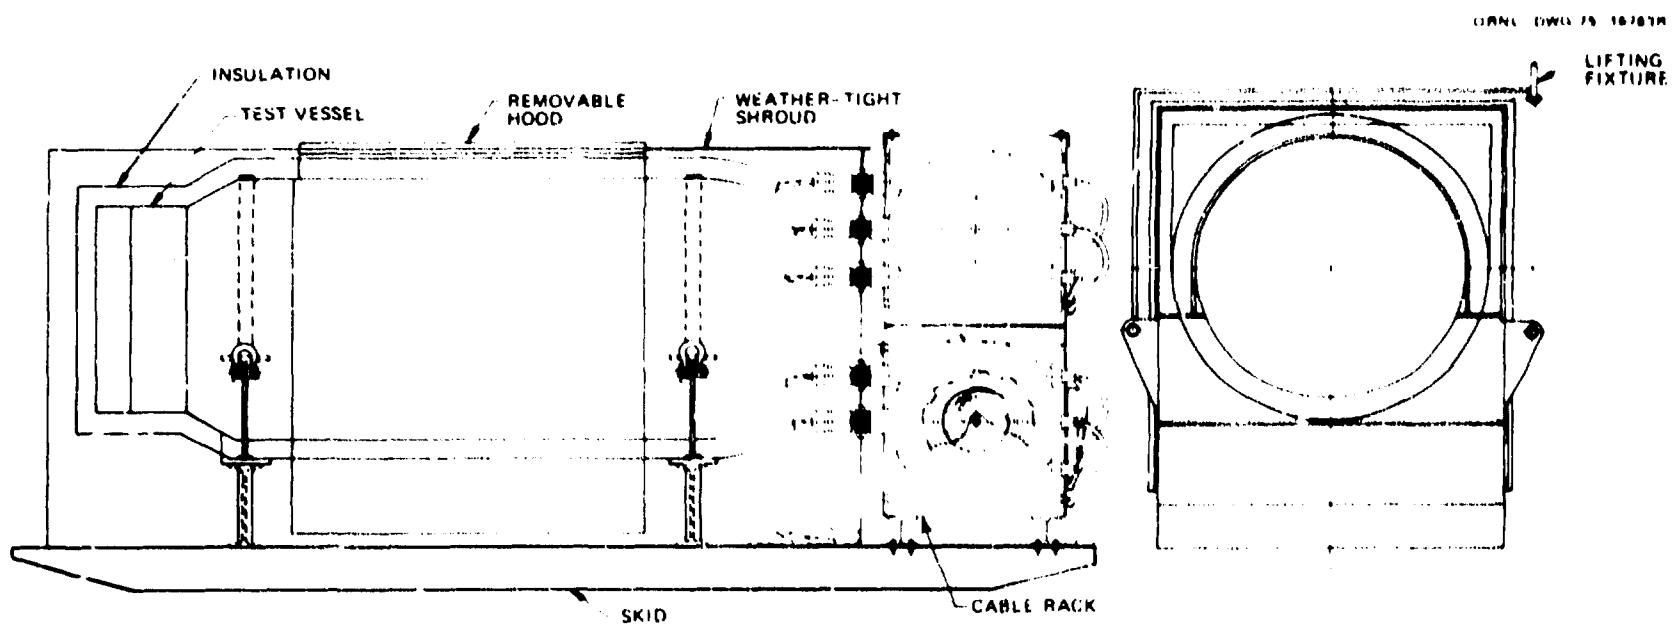
Fig. 4.8. Simplified views of vessel V-7A test assembly.

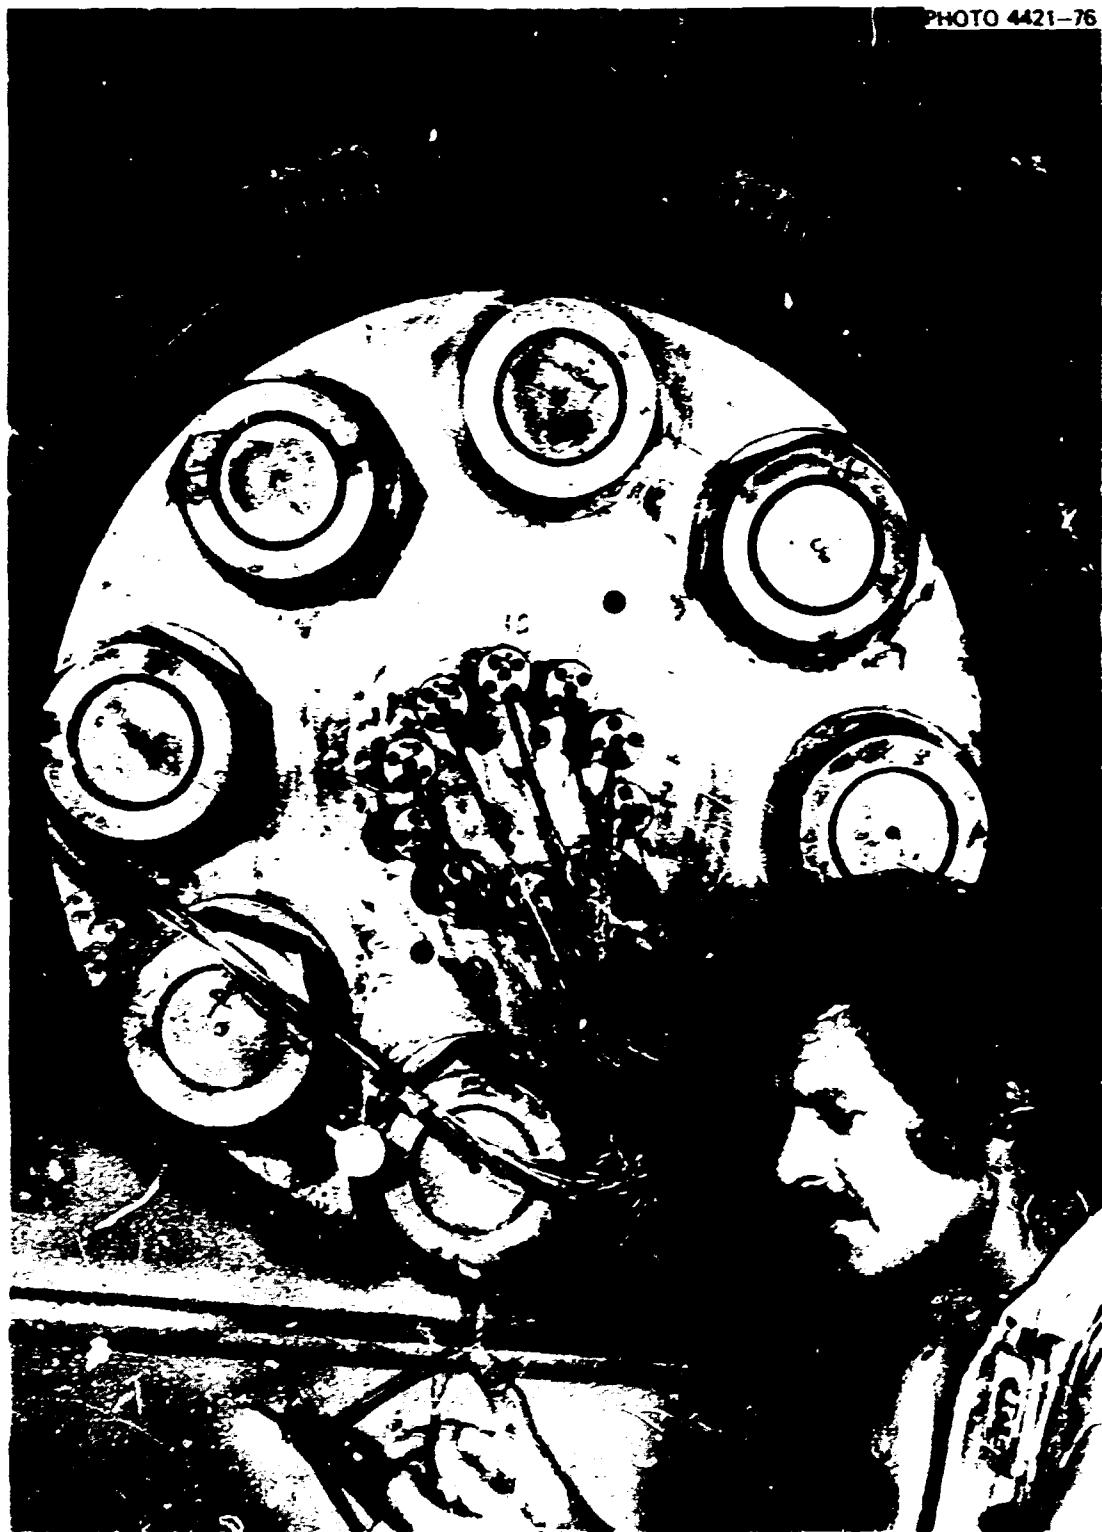
PHOTO 4424-76

Fig. 4.11. Closure end view of V-7A vessel assembly showing Autoclave Engineers high-pressure penetration fittings for instrumentation cables.

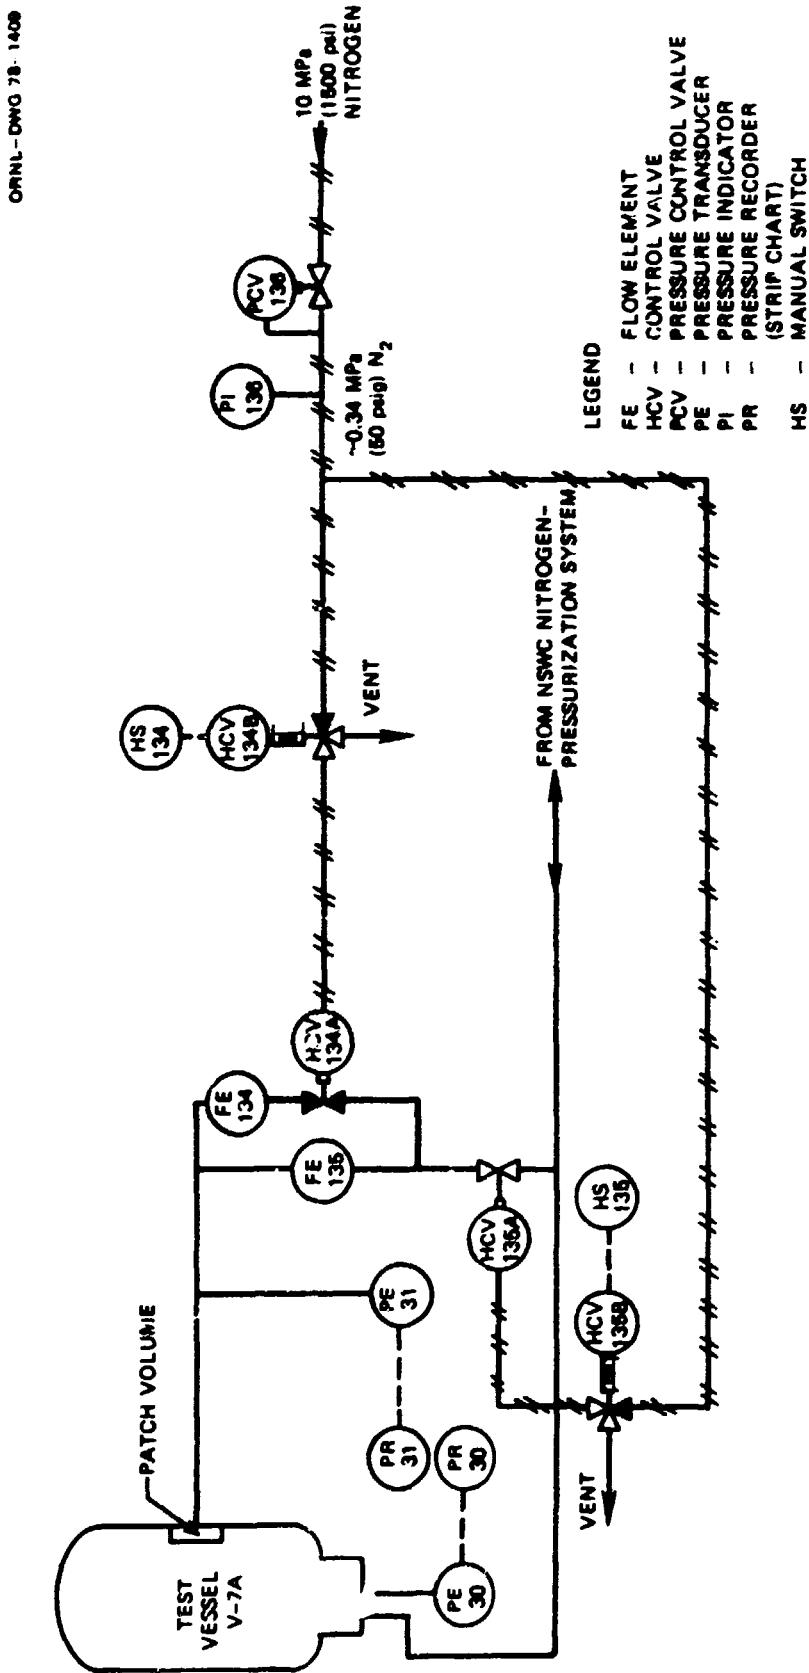
Fig. 4.14. Diagram of patch-pressurization system for V-7A.

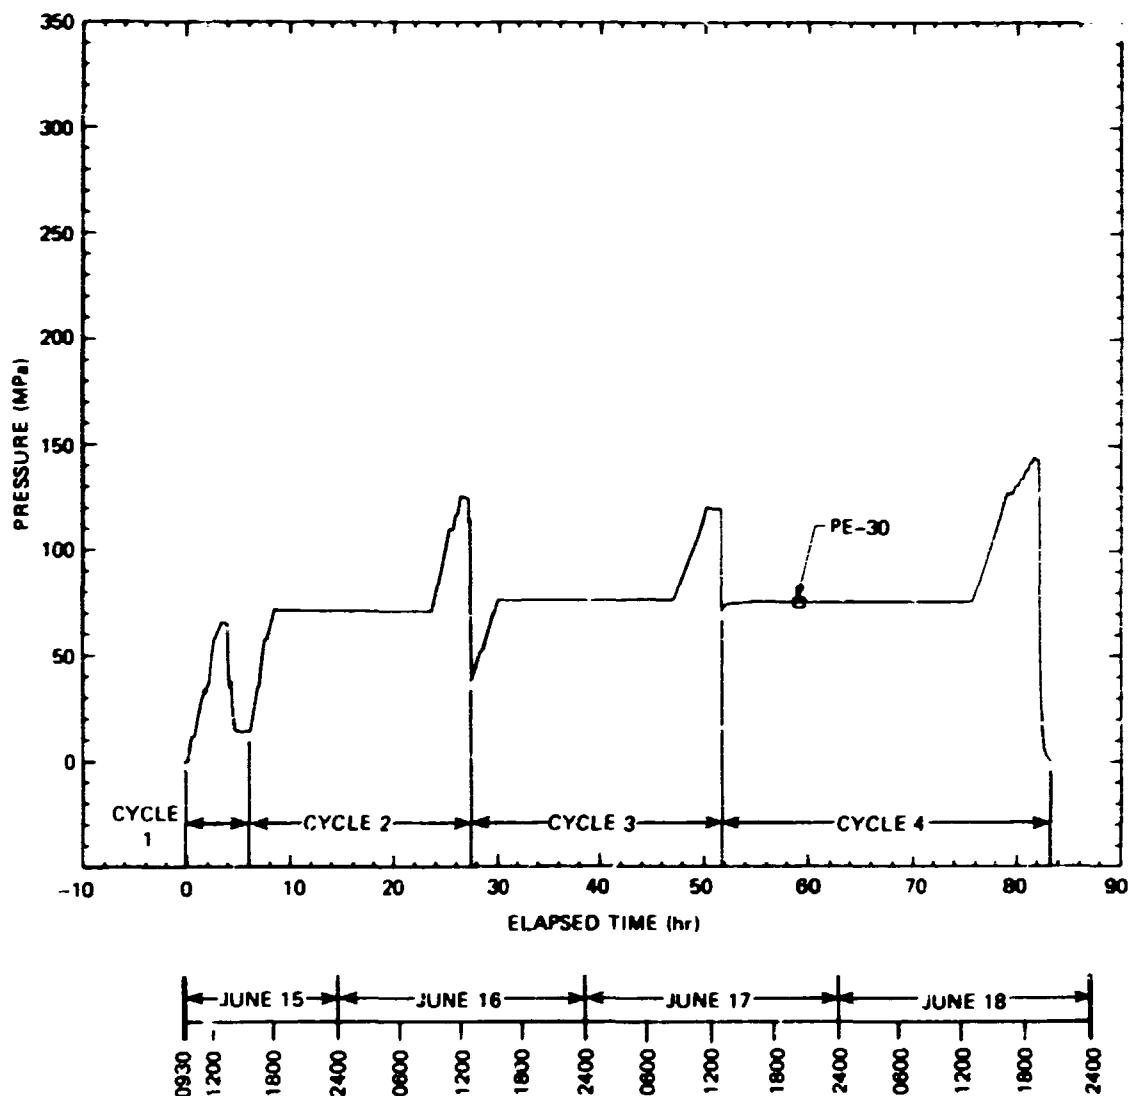
Fig. 4.17. Pressurization history of intermediate vessel test V-7A, June 15-18, 1976 (1 MPa = 145.04 psi).

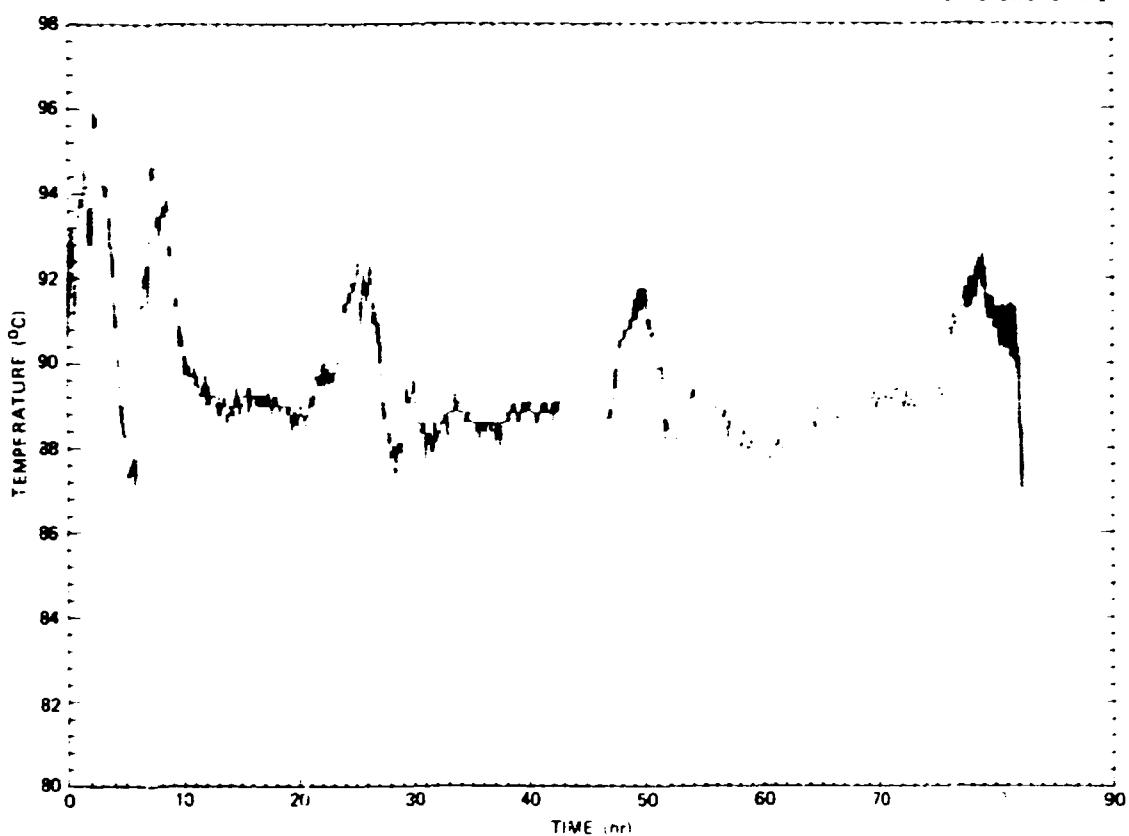
Fig. 4.18. Temperature history of intermediate vessel test V-7A, June 15-18, 1976, as measured by thermocouple TE 21 on inside surface near end of notch.

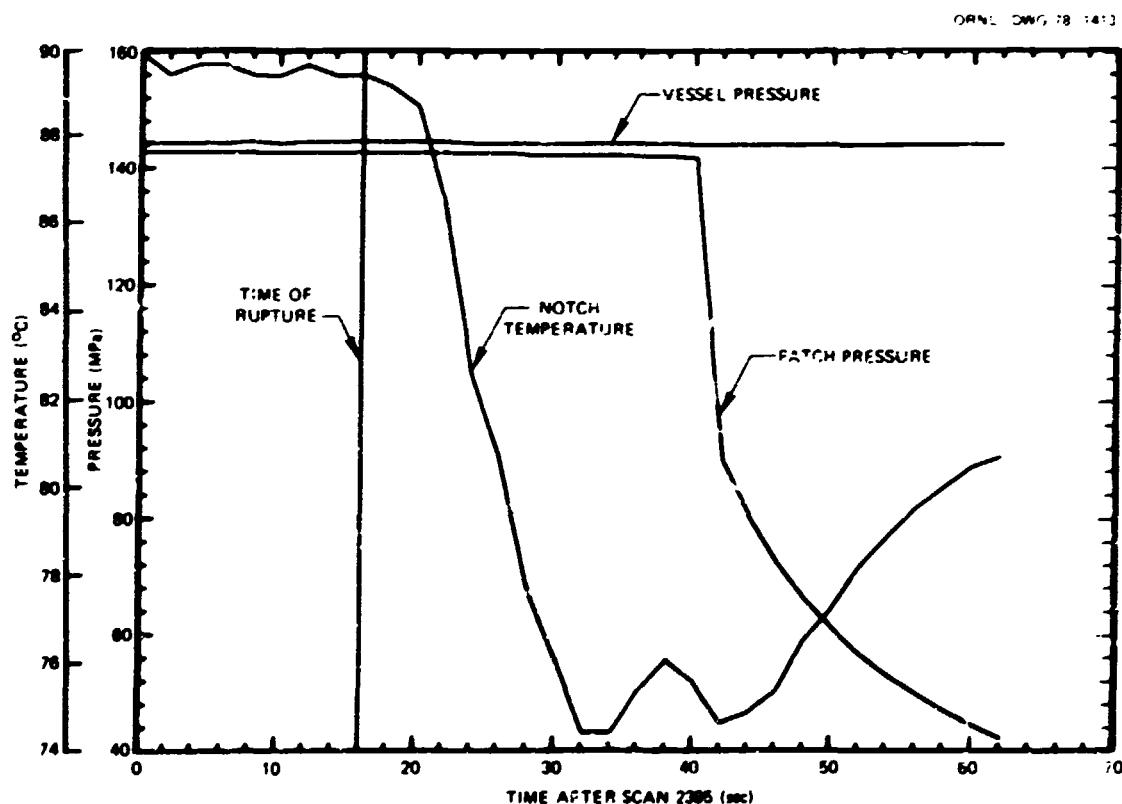
Fig. 4.19. Data defining the nominal time of rupture in V-7A test at 19:02:26, June 18, 1976 (1 MPa = 145.04 psi).

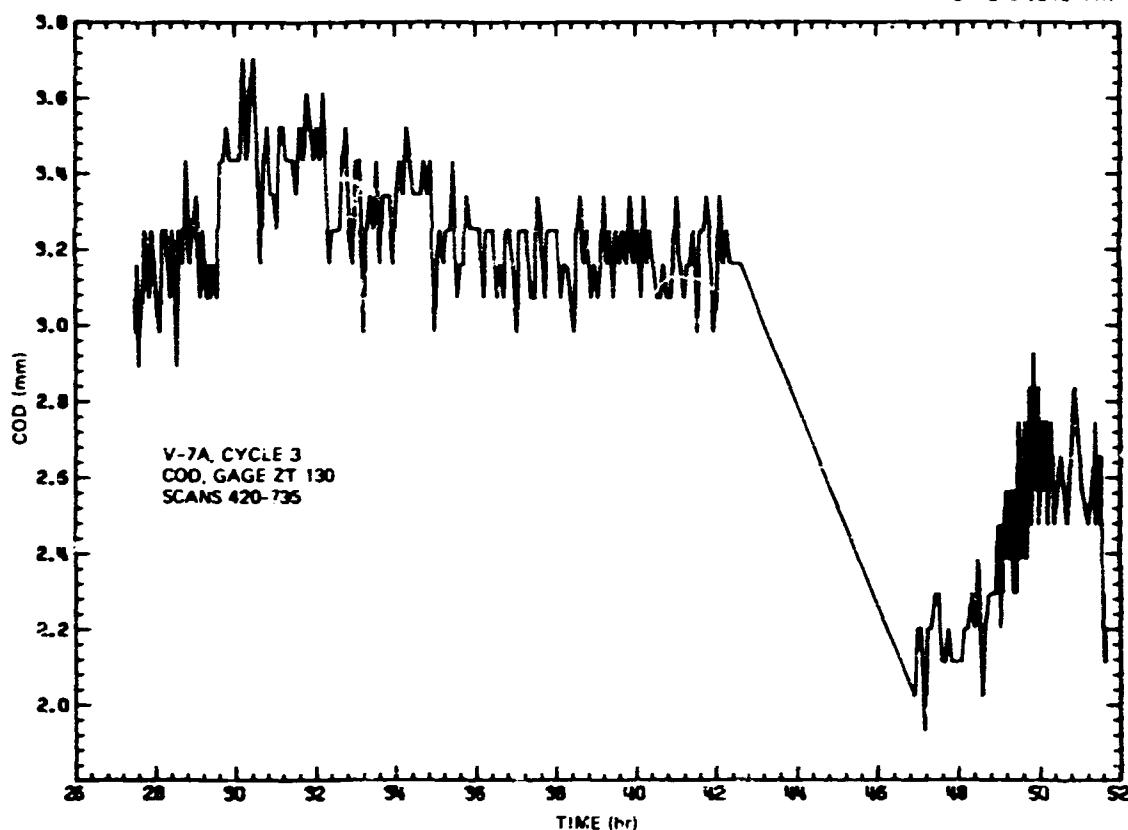
Fig. 4.25. Drift in COD (ZT 130) during hold period in 3rd cycle (1 mm = 0.0394 in.).

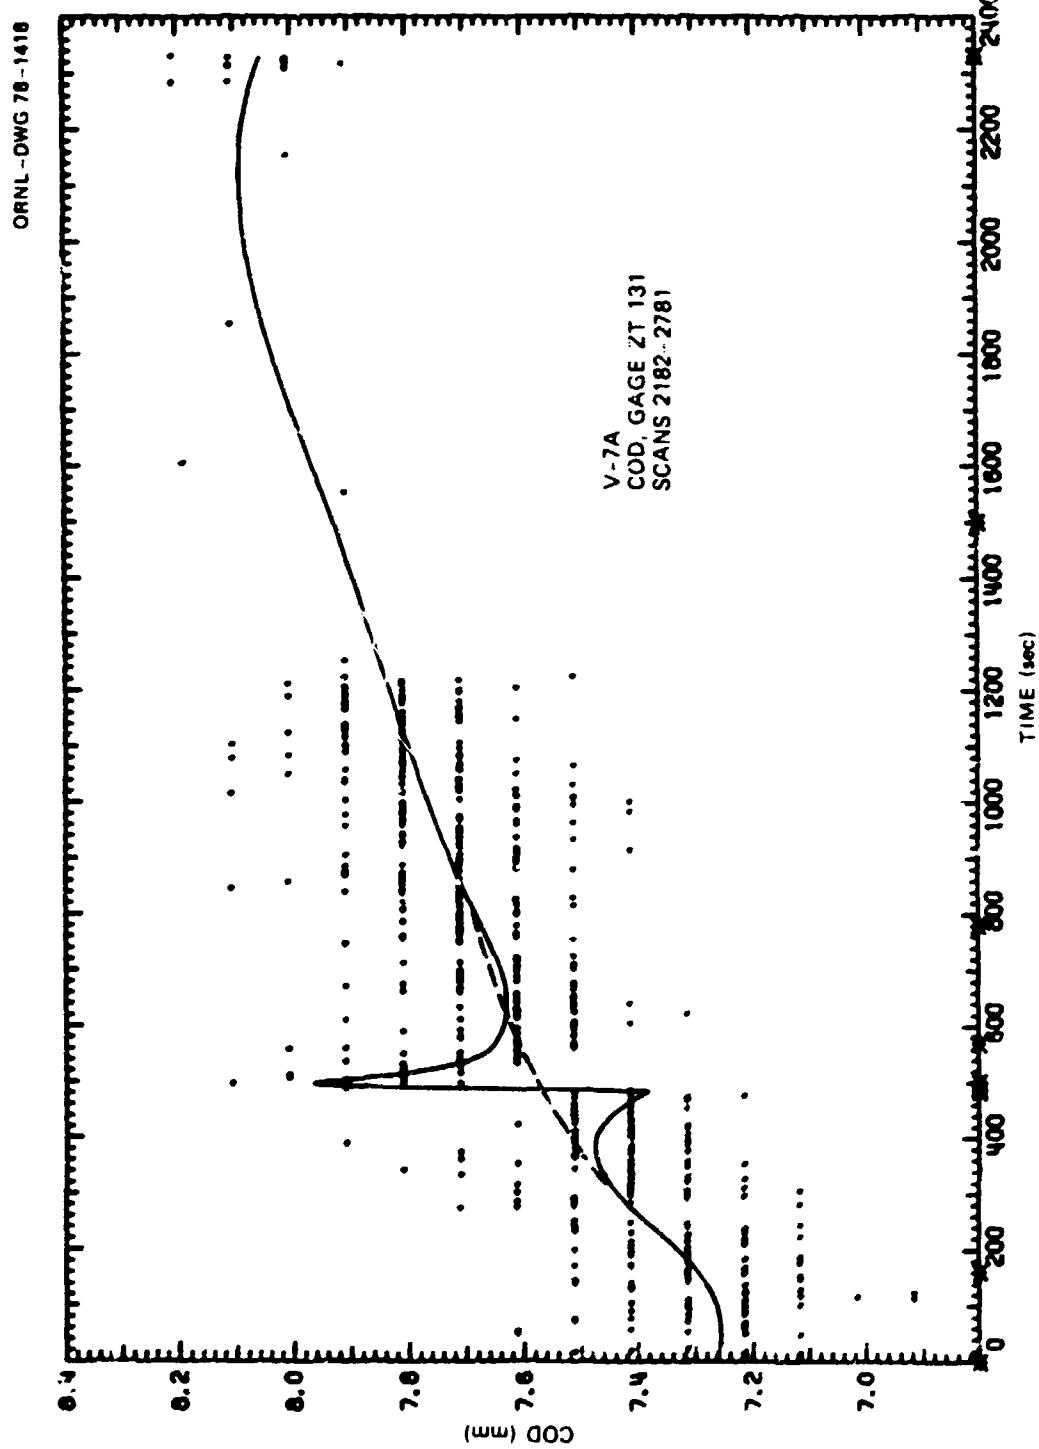
Fig. 4.26. Piecewise cubic spline fit of COD data from ZT 131; nominal time of rupture is at 484 sec on this plot (1 mm = 0.0394 in.).

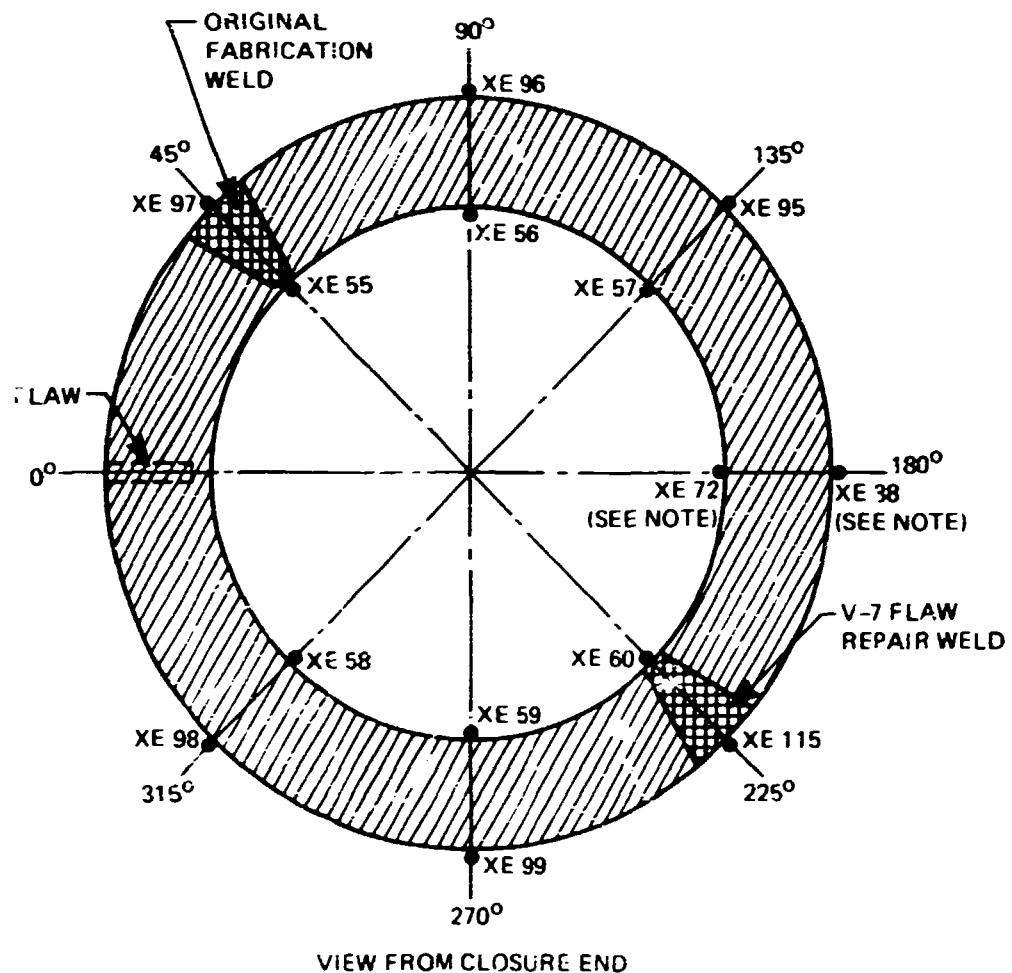
NOTE: XE 72 AND XE 88 ARE 51 mm (2 in.) FROM THE CIRCUMFERENTIAL MIDPLANE OF THE FLAW IN V-7A. THESE ARE PLOTTED BECAUSE ONE MIDPLANE GAGE WAS DEFECTIVE AND THE OTHER WAS ON THE VISHAY SYSTEM, WHICH RECORDED FEWER DATA.

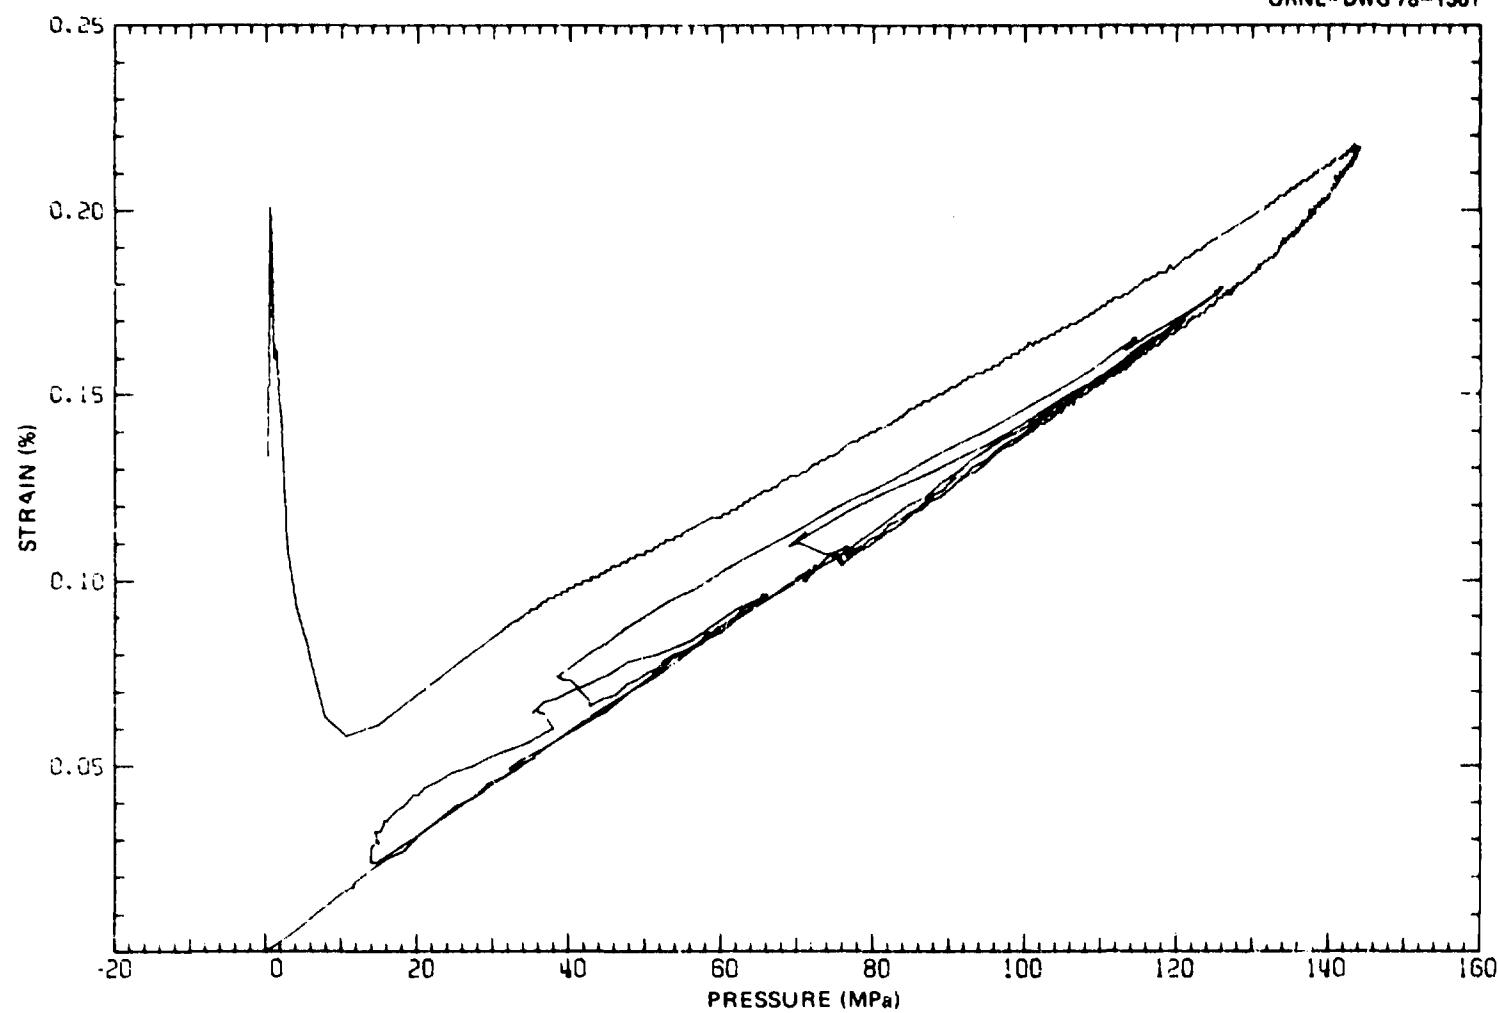
Fig. 5.2. Inside circumferential strain (XE 72) 180° from flaw vs pressure during four cycles in V-7A test.

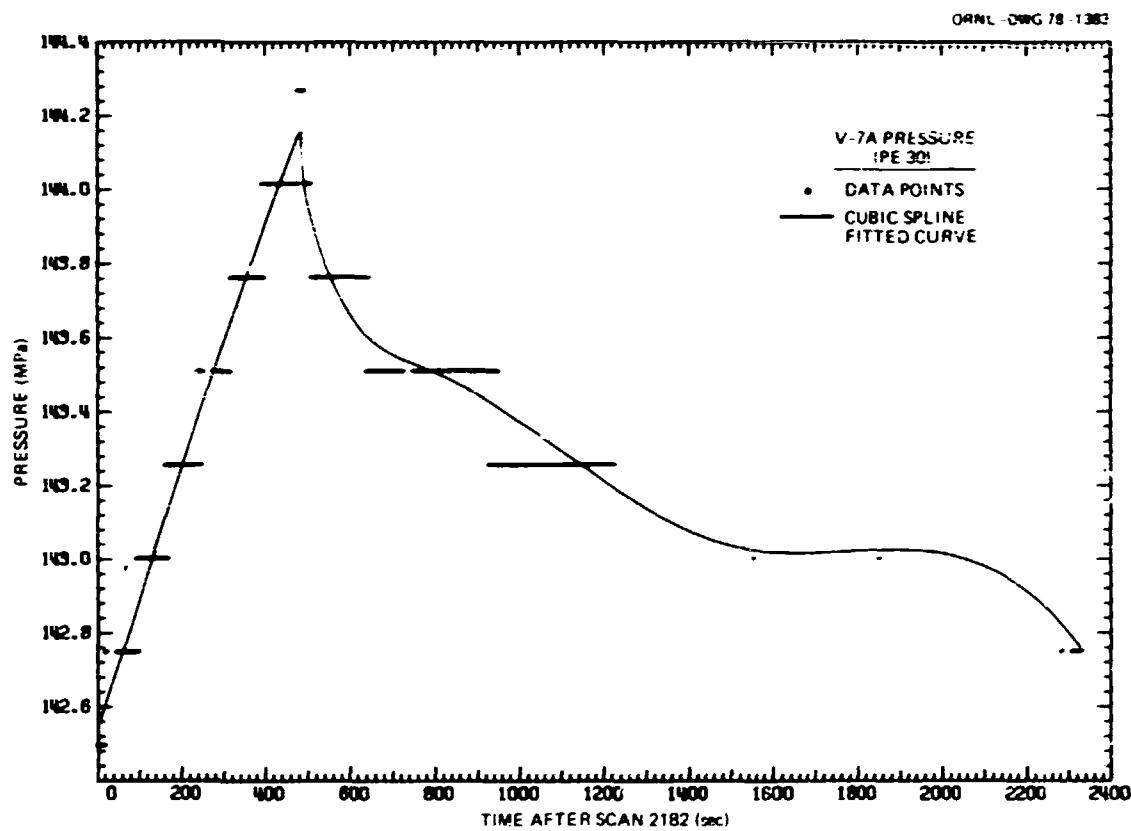
Fig. 5.24. Vessel pressure vs time during postrupture sustained load.

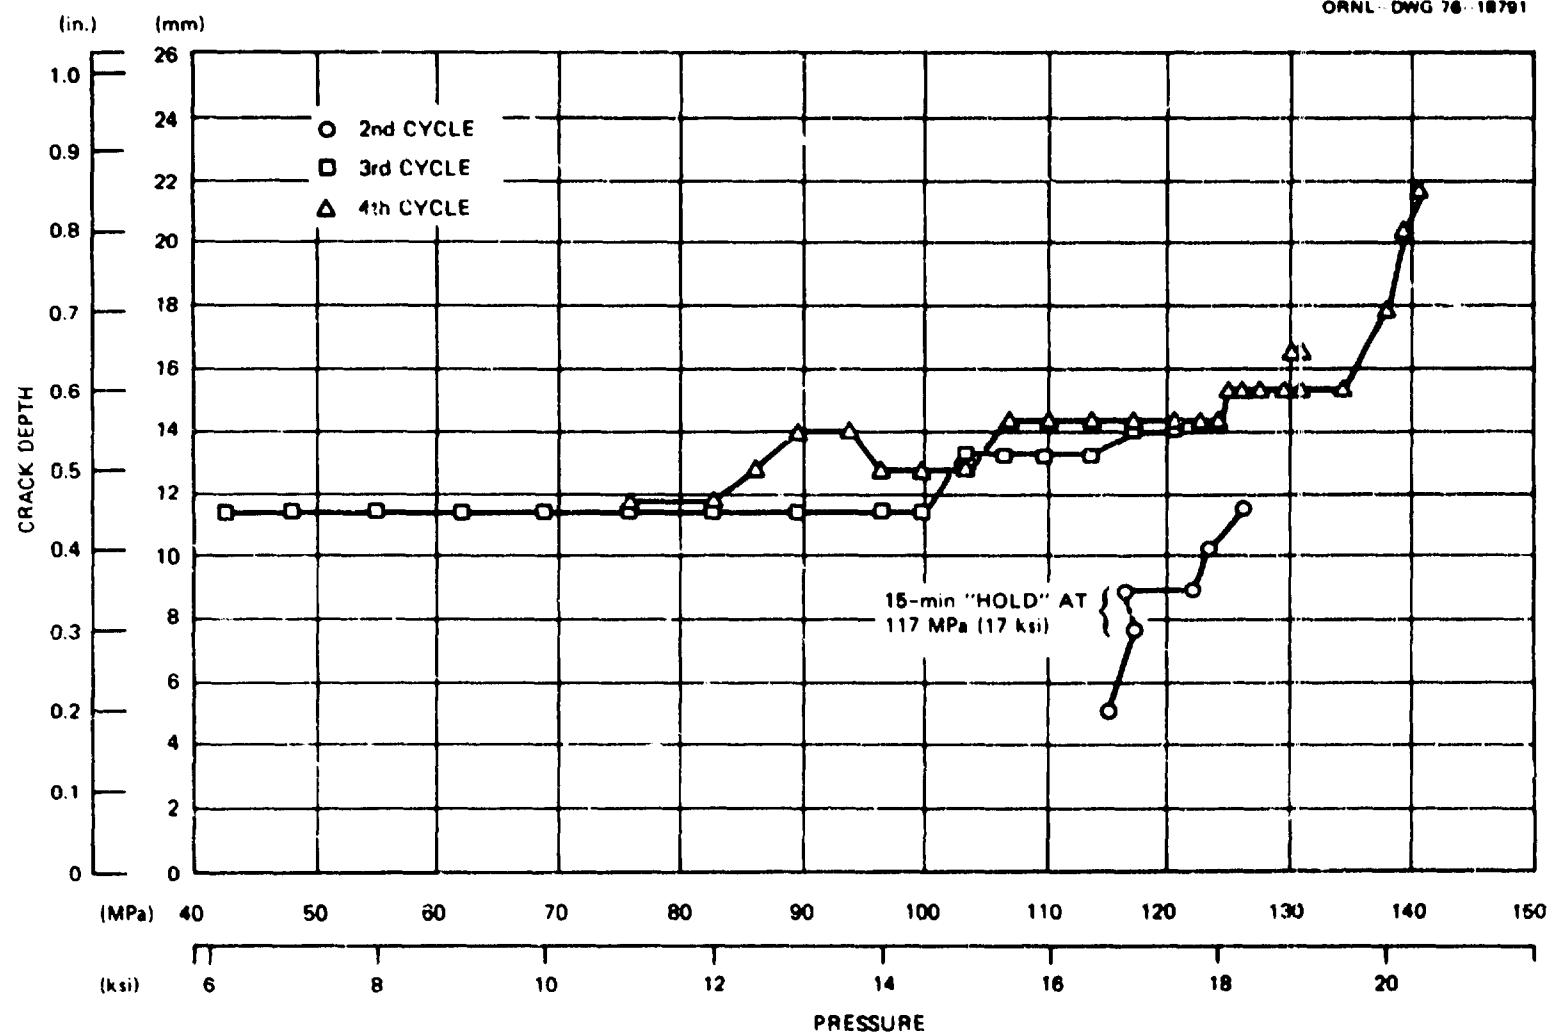
Fig. 5.33. Ligament crack depth as measured ultrasonically from machined bottom surface of the notch in vessel V-7A.

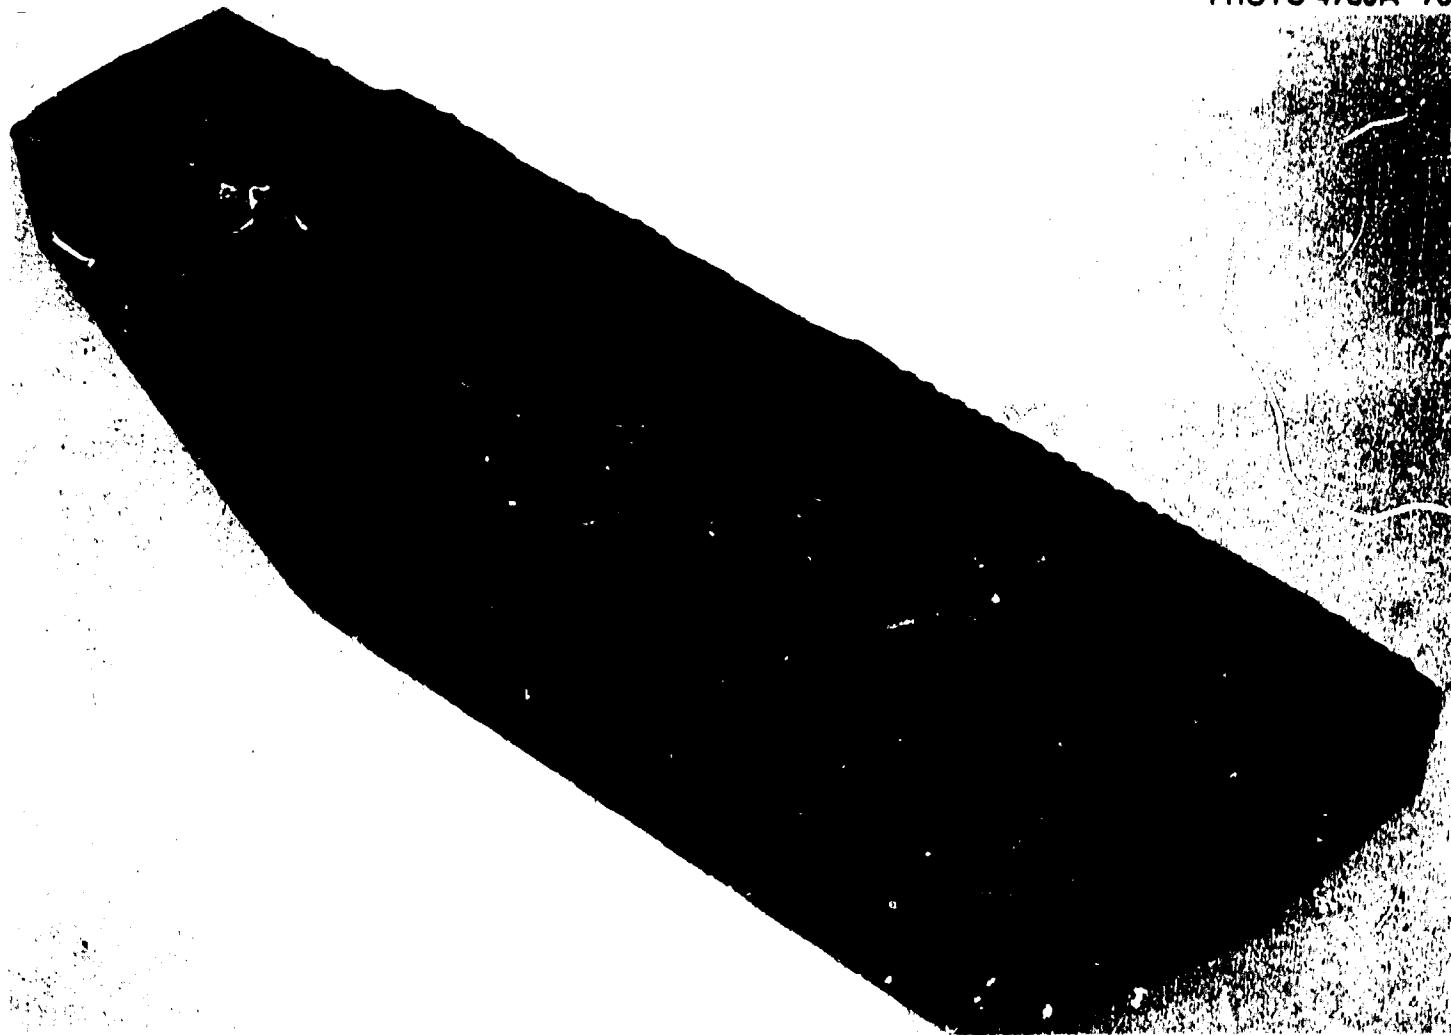
Fig. 5.40. Fracture zone flame cut from vessel V-7A (1 cm = 0.394 in.).

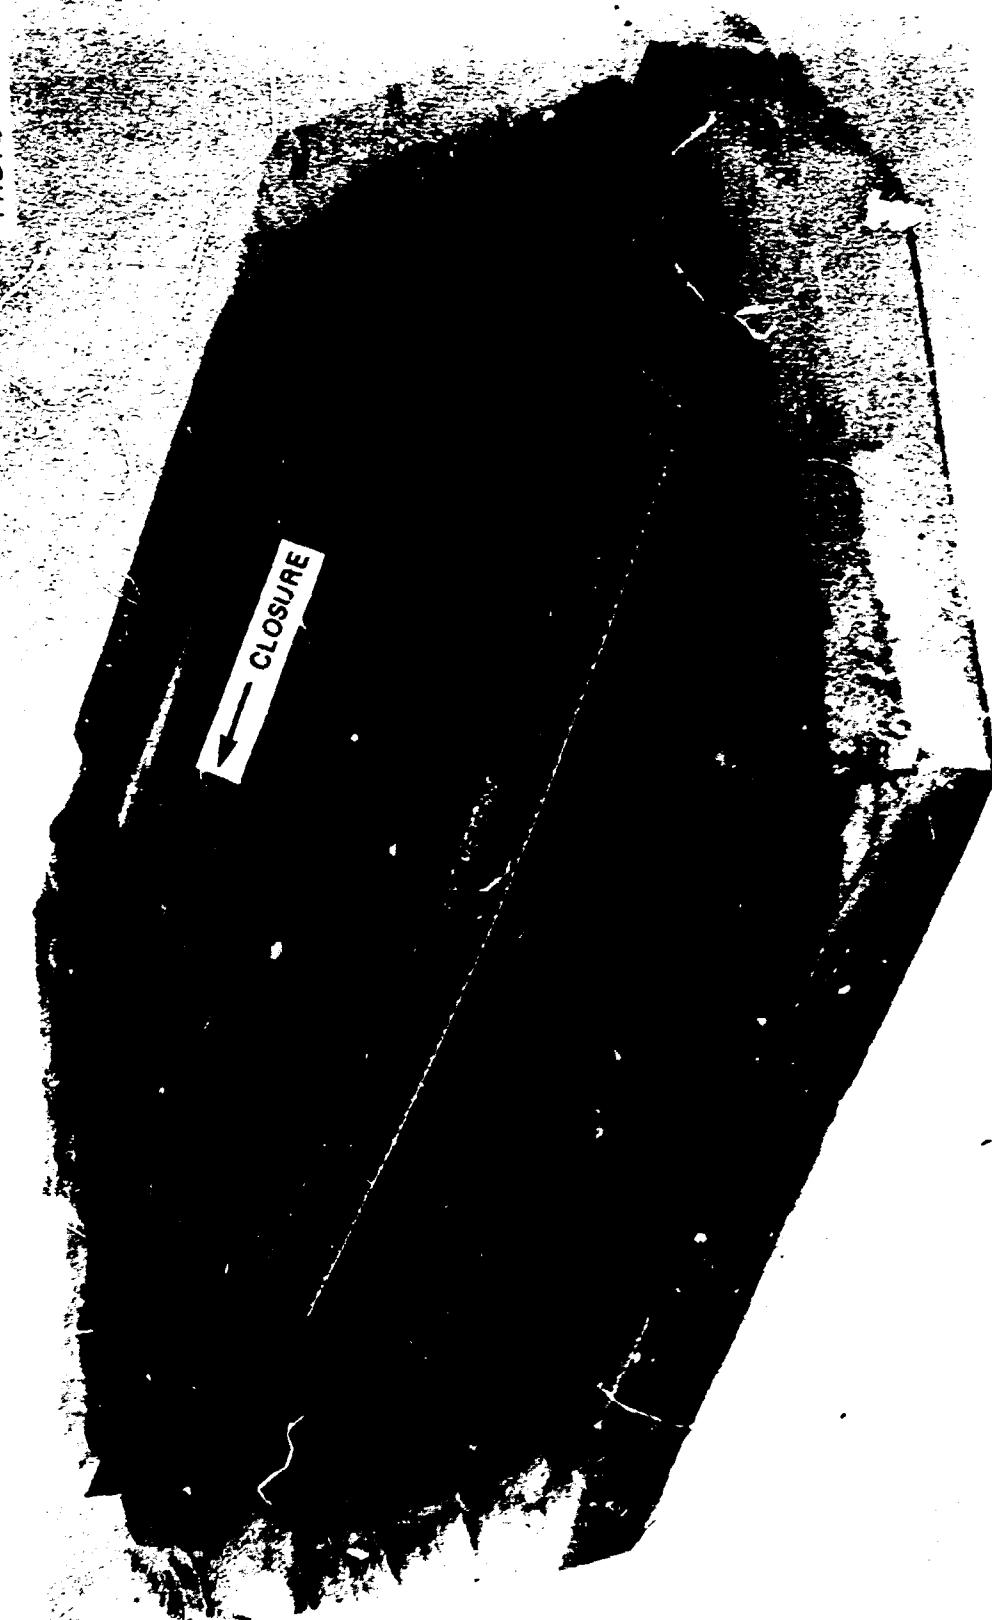
Fig. 5.41. Fracture surfaces of V-7A flaw (1 cm = 0.394 in.).

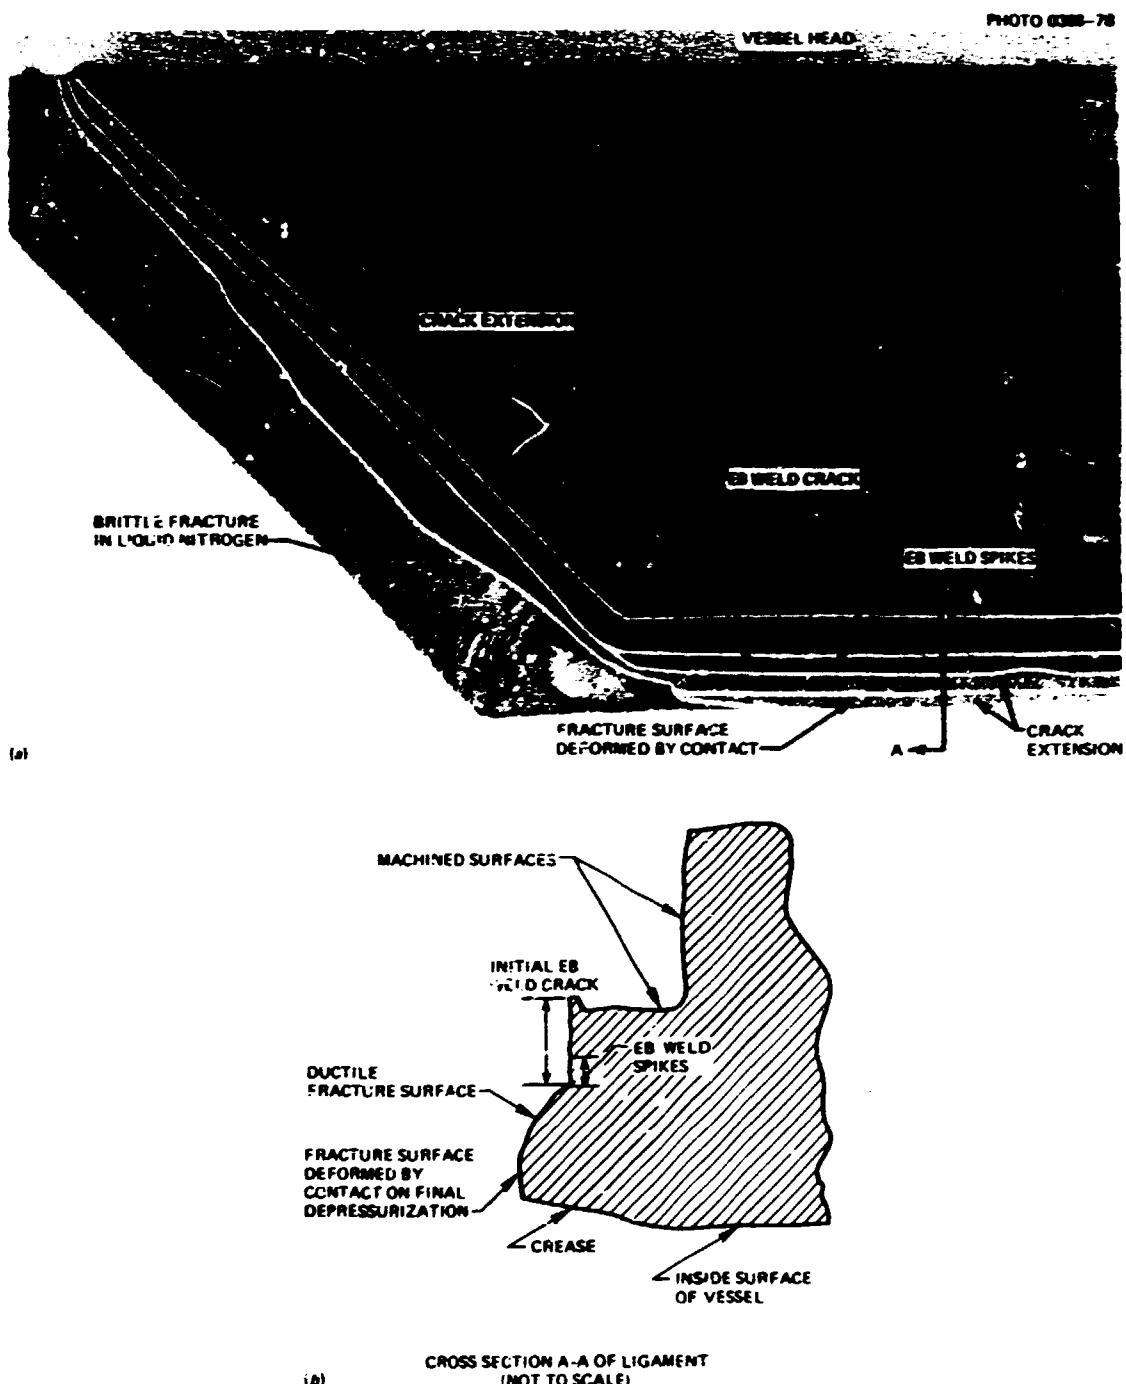
Fig. 5.42. Schematic of V-7A fracture surface.

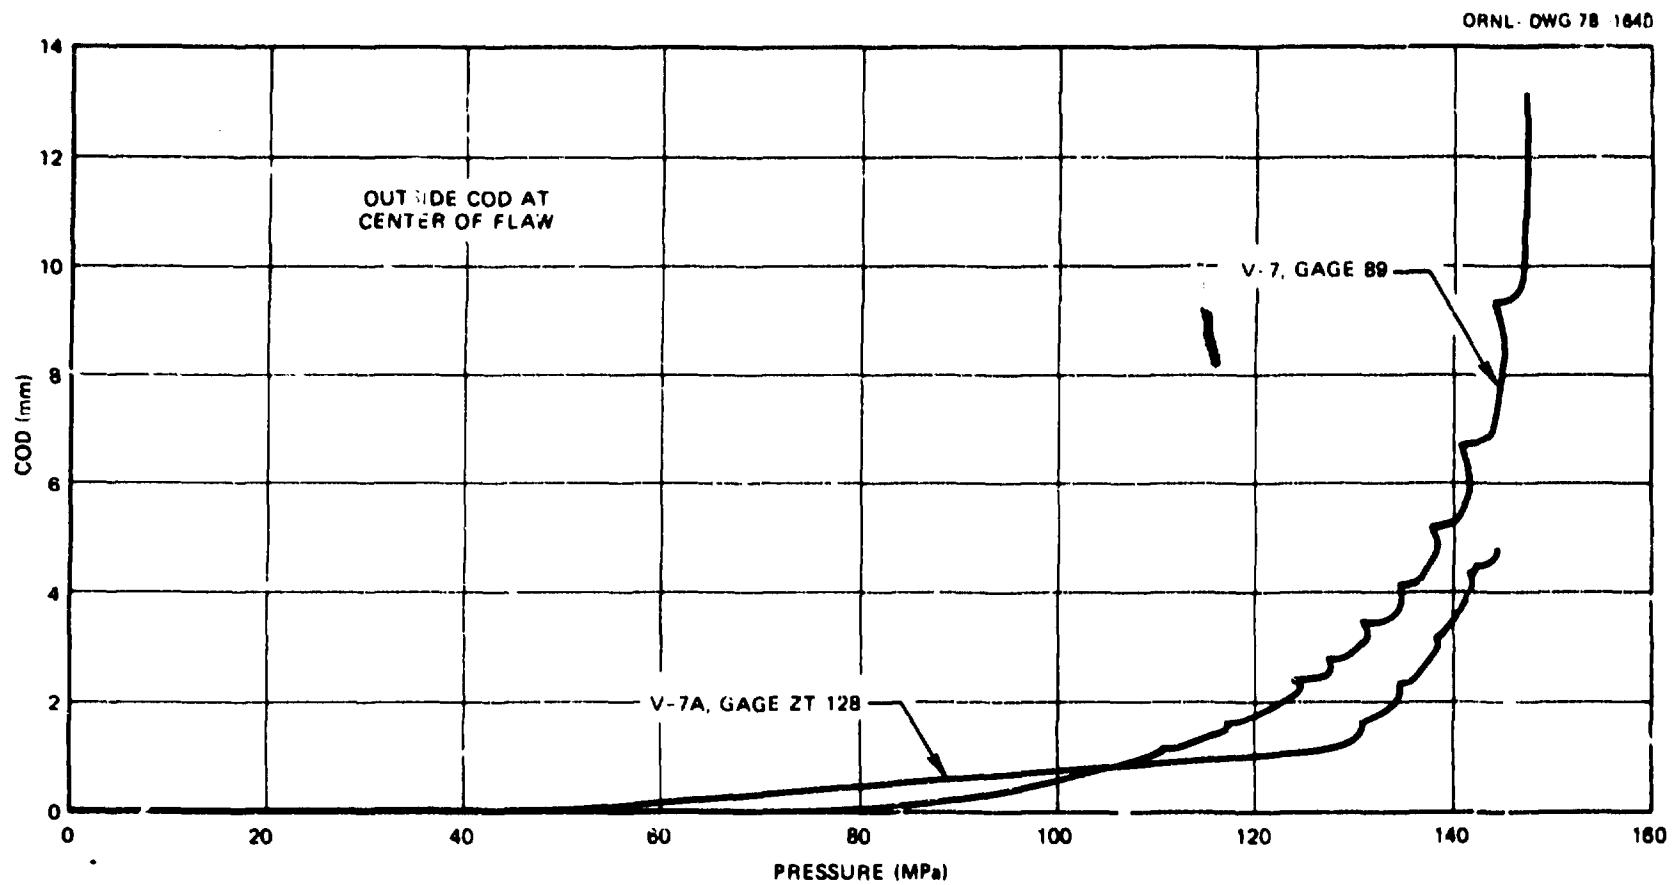
Fig. 6.2. Comparison of COD measurements in tests V-7 and V-7A
(1 MPa = 145.04 psi; 1 mm = 0.0394 in.).
