**Test of 6-in.-thick Pressure Vessels
Series 3: Intermediate Test Vessel V-7A
Under Sustained Loading**

ORNL/NUREG-9
Dist. Category NRC-5

TEST OF 6-IN.-THICK PRESSURE VESSELS
SERIES 3: INTERMEDIATE TEST VESSEL V-7A
UNDER SUSTAINED LOADING

Prepared by the
OAK RIDGE NATIONAL LABORATORY
Oak Ridge, Tennessee 37830
operated by
UNION CARBIDE CORPORATION
for the
DEPARTMENT OF ENERGY

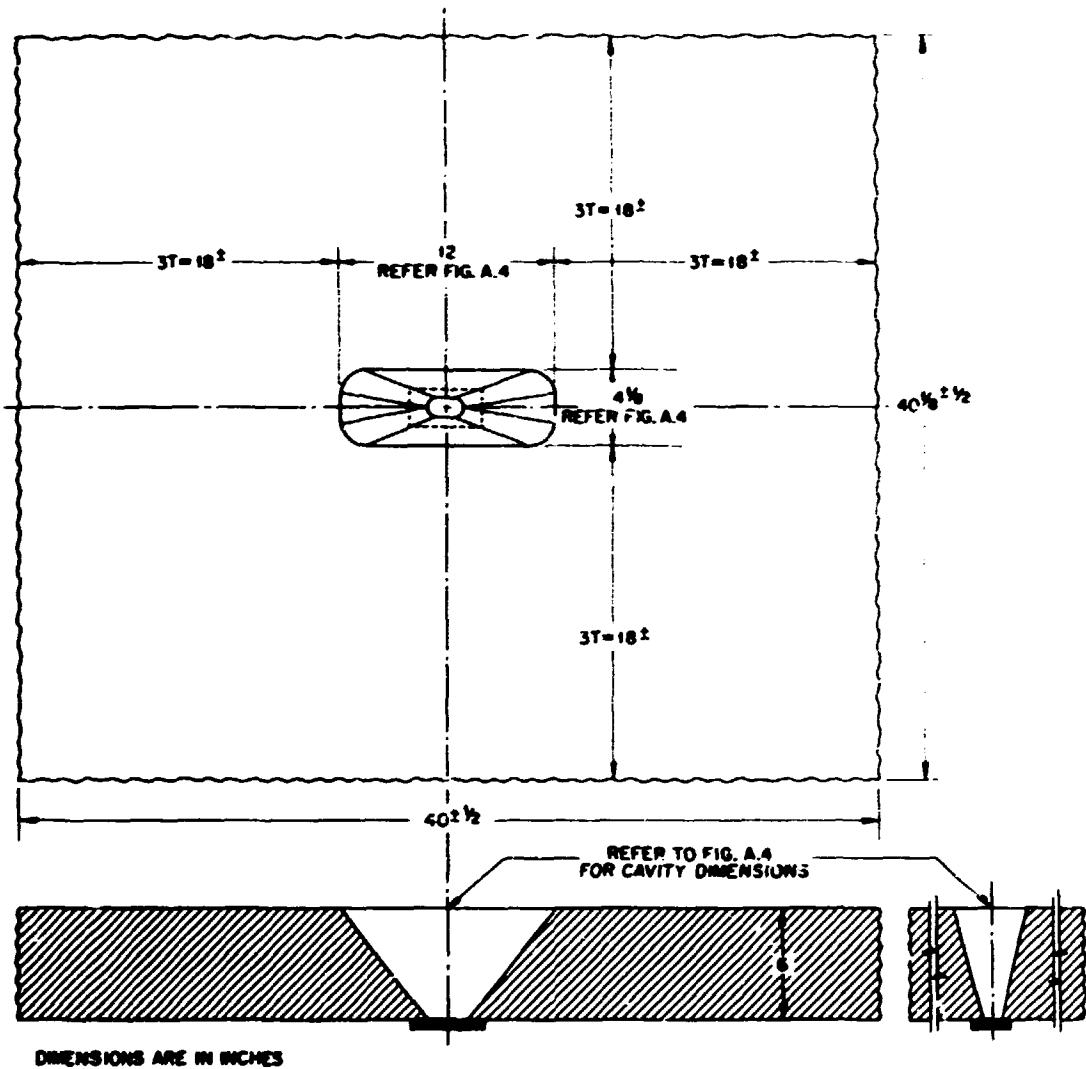
Fig. A.3. Preparations for 6-in. qualification plate weld. Welding position - 1G, fixed flat.

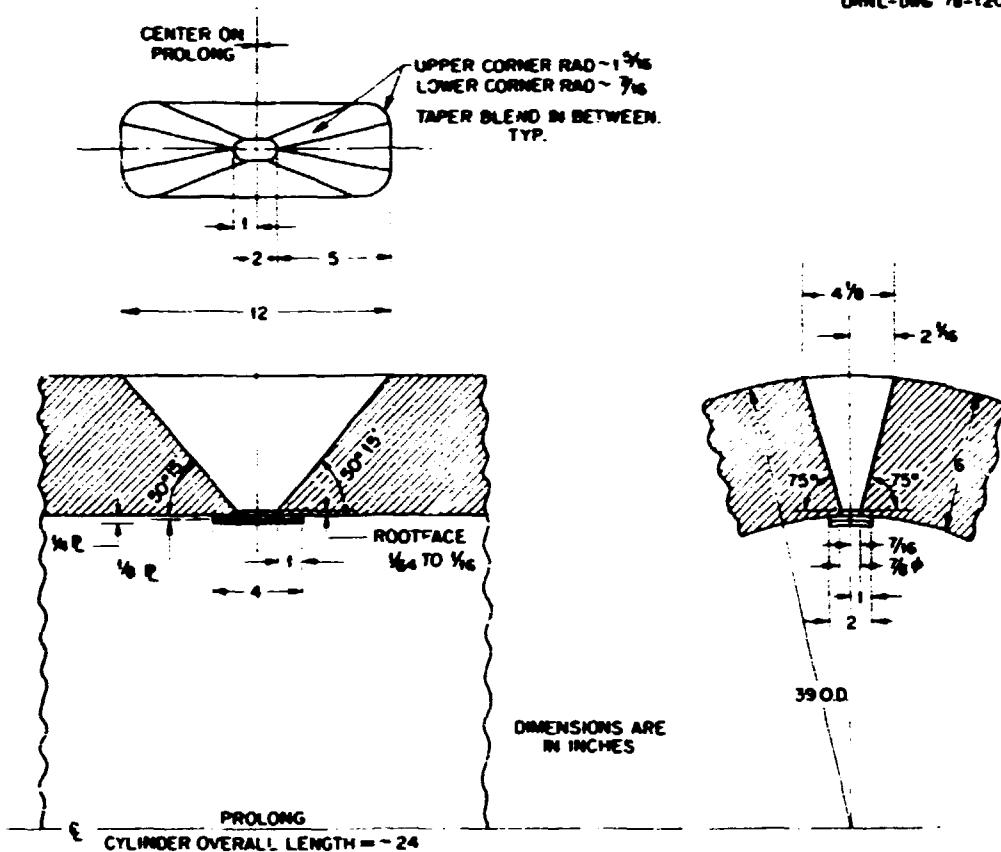
Fig. A.4. Weld repair preparations for intermediate test vessel V-7 prolongation. Welding position - 1G fixed flat. (Not shown: a center brace arrangement for the 1/8-in. backing plates and end restraints for the cylinder ends.

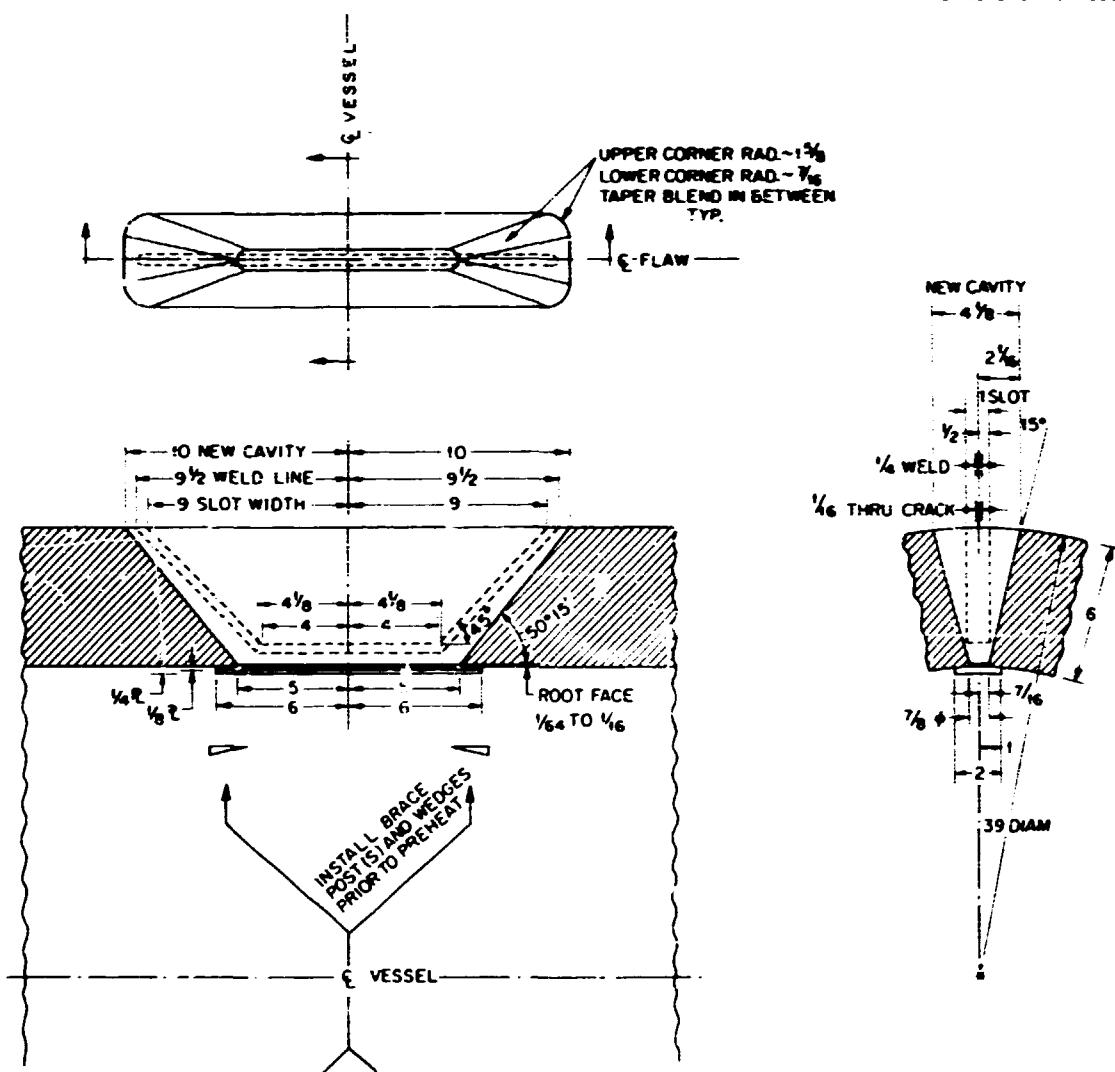
Fig. A.5. Weld repair preparation for intermediate test vessel V-7. Welding position - 1G, fixed flat.

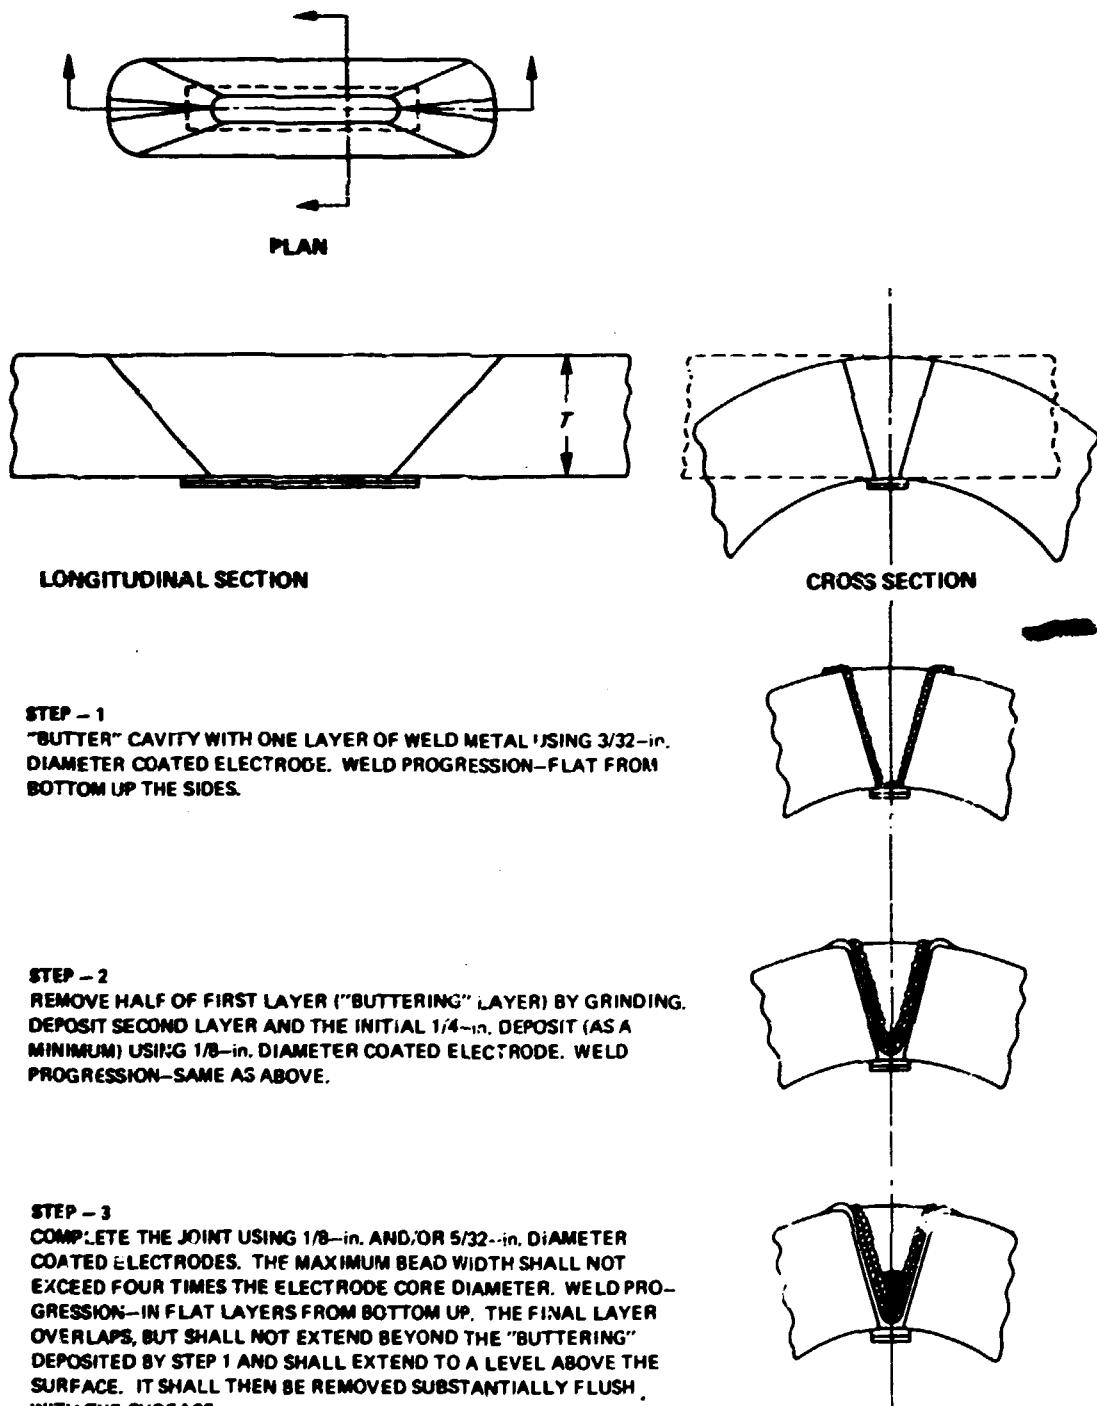
Fig. A.6. Half bead weld repair and weld temper bead reinforcement for heavy wall vessels and/or thick plates. Welding position - 1G, fixed flat.

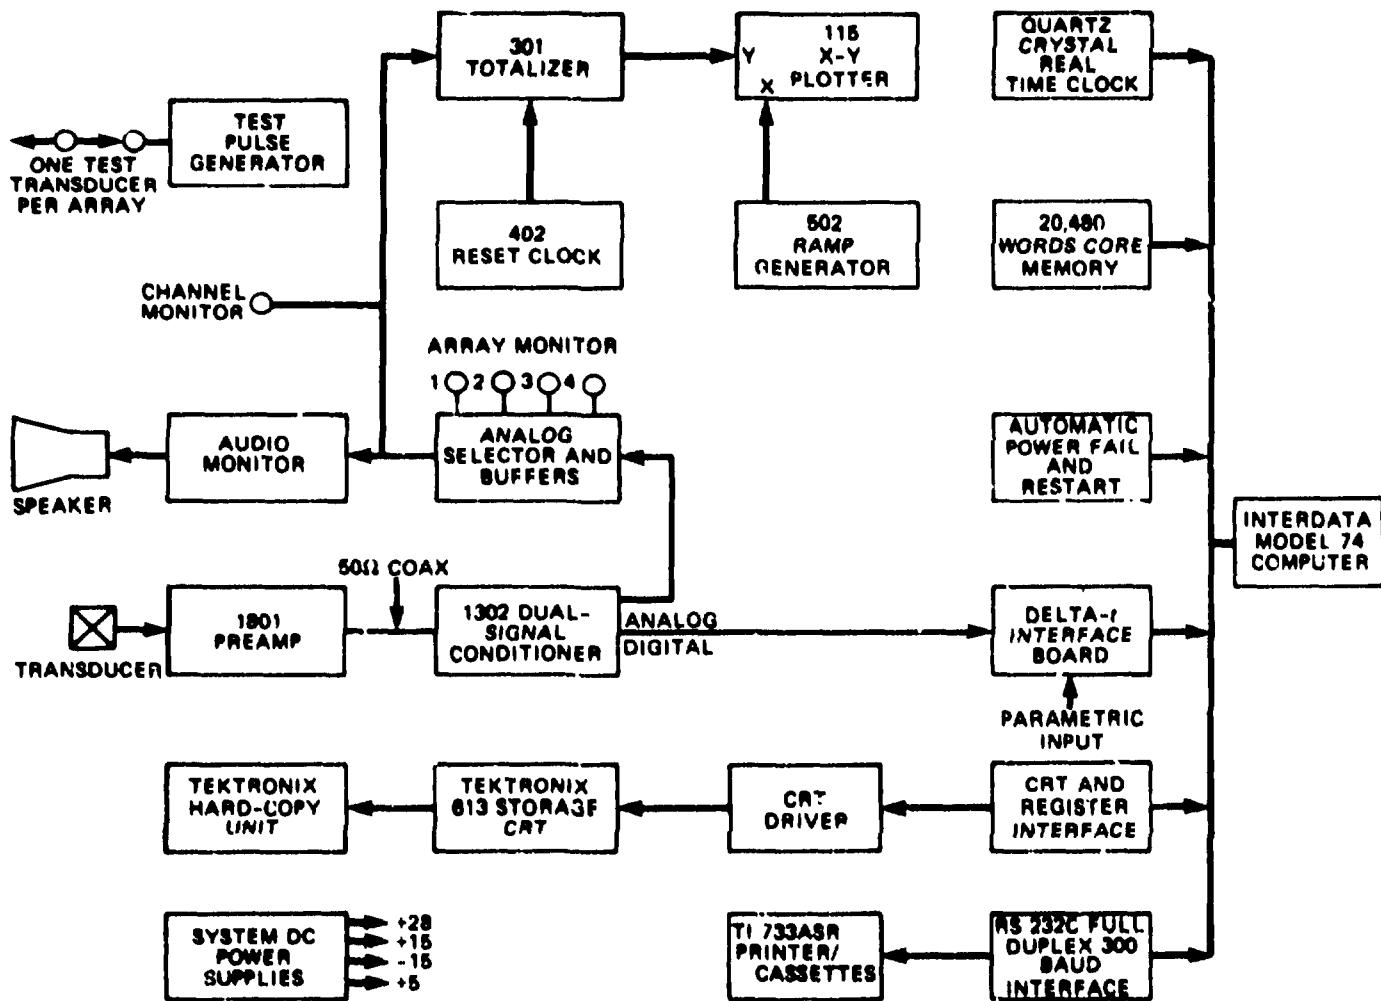
Fig. C.1. D/E model 1032 block diagram.

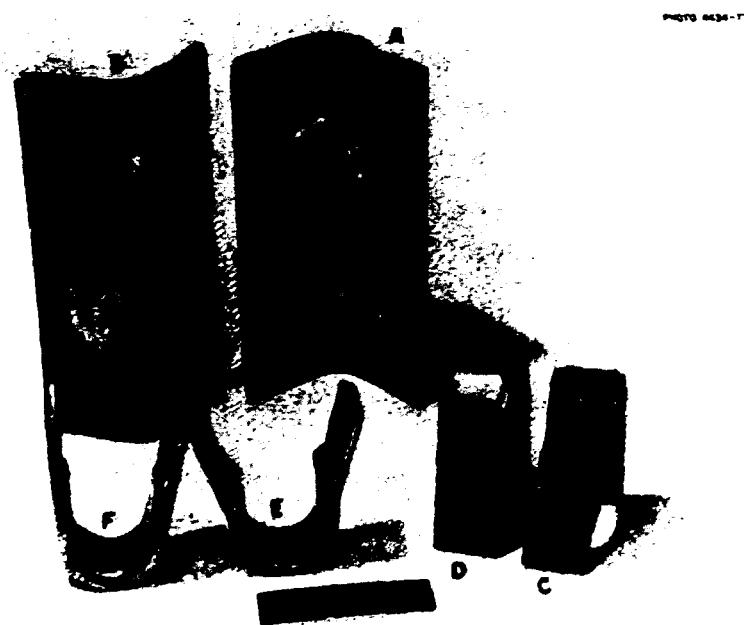
ORNL-DWG 78-1245

Fig. E.2. Patch weld test coupons for vessel V-7A.

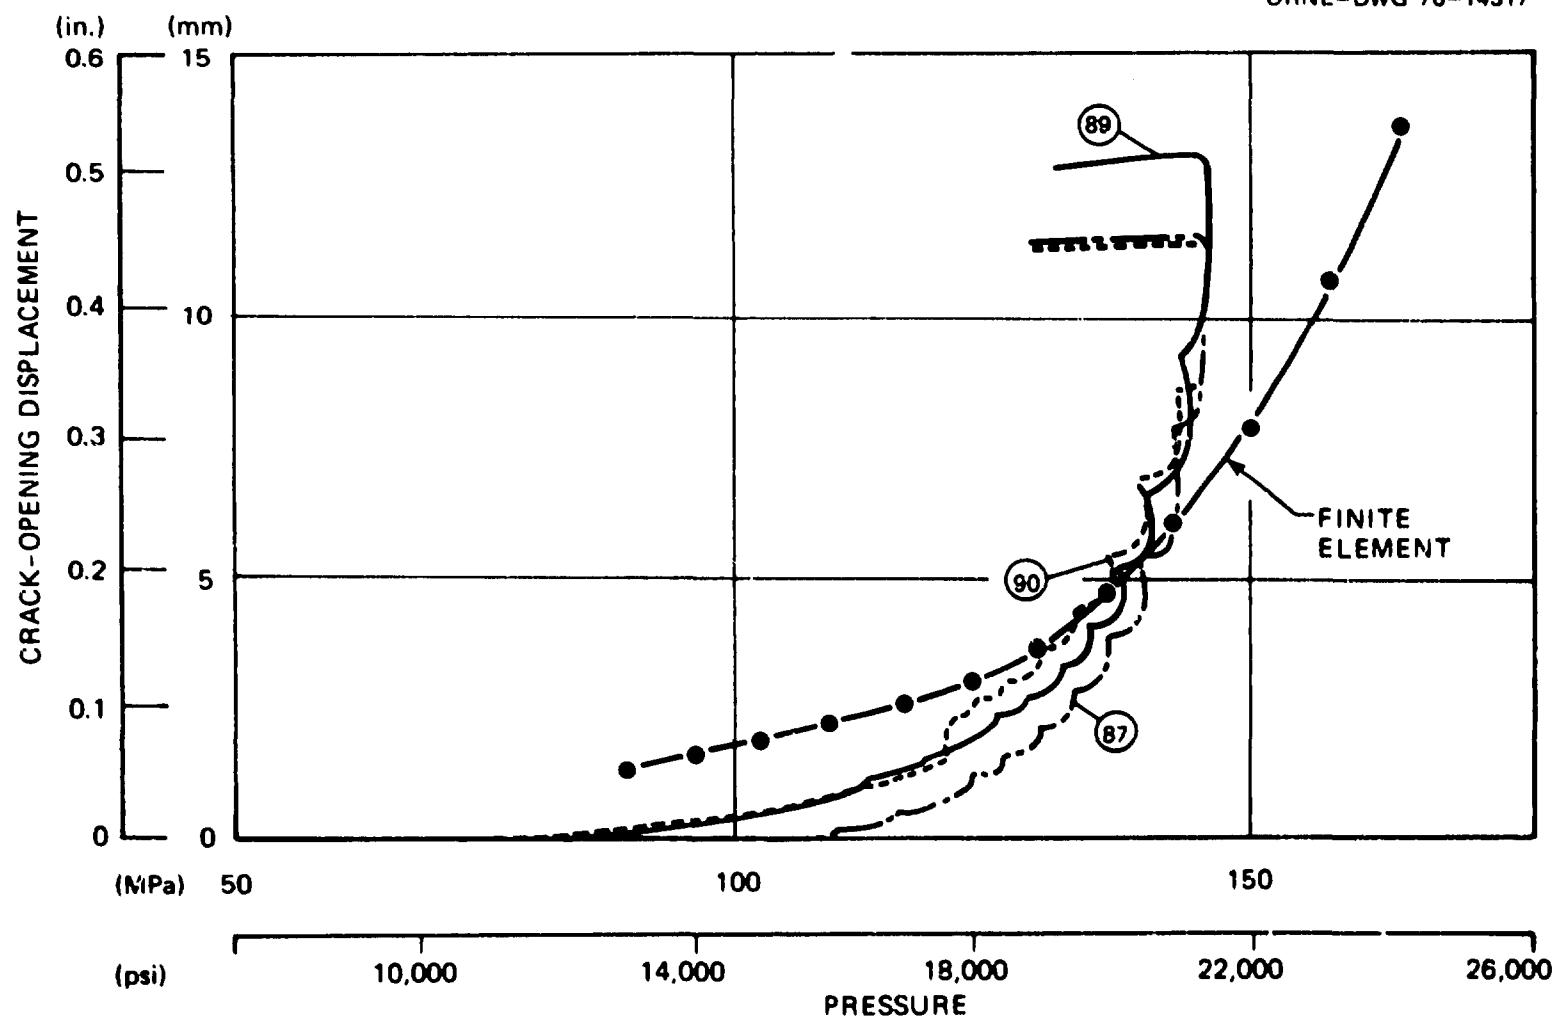
Fig. G.4. Crack-opening displacement vs pressure recorded by transducers 87, 89, and 90 in V-7 test compared with finite-element calculations.

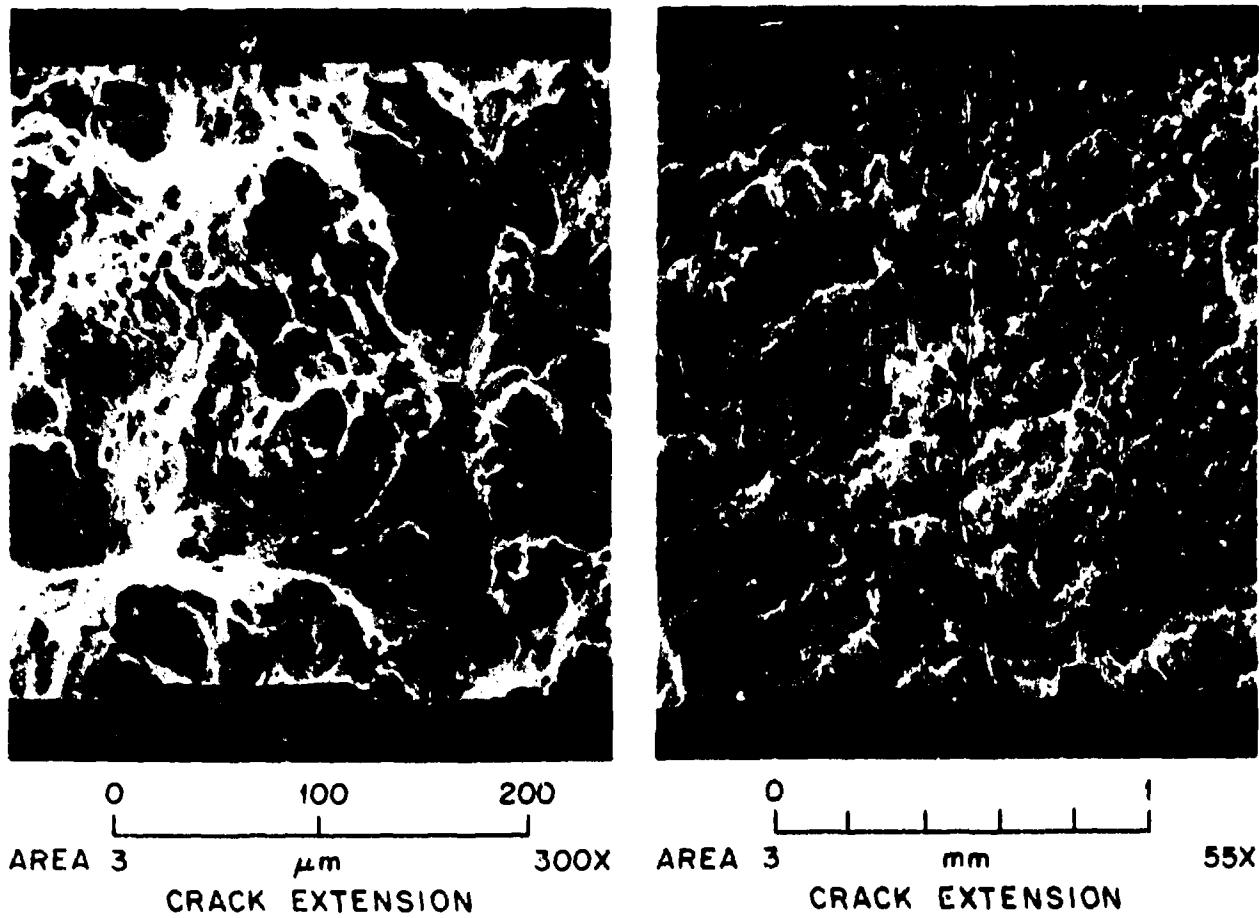
Fig. I.3. SEM photomicrographs of the region of the crack in V-7A that breached the inner wall (area 3 in Fig. I.1). The fracture surface was flat facets, indicative of an area that was plastically deformed. This deformation undoubtedly occurred when the internal pressure was released and the two surfaces were brought into intimate contact. Original reduced 27%.
