HEDL-SA-1225FP  
(Revision)

MICROSTRUCTURAL CHARACTERIZATION OF ADVANCED FERROUS  
ALLOYS EXPOSED TO LIQUID SODIUM

July 1977

Paper to be presented at the Tenth Annual Technical Meeting of the  
International Metallographic Society, Houston, Texas, July 20, 1977.

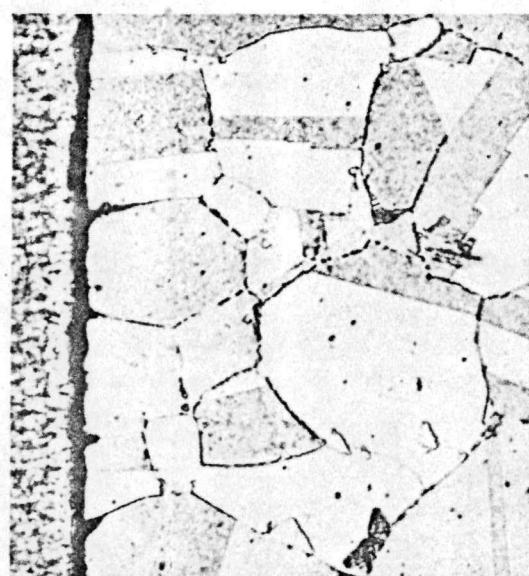
FIGURE 1

INCONEL 706

Sodium Exposed / 2000 hr / 700°C

OD Surface

Transverse / OD

Lamellae Formations and Localized Attack

As noted, the two alloys (A-286 and Inconel 706) which show the lowest corrosion rate also exhibit similar morphological features after sodium exposure, i.e., grain-orientation dependent dissolution giving rise to lamella-type surface formations (Figure 1). For each material, surface depletion of Ti, Cr, and Ni has been observed; in addition, surface depletion of Al and Nb has been observed in Inconel 706, penetrating to a depth of  $10\mu\text{m}$ .

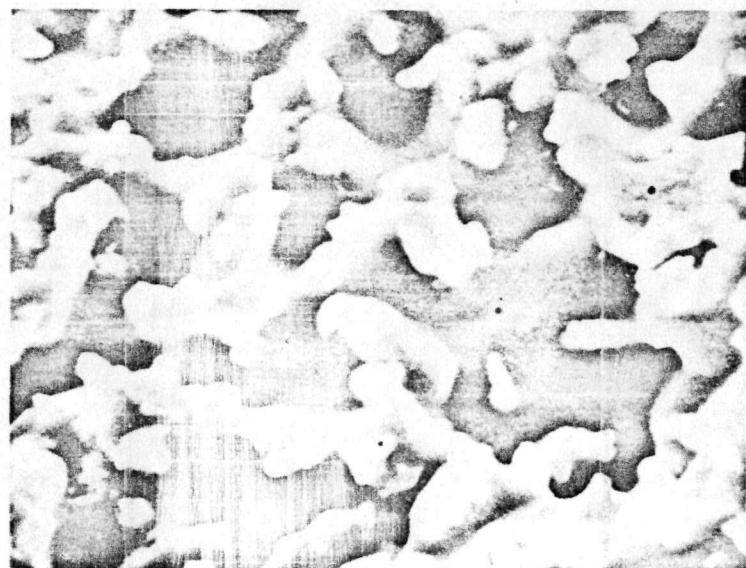
FIGURE 2

NIMONIC PE 16

Sodium Exposed / 2000 hr / 700°C

OD Surface

Transverse/OD

Mo-Rich Corrosion Resistant Phase

Alloys Nimonic PE16, AISI 316, M-813 (sintered) and Inconel 718 exhibit a somewhat higher (intermediate) sodium corrosion rate. Molybdenum-rich node formations containing Fe with lesser amounts of Cr and Ni, which appear to be resistant to sodium corrosion, appear on the exposed surface (Figure 2). Analysis of the nodes extracted from the surface indicated these particles to be of  $\text{Fe}_2\text{Mo}$  Laves phase. In addition, the X-ray intensity data indicated the molybdenum enrichment of the surface to be a function of not only the molybdenum concentration of the alloy, but also the corrosion rate of the alloy. An equally important feature to note is that the alloys which contain Ti, Al, Cr, and Ni (PE16, M-813, and Inconel 718) also show evidence of grain boundary attack and hole formations after sodium exposure, suggesting the removal of a specific phase or compound. Specifically, grain boundary attack to a depth of  $\sim 10\mu\text{m}$  has been observed for Nimonic PE16 and somewhat greater attack (to a depth of  $20\mu\text{m}$ ) has been observed for M-813. Severe "pocket attack" to a depth of  $40\mu\text{m}$  has been observed for Inconel 718. As expected, a ferritic surface, approximately  $4-5\mu\text{m}$  thick is found on the AISI 316 reference material.
