"FUEL ROD MECHANICAL DEFORMATION DURING
THE PBF/LOFT LEAD ROD LOSS-OF-COOLANT EXPERIMENTS"

CONF-800723--18

D. J. Varacalle, Jr., P. E. MacDonald, S. Shiozawa, W. E. Driskell
EG&G Idaho, Inc.
P.O. Box 1625
Idaho Falls, Idaho 83401

ABSTRACT

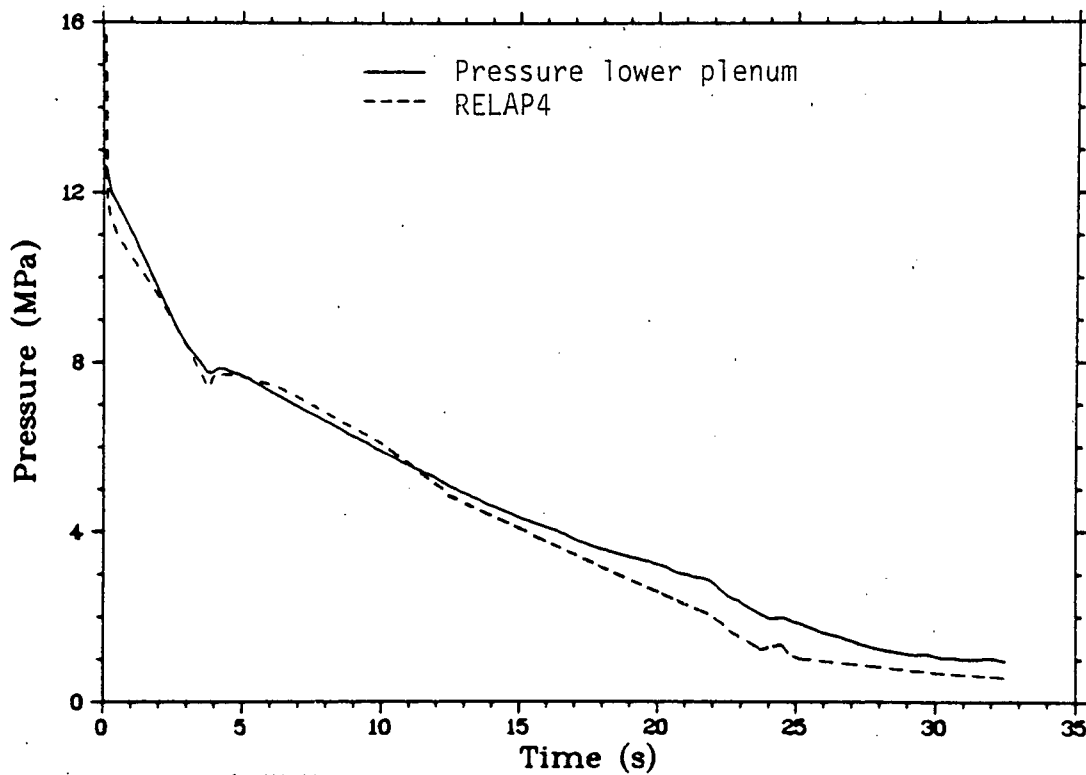
Figure 4. Comparison of lower plenum pressure for Test LLR-5 with RELAP4.

Figure 4 presents the measured and calculated (RELAP4) system depressurization in the lower plenum during Test LLR-5. The steady state pressure prior to blowdown was approximately 15.5 MPa. With the initiation of the cold leg blowdown transient, the system depressurized to the vapor pressure of the coolant (12.5 MPa corresponding to a saturation temperature of 601 K) in approximately 50 ms. The cold leg flow became choked at the converging - diverging nozzles at approximately 50 ms. The system was fully depressurized by about 30 s.

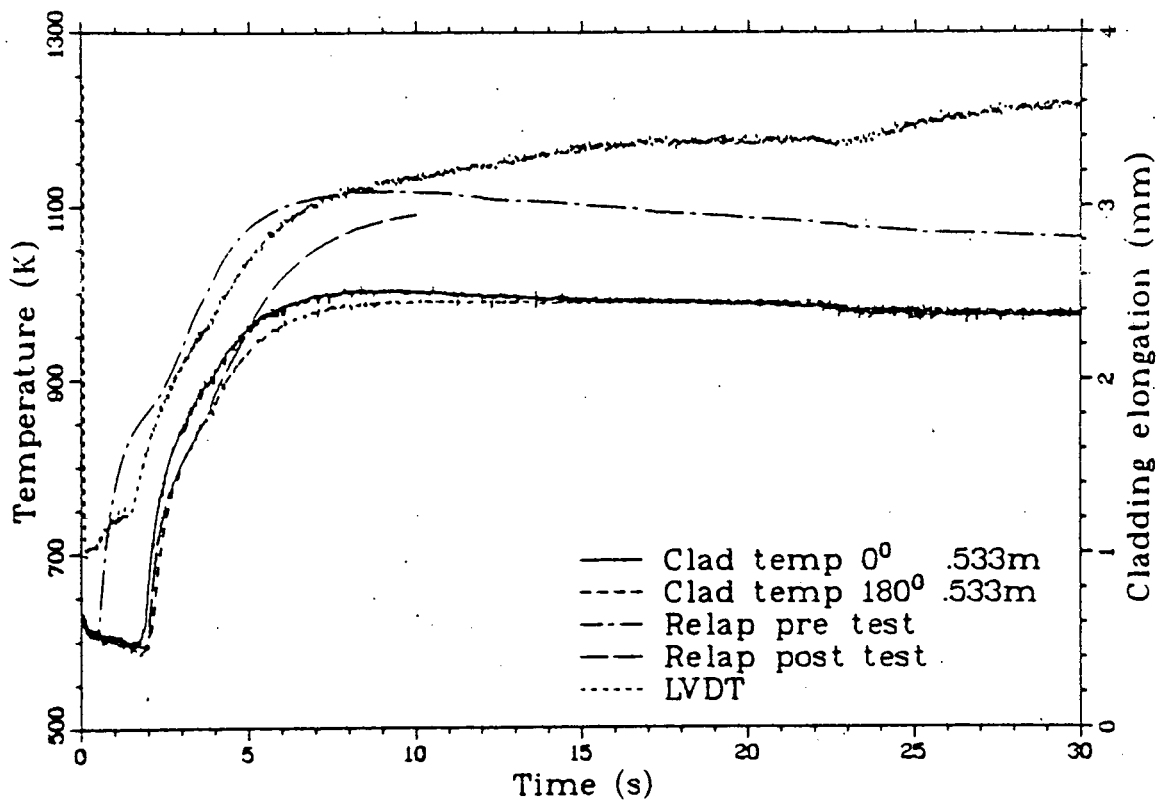
Figure 8. Thermal and mechanical behavior for Rod 312-1 for Test LLR-5.

Figure 8 illustrates the cladding temperature and elongation response of Rod 312-1 during the first 30 seconds of Test LLR-5. The peak rod power for Rod 312-1 was calculated to be 47.3 kW/m just prior to blowdown. The cladding surface thermocouple data at the 0°-0.533 m thermocouple location indicated that the rod achieved DNB at 1.8 seconds and reached a maximum surface temperature of 1000 K at 10 seconds. The 180°-0.533 m thermocouple achieved DNB at 1.95 s and reached a maximum surface temperature of 990 K at 10 seconds. The LVDT first recorded a moderate increase in cladding length at 0.5 seconds, and then a stronger indication at 1.5 seconds. The rod departed from nucleate boiling at an elevation lower than the cladding thermocouples and the film boiling propagated up the rod. This indicates that the surface thermocouples delayed DNB in the upper portion of the rod and may have affected the transient response of the fuel rods.

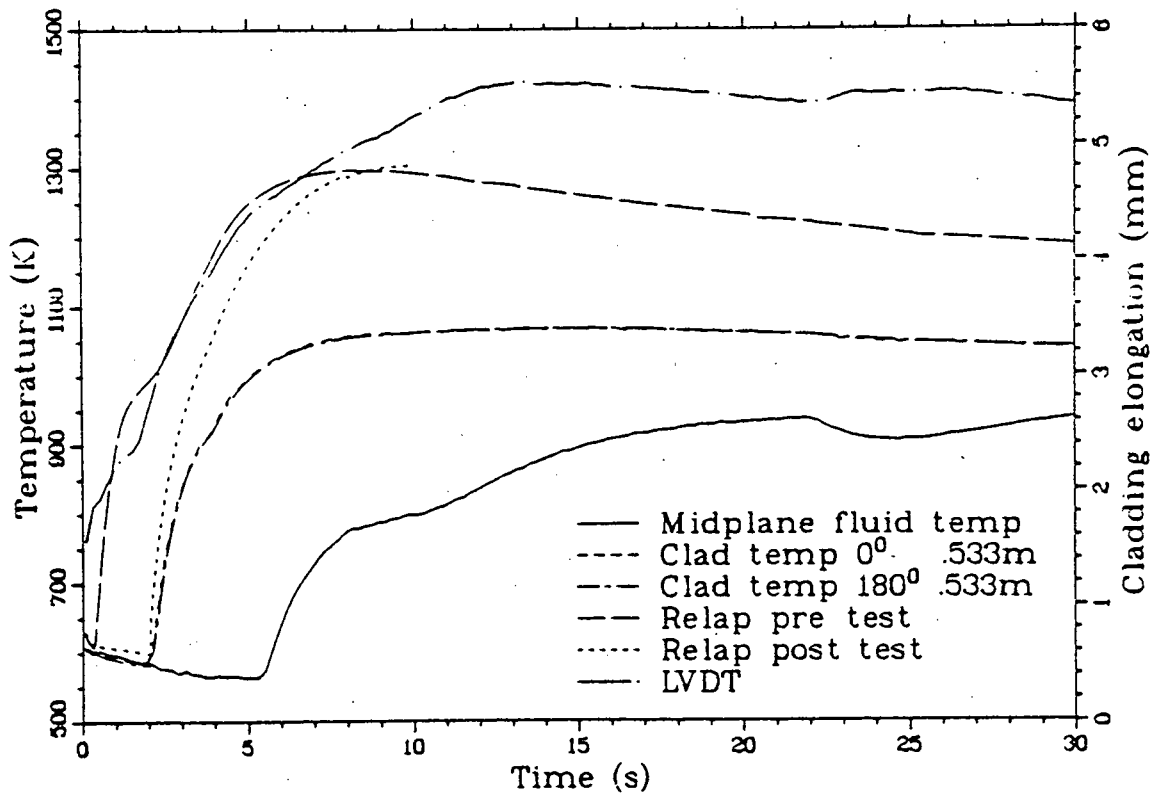
Figure 10. Thermal and mechanical behavior for Rod 345-1 for Test LLR-4A.

LLR-5 and -4 was similar to the response of Rod 312-1 as indicated by the maximum temperatures shown in Table 1. Figure 10 illustrates the cladding temperature, cladding elongation, and coolant midplane temperature response of Rod 345-1 during the first 30 seconds of Test LLR-4A. The peak rod power for Rod 345-1 was 53.3 kW/m just prior to blowdown. The 180° 0.533m thermocouple overlays the 0° thermocouple throughout the blowdown transient. The cladding temperature data indicate that the rod achieved DNB at approximately 2.0 s at both thermocouple locations. Both thermocouples measured a maximum cladding temperature of 1070 K at 15 s. The cladding elongation transducer indicated a moderate increase at 0.25 s with a stronger indication at 1.5 s as CHF occurred over a significant length of the fuel rod surface below the thermocouples and then propagated up the rod. This, again, indicates a thermocouple effect on fuel rod response.

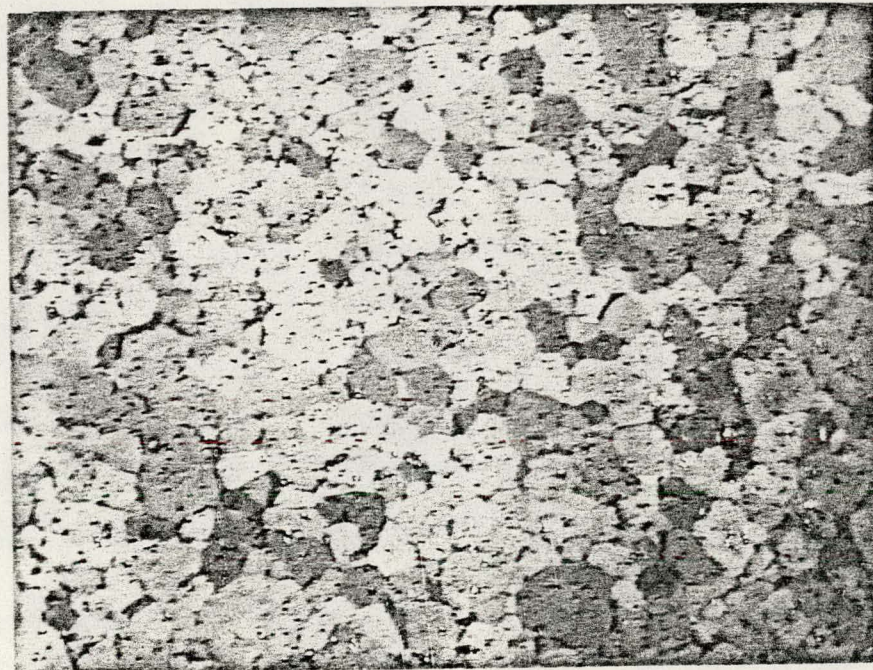
Figure 16. Rod 312-1 transverse cladding microstructure from 0.53 to 0.55 m.

range of 1100 to 1270 K. Figure 16 presents the cladding microstructure at the thermocouple junctions located 0.533 m above the bottom of the fuel stack. Equiaxed α -zircaloy structure is present throughout the entire cladding thickness, including some β precipitates at the grain boundaries, which indicates temperatures in the vicinity of 1100 to 1150 K. A longitudinal section was made at an axial elevation at 0.49 to 0.51 m above the bottom of the heated length (below the thermocouples) in the 0-180° plane to characterize the axial temperature profile of the rod. Again, an alpha plus beta zircaloy structure was observed.

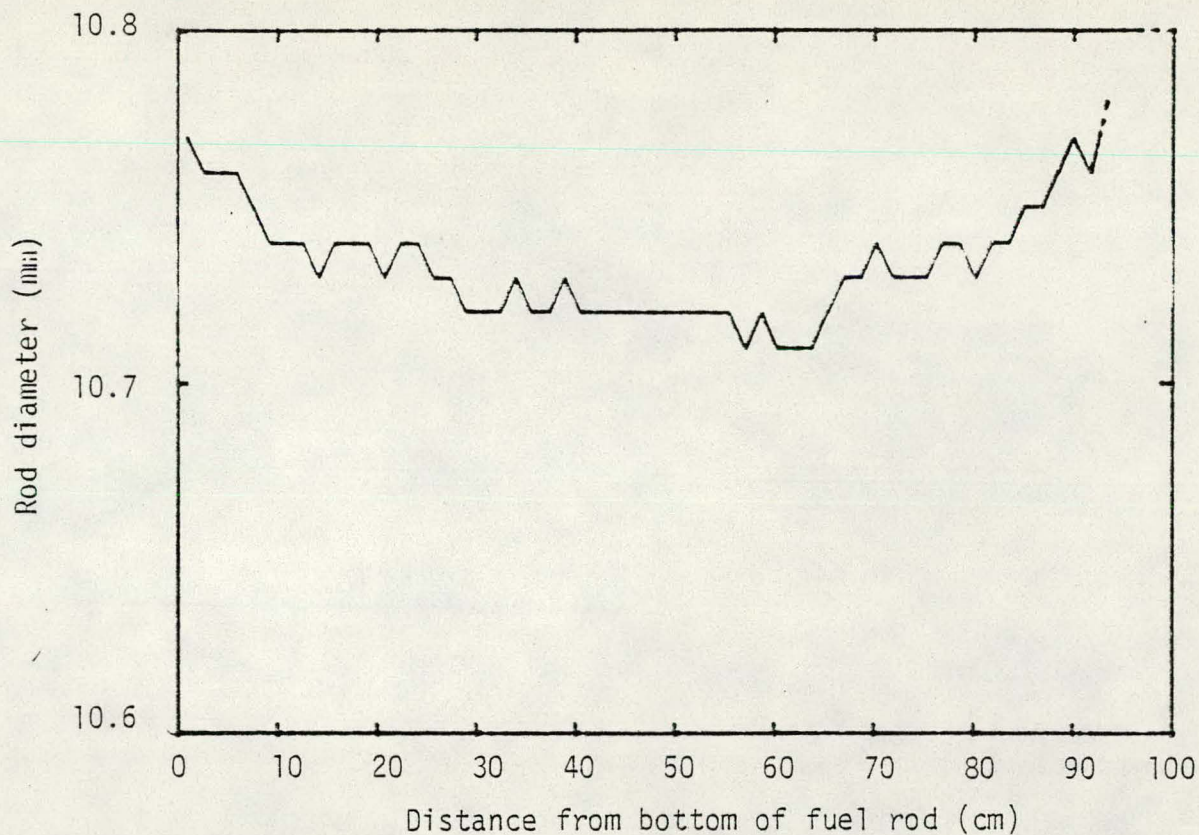
Figure 17. Postirradiation examination measurements of cladding diameter for Rod 312-1.

Diametral measurements were made 90 degrees apart along the length of each fuel rod. The averaged data for Rod 312-1 is plotted versus the fuel stack axial length in Figure 17. The rod exhibited collapse, with the maximum diametral decrease of 0.06 mm along the rod midsection about 61 cm from the bottom of the active fuel stack. The location of maximum collapse did not correspond to the axial region of maximum power (45.7 cm). The decrease in diameter at this point was only slightly less than the maximum decrease.

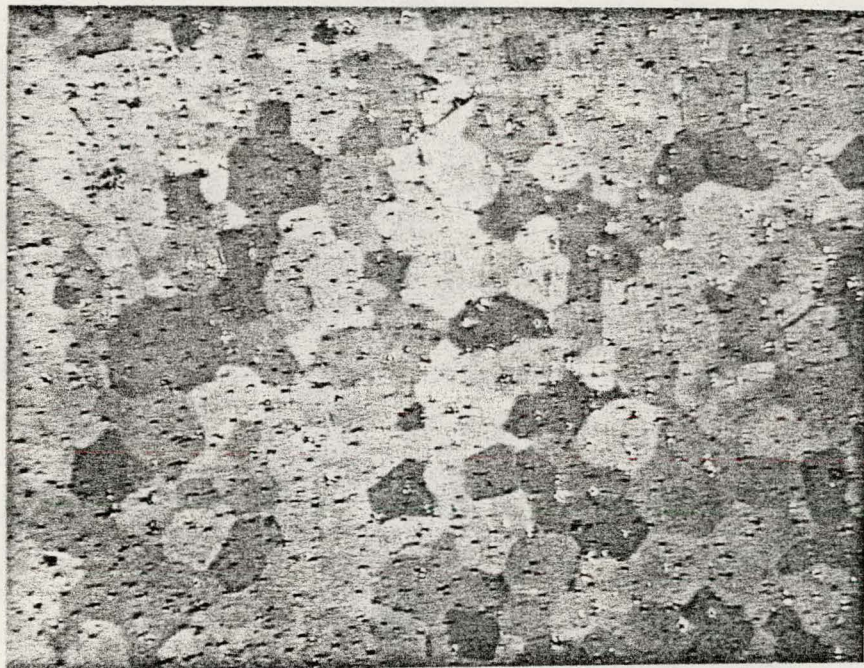
Figure 18. Rod 345-1 transverse cladding microstructure at 0.533 m.

Permanent changes to the cladding of Rod 345-1 also occurred as a result of the three successive blowdowns it was subjected to (LLR-5, LLR-4 and LLR-4A). A maximum temperature of 1070 K was measured at the 0.533 m location on Rod 345-1. The cladding microstructure which corresponds to this temperature is the recrystallized α -zircaloy regime which exists in the temperature range of 920 to 1100 K. Figure 18 presents the cladding transverse microstructure at the thermocouple junctions located 0.533 m above the bottom of the fuel stack. As expected, recrystallized α -zircaloy structure was present throughout the cladding thickness thereby confirming the thermocouple measurement.

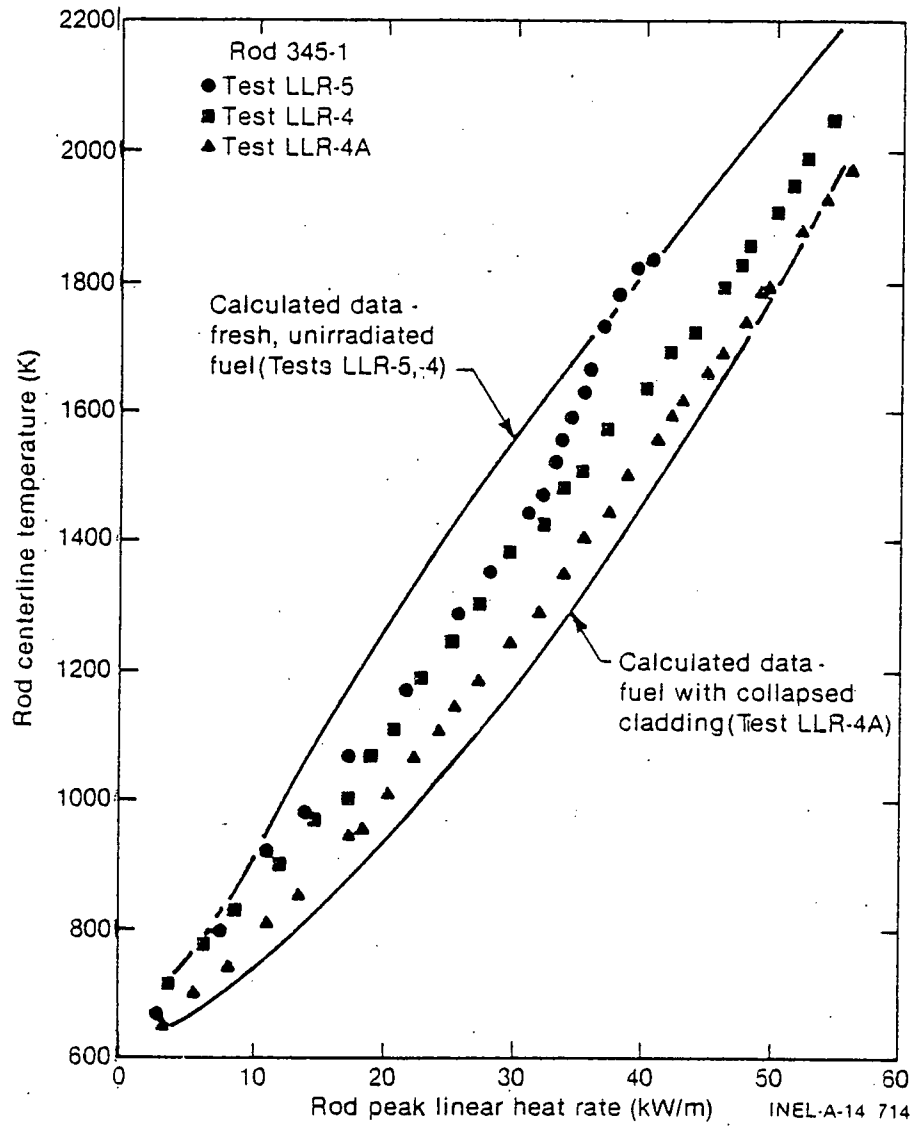
Figure 21. Comparison of steady-state response of Rod 345-1 with FRAP-T5 during Tests LLR-5, -4, and -4A.

The centerline temperature data obtained from fuel Rod 345-1 during Tests LLR-5, -4, and -4A are illustrated in Figure 21 with the corresponding FRAP predictions. For linear heating rates less than 30 kW/m, the measured centerline temperatures for Tests LLR-5 and -4 agree closely. At heating rates greater than 30 kW/m, the data for the two tests begins to diverge. This is not attributed to cladding deformation occurring during the LLR-5 test since Olsen's criteria indicated the fuel rod only reached incipient buckling at the thermocouple locations. The difference could be attributed to significant pellet relocation during LLR-4 that resulted in an decrease in the radial thermal resistance across the fuel rod.

Comparison of the steady state centerline temperature data from Tests LLR-4 and -4A for Rod 345-1 indicates that the LLR-4A data is consistently lower than the LLR-4 data. Since waisting was verified on fuel rod 312-1 after Test LLR-4, cladding collapse probably occurred on portions of all of the other fuel rods during the LLR-4 test. The lower centerline temperature recorded during the steady state portion of the LLR-4A test is a positive indication of collapsed cladding and a higher gap conductance for Rod 345-1 prior to the LLR-4A blowdown transient.
