SOME RECENT OBSERVATIONS ON THE RADIATION BEHAVIOR OF URANIUM SILICIDE DISPERSION FUEL*

Gerard L. Hofman
Argonne National Laboratory
Argonne, Illinois 60439

International Meeting on
Reduced Enrichment for Research and Test Reactors

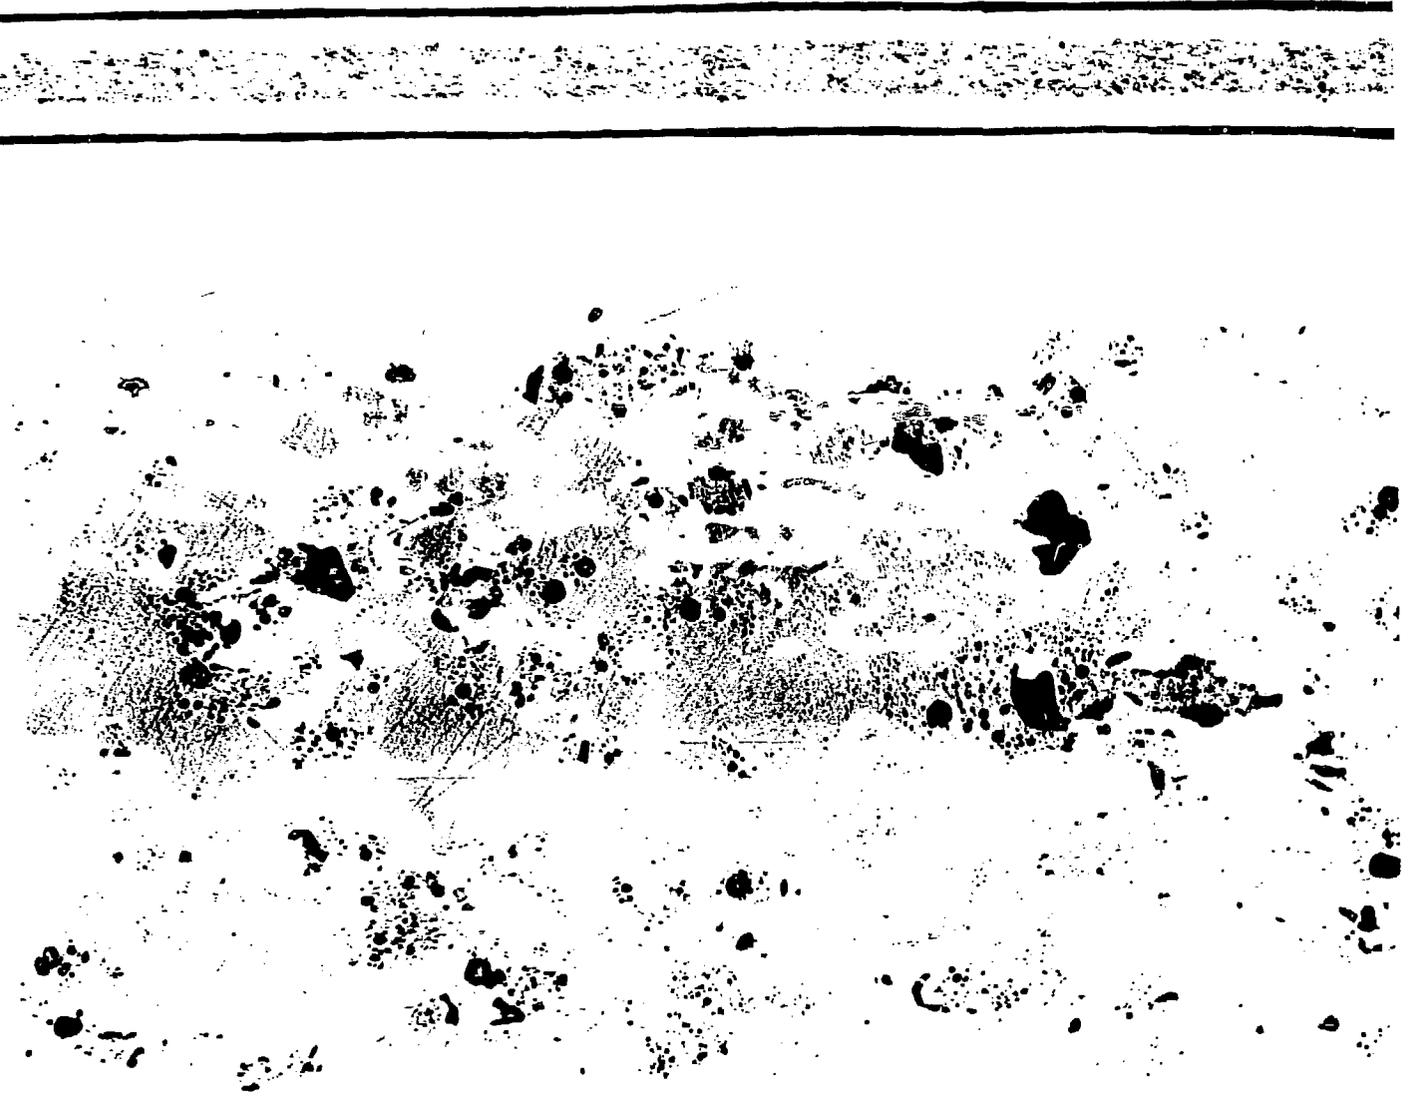
Fig. 1. Microstructure of Plate A-199P, U_3Si_2 & B_4C , Showing Retained As-Fabricated Porosity and Bubble Clusters in Fuel After Irradiation

The amount of helium generated in a particle of the size shown in Fig. 3 at complete burnup of the ¹⁰B isotope is approximately 7×10^{-10} moles. If all this helium is released into the pore shown in Fig. 1, a pressure of approximately 800 psi could be generated at 100°C. Such a high pressure would certainly prevent closure of the pore, but a lower pressure due to only fractional helium release from the B₄C particle might well be sufficient to prevent pore closure. Without further analyses it seems nevertheless plausible at this point to conclude that helium release is responsible for the observed retention of as-fabricated porosity.

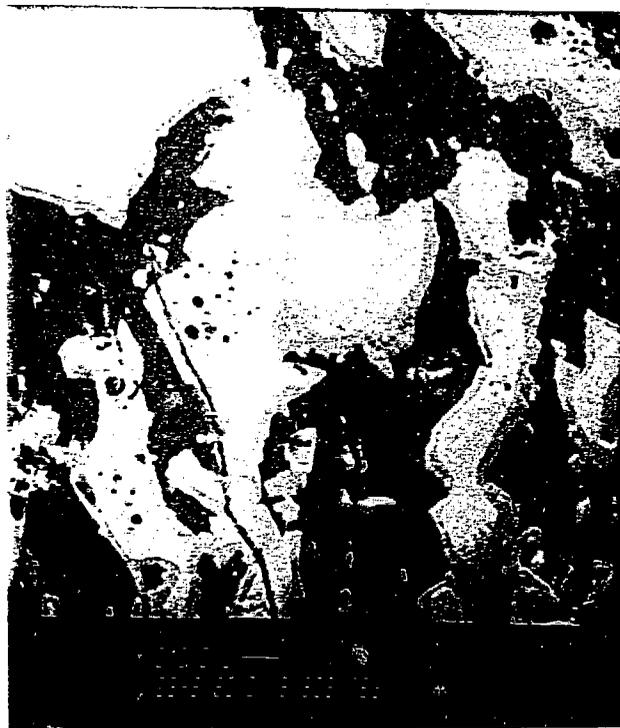
(210716) SAM, Specimen Current

(210717) SAM, Boron

SEM

(210739) SAM, Boron, Detail

Fig. 3. Fuel Core Microstructure Showing B_4C Particles,
Upper: Unirradiated; Lower: Irradiated

Figure 3 shows the distribution of B₄C particles (dark angular features) in an unirradiated fuel plate. The B₄C particles are clearly identified by the boron Auger-electron dot-map shown in Fig. 3.

The meat microstructure after irradiation is also shown in Fig. 3. Again clearly identified by SAM are the B₄C particles, which now appear less angular in shape presumably as a result of irradiation damage. Bigger B₄C particles are found at residual as-fabricated porosity suggesting that the presence of B₄C prevents closure of the pores. Detailed SAM analysis did not detect boron, carbon, or the reaction product lithium in the residual pores. The only other element involved is helium produced through α generation by the reaction:

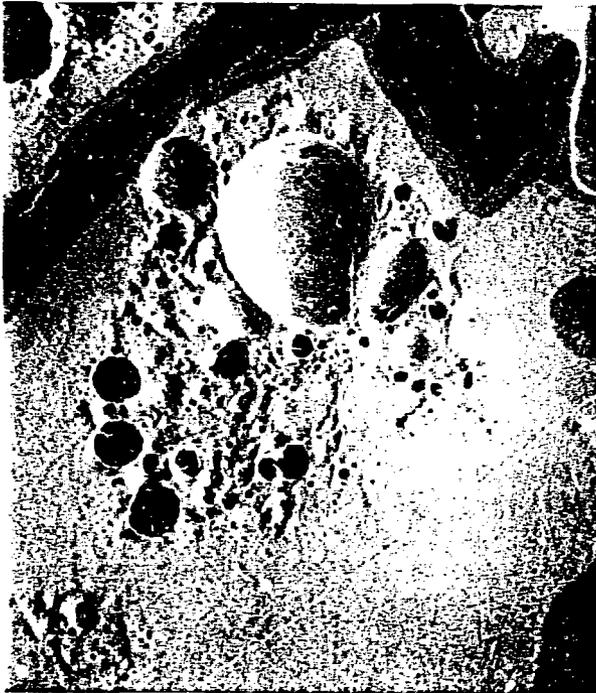
Optical Etched

SAM

SEM

Fig. 4. Fuel Microstructure Showing Structural Difference Around Bubble Clusters in Fuel Particles

Next we examined the clusters of large pores in the fuel particles that account for the larger fuel particle swelling in the B₄C-containing plates. Optical metallography of etched meat microstructure and a SAM micrograph shown in Fig. 4 reveal a different fuel microstructure around the clusters. The appearance of this etched fuel microstructure is similar to that of fuel that has reacted with aluminum; however, SEM analysis found no difference in composition between the

High magnification SEM examination of the fuel, also shown in Fig. 4 shows the typical small, regular-spaced fission gas bubbles in the bulk U_3Si_2 , but absence of these small bubbles in the different structure around the large pore clusters. Apparently fission gas diffusivity in the cluster area was much higher leading to the growth of large bubbles. We can only speculate that a small amount of lithium and possibly also helium diffused from B_4C particles into adjacent fuel causing an increase in fission gas diffusivity. We believe that there is enough circumstantial evidence to state that activation products from the B_4C particles are the root-cause of the higher swelling of B_4C -containing fuel plates. The effect of B_4C on U_3Si plates was similar to that in U_3Si_2 plates.

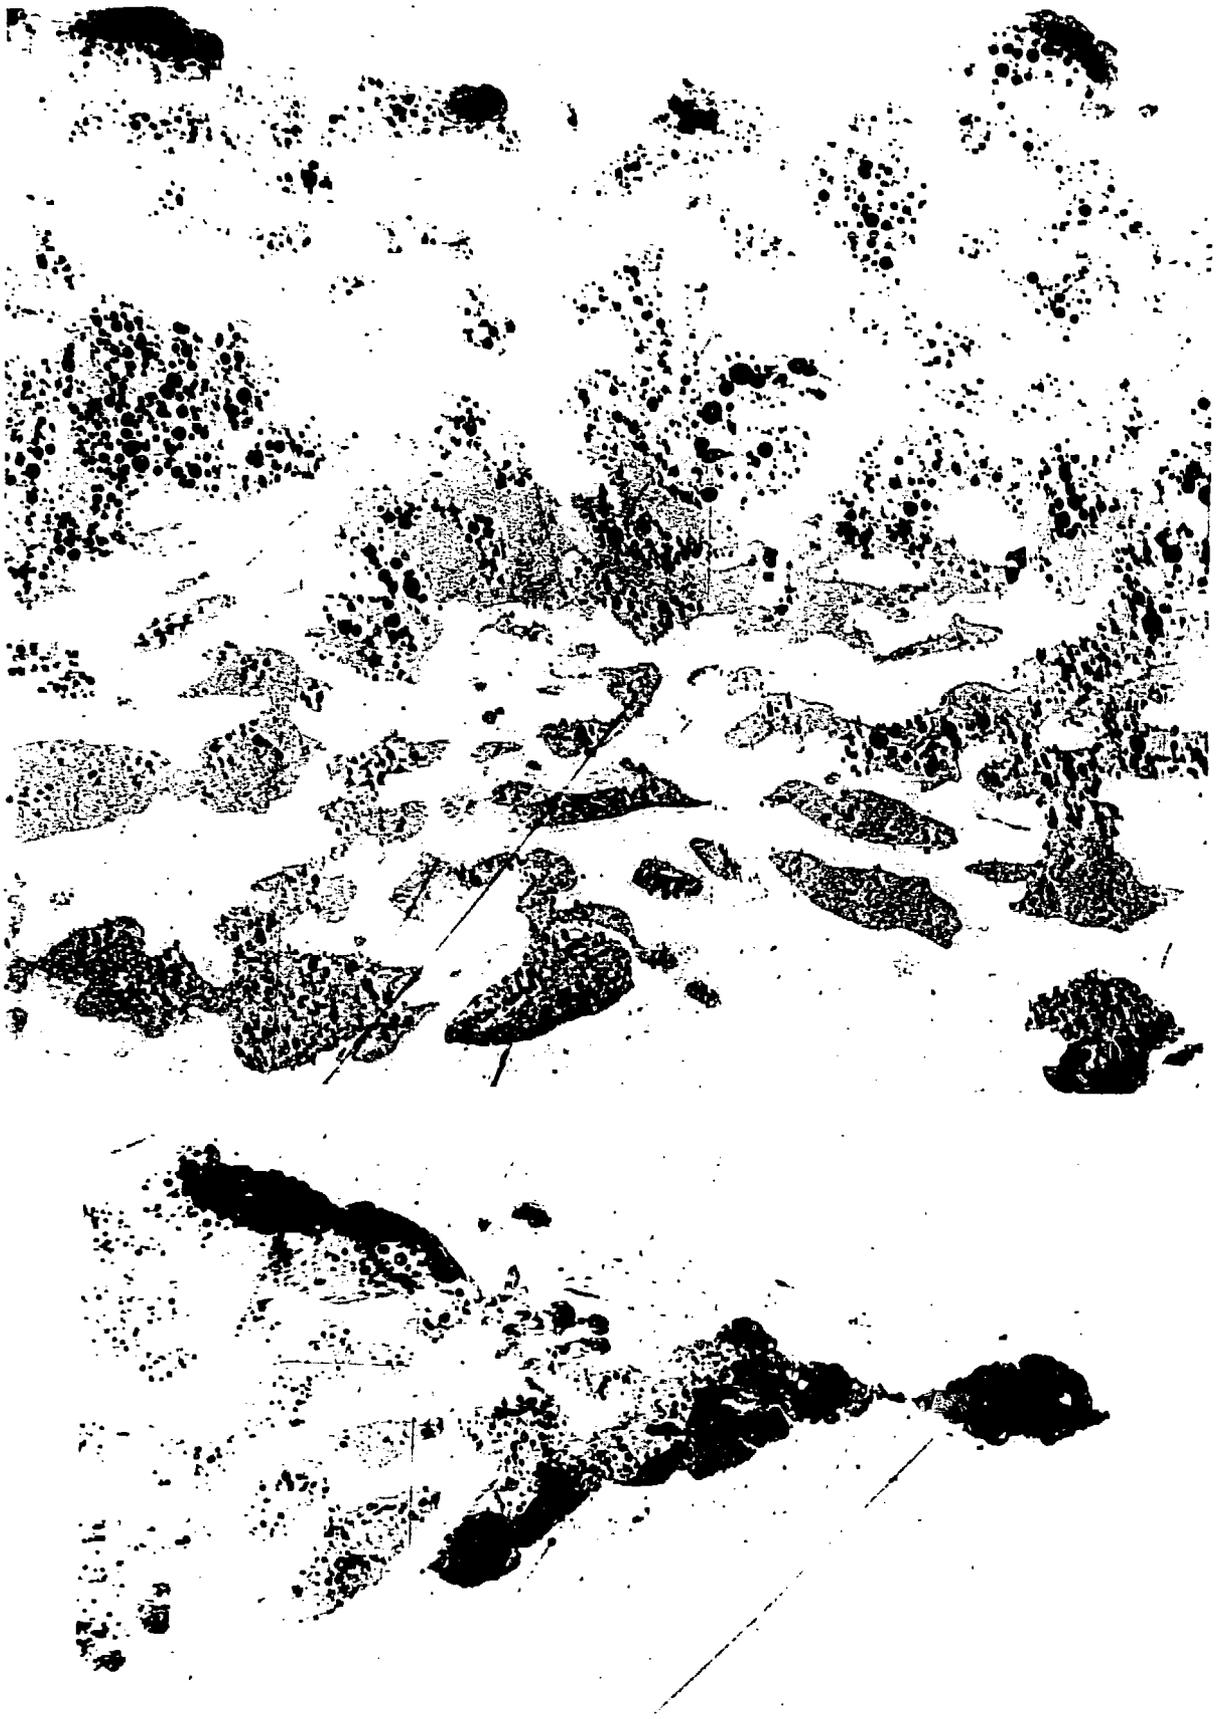
Fig. 6. Fuel Core Microstructure of Irradiated U_3Si Plate Showing Location of Oxide Particles at Core Edge and Dog Bone End

An example of blister formation is shown in Fig. 5. Blisters form typically first at the edges of the fuel core and then at locations throughout the fuel plate. These locations coincide with oxide inclusions at the fuel core-cladding interface (see Fig. 6). Inclusions are usually larger and more numerous at the core edges, hence, the predominant formation of blisters in these areas. During continued annealing blisters, particularly those at the ends of the fuel core grow in size and eventually rupture, as shown in metallographic cross-section in Fig. 7. Fig. 7 also shows the correlation of a large amount of oxide inclusions and large blister formation. Apparently for a blister to continue to grow and rupture, a large amount of oxide needs to be present. This oxide evidently reacts with aluminum and fuel. Fission gas released as a result of this reaction pressurized the blister, eventually rupturing the cladding.

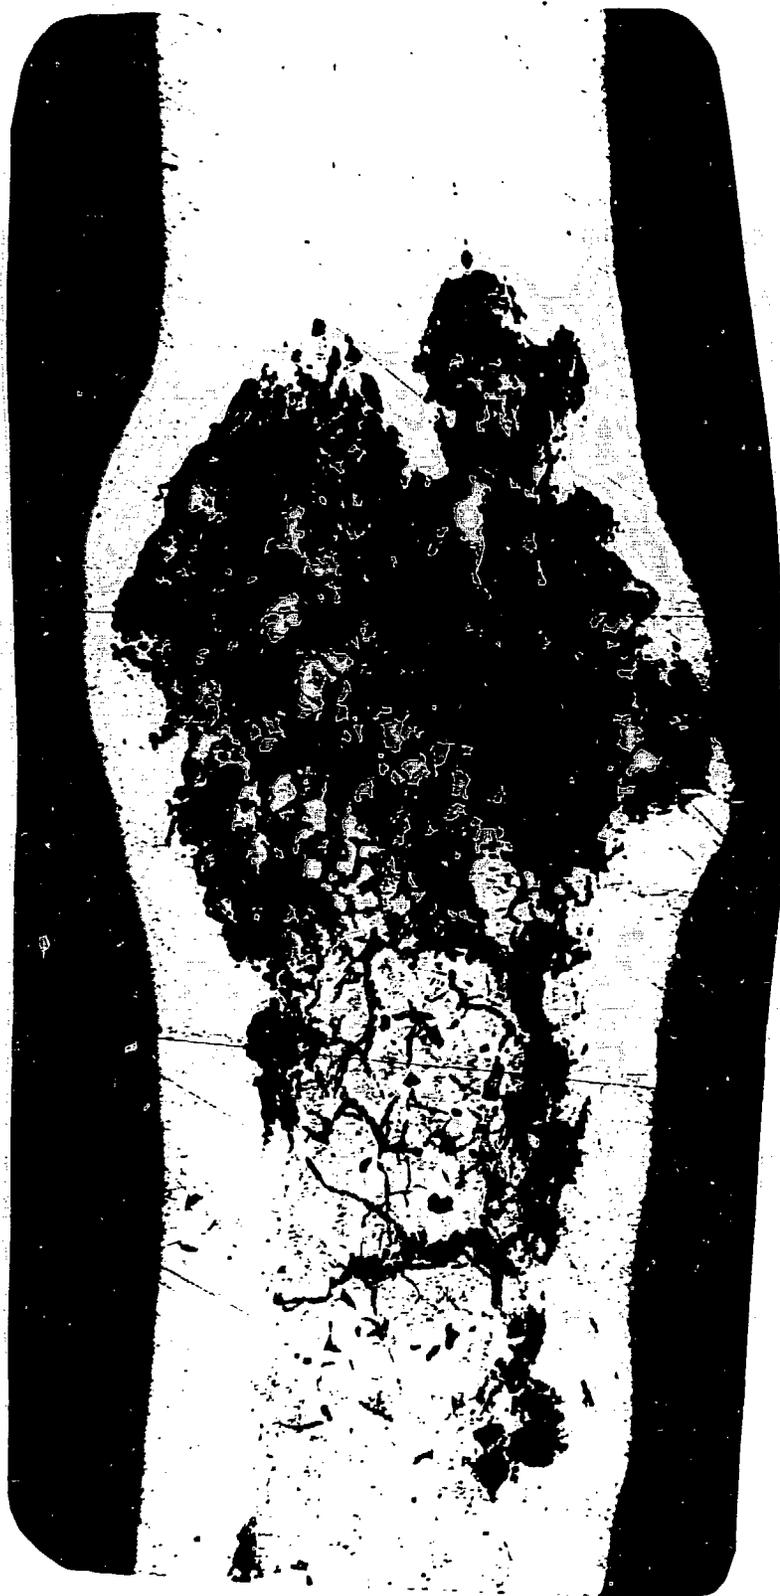
Fig. 7. Cross-section of Ruptured Blister at Dog Bone End of Irradiated U_3Si_2 Plate After Prolonged Annealing at $450^\circ C$

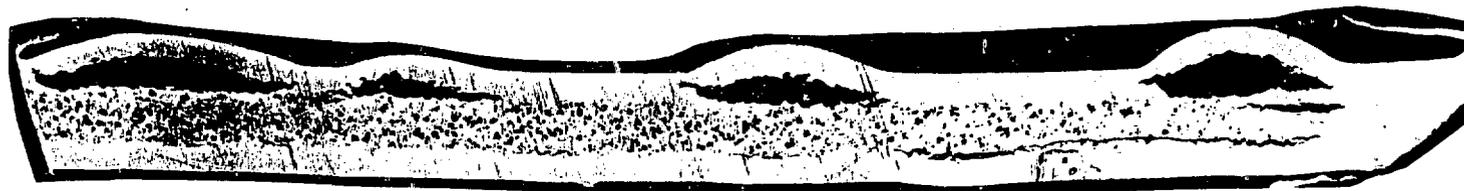
Fig. 8. Blisters and Crosssection Through Blisters of B_4C Containing U_3Si_2 Plate after Prolonged Annealing at $450^\circ C$

Plates containing B_4C (see previous section) were also subjected to the blister test and were found to have a $100^\circ C$ lower threshold than plates without B_4C . The blisters in these plates were also more numerous after prolonged annealing (see Fig. 8). A cross-section through some blisters, also shown in Fig. 8, reveals that the blisters form at the fuel core-cladding interface. Oxide inclusions are the most likely initiation sites; however, it seems plausible that helium originating from the $n-\alpha$ reaction in the B_4C particles diffused to these sites and pressurized the blisters, thereby promoting their growth.
