Field Testing of Fugitive Dust Control Techniques at a Uranium Mill Tailings Pile - 1982 Field Test, Gas Hills, Wyoming

Prepared by M. R. Elmore, J. N. Hartley

Pacific Northwest Laboratory
Operated by
Battelle Memorial Institute

Prepared for
U.S. Nuclear Regulatory
Commission

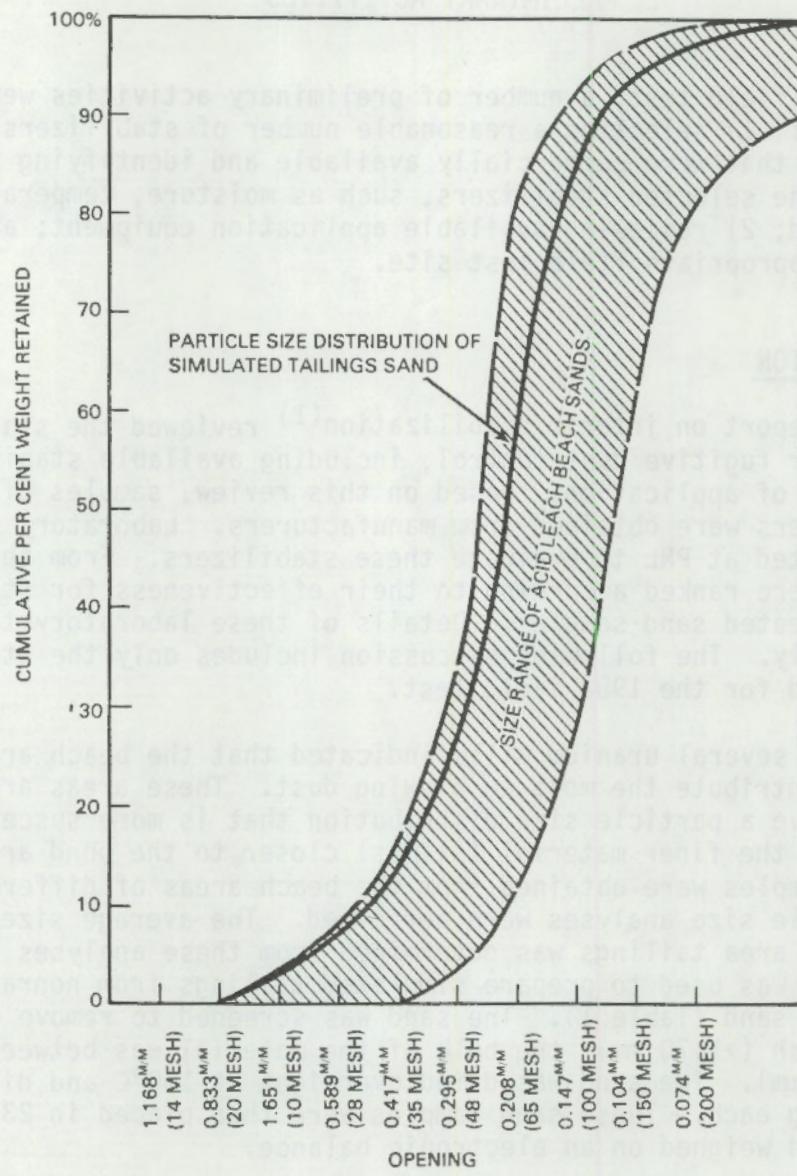
FIGURE 1. Average Size Distribution of Beach Area Tailings

Operators at several uranium mills indicated that the beach areas of the tailings piles contribute the most to blowing dust. These areas are the first to dry out and have a particle size distribution that is more susceptible to wind erosion than the finer material (slimes) closer to the pond area of the tailings dam. Samples were obtained from the beach areas of different tailings piles, and particle size analyses were performed. The average size distribution of the beach area tailings was determined from these analyses (Figure 1). This distribution was used to prepare simulated tailings from nonradioactive, locally available sand (Table 1). The sand was screened to remove material larger than 12 mesh (>1.70 mm); the bulk of the material was between 20 and 100 mesh (150 to 850 μm). The sand was dried overnight at 100°C and divided into samples of ~ 4000 g each. These sand samples were then placed in 23 x 30.5-cm pans, leveled, and weighed on an electronic balance.

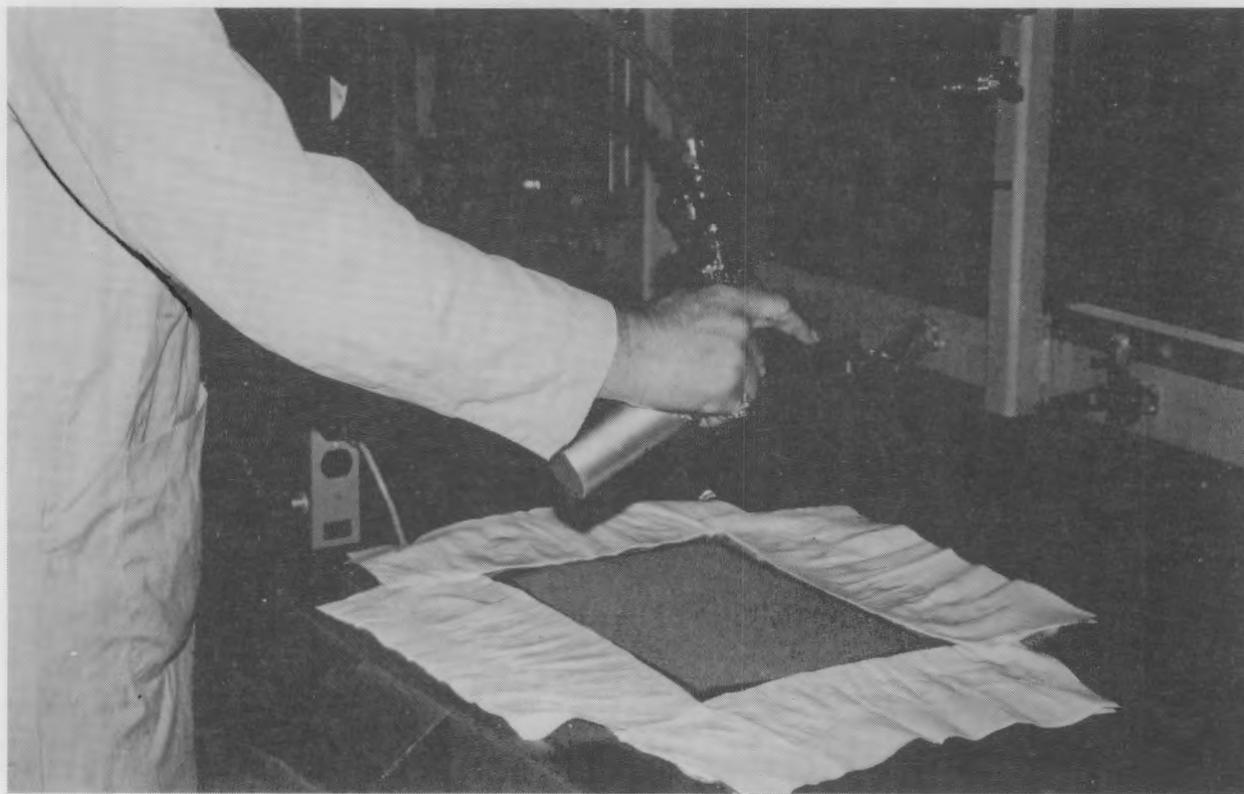
FIGURE 2. Spraying Stabilizers on Sand Samples for Wind Tunnel Tests

Each of the chemical stabilizers was applied to the simulated tailings according to the manufacturer's recommendations for dilution and application using a small compressed air paint sprayer (Figure 2). The total application of each material was calculated for the surface area of the pan and was determined by the weight gain of the pans as they were sprayed. The treated sand was allowed to cure for a minimum of 3 days at room temperature ($\sim 21^{\circ}\text{C}$).

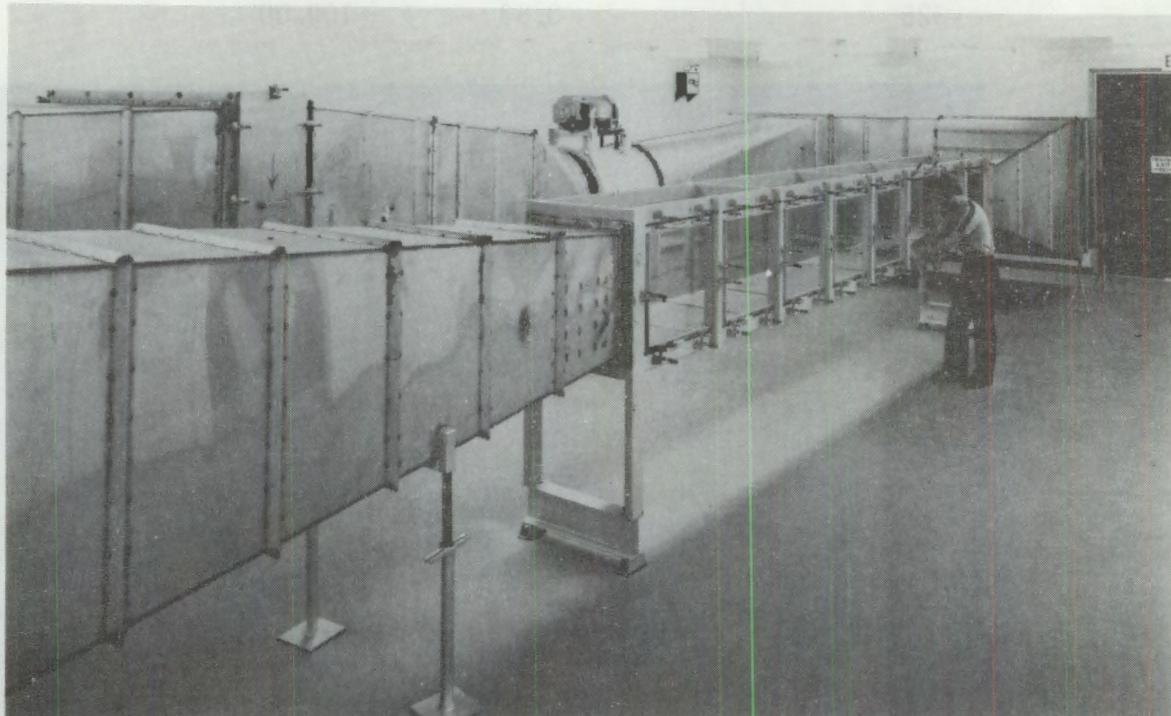
FIGURE 3. Wind Tunnel Used in Laboratory Tests

After the curing period, the samples were reweighed and subjected to a variety of tests using a large wind tunnel (Figure 3). The wind tunnel had a 9.1-m long test section with a 0.6 x 0.6-m cross section and was capable of generating winds in excess of 27 m/s. A floor panel in the middle of the test section was removed and replaced with a stainless steel cutout to hold the sample pan level with the floor of the wind tunnel. The sample pan was placed in the cutout and the edges were taped to minimize any turbulence caused by obstructions in the airflow around the sample. Figure 4 shows a sample pan being placed in the wind tunnel for testing.

The sample was placed in the tunnel, the turbine was started, and the wind speed across the sample was gradually increased until sand erosion occurred or a wind velocity of 27 m/s (near the upper limit of the wind tunnel) was reached. The usual test period was 15 min. The sample pans were then removed and weighed, and any weight loss was recorded along with observations made during the test. These results were compared with base-line tests run on untreated pans of sand under the same conditions.

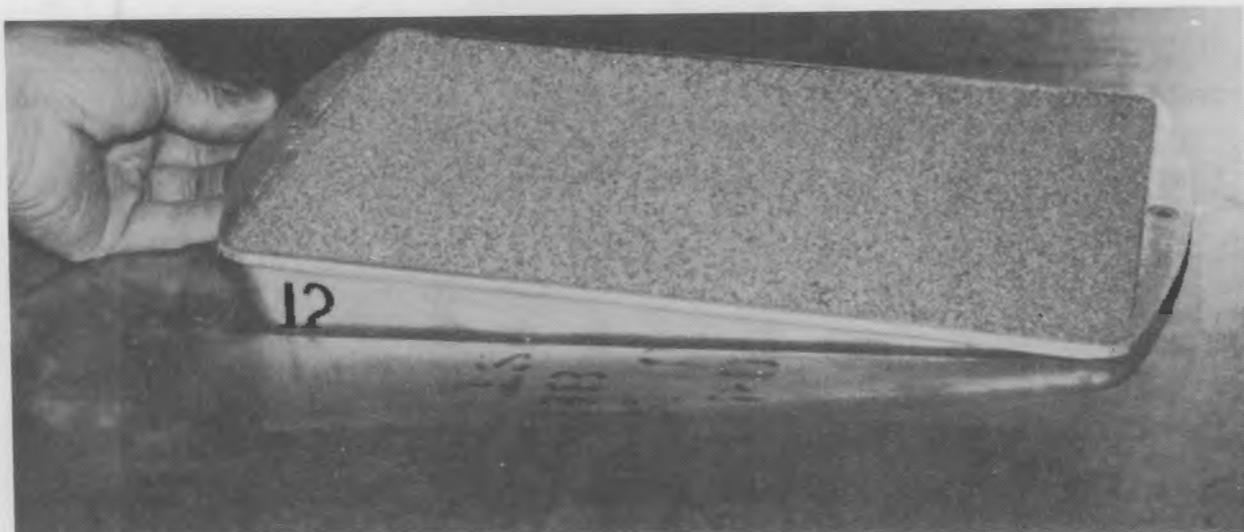
FIGURE 4. Sample Being Inserted in Cutout Floor Section of Wind Tunnel

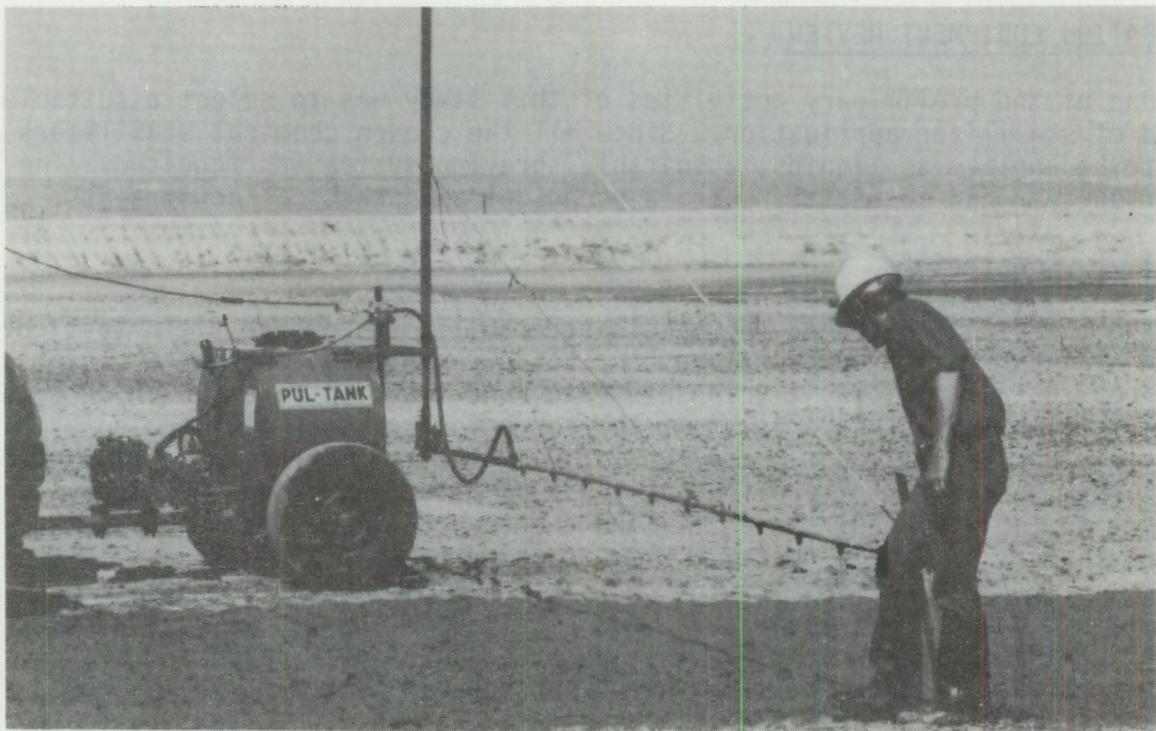
FIGURE 5. Application of Chemical Stabilizers with a Small Field Sprayer

Various spray systems were considered for the field test, including several airless sprayers, compressed air sprayers, gas and power-takeoff field sprayers, sprayers with hose and nozzle delivery systems, and others with boom-type spray bars. The most suitable sprayer--and the one chosen for the field test--was a boom-type field sprayer pulled behind a tractor. The Pul-Tank® sprayer had a 380-l stainless steel agitated storage tank and a pump powered by a small gasoline engine (Figure 5). The sprayer output was adjustable through a recycle valve. Stabilizer application to the test plots was also adjustable by varying the speed of the tractor. Calibration of the sprayer and application of the stabilizers are described in more detail in later sections.

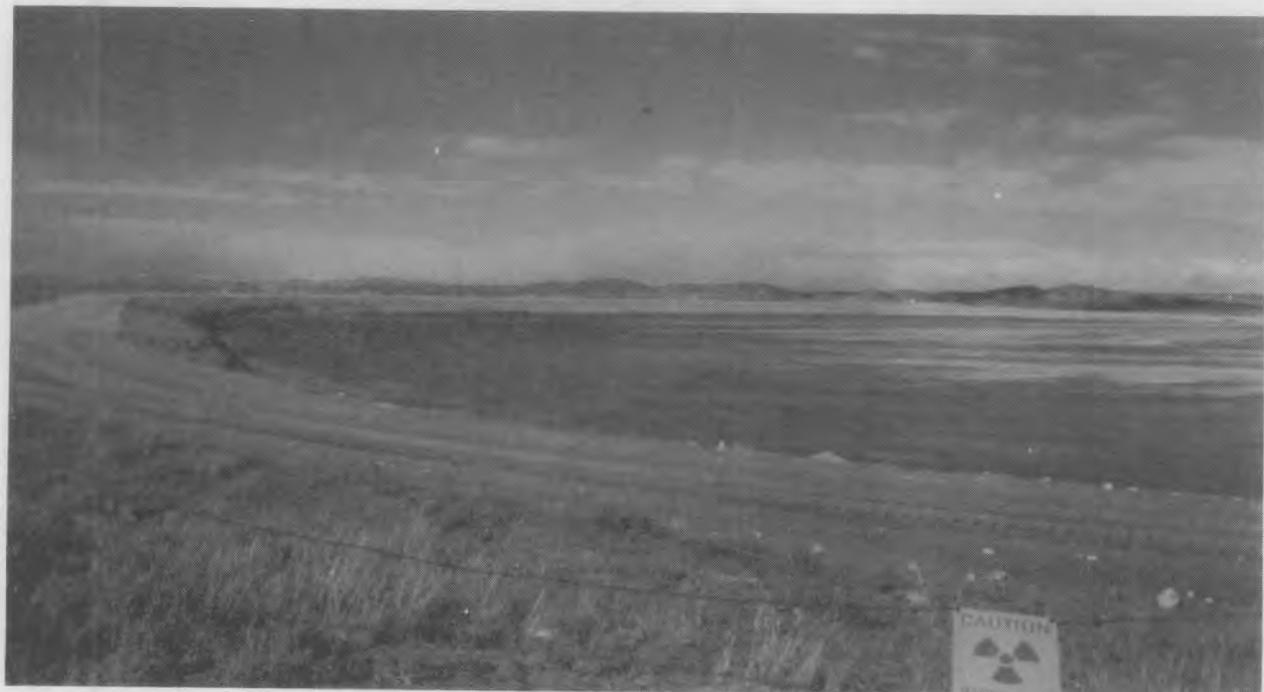
FIGURE 6. Federal American Partners Tailings Pile, Gas Hills, Wyoming

The field test site was located on the FAP No. 2 tailings pile (Figure 6). This tailings pile is elevated above the surrounding grade allowing maximum exposure to winds from all directions. This location was also convenient for vehicle access and close to the mill buildings where materials and equipment were stored. A portion of the beach area on the south-southwest side of the tailings pile was selected for the test site. This area is shown in Figure 7 in relationship to surrounding features at the mill site.

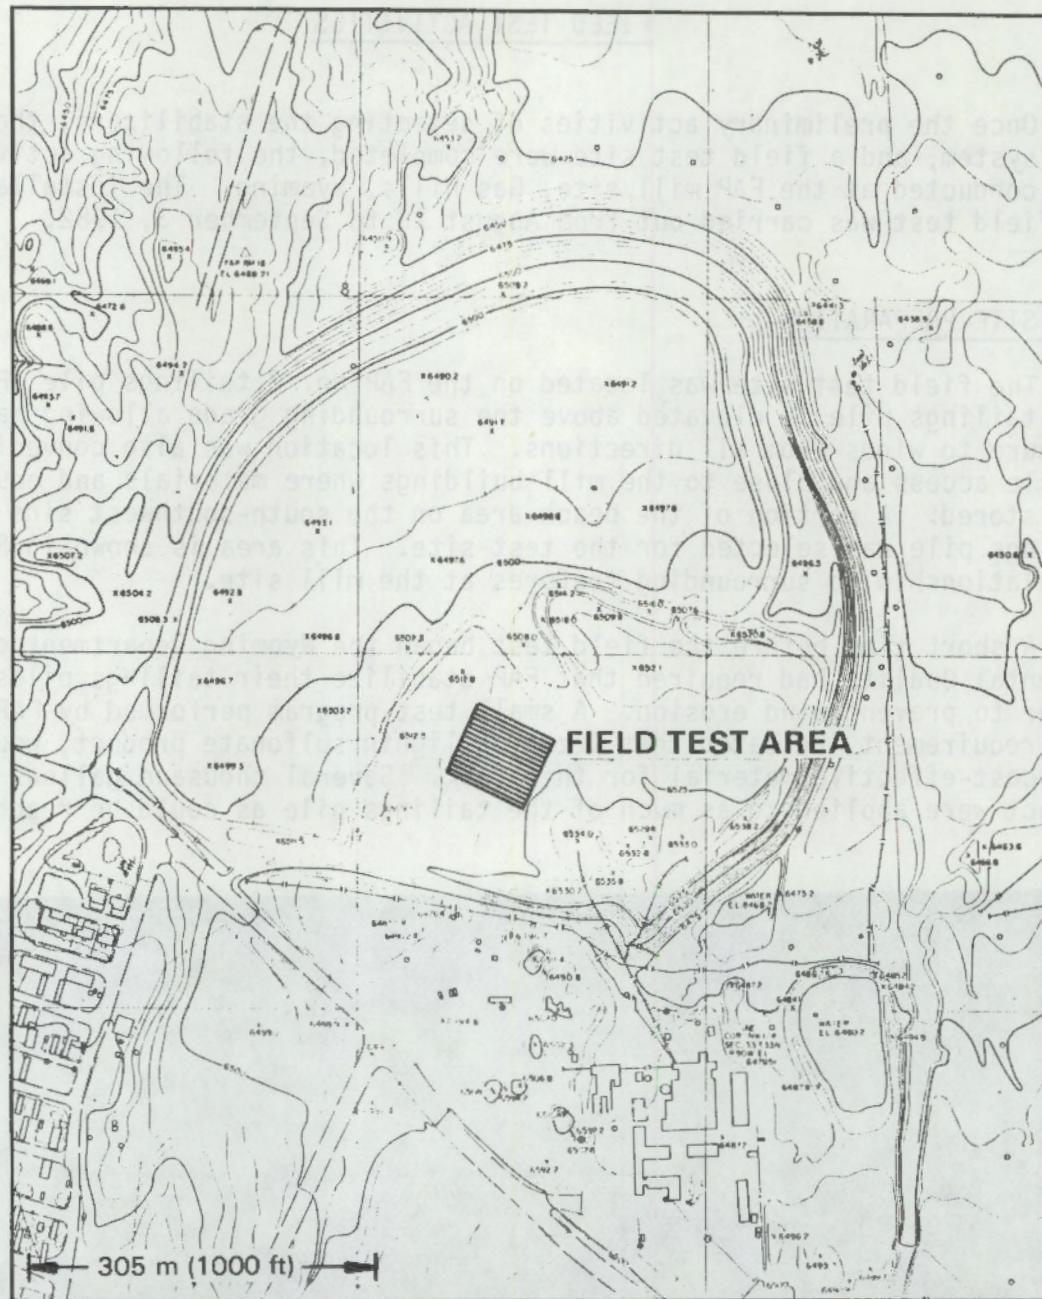
FIGURE 7. Plan View of Field Test Site on FAP Tailings Pile and Surrounding Features

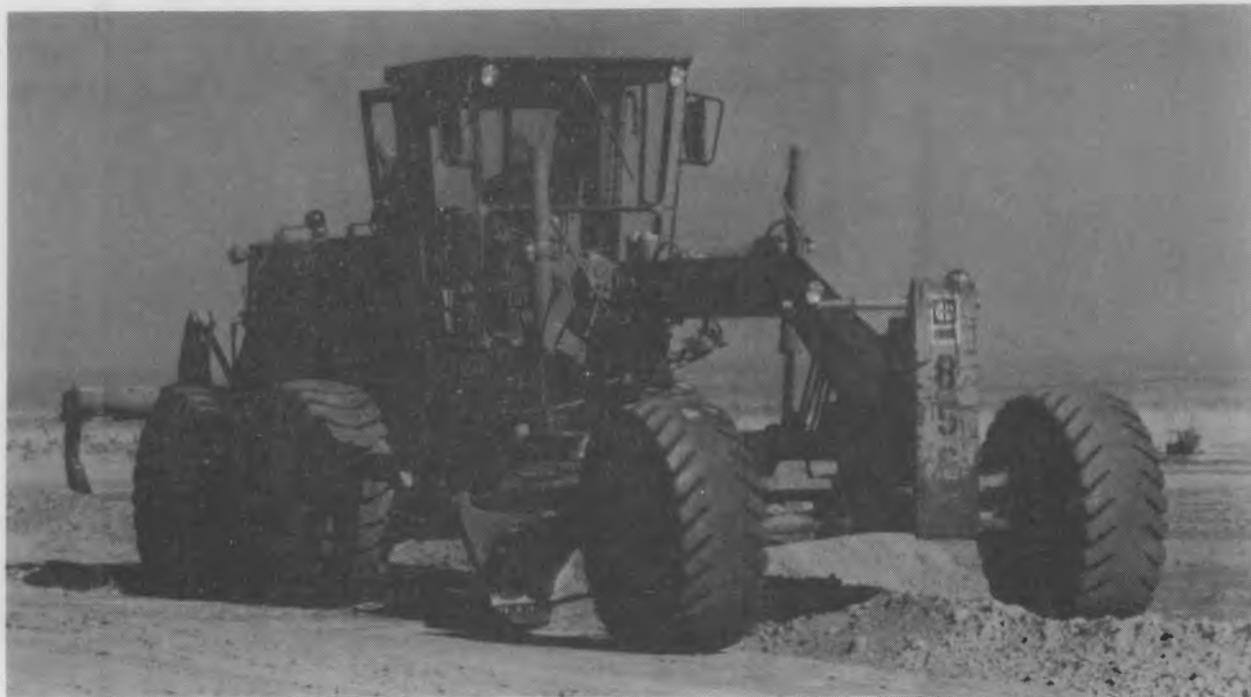
FIGURE 8. Grader Removing Treated Surface Tailings from Test Plot Area

For the field test, an area slightly larger than the subsequent test plot was prepared. Several cross-sectional samples of the surface showed ~1 to 2 cm of penetration by the stabilizer. The Orzan had been applied to the tailings ~1 month earlier, and very little rain had fallen to cause further penetration of the stabilizer. A motor-grader removed the top ~5 cm of tailings and pushed them to the north side of the test plot. The tailings with the Orzan were a much darker color than the untreated tailings, which allowed the grader operator to effectively remove all of the stabilized tailings, leaving an exposed surface of untreated tailings for the field test. Surface removal operations with the grader are shown in Figure 8.

The grader left a very uneven, undesirable surface of deep tire tracks and small windrows of tailings. Therefore, the test area was leveled and smoothed by several passes of a tractor and disk, followed by a tractor and harrow (Figures 9 and 10). This procedure produced a very level and more compacted surface that made subsequent stabilizer application much easier.

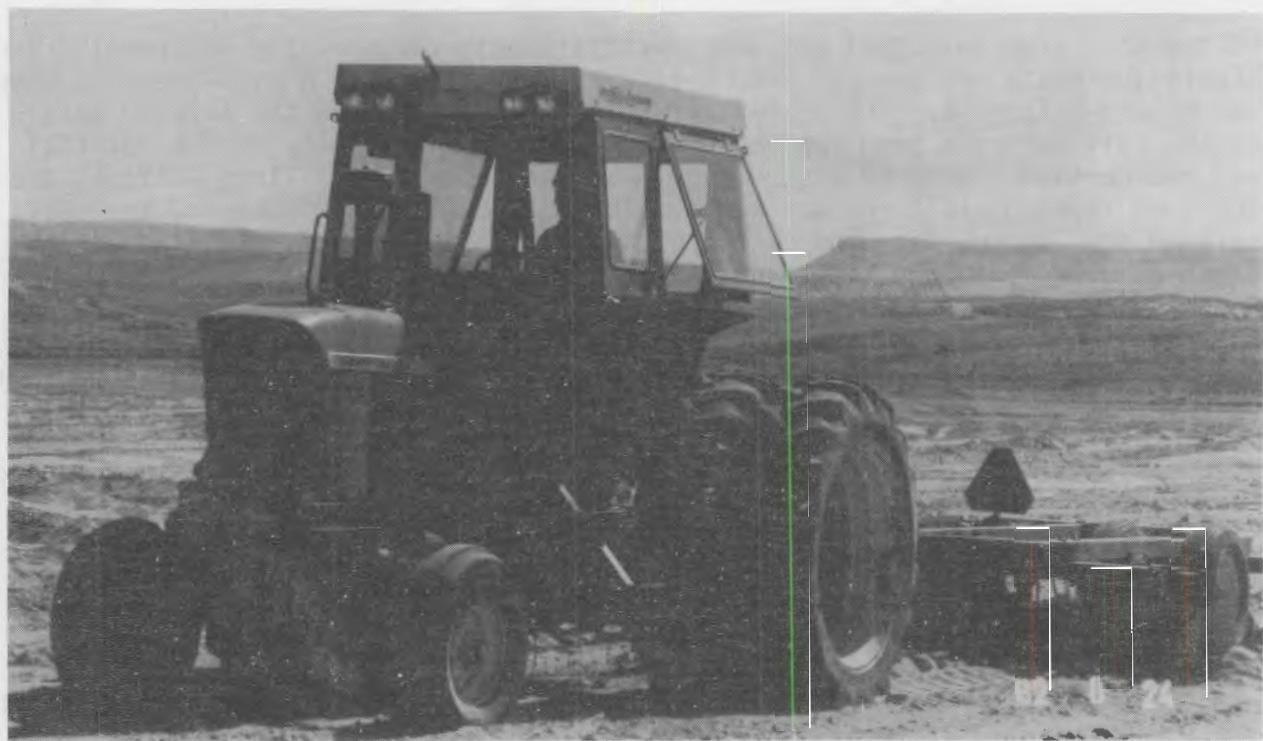
FIGURE 9. Tractor and Disk Leveling Test Plot Area

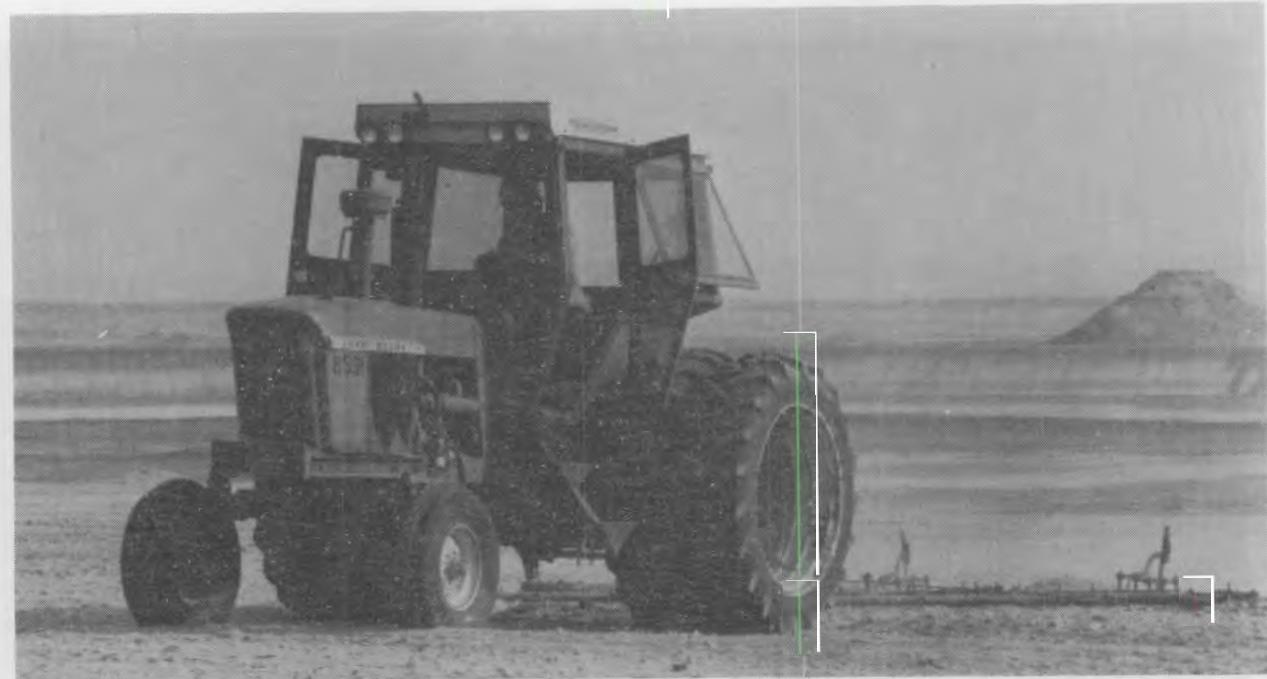
FIGURE 10. Tractor and Harrow Preparing a Smooth Surface on Test Plot Area

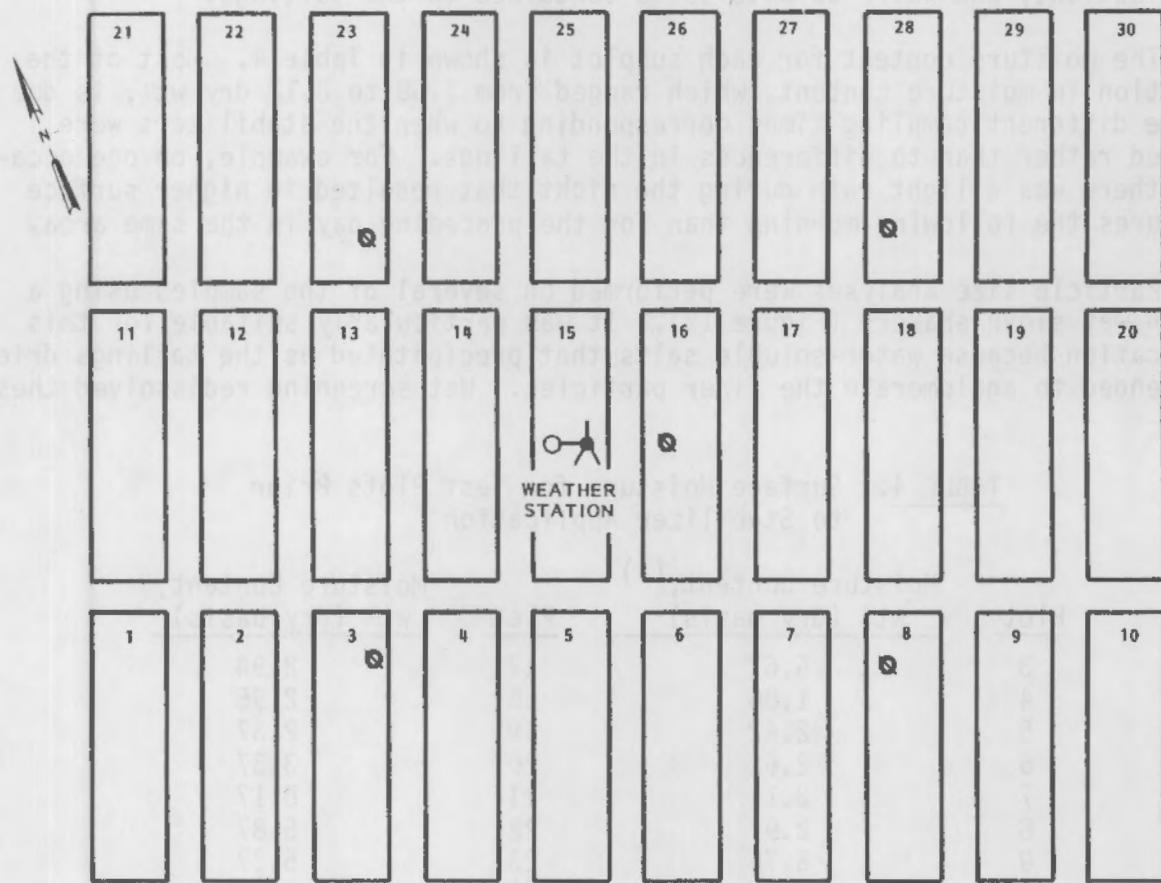
FIGURE 11. Field Test Area Consisting of 30 Test Plots

The perimeter of the actual test site was marked by an FAP survey crew. The overall test area measured 87 x 66 m and was composed of 30 subplots, each 6 x 18.45 m. Access strips for driving on the test area were placed between each test plot. Weather data for this area indicated that the prevailing winds occur out of the south-southwest; therefore, the test area was oriented with the length of the subplots aligned in this direction. Figure 11 shows the test area layout and the locations of the weather station and the five moisture sensors.

The weather station was erected in the center of the test area on Plot 15 (see Figure 11). Meteorological conditions monitored by the weather station

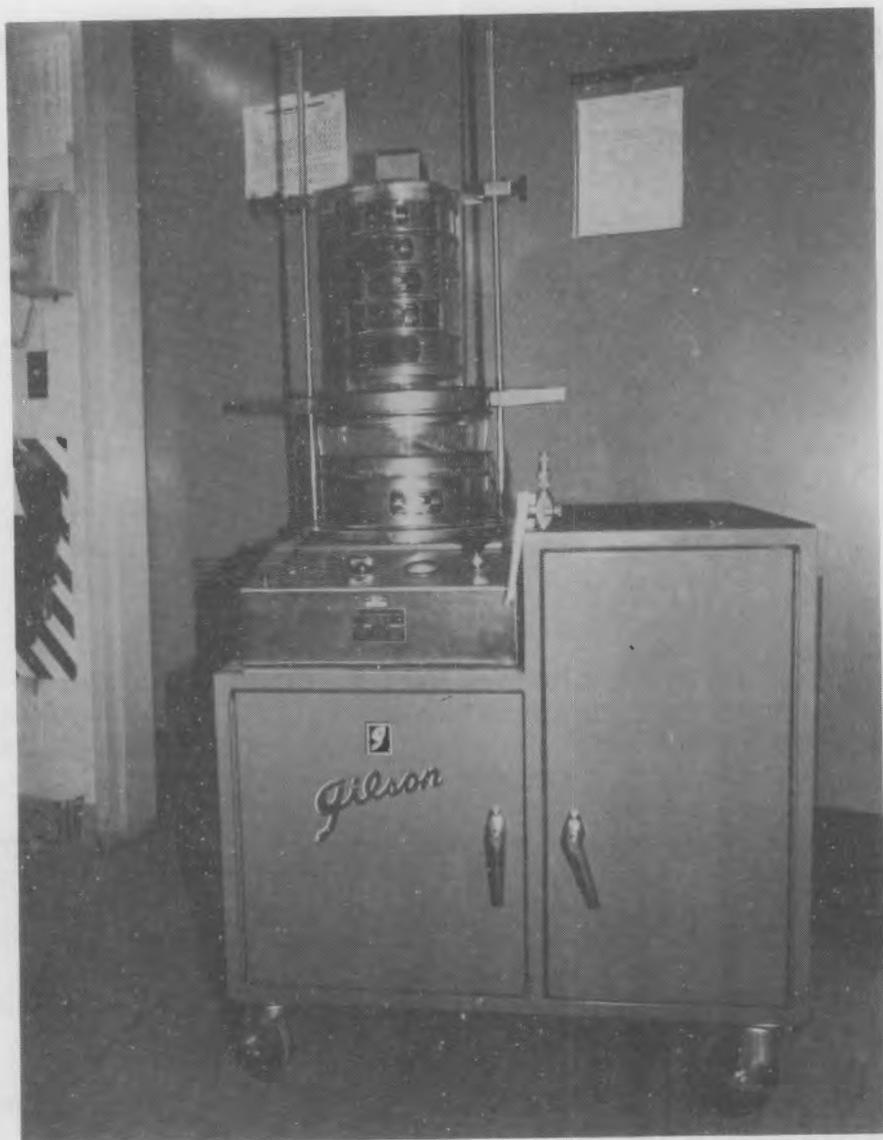
FIGURE 12. Gilson Wet Sieve Shaker Used for Tailings Particle Size Distribution Studies

salts, giving a more accurate size distribution of the material. Size distribution determinations indicated that the material on the surface of the test plot was very uniform (Table 5).

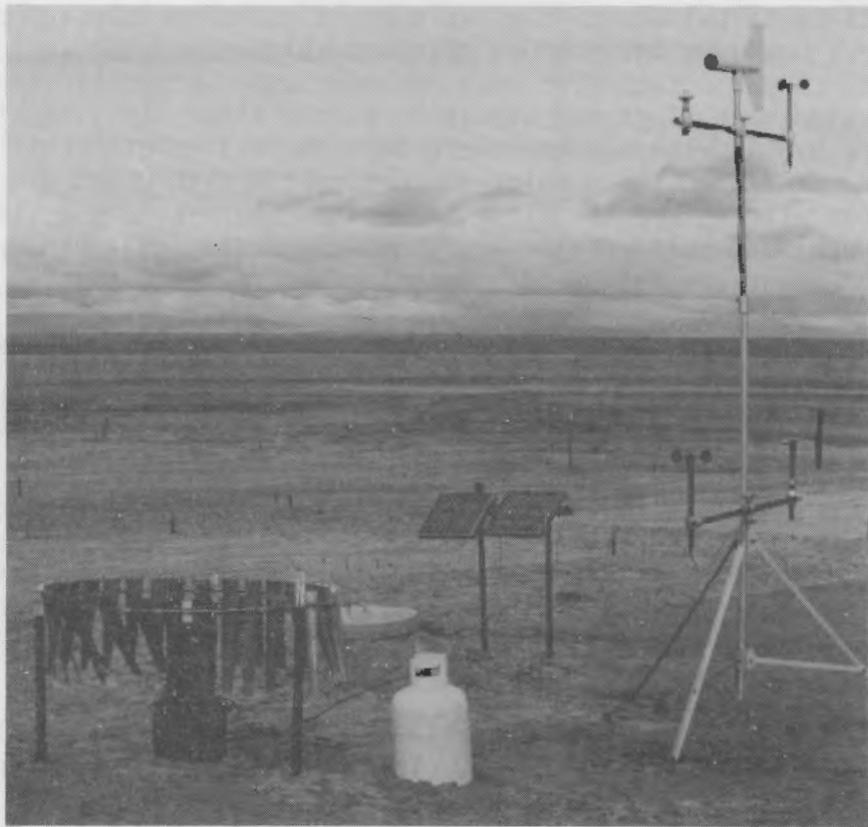
FIGURE 13. Weather Station Installed at Field Test

A self-contained remote weather station (Figure 13) was installed to monitor meteorological conditions, and instrumentation was added to monitor the temperature and moisture content of the tailings surface in the test area. Gypsum moisture blocks were placed in five of the plots just beneath the surface of the tailings to monitor moisture (Figure 11). The moisture blocks were buried prior to spraying the stabilizers so that once the stabilizers were applied the test plot surface would not be disturbed.

include: wind speed (1 m and 3 m above the surface), wind direction, air temperature, relative humidity, solar radiation, precipitation, soil temperature, and soil moisture with a second type of moisture sensor. The precipitation gauge is propane heated to measure snowfall.

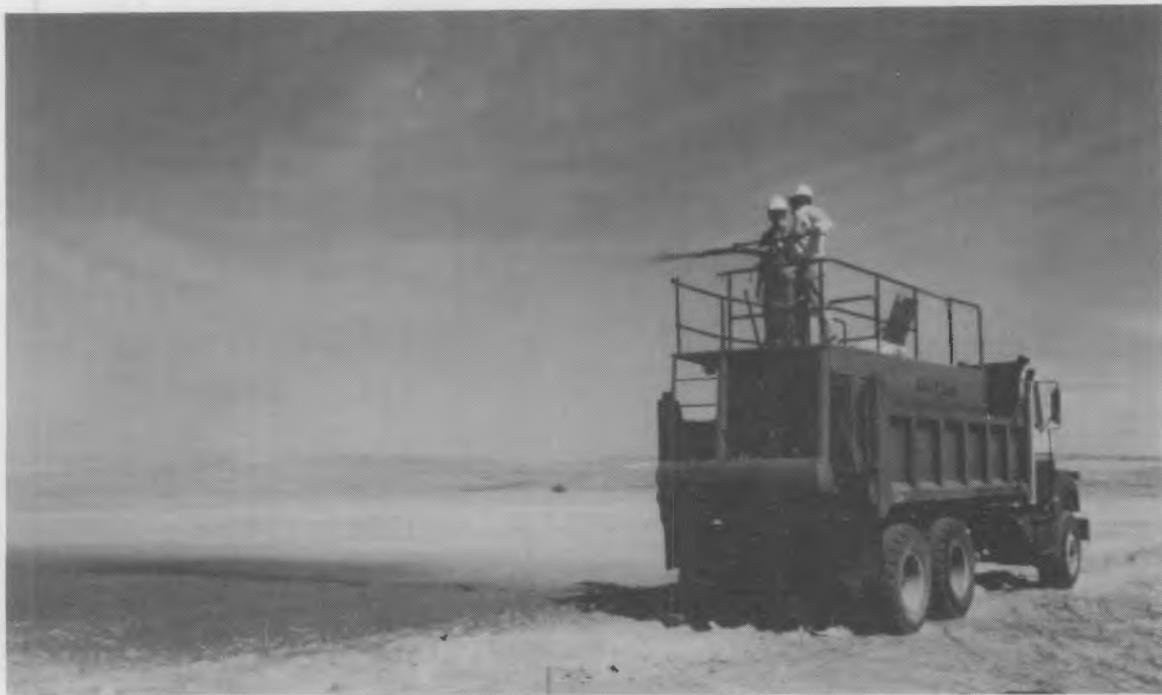
FIGURE 14. Application of Hydro Mulch (wood fiber/water slurry) with Hydroseeder

Plot 1 was treated with 27 kg of Hydro Mulch and 2.3 kg of tackifier slurried with 757 ℓ of water. Plot 2 was treated with 13.6 kg of Hydro Mulch and 1.15 kg of tackifier in 380 ℓ of water. The slurry was applied as evenly as possible to the test plots, but uniform coverage was difficult with this system. Application of the Hydro Mulch with the hydroseeder is shown in Figure 14.

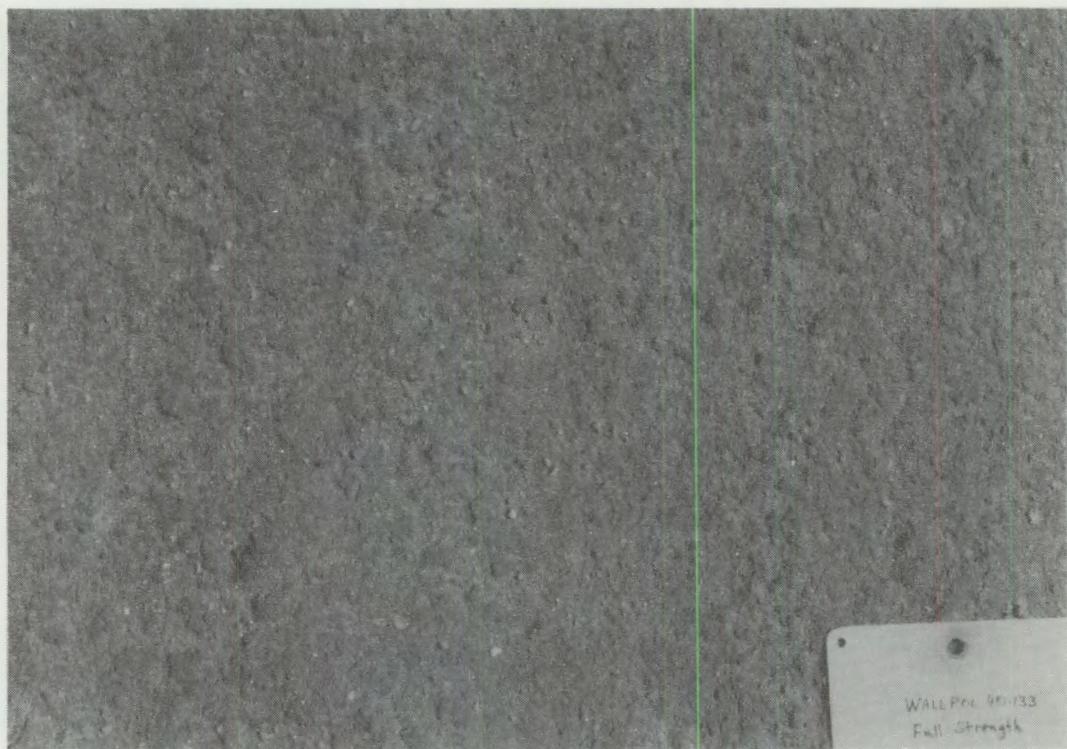
FIGURE 15. Test Plot Surface Stabilized with Wallpol 40-133 After 11 Months of Weathering (minor amount of surface erosion)

Photographs of the original stabilized surfaces were compared with photographs taken 11 months later. Photographs of selected test plots after exposure to weathering are shown in Figures 15 and 16, which illustrate the most effective stabilizer and one showing considerable degradation. Additional test plot photographs are shown in Appendix A.

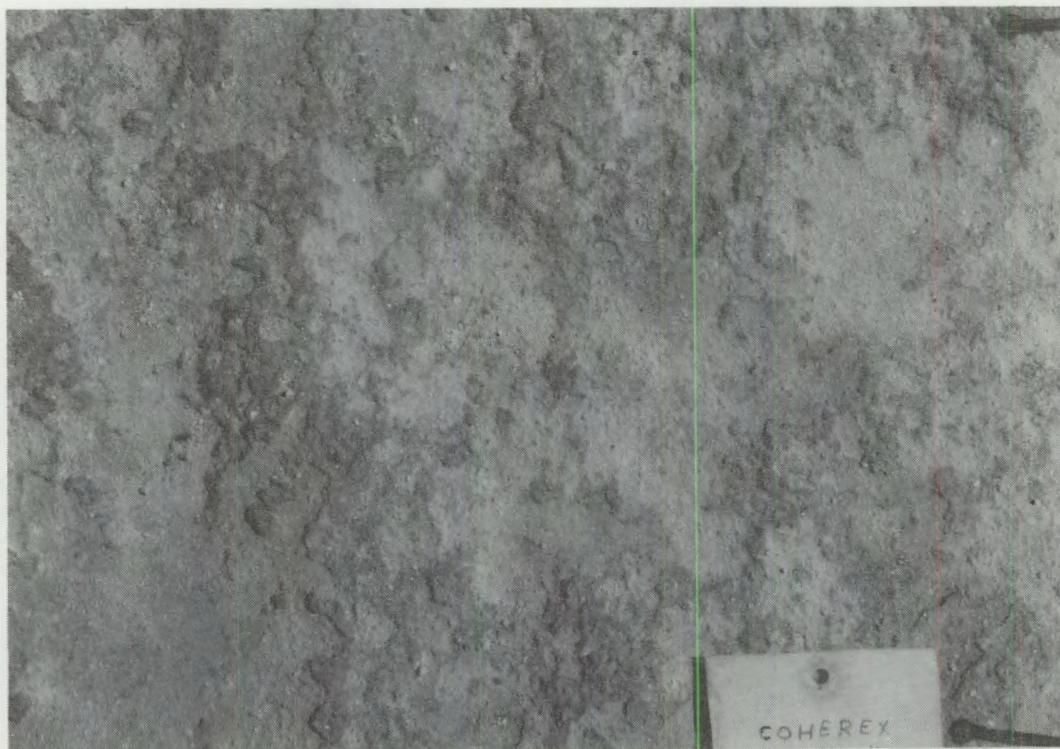
FIGURE 16. Test Plot Surface Stabilized with Coherex After 11 Months of Weathering (severe surface erosion)

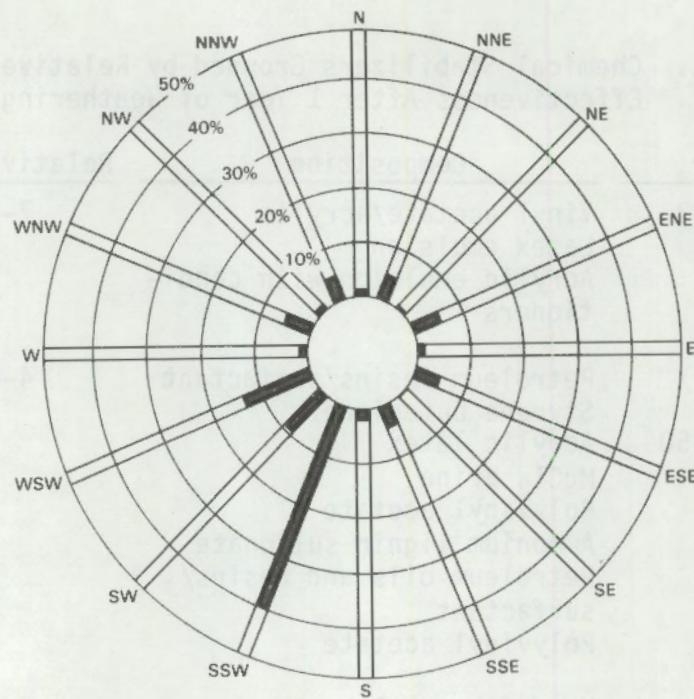
FIGURE 17. Wind Rose Using Wind Velocity and Direction Data Collected at the FAP Field Test Site from September 1982 through June 1983

Weather data are recorded continually by a weather station at the test site. A summary of temperature and rainfall data is shown in Table 10 for the period from the beginning of September 1982, when the stabilizers were applied, to the end of June 1983, the last full month of data collected at the time of this report. A complete table of precipitation data for this time period is presented in Table B.1 of Appendix B. The data used to construct the wind roses presented in Figures 17 and 18 are given in Tables B.2 through B.10.

Figure 17 is a wind rose of wind speed and time data collected during the September 1982 through June 1983 test period. The wind rose shows the percent of time that wind was blowing from any particular direction across the test plot. Figure 18 is a wind rose that represents the erosion potential of the wind. Data shown here are adjusted by the "cube" of the wind speed (V^3), giving a percent of the erosion potential of the winds distributed by direction. In doing so, the wind rose more accurately represents the severity of the wind as it may affect the erosion of the tailings. In general, soil erosion studies have shown that the horizontal flux of sand, particularly for larger particles, is proportional to the cube of the velocity.⁽²⁾ Results of this method indicate the fraction of time that the wind was blowing from a particular direction but weights the higher velocity winds by a higher factor since it is wind velocities above ~9 m/s (20 mph) that contribute most to tailings erosion. Results indicate that the southwest is the very predominant prevailing wind direction, particularly for stronger, erosion-causing winds.

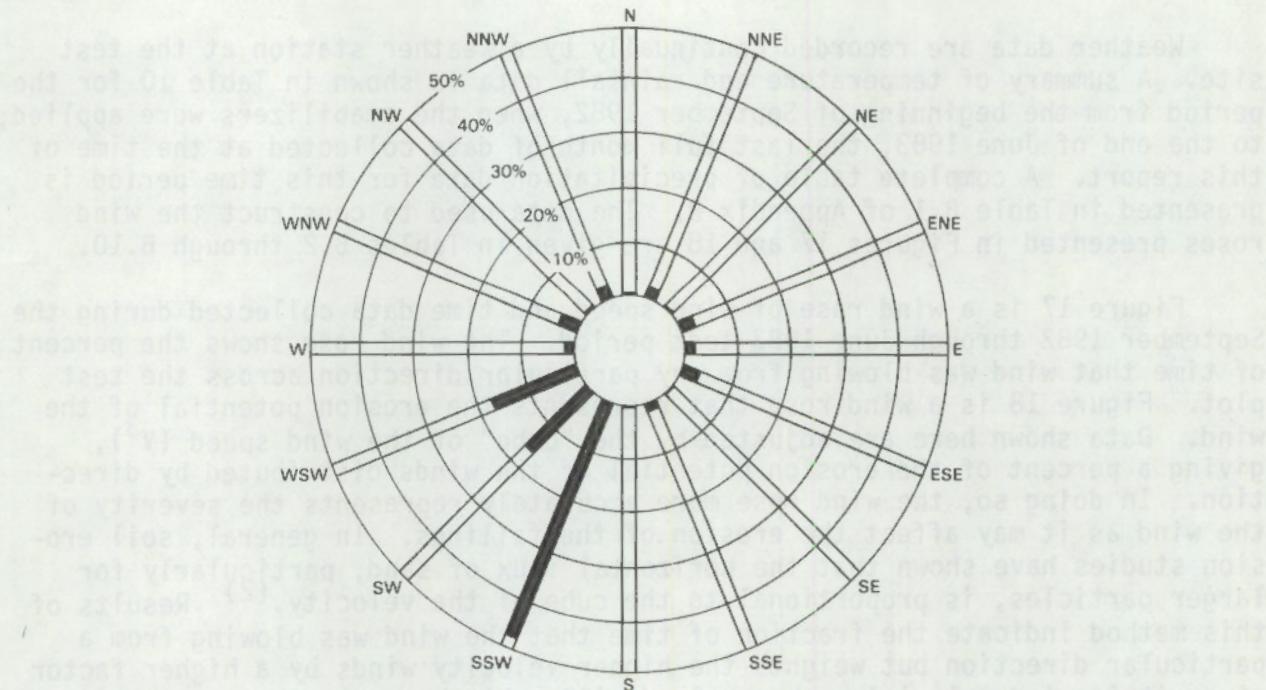
FIGURE 18. Wind Rose Using $(Wind Velocity)^3$ and Direction Data Collected at the FAP Field Test Site from September 1982 through June 1983

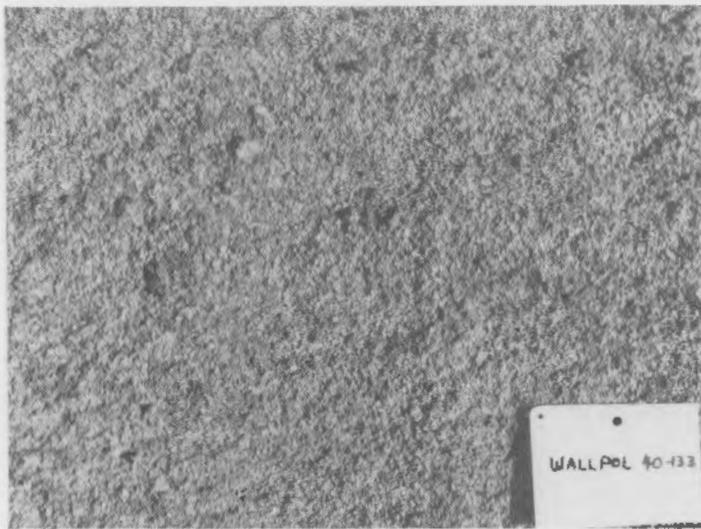
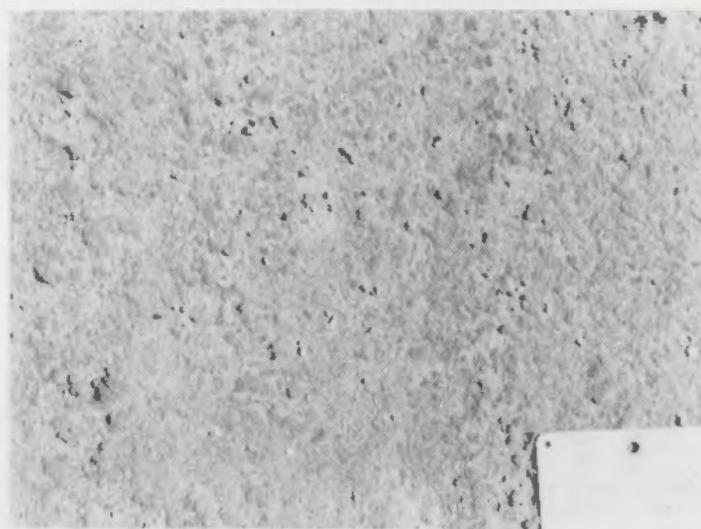
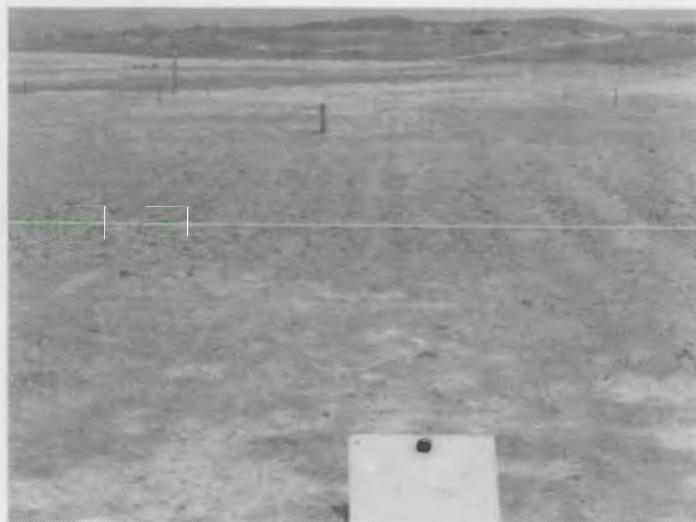
FIGURE A.1. Test Plot Stabilized with Wallpol 40-133

This appendix consists of photographs of test plots stabilized with each of the 15 stabilizers investigated in this field test. A 0.5 x 0.5-m area as of August 1982, the same area as of June 1983, and a view of the test plot are shown for each stabilizer. The figures in this appendix are arranged in order of relative effectiveness.

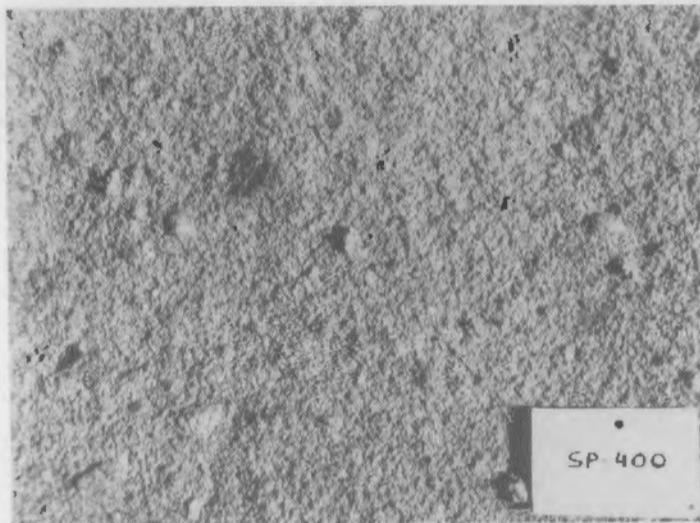
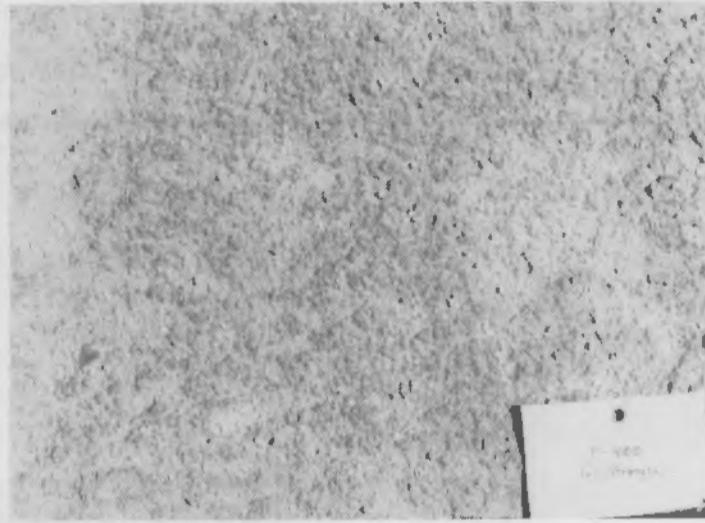
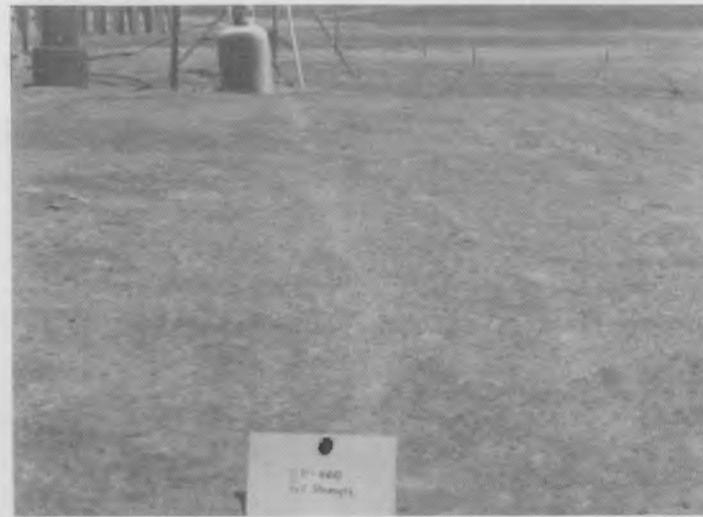
FIGURE A.2. Test Plot Stabilized with SP-400

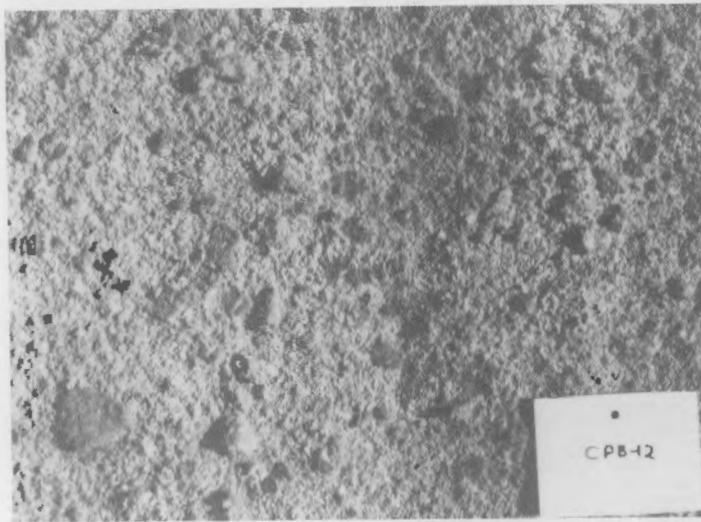
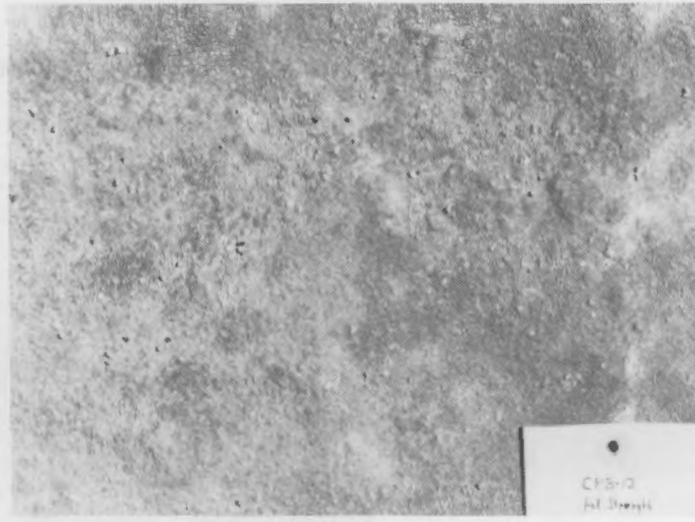
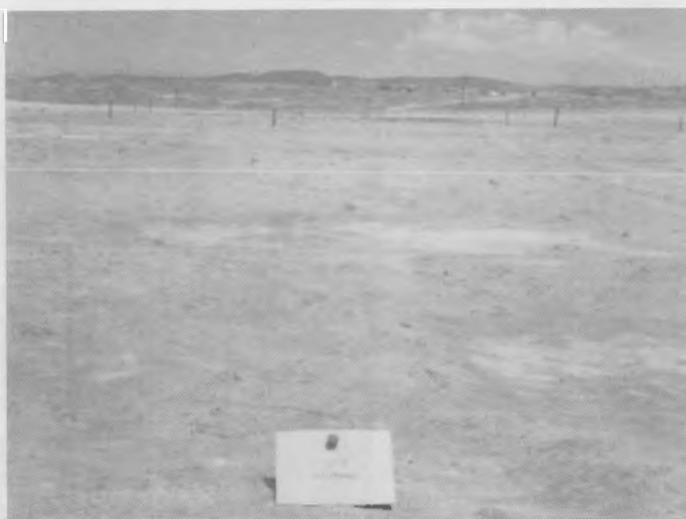
FIGURE A.3. Test Plot Stabilized with CPB-12
