Field Testing of Fugitive Dust Control Techniques at a Uranium Mill Tailings Pile - 1982 Field Test, Gas Hills, Wyoming

Prepared by M. R. Elmore, J. N. Hartley

Pacific Northwest Laboratory
Operated by
Battelle Memorial Institute

Prepared for
U.S. Nuclear Regulatory
Commission

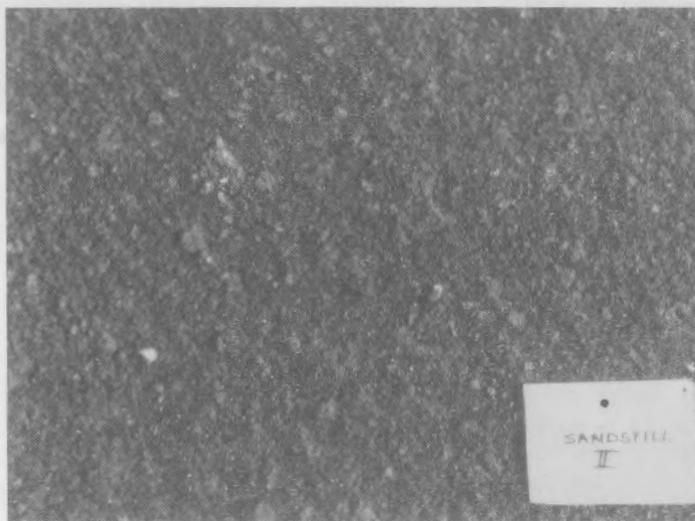
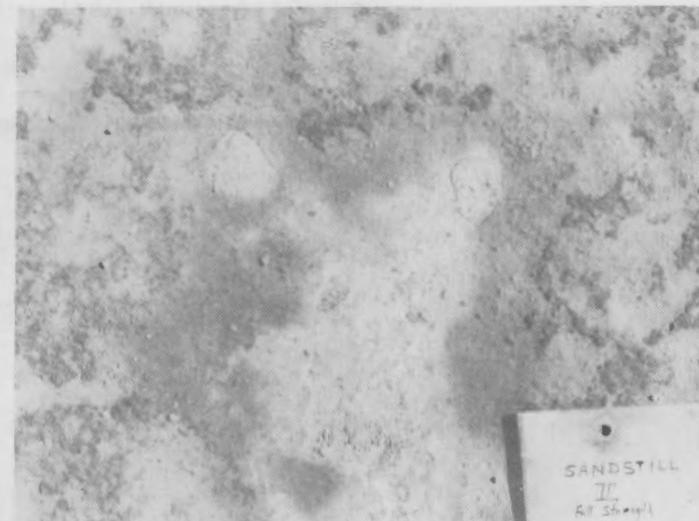
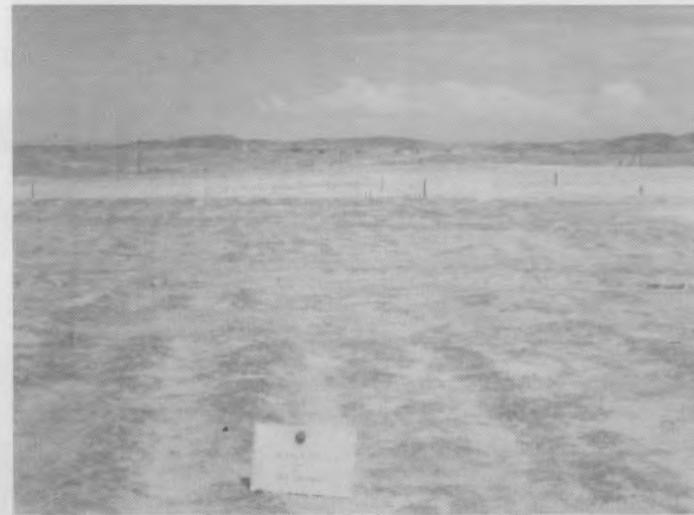
FIGURE A.4. Test Plot Stabilized with Sandstill II

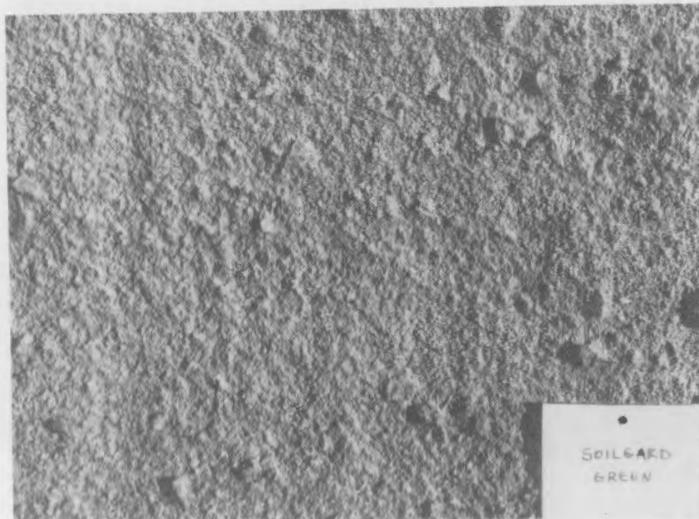
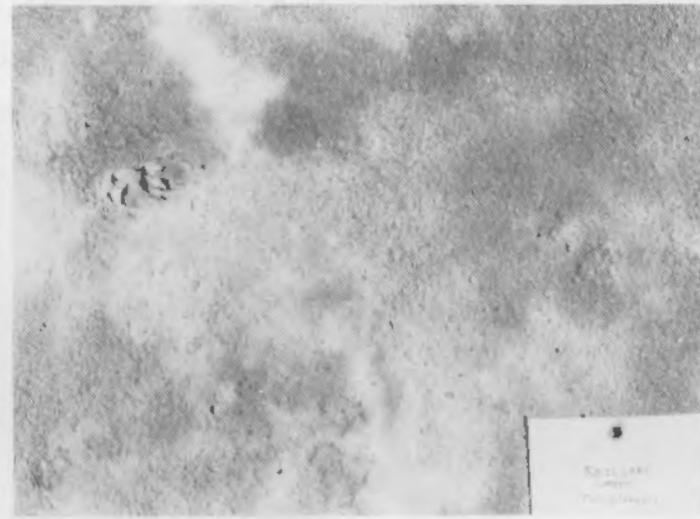
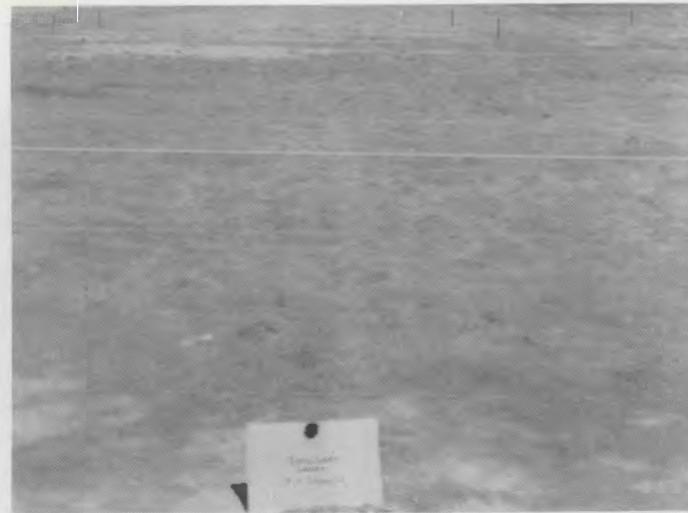
FIGURE A.5. Test Plot Stabilized with Soil Gard

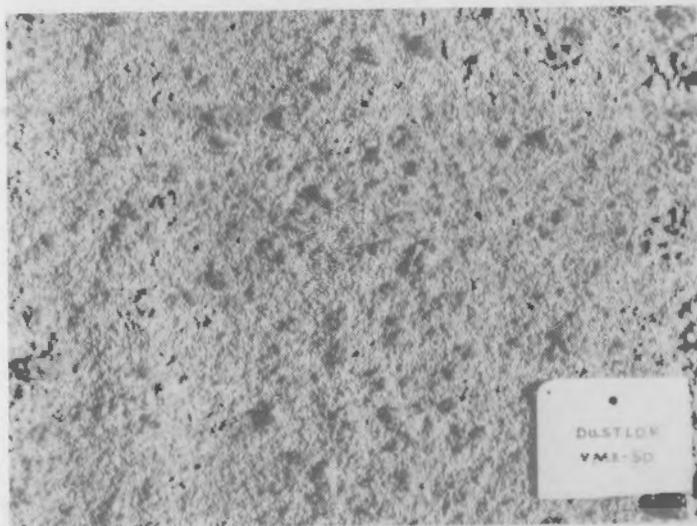
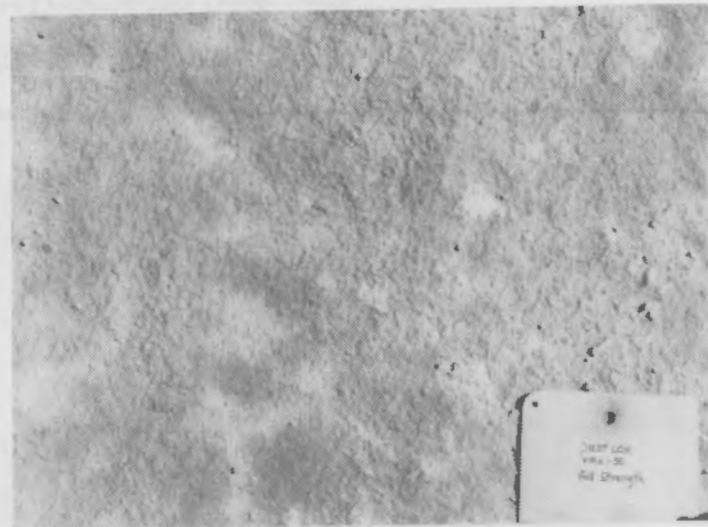
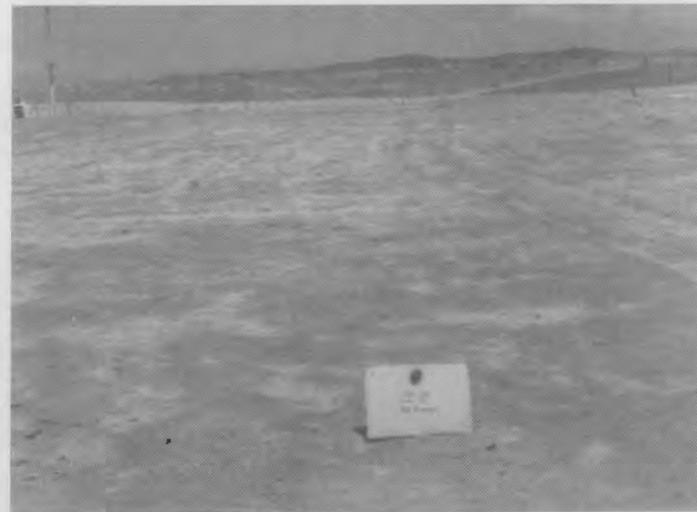
FIGURE A.6. Test Plot Stabilized with Dust Loc VMX-50

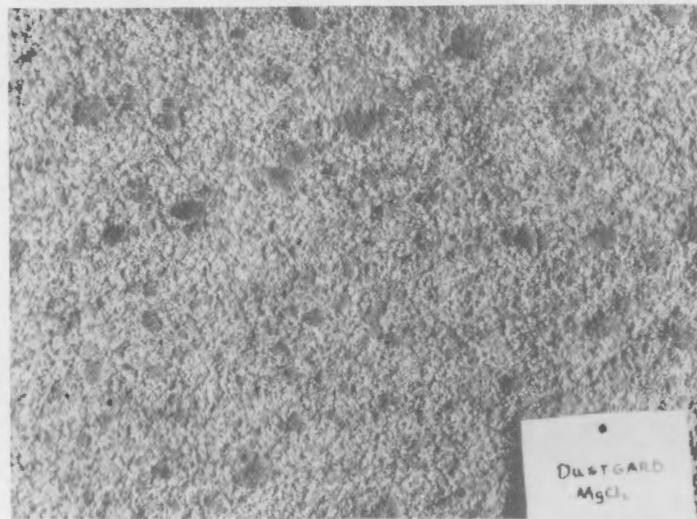
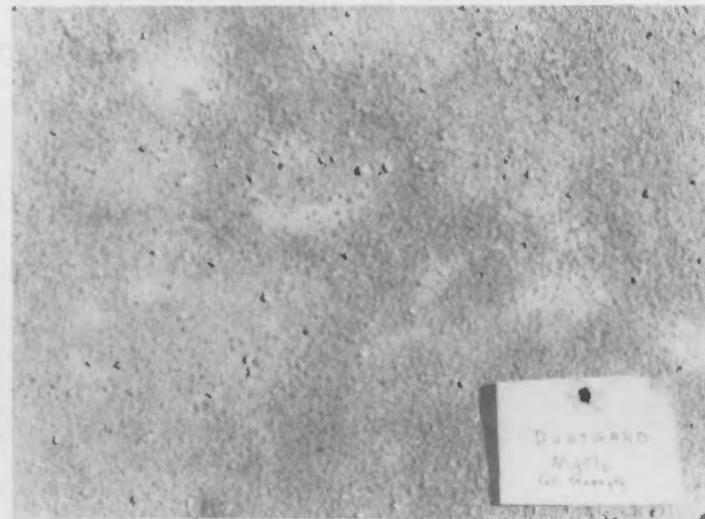
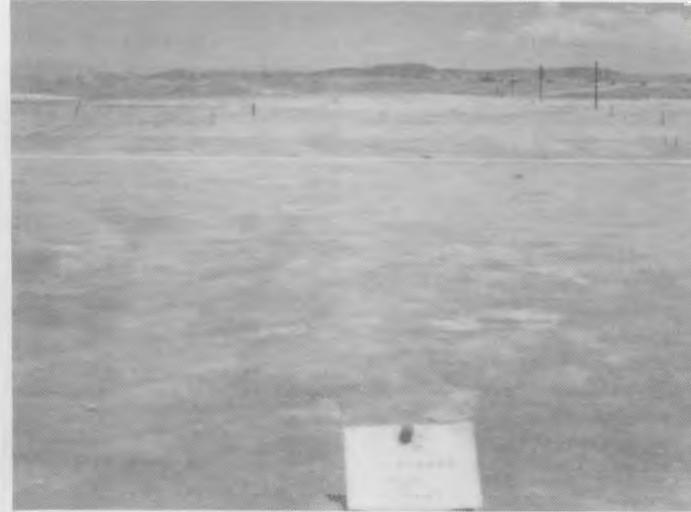
FIGURE A.7. Test Plot Stabilized with Dust Gard

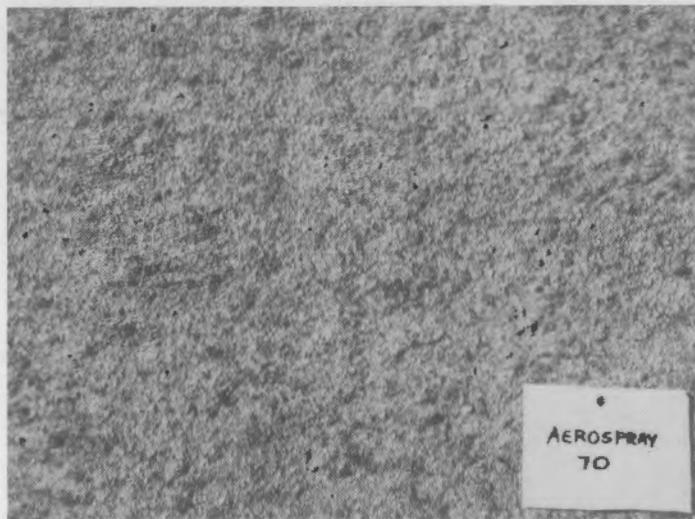
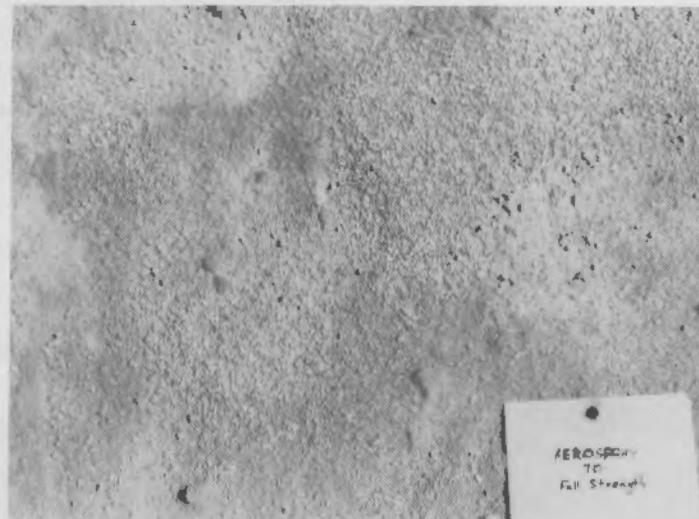
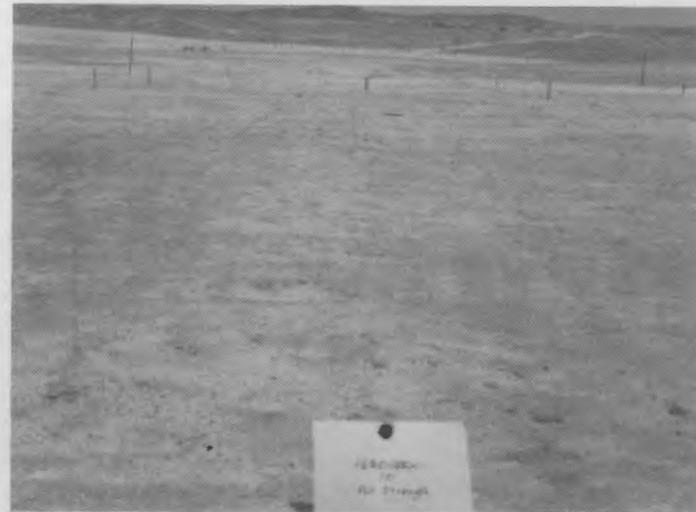
FIGURE A.8. Test Plot Stabilized with Aerospray-70

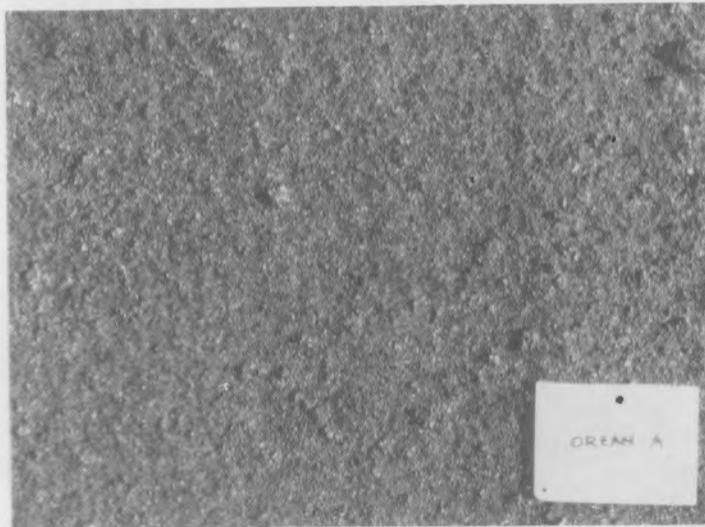
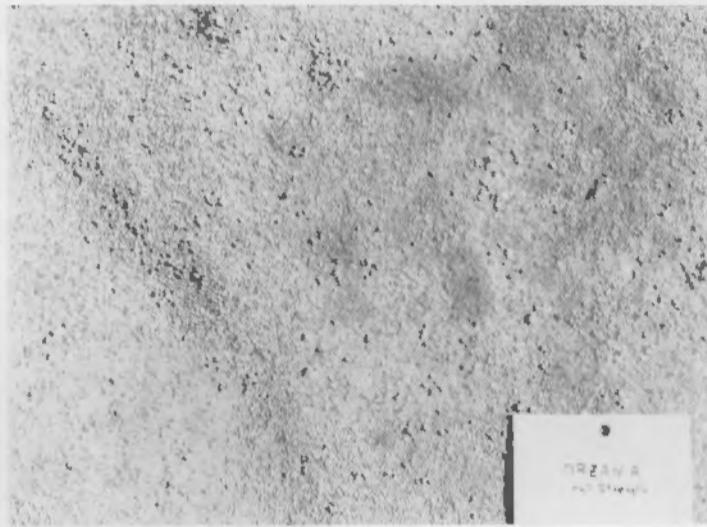
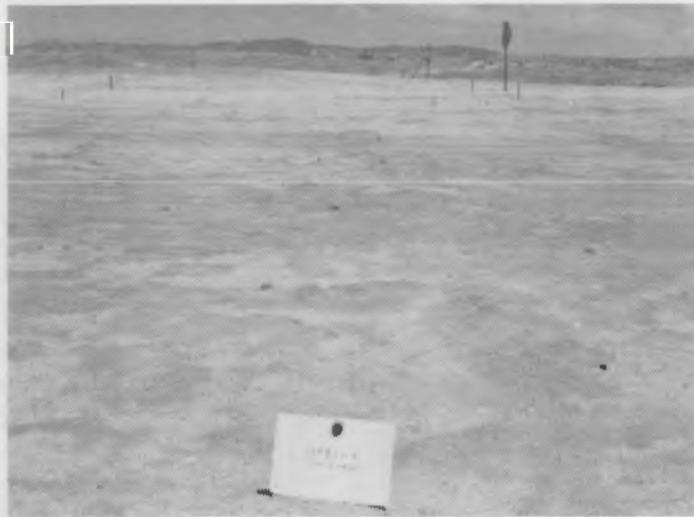
FIGURE A.9. Test Plot Stabilized with Orzan A

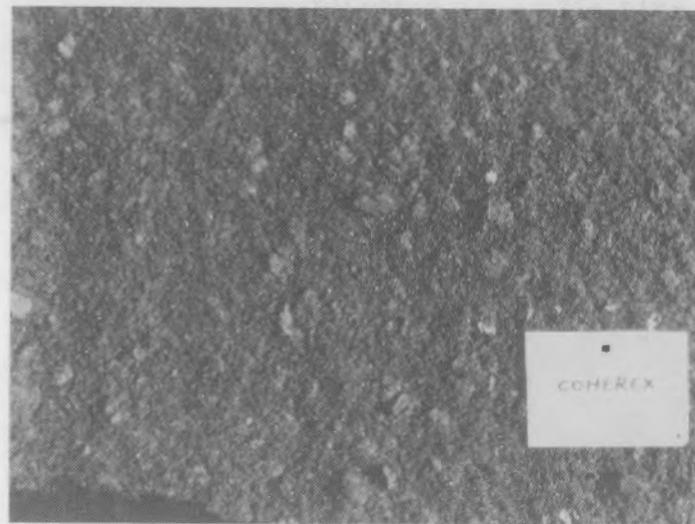
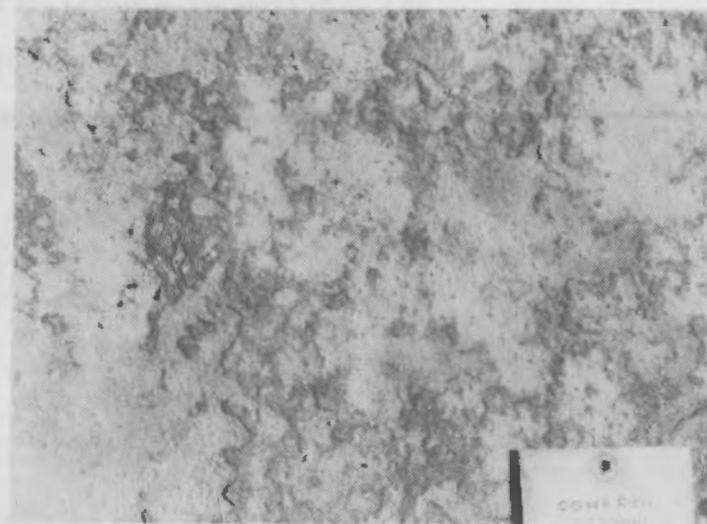
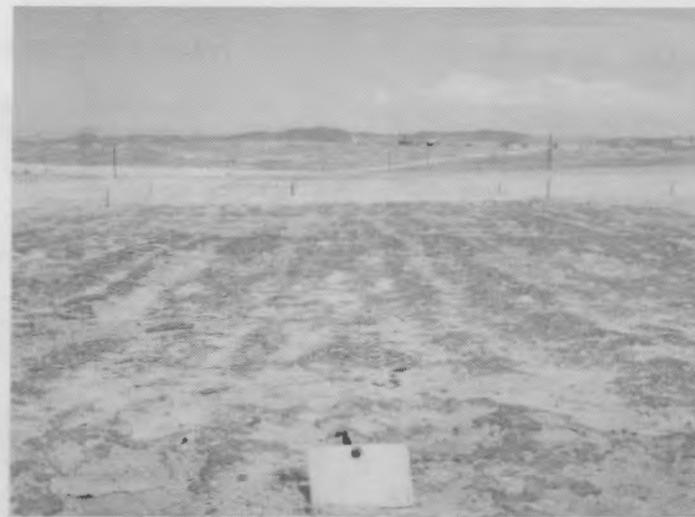
FIGURE A.10. Test Plot Stabilized with Coherex

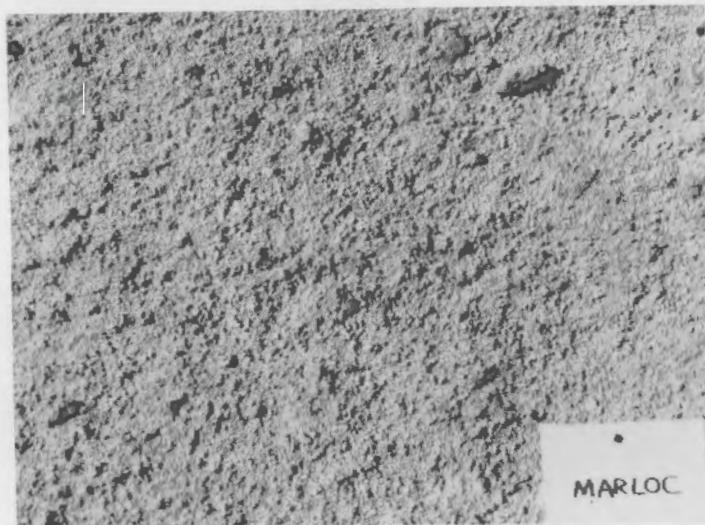
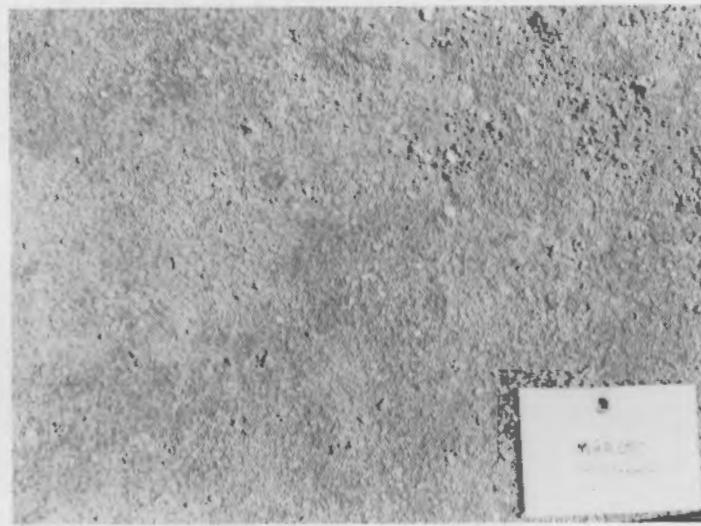
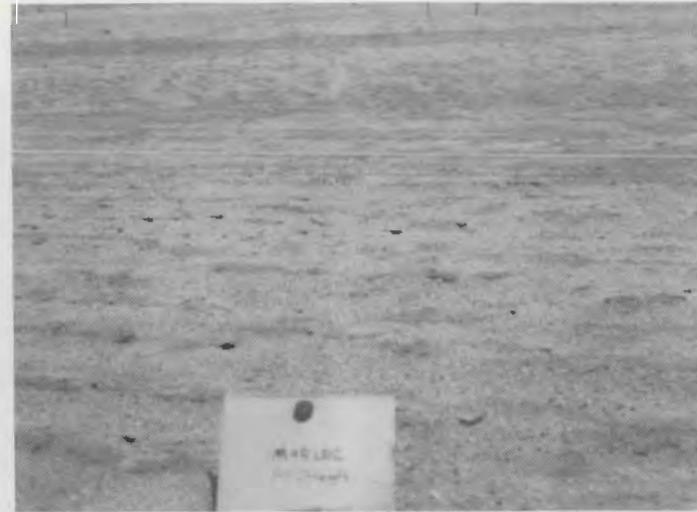
FIGURE A.11. Test Plot Stabilized with Marloc

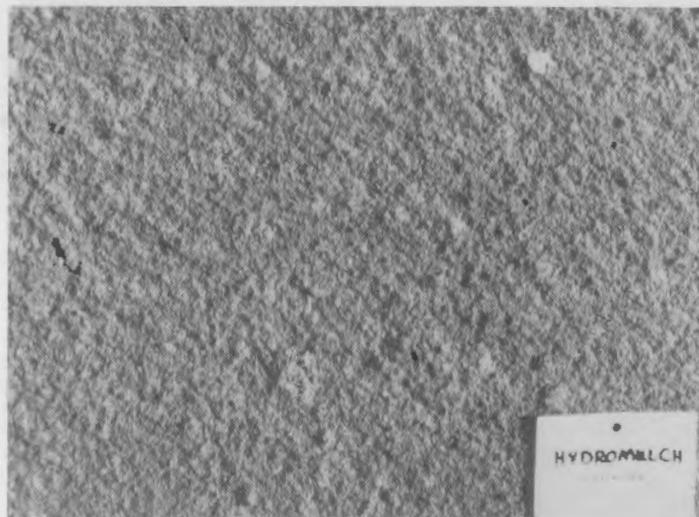
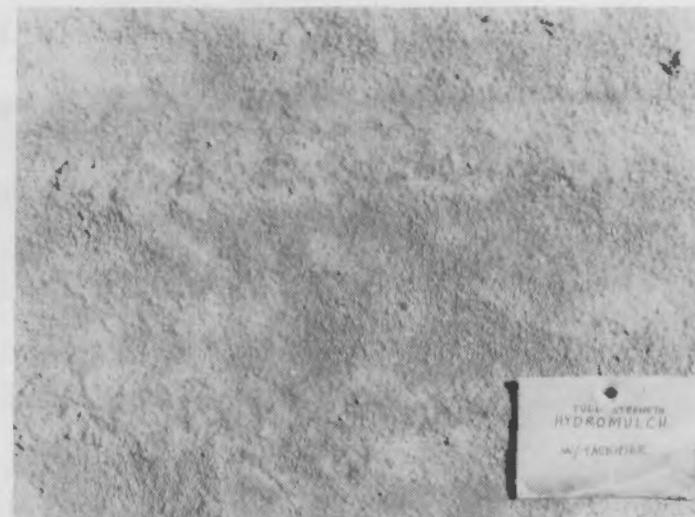
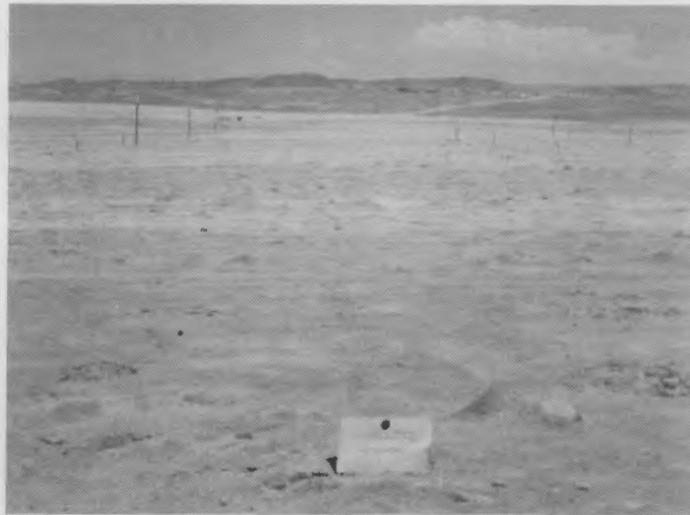
FIGURE A.12. Test Plot Stabilized with Hydro Mulch

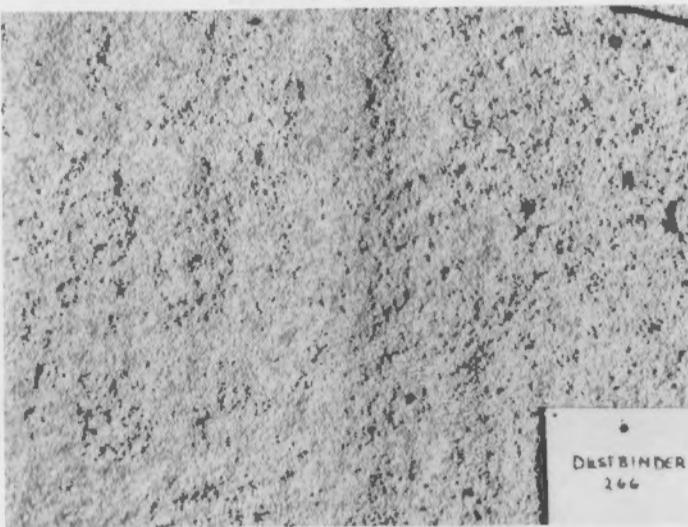
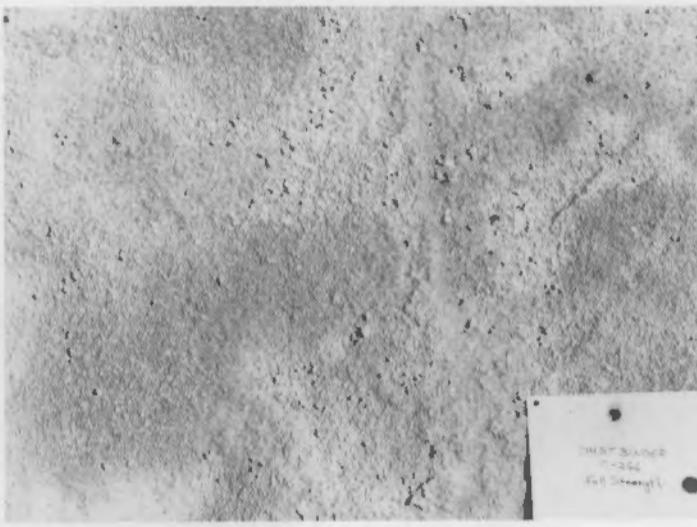
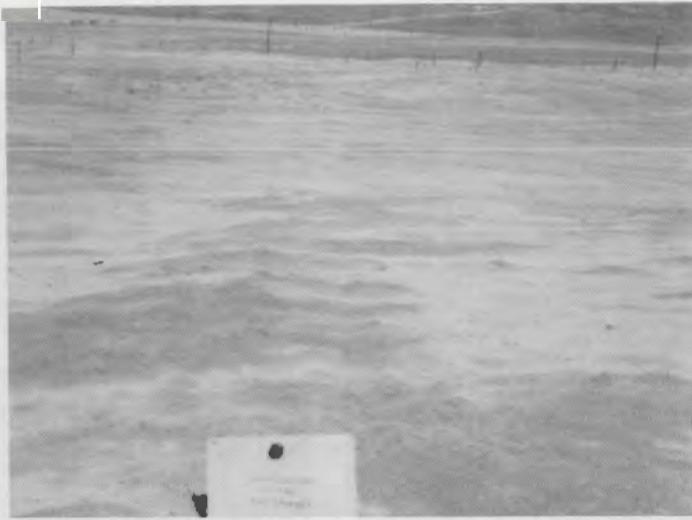
FIGURE A.13. Test Plot Stabilized with Dust Binder C-266

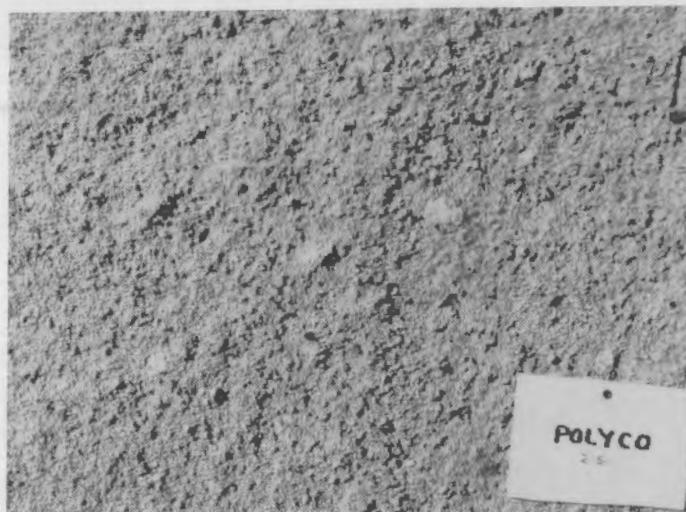
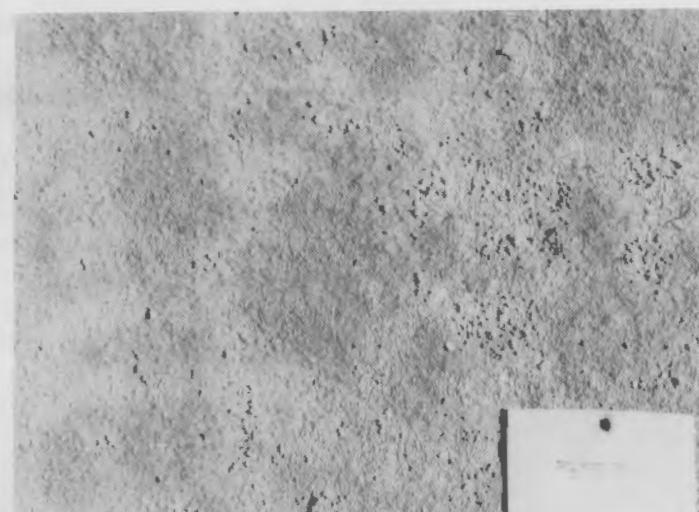
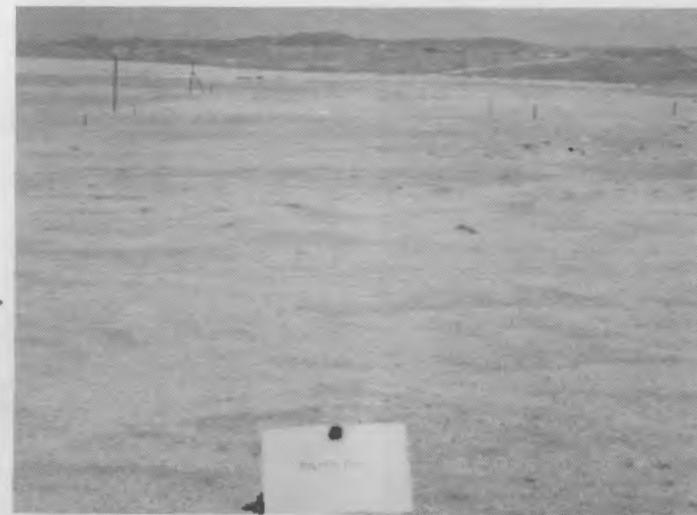
FIGURE A.14. Test Plot Stabilized with Polyco 2151

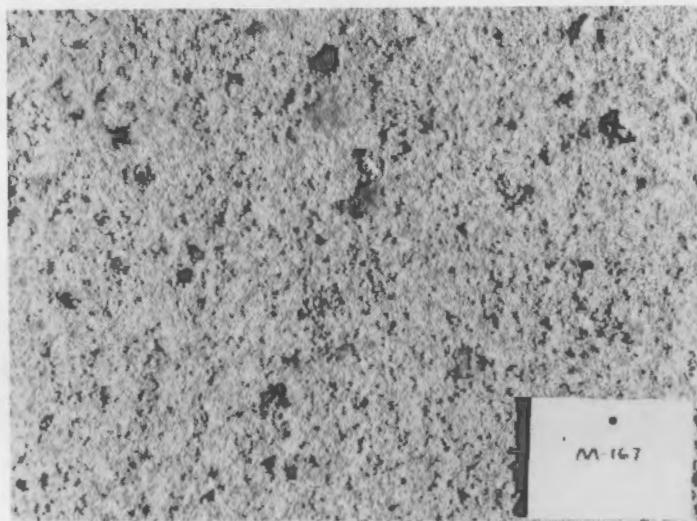
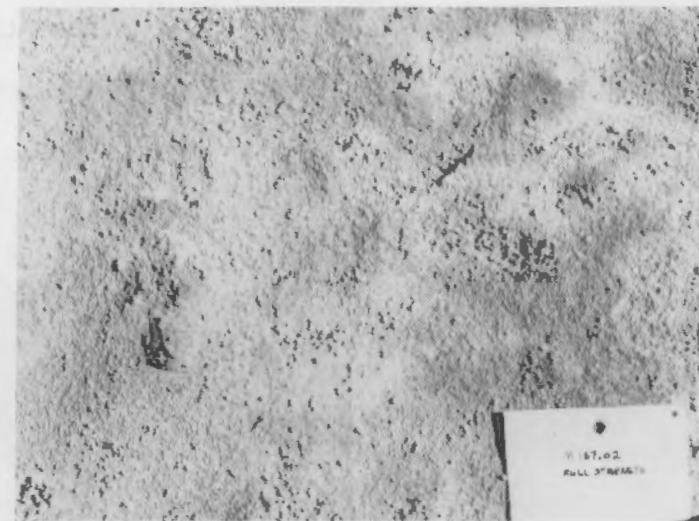
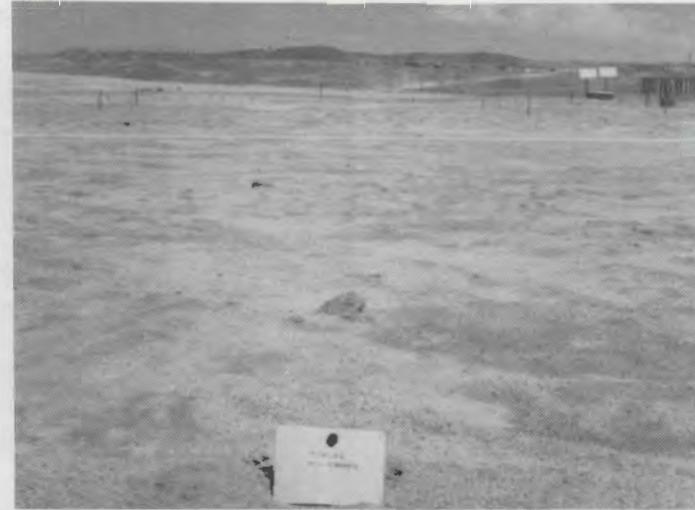
FIGURE A.15. Test Plot Stabilized with M-167
