Mason & Flanger-
Silas Mason Co., Inc.

4-INCH SAMPLE RECOVERY CANISTERS

TEST MODEL D SERIES

September 1969 to May 1970
Purchase Order No. 94-4639 and 94-4683

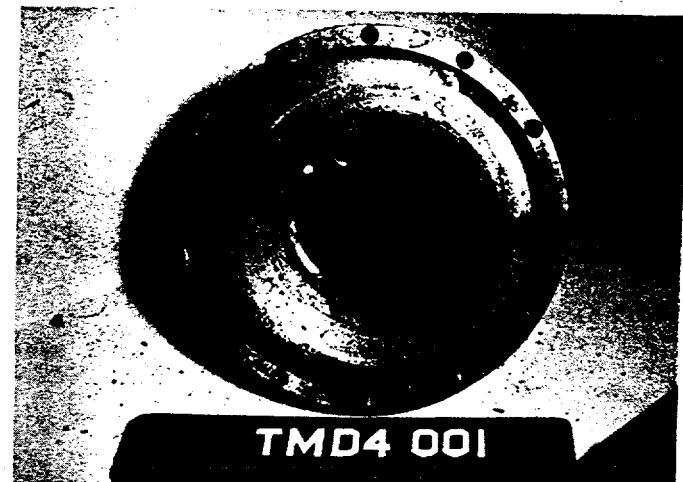
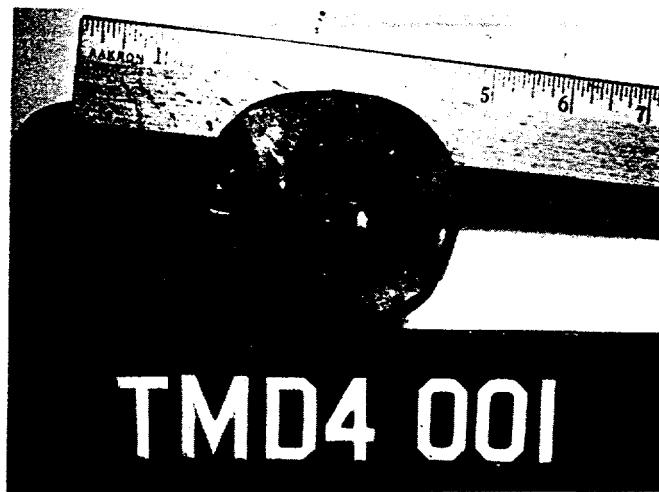
Fig. 14

TMD4-001 Postshot

Fairly good closure was achieved, but it was overdriven, similar to TMB4-017³. The liner was fairly solidly closed, but forward end was lost, shrouded or

shreaded (3½ inches retained). Unit separated at the stress riser. The forward end of the gage filler assembly was shattered and blackened. Considerable damage was done to the unshielded 300 psi gage, probably due to high temperature material. There was evidence of "jetting" upon closure with particulate matter near the center line of the unit damaging the gage filler assembly. The unit apparently experienced an internal pressure of approximately 300 psi. No large shrapnel was generated.

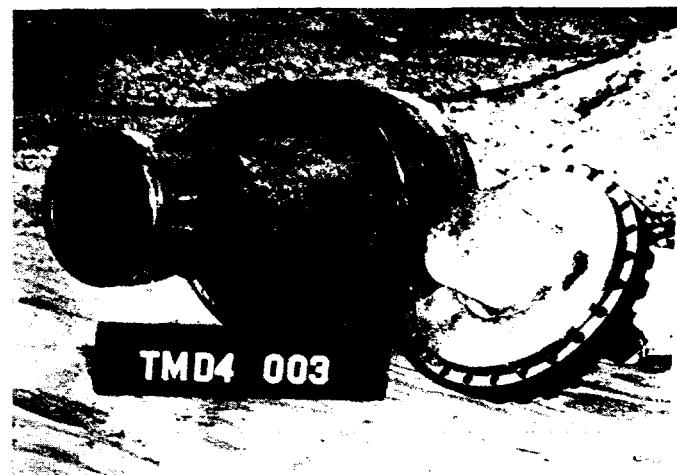
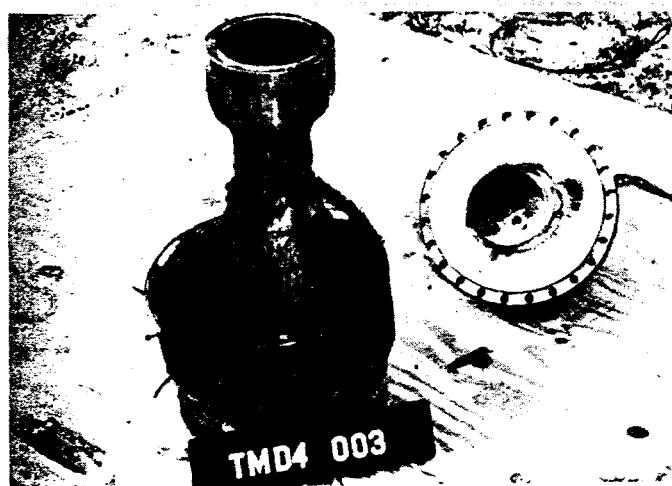
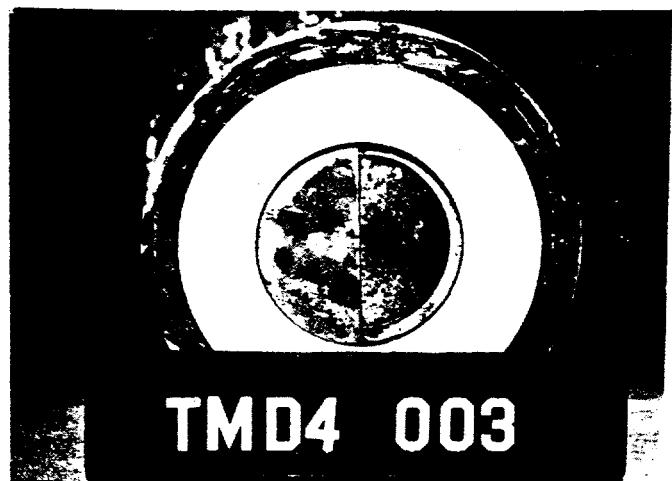
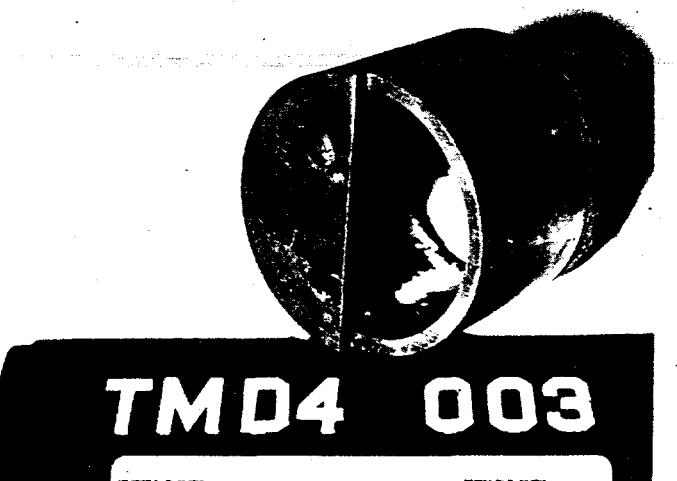
Fig. 20

TMD4-003 Post Shot

Good closure was produced, but the inner sleeve had longitudinal splits. The liner was fully retained and was solidly closed for 5/8 inch. The forward flange was separated from the unit. The filler was not exposed to gas, shrapnel, or jetting damage. A filament wound cover was used, but it appeared to influence the closure quality very little.

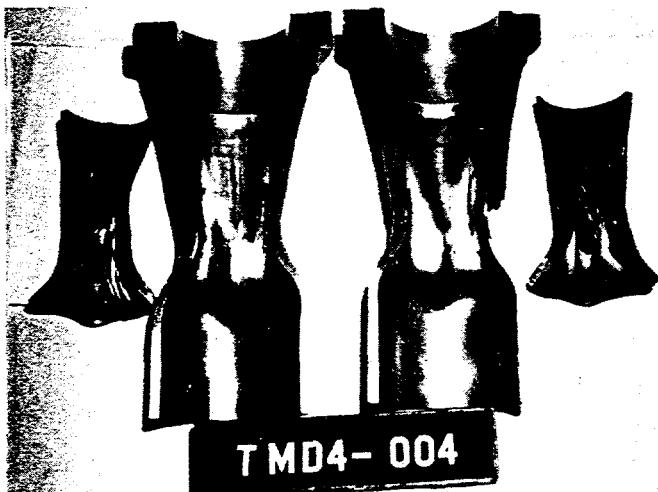
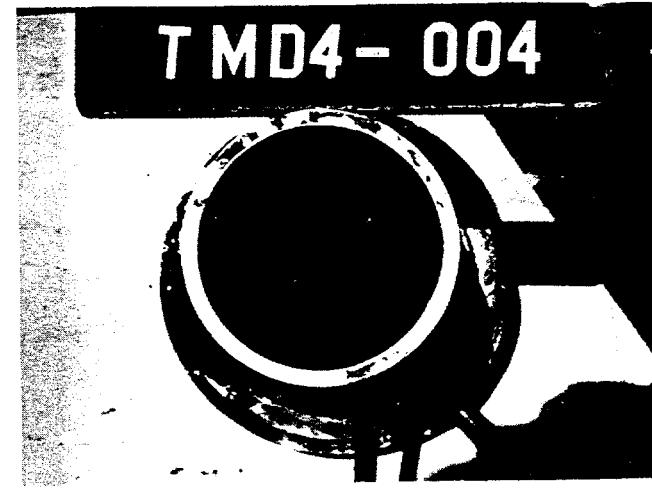
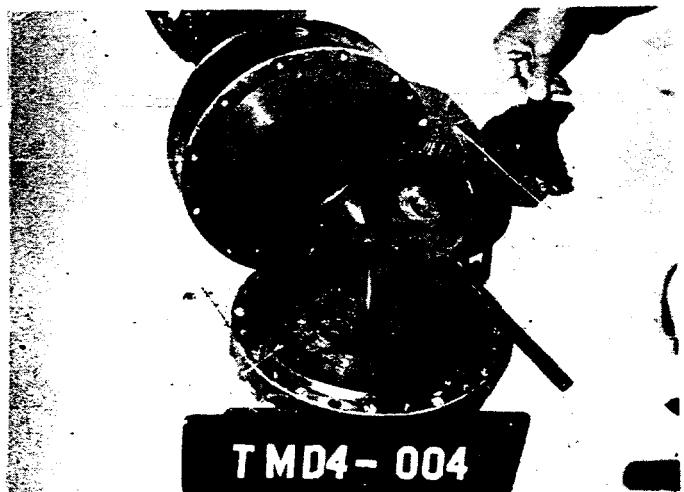
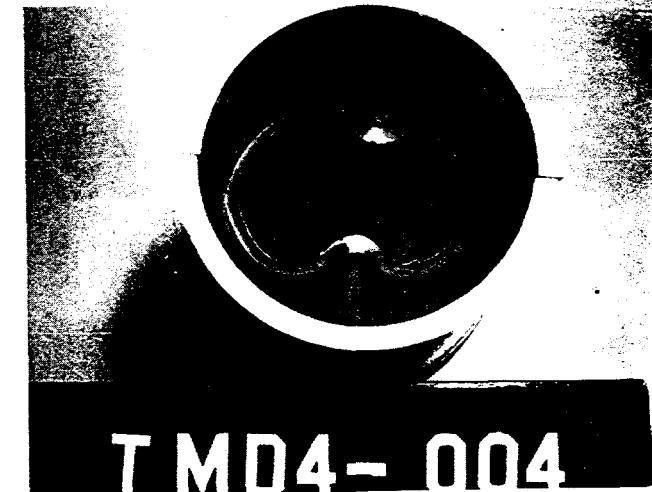
Fig. 24

TMD4-004 Postshot

This closure was underdriven, leaving an aperature of approximately ¼ inch remaining at the center; maximum area closed off was 99 percent. All of the liner was retained. The liner did not separate into two parts. The forward flange was separated from the unit. as planned.

The gage filler assembly consisting of an aluminum passive pressure gage was coated with a light layer of black dust. There were no other indications of gas, shrapnel, or particulate matter damage. There was no evidence of jetting, which should occur only when the liner completely closes. The passive pressure gage gave no indications of having compressed, therefore, the internal pressure was not more than 410 psi.

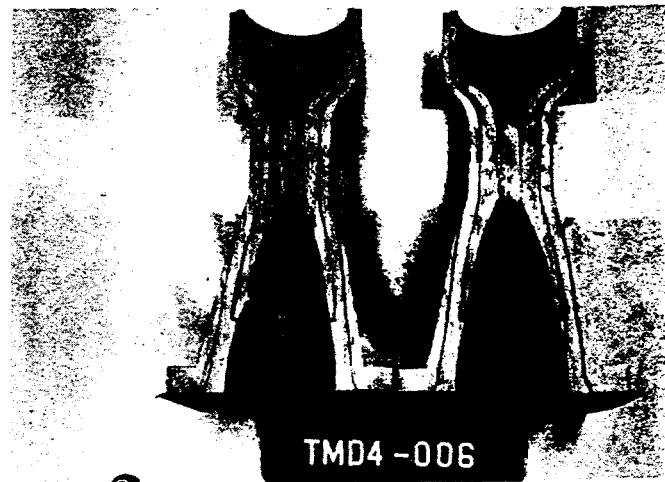
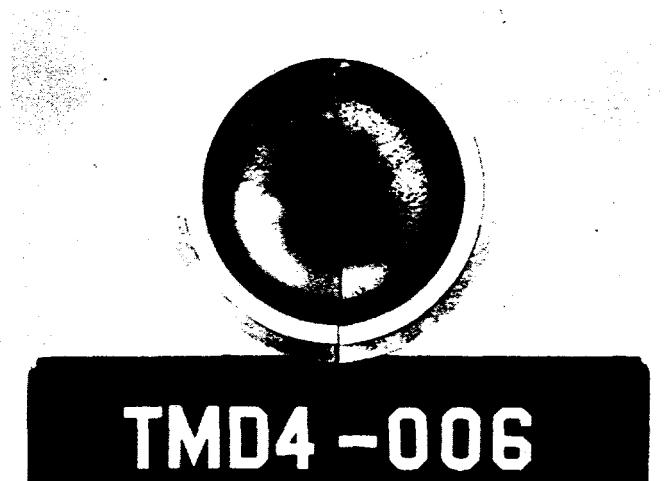
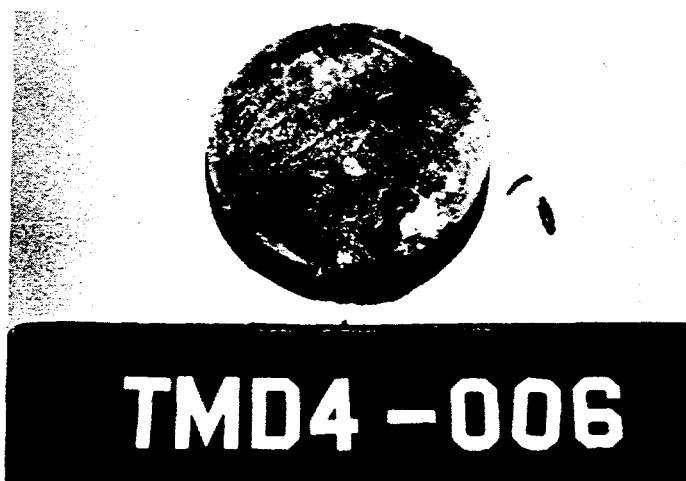
Fig. 28

TMD4-006 Postshot

The closure was good and splitting was virtually eliminated, but a very thin band was left open about ¼-inch wide by 1/16-inch near the center of the liner. The liner was fully retained and the foam filler was not damaged other than being blackened.
