LONG-TERM SURVEILLANCE PLAN FOR THE ESTES GULCH DISPOSAL SITE NEAR RIFLE, COLORADO

Uranium Mill Tailings Remedial Action Project

DOE/AL/62350-235 (9/97)
REV. 0

OPERATION AND CONTINGENCY PLAN FOR MONITORING WELL CLOSURE, ESTES GULCH DISPOSAL CELL

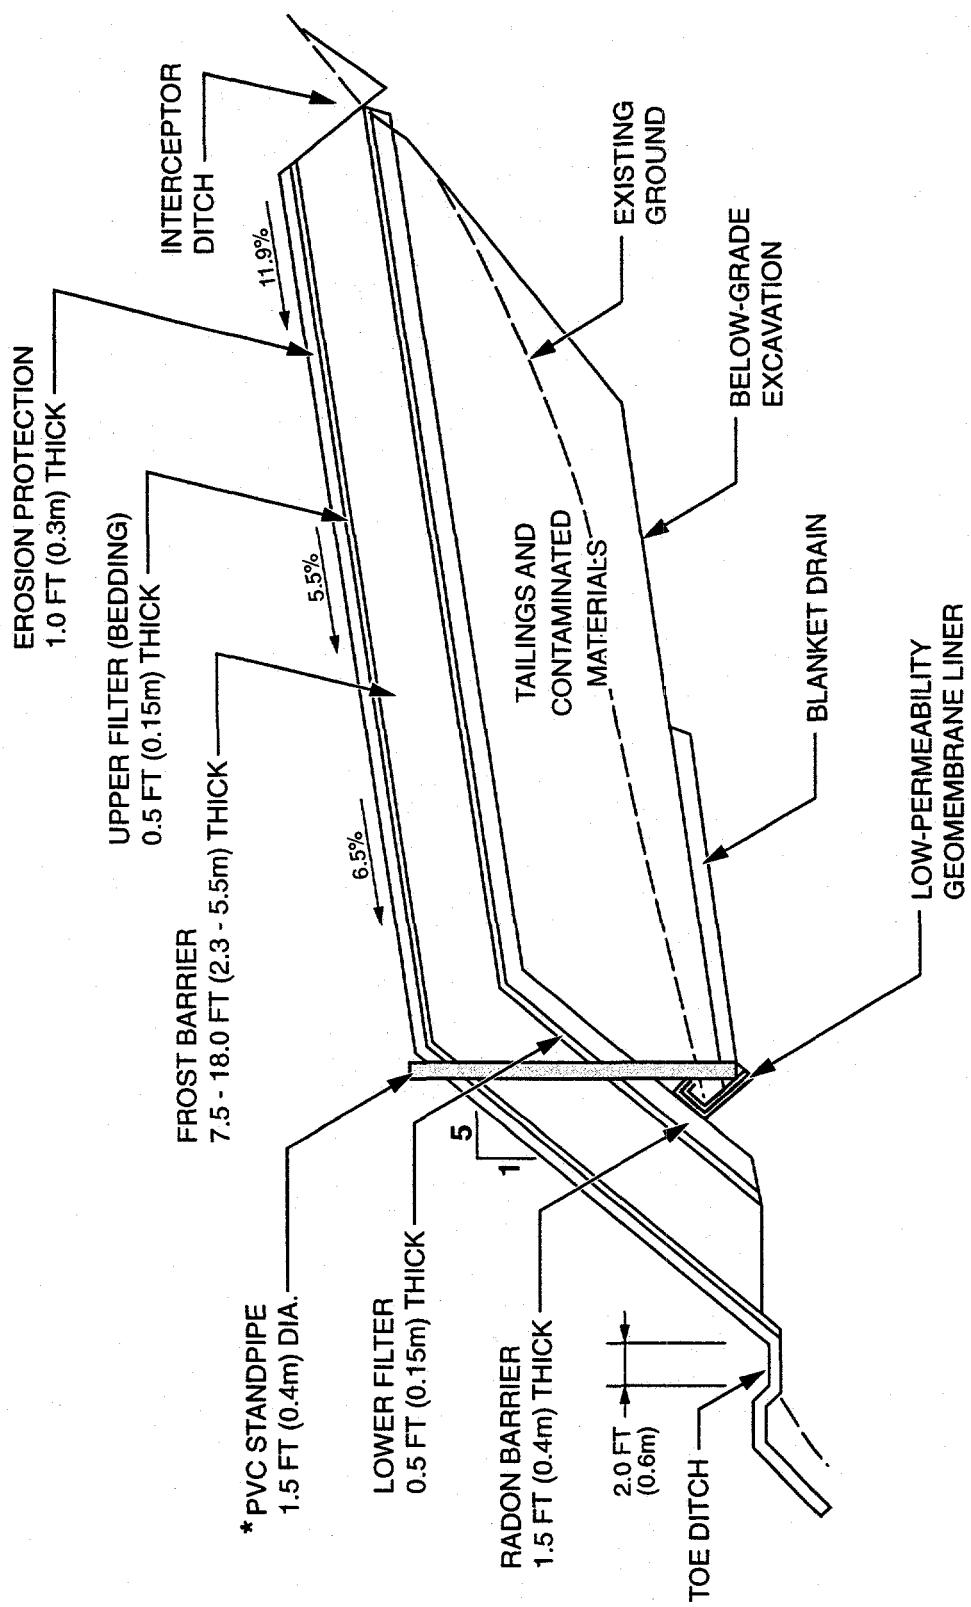
A 1.5-ft (0.45-m)-thick radon/infiltration barrier is placed over the contaminated materials. The radon barrier is constructed of two layers: a 0.5-ft (0.15-m) compacted clay layer and a 1-ft (0.3-m) layer of bentonite-amended clay. The barrier is designed to reduce the radon-222 flux from the disposal cell to less than 20 picocuries per square meter per second and minimize water infiltration into the tailings. Over much of the radon/infiltration barrier an additional 0.5- to 0.7-ft (0.1- to 0.2-m) layer was placed to prevent drying. A 0.5-ft (0.15-m)-thick coarse-grained filter layer is placed on top of the radon/infiltration barrier to provide a capillary break and promote drainage of infiltrating water away from the radon barrier. A layer of compacted soil lies on top of the filter layer to insulate the radon/infiltration barrier and keep it from being adversely affected by freeze-thaw cycles. The typical thickness of this layer is 7.5 ft (2.3 m), and it has a maximum thickness of 18 ft (5.5 m) where the cell joins the natural slope. The topslopes and sideslopes of the disposal cell are capped with rock (riprap) to protect against wind and water erosion and prevent damage to the underlying frost protection and radon/infiltration layers.

The erosion-protection layer is 1-ft (0.3-m) thick. A 0.5-ft (0.15-m)-thick bedding layer is beneath the erosion-protection layer to prevent damage to the underlying frost protection layer from rocks and soil loss from runoff water. These grades, in conjunction with the bedding layer, will allow excess surface water to run off the disposal cell and be conveyed to adjacent site grades, thereby minimizing the risk of significant erosion. The components of both the

* THREE STANDPIPES TO BE REMOVED.
SEE APPENDIX A.

SCHEMATIC - NOT TO SCALE

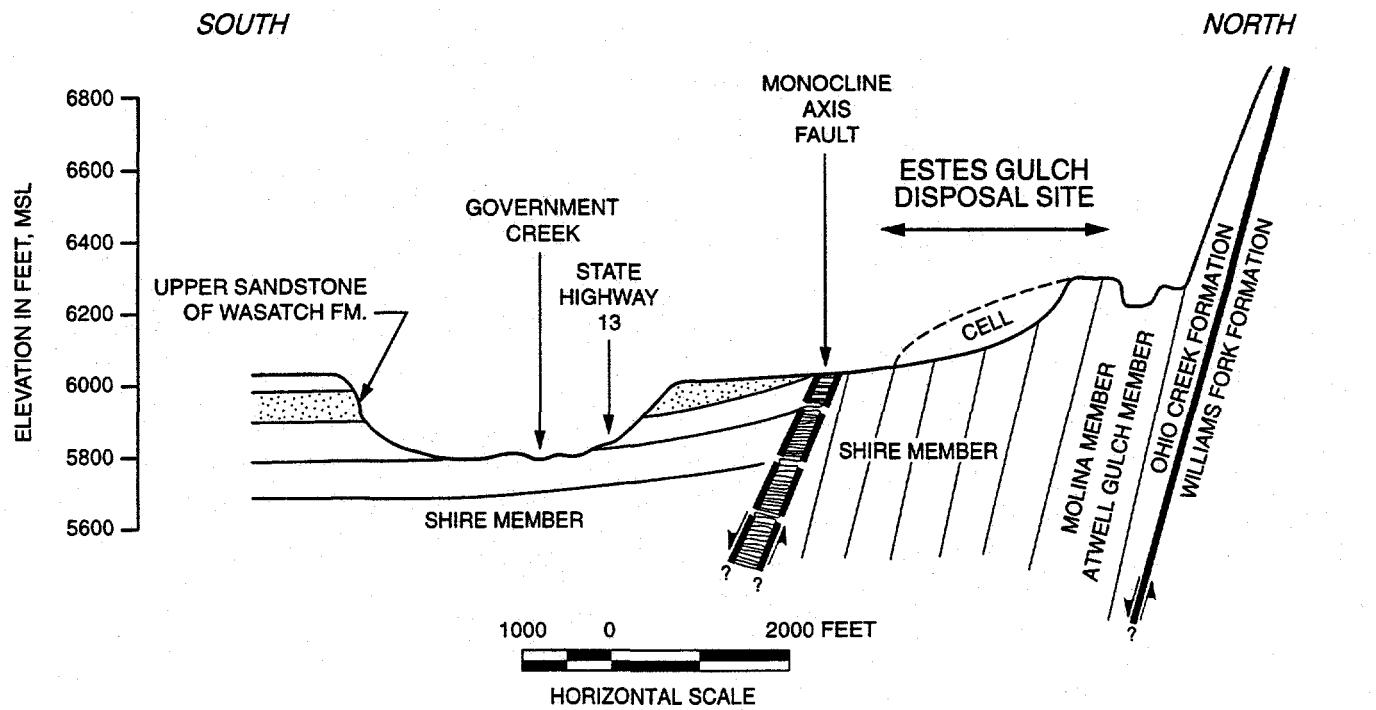
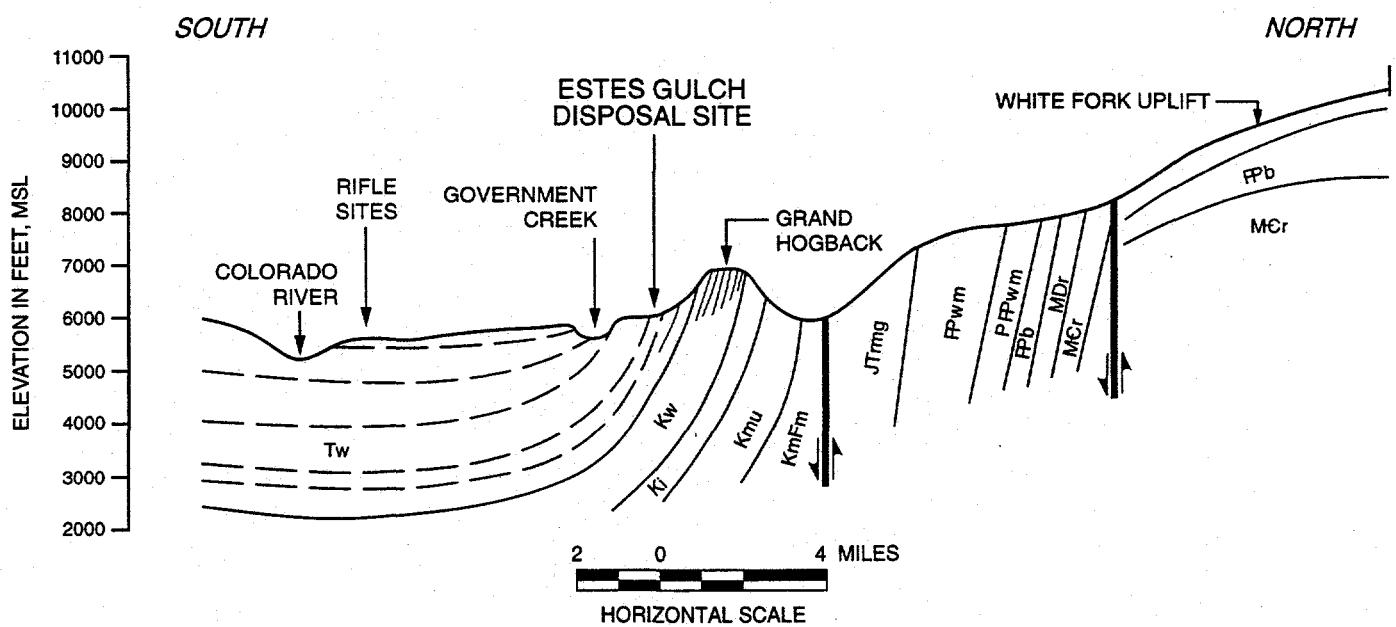
Exploratory drilling conducted during characterization of the Estes Gulch disposal site encountered several faults paralleling the bedding planes and occurring randomly in the steeply-dipping strata beneath the site. Exploratory drilling shows that these faults are filled with clay gouge having a hydraulic conductivity of approximately 1×10^{-9} cm per second. Therefore the faults do not appear to be a significant ground water transport pathway. Closely spaced fractures sometimes occur near these minor faults, becoming widely spaced within a few feet of the faults.

The Wasatch Formation is generally an aquitard, and does not contain significant quantities of ground water (Wright Water Engineers, 1979; Giles, 1980; Coffin et al., 1968, 1971). The limited ground water in the Wasatch Formation beneath the site flows primarily through fractures and joints in the siltstone and sandstone beds. Localized recharge to the bedrock occurs through weathered zones and fractures, and in areas where more permeable beds crop out at the surface. Recharge percolates down to limited zones of saturation,

Tw	WASATCH FORMATION	PPwm	WEBER SANDSTONE AND MAROON FORMATION
Kw	WILLIAMS FORK FORMATION, MESAVERDE GROUP	PPm	MINTURN FORMATION
Ki	ILES FORMATION, MESAVERDE GROUP	FPb	BELDEN FORMATION
Kmu	UPPER UNIT OF MANCOS SHALE	MDr	MISSISSIPPIAN AND DEVONIAN ROCKS
KmFm	FRONTIER SANDSTONE AND MOWRY SHALE MEMBER OF MANCOS SHALE	MCr	MISSISSIPPIAN AND CAMBRIAN ROCKS
JTrmg	MORRISON, ENTRADA, AND GLEN CANYON FORMATIONS	FAULT/FRACTURE ZONE

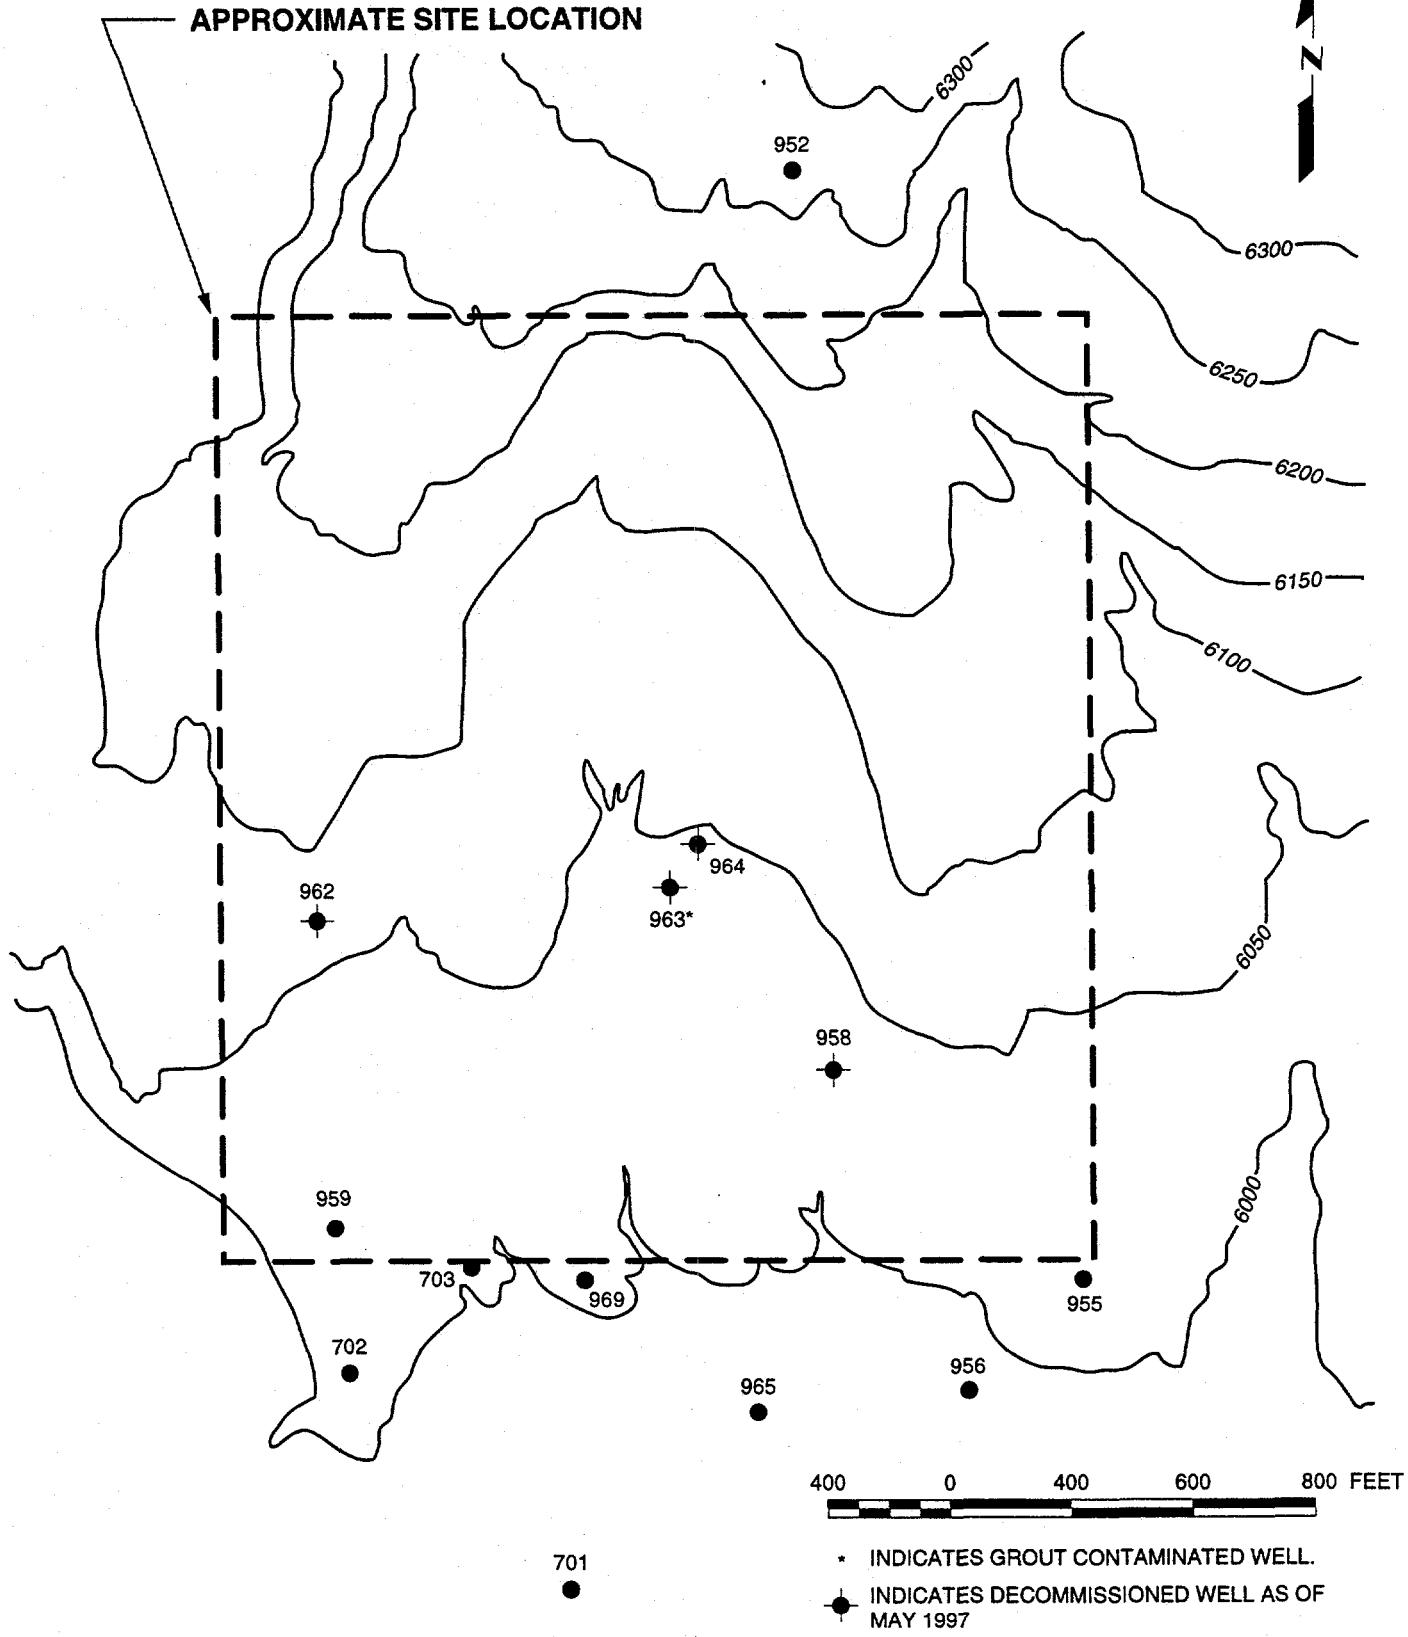
FIGURE 2.5
MONITOR WELL LOCATIONS
ESTES GULCH DISPOSAL SITE NEAR RIFLE, COLORADO

The DOE installed a total of 13 monitor wells at the Estes Gulch disposal site prior to disposal cell construction (Table 2.2). In 1986, the DOE installed 10 monitor wells at the Estes Gulch site. The wells ranged from 60 to 301 ft (18 to 92 m) deep. Nine of the wells are dry and one found ground water. Water was encountered in the deepest well (well 963) at a depth of 270 ft (82 m) below ground surface. The water level then slowly rose to a depth of 150 ft (46 m) below ground surface when last measured. In 1988, the DOE installed three additional wells (wells 701, 702, and 703) completed to depths of 500 to 545 ft (150 to 165 m). These three wells showed little or no water at completion; however, water levels rose in these wells following completion until 1990. When last measured in March 1992, ground water levels ranged from 274 to 434 ft (84 to 132 m) below ground surface in the three wells (Figure 2.5).

^aMonitor well locations are shown on Figure 2.5. All are RFL-08-OXXX.^bAll monitor wells are completed in the Wasatch Formation and have casing diameters of 4 inches.^cDecommissioned May 1997^dThe depth from the land surface to ground water in monitor well 963 was 270.2 ft on 01/14/86 and 183 ft on 10/20/87.

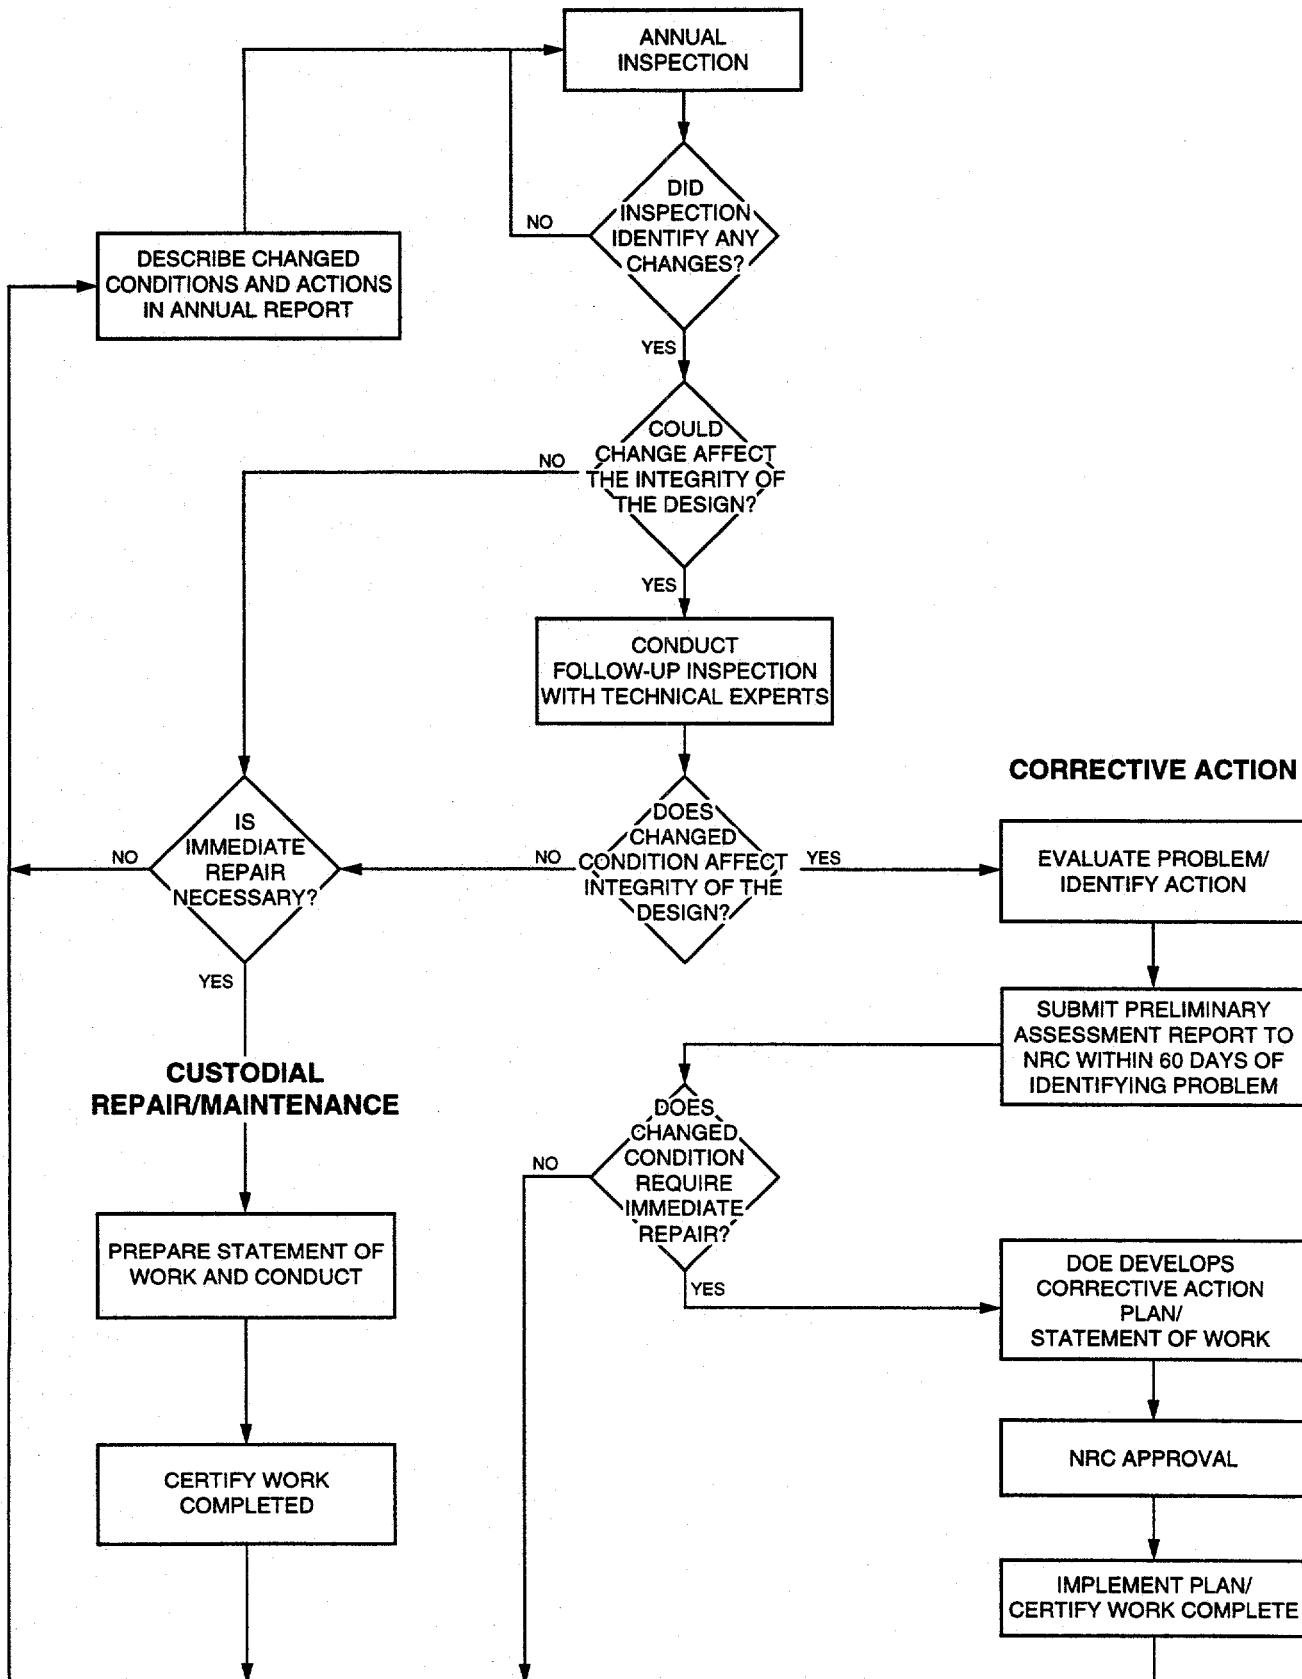
FIGURE 3.1
STEPS FOR FOLLOW-UP INSPECTIONS,
CUSTODIAL MAINTENANCE, AND CORRECTIVE ACTION
AT THE ESTES GULCH DISPOSAL SITE NEAR RIFLE, COLORADO

The DOE will inspect of the Estes Gulch disposal site to detect progressive changes caused by slow-acting natural processes and to identify potential problems before there is a need for extensive maintenance, repairs, or corrective action. Inspections may also be conducted to follow up on events or conditions that have affected or potentially could affect the disposal site. The DOE will compare the findings from these inspections to initial baseline conditions to identify changes over time and to provide a basis for future inspections, repairs, and corrective actions. This process is shown in Figure 3.1.

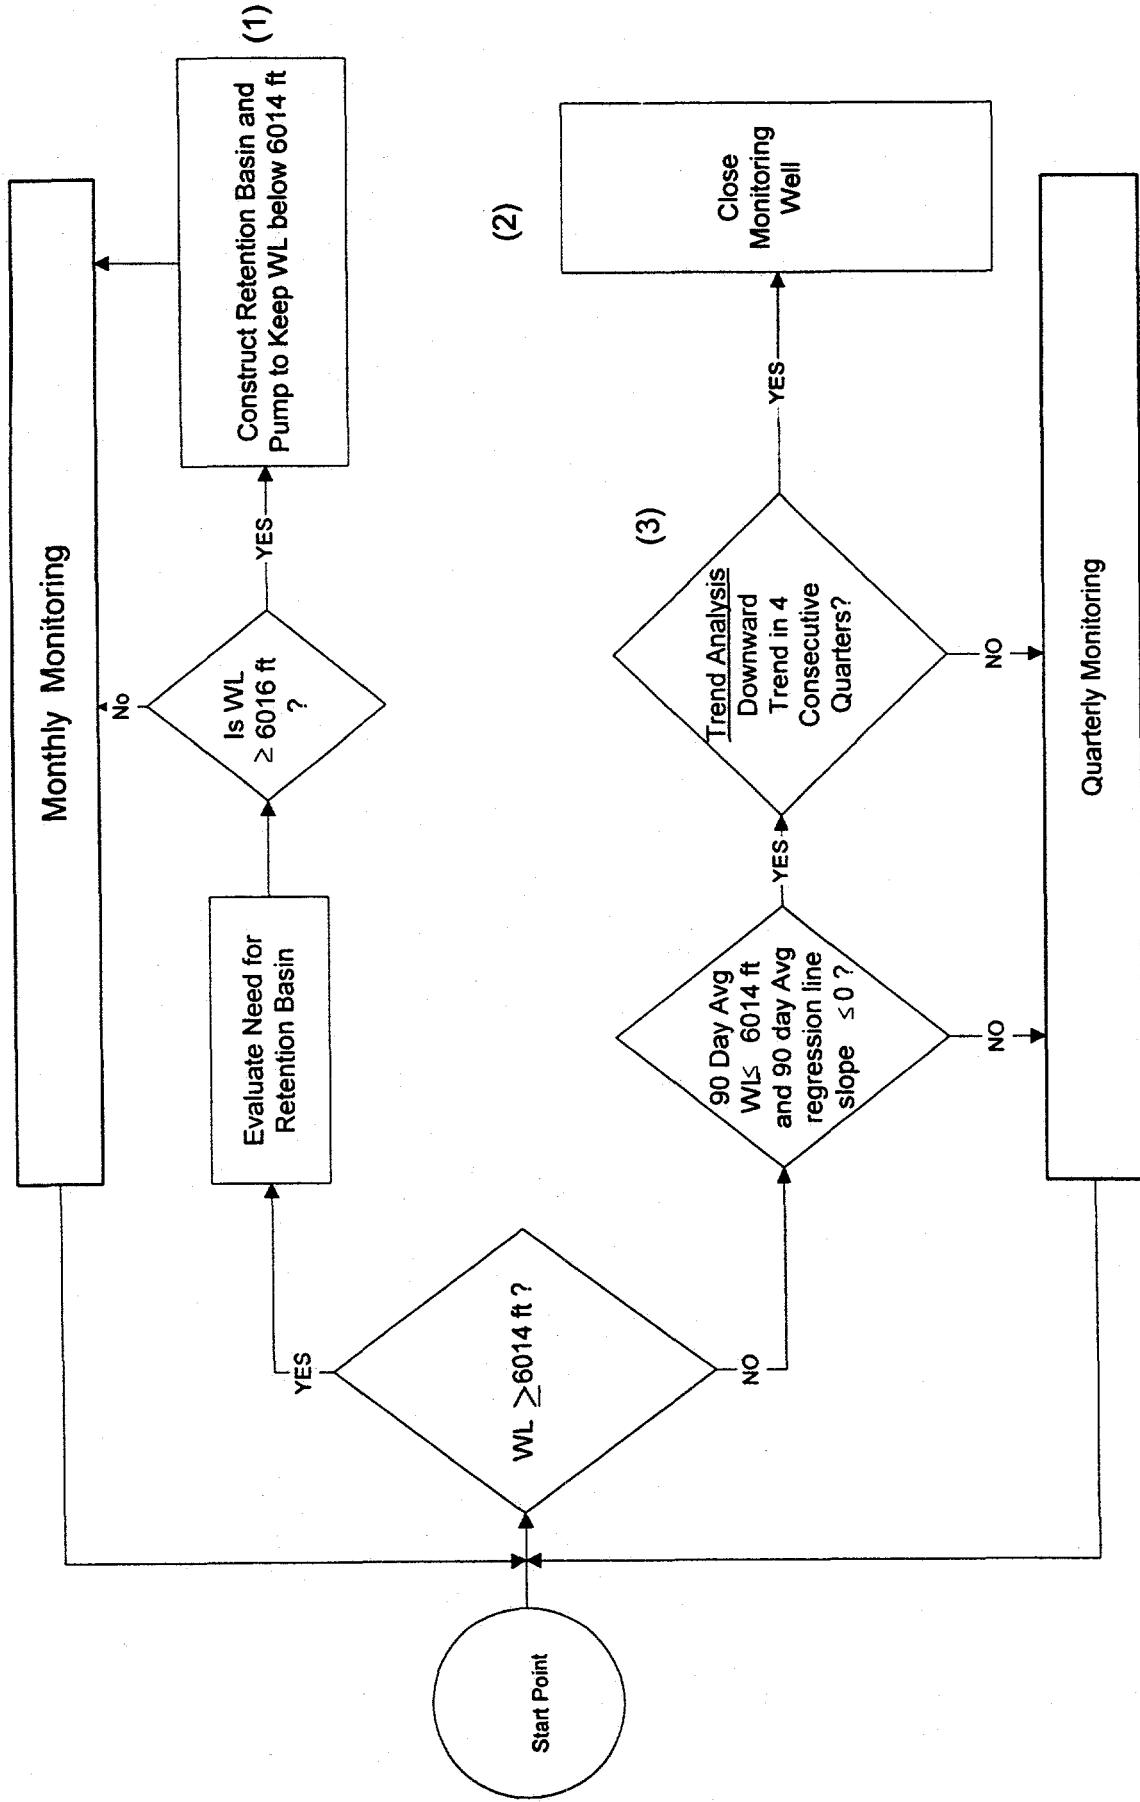
FIGURE 4

(1) Pump intermittently as required to keep WL under 6014 ft for about 90 days and monitor WL at 2-day intervals for 8 days to ensure WL is below 6014 ft under no pumping condition.

(2) No well will be closed unless all three wells satisfy the closure requirements.

**SIMULATED LEACHATE LEVELS DURING
EARLIER TRANSIENT PERIOD
ESTES GULCH DISPOSAL CELL**

Model prediction and field measurements will be compared quarterly during the monitoring period following the construction of the disposal cell. Among all simulation runs performed to date, RUN 21EE (Figures 4 and 5) best represents the field conditions during the first one to two years after the construction of the disposal cell. The results of Run 21EE show that the maximum leachate level predicted at the beginning of this period reaches an elevation of 6015.4 ft. at Node 377 which is located just above the sandstone unit near MW-2 (Ref. 1). To be conservative, leachate levels will be evaluated and construction of a retention basin will be considered when the leachate level reaches an elevation of 6014 ft in MW-2. In the event that the measured level would rise above 6016 ft., construction and pumping to the retention basin will be started as described in Section 3.2.

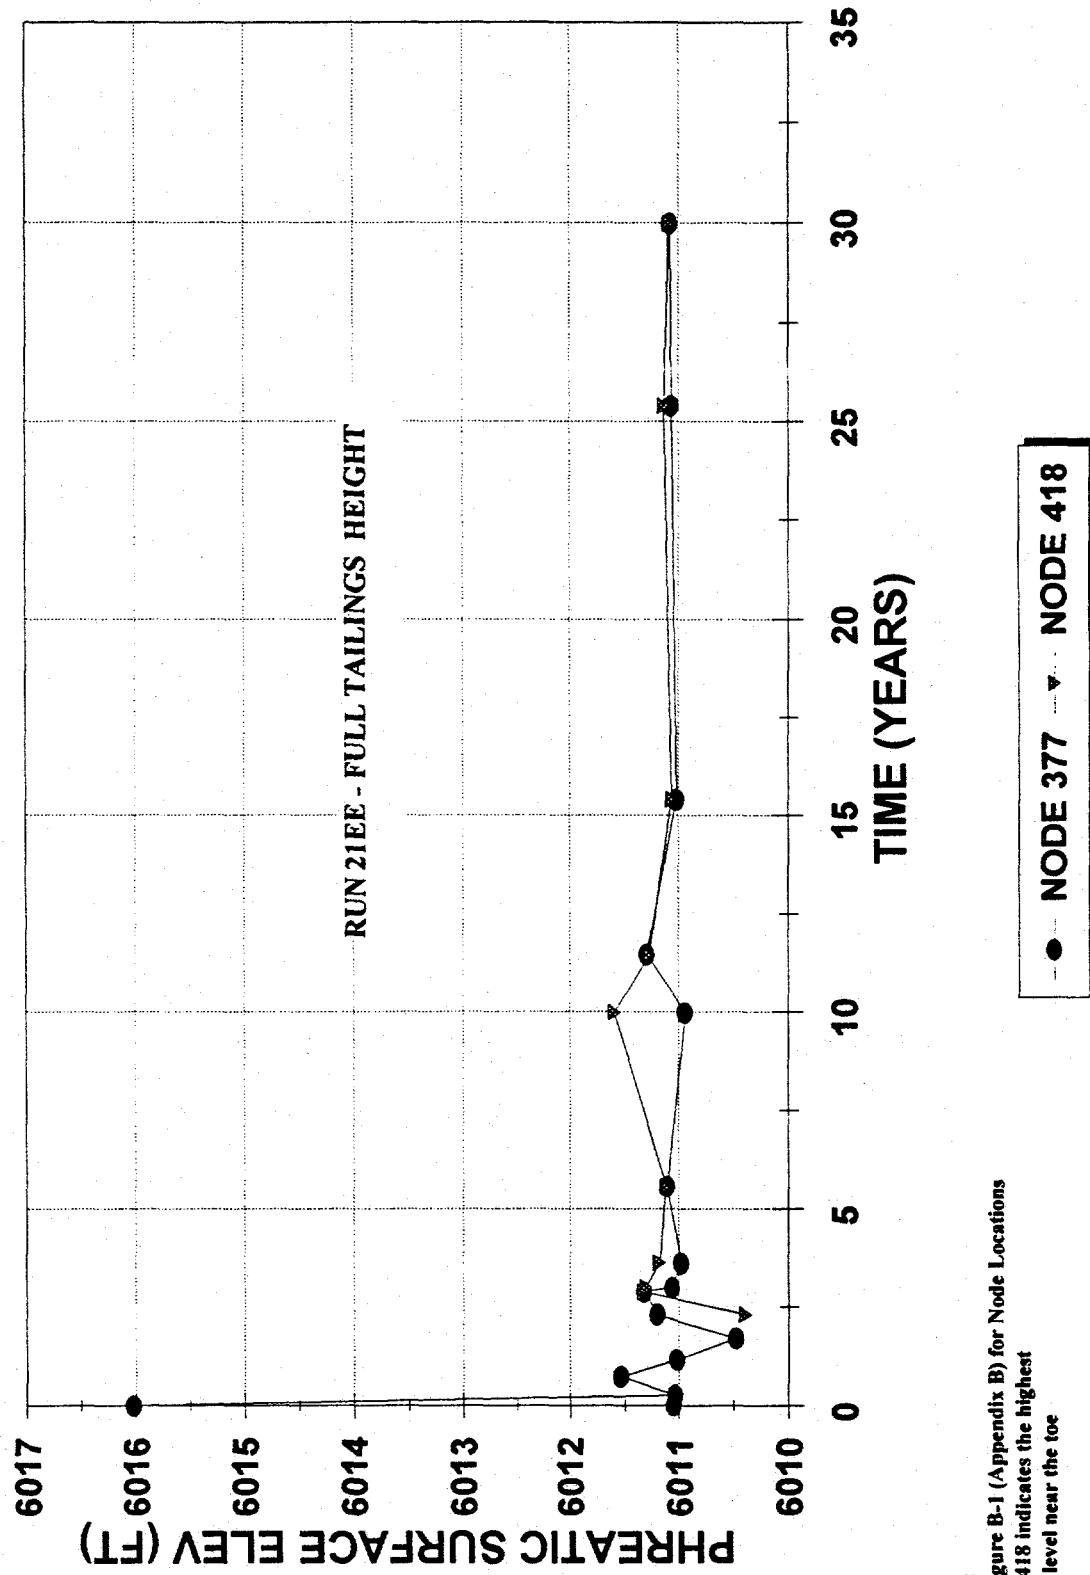
FIGURE 5

1. See Figure B-1 (Appendix B) for Node Locations
2. Node 418 indicates the highest water level near the toe

LEACHATE LEVEL BUILDUP
ESTES GULCH DISPOSAL CELL

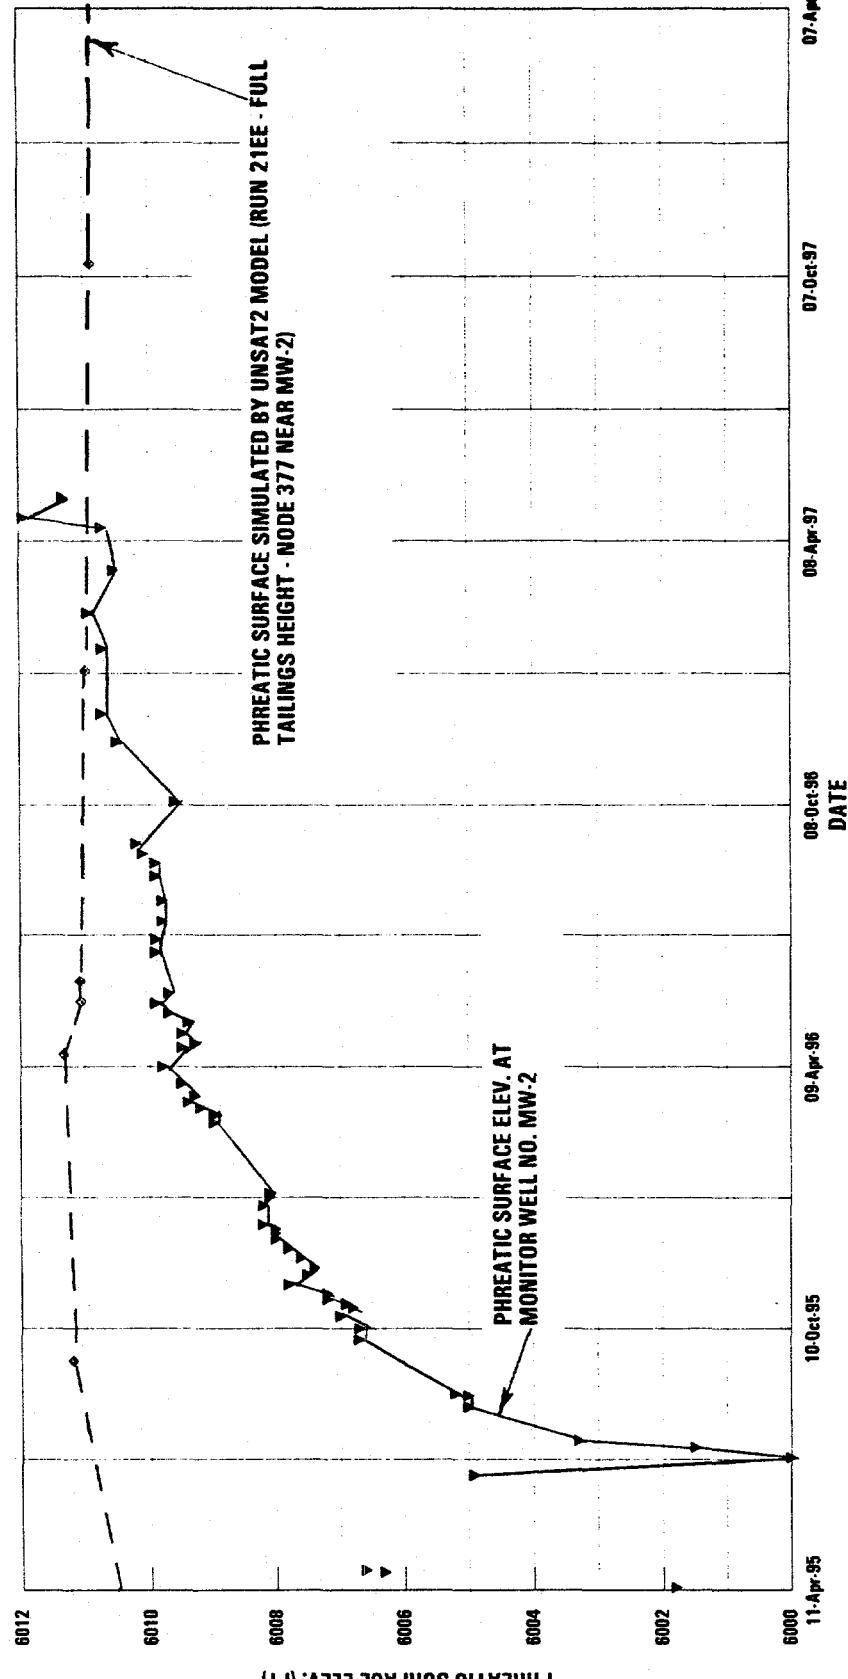
FIGURE 6

ESTES GULCH DISPOSAL CELL
LEACHATE ELEV. VS. STORAGE CURVE

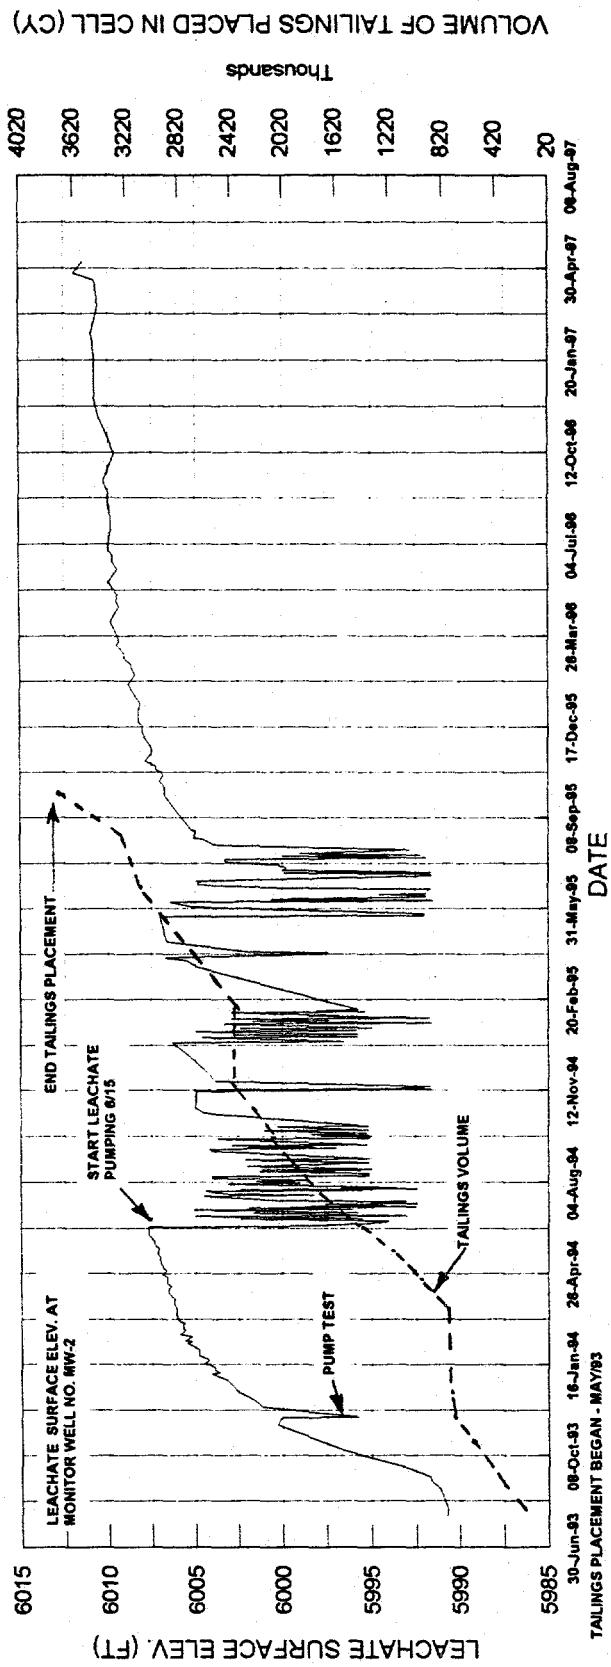
FIGURE A-1

ESTES GULCH DISPOSAL CELL
LEACHATE LEVEL AND TAILINGS VOLUME WITH TIME

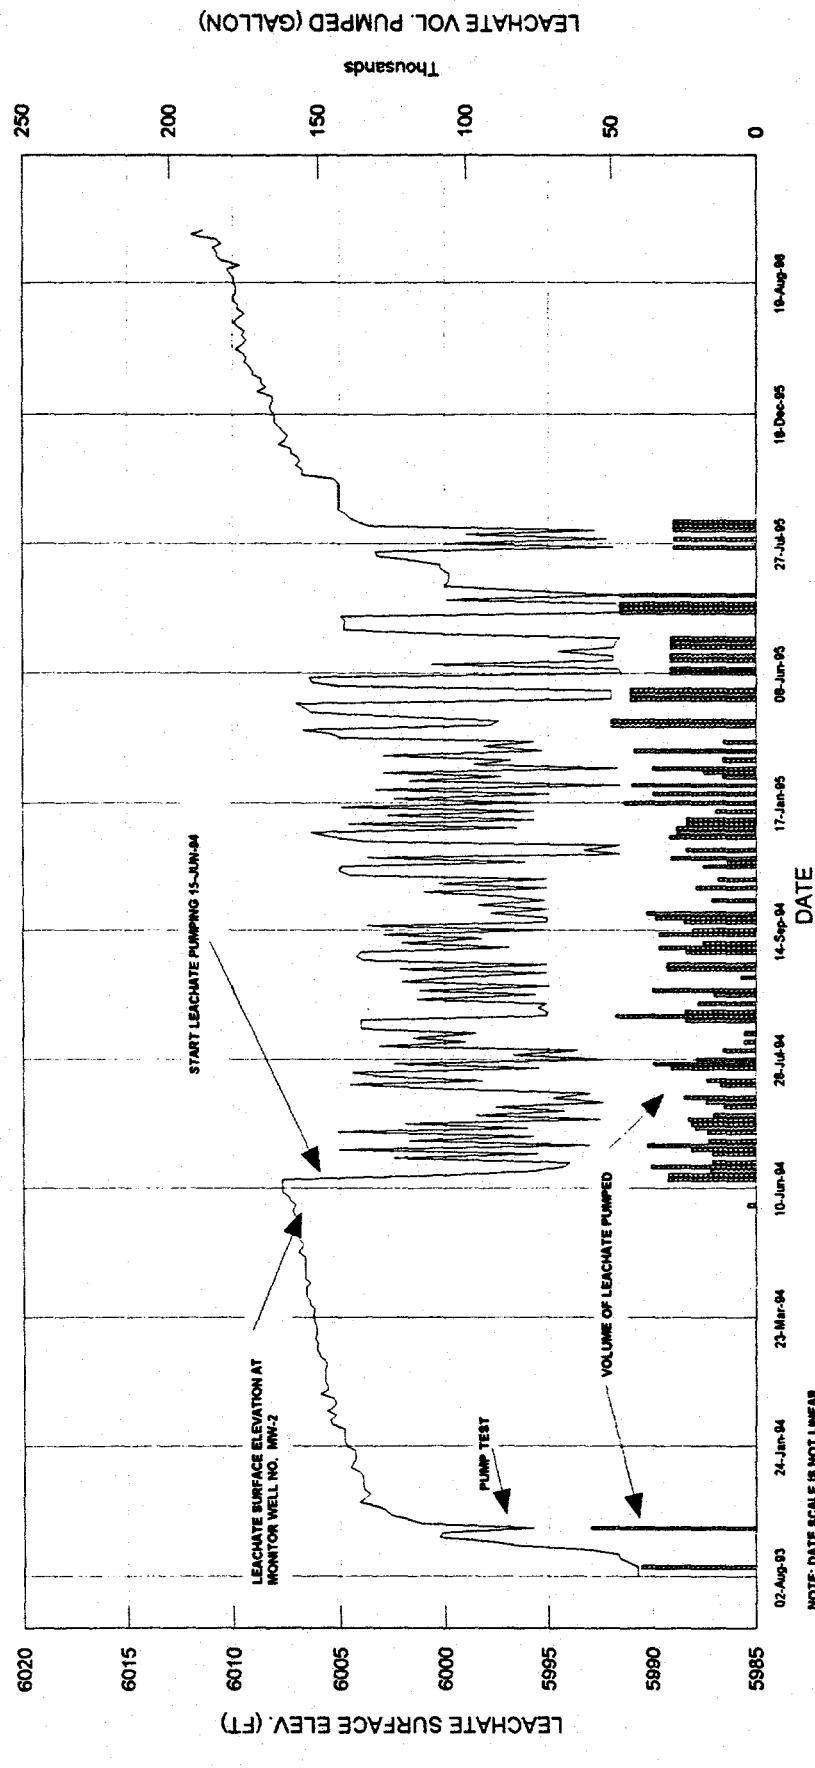
FIGURE A-2

UMTRA/RIFLE - ESTES GULCH DISPOSAL CELL
LEACHATE ELEVATION AND PUMPED VOLUME WITH TIME

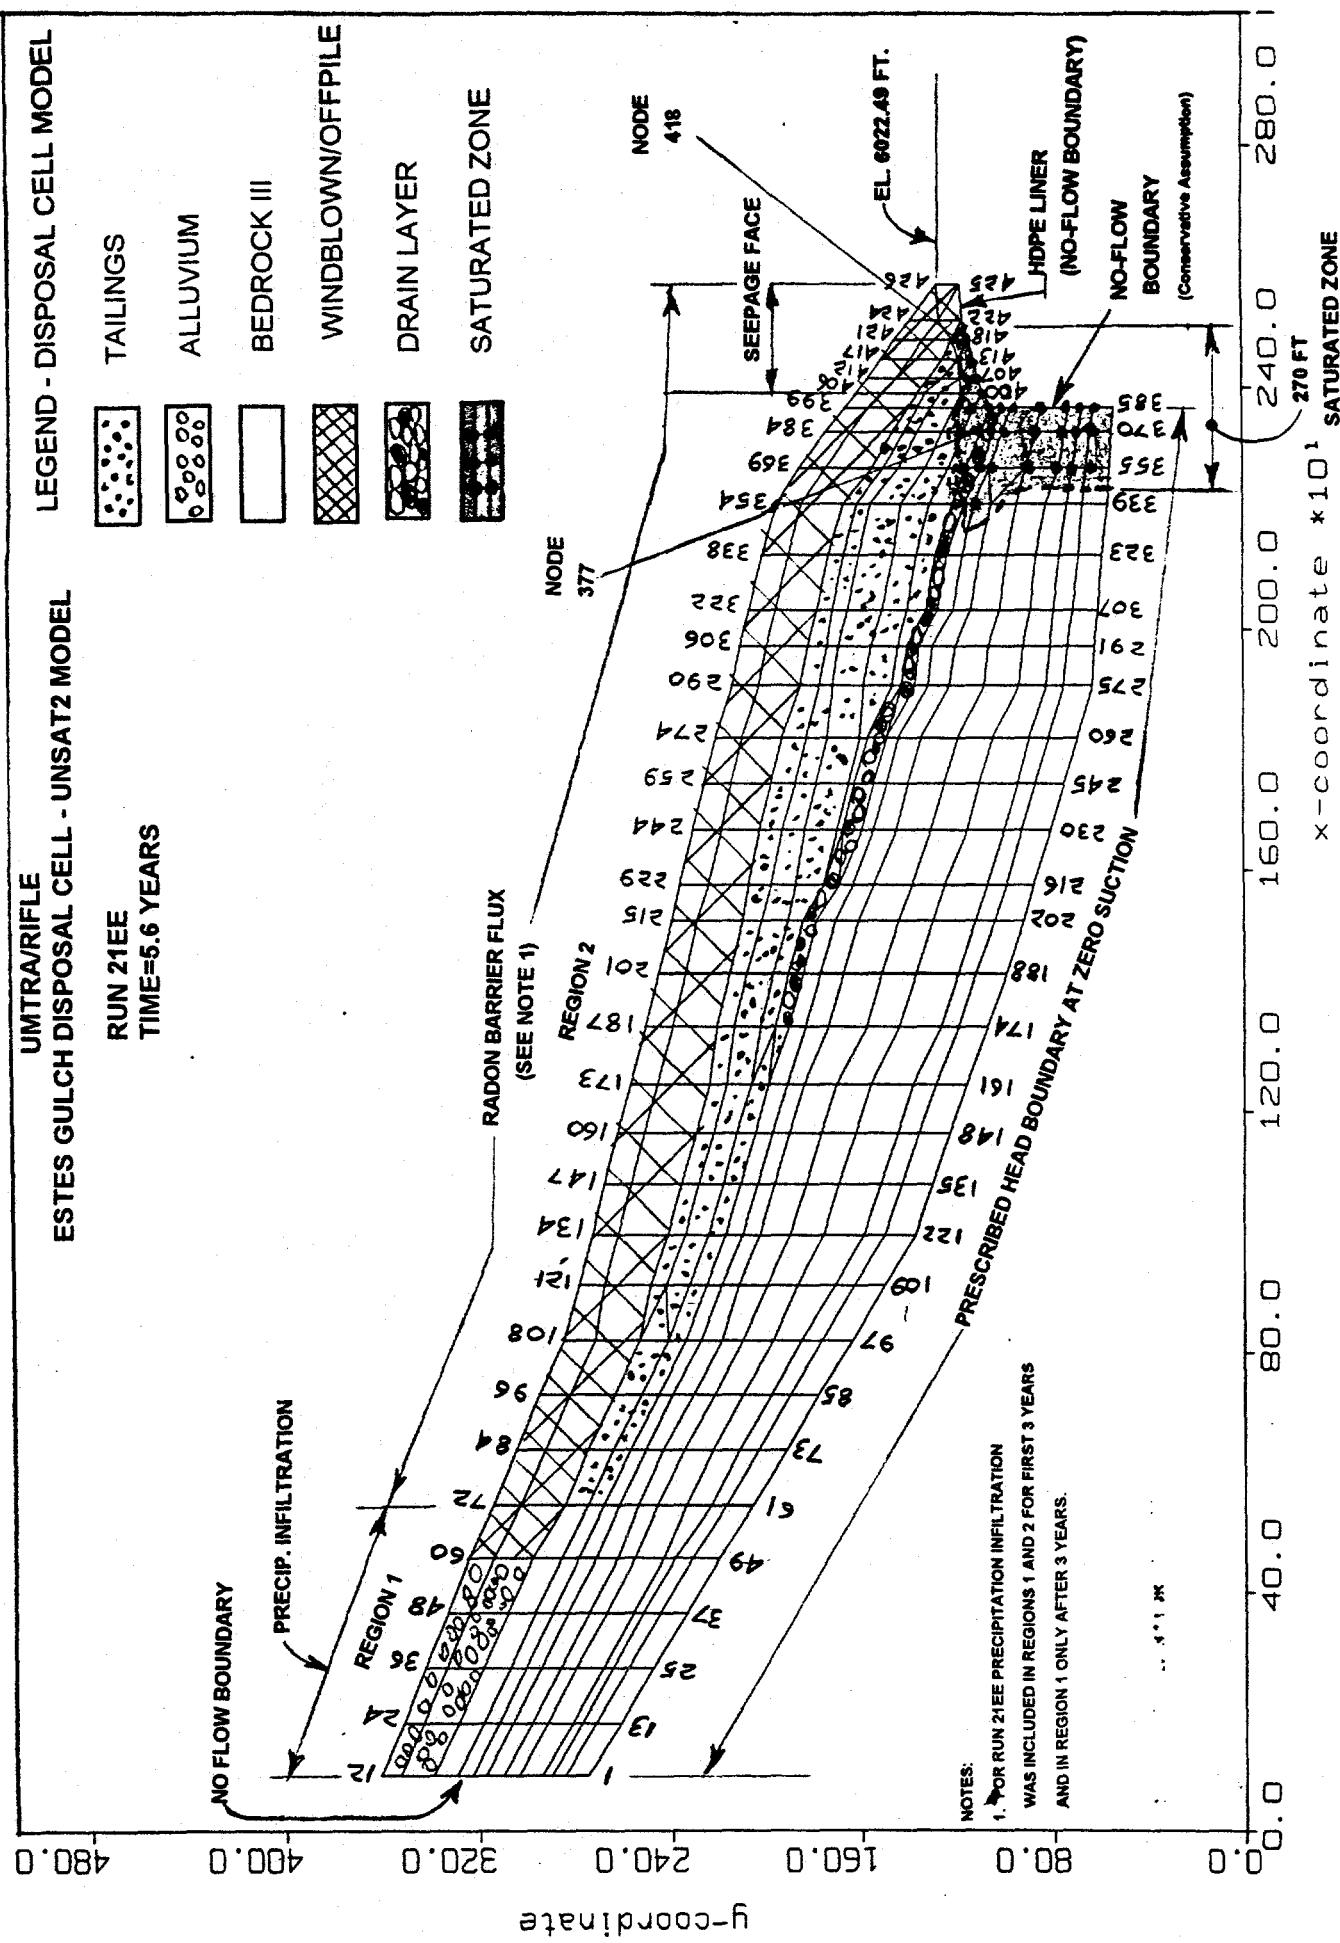
FIGURE B-2

UMTRARIFLE
ESTES GULCH DISPOSAL CELL - UNSAT2 MODEL

RUN 21EE
TIME=5.6 YEARS
