A 20-kW Solar Photovoltaic Flat-Panel Power System for an Uninterruptible Power-System Load in El Paso, Texas

Phase II - System Fabrication (October 1, 1979 to May 31, 1981)

V. Vernon Risser
New Mexico Solar Energy Institute
New Mexico State University

PHASE II--SYSTEM FABRICATION

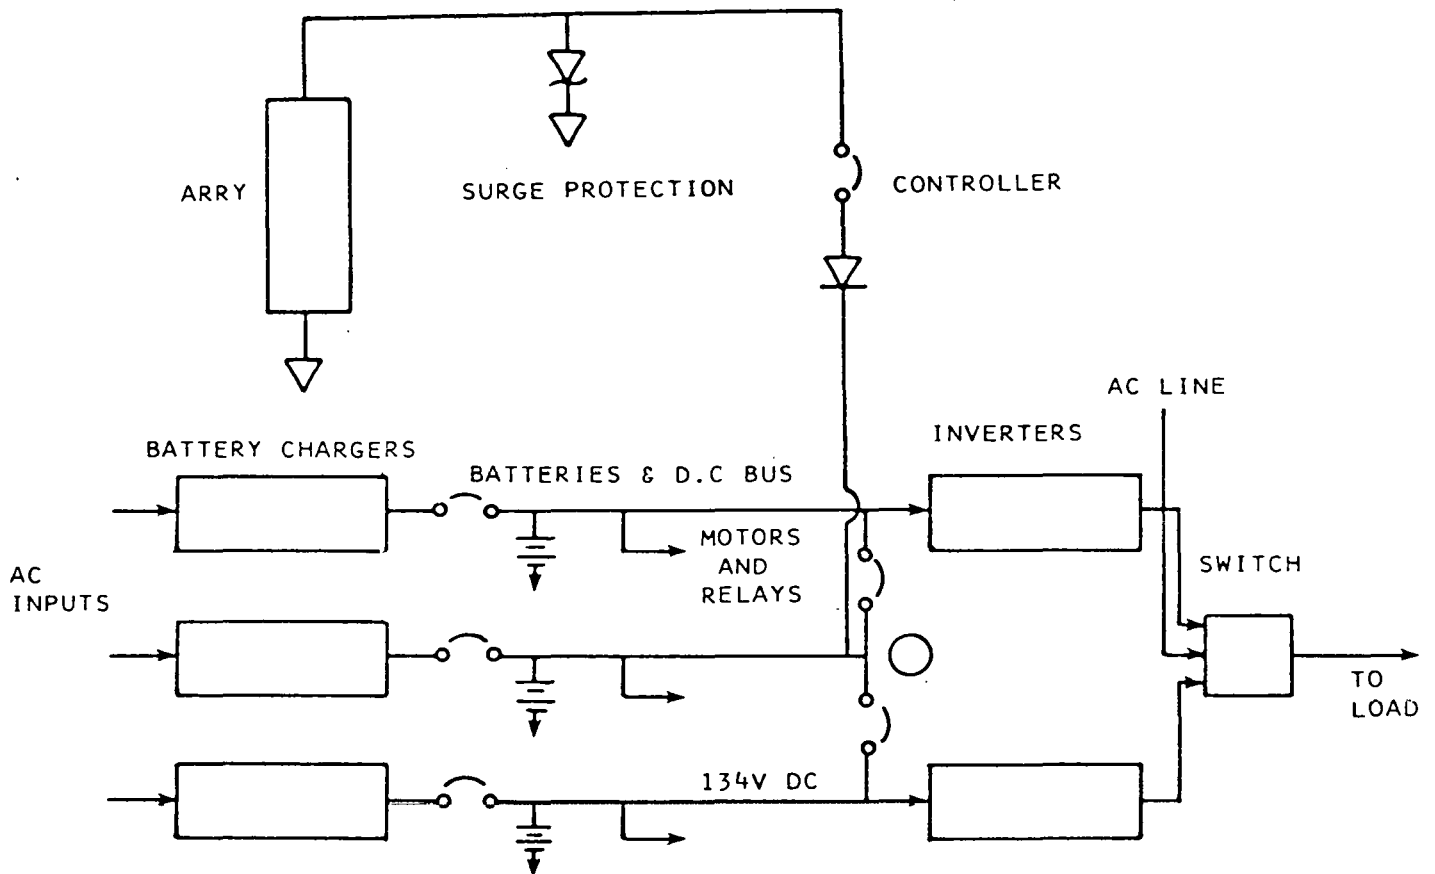
- °64 Panels in Parallel
- °9 Modules/Panel in Series
- °3 Rows of 20, 22, 22 Panels
- °6 Subarrays - 2 per Row

Each subarray may be isolated and shorted.
