**PROGRAM TO DEVELOP  
ACOUSTIC EMISSION-FLAW RELATIONSHIP  
FOR INSERVICE MONITORING OF  
NUCLEAR PRESSURE VESSELS**

**Progress Report  
February 1 - July 1, 1977**

**Battelle Pacific Northwest Laboratories  
for  
U. S. Nuclear Regulatory Commission**

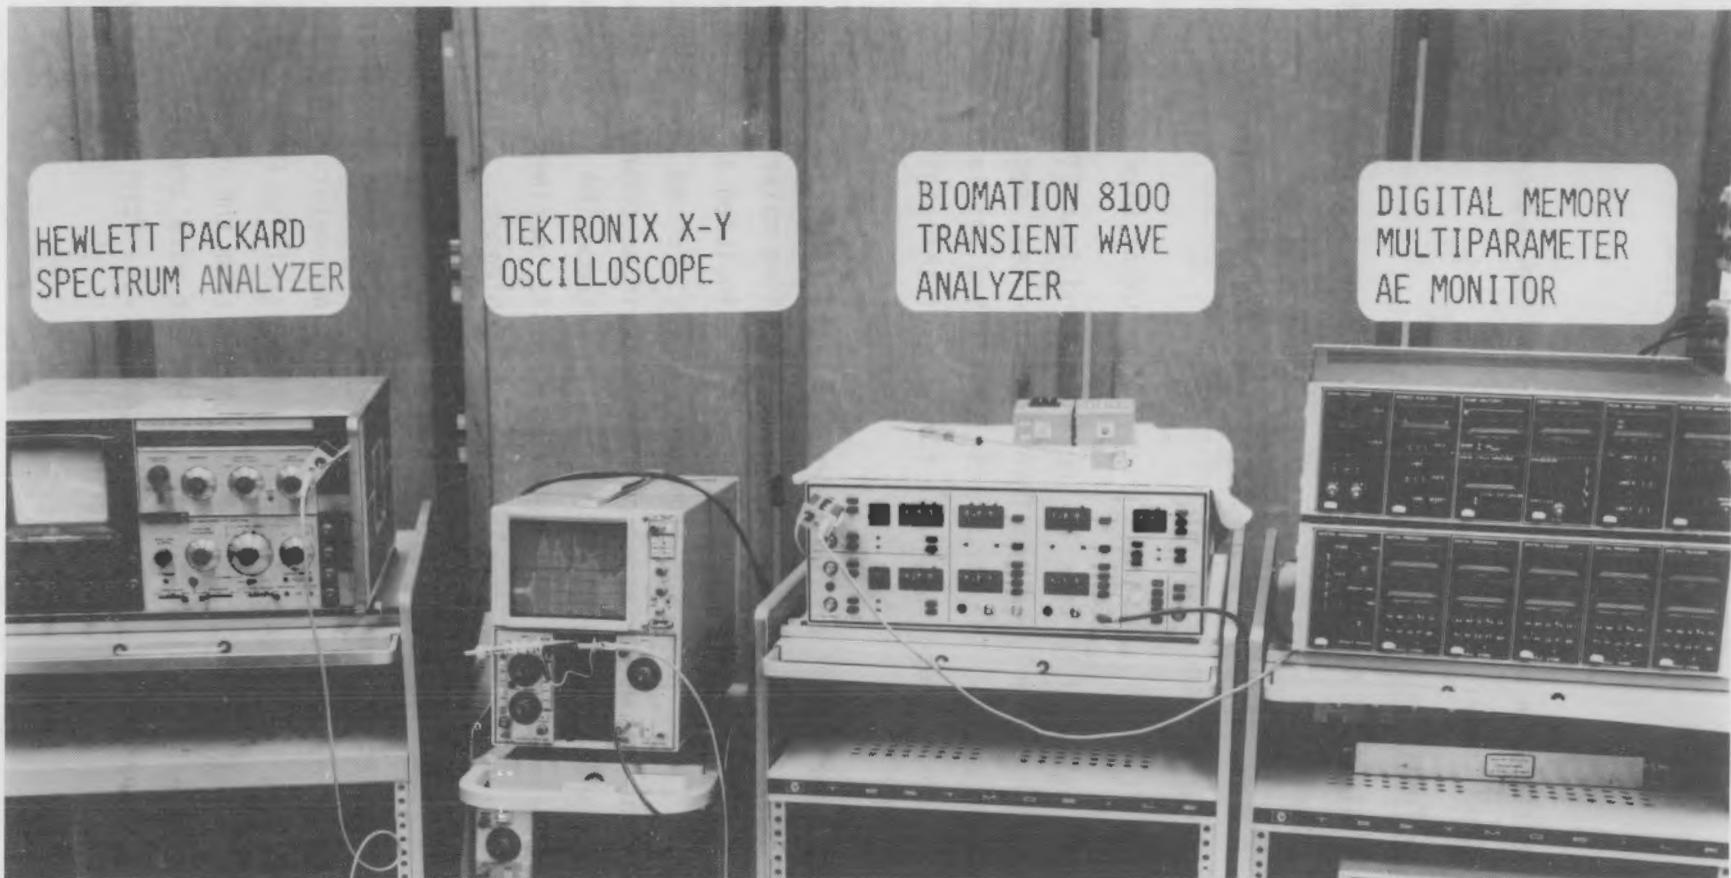
The AE test instrumentation currently being used on the program is shown in Figure 1. The digital memory multiparameter AE monitor which is the primary instrument was described in detail in Progress Report No. 1.<sup>(1)</sup> A valid signal verification pulse from the digital memory monitor triggers the Biomation 8100 transient wave analyzer to display the valid signal on an X-Y oscilloscope for wave form examination.

FIGURE 1. Acoustic Emission Analysis System

The same information is also routed to a Hewlett Packard Spectrum Analyzer for frequency analysis.

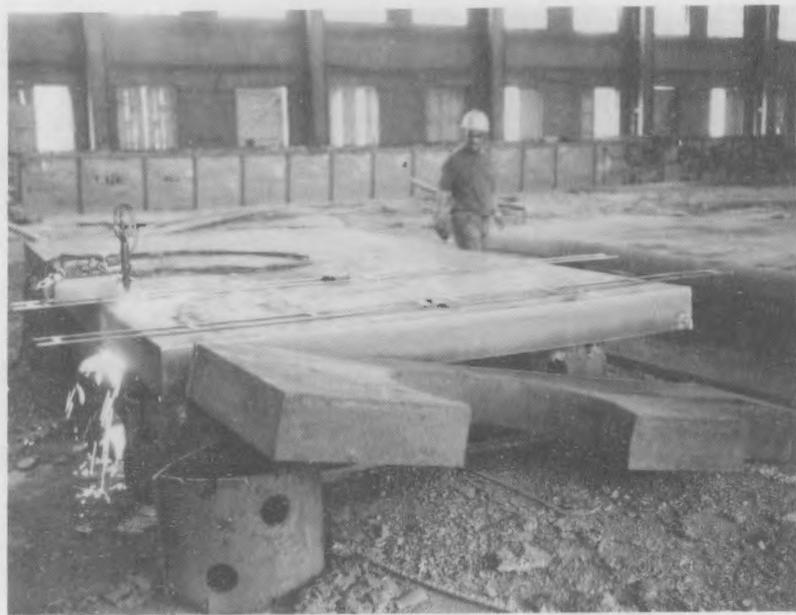
Figure B. Flame cutting of sub-plates III-1 and III-2 of 8 1/4 inch A533B CL-1 plate

The plate was marked for flame cutting as shown on page 1 of the attached, "Flame Cutting and Specimen Machining Layout". Photos of the layout and flaw cutting process are shown in Figures A and B. Figure A shows the entire plate. The round cutout was apparently done to remove a localized defect that was detected during preliminary ultrasonic examination. Tensile, charpy and drop weight test specimens were fabricated from the other smaller cutout in the background. Figure B shows the flame cutting proceeding on plate sections III-1 and III-2.
