SAND79-7052  
Unlimited Release  
UC-62 Distribution

## Cleaning Agents and Techniques for Concentrating Solar Collectors

**M.B. Sheratte**

**McDonnell Douglas Astronautics Company**

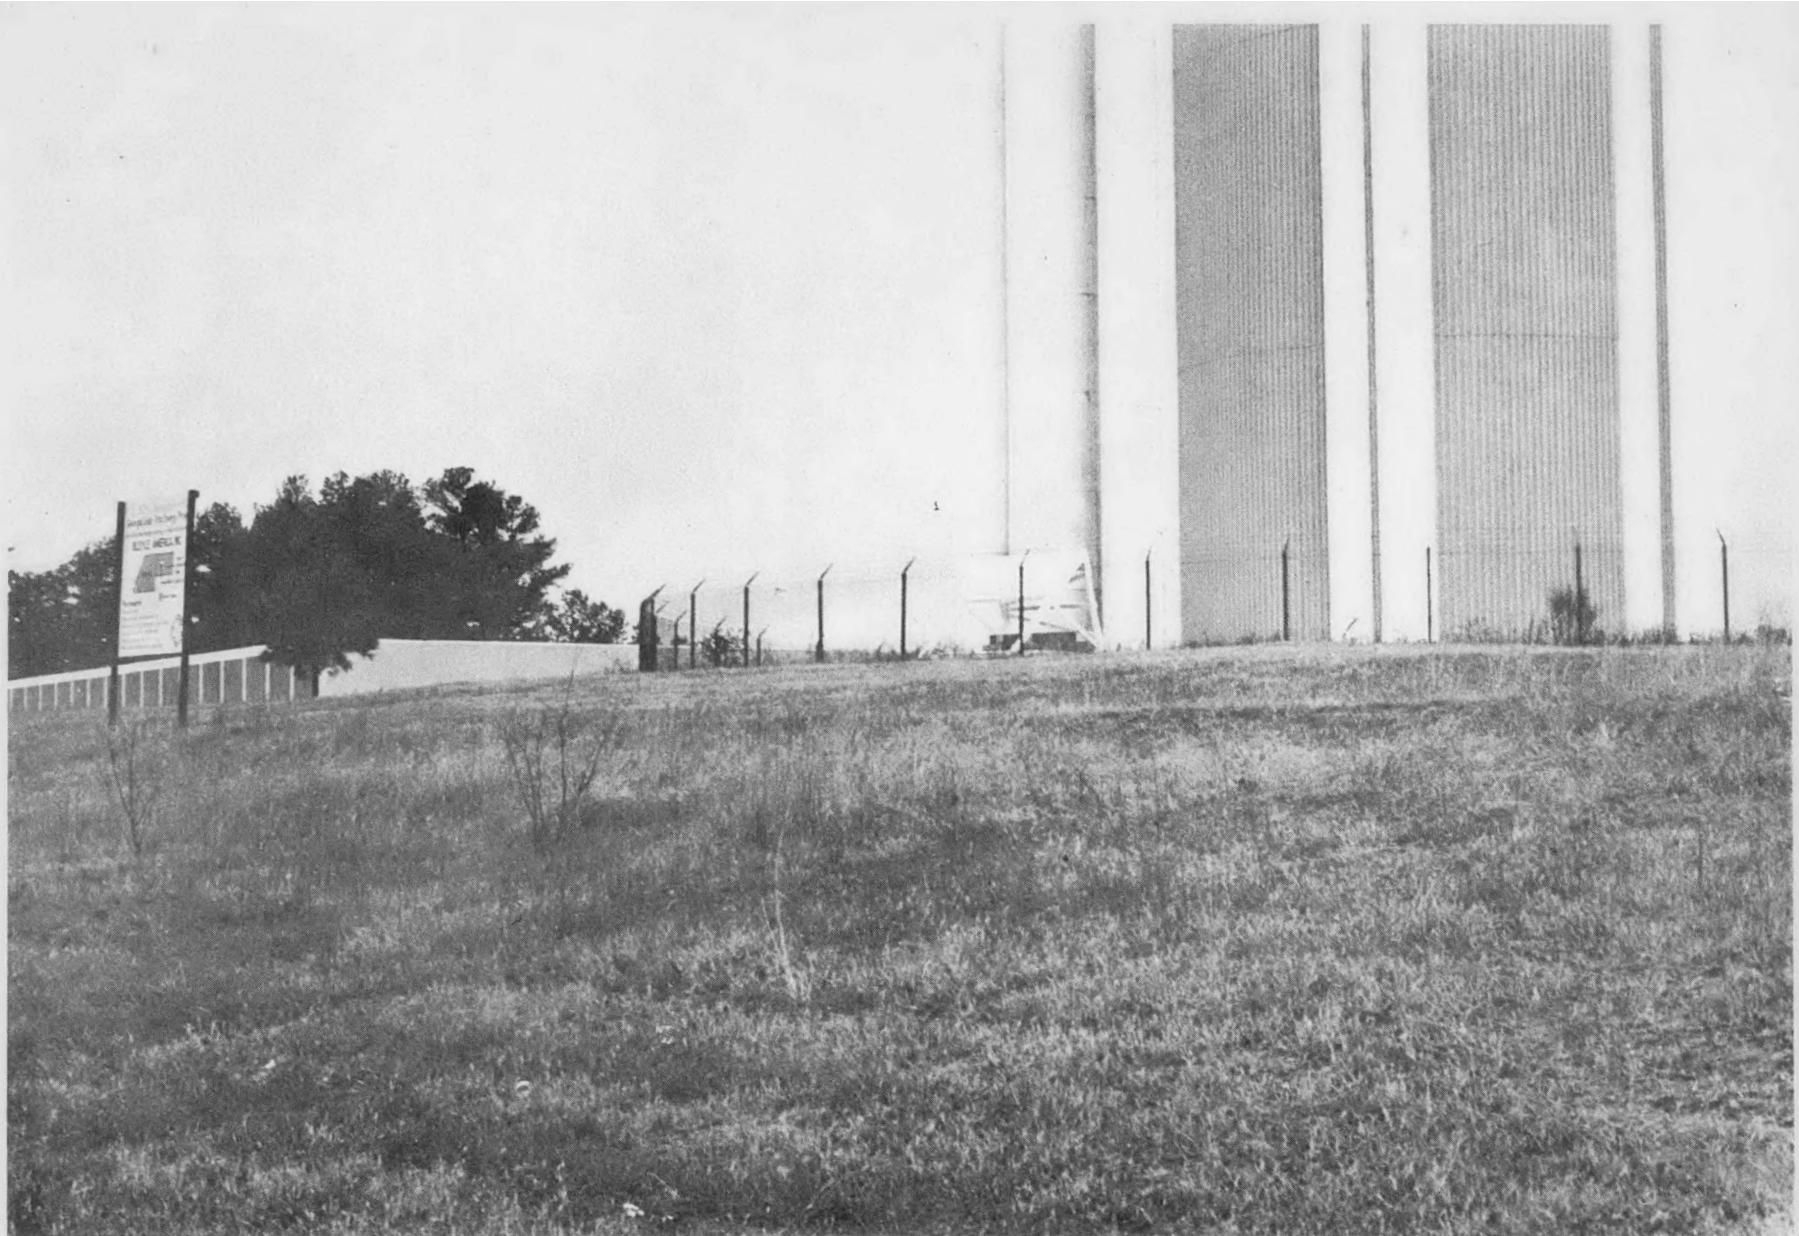
Figure 1. Exposure Rack in Place at Base of Water Tower, Shenandoah, GA.

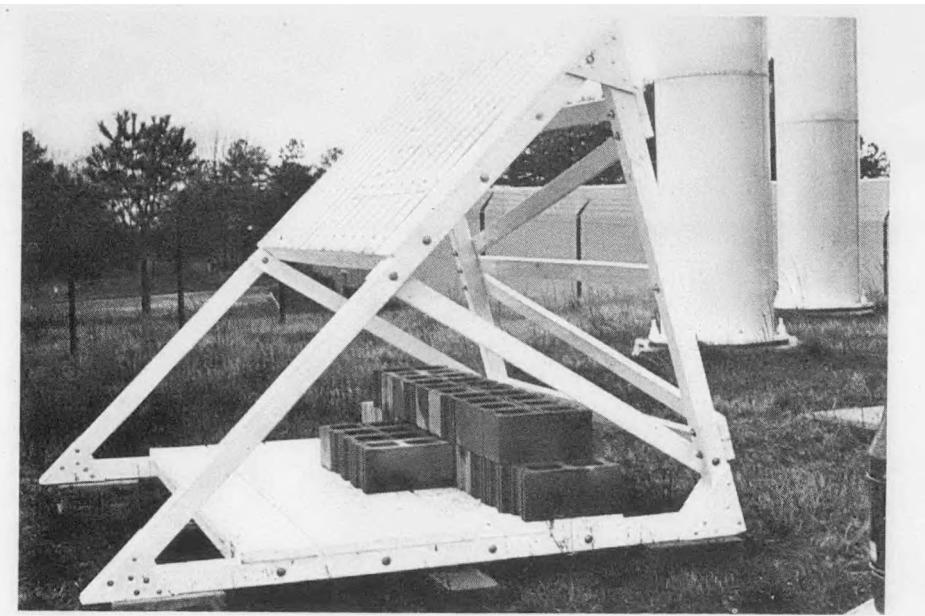
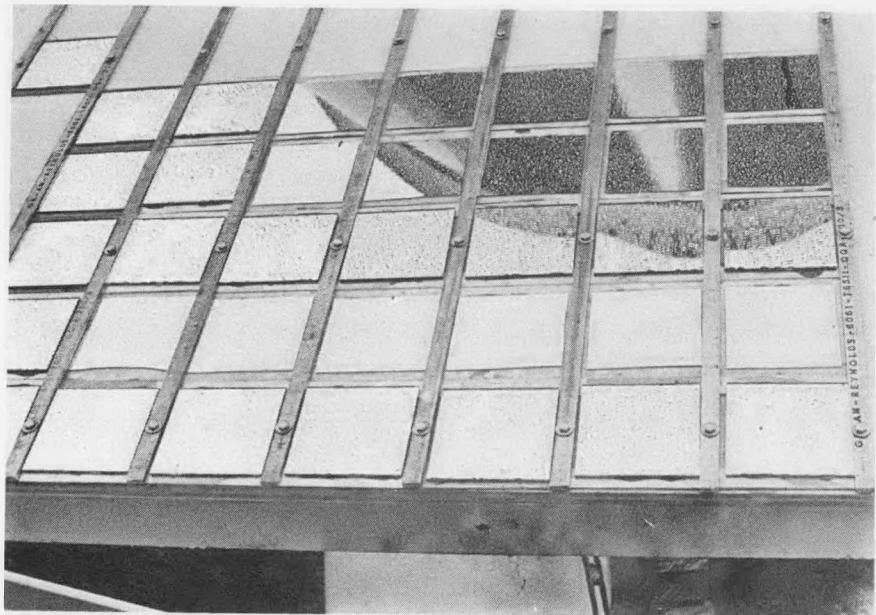
a. Overall View of Rack

b. View of Samples on Rack

Figure 2. Exposure Rack With Samples Mounted On It.

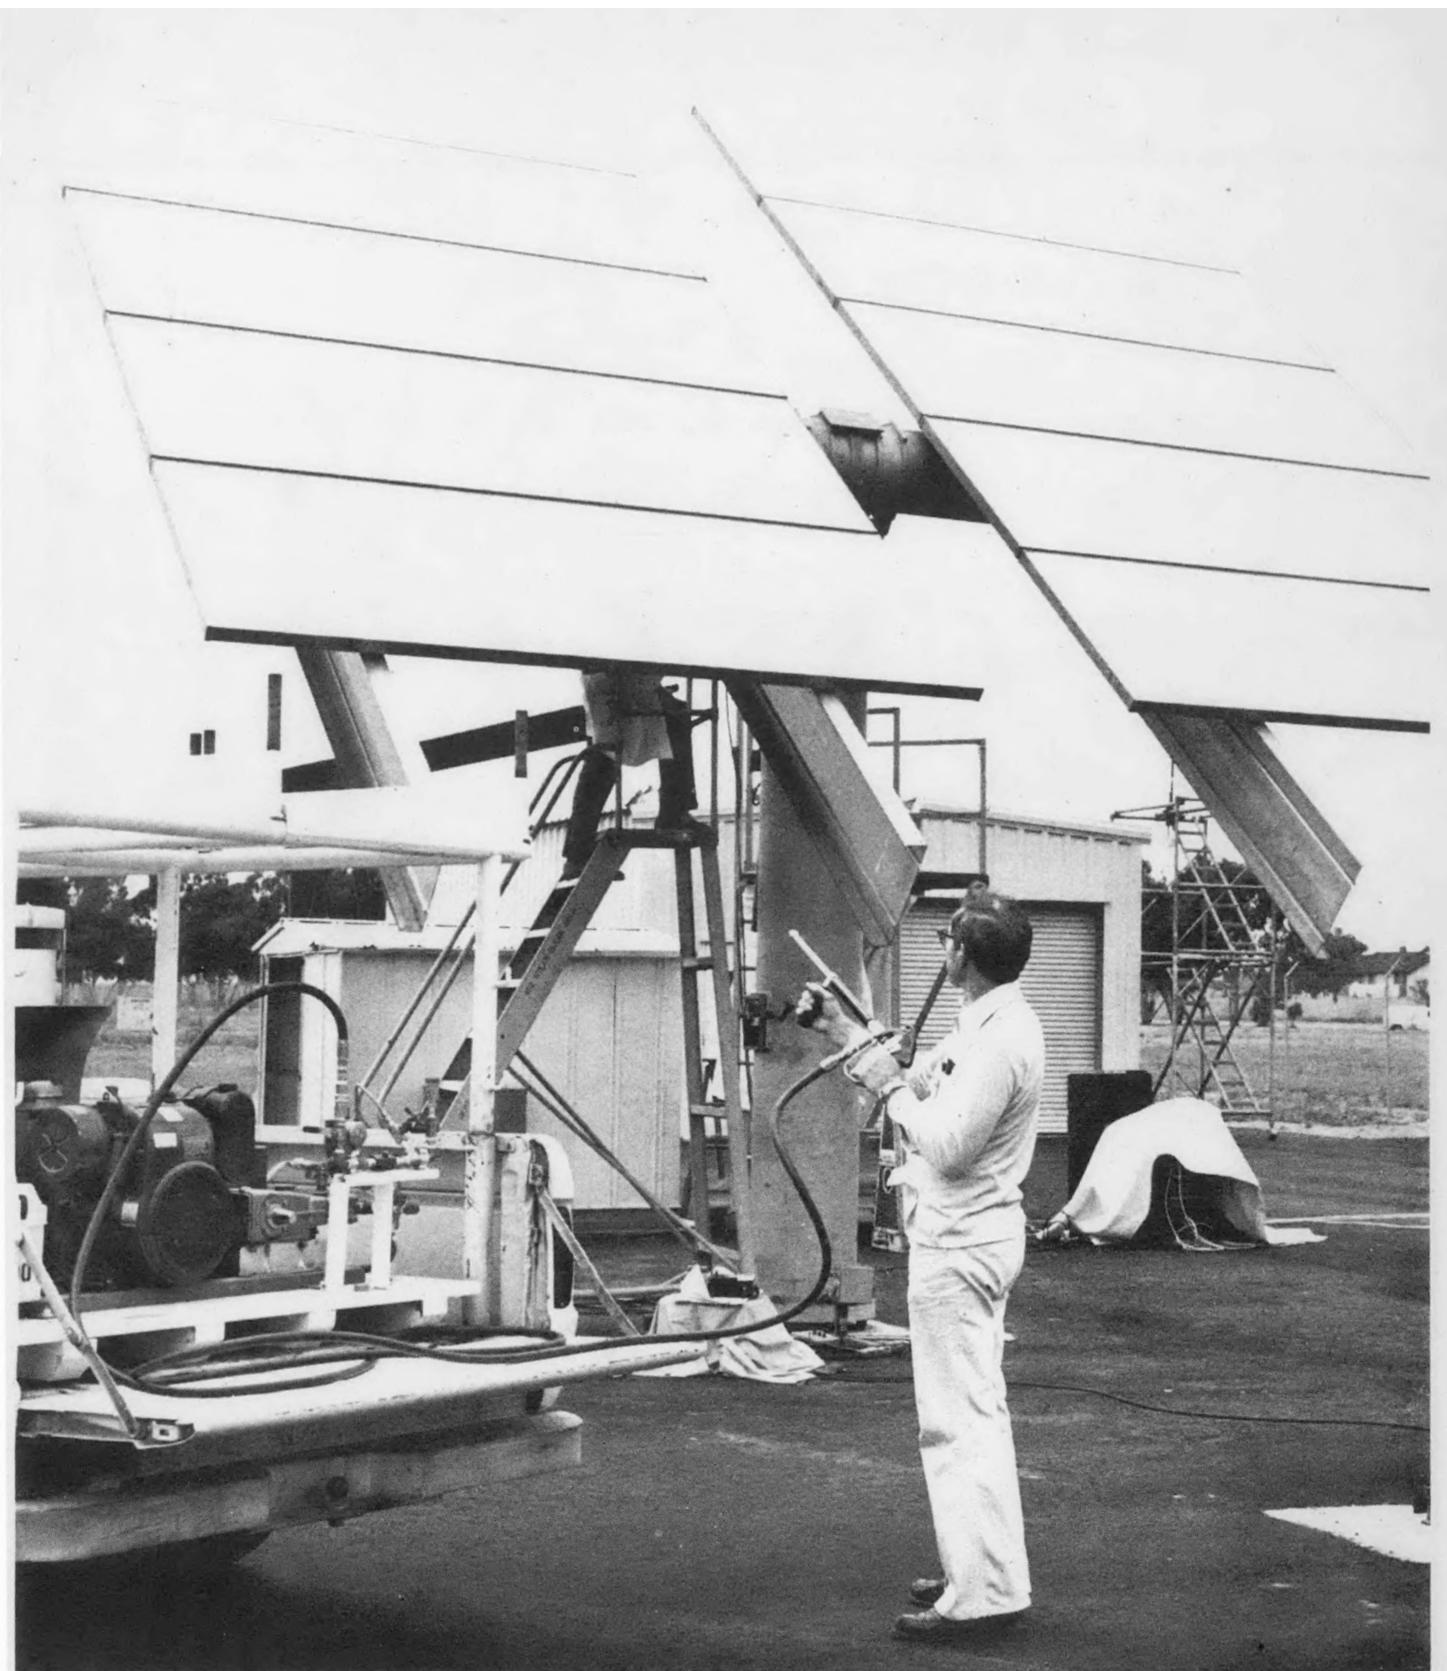
Figure 3. High Pressure Spray System in Back of Truck.

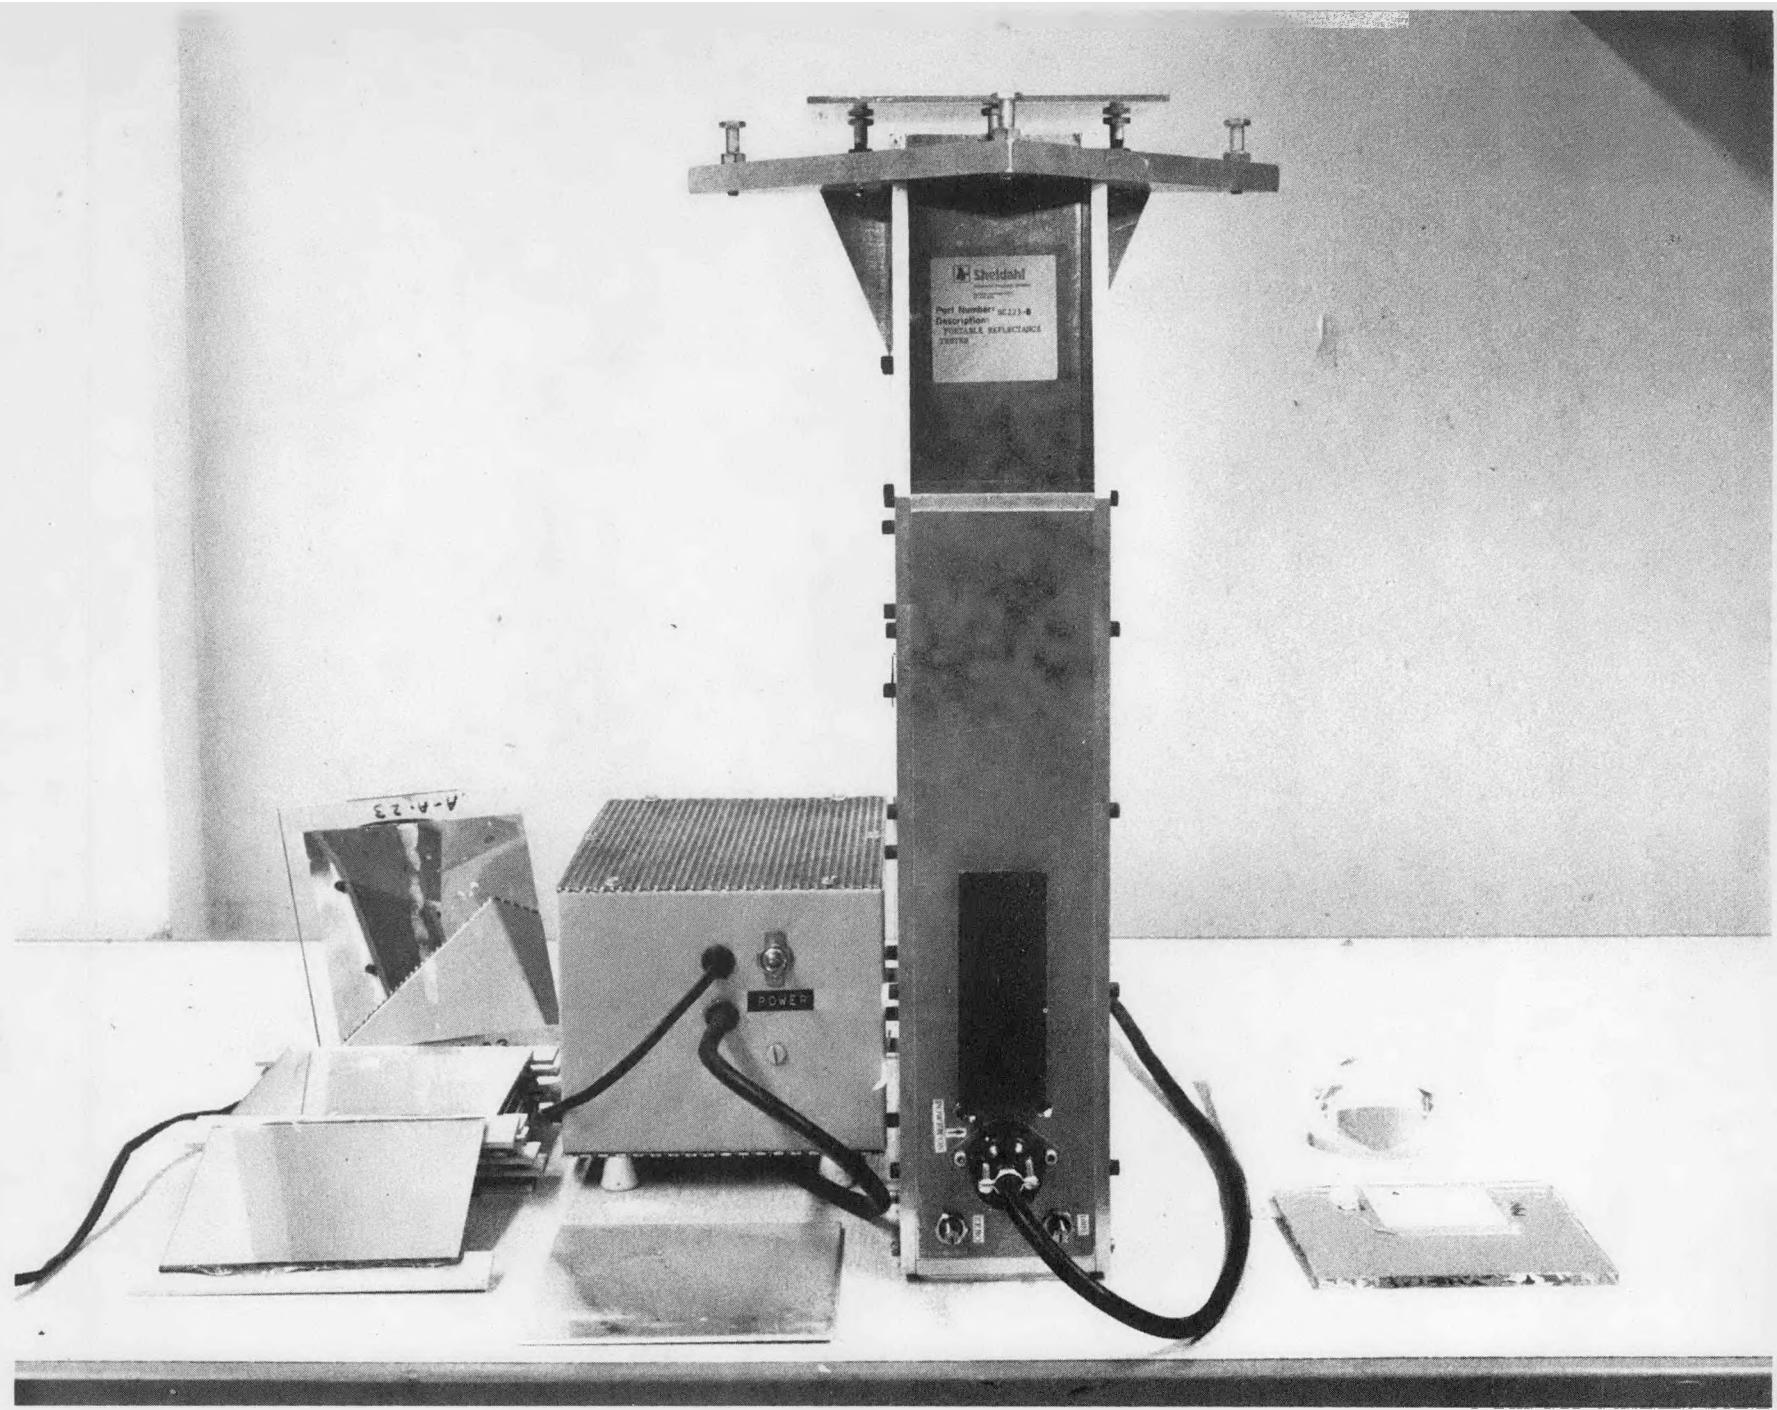
Figure 4. Scheldahl Reflectometer With Samples at Left and Standards on Right.

Measurements were made by adjusting the instrument with a standard of known reflectivity. The standard used was a front surface silver mirror which was stored in a dessicator between measurements.

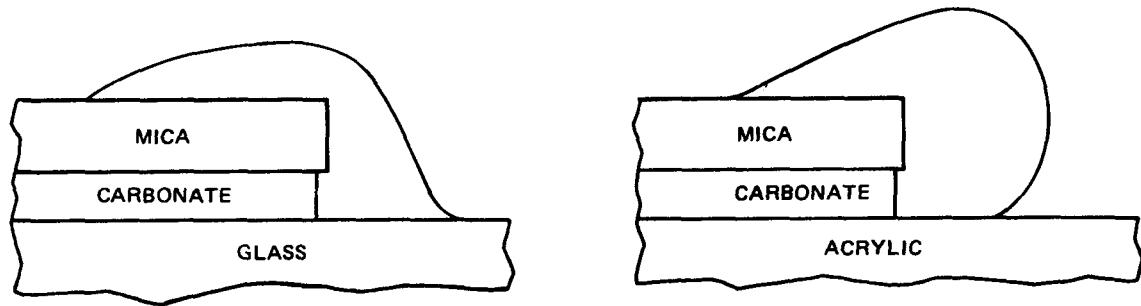
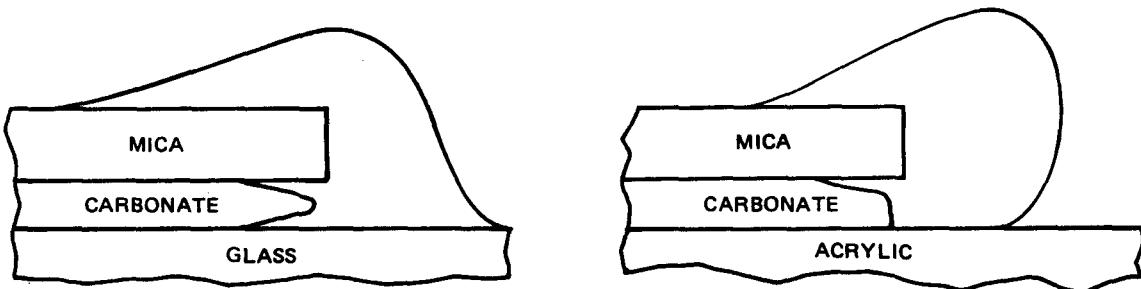
**Figure 5 - Section Through Mica Crystal Cemented on Glass and Acrylic Surfaces  
Showing the Increased Surface Area Due to Solution**

These observations provided some insight into the mechanism(s) of soil adhesion. It is easy to understand how long-term soaking would remove the montmorillonoid soil, since it would eventually absorb water and swell, thus losing structural integrity and strength and becoming susceptible to removal by relatively low energy water impingement. The removal of the carbonate "cements" from glass surfaces can be understood in terms of the kinetic phenomena associated with wetting. Figure 5 shows a cross section of an interface between a particle of carbonate cement and a reflector surface, with liquid water adjacent to the carbonate particle. In Figure 5A no penetration has yet occurred, while Figure 5B shows the condition of the interface with some water penetration. The penetration of water has created a certain area of new interface - water/glass and water/carbonate. Creation of new interfacial regions requires energy, which is supplied by molecules in the water which have higher kinetic energy than the average. The rate at which water penetration of the interface occurs is a function of the average kinetic energy of the water molecules (i.e., the temperature of the water), of the duration of exposure, and of the "wettability" of each of the surfaces. Since glass is known to be much more wettable than organic materials, it is not surprising that tightly bound soil is more readily removed from glass surfaces. The implication here is that there is no chemical interaction between the soil particle and the glass substrate, for if there were, much more energy would be needed to separate the two materials.

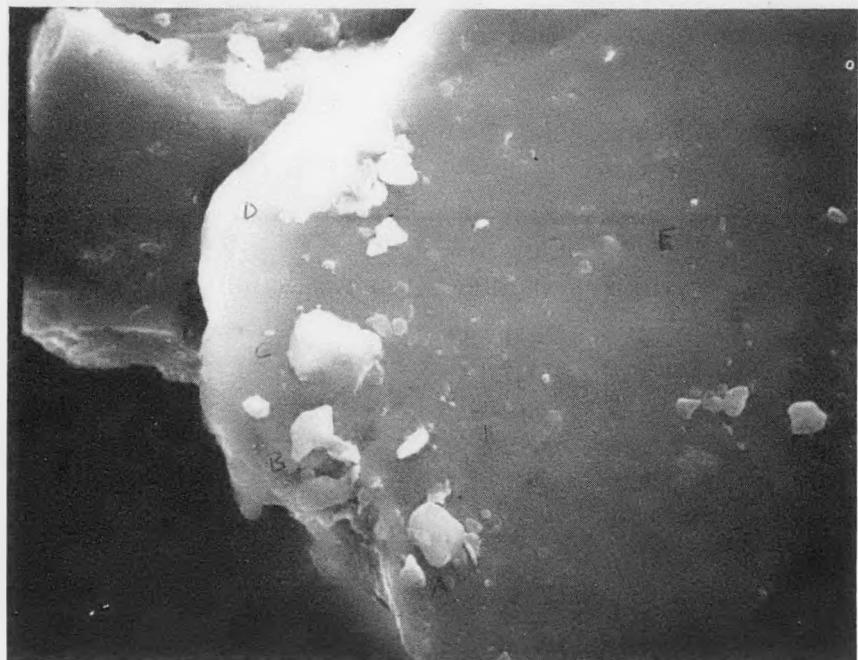
Figure 1. Plaque of minute grains of clay and/or salt deposits on a quartz grain.

Daggett, naturally soiled glass mirror. 2900 X.

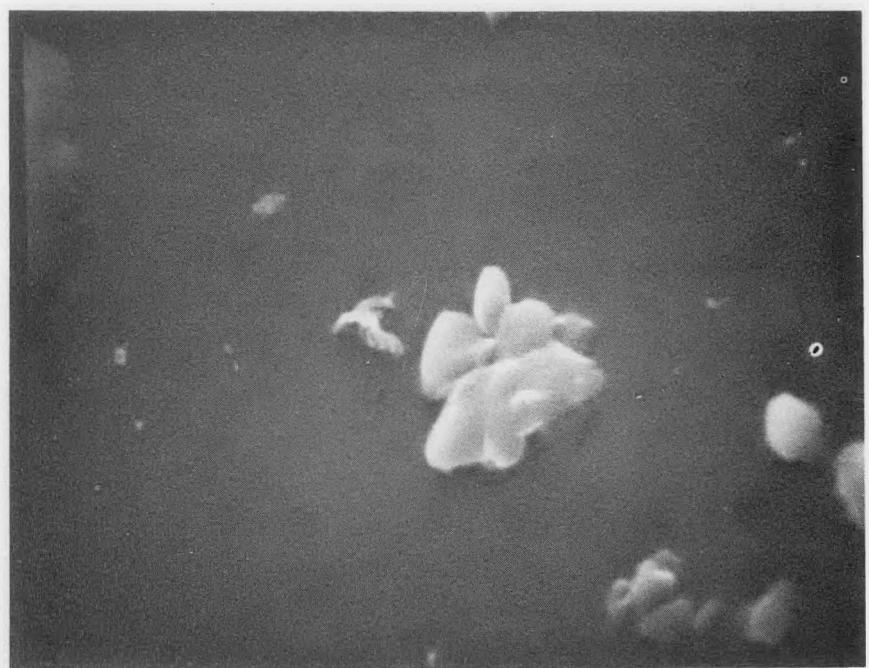
Figure 2. Cluster of gypsum crystals with typical parallelogram outline. These occur well inside a drop.

Daggett, naturally soiled glass mirror. 9000 X.

Examples of various grain species observed with the SEM are shown in Figures 2 through 5. Examples of EDAX analyses are given in Figures 6 through 8.

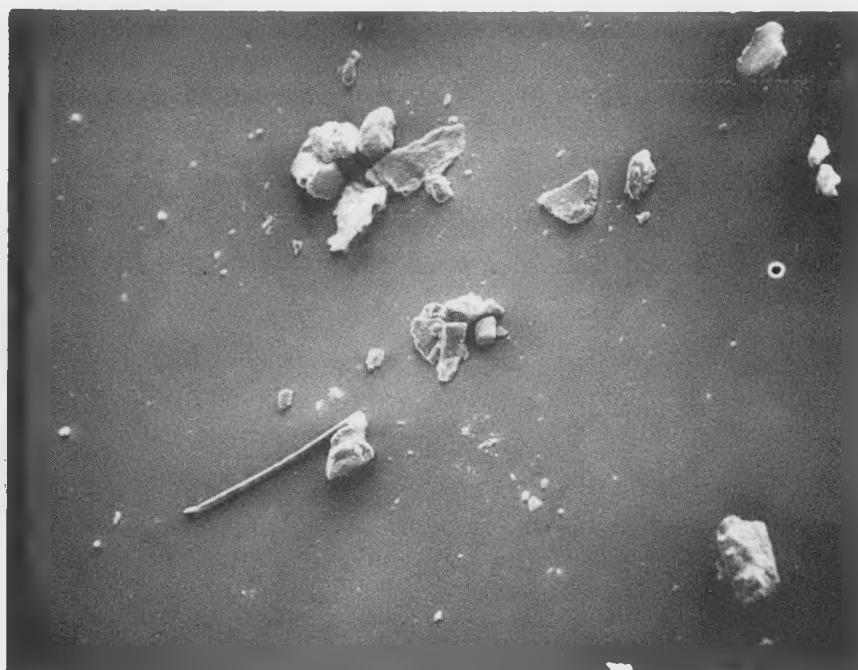
Figure 3. Wind-deposited grains. Note the preponderance of mica flakes.

Daggett, naturally soiled glass mirror. 90 X.

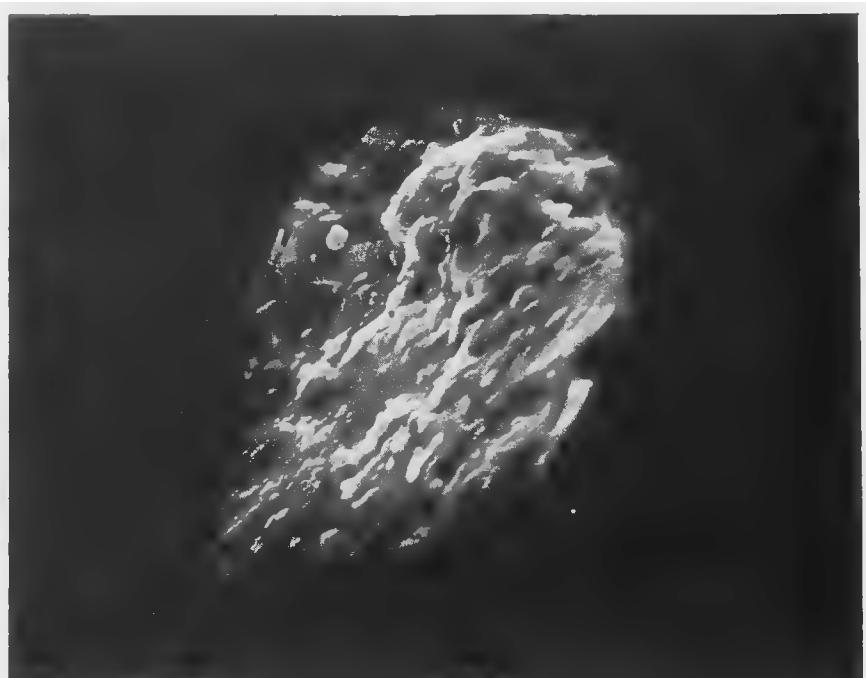
Figure 4. Tabular alumino-silicate grain with minute grains that adhere to its surface. Probably a mica, characterized by flaky habit.  
Albuquerque. 2800 X.

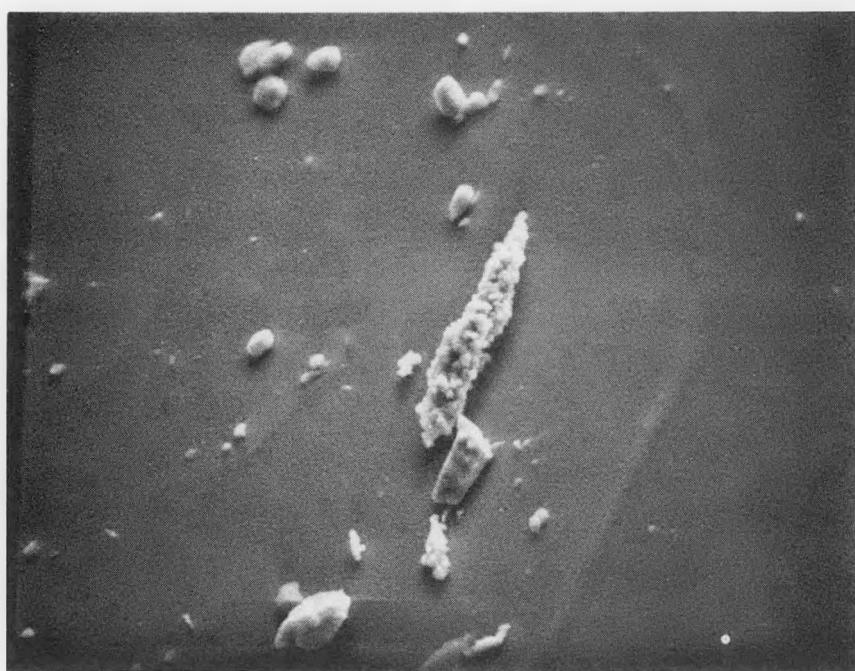
Figure 5. Two bladed crystals (center) are covered with a drusy crust of rhombohedral calcite but a tabular grain between them is not encrusted. Somewhat rounded-tetrahedral grains in the upper left are not encrusted.

Daggett glass mirror, naturally soiled, treated with anti-static, and washed. 2000 X.

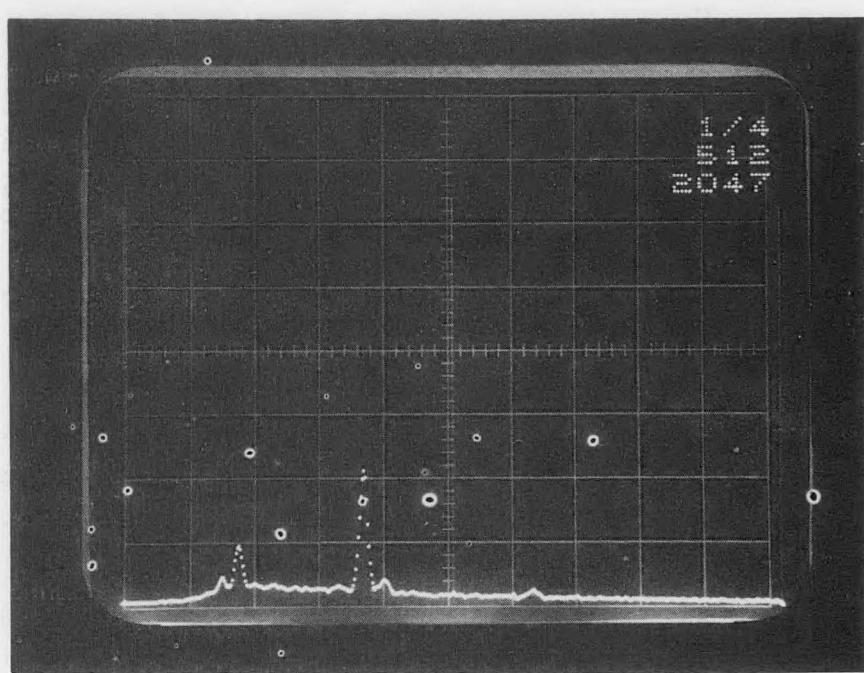
Figure 6. EDAX analysis of a calcite plaque on biotite showing the high Ca peak of 2.2 on a background of 0.3 Al, 1.0 Si, and 0.2 Fe.

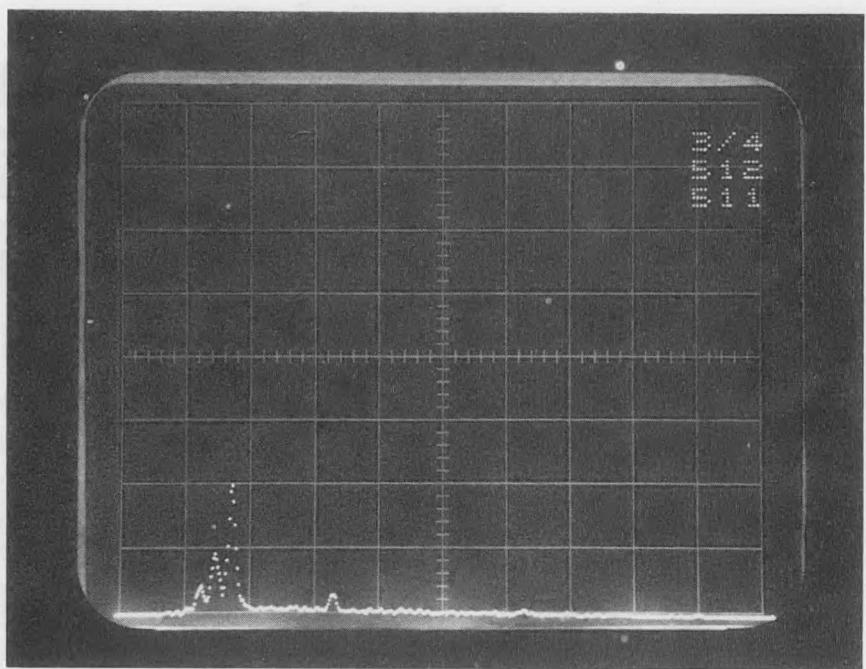
Figure 7. EDAX analysis of a typical alumino-silicate from Albuquerque. The composition: 0.3 Mg, 1.0 Al, 2.0 Si, 0.2 K, tr. Fe is typical of illite clay. Biotite is similar with more Fe.

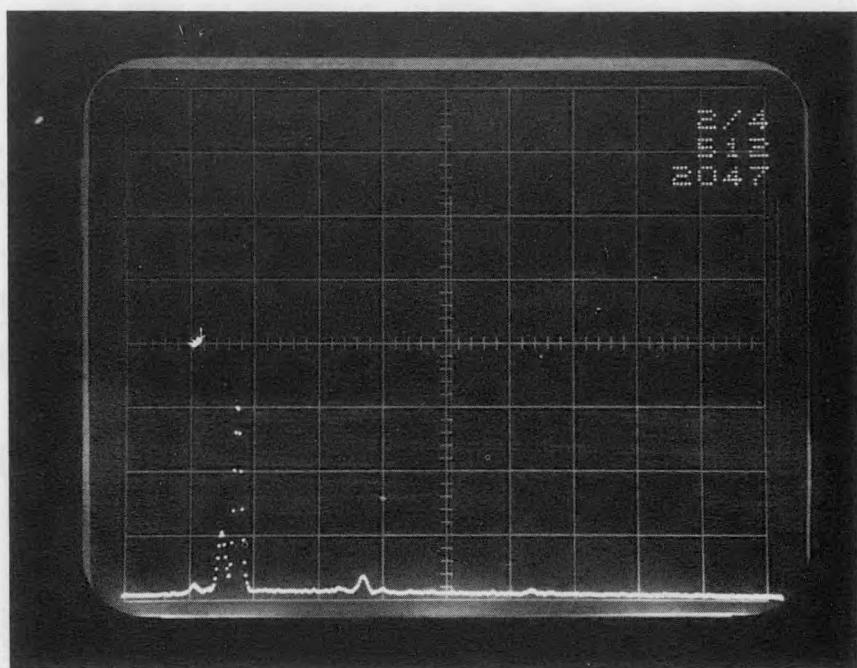
Figure 8. EDAX analysis of a blocky grain of plagioclase: 0.2 Na, 1.1 Al, 3.0 Si, 0.3 Ca.

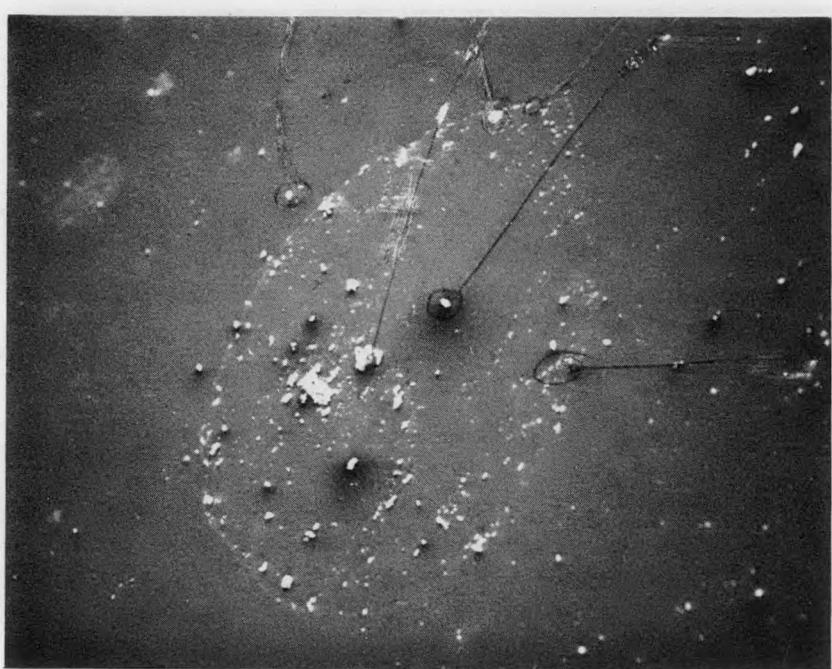
Figure 9. Drop outline showing the distribution of fine grains at the very edge of the drop.

Artificially soiled acrylic mirror from Albuquerque. 90 X.

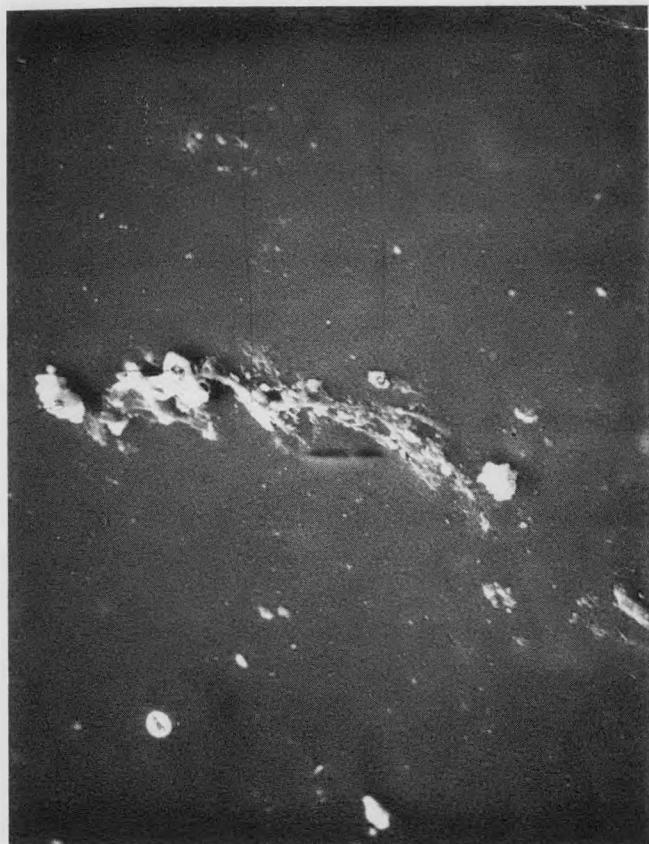
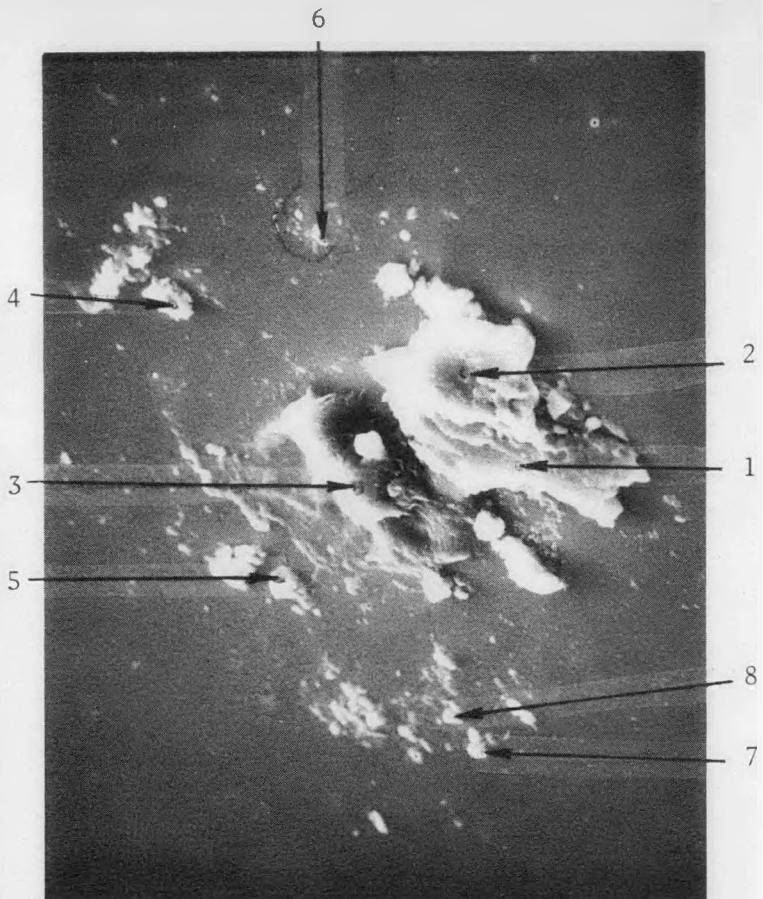
Figure 10.

A. Naturally soiled acrylic-surfaced mirror from Albuquerque (AAN-1) shows equant, angular mineral grains cemented to mirror surface with arcuate shaped mass of unknown precipitate (most likely to be calcite, gypsum or sylvite).

B. Naturally soiled glass mirror from Daggett shows mineral grains (#1, 2, 4 and 5) with solution etched crystals of gypsum (#3) acting as cement. Smaller grains such as #6 have compositions indistinguishable from glass whereas grains such as #7 and 8 may be clay minerals.

Naturally soiled mirrors with as little as six weeks exposure to precipitation and evaporation show moderate build-up of precipitates. Around the edges of grain "drops" (Figure 10), precipitates cement the grains together and form an arcuate pattern that forms pseudomorphs of the grain "drop". The concentration of precipitates near the water bead edges is what is expected if the precipitate formed during evaporation of the rain or dew. Isolated grains also have small spherules of precipitate covering the exposed surfaces. When these grains are turned over, the small spherules are found on the grain surface next to the mirror and on the mirror surface as well. Although the small size of these spherules prevents accurate chemical composition or optical microscope identification, they appear to be identical to the precipitate formed at the edges of "drops".

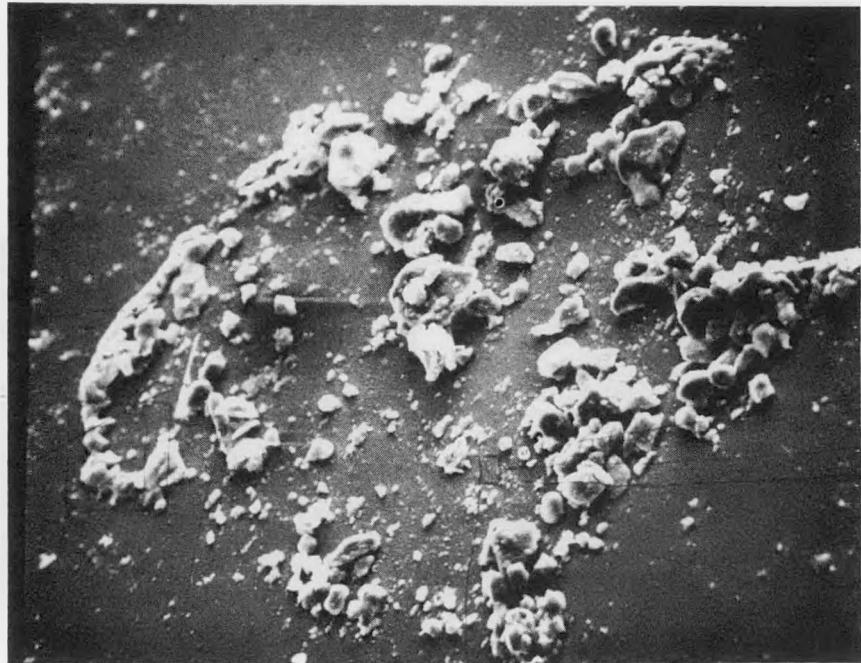
Figure 11. Aggregate of grains in drop-form on heavily soiled mirror. Note the merged grains on the left edge of the drop.  
Fort Irwin glass mirror, naturally soiled and unwashed after two years. 360 X.

2. The effects of long term exposure of mirror surfaces are unknown. One mirror examined (50-3), exposed for 700 days, showed minute spherules and diamond or rhombohedral shaped crystals of unknown origin (Figures 11-13) which show that significant surface degradation has

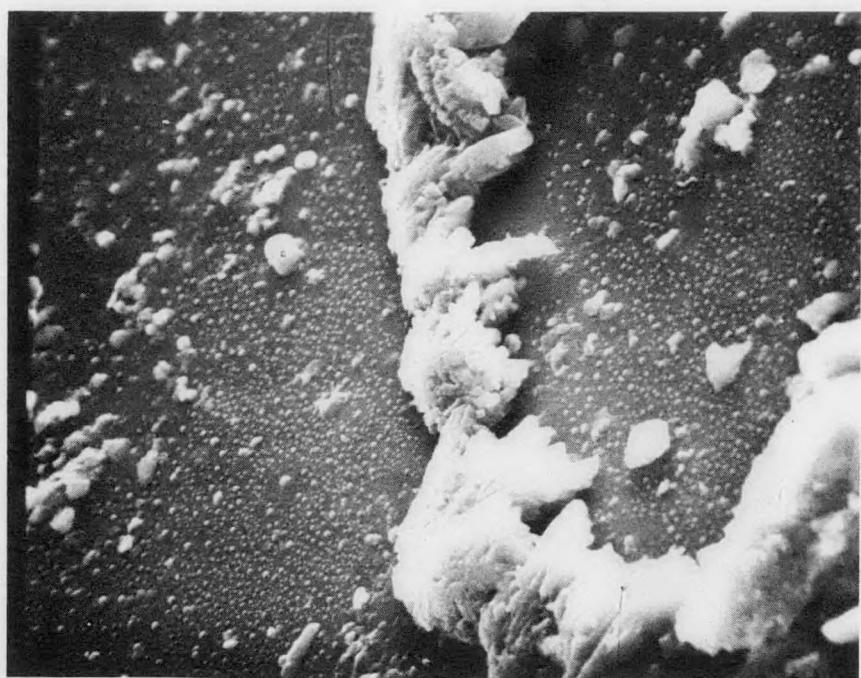
Figure 12. Close-up of the edge of the drop from the preceding photograph. Tabular crystals of gypsum are oriented normal to the drop border. The glass surface is covered with minute spherules. Fort Irwin glass mirror, naturally soiled and unwashed after two years. 2000 X.

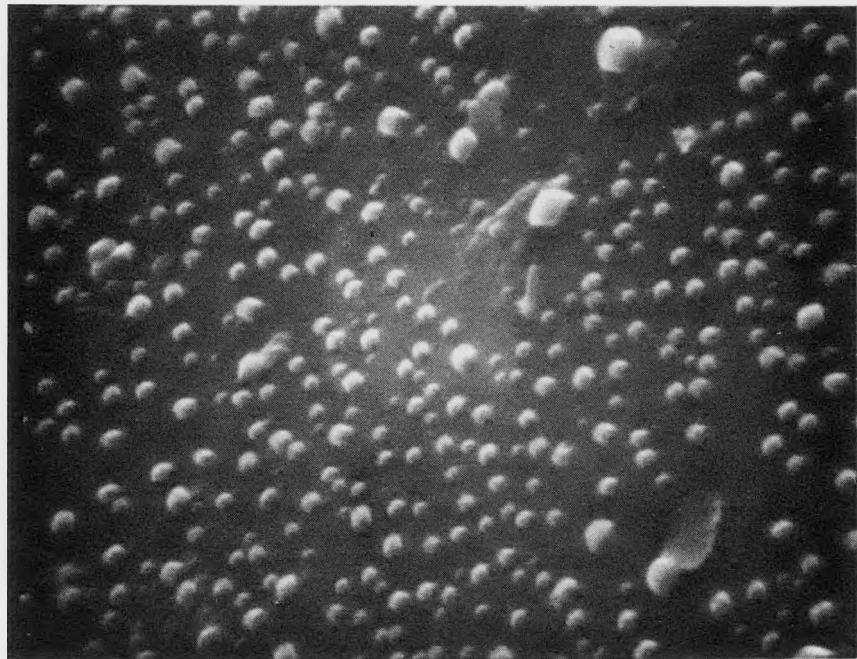
Figure 13. Close-up of the minute spherules from the preceding photograph. They are evenly spaced as if a precipitate or electrostatically controlled. Some grains (c.f. upper center) have a rhombohedral shape like calcite. An experiment has shown that solution growth of calcite preferentially forms a rhombohedral face. Fort Irwin glass mirror, naturally soiled and unwashed after two years. 10,000 X.
