IMPROVEMENT OF THE MECHANICAL RELIABILITY OF MONOLITHIC REFRACTORY LININGS FOR COAL GASIFICATION PROCESS VESSELS

Prepared for
United States Department of Energy

Final Report

Compiled by
R. A. Potter
Materials & Chemistry Laboratory
Lynchburg Research Center

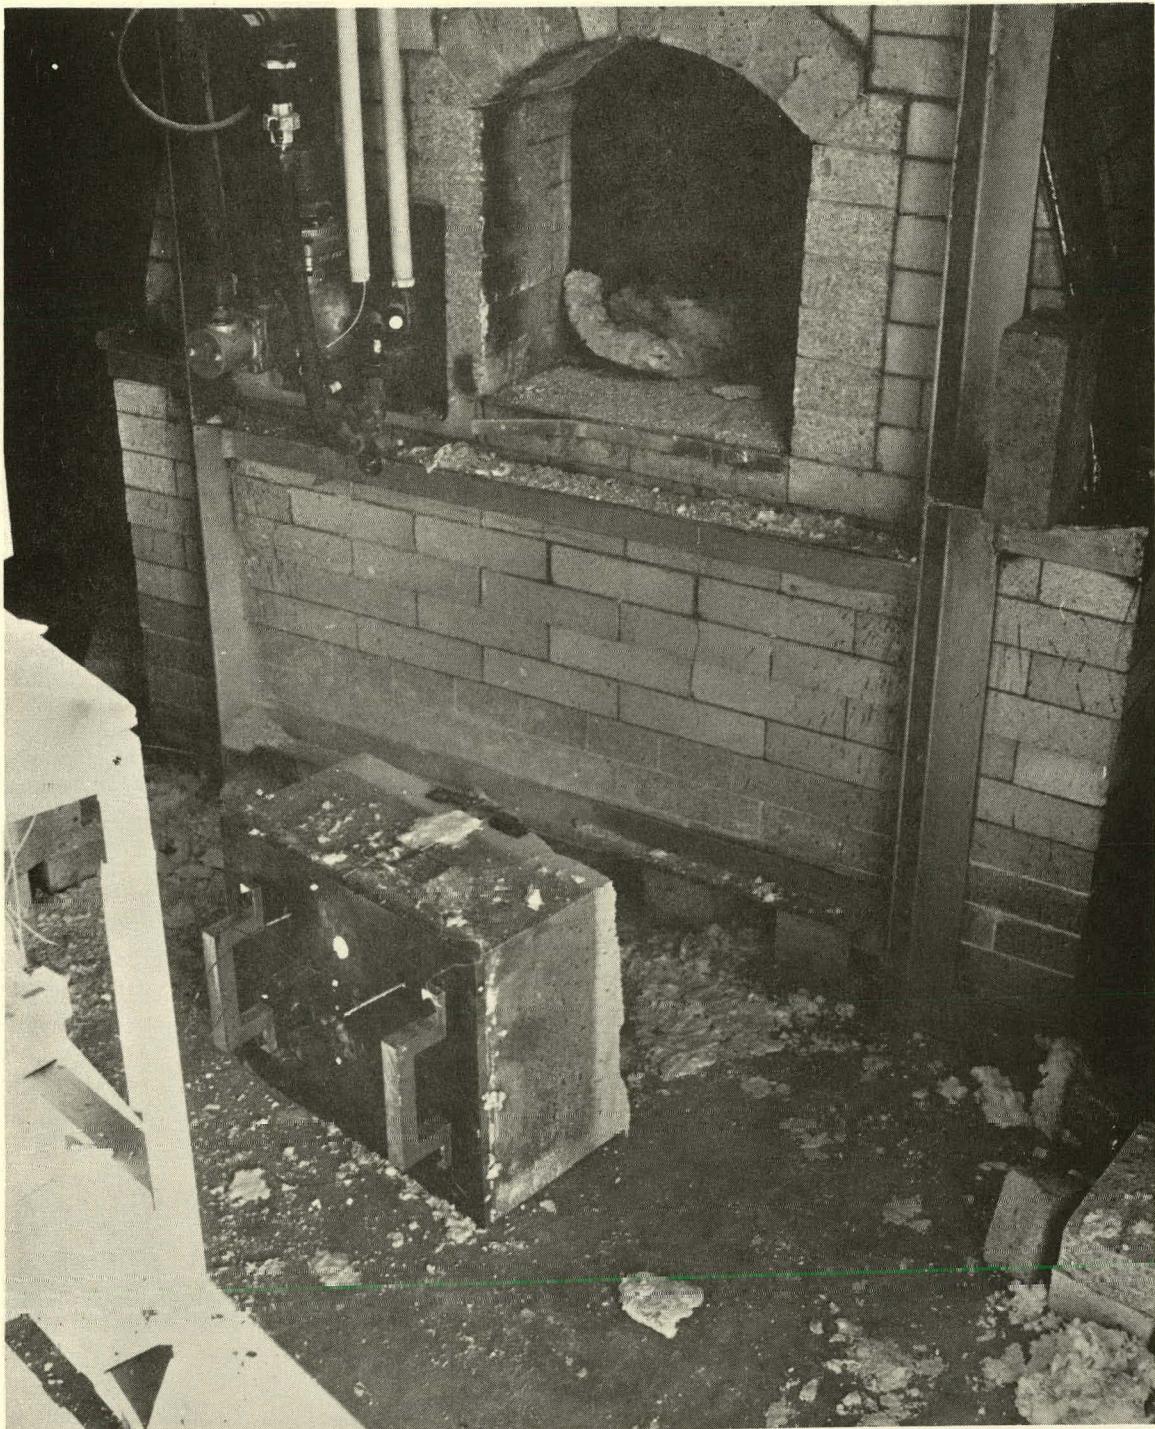
FIGURE 28. Photograph of Panel #5 and Test Furnace After Specimen Failed by Explosive Spalling

Less typical but highly significant AE results were obtained during the testing of panel #5. This panel had a dual component configuration that failed by explosive spalling. The spall occurred at 1000°F after the furnace control malfunctioned and caused a severe heating rate of 480°F/hour. Figure 28 is a photograph of the spalled panel and furnace as they appeared immediately after the explosion. Prior to the controller malfunction, the panel had been heated at 100°F/hour to 200°F where it was held for thirteen hours. Little AE was recorded during that period. Figure 29 details the acoustic events for the two hours following the 200°F hold and preceding the spall. Up to about 1.3 hours following the end of the hold the Relative Energy per Event graph displayed amplitudes and patterns that were similar to those recorded from panel #6 (Figure 27). At about 1.4 hours, the relative activity showed a sharp increase, as indicated in Figure 29. Three minutes later this "precursor" activity resumed a momentary low level, followed by rapidly increasing activity which continued until failure. Note that the amplitude of the Relative Energy per Event graph continued to increase up to the spall's occurrence.

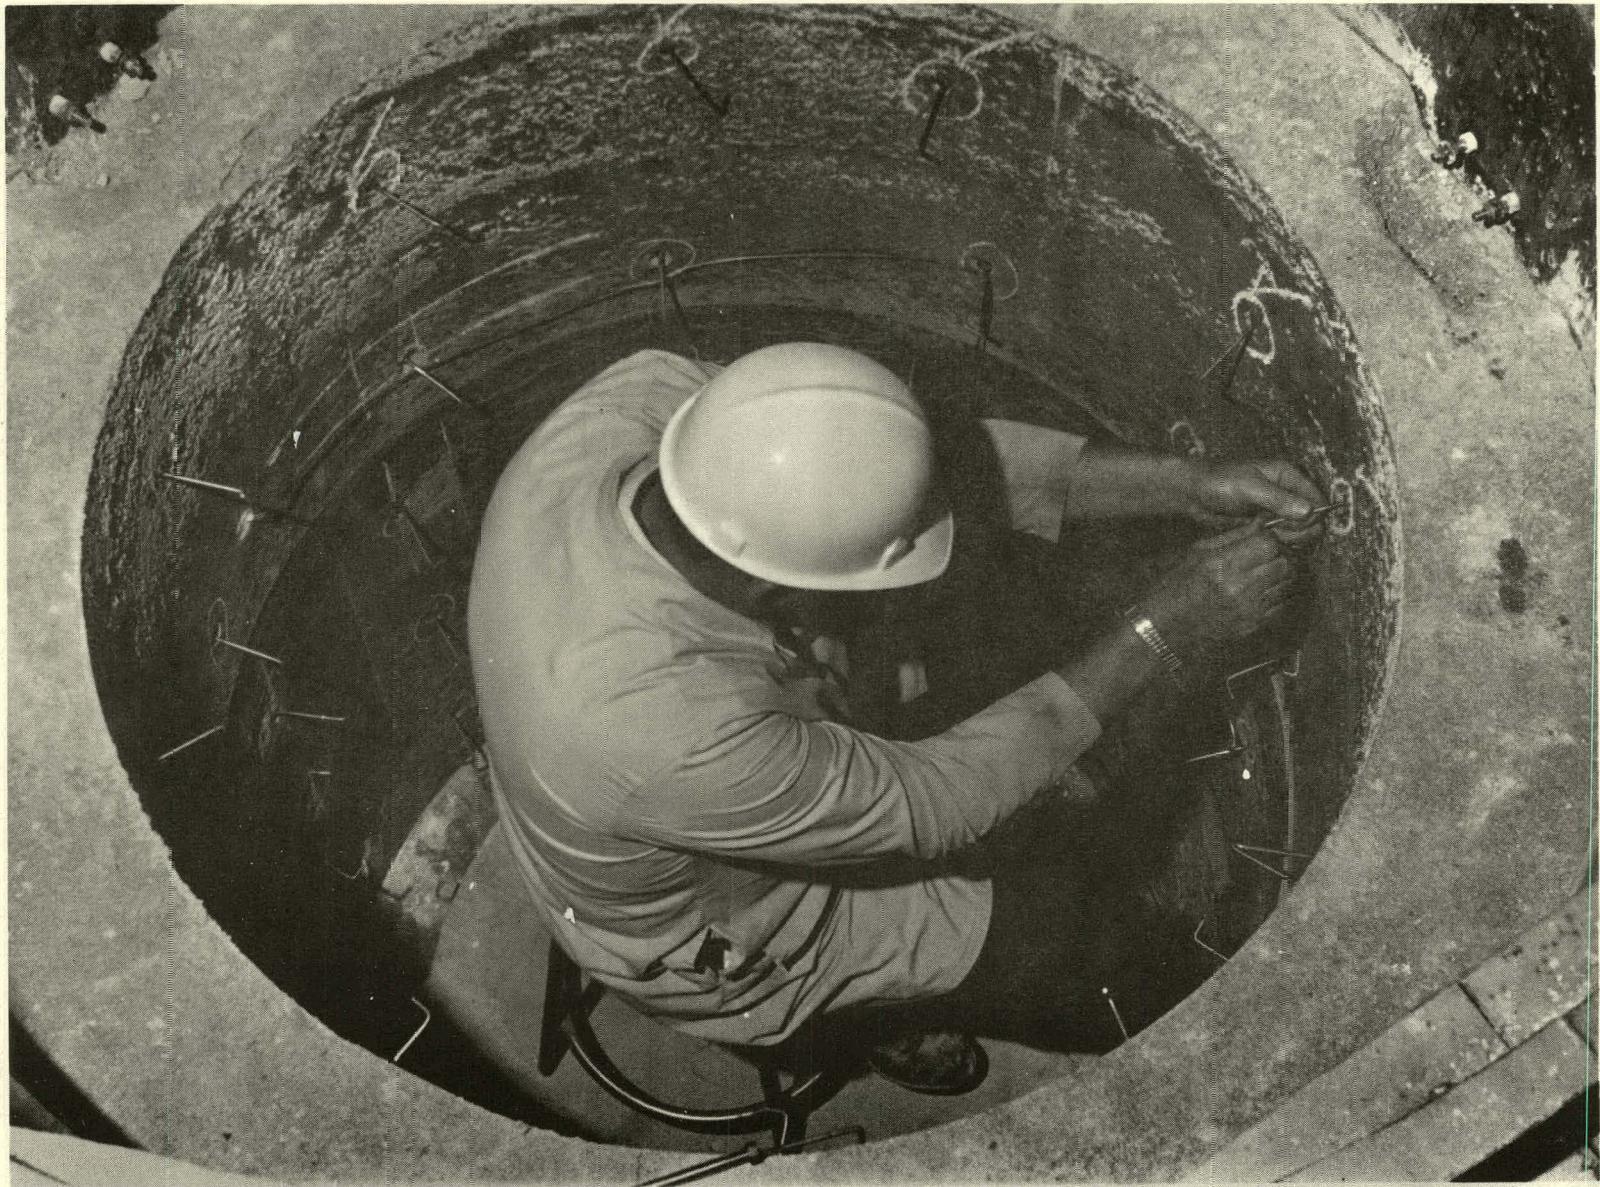
FIGURE 67. Installation of Anchor Extensions Prior to Casting the Dense Component.

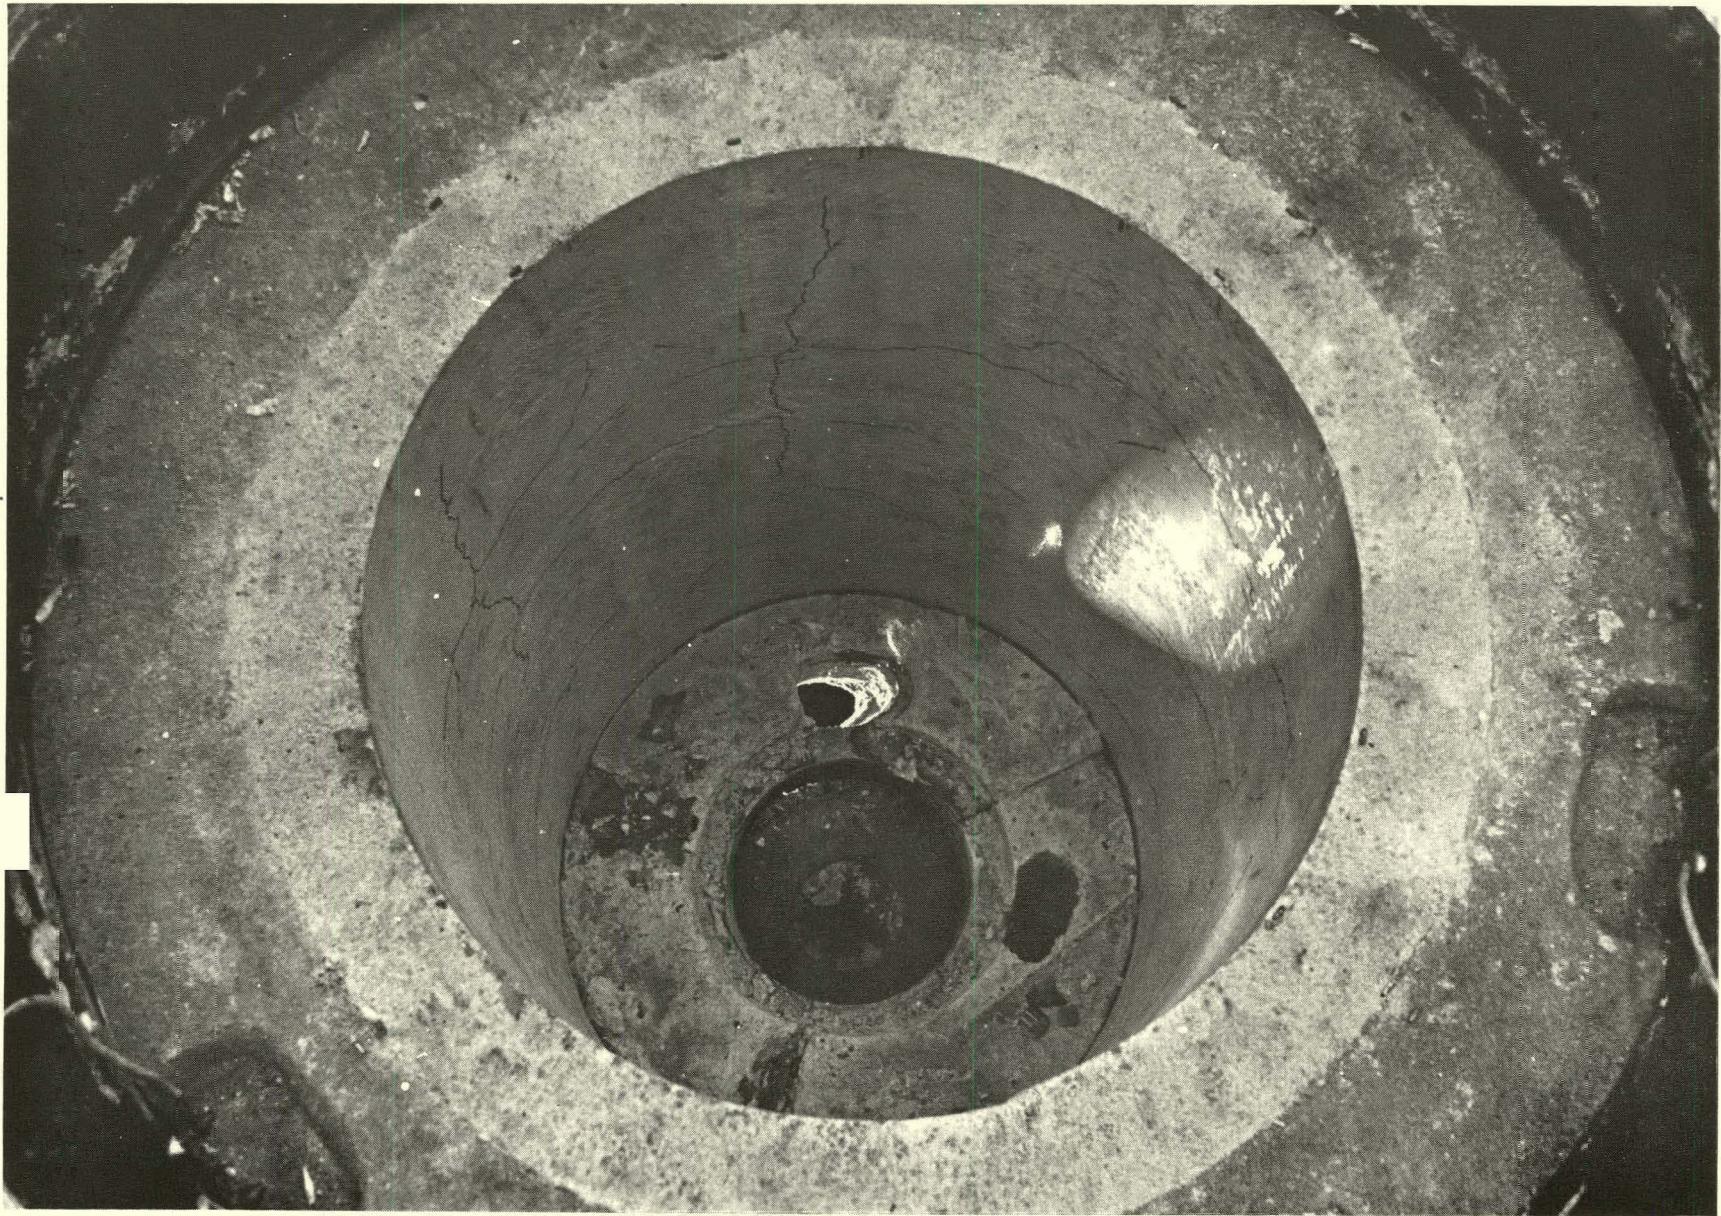
FIGURE 98. Top View of Pressure Vessel/Test Furnace
Showing Crack Pattern After Heat-up Test
of Lining #3 to 400°F.

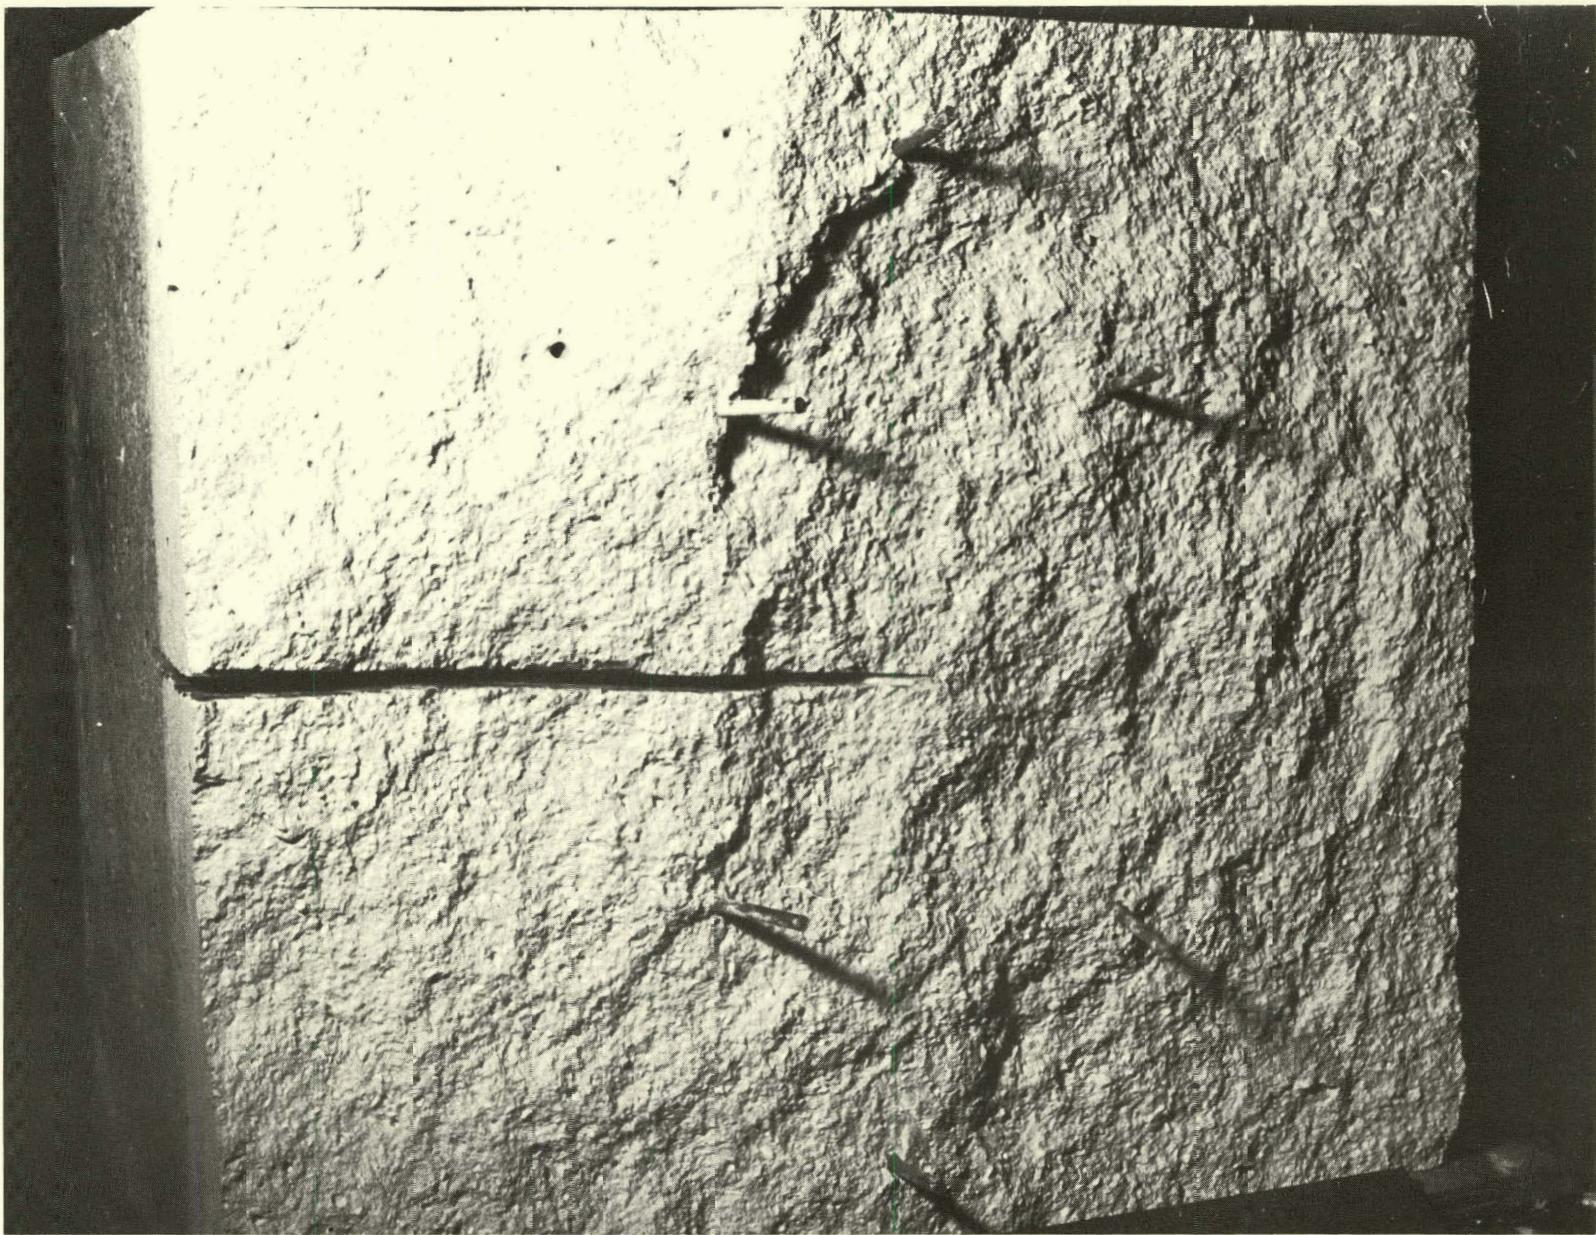
FIGURE 128. Spalled Panel #4.
Straight Anchor Sticking Out of Insulator.

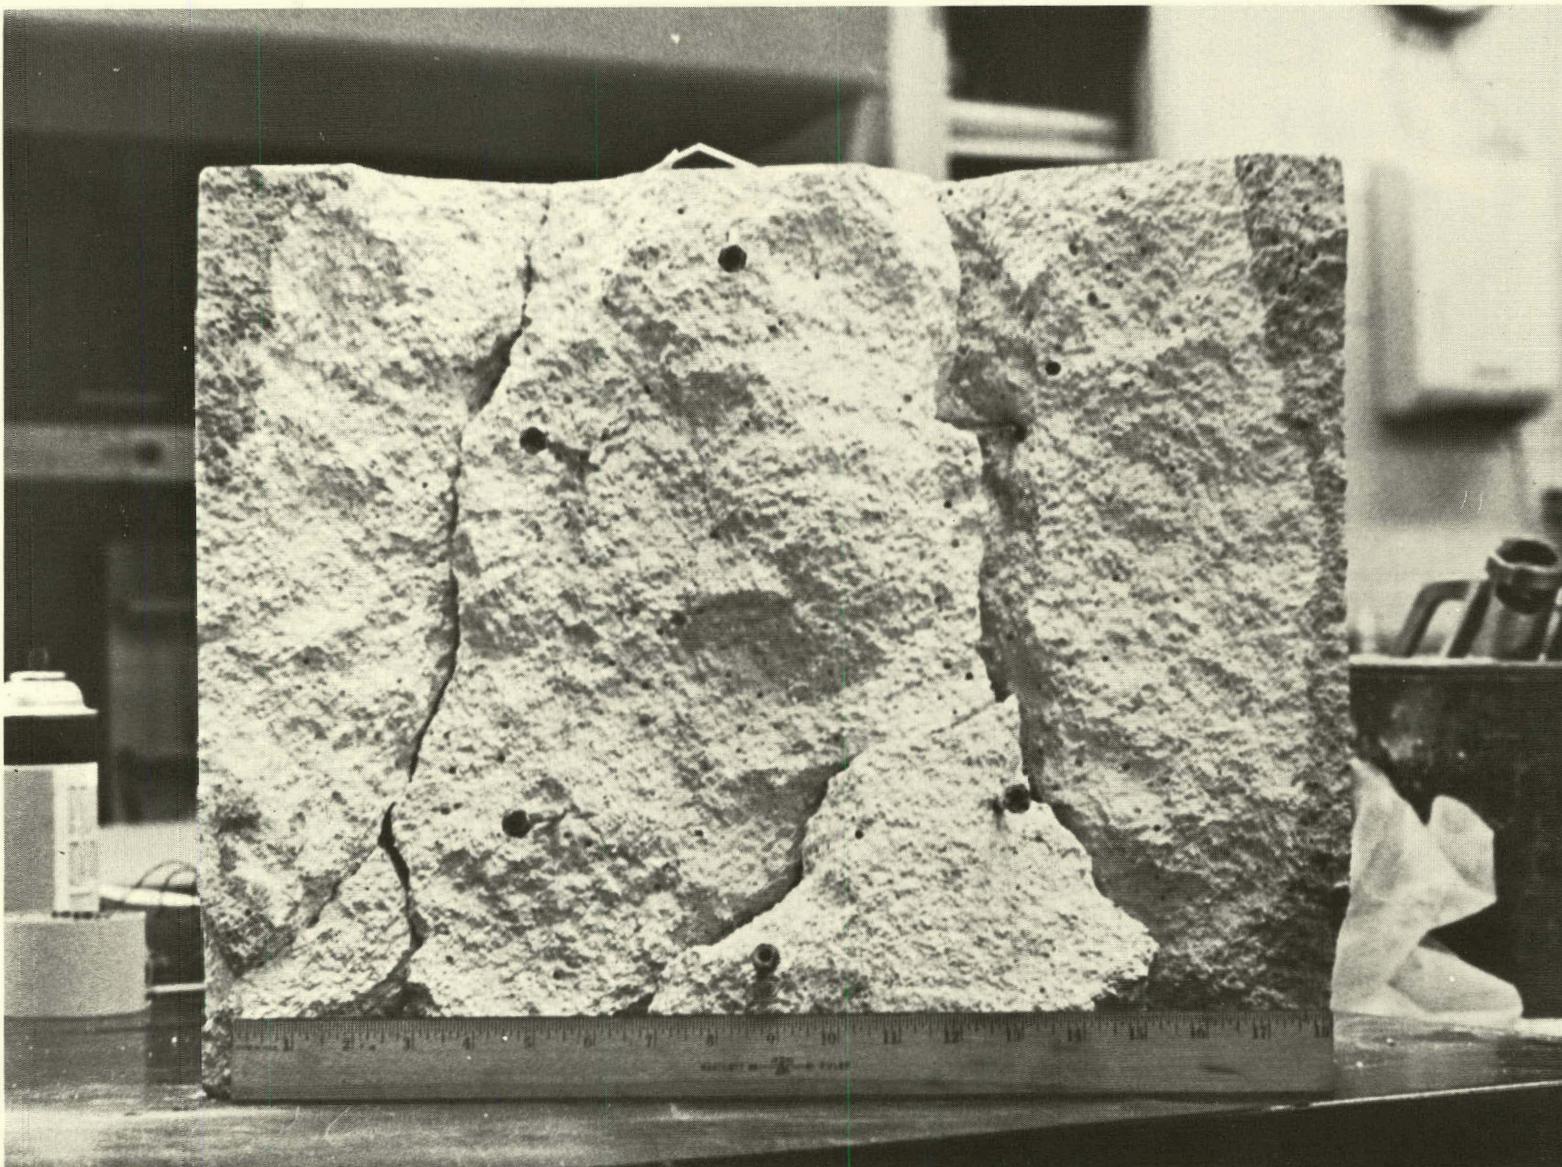
FIGURE 129. Spalled Panel #5 Showing Stripped Anchor Nuts.

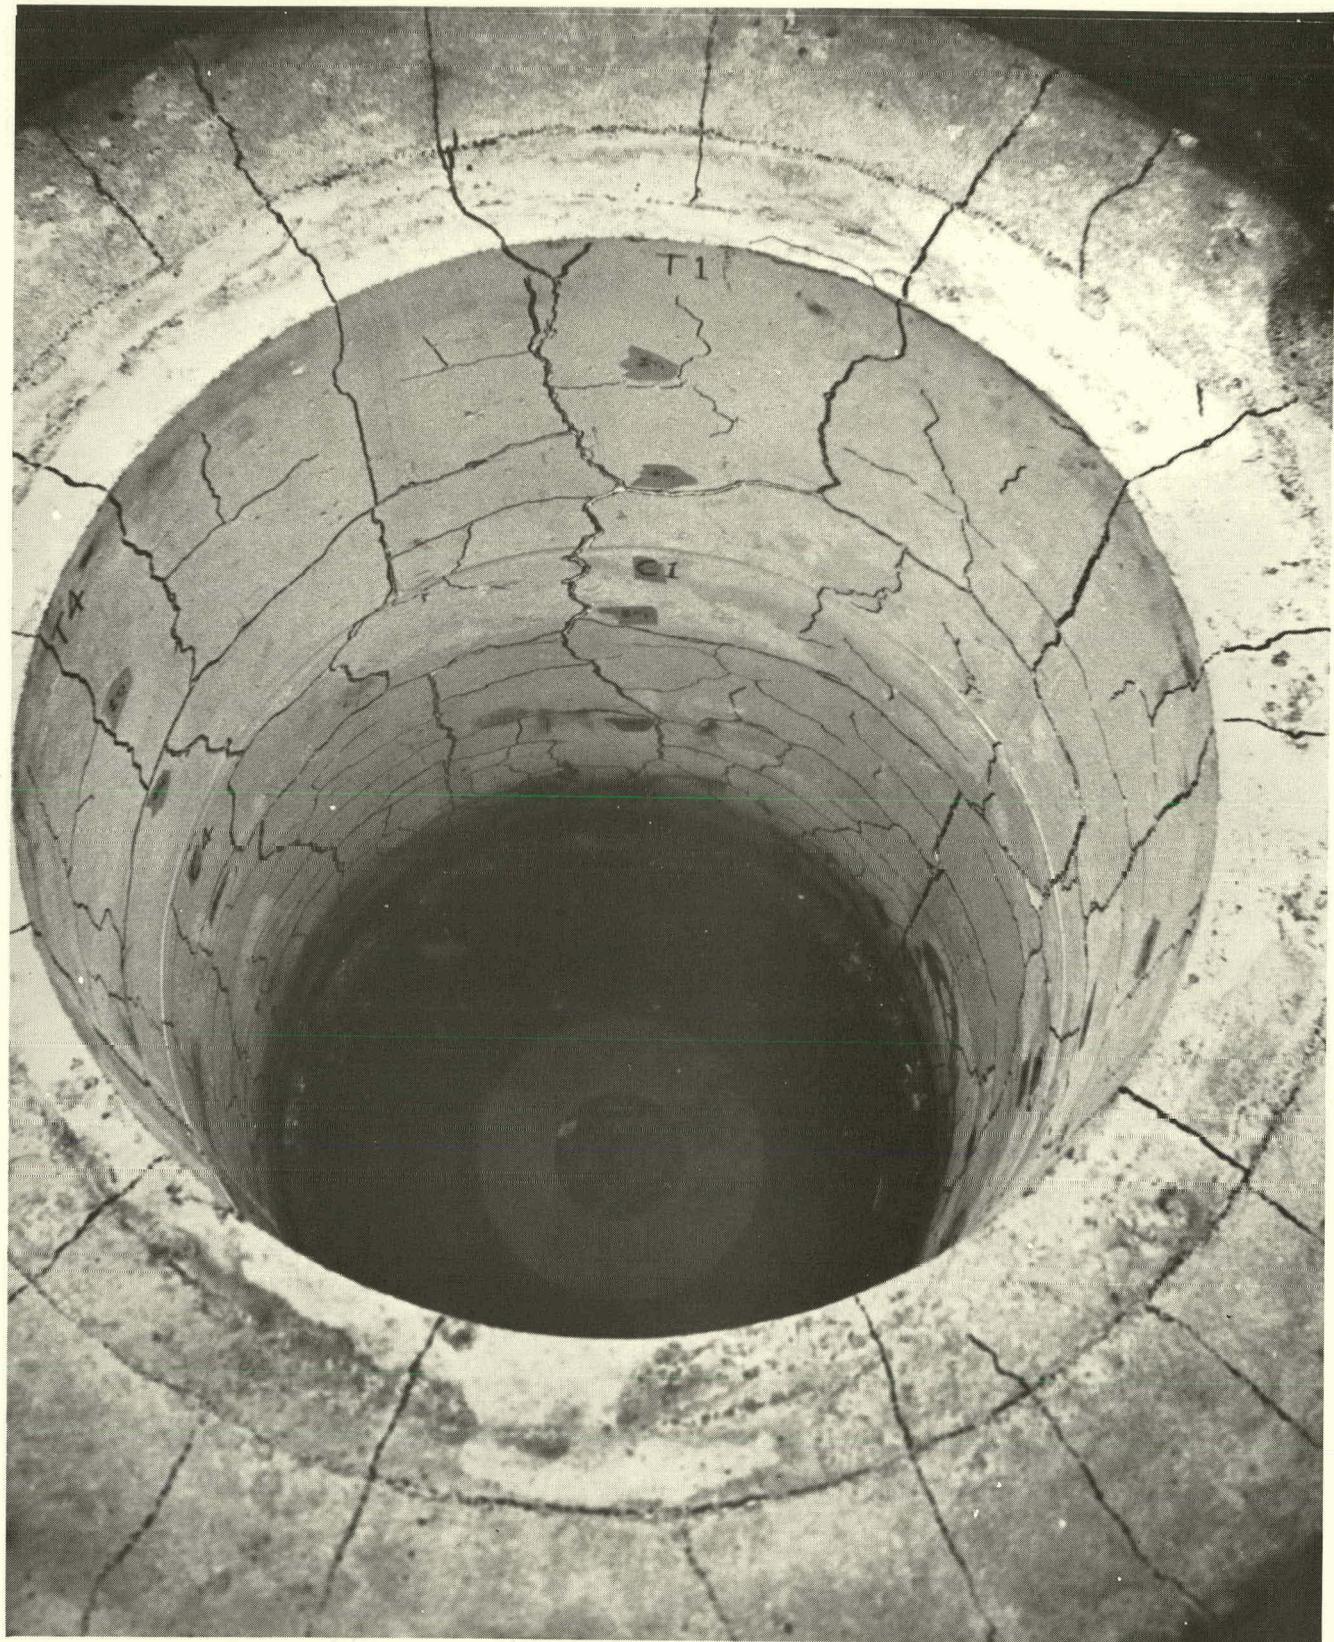
FIGURE 155. Appearance of Lining #1 After Cracks Are Inked
Following Two Thermal Cycles to 1200 and 2000°F.

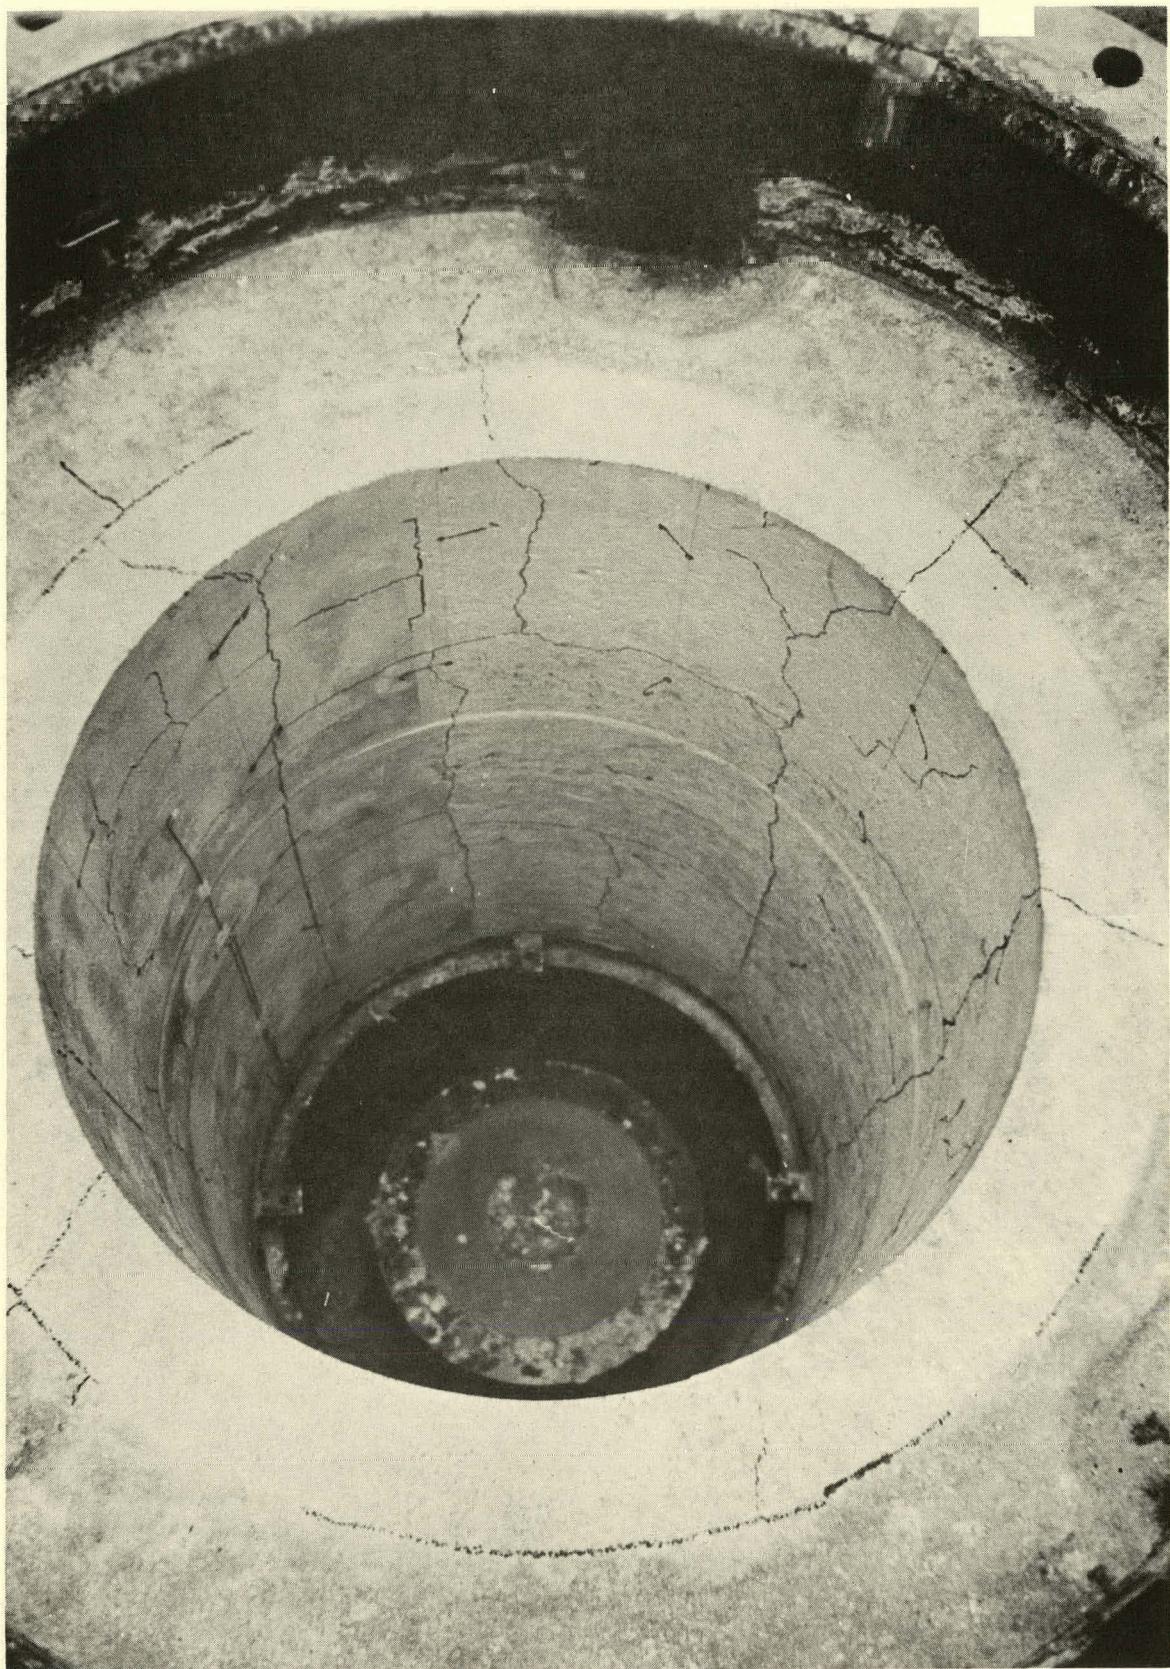
FIGURE 156. Appearance of Lining #2 After Cracks Were Inked
Following One Thermal Cycle to 1200°F.

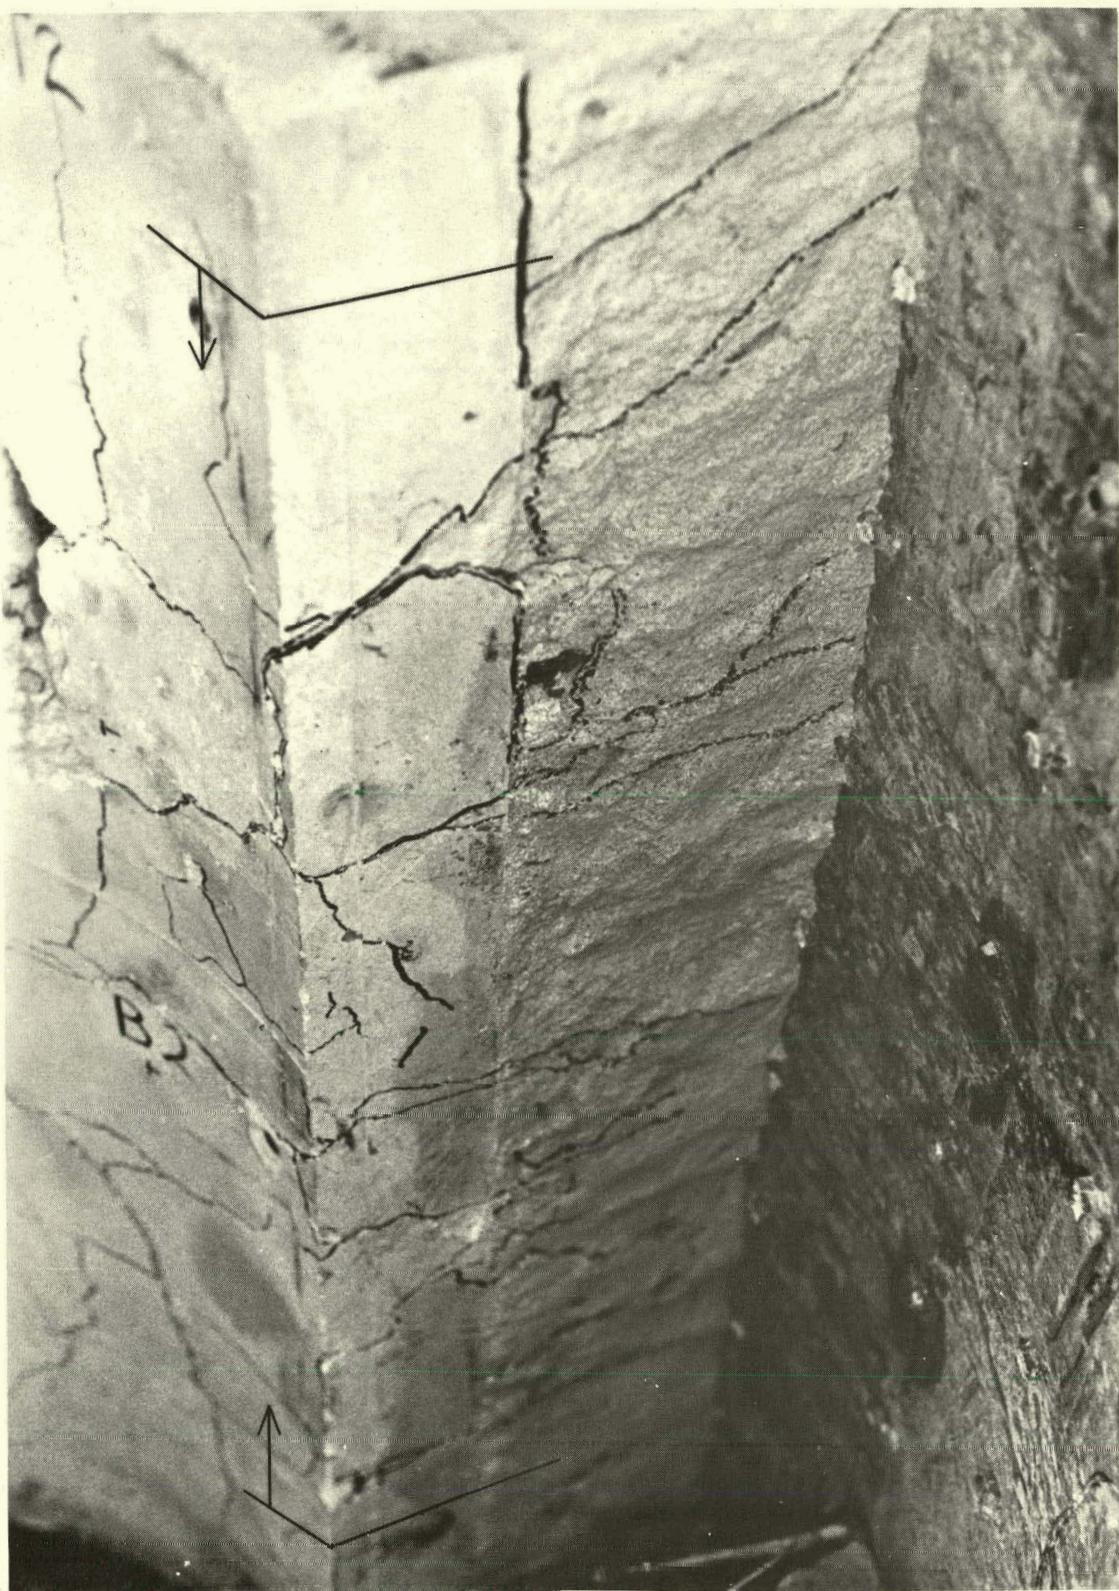
FIGURE 157. Top View of Lining #1 During Tear-Out and Examination. Dense component cut with diamond saw and insulator dressed with a chisel. Cracks are marked with ink. Four foot test zone lies within the arrows.

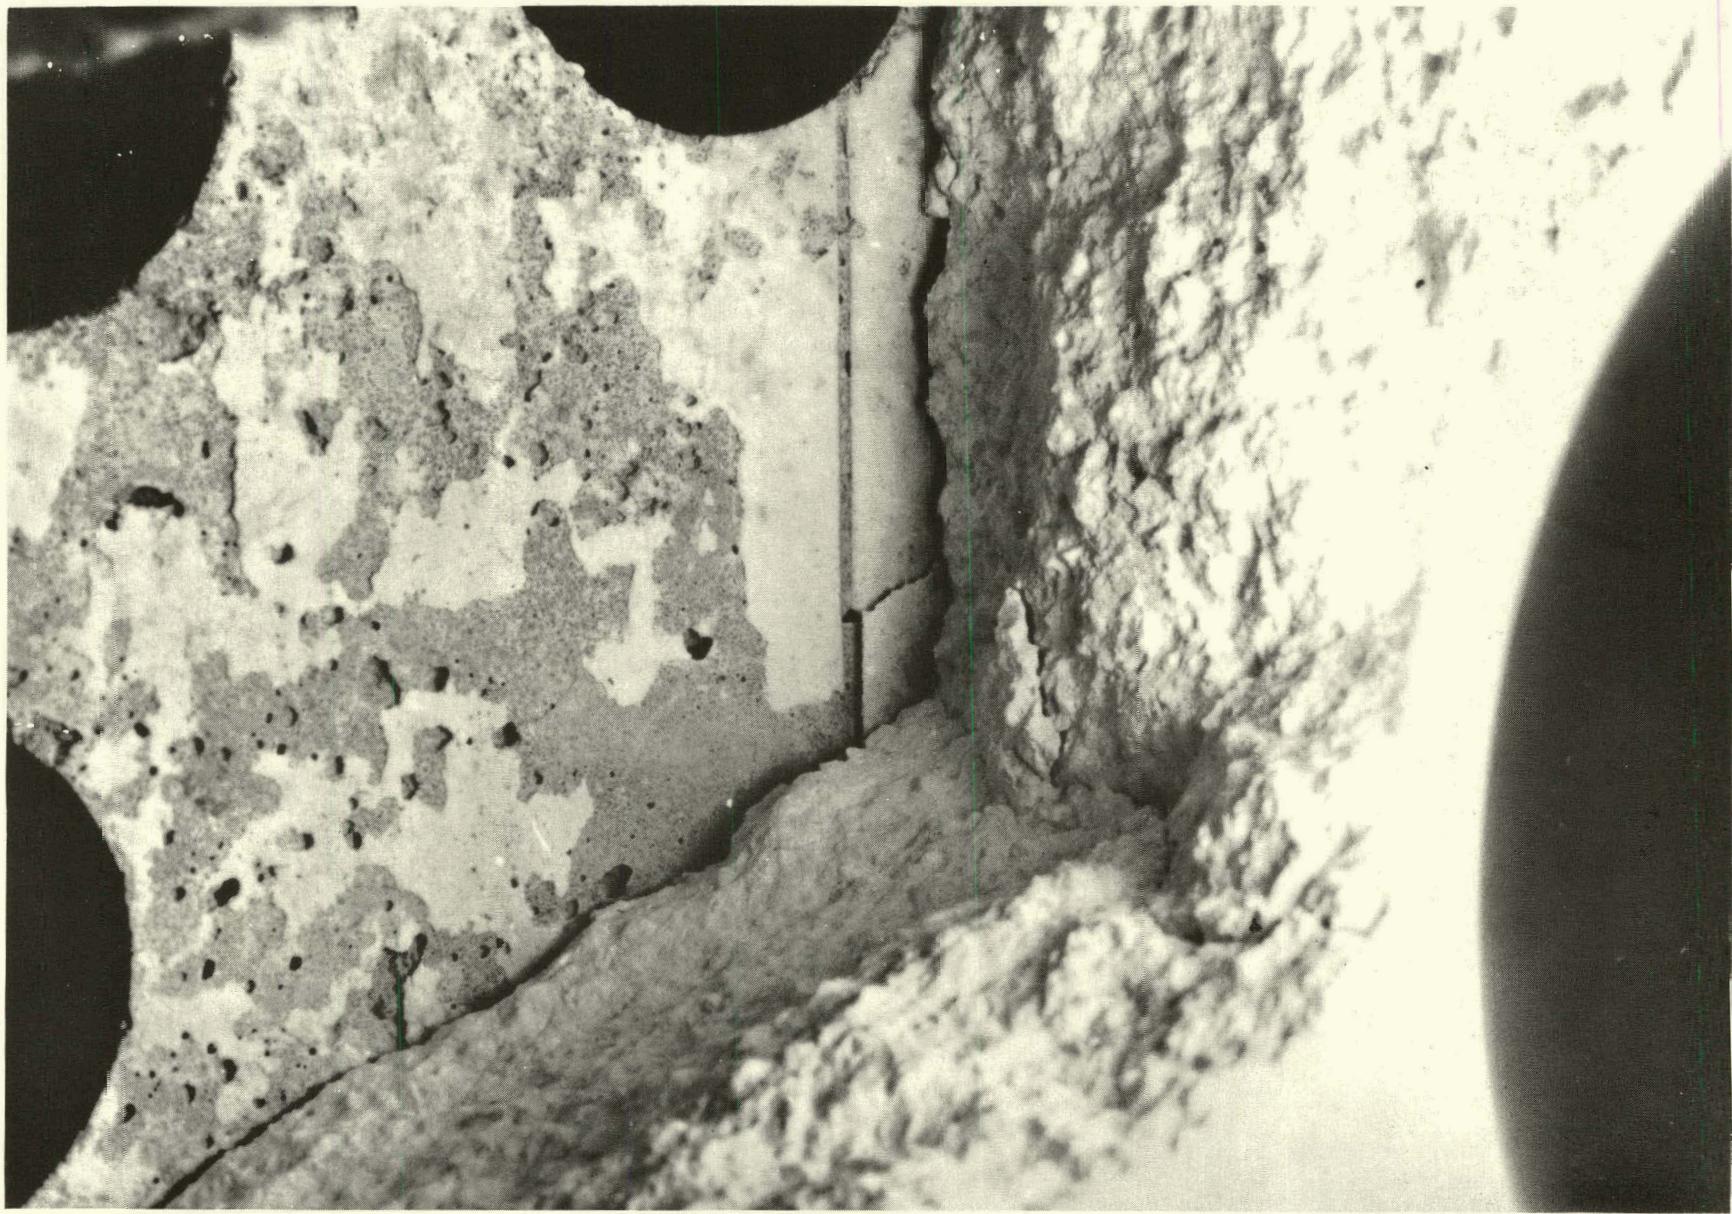
FIGURE 164. View of Dual Component Lining With Section of Dense Component Removed to Show Insulator and Gap at Interface.

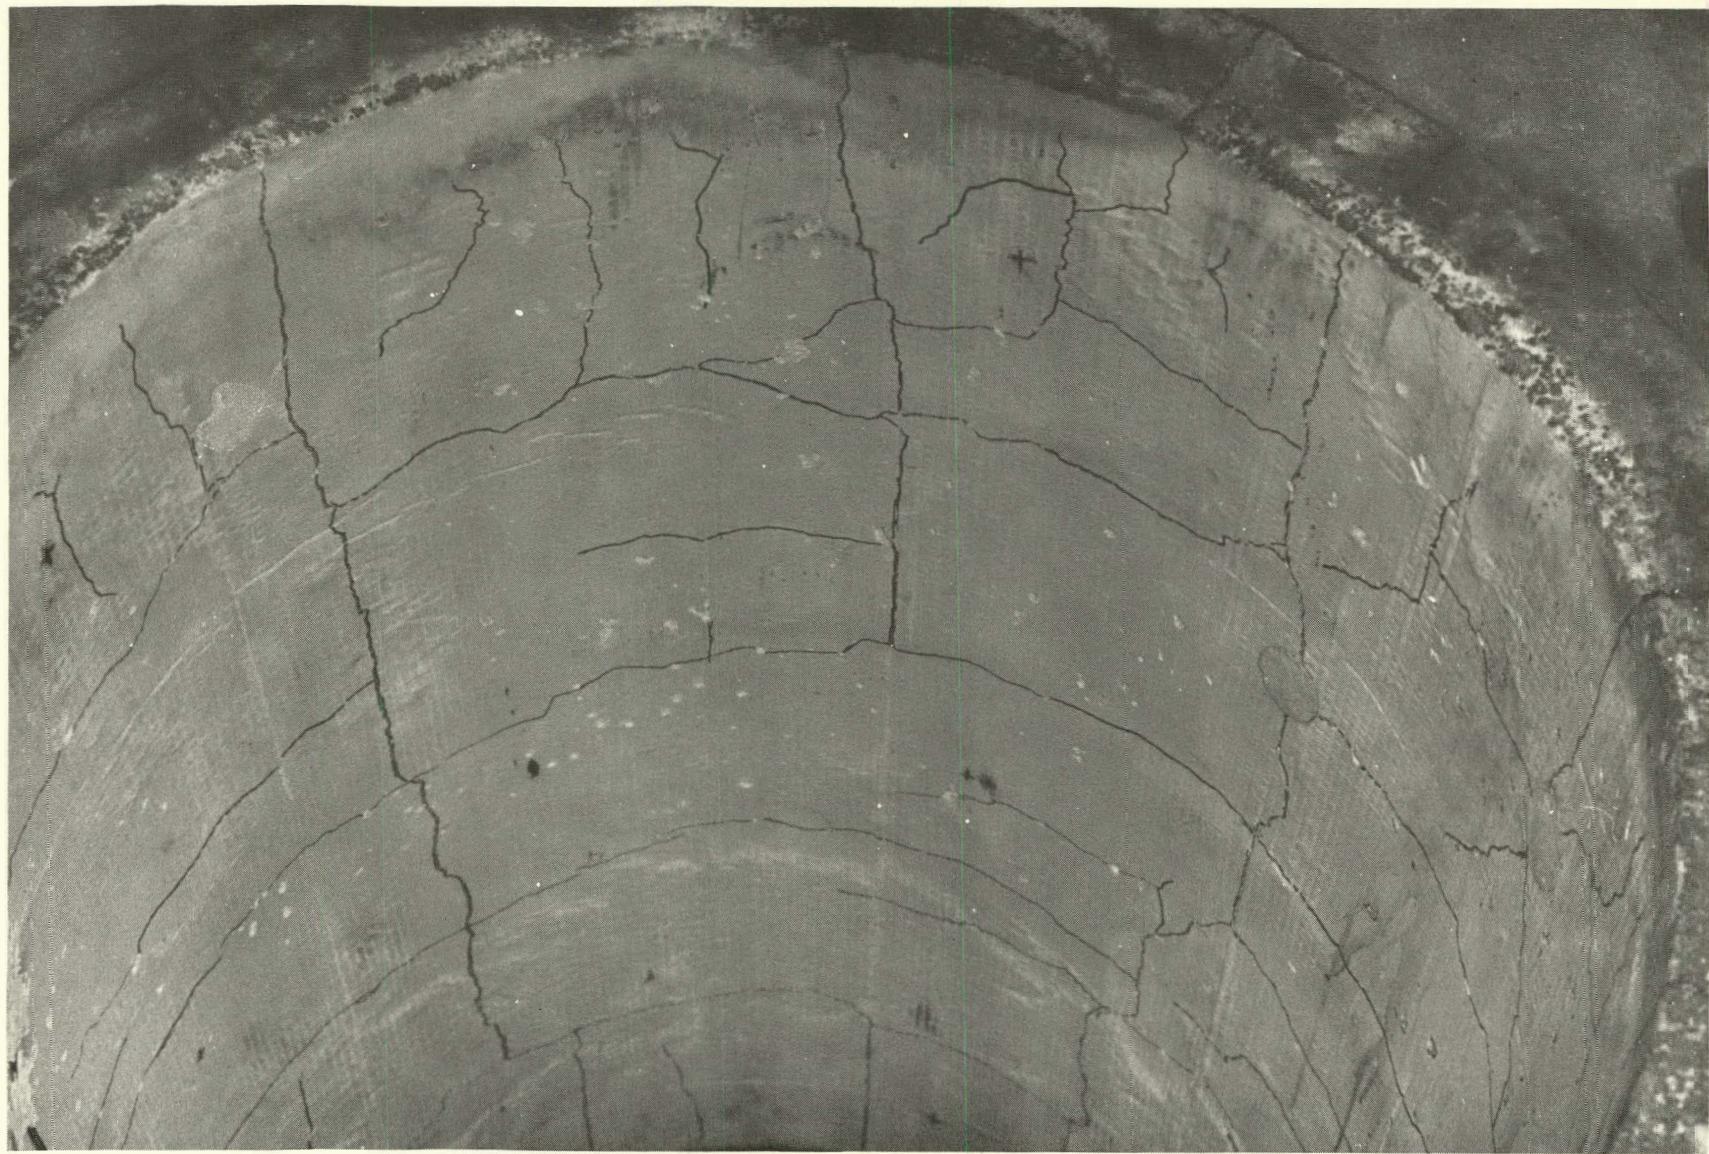
FIGURE 169. Top View of Lining #4 Hot Face After Heat-up Test to 1850°F and 120 psig Steam.

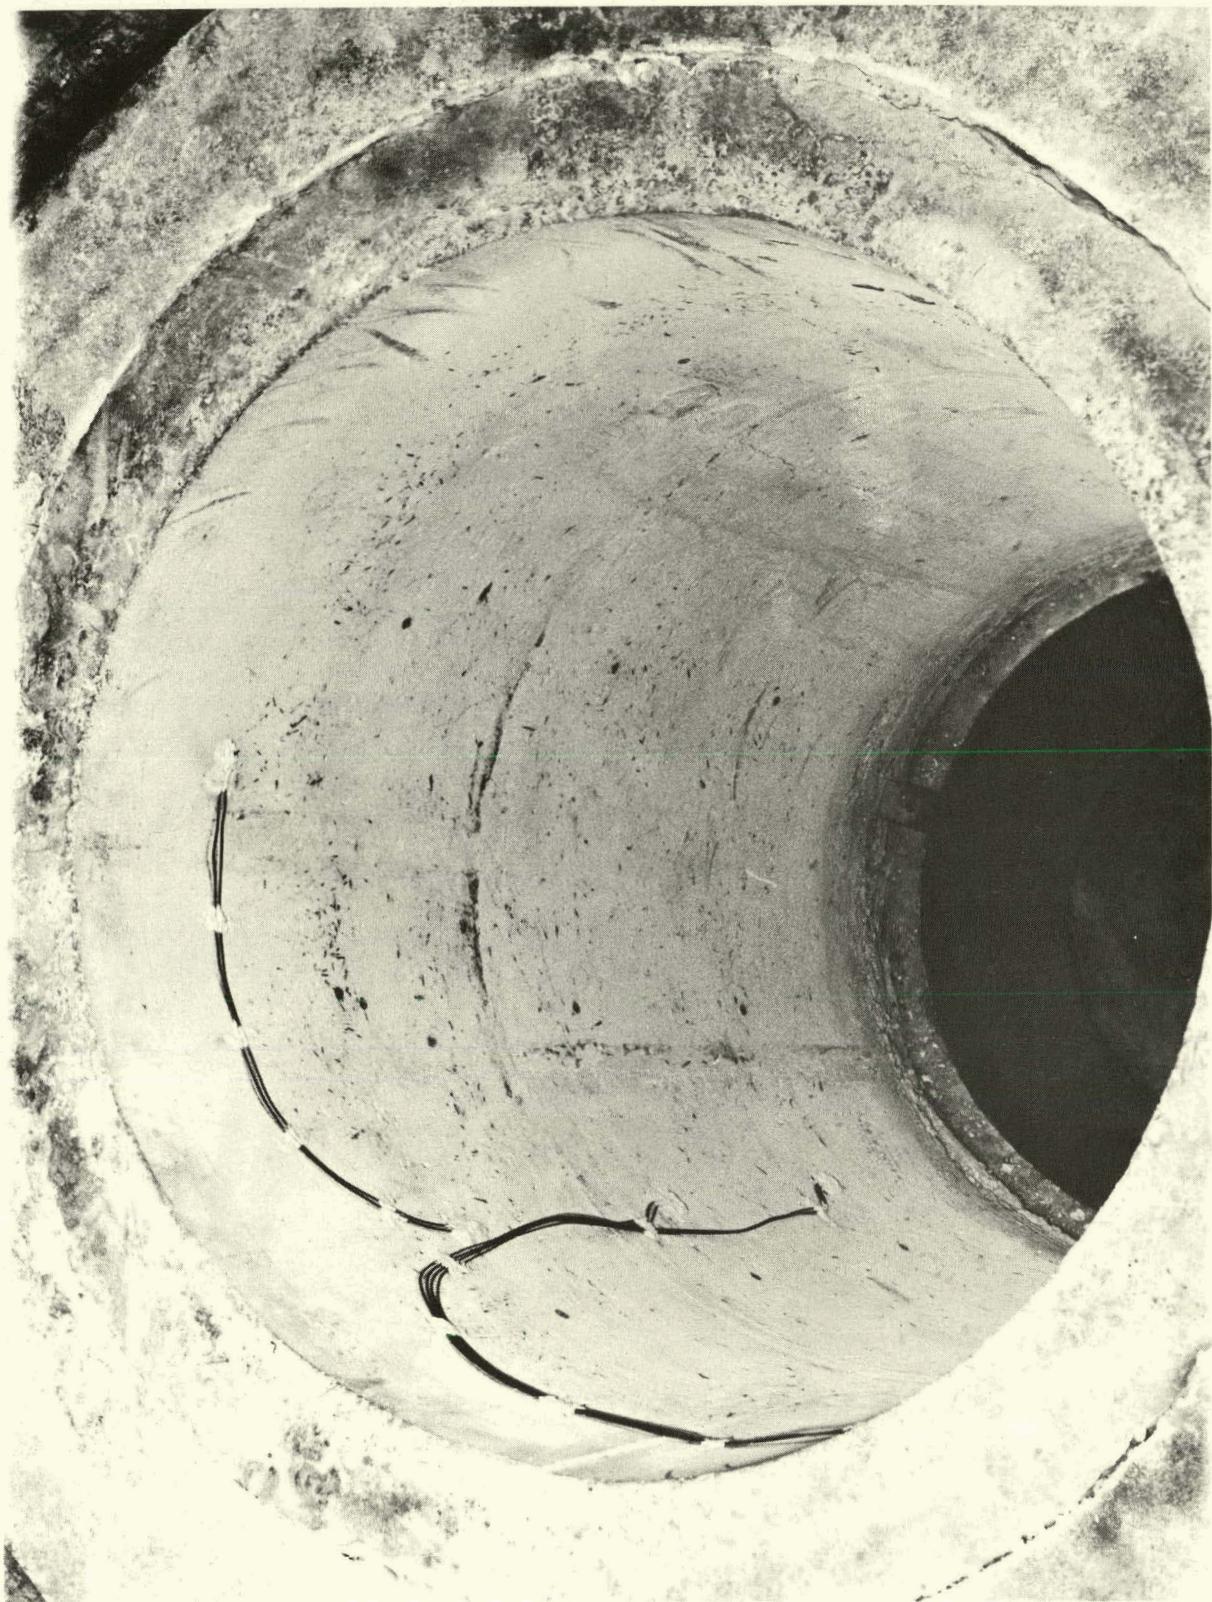
FIGURE 178. Top View of Lining #7 Showing Oxidized Metal Fibers (Dark Spots) After 1850°F Heat-Up Test In Air.
