IMPROVEMENT OF THE MECHANICAL RELIABILITY OF MONOLITHIC REFRACTORY LININGS FOR COAL GASIFICATION PROCESS VESSELS

Prepared for
United States Department of Energy

Final Report

Compiled by
R. A. Potter
Materials & Chemistry Laboratory
Lynchburg Research Center

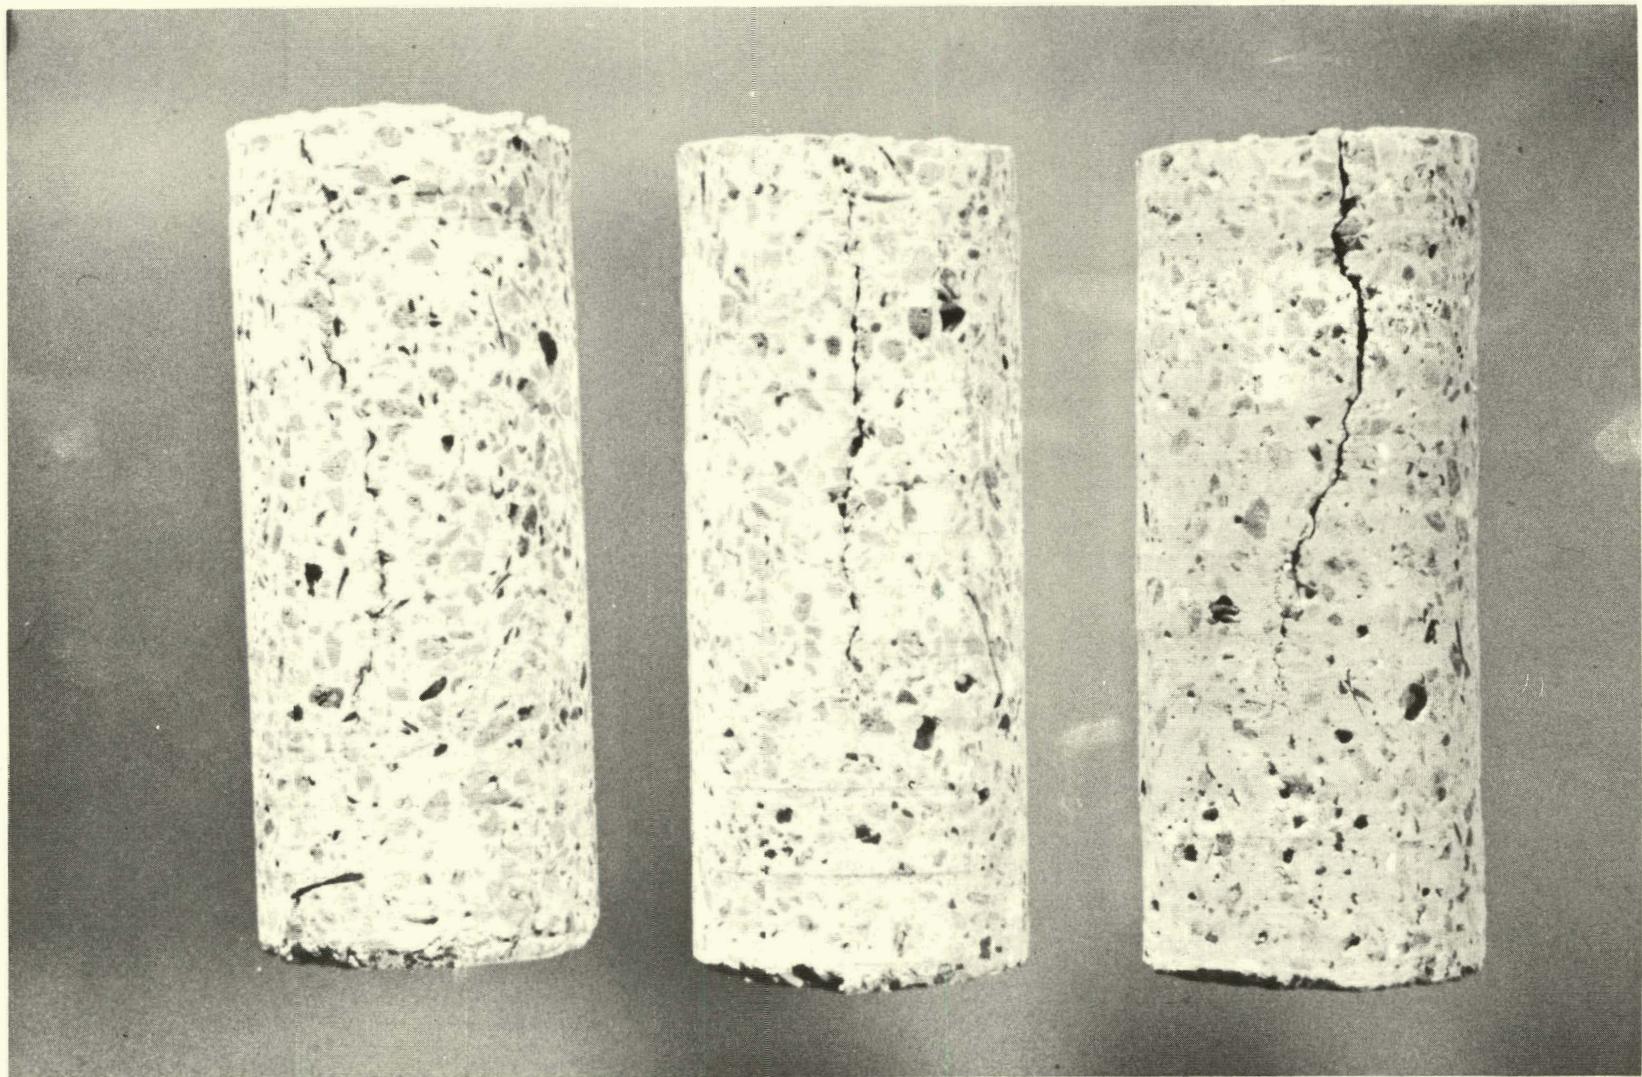
FIGURE 180. Drill Cores of Dense Component Adjacent to Same Vertical Crack (Lining #7 - Three Thermal Cycles).

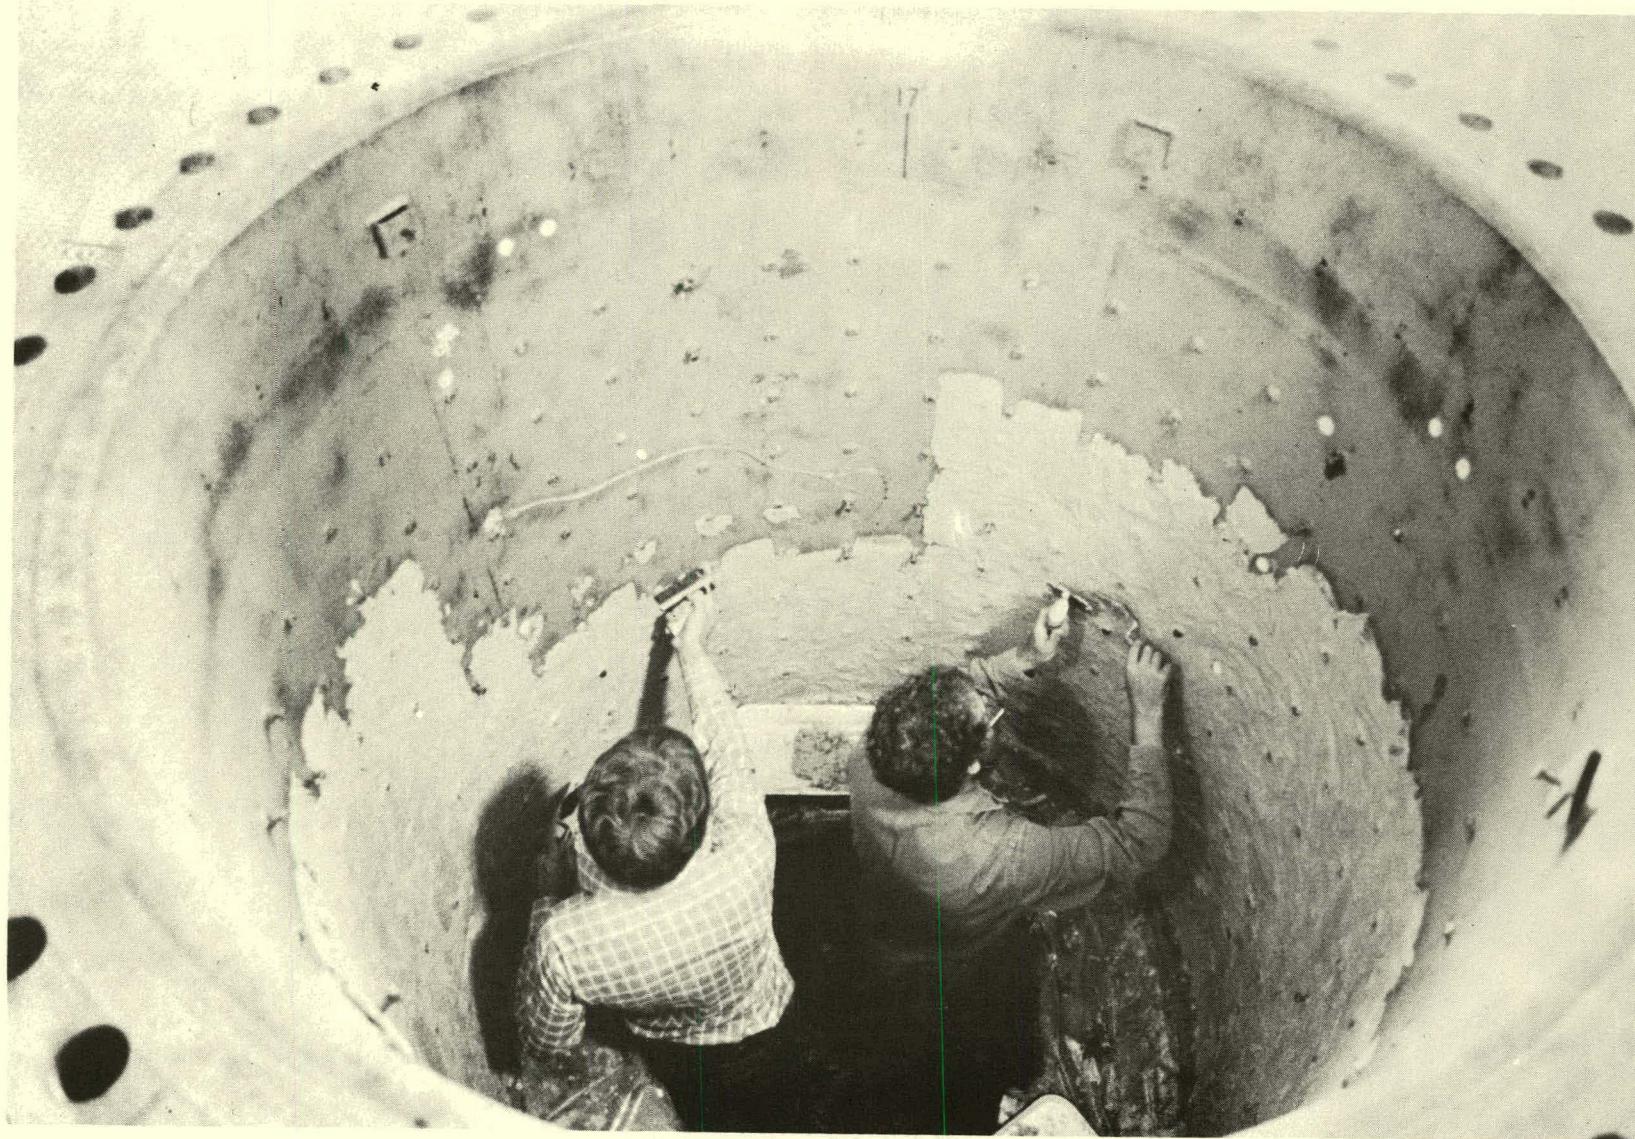
FIGURE 186. Installation Technique Used to Place HES Mortar on Inside of Vessel For Lining #9 Test.

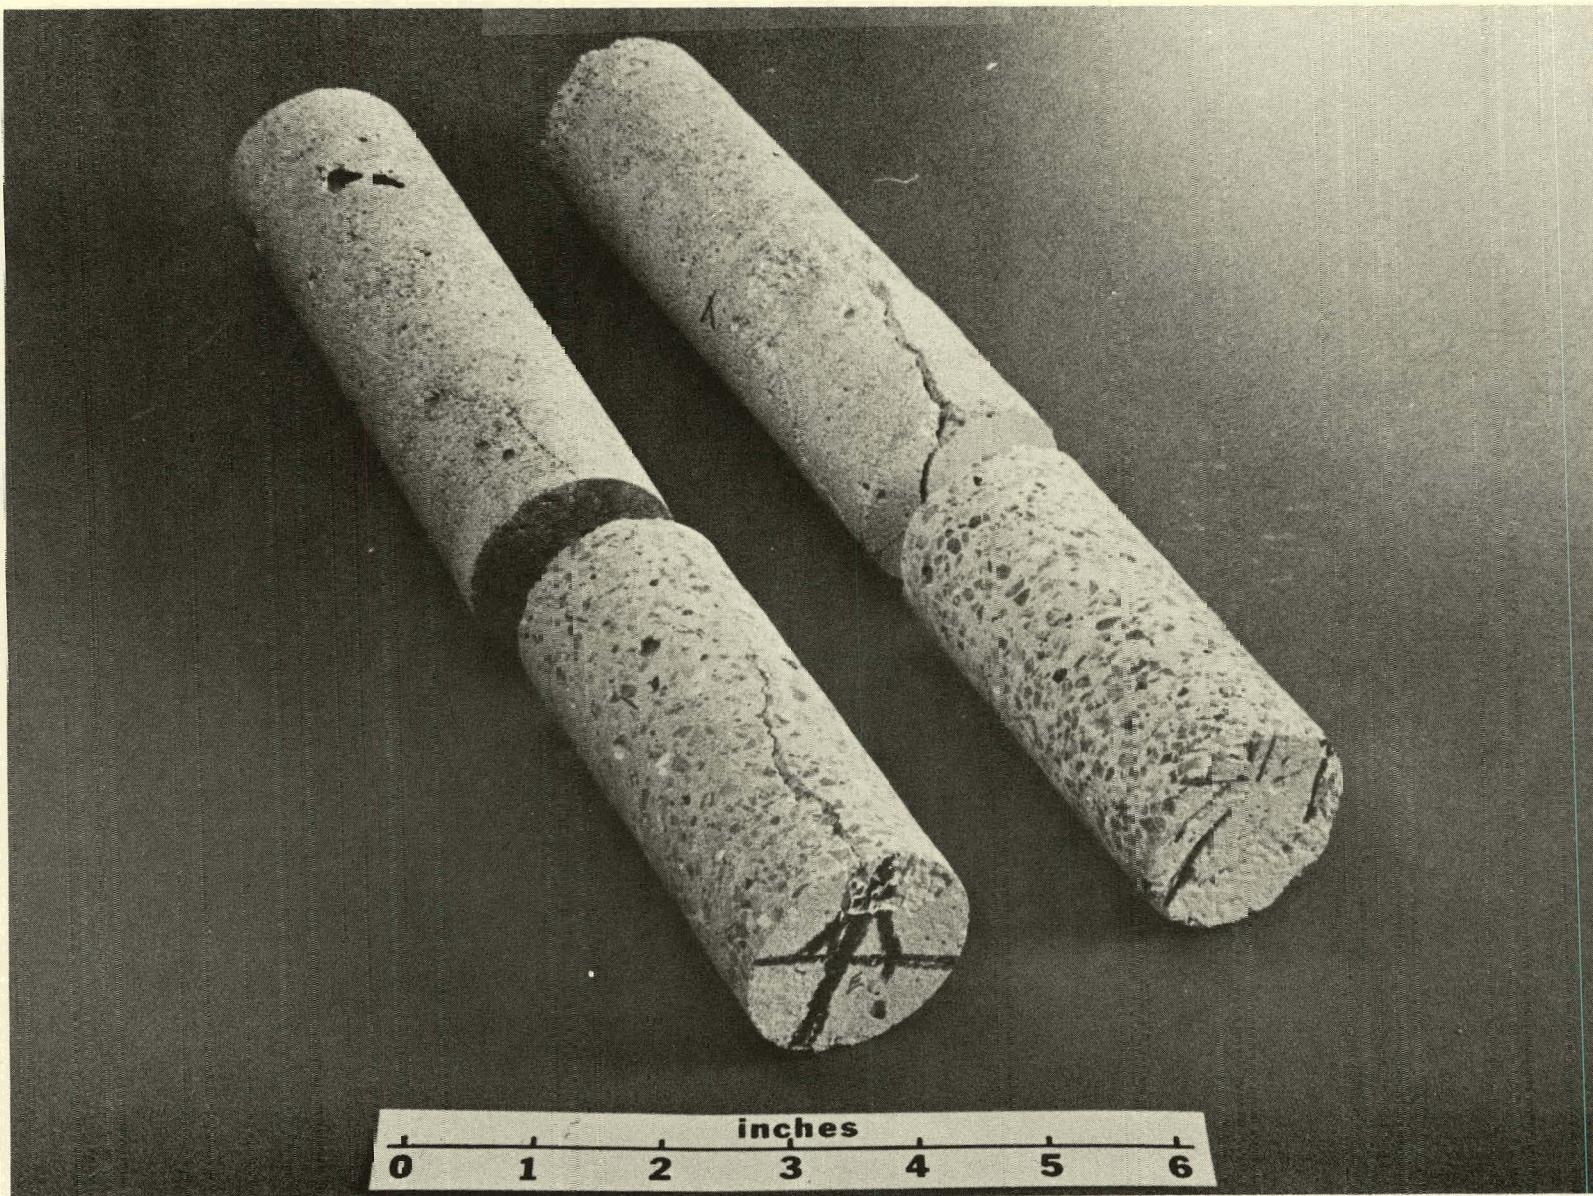
FIGURE 189. Drill Cores of Lining #7 and #9
After 1850°F Heat-Up Tests.
