ABSTRACT

Horak, Sikka, and Raske

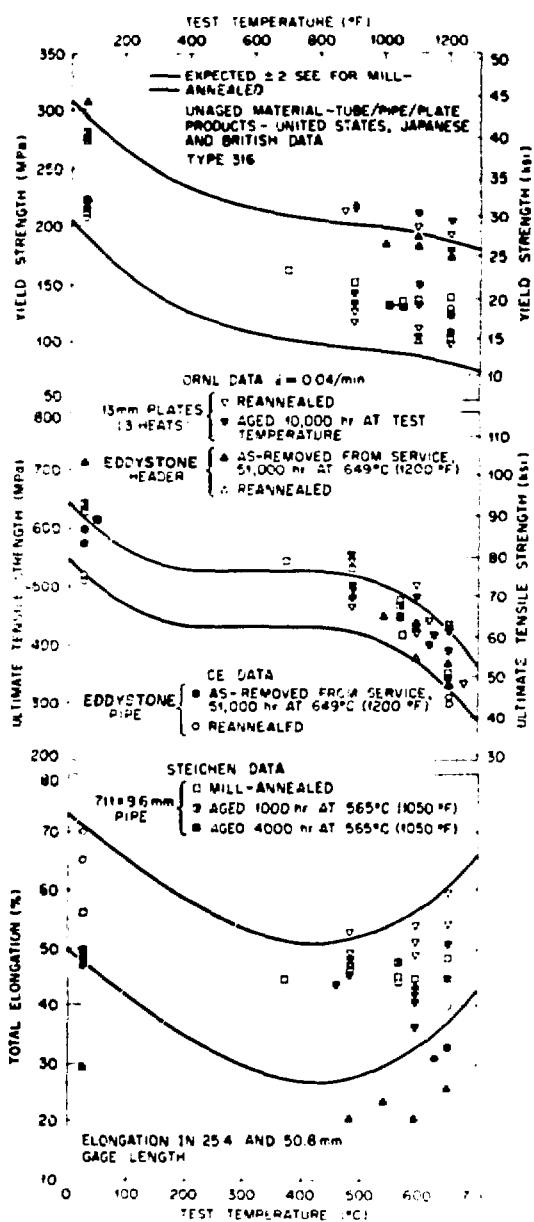
Fig. 1 - Tensile properties and microstructures of mill-annealed type 316 stainless steel aged for times to 5.1×10^4 h (about 6 years) and reannealed after the 10^4 h and 5.1×10^4 h aging conditions²

TENSILE PROPERTIES - The effects of laboratory aging or service exposure to times of 5.1×10^4 h at temperatures to 649°C (1200°F) on the microstructure and tensile properties of mill-annealed type 316 stainless steel are shown in Fig. 1.² In the unaged condition the microstructure shows only high-angle grain boundaries. After 4.4×10^3 h (about 6 months) at 649°C (1200°F) (0.53 T_m for this alloy where T_m is the absolute melting temperature), large carbide particles are present on these boundaries. After 5.1×10^4 h (about 6 years) at this temperature, carbide precipitation has occurred within the grains as well as at the grain boundaries; carbon, chromium, nickel, and molybdenum originally in solid solution are found in the large particles shown in Fig. 1. The strength properties after aging are within the scatter band of these properties for unaged material.

Additional information on the effects of longer term aging on the tensile properties of type 316 stainless steel is contained in Figs. 2 and 3. The data in Fig. 1 are for only four aging times, but those in Figs. 2 and 3 are for 12 aging times.³⁻⁹ For the important temperature range of application for this steel in LMFBRs [500-625°C (930-1160°F)], the 0.2% yield and ultimate tensile strengths are either unaffected or increased by aging. Thus, it is reasonable to state that no unforeseen decreases in strength will occur for unstressed material for service times between about 10 1/2 years (Figs. 2 and 3) and service lifetimes of approximately 28 years for commercial LMFBRs. For some of the times shown in Figs. 2 and 3, at temperatures above 550°C (1022°F) precipitation reactions are essentially complete for this alloy, and a stable matrix and grain-boundary structure should be present. For aging temperatures of 593°C (1100°F) and above the ductility falls below the minimum ductility measured on unaged material. However, total elongation and reduction of area are still above 20%, which is acceptable. Some implications of the lower ductility of aged material are discussed later under "TOUGHNESS PROPERTIES."

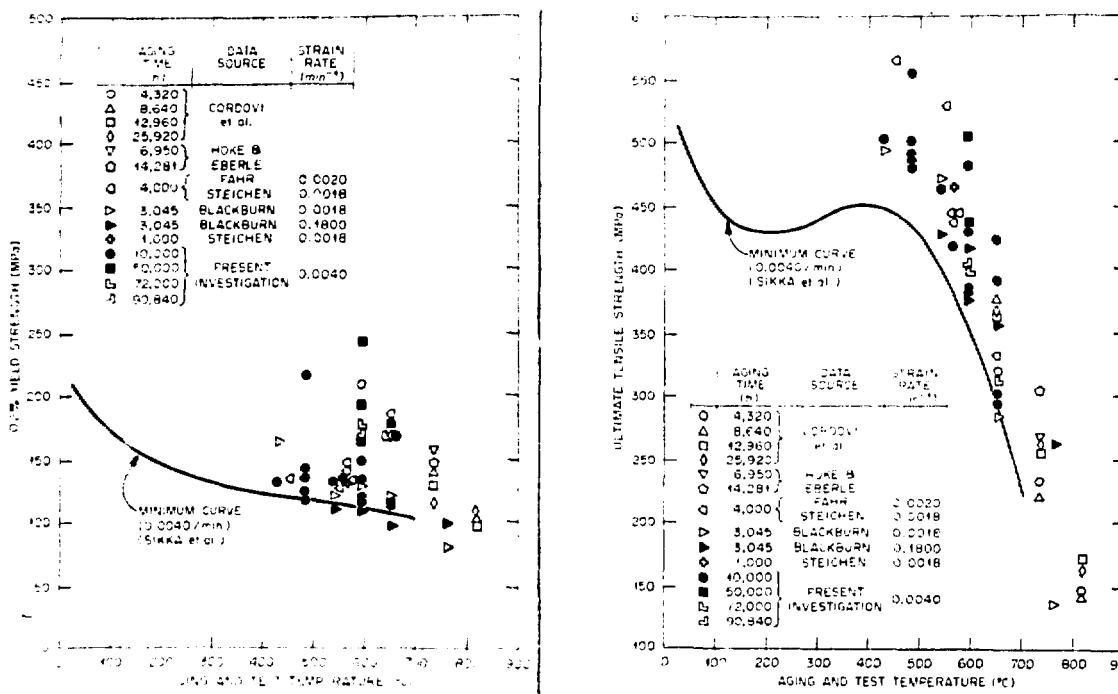
Fig. 2 - Yield and ultimate strengths of type 316 stainless steel in the annealed condition and after aging for times to 9.1×10^4 h (about 10 1/2 years)³⁻⁹

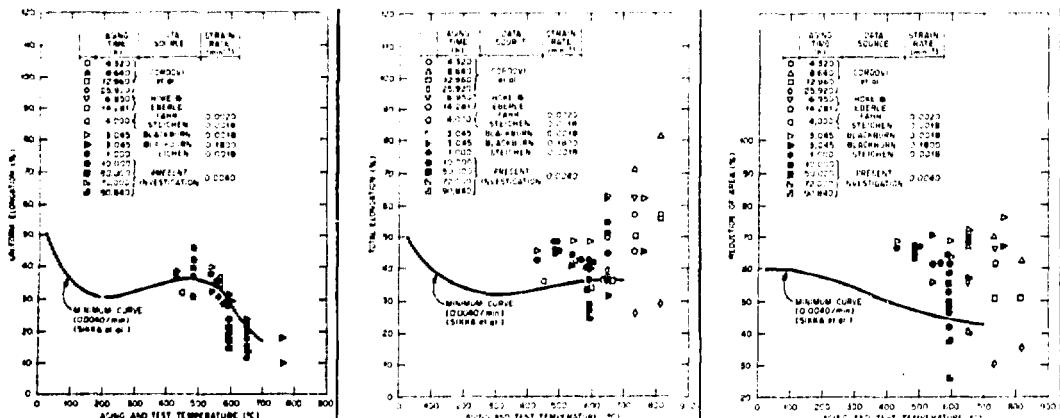
Fig. 3 - Uniform and total elongation and reduction of area of type 316 stainless steel in the annealed condition and after aging for times to 9.1×10^4 h (about 10 1/2 years)³⁻⁹

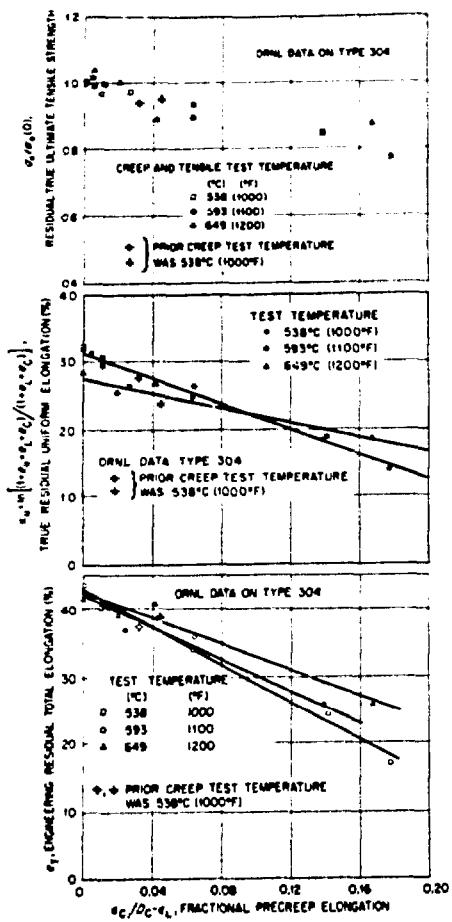
Fig. 4 - Residual tensile properties of type 304 stainless steel at 538, 593, and 649°C (1000, 1100, and 1200°F) as a function of prior creep elongation²

- ϵ_L = engineering loading strain,
- ϵ_C = engineering creep strain,
- ϵ_{C_p} = true prior creep strain,
- ϵ_L = true loading strain = $\ln(1+\epsilon_L)$,
- D_C = true creep ductility = $\ln(100/100 - RA)$,
- RA = reduction of area (%)

assure high plant availability and reliability. Figures 4 and 5 contain data on the effects of prior creep and fatigue loading, respectively, on the tensile properties of type 304 stainless steel.^{2,10} At 538 and 593°C (1000 and 1100°F), strength and ductility properties decrease linearly as a function of prior creep strain². Prior creep strain of 0.17 to 0.18 produces a 20% decrease in ultimate tensile strength but a much larger decrease in ductility, as shown by the 50% decrease in total elongation.

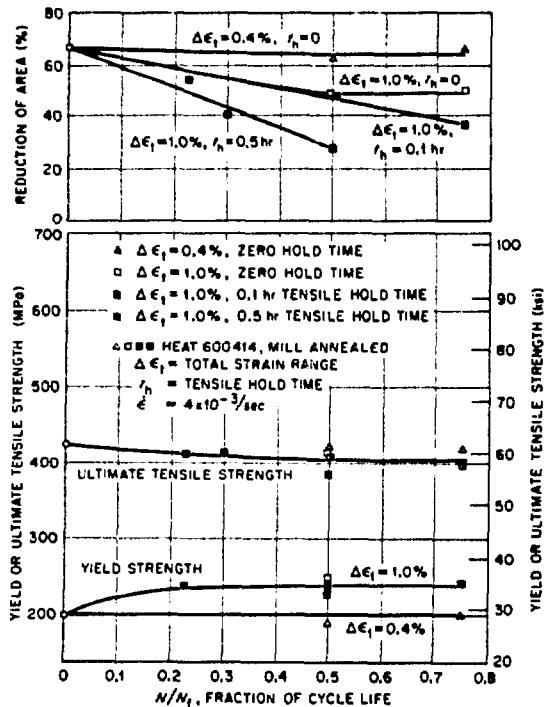
Fig. 5 - Tensile properties as a function of cycle life expended for type 304 stainless steel cycled in strain control at 593°C (1100°F) (N_f = cycles to failure)¹⁰

For these tests, cyclic loading at 593°C (1100°F) and a total strain range of 0.4% has no effect on the tensile properties of type 304 stainless steel at this temperature, even for cycling to 75% of the fatigue life (cycles to failure). For a total strain range of 1.0%, cyclic strengthening increases the yield strength by about 25%, the ductility decreases by about 25%, and the ultimate tensile strength is not affected. Adding tensile hold times of 0.1 and 0.5 h in each cycle at the 1% strain range has no further effect on the yield or ultimate tensile strength, but the ductility decreases with increasing hold time. At 75% of the fatigue life, the ductility (as measured by reduction of area) decreases almost 50% by a 0.1-h hold time, and at only 50% of the fatigue life the ductility is reduced by a 0.5-h hold time to only 43% of that before the creep-fatigue loading. This information indicates that continuous-cycling fatigue loading at maximum strain ranges to 1% at 593°C (1100°F) has little, if any, effect on the tensile properties of type 304 stainless steel. The data in Fig. 5, combined with the data shown in Fig. 4, illustrate that creep damage produced in either monotonic or cyclic loading is detrimental to tensile properties. The tensile property most affected by creep loading is ductility.

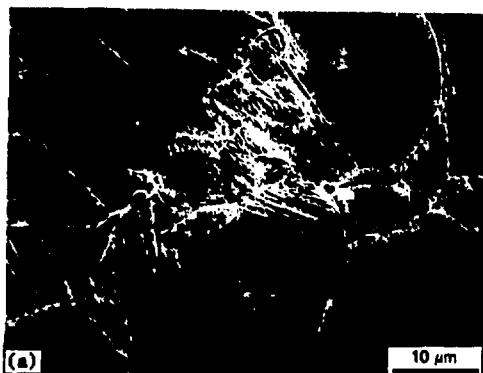
Fig. 8 - Scanning electron micrograph showing large islands of ferrite containing fine particles of sigma phase precipitated in the stressed region of type 304 stainless steel during 6×10^4 h (about 7 years) at 593°C (1100°F) and 117 MPa (17 ksi)¹²

CREEP-RUPTURE PROPERTIES - Figure 6 shows the forms of Cr_{23}C_6 precipitate particles in type 304 stainless steel after a creep-rupture test lasting 6×10^4 h (about 7 years) at 593°C (1100°F) and 117 MPa (17 ksi).^{11,12} The precipitate particles are large (50-100 nm across) and primarily rectangular. Figure 7 shows massive precipitates of sigma phase and fine precipitates of Cr_{23}C_6 in the same sample. Figure 8 shows that sufficient localized chromium depletion from the austenite during precipitation of sigma phase can result in the sigma phase particles being surrounded by ferrite.

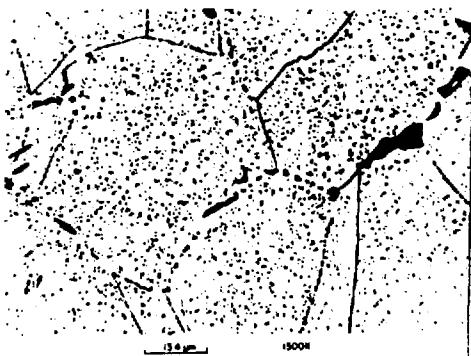
Fig. 9 - Optical micrograph showing large amounts of carbide precipitation within the matrix and large sigma phase particles at the grain boundaries in the stressed region of type 304 stainless steel during 7.3×10^4 h (about 8 1/2 years) at 593°C (1100°F) and 117 MPa (17 ksi).

Figure 9 is an optical micrograph from a creep-rupture specimen of type 304 stainless steel that ruptured after 7.3×10^4 h (about 8 1/2 years) at 593°C (1100°F) and 117 MPa (17 ksi). At the lower center of the micrograph is evidence that the original grain boundary moved during the test. The matrix in this area is apparently void of any precipitates. Apparently they were dissolved during

the grain-boundary movement under the applied stress. The grains contain an essentially uniform distribution of carbide particles, and massive sigma phase particles are found at grain-boundary intersections. The information derived from these figures shows that the time-temperature-precipitation diagrams developed by Stickler and Vinckier for type 304¹³ and by Weiss and Stickler for type 316

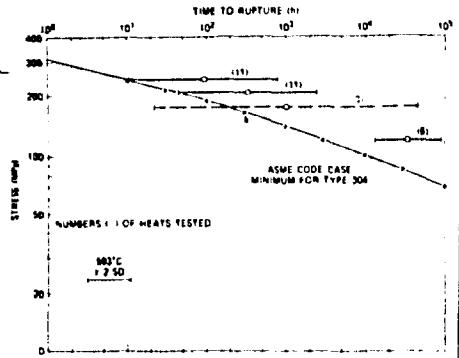
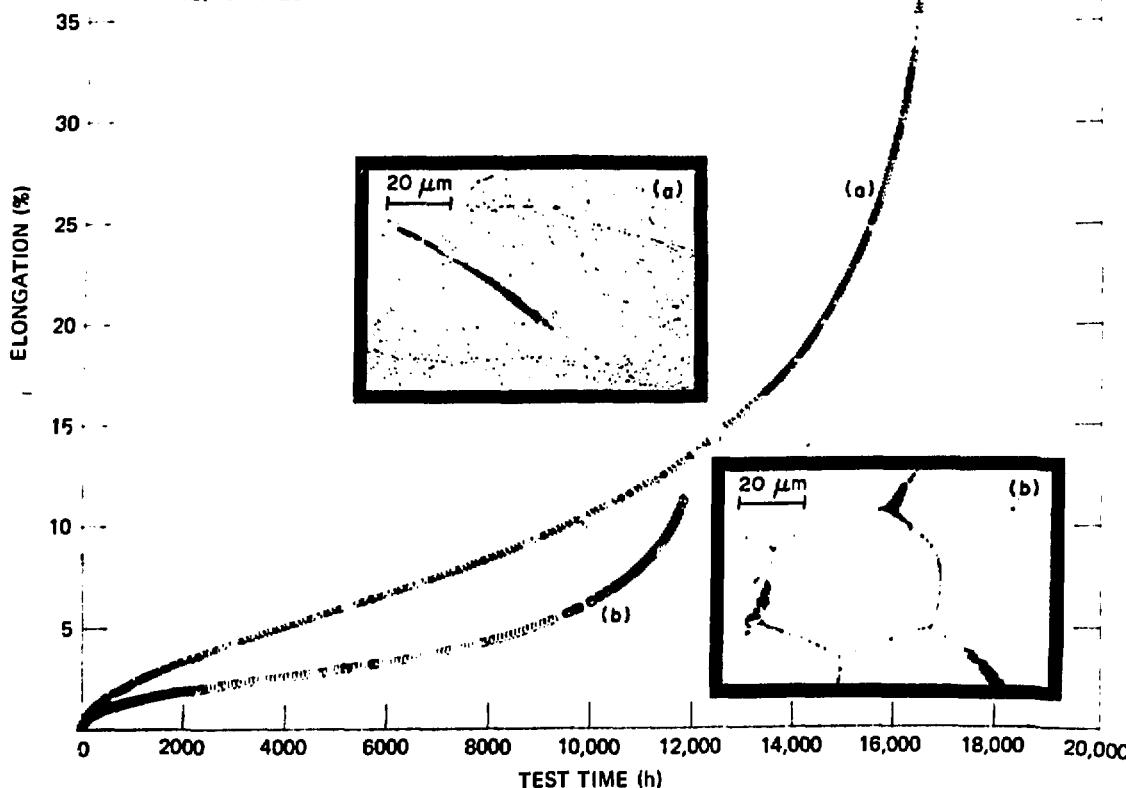
TYPE 316
TEST TEMPERATURE 593°C
STRESS 172 MPa
(a) AGED 10,000h AT 593°C
(b) UNAGED

Fig. 11 - Elongation as a function of test time at 593°C (1100°F) and 172 MPa (25 ksi) and optical microstructures for type 316 stainless steel annealed and after aging for 10^4 h (about 1 year). The micrographs show (a) fine precipitate structure, intragranular deformation, and annealing twin cracks in aged materials and (b) lack of grain deformation and intergranular cracks in annealed material.

Figure 11 shows the creep curves at 593°C (1100°F) and a stress of 172 MPa (25 ksi) for type 316 stainless steel in the annealed condition and after aging for 10^4 h (about 1 year) at 593°C (1100°F). This aging increases the secondary (steady-state) creep rate, the rupture life, the rupture ductility, and the time to onset of tertiary creep. The effects of a much longer aging time [4.4×10^4 h (about 5 years)] on the creep rupture

Figures 14 and 11 show optical metallography for type 316 stainless steel after creep testing at 593°C (1100°F) and 172 MPa (25 ksi) in the annealed condition and after aging for 10^4 h (about 1 year) at 593°C

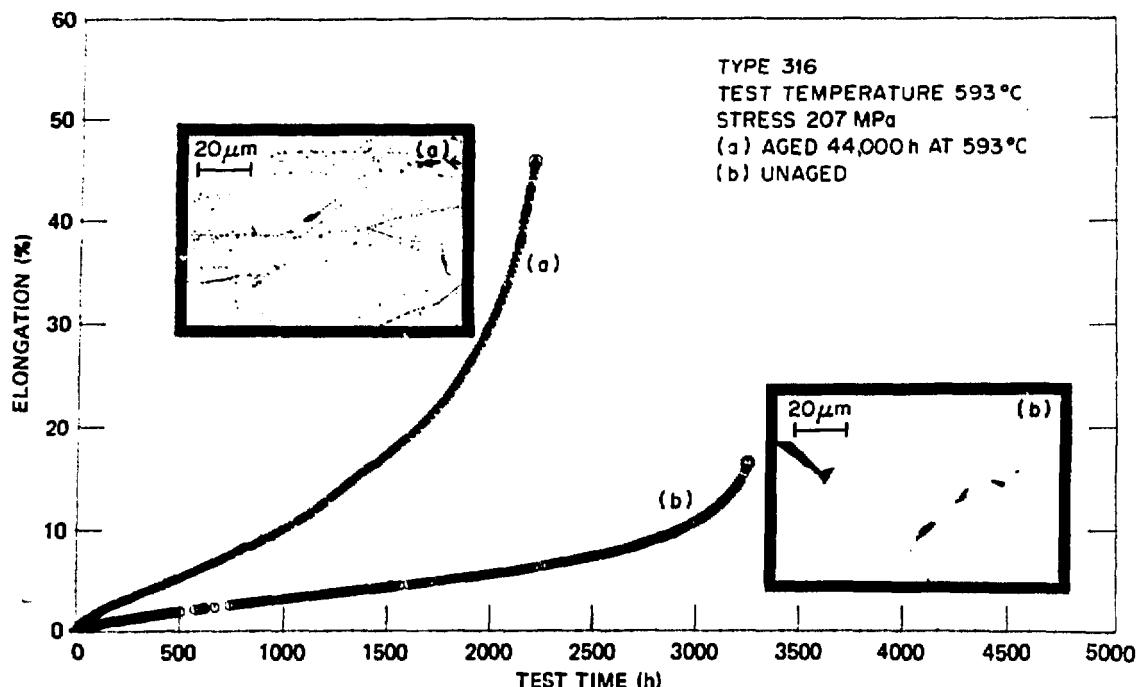
Fig. 12 - Elongation as a function of test time at 593°C (1100°F) and 207 MPa (30 ksi) and optical microstructures for type 316 stainless steel annealed and after aging for 4.4×10^4 h (about 5 years)

curves for type 316 stainless steel at 593°C (1100°F) are shown in Fig. 12 for a stress of 207 MPa (30 ksi). At 172 MPa (25 ksi) (same stress as in Fig. 11) aging for 4.4×10^4 h (about 5 years) results in a large increase in secondary creep rate, a slight increase in ductility, and in a slight decrease in the times to the onset of tertiary creep and rupture. For the higher stress of 207 MPa (30 ksi) this aging results in a large increase in the secondary creep rate and ductility and in large decreases in the times to onset of tertiary creep and rupture. Note that aging increases creep ductility (low strain rates) but decreases tensile ductility (high strain rates).

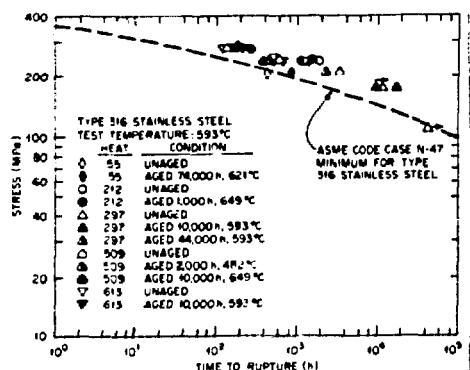
Fig. 13 - Stress-rupture properties at 593°C (1100°F) for type 316 stainless steel annealed and after aging to 7.4×10^4 h (about 8 1/2 years) and ASME Code Case N-47 minimum for type 316 stainless steel at 593°C (1100°F)

Figure 13 shows stress versus time to rupture at 593°C (1100°F) for type 316 stainless steel annealed and after aging for times to 7.4×10^4 h (about 8 1/2 years) at temperatures from 482 to 649°C (900 to 1200°F). Also shown in Fig. 13 is the minimum stress versus time to rupture from ASME Code Case N-47. For all aging histories shown, the time to rupture for aged material exceeds that for the ASME minimum. Hence, long-term thermal exposures (~5 years) at temperatures up to 649°C (1200°F) and stresses too low to drastically alter the precipitation reactions do not shorten the subsequent creep-rupture life of type 316 stainless steel at temperatures to 593°C (1100°F). As stated for the tensile properties, little or no further effects of aging on the creep-rupture properties are expected as a result of additional thermal exposures at low stresses for temperatures to about 593°C (1100°F).¹⁴

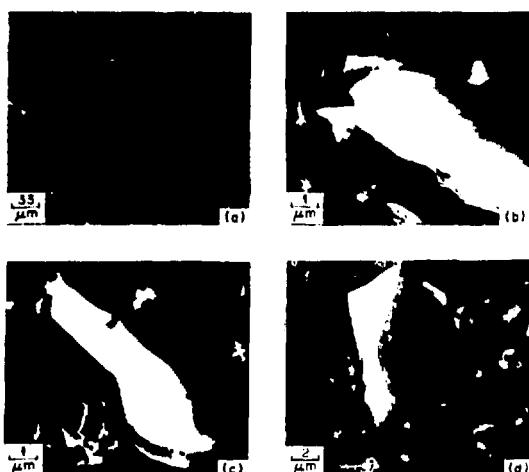
Fig. 15 - Scanning electron micrographs of type 316 stainless steel pipe after 1.25×10^5 h (about 14 1/2 years) of service at 621°C (1150°F). (a) Overview. (b) Laminated structure of large sigma phase particles in the grain boundaries of (a). (c) Delamination of sigma phase particles and matrix precipitate. (d) Delamination of another sigma phase particle and additional matrix precipitate

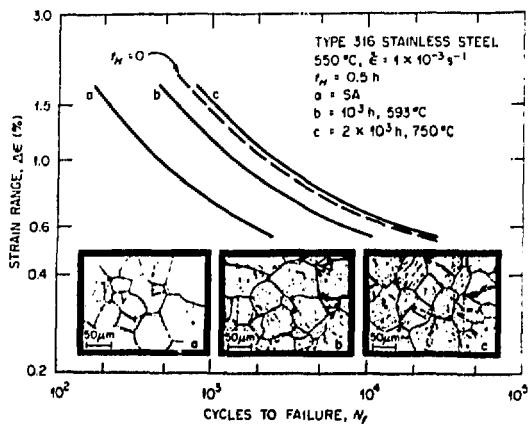
Fig. 16 - Strain range versus cycles to failure for cyclic creep-fatigue of type 316 stainless steel at 550°C (1022°F) and optical micrographs for material (a) as annealed, (b) aged for 10^3 h (about 1 month) at 593°C (1100°F), and (c) aged for 2×10^3 h (about 3 months) at 750°C (1382°F). Dashed line is for continuous cycling fatigue with no hold time; solid lines for cyclic creep-fatigue with 0.5 h tensile hold time.

FATIGUE AND CREEP-FATIGUE PROPERTIES -
Figures 16 through 18 show the effects of relatively short-term aging on the cyclic creep-fatigue lifetimes and microstructures of type 316 stainless steel tested at 550°C (1022°F). All three figures show the same plots of strain range versus fatigue life; however, each of these figures shows a different and important aspect of the

microstructures associated with the different fatigue curves. The dashed curve is for continuous cycling. For annealed material (curve a) a tensile hold period of 0.5 h during each cycle reduces the creep-fatigue life to only one-fourth that for continuous cycling. Aging for 10^3 h (about 1 month) at 593°C (1100°F) (curve b) improves the creep-fatigue life to approximately two-thirds of that for continuous cycling. Aging for 2×10^3 h (about 3 months) at 750°C (1382°F) (curve c) improves the creep-fatigue life to almost 25% greater than that for continuous cycling and more than 4 times that for unaged material under the same test conditions. Aging also improves the continuous-cycling fatigue life, but the magnitude of the improvement is not as great as that for the creep-fatigue life.

The microstructure is shown by optical microscopy in Fig. 16. The annealed material (a) shows a small amount of precipitation ($M_{23}C_6$) at the grain boundaries and very little observable precipitation within the grains. In (b) more precipitation occurs at the grain boundaries, and precipitation is observable at annealing twin boundaries and other sites within the grains. In (c) more massive precipitation is seen at the grain

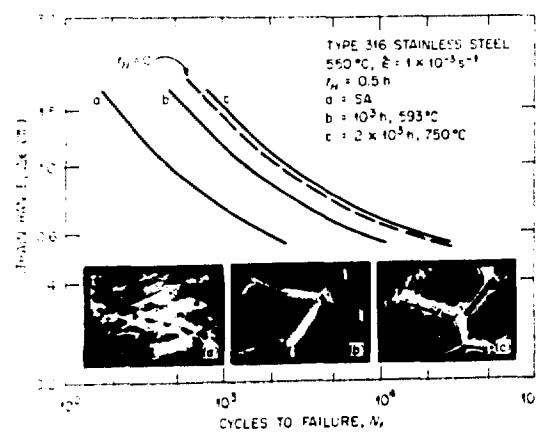
Fig. 17 - Strain range versus cycles to failure for cyclic creep-fatigue of type 316 stainless steel at 550°C (1022°F) and scanning electron micrographs for material (a) as annealed, (b) aged for 10^3 h (about 1 month) at 593°C (1100°F), and (c) aged for 2×10^3 h (about 3 months) at 750°C (1382°F). Dashed line is for continuous cycling fatigue with no hold time; solid lines for cyclic creep fatigue with 0.5 h tensile hold time

boundaries and within the grains, and the intragranular precipitate particles appear to be larger than in (b). Figure 17 shows scanning electron microscopy for material having the creep-fatigue lives shown by curves a, b, and c. The amount of grain-boundary precipitate increases by large increments during aging, as shown in micrographs (a), (b), and (c). Data trends in Fig. 17 clearly show that the increase in creep-fatigue life on aging is due to the alteration of the grain-boundary and matrix structure by precipitation.

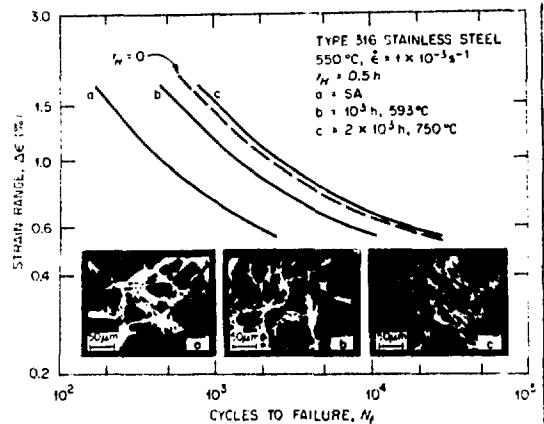
Fig. 18 - Strain range versus cycles to failure for cyclic creep-fatigue of type 316 stainless steel at 550°C (1022°F) and scanning electron fractographs for material (a) as annealed, (b) aged for 10^3 h (about 1 month) at 593°C (1100°F), and (c) aged for 2×10^3 h (about 3 months) at 750°C (1382°F). Dashed line is for continuous cycling fatigue with no hold time; solid lines for cyclic creep-fatigue with 0.5 h tensile hold time

Figure 18 shows scanning electron fractography associated with creep-fatigue curves (a), (b), and (c). For annealed material (a) fracture is intergranular with some ductile tearing. For (b) some intergranular failure is combined with an increased amount of ductile tearing. In (c) the fractograph indicates that failure was totally by intragranular ductile tearing, with no evidence of brittle intergranular failure. As discussed earlier, alteration of the grain-boundary and matrix microstructure by these precipitates reduces or eliminates grain-boundary cavitation and cracking during creep loading and thereby improves the creep-rupture and creep-fatigue properties.

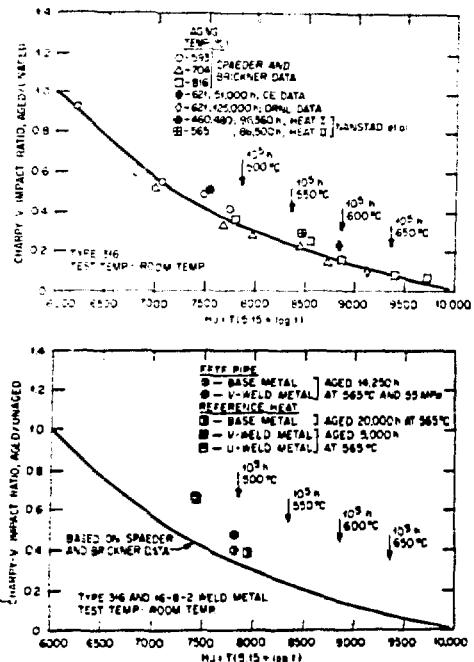
Fig. 19 - Room-temperature Charpy impact energy as a function of Holloman-Jaffe parameter for (a) type 316 stainless steel after thermal aging or in-service exposure and (b) curve for base metal and data for 16-8-2 weld metal after aging for up to 2×10^4 h (about 2 1/4 years) at 565°C (1050°F). (Ref. 7 and unpublished data from tests performed by ORNL and Combustion Engineering, Inc.) (T = test temperature and t = test time)

TOUGHNESS PROPERTIES - The Charpy impact properties of austenitic stainless steels are not measured or cited very often because austenitic stainless steels normally do not lose fracture toughness or change from ductile to brittle behavior at low temperatures. However, as shown in Fig. 19(a), prolonged elevated-temperature exposure of type 316 stainless steel can result in room-temperature Charpy impact energies that are less than 10% of that for material in the annealed and unaged condition. Data in Fig. 19(a) are for both laboratory test specimens and material taken from actual power plant components.

Recall that, as shown in Figs. 1 through 5, tensile ductility is the property that is affected most by prior creep or fatigue loading or by thermal exposure for type 316 stainless steel. This decrease in tensile ductility is further manifested in the Charpy impact energy values. Charpy impact energy values for type 316 stainless steel weldments with type 16-8-2 weld alloy agree reasonably well with those for base metal, as shown in Fig. 19(b). For the time, temperature, and stress conditions shown in Fig. 19(b), the Charpy impact properties of the weld metals are superior to those of the base metal.
