MHD ELECTRODE DEVELOPMENT

Quarterly Report for January—March 31, 1979

Westinghouse Electric Corporation
Advanced Energy Systems Division
Pittsburgh, Pennsylvania

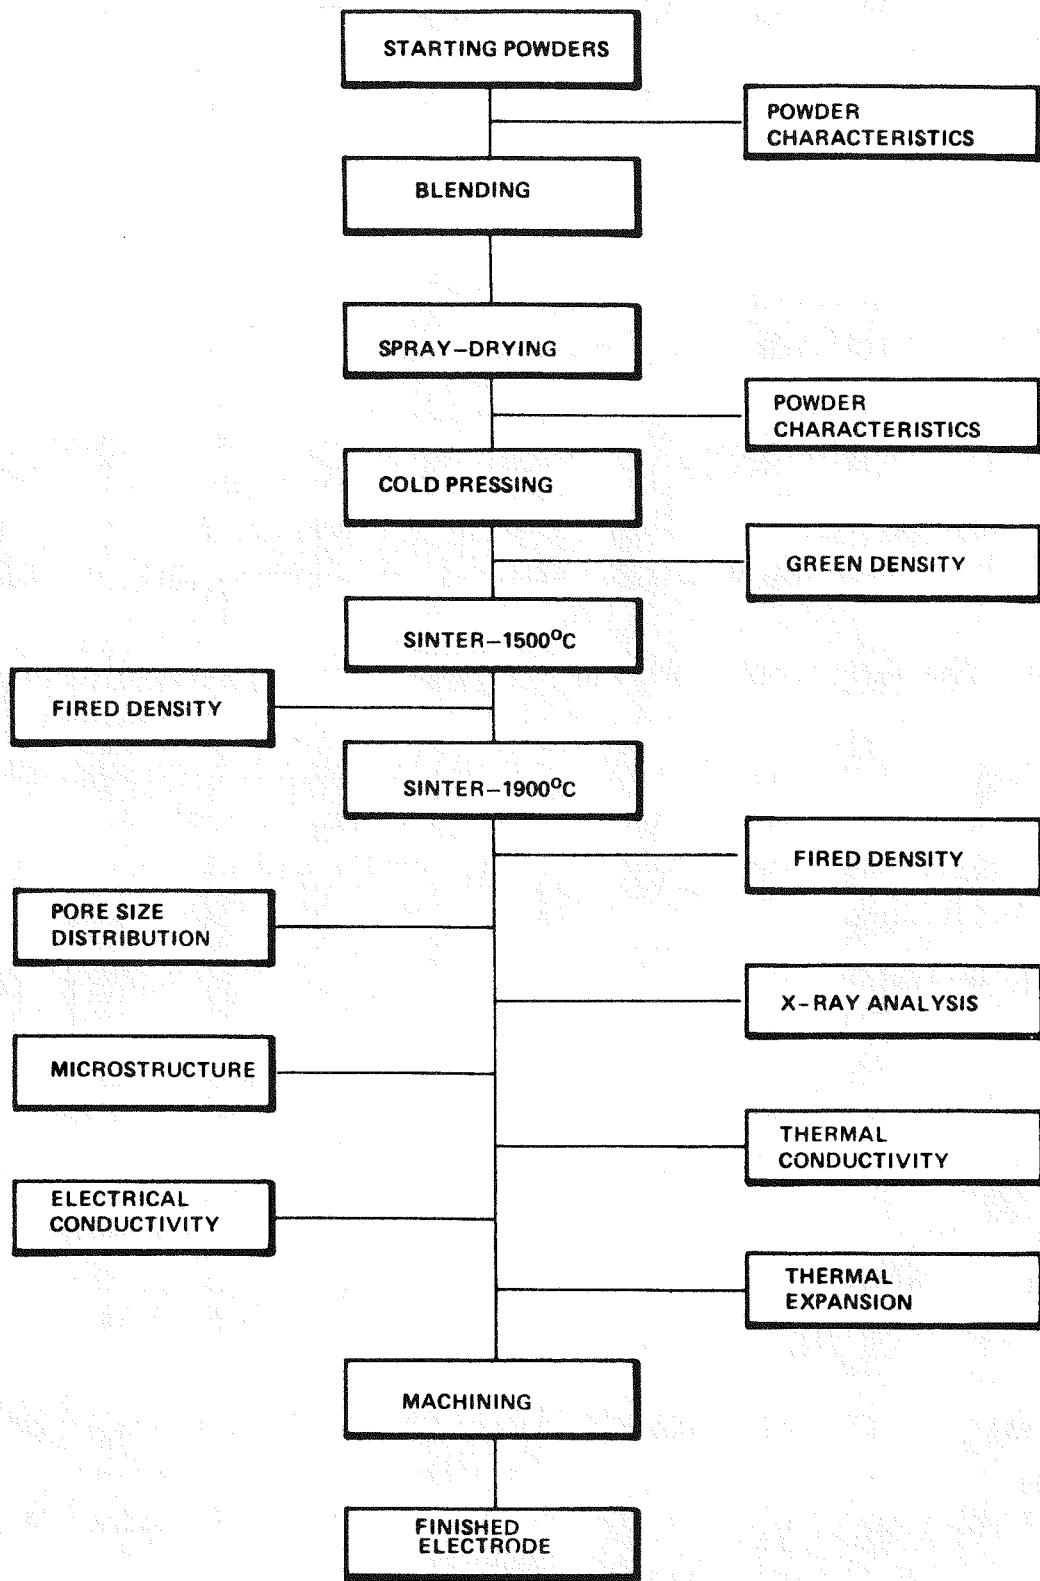
Figure 2. Flow Chart of ZrO_2 -Based Electrode Fabrication and Characterization

The processing and characterization scheme for fabricating the ZrO_2 -based electrodes is shown in Figure 2. All of the starting powders were of very pure quality and very fine grain size. They were all obtained commercially from the following sources: ZrO_2 from UGE Kuhlmann, Paris, France; CeO_2 ,

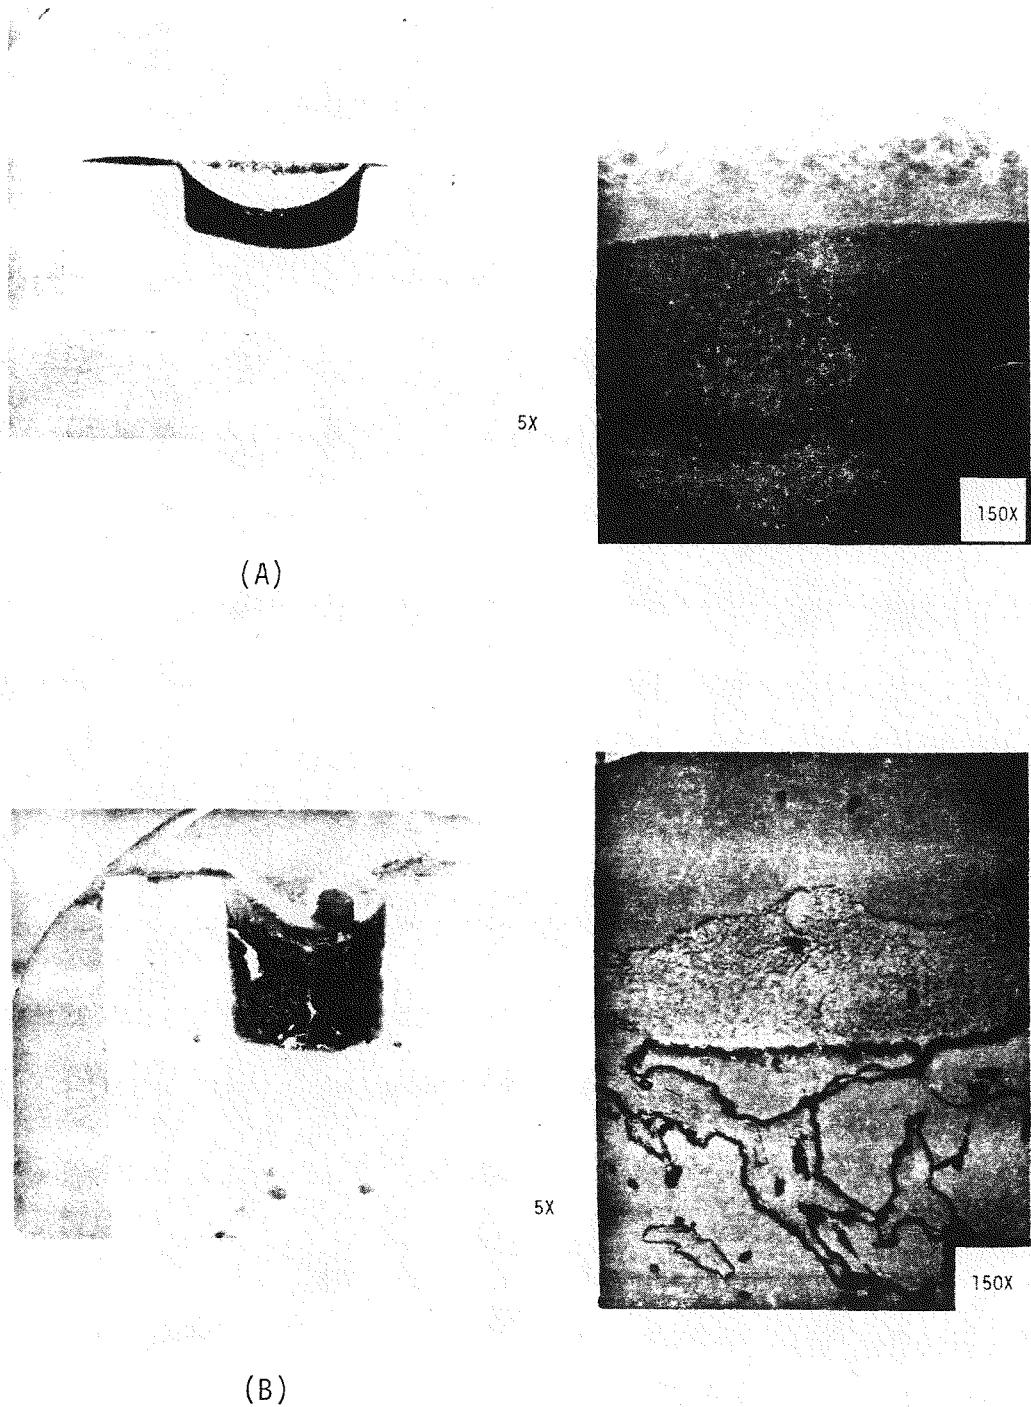
Figure 8. Appearance of (A) Al_2O_3 (high sintered) from Trans-Tech, (B) Al_2O_3 (Fused Cast) from Carborundum after Exposure to Western Coal Slag at 1400°C for 20 Hours

Photographs of the fourteen sectioned insulators are shown in Figures 7 to 13. Macrophotographs of the sectioned "mini-crucibles" are shown on the left side of the pages along with higher magnification photos of the insulator/slag interface on the right-hand side. Table 4 lists the fourteen insulators along with their density, source, processing history and relative observations of their corrosion resistance. Our determination of how well an insulator fares in a corrosive slag environment is based on its ability to resist:

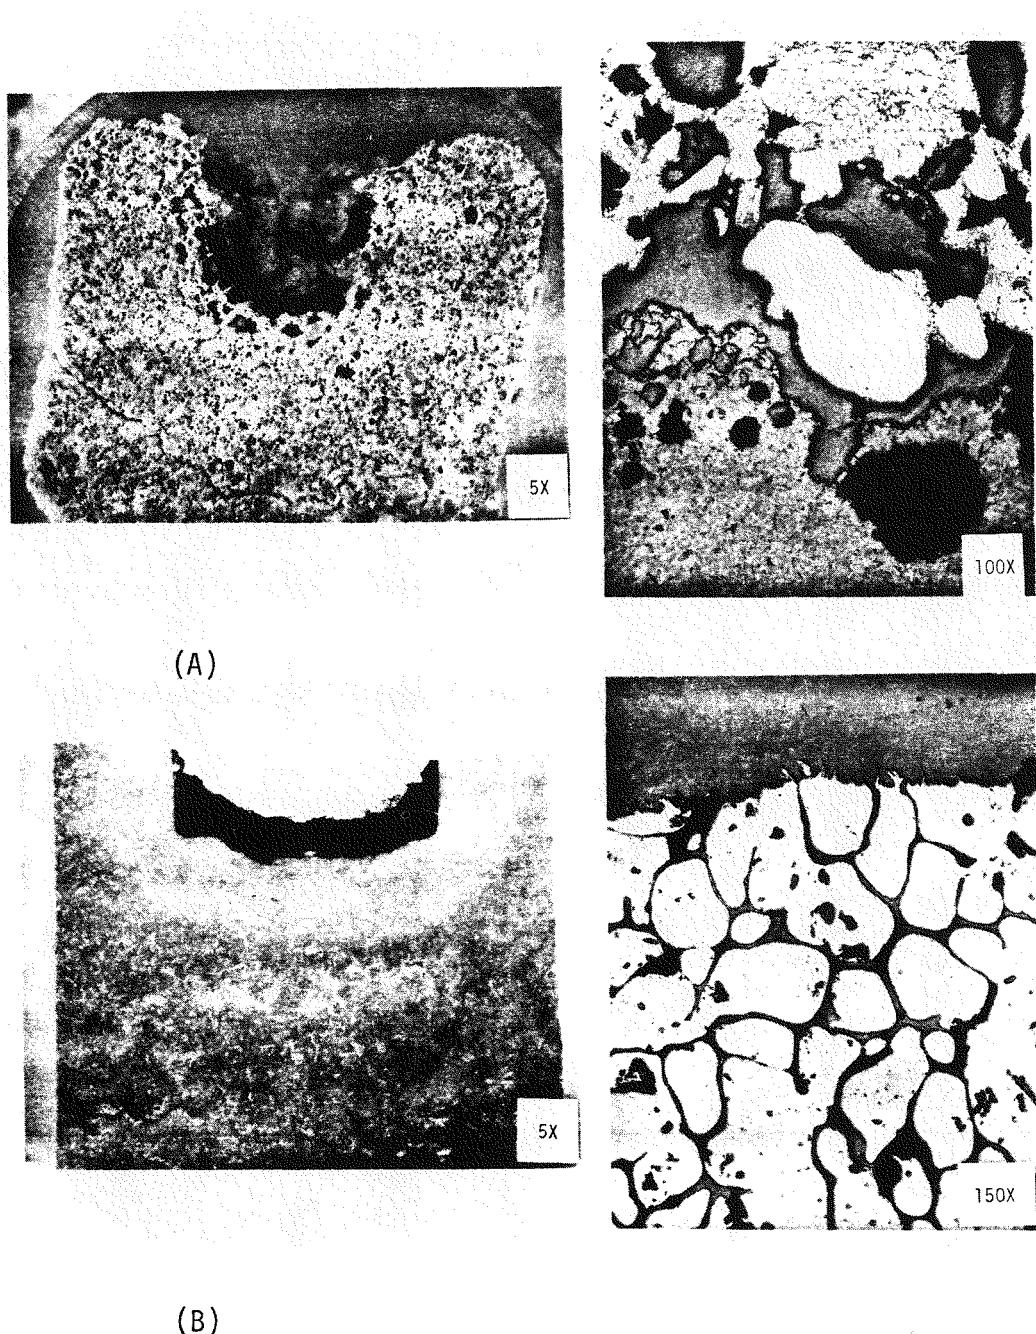
Figure 12. Appearance of (A) ZrO_2 (castable ceramic) from Zircoa, (B) ZrO_2 (fused cast) from Carborundum after Exposure to Western Coal Slag at $1400^{\circ}C$ for 20 Hours

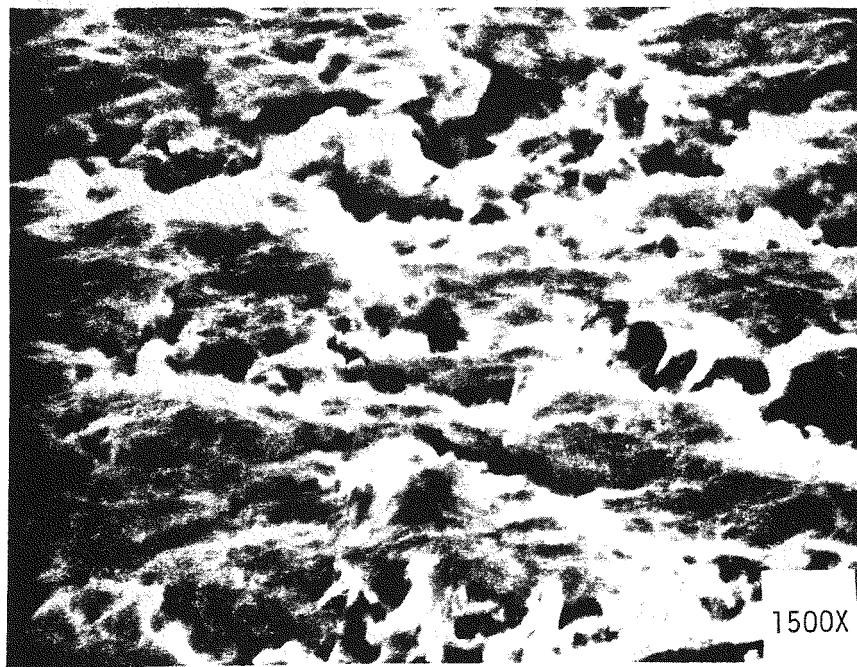
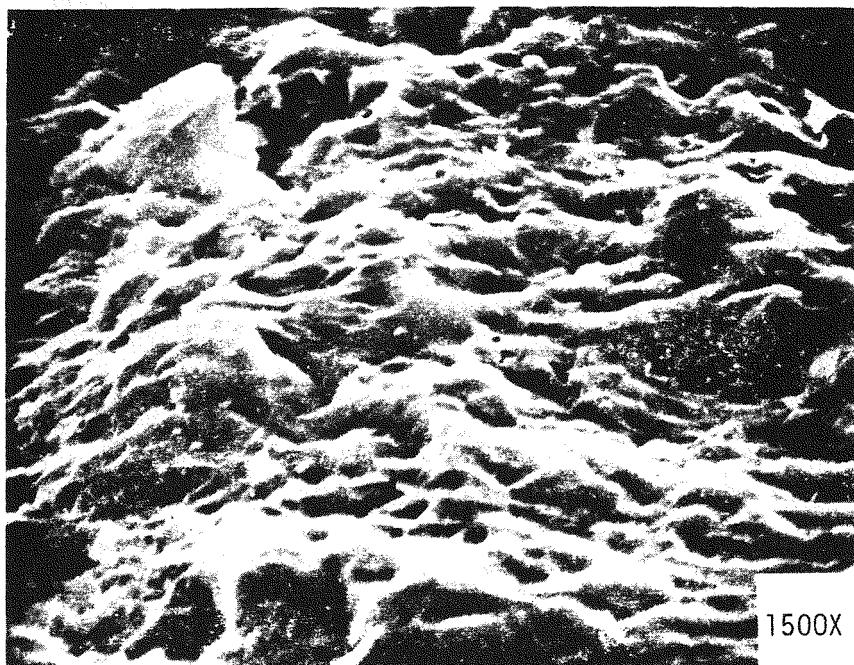
Figure 14. SEM Microphotographs of Fractured Surfaces of (A) 82% Dense KA1 SiO₄, (B) 98% Dense Kalsilite

X-ray diffraction measurements on the solid billets of KAISiO_4 revealed two phases - the major phase being a high temperature orthorhombic KAISiO_4 (94 w/o) and a minor phase $\text{K}_{1+x}\text{Al}_{1+x}\text{Si}_{1-x}\text{O}_4$ (6 w/o). Fractured surfaces of the two different density billets are displayed in Figure 14. The more porous KAISiO_4 shows a very 'feathery' open type surface, with a great deal of surface area open to any outside elements. The denser material, in contrast, displays very little noticeable open porosity. In both cases the predominant mode of fracture is intergranular. The thermal expansion of KAISiO_4 was determined using a standard dilatometer setup from room temperature to 1500°C. The data is shown in Figure 15. It is apparent that the relatively high thermal expansion coefficient of Kalsilite could present a problem e.g., fracturing or spalling, if large thermal gradients were imposed in the material during an MHD generator test. This may be somewhat alleviated if it is found that the material has relatively low creep resistance. Increased investigation into Kalsilites thermal shock resistance is definitely needed in the near future. The electrical resistivity of KAISiO_4 at various temperatures is shown in Figure 16. It has been determined that to maintain adequate electrical insulation between electrodes an electrical resistivity of greater than 100 ohm-cm in the insulation is required. In looking at the resistivity curve for Kalsilite it appears that temperatures up to 1400°C can be reached without the possibility of exceeding the 100 ohm-cm resistivity value. Preliminary slag corrosion studies in Western coal slag were completed for both the 82 and 98% dense KAISiO_4 materials. A comparison of the corrosion rate was made between the Kalsilite samples and a dense spinel (MgAl_2O_4), which has shown the best overall corrosion performance of the insulators tested to date. This initial study was

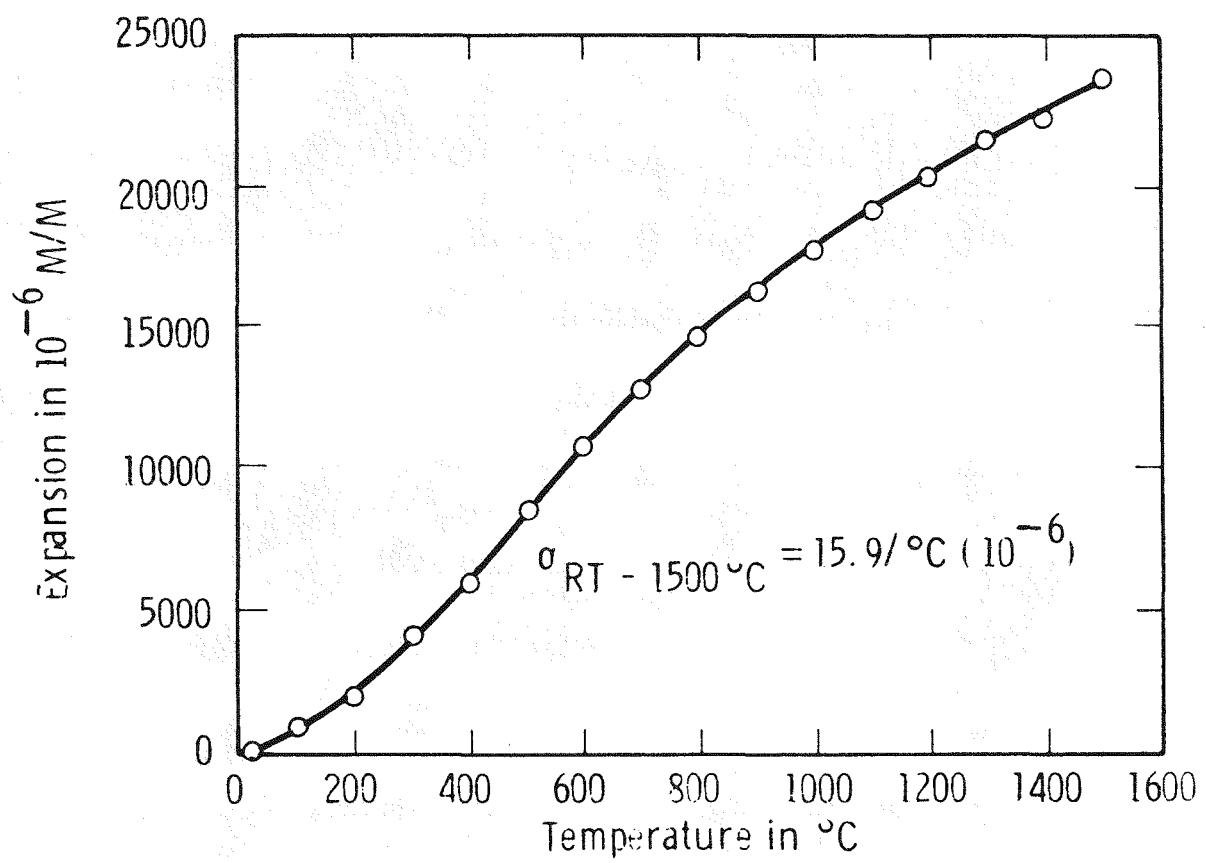
Figure 15. Thermal Expansion of Kalsilite (KAlSiO_4)

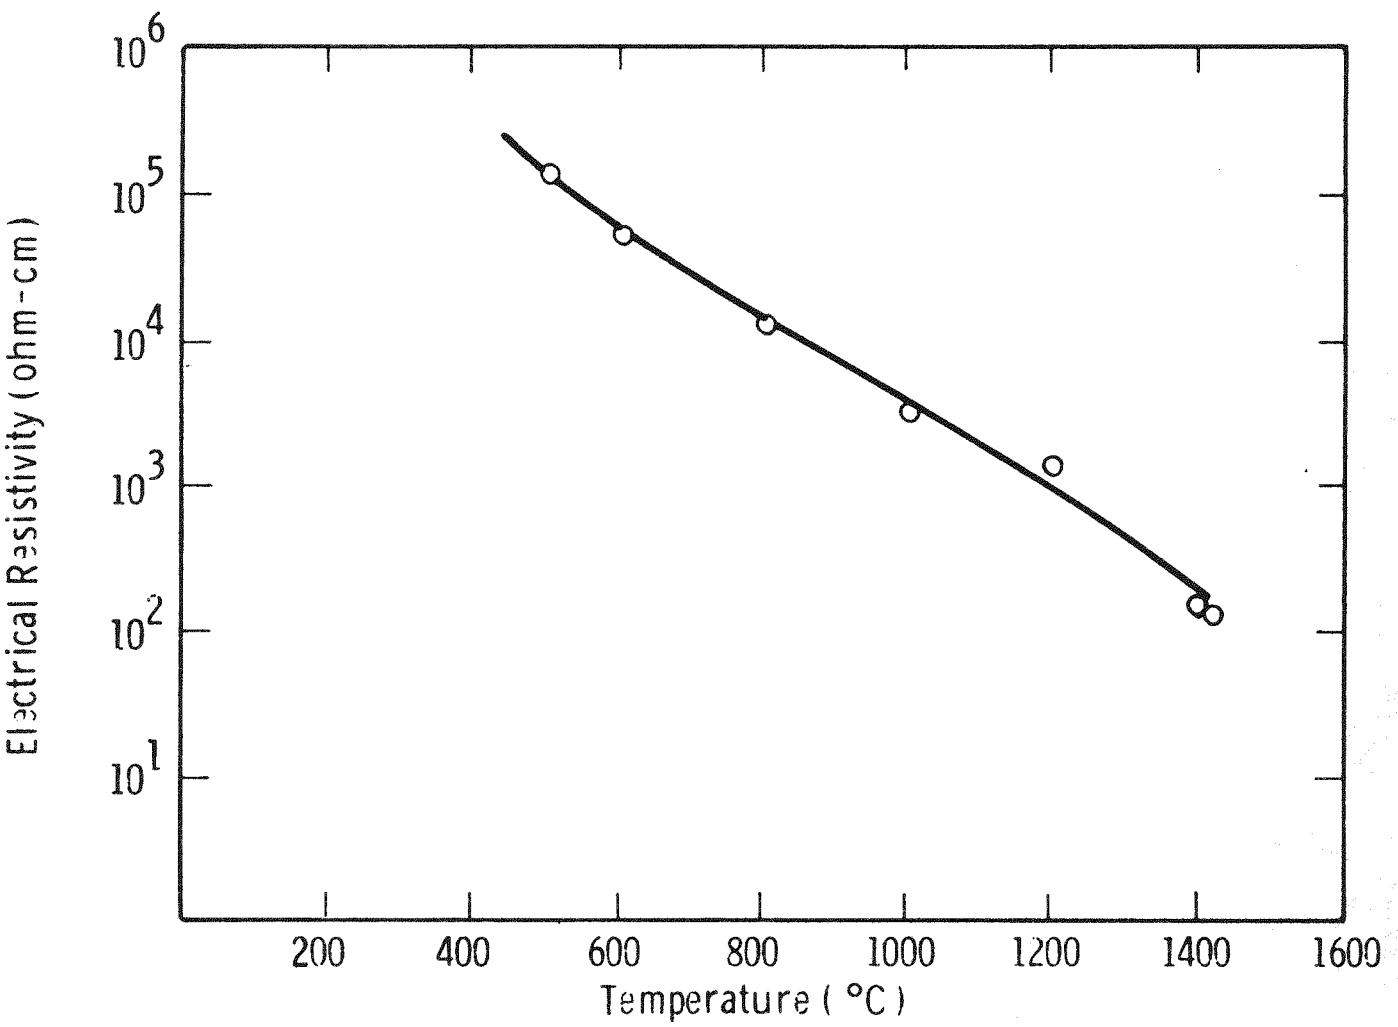
Figure 16. Electrical Resistivity of Kalsilite (KAlSiO_4)

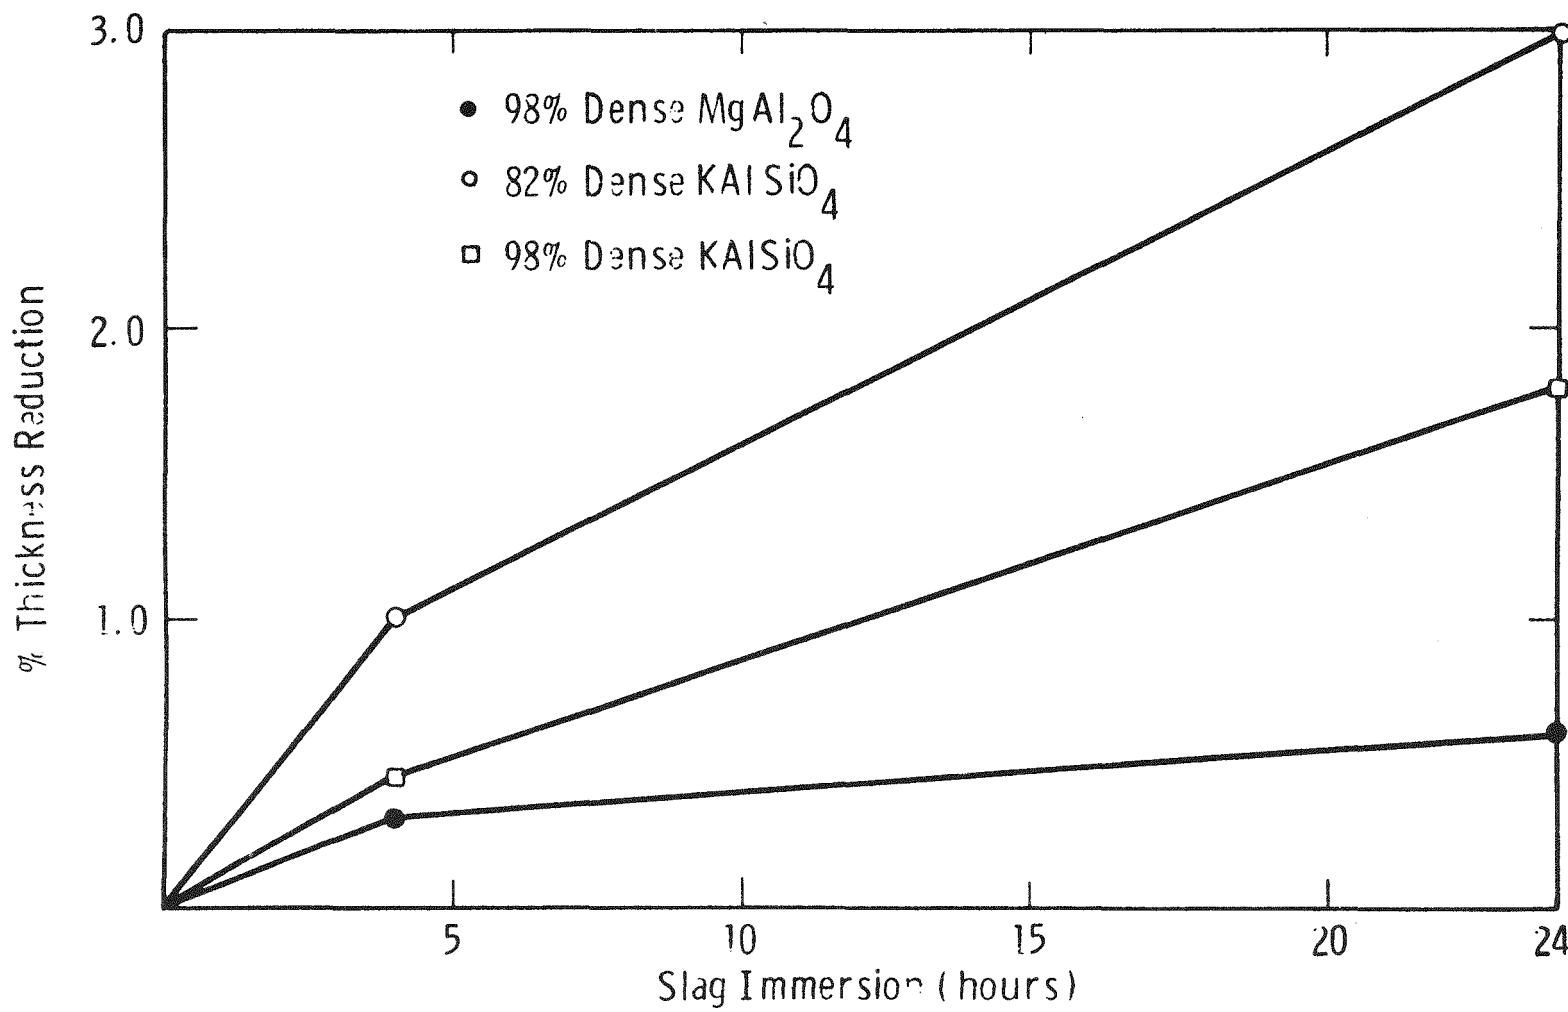
Figure 17. Corrosion Rate of Spinel and Kalsilite (KAlSiO_4) in Western Coal Slag

basically a static immersion test, where samples 0.25" x 0.25" x 0.75" of each of the materials were hung with platinum wire from the top of small high alumina crucibles that were filled with a homogeneous mixture of Montana Flyash and K_2CO_3 . The crucibles were then positioned in a high temperature globar furnace at 1400°C for several immersion times. The crucibles were then sliced in half to expose the slag/insulator interface and the percent of thickness reduction was measured. Figure 17 presents the findings. From these initial test results the spinel insulator shows the best corrosion rate. The dense $KAlSiO_4$ displays a corrosion rate 2-3 times greater than the spinel but a rate of half as great as the more porous $KAlSiO_4$. More comprehensive corrosion tests will be undertaken in the next quarter.

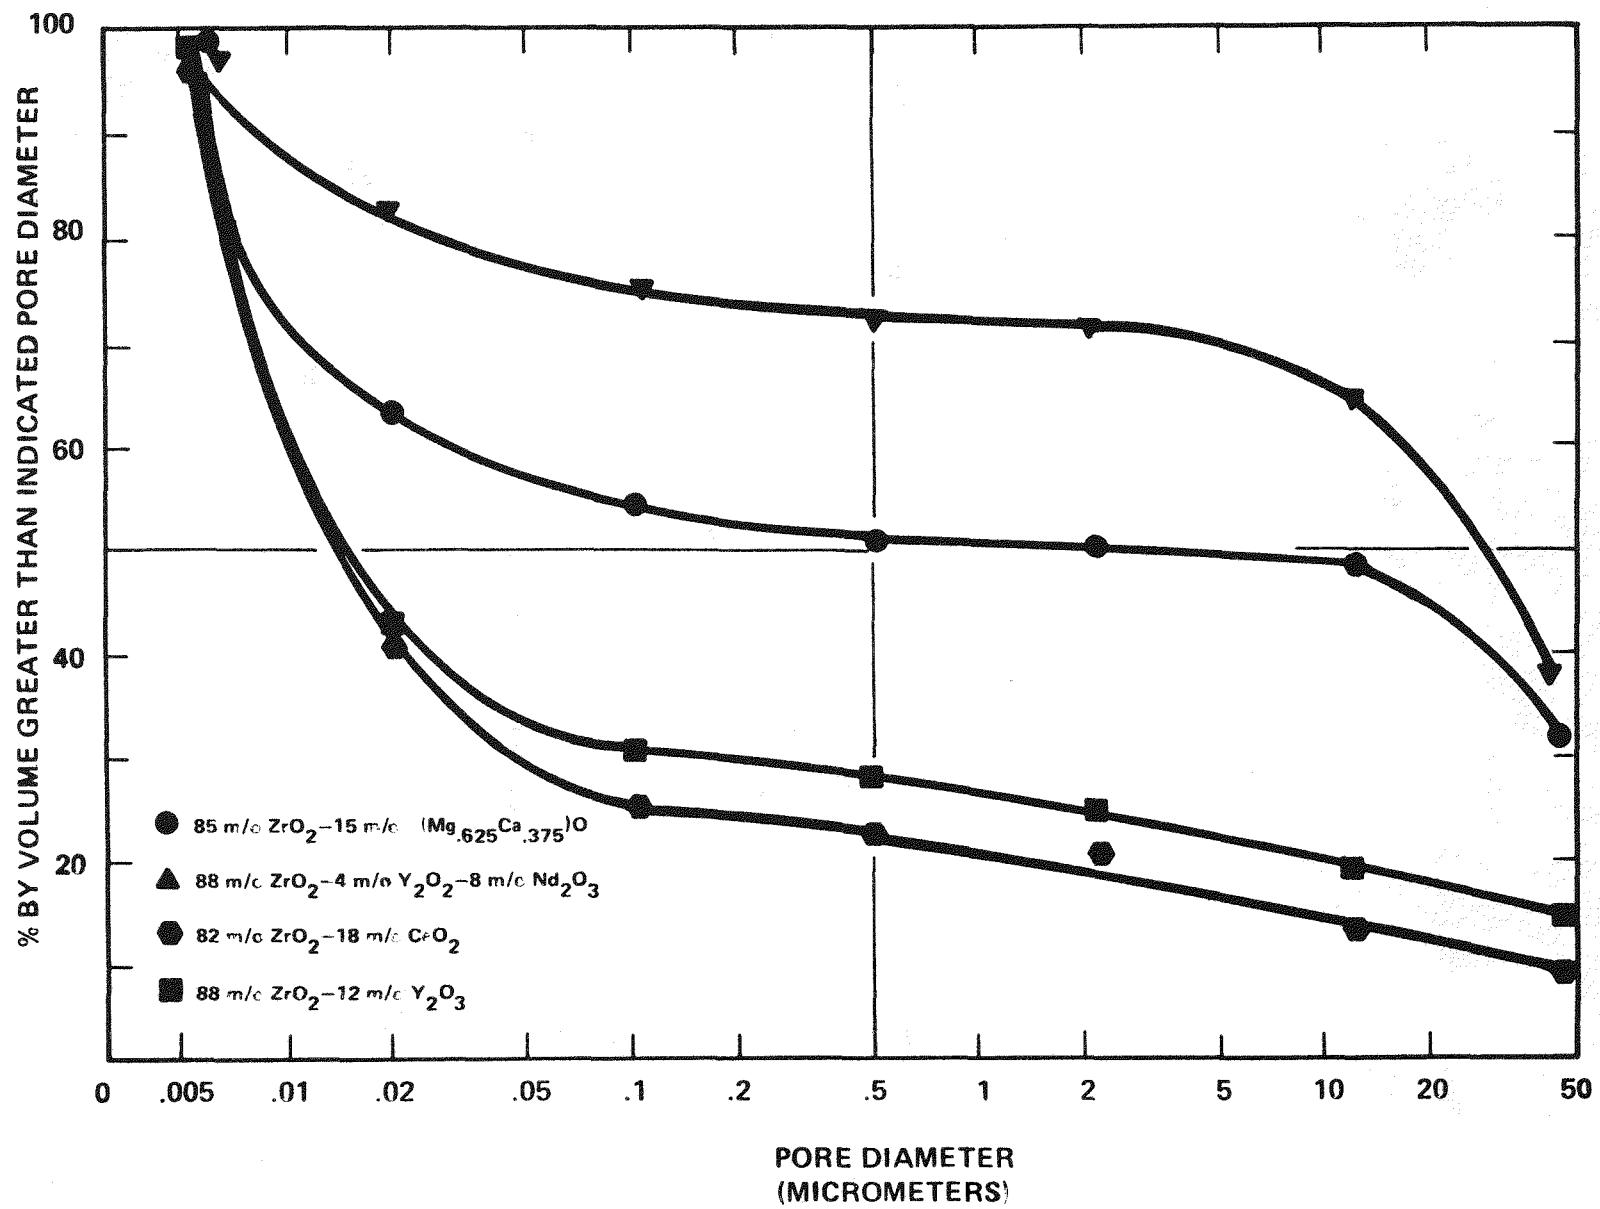
Figure 18. Pore Size Distribution of ZrO_2 -Based Electrode Materials

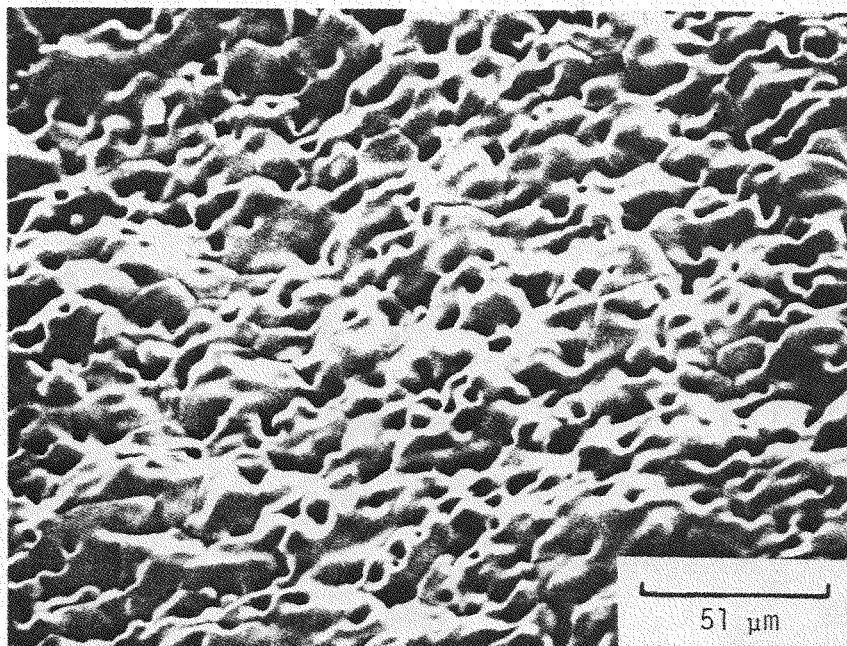
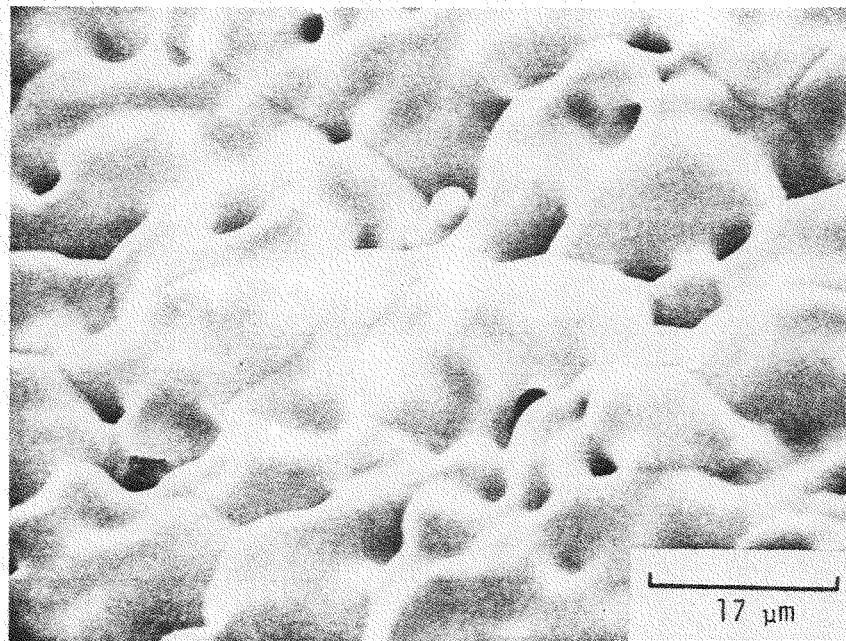
Figure 19. SEM Microphotographs of Fractured Surface of 85 m/o ZrO_2 - 15 m/o $(Mg_{.625} Ca_{.375})O$

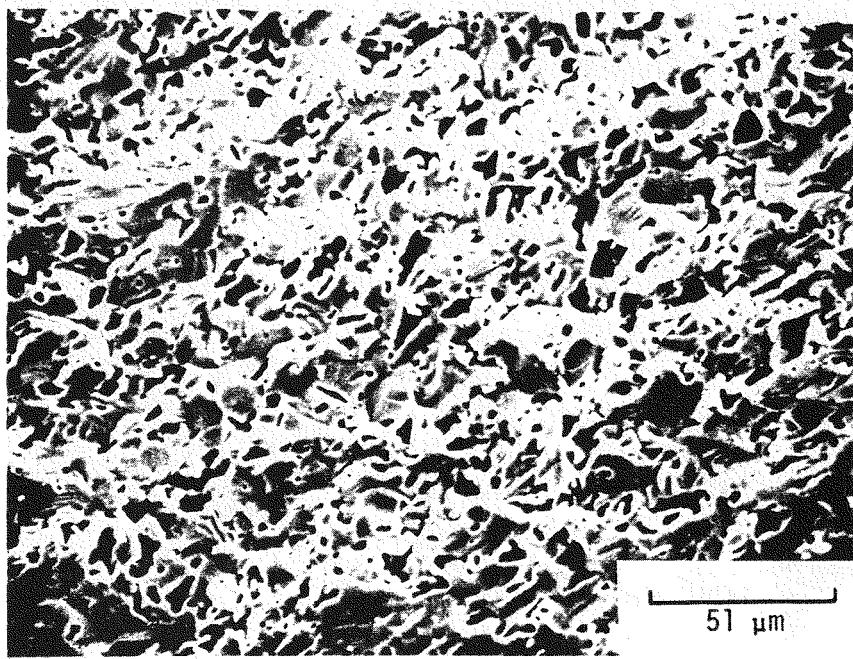
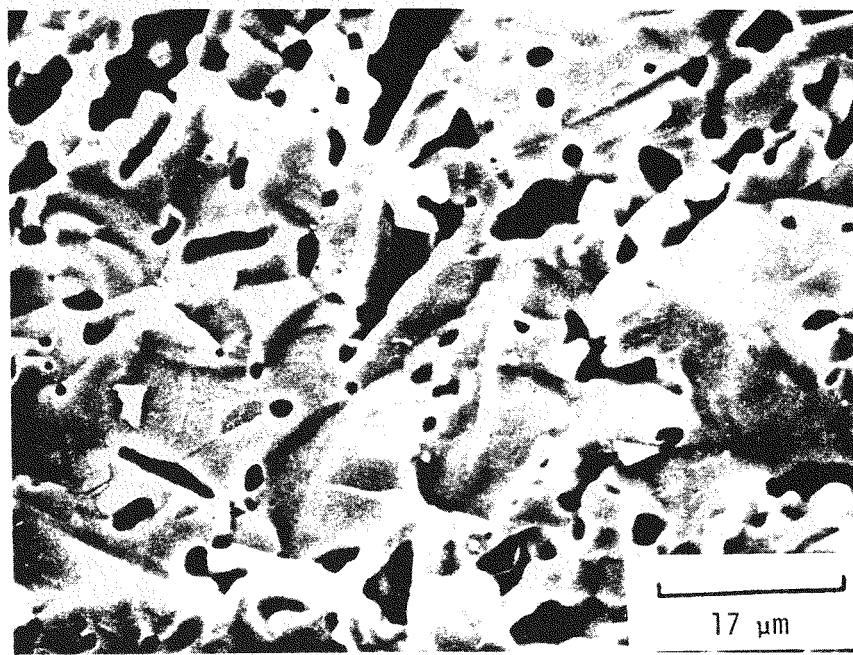
Figure 20. SEM Microphotographs of Fractured Surface of 88 m/o ZrO_2 -12 m/o Y_2O_3

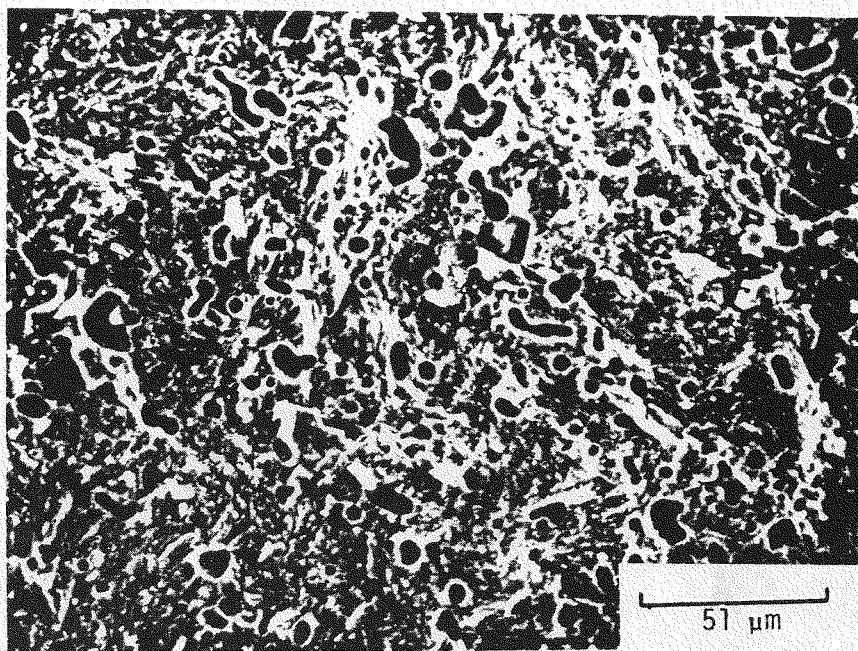
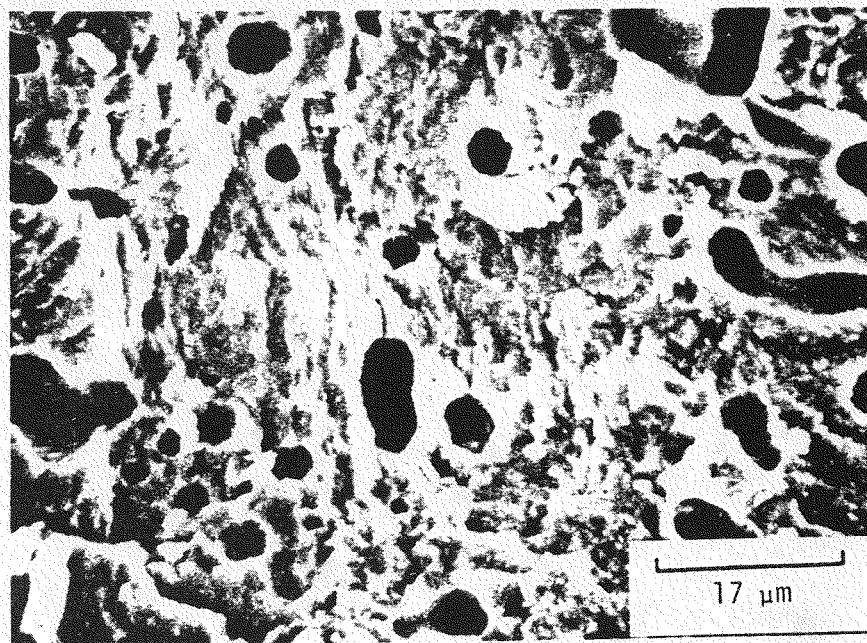
Figure 21. SEM Microphotographs of Fractured Surface of 82 m/o ZrO₂-18 m/o CeO₂

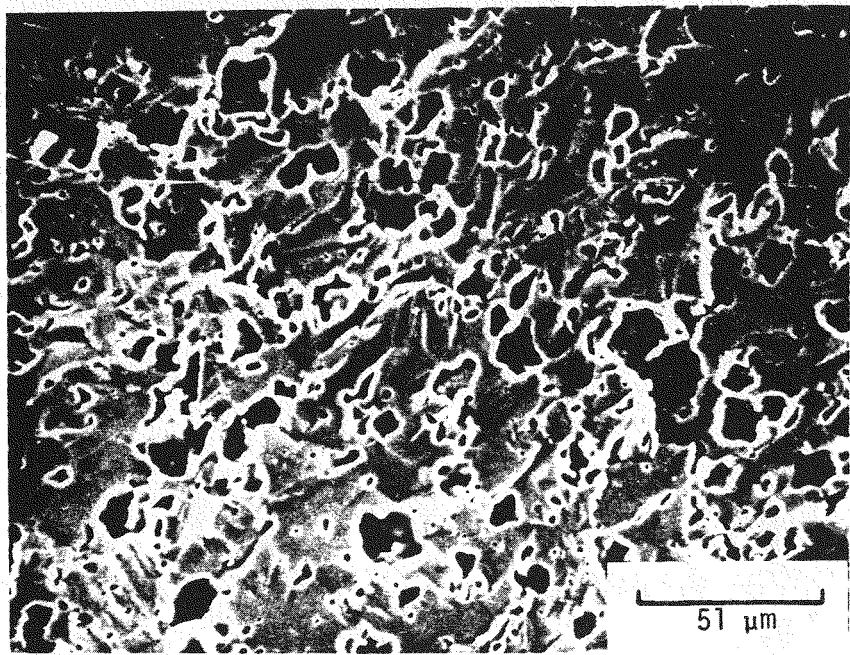
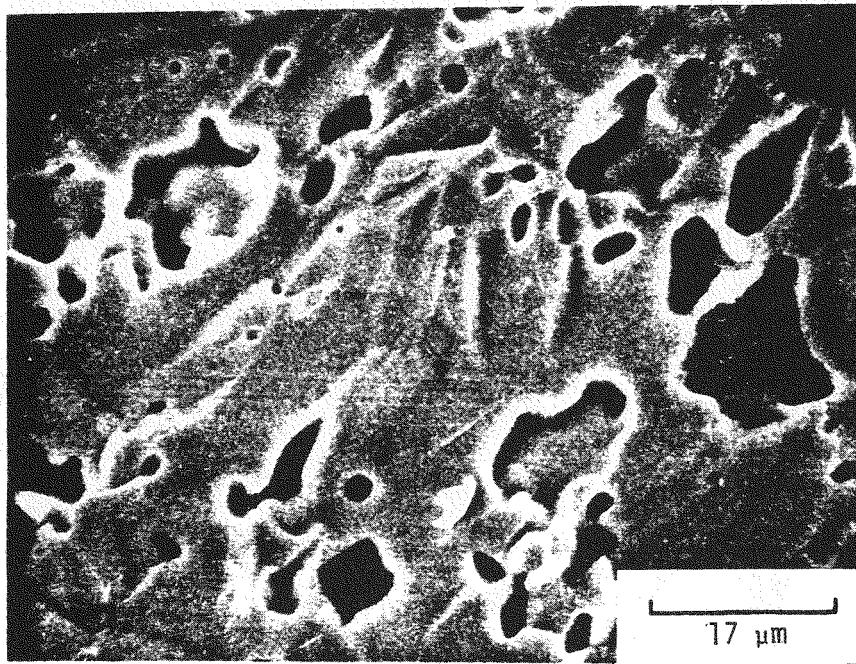
Figure 22. SEM Microphotographs of Fractured Surface of 88 m/o ZrO_2 -4 m/o Y_2O_3 - 9 m/o Nd_2O_3

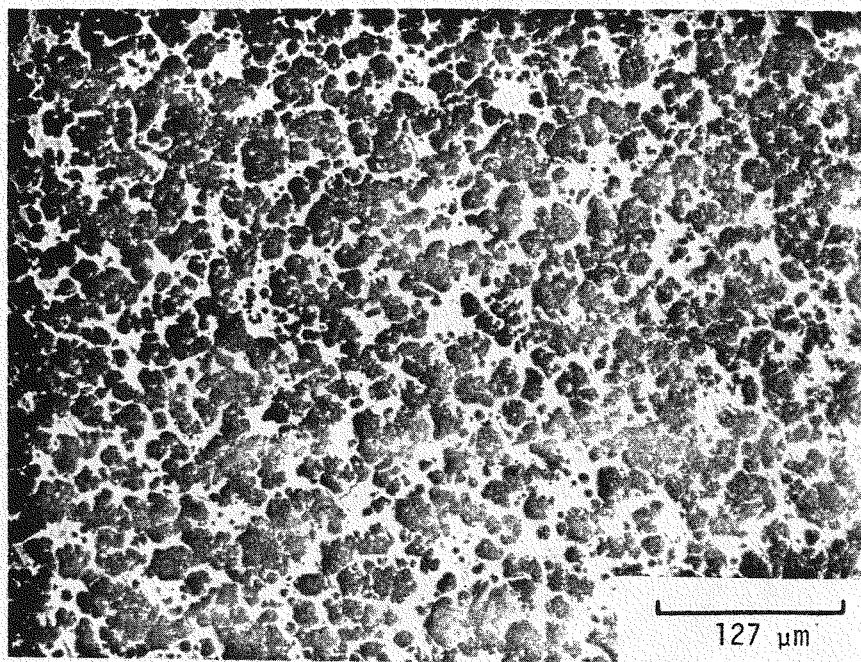
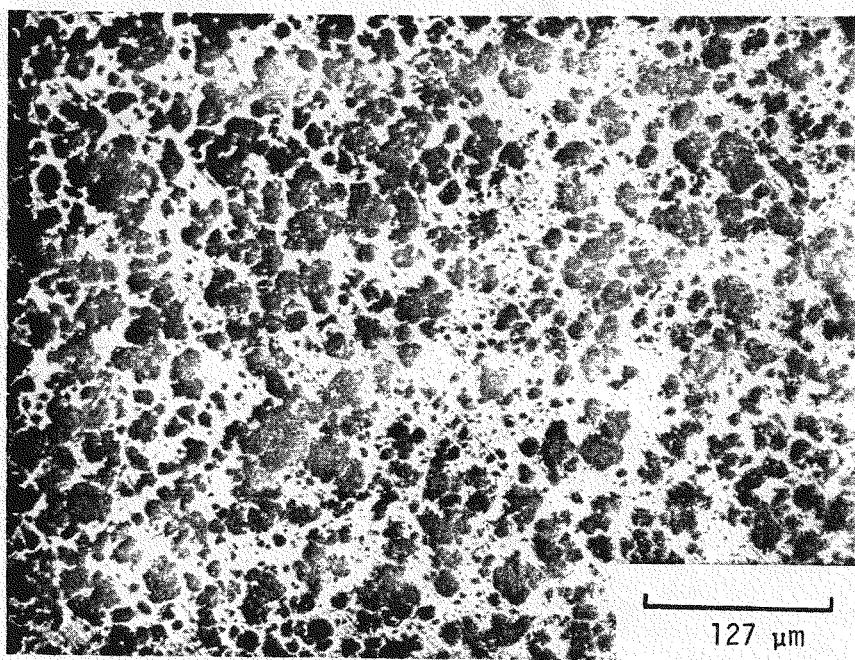
Figure 23. Microstructures of ZrO_2 -Based Electrodes: (A) 85 m/o ZrO_2 - 15 m/o $(Mg_{.625}Ca_{.375})O_2$; (B) 88 m/o ZrO_2 - 12 m/o Y_2O_3

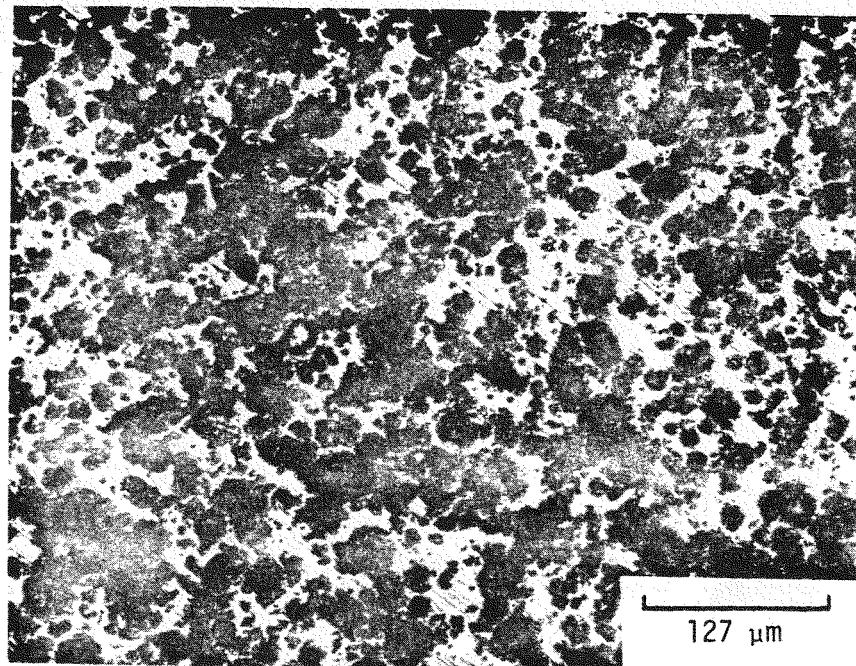
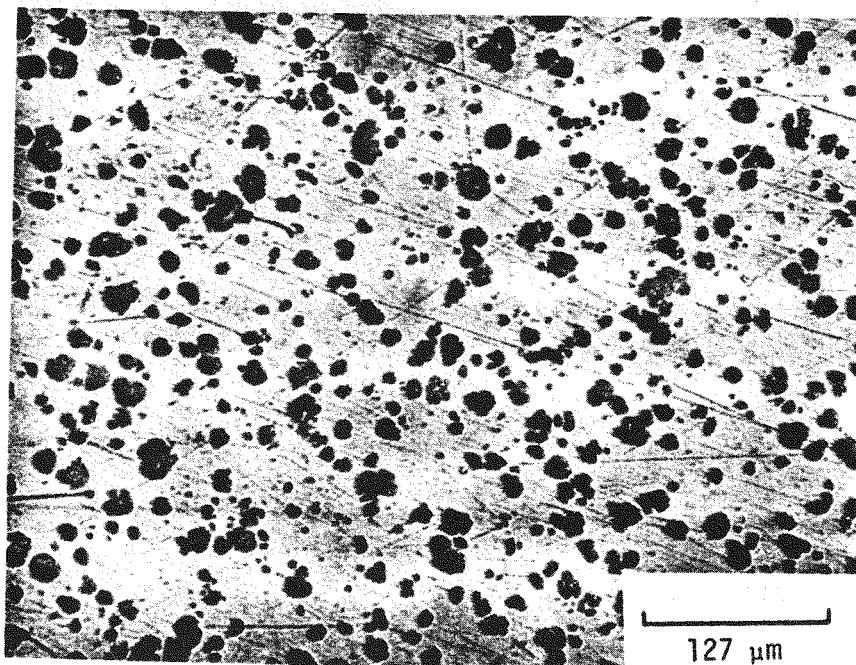
Figure 24. Microstructures of ZrO_2 -Based Electrodes: (A) 88 m/o ZrO_2 - 4 m/o Y_2O_3 - 8 m/o Nd_2O_3 ; (B) 82 m/o ZrO_2 - 18 m/o CeO_2

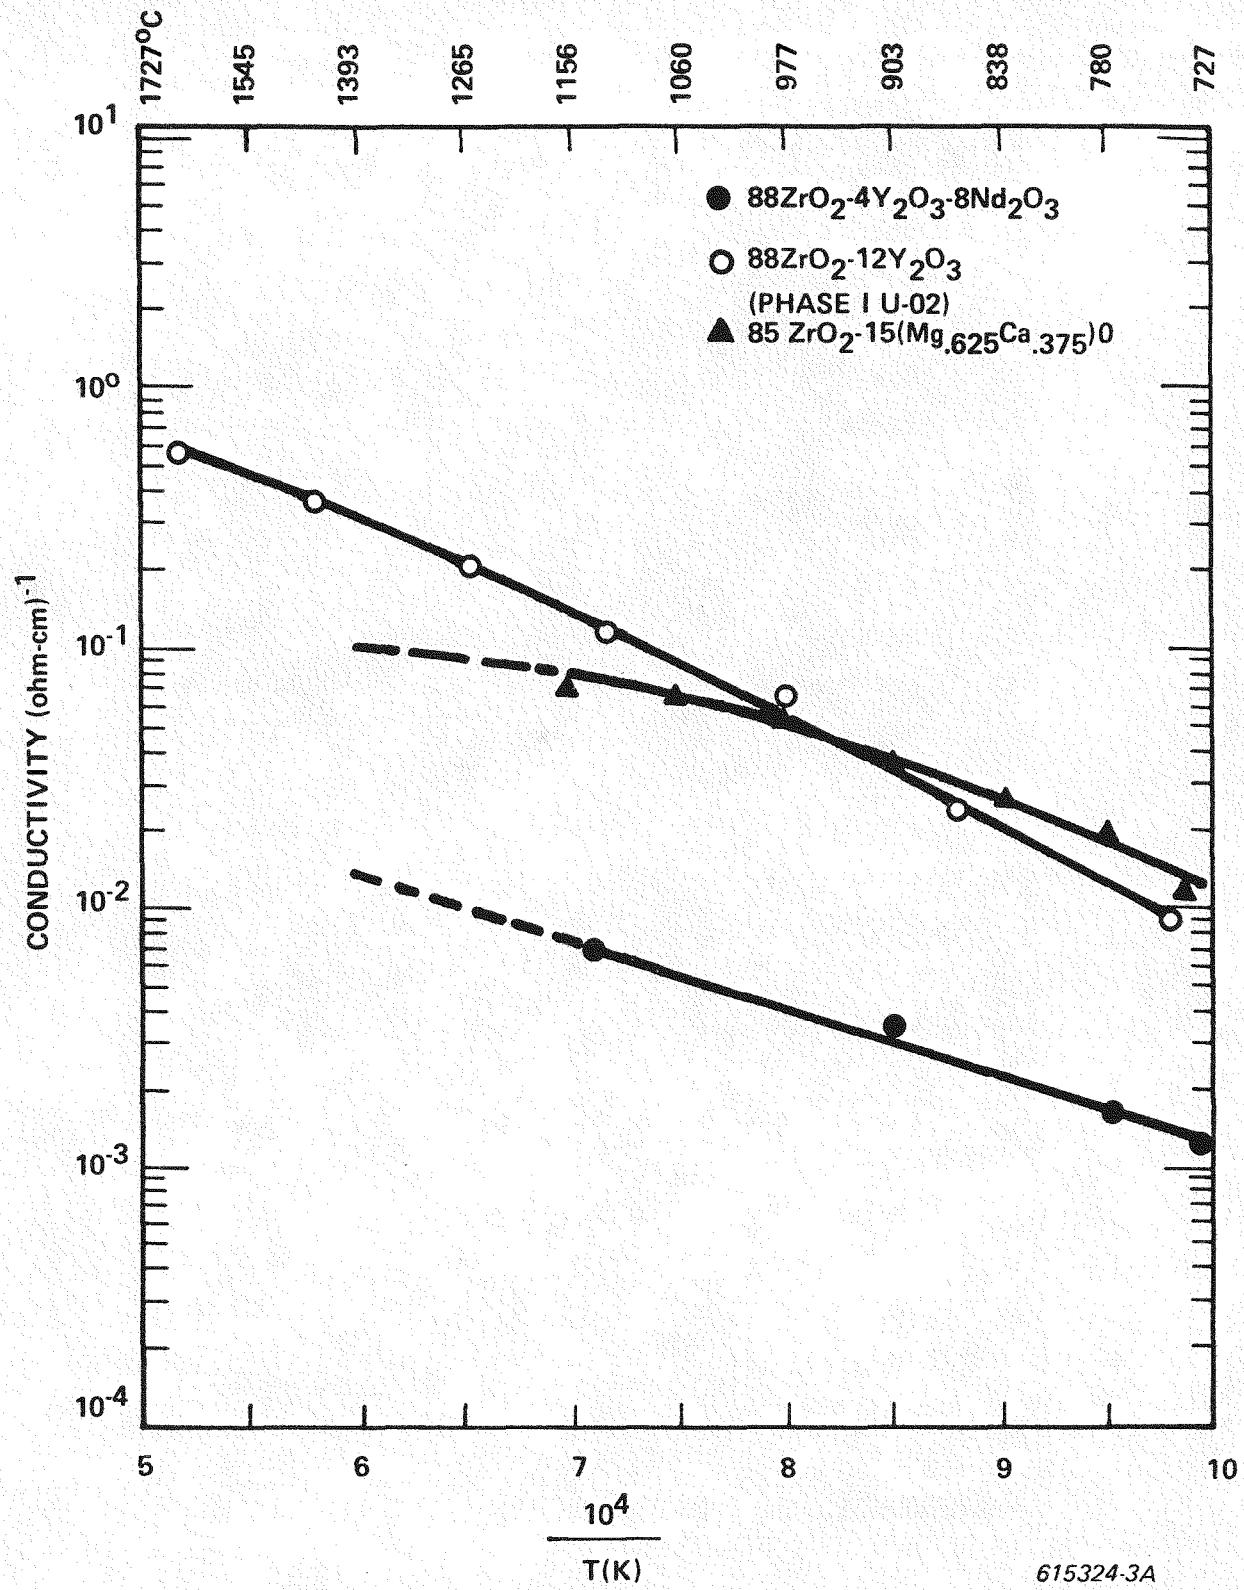
Figure 25. Electrical Conductivity of ZrO₂ Based Electrodes Taken in Air
