MHD ELECTRODE DEVELOPMENT

Quarterly Report for January—March 31, 1979

Westinghouse Electric Corporation
Advanced Energy Systems Division
Pittsburgh, Pennsylvania

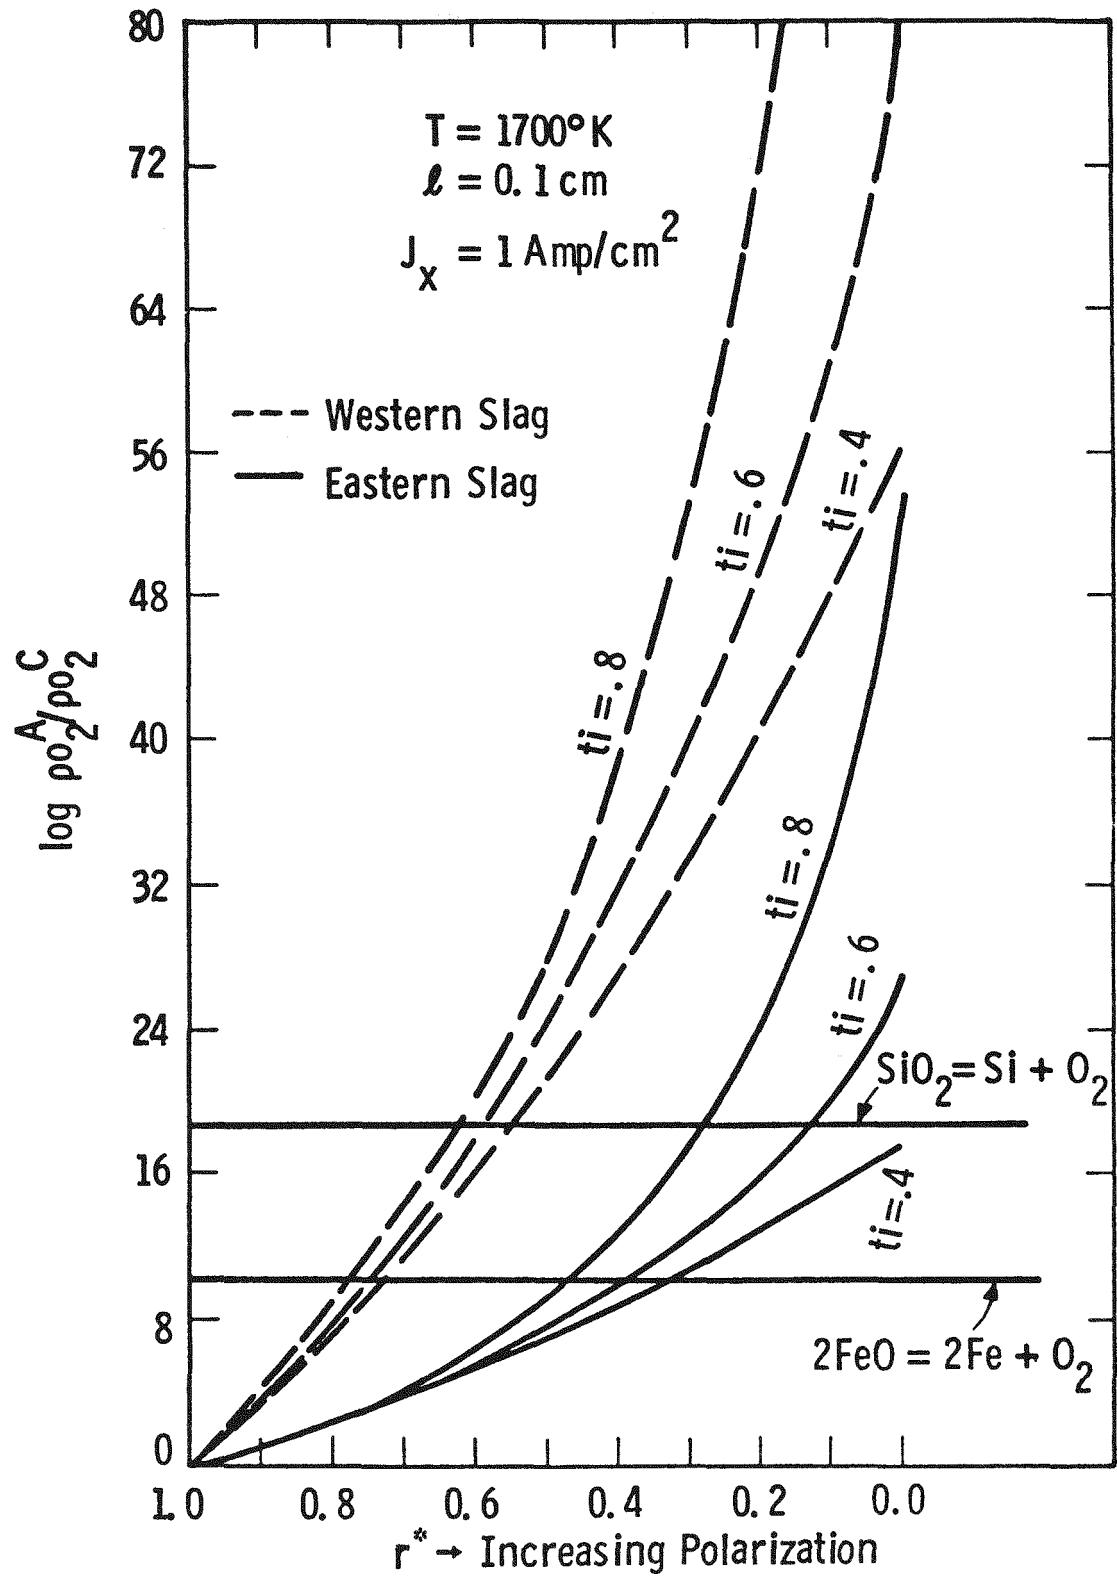
Figure 27. The Calculated Dependence of ECS ($\log pO_2^A/pO_2^C$) on Relative Polarization, r^* , for Eastern and Western USA Coal Slags at 1700 K

Figure 27 shows the interrelationship between ECS and the relative polarization factor, r^* . Calculations were made at 1700 K for a typical Eastern ($\sigma_T = 1.1 \times 10^{-1} (\Omega\text{-cm})^{14}$) and Western ($\sigma_T = 3.25 \times 10^{-2} (\Omega\text{-cm})^{14}$) coal slag for a variety of ionic transference numbers, \bar{t}_i , assuming a 1mm thick slag layer and a current density, J_x , of 1 amp/cm². Superimposed on this figure are horizontal lines which represent the values of ECS at which the FeO and SiO₂ components of the slag will decompose to their constituent elements. The curves in Figure 27 illustrate how sensitive ECS is to slag conductivity. For example, although σ_T (Eastern) is a little over three times greater than σ_T (Western), the ECS rises from $\approx 10^{18}$ for the Eastern slag to $\approx 10^{56}$ for the Western slag when $t_i = .4$. Similar increases in slag thickness and/or current density will also

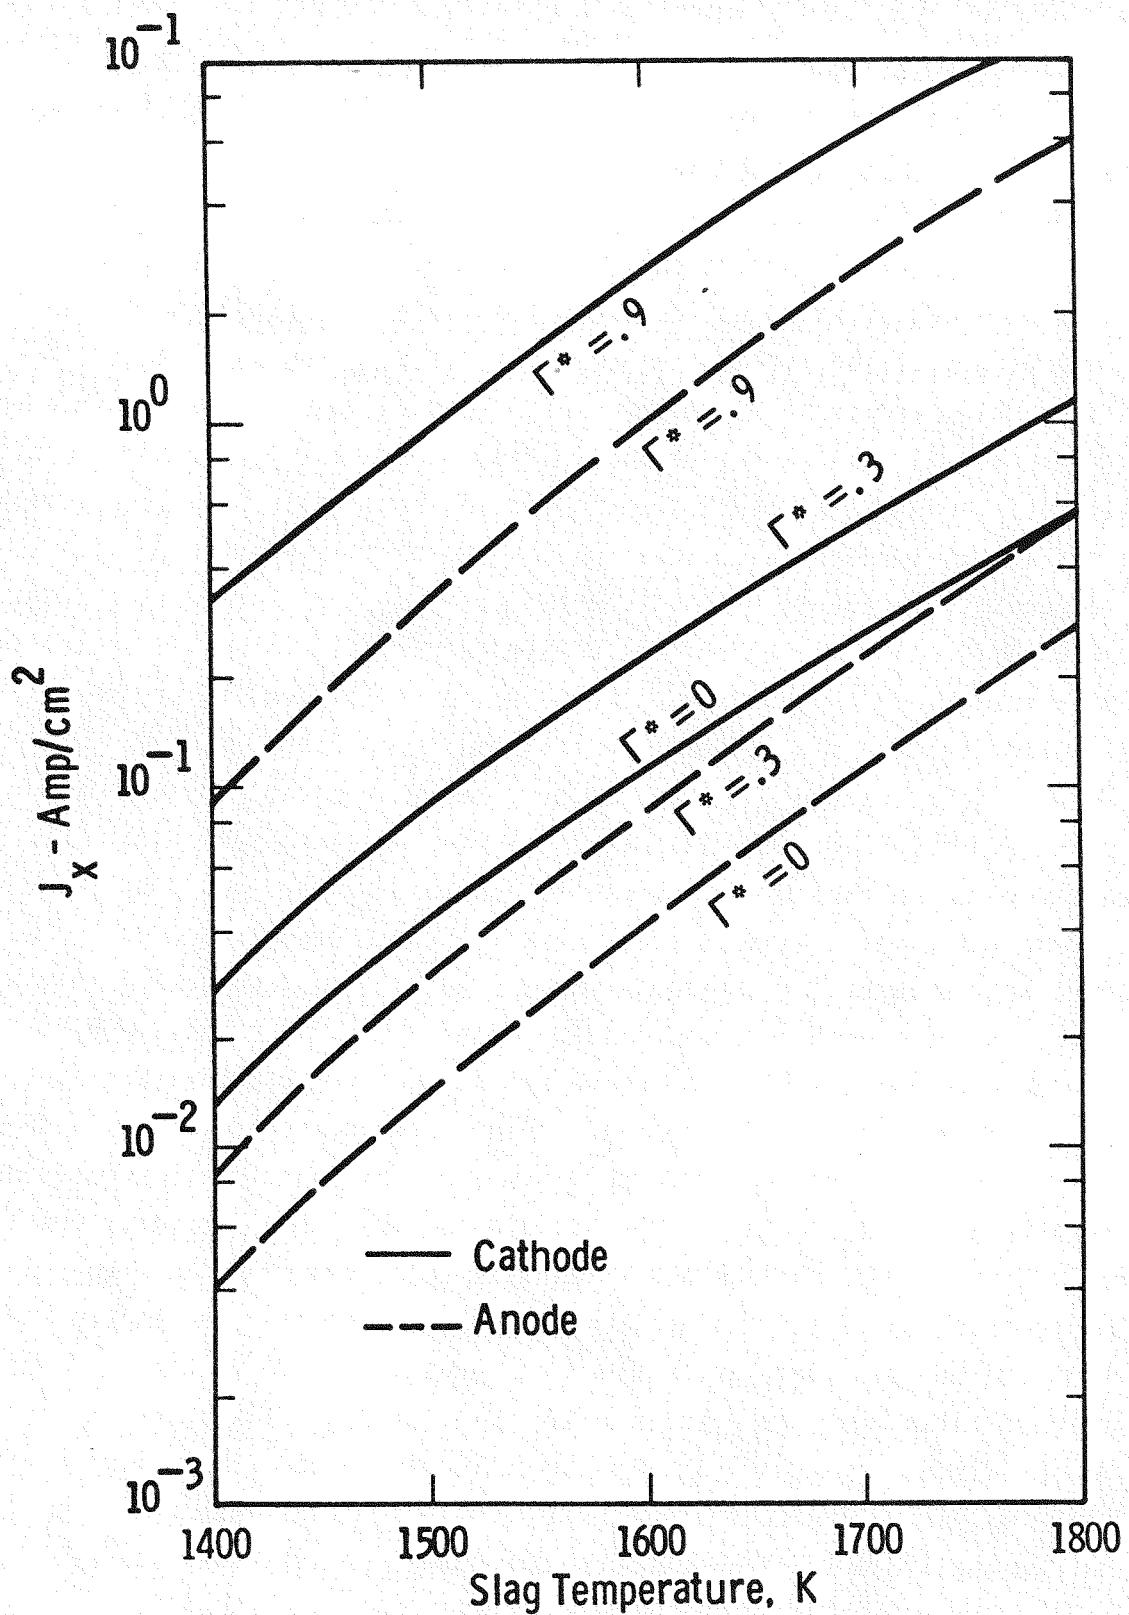
Figure 28. Calculated Temperature Dependence of Current Density, J_x , to Electrolyze a 1 mm Layer of Eastern Slag on Anode and Cathode Walls of a Channel for Various Values of Relative Polarization, r^*

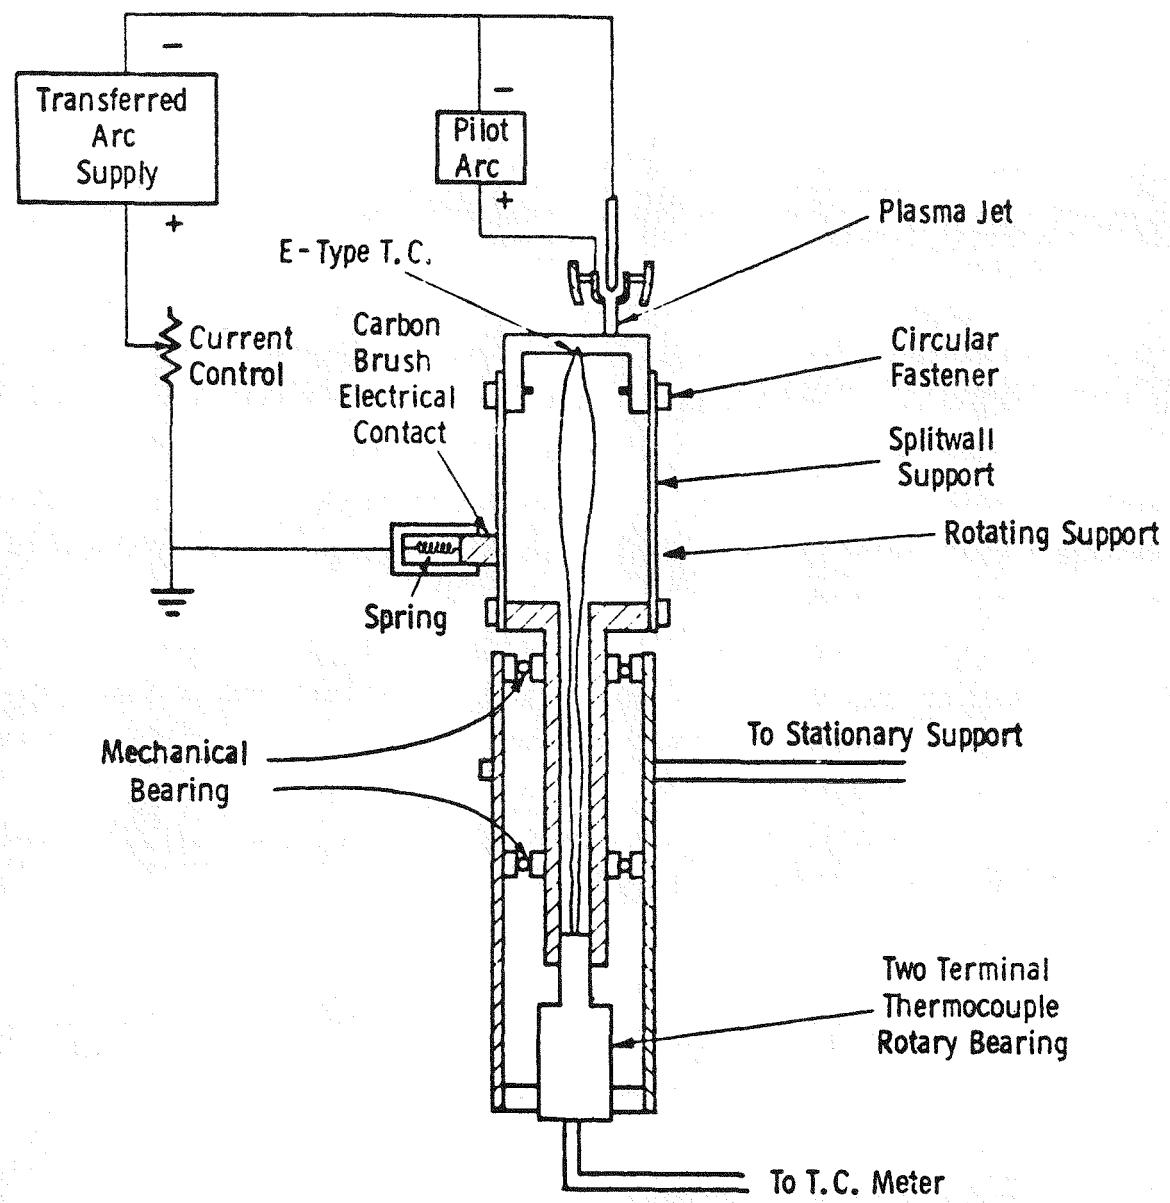
Figure 29. Schematic of Anode Arc Test Using Plasma Needle Arc Welder

The anode test samples, having a 2.5 cm O.D. and 1.8 cm height, are rotated under the arc jet in order to simulate arc mobility. Most of the back side of the sample is milled out to reduce thermal mass. The measurement of temperature is accomplished by insertion of E-type thermocouples to a position .010" distant from the anode surface exposed to the plasma. Sample temperature is controlled by varying the amount of air cooling directed against the sample. Temperatures of 200-600°C are easily obtained using this technique.

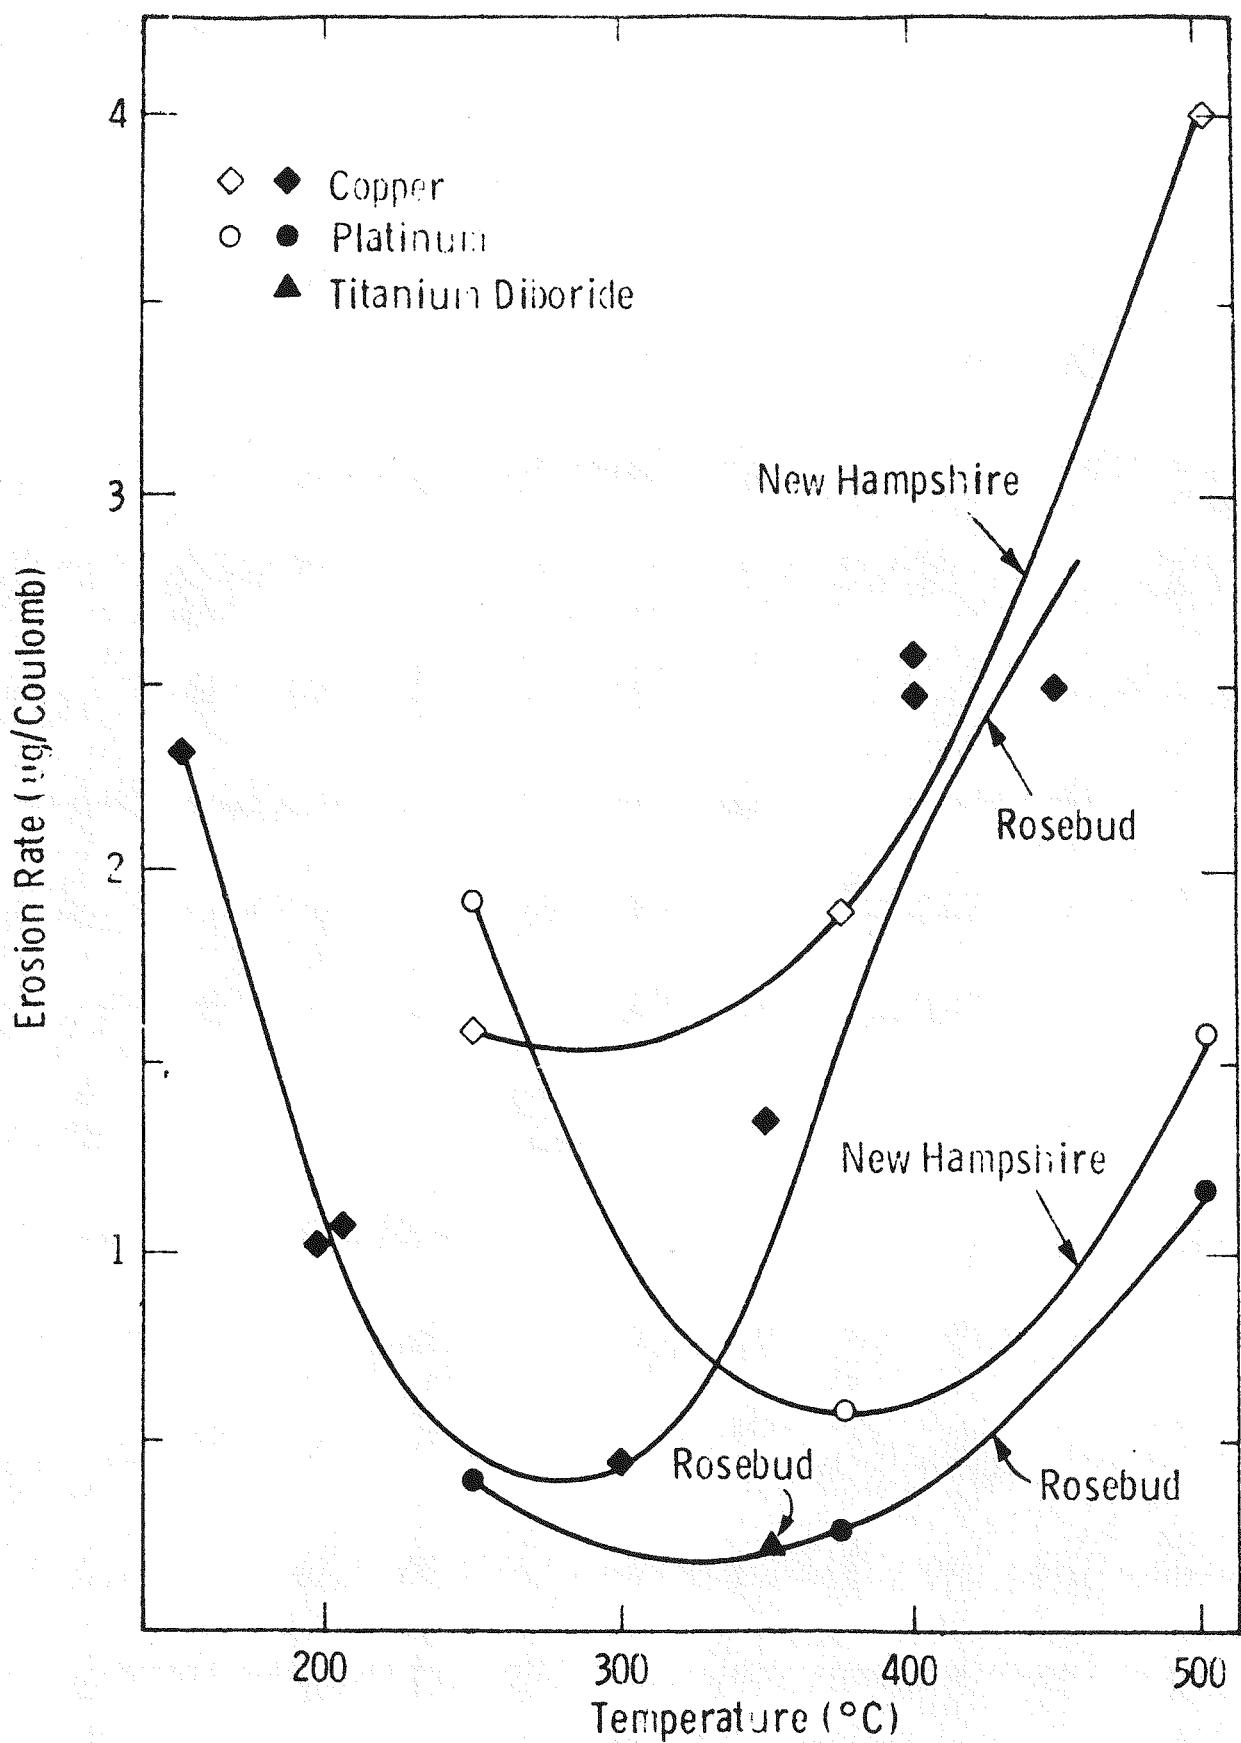
Figure 30. Erosion Rates of Coal Ash- K_2CO_3 Coated Anodes Versus Temperature

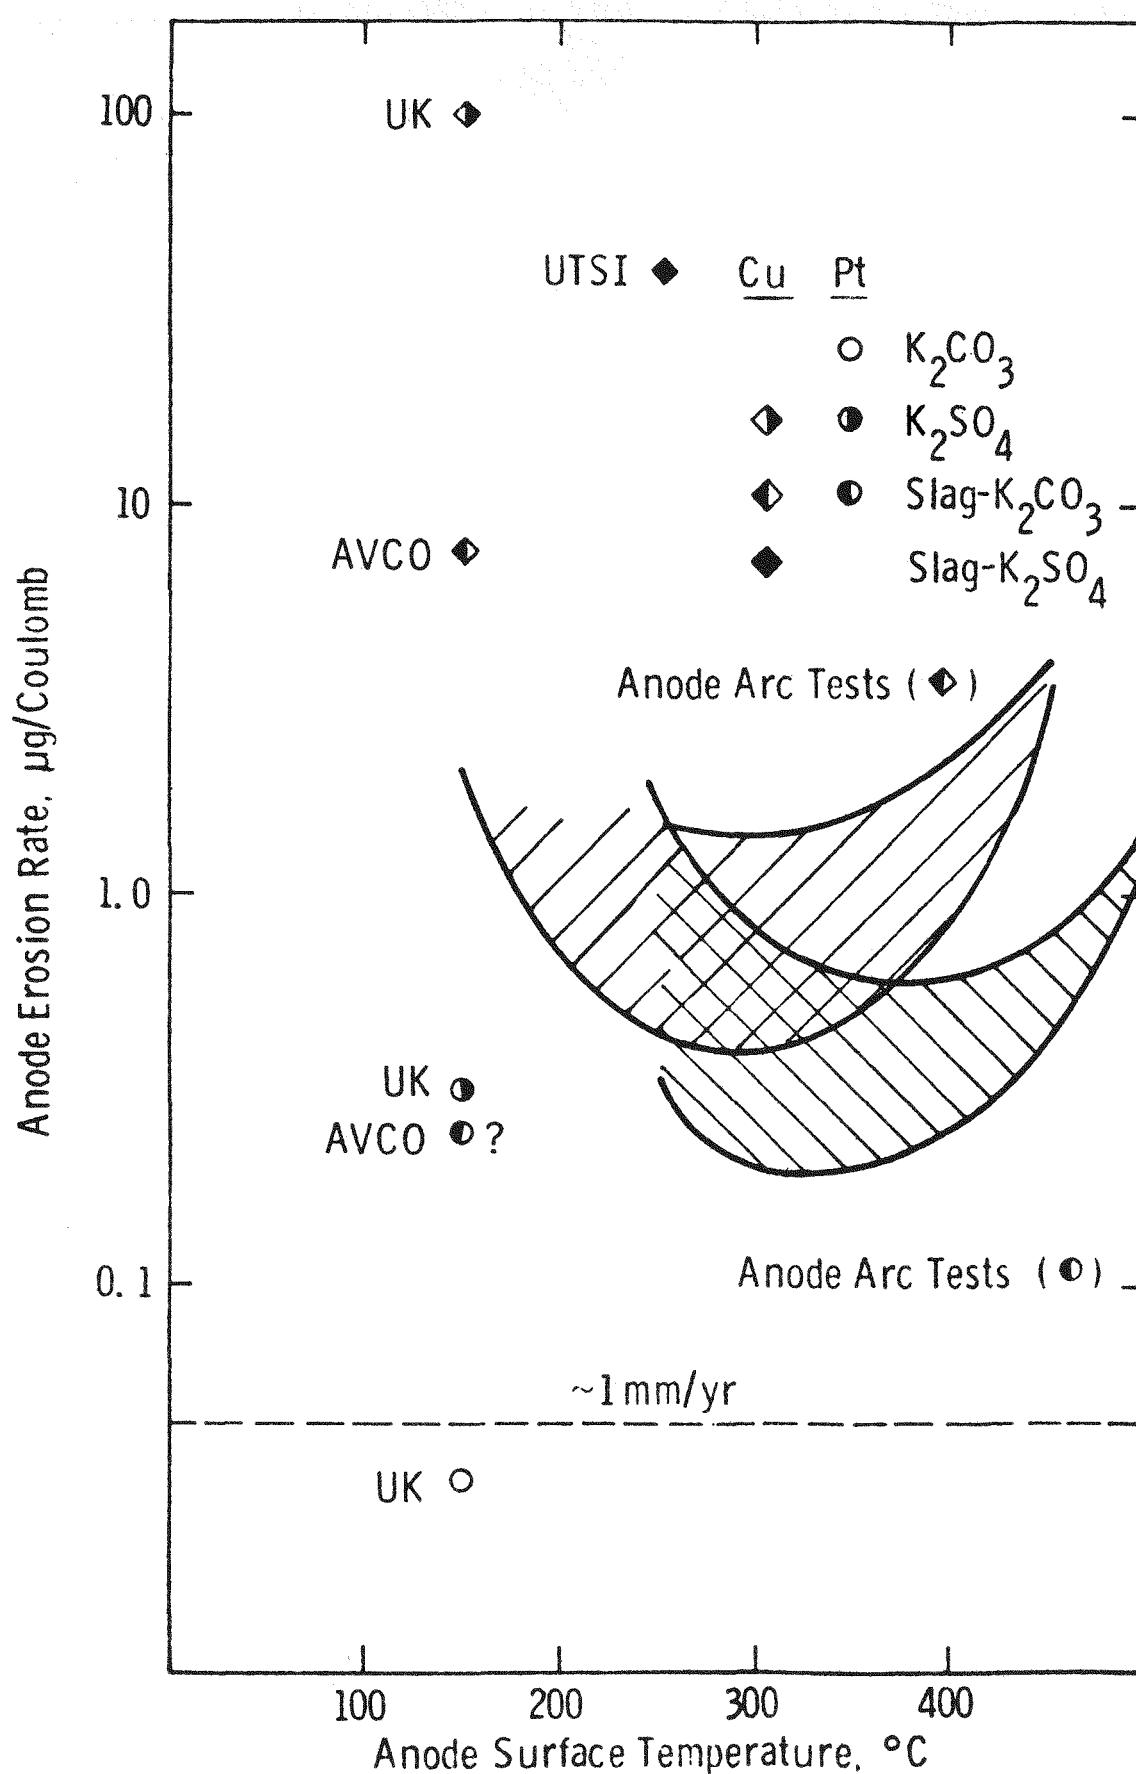
Figure 31. Comparison of Anode Erosion Rates From Laboratory and MHD Generator Tests

The effect of using seed in the sulfate form on the erosion rate of platinum is shown in Figure 32. The use of K_2SO_4 increases erosion by a factor of at least two when compared to the use of K_2CO_3 . Again, Figure 31 shows that previous

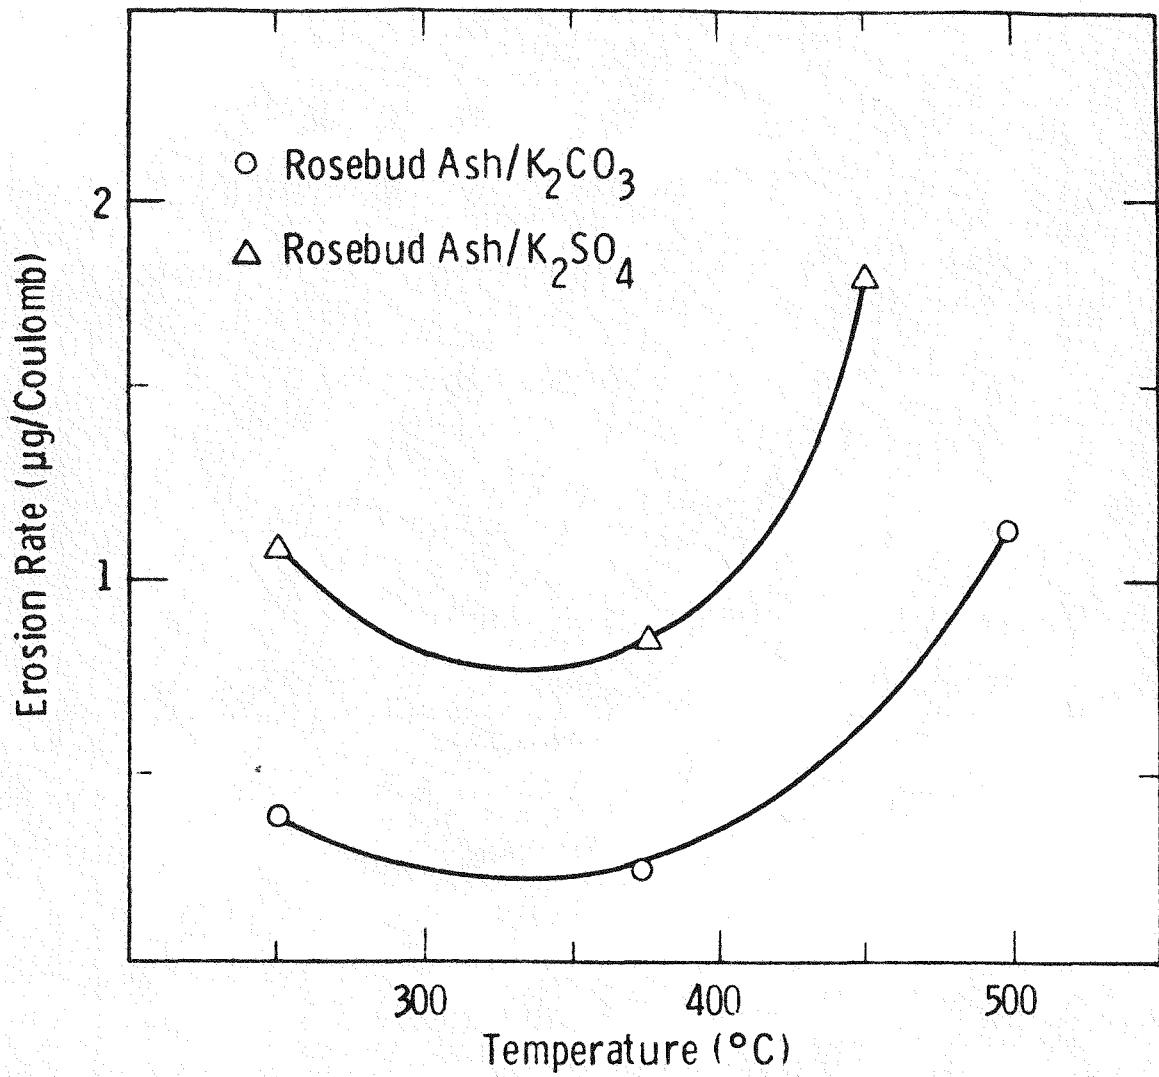
Figure 32. Erosion Rates of Platinum Anodes Coated with K_2CO_3 - and K_2SO_4 - Rosebud Ash Mixtures

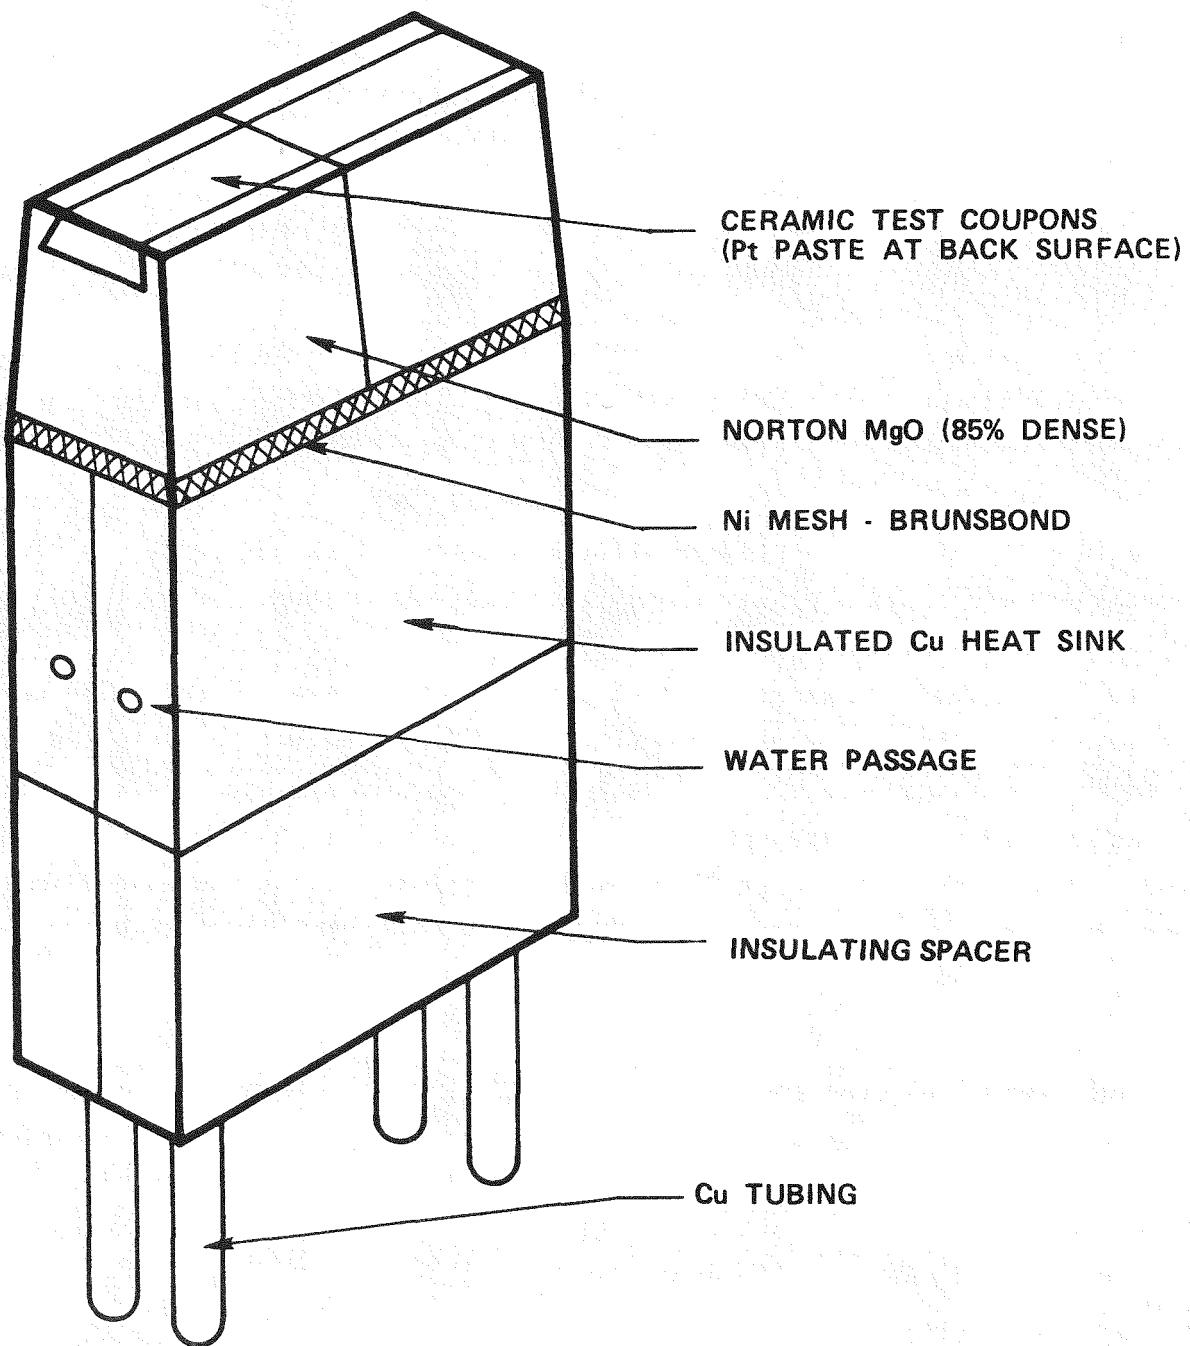
Figure 35. General Coupon Electrode

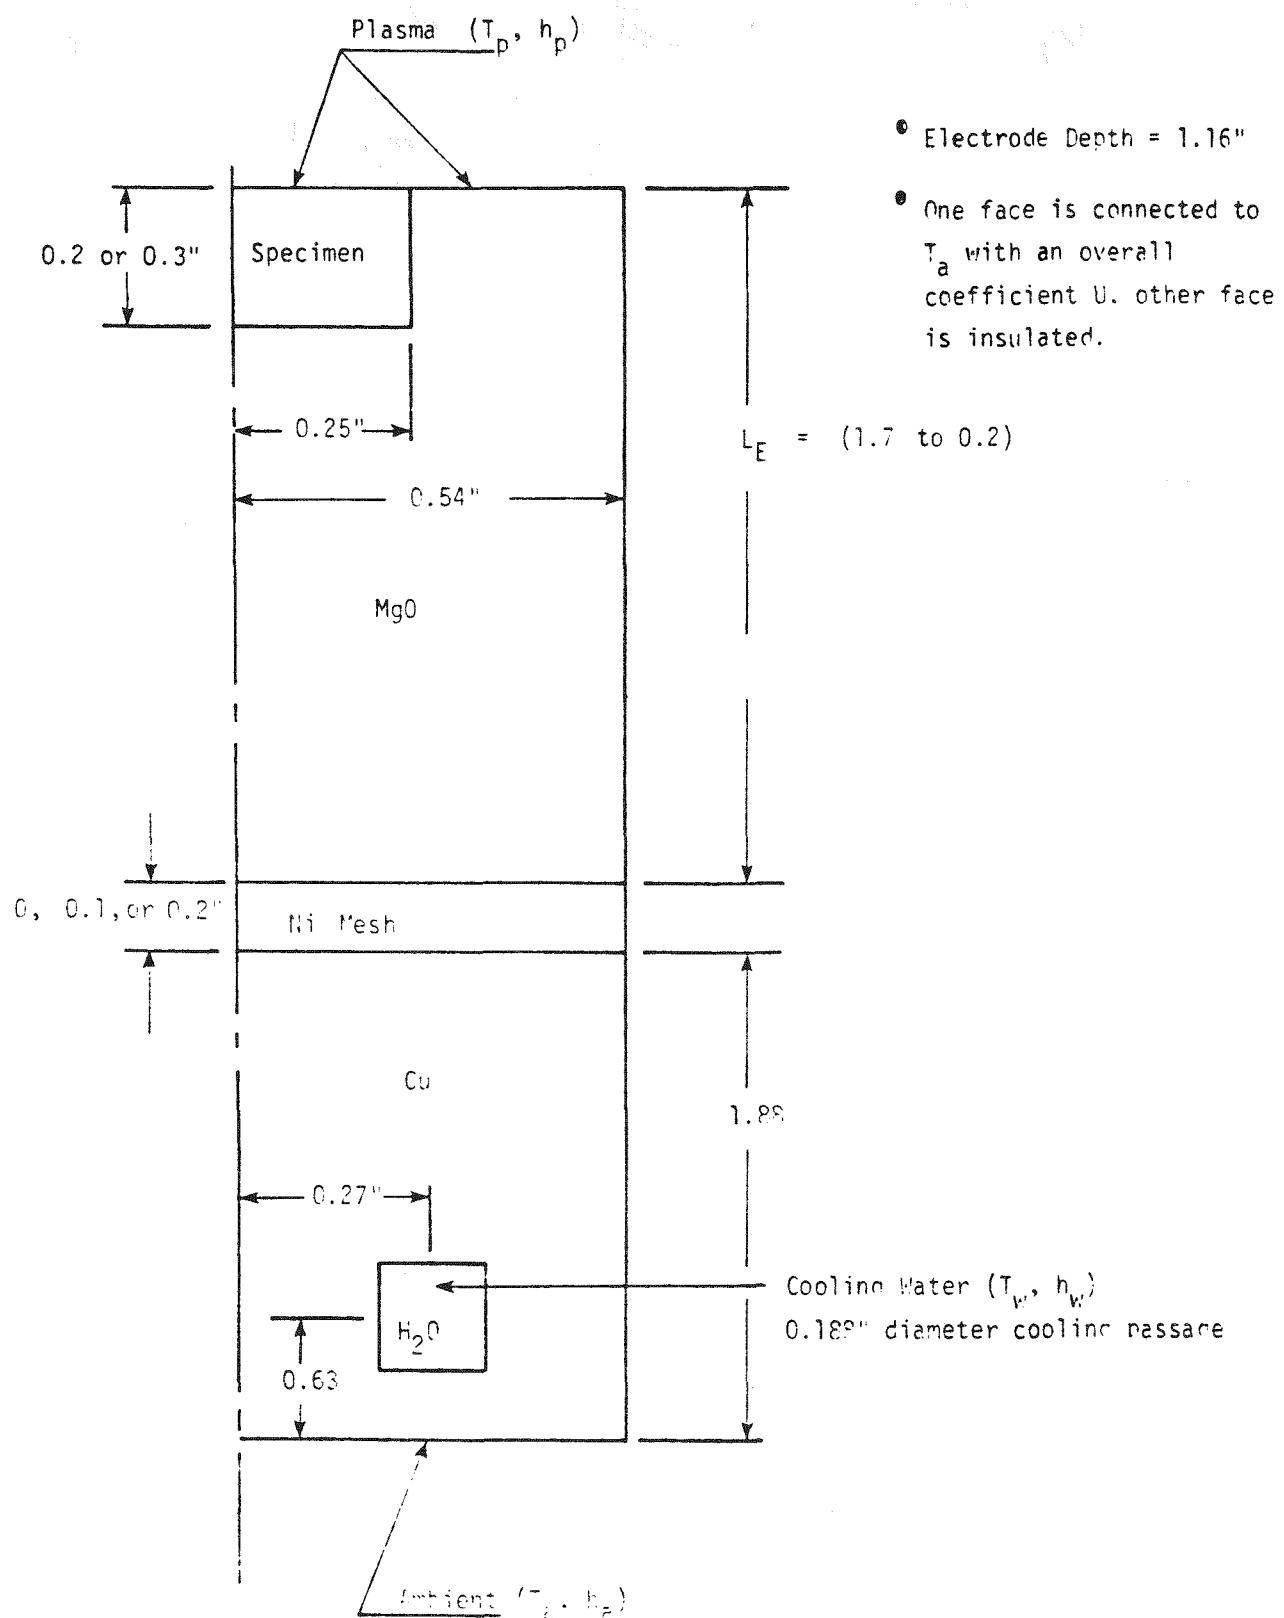
Figure 36. Coupon Electrode Model

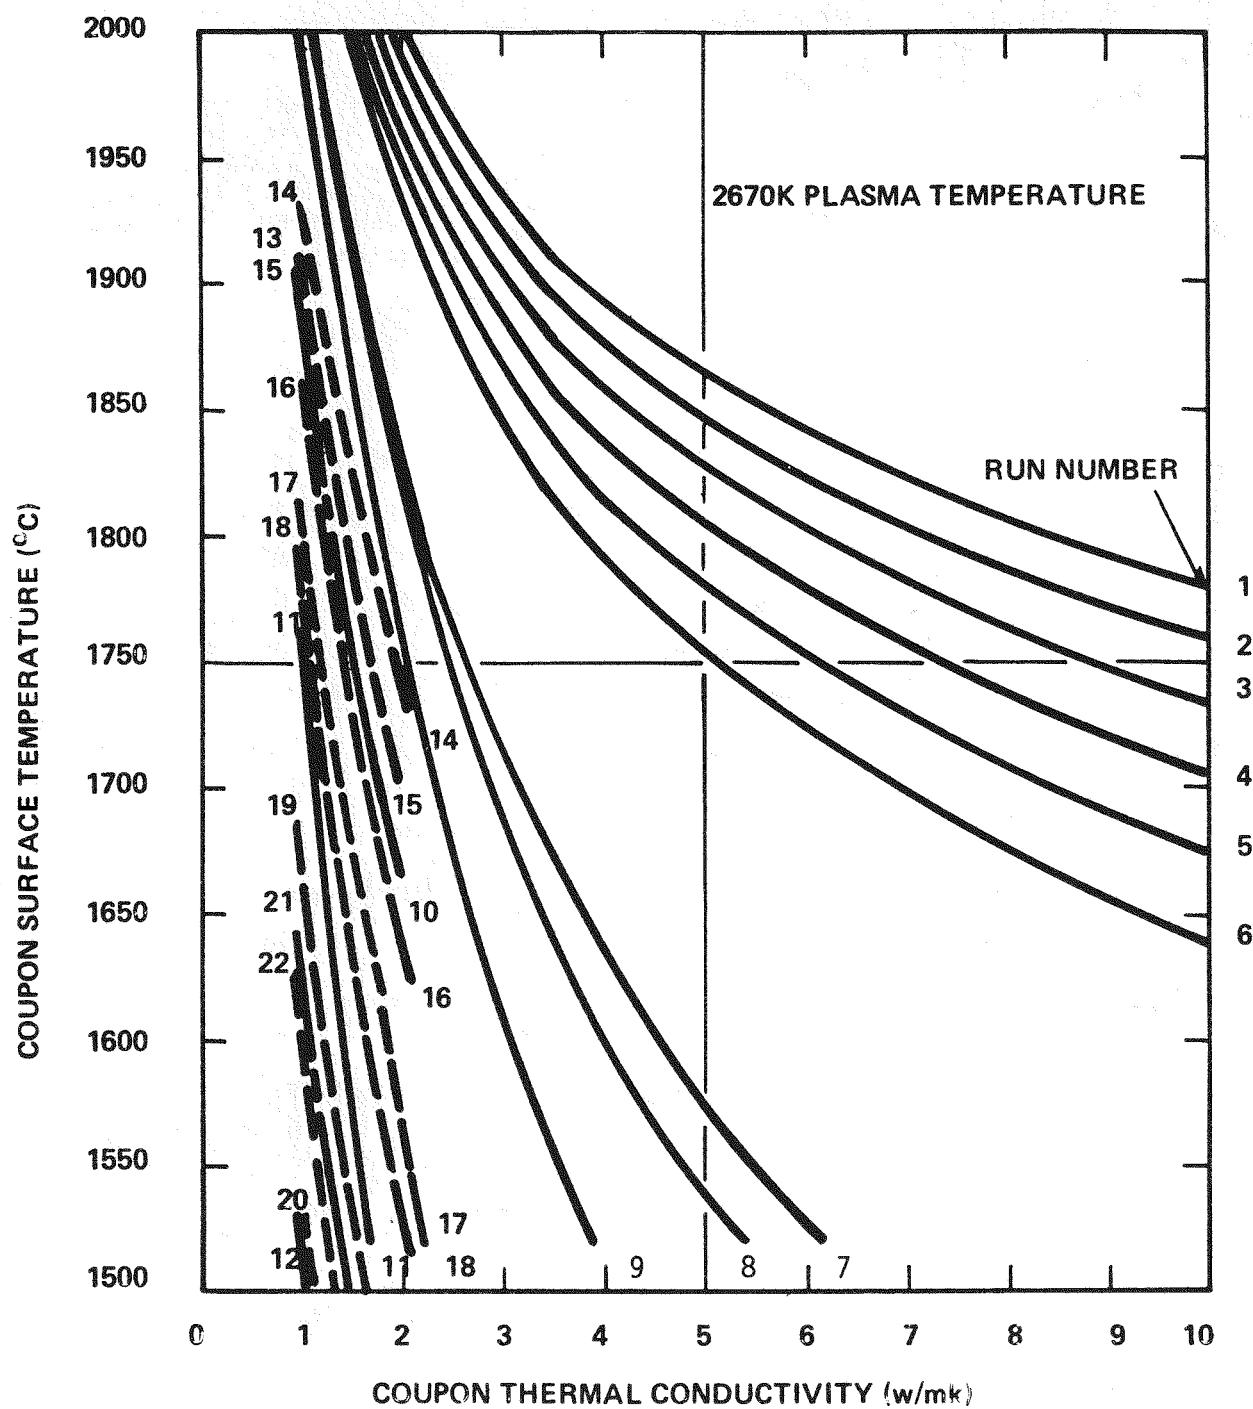
Figure 37. Coupon Surface Temperature

Figure 37 gives the coupon or specimen surface temperature as a function of specimen thermal conductivity, electrode geometry, and plasma flow rate for a 2670 K plasma temperature. Figure 38 gives the temperature at half the thickness

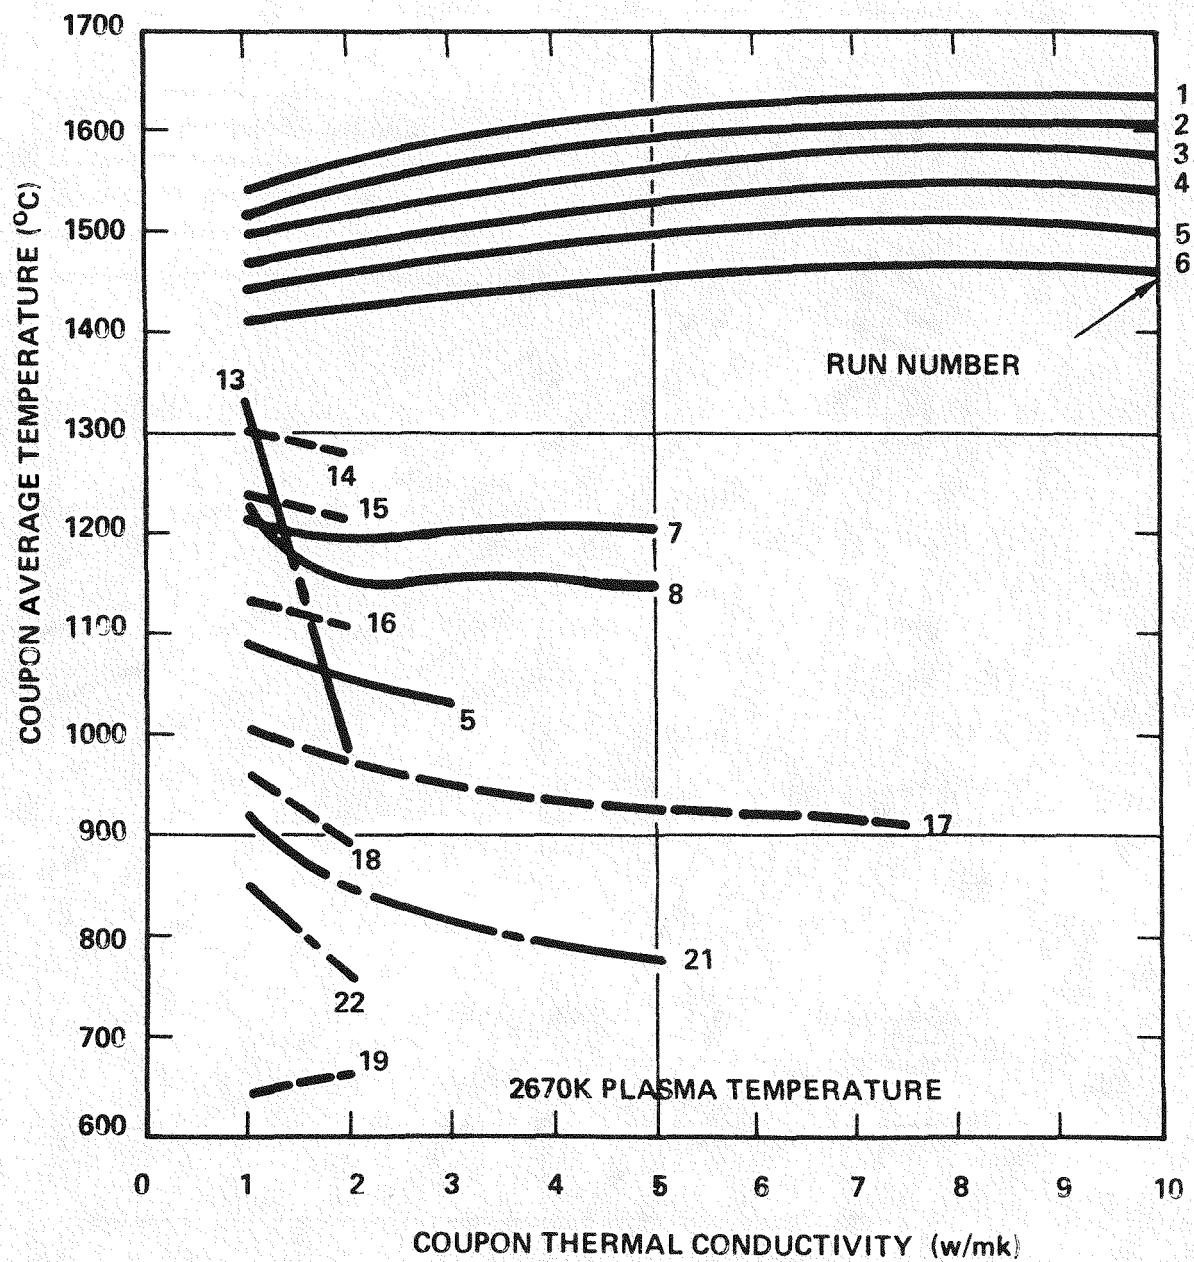
Figure 38. Coupon Average Temperature

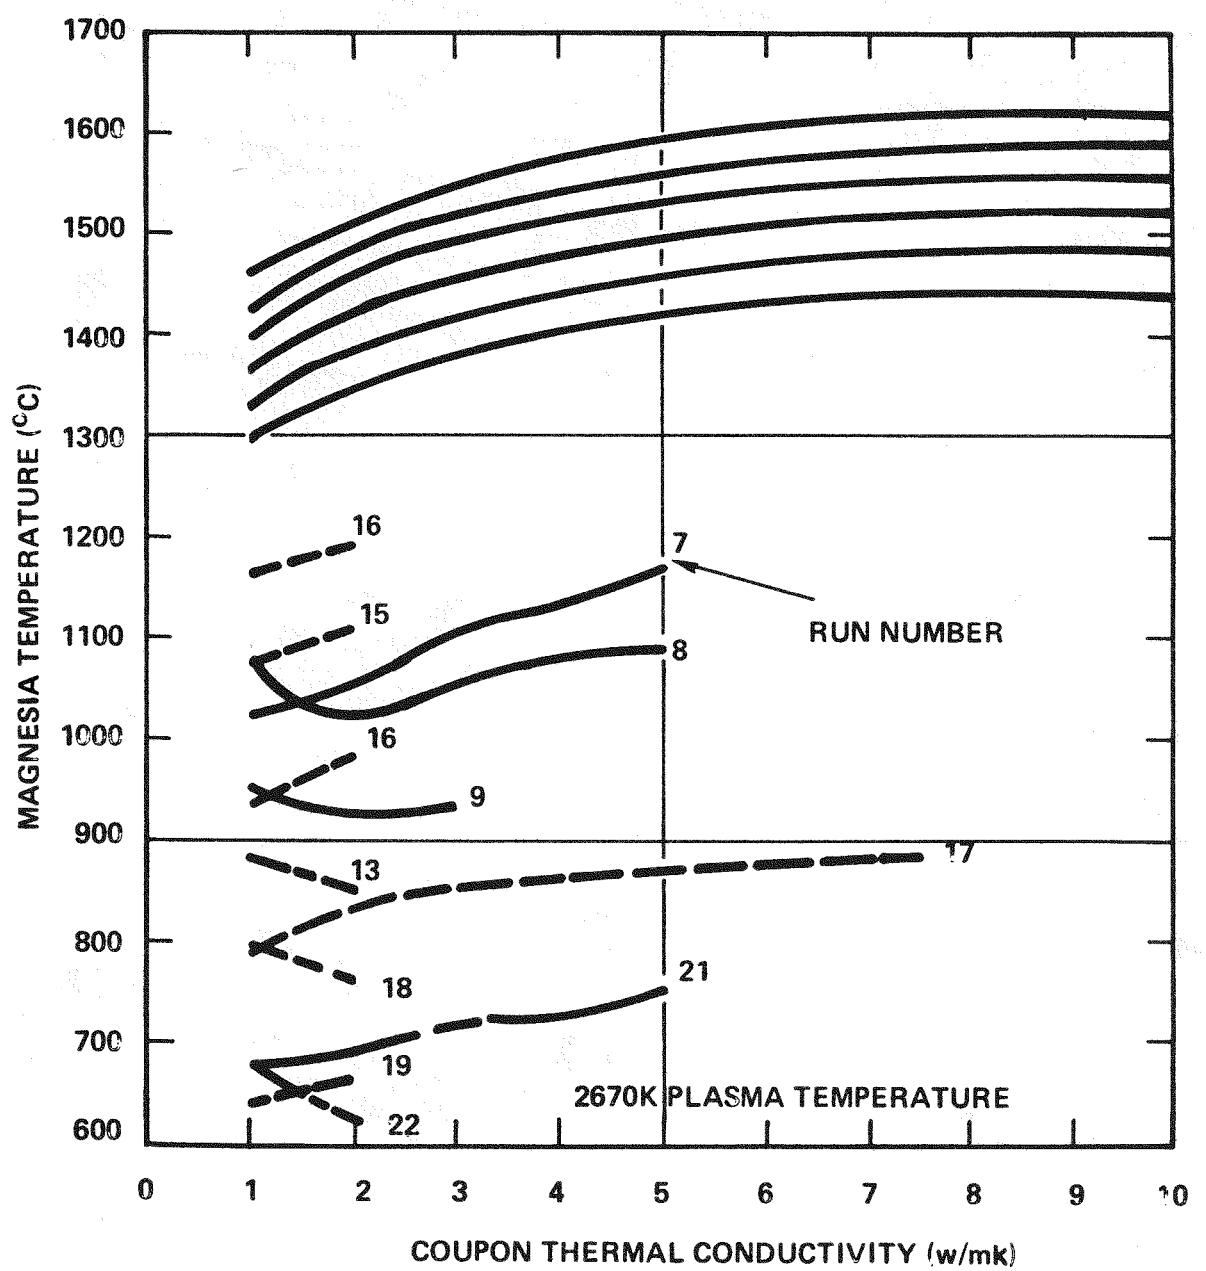
Figure 39. Magnesia Temperature - Thermocouple Location

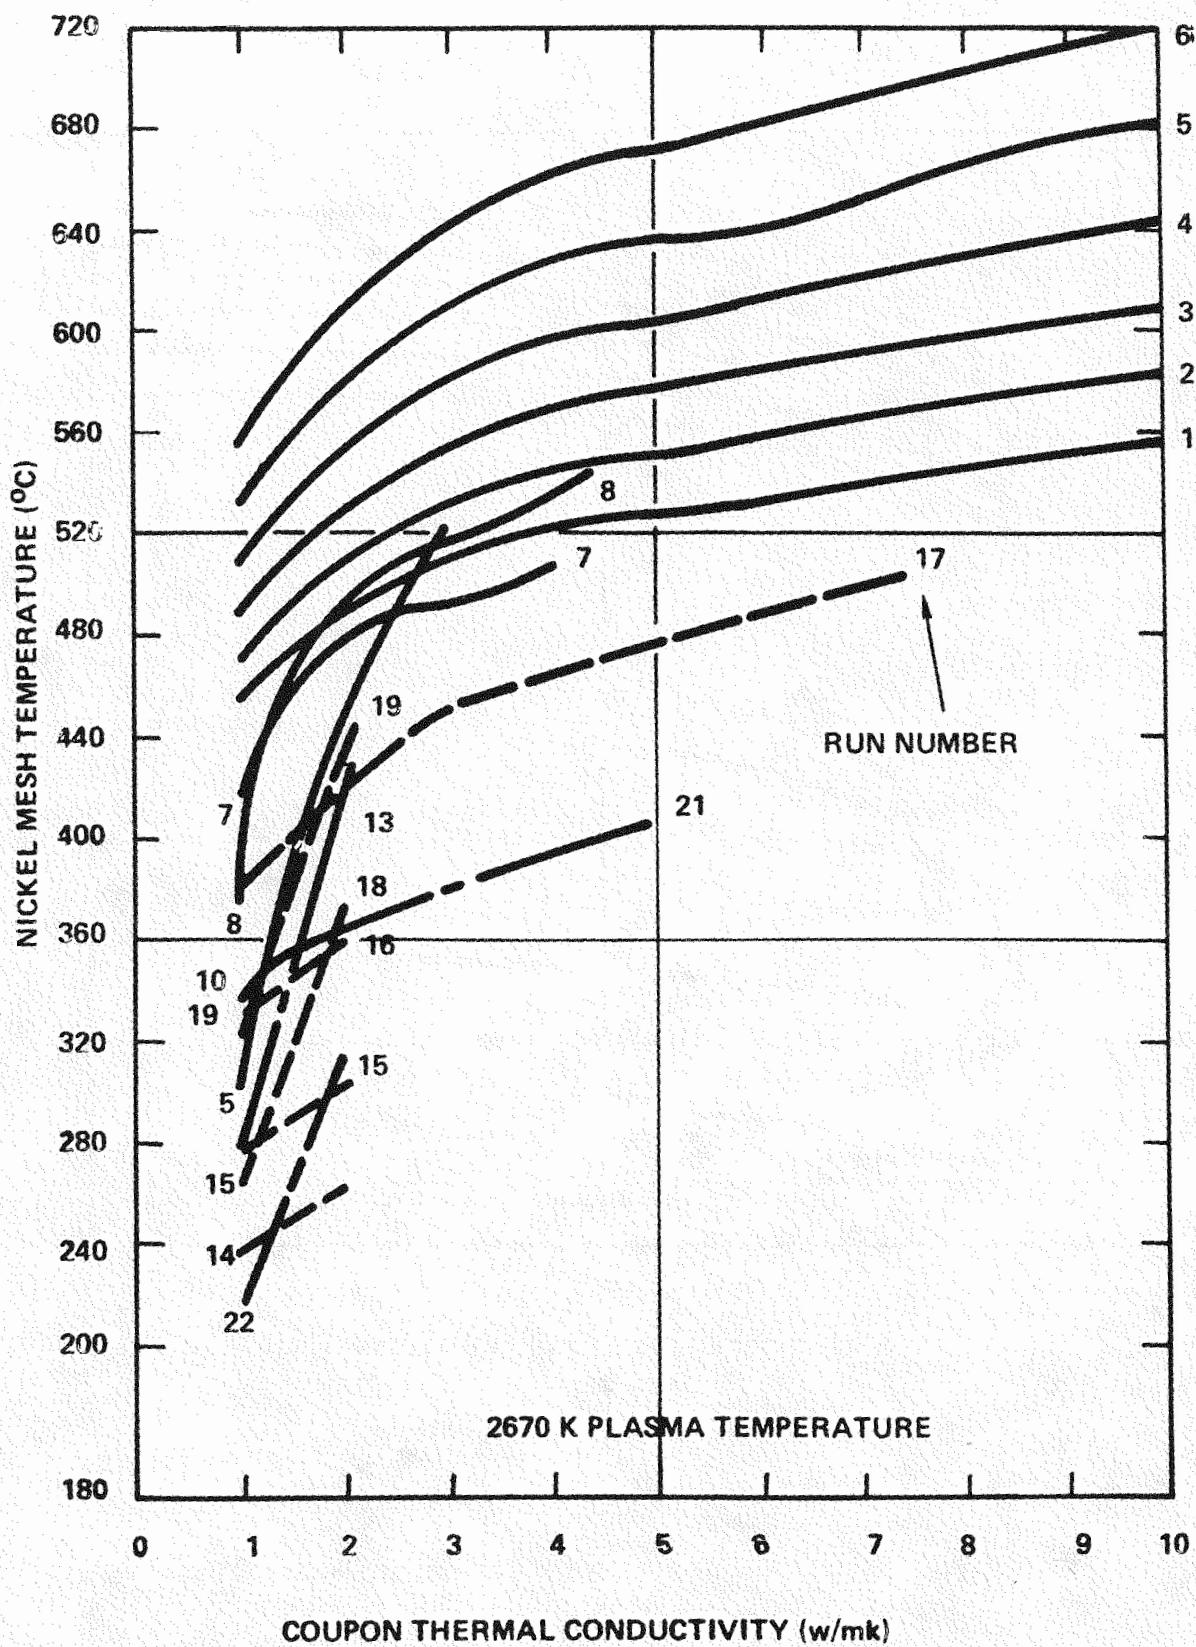
Figure 40. Maximum Nickel Mesh Temperature
