MHD ELECTRODE DEVELOPMENT

Quarterly Report for January—March 31, 1979

Westinghouse Electric Corporation
Advanced Energy Systems Division
Pittsburgh, Pennsylvania

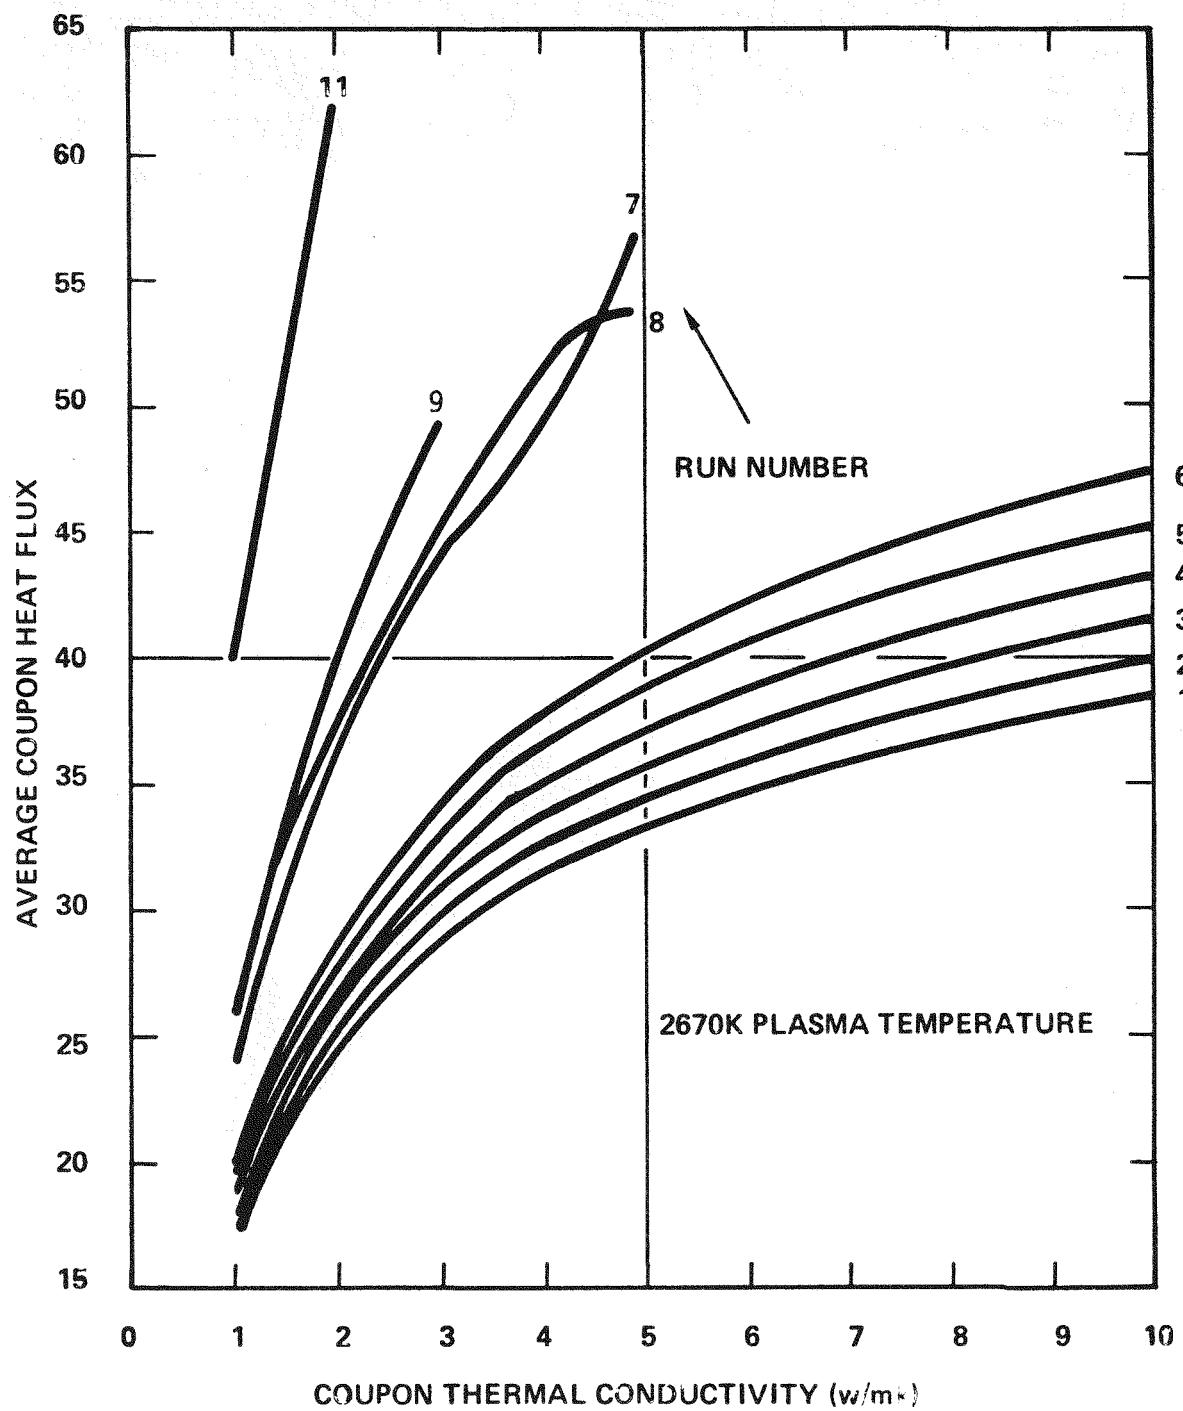
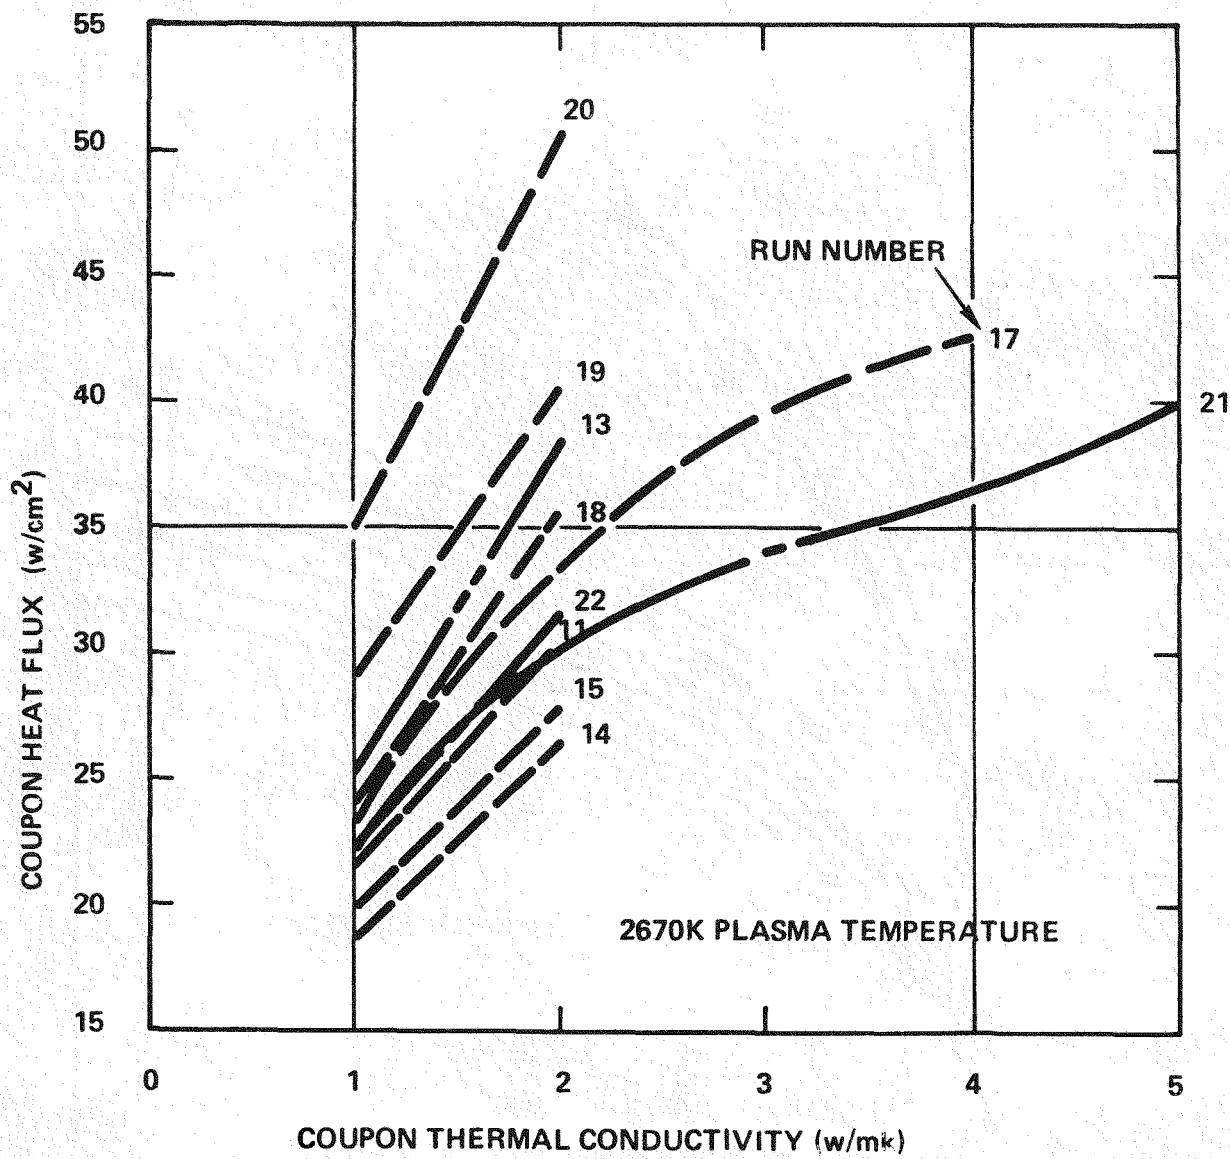
Figure 41. Average Coupon Heat Flux

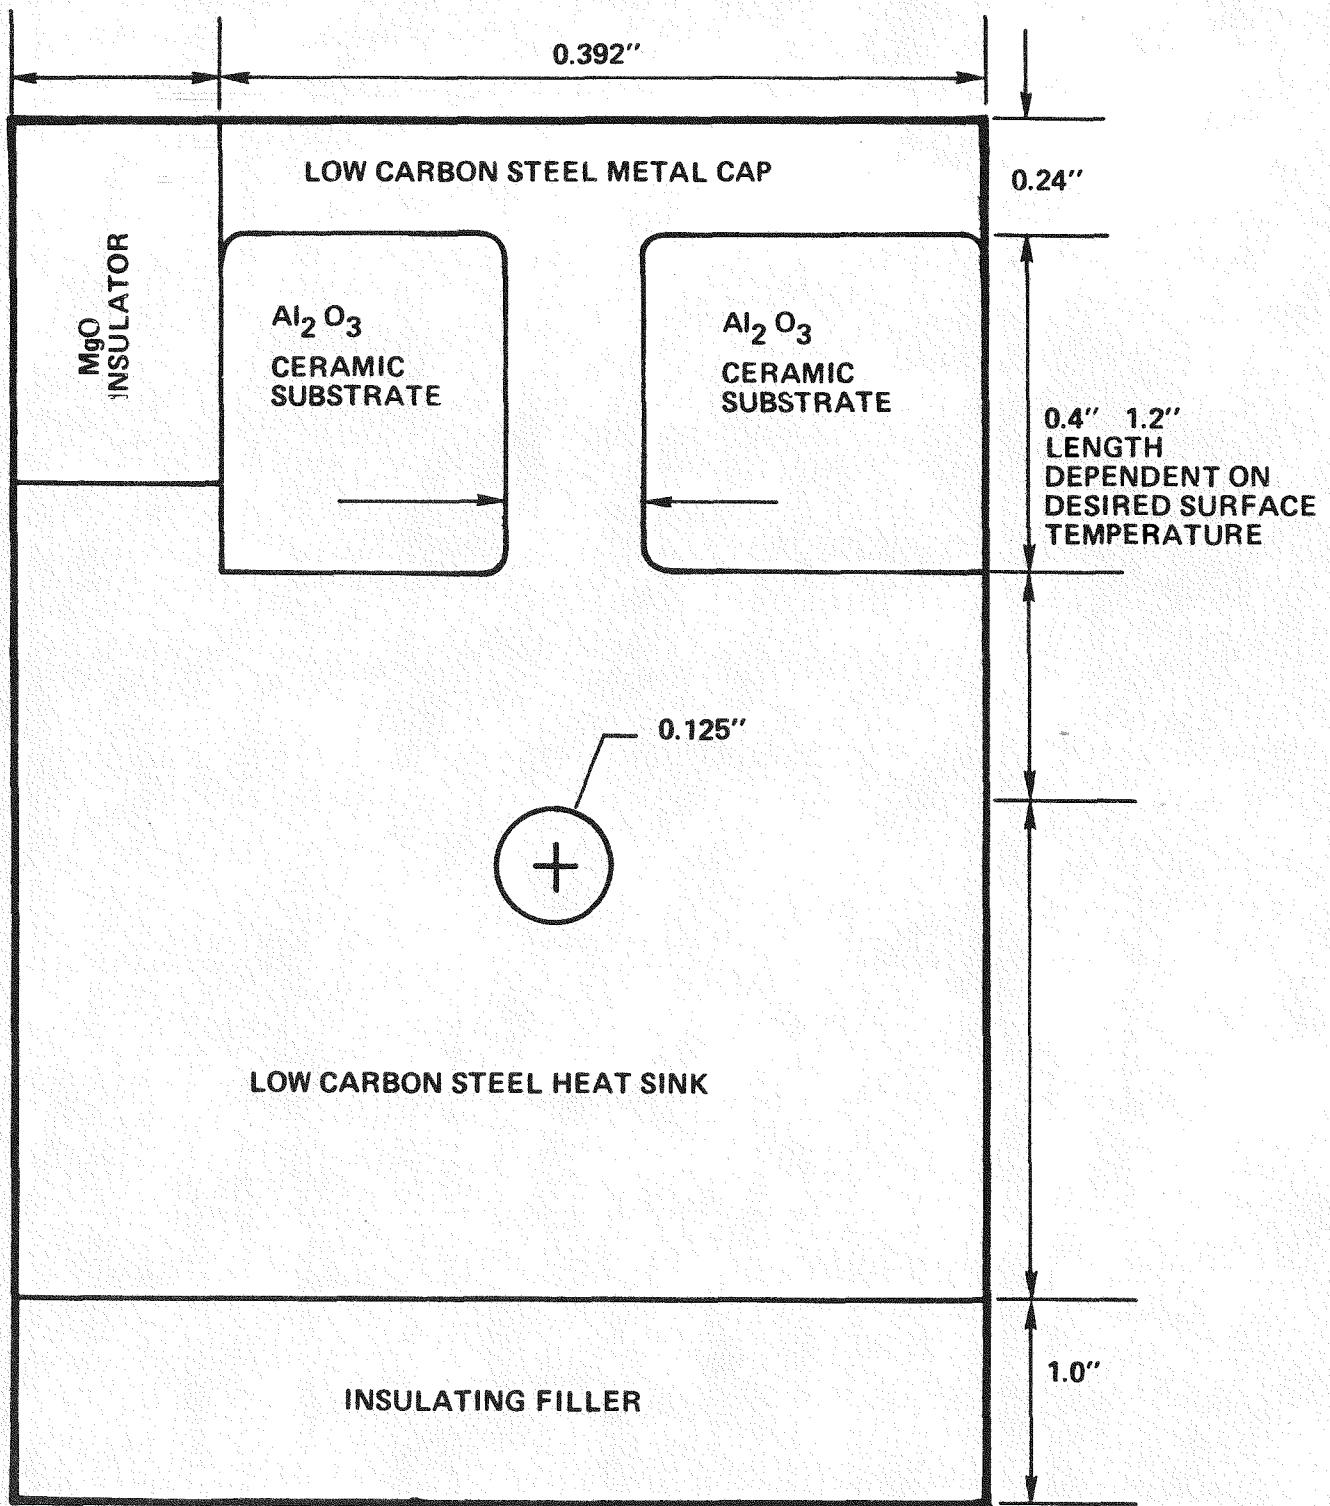
Figure 43. Conceptual Design Sketch-WESTF Test No. 43 Iron Cathode Wall/Typical Electrode

To satisfy the surface and interface temperature requirements of the cathode wall, the conceptual design in Figure 43 was developed from three dimensional

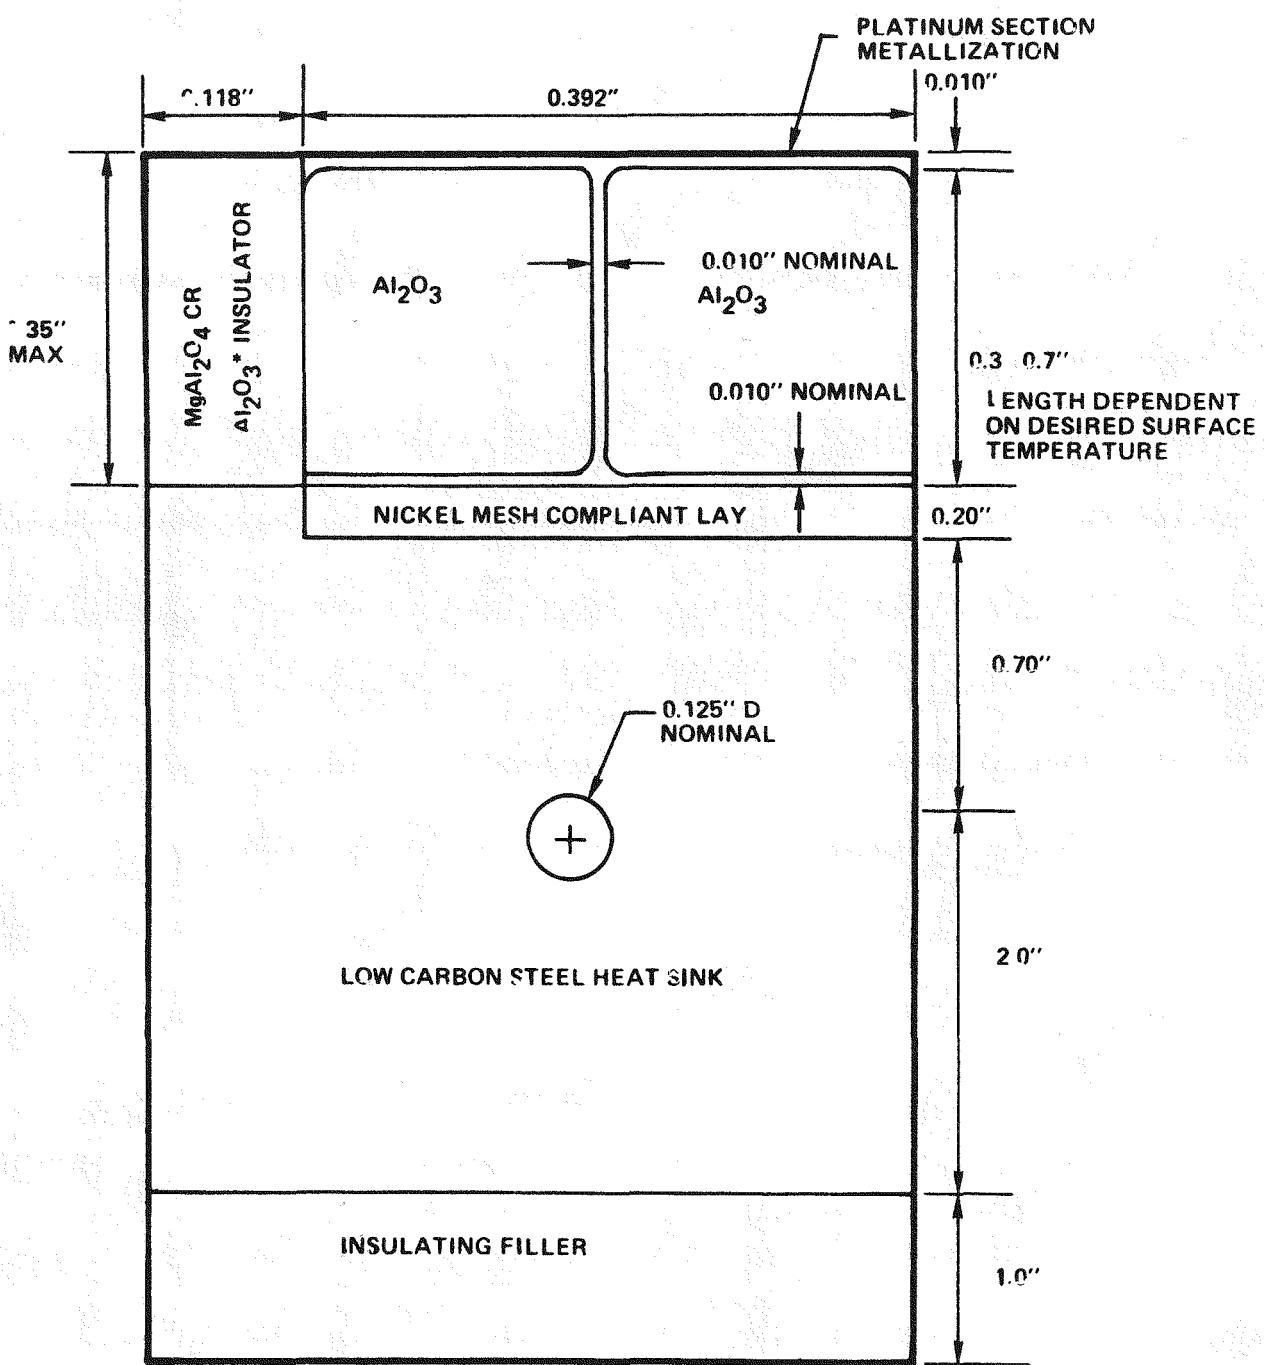
Figure 44. Conceptual Design Sketch - WESTF Test No. 43 Platinum Anode Wall/Typical Electrode

As the thermal specifications on Tests 41 and 43 are identical, the maximum refractory thickness will be the same as in Test 41. However, temperatures measured in Test 41 will be used to re-evaluate the insulating wall design procedure; and, if necessary adjustments will be made to the refractory thickness.

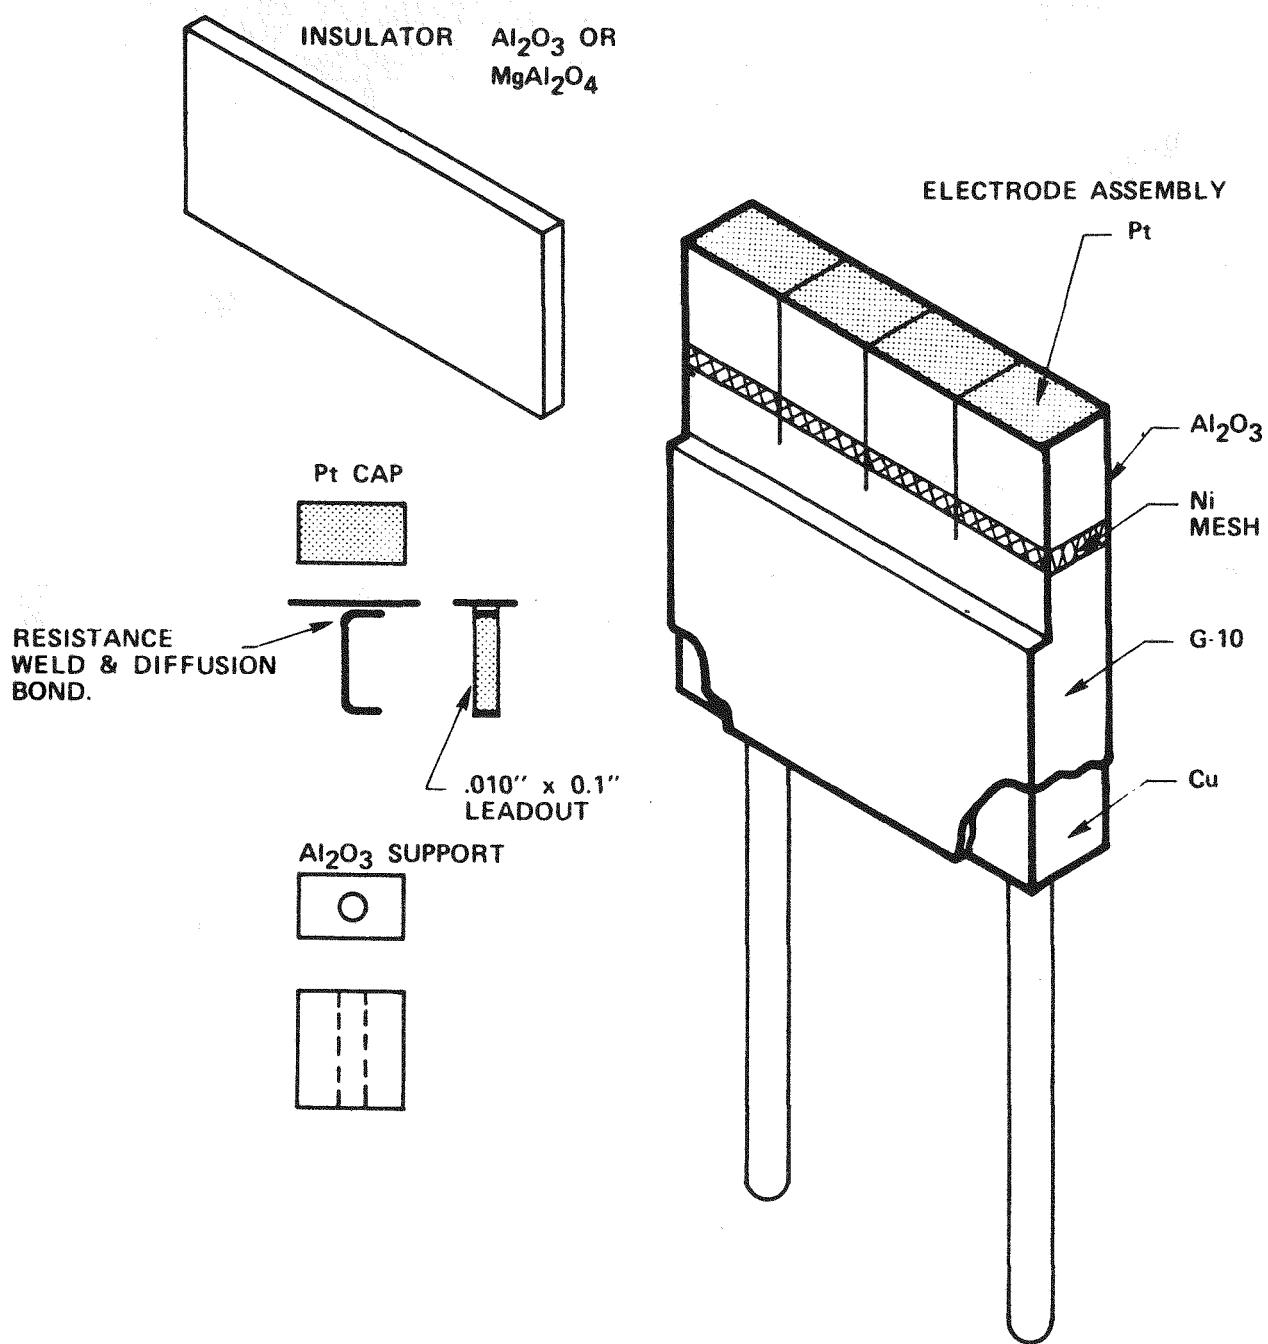
Figure 45. Test 43 Anode

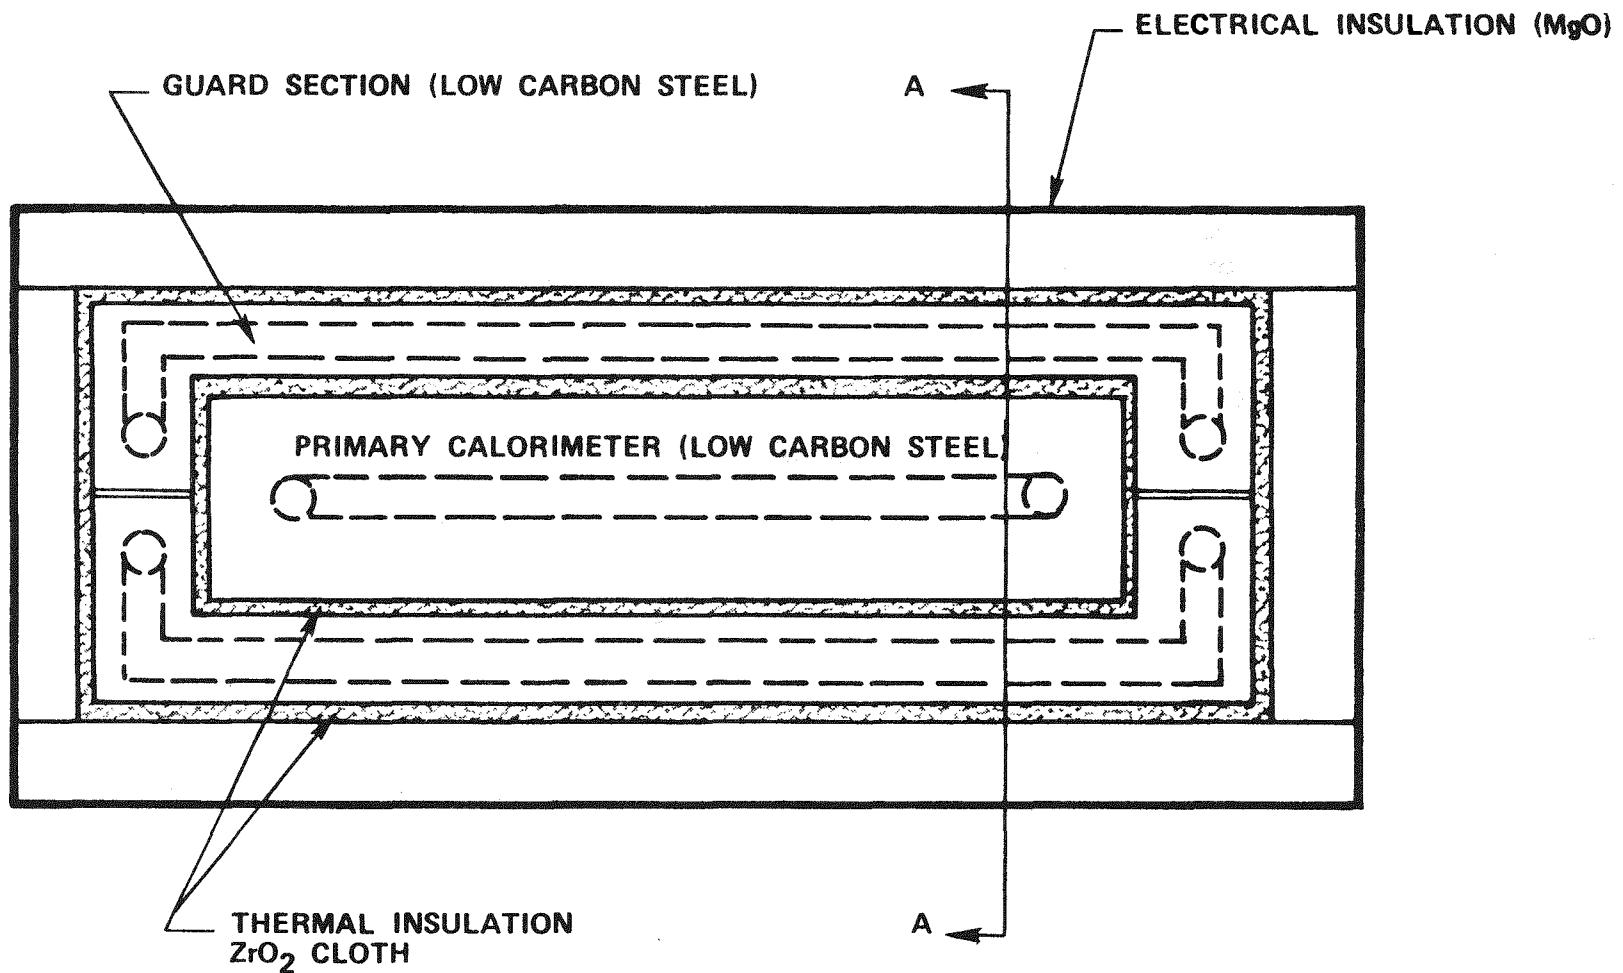
Figure 46. Design of Standard Calorimeter (Top View)

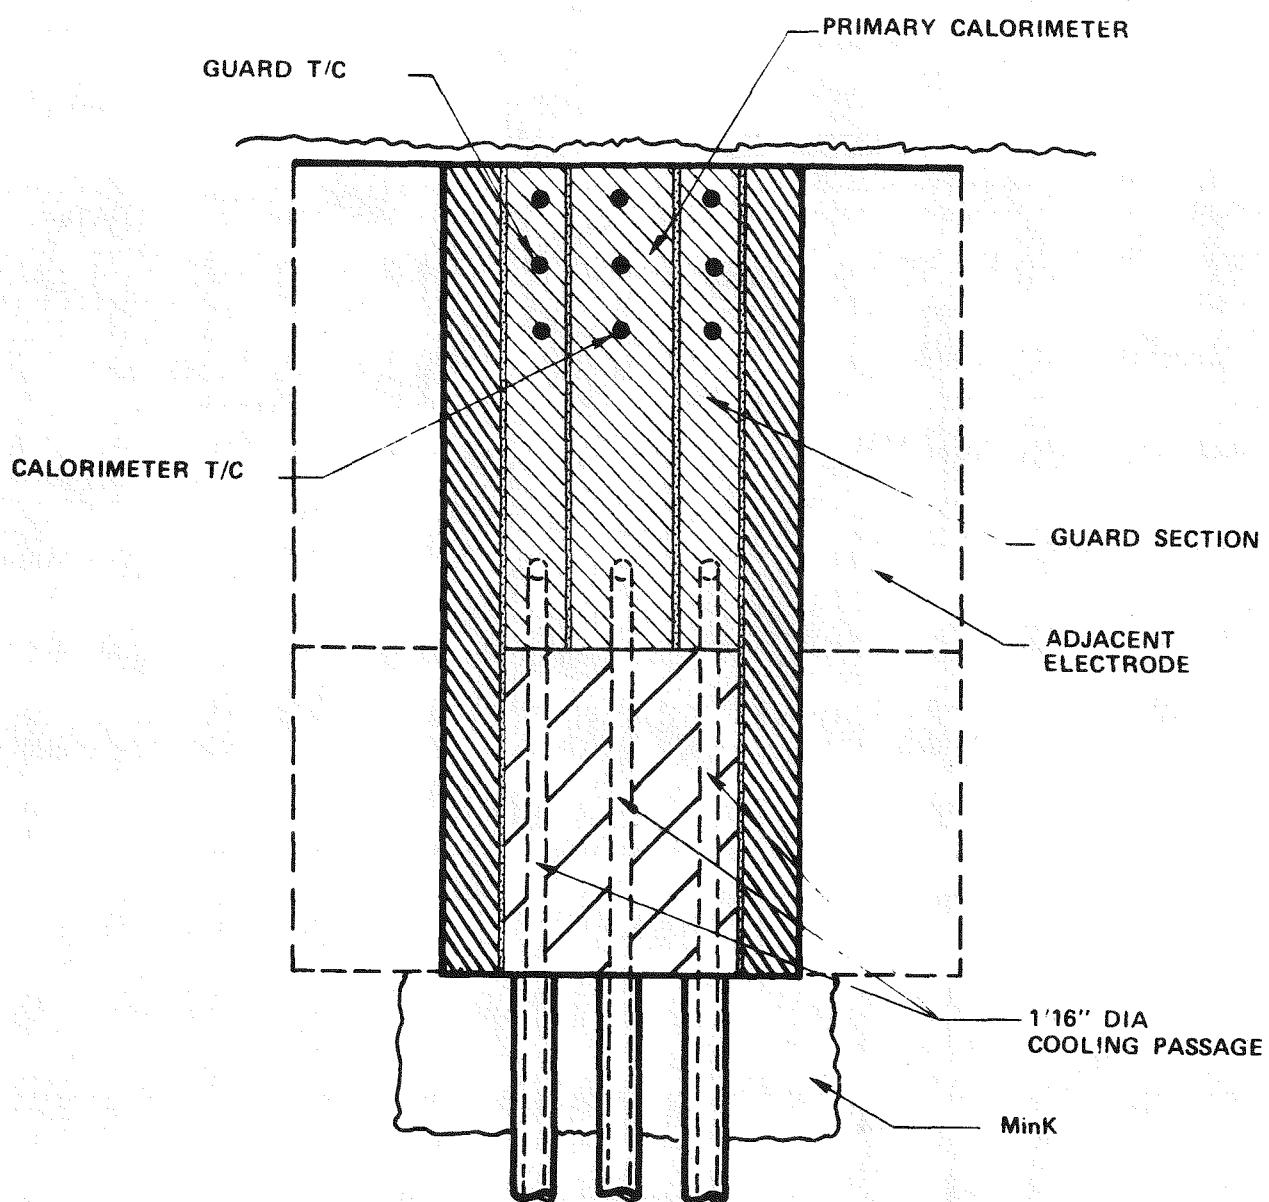
Figure 47. Design of Standard Calorimeter (Elevation)

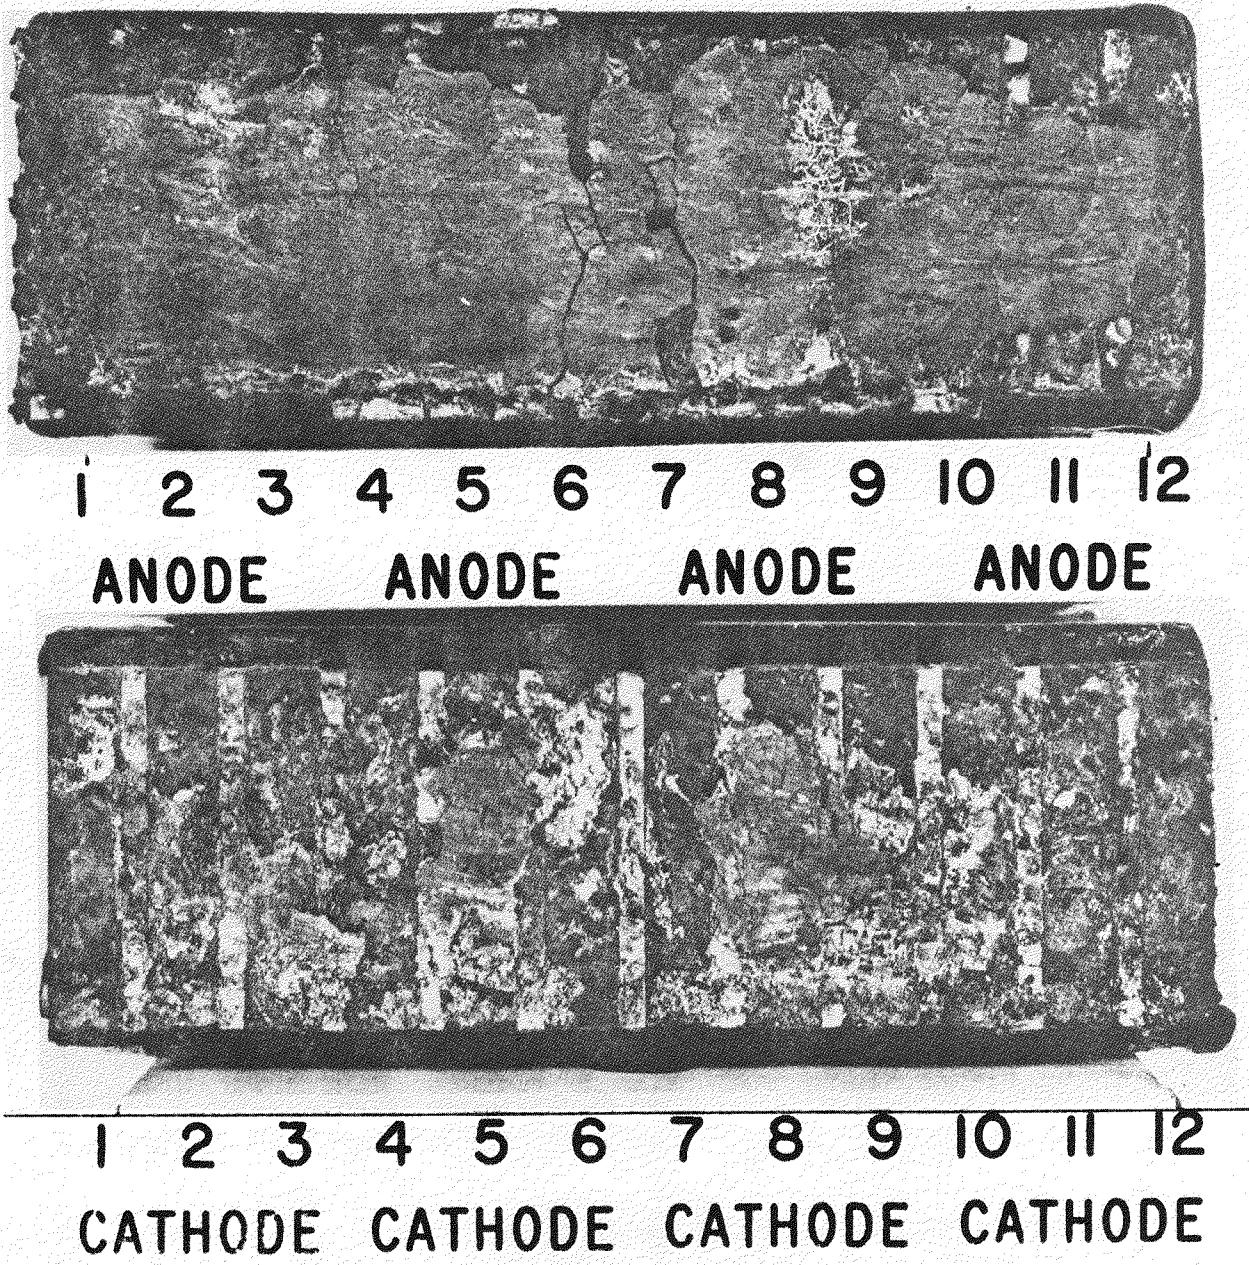
Figure 48b. WESTF Test 40 Electrode Walls After Separation and Partial Removal of Slag

the copper cathodes in those regions where slag was not present. The intercathode insulators were cracked but much less extensively than those at the anode.

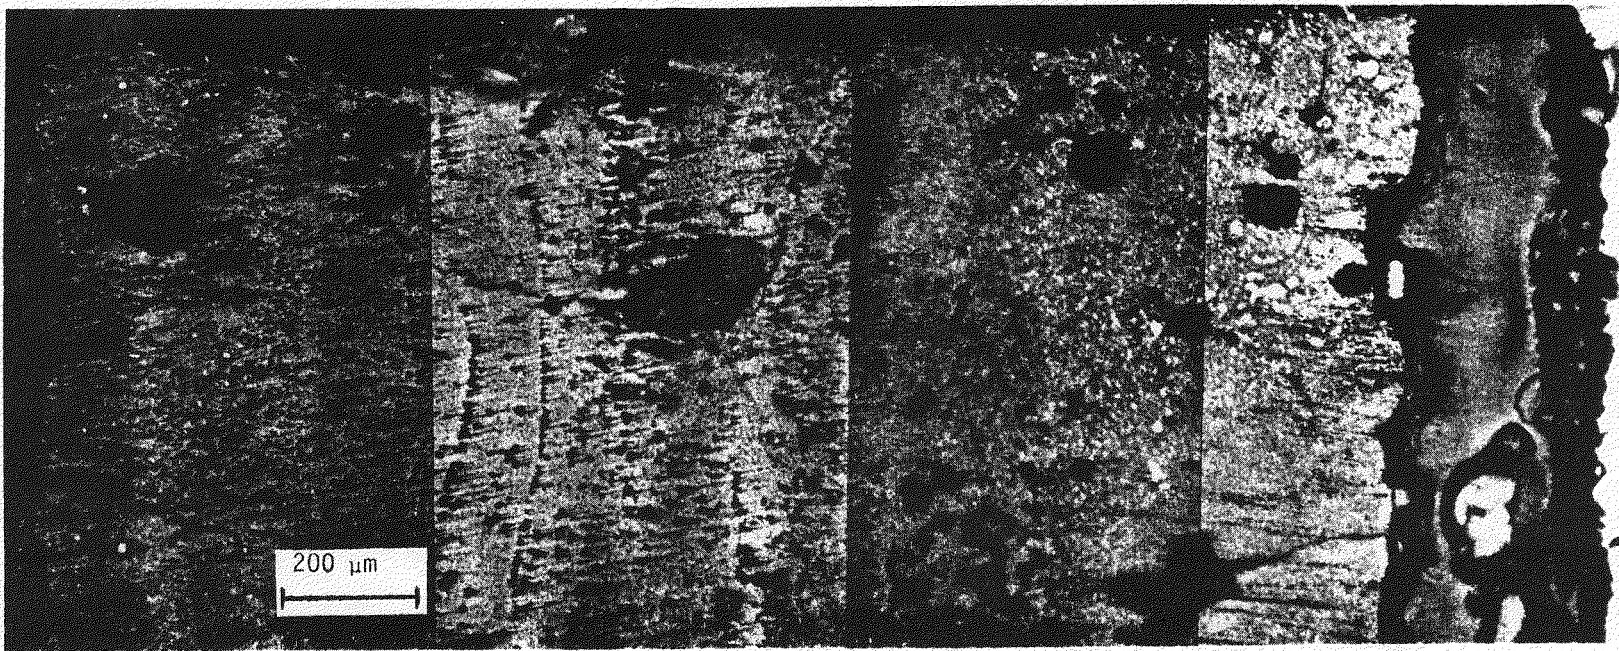
Figure 52. Cross-Section of Slag Layer Adhering to Copper Anode No. 8/WESTF Test No. 40

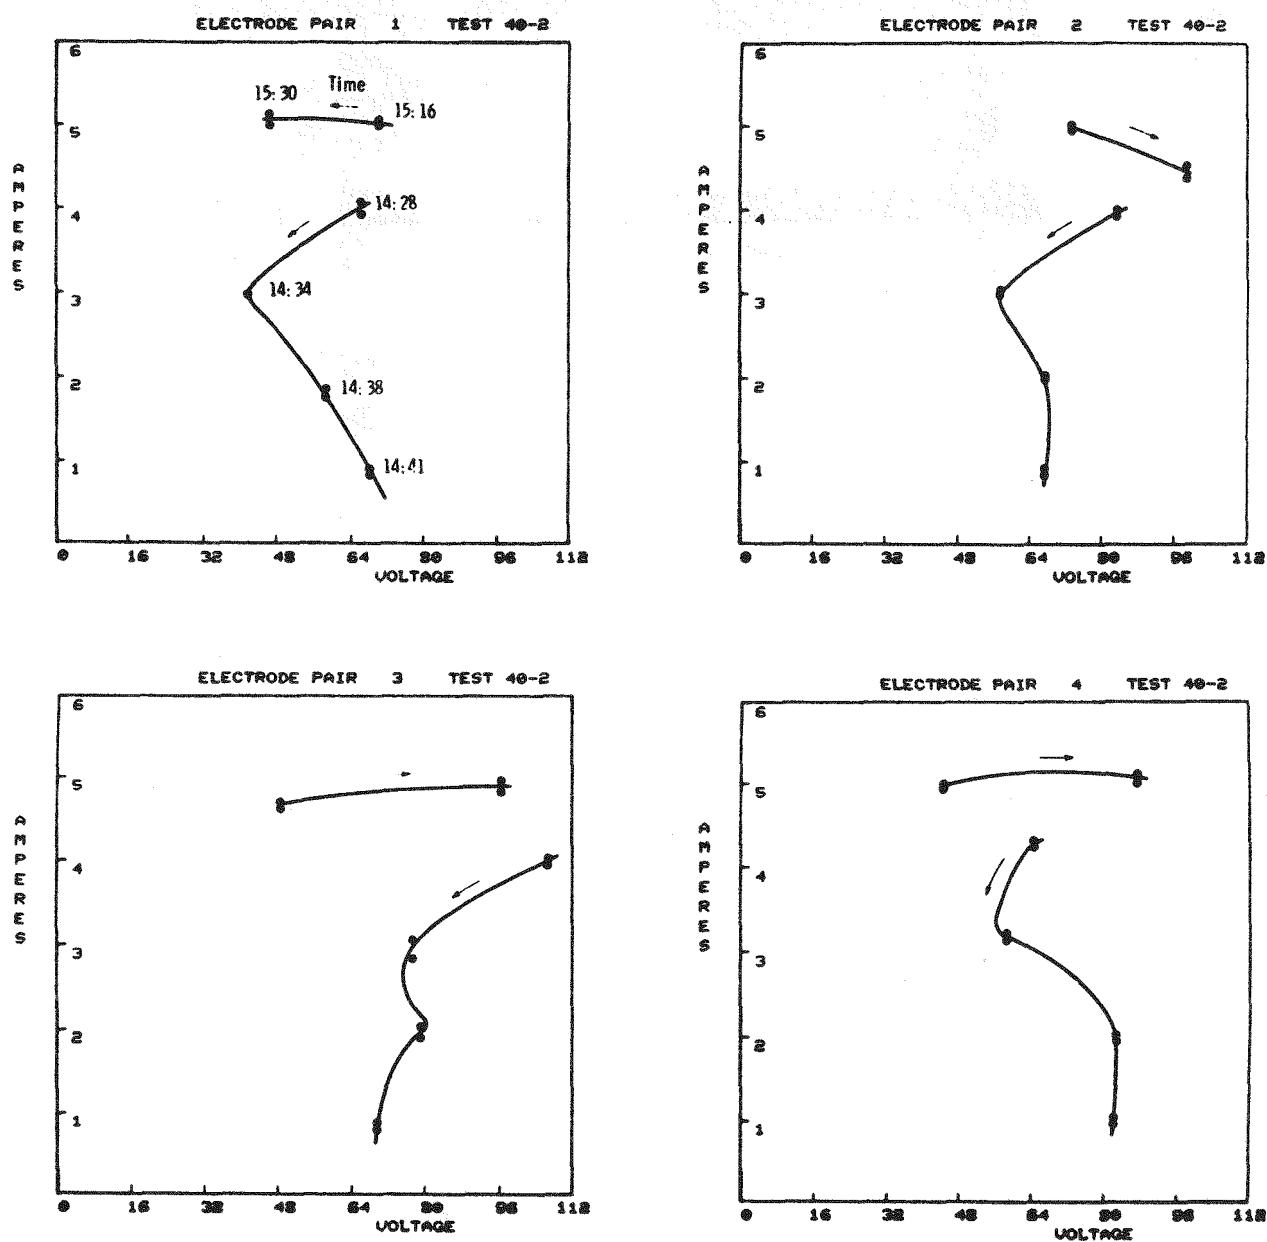
Figure 58. Amperes through Different Electrode-Pairs as Function of Impressed Voltage, Test 40 - Run 2

Voltage threshold effects can be seen in the curves for the first five electrode-pairs and in the curves for electrode-pairs 8 and 12. The remaining electrode-pairs either have a less-pronounced voltage threshold or a voltage threshold is

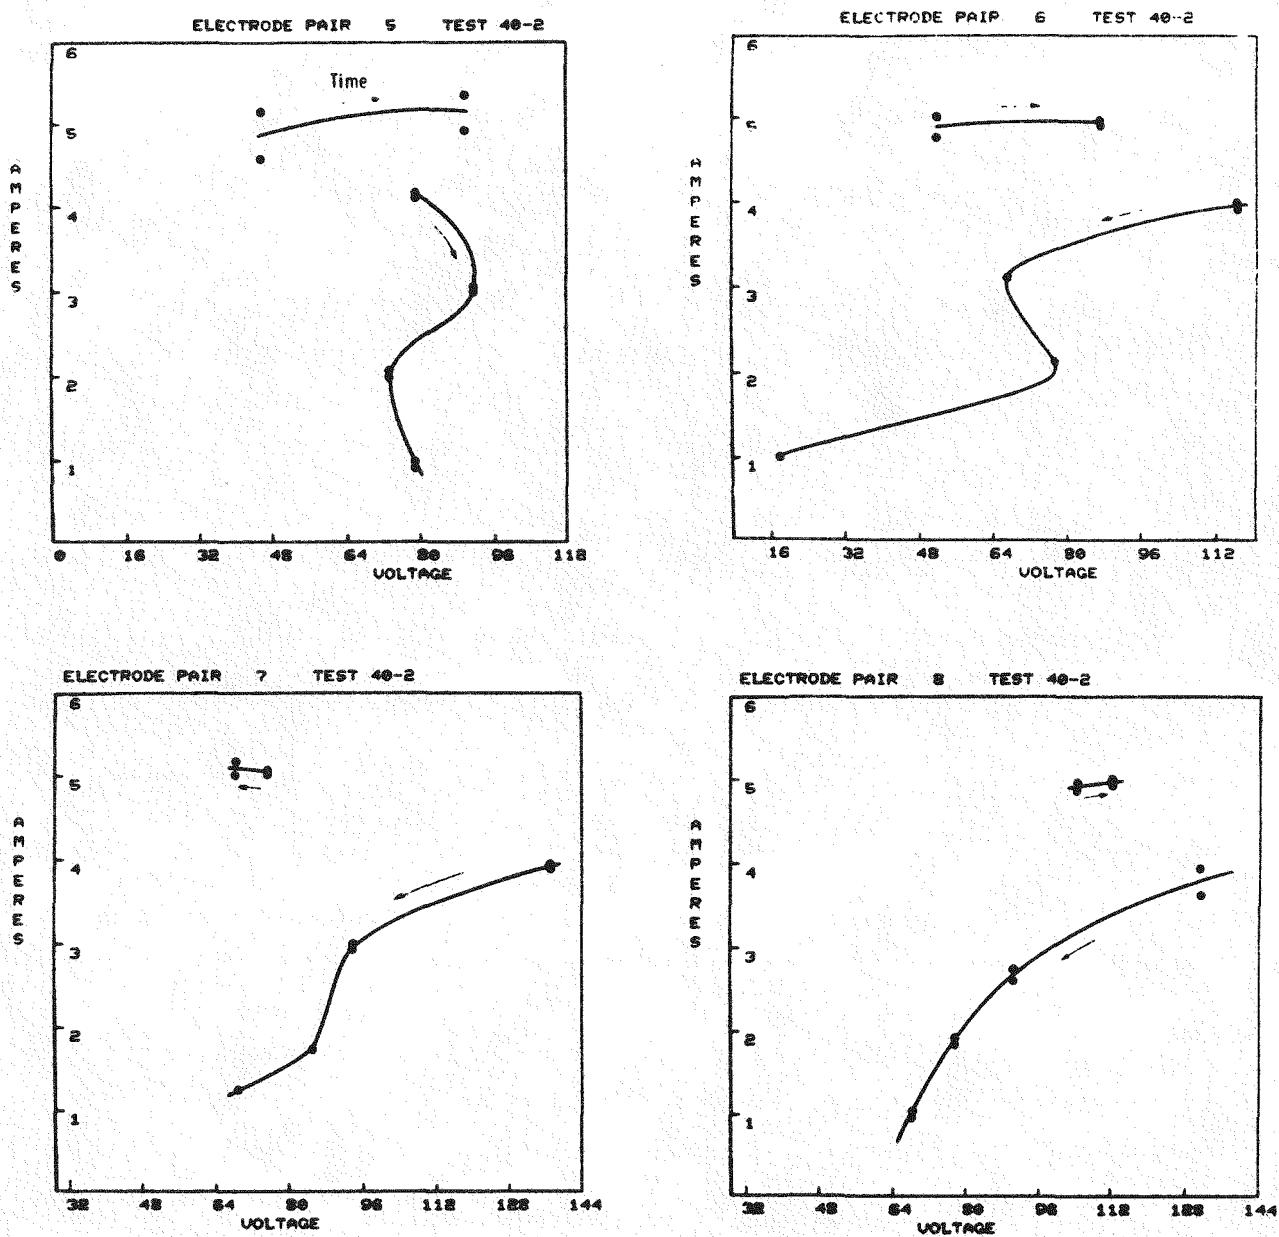
Figure 59. Amperes through Different Electrode-Pairs as Function of Impressed Voltage, Test 40 - Run 2

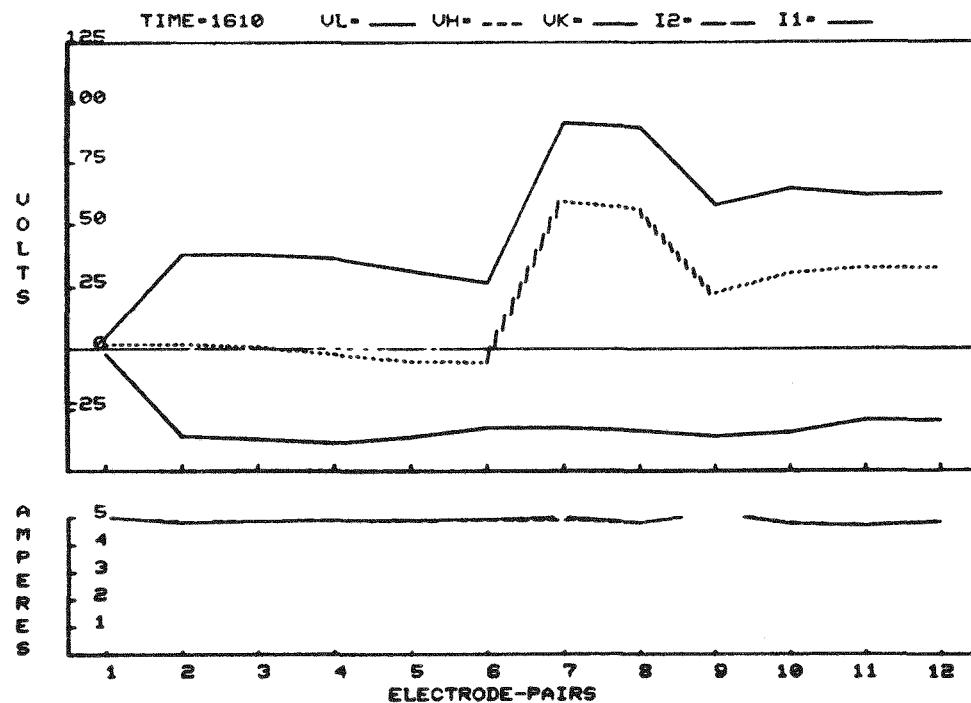
Figure 63. Applied Voltages and Currents, WESTF Test 40 - Run 3, No Axial Voltage

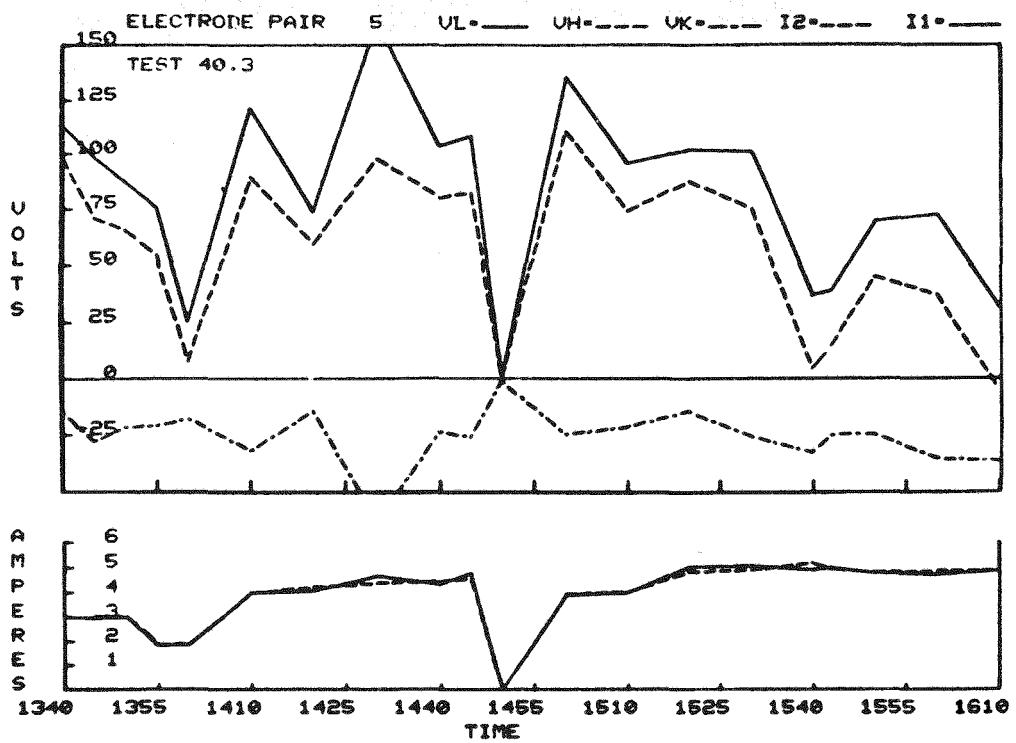
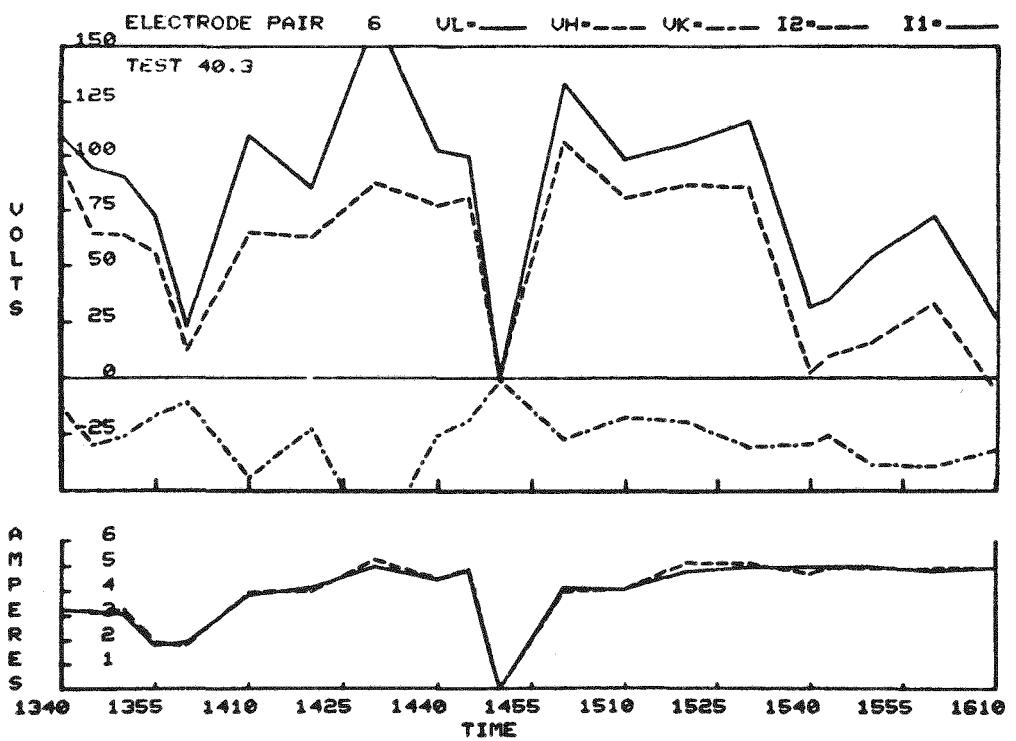
Figure 64. Voltages and Current through Different Electrode-Pairs as Function of Time, Test 40 - Run 3

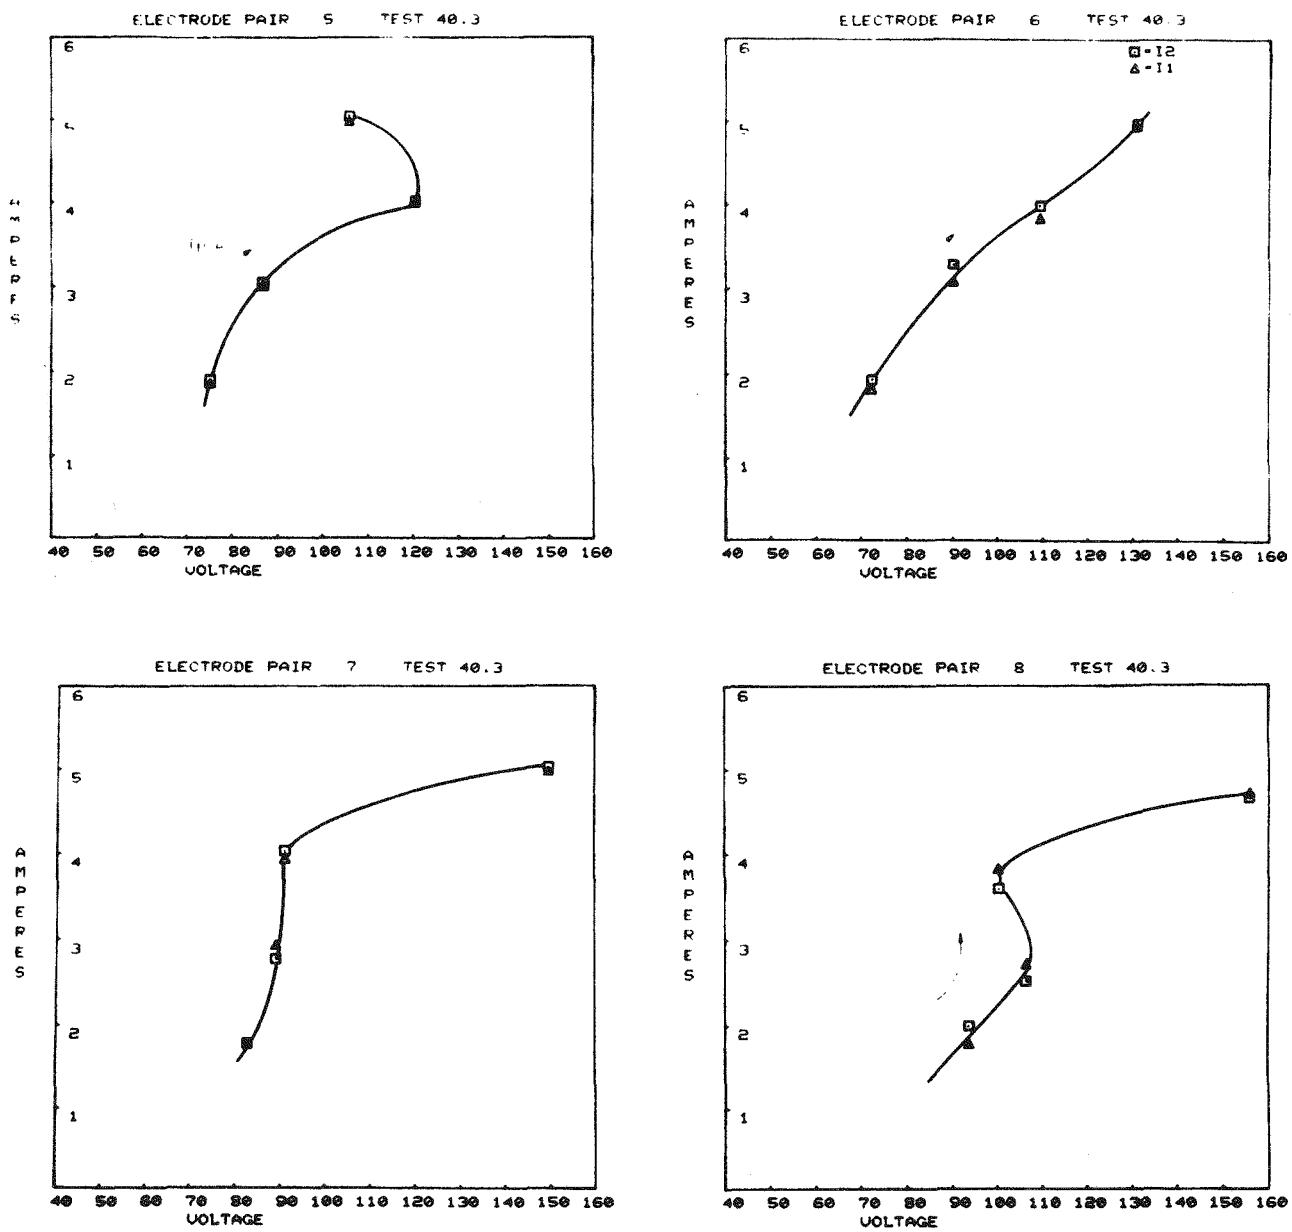
Figure 67. Currents through Different Electrode-Pairs as Function of Impressed Voltages, Test 40 - Run 3, 1350 to 1424 Hours

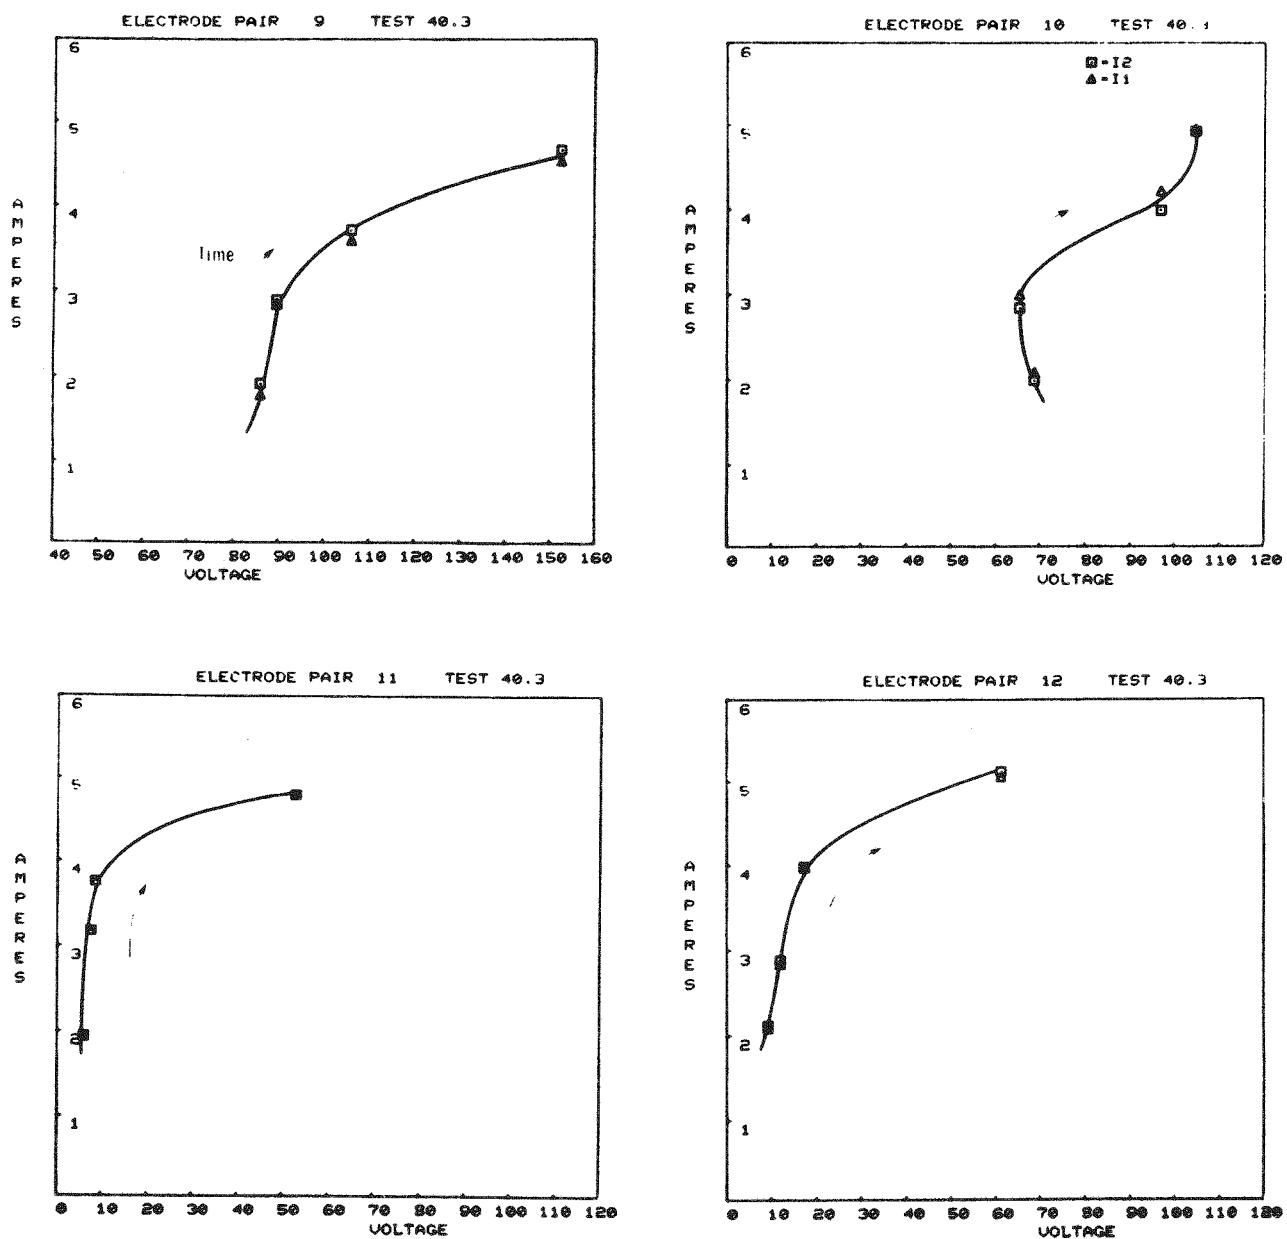
Figure 68. Currents through Different Electrode-Pairs as Function of Impressed Voltages, Test 40 - Run 3, 1350 to 1424 Hours
