MHD ELECTRODE DEVELOPMENT

Quarterly Report for January—March 31, 1979

Westinghouse Electric Corporation
Advanced Energy Systems Division
Pittsburgh, Pennsylvania

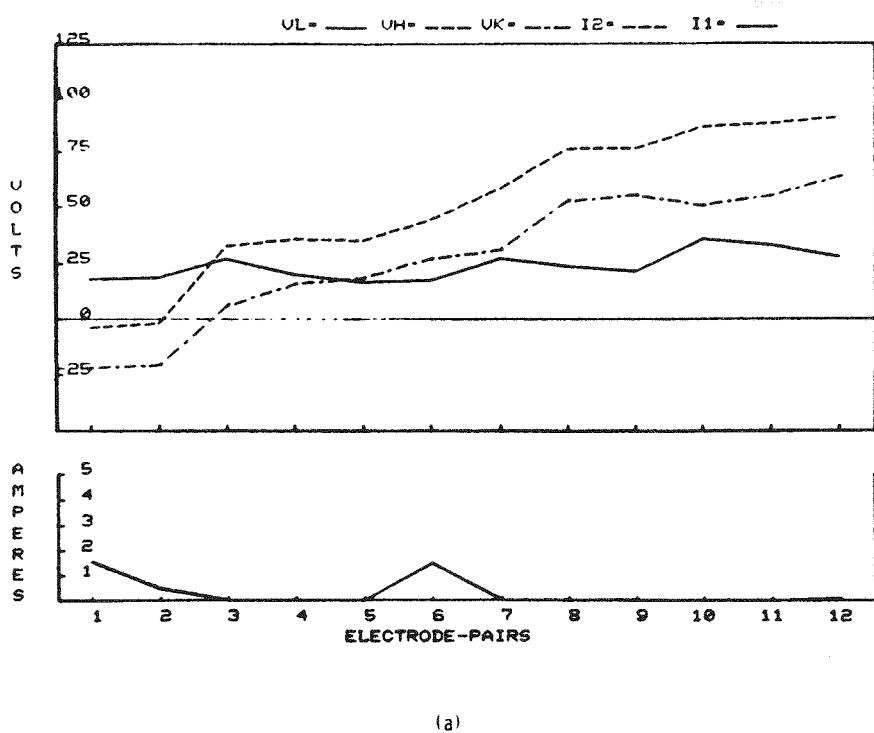
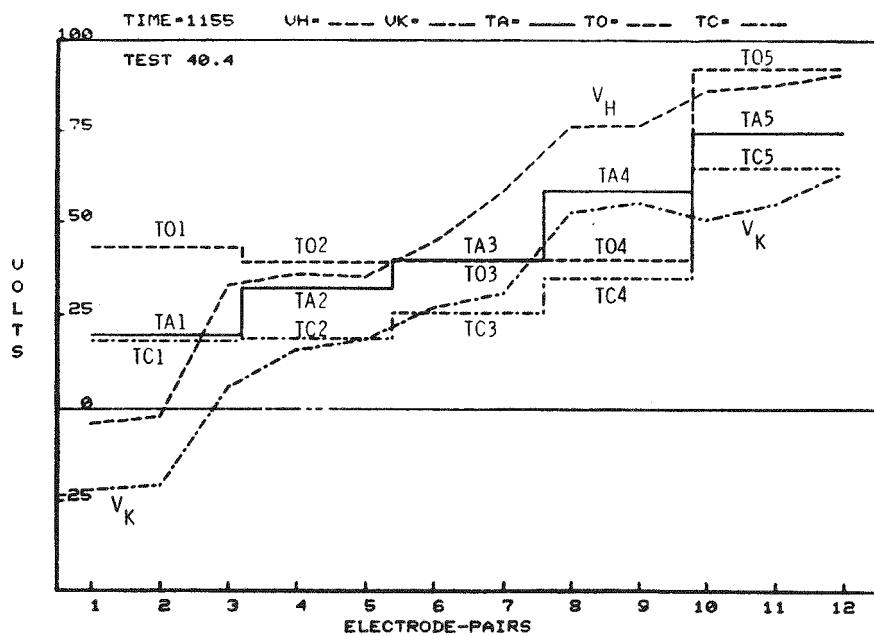
Figure 70. Applied Voltages, Currents and Floating Potentials of Water-Cooled Copper Heat Sinks in Top Insulating Wall, with Anode Axial Voltage of 98.2V, 5.3 Amperes, Time 1155, Test 40 - Run 4

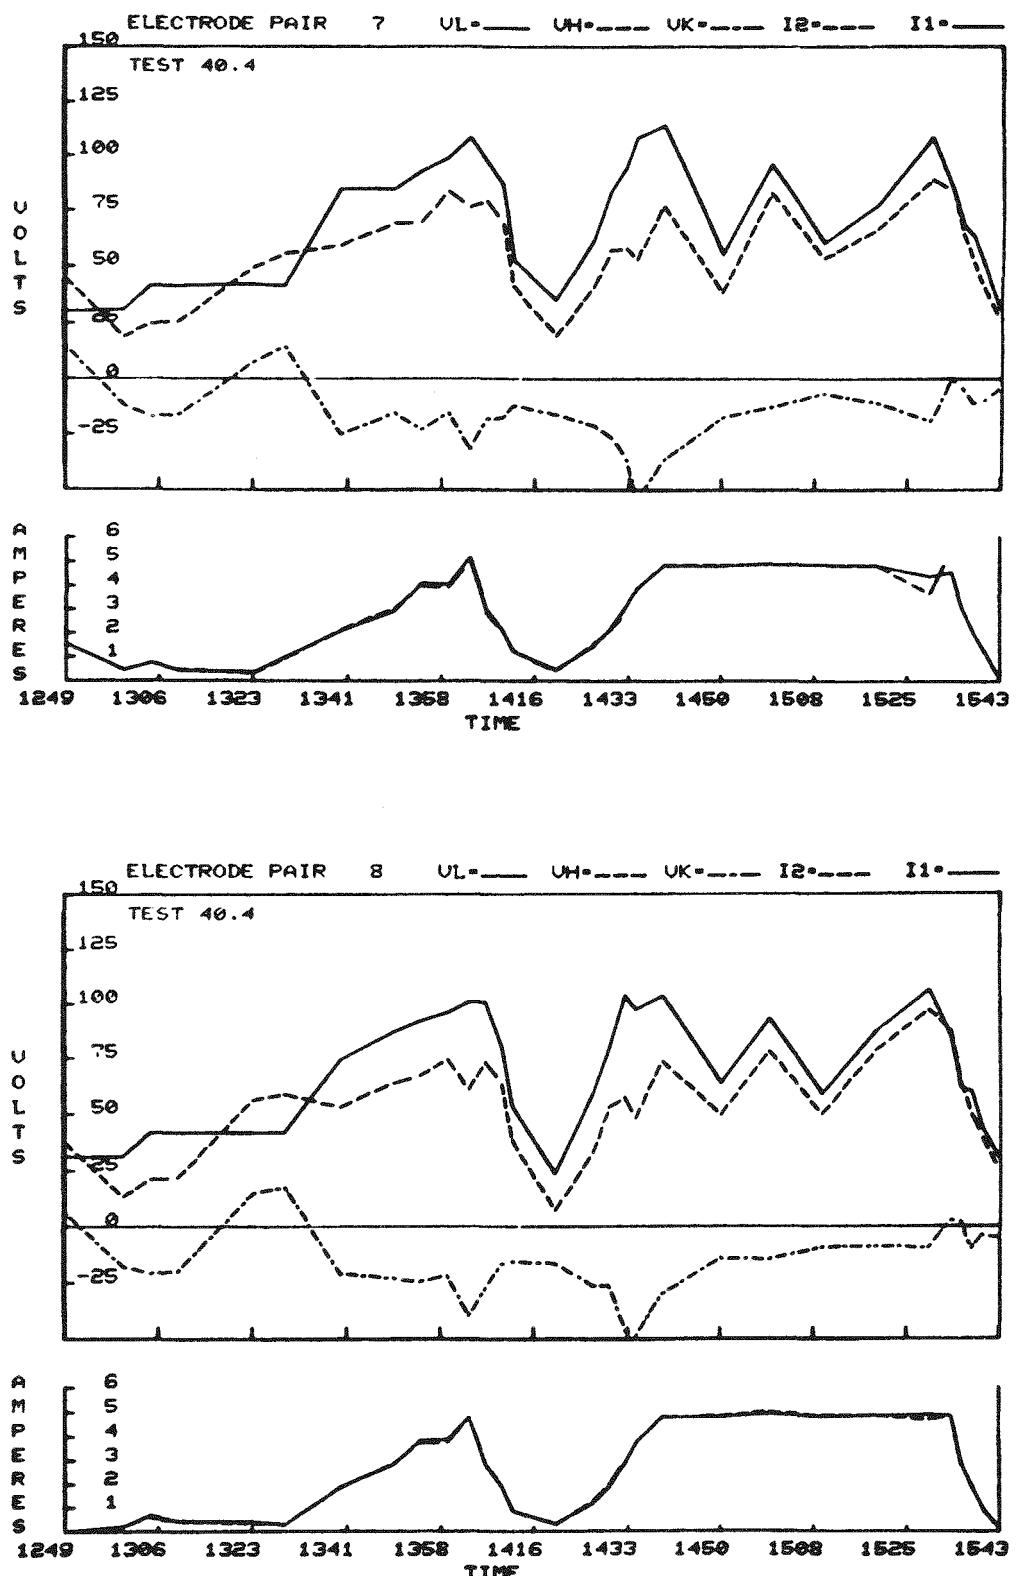
Figure 75. Voltage and Current Characteristics of Different Generators

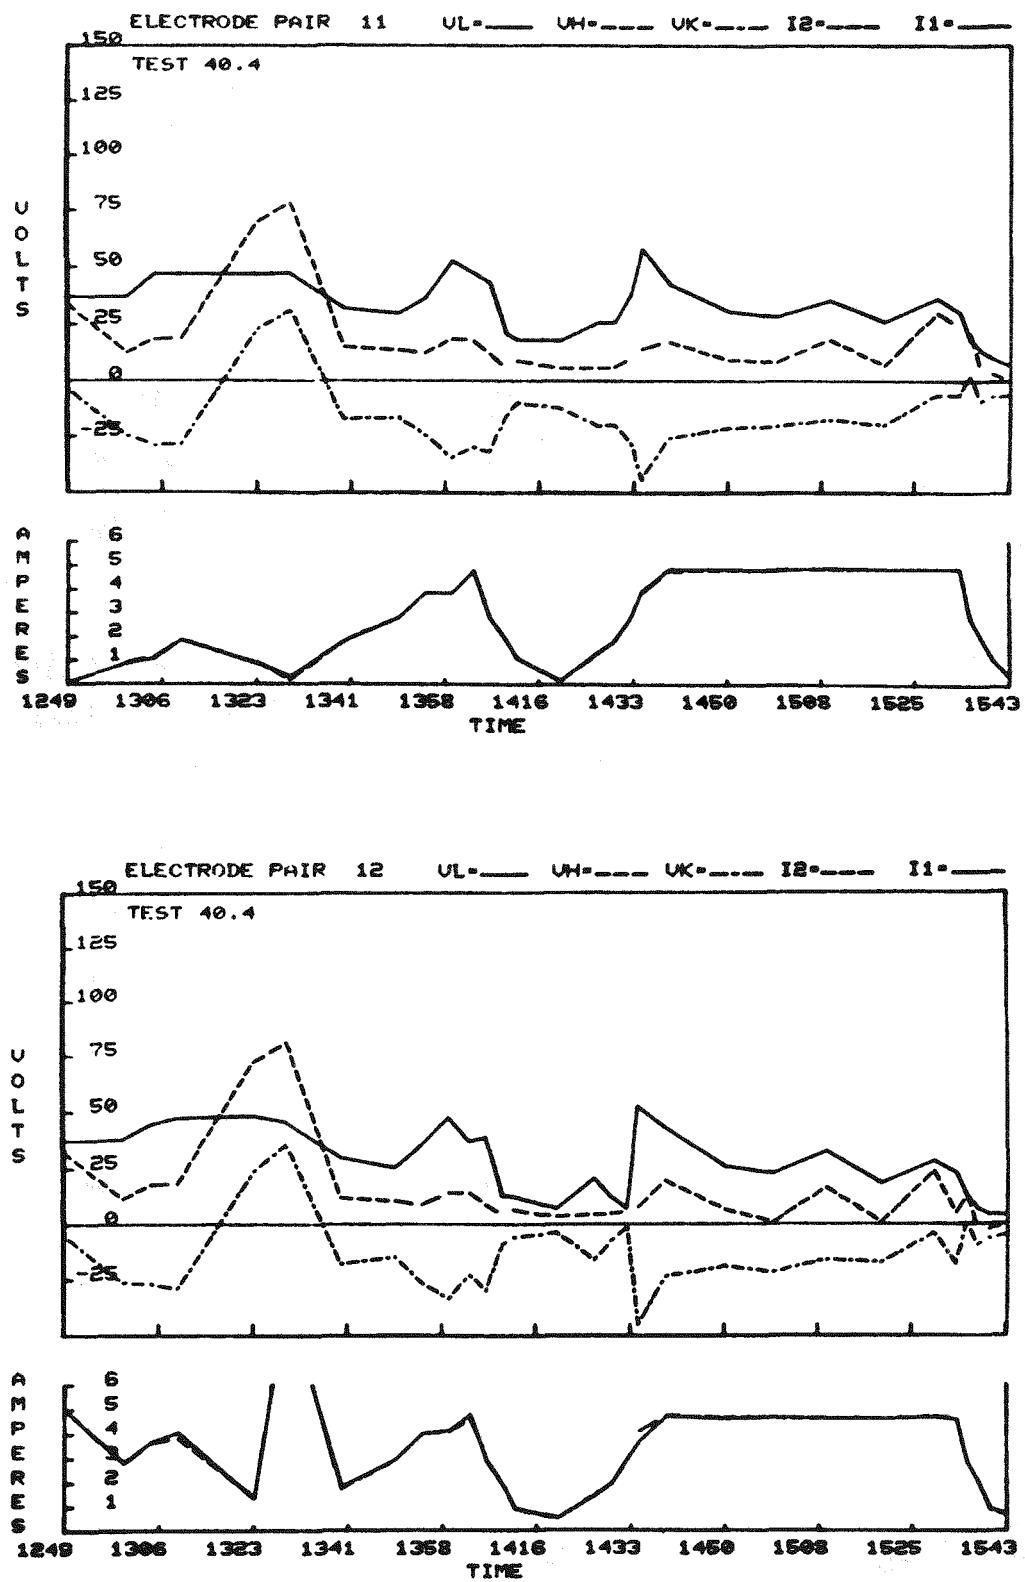
Figure 76. Voltage and Current Characteristics of Different Generators

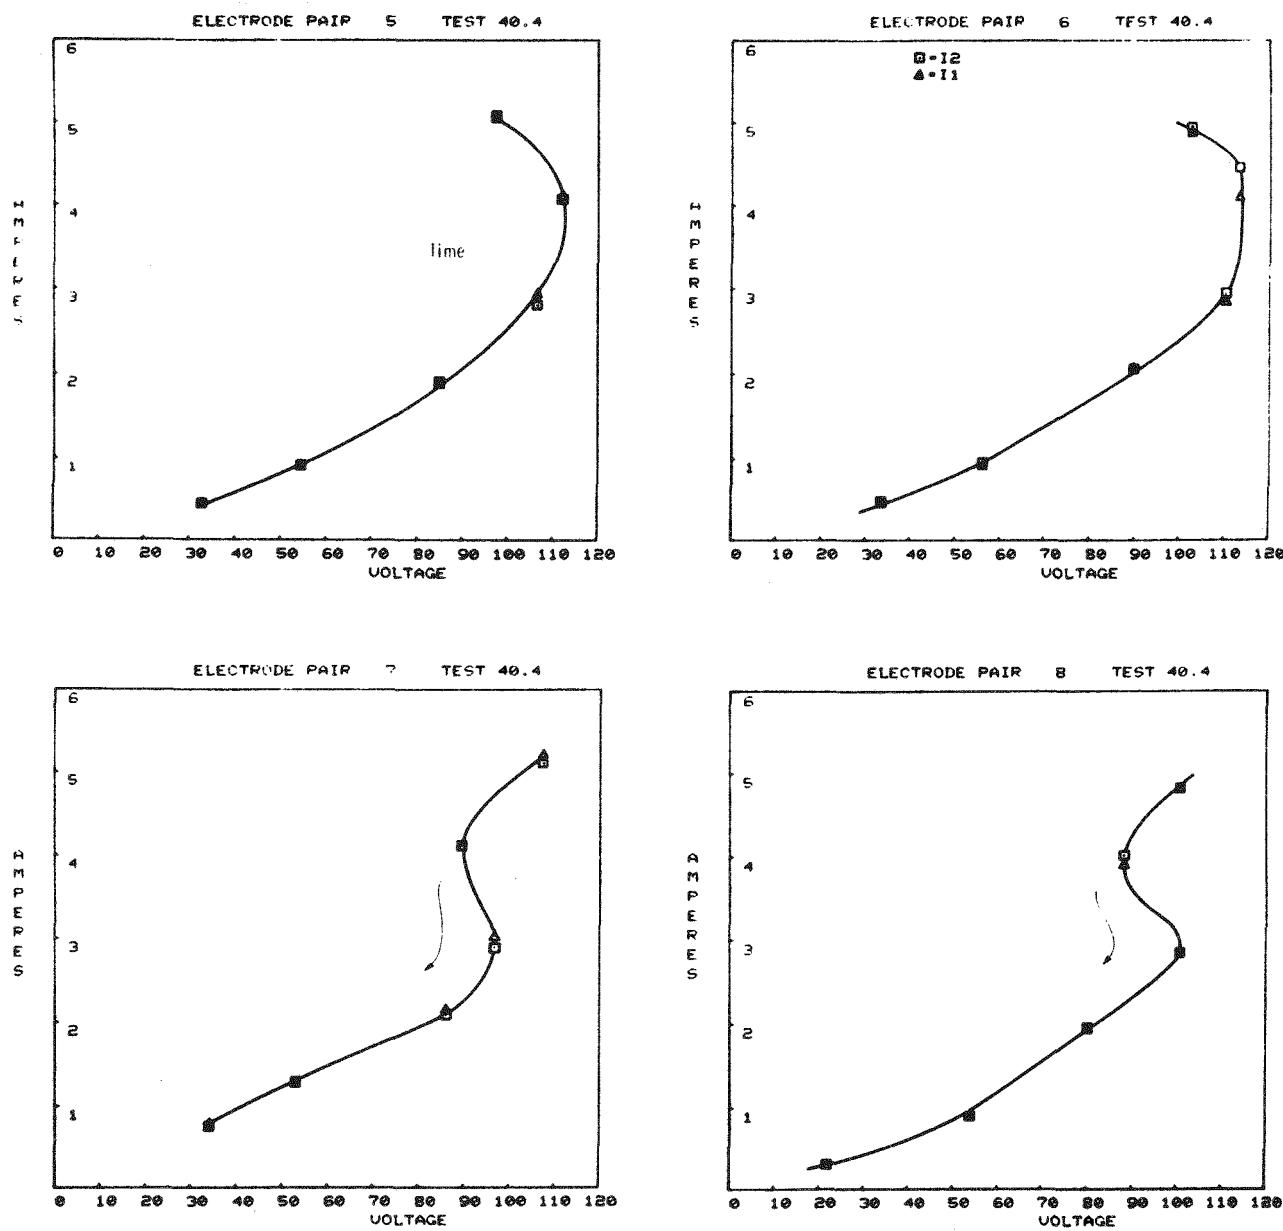
Figure 77. Currents through Different Electrode-Pairs as Function of Impressed Voltages, Test 4 - Run 4, Time 1404 to 1416 Hours, Current Decreasing

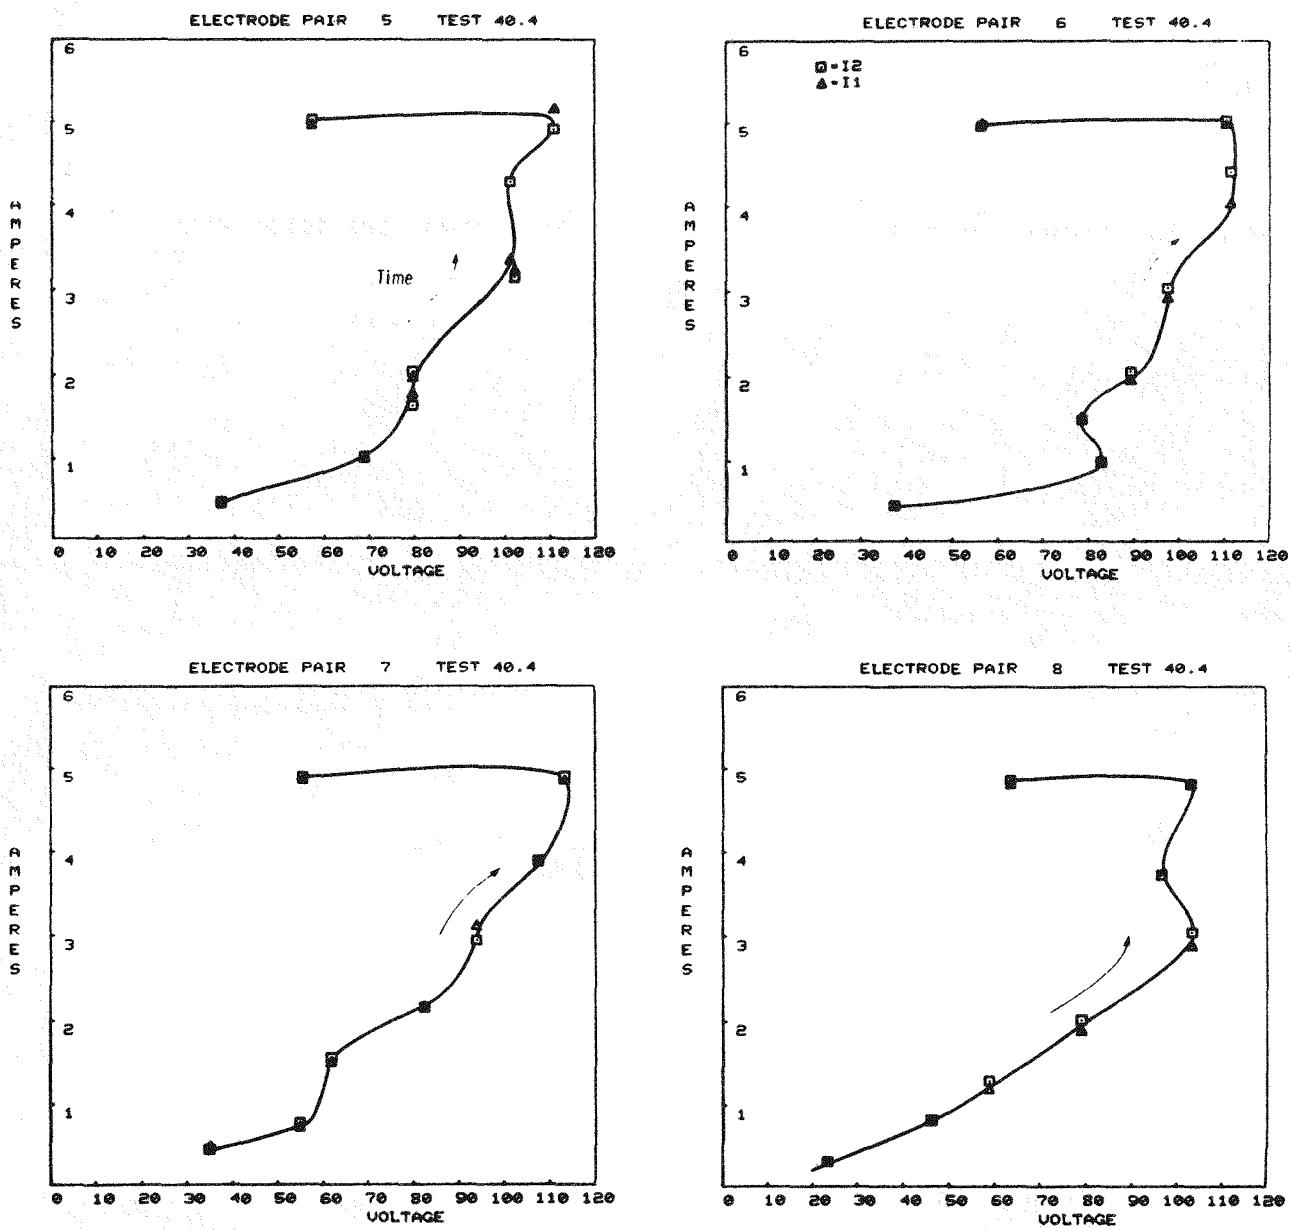
Figure 78. Currents through Different Electrode-Pairs as Function of Impressed Voltages, Times 1420 to 1451, Increasing Current, Test 40 - Run 4

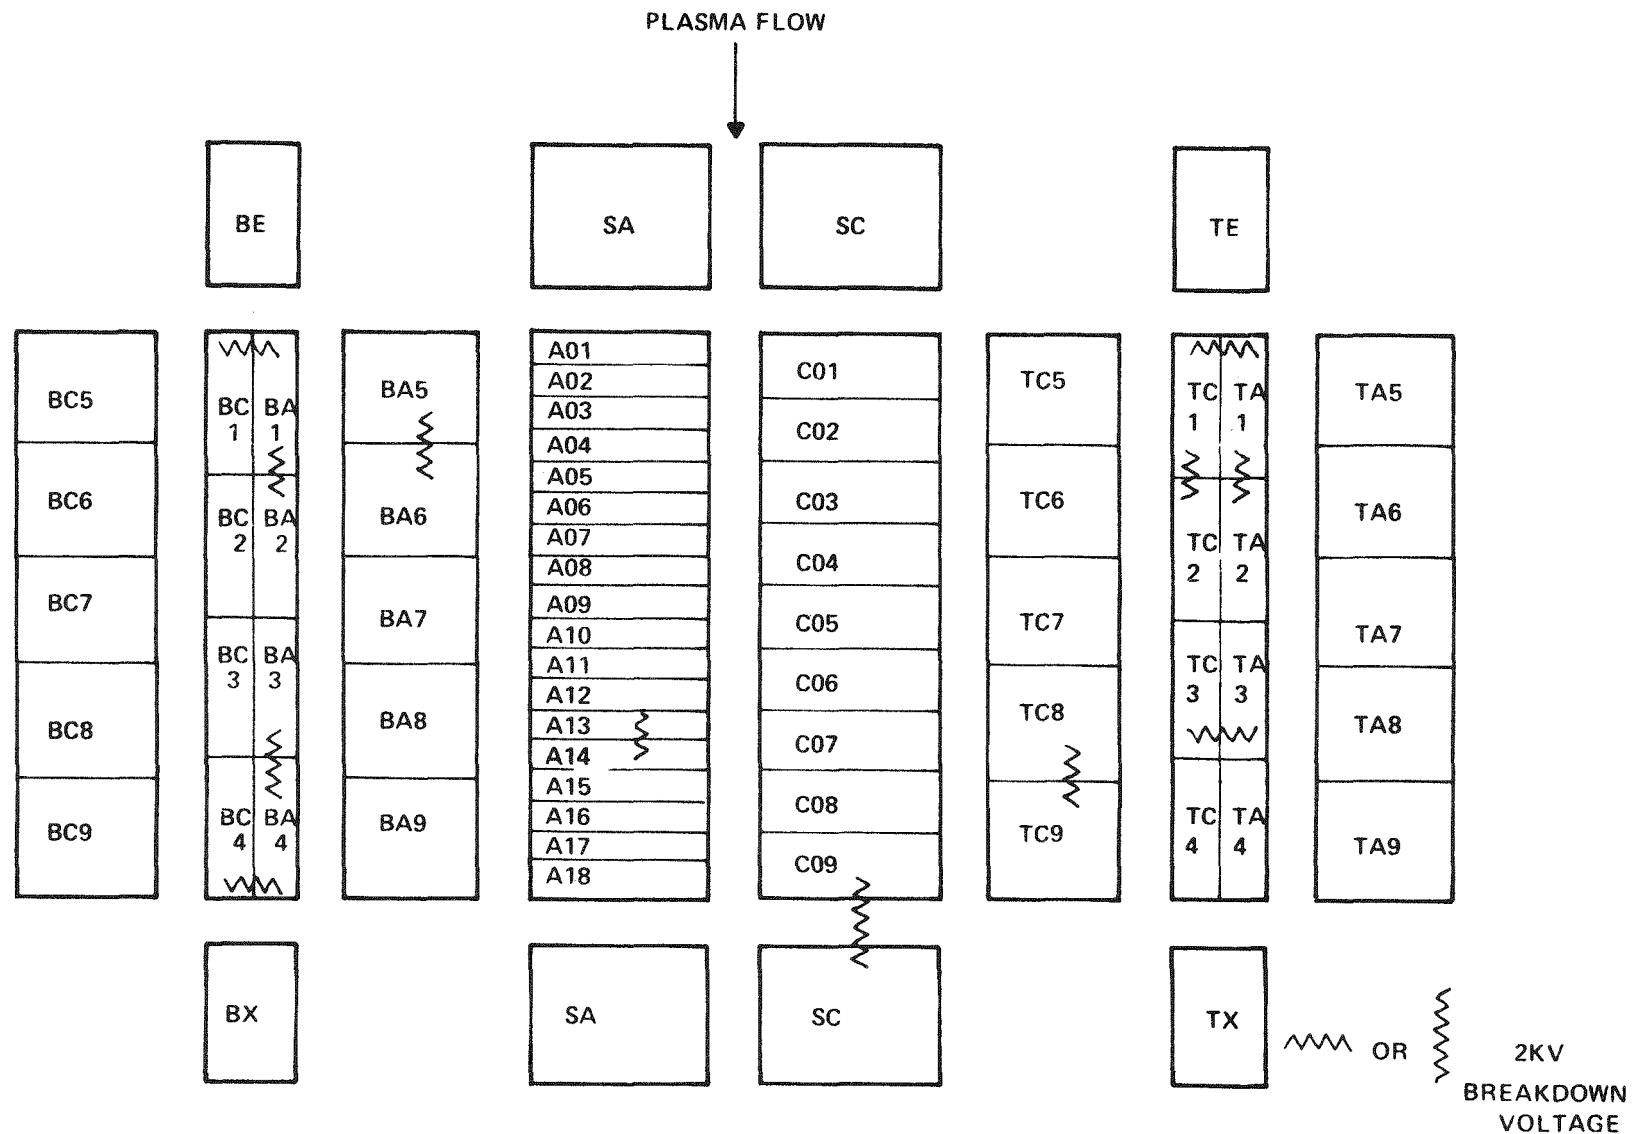
Figure 81. Channel Schematic - Test 41

In order to initiate the passage of load current it was usually necessary to bring the voltage up to a "breakdown" voltage. Once breakdown was initiated the voltage required to impress a given current tended to drop. Electrode pairs
