TUBING WASTAGE IN FLUIDIZED-BED COAL COMBUSTORS
(GRIMETHORPE PFBC TUBE BANK "E")

By
Charles E. Witherell

Prepared for
U.S. Department of Energy
Morgantown Energy Technology Center
Morgantown, West Virginia 26507-0880

Prepared by
Lawrence Livermore National Laboratory
Livermore, California 94550-0808

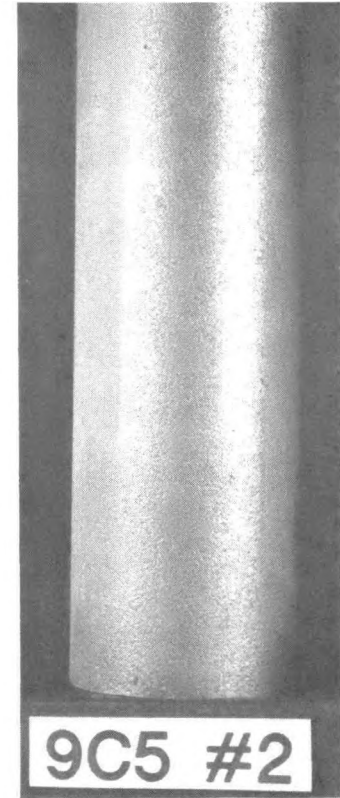
FIGURE 4

Appearance of As-Received Tubing Sample 9C5

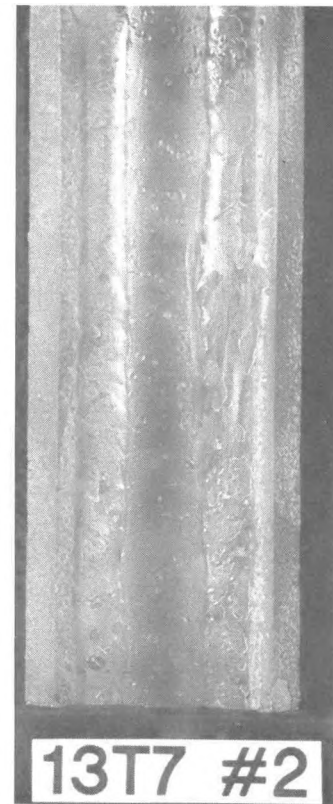
FIGURE 7

As noted in Table 1, three of the tubes submitted for study had been grooved in a helical pattern around their peripheries. These grooves are clearly evident in some photos of the as-received tubes (Figures 2 and 3) but they are probably not discernible in Figure 7 although they were distinguishable in some regions of the actual tube of Figure 7 (13T7) during visual examination.

Appearance of As-Received Tubing Sample 13T7

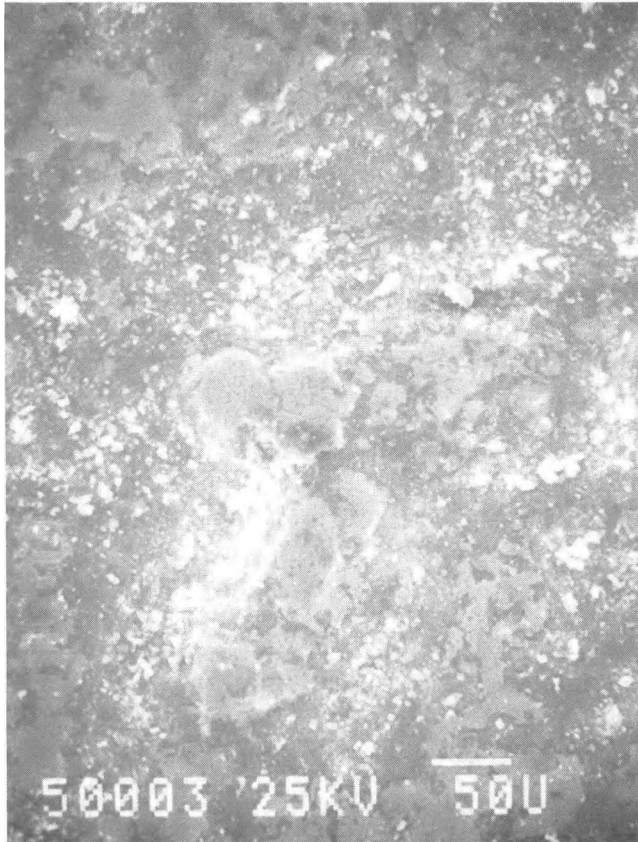
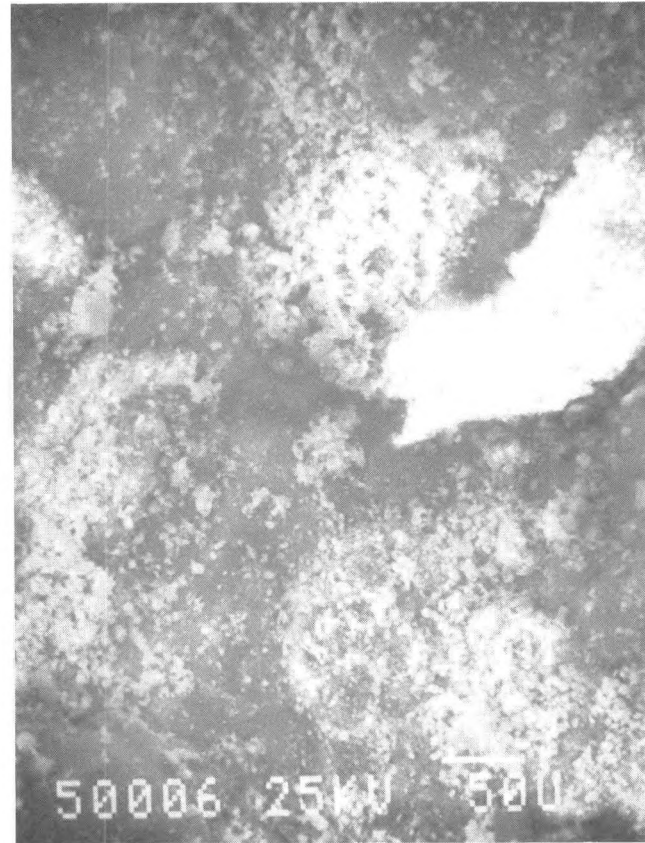
FIGURE 11

The surface of the unfinned chromized tube 9C5 revealed a roughly-pebbled texture with adherent debris in-between. The higher protrusions - particularly at the underside - appeared burnished, shiny, and smooth.

Appearance of Fireside Surface of Tubing Sample 9C5
(SEM Photomicrographs)
