**OAK RIDGE
Y-12
PLANT**

RECYCLE OF NITRIC ACID
AND ALUMINUM NITRATE

Preprint for submission to:
Waste Minimization Meeting
Y-12 Plant, Oak Ridge, Tennessee
July 8, 1991

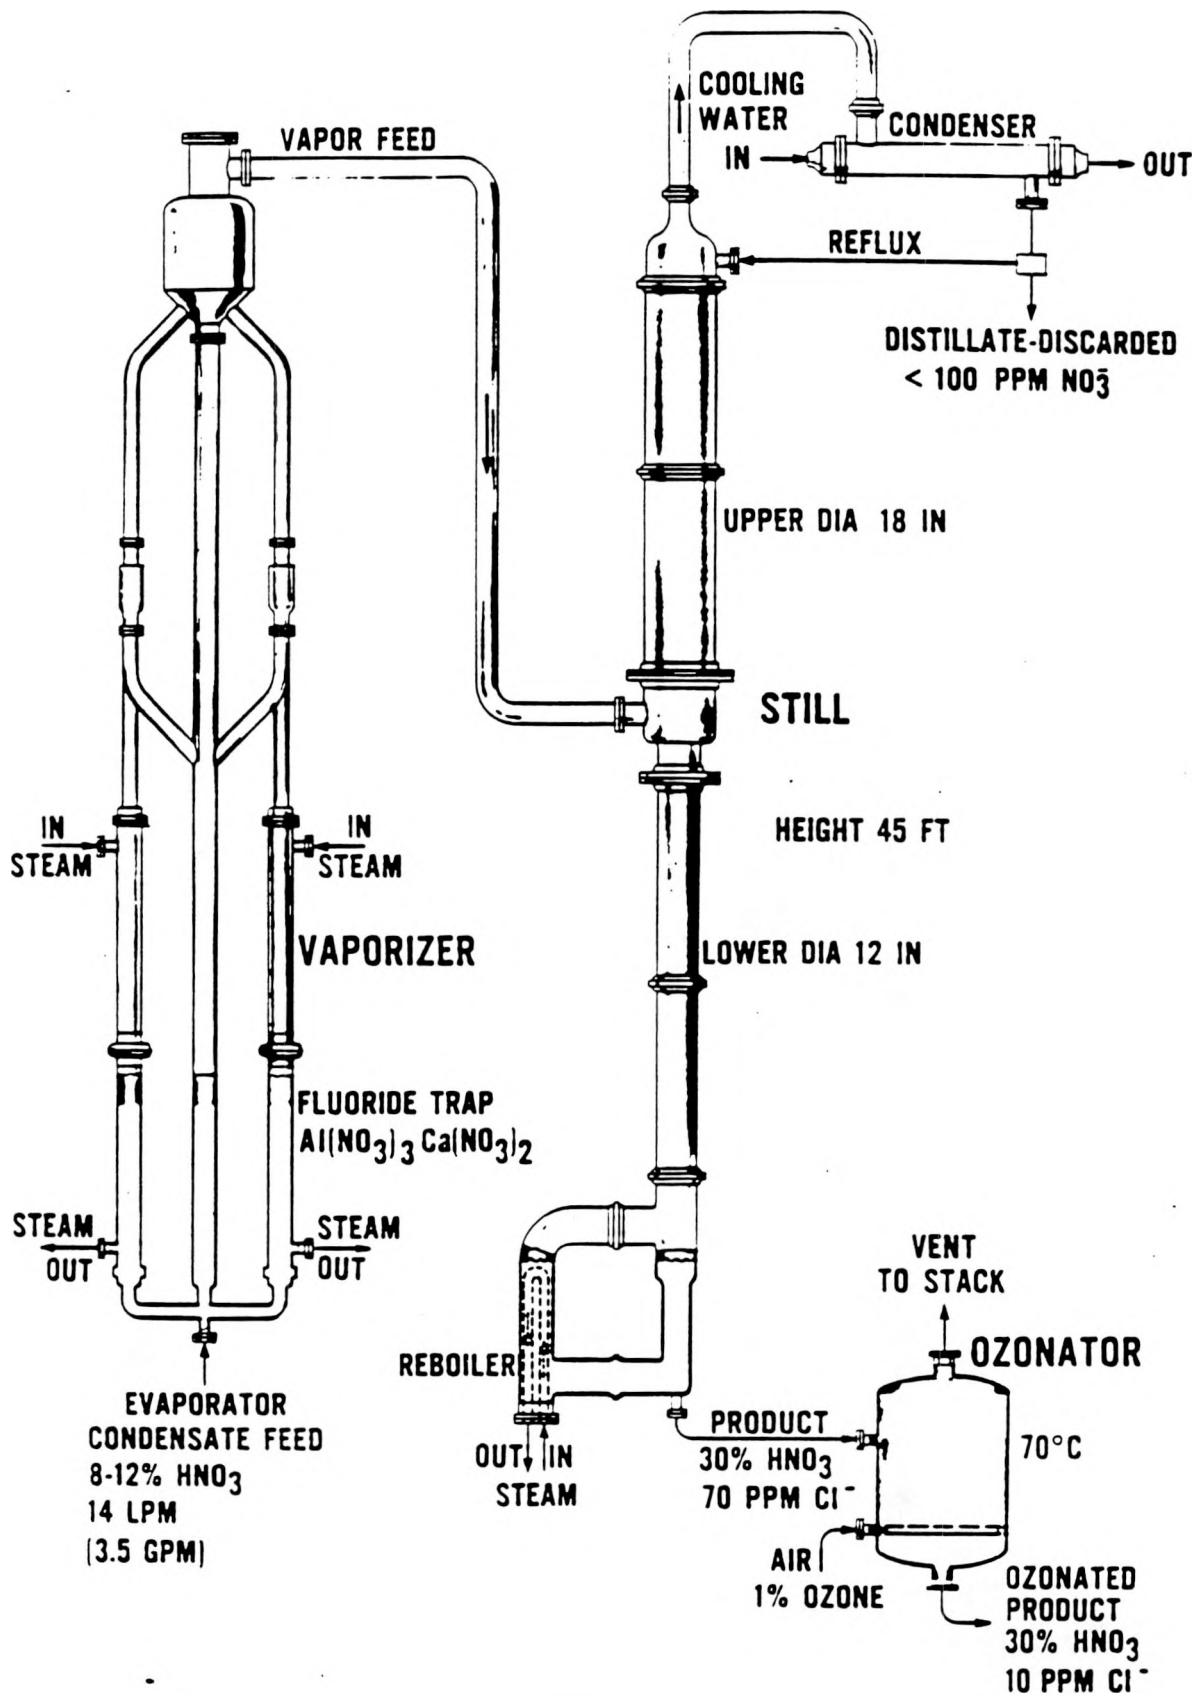
FIGURE 4

NITRIC ACID RECYCLE.

Recycle of Condensates - One of the waste streams was a dilute nitric acid stream (condensate) which contained trace amounts of impurities. In order to recycle the acid, it had to be concentrated to at least 30 wt. % and most of the impurities had to be removed. The increase of the impurities (i.e., chlorides and fluorides) during the evaporation and concentration of the dilute nitric acid caused major problems related to the materials of construction of the distillation equipment. Also, the trace quantities of certain organic impurities created potential safety problems due to their reactivity with the hot, concentrated nitric acid product.

The vapors from the salt bath are fed to a 50 ft. long glass distillation column which has a steam heater encased in tantalum in the re-boiler. Originally the acid was to be concentrated to 50 wt. % but trace amounts of organics from the solvent extraction process were found to be present. To prevent an organic-hot nitric acid reaction in the column, a decision was made to produce a 30 wt. % nitric product. No organic reaction is known to occur under these conditions. Most of the chloride ions remain in the 30 wt. % nitric acid product and an ozonation step was added to remove

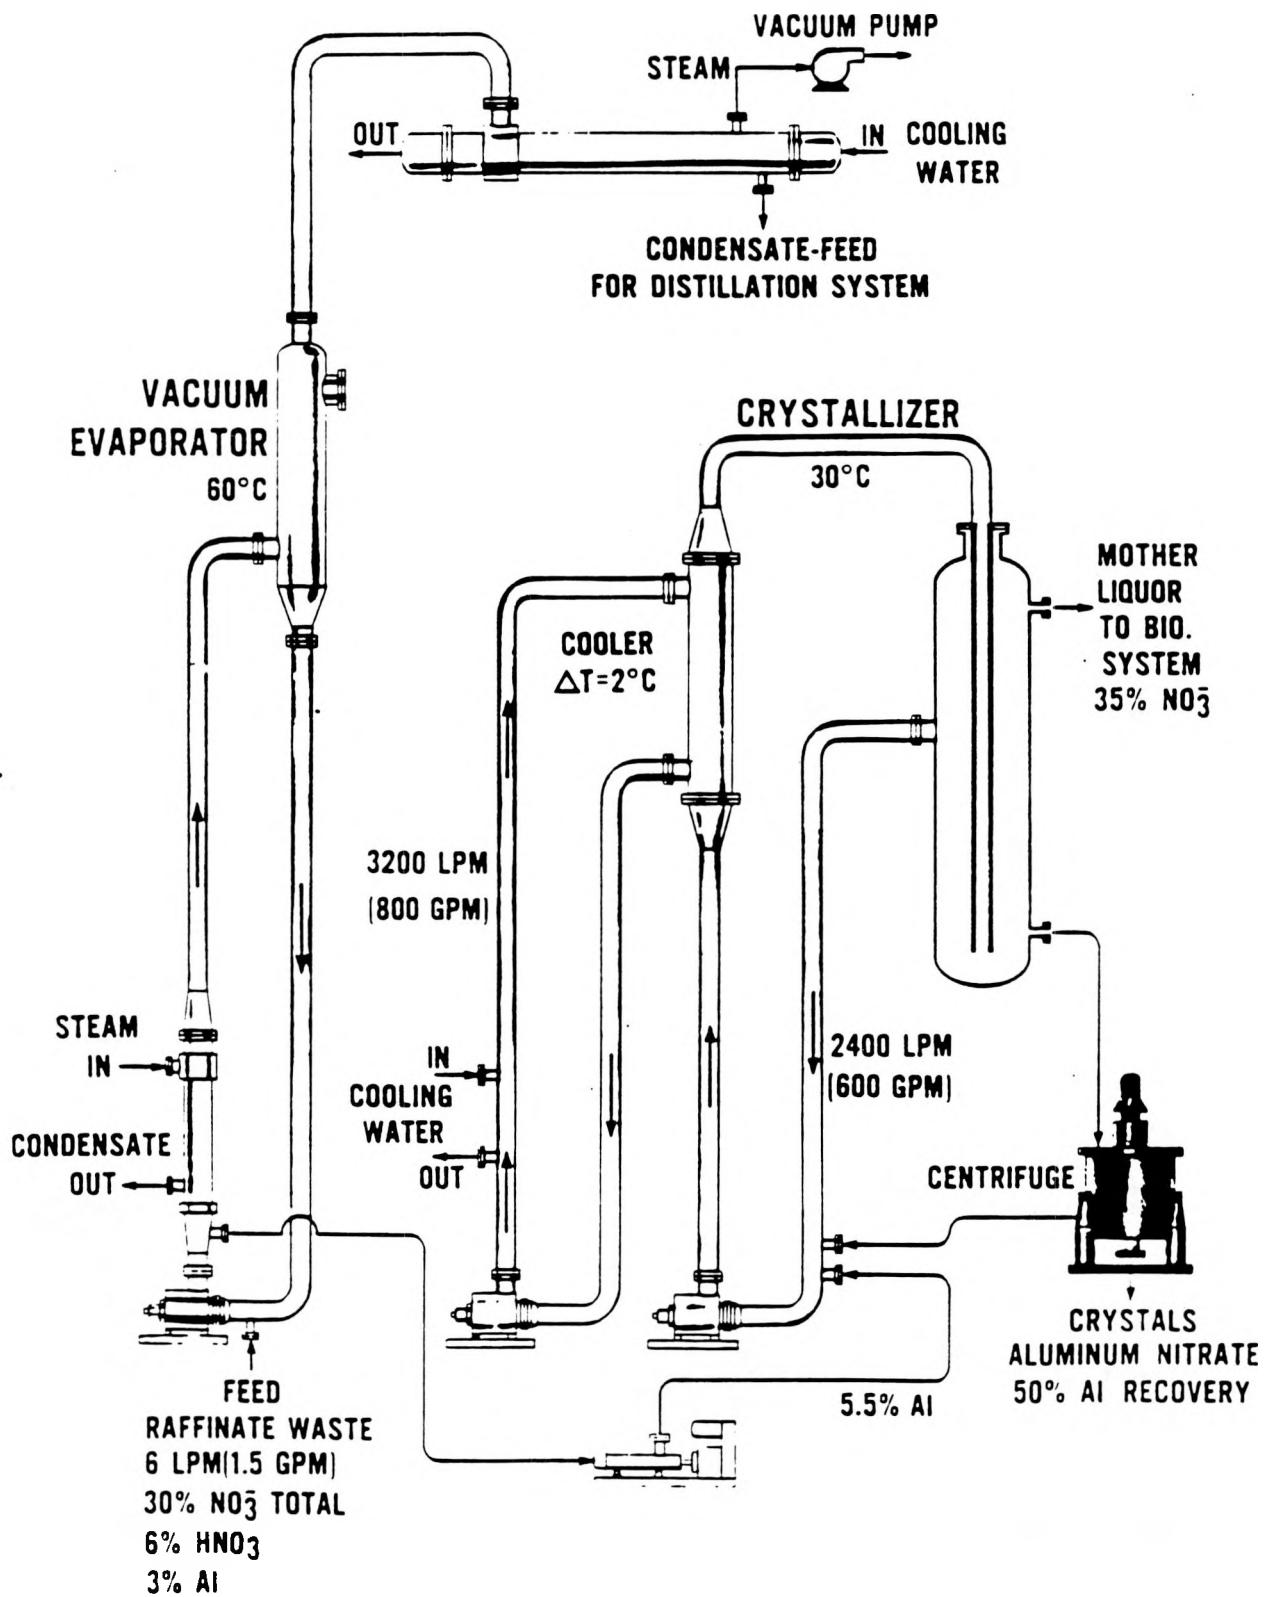
FIGURE 8

ALUMINUM NITRATE RECYCLE.

Recycle of Aluminum Nitrate - Typical chemical analysis of raffinate wastes are shown in Figure 7. As noted in Figure 8 (photo 174439), the raffinate waste is evaporated under vacuum at 60°C to concentrate the aluminum nitrate and to remove the free nitric acid in the overhead condensate. The acid is returned to the distillation process and is recycled to the plant. The density of the raffinate in the evaporator is controlled at 1.46 g/mL when measured at 60°C. A stream from the vacuum evaporator is fed to a cooler (30°C) and then into a crystallizer where the aluminum nitrate nanohydrate crystal increase in size. The solution is then put into a batch type centrifuge to remove most of the crystals. The crystal free solution is returned to the evaporator. Part of the solution is taken off as a waste stream to a holding tank where it is diluted with water to about 30 wt. % nitrate ion level and becomes the feed solution for the biological reactor. This waste solution, called mother liquor, contains the impurities from the uranium extraction process.

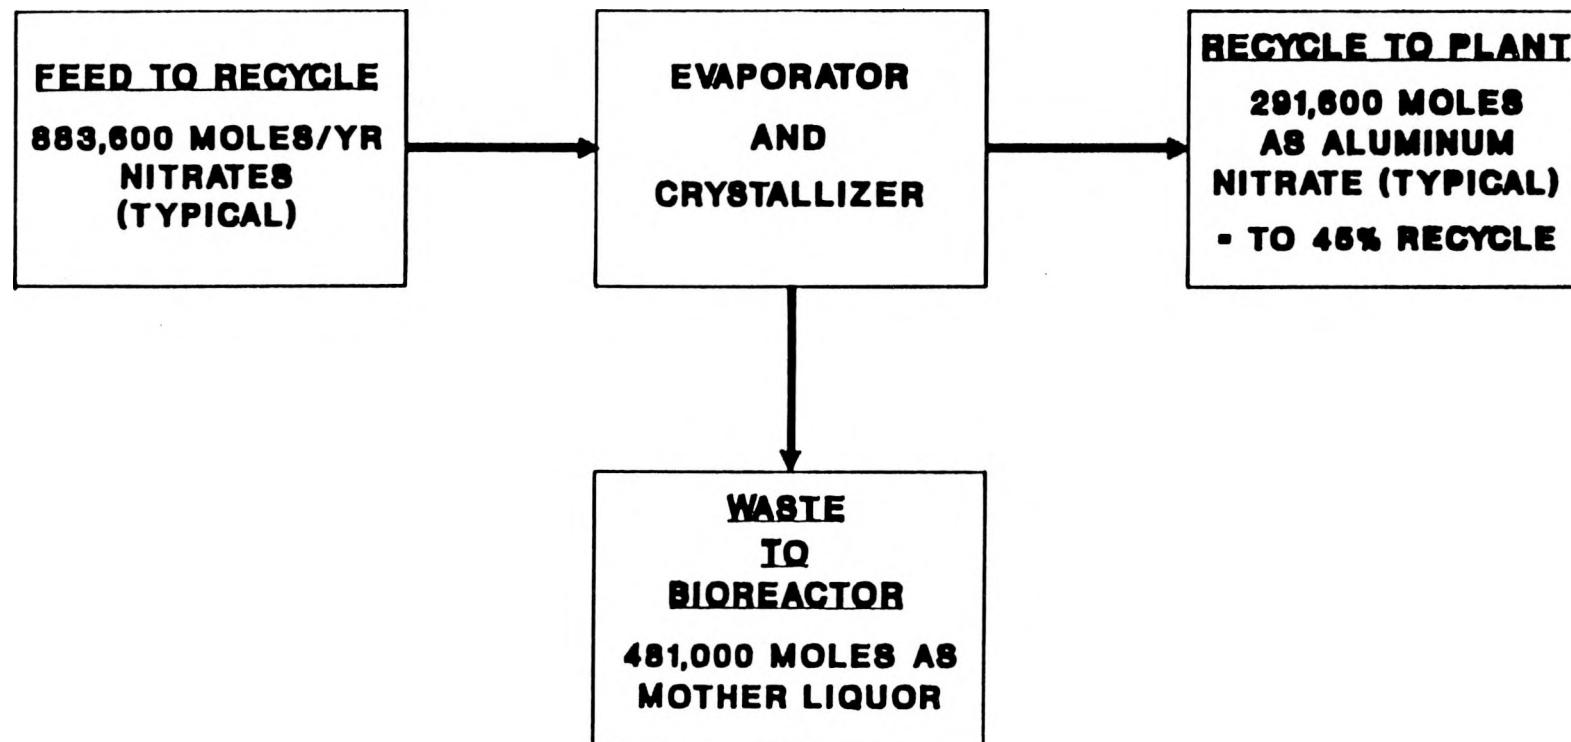
FIGURE 9

ALUMINUM NITRATE RECYCLE

Approximately 40 to 60 wt. % of the aluminum nitrate and all of the free nitric acid is recycled (Figure 9). The purity of the product is equal to or better than aluminum nitrate nanohydride prepared in the normal procedure (i.e., dissolving aluminum oxide trihydrate in 50 wt. % nitric acid). Recycle of the aluminum nitrate has reduced the purchases of nitric acid and aluminum oxide by about 30%. Future plans are being made to increase the amount of recycled aluminum nitrate and 20% more aluminum nitrate crystals are expected to be recycled without a significant increase in the impurities occurring in the product.

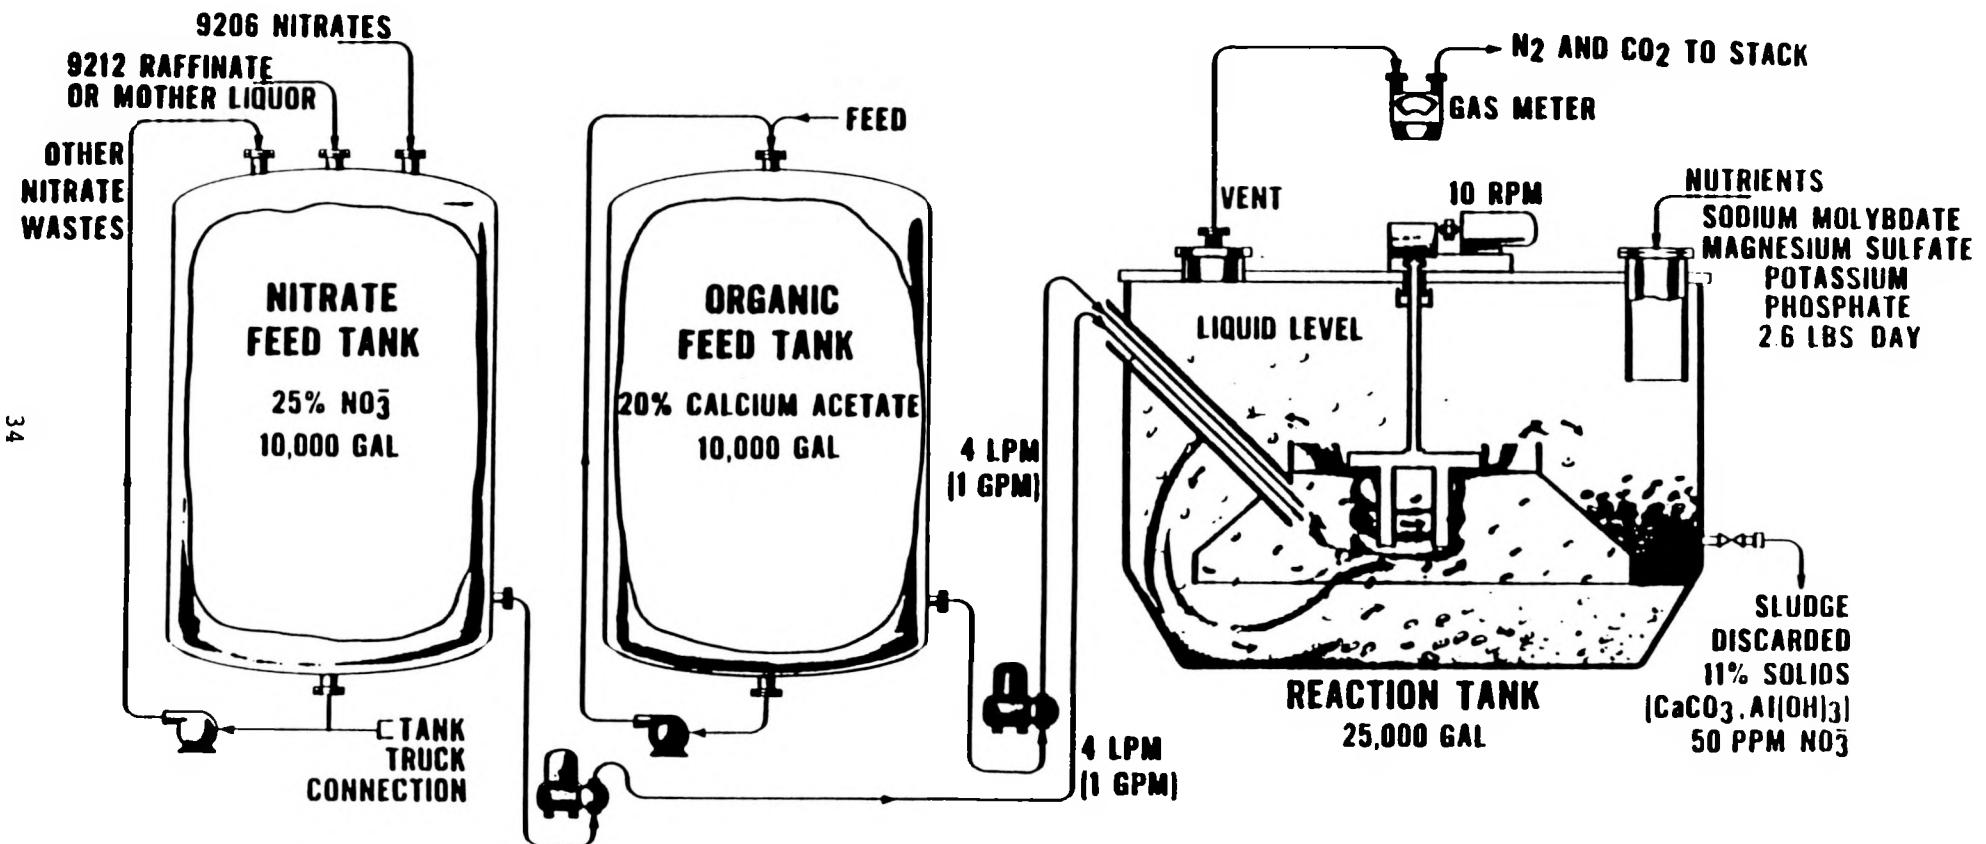
FIGURE 13

STIRRED TANK BIODENTRIFICATION.

Production Reactors - Two 25,000 gallon sized reactors (Figure 13, photo 174438) were installed in 1976 and have been successfully operated since that time. Each of these reactors normally decompose 4 grams of nitrate/day/liter of reactor solution (840 lbs NO₃/day/reactor) but rates as high as 6 grams/day/liter of reactor solution have been obtained. Occasional operational problems have been experienced with the feed pumps and PH control. However, the reactors operate more than 95% of the time and all of the down time is normally related to the lack of waste liquor.

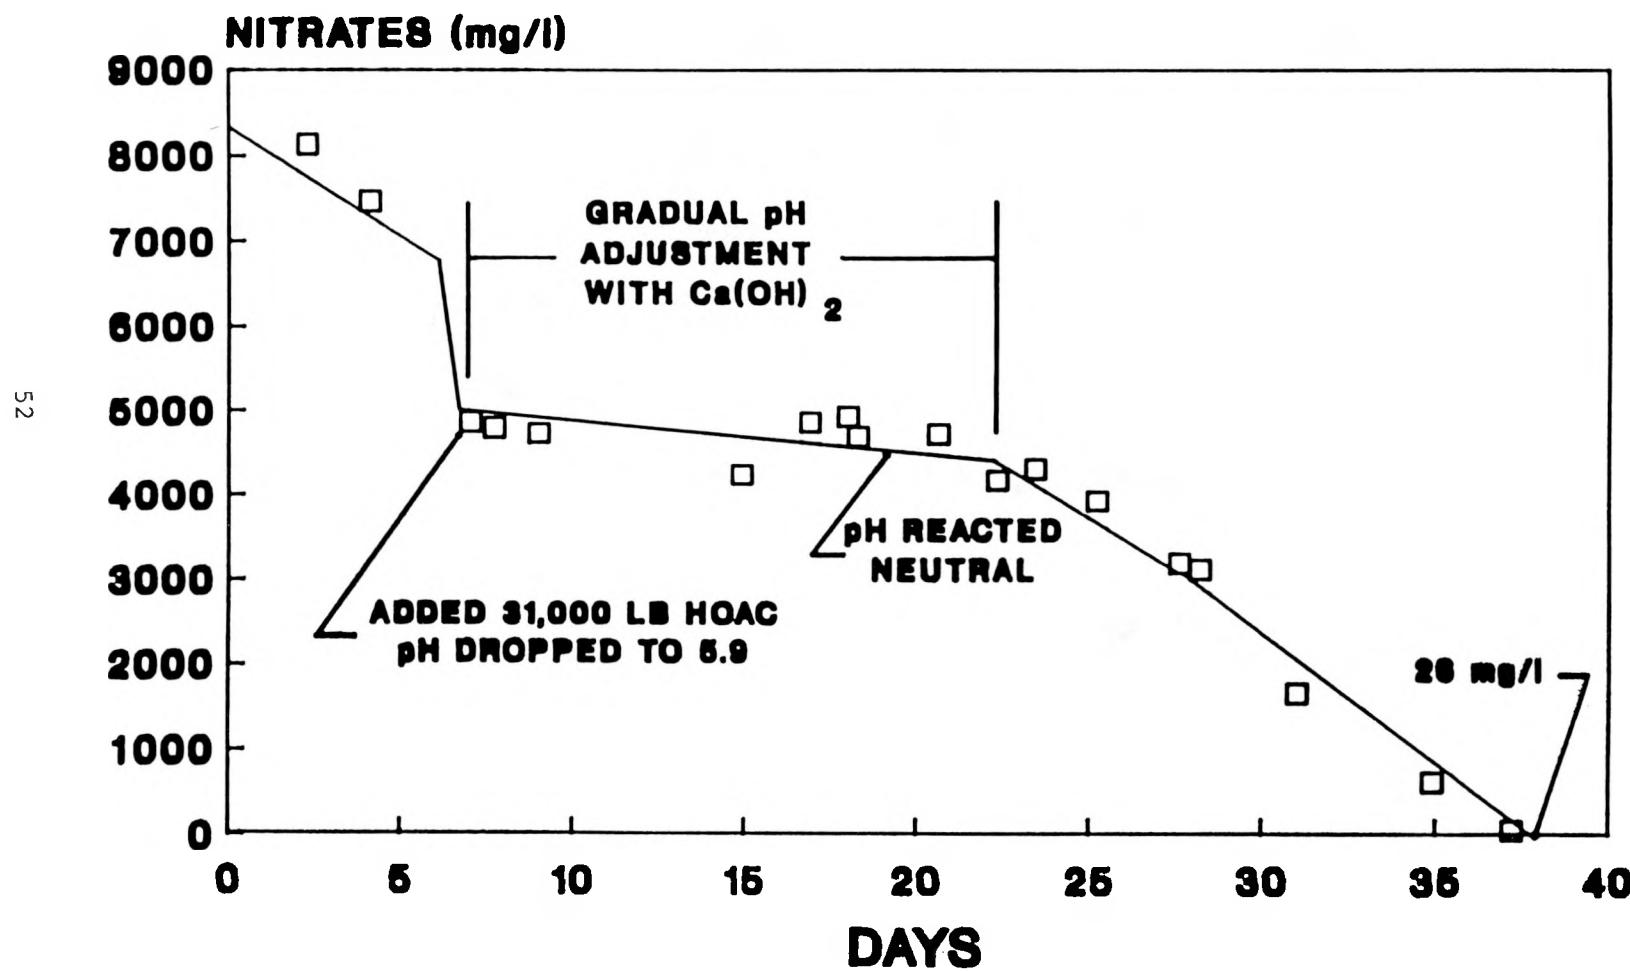
FIGURE 31

NITRATE CONCENTRATION SOUTHWEST POND

The southwest pond contained a nominal 167,000 pounds of nitrates before treatment. All of the nitrates were biologically destroyed in about 20 days when all biological parameters were met.

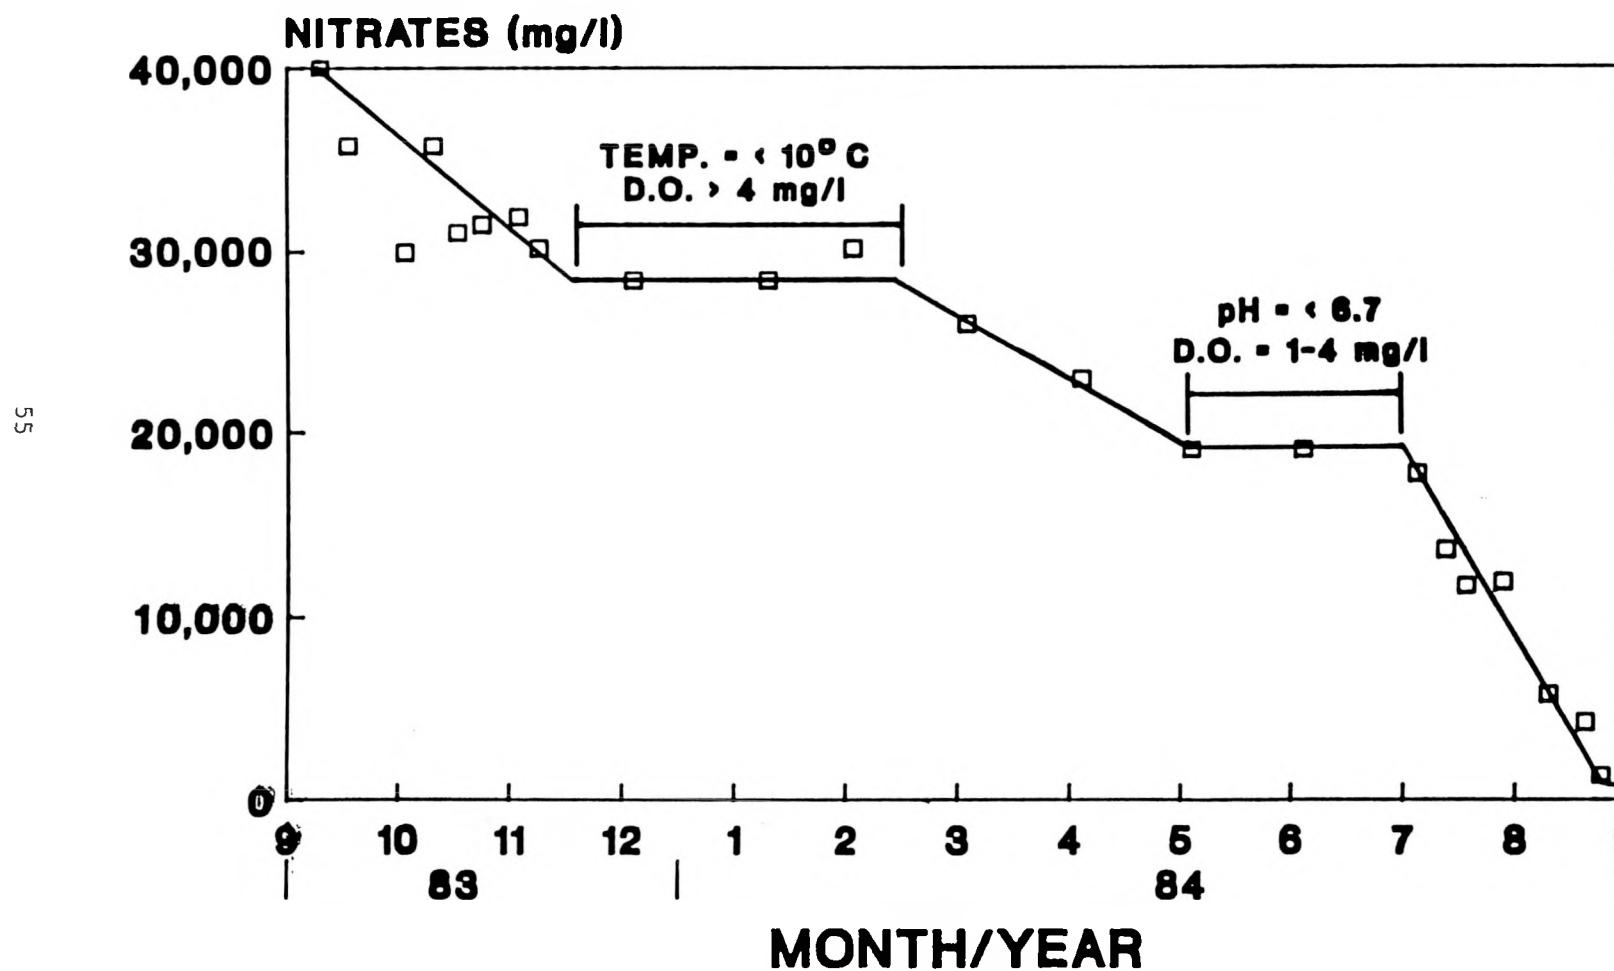
FIGURE 34

NITRATE CONCENTRATION NORTHWEST POND

Northwest Pond - In September 1983, the treatment of the northwest pond was begun. The mixing system was moved to this point and the procedure for introducing chemicals was the same as that of the southwest pond. The pH was less than 2, and the nitrates were over 40,000 mg/L nitrates (Figure 34). The treatment was begun when seasonal temperatures were on the decrease. Denitrification decreased the nitrates from a nominal 40,000 mg/L to a nominal 28,000 mg/L in the first six weeks and then stopped. At this time, the ambient temperature had dropped to below 10°C. There was no denitrification during the winter months (November 1983 to February 1984) until ambient temperatures began to increase). In May, the pH of the pond decreased below 6.7 and the reaction stopped until the pH was increased. After the pH adjustment, all of the nitrates were destroyed at a rate of 300 mg NO₃ per day.

This pond originally contained a nominal 837,000 pounds of nitrates. When favorable biological conditions were maintained (about 215 days), all of the nitrates were destroyed.

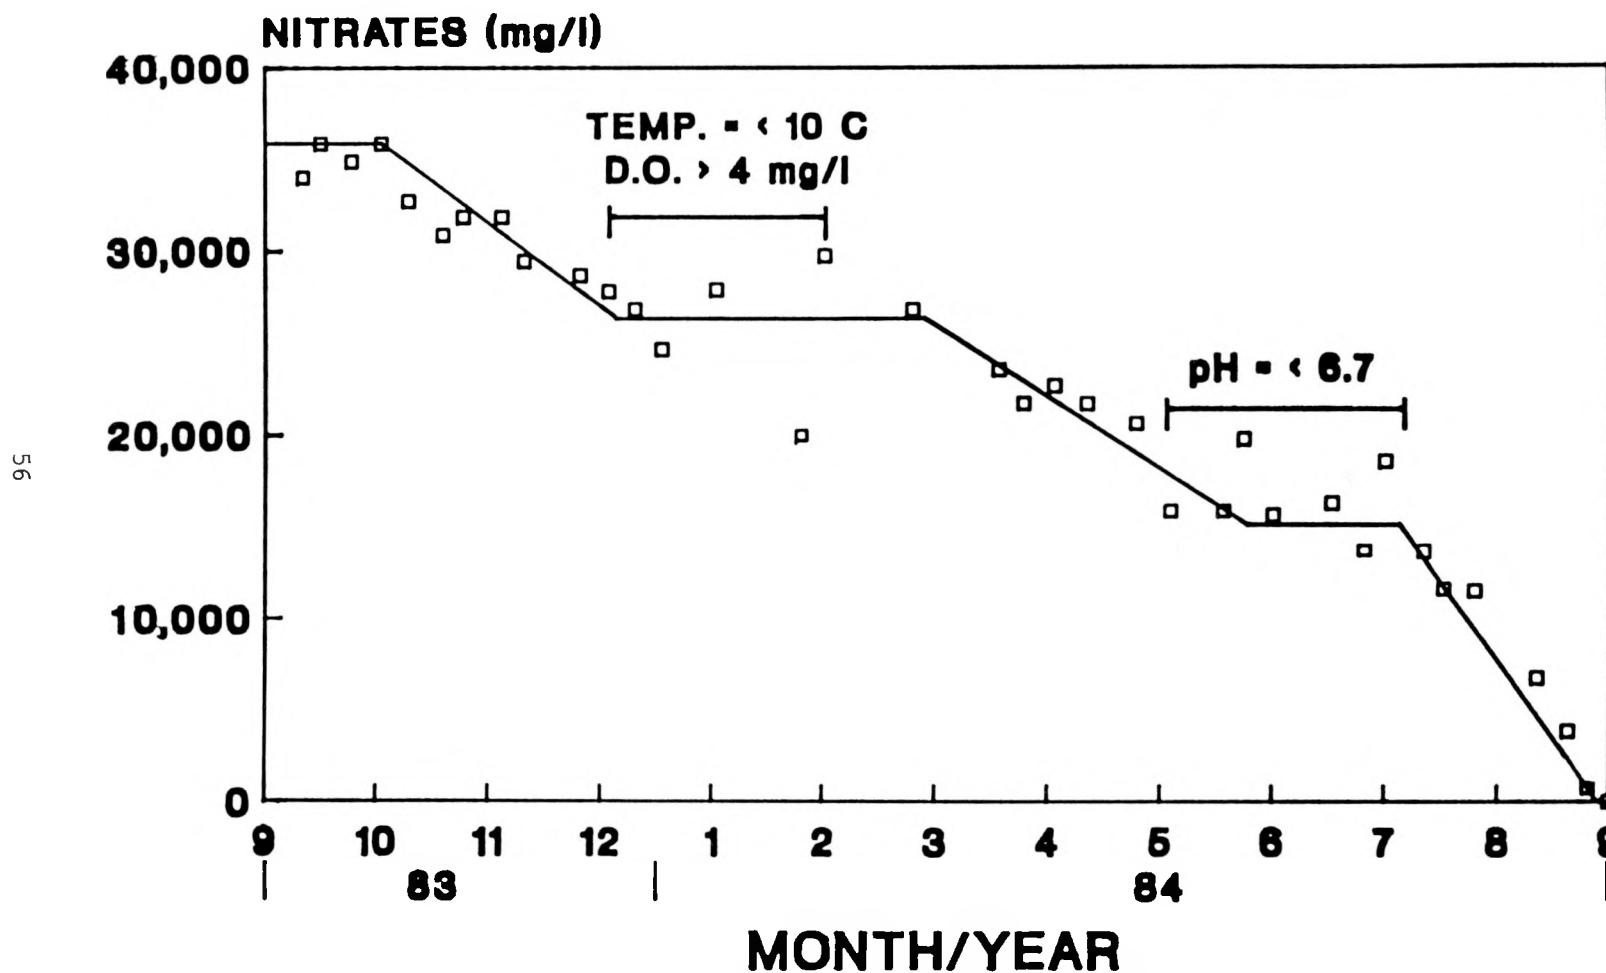
FIGURE 35

NITRATE CONCENTRATION NORTHEAST AND SOUTHEAST PONDS

Northeast and Southeast Ponds - In September 1983, piping and pumps were installed in these ponds so that the waters in these two ponds could be mixed to form a common water in the two ponds. Neutralization of the two ponds was completed using the same procedure as used for the northwest pond. The amount of chemicals added (calcium hydroxide and acetic acid) was similar to the northwest pond. As noted in Figure 35, the results are very similar to the northwest pond.

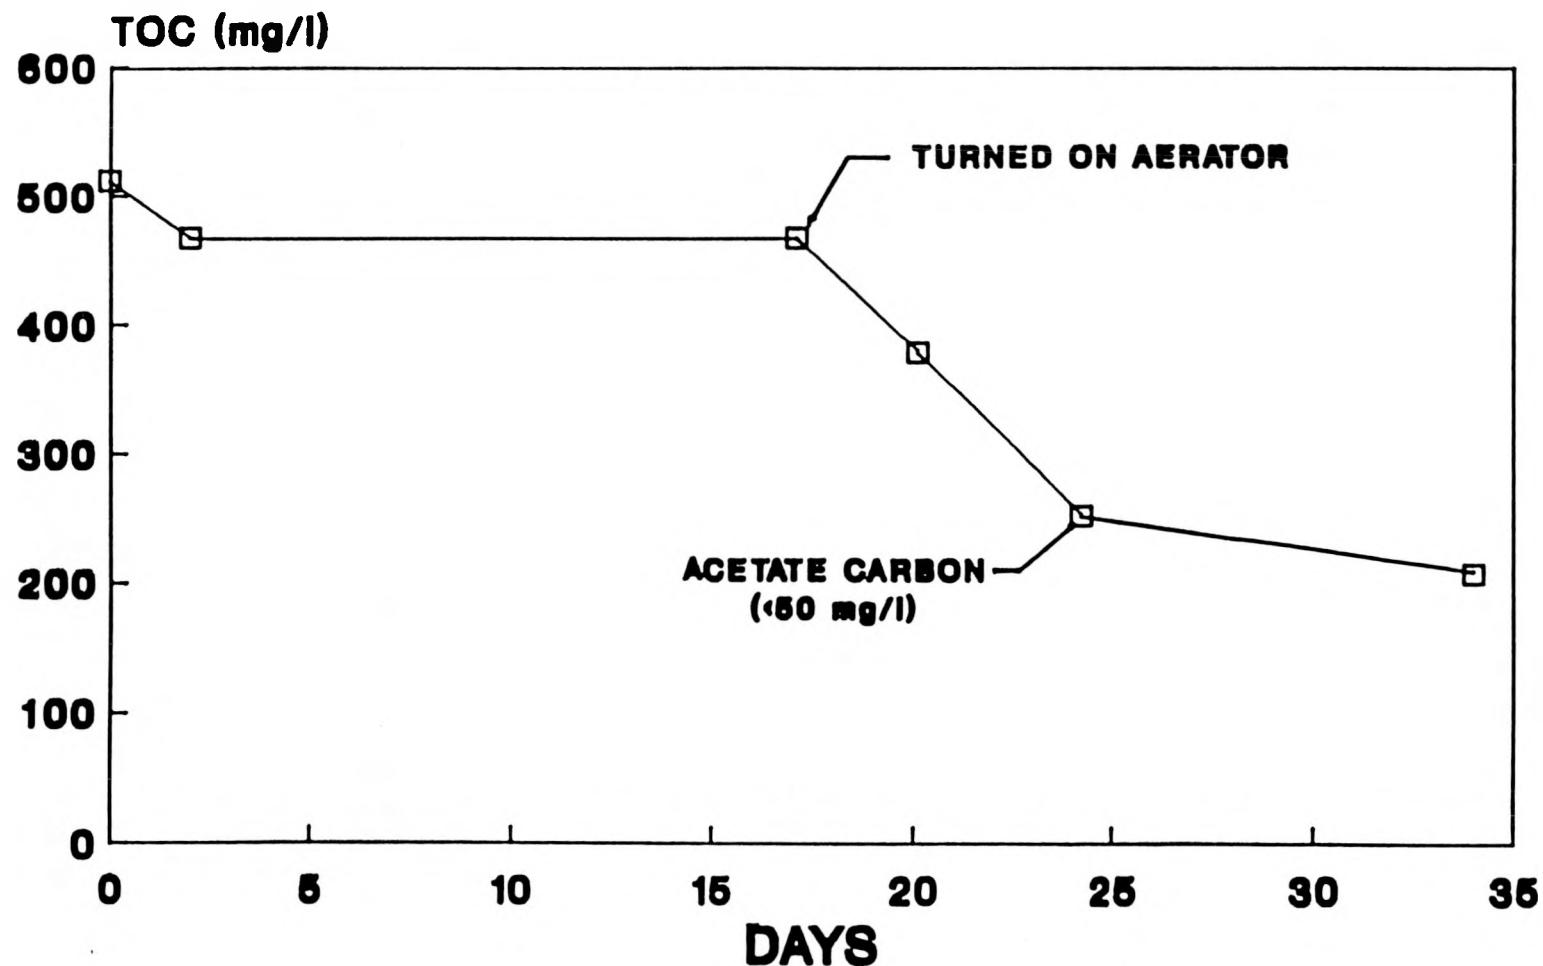
TOC CONCENTRATIONS DURING BIO-OXIDATION SOUTHWEST POND

As noted in Figure 40, the southwest pond had a typical 500 mg/L of total organic carbon (TOC). Aeration reduced the TOC to less than 200 mg/L in 34 days. Figures 41 (photo 224081) and 42 (photo 216750) are photographs of the ponds while aeration was in progress.

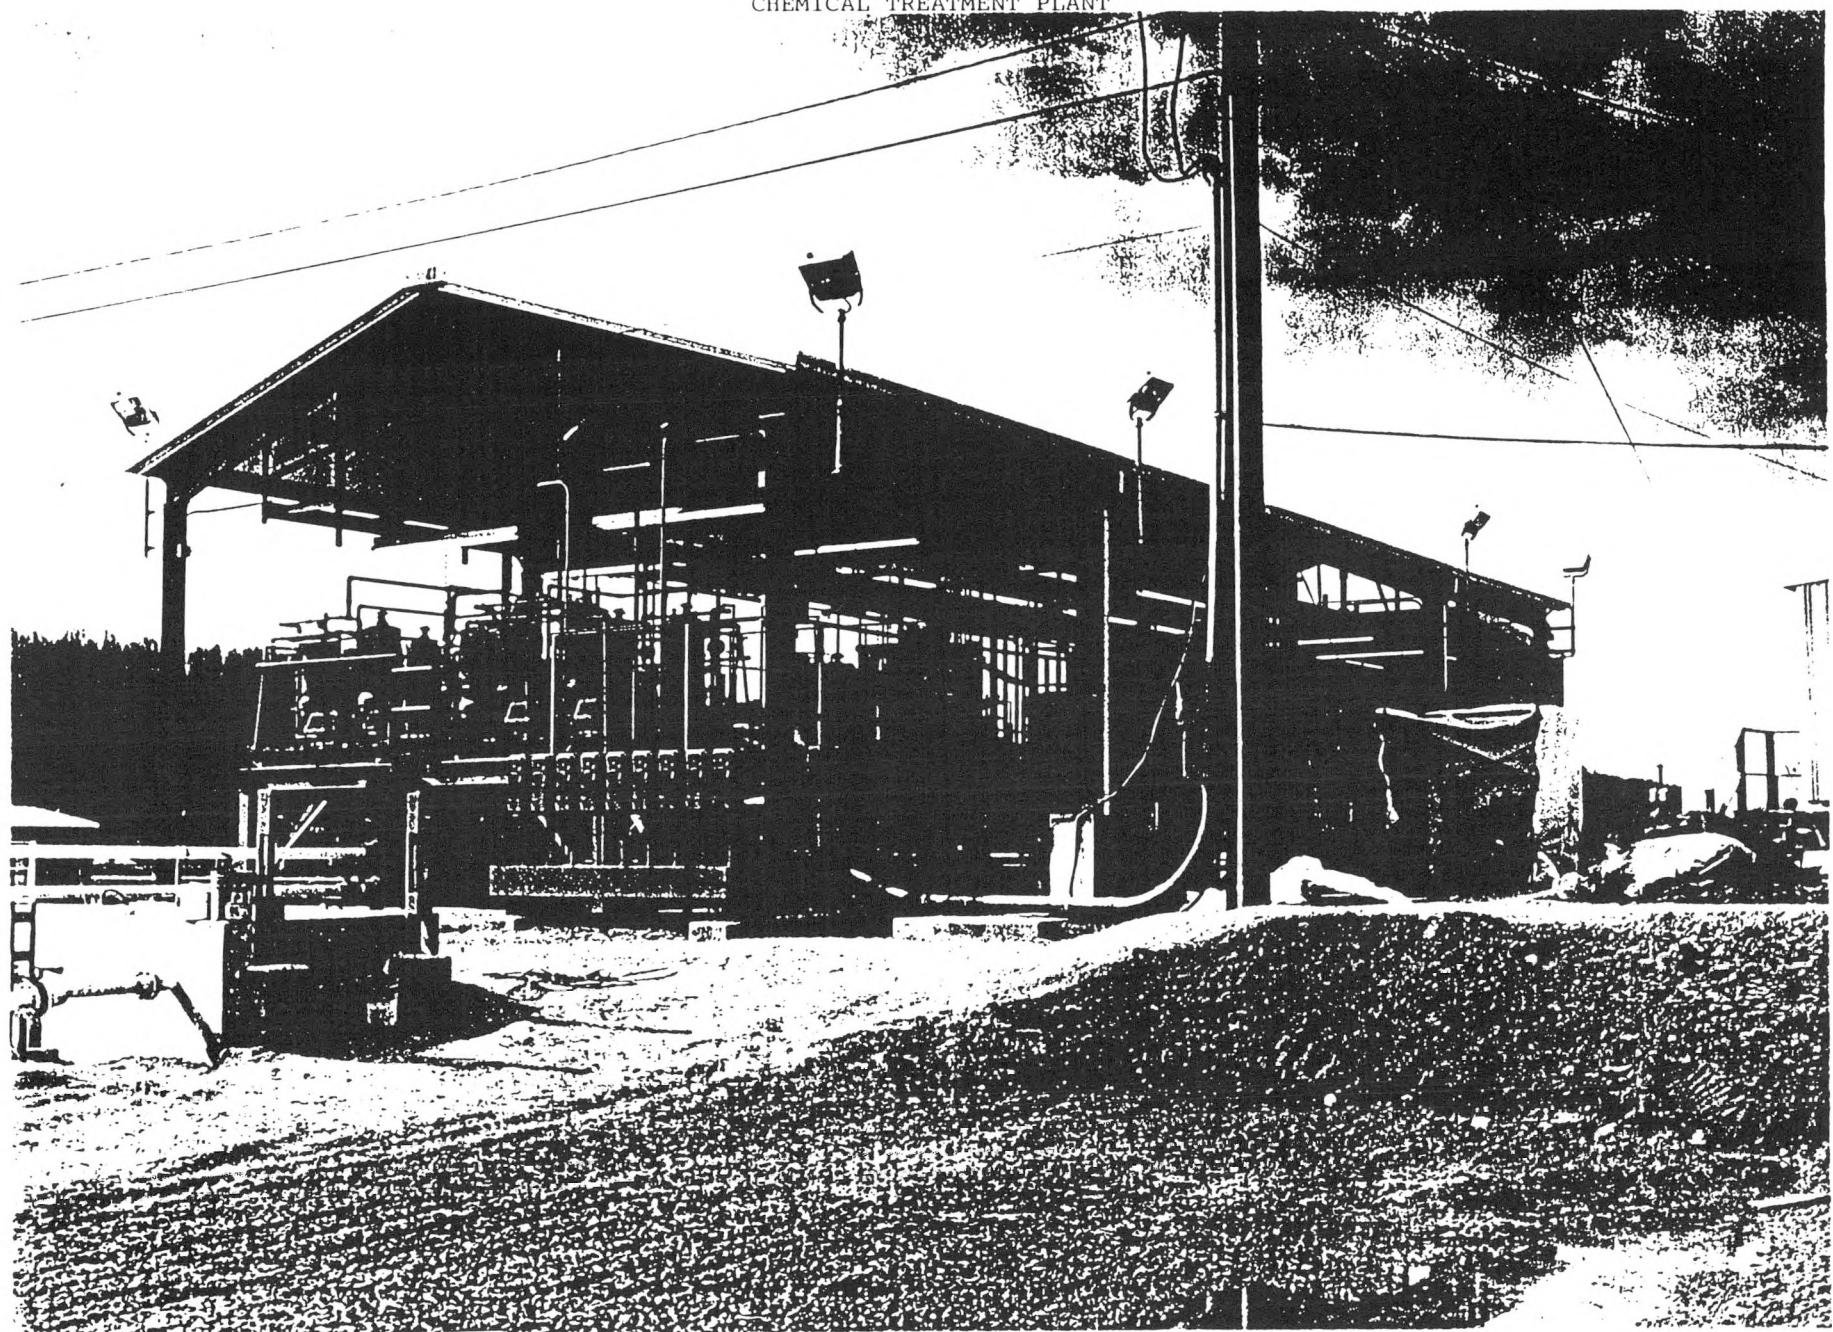
FIGURE 45

CHEMICAL TREATMENT PLANT

Figures 44 (photo 231946) and 45 (photo 231490) are photographs taken of the ponds and chemical treatment process. Typical chemical analysis of the treated water is shown in Figure 46. The solids removed during chemical treatment were returned to one of the ponds.

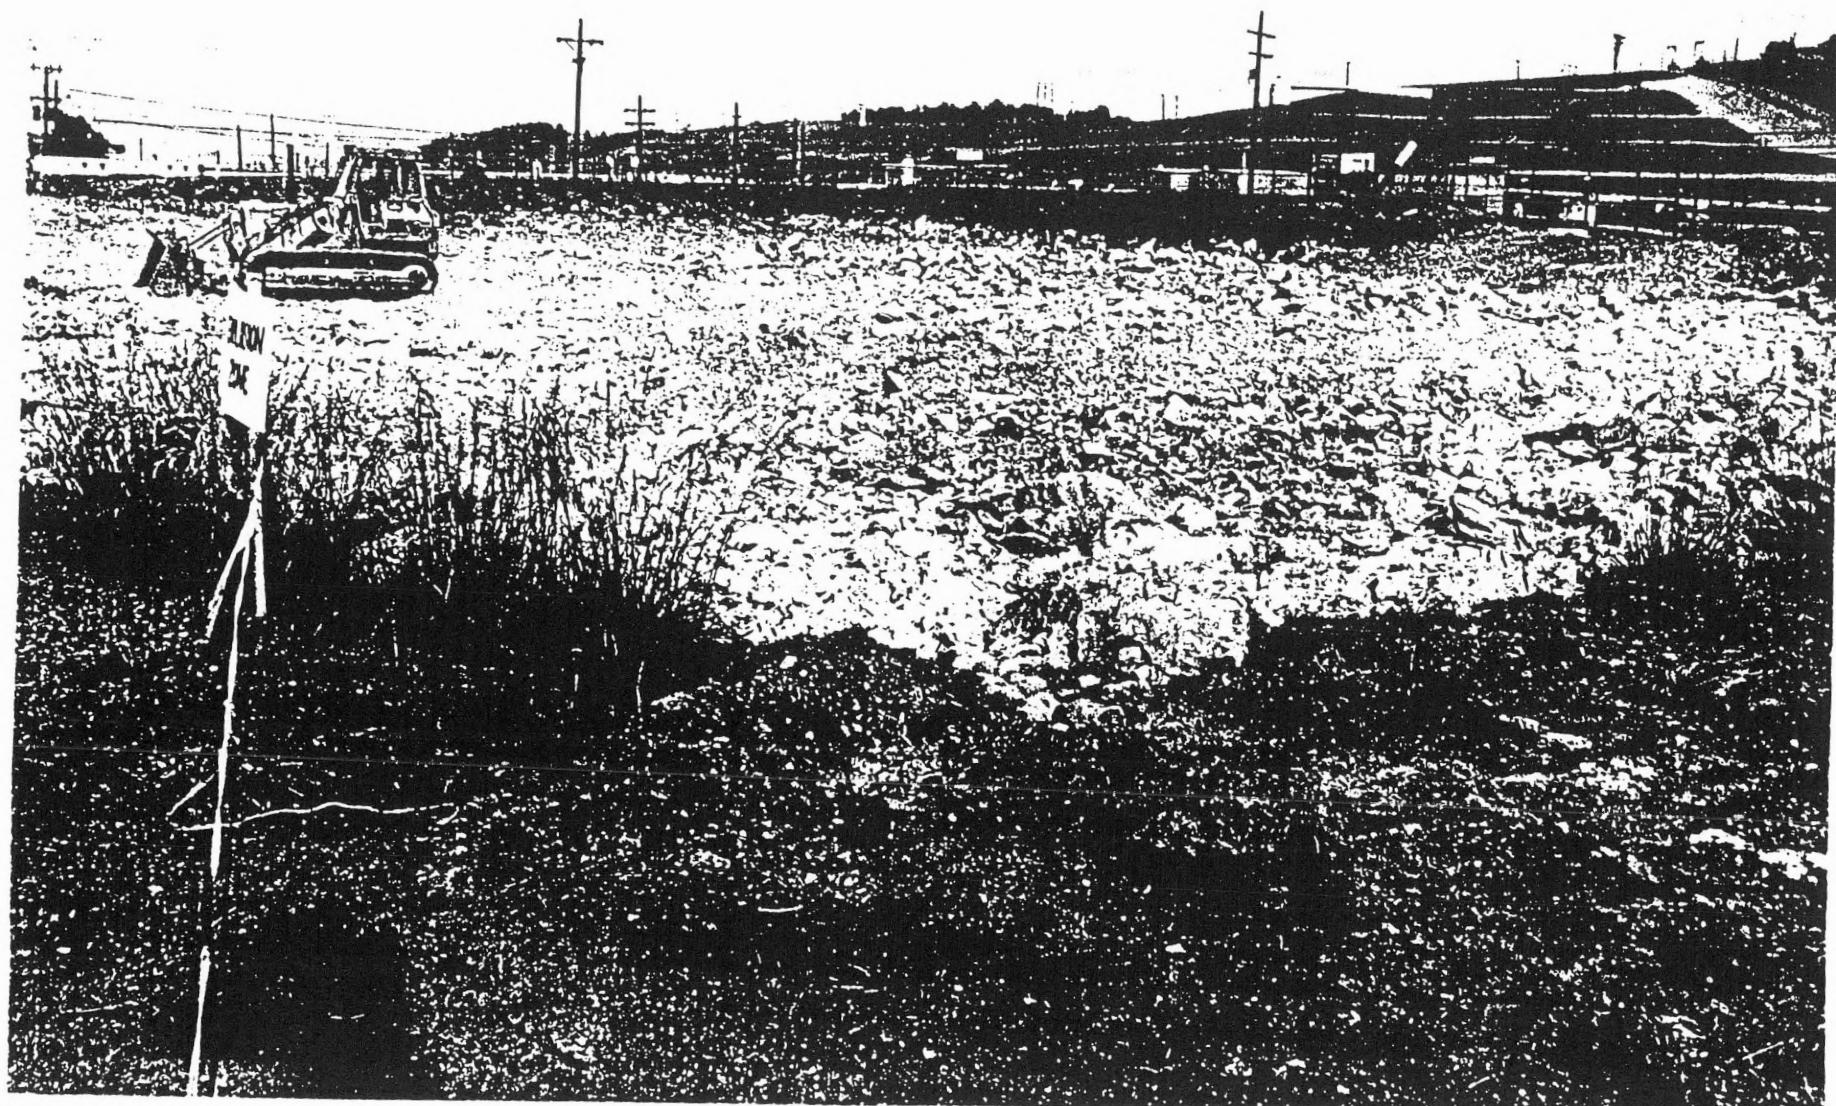
ADDING ROCKS TO PONDS

Filling Ponds - The next steps in closing of the ponds are noted in Figure 53. Six inch diameter or larger limestone rocks were added to stabilize the bottom of the ponds (Figures 54 and 55 photographs 258129 and 258133). A 24-inch clay cap (Figure 56 photo 258539) was packed to have a permeability of less than 1×10^{-7} cm/sec. A flexible plastic liner and a geotextile fabric was placed on top of the compacted clay. Eighteen inches of compacted clay (Figure 57 photo 258720) was placed on top of the fabric followed by three inches of crushed stone and three inches of asphaltic concrete. Several monitoring wells are located adjacent to the cap and if data from these wells show degradation of the groundwater quality, the water will be removed and subjected to the appropriate treatment. The last layer was an asphalt cap and the ponds are now used as a parking lot (Figure 58 photo 272658).

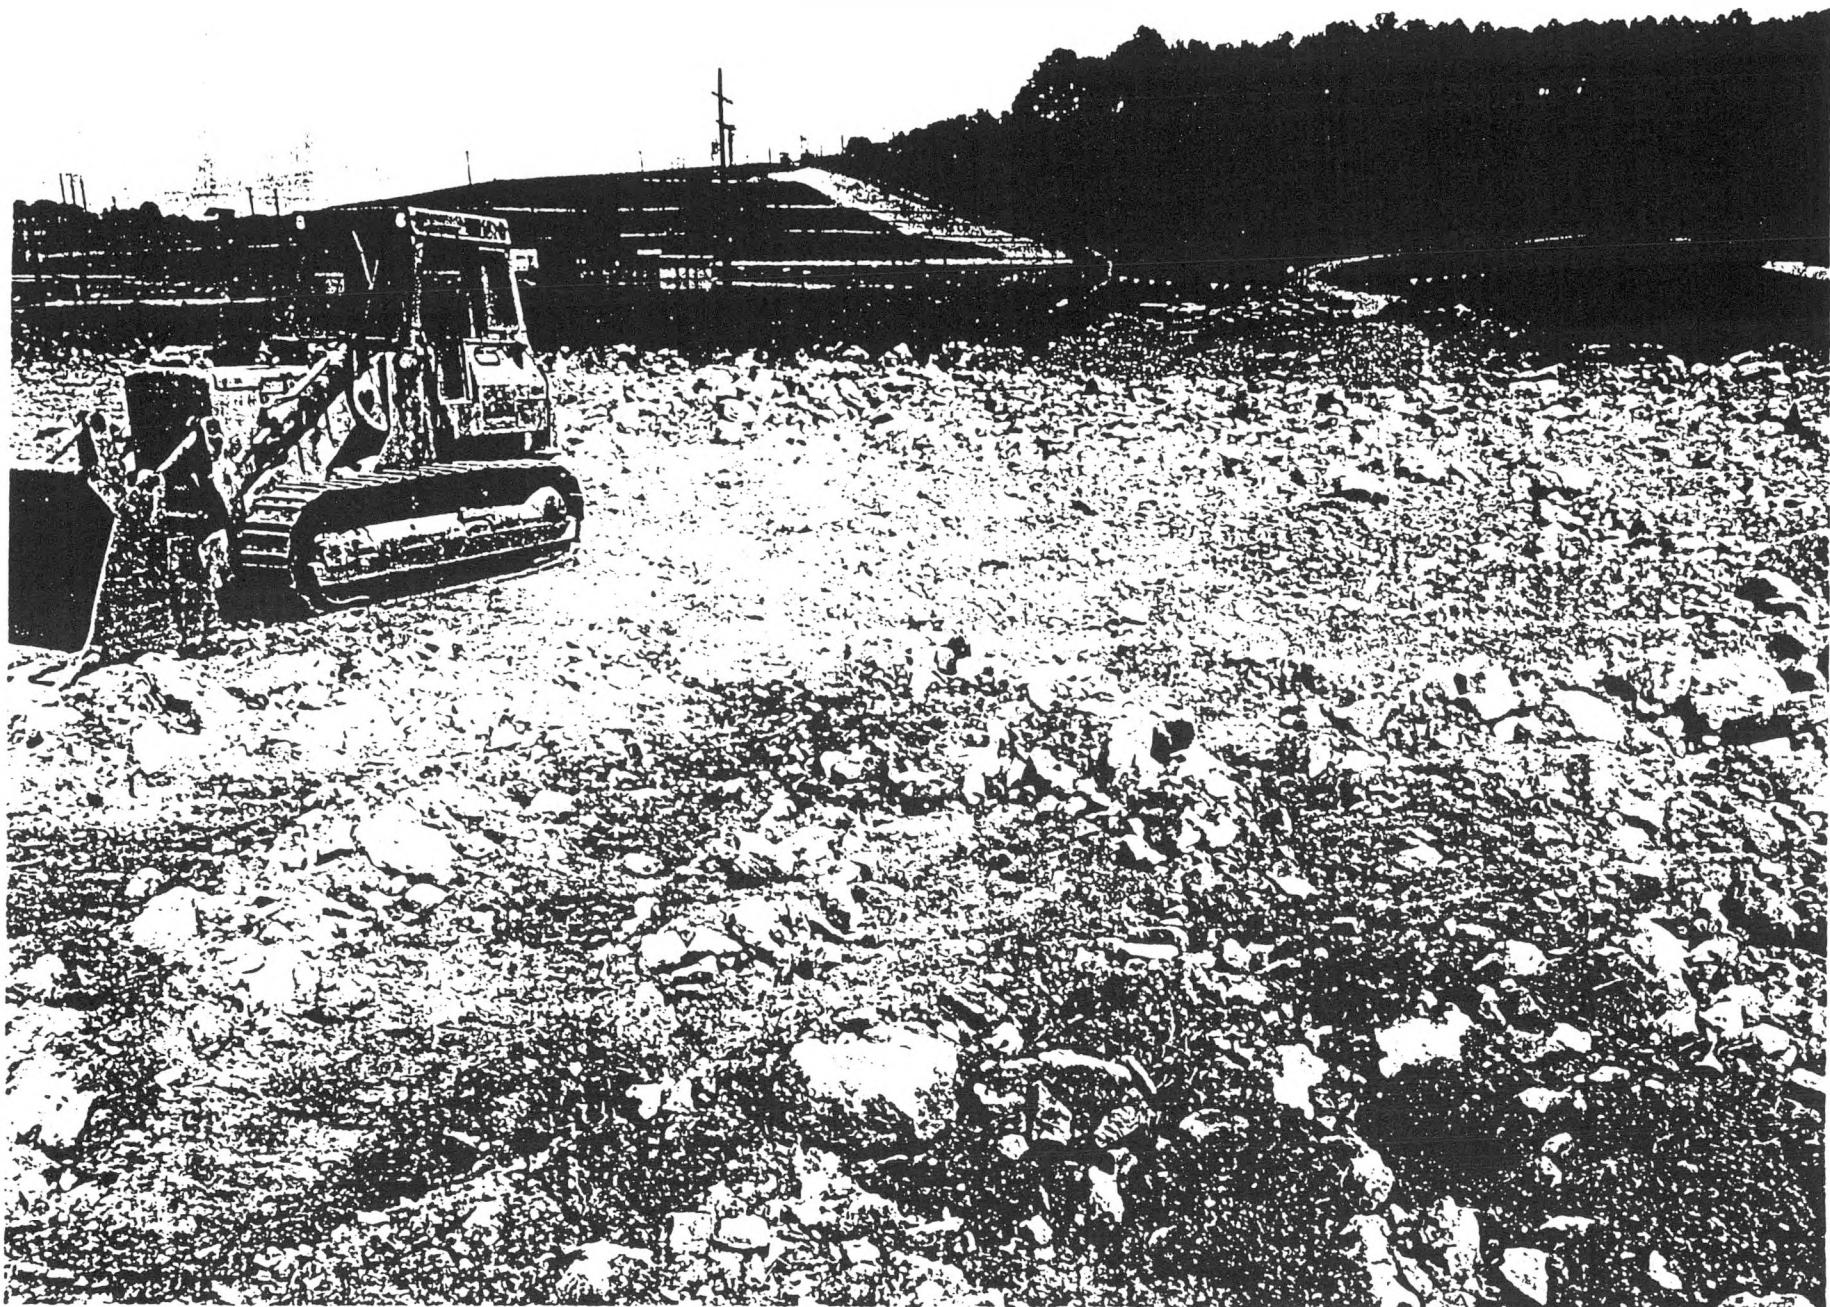
FIGURE 55

PONDS DURING FILLING PROCESS
