OBSERVATIONS OF THE SEVERITY OF NOTCH-ROOT RADIUS IN
INITIATION OF SUBCRITICAL CRACK GROWTH

W. G. Reuter, C. R. Eiholzer, M. A. Tupper

SUMMARY

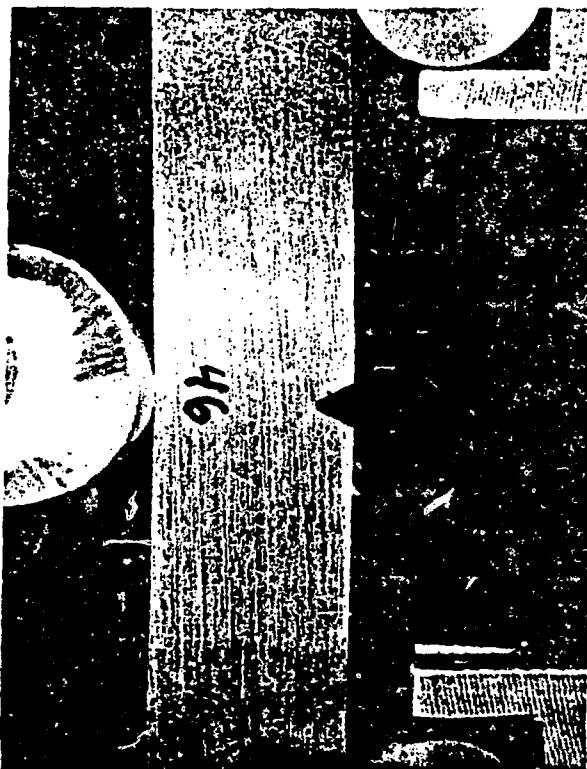
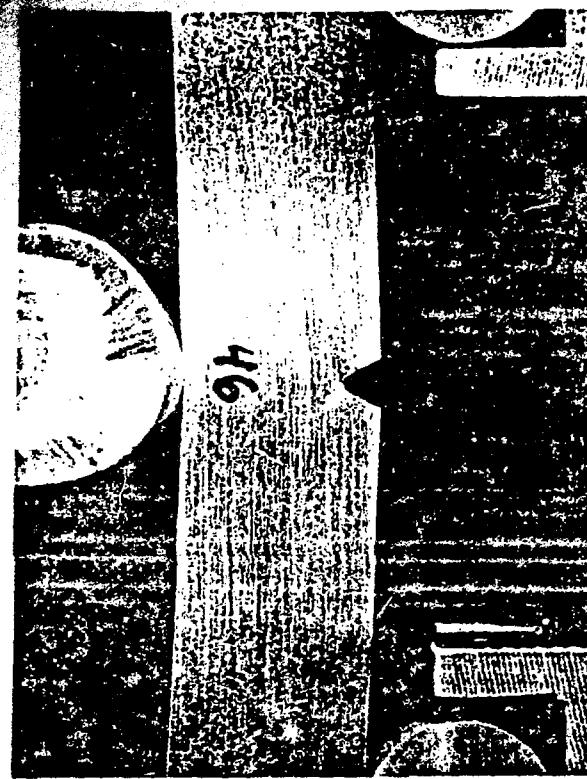
Figure 1. Normal view of slow-bend test of Specimen 46 (0.25-mm notch root radius).

Fig. 1. Three load steps of slow - load test of specimen 9H (0.25 mm initial net radius)

Figures 1 and 2 provide examples of some of the photographs taken at normal and oblique angles respectively for specimen 46 with a machined root radius of 0.25 mm. Figures 3 and 4 provide similar examples for specimen 38 with a machined notch root radius of 0.10 mm. Figures 5 and 6 provide similar examples for specimen 45 containing a precrack.

Figure 1 shows that some plastic deformation has occurred at the notch root at 7.78 KN and the notch root radius continues to grow as the load increases to 13.34 KN. The oblique photographs in Figure 2 suggest that the notch is simply being unrolled with a substantial increase in notch root radius. Similar observations may be made for Figures 3 and 4. For Figure 5, however, the crack is starting to open at 5.56 KN, it appears to be blunted at 11.12 KN, and is very sharp at 12.23 KN (specimen unloaded immediately after this photograph was taken). Figure 6 shows the crack opening as a function of increasing load.

As shown in Figures 1-4, there is very little difference between the behavior of specimens with a machined notch root radius of 0.08 or 0.25 mm. In both instances the notch root radius increased substantially throughout the test as shown in Figure 7. Evaluating the radius in Figure 7, at a constant load, for the same heat of material shows a substantial difference of notch root radius as a function of the original radius. In addition, there is a substantial difference in the radius in Figure 7, at a constant load, even when the initial values are the same but for two different heats.

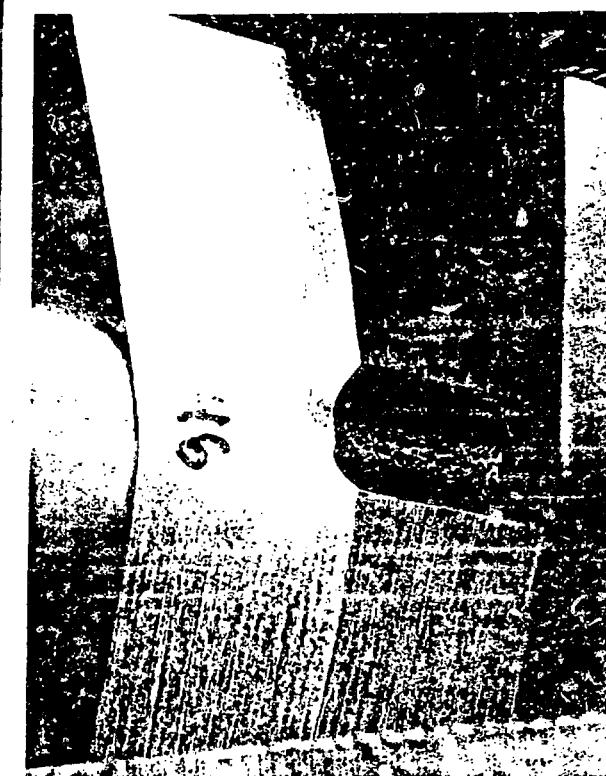
Figure 2. Oblique view of slow-bend test of Specimen 46 (0.25-mm notch root radius).

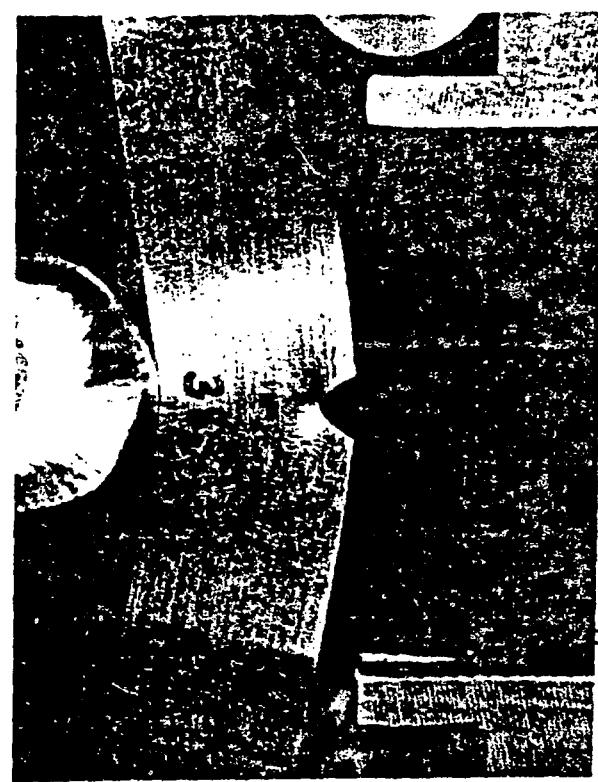
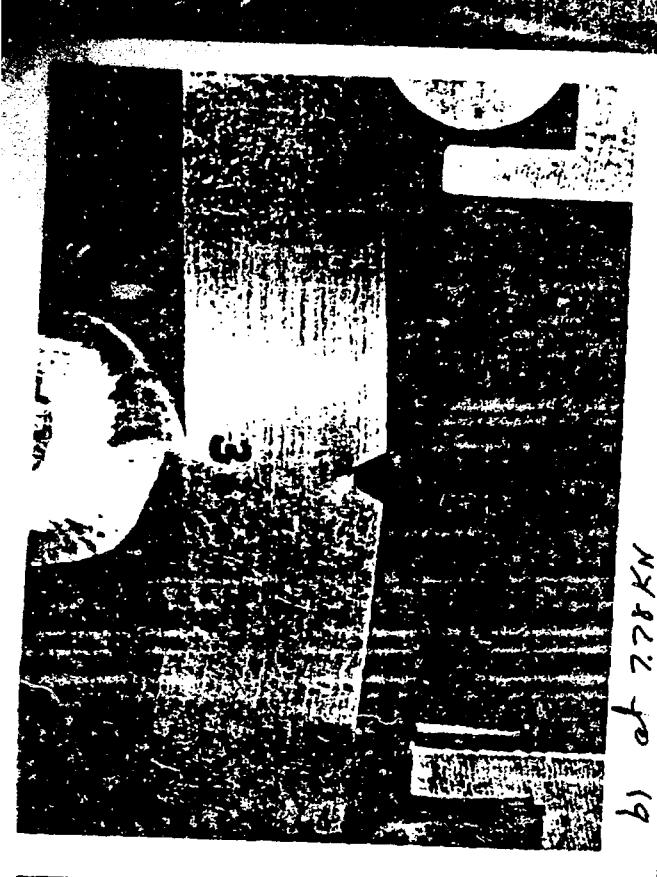
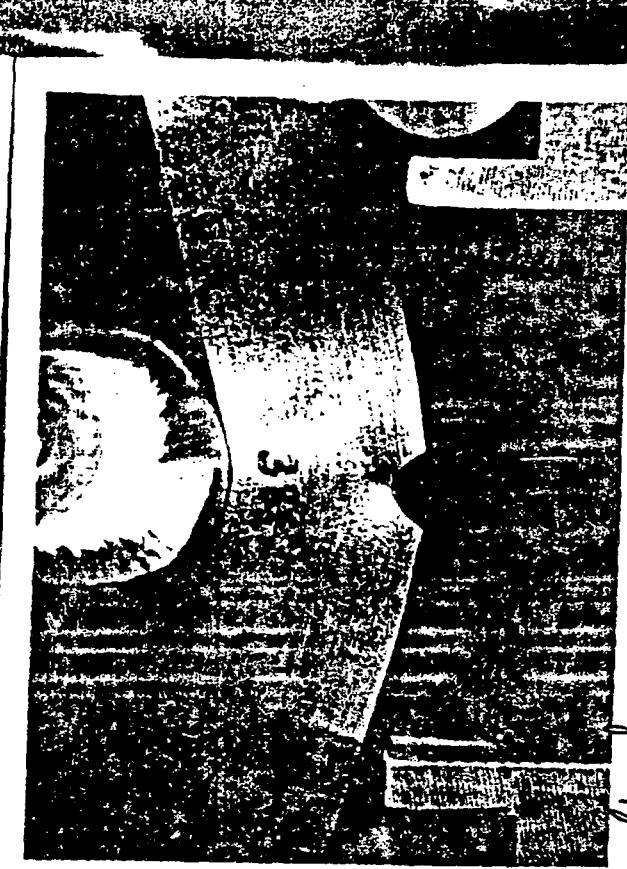
Figure 3. Normal view of slow-bend test of Specimen 38 (0.10-mm notch root radius).

Figure 3. Front view of slow-load test of Specimen 38 (0.1mm notch width value)

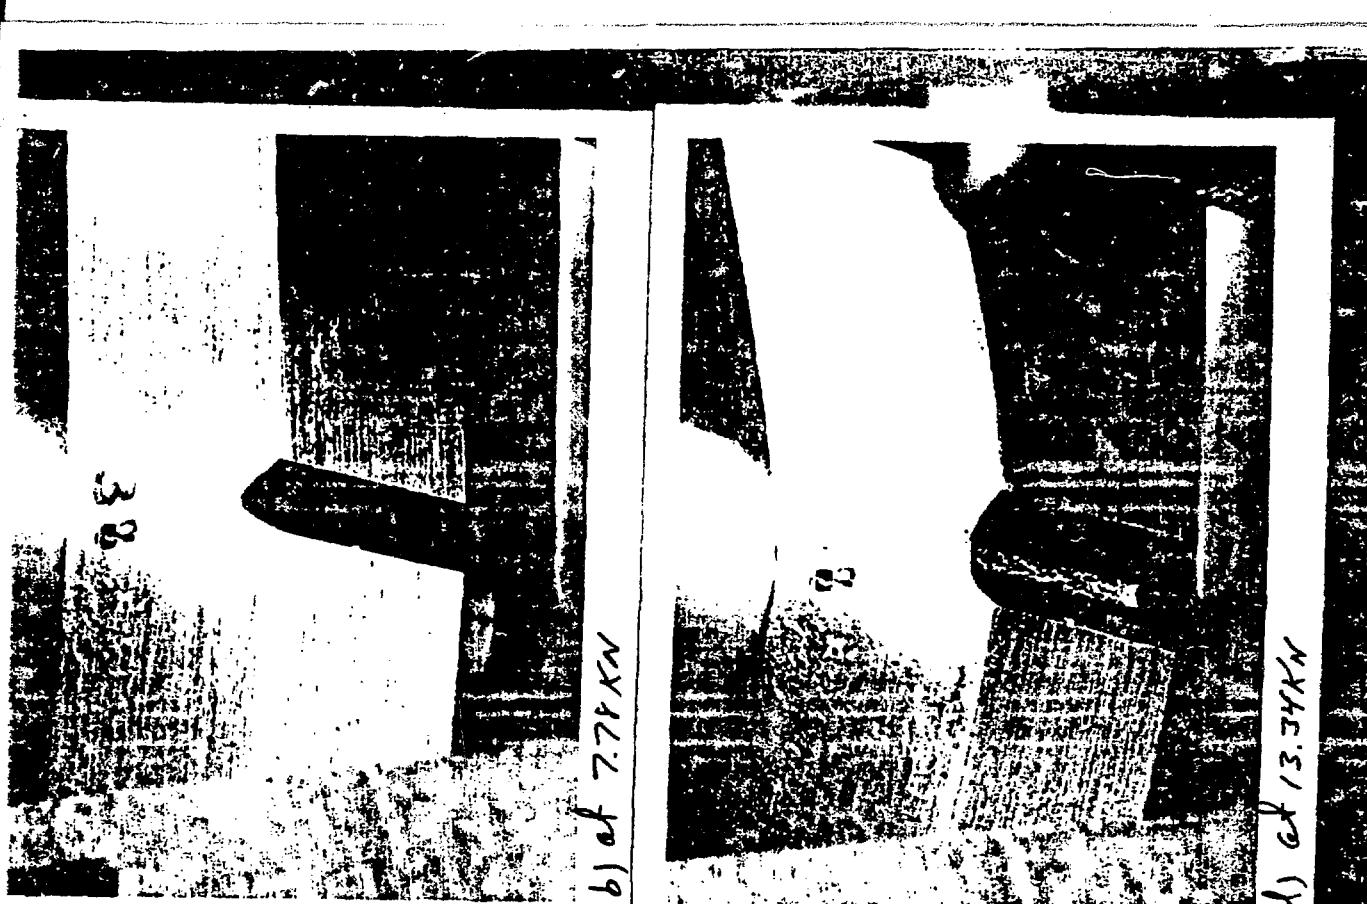
Figure 4. Oblique view of slow-bend test of Specimen 38 (0.10-mm notch root radius).

Figure 4 Oblique view of slow-bend test of Specimen 38 (0.10 mm notch root radius)

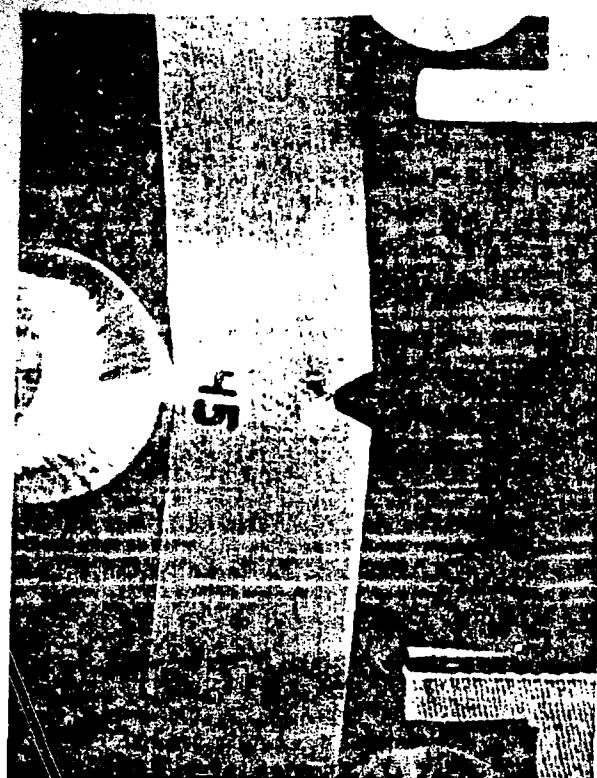
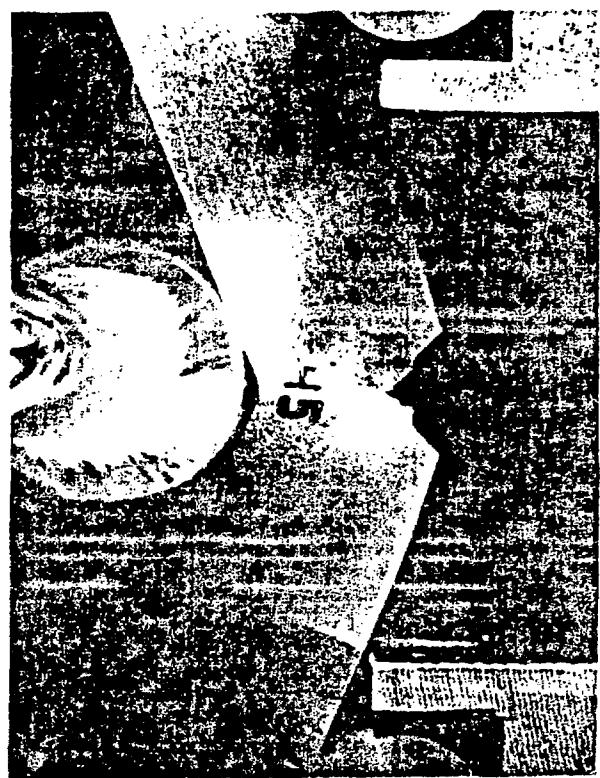
Figure 5. Normal view of slow-bend test of Specimen 45 (precracked, $a/w = 0.23$).

Figure 5 - Planed view of slow-bend test of Specimen 45 (pre cracked, $a_{in} = 0.23$)

There is considerable similarity in behavior of specimens containing a precrack and those containing a machined notch. Some blunting was observed for the fatigue crack, see Figure 5c. The extent of the blunting is much less than that observed for the specimens containing the machined notch. Note in Figure 5d the crack is again sharp. There is some crack growth apparent in Figures 6a-d, but it is obvious that the crack-tip opening displacement is substantial, see also Figures 5c and d. The appearance of the crack in Figure 5c suggests some misalignment of the specimen which appears to be within tolerance in Figure 5a.

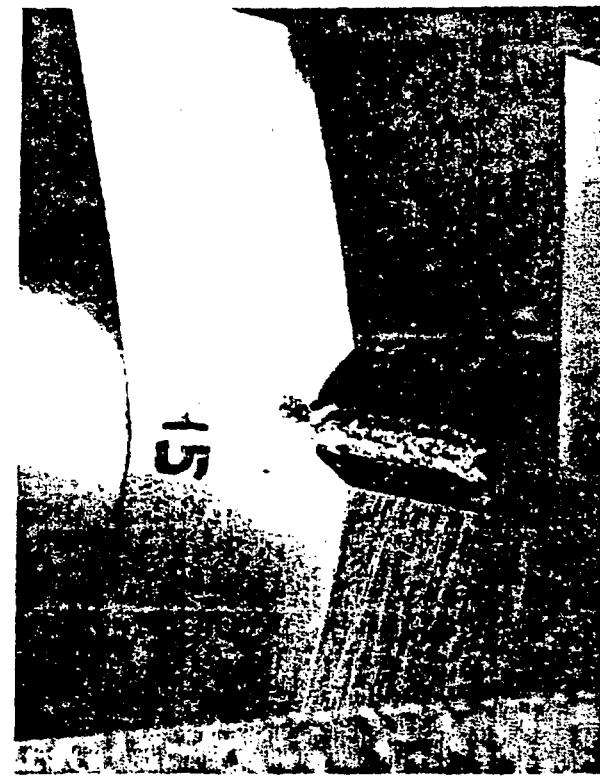
Figure 6. Oblique view of slow-bend test of Specimen 45 (precracked, $a/w = 0.23$)

Figure 6. Oblique view of slow-load test of Specimen 905 (Specimen 905, $\alpha_{lw} = 0.23$)

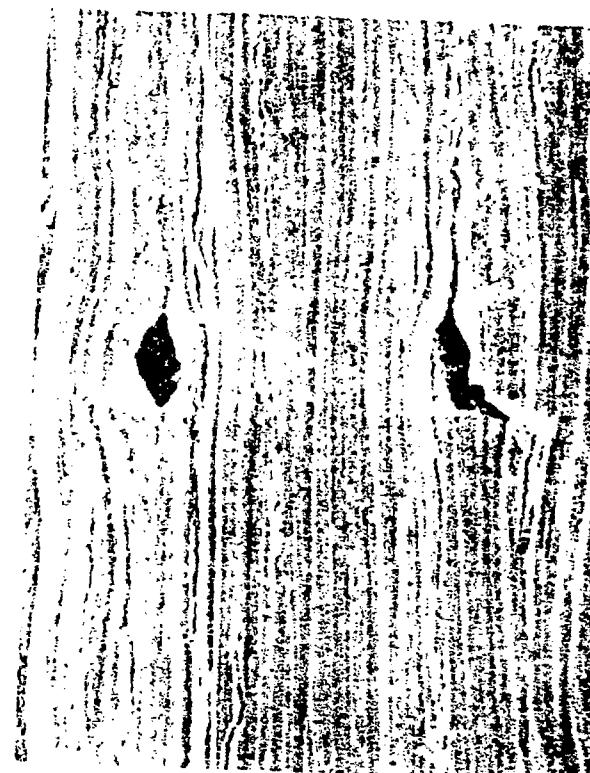
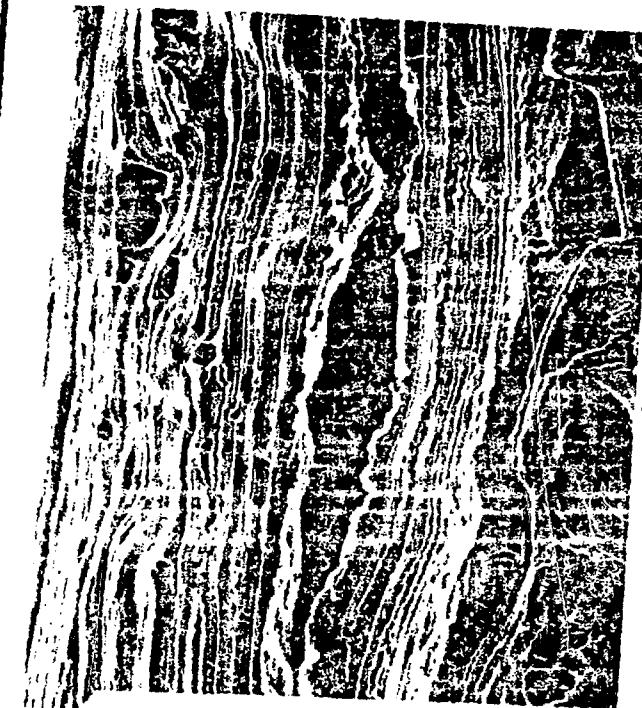
From Figure 10 it is apparent that very fine cracks and holes are visible in Figures 10b and 10c for specimen 59. As the loading for specimen 59 was terminated at 6.67 KN but acoustic emission detected onset of subcritical crack growth at 6.38 KN, there appears to be general agreement. Specimen 56 in Figure 10a shows that neither holes nor cracks of the type observed in Figures 10b and c are visible. This observation suggests that the cracks and holes observed in specimen 59 are indeed due to the testing and were probably the type of items detected by acoustic emission. Figure 10d shows that considerable cracking has occurred by the time the specimen is loaded to 8.90 KN.

Figure 10. SEM photographs of the notch tip region for three different specimens.

Figure 10 SEM Photographs of the noted top region for the different specimens

Another parameter that needs to be evaluated is the acoustic emission system. Even though acoustic emission detected the onset of subcritical crack growth, it is necessary to evaluate what was being detected. This is necessary because an increase in sensitivity will cause the system to generally detect initiation at a lower load. It was, however, possible to verify that cracking had occurred, in the Charpy specimen, at the load of 5.57 KN which exceeds the loads in Table 1, corresponding to initiation of cracking. This was done by loading five specimens from heat 2, each having a machined notch root radius of 0.10 mm. The tests were designed so that the load was terminated at 6.67 KN for specimen 59, at 8.90 KN for specimen 47, at 11.12 KN for specimen 44, at 15.57 KN for specimen 50, and 20.02 KN for specimen 35. As shown in Table 1, the loads corresponding to initiation of subcritical crack growth for specimens 59, 47, and 44 were 6.38, 5.78, and 5.94 KN respectively. Photomicrographs taken of the notch root radius are shown in Figure 10. Specimen 56 has not been exposed to any load and is used as an example of the notch root radius prior to application of a load.
