LA-10673-PR

Space Nuclear Safety Program

October—December 1984

Los Alamos National Laboratory
Los Alamos, New Mexico 87545

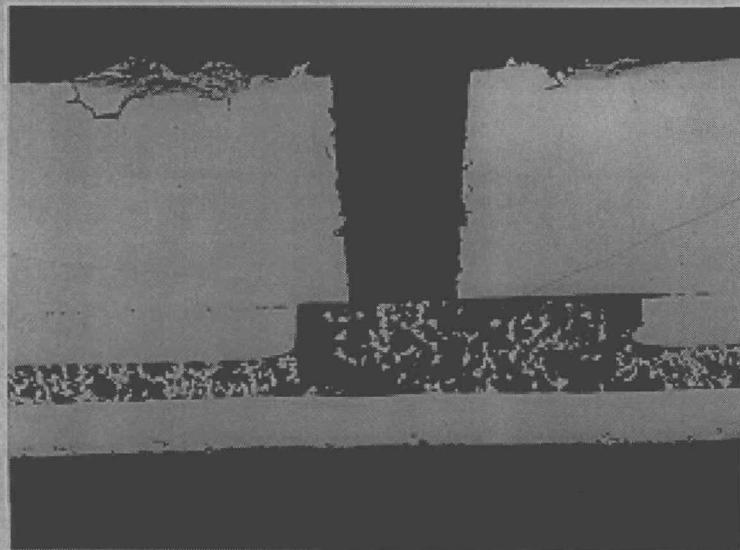
Fig. 1. Glassy deposits were observed adjacent to the FC-436 and FC-437 vent center holes, FC-436 vent, as polished, 50X.

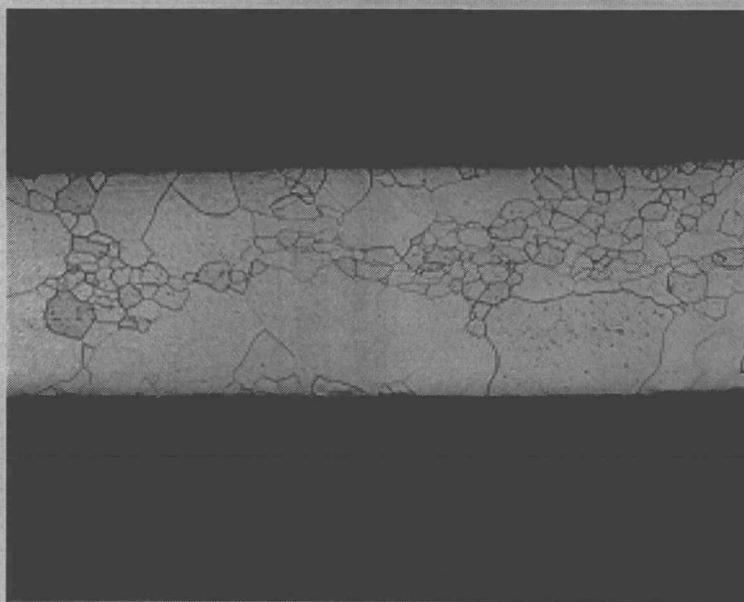
Fig. 2. An axial section of the FC-590 weld shield cup contained several abnormally large grains; 50X.

3. Iridium Microstructures. Metallographic examination of sections from capsules FC-152, FC-589, and FC-590 revealed that the cup microstructures were generally fine grained. The FC-590 weld shield cup did however contain several coarse-grained areas (Figs. 2 and 3). The average cup grain sizes ranged from 4 to 16 grains/0.635-mm nominal wall thickness. The cup grain

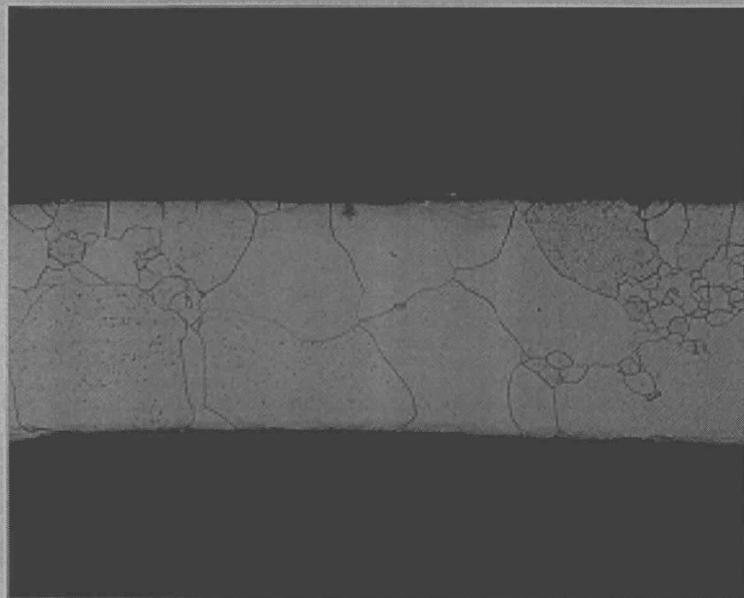
Fig. 3. Large grains were also observed in a transverse section of the FC-590 weld shield cup; 50X.

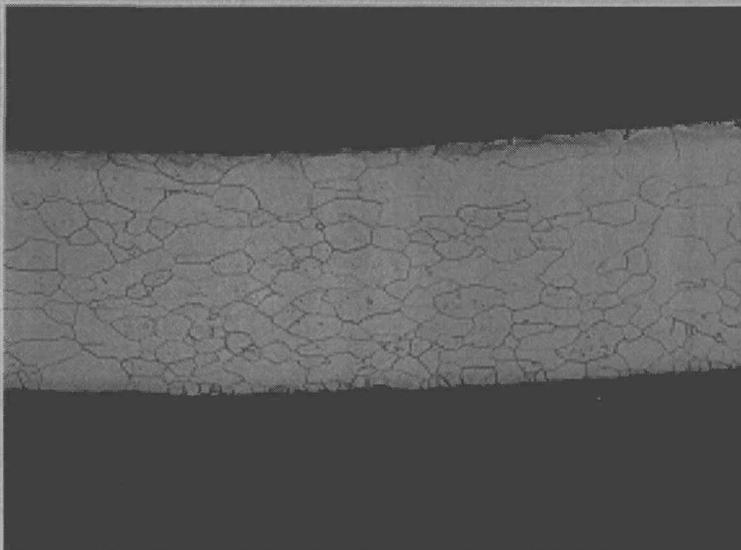
Fig. 4. The FC-589 vent cup had a fine-grained microstructure; transverse section, 50X.

sizes are listed in Table III. Representative microstructures are presented in Figs. 4 through 9.

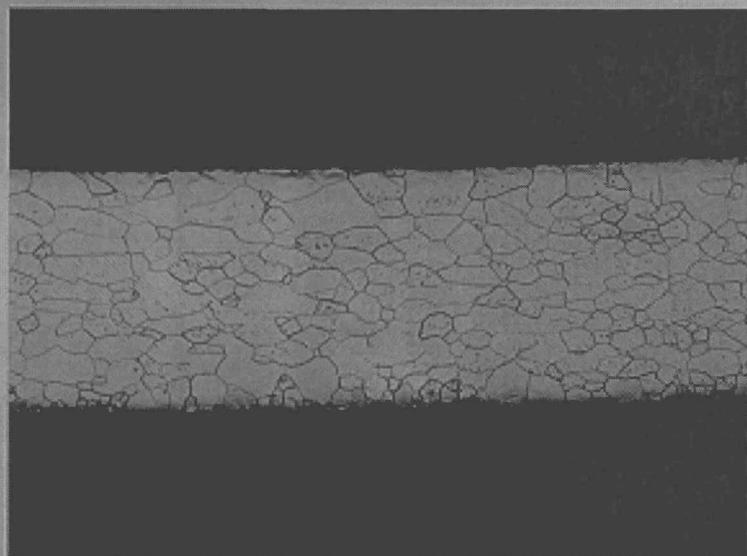
Fig. 5. The FC-589 weld shield cup had an acceptable microstructure; transverse section, 50X.

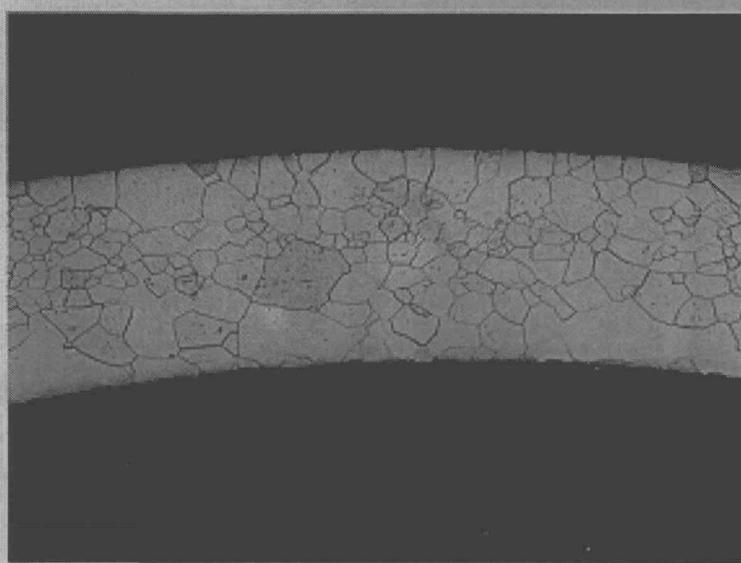
Fig. 6. The FC-590 vent cup had a generally fine grained microstructure; axial section, 50X.

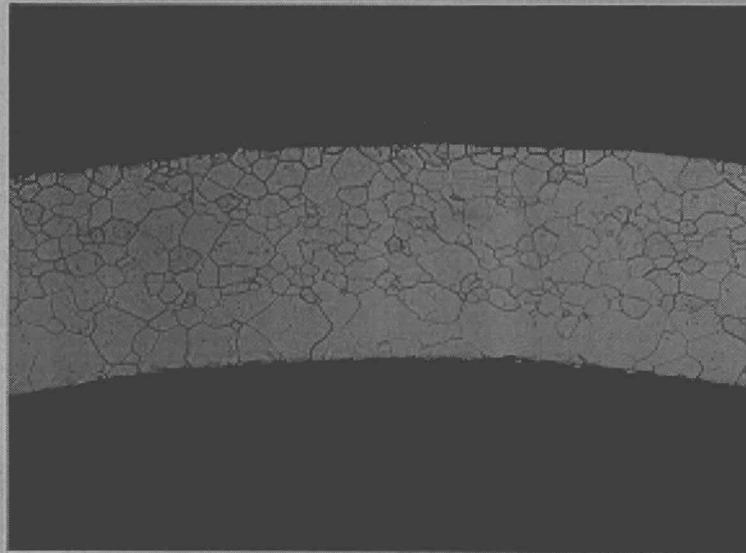
Fig. 7. Although the FC-590 weld shield cup contained some areas of excessive grain growth, the microstructure was generally acceptable; axial section, 50X.

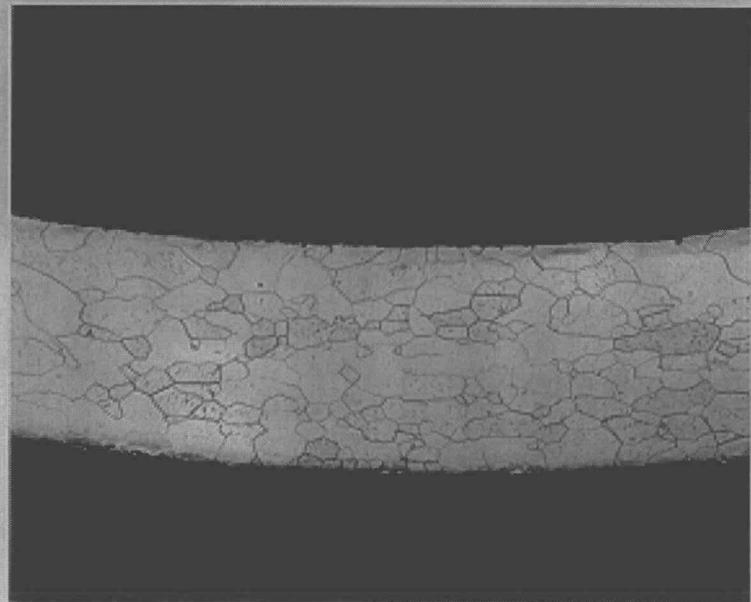
Fig. 8. The microstructure of the FC-152 vent cup was acceptable; axial section, 50X.

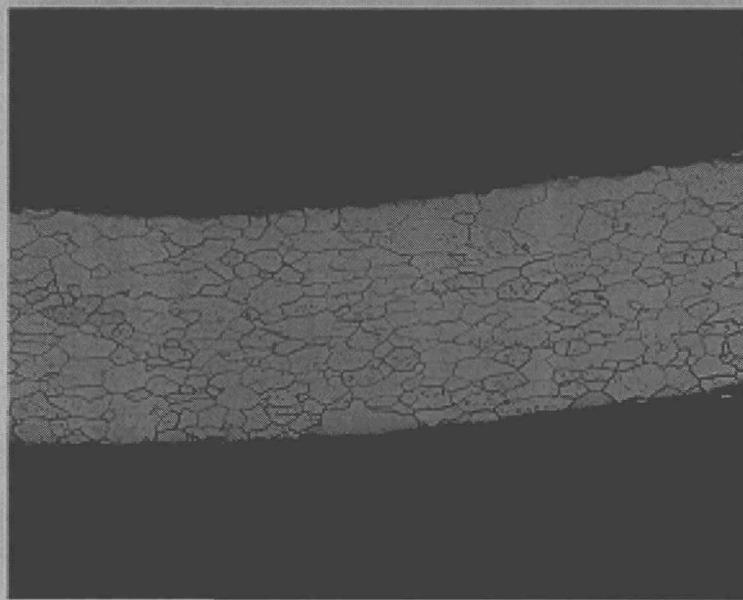
Fig. 9. The FC-152 weld shield cup had a fine-grained microstructure; transverse section, 50X.

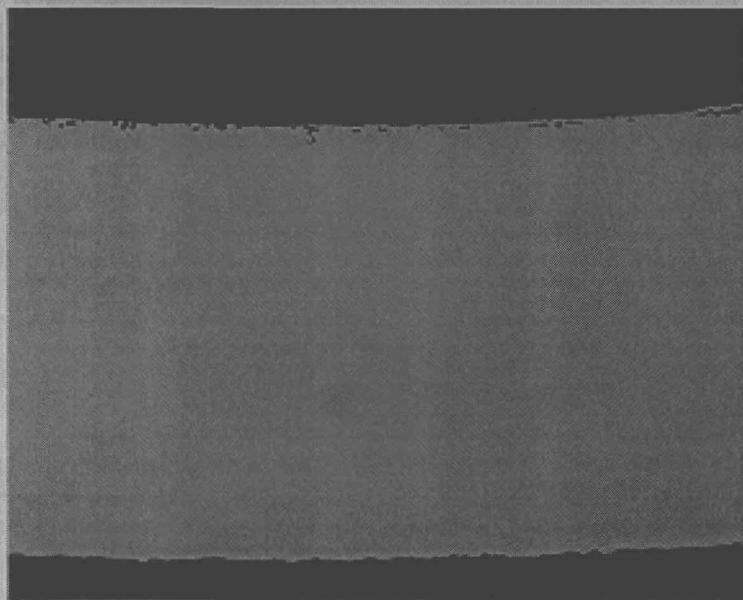
During examination of the FC-589 vent and weld shield cups, numerous delaminations were observed along the inner surfaces (Figs. 10 and 11). Although the cause of this defect is unclear, the occurrence along only the inner surfaces suggests some relation to the fuel. It is possible that the defects are not delaminations but are instead the sites of corrosion or intermetallic reactions. No similar defects were observed in any of the other capsules.

Fig. 10. Several subsurface delaminations were observed on the interior of the FC-589 vent cup; 100X.

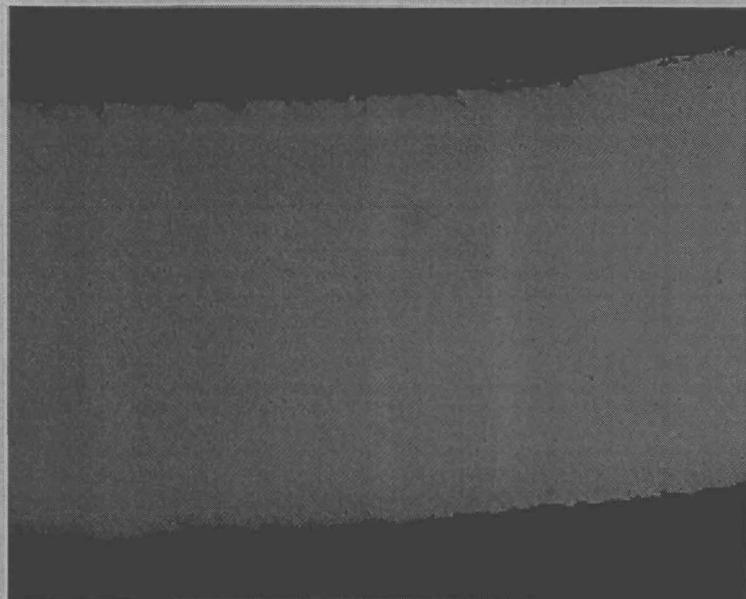
Fig. 11. Similar delaminations were observed on the interior of the FC-589 weld shield cup; 100X.

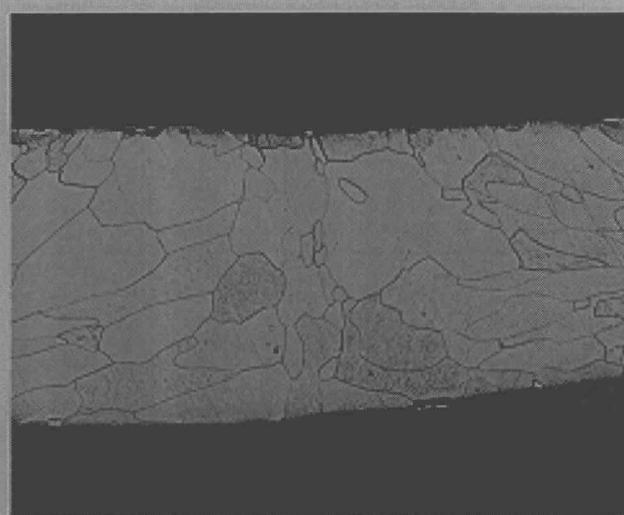
weld contained a significant amount of porosity (Fig. 12a), the microstructure (though somewhat coarse) was satisfactory (Fig. 12b). The FC-589 weld had a typical microstructure and contained no observable defects (Fig. 13).

Fig. 12. The FC-590 closure weld contained a significant amount of porosity and had a somewhat coarse microstructure. (a) Polished and (b) etched; both at 50X.

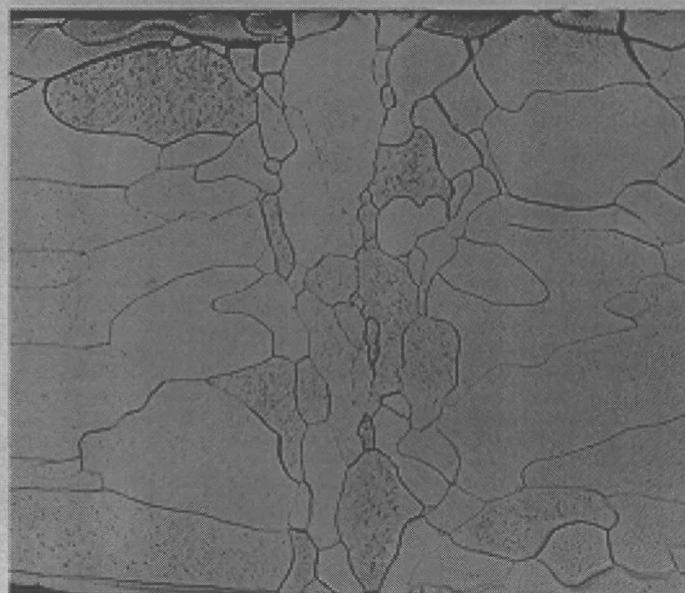
Fig. 13. The FC-589 weld had a typical microstructure; etched, 100X.

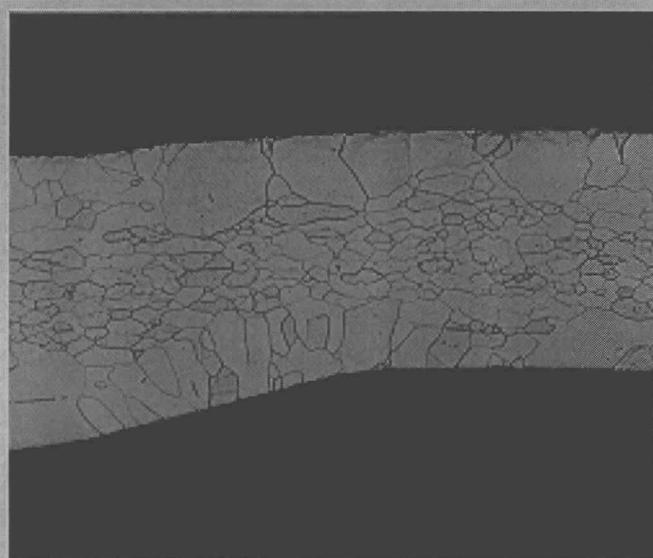
Examination of the vent cover welds revealed evidence of abnormal grain growth (Figs. 15 and 16). Although large grains were observed near both cover welds, the FC-590 weld was worst affected; wall sections adjacent to the FC-590 weld were only 2 grains thick (Fig. 16).

Fig. 15. Abnormal grain growth was observed on both sides of the FC-589 vent cover weld. (a) Impact face side and (b) trailing face; both at 50X.

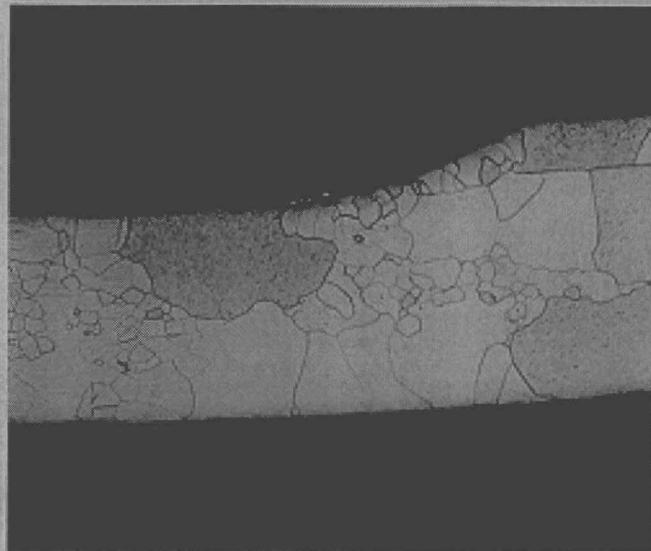
Fig. 16. The FC-590 vent cover weld was also affected by excessive grain growth. (a) Impact face side and (b) trailing face; both at 50X.

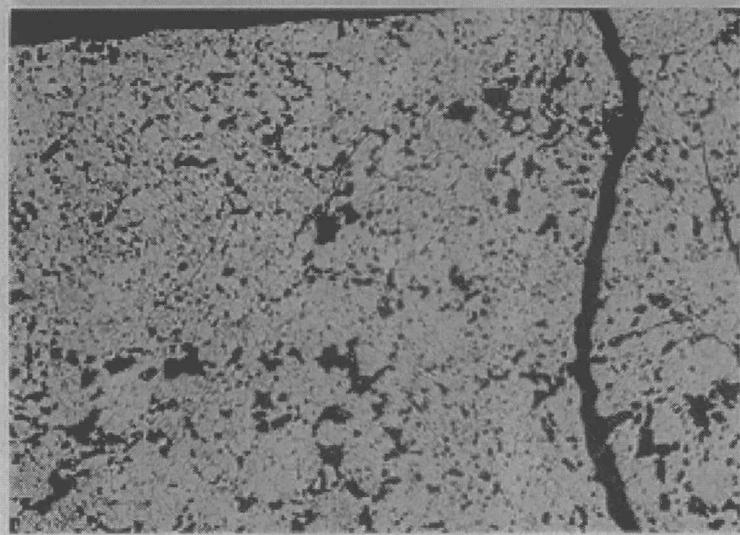
6. Fuel Ceramography. We sampled each fuel pellet to provide a specimen for ceramography. Microscopic examination of the polished samples did not reveal any unusual features (Figs. 17 through 20). The fuel microstructures were typical of SRP production and were similar to the microstructures of pellets used in previous SVT impacts.

Fig. 20. No unusual features were observed in the microstructure of the HF-590 fuel pellet; etched, 100X.

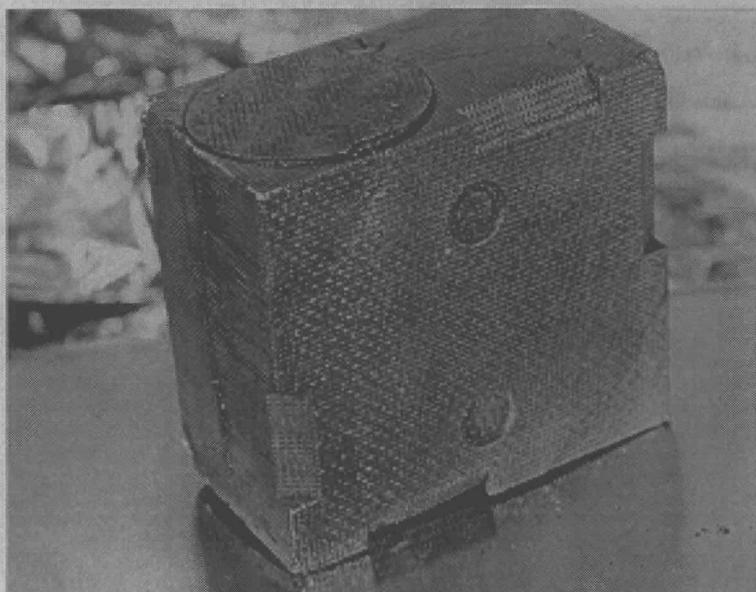
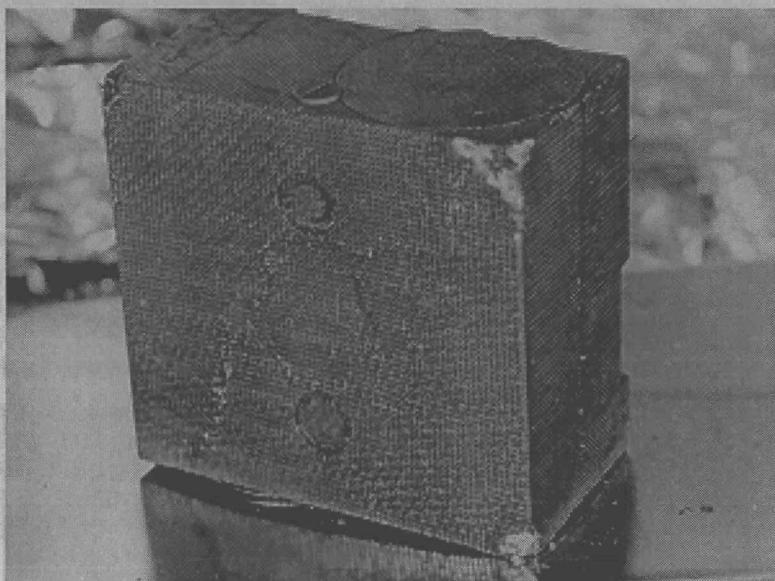
Fig. 21. Damage incurred by the aeroshell in SVT-11 was less than that in impact tests against a steel target: (a) Impact face forward and (b) back side forward.

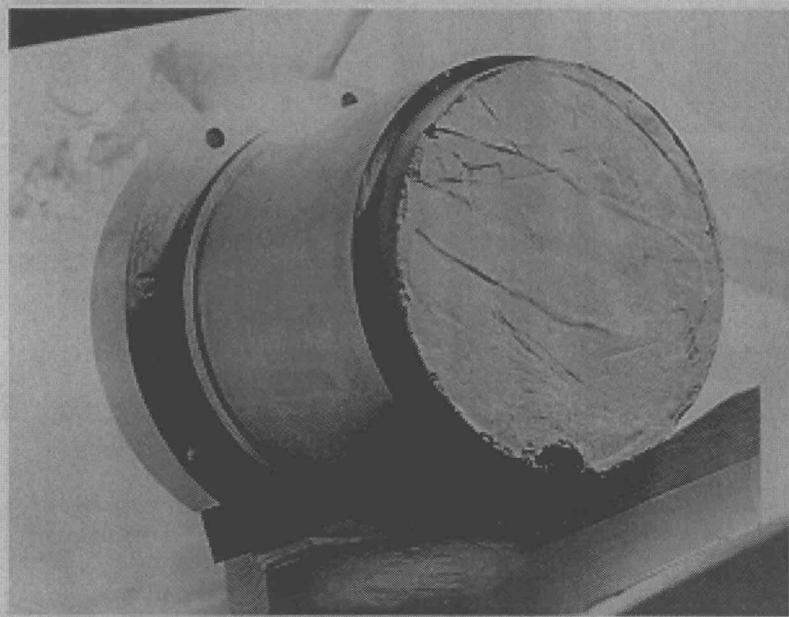
Fig. 22. An imprint of the aeroshell was present on the concrete target face in SVT-11.

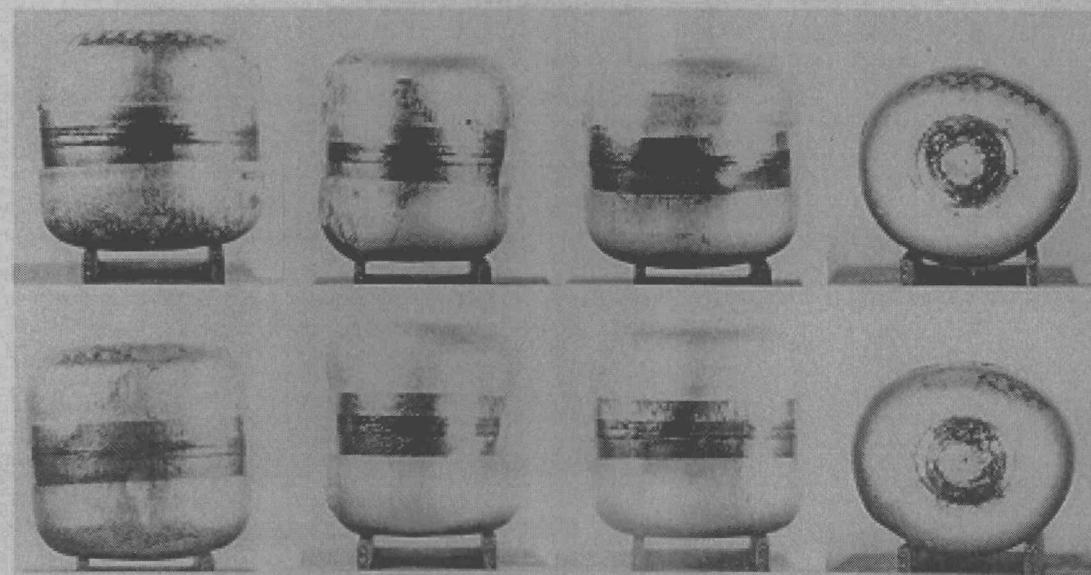
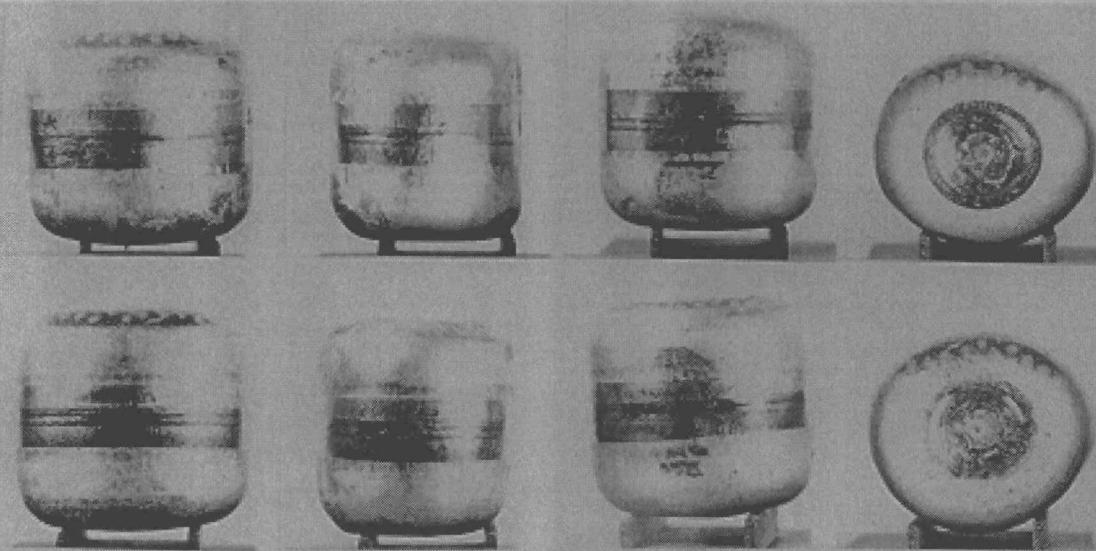
No failures of the iridium capsules occurred. Photographs of the fueled clads are shown in Fig. 24; the gross

Fig. 24. No failures of the iridium clad occurred in the SVT-11 fueled clads. The overall deformation was less than that of the impacts against steel targets.

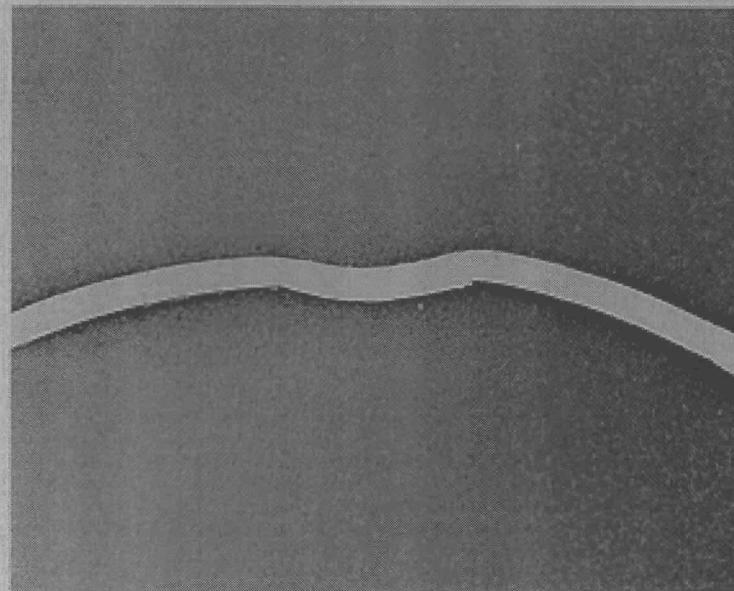
The most severe localized iridium deformation occurred on the center of the FC-345 impact face. Figure 25 shows two fuel fragment indentations with shallow re-entrant folds. No evidence of iridium failure was detected by subsequent metallographic examination.

Fig. 25. No failures of the iridium were observed at the location of most severe iridium deformation in FC-345 of SVT-11; ~7X.

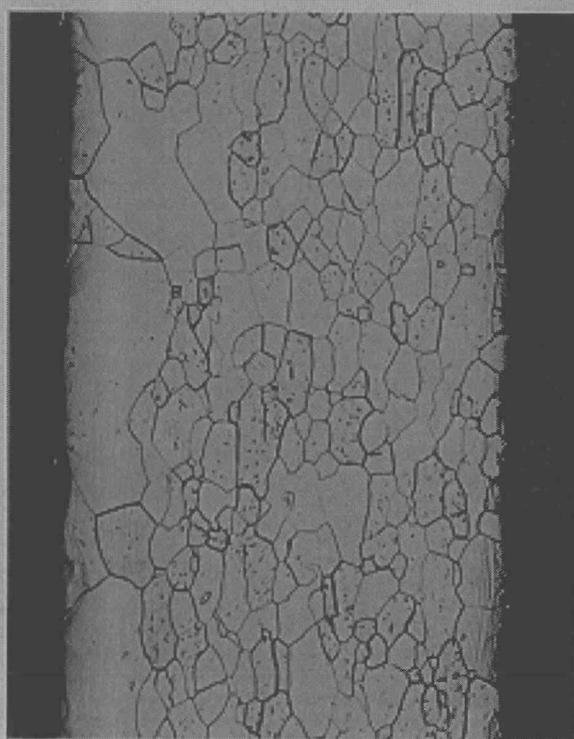
The iridium cup microstructures of the primary fueled clads were nonuniform across the thickness. Large grains observed on the cup interiors extended through 20-25% of the wall thicknesses. Typical cup microstructures are shown in Fig. 26, and the average number of grains/0.635-mm nominal wall thickness are tabulated in Table III. Although the grain size of cup QR820-4 (FC-372) was finer than that of the others, all of the cup microstructures were consistent with the grain sizes observed in previous test clads.

Fig. 26. Iridium microstructures in SVT-11 were nonuniform across the wall thickness. (a) FC-345 vent cup, (b) FC-345 shield cup, (c) FC-372 vent cup, and (d) FC-372 shield cup; all at 100X.

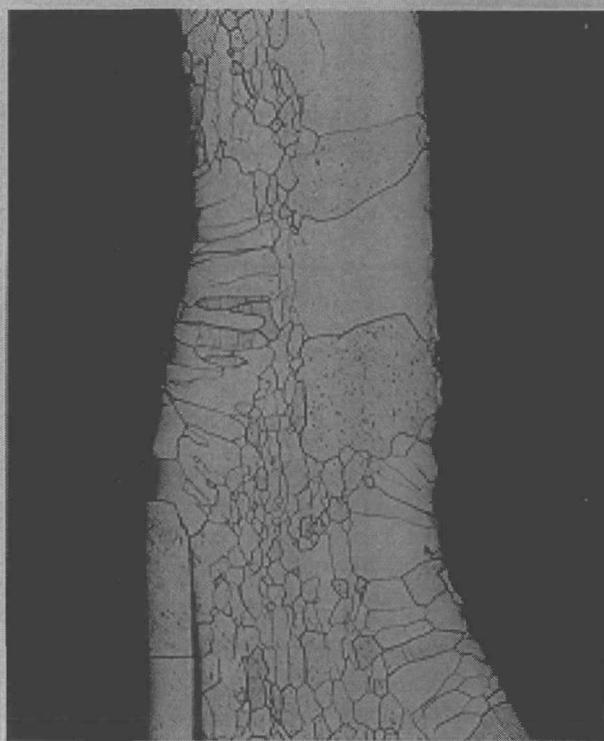
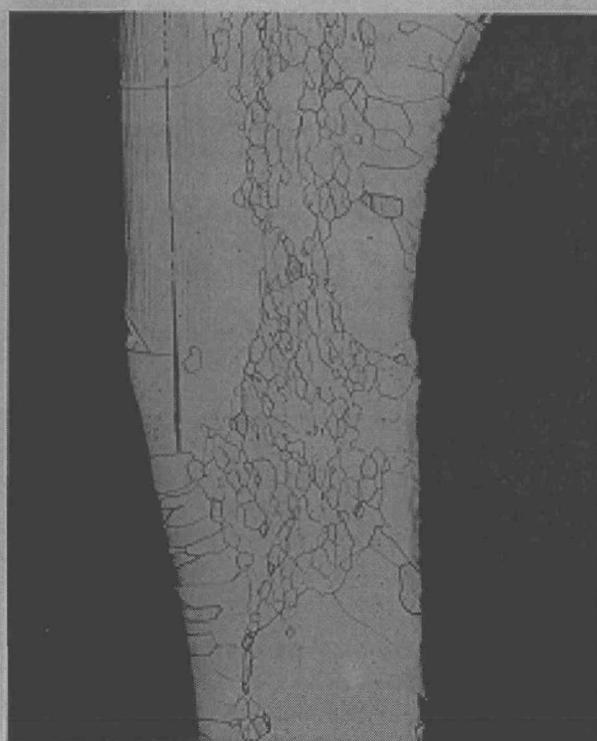
Metallographic examination of cross sections of the FC-345 and FC-372 vent assemblies indicated no vapor transported deposits in the vent orifices and only small amounts of plutonia deposited at the entrances to the vent filter elements. The decontamination cover welds and the vent assembly welds were free of cracks and porosity. However, in both fueled clads, abnormal grain growth in the parent metal on one side of the cross section was observed (Fig. 27).

Fig. 27. Abnormal grain growth occurred in the vent assembly welds of the primary fueled clads of SVT-11. (a) FC-345 and (b) FC-372; both at 50X.

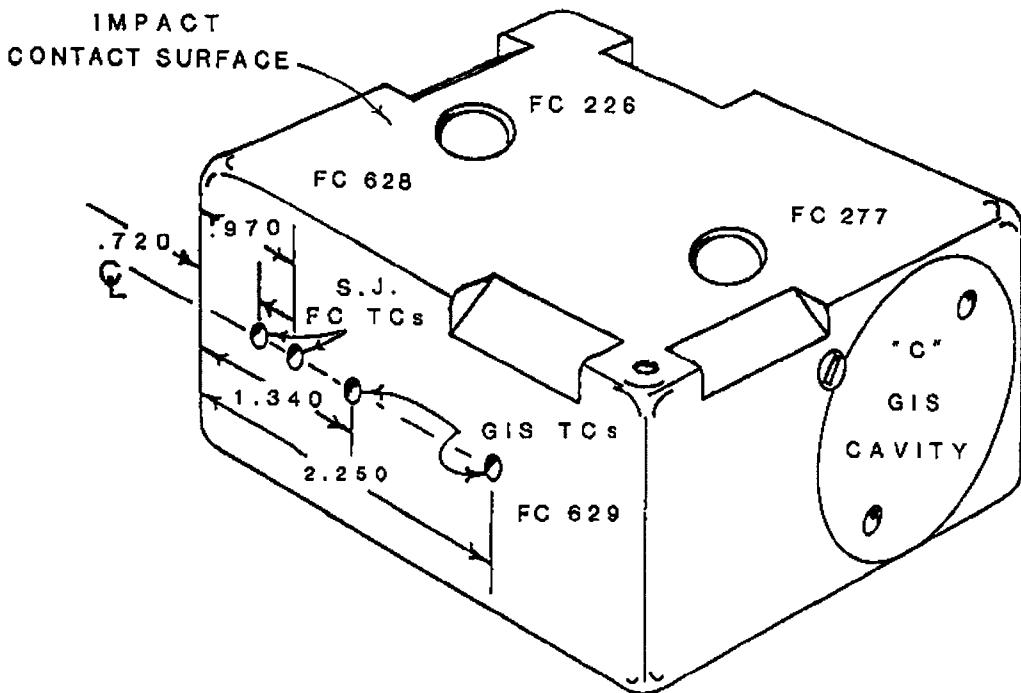
On December 13, 1984, a fully loaded GPHS module was impacted at 75.5 m/s and 975°C. The module orientation was $\alpha - \beta - \gamma = 0^\circ$ (Fig. 28), and the target material was concrete. Before impact, the test assembly was subjected to a simulated reentry cycle at 1375°C. In addition, the fueled clads had been aged for 90 days at 1287°C. The SVT-12 graphite components are listed in Table VII and encapsulated details for the SVT-12 fueled clads are given in Table VIII. Data describing the fuel pellets are presented in Table IX. After the test, a sealed catch tube containing the impacted module was

Fig. 28. The SVT-12 impact assembly.

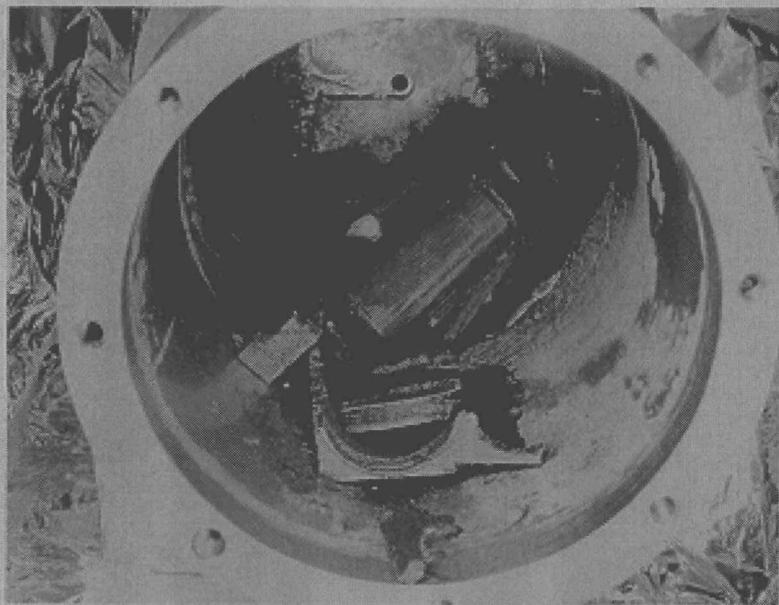
Examination of the catch tube interior revealed that the aeroshell had been completely destroyed (Fig. 29). The aeroshell fractured along the axial contact lines of the GISs and was broken into several small pieces. Aeroshell breakup was the most severe observed to date and reflected the high impact velocity.

Fig. 29. The SVT-12 aeroshell was badly broken up.

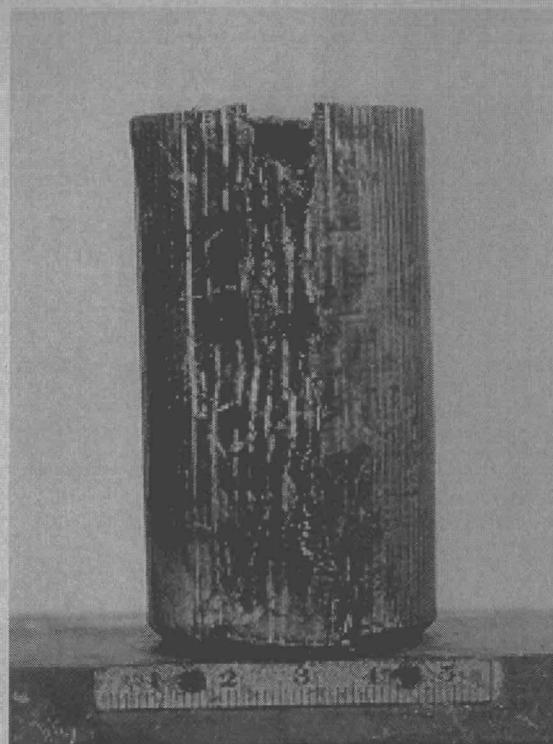
Damage to the GISs was similar to that observed in lower velocity impacts. The cap of the primary GIS had been removed, and the impact face of the GIS contained a network of axial cracks running the GIS length (Fig.

Fig. 30. The cap of the primary GIS had been removed. (a) Impact face, (b) profile, and (c) closure end; all at 1X.

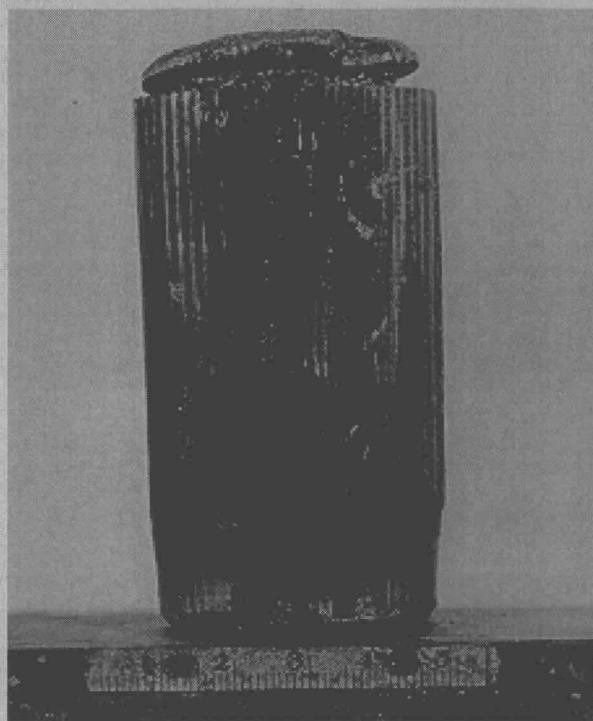
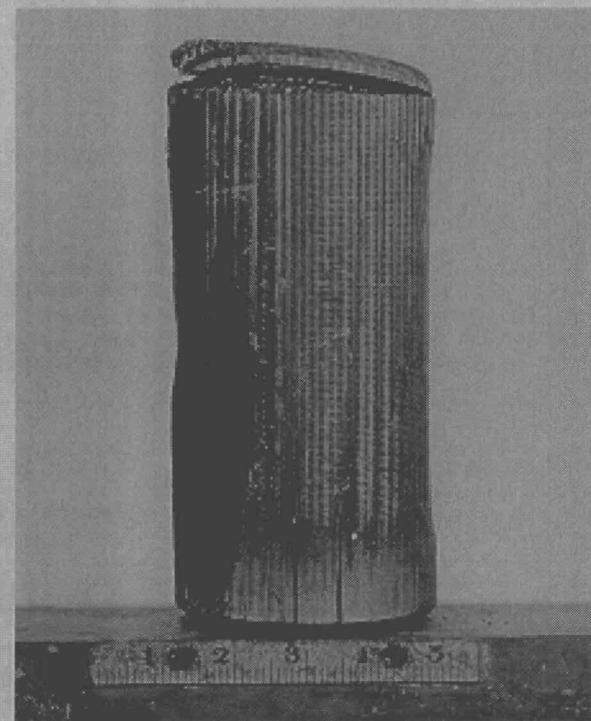
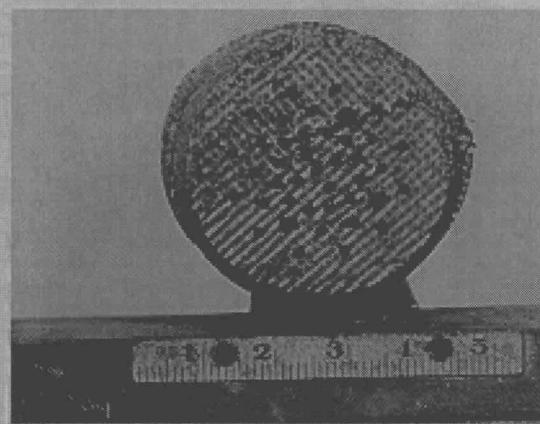
30). Although the cap had been removed, the capsule at the closure end of the GIS (FC-628) was not released. The secondary GIS also contained a wide axial crack on the impact face and several small cracks on the other faces (Fig. 31).

Fig. 31. The impact face of the secondary GIS contained a wide axial crack. (a) Impact face, (b) profile, and (c) closure end; all at 1X.

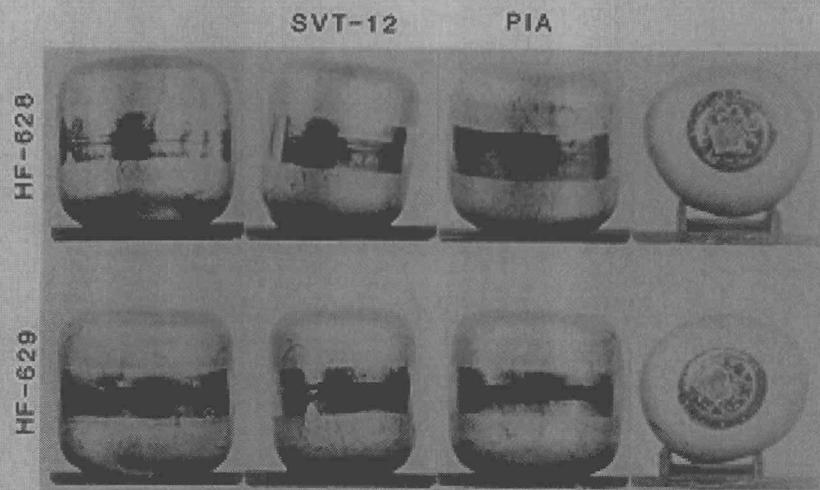
Fig. 32. Clads contained within the primary impact assembly.

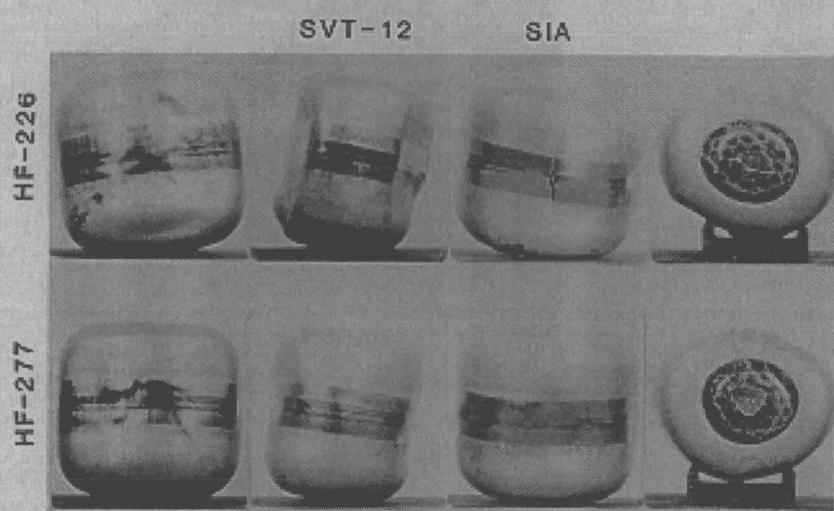
Fig. 33. Clads contained within the secondary impact assembly.

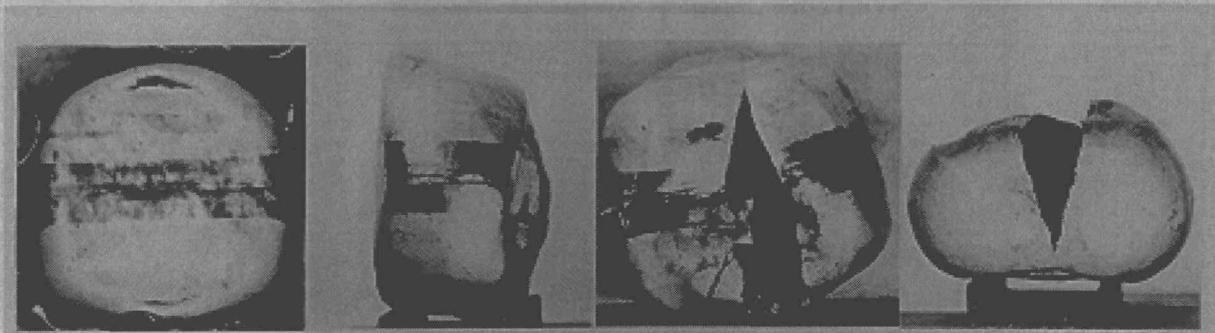
BCI-1 76.24 m/s

Photographs of the impacted fueled clad are shown in Fig. 34. An axial breach, ~44 mm long and 9 mm wide, occurred on the back side. The breach extended the full length of the clad. Transverse cracks, ~12 mm \times 1 mm and 8 mm \times 0.2 mm, were present on the impact face near the cylinder-to-end transition radius. Additionally, a failure occurred along the centerline of the weld bead, ~18 mm \times 1 mm. An area on the trailing face of the clad, roughly 6 mm \times 10 mm, exhibited extensive microcracking and surface spallation. Dark gray surface deposits were also present, suggesting possible contamination by materials used for the impact can hardware.

Fig. 34. The iridium clad in test BCI-1 sustained a severe breach on the back, two transverse breaches on the impact face, and a weld failure on the side; $\sim 0.7X$.

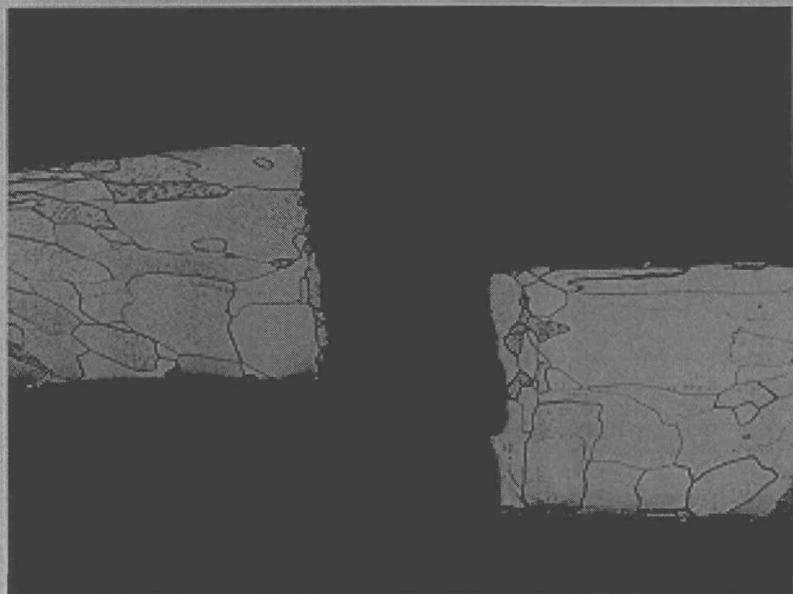
Metallographic cross sections through the weld failure, the impact can failure, and the area with surface spallation were examined. Figure 35 shows the weld bead microstructure. The offset of the capsule wall on either side of the fracture is indicative of nonuniform strain imposed by differential displacement of large plutonia fragments. The weld penetration was complete, there was no porosity, and the grain structure appeared to be free of transversely oriented columnar grains.

Fig. 35. The offset of the capsule wall on either side of the weld bead fracture of FC-209 indicates nonuniform strain imposed on the iridium capsule wall. The microstructure was acceptable; 50X.

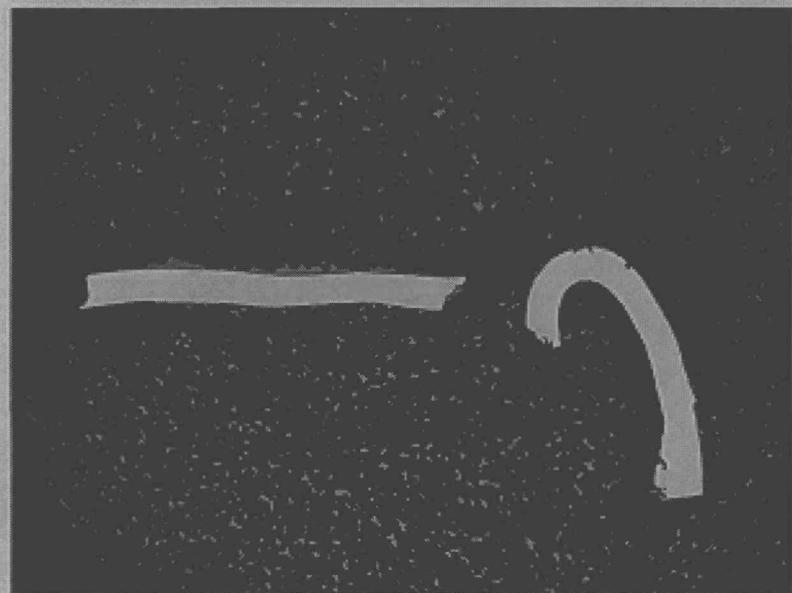
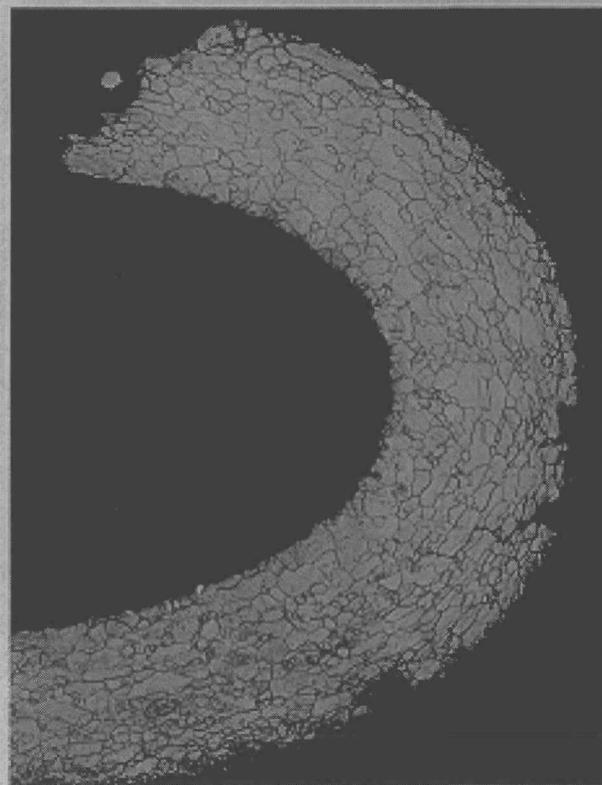
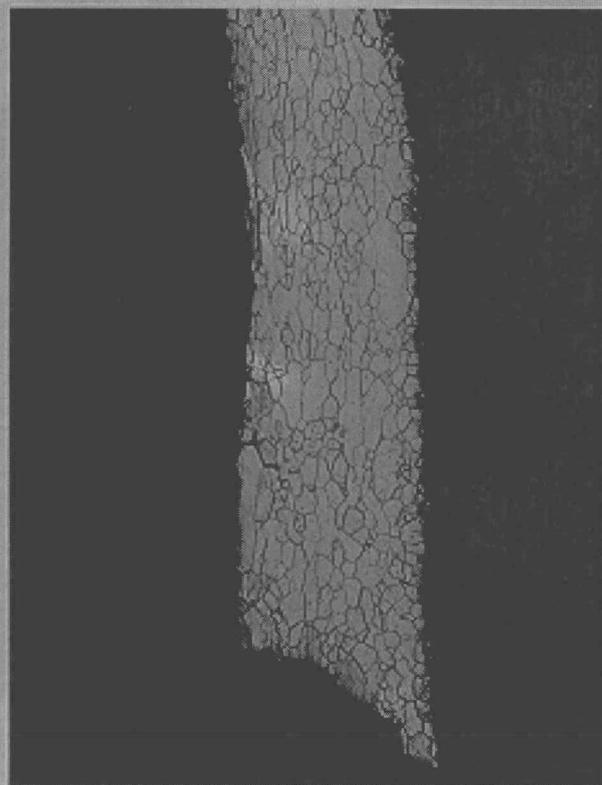
Photomicrographs of the impact face failure on the vent end are shown in Fig. 36. The photomicrographs show that the end of the capsule curled nearly 180° towards the interior. The fracture mode at the failure was intergranular, with no evidence of ductile iridium deformation. However, the generalized reduction in thickness of the capsule wall of about 33% both in the flat impact face and the curled region demonstrates the beneficial effect of compressive stresses normal to the wall thickness. The reduction of thickness indicates that the frictional forces at the plutonia/iridium and iridium/tantalum interface were low enough to permit the iridium to elongate. A narrow intergranular crack progressing from the exterior through about 50% of the thickness suggests that the potential exists for severing a relatively large piece of iridium to create a much larger fracture.

Fig. 36. Transverse impact face failures in FC-209 resulted from curvature of the capsule end towards the interior of the capsule. (a) 7X; (b) and (c) 50X.

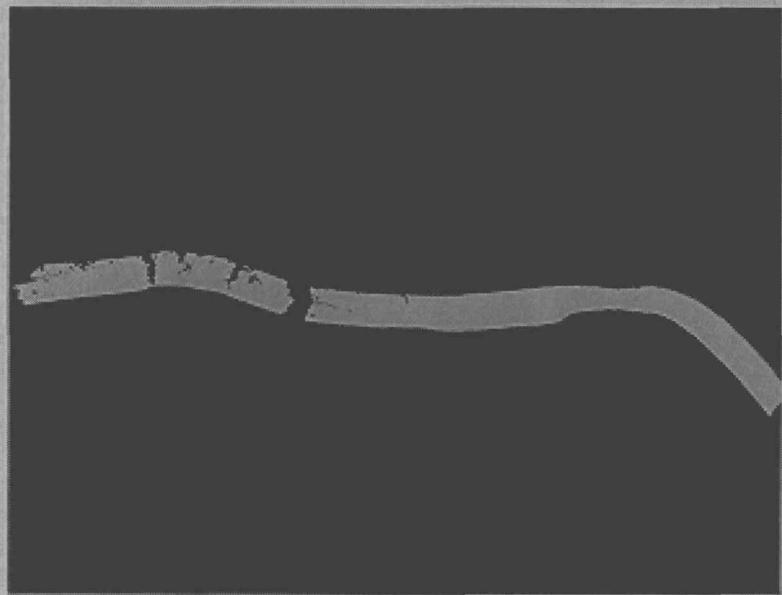
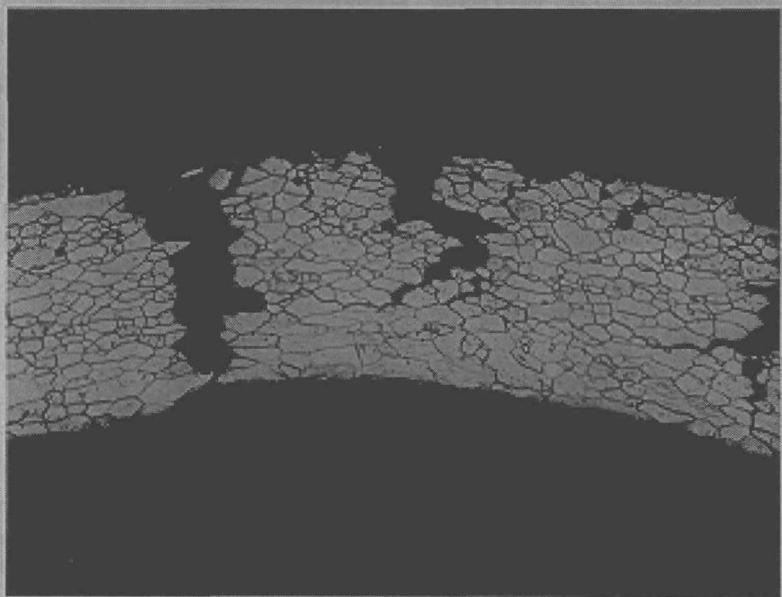
Figure 37 shows the microstructure of a transverse cross section including the surface-spalled area. The microstructure consisted of relatively fine grains elongated in the plane of the capsule wall. Extensive grain boundary fracturing resulted in loss of material from the surface, as well as loss of a few individual grains from the face of the metallographic sample. Longitudinal cracks existed at about two-thirds of the thickness from the exterior surface. There were no tensile stresses normal to the wall thickness during the impact event to account for these fractures, and they perhaps indicate the depth of contaminant penetration.

Fig. 37. Microstructure of the FC-209 capsule wall that exhibited surface spallation. Extensive grain boundary fracturing occurred; (a) 7X and (b) 50X.

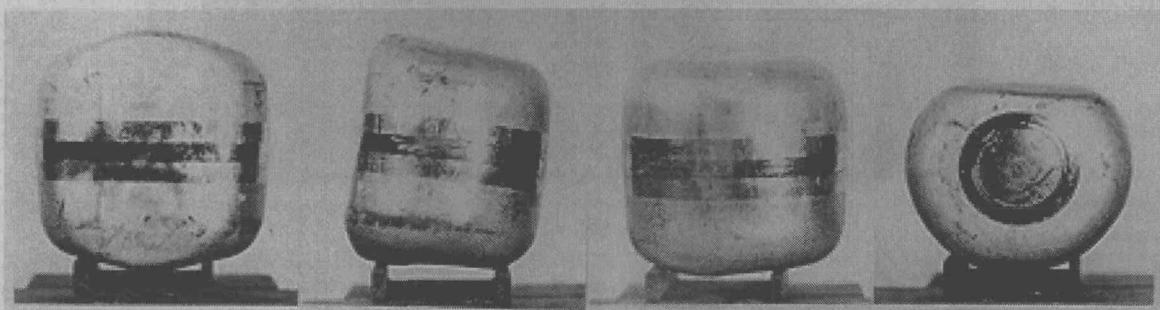
BCI-2 53.7 m/s

No failures of the iridium clad were observed. A shallow depression was present on the face of the concrete target, and the impact face of the fueled clad was roughened, replicating the concrete target surface. An axial ridge at the location of a fuel fragment push-through was present on the impact face, but the most severe localized iridium deformation occurred at the ends of the impact face. Photographs of the impacted capsule are shown in Fig. 38; test results are summarized in Table XI.

Fig. 38. Photographs of the impacted fueled clad FC-164. There were no failures. Left to right — impact face, side profile, back, and vent end; all at ~0.7X.

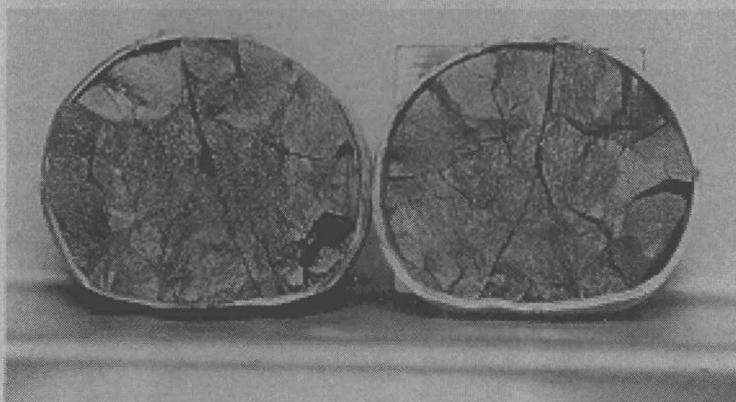
The plutonia fracture pattern is shown in Fig. 39. The pellet fractured into several relatively large fragments; the fracture plane that caused the axial ridge on the impact face was readily apparent. Although the impact target was a rigid material, extensive crushing of the plutonia at the impact face did not occur. Instead, the change in shape appears to have been accommodated primarily by the relative displacement of fuel fragments.

Fig. 39. The plutonia pellet of FC-164 fractured into relatively large fragments. Extensive crushing on the impact face was not observed; $\sim 1.5X$.

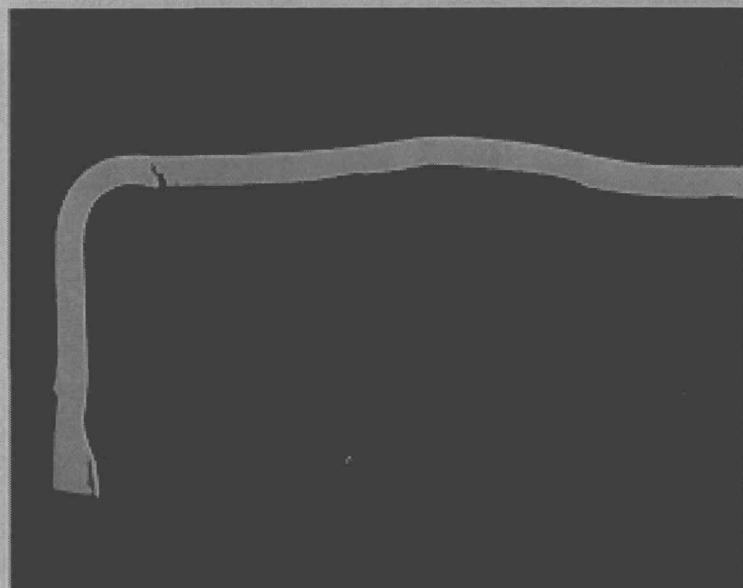
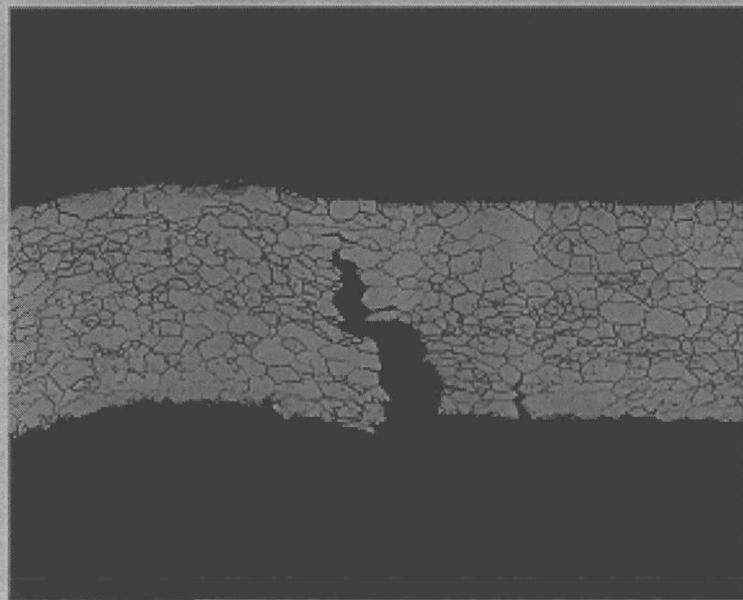
Small transverse cracks were observed on the interior of the iridium clad at the ends of the impact face. The largest of these occurred near the vent end. Figure 40 shows a photomicrograph and a photomicrograph of

the metallographic cross section through this region of the capsule. The crack was widest at the interior surface and extended through $\sim 85\%$ of the wall thickness. A secondary crack, extending through $\sim 20\%$ of the thickness, was present near the principal crack. The fracture mode was intergranular with no indication of ductility at the fracture site.

Fig. 40. A crack was initiated on the interior surface of the iridium at the vent end of the impact face. (a) 6.5X and (b) 50X.
