LA-10673-PR

Space Nuclear Safety Program

October—December 1984

Los Alamos National Laboratory
Los Alamos, New Mexico 87545

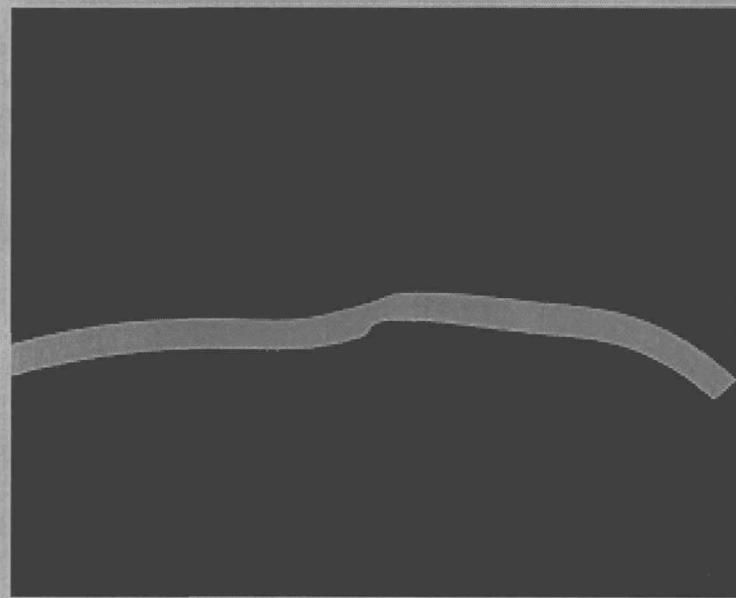
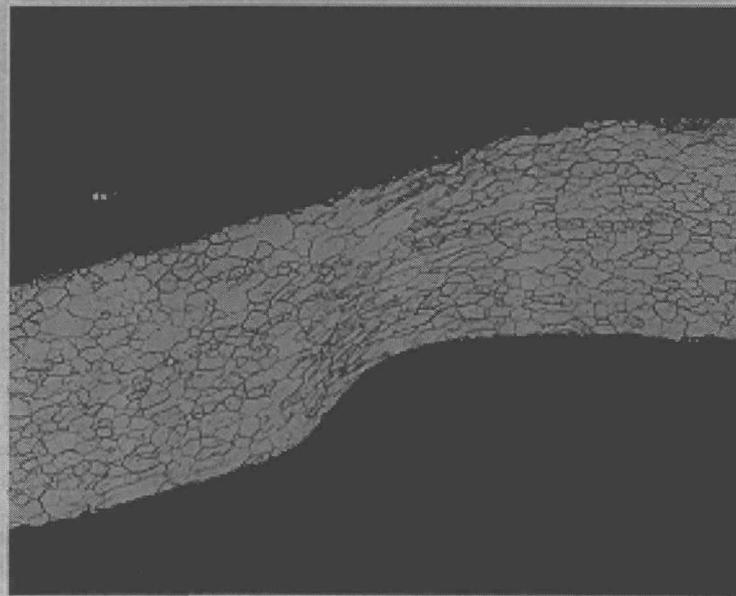
A transverse cross section through a ridge on the impact face is shown in Fig. 41. Mild reverse bending occurred near the site of the fuel fragment indentation. Reduction of thickness at the point of indentation was about 30%. No evidence of cracking was detected in the reverse bend region. Because the impact occurred against a rigid target (concrete), only limited deformation of the iridium was possible and a breach of the capsule was averted. Had the impact occurred with a compressible material such as FWPF graphite between capsule and target, a breach might well have occurred.

Fig. 41. Fuel fragment push-through caused an axial ridge on the impact face in BC1-2. The iridium was supported by the rigid target and did not breach; (a) 6.5X and (b) 50X.

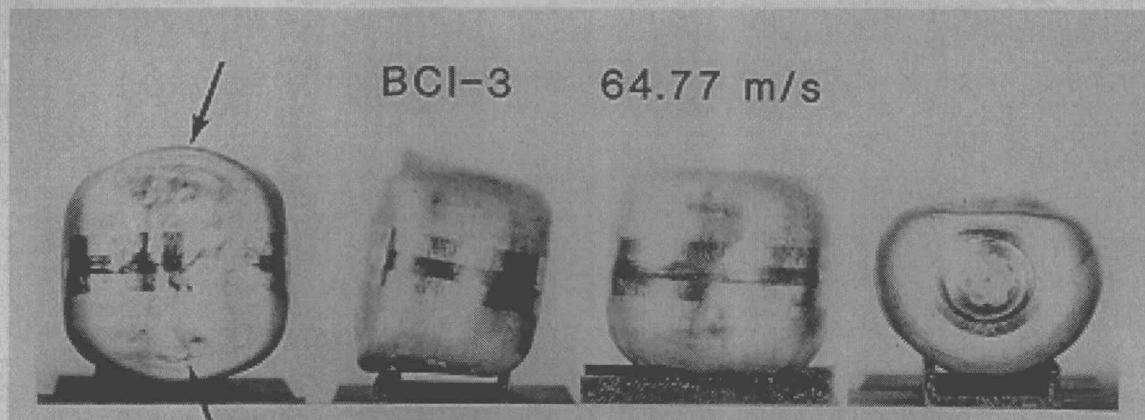
Fig. 42. Transverse cracks at the ends of the impact face occurred in FC-351. Left to right—impact face, side profile, back, vent end; all at 0.7X.

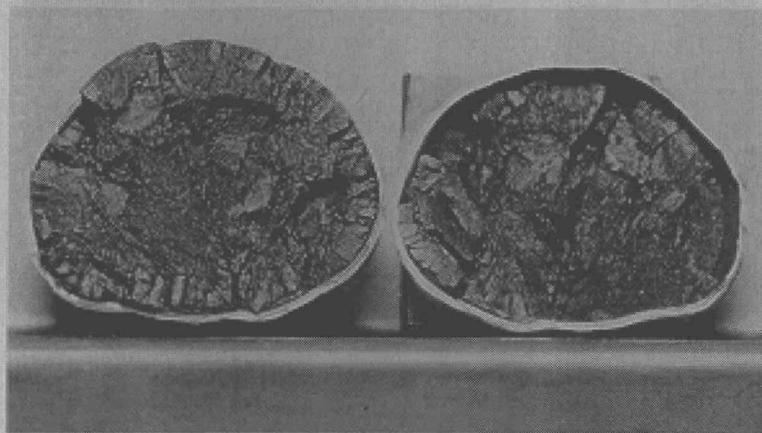
The plutonia fracture pattern is shown in Fig. 43. There appeared to be a tendency toward the formation of small, elongated, radially oriented fragments around the periphery of the cross section. The remainder of the pellet consisted of relatively large, irregularly shaped

Fig. 43. The plutonia fracture pattern of FC-351 exhibited a tendency to form small, radially oriented fragments on the periphery, although the principal fracture mode was large, irregularly shaped fragments; ~1.5X.

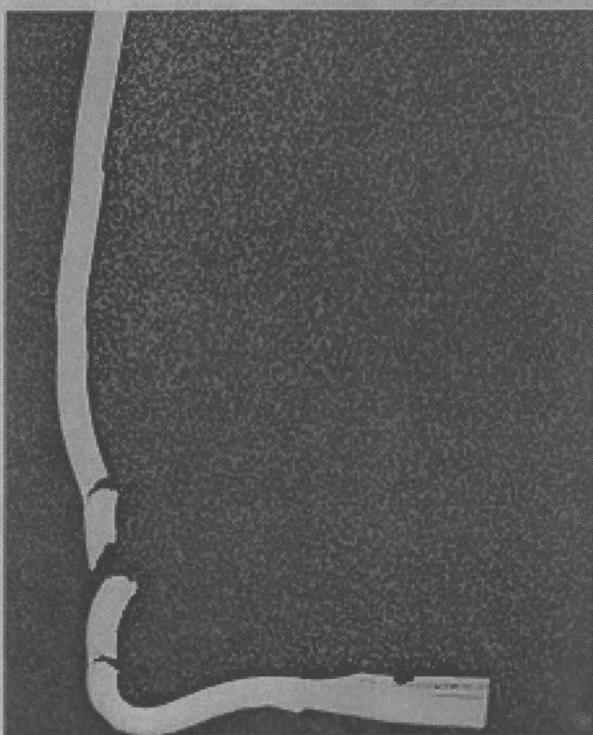
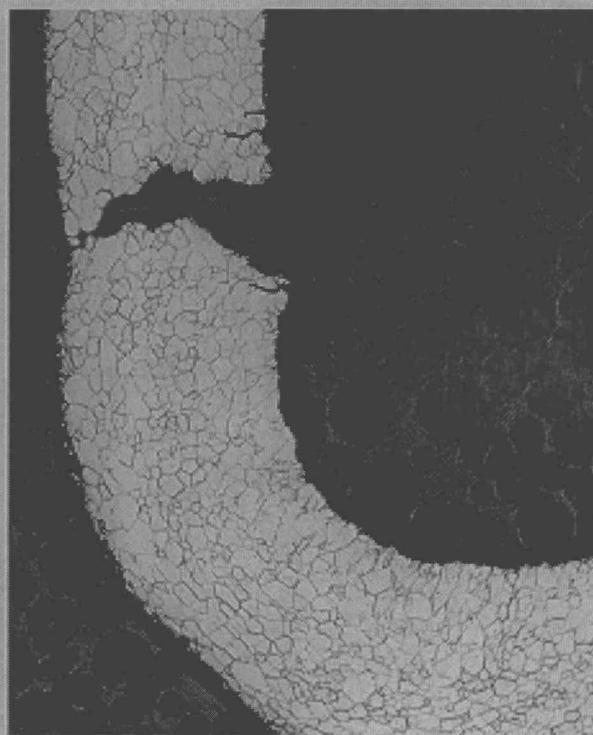
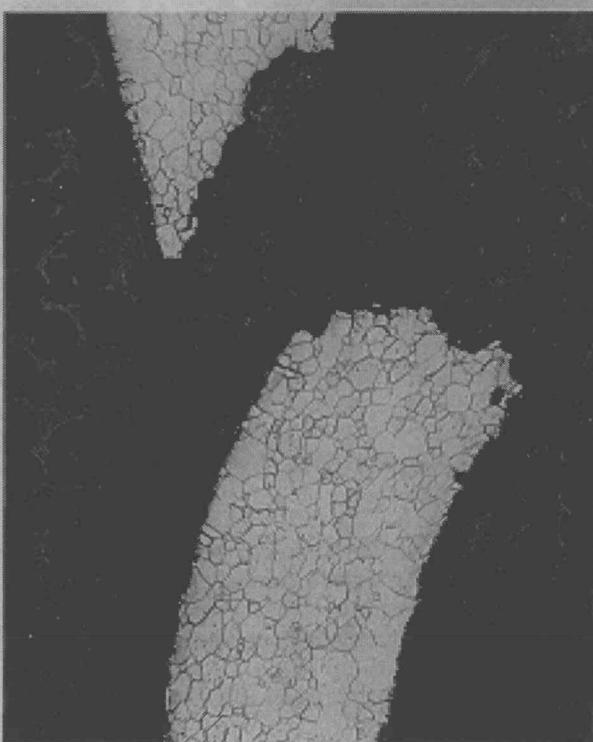
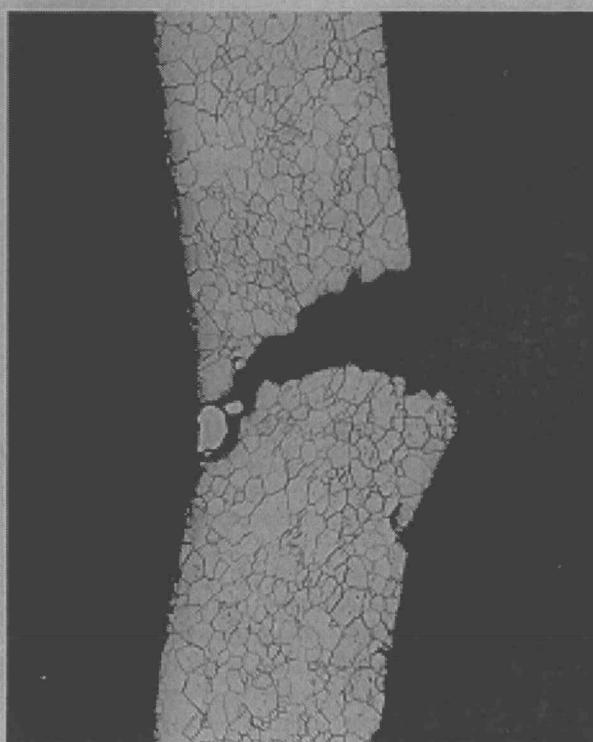
Fig. 44. Three transverse impact face cracks were present on the vent end of the impact face of FC-351; (a) 6.5X; (b), (c), and (d) 50X.

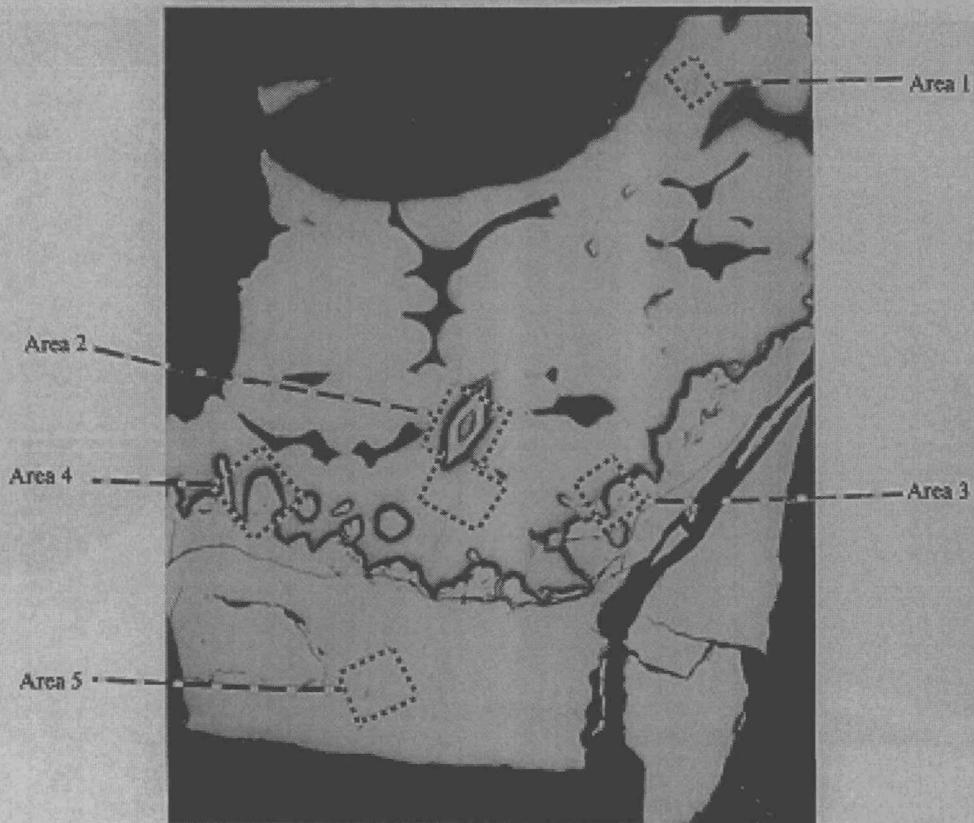
Fig. 45. Optical metallography revealed several phases on a cross section of the intermetallic blob; 40X.

Results of analyses at specific areas on the deposit cross section are presented in Table XII. The 27 to 31% Al/78 to 69% Ir compositional range was particularly interesting because electron imaging of an area with this composition revealed three distinct phase regions.

*A micrograph of the deposit cross section, showing the five areas of interest, may be seen in Fig. 45.

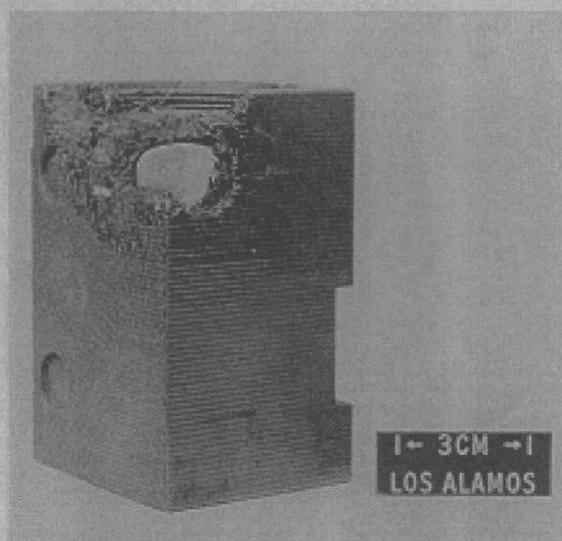
Fig. 46. Fifth bullet test on GPHS half-module after impact by .50-caliber aluminum alloy bullet at 555 m/s (1820 ft/s).

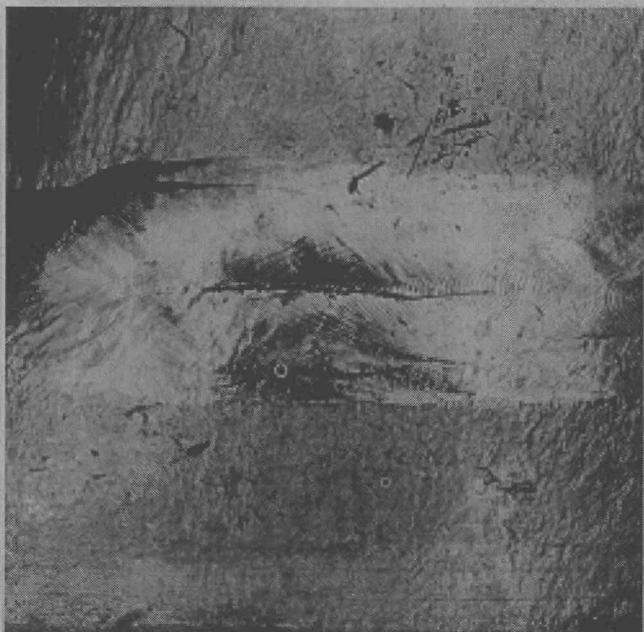
Fig. 47. Crack in the weld seam of the simulant-fueled GPHS clad after bullet impact at 555 m/s; 11X.

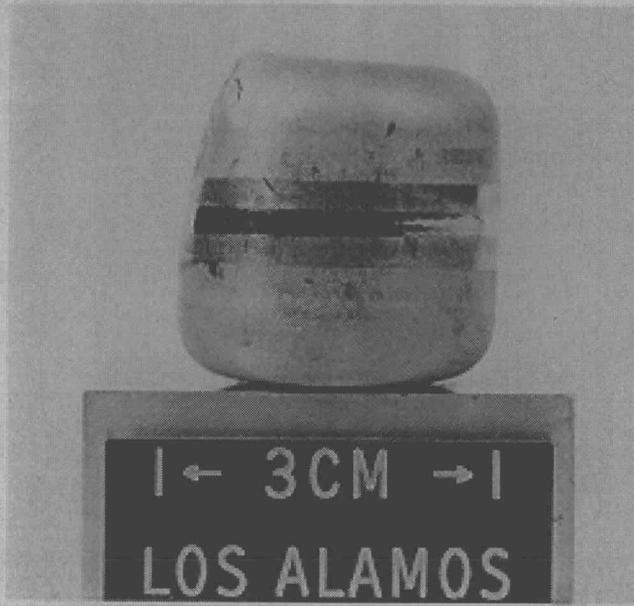
Fig. 48. Targeted GPHS fuel clad after bullet impact at 55 m/s. Note semicircular crack in upper left corner.

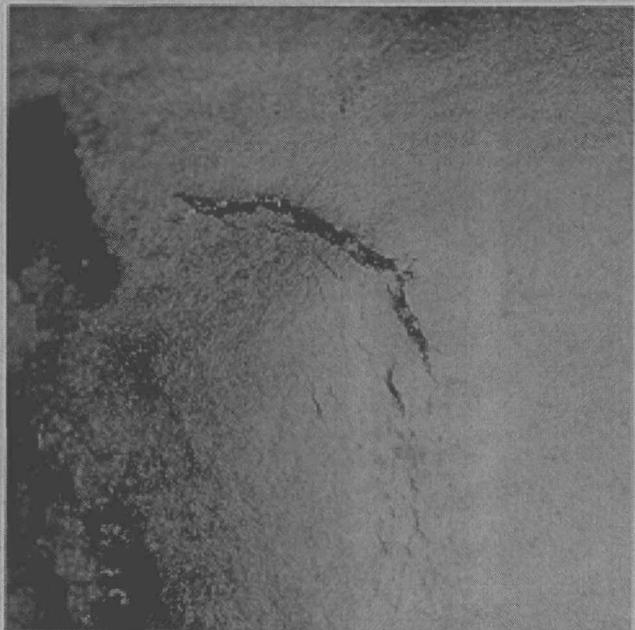
Fig. 49. Enlarged view of crack in the cup radius area of the targeted GPHS fuel clad after bullet impact; 11X.

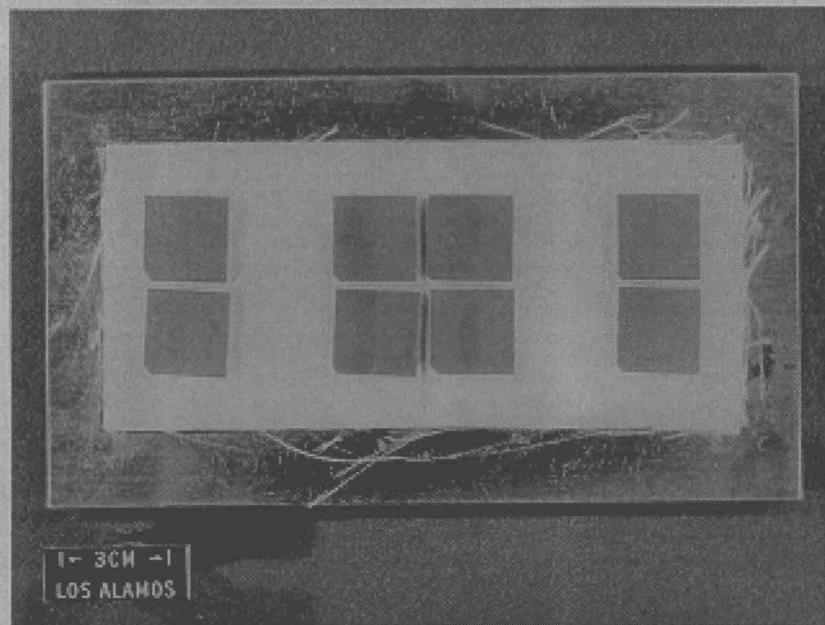
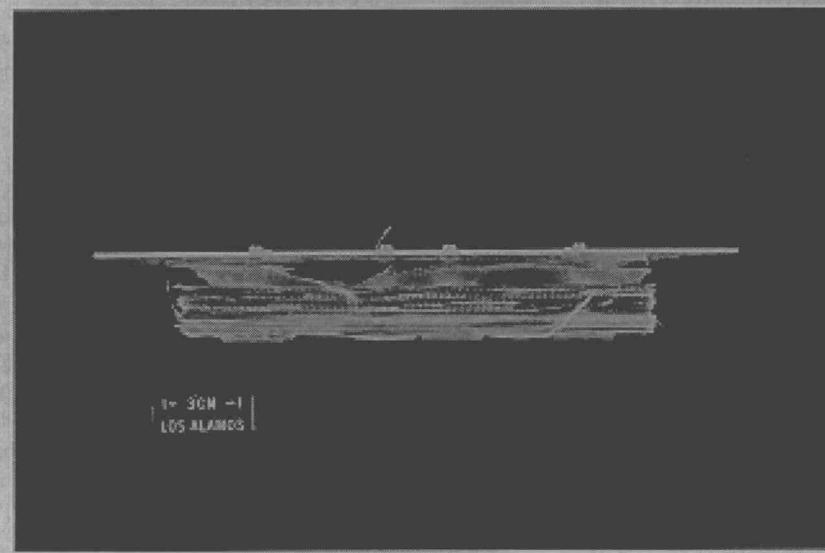
Fig. 50. GE converter test segment.

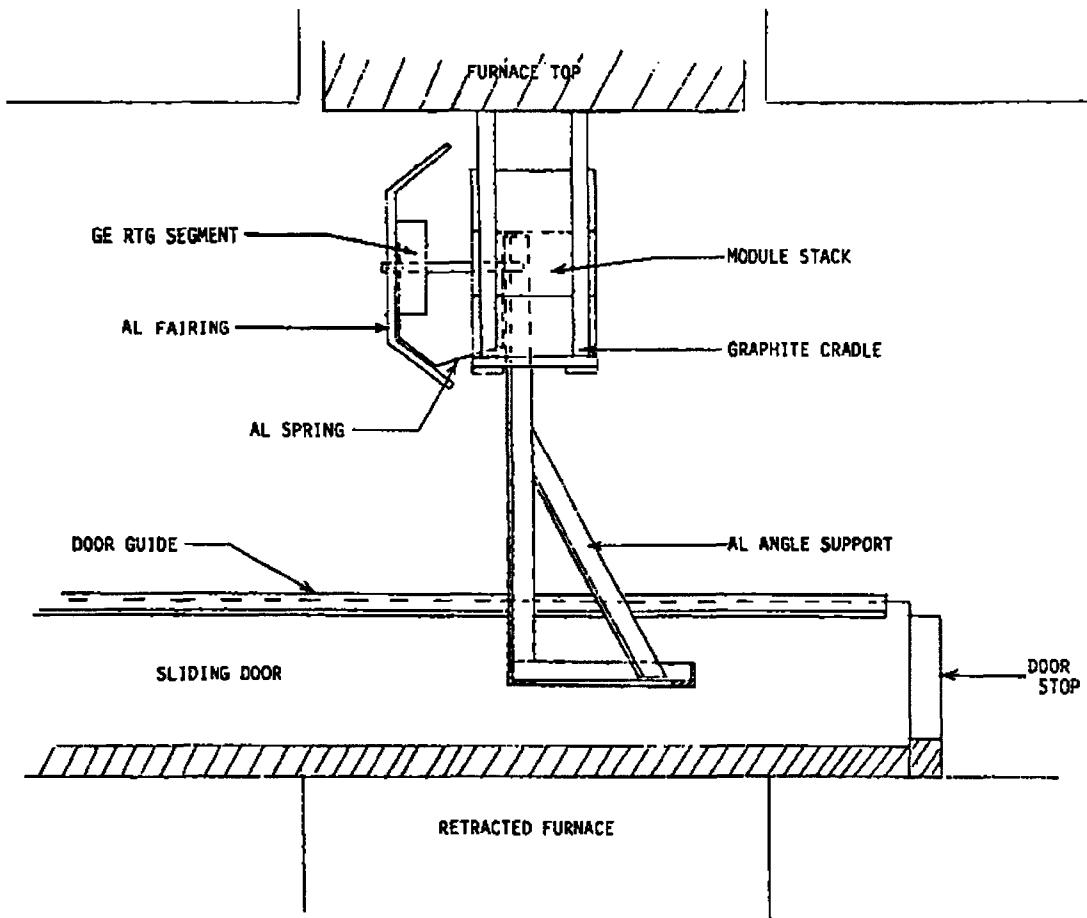
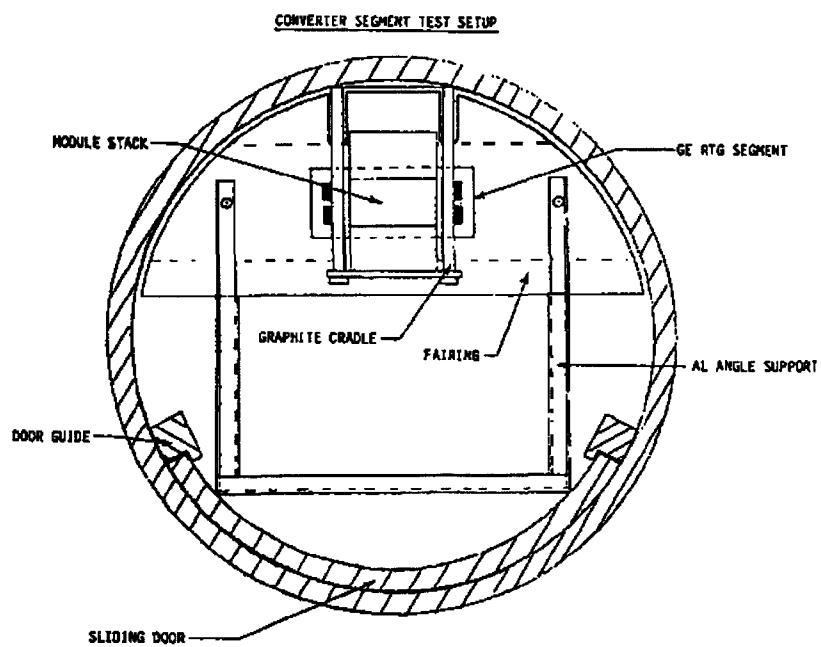
Fig. 51. CST test configuration. (a) Section view and (b) end view.

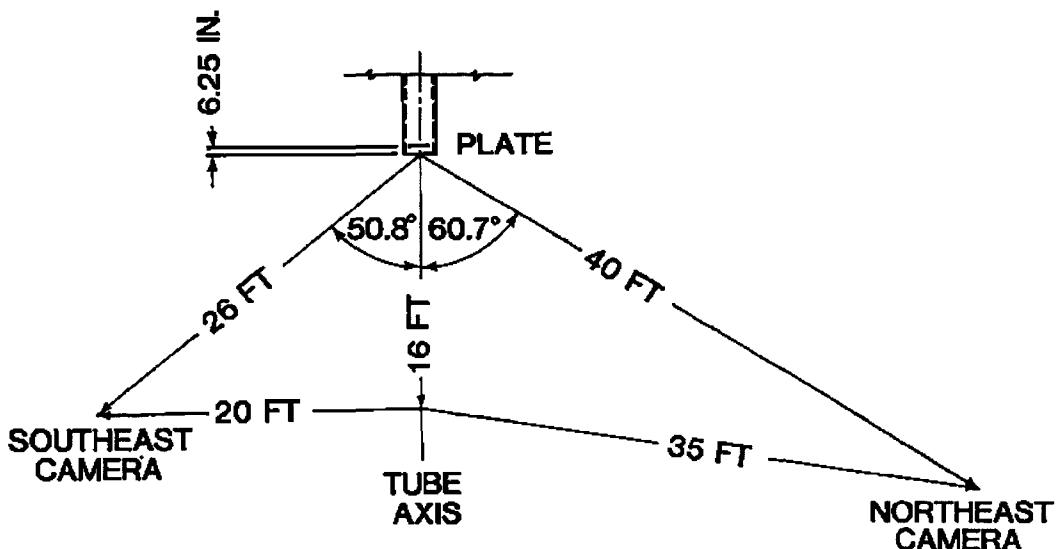
Fig. 52. Camera positions for engineering shock tube test.

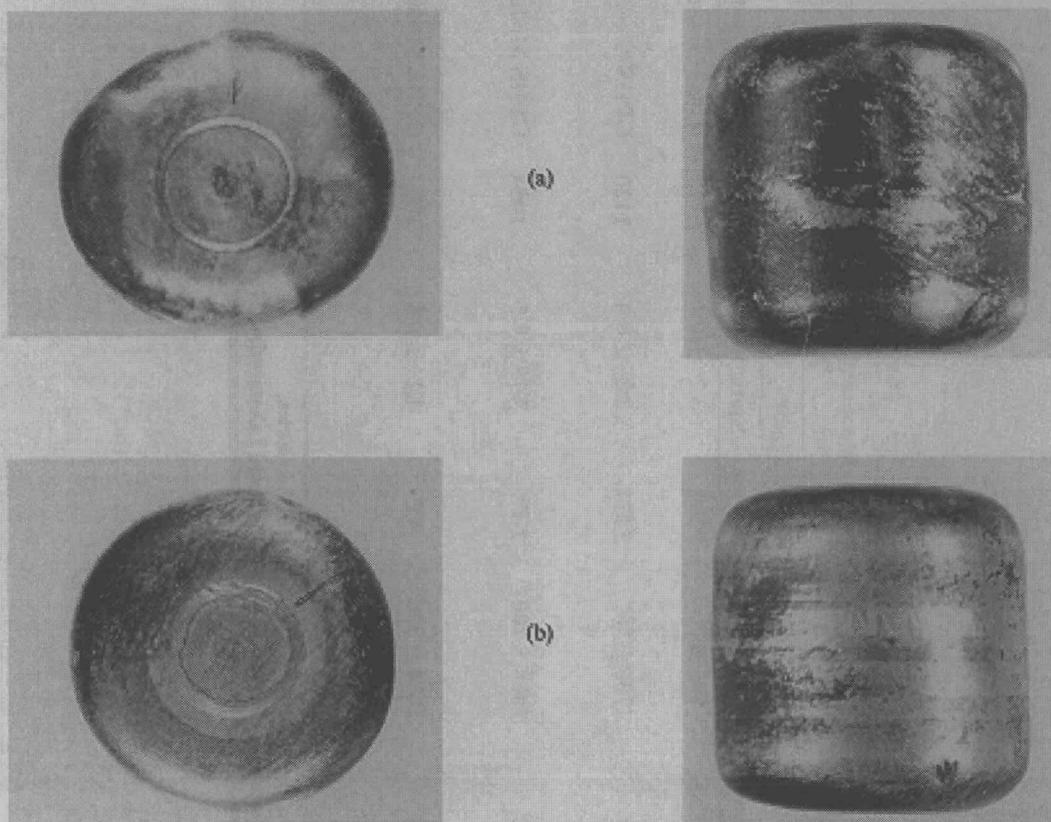
Fig. 53. CST-1 fueled clads 1 and 2, vent end and side views. (a) Fueled clad 1 and (b) fueled clad 2.

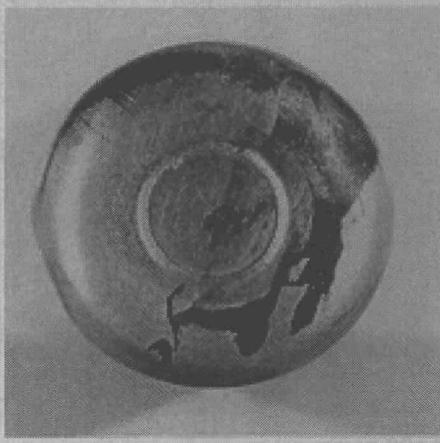
Fig. 55. CST-2 fueled clads 1 (A GIS, blind end) and 2 (C GIS, open end), vent end and side views. (a) Fueled clad 1 and (b) fueled clad 2.

3. CST-2. The second CST was conducted on November 28, 1984, at Coyote Test Site. An identical test setup was subjected to a static overpressure of 1028 psi and a static impulse of 3.75 psi · s. The clads were again deformed, but none breached. Posttest diametral measurements of the fuel clads are listed in Table XIV. Posttest identification of the fuel clads was made possible by comparing pretest and posttest photographs of the clad vents. Figures 55 and 56 show the deformed fuel clads. Data and results from this test are summarized in Table XIII.

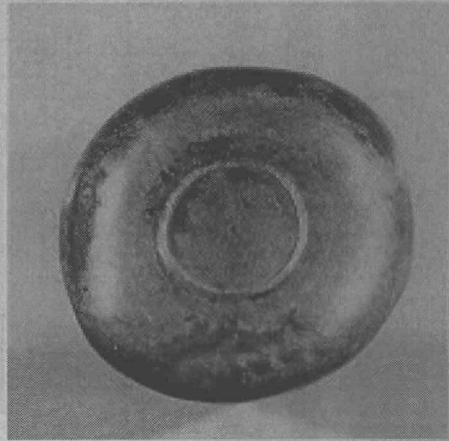
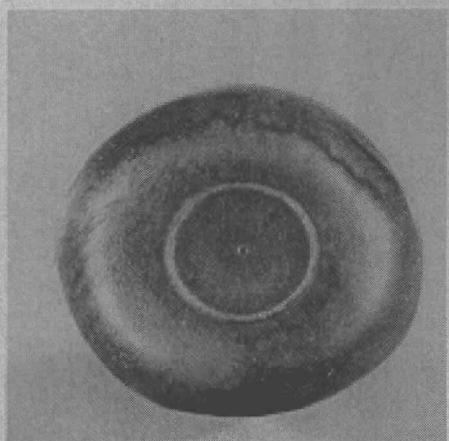
Fig. 56. CST-2 fueled clads 3 (A GIS, open end) and 4 (C GIS, blind end), vent end and side views. (a) Fueled clad 3 and (b) fueled clad 4.

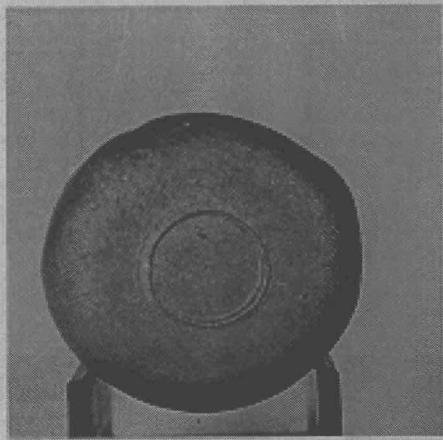
Fig. 57. CST-3 fueled clads L-12 (A GIS, blind end) and L-14 (A GIS, open end), vent end and side views.
(a) Fueled clad L-12 and (b) fueled clad L-14.

fuel clads is shown in Figs. 57 and 58. The shock tube end was bulged and, therefore, was not reusable. Data and results are summarized in Table XIII.

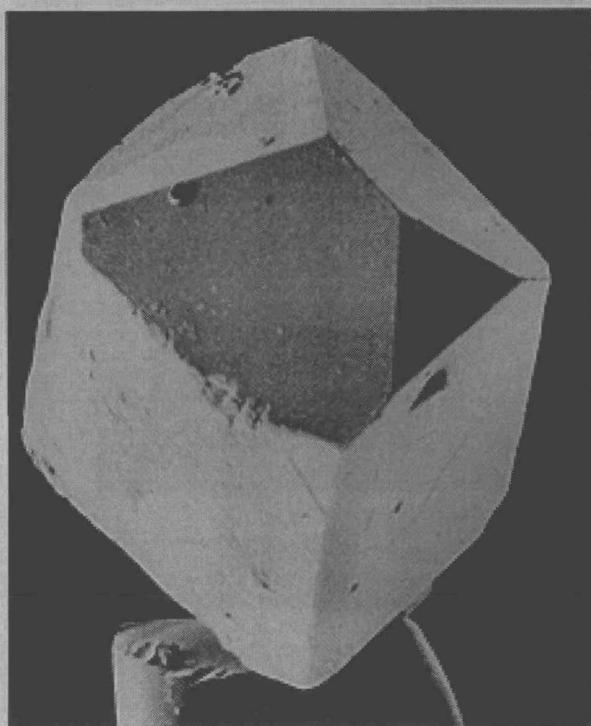
Fig. 60. Ir/P single crystal. SEM micrograph; 350X.
