**WELD REPAIR OF HELIUM DEGRADED  
REACTOR VESSEL MATERIAL (U)**

A paper proposed for presentation at the  
*Fifth International Symposium on Environmental Degradation  
of Materials in Nuclear Power Systems - Water Reactors*  
Monterey, California  
August 25-29, 1991

Welding methods for modification or repair of irradiated nuclear reactor vessels are being evaluated at the Savannah River Site. A low-penetration weld overlay technique has been developed to minimize the adverse effects of irradiation induced helium on the weldability of metals and alloys. This technique was successfully applied to Type 304 stainless steel test plates that contained 3 to 220 appm helium from tritium decay. Conventional welding practices caused significant cracking and degradation in the test plates.

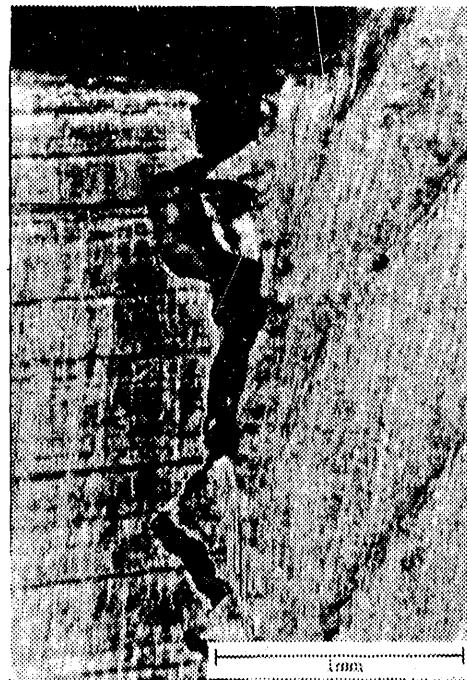
B. Surface photograph of run-on toe crack

Figure 2. Toe cracks at run-on end of stringer beads

Surface examination of the welded plates revealed no toe cracks or porosity associated with the overlay welds. However, welds made by the conventional GTA process had both toe cracks and extensive surface porosity. Toe cracks for the highest heat input stringer beads were typical of those seen during repair of the reactor tank. Numerous toe cracks were present at the run-on end of the GTA stringer beads. The crack location relative to the plate and the welding direction is shown schematically in Figure 2a. The surface appearance of a toe crack at a run-on location is shown in Figure 2b.

The presence of toe cracks preferentially at run-on locations is consistent with the hypotheses that stress and temperature are key factors in helium embrittlement cracking during welding. Initiating the weld bead in the starting
