HYDROGEN ASSISTED FRACTURE OF SENSITIZED TYPE 304L
AUSTENITIC STAINLESS STEEL

G. R. Caskey, Jr.

Savannah River Laboratory
E. I. du Pont de Nemours and Company
Aiken, South Carolina 29801

To be presented at the 109th Annual AIME Meeting
Las Vegas, Nevada
February 24-28, 1980

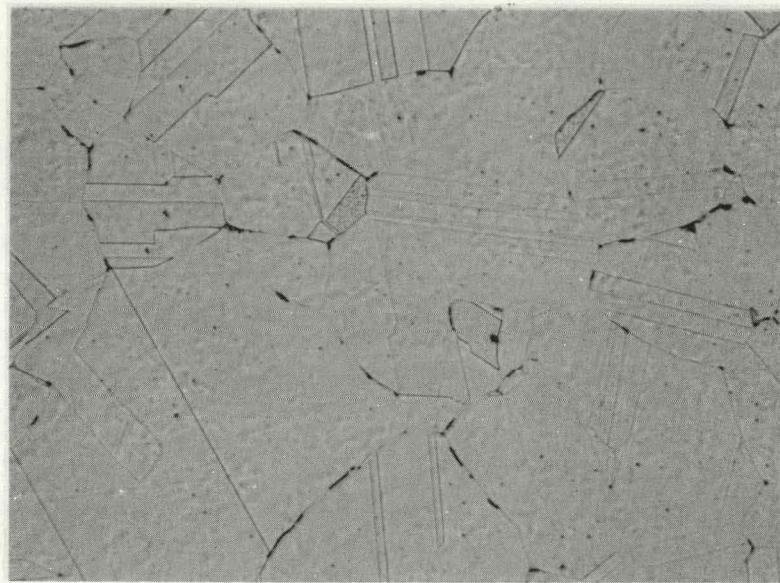
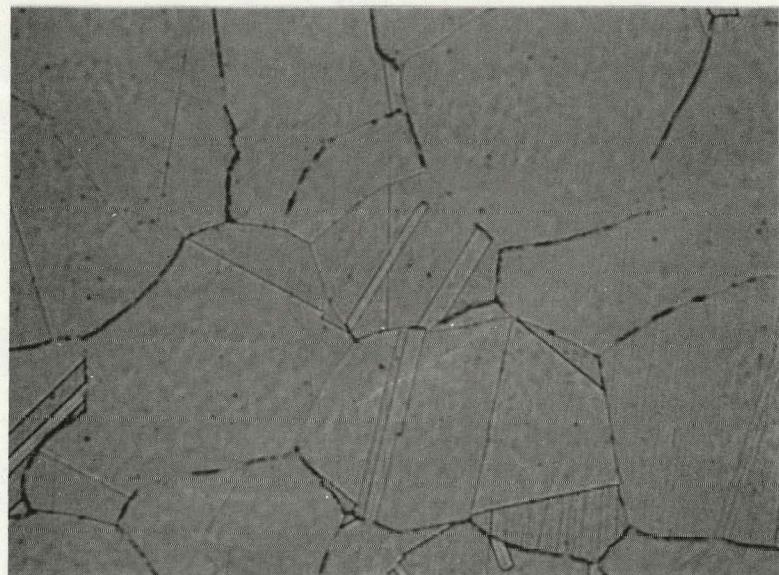
Isolated Carbides

Continuous Carbides

FIGURE 1. Intergranular Carbide Precipitation in
Sensitized Type 304L Stainless Steel

and 3 were attained by machining V-notches to depths of 0.015 cm or 0.06 cm, respectively. In all cases the notch root radius was 0.013-cm and the flank angle was 30°. Both solution annealed and sensitized specimens were tested. The specimens were sensitized by annealing at 920 K for 24 hours. Microstructures of the sensitized alloy exhibited carbide precipitation in the grain boundaries. The extent of grain boundary carbide precipitation varied from a few isolated carbides to more nearly continuous networks (Figure 1). Other samples of this alloy sensitized by the same annealing schedule did not show grain boundary attack in the Strauss test (a copper - copper sulfate - sulfuric acid test for susceptibility to intergranular attack). Tensile tests were made in air at ambient temperature and pressure, and in helium or hydrogen at high pressure (69 MPa). Results are shown in Tables II and III.

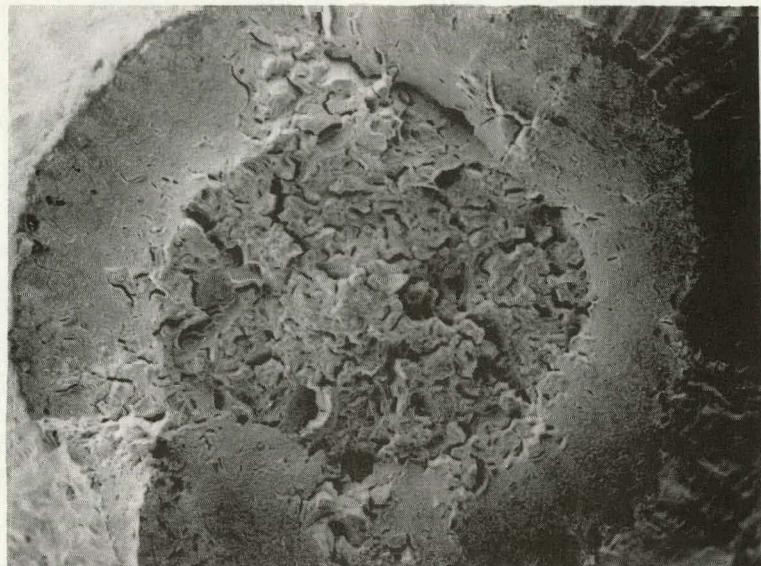
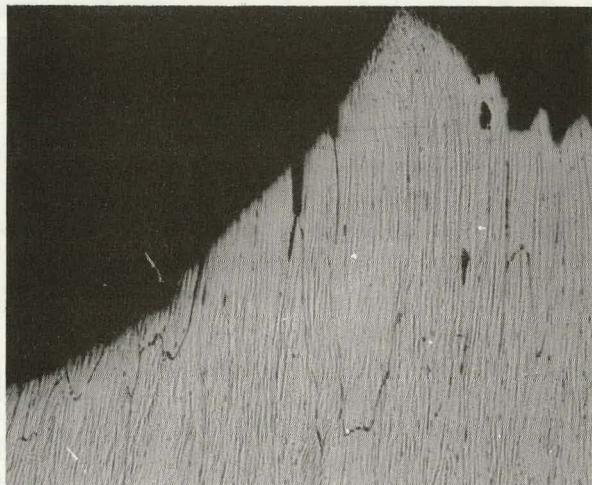
Cup-Cone Fracture with Secondary Cracks

Longitudinal Section Showing
Cracks Along Grain Boundaries

**FIGURE 2. Tensile Fracture of Sensitized
Type 304L Stainless Steel**

Intergranular fracture was a characteristic feature introduced by sensitization of Type 304L stainless steel. This appeared in smooth bar tensile specimens tested in air as secondary cracking or longitudinal splitting along grain boundaries (Figure 2). The principal fracture mode was void coalescence, producing equiaxed dimples on surfaces normal to the tensile axis and elongated dimples on the longitudinal faces (Figure 3). Overall tensile failure of solution annealed and sensitized specimens was a cup-cone fracture.

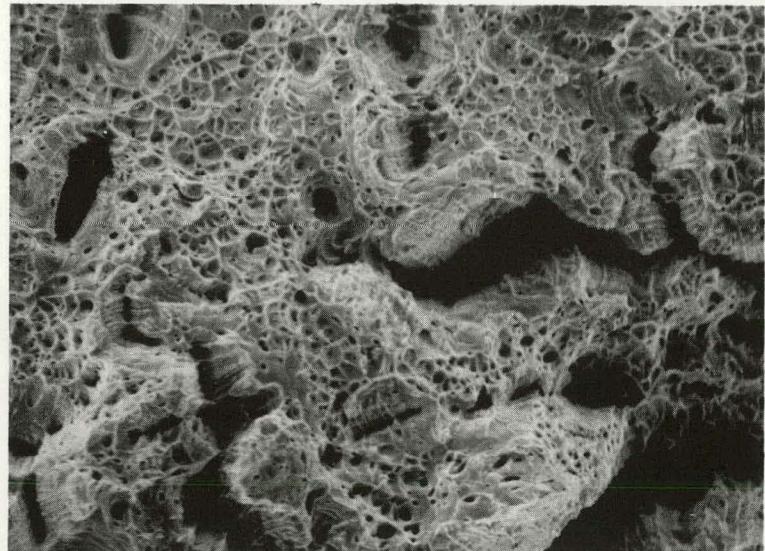
**FIGURE 3. Void Coalescence in Fracture of
Sensitized Type 304L Stainless
Steel**

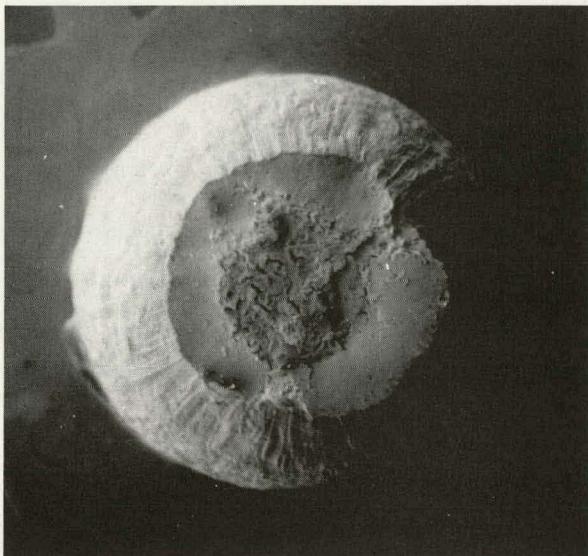
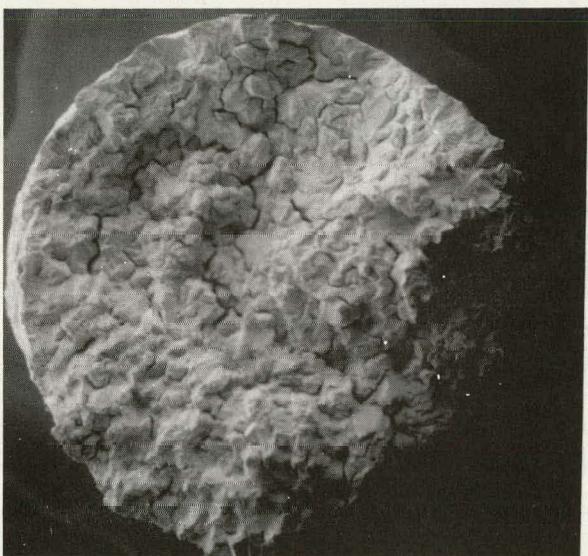
Helium

Hydrogen

**FIGURE 4. Fracture of Sensitized Type 304L
Stainless Steel in 69 MPa Gas**

Sensitized specimens of Type 304L stainless steel tested in a 69 MPa helium environment fractured in the same manner as if tested in air. However, extensive intergranular fractures ensued if the specimens were tested in 69 MPa hydrogen (Figure 4). Void coalescence was absent in the specimen tested in hydrogen, but not all fracture regions were clearly intergranular. Rough faces that could arise from fracture along a crystallographic or interphase path were visible as well as clearly defined grain faces (Figure 5).

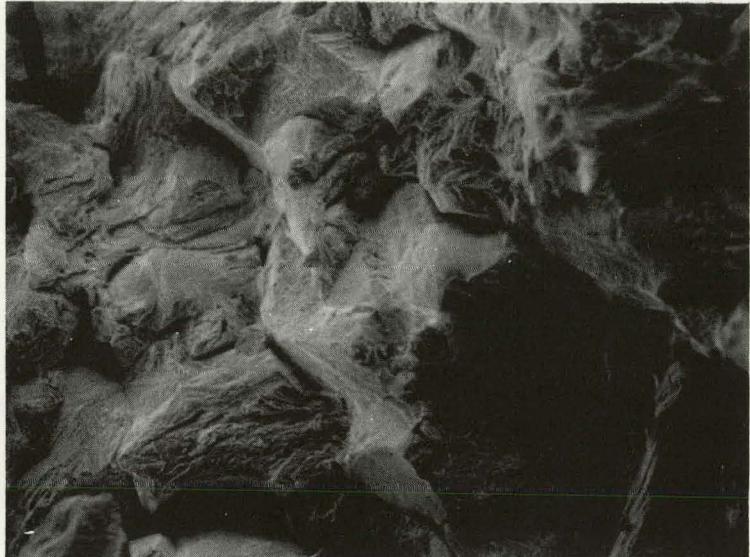
FIGURE 5. Intergranular Fracture in Sensitized Type 304L Stainless Steel Tested in 69 MPa Hydrogen

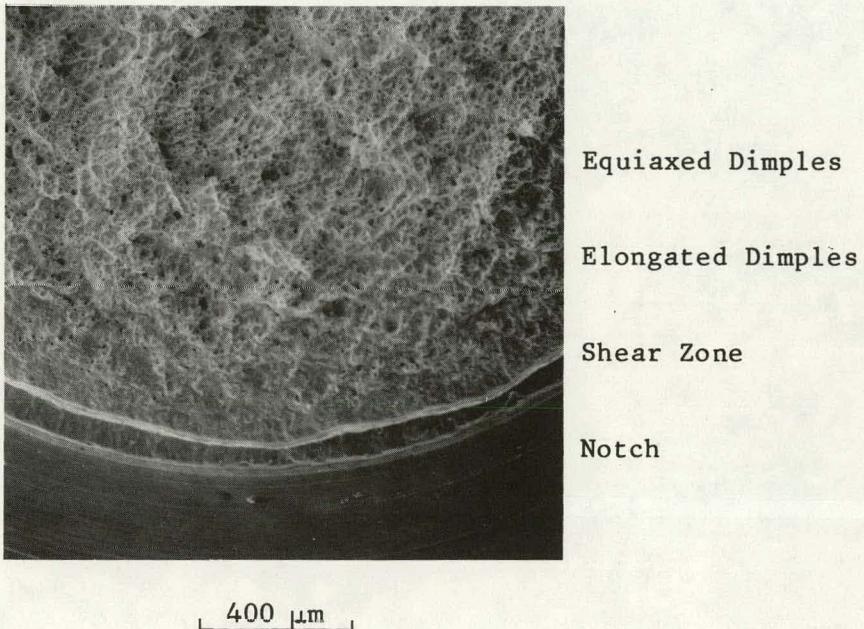
FIGURE 6. Fracture Zones in Notch Tensile Specimen of Type 304L Stainless Steel

Fracture of notched specimens in air at one atmosphere pressure, or in helium at high pressure, was generally flat because of the constraint of the notch. However, the fracture mode was ductile with varying amounts of intergranular fracture in the sensitized alloy. The central region of equiaxed dimples was surrounded by a zone of elongated dimples and an outer zone of extensive shear next to the root of the original notch (Figure 6). Secondary cracks along grain boundaries appeared as voids on the boundary in their early stages of formation (Figure 7).

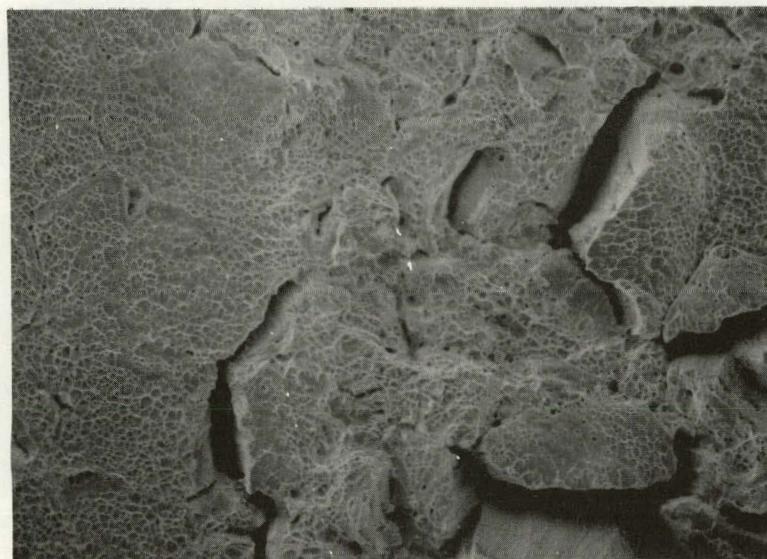
FIGURE 7. Intergranular Fracture - Sensitized and Notched Specimen Tested in High-Pressure Helium

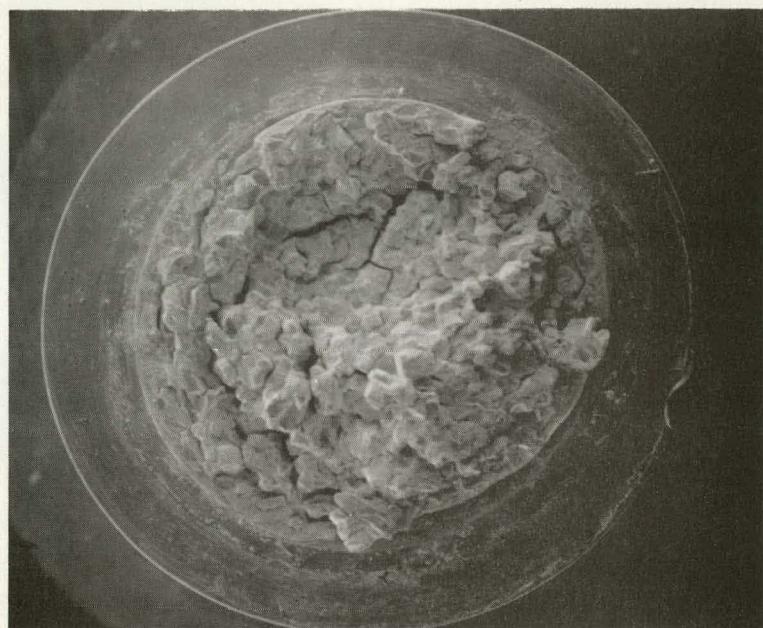
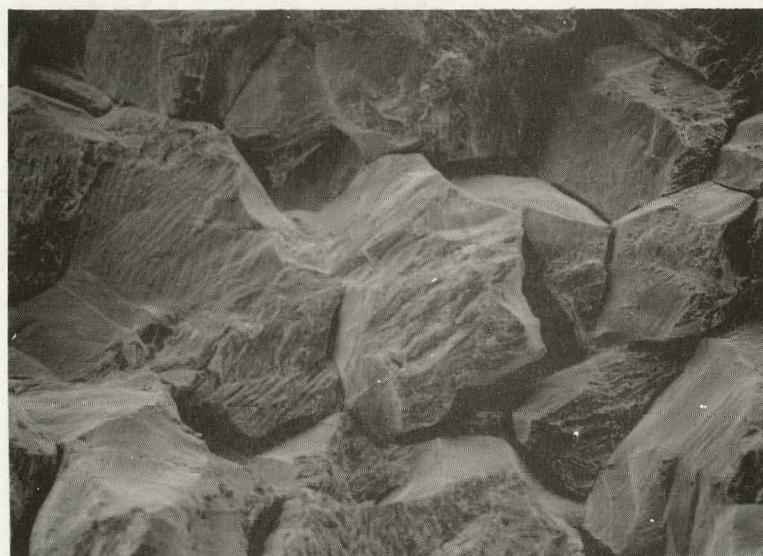
FIGURE 8. Fracture of Notch Tensile Specimen of Sensitized Type 304L Stainless Steel in High-Pressure Hydrogen

Fracture of sensitized alloy in a high-pressure hydrogen environment was characterized by a flat intergranular fracture over the entire cross section, secondary cracks along grain boundaries, absence of the outer shear zone, and a reduced amount of microvoid coalescence (Figure 8). Variations in extent of intergranular fracture and microvoid coalescence between specimens that were nominally alike may be attributed to differences in volume fraction carbide phase along the grain boundaries. Grain faces were smooth in some cases and rough in others (Figure 7). The rougher faces suggest fracture along intersecting boundaries spaced on a very fine scale or along twin boundaries in some instances (Figure 8). The smoother boundaries exhibited fine shallow voids, ridges, and plateaus (Figure 9). There were no significant compositional differences evident among grain faces as judged from the intensities of characteristic x-rays measured with the energy-dispersive x-ray spectrometer on the scanning electron microscope.

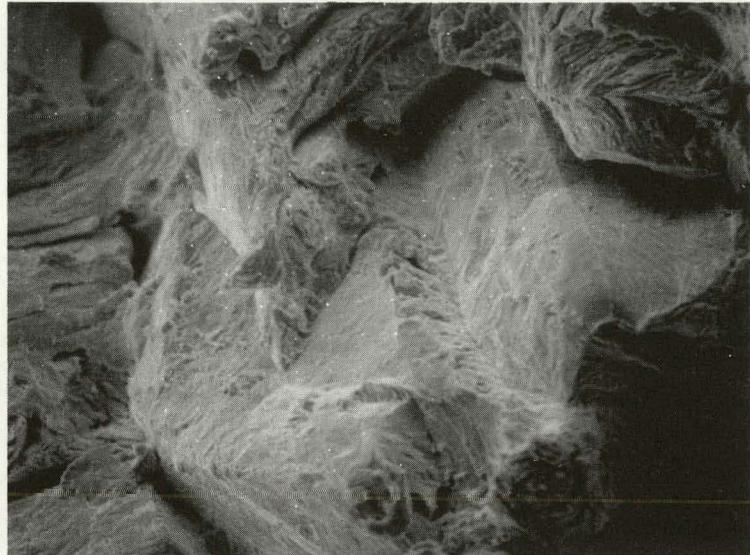
FIGURE 9. Rough Fracture Face Sensitized Specimen Tested in High-Pressure Hydrogen

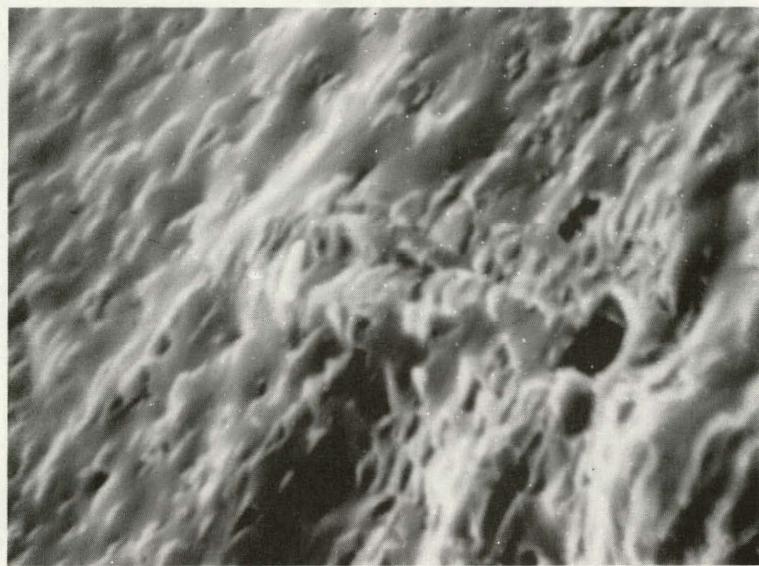
FIGURE 10. Smooth Grain Faces on Sensitized Specimen Tested in High-Pressure Hydrogen
