**Development of an Acoustic
Sensor for a Geothermal Borehole Televiwer**

**U. S. Department of Energy
Division of Geothermal Energy**

March 1979

**Westinghouse Electric Corporation
Research and Development Laboratories
Pittsburgh, PA 15235**

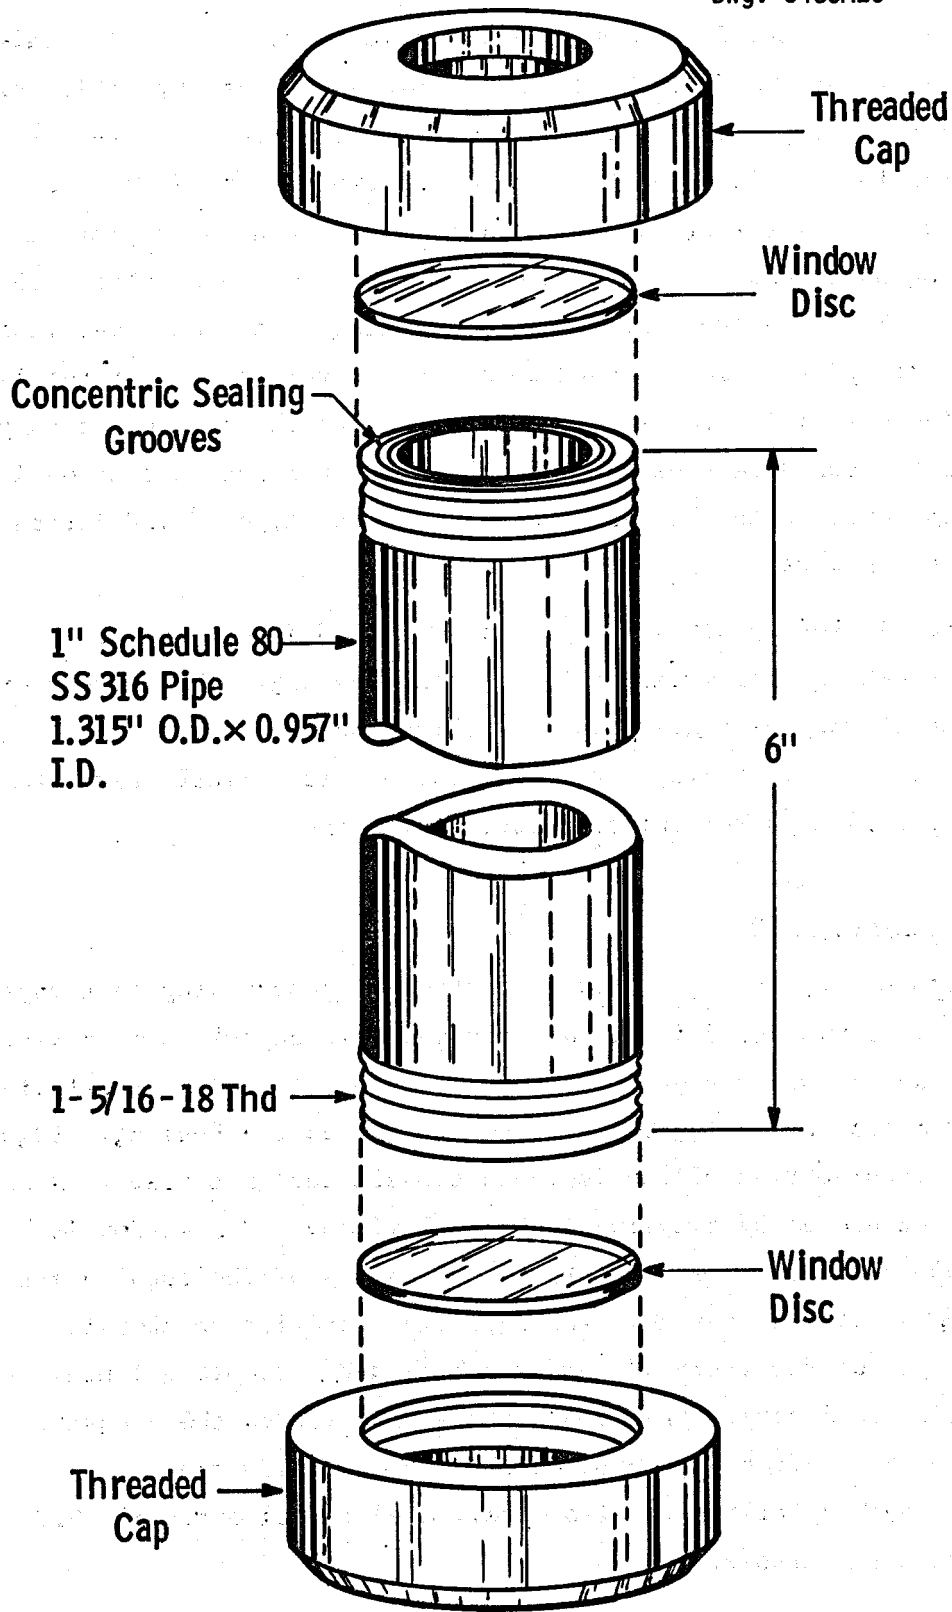
Dwg. 6430A26

Figure 5.1. Assembly drawing of capsule for early screening tests.

Recognizing the limitations of the simple screening test capsule of Figure 5.1, it was decided that an improved test capsule was needed. An improved capsule was designed, incorporating a cylindrical shell window and improved means of sealing between the window and the housing. Figure 5.3 shows a cross-section of the improved capsule design concept. A SS 316 spool is enveloped by a cylindrical shell window. The window is sealed around the circumference of both end flanges of the spool using a SS hose clamp or similar device. The resulting interior chamber is charged with prototypical transducer assemblies and a coupling fluid. A bellows is used to minimize pressure differential across the acoustic window and to permit free expansion of the fluid at elevated temperature. Such a bellows is also widely used in conventional BHTV tools for the same purpose.

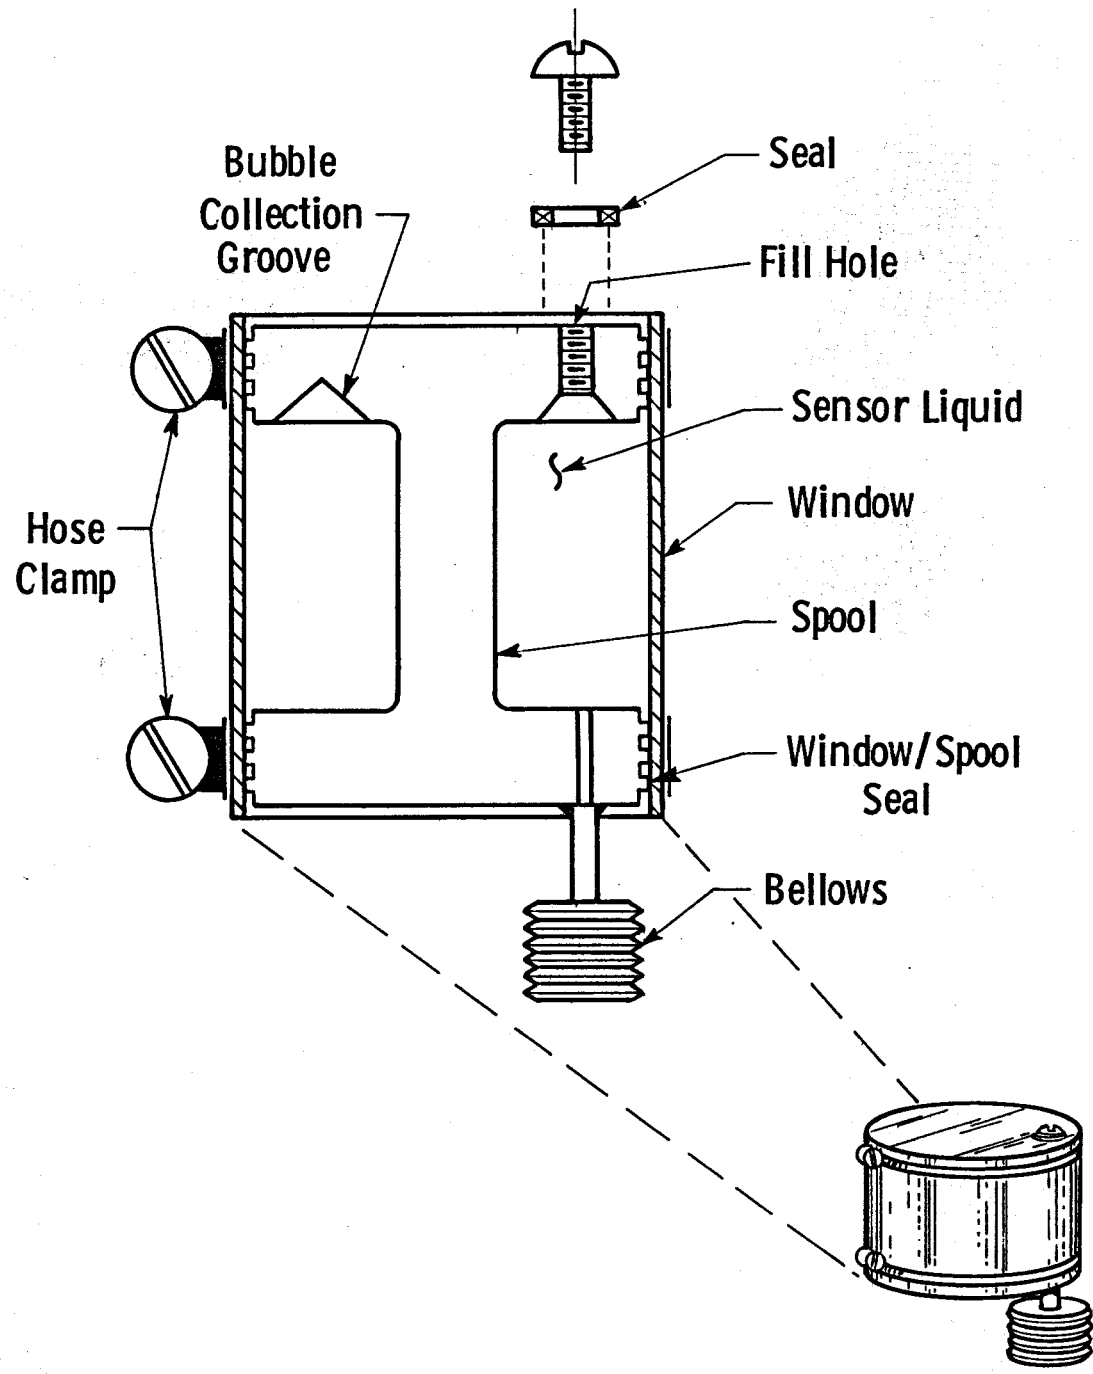
Figure 5.3 Diagram of improved capsule for advanced screening tests.

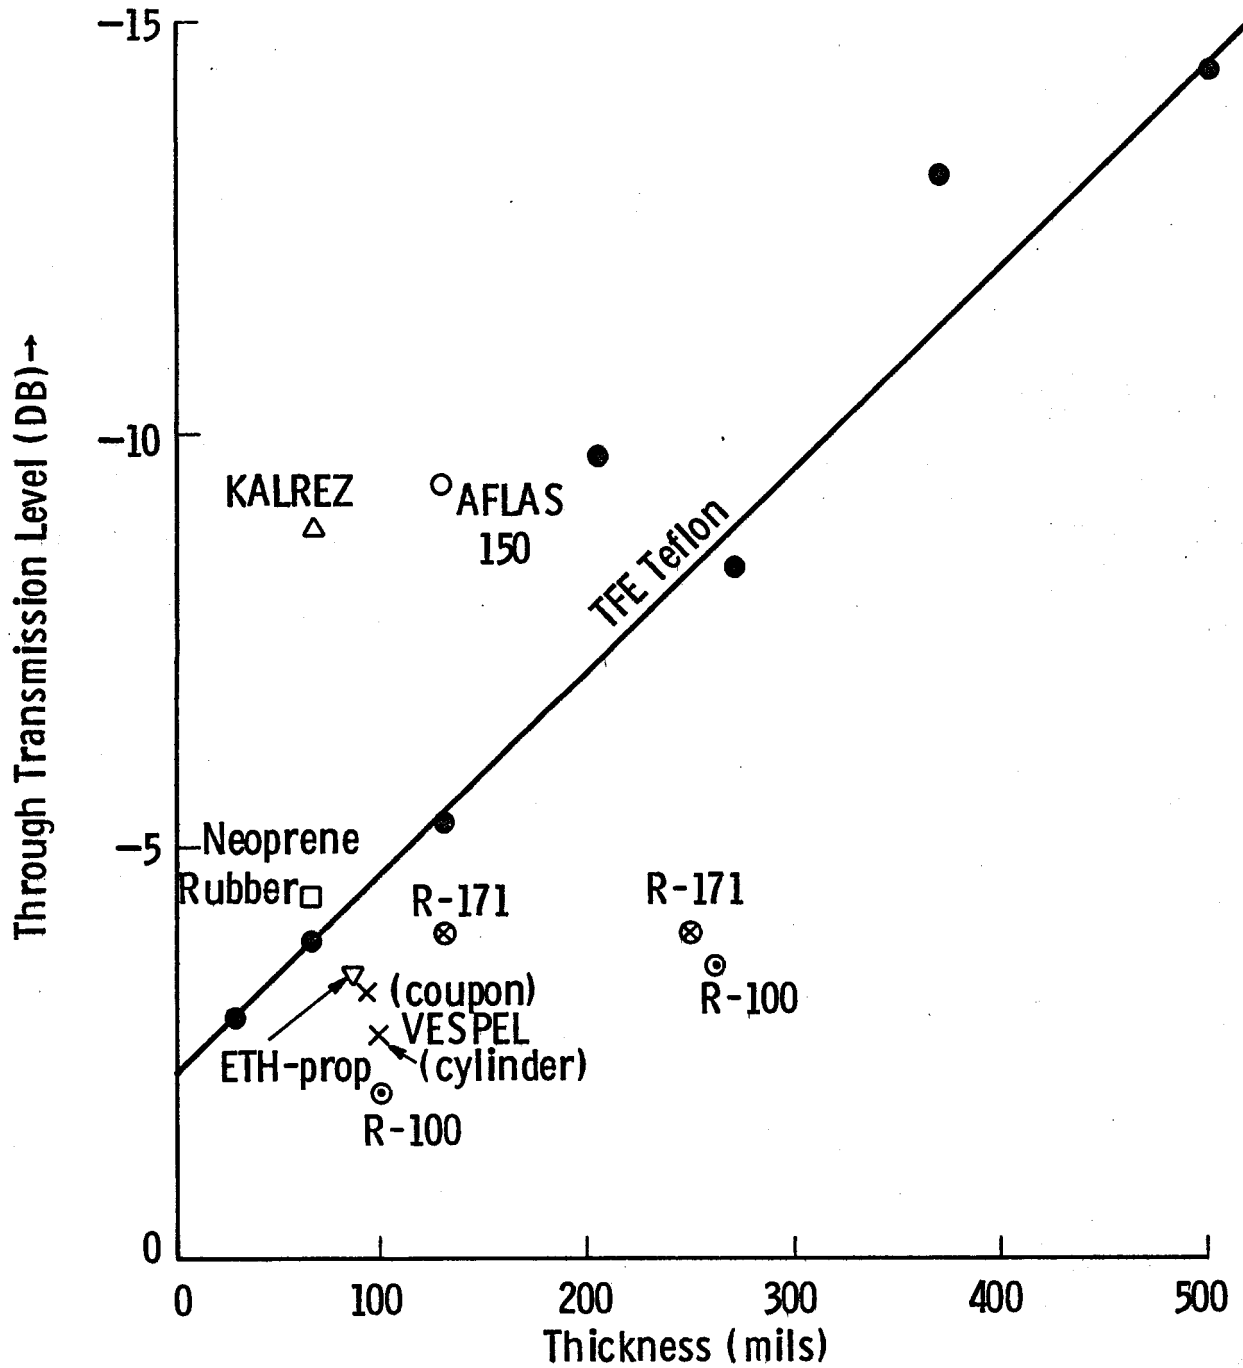
Figure 5.11 Data showing signal drop through certain window materials of various thicknesses. Solid line depicts drop through TFE Teflon. Measured with specimens immersed in transformer oil. Data generally indicates Ryton is low-loss, high temperature material.

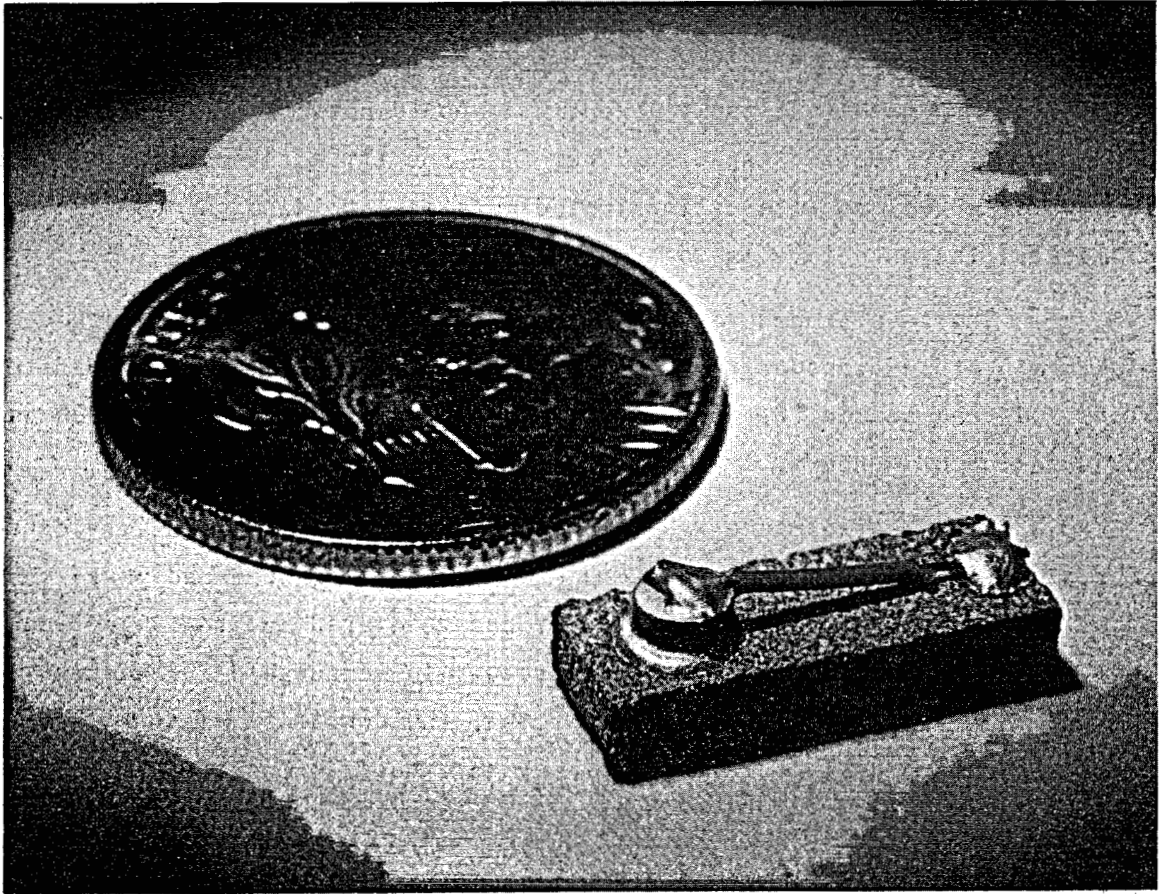
Figure 6.4 Photo of fabricated miniature transducer assembly.

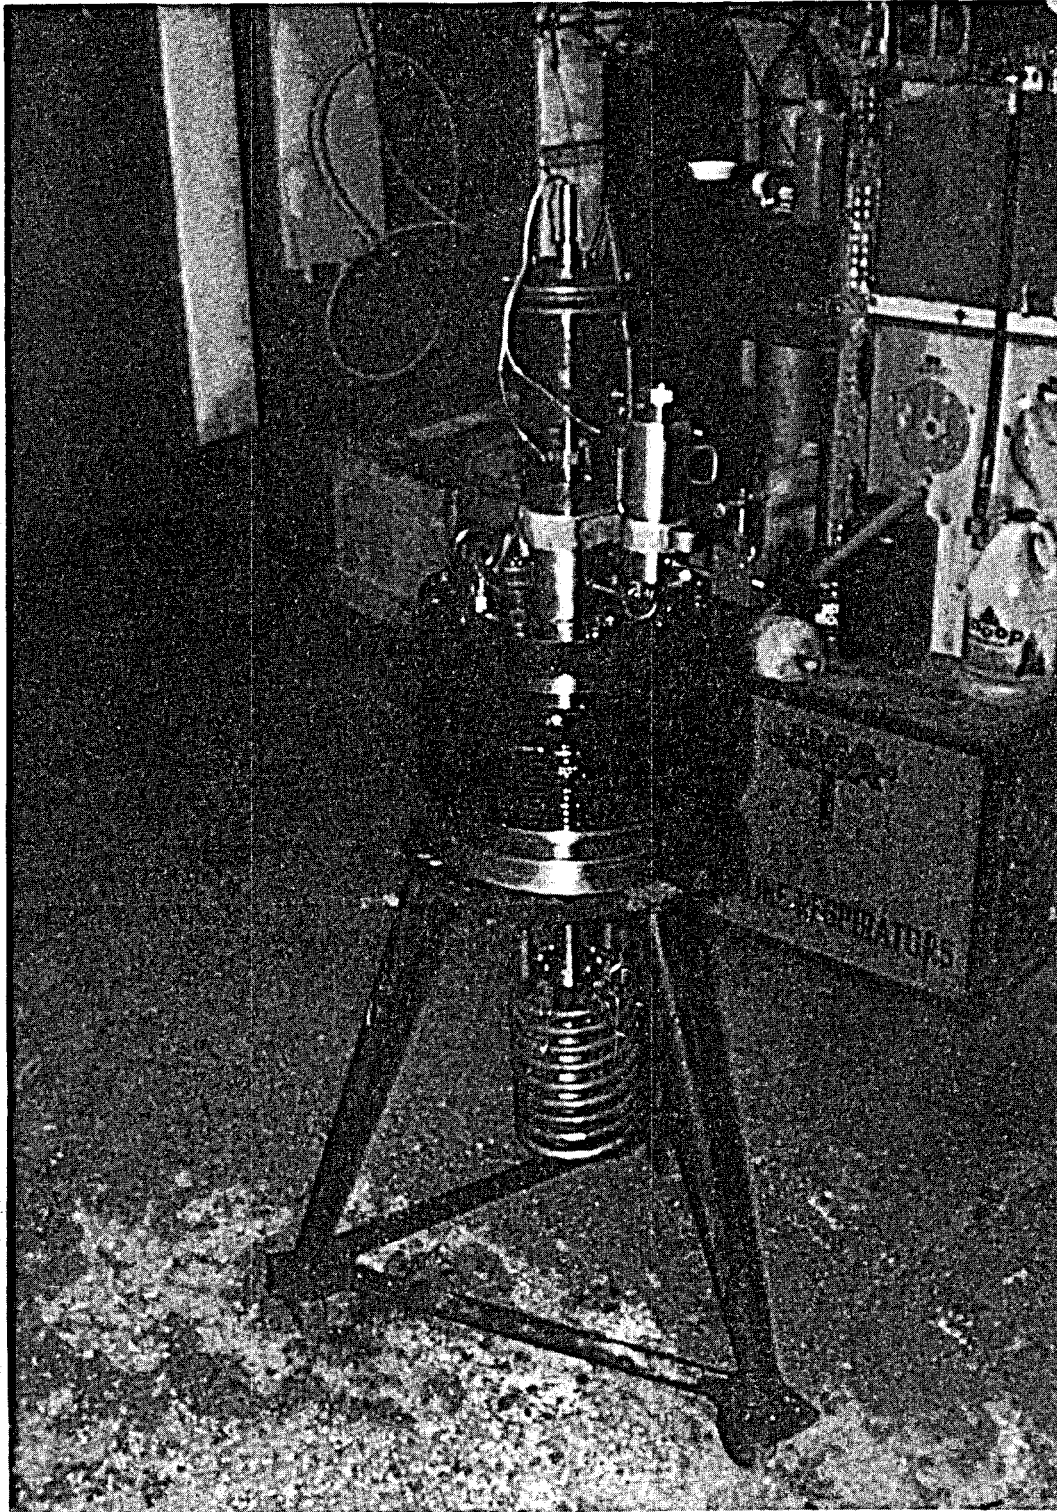
Figure 10.3. Experimental sensor and three targets shown installed (inside cooling coil) in the autoclave head assembly prior to testing. Electrical leads can be seen coming out of the top of the hollow support shaft.

Figure 10.3 shows the test sensor installed in the autoclave head just prior to installing the head on the autoclave vessel. The electrical leads can be seen coming out of the top of the hollow support shaft. The acoustic targets are wired in place on the inside of the spiral cooling coil.
